## Failure Analysis: Evaluating a Low Strength Solder Joint

Rebecca Wheeling, Don Susan, Chris Finrock, Celedonio Jaramillo, Christina Profazi  
Sandia National Laboratories, Albuquerque, New Mexico, USA

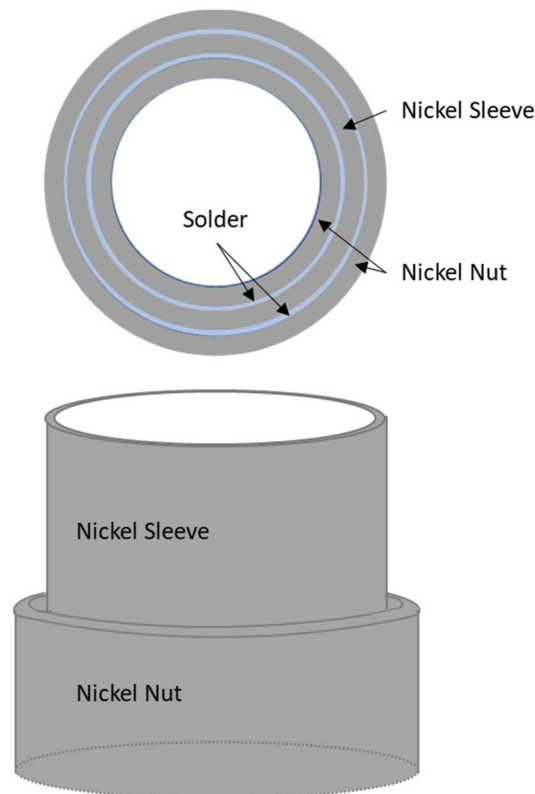
Figure 1. Schematic of the cylindrical double-lap joint. Note: this schematic is not to scale.

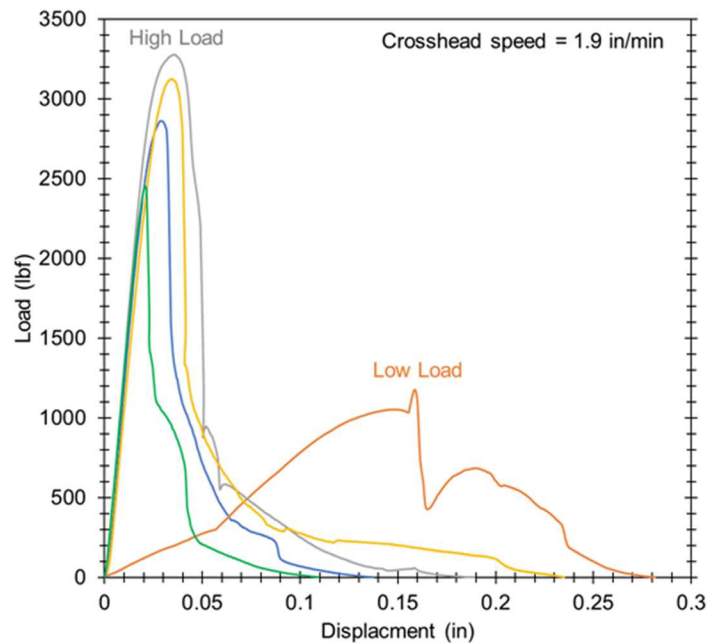
Figure 2. Surveillance pull-test load-displacement data.

While average strength values of the units decreased, a few units fell below the required strength value, and one unit exhibited very low strength compared to the others. A failure analysis was performed to explain this strength reduction.

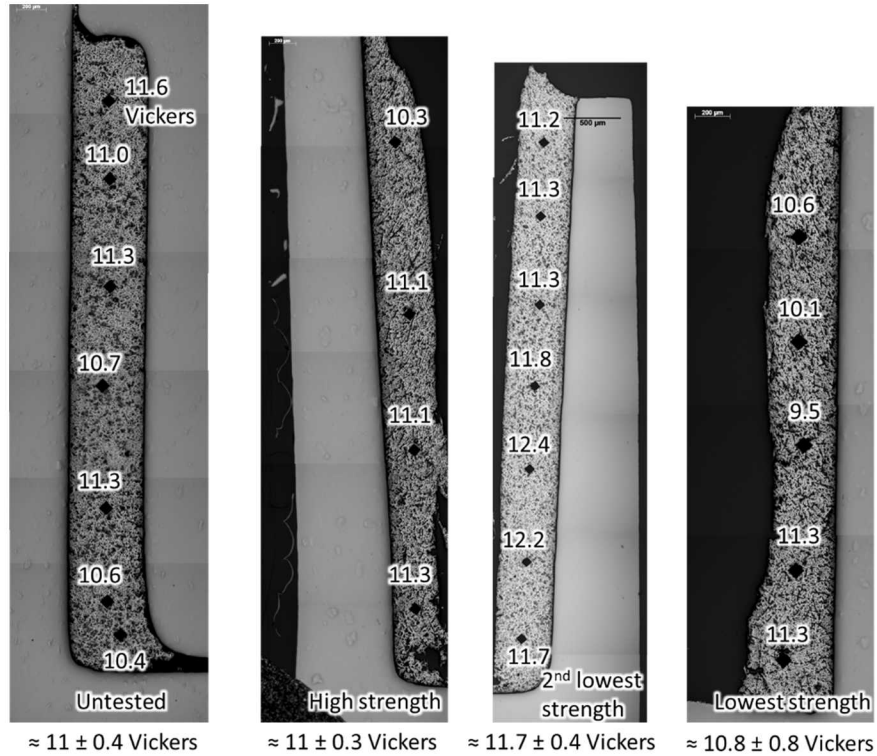
Hardness testing, SEM imaging, and wavelength dispersive spectroscopy (WDS) reveal similar microstructures between untested, high, and low strength joints. These similarities indicate that the joints were all aged in similar conditions and confirm the solder composition to be the same. Hardness values hovered around a nominal 11 Vickers as shown in Figure 3.

Figure 3. Microhardness indents and corresponding hardness values along the longitudinal axis of the solder joints. Average values are listed at the bottom of each joint.

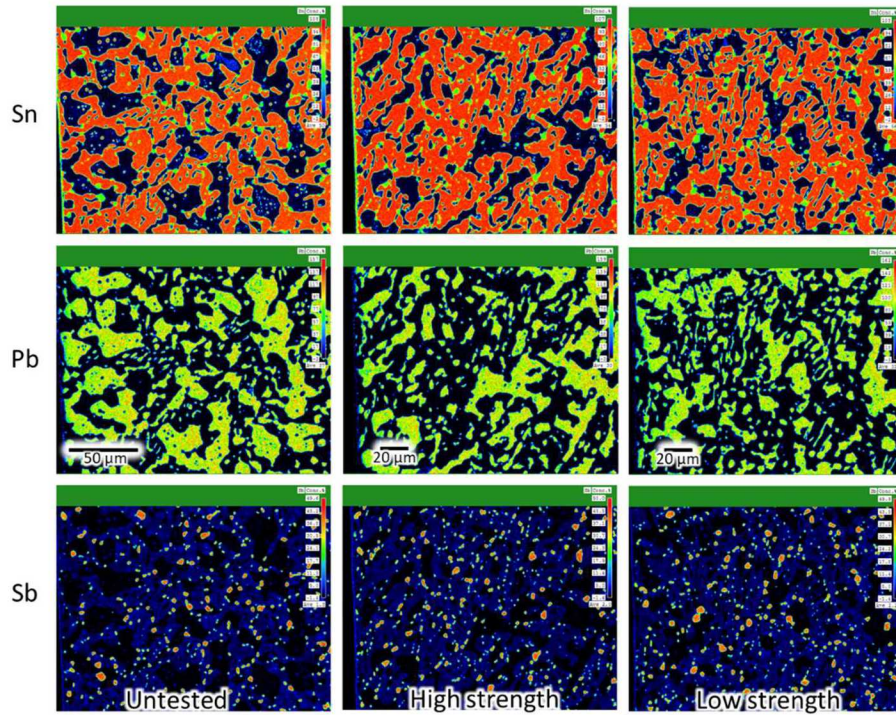
WDS maps in Figure 4 show similar phase morphology and distribution throughout the solder joint between an untested, high, and low strength joint.

Figure 4. WDS maps of the bulk solder microstructure in high, average, and low strength units. Each column represents 3 different elements mapped onto the same image from a given sample. Each row maps a different element, from top to bottom: Sn, Pb, Sb. The colors correspond to signal intensity level, with red being the highest and blue being the lowest. Scale bars can be applied to their respective columns.

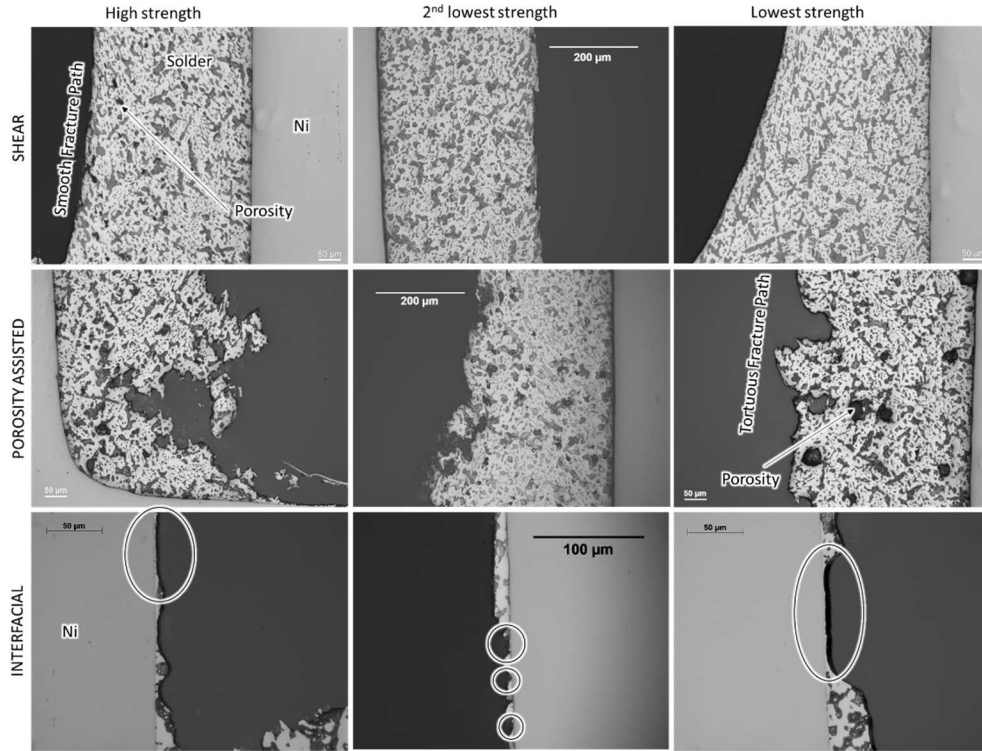
Fractographic and metallographic analyses identified 3 failure modes within the solder joints: 1) shear ductile; 2) porosity-assisted; and 3) interfacial. Higher fractions of porosity-assisted and interfacial failure likely contributed to low strength. Evidence of these failure modes in a high strength and 2 low strength joints is shown in Figure 5.

Figure 5. Optical images highlighting the 3 longitudinal fracture paths exhibited between high and low strength joints.

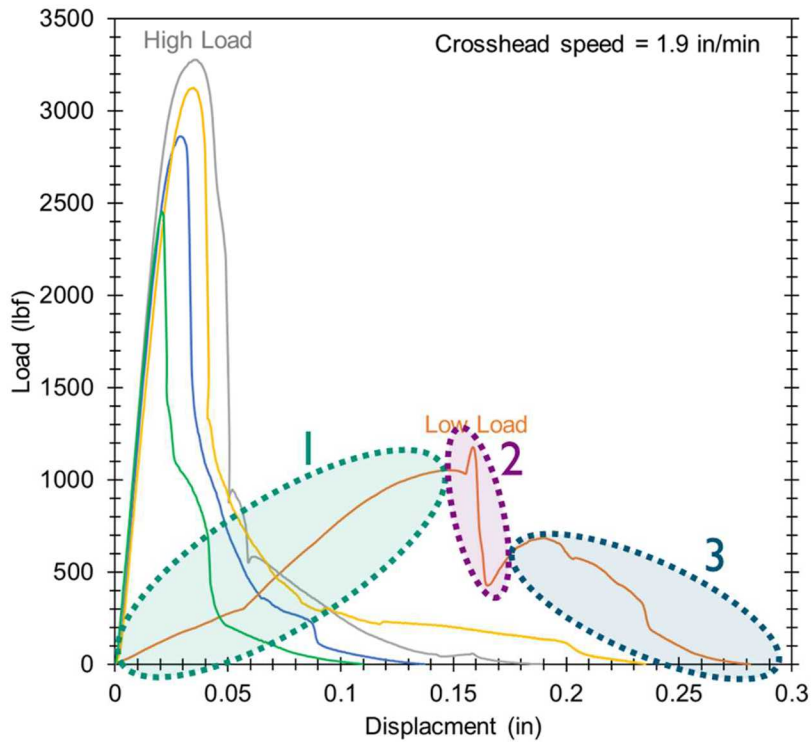
Fractographic and metallographic comparisons between the high and low strength tested units suggest that the prevalent, local porosity-assisted and interfacial failure modes contributed to the low-strength failure. While other units exhibited some interfacial failure and porosity-assisted failure, the conditions were not as extreme as that exhibited in lowest strength unit. Figure 6 illustrates how these failure modes may have manifested during the tensile test.

Figure 6. Load-displacement curves recorded during the surveillance tensile testing. The anomalous, low load curve is separated into 3 regions: 1) porosity-assisted failure; 2) rapid, interfacial failure; and 3) porosity-assisted failure with uneven loading conditions.

It is plausible that localized porosity aligned near a stress path contributed in regions 1 and 3, while rapid, interfacial failure occurred at region 2. Uneven loading likely resulted after the interfacial failure. Possible artifacts from testing are not presented or discussed.

The source of porosity could have been due to an undocumented process variable during the soldering procedure (i.e. inappropriate type/amount of flux). Poor wetting may have also resulted from inappropriate type/amount of flux in addition to joint disturbance prior to solidification, porosity accumulating at the interface, and/or improper cleaning methods, therefore facilitating interfacial failure.
