Characterization of Composite Wind Turbine Blades

Wind Turbine Background

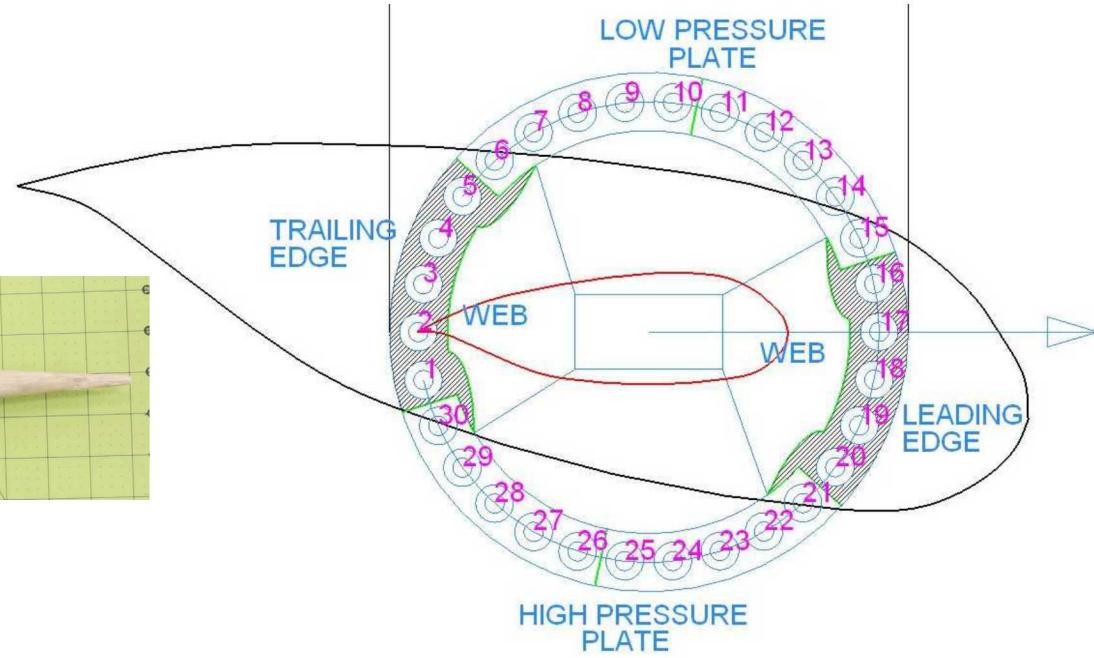
Blade 4 Investigation: adhesive failure?

- The photo clearly shows all but 5 carrots of Blade 4 are exposed after the failure. This raised questions of a possible premature adhesive failure between the SS carrots and the fiberglass root inserts.

- Only the Trailing Edge Web root insert remains attached (seen at top of picture).
- Examination of the remaining 24 SS carrots shows little remaining adhesive.
- Some carrots show signs of surface contamination near the base of the carrot.
- Investigation focused initially on the remains of Blade 4 and the Trailing Edge Web Insert.

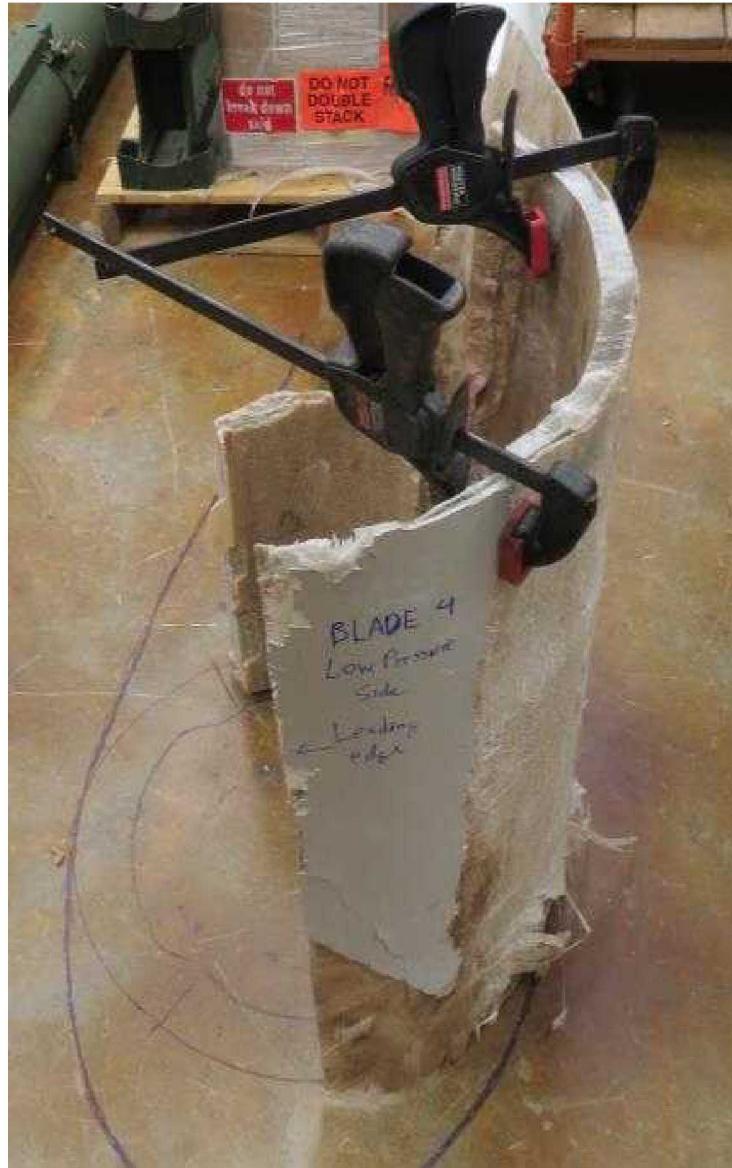
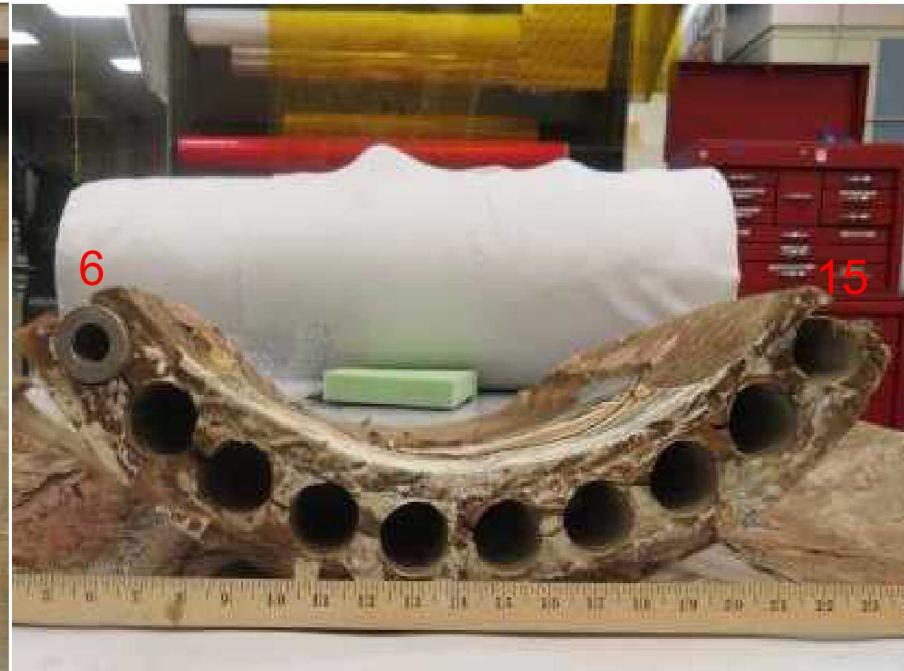
Blade 4 Investigation (continued)

- Low Pressure Plate shows 9 empty carrot sockets (and 1 socket still containing the SS carrot).
- Carrot pockets 10, 12, 13, 14, and 15 still contain the fiberglass carrot inserts, while carrot pockets 7, 8, 9, and 11 are empty, with the fiberglass insert remaining bonded to the stainless steel carrots mounted on the hub.
- Both carrot wedge inserts are cracked about 100 mm down the bond line from the base.

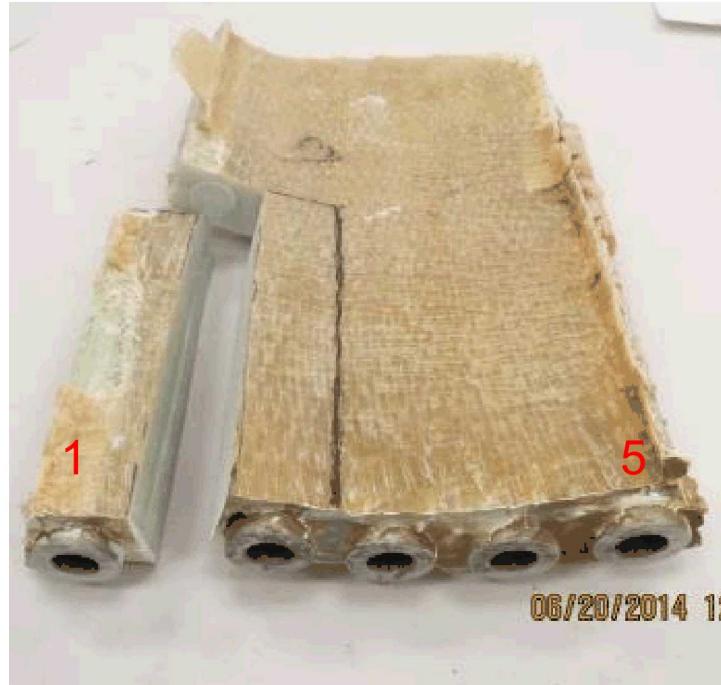
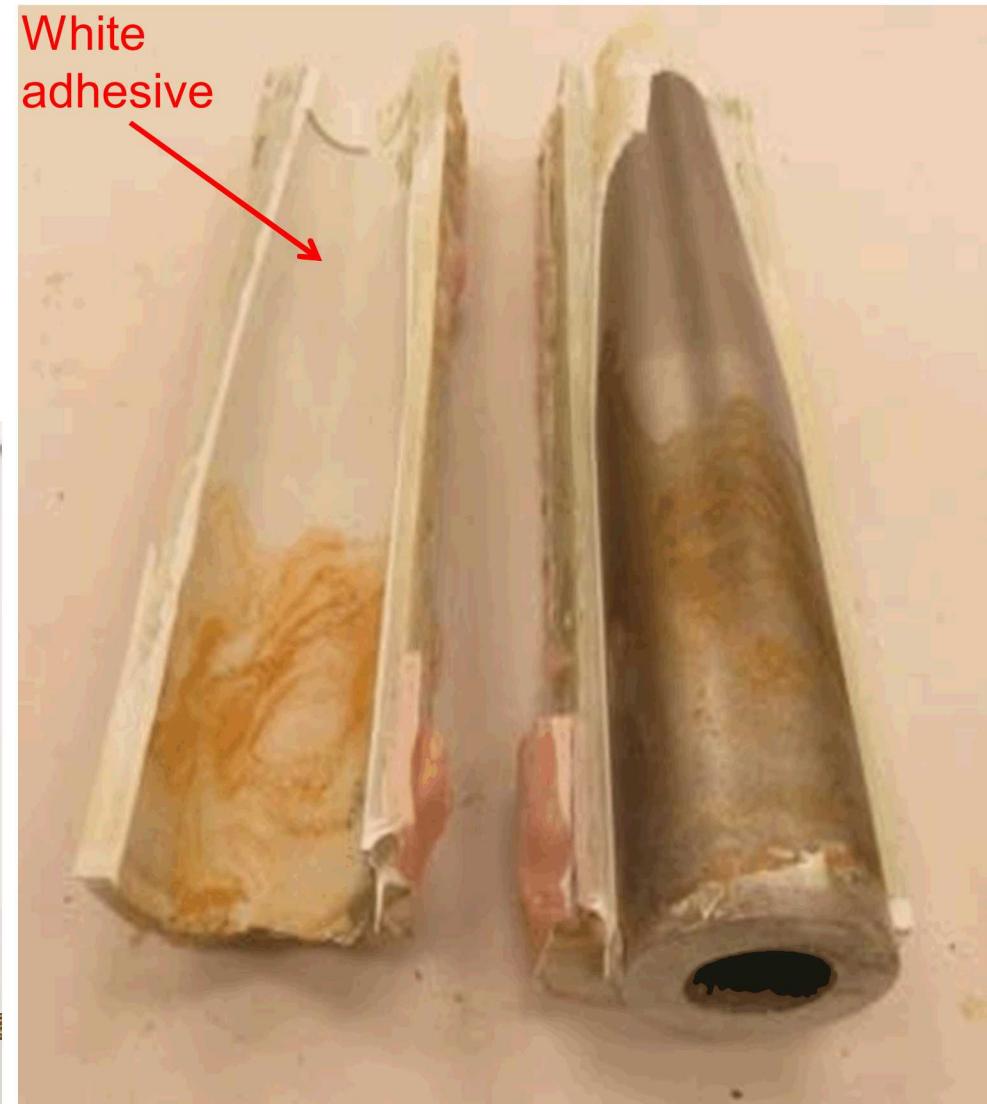
Blade 4 Investigation (continued)

- Trailing Edge Web
 - Root carrot 1 is cut free from root insert.
 - Root carrot 1 is split open to inspect/evaluate adhesive bond, metal surface finish, etc.
 - Brown discoloration was further investigated.

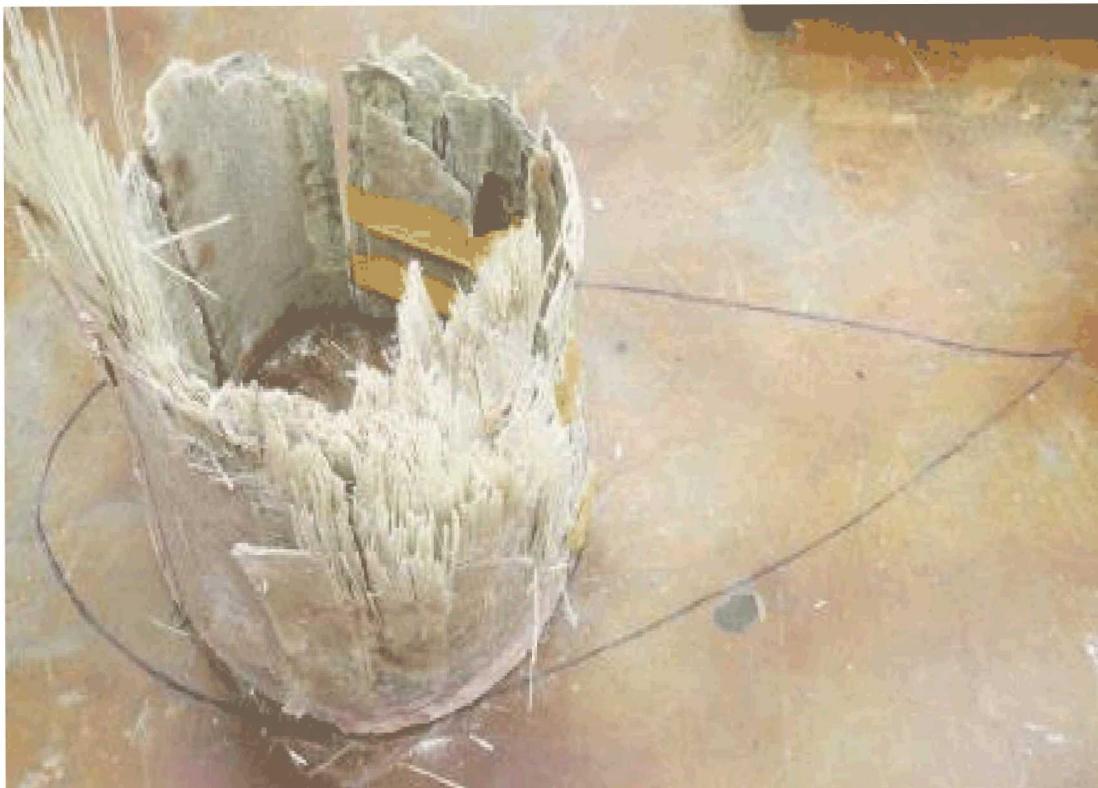
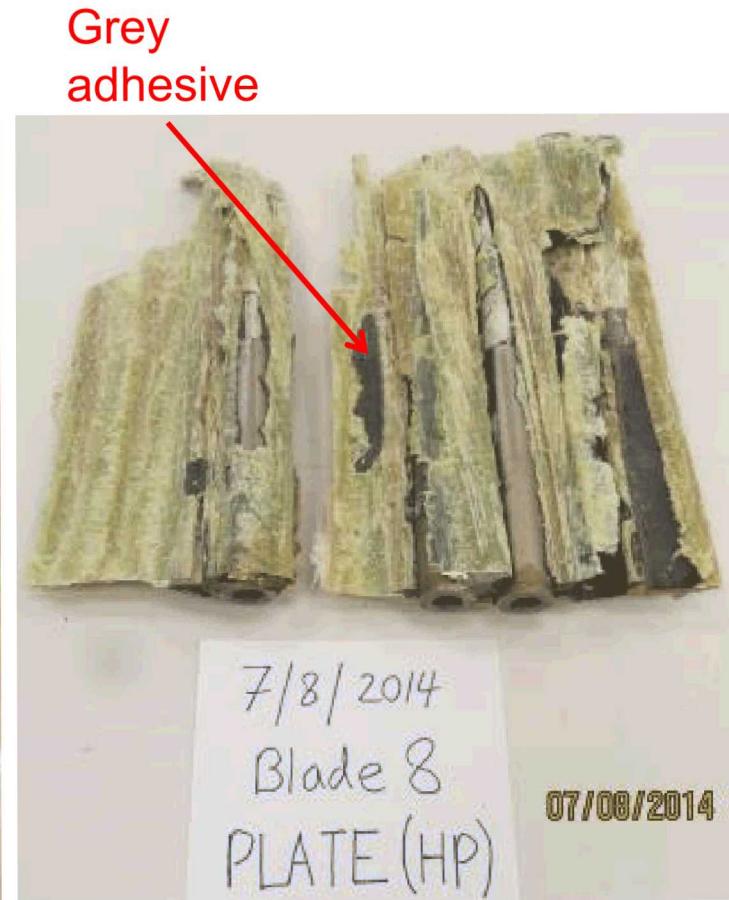
Blade 8 Investigation

- Most of the root of Blade 8 is intact.
- Trailing Edge Web and part of the High Pressure (HP) Plate is damaged.
- We observed that the structural adhesive on Blade 8 looked different (grey in color) compared to that used on Blade 4 (white in color).

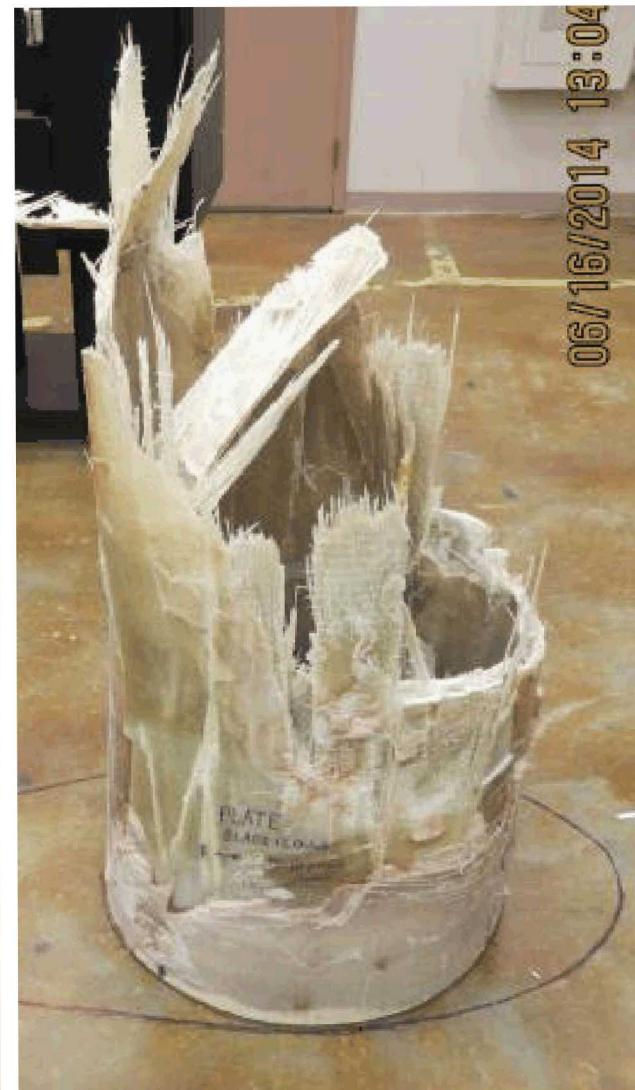
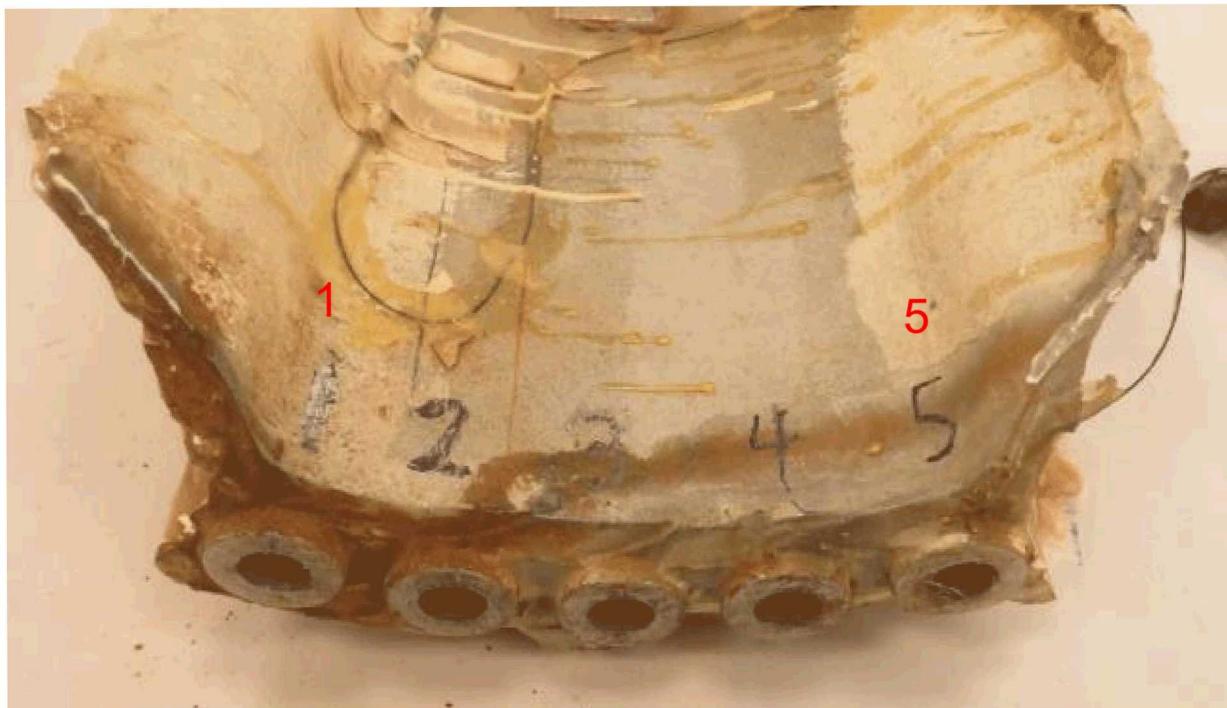
Blade 12 Investigation

- Blade 12 was the most intact of the 3 blades.
- The root section was intact and in one piece.
- In fact, the entire length of HP and LP Plates survived.
- Carrot 1 shows the same characteristic rust colored contamination at the base as the Carrots from Blade 4.
- Blade 12 has white adhesive.
- The main goal of our harvesting work was to collect adhesive samples for analysis.

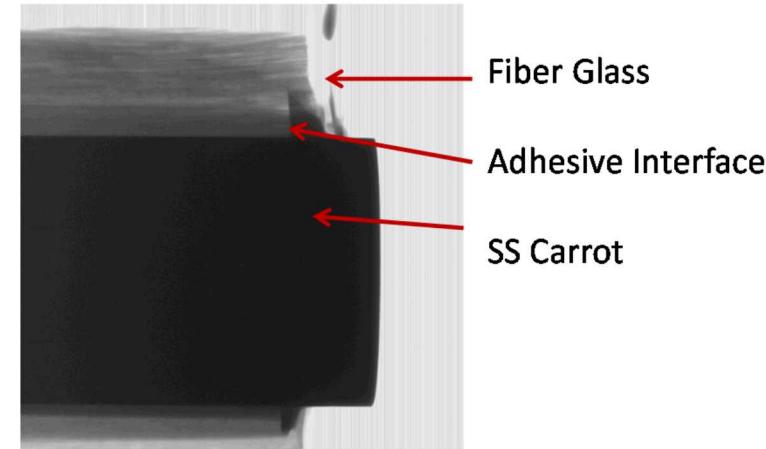
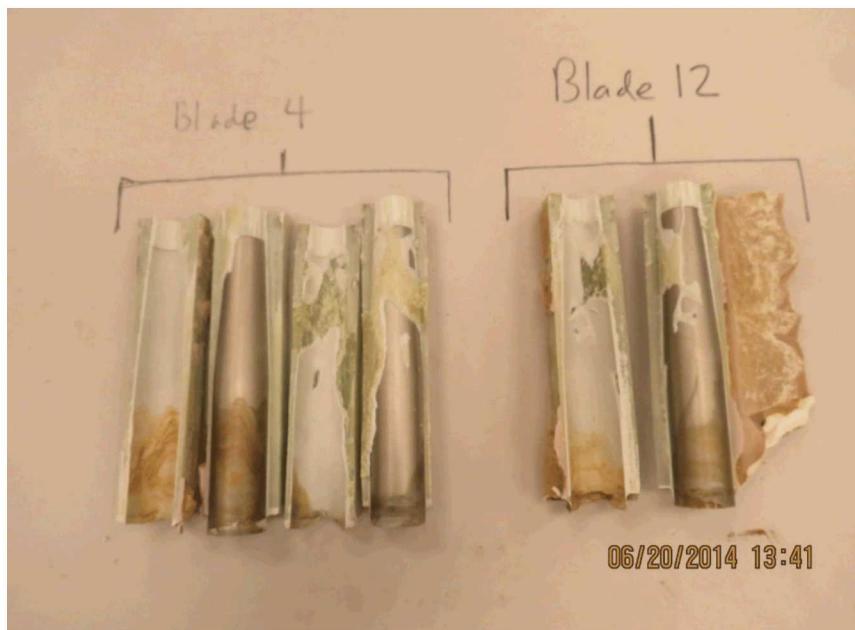
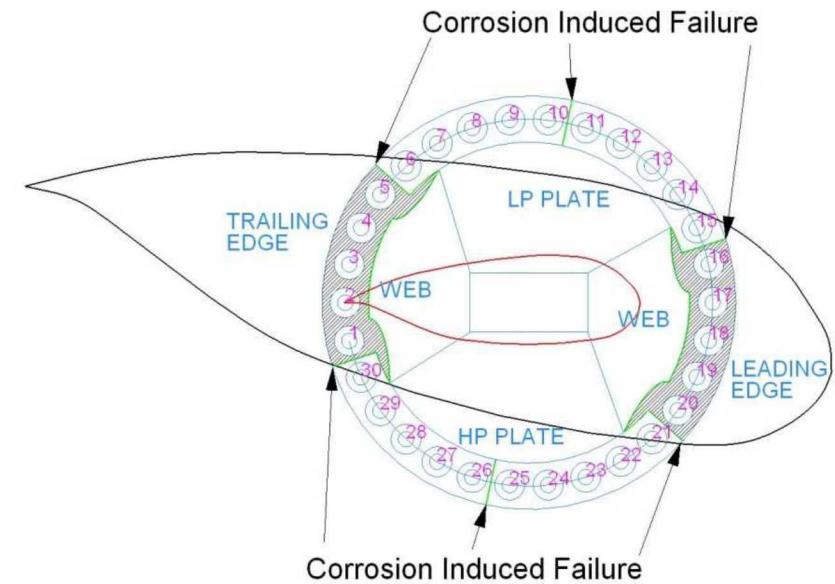
Corrosion /NDI Investigation

- Brown discoloration is indicative of corrosion, per visual inspection by metallurgy/corrosion expert (Rob Sorenson, Sandia).
- Inspection under an optical microscope showed crack formation in the SS and metal flakes embedded into the adhesive after mechanical failure. Sorenson's hypothesis is that the prevailing aging mechanism is grain edge boundary corrosion of the SS.
- Given what we understand about the aging history of these blades (including long term service near an ocean), typical corrosion precursors (moisture, chloride) were certainly available to promote this aging/degradation of the stainless steel carrots.
