Clamp Ring Failure

SAND2019-11065D

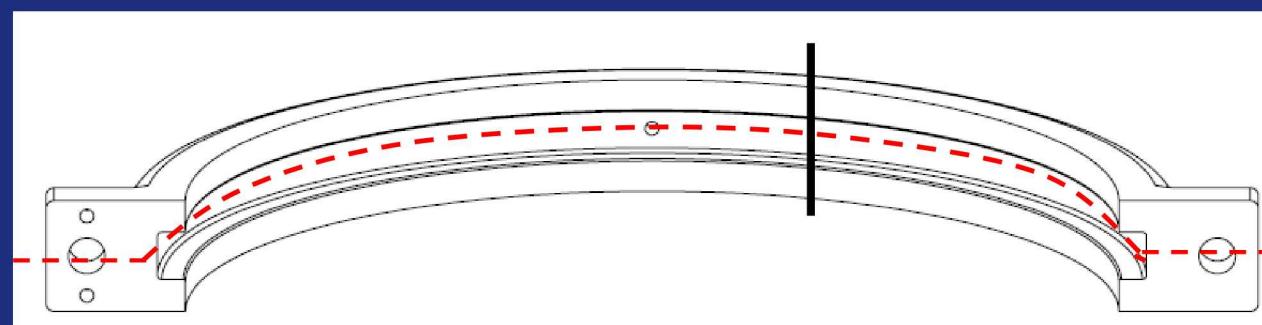
Figure 1. Drawing of containment ring – dotted line is approximate failure location

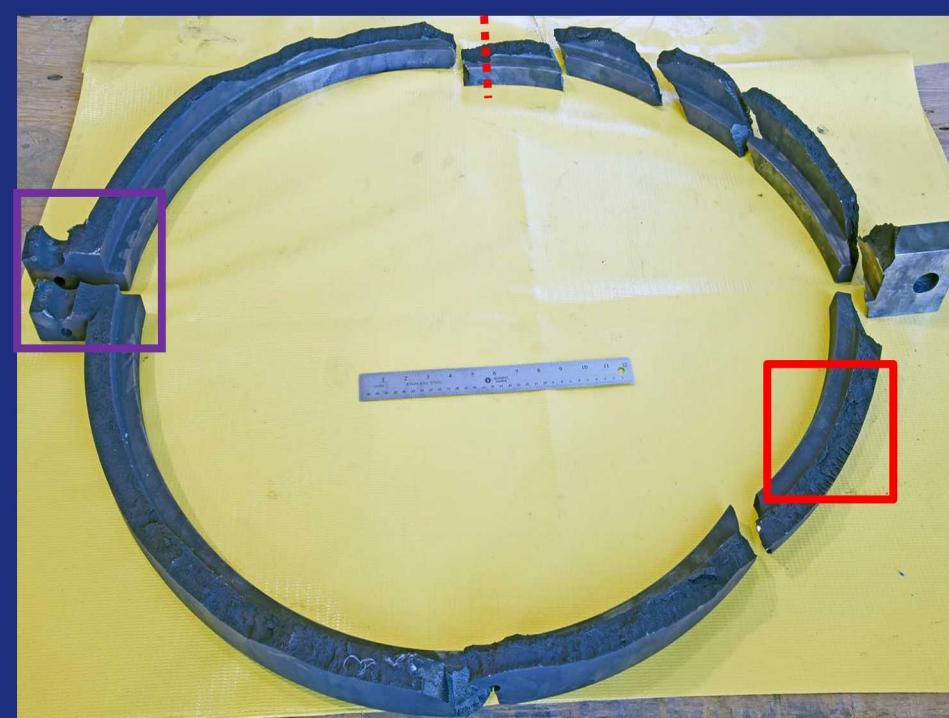
Figure 2. Failed ring, parts are displayed with mirrored mating sections.

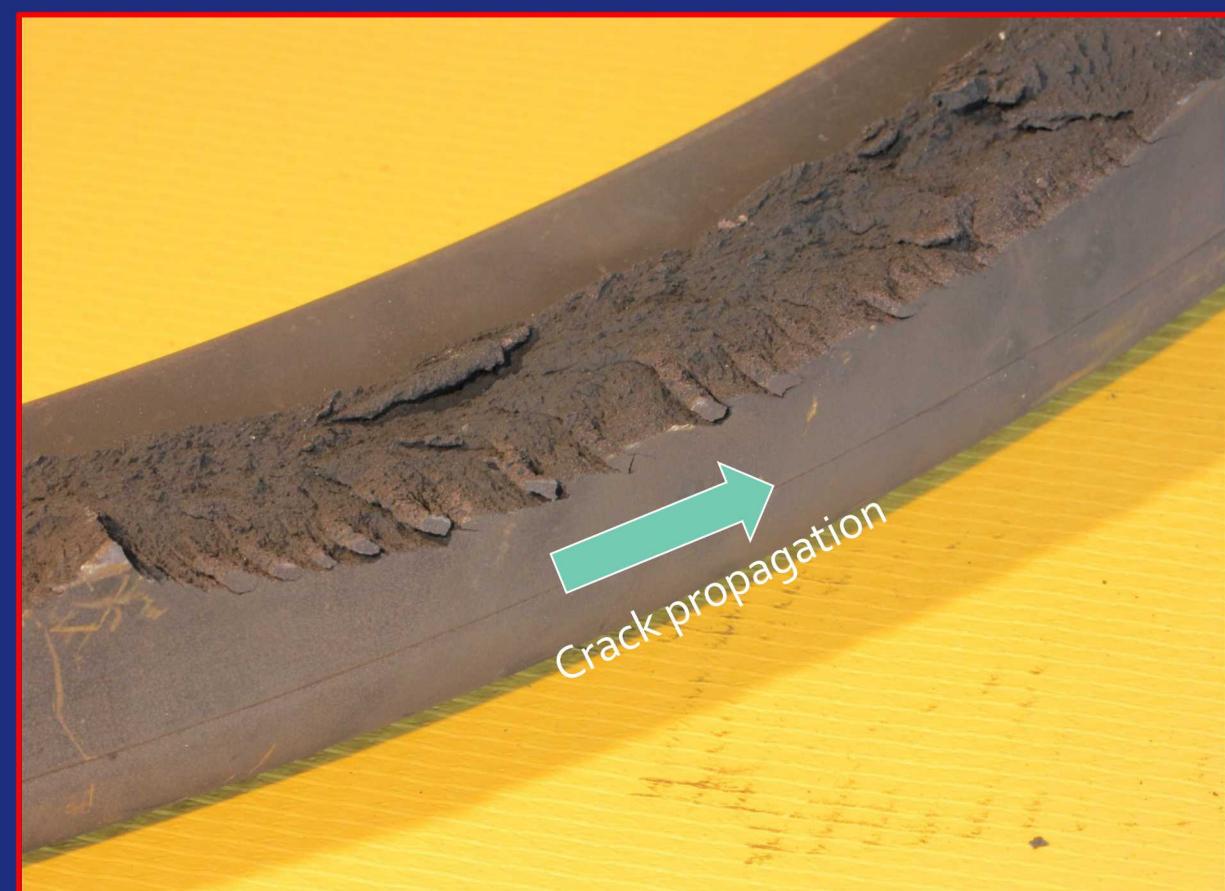
Figure 3. Detail of section showing clear direction of crack propagation (red box in Figure 2.)

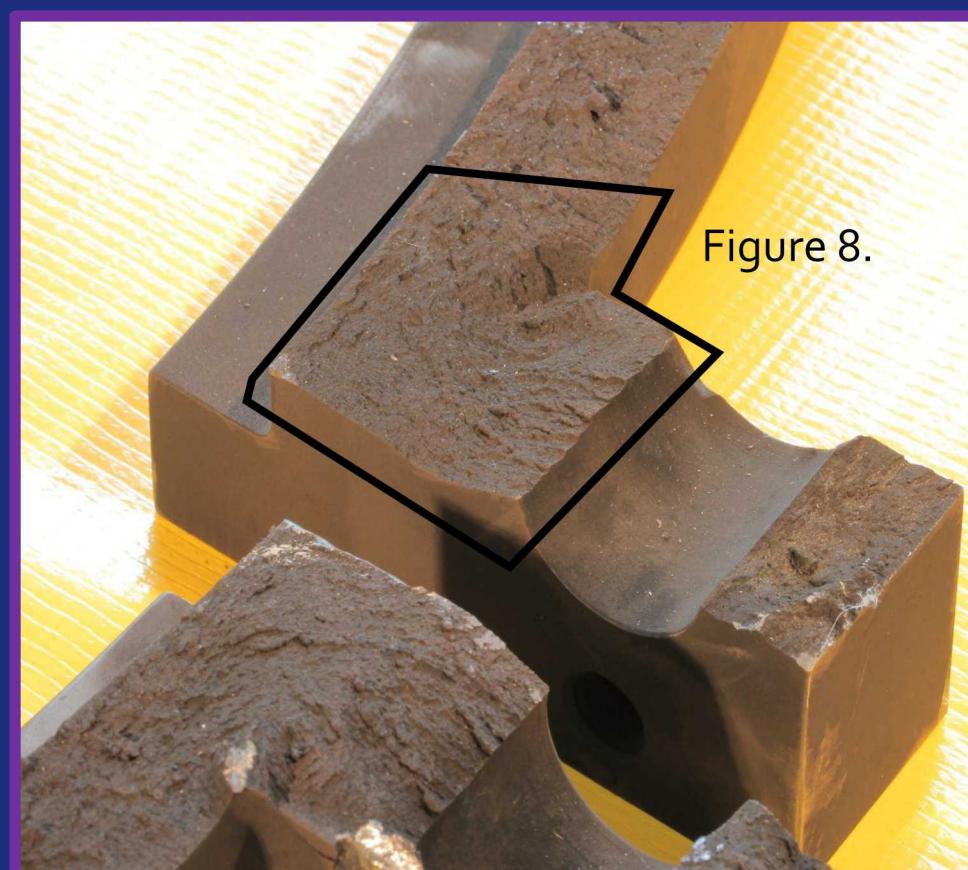
Figure 4. Crack initiation somewhere in these sections (purple box in Figure 2.)

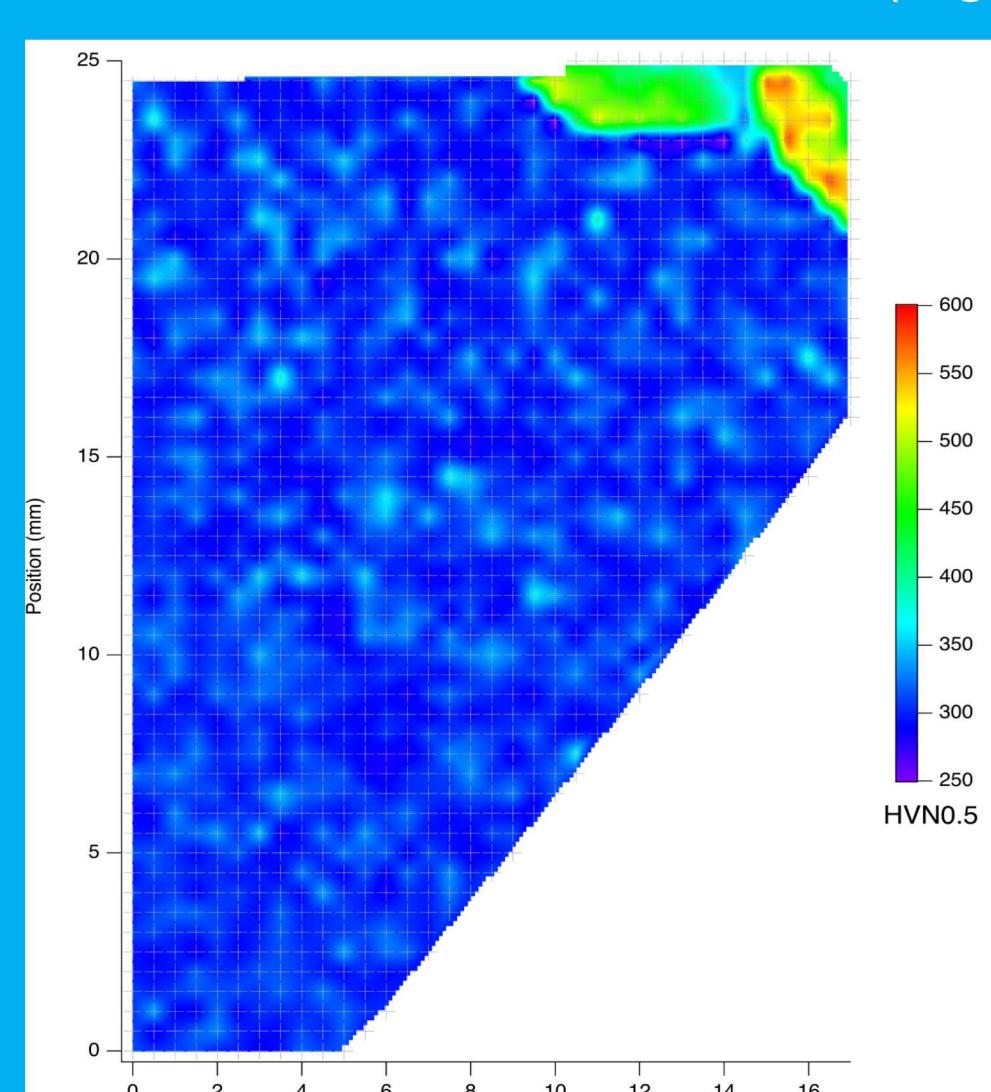
Figure 5. Vickers hardness map showing higher hardness weld (up to 600 VHN) with lower hardness base material (~300 VHN)

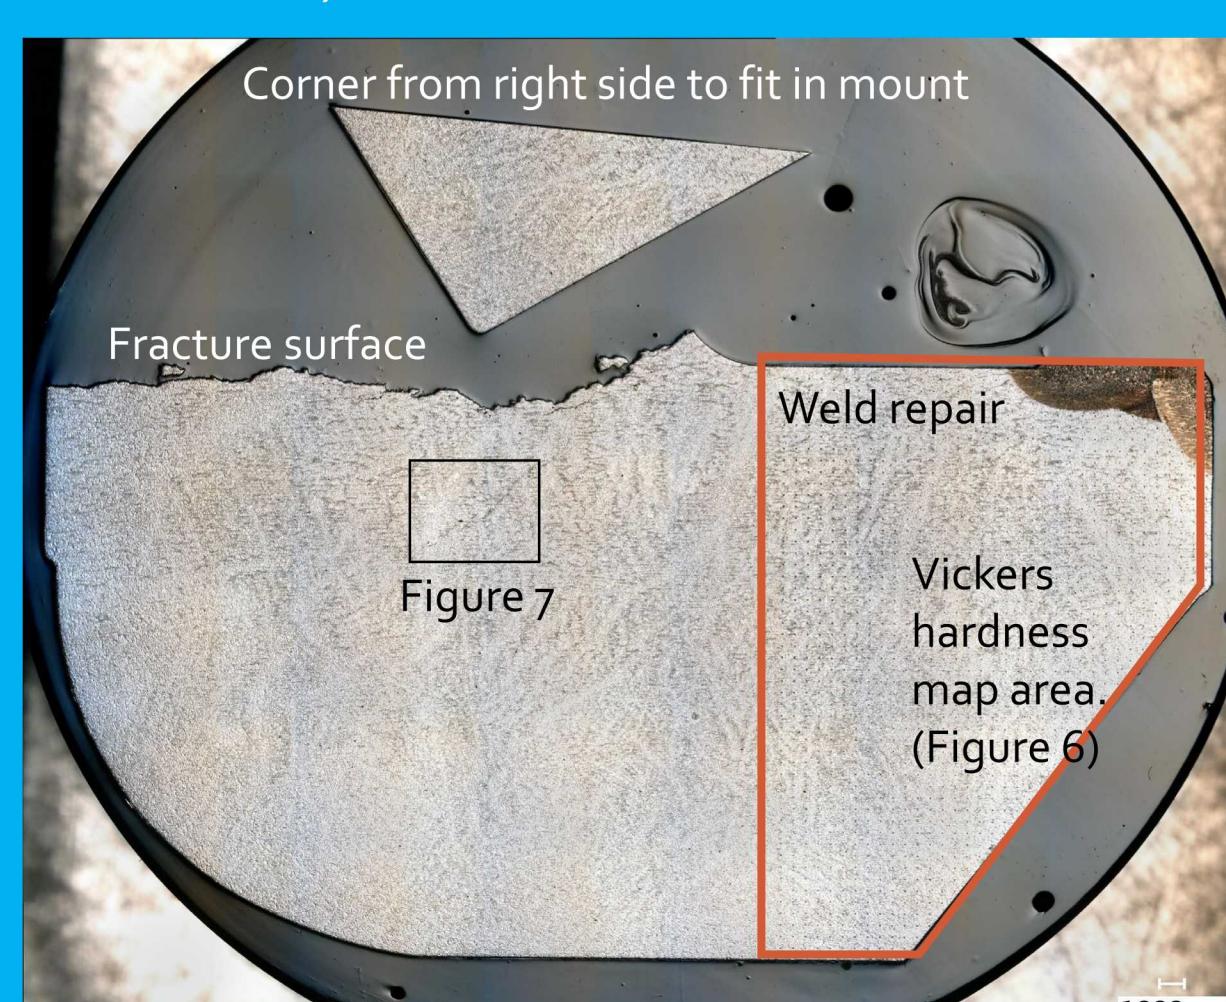
Figure 6. Nital etch reveals microstructure and a weld repair with three passes on the corner.

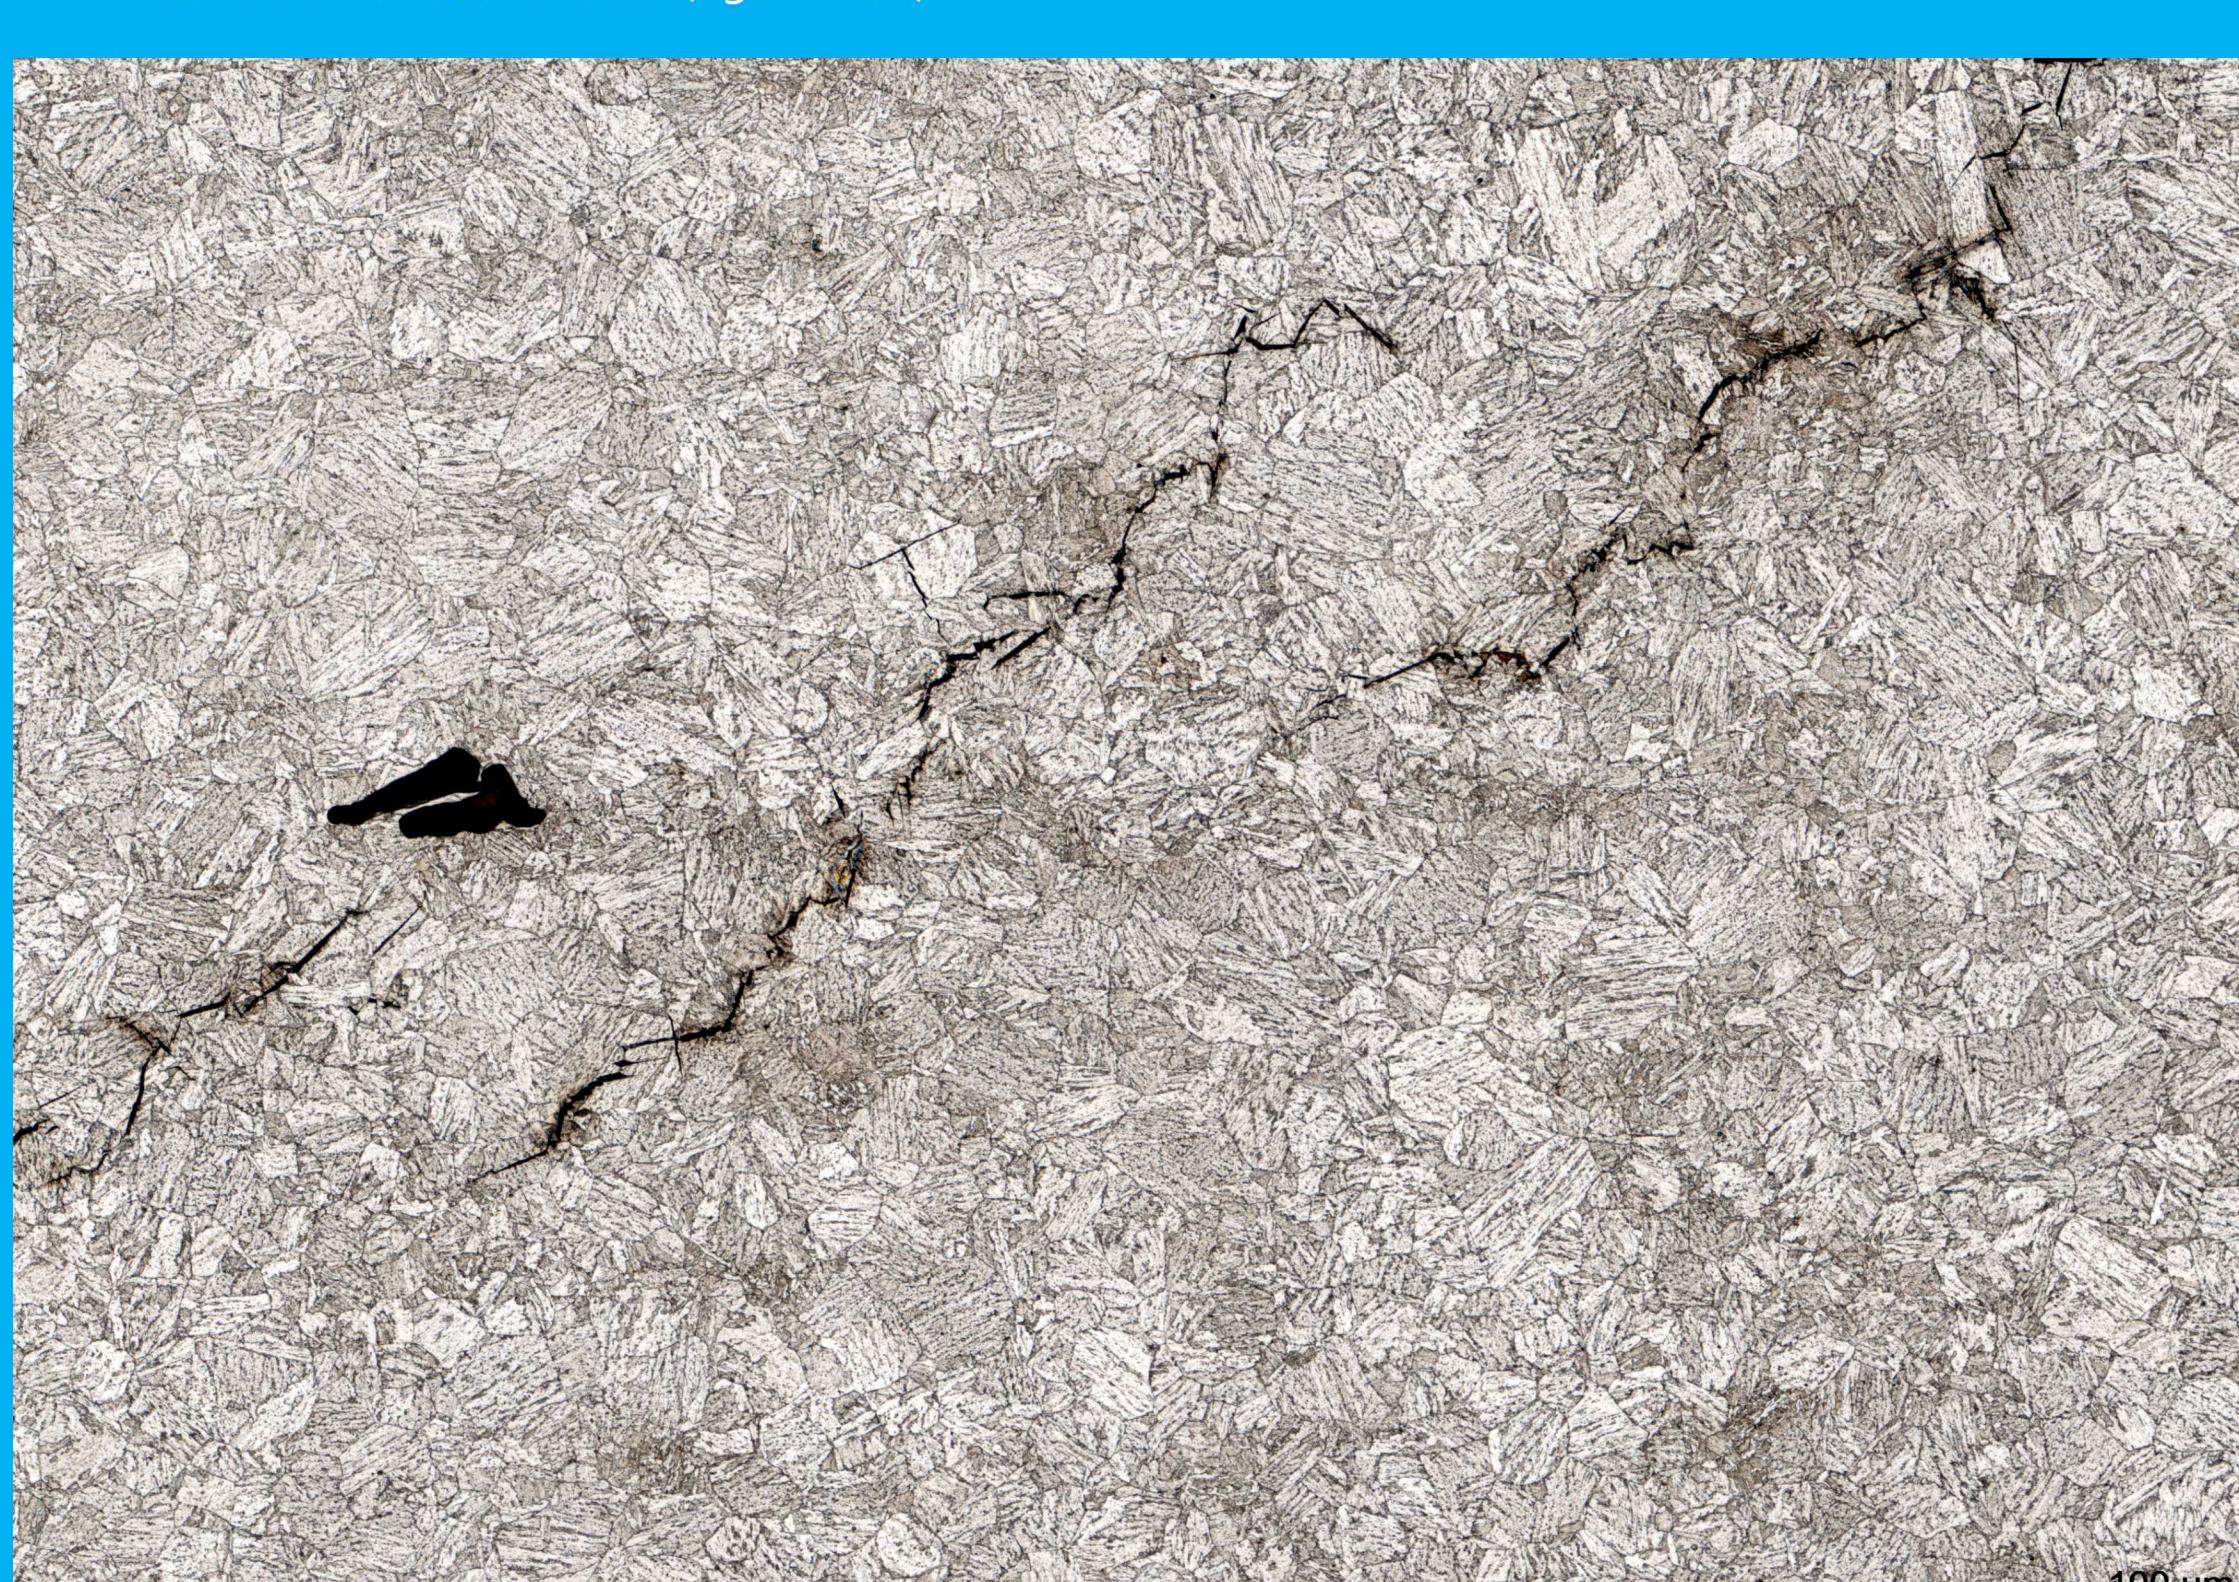
Figure 7. Microstructure is SOMETHING, secondary transgranular cracks are visible.

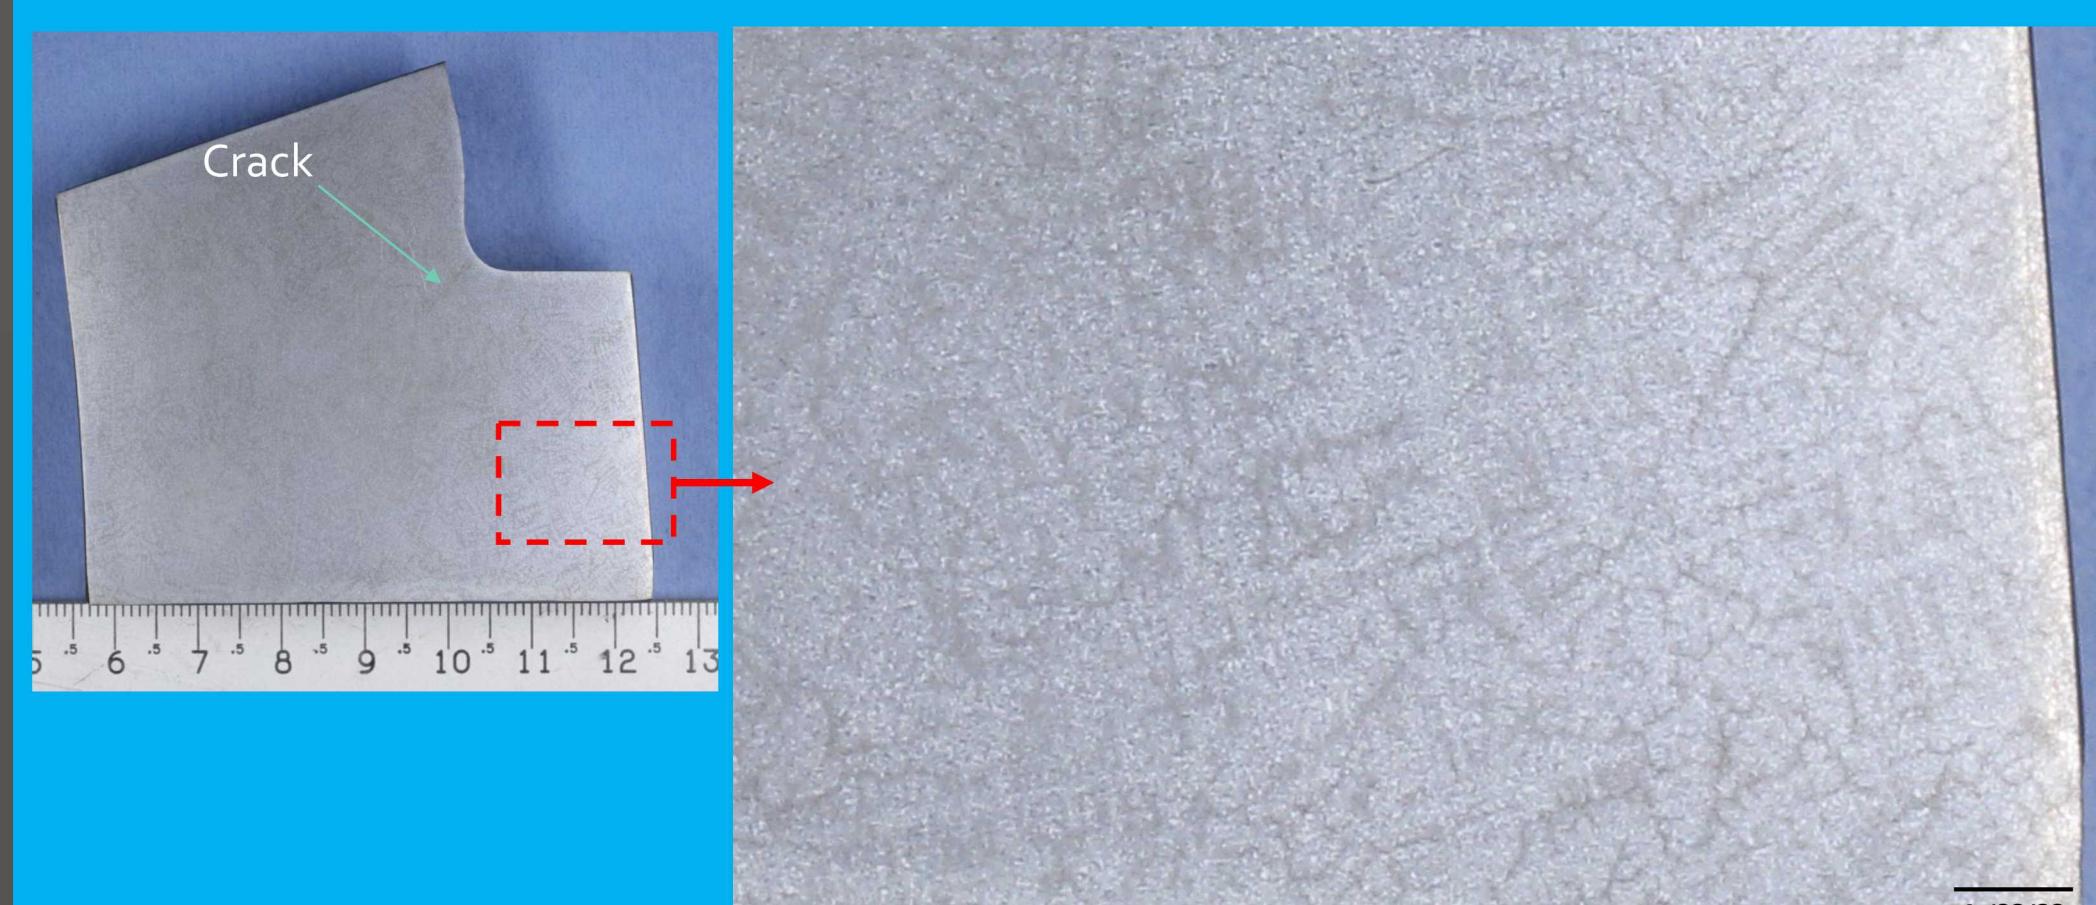
Sections for macroetching were taken from the suspected failure region in what would be a planar orientation to the original plate (outlined area in Figure 4) after cutting off the fracture surface to preserve it and from the intact ring from the other side of the assembly in what would be a transverse section on the original plate (Black line in Figure 1). These sections were ground and polished by hand with an 8" grinding wheel. Next a macro etch with Nital was performed to reveal the macro structure. The planar section near the failure initiation (Figure 8) showed a coarse dendritic structure. The transverse section on the intact part (Figure 9) shows the edge-on view of those dendrites only in the center of the plate thickness. This indicates that the plate was not worked enough to break up the dendritic cast structure.

Figure 8. Planar section from the failed portion of the ring which revealed a dendritic as-cast structure.

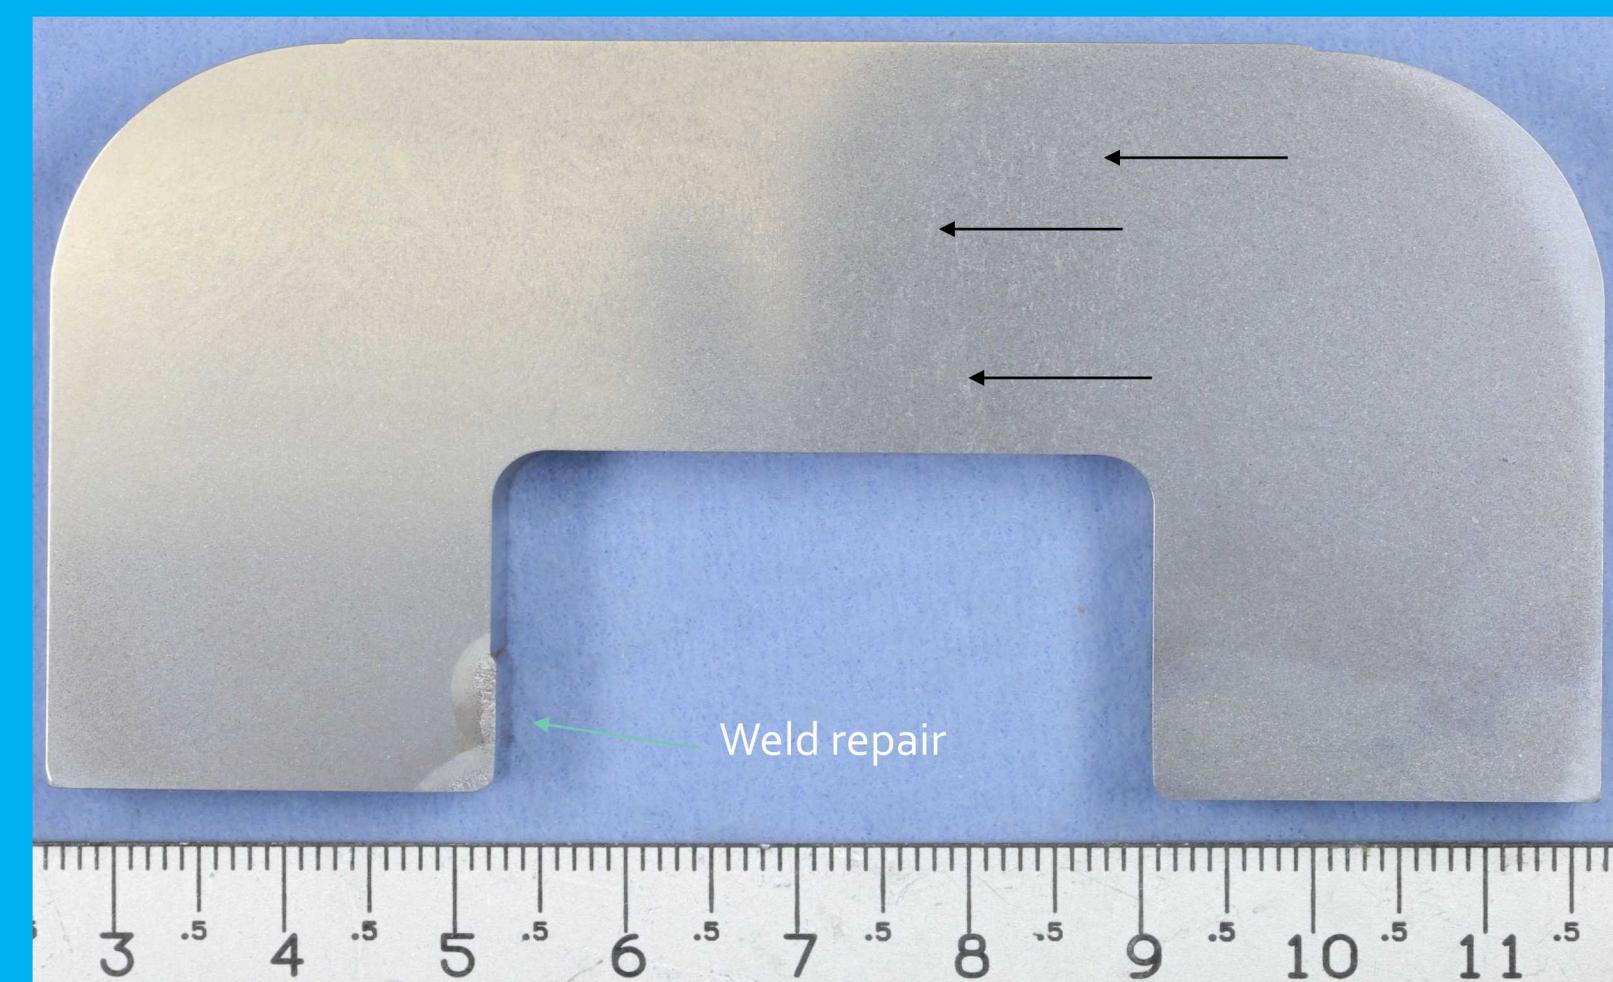
Figure 9. Transverse section from non failed half of the ring. Arrows point out indications of inhomogeneous structure near center of plate thickness.

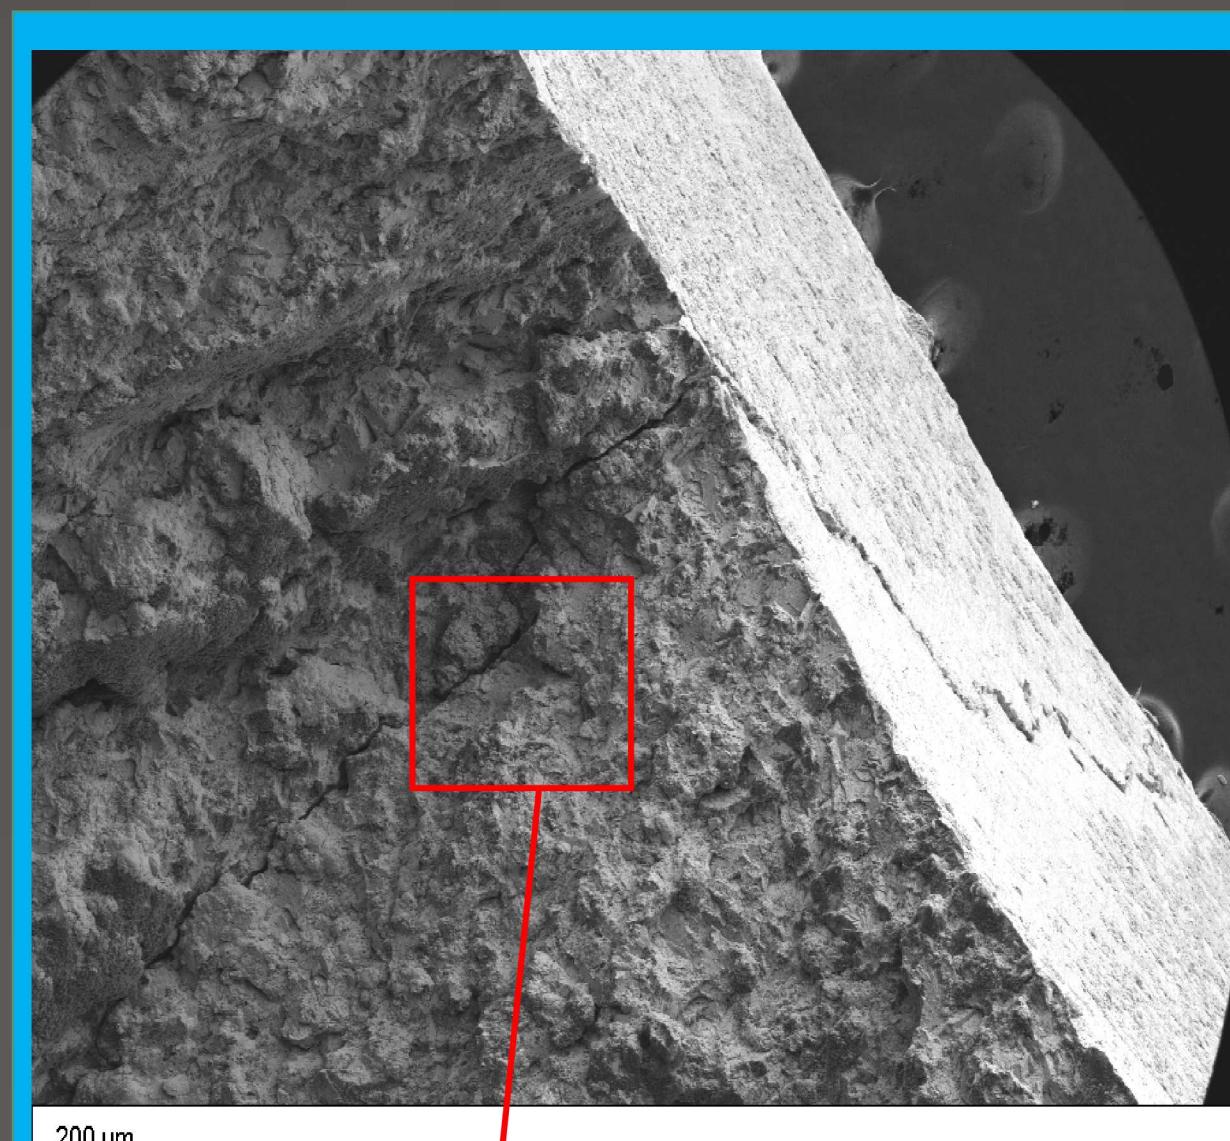
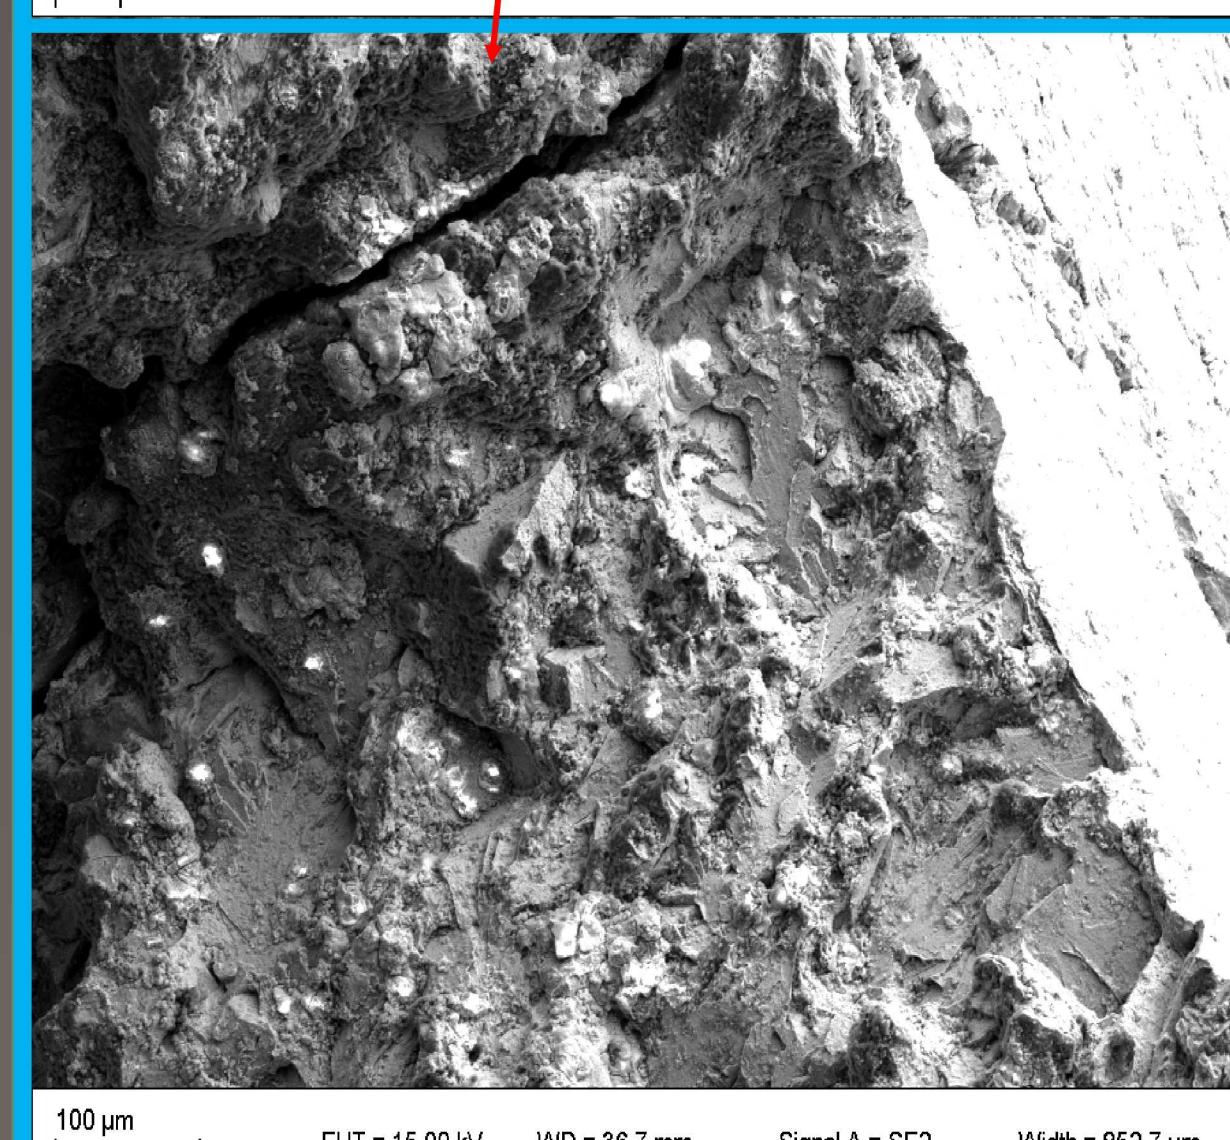
Scanning electron microscopy near the suspected initiation reveals brittle fracture indicative of low toughness alloys. These fracture features would NOT be expected for AISI 4130 tempered per the drawing.
