# Annular Core Research Reactor

## ACRR Operational Challenges

**SAND # TBD**  
**TRTR Conference 2020**

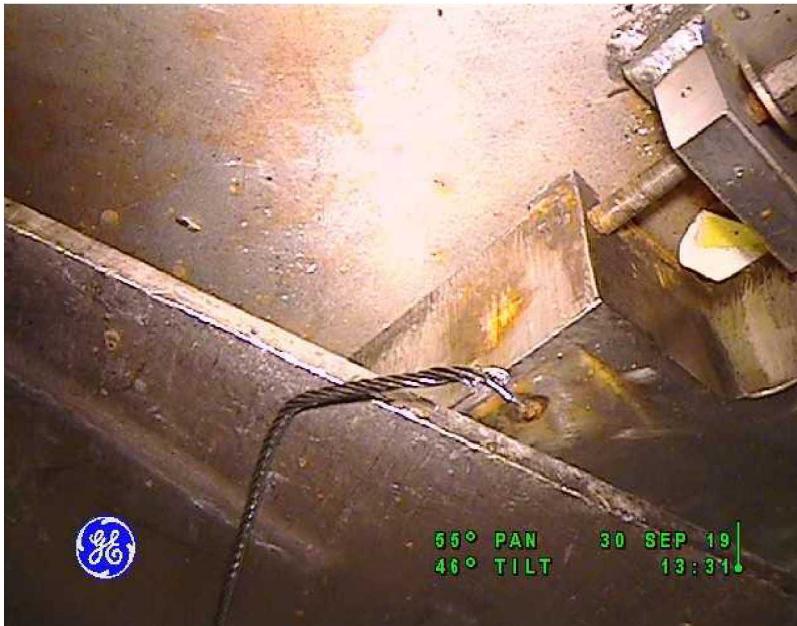
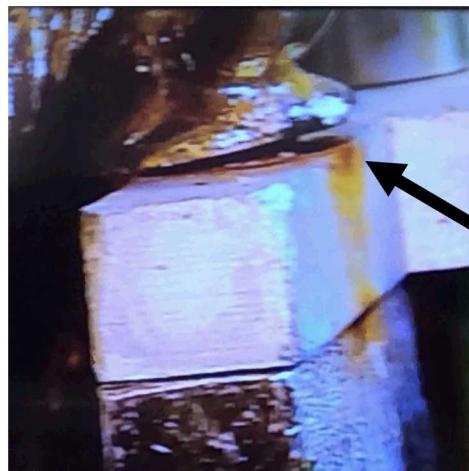
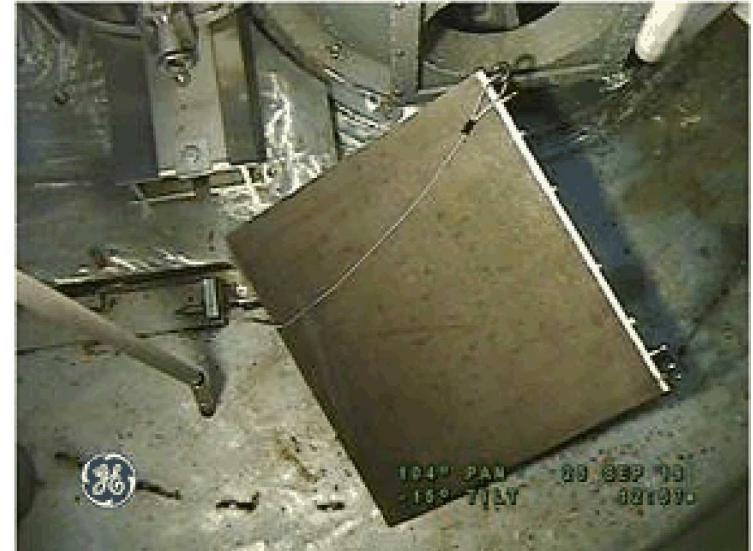
- During de-coupling of FREC-II and movement of the nickel plate, one leg of the attached rigging failed

Eyebolt not  
fully seated  
and bent

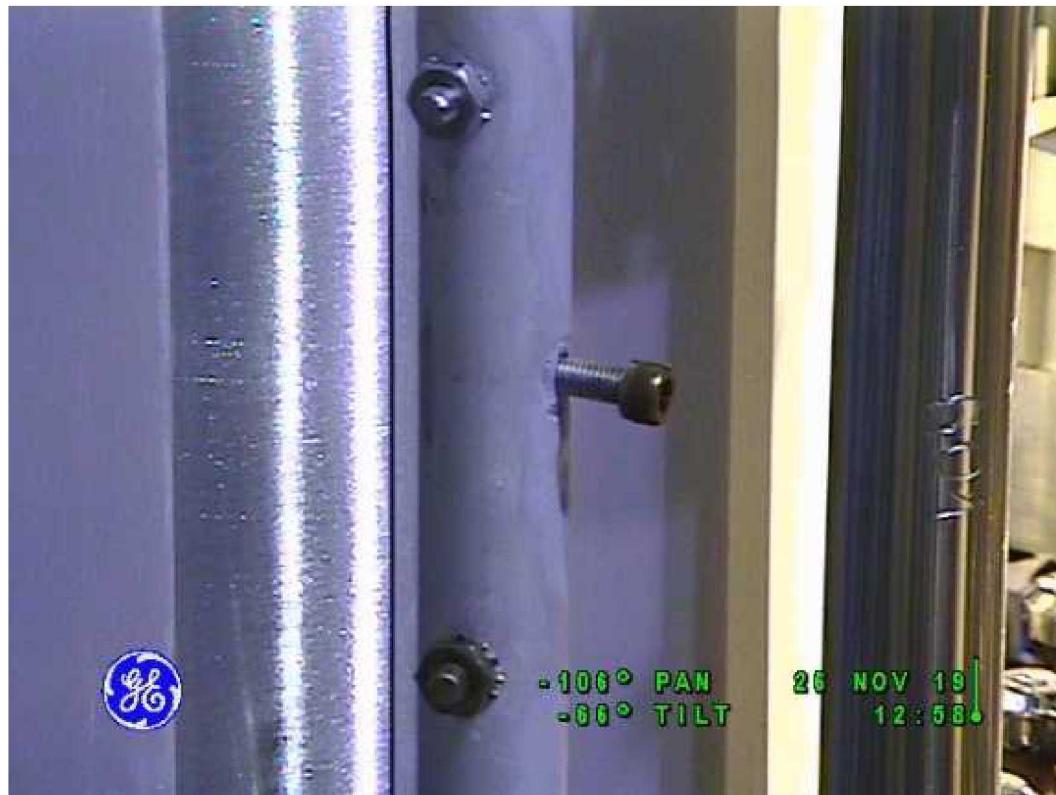
- During a pre-operation checkout, operator discovered a bolt backing out on SR1 connecting rod
- The nut and washer were no longer on the bolt
- Removed rod drives in preparation to repair loose bolt and to locate the missing nut and washer

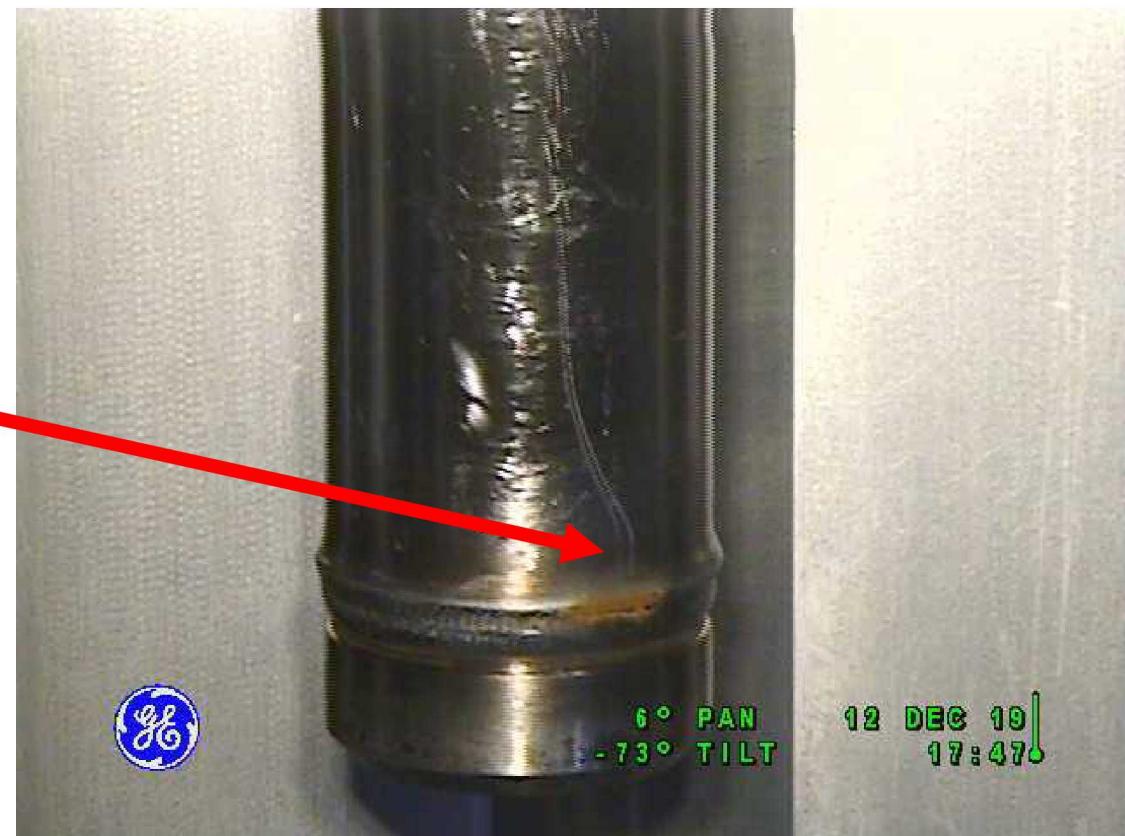
- During maintenance on SR1, operators discovered a breach in the cladding by visual indication of bubbles from the bottom weld seam
- Began remote monitoring of Pool CAM and Ventilation System

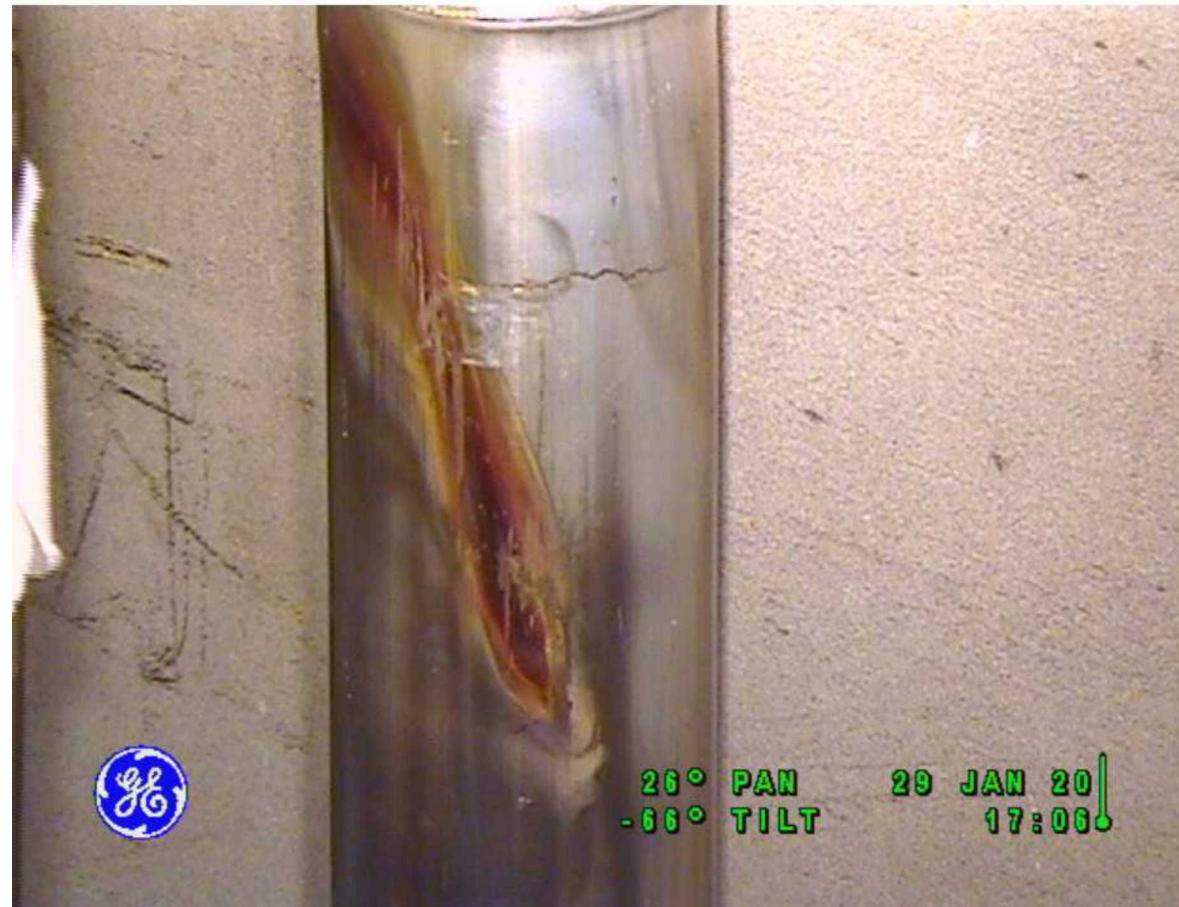
- During the search for the missing nut and washer, operators identified suspect fuel damage on FE #134
- FE #134 was sequestered into fuel storage for further evaluation

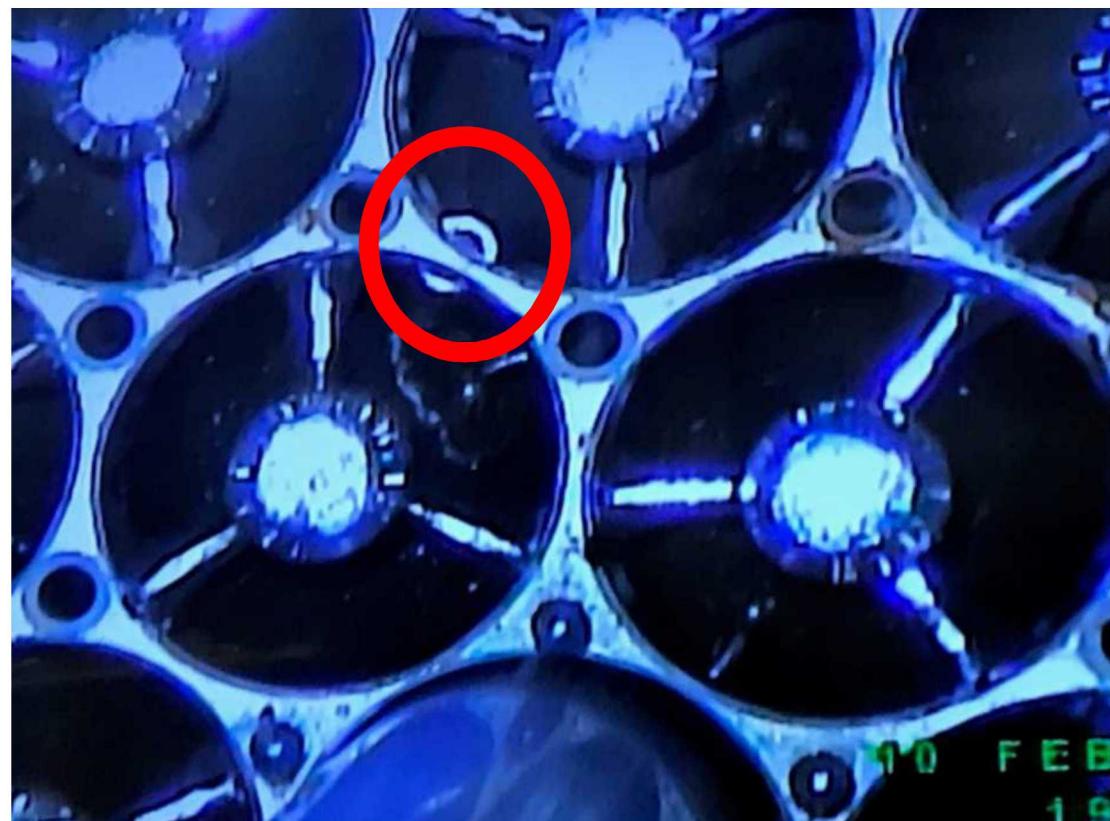
- In preparation for inspection of regulating rods, a small bolt was dropped
- The bolt fell on the core. During retrieval attempt, bolt fell through the core onto the safety plate.
- Bolt could not be retrieved from the safety plate

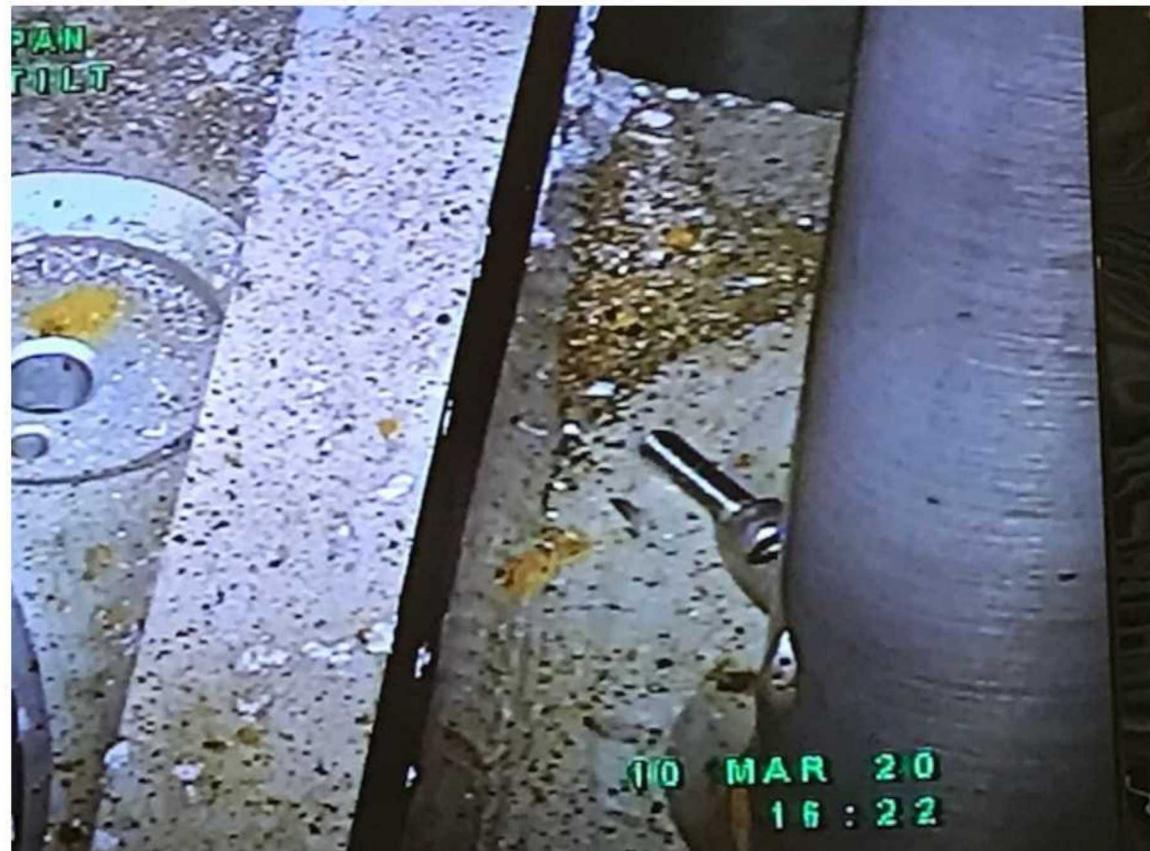
- While searching for the dropped bolt on the safety plate, additional foreign material was discovered
- It was also determined that CR2 and CR5 were striking the safety plate (normally the bottom of the rods are approximately an inch above the safety plate)

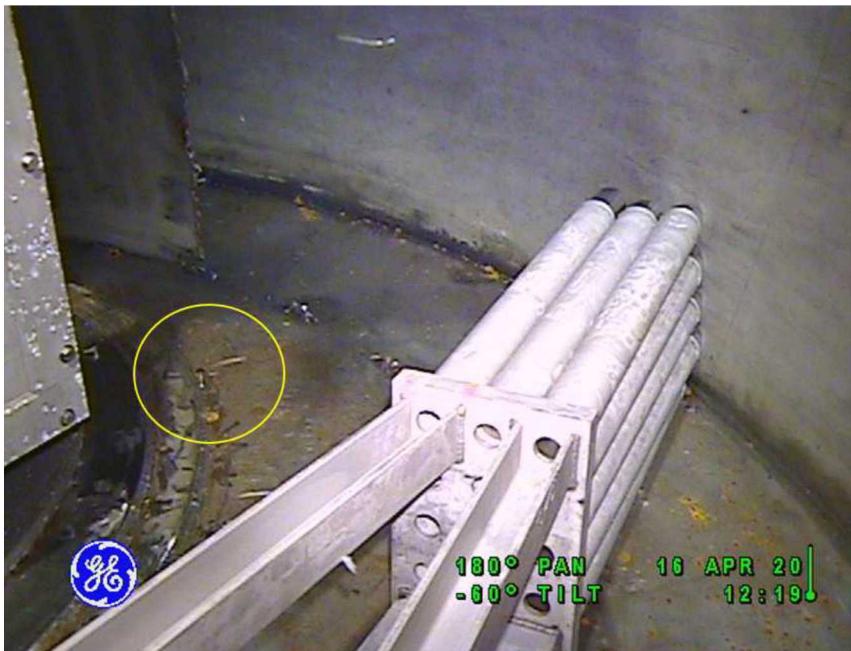
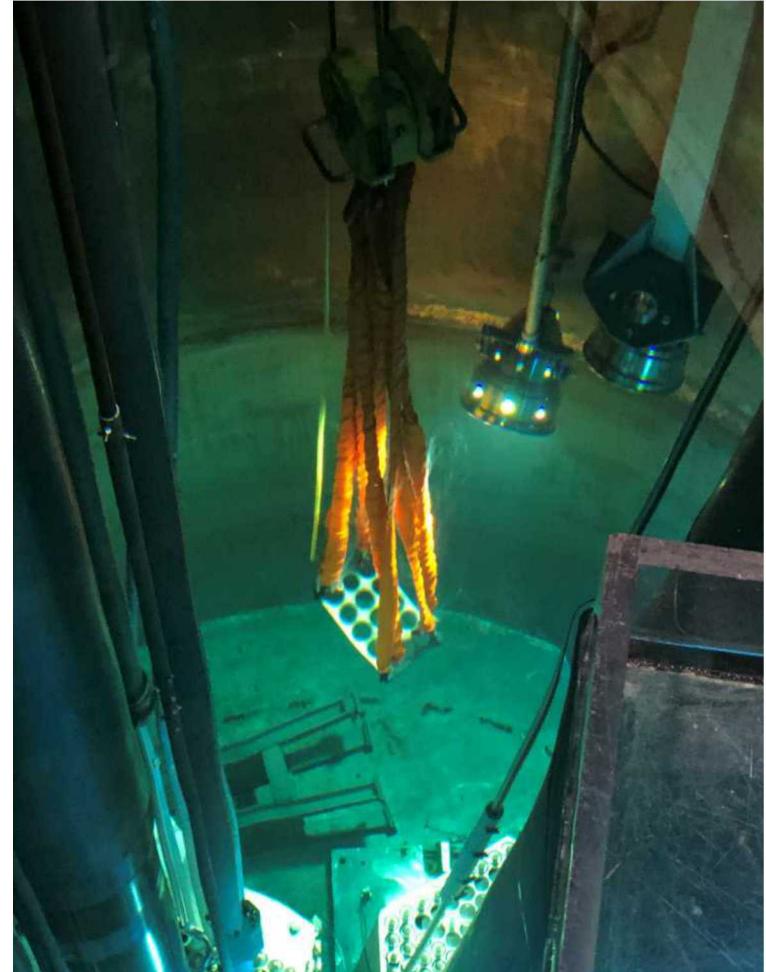
- During a test lift of the 15-element rack loaded with steel billets, the top grid plate detached and the remainder of the stand fell over in the pool

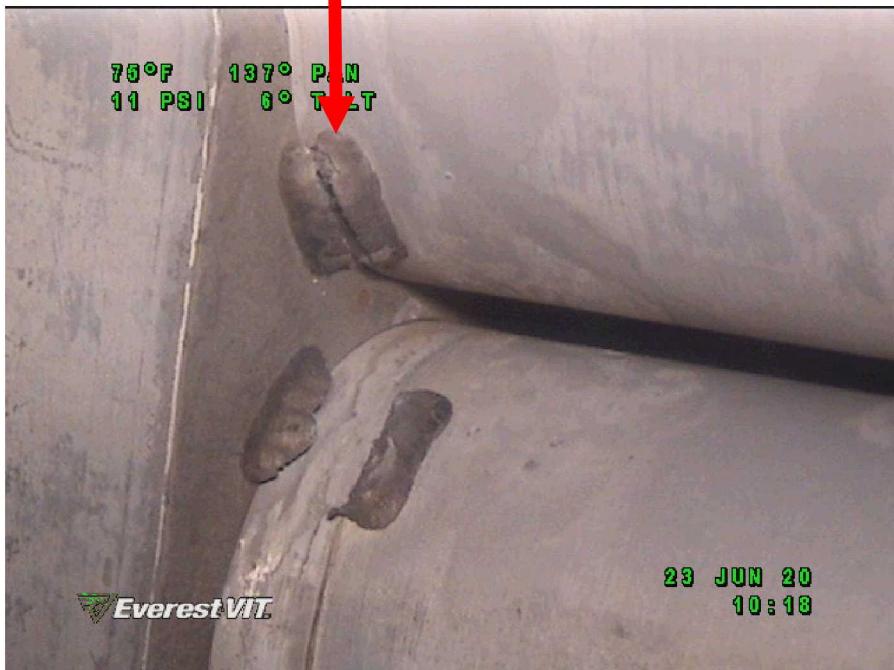
Failed tack welds

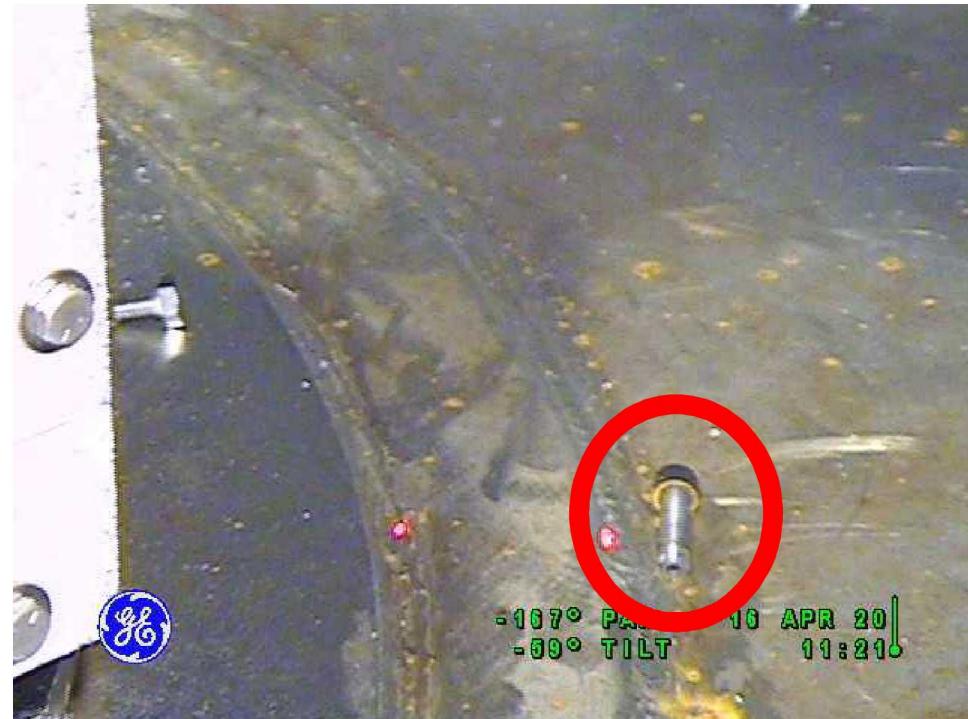
- During maintenance activities, a bolt from a dust cap fell into the tank
- Bolt was subsequently found and retrieved
- Lessons learned:
  - FME practices were improved
  - New FME prevention tools were purchased
  - FME covers installed on Reactor Bridge
