**Title:** Historic Buildings Report: Five-Year Preservation Planning for Manhattan Project National Historical Park Sites

# **Historic Buildings Report: Five-Year Preservation Planning for Manhattan Project National Historical Park Sites**

**Fiscal Years 2022 - 2026**

Historic Building Report No. 394  
Survey No. 1257

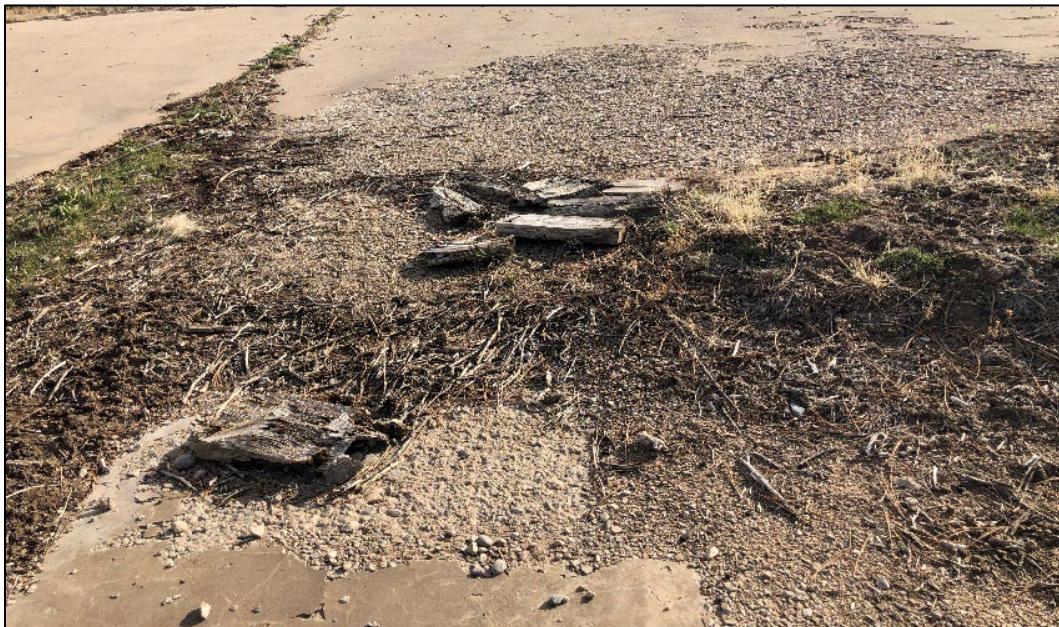
The majority of the visible concrete deterioration represents surface friability. The surface concrete has separated from the main structure and broken up into smaller pieces. This condition is prevalent throughout the entire structure.

*Figure 4. Extreme friability is exhibited in the photograph - a typical occurrence on the surface of the Concrete Bowl.*

Research should be conducted prior to any on-the-ground treatments. Initial monitoring of the amount of deterioration currently occurring to better quantify the amount of deterioration occurring over a given period of time is needed to better understand the degree of loss and establish an appropriate timeframe for a prescribed treatment.

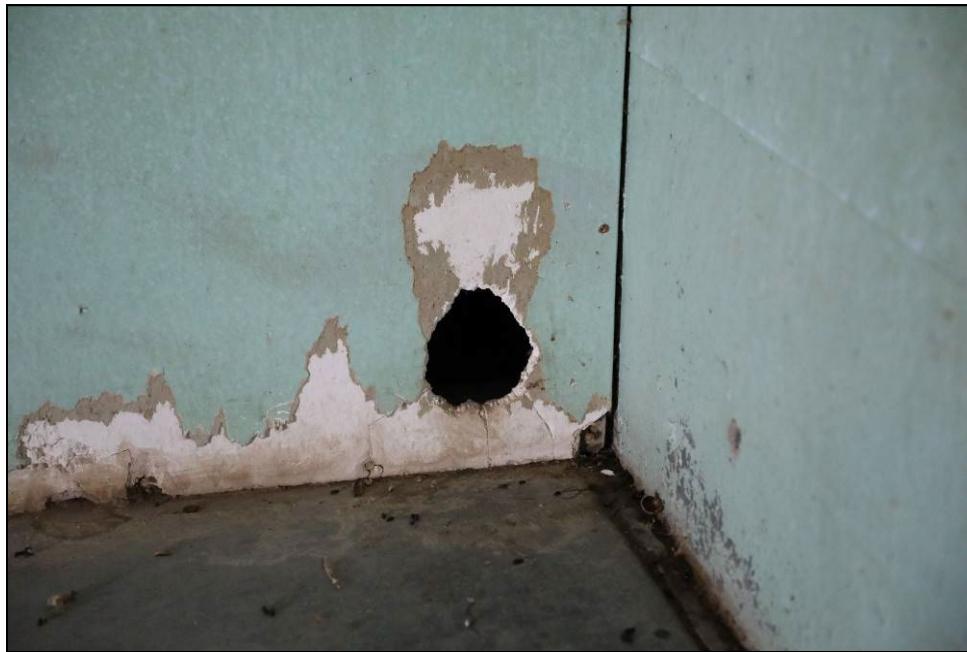
Figure 9. Holes like this one allow rodents an nice place to nest and reproduce.

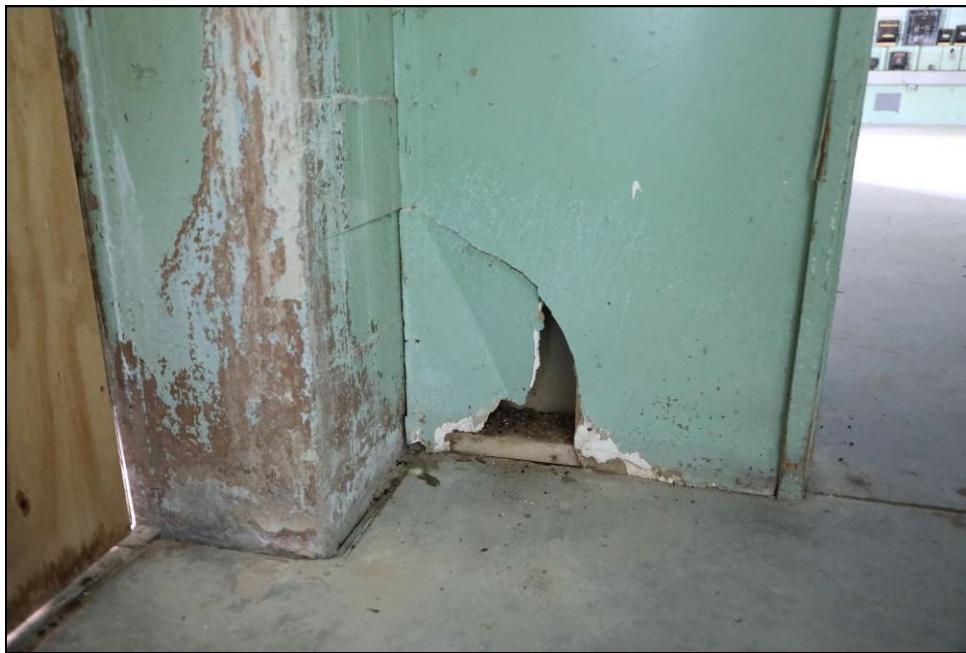
Figure 10. A larger example of the type of damage seen in the interior walls.

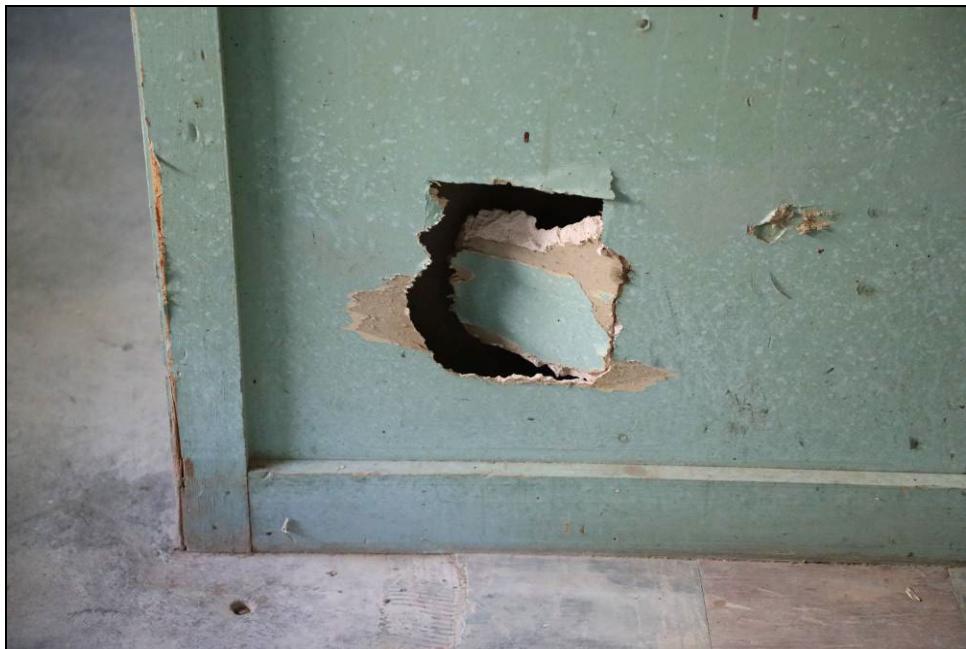
Figure 11. This example is fairly typical of the types of holes throughout the building.

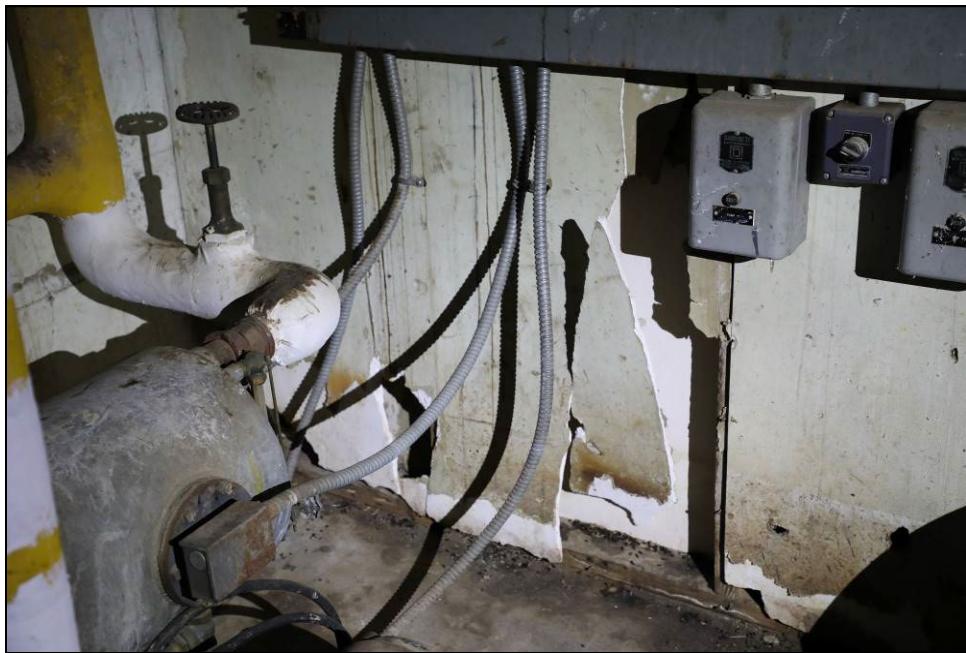
Figure 12. Whole sections of interior siding will need replacement.

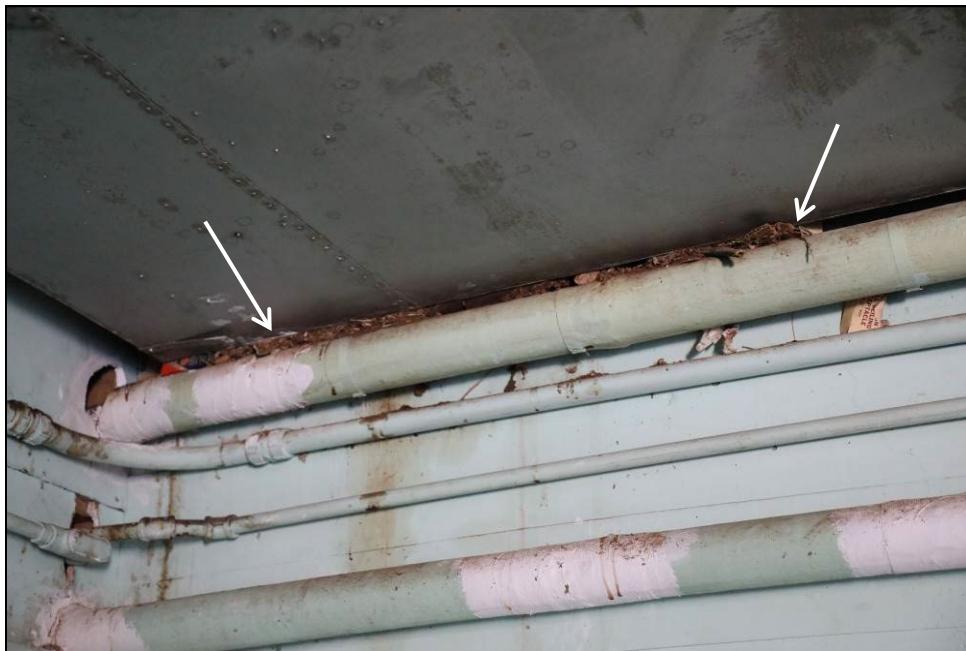
Figure 13. A large pack rat nest is visible on top of utility line that has a larger-than-needed penetration hole through the wall.

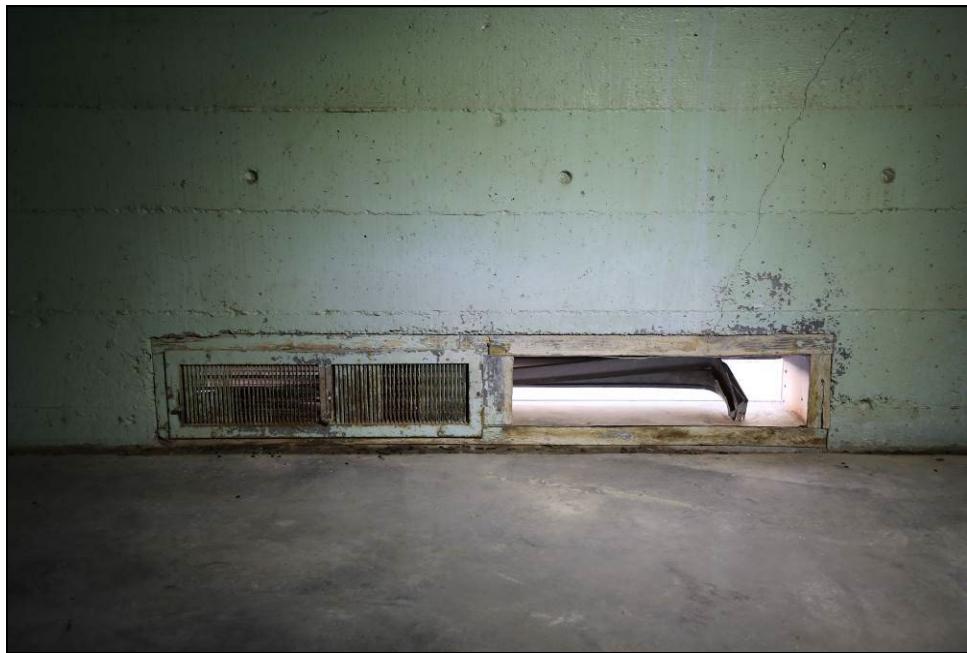
Figure 14. The vent cover is missing and needs replacing.

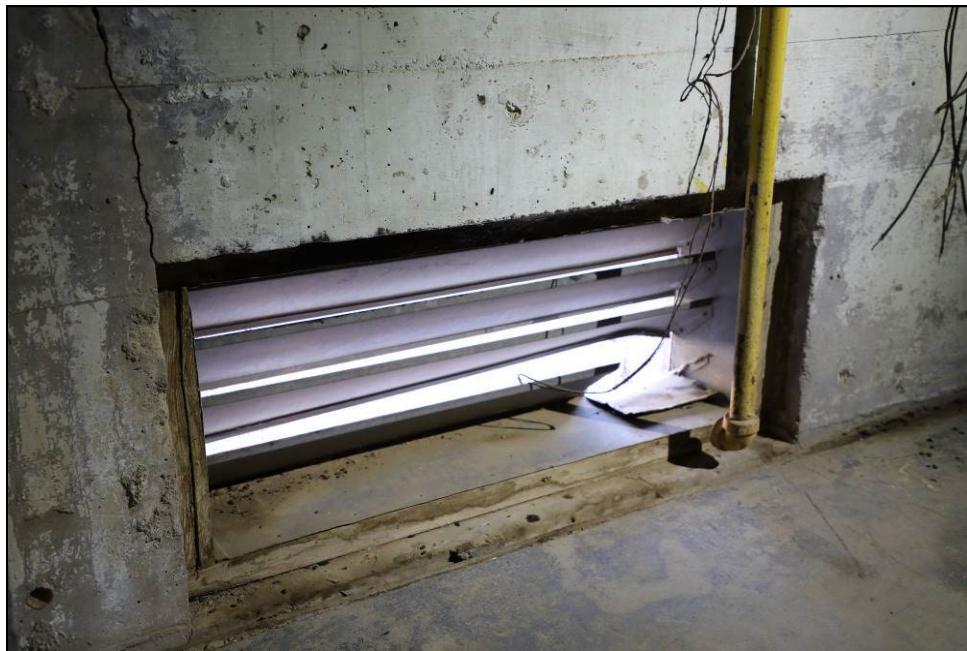
Figure 15. The broken louver is unsightly and the worn screen cover needs replacement.

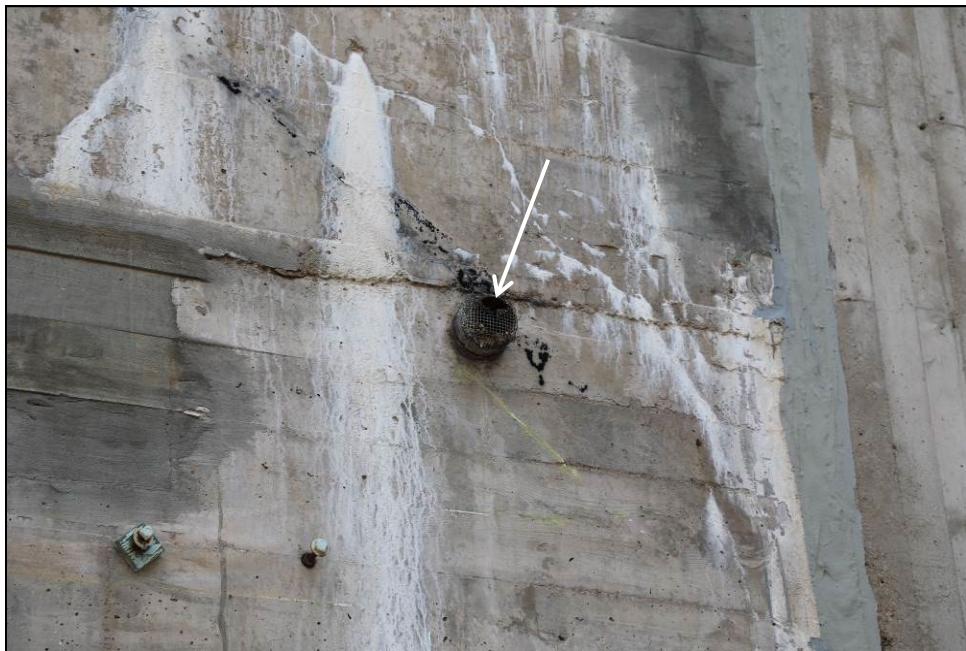
Figure 16. The screen covering this wall penetration is cracked and aged; allowing access for pests to the inside.

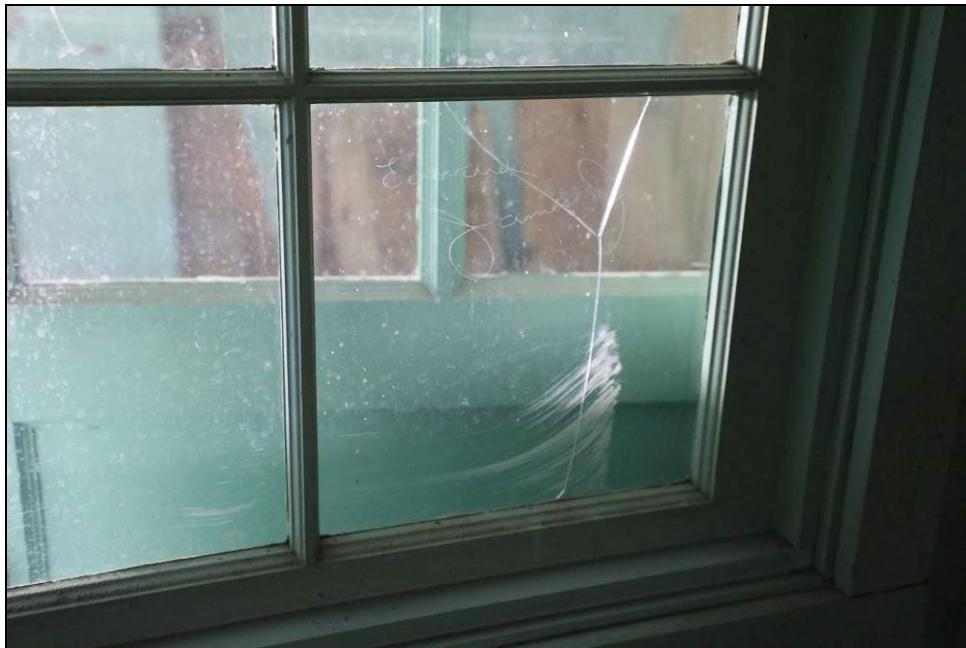
A noticeable crack is present in the bottom right corner (from inside) glass pane of an interior widow of Room 3. Also of note, a lab employee etched their name into the same pane at an unknown date in the past.

*Figure 25. View from the interior of the cracked glass pain with etching.*

The pane should be removed and replaced with pane of matching dimensions. Care should be taken not break any of the remaining glass panes during the replacement process. Additionally, the name etched into the pane should be researched to determine any historical importance prior to removal.

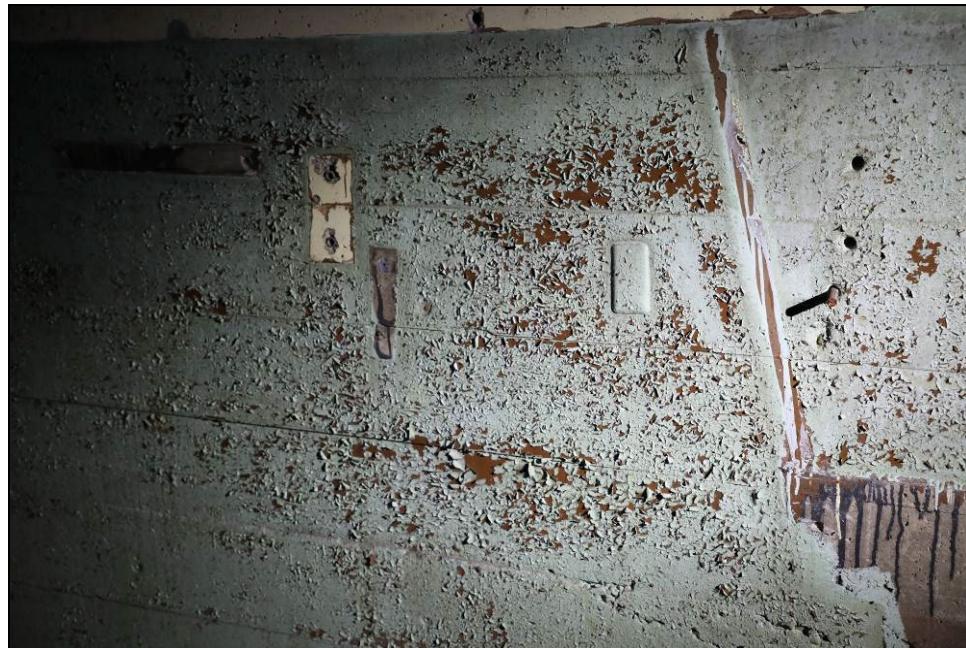
The interior paint exhibits severe deterioration from general wear and tear, past roof leaks, and interior efflorescence. Paint is flaking, worn, and stained.

*Figure 26. Example of peeling interior paint.*

The interior of the building should be repainted with the same colors that are currently present on the wall surface. Failing paint should be removed to provide a stable surface for the new coating, however, paint that is structurally sound should remain in-place to provide historical evidence for future paint analyses. A primer is recommended to help with adhesion and durability. Non-period significant conduit may also be removed in preparation for this job. Subject matter experts with the Historic Buildings Program should be consulted prior to any removal of conduit in order to ensure period significant conduit is not removed.

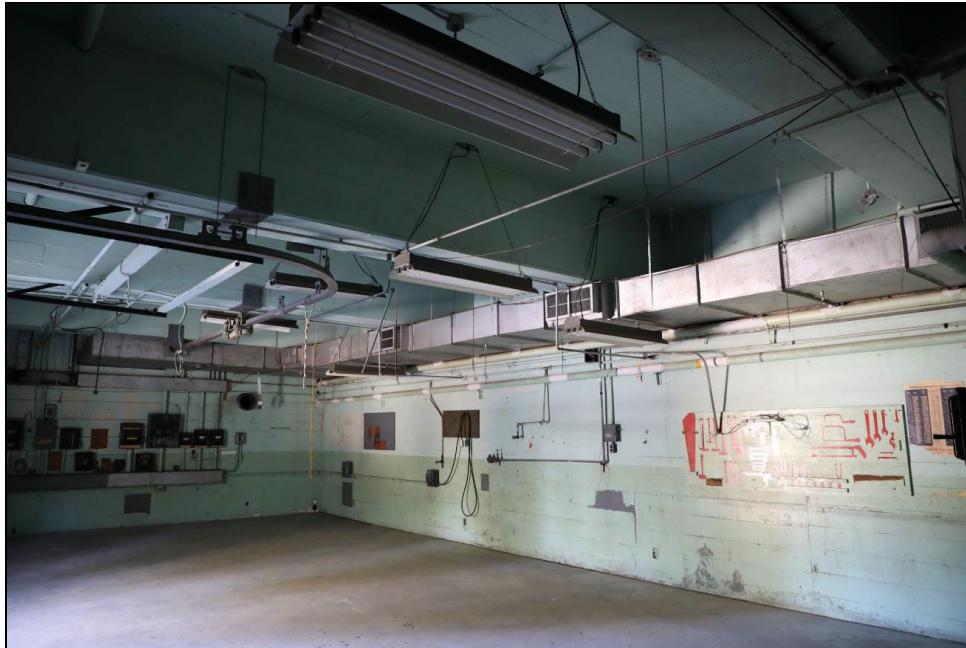
Figure 29. The non-period ductwork stands out in the interior rooms, and also provides a surface for rodent movement.

Complete removal of the ductwork is recommended along with the possible removal of the main core of the HVAC system if appropriate. The core system is covered in what may be asbestos. Care should be taken during the removal process when removing elements that are anchored into walls. Harsh removal techniques can cause irreversible damage to the concrete walls and ceiling.

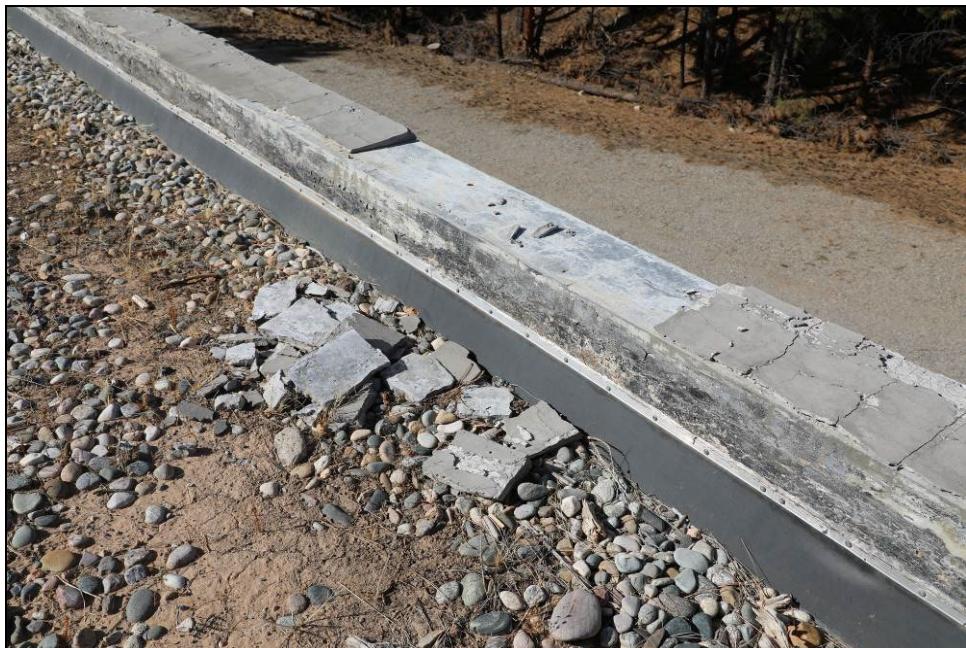
*Figure 34. An example of the failing parapet cap.*

Complete removal of the failing cap is needed. Most section still attached to the parapet can likely be removed with simple hand tools. Some power tool work may be required in some areas.

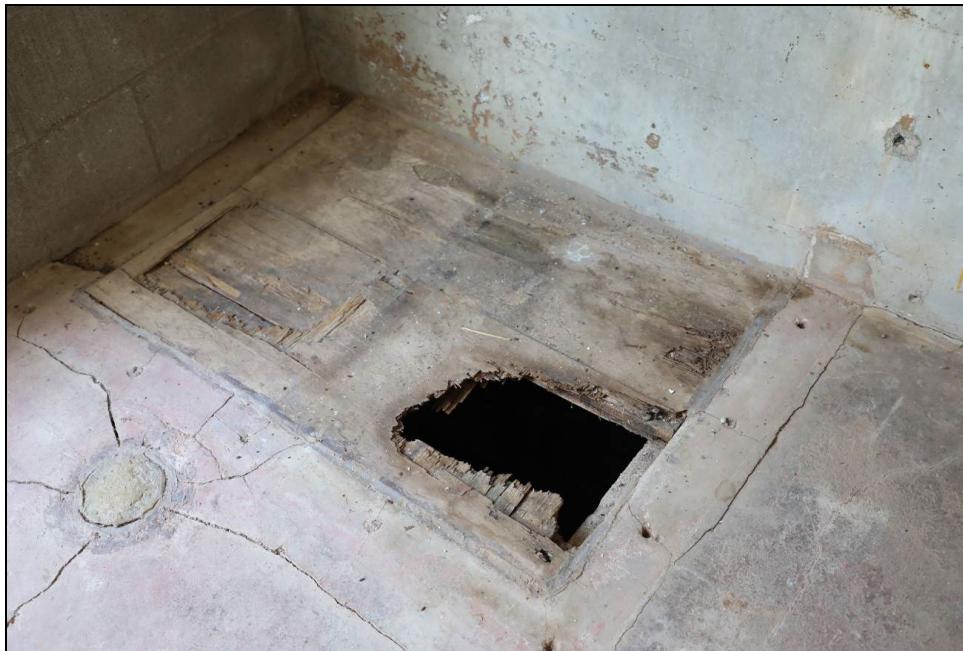
*Figure 43. The plywood cover that once successfully covered the utility pit no longer functions properly.*

A reinforced cover should be constructed and installed after removal of the unsalvageable plywood cover. A plywood replacement is not recommended due to the likelihood of people standing on top of this area in the future. A double-layer plank construction is recommended where the two layers of planks run perpendicular to each other. The new cover should be flush to the surrounding floor surface to avoid a tripping hazard.

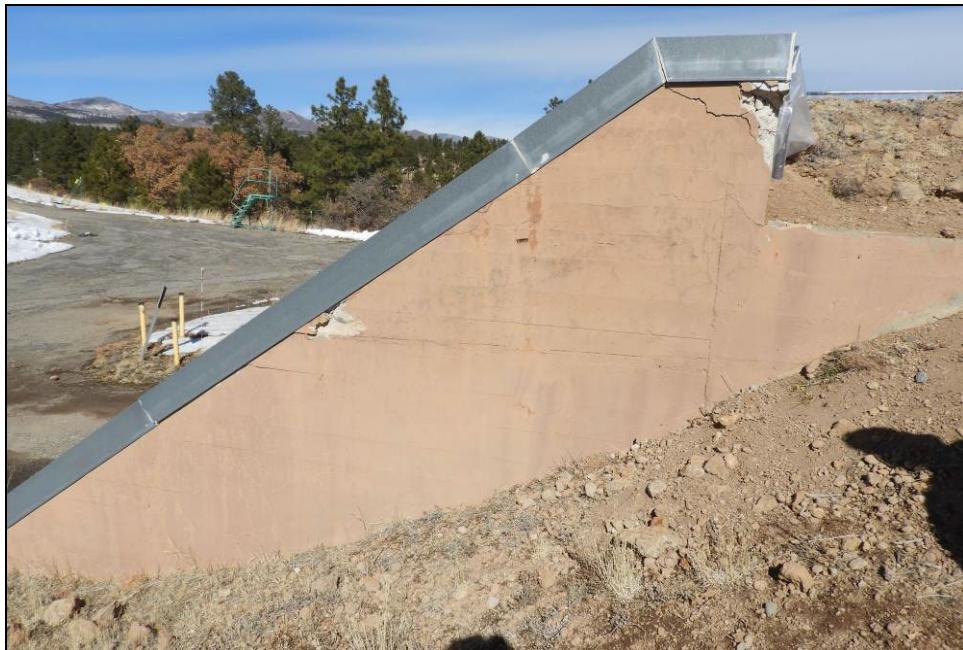
*Figure 52. Photo shows the missing corner along with cracking and other issues.*

The top corner will likely require rebuilding once an appropriate mix is determined. Other areas and cracks can be patched as needed.

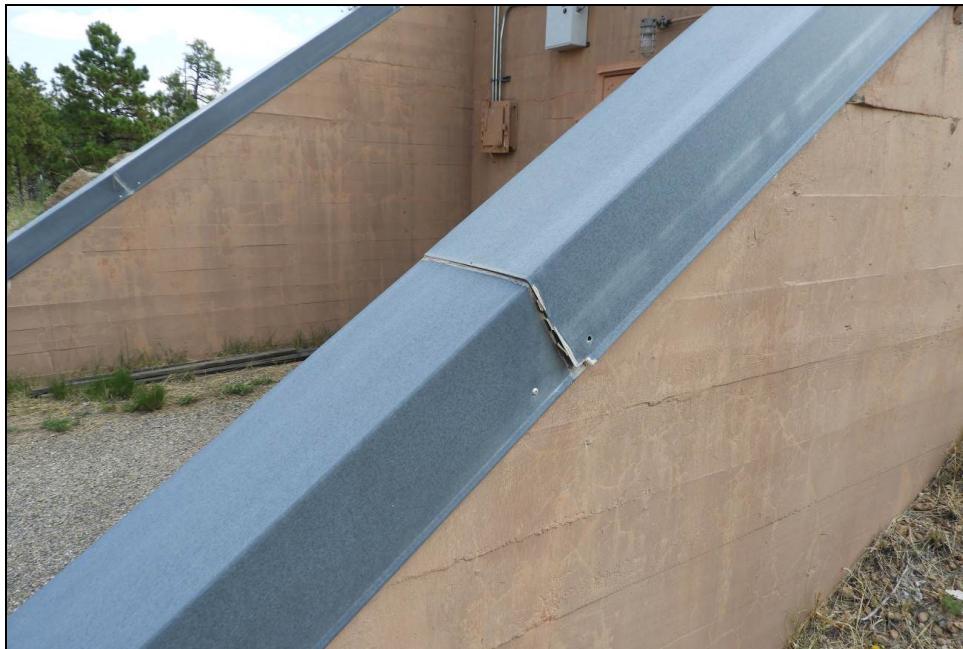
*Figure 54. The detached flashing can be seen in the middle of the frame.*

The immediate recommendation should be to re-affix the flashing to the concrete. Reuse of the original anchor hole would be the most appropriate for preservation purposes in order not to create additional holes in the original concrete. A long-term plan should be developed however to assess the prospect of entirely removing the flashing. Complete removal of the flashing will help with the aesthetics of the building and possibly be beneficial for the preservation of the wing walls. Metal capping over historic concrete can trap moisture in the top of the wall and accelerate deterioration. If complete removal is not recommended after further consideration then painting should be considered to help blend in the metal to the rest of the building.

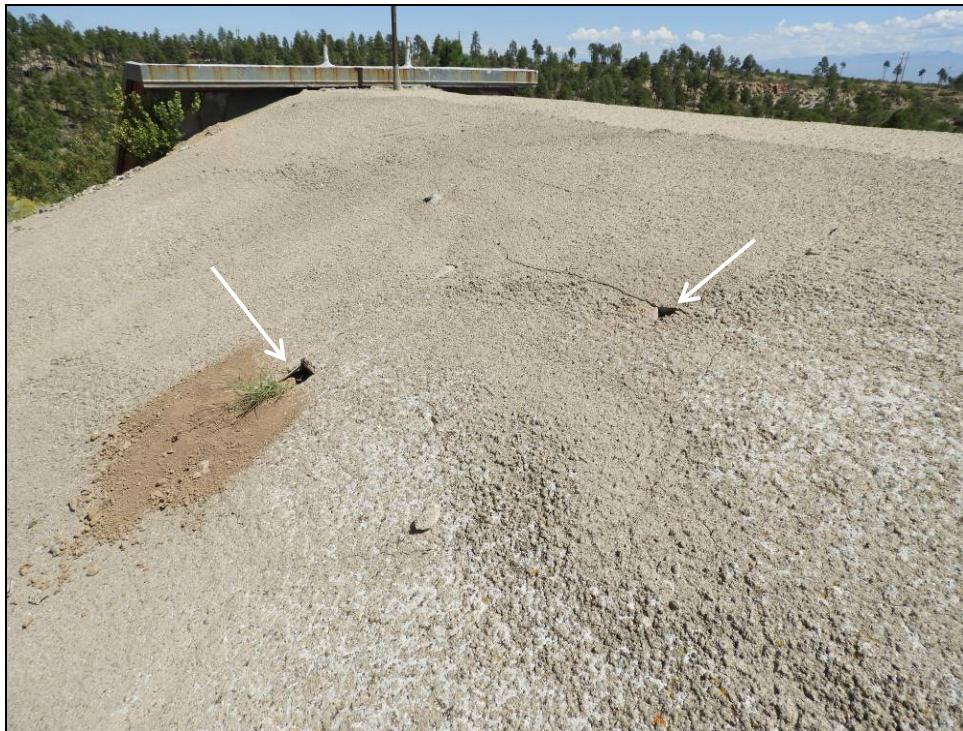
Figure 59. Active burrowing is evident in this recent photo.

The burrow hole should be filled back in with soil, lightly compacted, and covered with a similar-looking concrete mix patch. The other smaller holes should also be tested and the same recommendation for the active burrow hole should be applied.

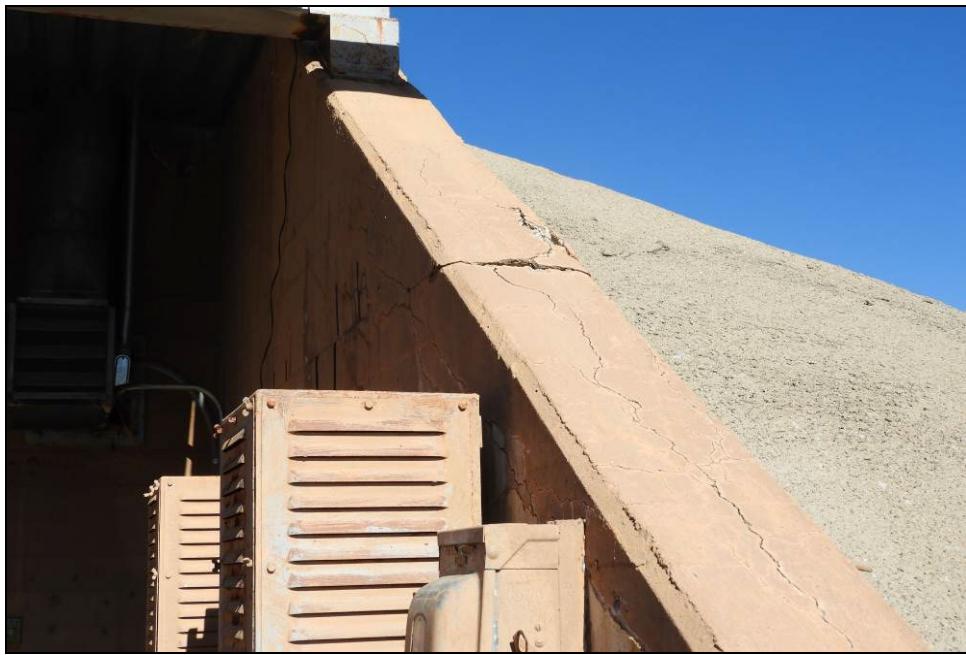
Figure 66. Significant cracking can be seen on the cap of the east wing wall.

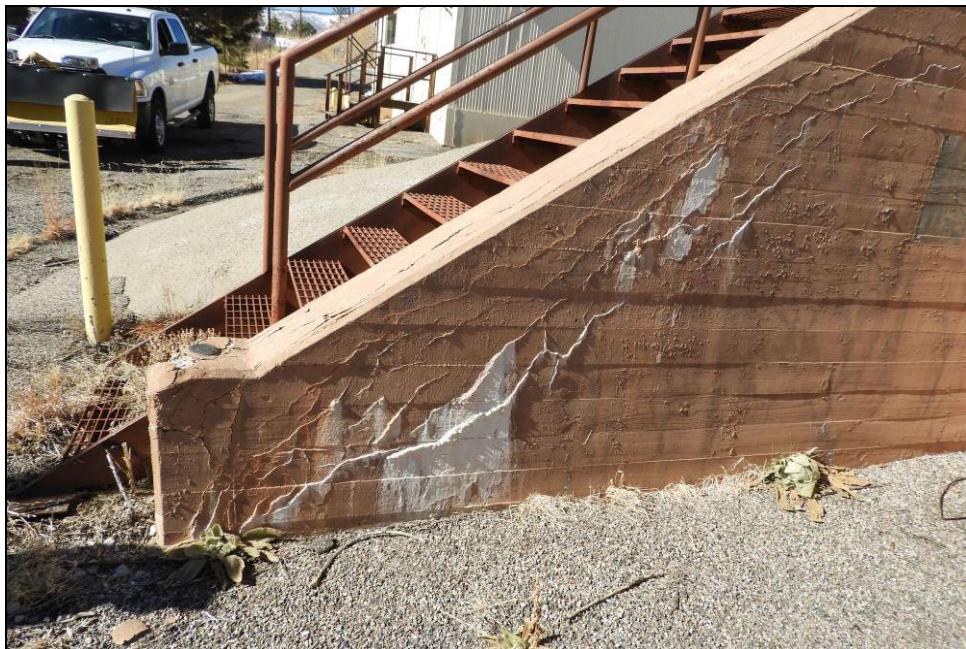
Figure 67. Efflorescence is present on the exterior of the east wing wall.

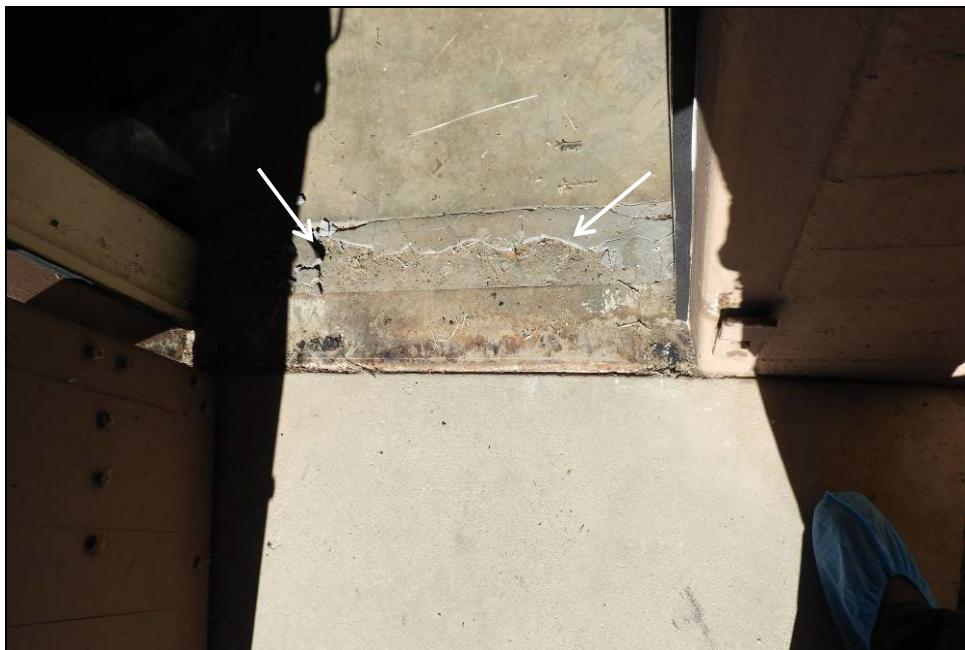
*Figure 68. Patched concrete on the interior of the threshold is worn and presents a trip hazard.*

The rest of the failing concrete should be removed; taking care not to damage the concrete threshold under the door or the original concrete underneath the patch. The initial reason for the patch is unclear, however, it may have been to reduce the height of the original threshold and prevent trip hazards when the building was in use. The recommendation for now would be not to replace the patch – only remove it, and if we find that it is required in the future, then replace it.

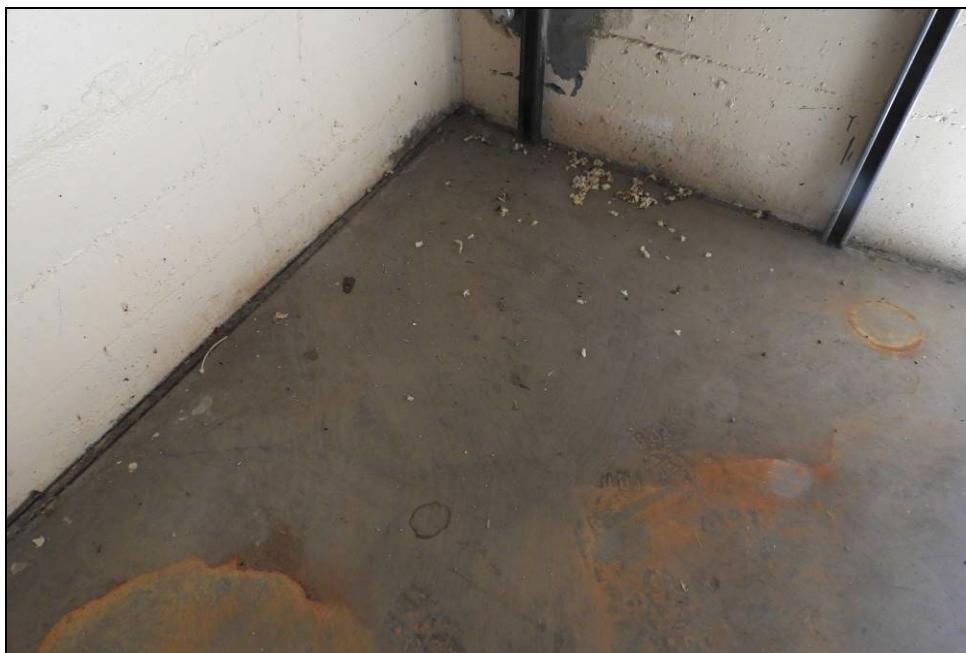
*Figure 69. Rodent debris scattered under vent and utility hole openings to the left of the entrance door.*

Sealing the envelope of the building is best way to prevent rodent access into the building. Copper wool can be used to temporarily seal around vent holes and larger-than-needed utility line holes found above the rodent debris pictured below.

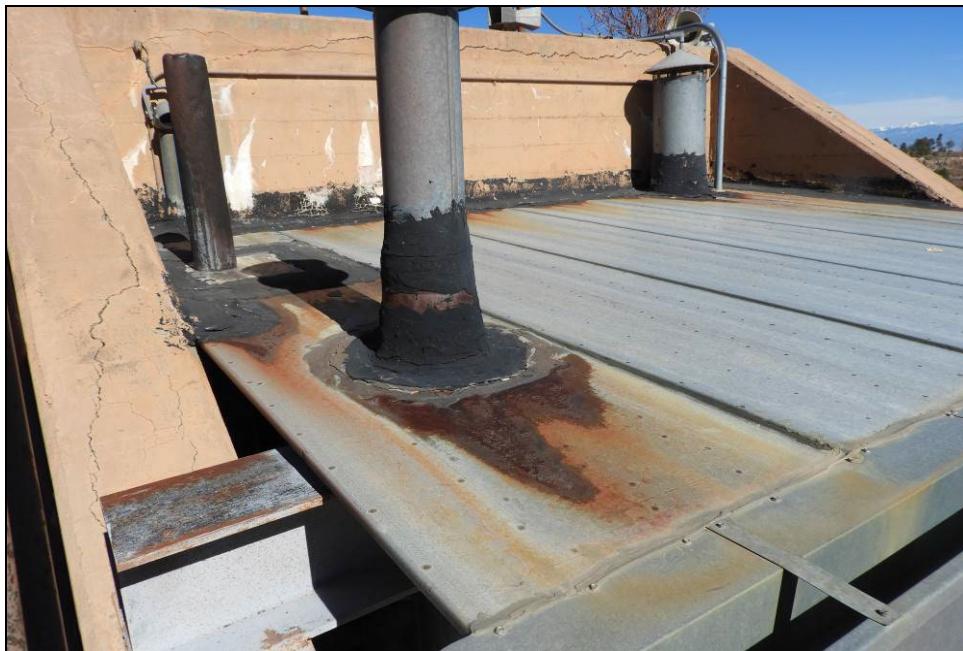
Figure 71. The age of the sealant around the points of penetration can be seen in this photo.

A new tar sealant can be applied over the top of the old sealant. Previous applications, however, were sloppy next to the original concrete and a direct application of the new sealant should avoid being placed directly on top of original fabric. A barrier that separates the sealant from the concrete is recommended.

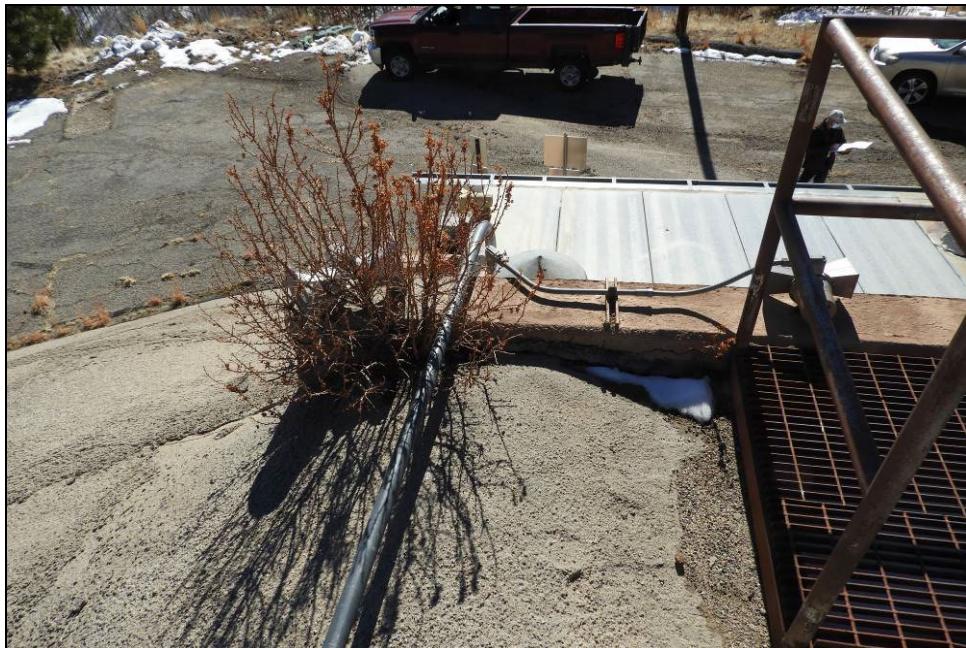
Figure 73. The shrub is growing up against the parapet and causing damage to the original architecture.

Clip the shrub as close to the ground surface as possible. Additional fill will likely be necessary to line against the adjacent parapet to help keep moisture from pooling up against the structure.

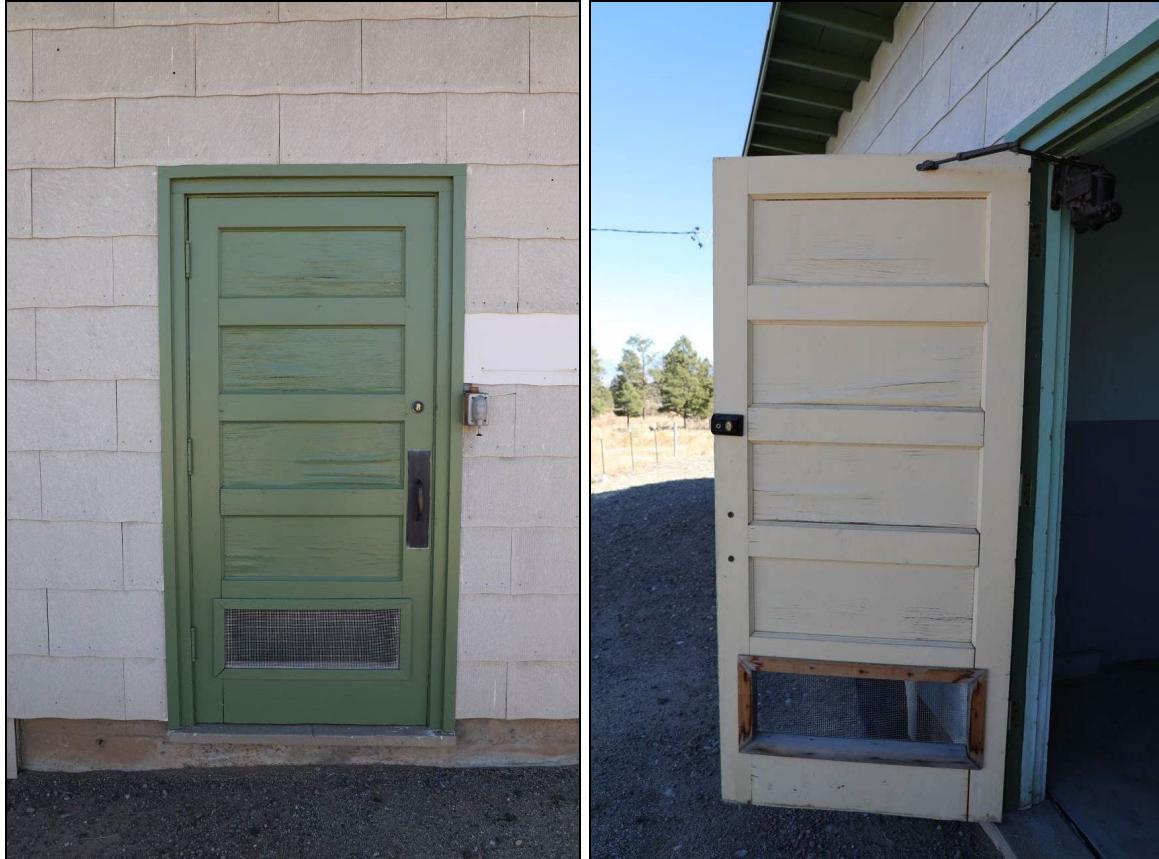
*Figure 76. Exterior and interior views of the north elevation door.*

The interior of the door should be repainted soon while the exterior can likely wait until the end of the upcoming five-year period. Prior to repainting bubbling in the panels should be removed with some light sanding. The paint over the bubbled-up areas will fail quickly.

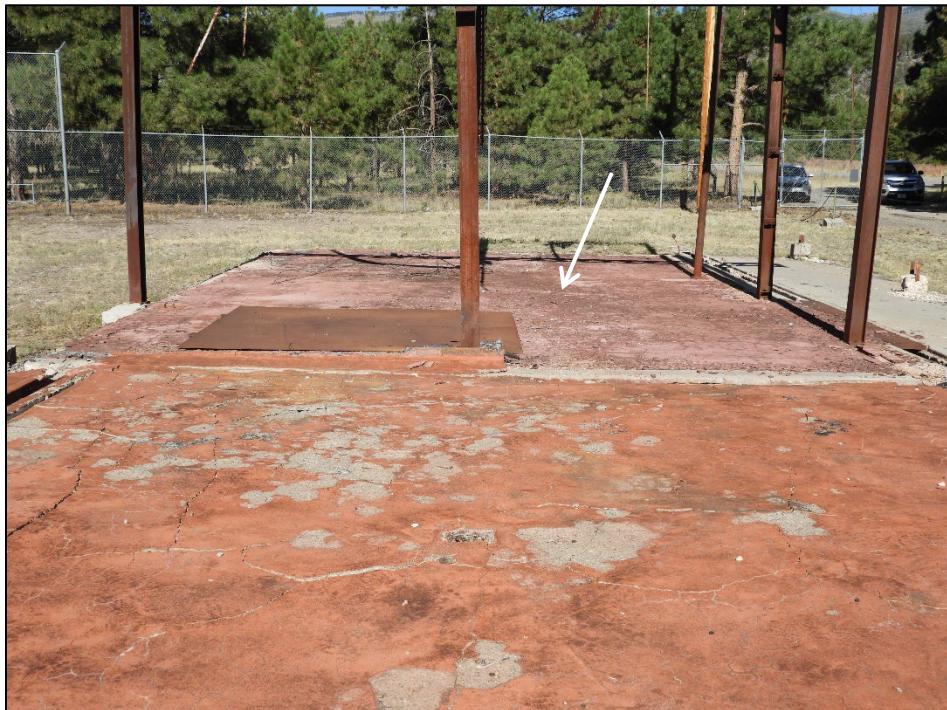
*Figure 91. The Hubbelite pad is farther pad in the photograph. Chipping and breakage is severe and likely releases low levels of asbestos into the nearby environment.*

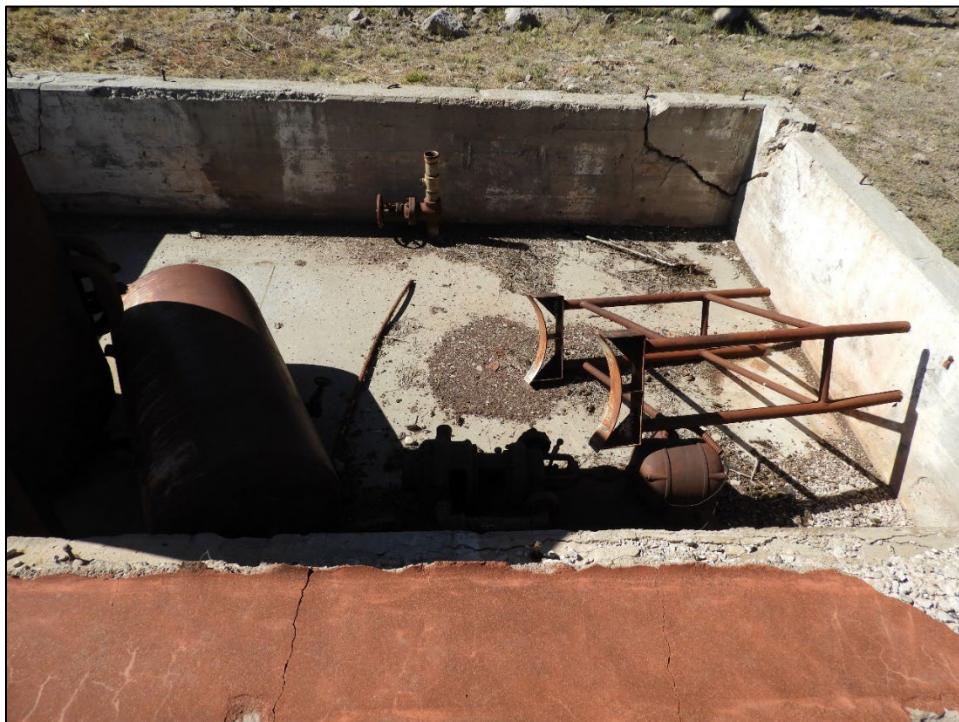
*Figure 92. Debris has collected on the surface of the floor; trapping moisture and presenting an untidy appearance.*

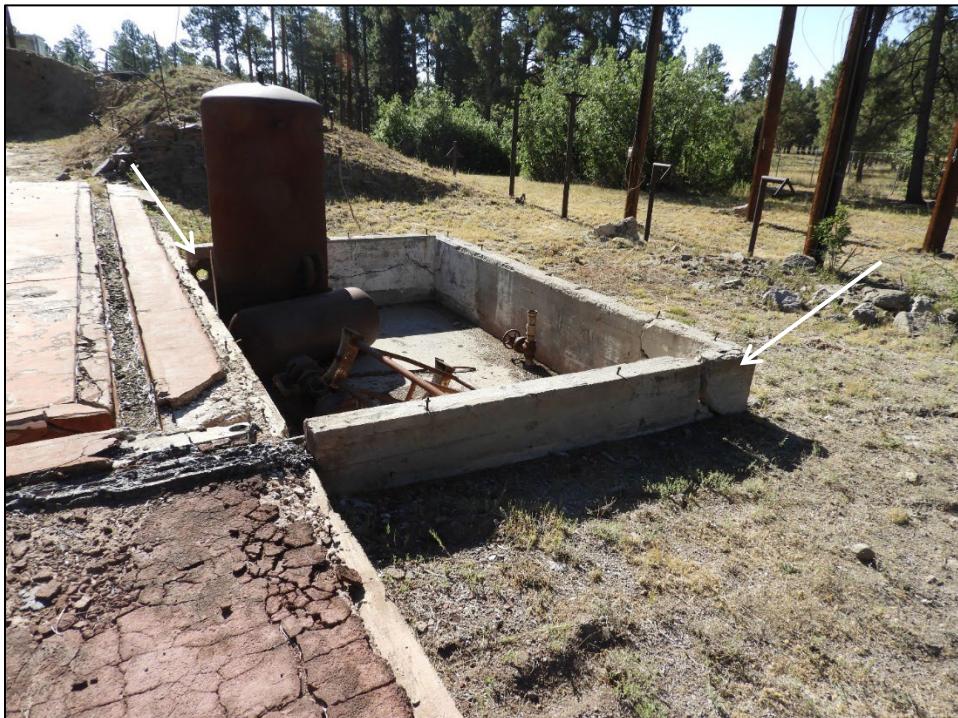
Figure 93. A larger corner separation is evident in the southwest corner and a utility hole can be seen in the northeast corner.

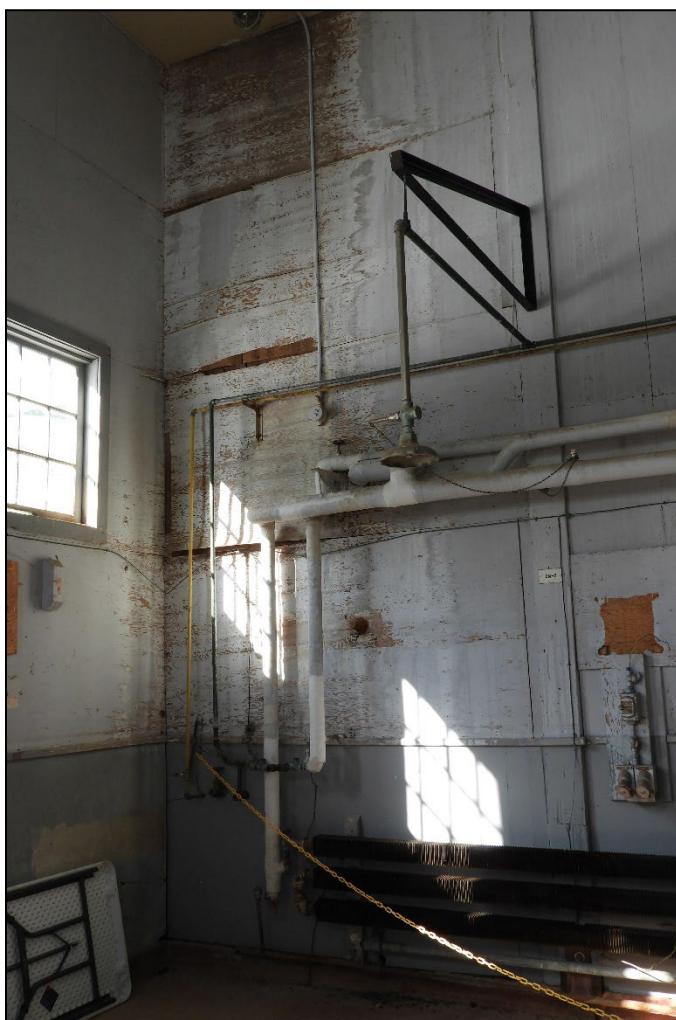
*Figure 107. Water damage from a past roof leak is evident in the southwest corner of the building.*

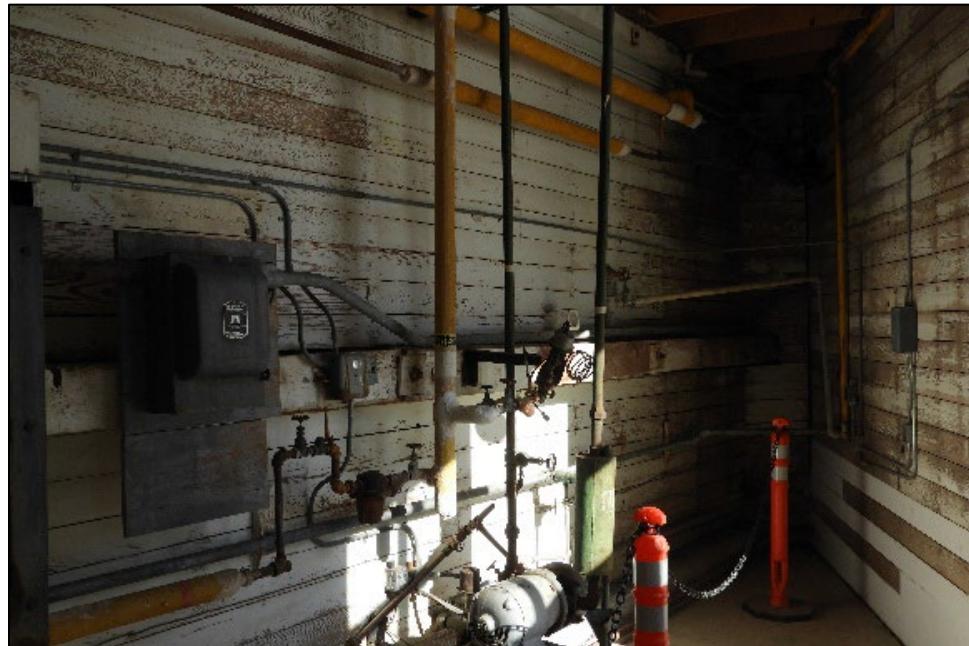
*Figure 119. Paint has worn off considerably.*

Encapsulate lead paint with historically appropriate color.

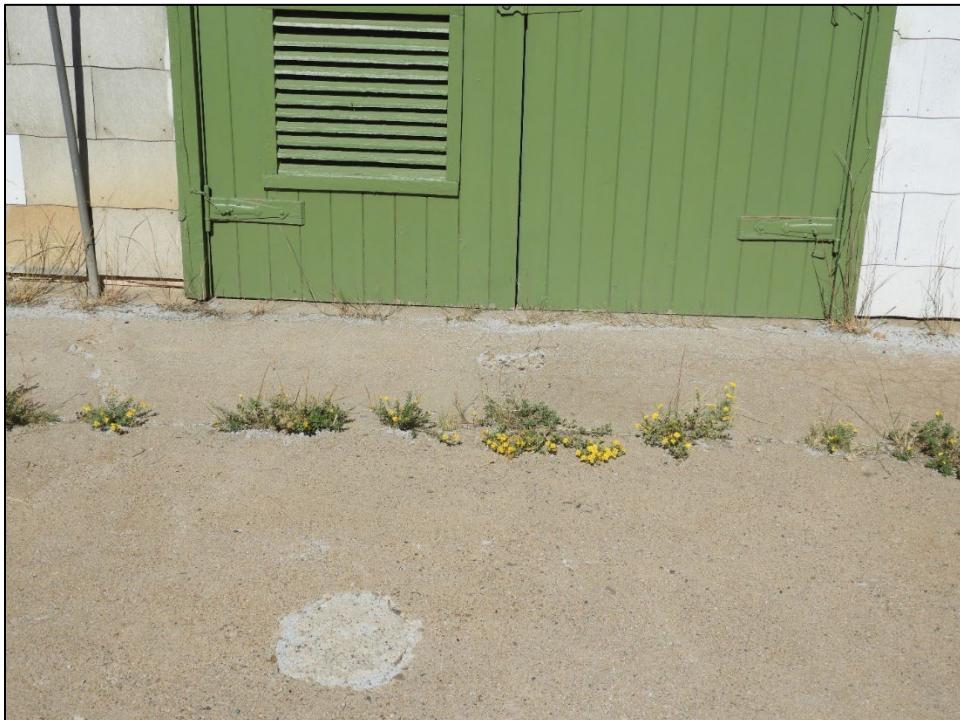
Figure 121. Damage is starting to occur at the base of both doors due to moisture penetrating the bottom of the doors.

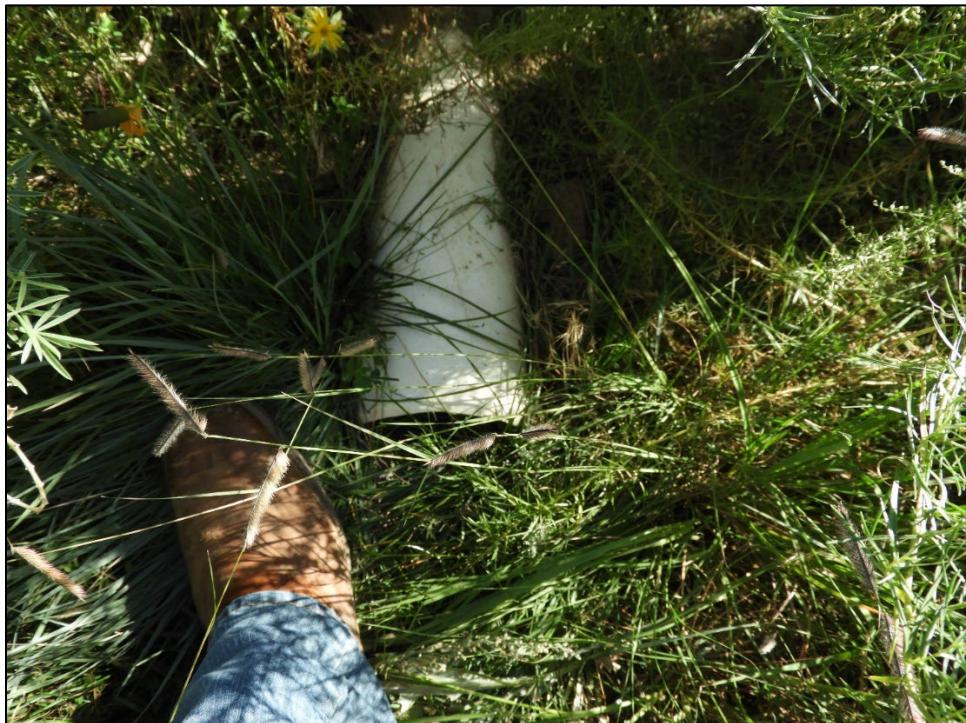
*Figure 122. Drainage pipe needs a hardware cloth cover that can be easily removed if clogging occurs.*
