**Title:** Historic Buildings Report: Five-Year Preservation Planning for Manhattan Project National Historical Park Sites

# **Historic Buildings Report: Five-Year Preservation Planning for Manhattan Project National Historical Park Sites**

**Fiscal Years 2022 - 2026**

Historic Building Report No. 394  
Survey No. 1257

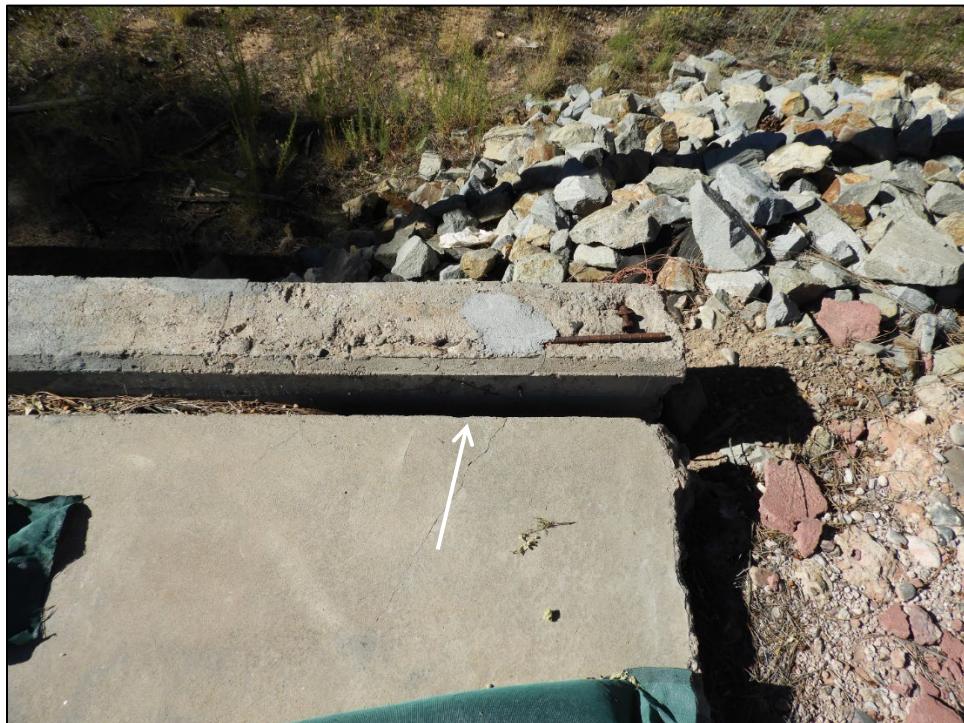
*Figure 127. The photo shows the slab separation from the stem wall from above.*

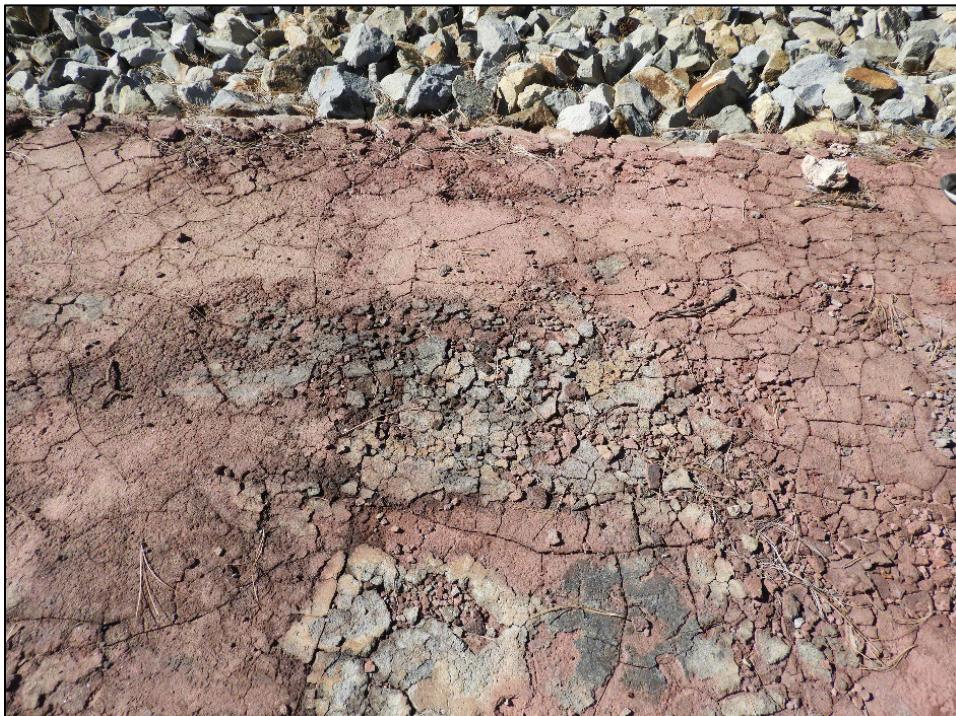
*Figure 132. Cracking and general deterioration of the Hubbelite are severe.*

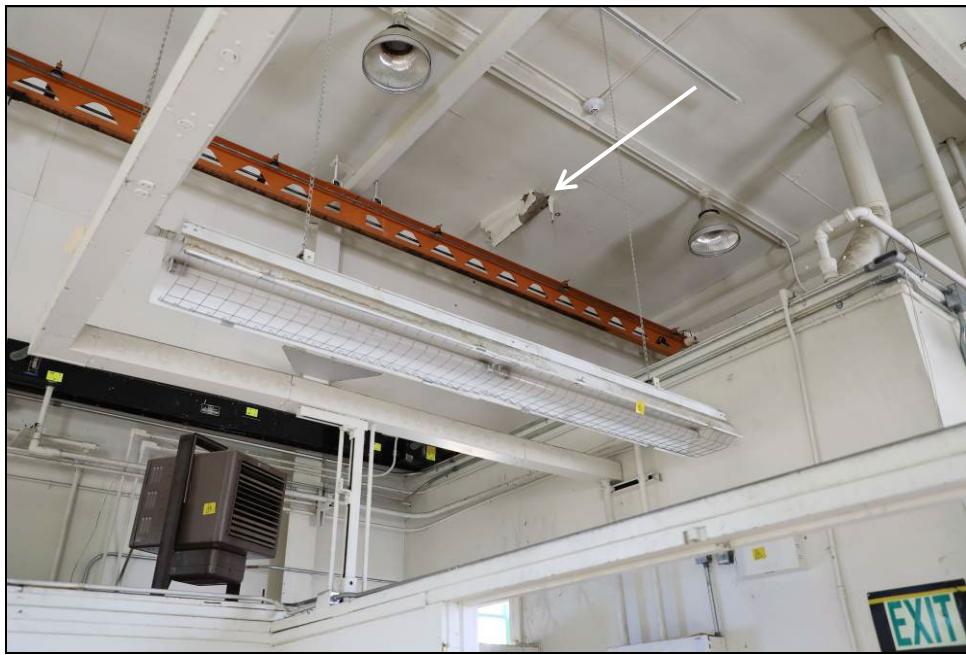
Figure 164. This damage can be seen on the western side of the building.

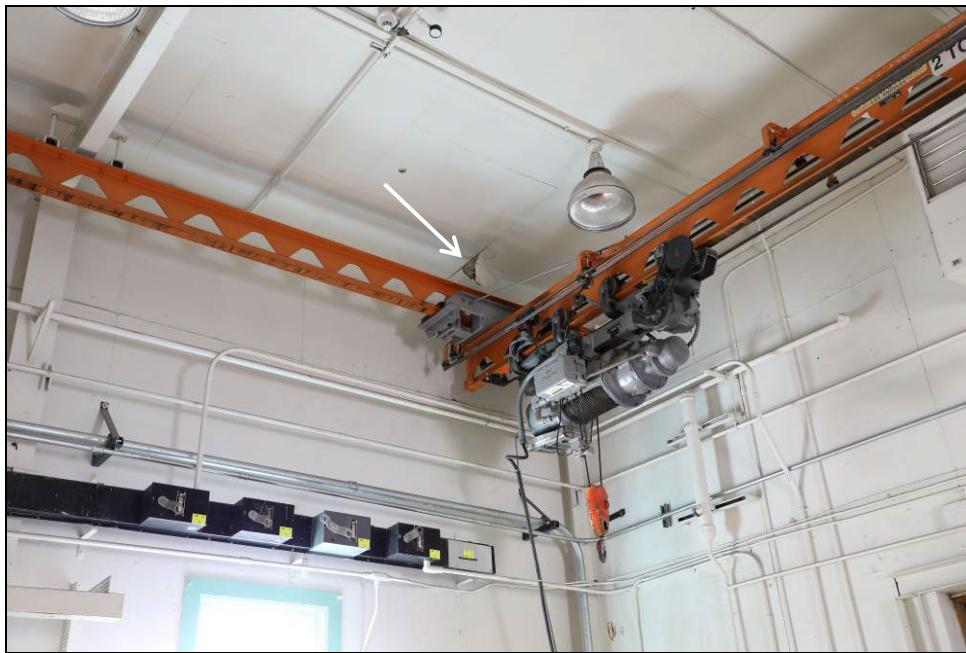
Figure 165. Previous roof leak damage on the southeast portion of the ceiling.

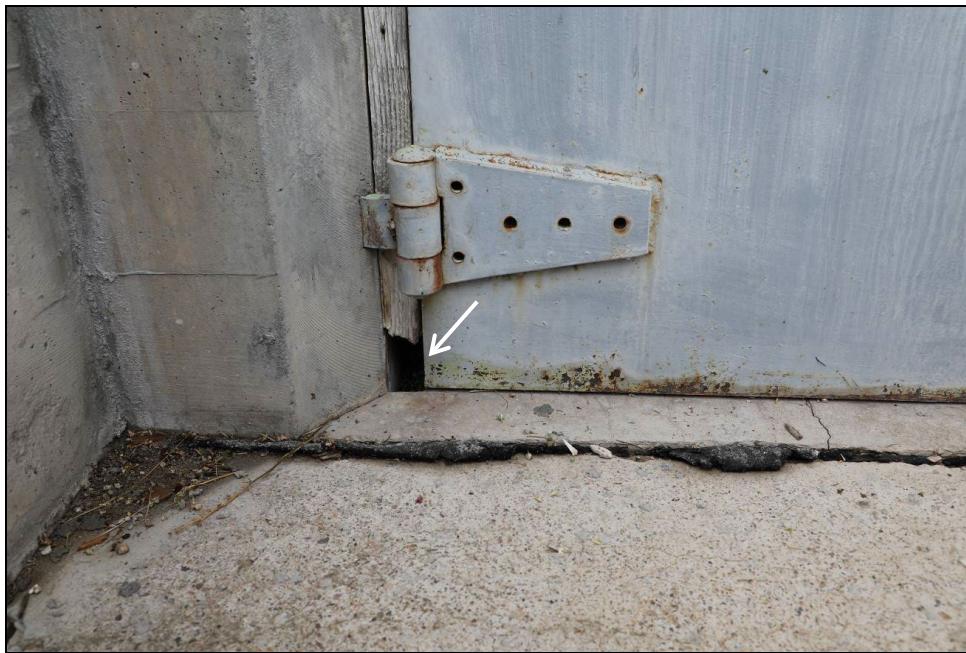
Figure 169. Close-up view of the missing piece of the frame.

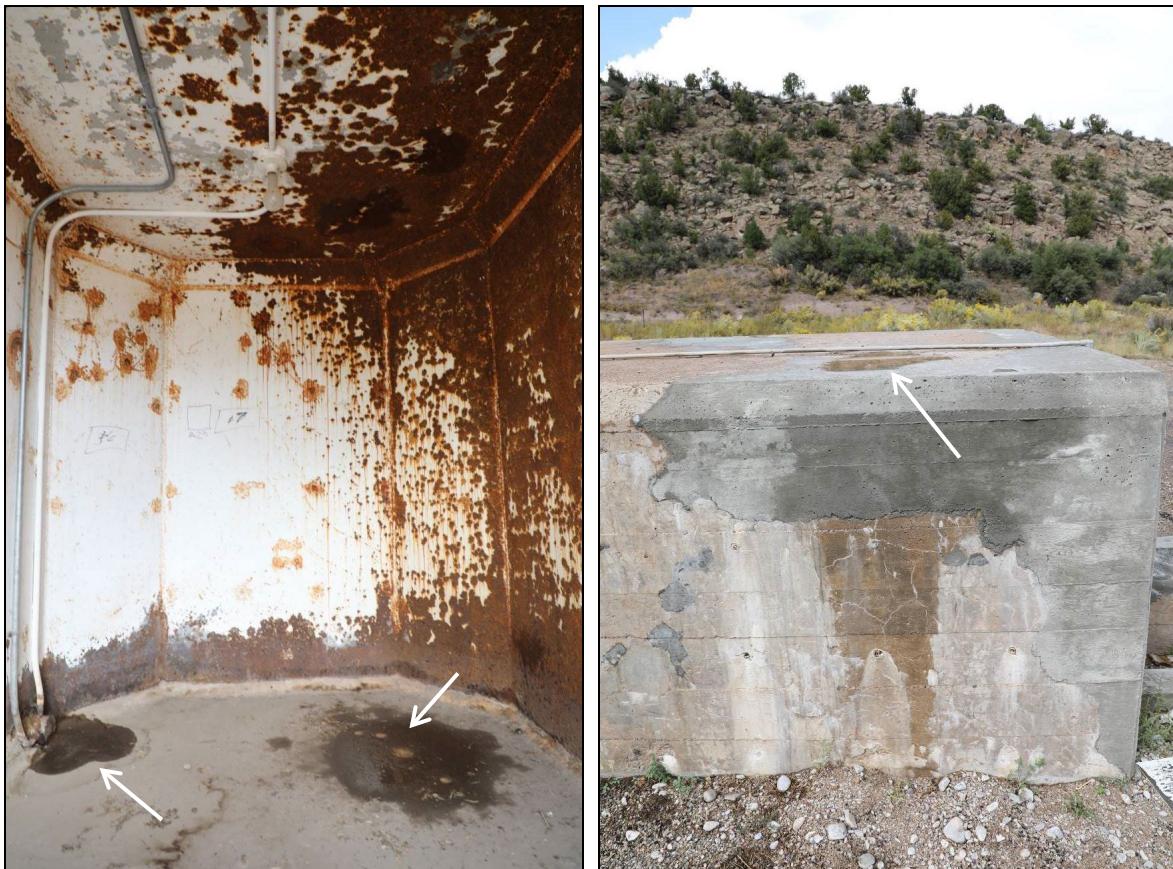
Figure 175. Photographs show active leaks and standing water on the roof.

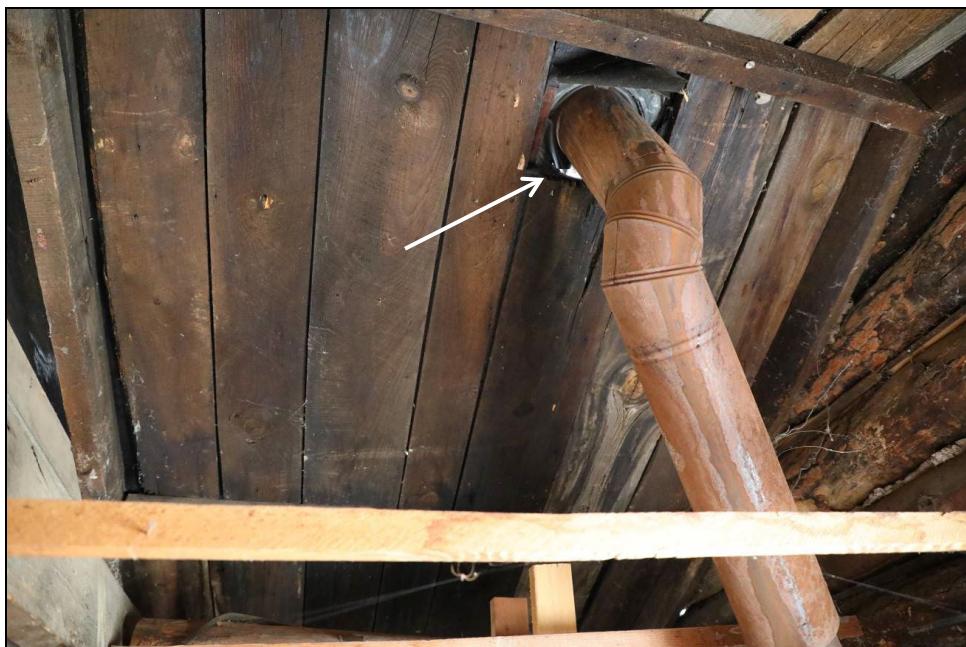
Figure 182. Arrow points to daylight as seen around the stovepipe penetration from the inside of the cabin.

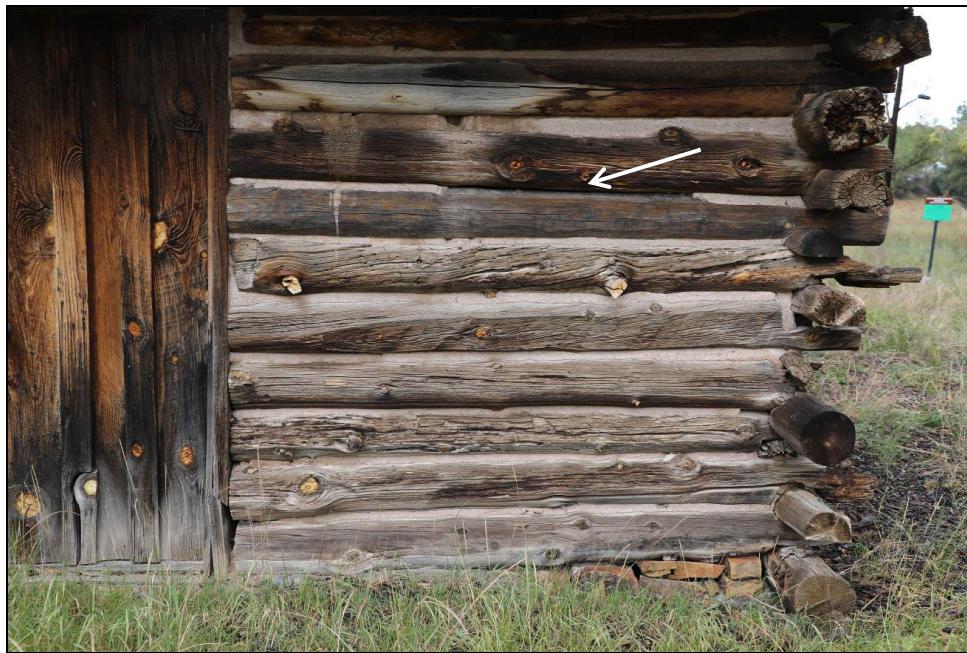
Figure 184. Daubing has also eroded from this area.

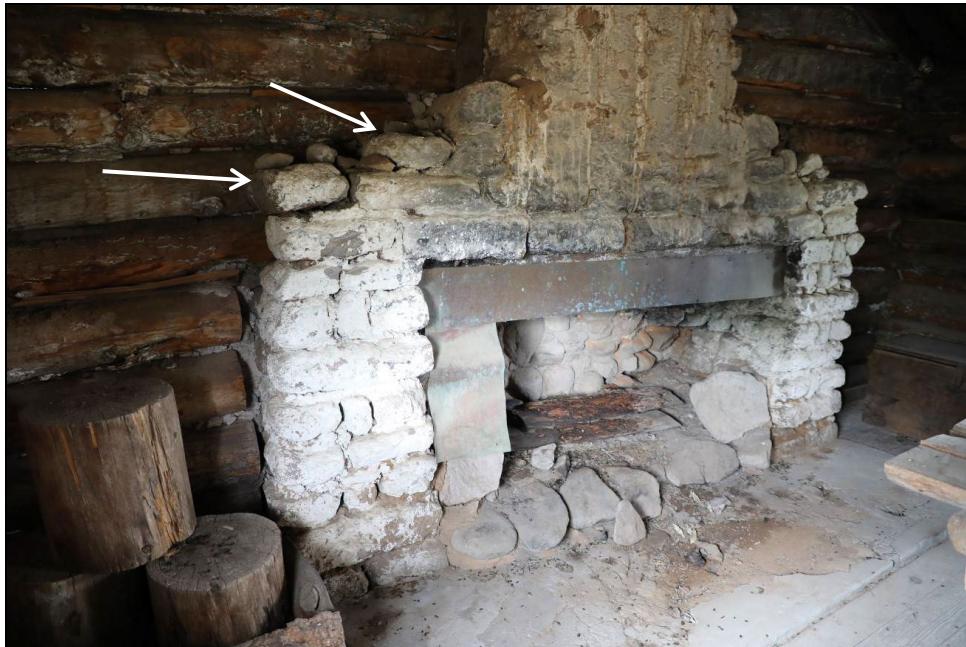
*Figure 190. Arrows point to the loose stone visible in the photograph.*

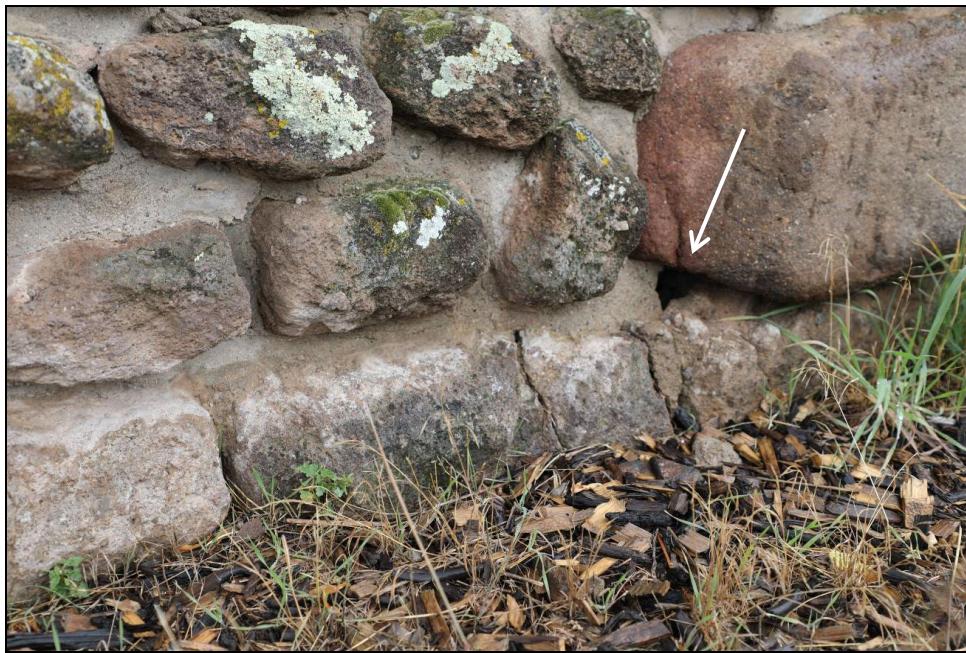
Figure 191. Minor voids can also be found on the exterior of the chimney.

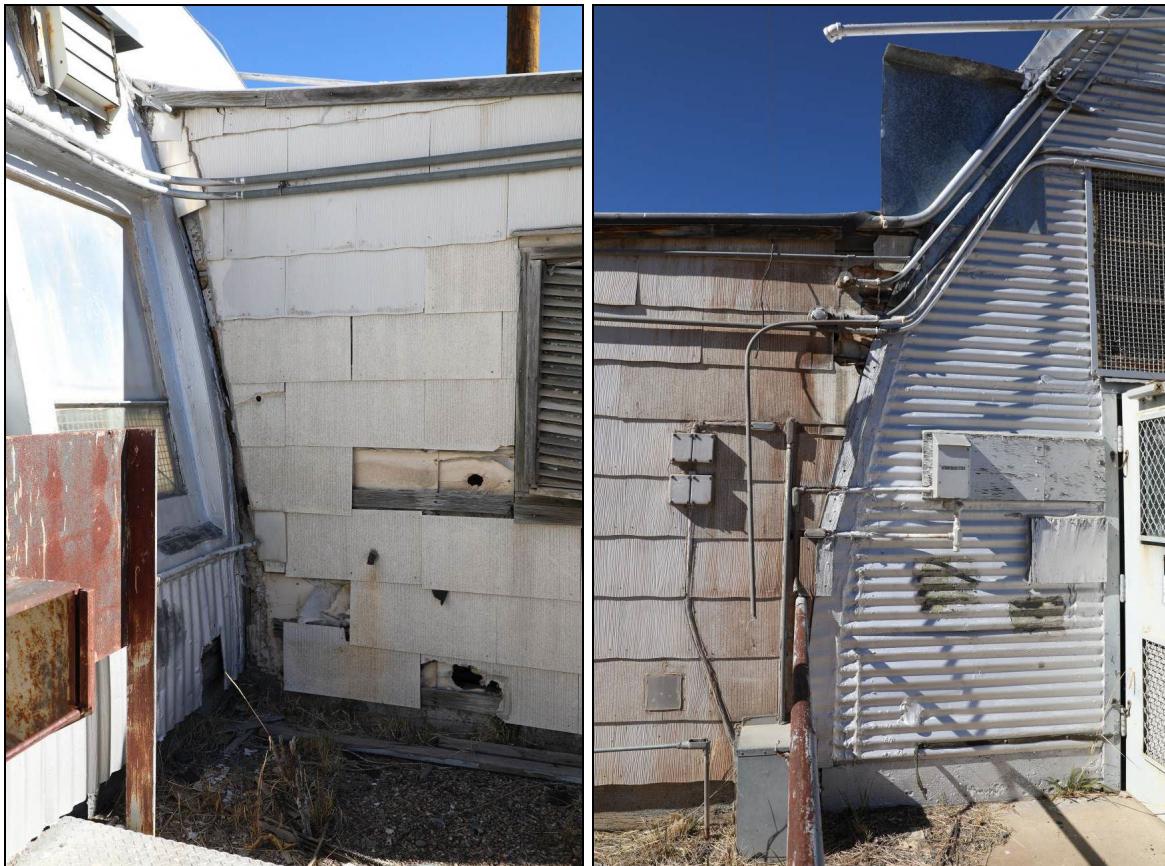
*Figure 204. The utility annex has separated from the main building.*

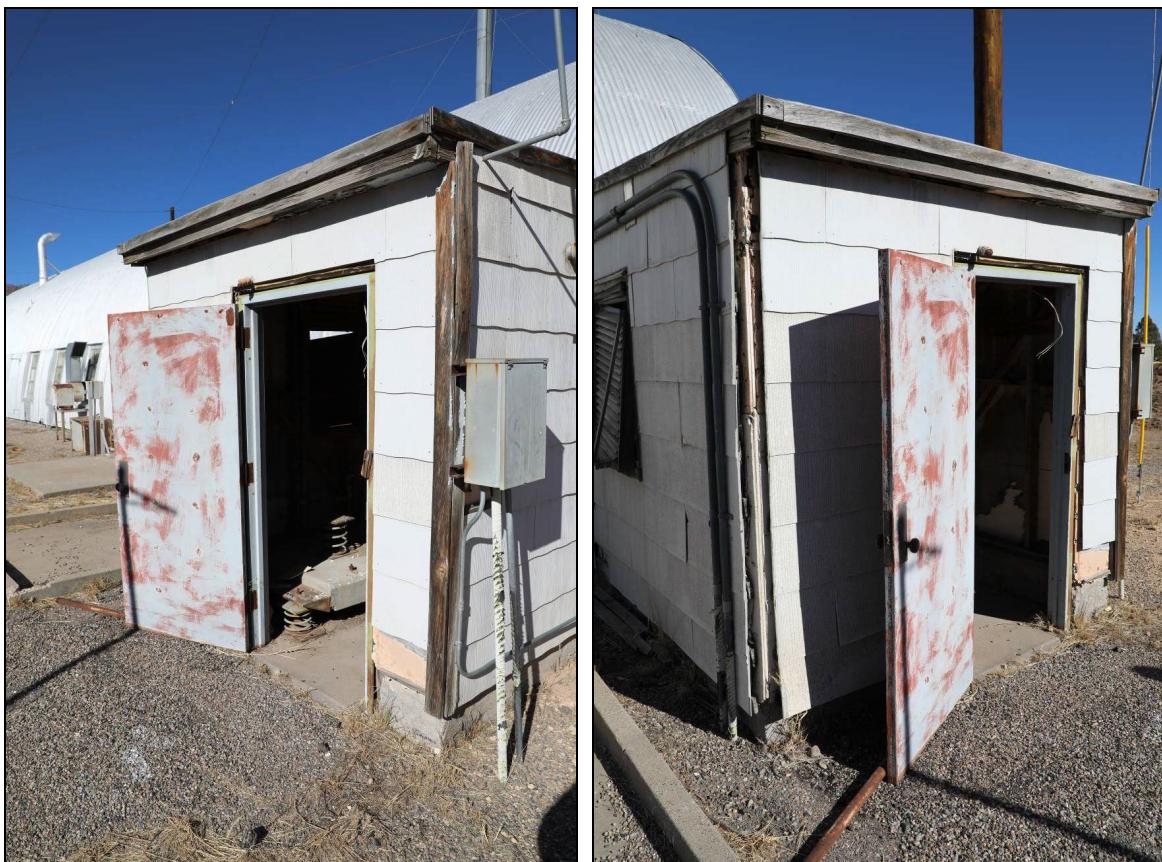
*Figure 206. The door trim will require extensive work due to a long period of neglect.*

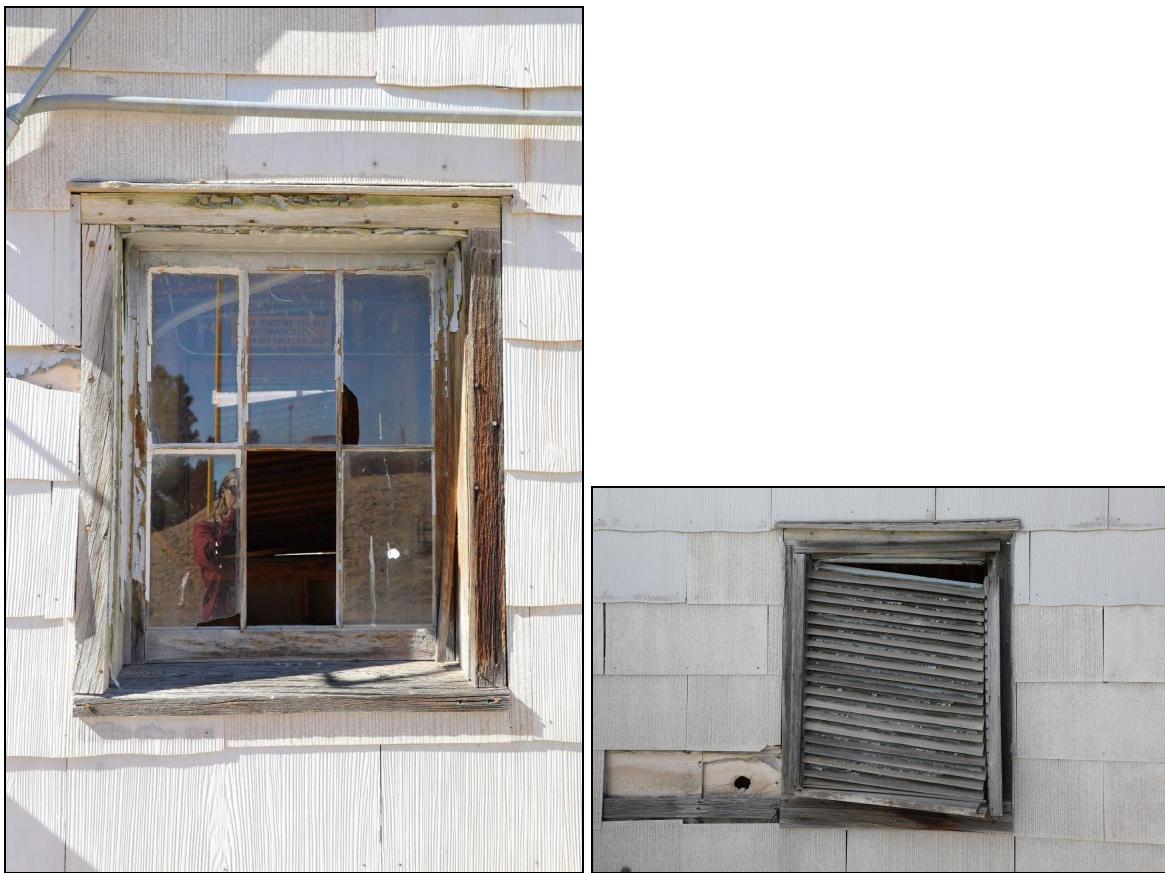
Figure 207. The east elevation window opening (left) and the west elevation opening (right) will require extensive work.
