Crevice Corrosion in Seawater Using CFRP Composite as Part of a Novel Crevice Former

F. Presuel-Moreno*, B. A. Hernandez-Sanchez**,

Materials Challenges for Marine Renewables

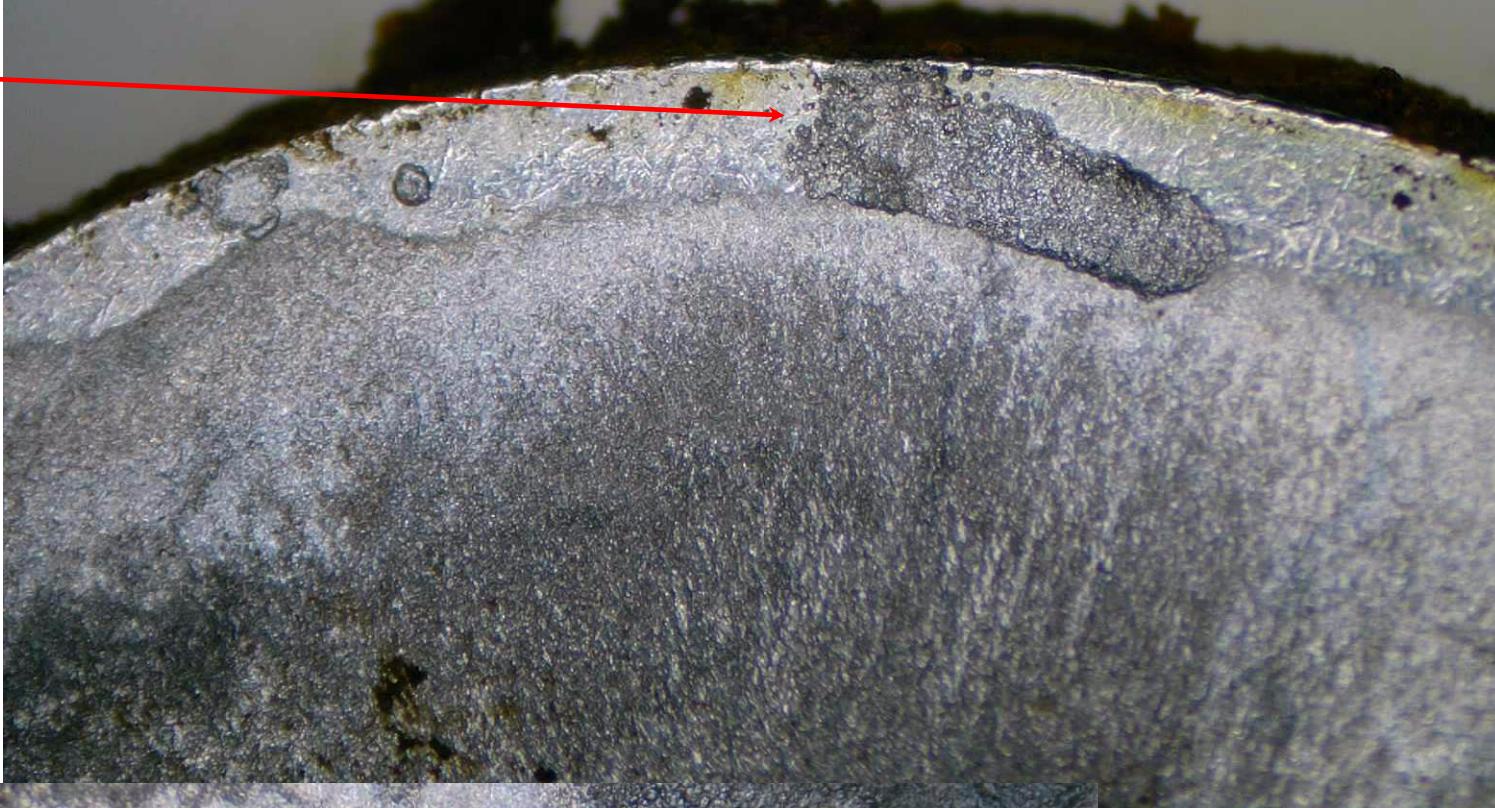
Stainless Steel Washers in contact with the CFRP composite, top row smooth side, bottom row rough side

C1

C2

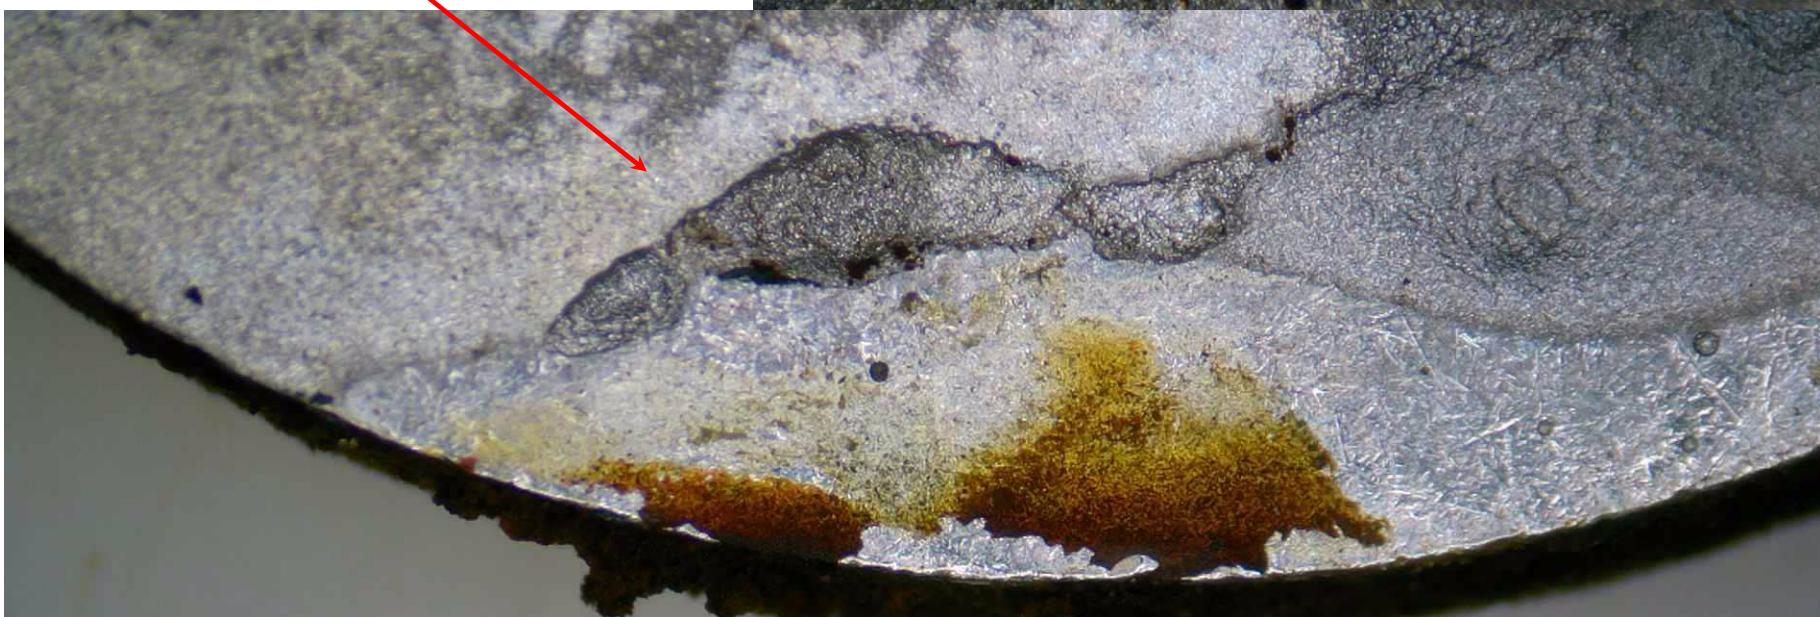
806 days
Washer in contact with
smooth composite

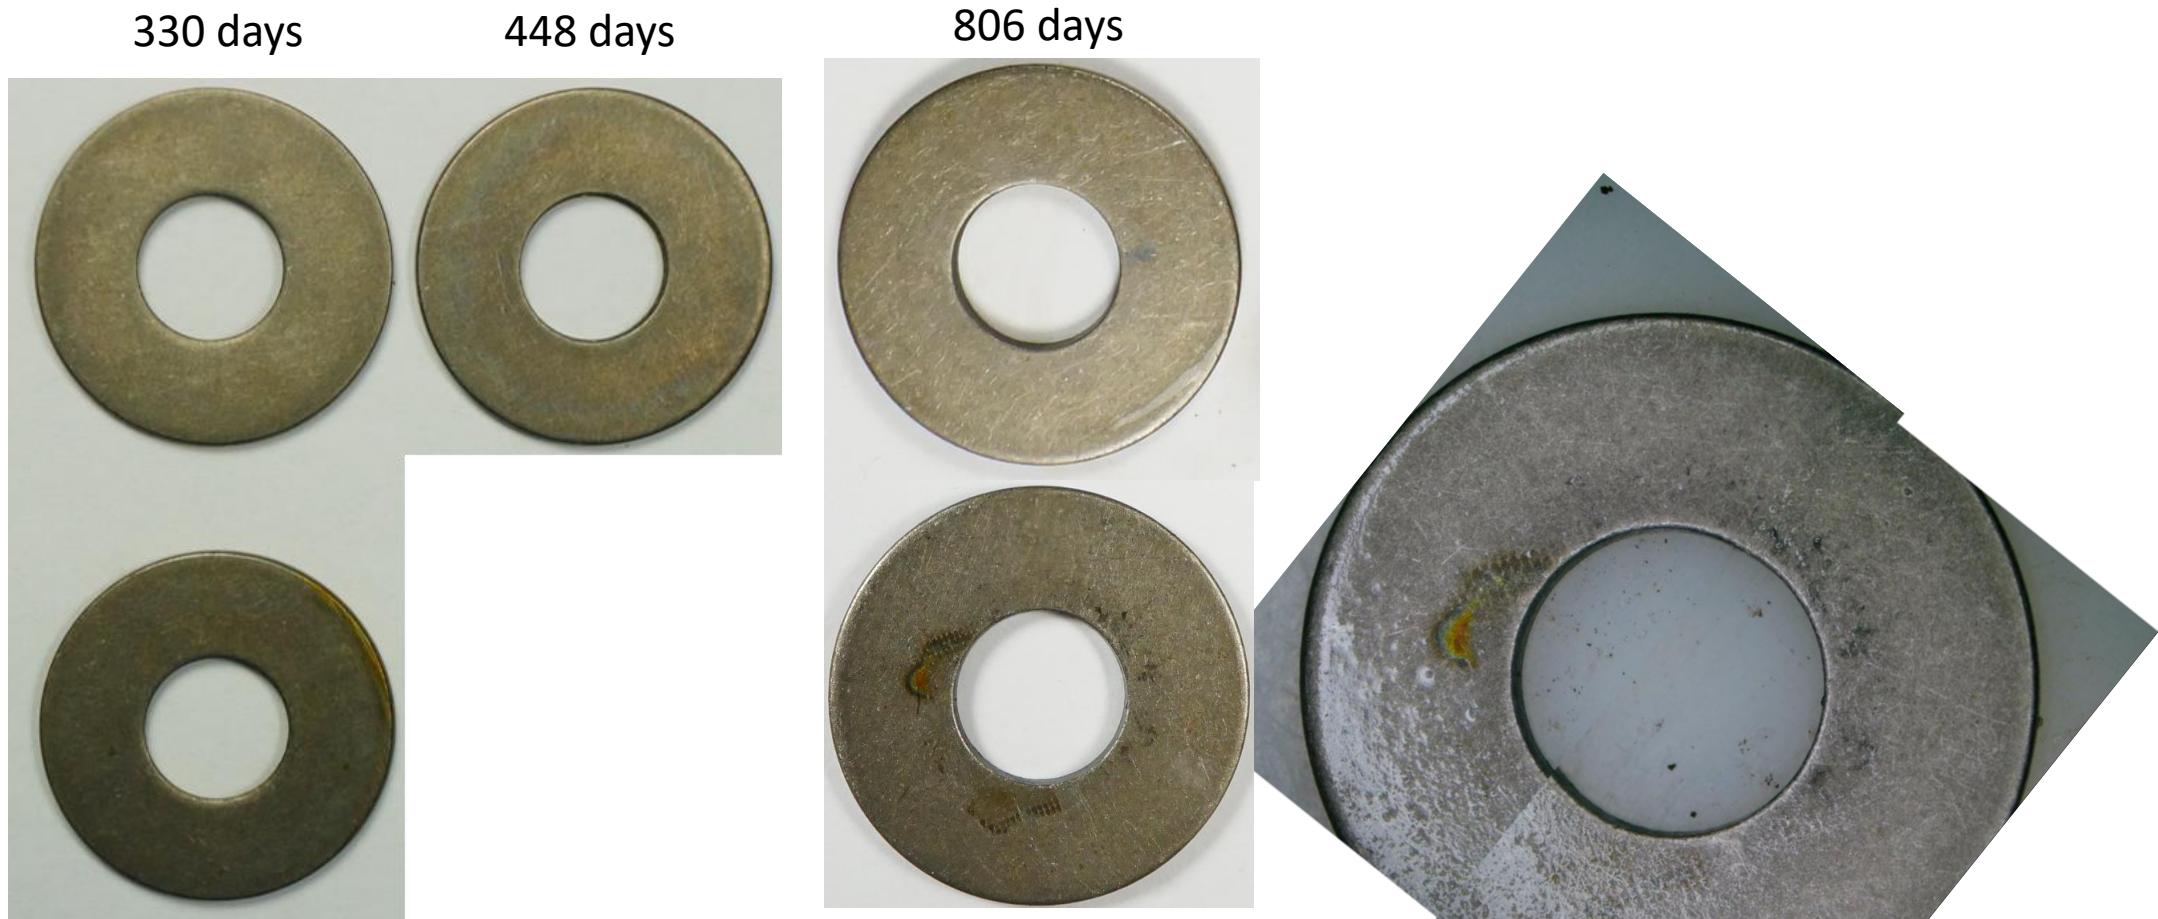
Ti washer surfaces in contact with the CFRP composite, top row smooth side, bottom row rough side

No corrosion took place on the Titanium washers within the time monitored

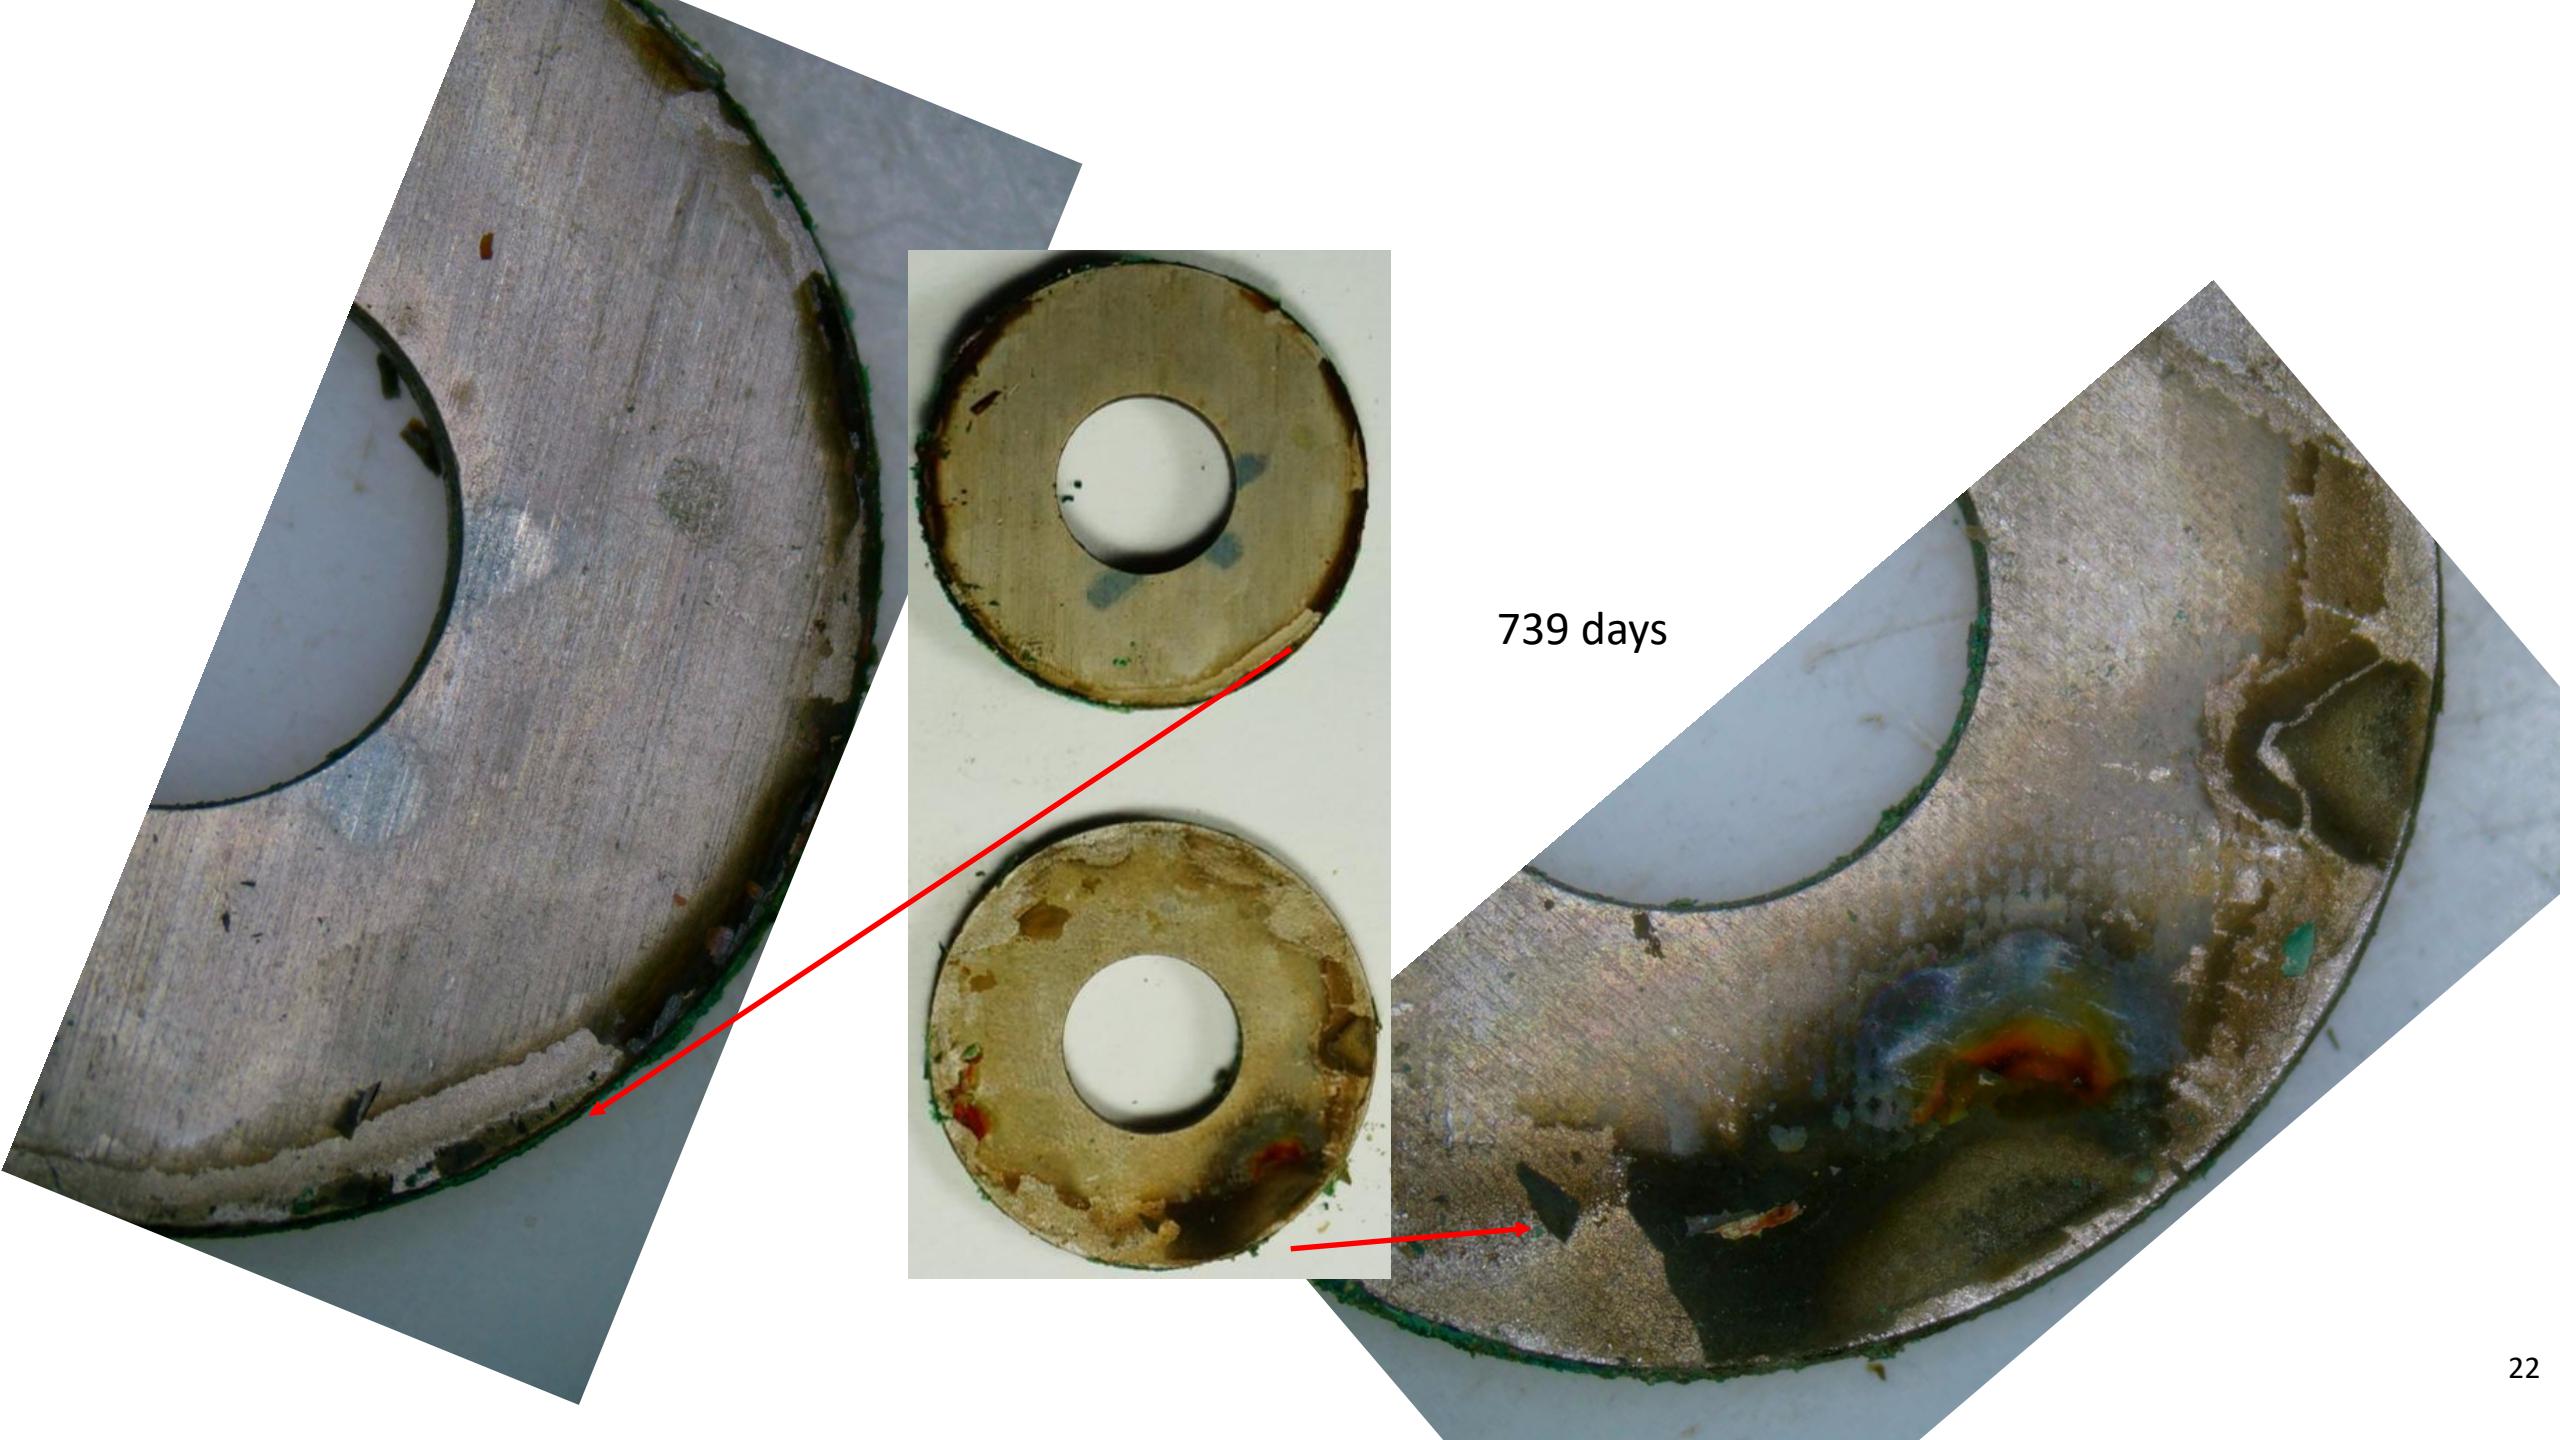
Monel Washers in contact with the CFRP composite, top row smooth side, bottom row rough side

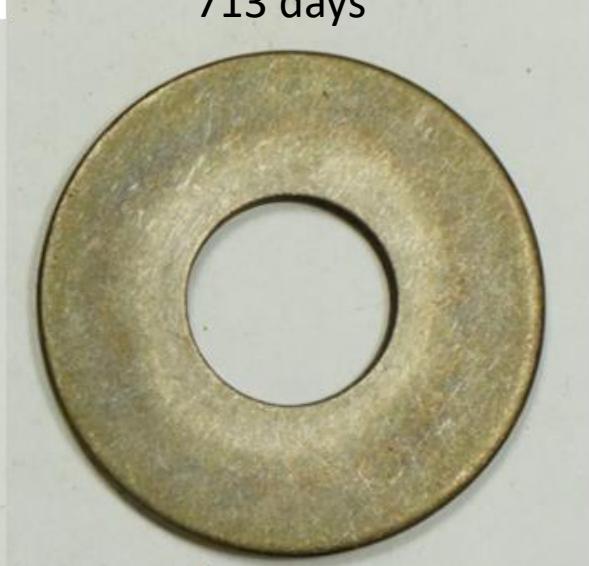
Washers in contact with the Hybrid composite, top row – bolt side, bottom row –nut side

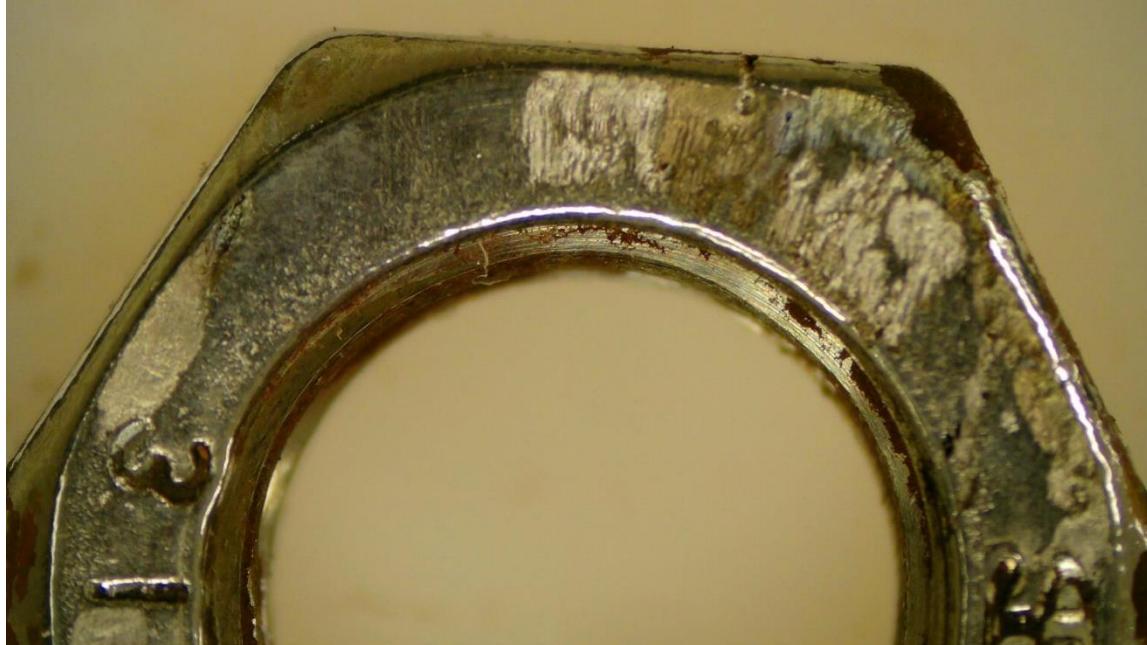
Example of a C3 site (crevice corrosion between nut and washer surfaces)

Nut side in contact with washer

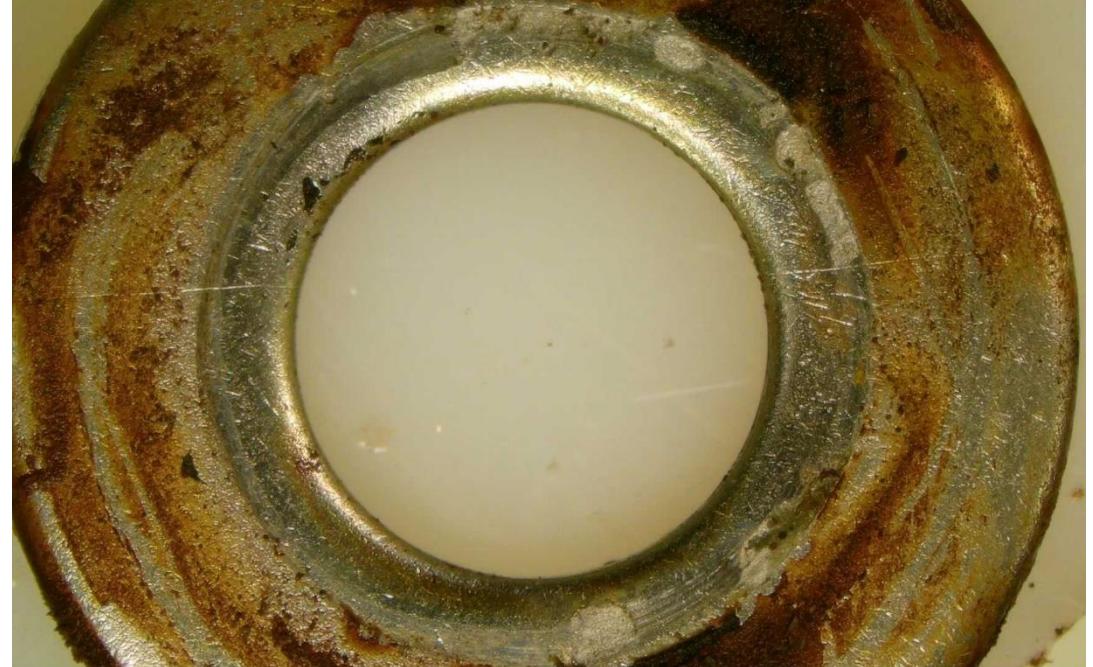
Washer in contact with nut

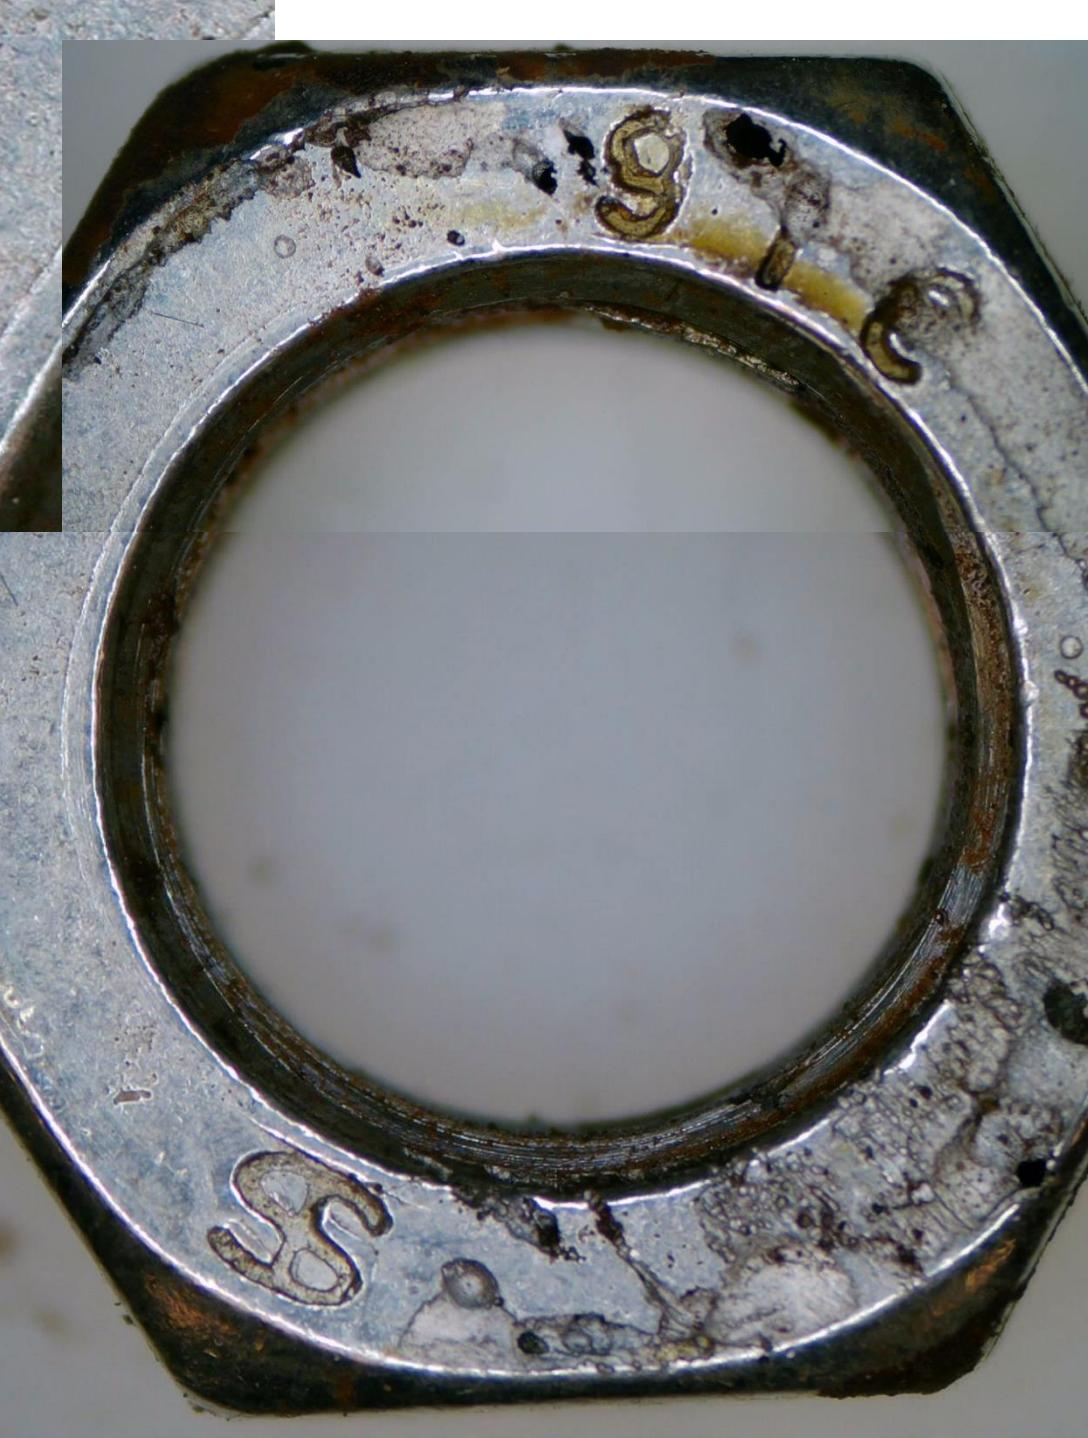
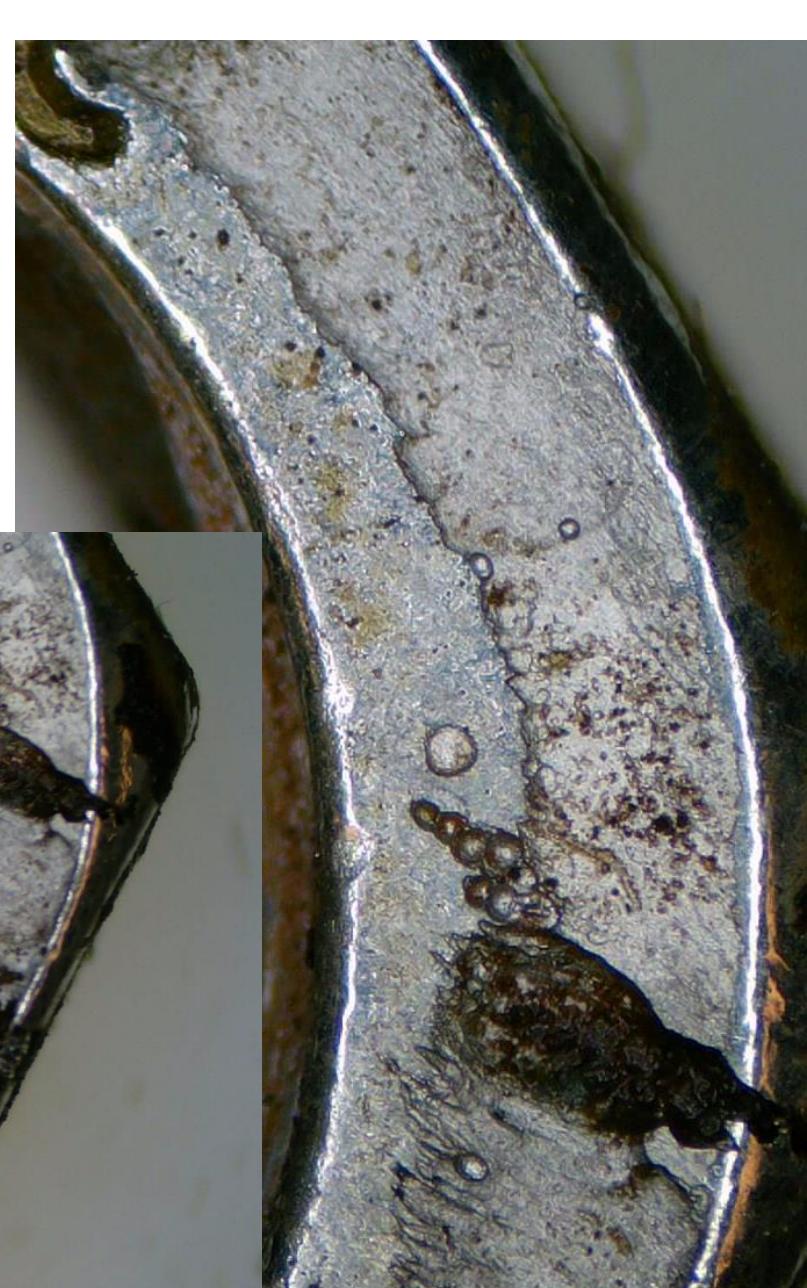
Example of a C3 site
(crevice corrosion
between nut and
washer surfaces)

Elevated Temperature –
Stainless Steel (652 days)

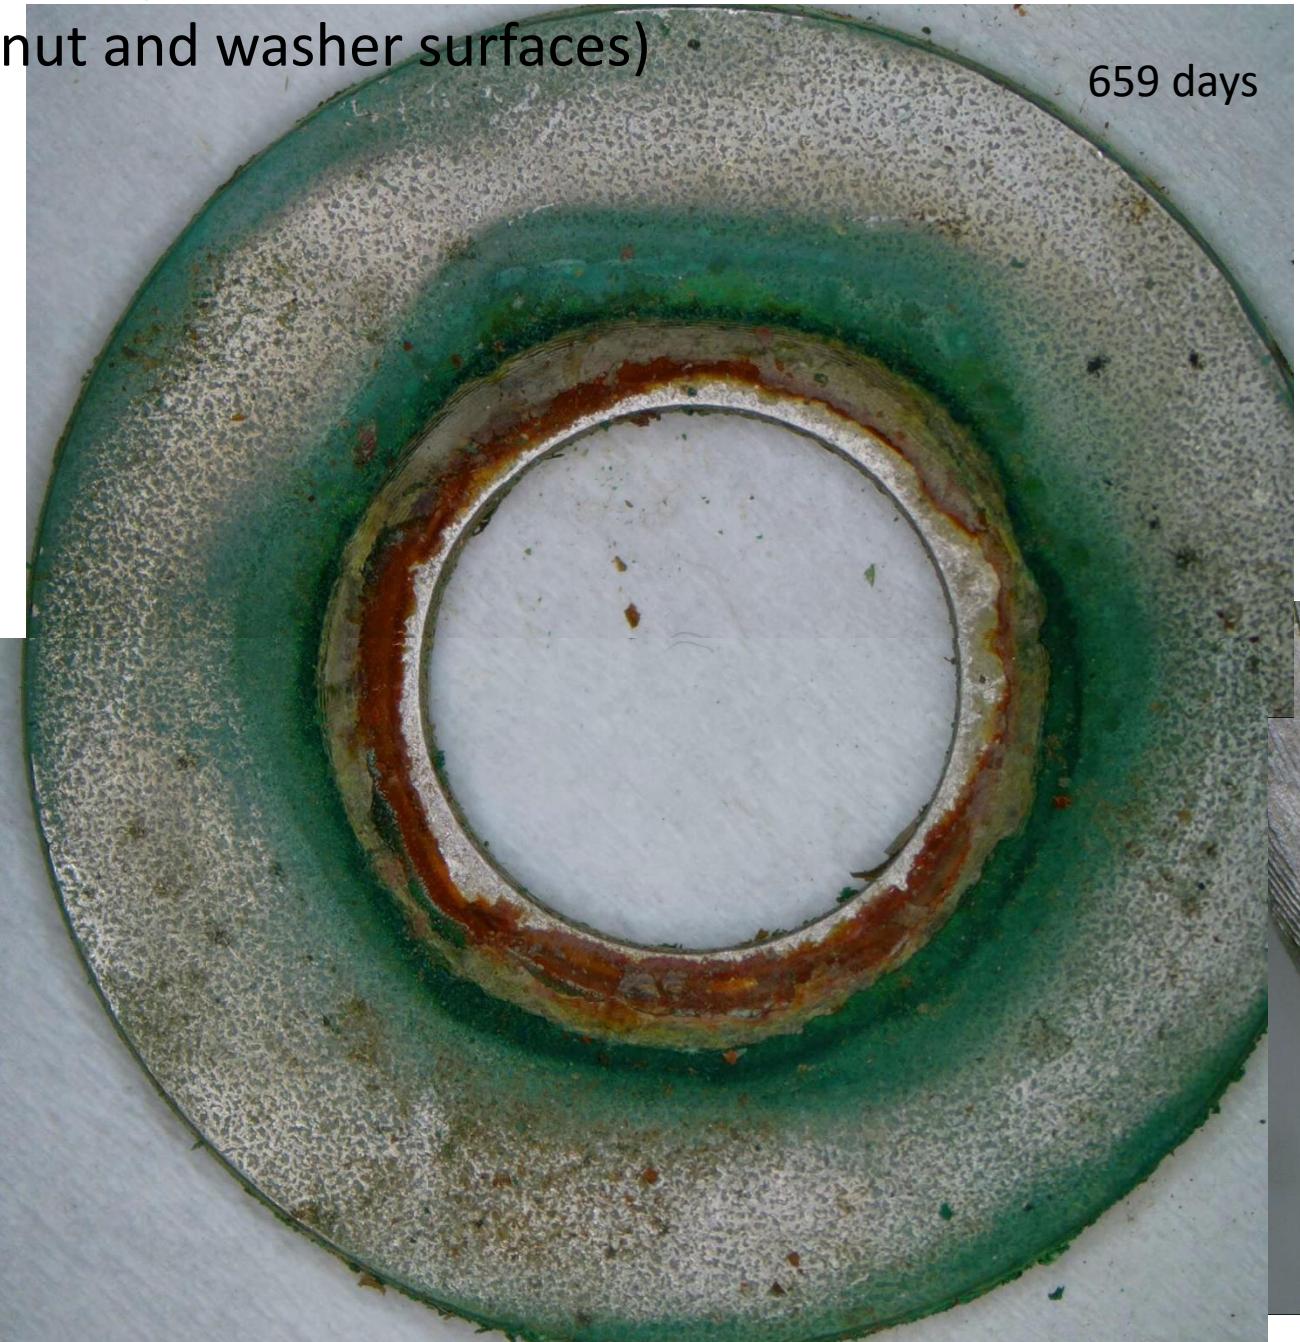
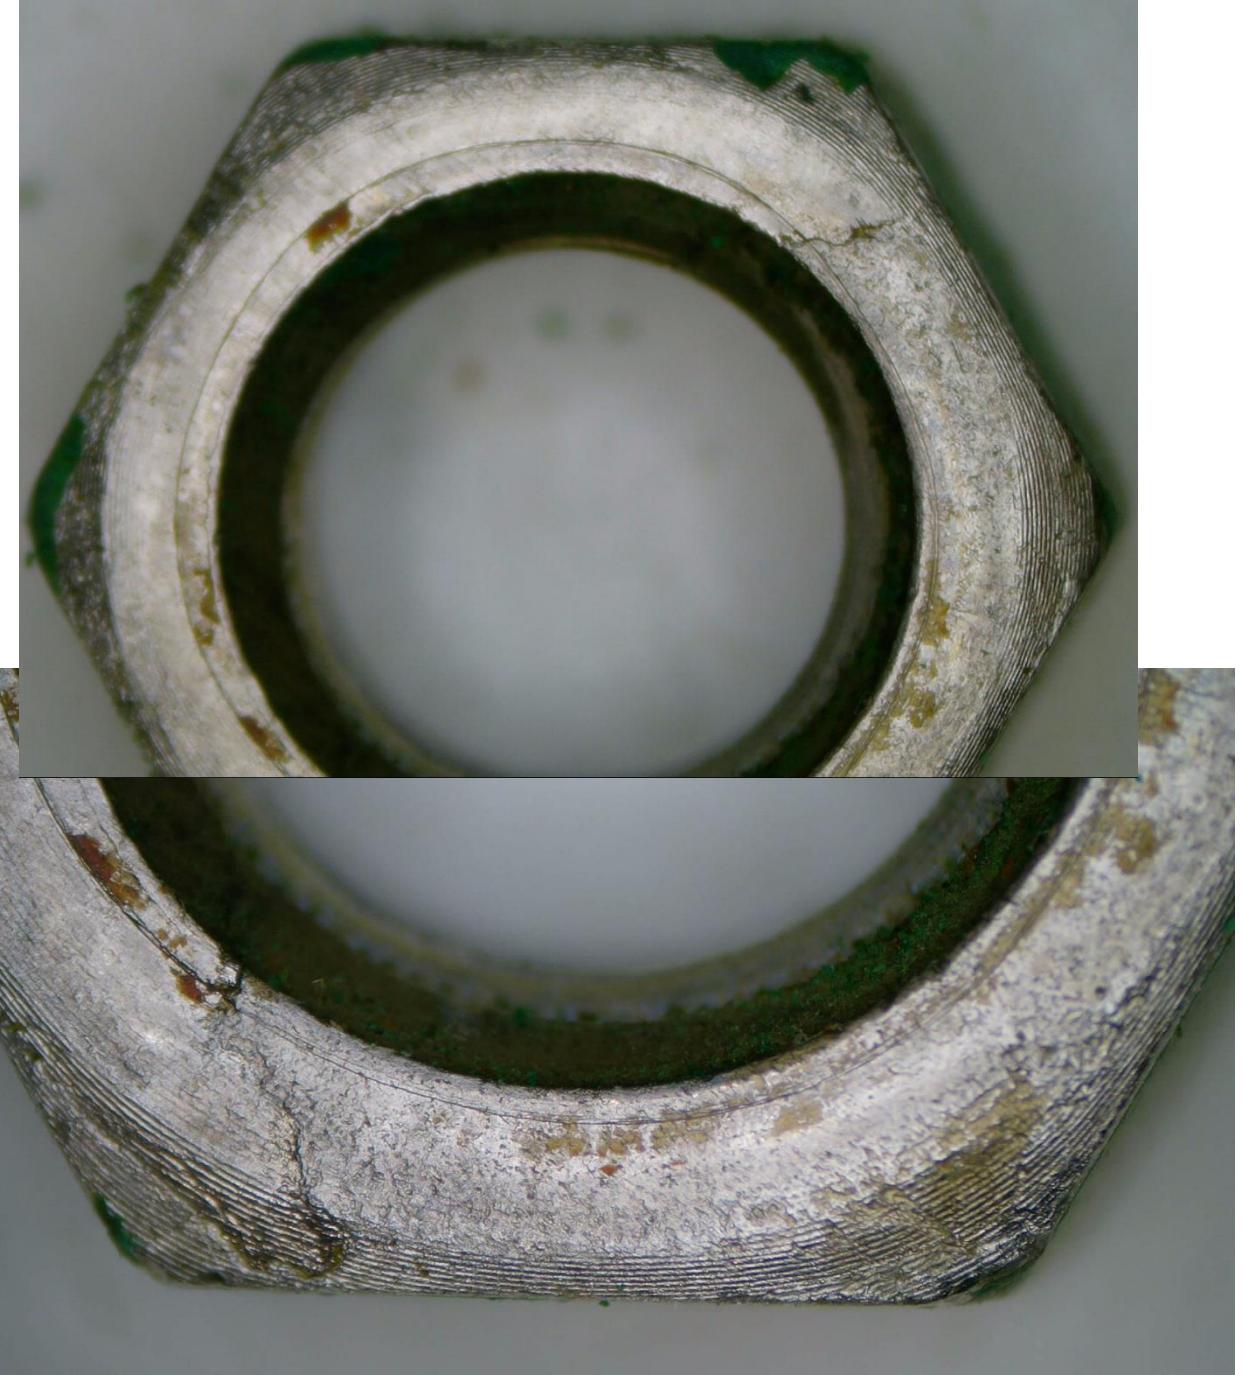
Example of a C3 site (crevice corrosion between nut and washer surfaces)

659 days

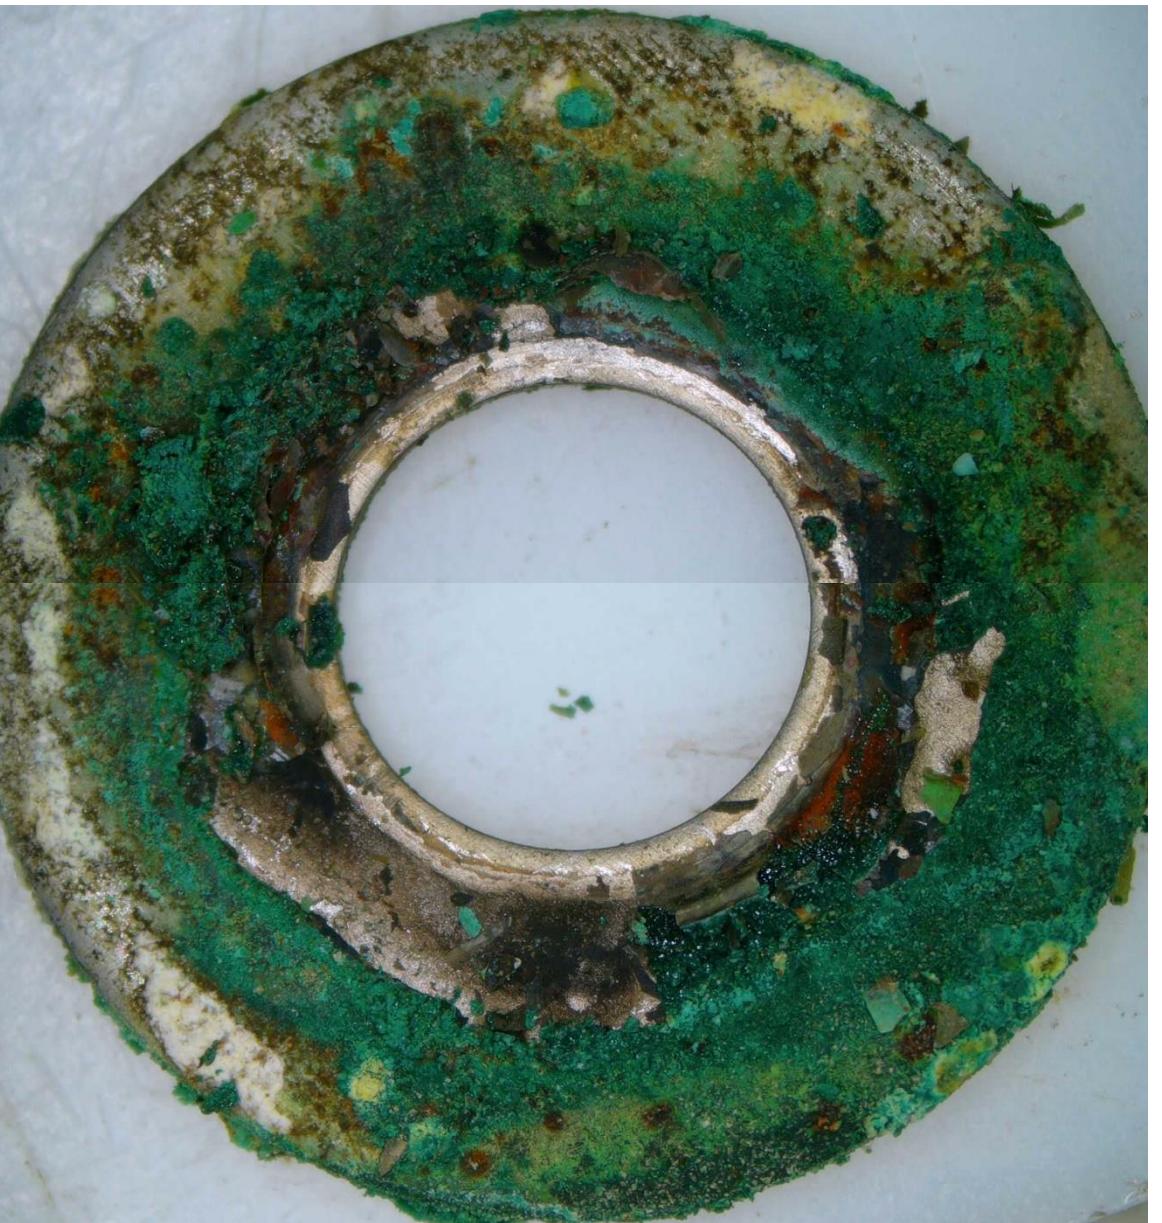
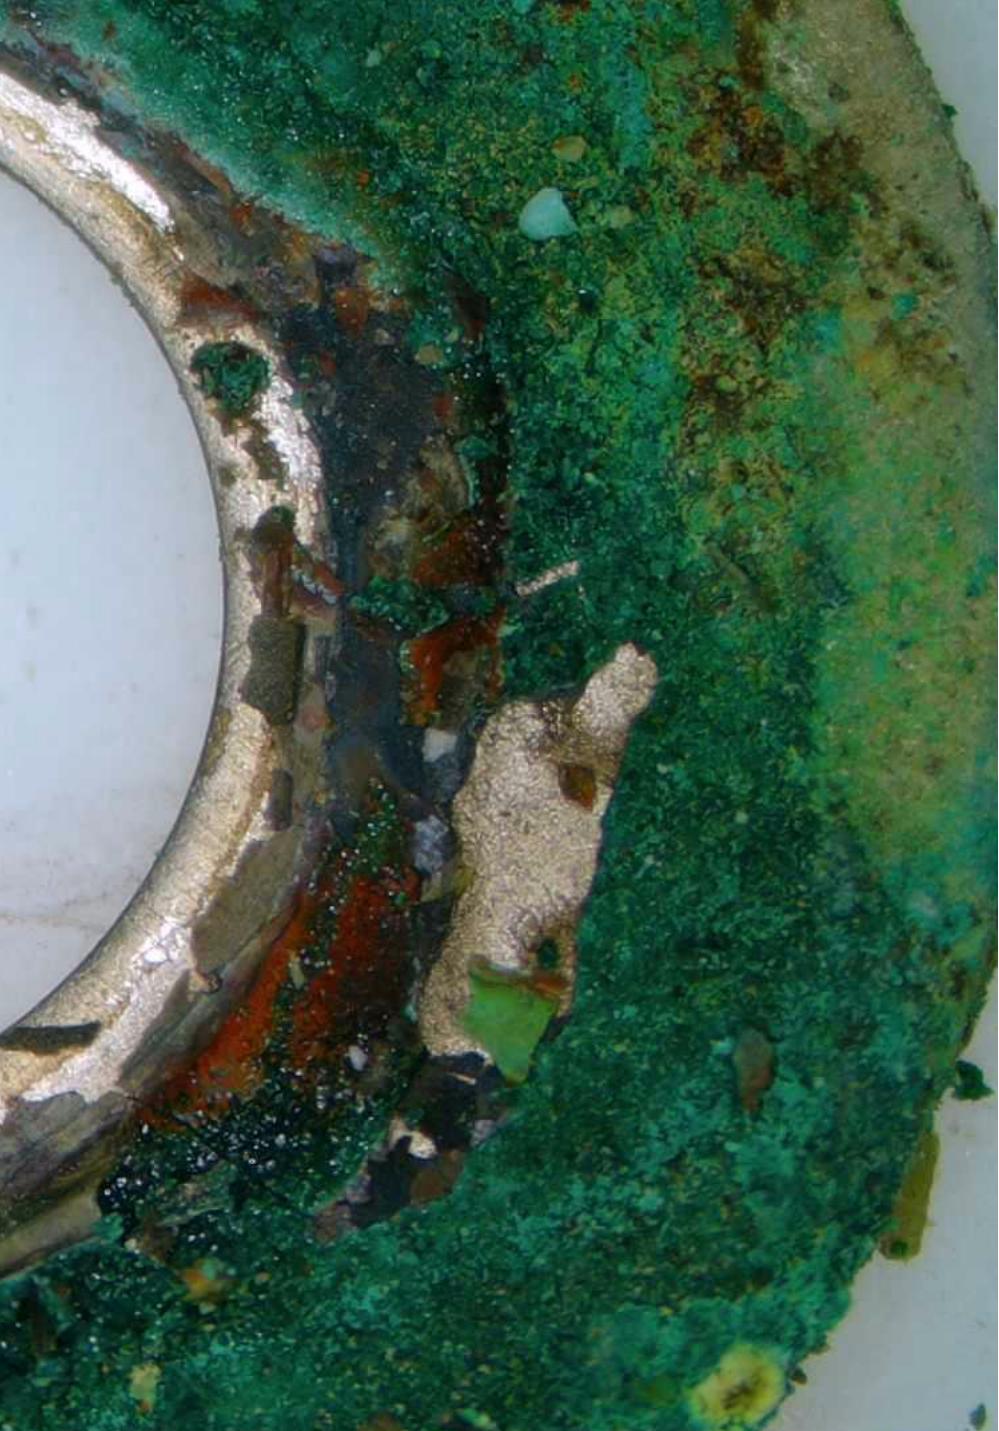
Example of a C4 site (crevice corrosion between bolt and washer surfaces)

739 days

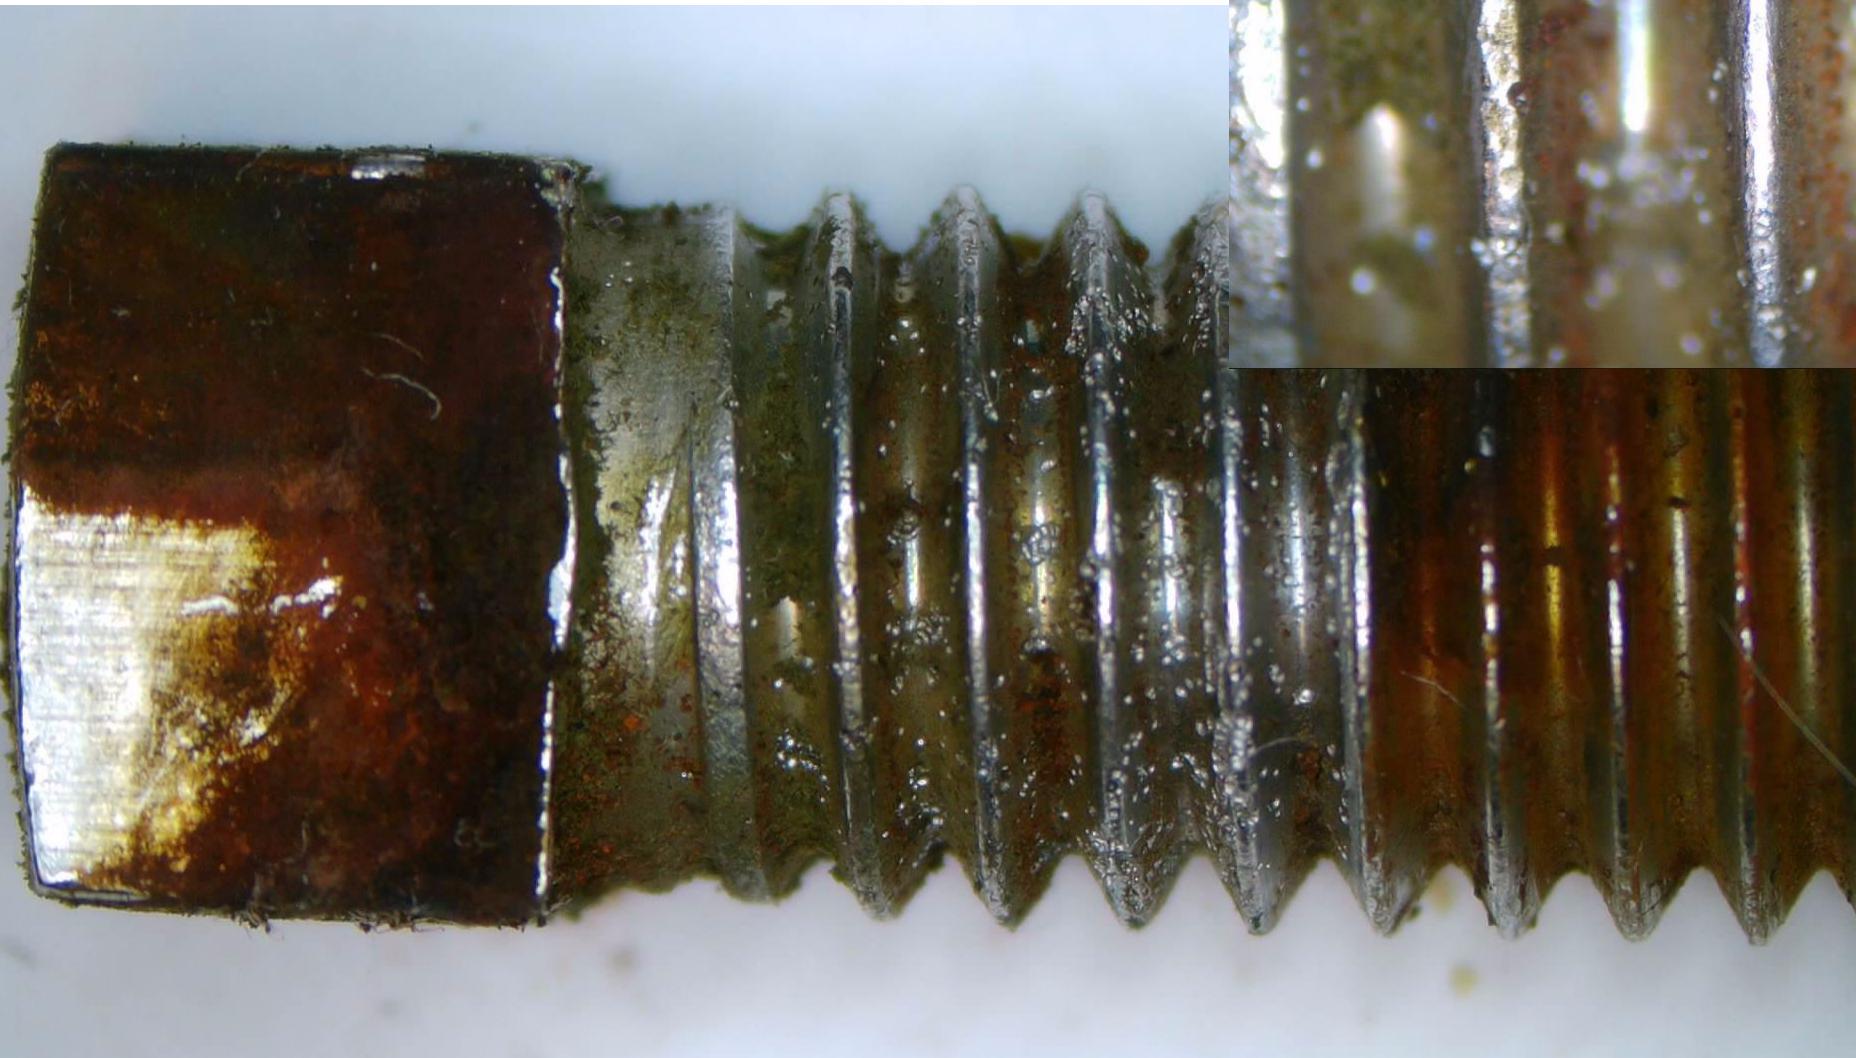
Example of a C5 site (crevice corrosion between threads of bolt and nut)

Elevated Temperature – Stainless Steel (652 days)

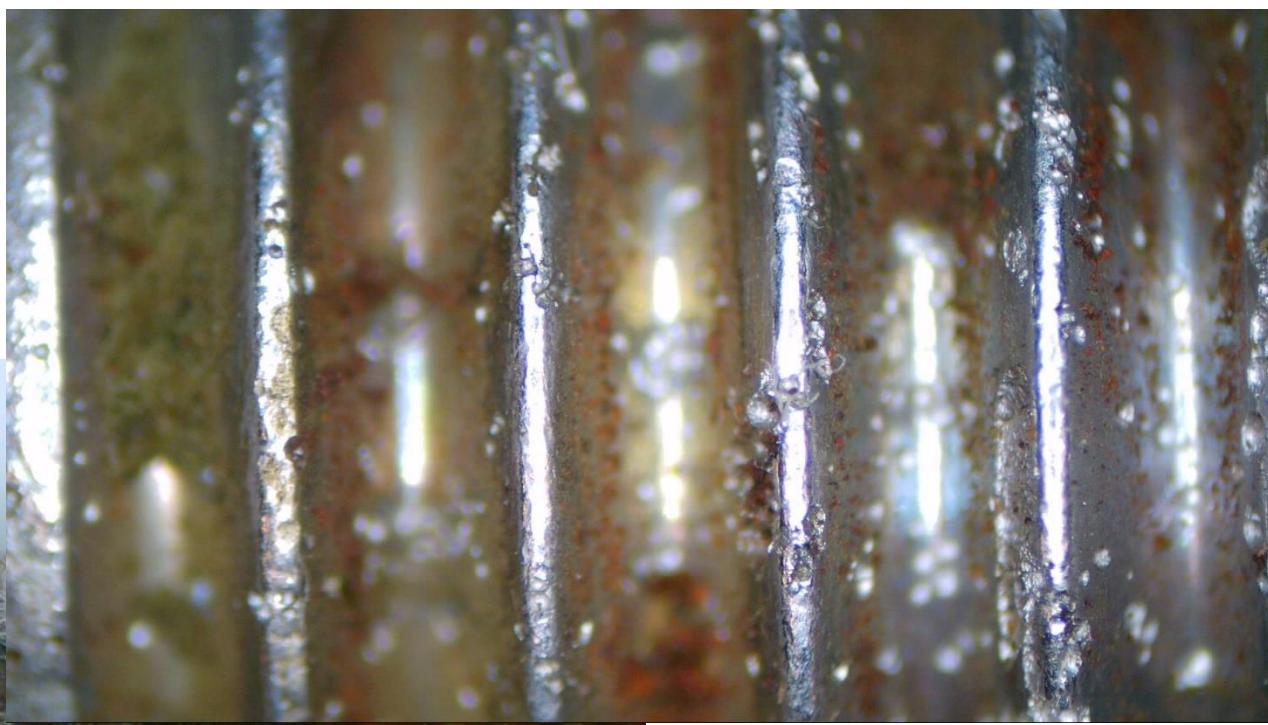
Pitting Corrosion
