Detecting Thermal Crack Growth on a Large Additive Manufactured Structure using Acoustic Emission

Ryan Spencer^{1,2,*}, Miguel González Núñez³, Hossain Saboonchi⁴, Valery Godinez-Azcuaga³, Uday Vaidya^{1,2}, Vlastimil Kunc², Ahmed Arabi Hassen^{2,1}

Keywords: Large Format Additive Manufacturing, Acoustic Emission, Nondestructive Evaluation

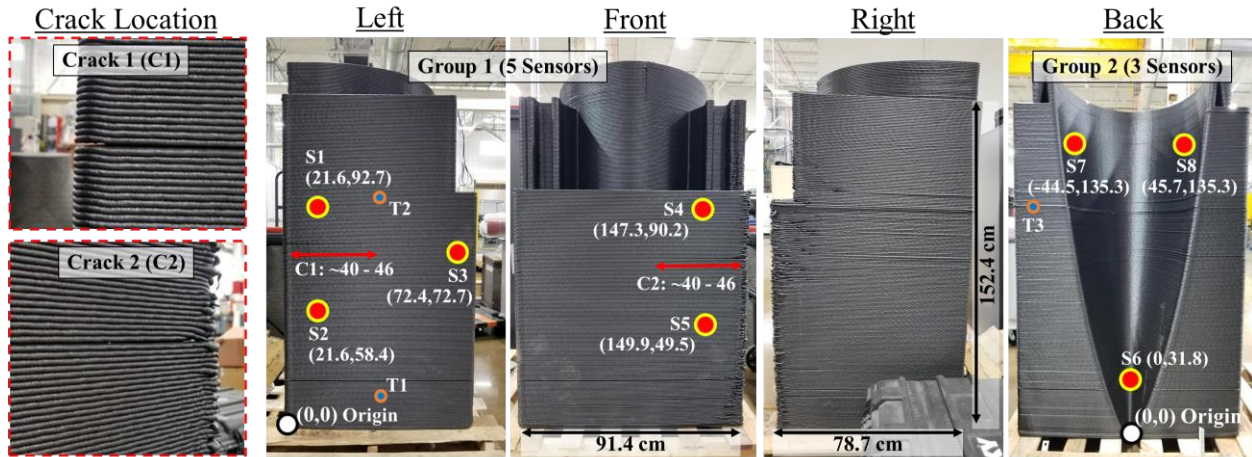
Figure 1: Large AM structure with pre-existing crack locations (C1 & C2) measuring 40 - 46 cm in length for each. Associated AE sensor locations (Group 1 and 2) to monitor crack growth in corresponding locations. Thermocouples (T1-T3) monitor temperature. Units in cm.

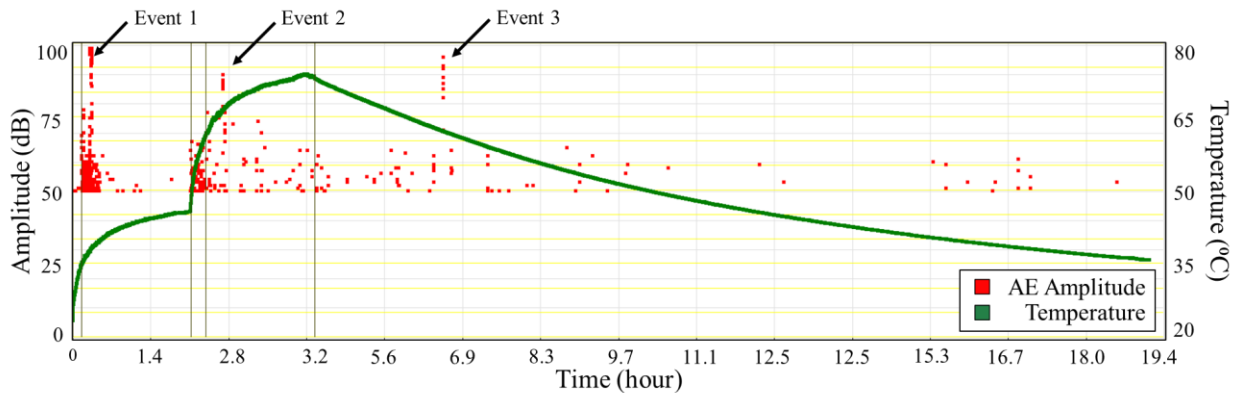
Multiple AE events were captured during the heat cycle of the printed structure. **Figure 4** shows the captured AE amplitude events along with the temperature of the structure over the time duration. Event 1 occurred right after the initial ramp up at 35 °C. Event 2 was captured right after the second ramp up at a temperature of 63 °C. Then, Event 3 occurred around 3.5 hours into the cooling stage where the structure was at 64 °F. From the results it can be noticed that ~64 °F can be correlated to layer separation for this print material and structure. The amplitude for Event 1, 2, and 3 were 99, 90, and 96 dB, respectively. Other events were captured but are related to noise features based off of low amplitude response and waveform analysis.

Figure 4: AE Amplitude vs Time with temperature parametric during the heat cycle. Events 1, 2, and 3 correlating to crack propagation/nucleation on the AM structure.

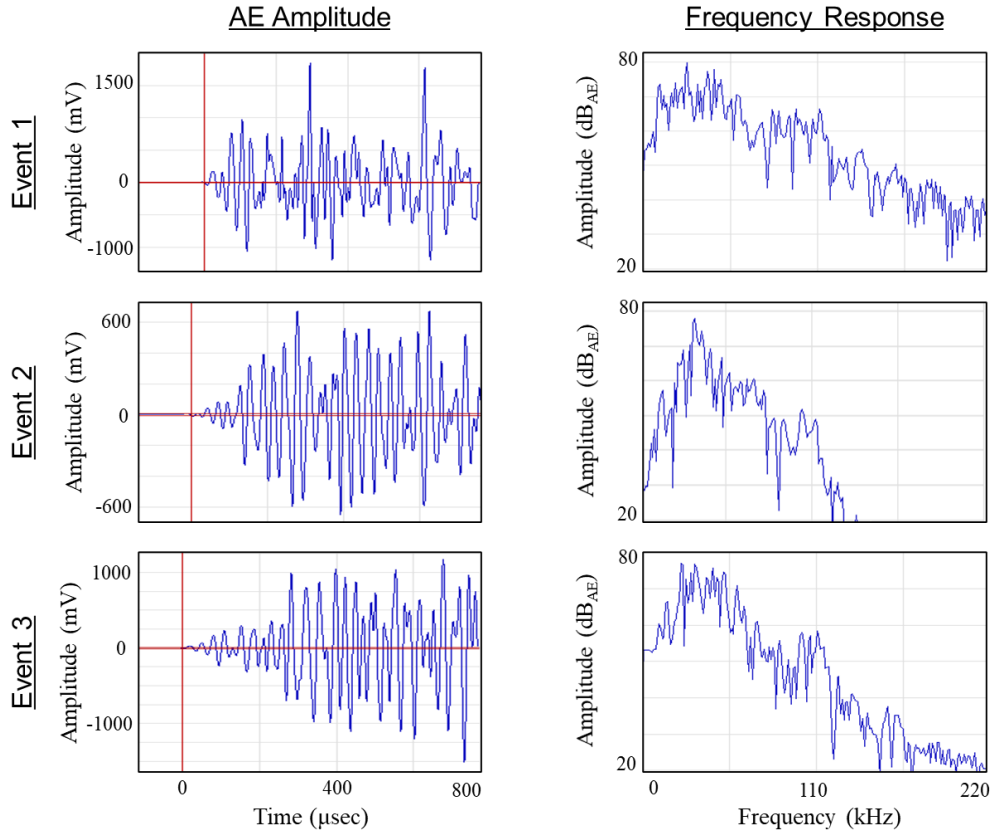
Figure 5 displays Event 1, 2, and 3 waveforms and spectrum analysis. Event 1 and 3 had a broad band frequency response (0 kHz – 220 kHz) including higher frequencies (above 150 kHz). Event 2 had a mid-frequency response (0 kHz – 125 kHz). High-frequency responses in polymer composites are related to fiber breakage, mid-frequencies correlate to delamination and interfacial debonding, and low-frequencies are from matrix cracking within traditional laminate composites [18]. Event 1 and 3 can be correlated to layer separation along with fiber breakage due to the presences of high amplitude with mid-to-high frequency response. Event 2 can be characterized as layer separation due to its medium amplitude and mid-frequency response.

Figure 5: The AE amplitude and frequency response for Events 1, 2 and 3.

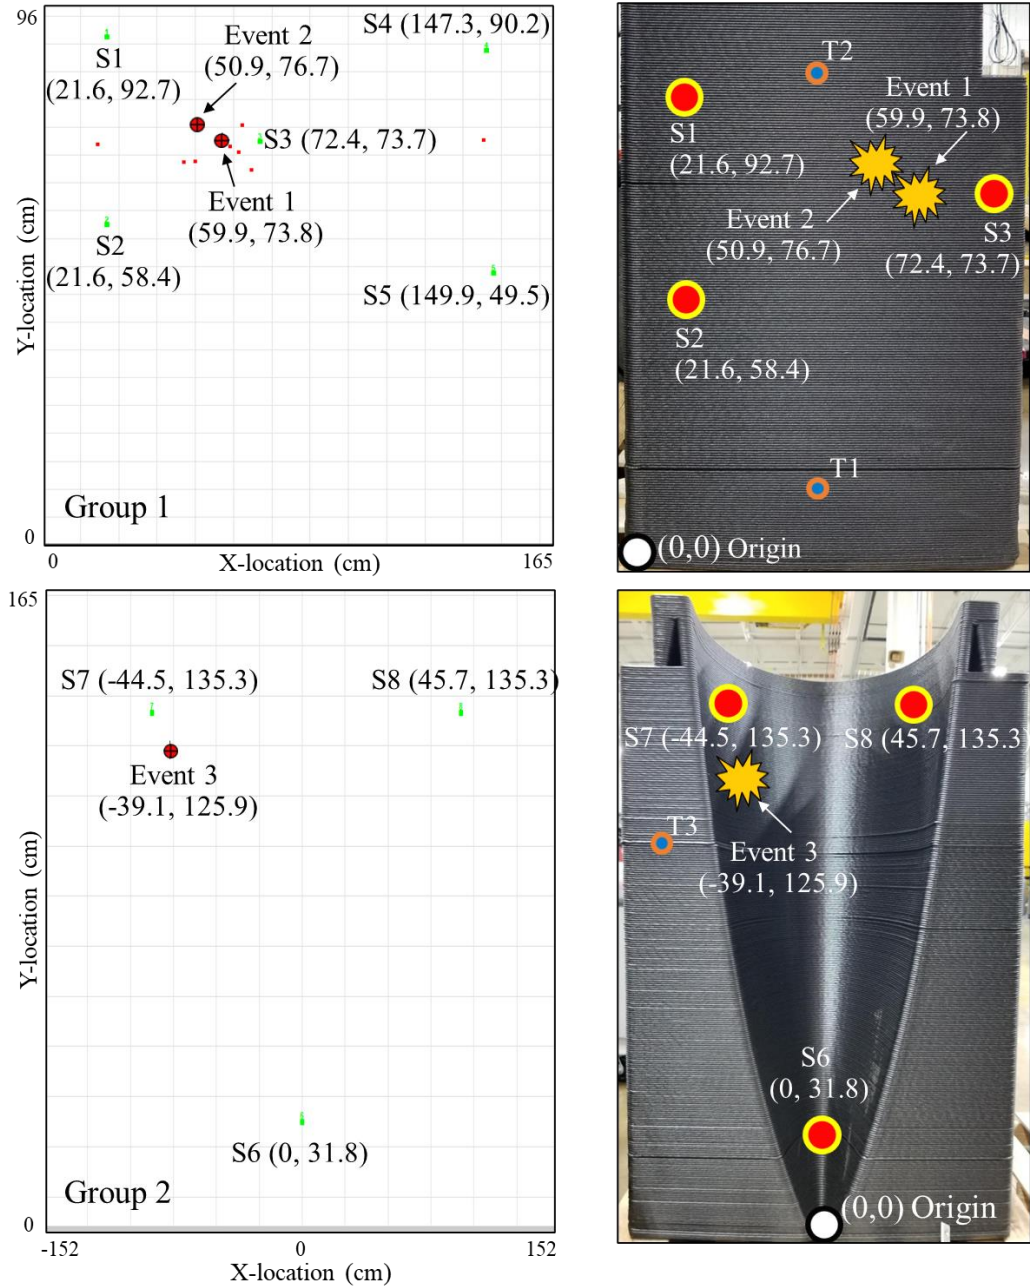
The continuation of crack 1 (C1) was captured in Event 1 and 2 with XY locations of 59.9 cm, 73.8 cm and 50.9 cm, 76.7 cm, respectively, within Group 1. Crack 1 had an initial length of 40 cm to 46 cm in in length (X direction) and seems to continue to a length of ~50 cm to 60 cm. The initial length was visually performed and may not have been the true starting length. It can be hypothesized with some confidence Events 1 and 2 are capturing crack 1 continued layer separation. For crack 2, no crack propagation was captured by AE due to lack of amplitude response typically associated with crack propagation. It can be notice there were other multiple events captured in the Group 1 location plot, but have been classified as low-level events (noise) when viewing the Amplitude-Time plot (**Figure 4**) and individual waveforms. Group 2 within the conical geometry of the AM structure captured Event 3 with a position of -39.1 cm, 125.9 cm. No preexisting crack was visually found in this location before the thermal cycle.

Figure 6: AEwin crack location within Group 1 and 2. Group 1 captured the continuation of crack 1 with Events 1 and 2. Group 2 captured a new crack anomaly with Event 3. Sensors and events overlay on AM structure. Units in cm.

This work focuses on the preliminary findings of the validity of using AE to monitor large composite AM structures for thermal-residual cracking, however, it is suggested to cross-verify AE results with other NDE techniques, such as in-situ digital image correlation [20, 21] or ultrasound testing [7]. It is suggested to investigate if the acoustic responses (amplitude, frequency, etc.) for damage characterization (fiber breakage, matrix cracking, and delamination) of discontinues reinforced composite materials used for AM structures.
