Final Technical Report (FTR)

<i>a. Federal Agency</i>	Department of Energy	
<i>b. Award Number</i>	DE-EE0009378	
<i>c. Project Title</i>	Innovative Method for Welding in Generation 3 CSP to Enable Reliable Manufacturing of Solar Receivers to withstand Daily Cycling at Temperatures Above 700°C	
<i>d. Recipient Organization</i>	Electric Power Research Institute	
<i>e. Project Period</i>	<i>Start</i> : 03/01/2021	<i>End</i> : 08/31/2022
<i>f. Principal Investigator (PI)</i>	John Shingledecker Principal Technical Executive jshingledecker@epri.com 704-595-2619	
<i>g. Business Contact (BC)</i>	Cindy Colwell Government Contract Administrator ccolwell@epri.com 865-218-8109	
<i>h. Certifying Official (if different from the PI or BC)</i>

3.1.1: Characterization of Stress Relaxation Cracking Failures in 740H Weld Fabrications

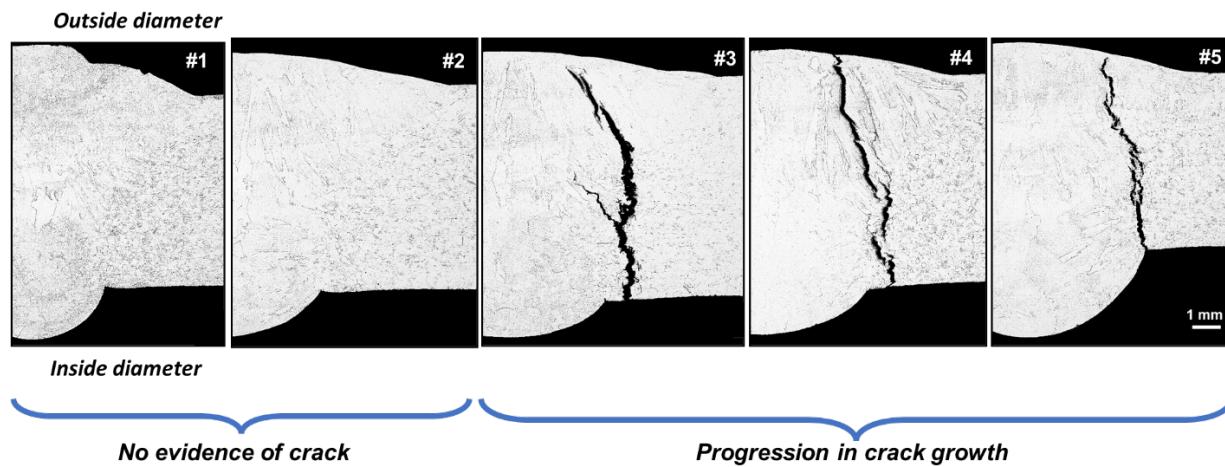
Figure 6: Metallographic images of the polished sections of sample Row 3 Weld 3 showing the progression of cracking around the tube circumference

These images in Figure 6 also show that the main crack appears to have very little branching and there were no clear indications of secondary cracks surrounding the main crack. Initiation of the crack at or near the toe of the weld may further suggest that geometrical factors that increase local stress concentration, may play a part in the formation of these cracks. Figure 7 shows one representative weld cross section each from the five welded tubes. All these images show cracks originating at the toes of the welds. The images also show that all the welds had marked weld pushthrough at regions near cracking, sometimes even greater than the wall thickness for the tubes,

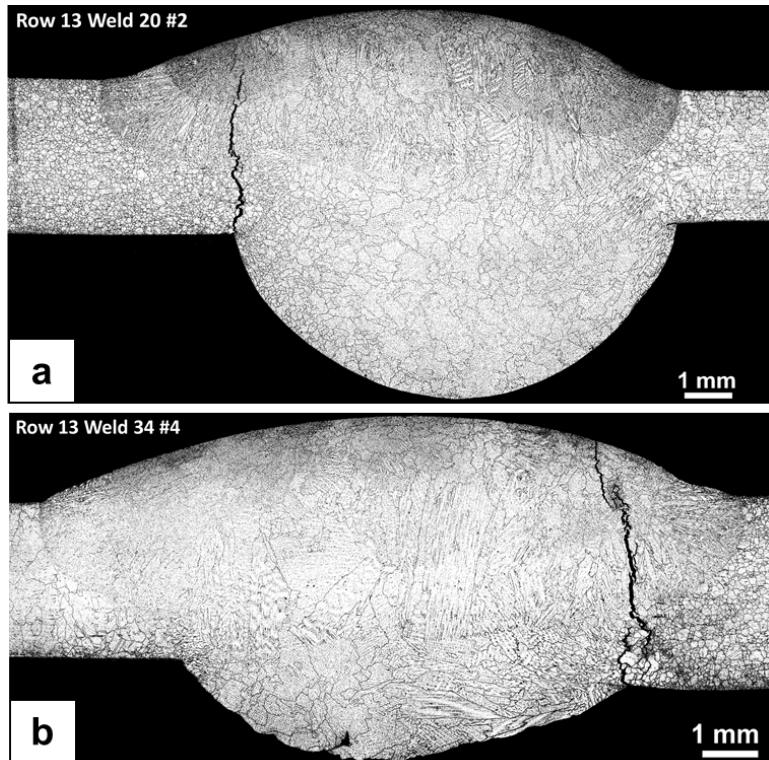
Figure 9: Etched weld microstructures of one of the cross sections taken from a) sample Row 13 Weld 20 and b) Row 13 Weld 34.

Figure 9a and Figure 9b each show similarly etched macro images of the one of the weld cross sections from samples 'Row 13 Weld 20' and 'Row 13 Weld 34'. These images again confirm that cracks were originating from or near the toes of the welds in these samples. Another important observation made from these etched samples was that the cracks had formed on the side of the weld where the base material has finer grains. For example, in sample Row 13 Weld 20, the grain size of the base material that had cracked ranged between ~ 80 to 250 μm , whereas the grain size of the tube with no evident crack formation was in the range of ~ 100 to 650 μm . In this example, the base material that did not show any cracks had prominently large grains distributed within the matrix.

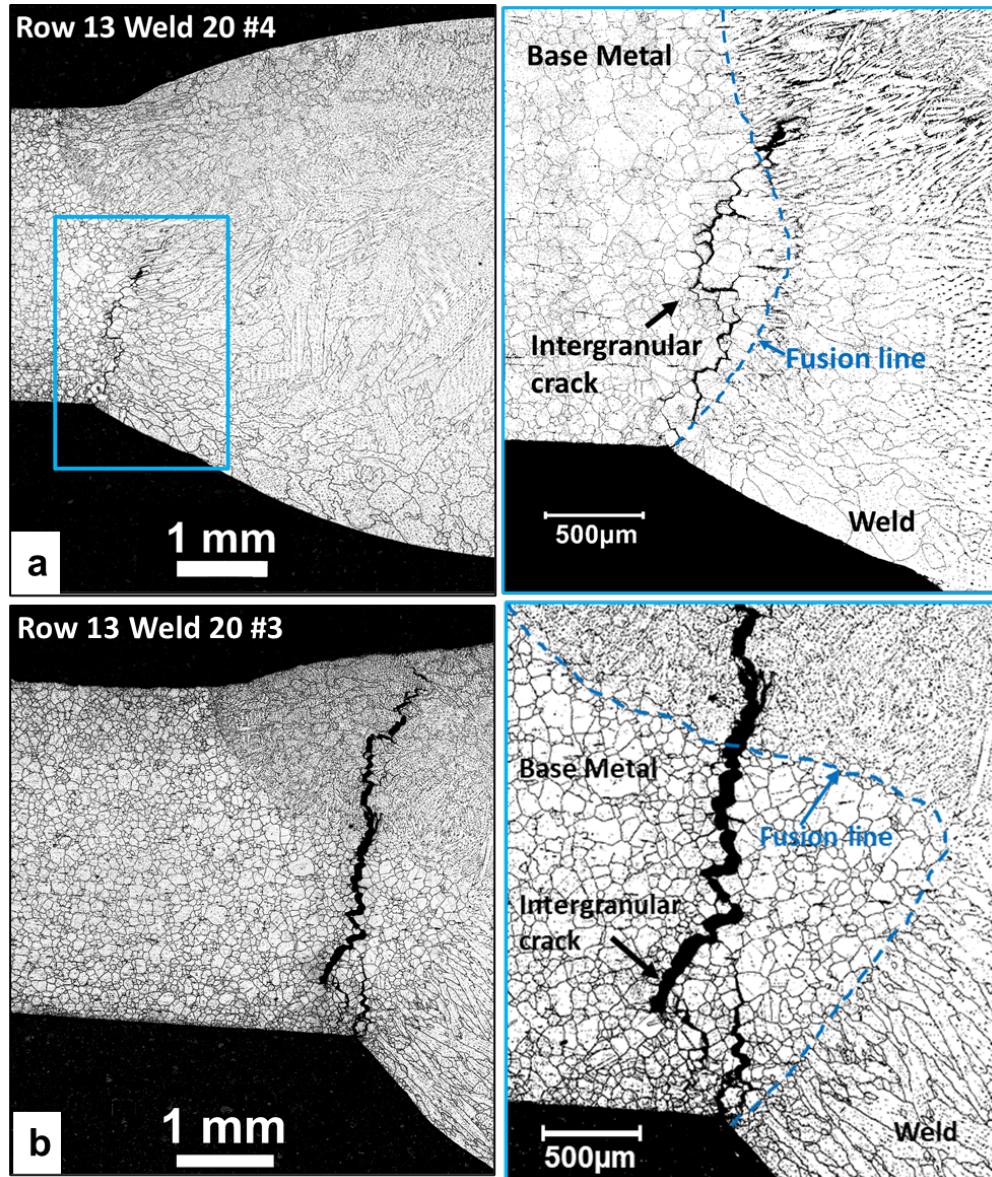
Figure 10: Lower and higher magnification images of the cracks in sections a) Row 13 Weld 20 #4 and b) Row 13 Weld 20 #3 showing that the growth of the crack formed is intergranular.

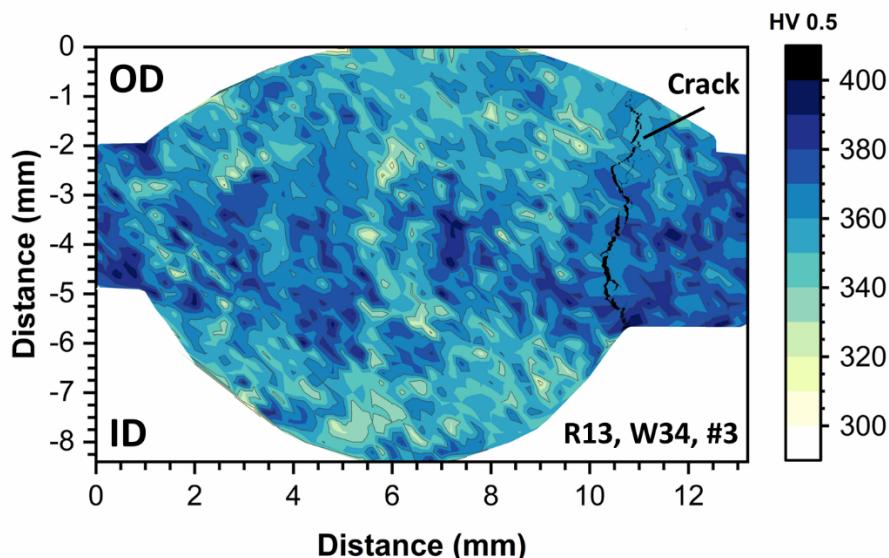
indents made over the sample cross-section 'Row 13 Weld 34 #3'. A 500g load was used for hardness testing. The hardness distribution map shows that the range of hardness within the weld metal was ~320 to ~380 HV, whereas the hardness at both base metals was in the ~360 to 380 HV range. From the map, there were regions of local hardening at the ID weld toes, where the hardness values were ~380 HV. However, this increase was evident on both weld toes and did not in itself explain the formation of a crack on one side of the weld.

Figure 11: Microhardness distribution map on the cross-section Row 13 Weld 34 #3.

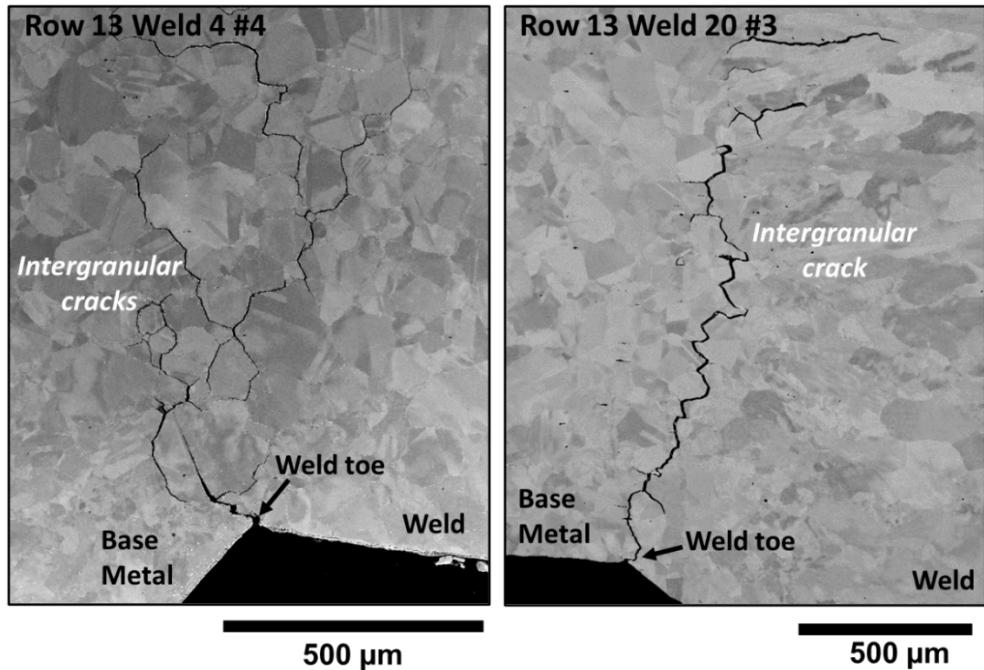
Figure 12: BSE images from the weld toes of cross sections from two samples a) sample Row 13 Weld 4 #4 and b) Row 13 Weld 20 #3, showing that the cracks formed are intergranular.

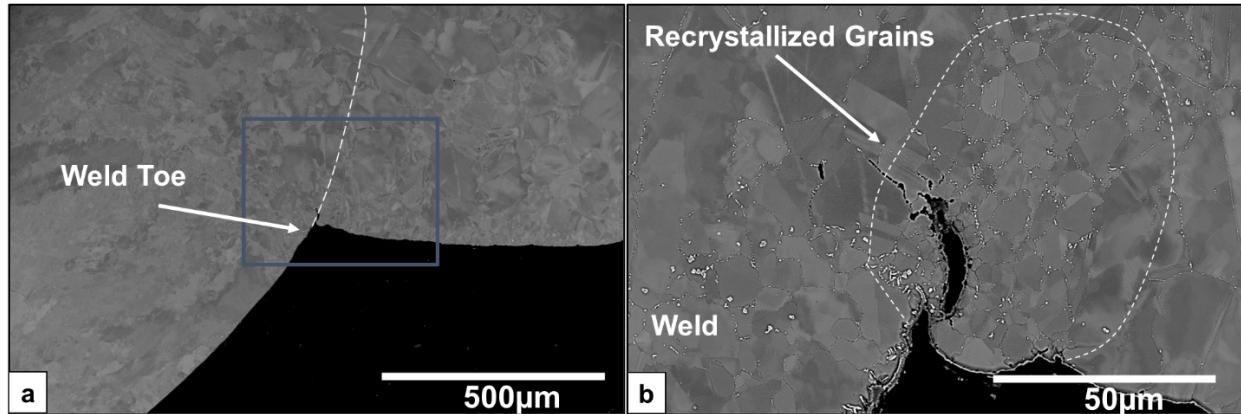
Figure 16: BSE a) low magnification and b) higher magnification images of etched grains near the ID weld toe of a weld cross section from sample Row 3 Weld 3 #2.

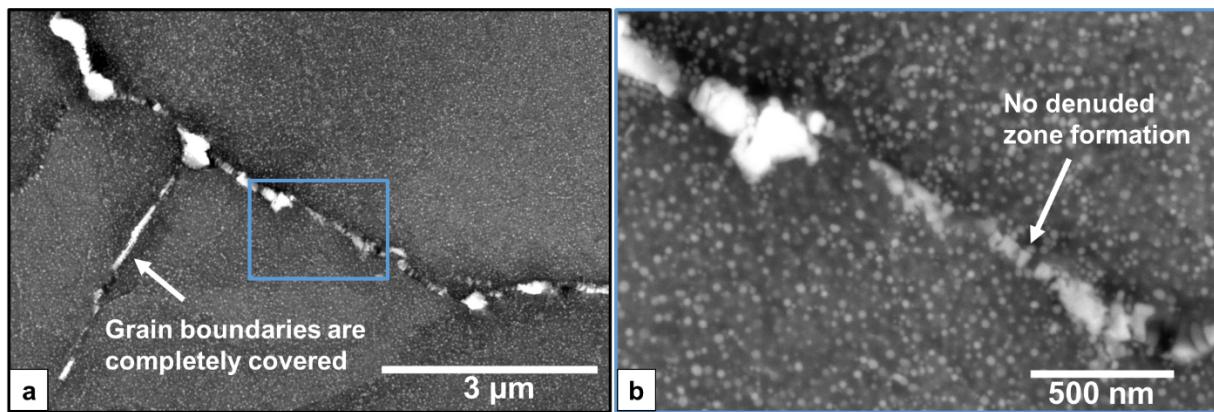
Figure 19: BSE images of etched grains from regions away from the ID weld toe of a weld cross section from sample Row 3 Weld 3 #2, showing various precipitate features at the boundary and no precipitate free zone formation.

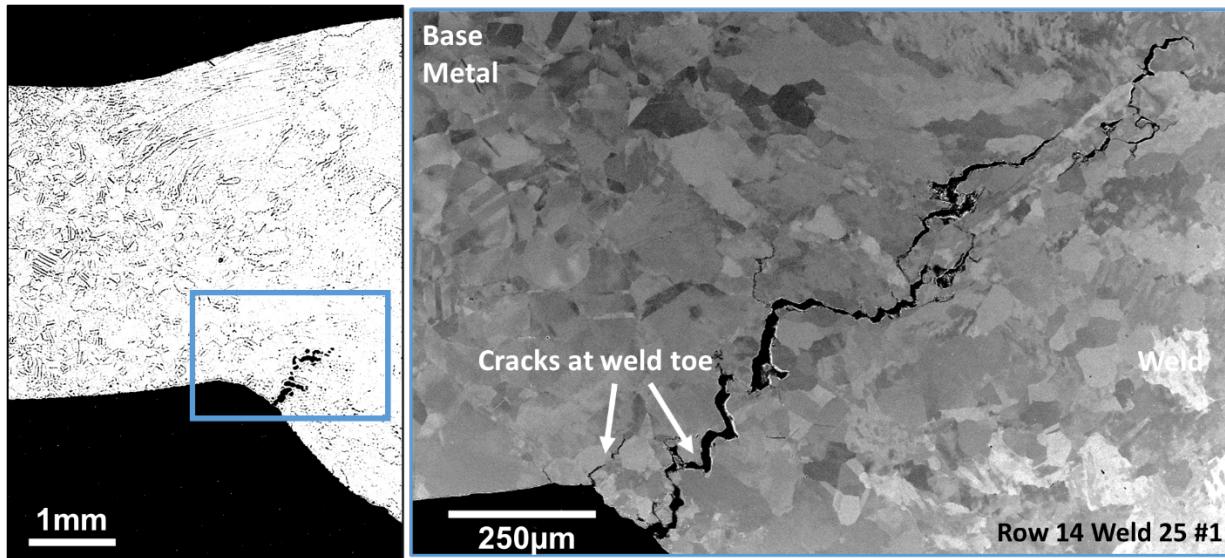
Figure 20: Image showing presence of an intergranular crack originating near the ID weld toe in the cross section Row 14 Weld 25 #1.

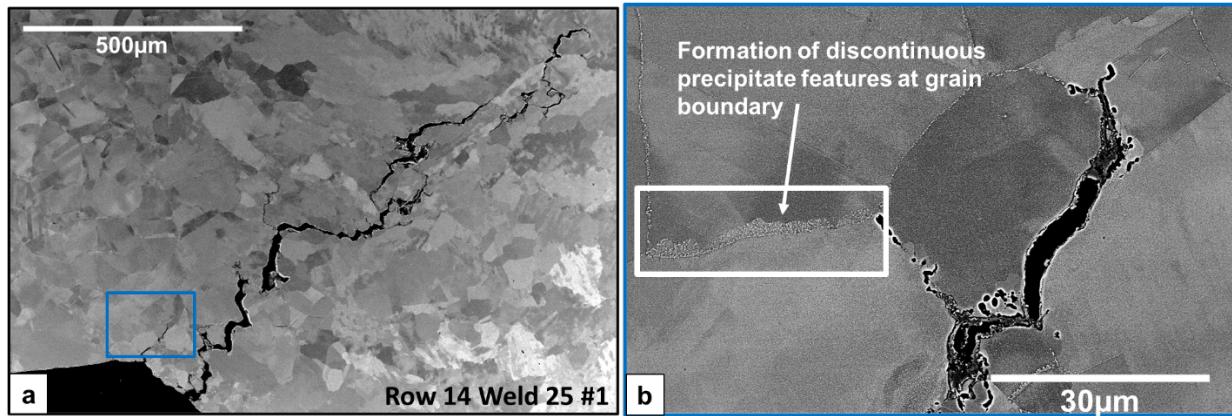
Figure 21: a) BSE images of the crack in Figure 20 showing the location of higher magnification image Figure 21b. b) BSE image showing the formation of discontinuous coarsening at grain boundary ahead of the crack tip.

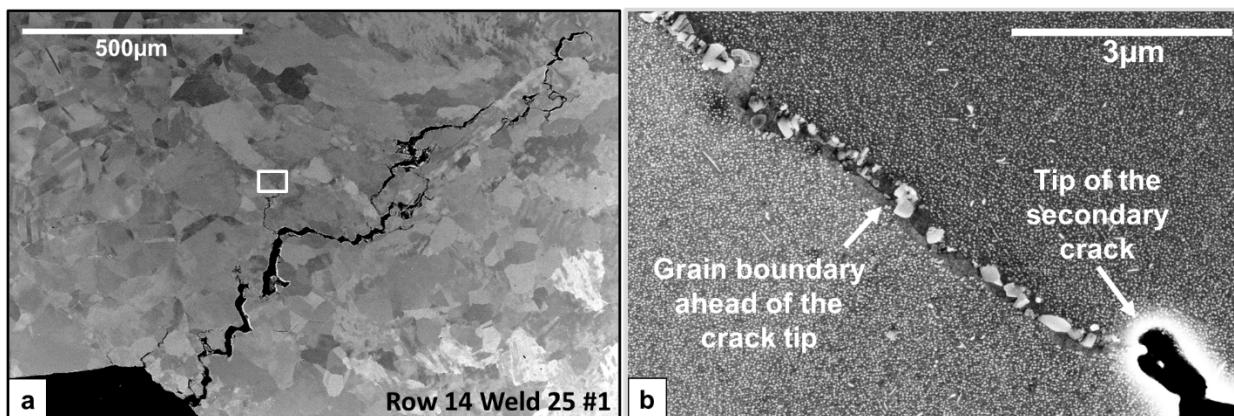
Figure 22: a) BSE images of the crack in Figure 20 showing the location of higher magnification image Figure 22b. b) BSE image showing the formation of discontinuous coarsening and grain boundary denuded zones at grain boundary ahead of the crack tip.

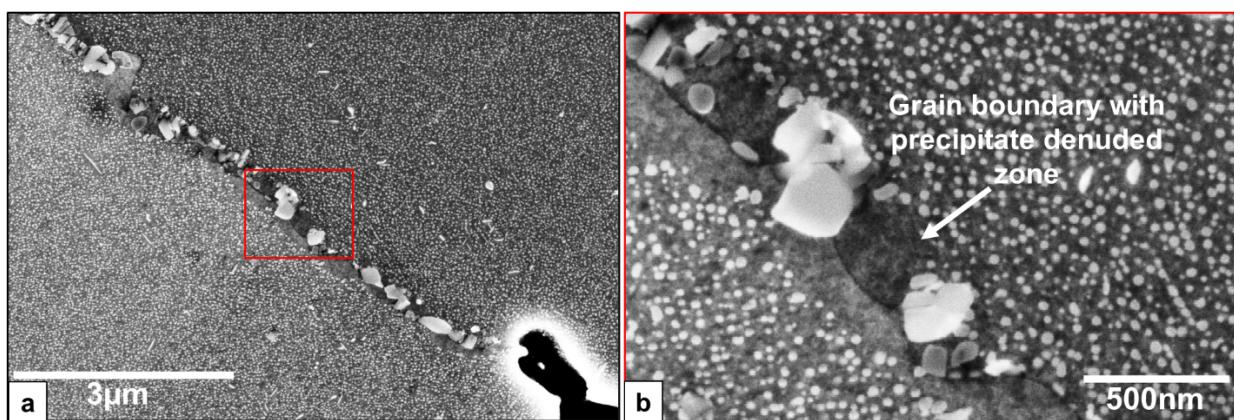
Figure 23: a) BSE images of the crack in Figure 22 showing the location of higher magnification image Figure 22b. b) BSE image showing the formation of discontinuous coarsening and grain boundary denuded zones at grain boundary ahead of the crack tip.

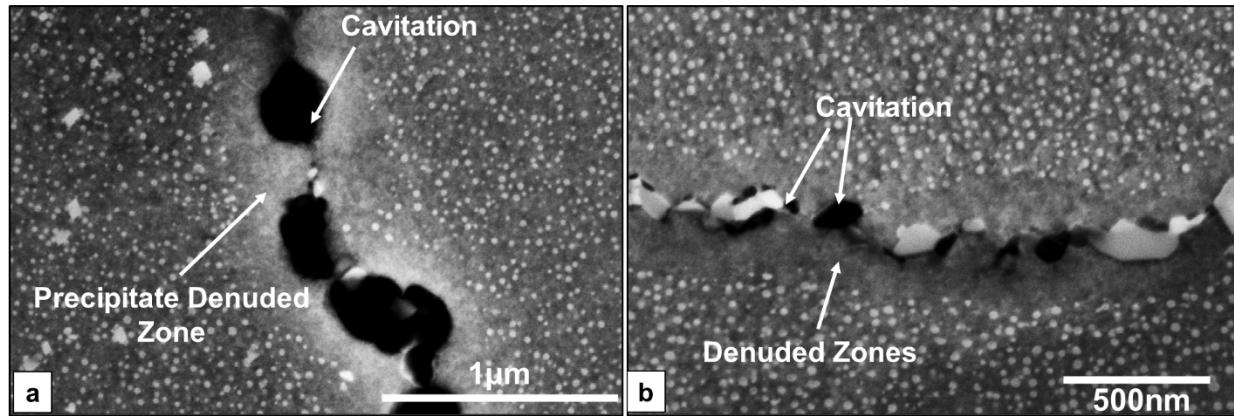
Figure 24: BSE images of grain boundary regions showing regions of cavitation damage at sites with grain boundary denuded zones.

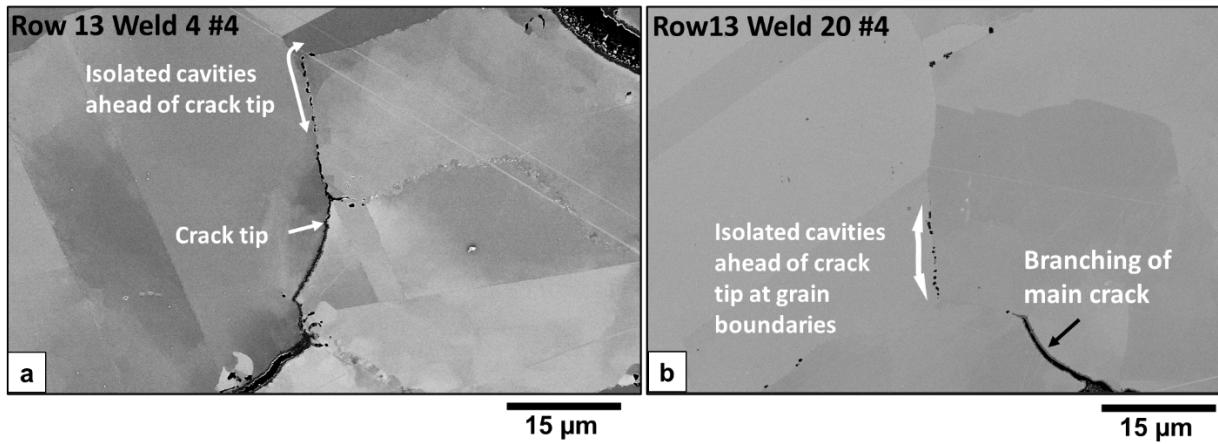
Figure 24: BSE images of grain boundary regions showing regions of cavitation damage ahead of crack tips.

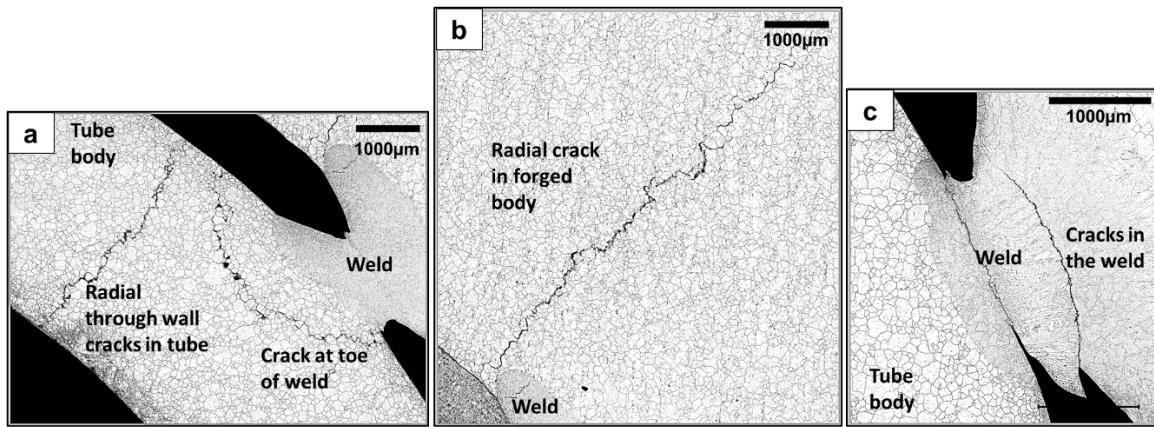
Figure 45: Select images of cracks see in the section A5 which show a) cracking in the tube, b) cracking in the forged body and c) cracking in the fillet welds.

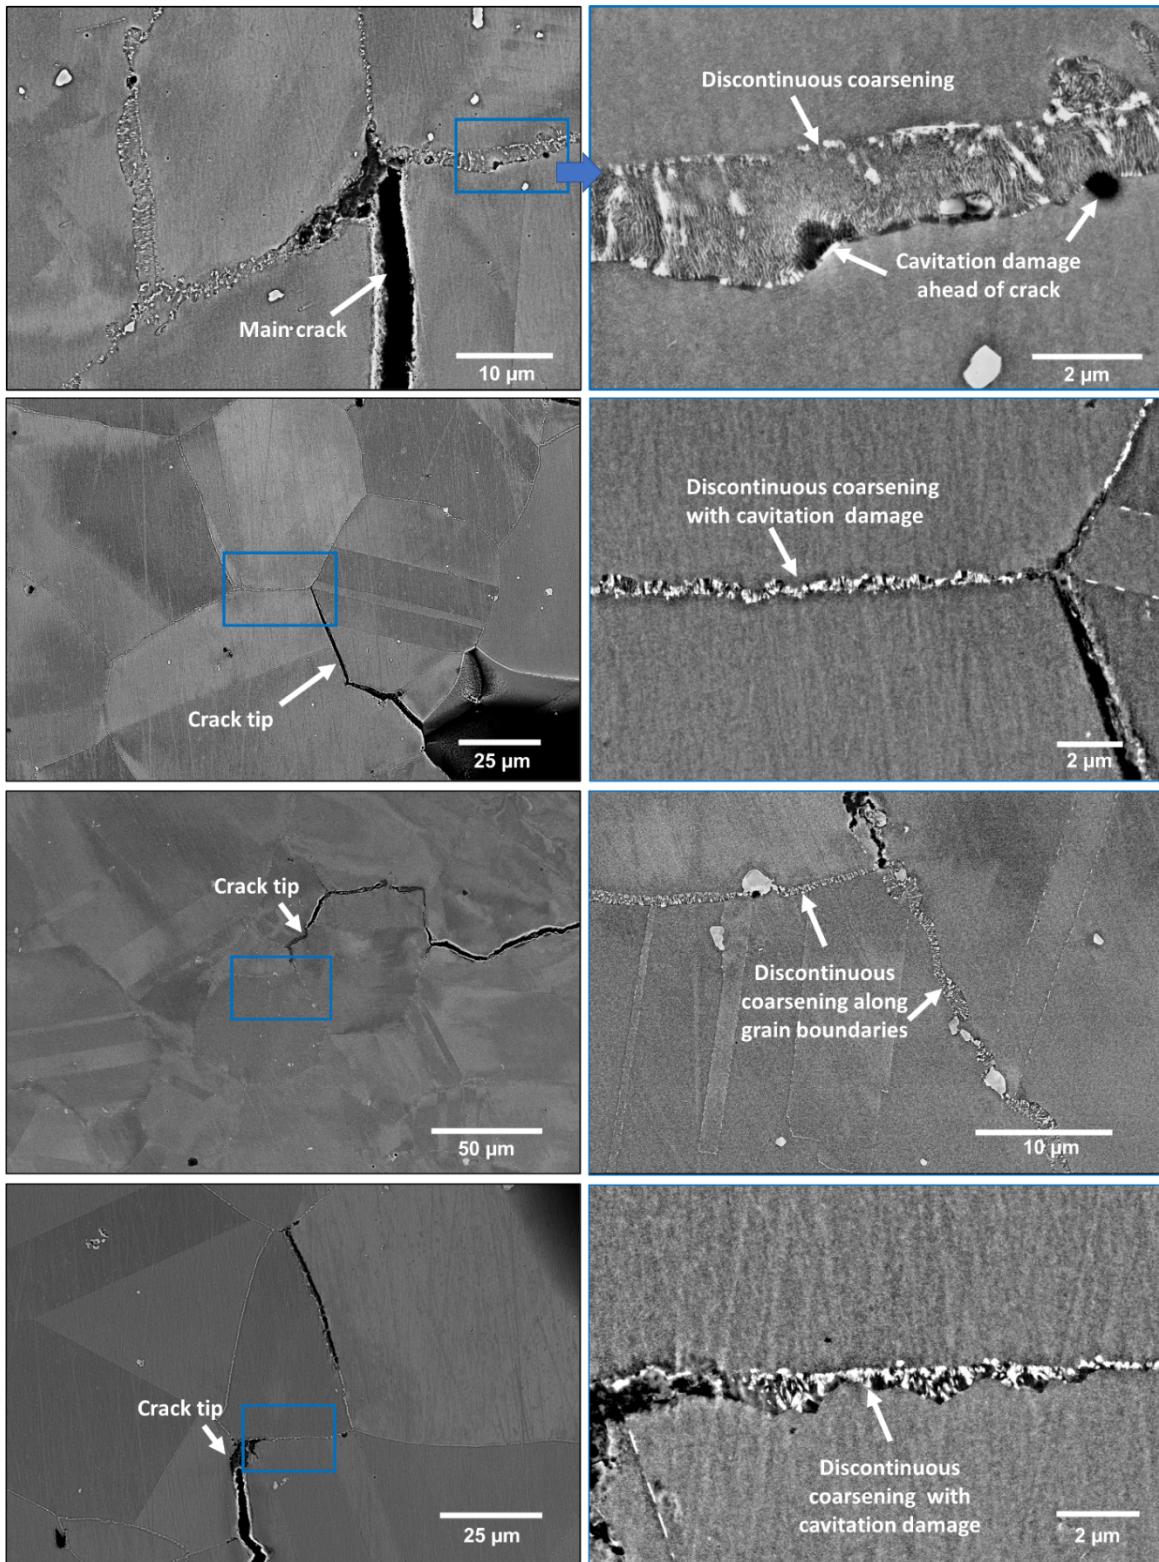
Figure 47: Lower magnification images (left column) of different crack tips from various cross sections and corresponding higher magnification images showing discontinuous precipitation at grain boundaries

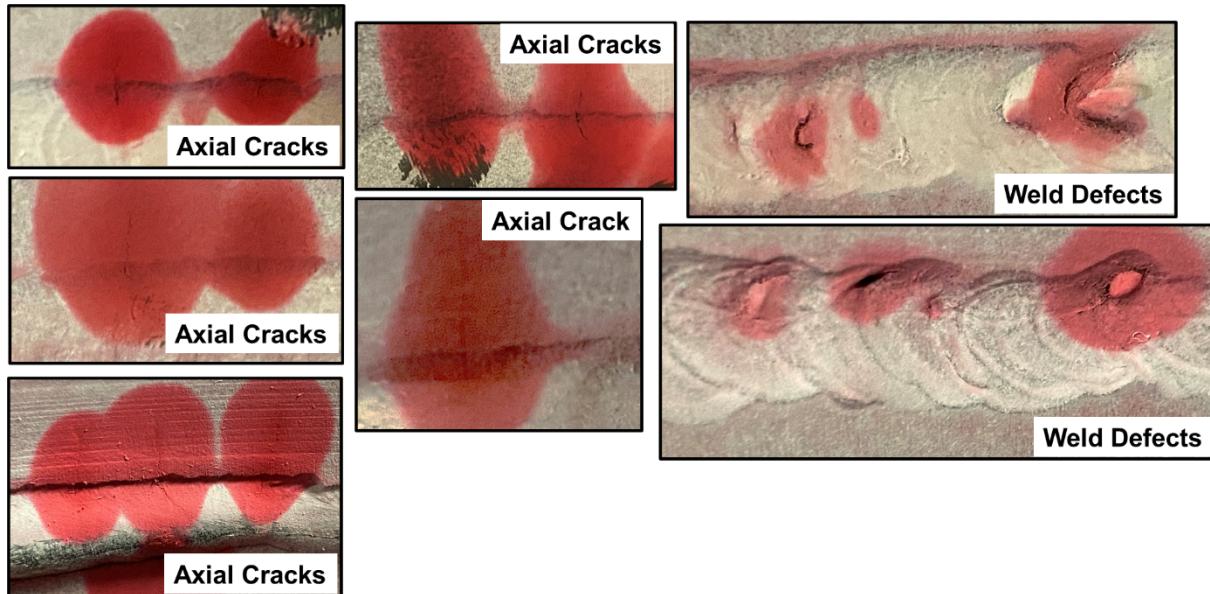
Figure 49: Results from LP testing of Pipe C showing axial cracks and weld defects

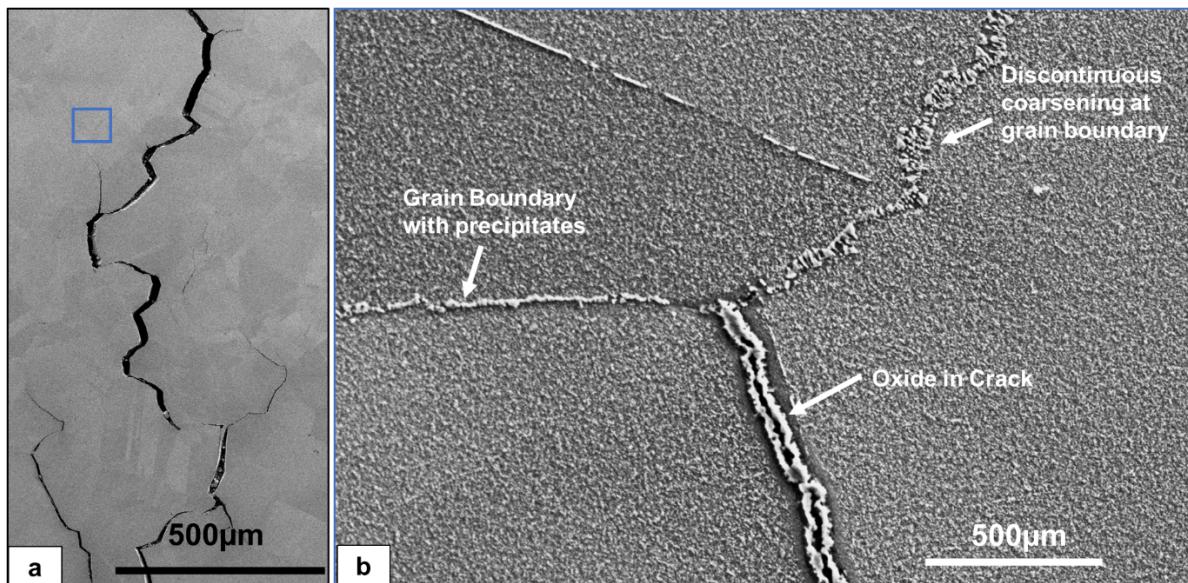
Figure 52: a) Low magnification BSE image showing a portion of the intergranular crack and high magnification BSE image (right) show the grain boundary structure ahead of a secondary crack in Figure 52a.

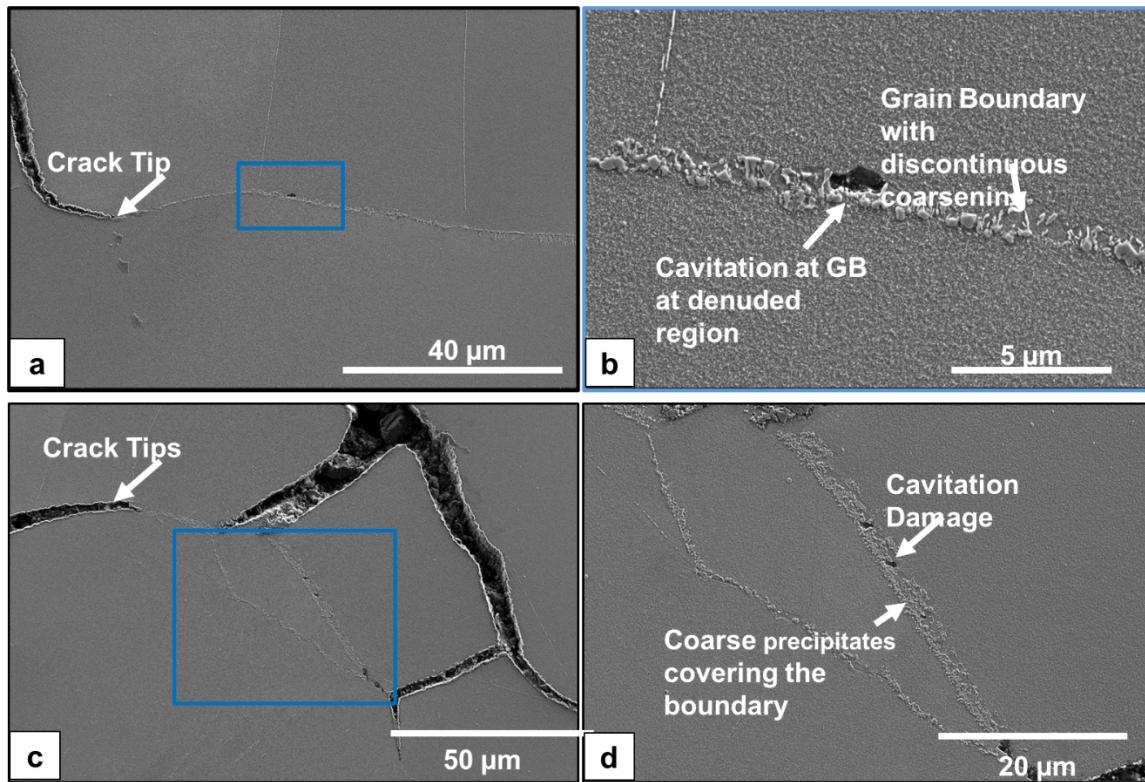
Figure 54: Low magnification (left column) and high magnification (right column) images showing instances of discontinuous coarsening and cavitation damage.

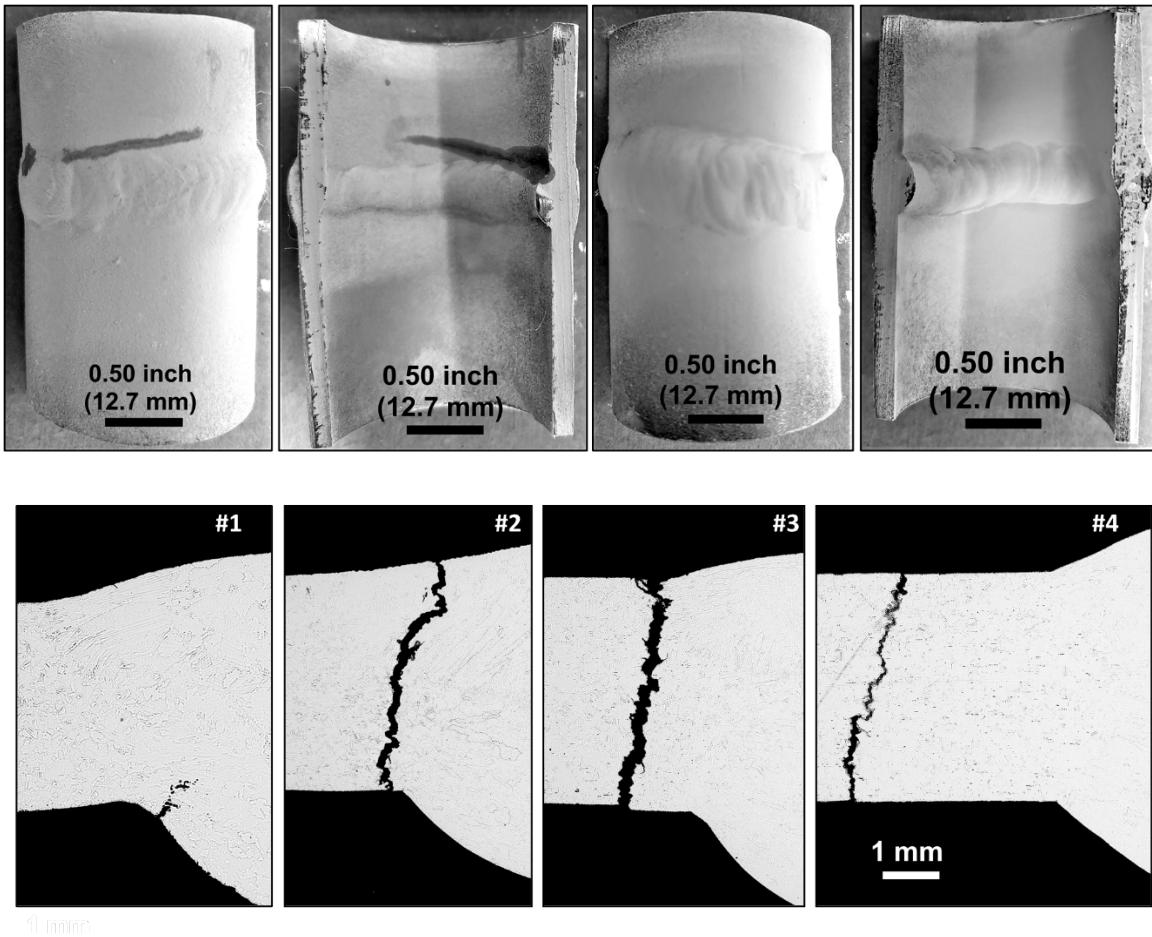
Figure A1: Images of LP testing showing the ID and OD surfaces of split tubes along with crack and polished cross section images of crack showing crack propagation characteristics in sample Row 14 Weld 25

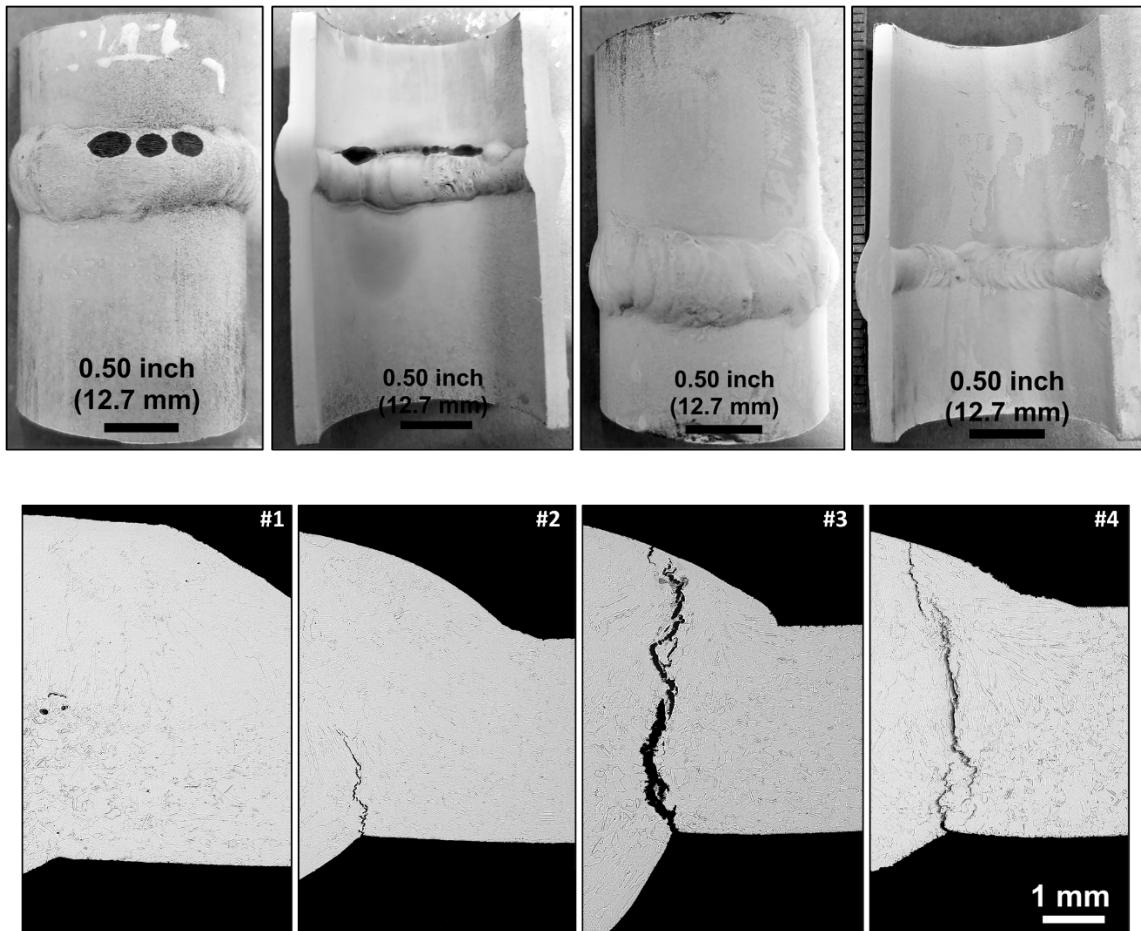
Figure A2: Images of LP testing showing the ID and OD surfaces of split tubes along with crack and polished cross section images of crack showing crack propagation characteristics in sample Row 13 Weld 34

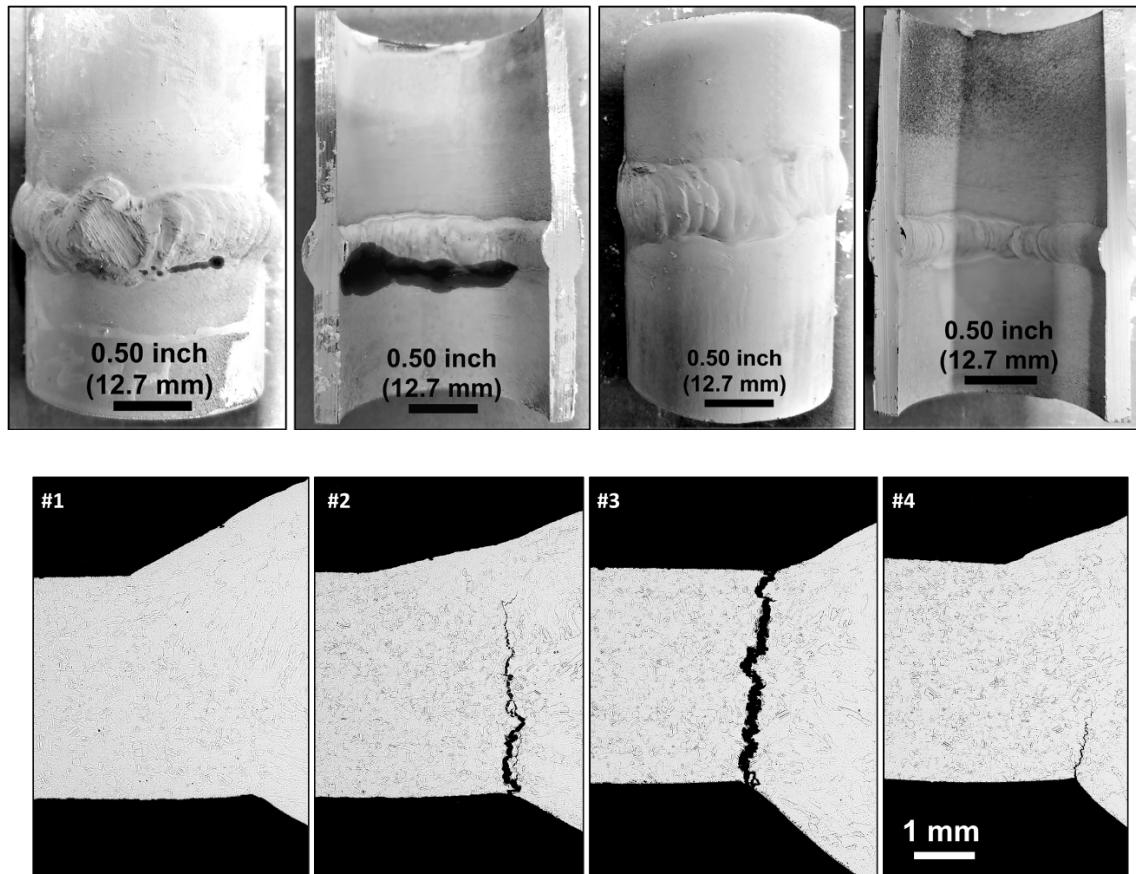
Figure A3: Images of LP testing showing the ID and OD surfaces of split tubes along with crack and polished cross section images of crack showing crack propagation characteristics in sample Row 13 Weld 4

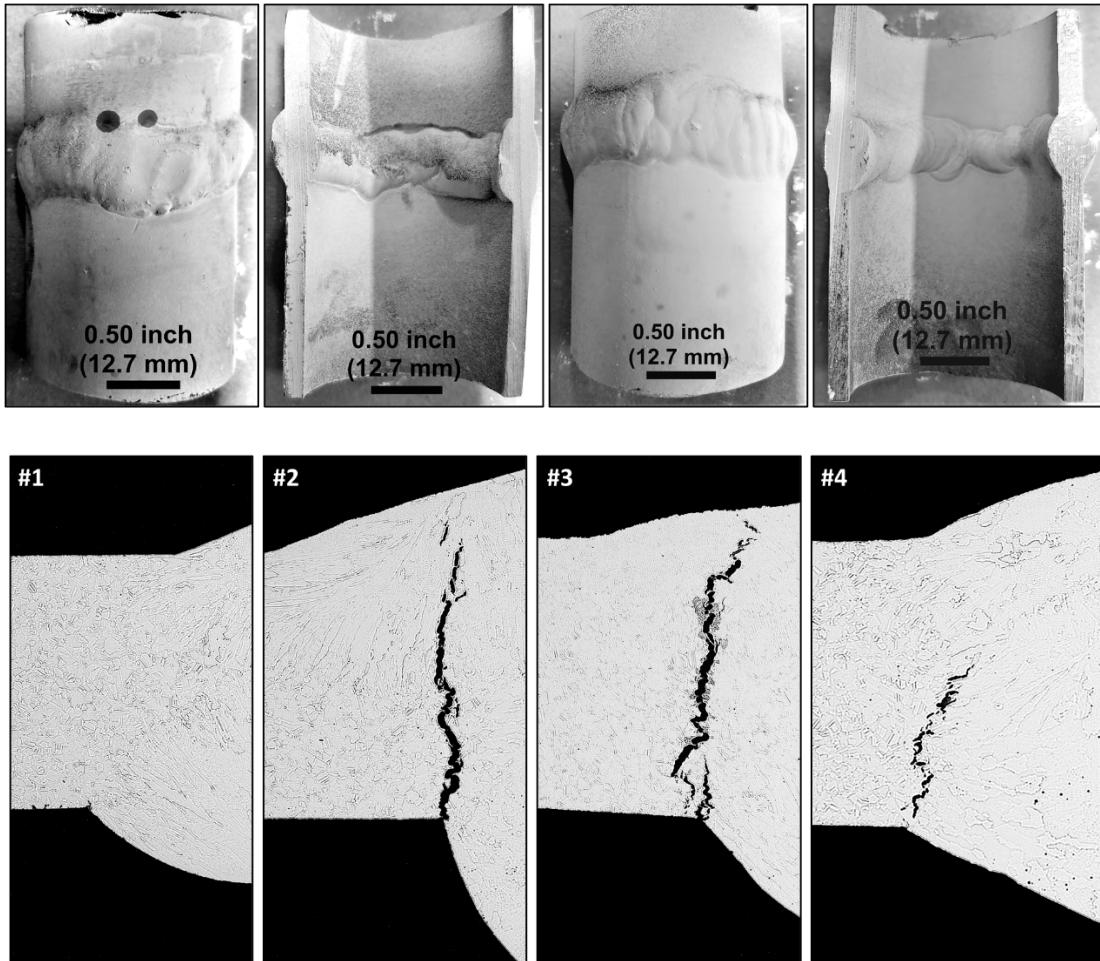
Figure A4: Images of LP testing showing the ID and OD surfaces of split tubes along with crack and polished cross section images of crack showing crack propagation characteristics in sample Row 13 Weld 20

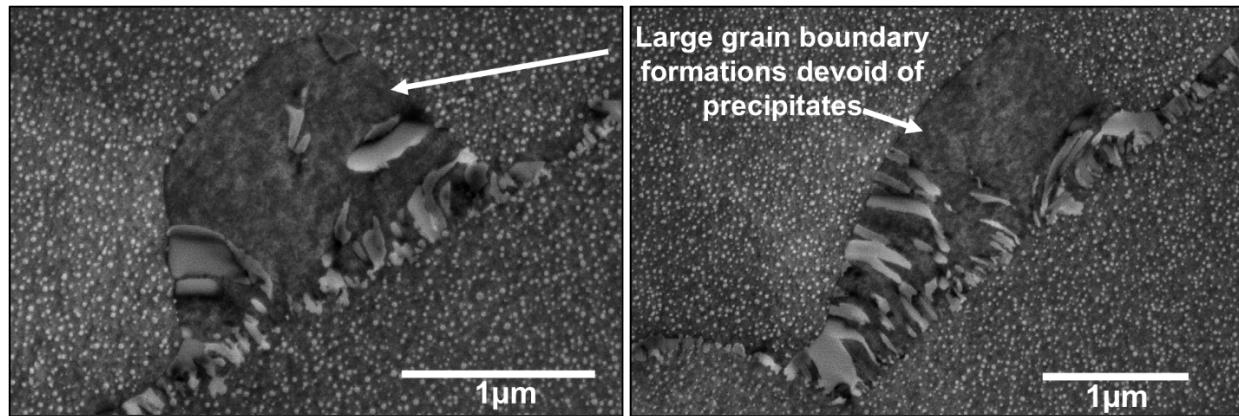
Figure A5: Images showing examples of large grain boundary denuded zones with discontinuous coarsening.

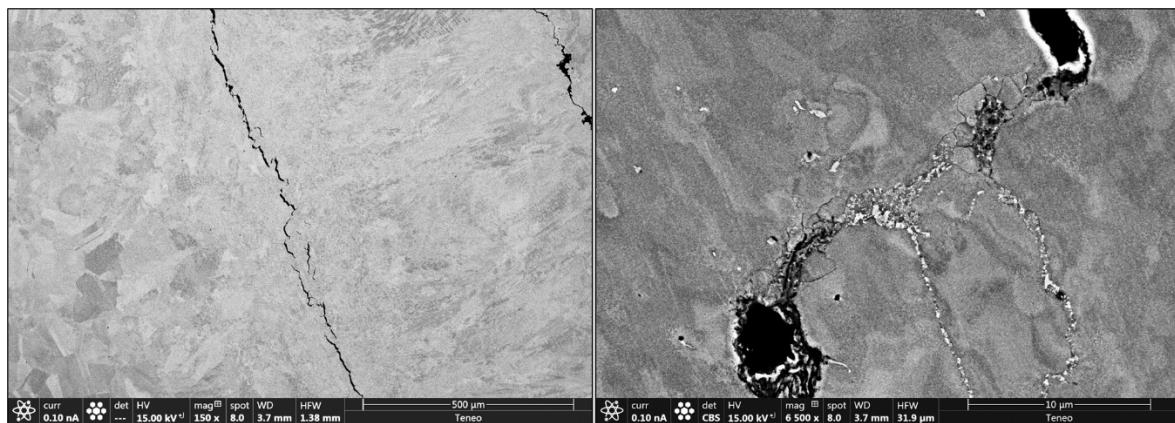
Figure A14: BSE images showing the cracks formed inside the weld metal regions of the sample section A5 in Demonstration Project #2 and the microstructural features formed ahead of the cracks.

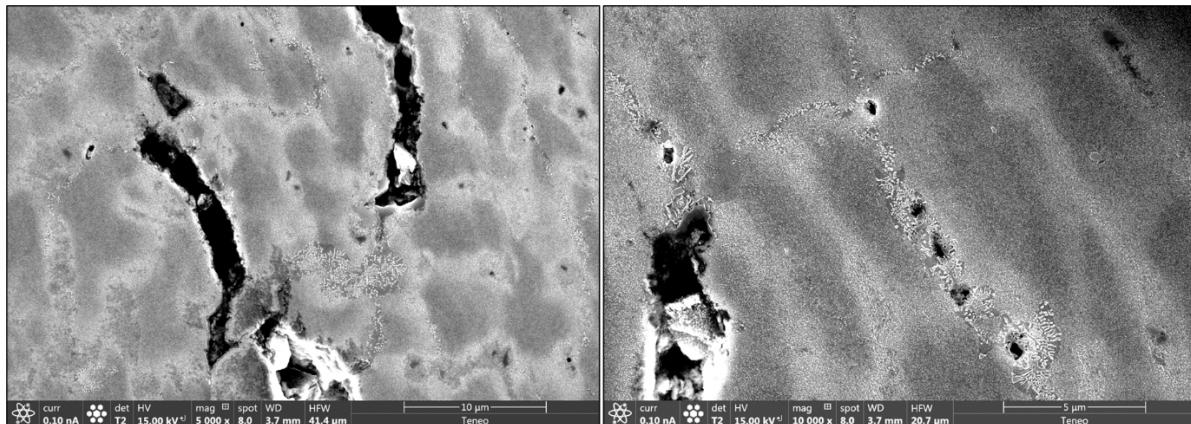
Figure A15: BSE images showing the cracks formed inside the weld metal regions of the sample section A5 in Demonstration Project #2 and the microstructural features formed ahead of the cracks.

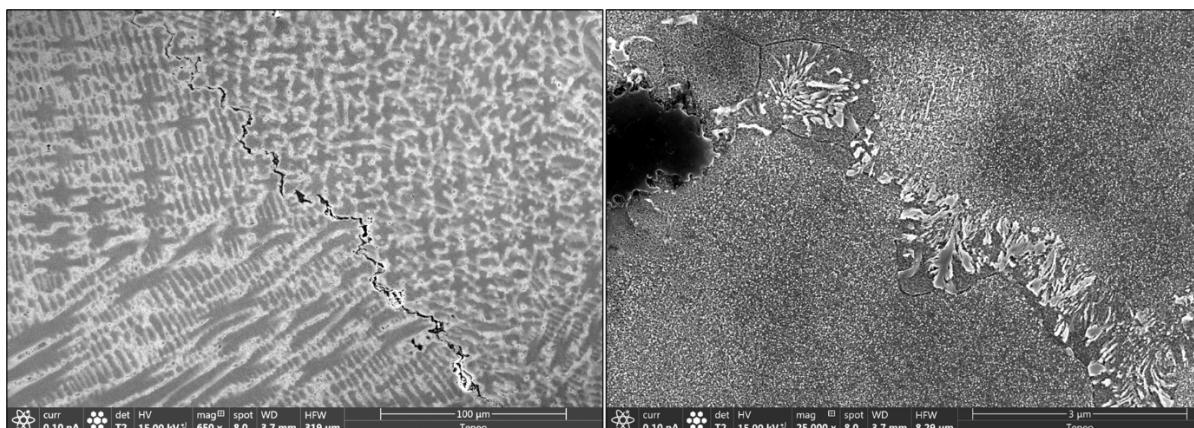
Figure A16: BSE images showing the cracks formed inside the weld metal regions of the sample section A5 in Demonstration Project #2 and the microstructural features formed ahead of the cracks.

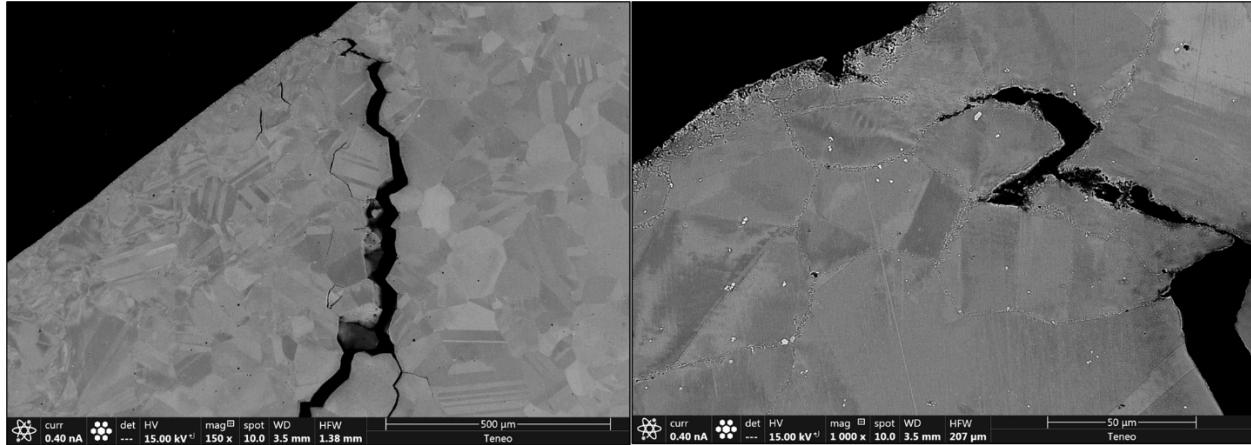
Figure A17: BSE images showing the cracks formed near the OD regions of the tube metal of the sample section A5 in Demonstration Project #2 and the microstructural features formed near the regions of the cracks.
