ORNL/RASA-95/14

**Results of the Radiological
Verification Survey at the Former
Herring-Hall-Marvin Safe Company,
1550 Grand Boulevard, Hamilton Ohio
(HO001V)**

Date issued —November 1995

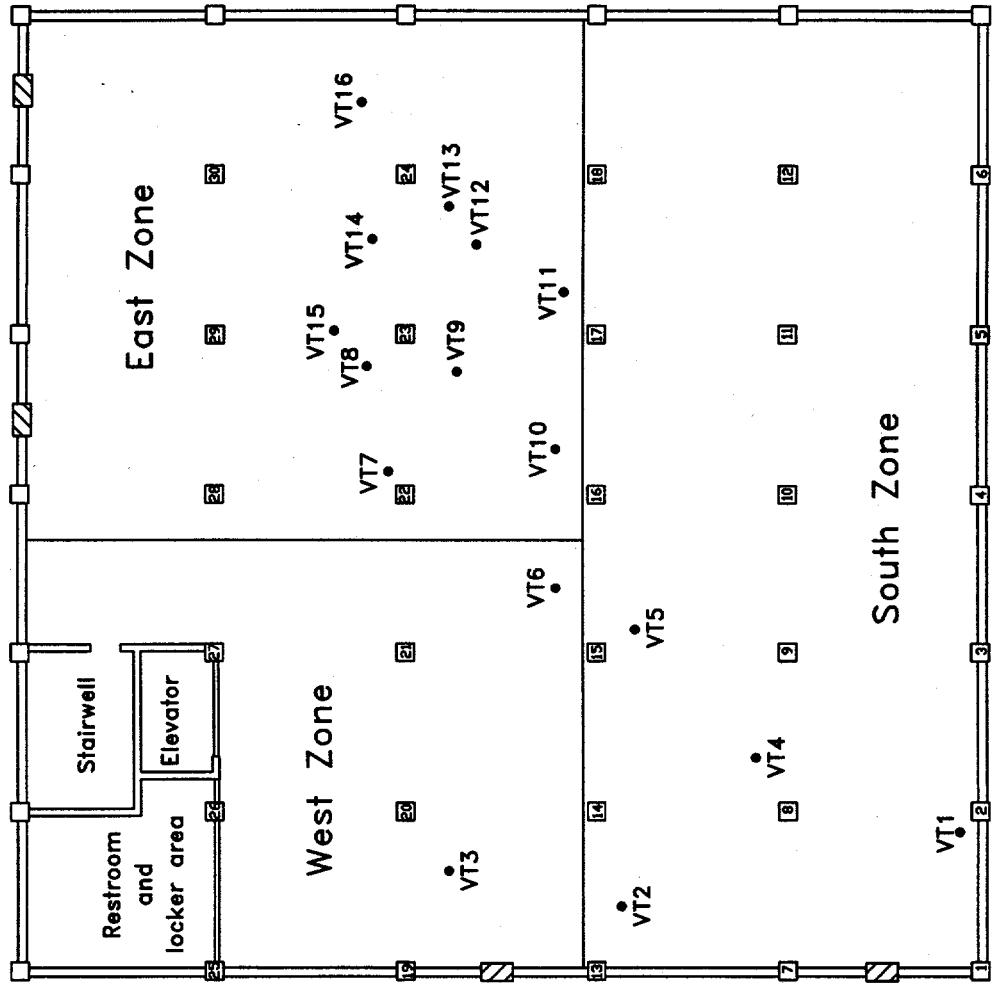
The radiological verification survey began by collecting and analyzing smears from 3-inch core holes across the entire third floor. Cores were cut from the floor by the remediating subcontractor to remove lead floor anchors. No discernible radioactivity above naturally occurring background was detected in scans or on smears collected from the core holes in any of the three established zones. Locations of transferable smear samples are shown on Fig. 2 and analytical results are presented in Table 2.

Fig. 2. Diagram of the third floor of the former Herring-Hall-Marvin Safe Company facility, showing locations of smears (relative to the numbered columns) taken from 3-in core holes in the floor throughout this area. The 3rd floor was divided into three zones for the remedial action and verification survey.

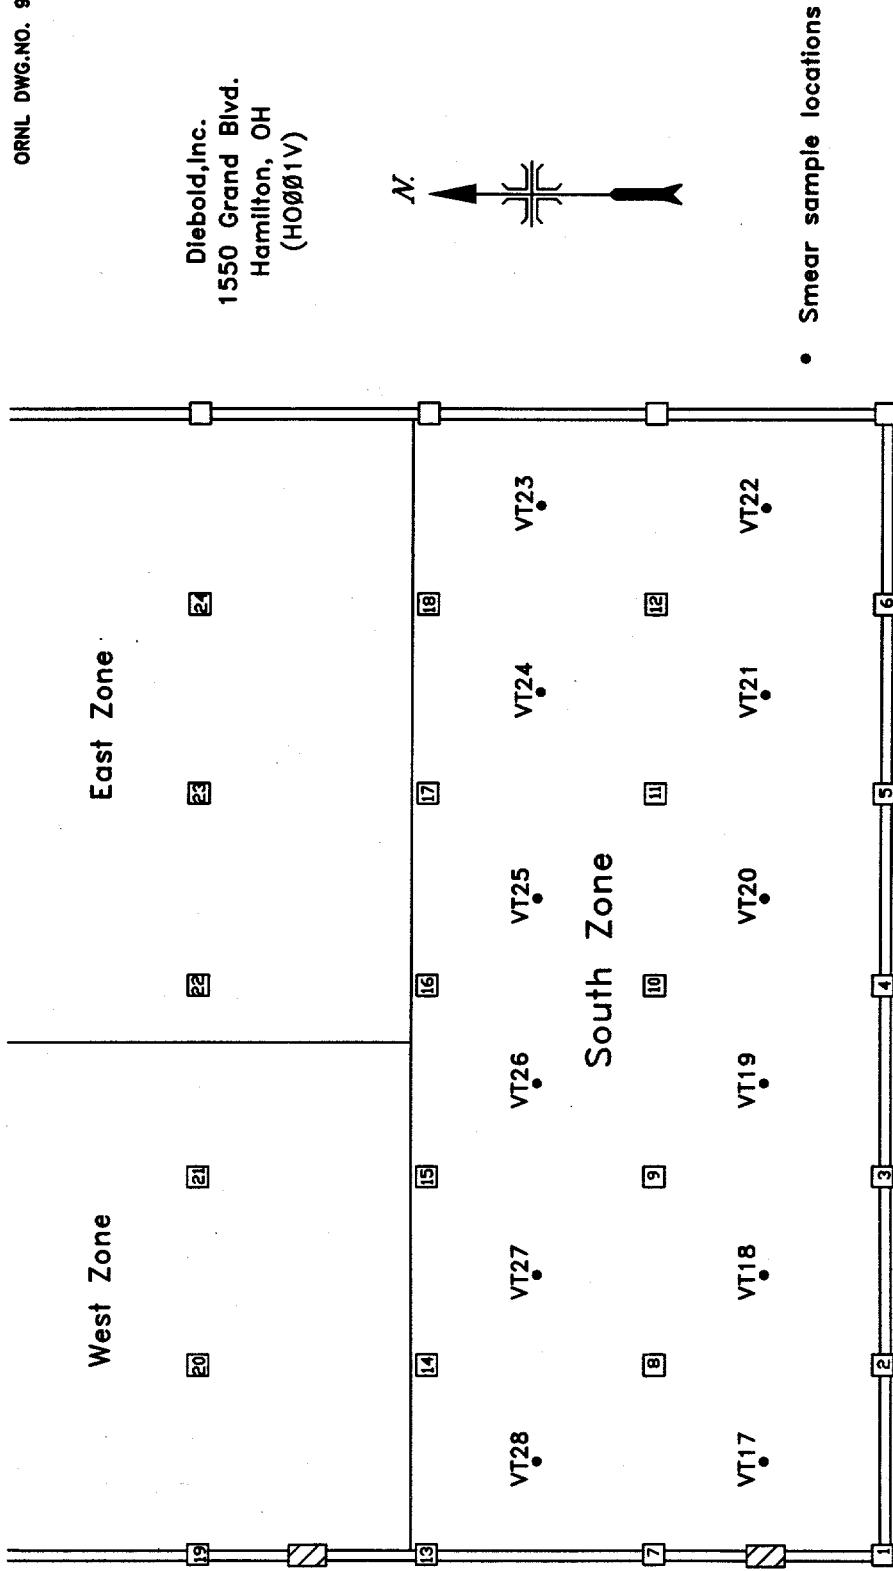
Fixed beta-gamma activity on floors, walls, columns and wall drains ranged up to 1300 dpm/100 cm². Fixed beta-gamma activity on ceilings ranged up to 700 dpm/100 cm². Alpha activity on the floors and walls was below guidelines. Gamma exposure rates at one meter above floor level ranged from 3 to 5 μ R/h. Results of the smear analysis showed that all smears were below guidelines for transferable alpha and beta-gamma activity. Locations of the smears are shown in Fig. 3, and analytical results are presented in Table 2.

The south zone was verified by the ORNL survey team as having no fixed or transferable contamination in excess of established guidelines, and the zone remained isolated by the plastic curtain until the entire third floor was verified below guidelines.

Fig. 3. Diagram indicating smear locations in the South Zone on the 3rd floor of the former Herring-Hall-Marvin Safe Company facility.

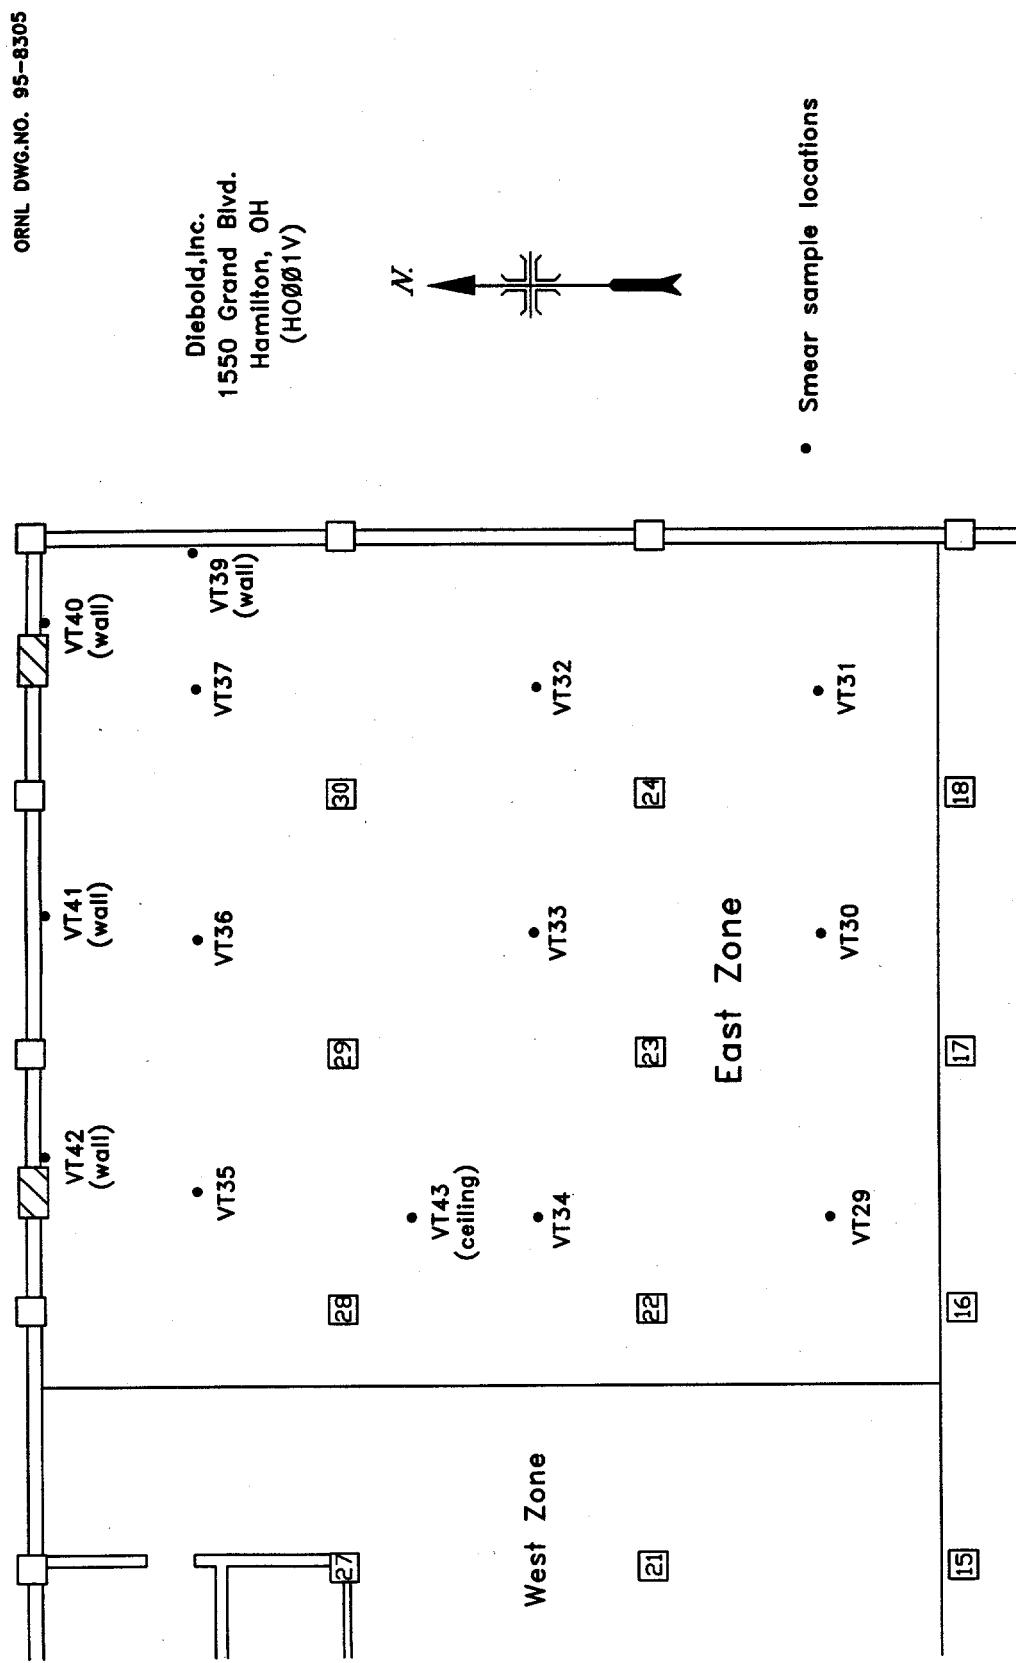
Initially, the investigation of the east zone revealed numerous areas in which established guidelines were still exceeded, requiring additional remediation (e.g., beta-gamma residuals measured up to 120,000 dpm/100 cm² around the column located in the southwest corner of block 22. Other areas within the east zone ranged from just slightly above guideline levels up to 21,000 dpm/100 cm²). These areas were identified with paint to expedite remedial efforts within the zone. Remediation continued in the evenings, and areas not meeting guidelines were rechecked for residuals the next morning.

Final fixed alpha contamination of the floor and walls ranged from none detectable up to 140 dpm/100 cm². Maximum fixed beta-gamma activity on floors was 1100 dpm/100 cm², and maximum fixed beta-gamma on walls, including columns and wall drains measured 4500 dpm/100 cm². Fixed beta-gamma on ceilings ranged from none detectable up to 4100 dpm/100cm². Gamma exposure rates at one meter above floor level ranged from 3 to 5 μ R/h. Analysis of the smears taken from the east zone indicated that all transferable radioactivity levels were below guidelines. Locations of the smears are shown in Fig. 4, and analytical results are presented in Table 2.

The east zone was verified below established cleanup guidelines and a memo to that effect was provided at the request of the Bechtel site supervisor.

Fig. 4. Diagram indicating smear locations in the East Zone on the 3rd floor of the former Herring-Hall-Marvin Safe Company facility.

Following these remedial efforts, the east zone was resurveyed over all overhead pipes and conduits, floor surfaces, walls, wall drains, and support columns. Approximately 30 % of the ceiling was surveyed for beta-gamma and ~ 1% of the same surface was scanned for alpha radiation. Systematic smear samples were collected and analyzed for transferable radioactivity.

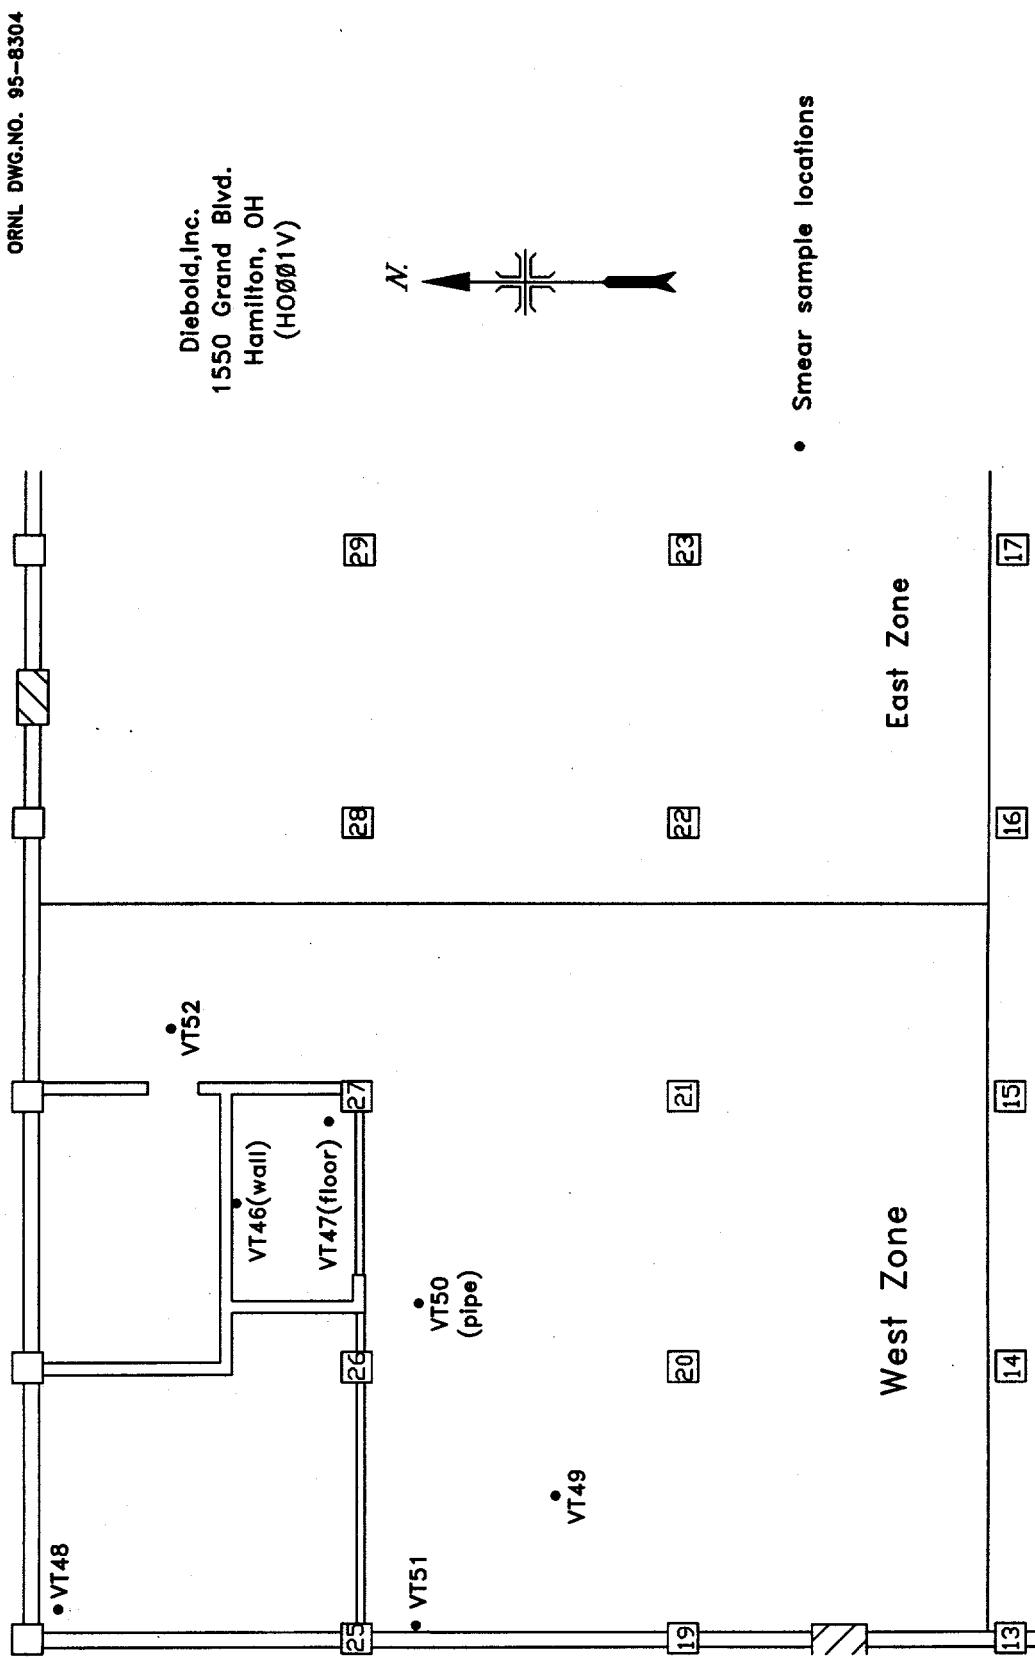
The west zone included the elevator penthouse and elevator shaft. The initial survey located limited contamination in excess of established guidelines on the third floor and elevator penthouse (e.g., one small floor area on the third floor just south of the elevator doorway measured 31,000 dpm/100 cm² of fixed beta-gamma activity. Several deposits of beta-gamma contamination were located on the floor of the elevator shaft where a maximum of 128,000 dpm was measured. Most of these deposits were around the interface between the elevator shaft walls and elevator shaft floor). One small deposit of

When final measurements for fixed contamination in this zone were made, maximum alpha contamination of the floor and walls was 280 dpm/100 cm²; maximum beta-gamma activity on floors and floor drains was 1900 dpm/100 cm²; maximum beta-gamma on walls including columns and wall drains was 3300 dpm/100 cm²; and maximum beta-gamma on ceilings was 3500 dpm/100 cm². Gamma exposure rates at one meter above floor level ranged from 10 to 13 μ R/h. In the restroom where red brick was present, gamma measurements ranged from 10 to 18 μ R/h. All of these measurements are well below DOE guidelines.

Fig. 5. Diagram indicating smear locations in the West Zone on the 3rd floor of the former Herring-Hall-Marvin Safe Company facility.

Following these further remedial efforts in the west zone, beta-gamma scans were again conducted by the ORNL team over all overhead pipes and conduits, floor surfaces, and accessible surfaces of all drain openings. Also, ~30% of all walls and exposed ceilings and ~75% of all support columns were re-scanned for beta-gamma activity. Alpha measurements were collected over ~1% of these same surfaces. Smear samples were systematically collected in the west zone, including the elevator, elevator shaft and penthouse, and analyzed for transferable radioactivity. Locations of the smears are shown in Figs. 5 and 6, and analytical results are presented in Table 2.

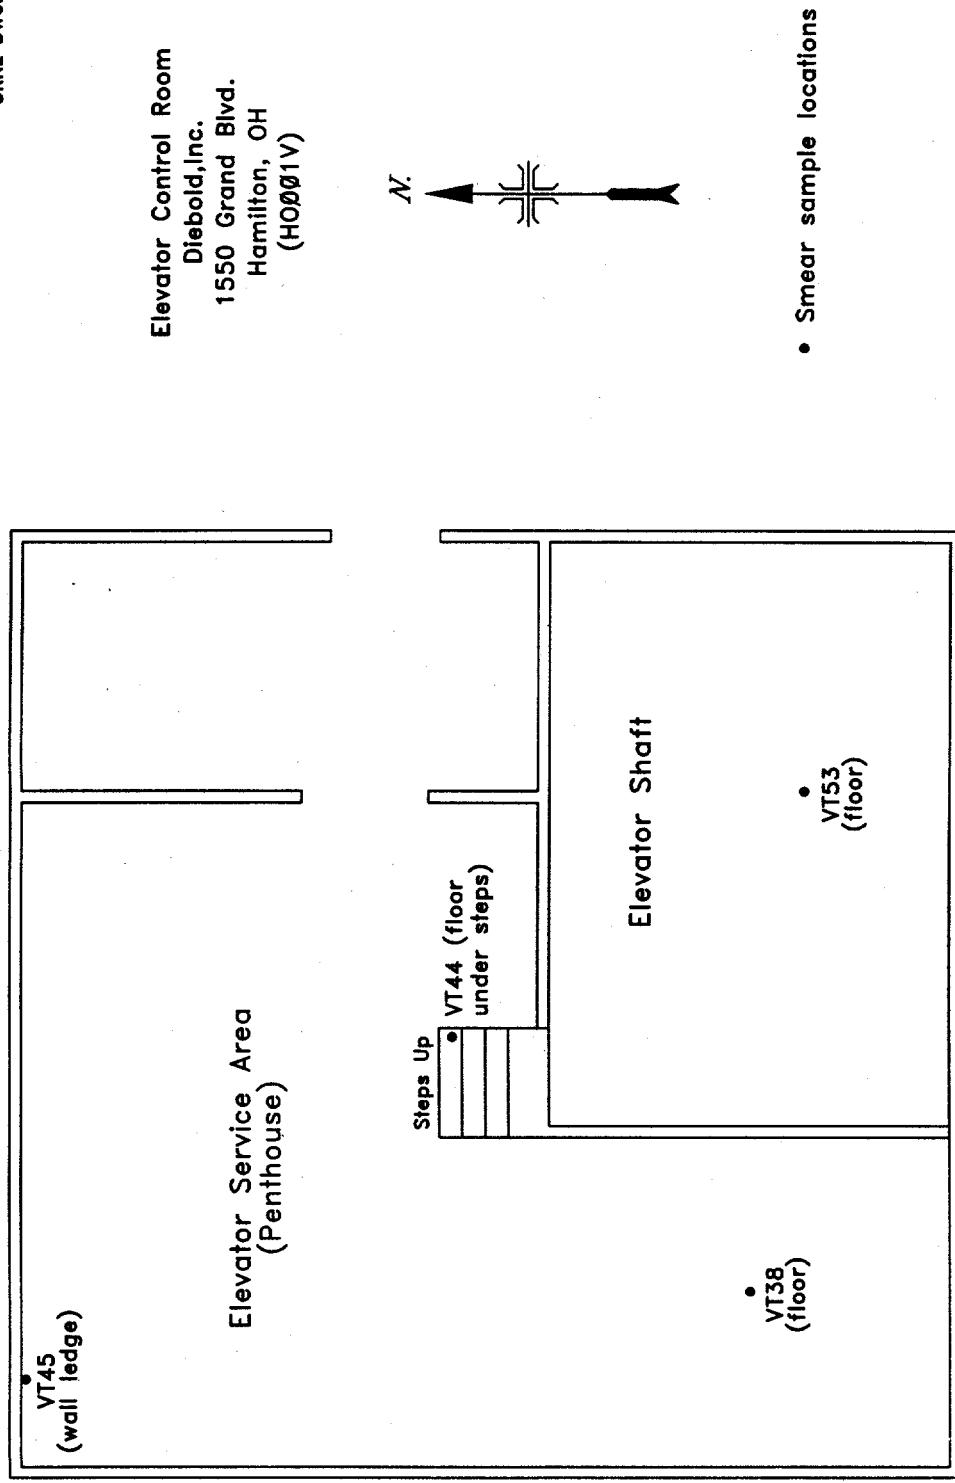
5,000 dpm/100 cm² beta-gamma was also located in dust on a board attached to the north elevator shaft wall; however, it was immediately remediated to background levels by the ORNL survey team. The contractor continued remediation in the west zone until no other uranium residuals in excess of guidelines could be located.

The west zone, including elevator penthouse and elevator shaft, was verified by the ORNL survey team as below established cleanup guidelines, and a memo to this effect was provided to the Bechtel site supervisor.

Fig. 6. Diagram indicating smear locations in the elevator shaft and service area above the shaft (penthouse) in the former Herring-Hall-Marvin Safe Company facility.
