ANL/ESD/TM-105

**Contamination Source Review for Building E3613,
Edgewood Area, Aberdeen Proving Ground, Maryland**

**Energy Systems Division
Argonne National Laboratory**

September 1995

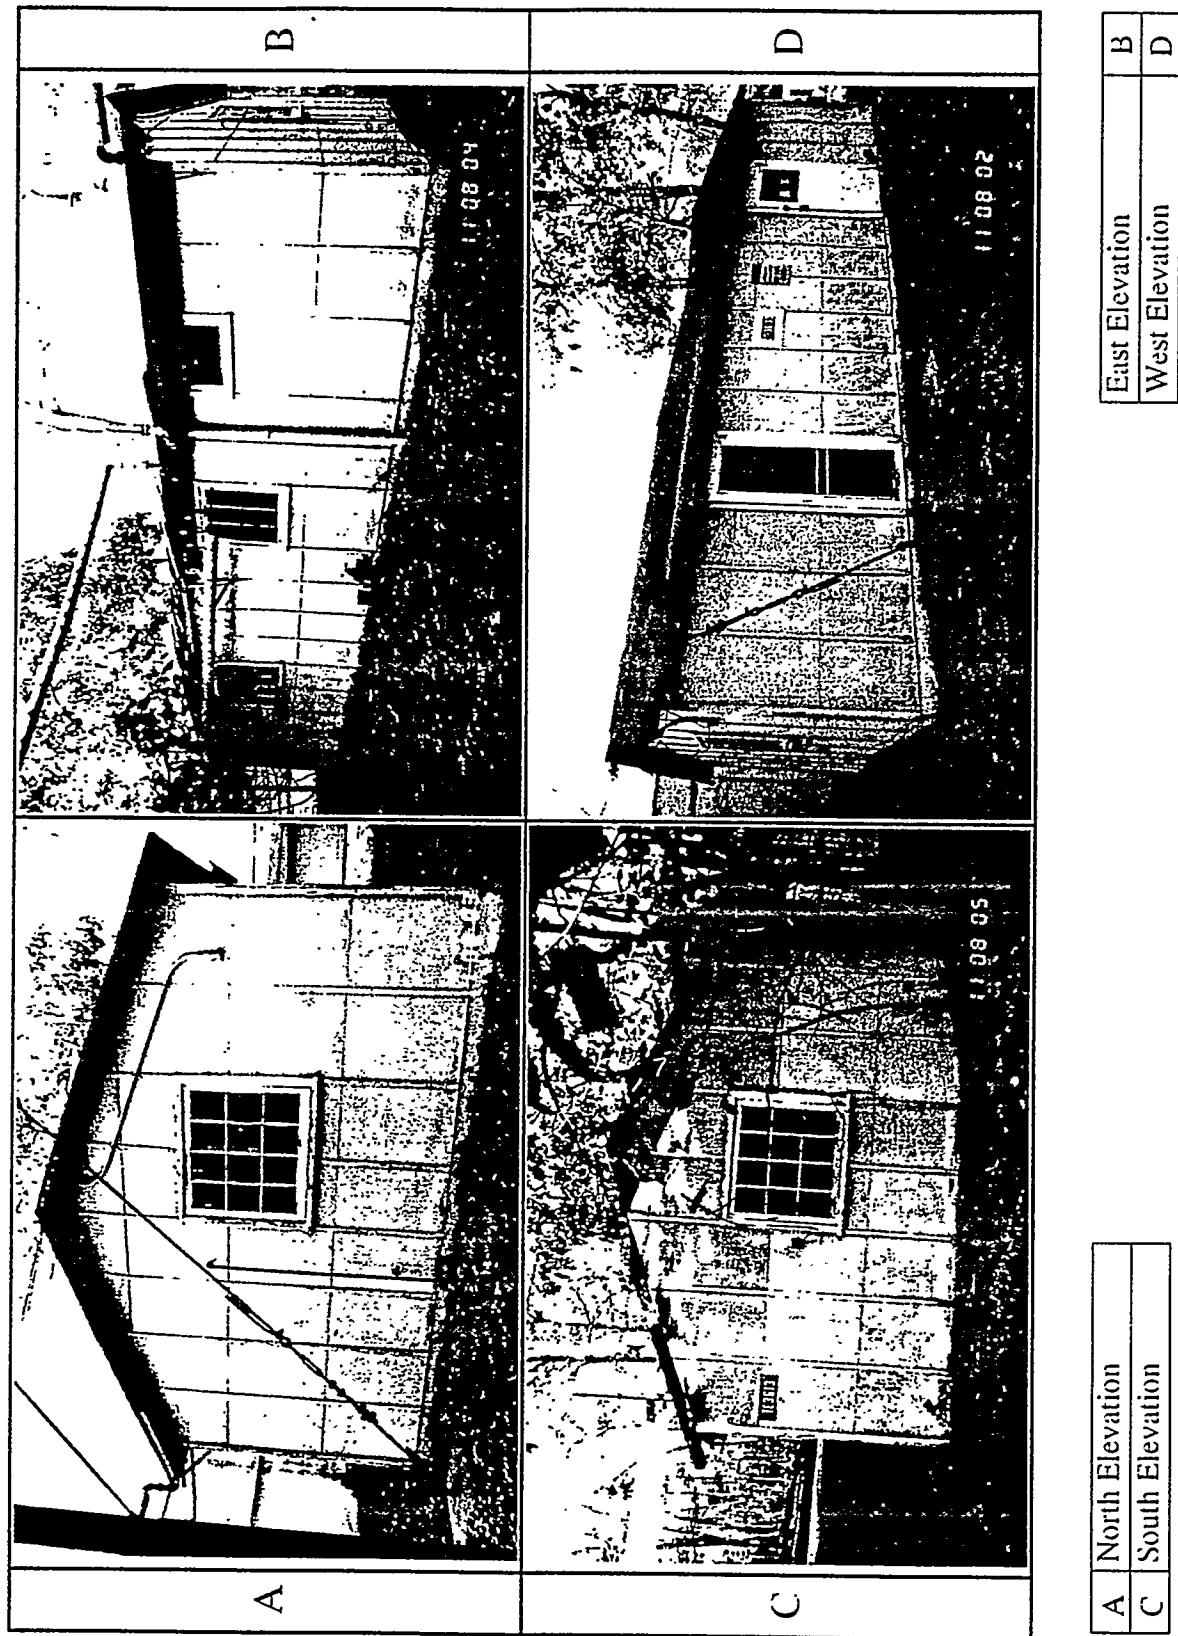
FIGURE 4 Photographs of Building E3613 Exterior

Because of a lack of maintenance, the north exterior wall shows signs of deterioration and weathering. Oxidized metals and cracked, chipped, and peeling paint were observed.

Because of a lack of maintenance, the east exterior wall shows signs of deterioration and weathering. Oxidized metals and cracked, chipped, and peeling paint were observed.

Because of a lack of maintenance, the south exterior elevation shows signs of deterioration and weathering. Oxidized metals and cracked, chipped, and peeling paint were observed.

Because of a lack of maintenance, the west exterior elevation shows signs of deterioration and weathering. Oxidized metals and cracked, chipped, and peeling paint were observed.

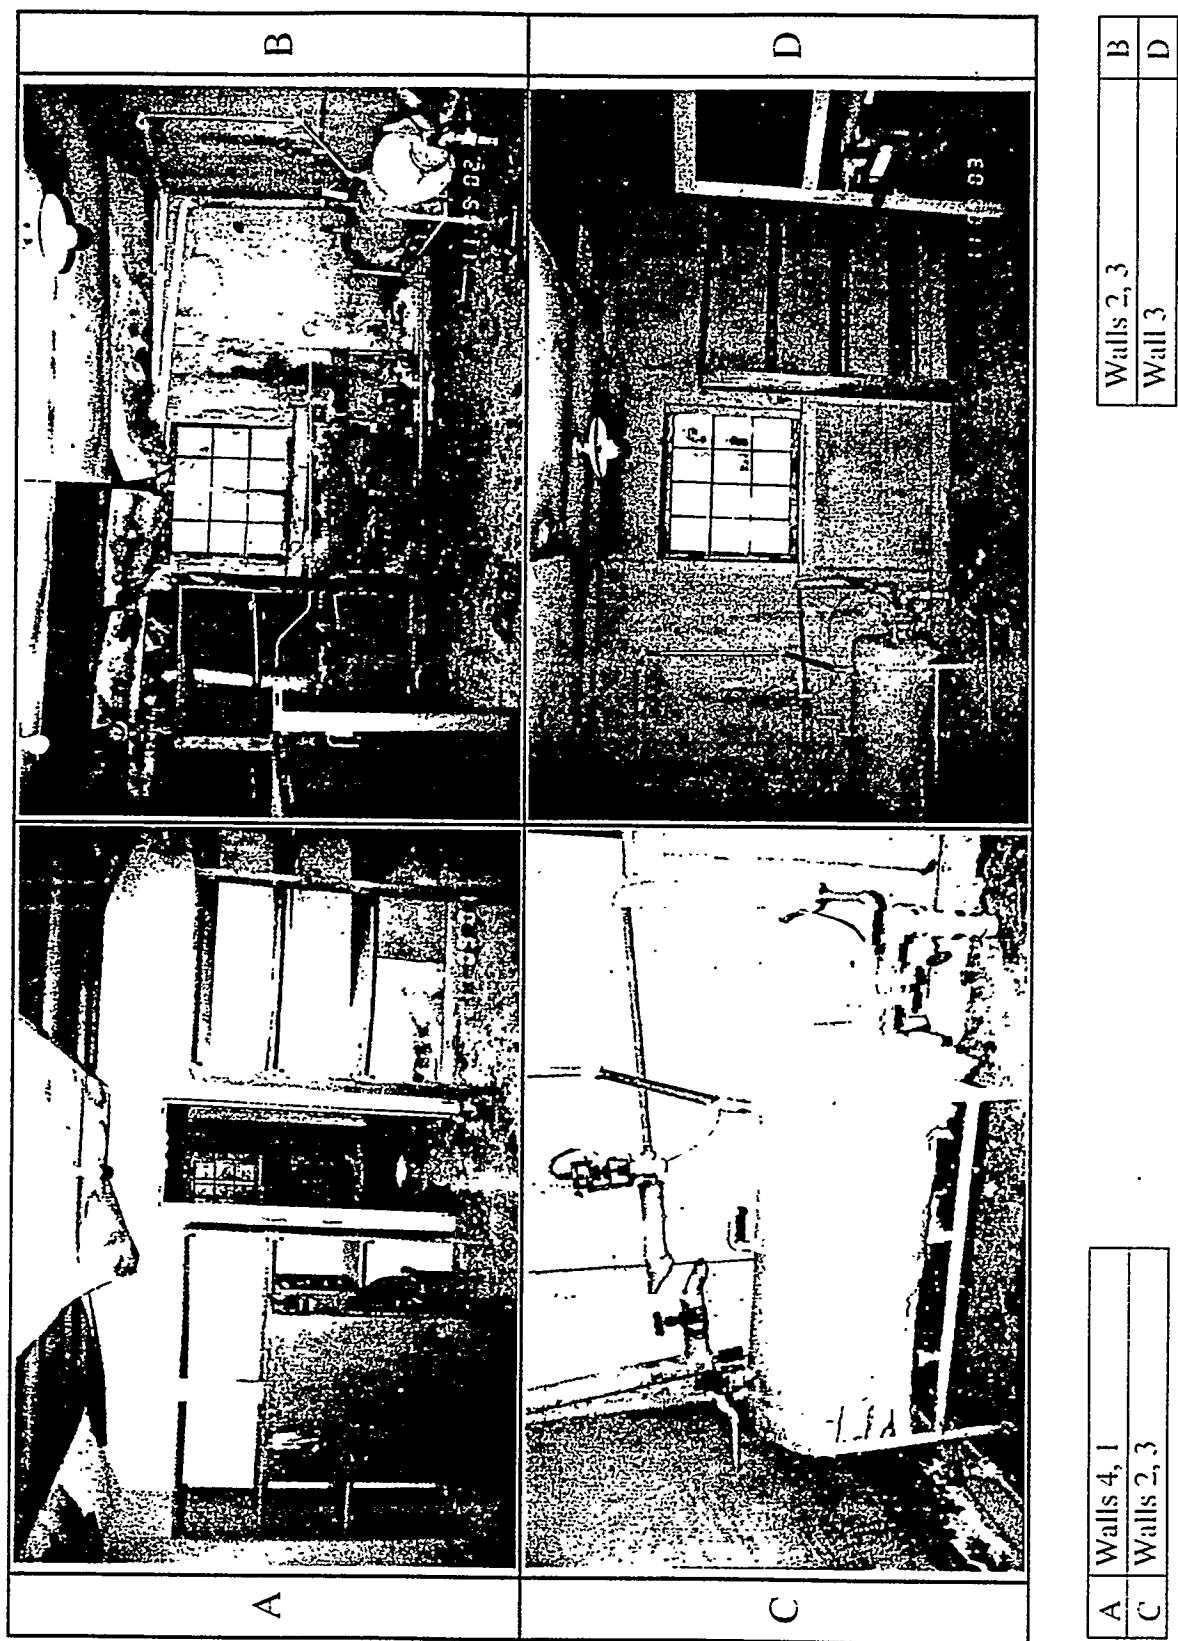
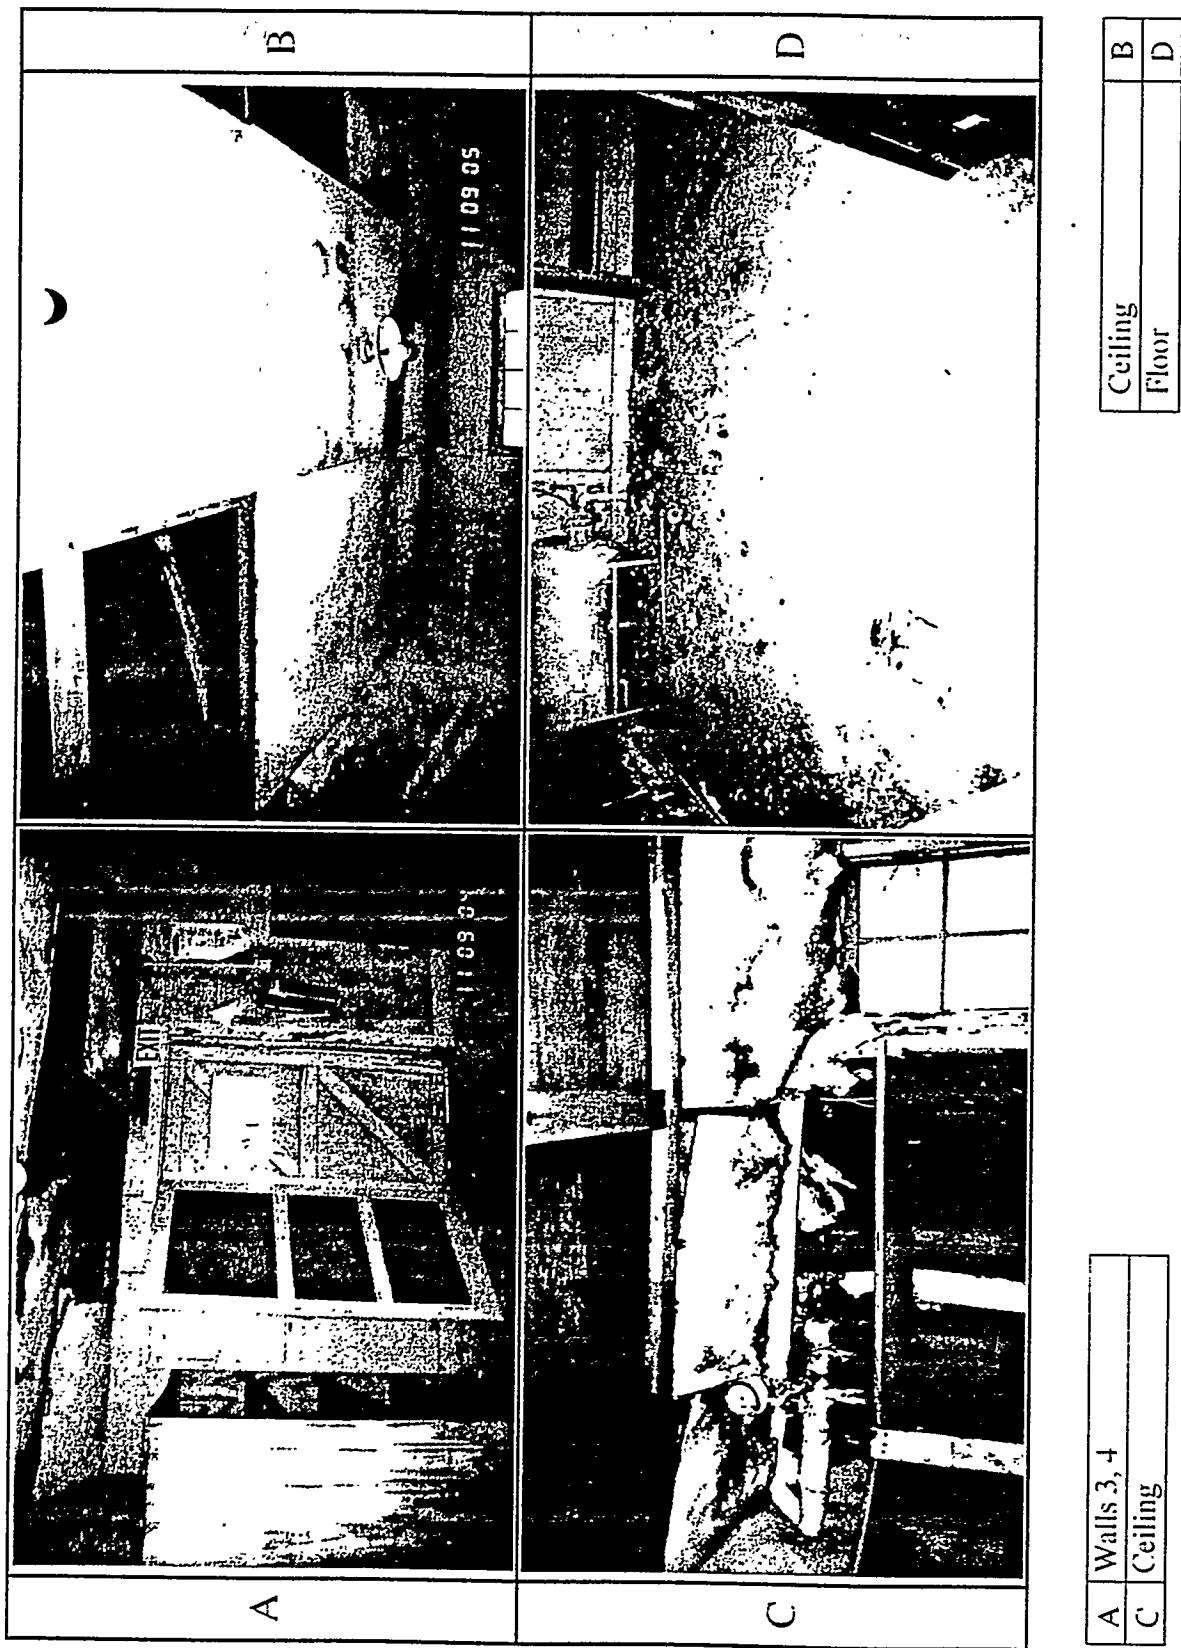
FIGURE 5 Photographs of Room 1 — Walls

Two pipes measuring 2 in. in diameter and covered with suspected asbestos-containing insulating materials run vertically from a storage tank to the ceiling on wall 3. The pipes bend 90° and continue horizontally along the entire length of the ceiling of wall 2. The piping appears to

again bend 90° and continue halfway down wall 2. A 1-in.-diameter electrical conduit runs vertically to the ceiling from an electrical switch located 2 ft north of the doorway and 5 ft above the floor on wall 4 (Figures 5 and 6).

The ceiling of Building E3613 is white drywall nailed to a wooden frame. Although the ceiling was not leaking at the time of the inspection, extensive staining of the ceiling panels was assumed by ANL to be caused by water damage. In addition, sections of the drywall are missing, exposing the wood framework and piping above the ceiling (Figures 5-11).

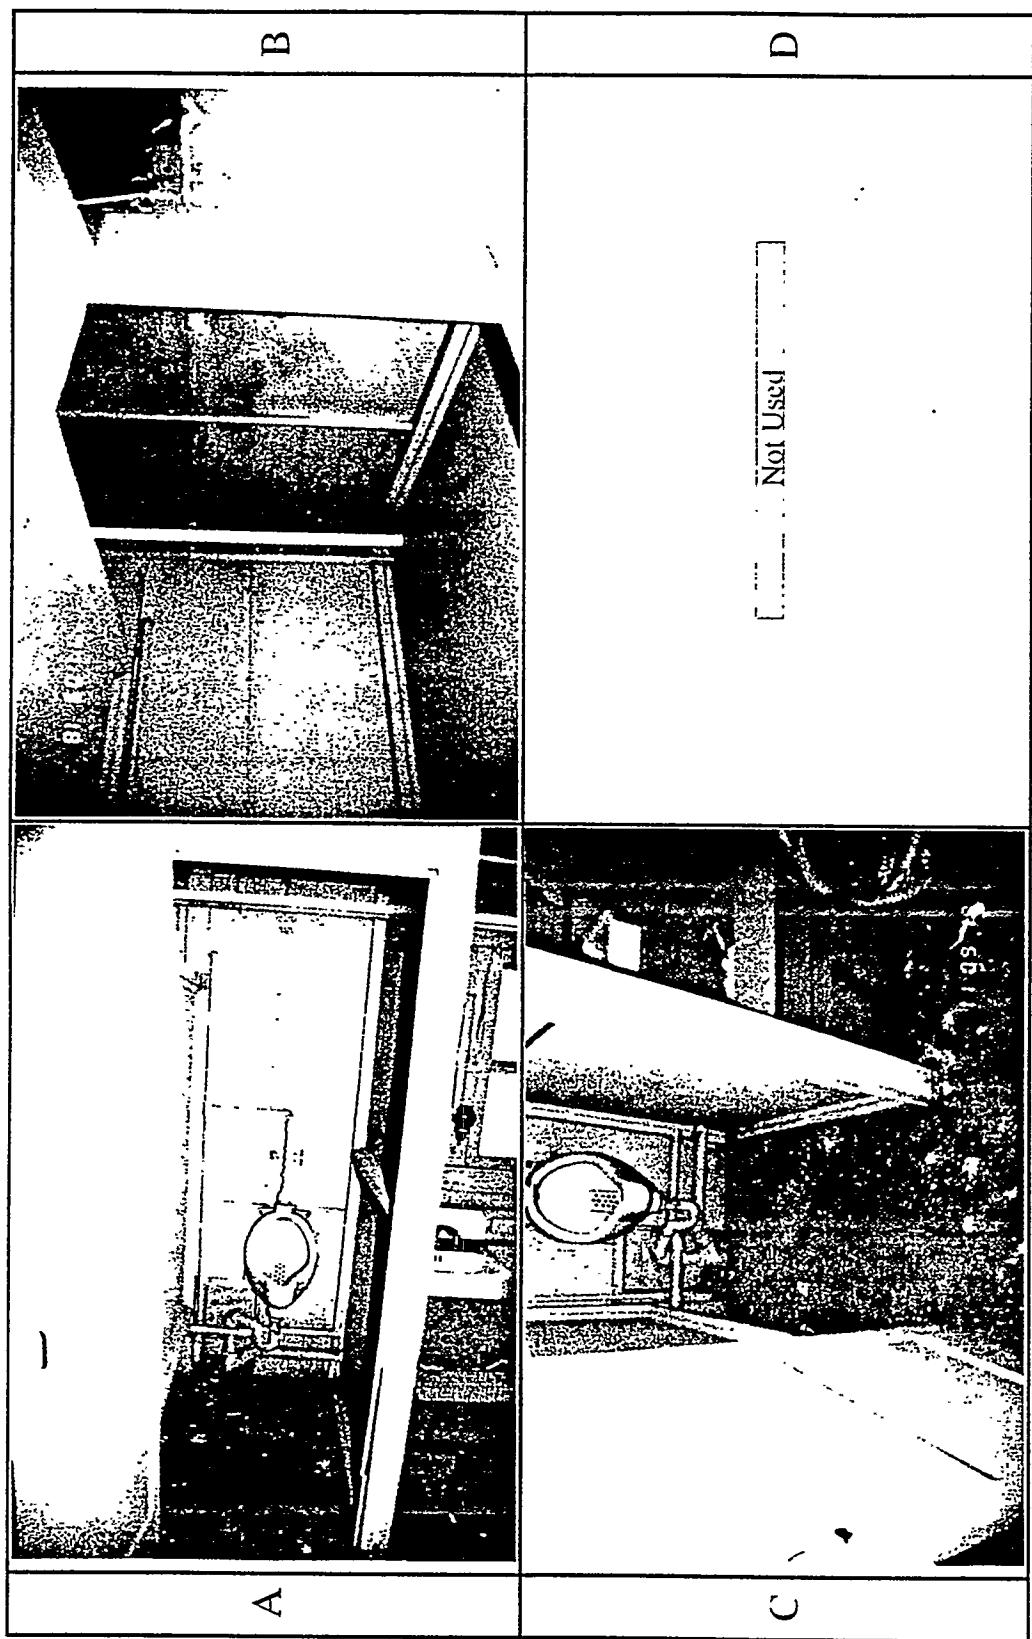
The walls in room 3 are constructed of drywall over a 2-in. by 4-in. wood frame (Figure 9).

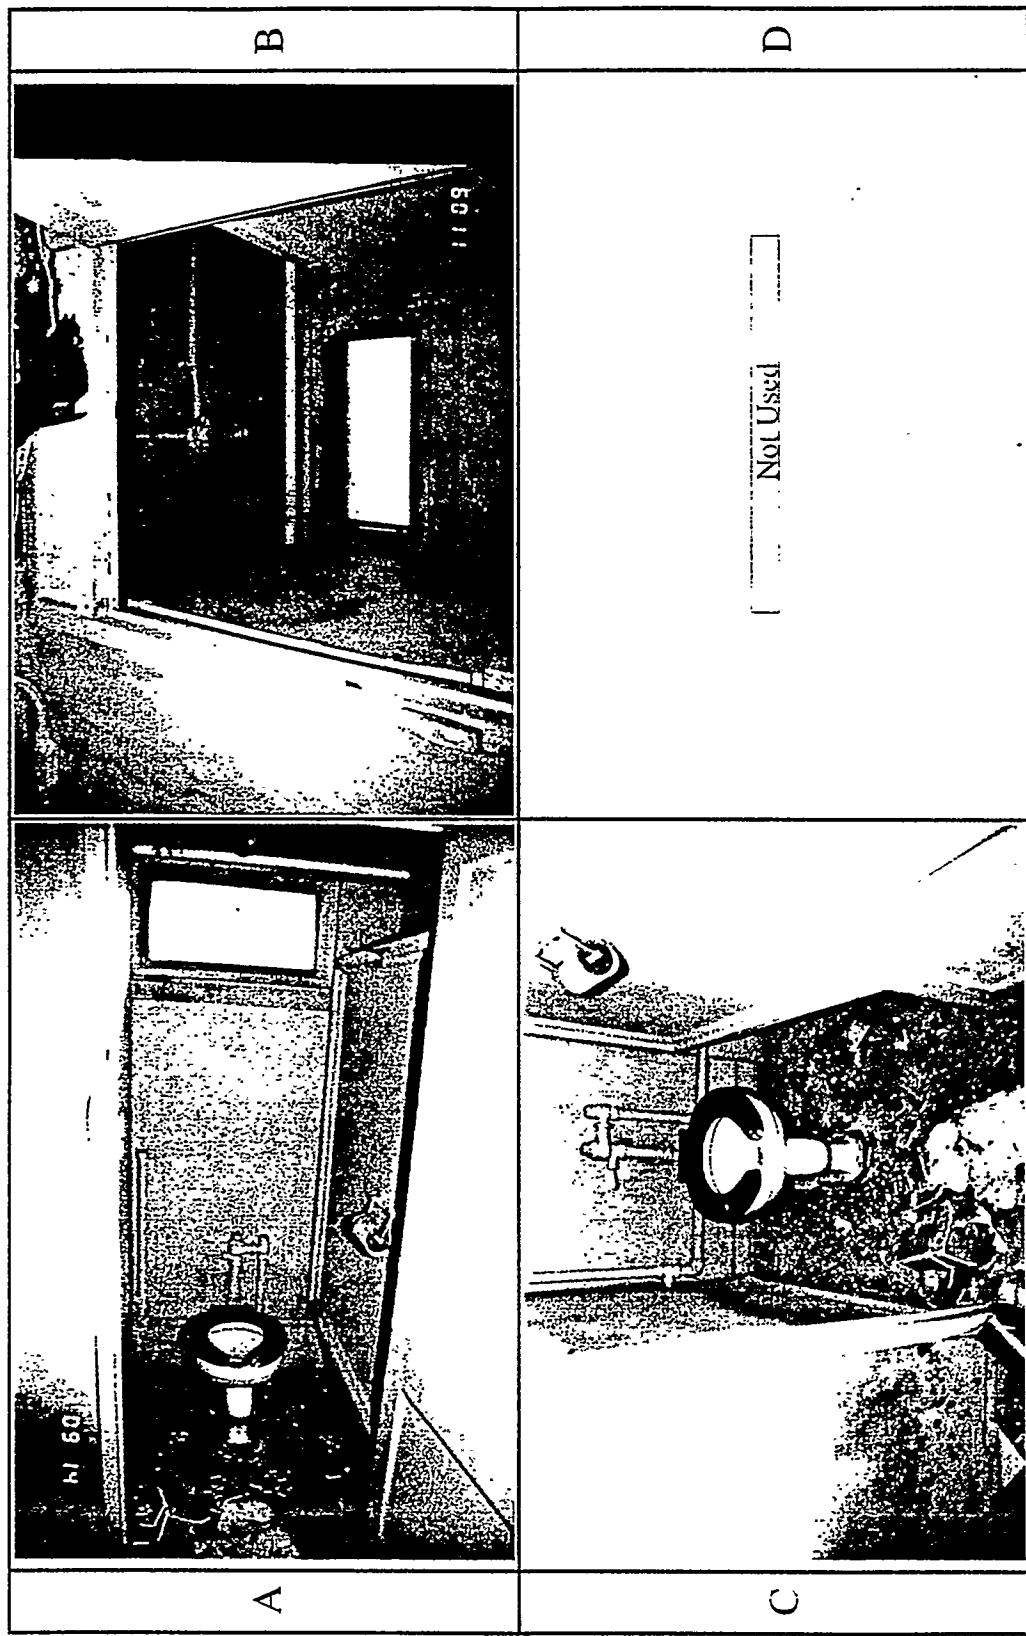
The walls in room 4 are constructed of drywall over 2-in. by 4-in. wood framing (Figure 10).

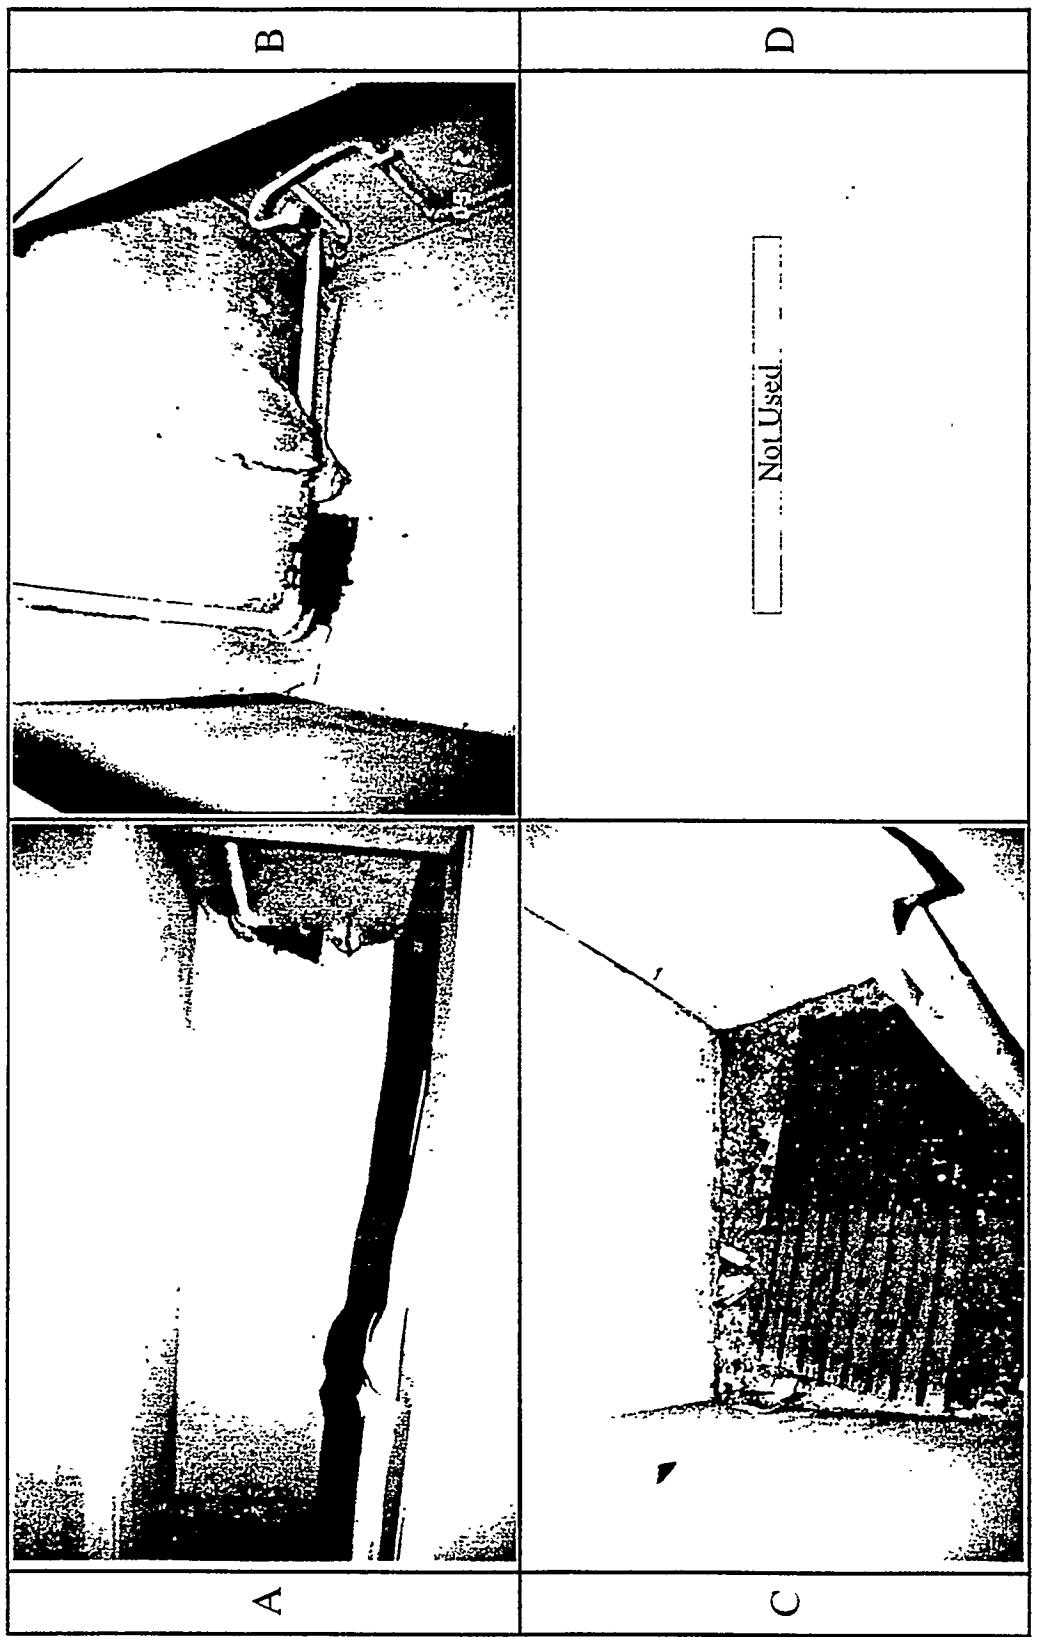
FIGURE 11 Photographs of Room 5

The walls in room 5 are constructed of drywall over 2 in. by 4 in. wood frame (Figure 11).

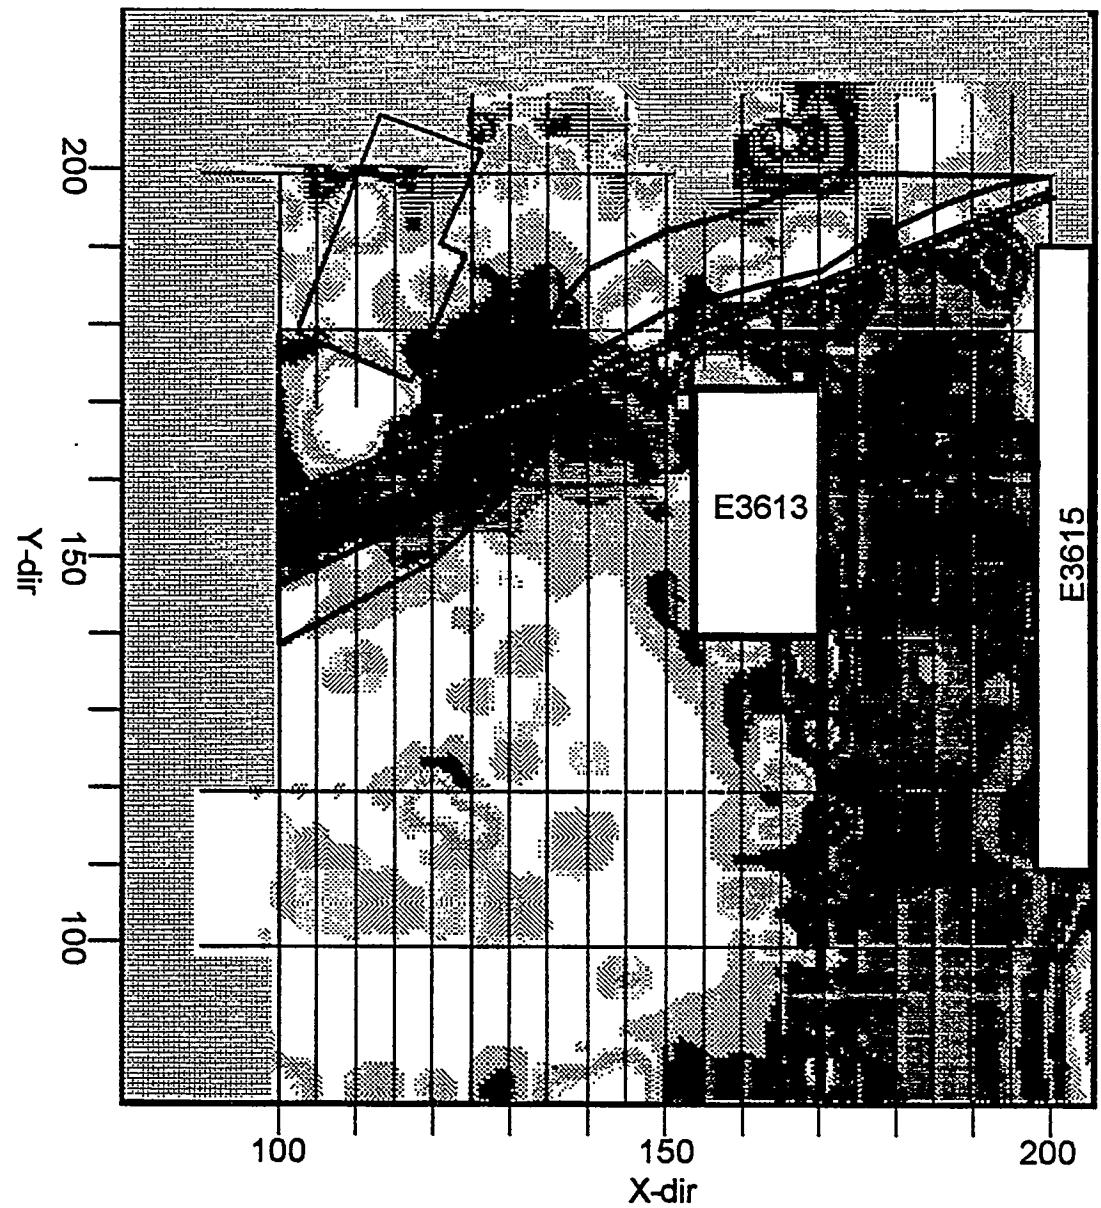
Bldg. E3613 Magnetics

The magnetic field around Building E3613 is shown in Figure 3. Magnetic anomalies are associated with overhead steam pipes and the foundation in the northwest corner of the survey area. The anomalies at the southern end of the survey area at X=100 and X=135-145 are caused by Building E3607.

A prominent magnetic anomaly extends from (120, 120) to about (125, 115). Near-surface GPR anomalies are also observed at about (120, 120) and (130, 115). Lower-amplitude point magnetic anomalies are also detected at (145, 95), (130, 105) and (110, 138). The cause of these anomalies is unknown.

A point source positive anomaly at (160, 108) is 10 ft west of the overhead steam pipe and may not be related to that feature because a small hyperbolic GPR anomaly is also observed at this location. Other unexplained magnetic anomalies are observed south of E3619 and along line Y=200 between about X=120 and X=148.

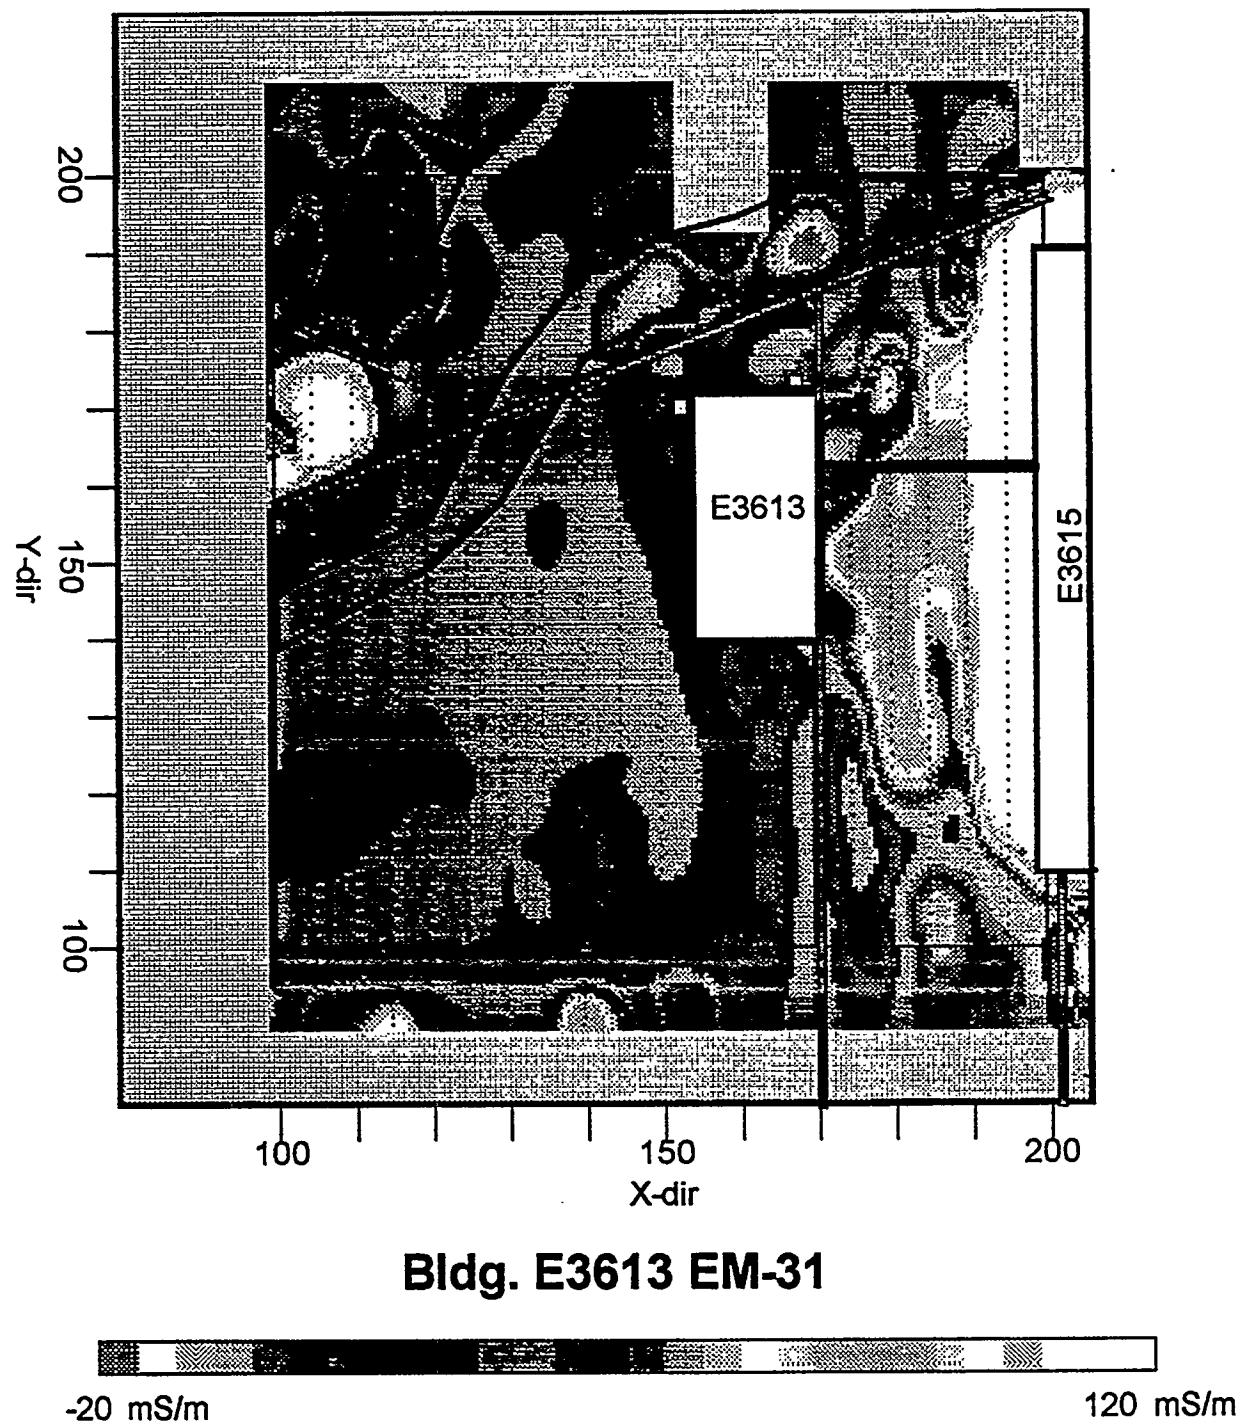
FIGURE 4 N-S EM-31 Transects (Also depicted are the positions of data points collected along the geophysical profiles. Overhead steam pipes are plotted in blue and the gravel road is depicted with thick black lines.)

Between buildings E3613 and E3615, a complex pattern of EM-31 anomalies is observed in Figures 4 and 5. However, the buildings and the overhead steam pipes cause interference in the EM-31 signals, making it difficult to detect buried materials. Furthermore, no other data set detected an anomaly in this area. The conductivity minimums at (150, 185) and (170, 190) are probably caused by a combination of metals associated with the overhead steam pipe and amphibolitic road grade material (Figure 4).

Figure 4 shows a prominent conductivity high just south of E3619. This anomaly was also detected as a magnetic high and EM-61 high and could be sourced by metals associated with the overhead steam pipe and the foundation of Building E3619.

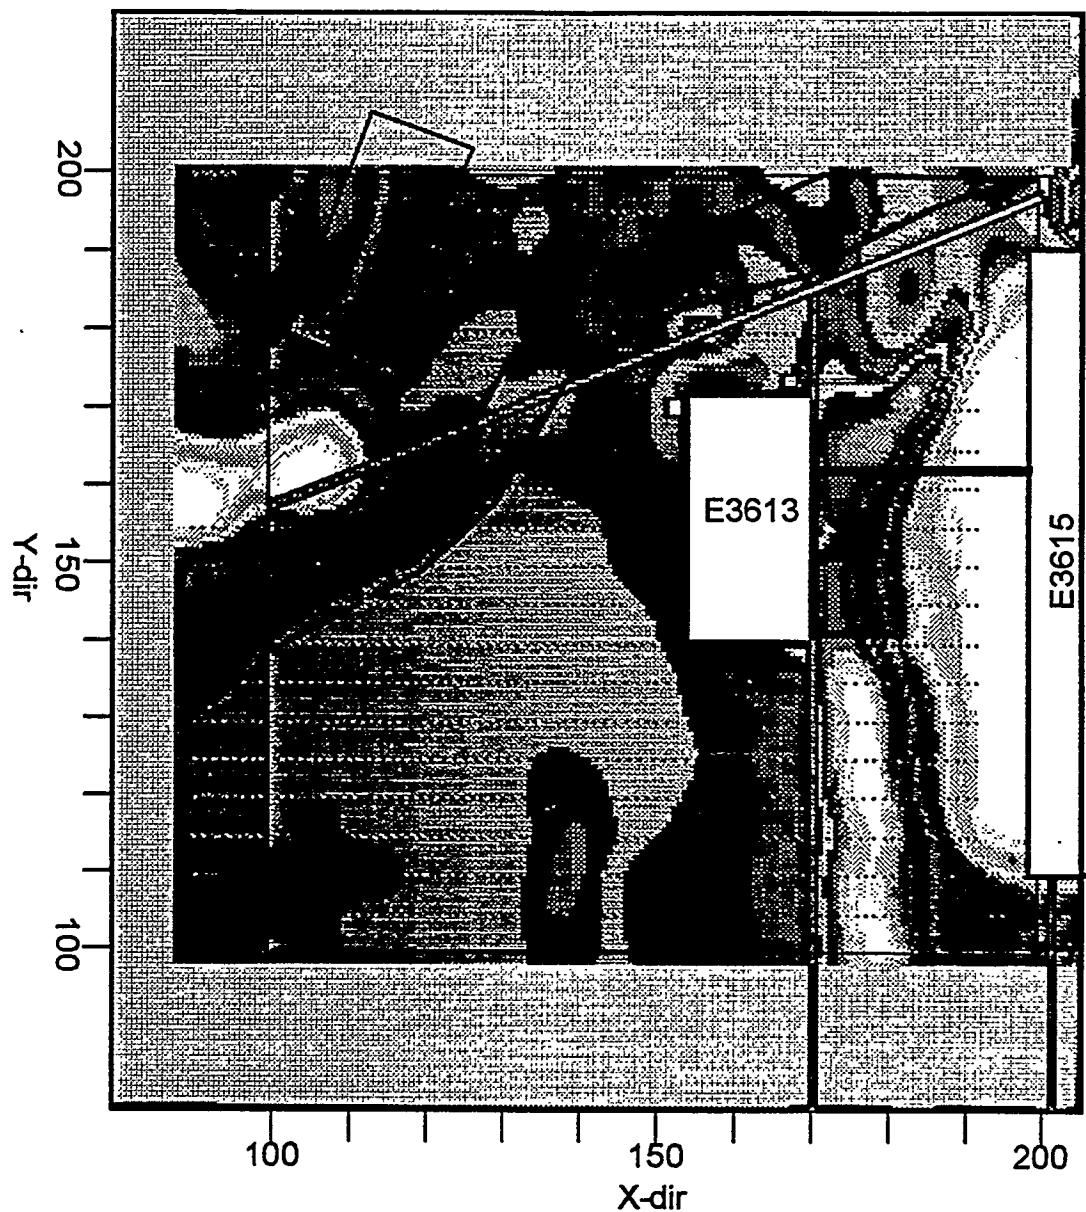
Bldg. E3613 EM-31

A prominent N-S trending anomaly is observed at about $X=175$ (Figure 5), parallel to the overhead steam pipe. Strong GPR anomalies are also detected along three east-west lines ($Y=110$ through $Y=130$) at about $X=175$. Since this anomaly is not detected with the magnetometer or the EM-61 instruments, it is probably sourced by a non-metallic large-diameter cylindrical object, such as a clay sewer pipe. A similar conductivity anomaly was interpreted to be a clay or concrete sewer pipe at the Ghost Town complex (McGinnis et al. 1994).

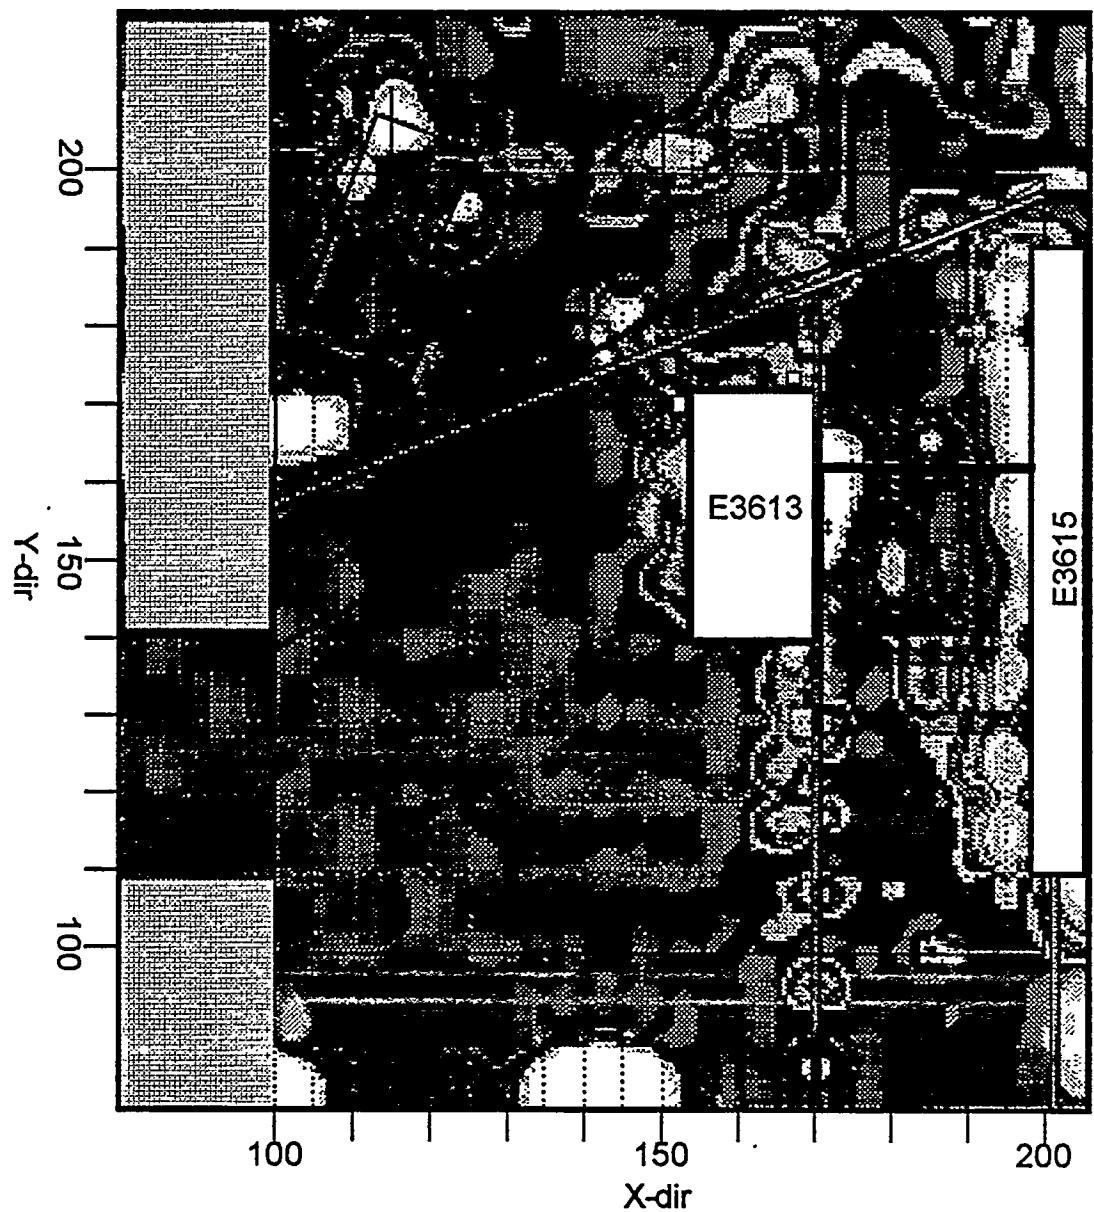
FIGURE 6 EM-61 Millivolt Anomaly Map (Also depicted are the positions of data points collected along the geophysical profiles. Overhead steam pipes are plotted in blue and the gravel road is depicted with thick black lines.)

A color-contour map constructed from EM-61 lower coil data is shown in Figure 6. EMF anomalies are associated with building E3613, the foundation of E3619 and the overhead steam pipes. The positive anomalies along Y=80 are associated with Building E3607.

As discussed earlier, a strong EMF positive is observed south of E3619 (Figure 6) that correlates with both conductivity and magnetic observations. EMF highs on the northwest corner of the foundation of E3619 match the locations of a control box and a vertical pipe (Figure 2). A magnetic high (Figure 3) is also observed near the EM-61 anomaly (Figure 6) along the eastern edge of the foundation.

Along the northern edge of the survey area, an EMF high between (150, 200) and (165, 210) follows the trend of a surface depression that was noted by ANL personnel, but not tied in to the survey grid. Isolated magnetic anomalies are also observed at (147, 200) and (160, 210) (Figure 3). These observations suggest that the depression is underlain by buried metals, such as a sewer pipe. Toward the northwest, an EMF positive is observed near (105, 220). The source of this anomaly is unknown.

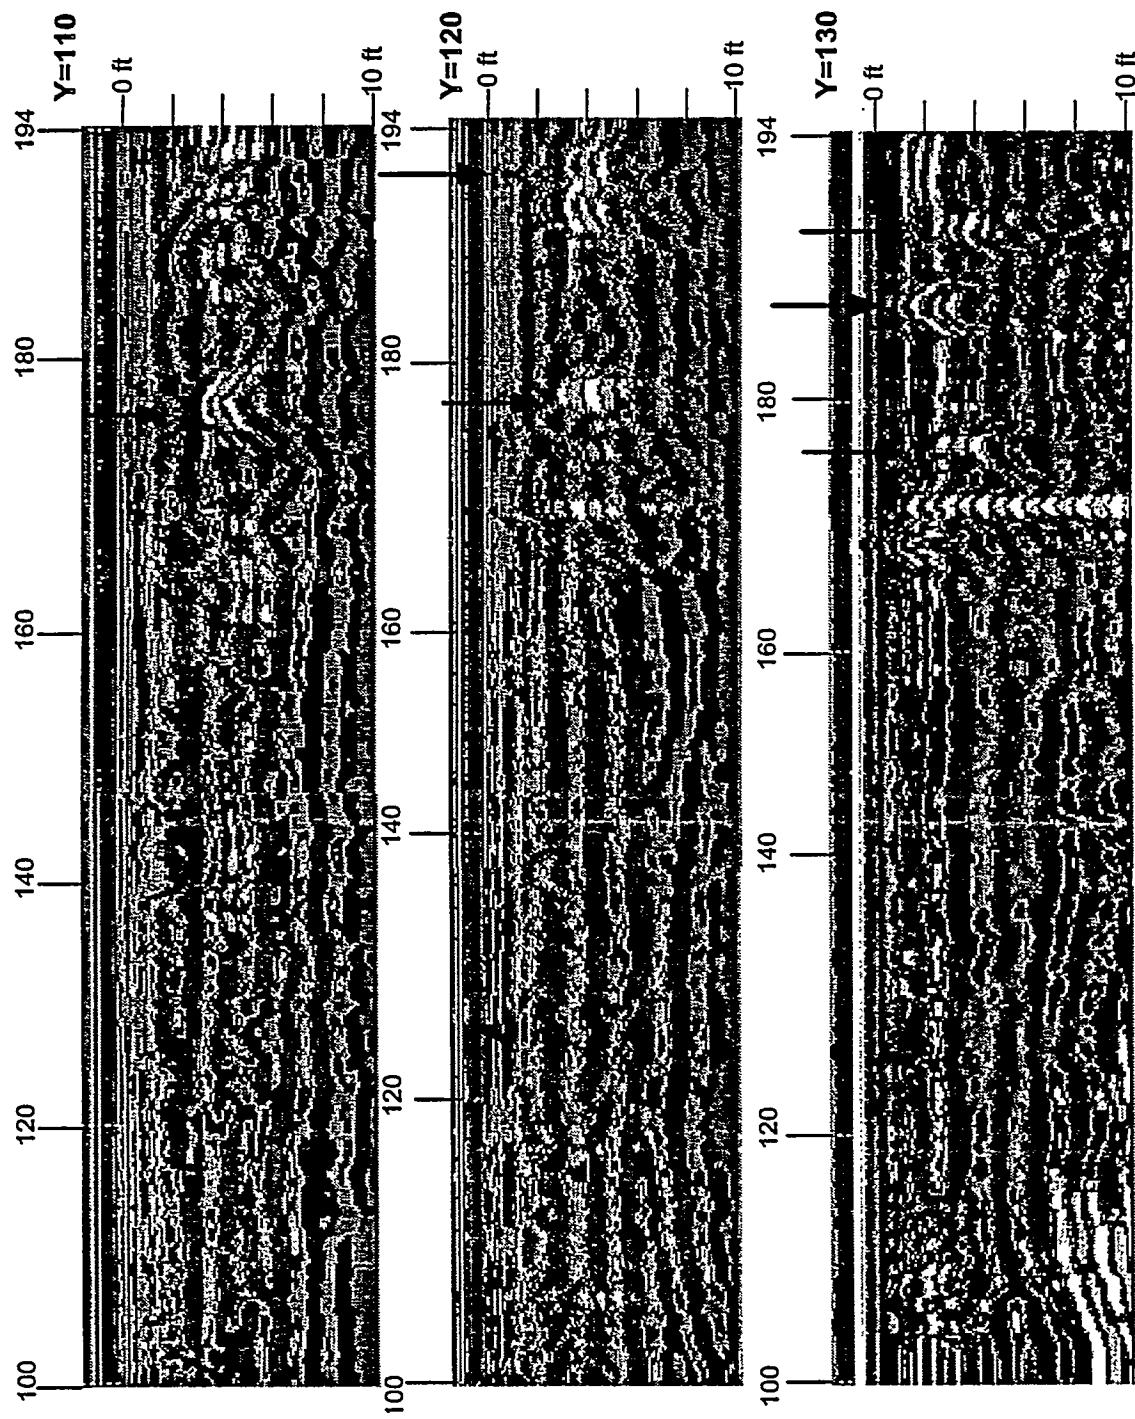
FIGURE 8 Ground Radar Images along Transects Parallel to the X-Axis South of E3613 (Strong hyperbolic GPR anomalies near $X=175$ correlate with a conductivity low [Figure 5]. The maximum penetration depth is estimated at 7 ft.)

Good penetration was observed over most of the site, with resolution down to about seven feet below the ground surface. Near about $X=192$, clear hyperbolic GPR anomalies parallel Building E3615 from about $Y=170$ to about $Y=140$ (Figure 8). This trend may extend southward as subtle hyperbolas are also observed along lines $Y=120-130$ at about $X=190$ (Figure 9). An EM-61 high follows the same pattern (Figure 6). A second set of GPR anomalies appears to follow the trend of EM-61 anomalies (Figure 7) located on a diagonal between E3613 and E3615. This anomaly is not present along profiles $Y=170$ or $Y=120$. Both anomalies have their origins within 2 feet of the surface and could indicate the presence of buried pipelines. The near-surface anomaly along profile $Y=150$ at about $X=188$ is not detected with other geophysical profiles and may be sourced by an antenna bump.

Along profiles $Y=110-130$, strong hyperbolic GPR anomalies (Figure 8) are observed at about $X=175$, near the north-south trending conductivity low (Figure 5). According to the review of building history by EAI Corp. (1989) a 4 in. sewer line services E3613, which could be the source of the observed anomalies. The strong reflections at about $X=170$ along profiles $Y=120-130$ are probably sourced by the overhead steam pipe.

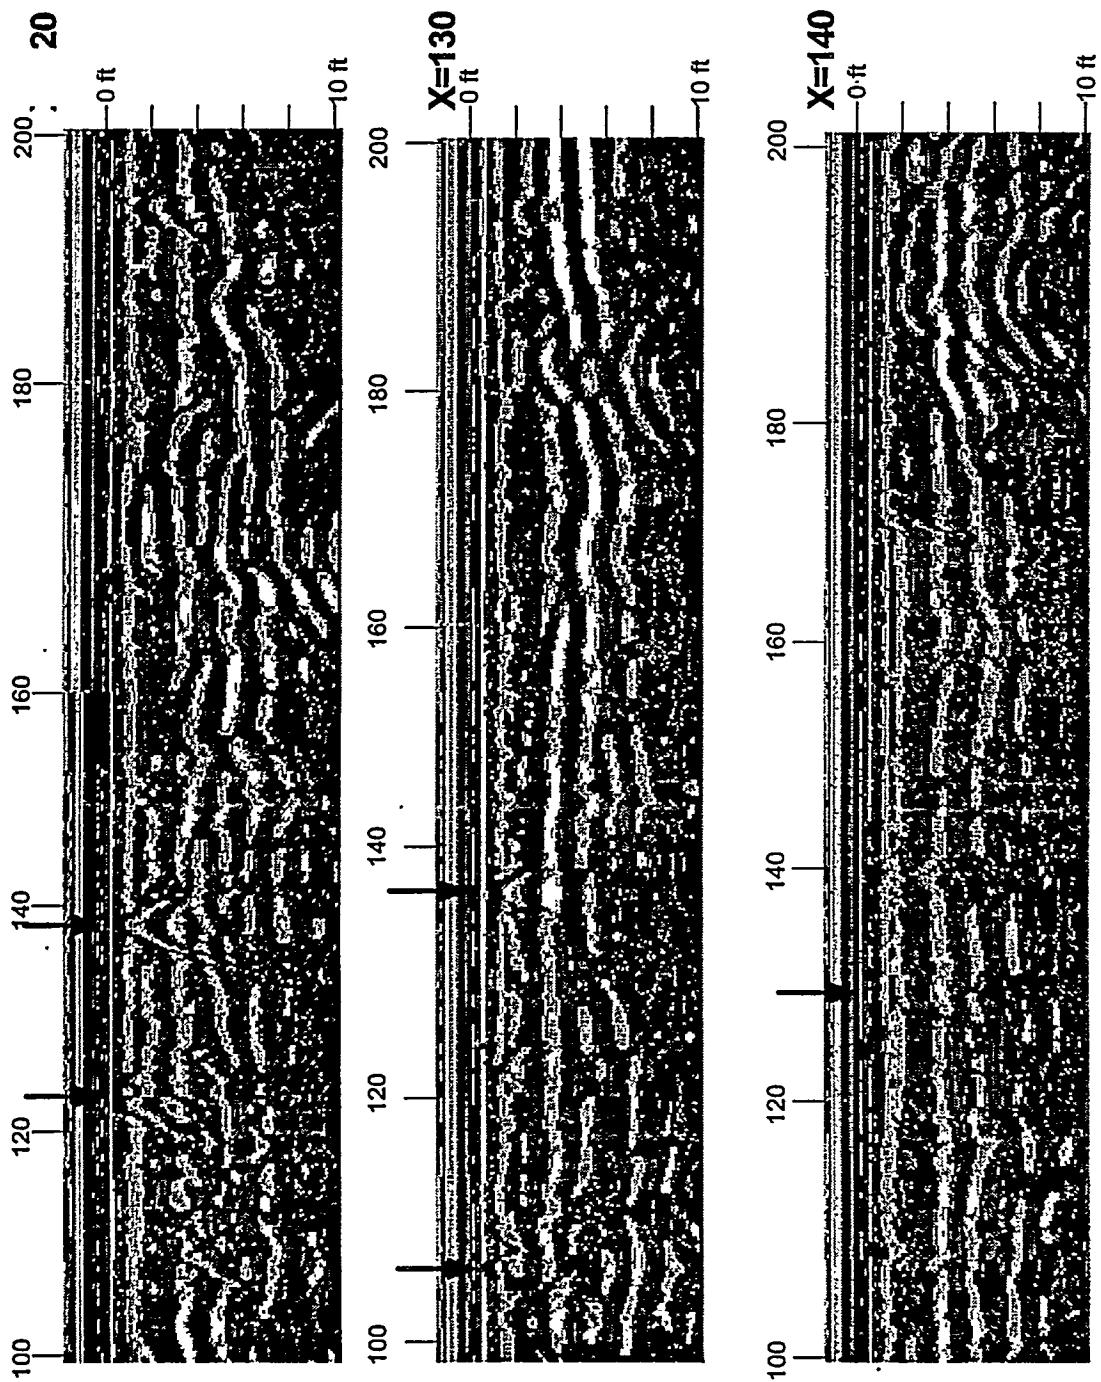
Other GPR anomalies are observed on profiles run along the X survey direction (Figure 9). Near-surface anomalies are observed at (120, 138), (130, 138) and (140, 135), however, anomalies were not detected by other geophysical instruments in this area. Strong magnetic anomalies (Figure 4) are observed near the GPR anomalies at (120, 122) and (130, 115). According to EAI Corp. (1989), Building E3613 was serviced by a 1.5 in. waterline. ANL personnel report that a water tower is located west of the geophysical survey area. However, lineations, which would suggest a buried pipe, are not well-defined by the data. The sources of these anomalies are unknown.

Between $Y=170$ and $Y=190$, hyperbolic anomalies are detected on profiles oriented EW (Figure 9) and on one profile oriented NS (not shown). These anomalies have a deeper origin than those discussed earlier. Other geophysical instruments did not detect anomalies in this region. Therefore, this anomalous GPR signal may not have anthropogenic origins and may represent undulations in the former land surface.

Between X=120 to 140, deep-seated deep GPR hyperbolas are observed near Y=180 and are probably sourced by a former land surface (Figure 9). At (150, 180), strong GPR reflections are observed near conductivity, EMF and magnetic anomalies. A combination of metals associated with the overhead steam pipe and amphibolitic road grade material can explain these observations.
