ANL/ESD/TM-105

**Contamination Source Review for Building E3613,
Edgewood Area, Aberdeen Proving Ground, Maryland**

**Energy Systems Division
Argonne National Laboratory**

September 1995

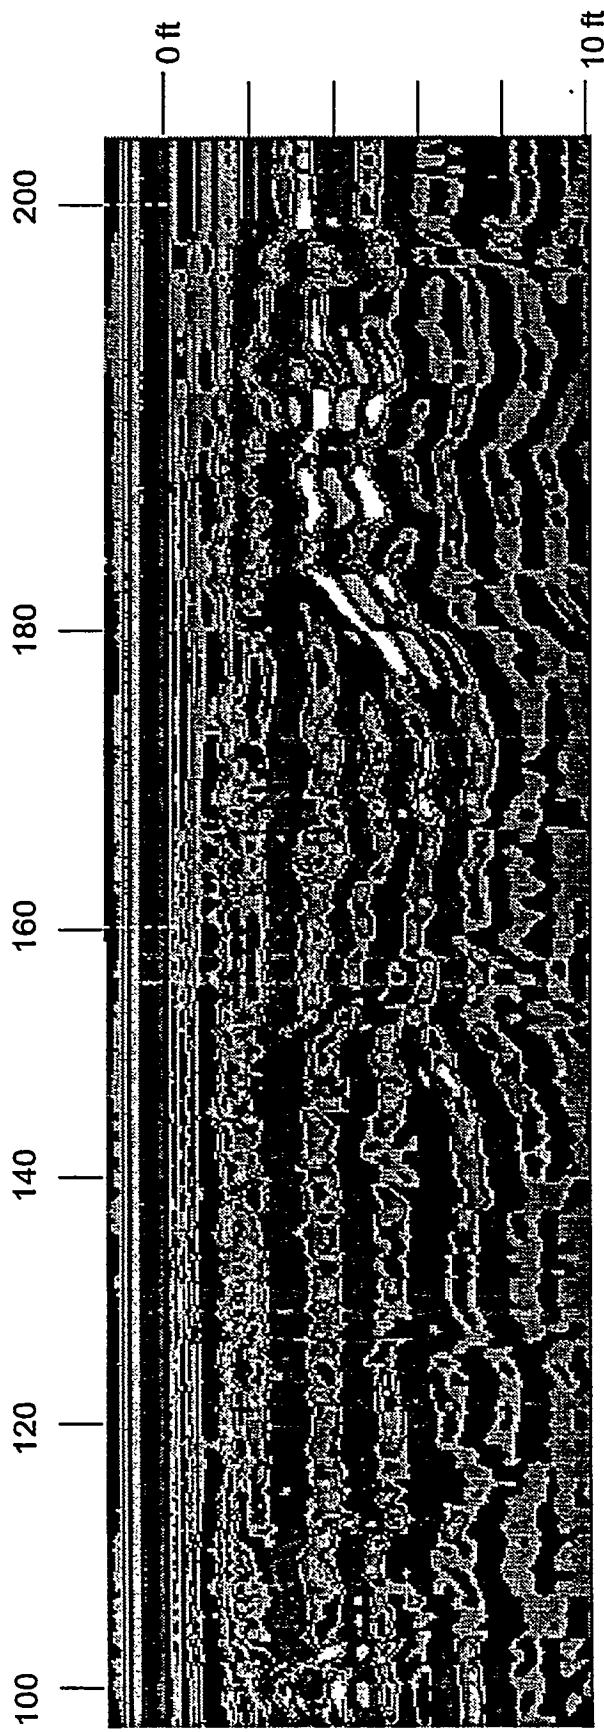
FIGURE 10 Ground Radar Image along Line $X=150$ Showing Strong Reflections at About $X=180$ (The maximum penetration depth is estimated at 7 ft.)

Along profile $X=150$, strong reflections are observed near $Y=180$ (Figure 10). Magnetic (Figure 3), EM-31 (Figure 4) and EMF (Figure 6) anomalies are also observed in the area. These anomalies may be related the overhead steam pipe located south of the anomalies. A weak GPR anomaly is observed near $Y=100$ (Figure 10) that is not validated by other evidence. Similar anomalies (not shown) are observed at (140, 100); (100, 140); and (130, 170); and (160, 108). The cause of these anomalies is unknown. Other GPR disturbances define the perimeter of the foundation of E3613.
