**Contamination Source Review for Building E3642,
Edgewood Area, Aberdeen Proving Ground, Maryland**

M.N. Booher, D.P. O'Reilly, A.K Draugelis, J. Rueda, and R.E. Zimmerman

September 1995

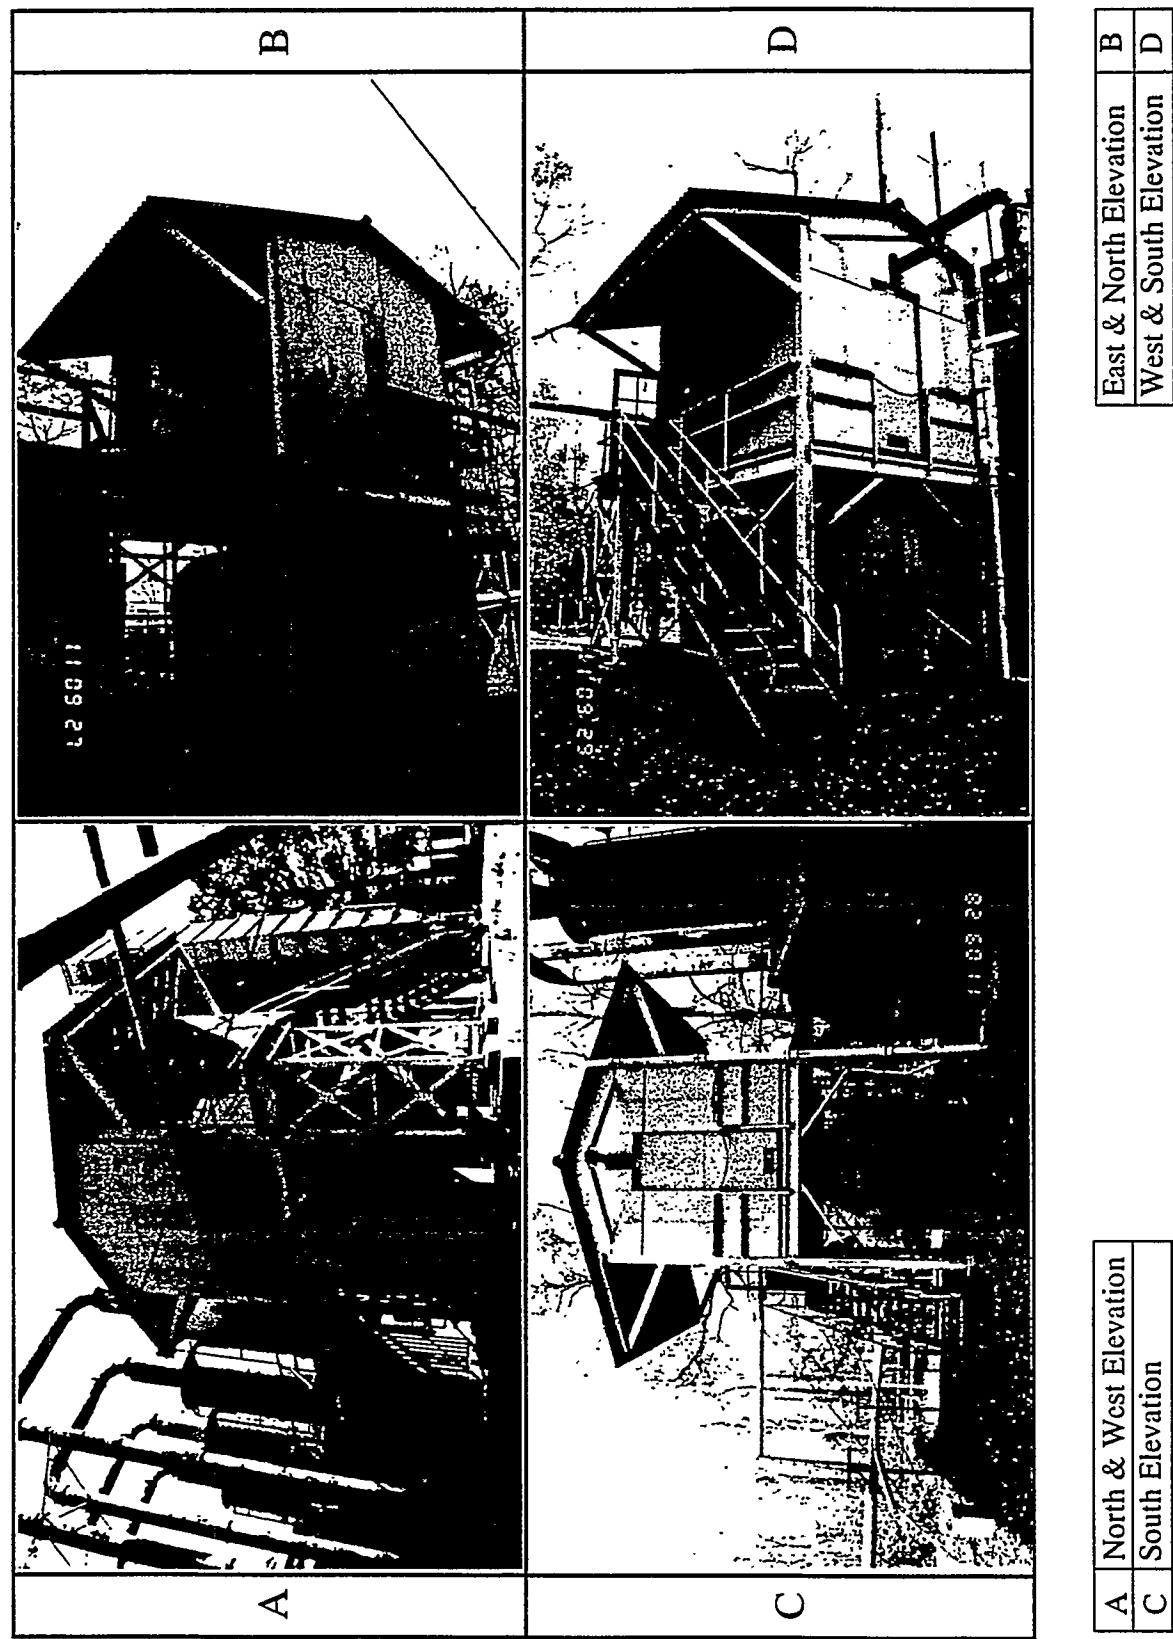
FIGURE 5 Photographs of Building E3642 Exterior

Because of a lack of building maintenance, the north elevation shows signs of deterioration and weathering. Oxidized metals were observed at the time of the investigation.

Because of a lack of building maintenance, the east elevation shows signs of deterioration and weathering. Oxidized metals were observed at the time of the investigation.

Because of a lack of building maintenance, the south elevation shows signs of deterioration and weathering. Oxidized metals were observed at the time of this investigation.

Because of a lack of building maintenance, the west elevation shows signs of deterioration and weathering. Oxidized metals were observed at the time of the investigation.

Building E3642 is covered by a sloping, corrugated transite roof measuring approximately 20 ft 4 in. long by 18 ft 10 in. wide and 0.25 in. thick (Figure 5).

The roof of Building E3642 was intact; no leaks were observed.

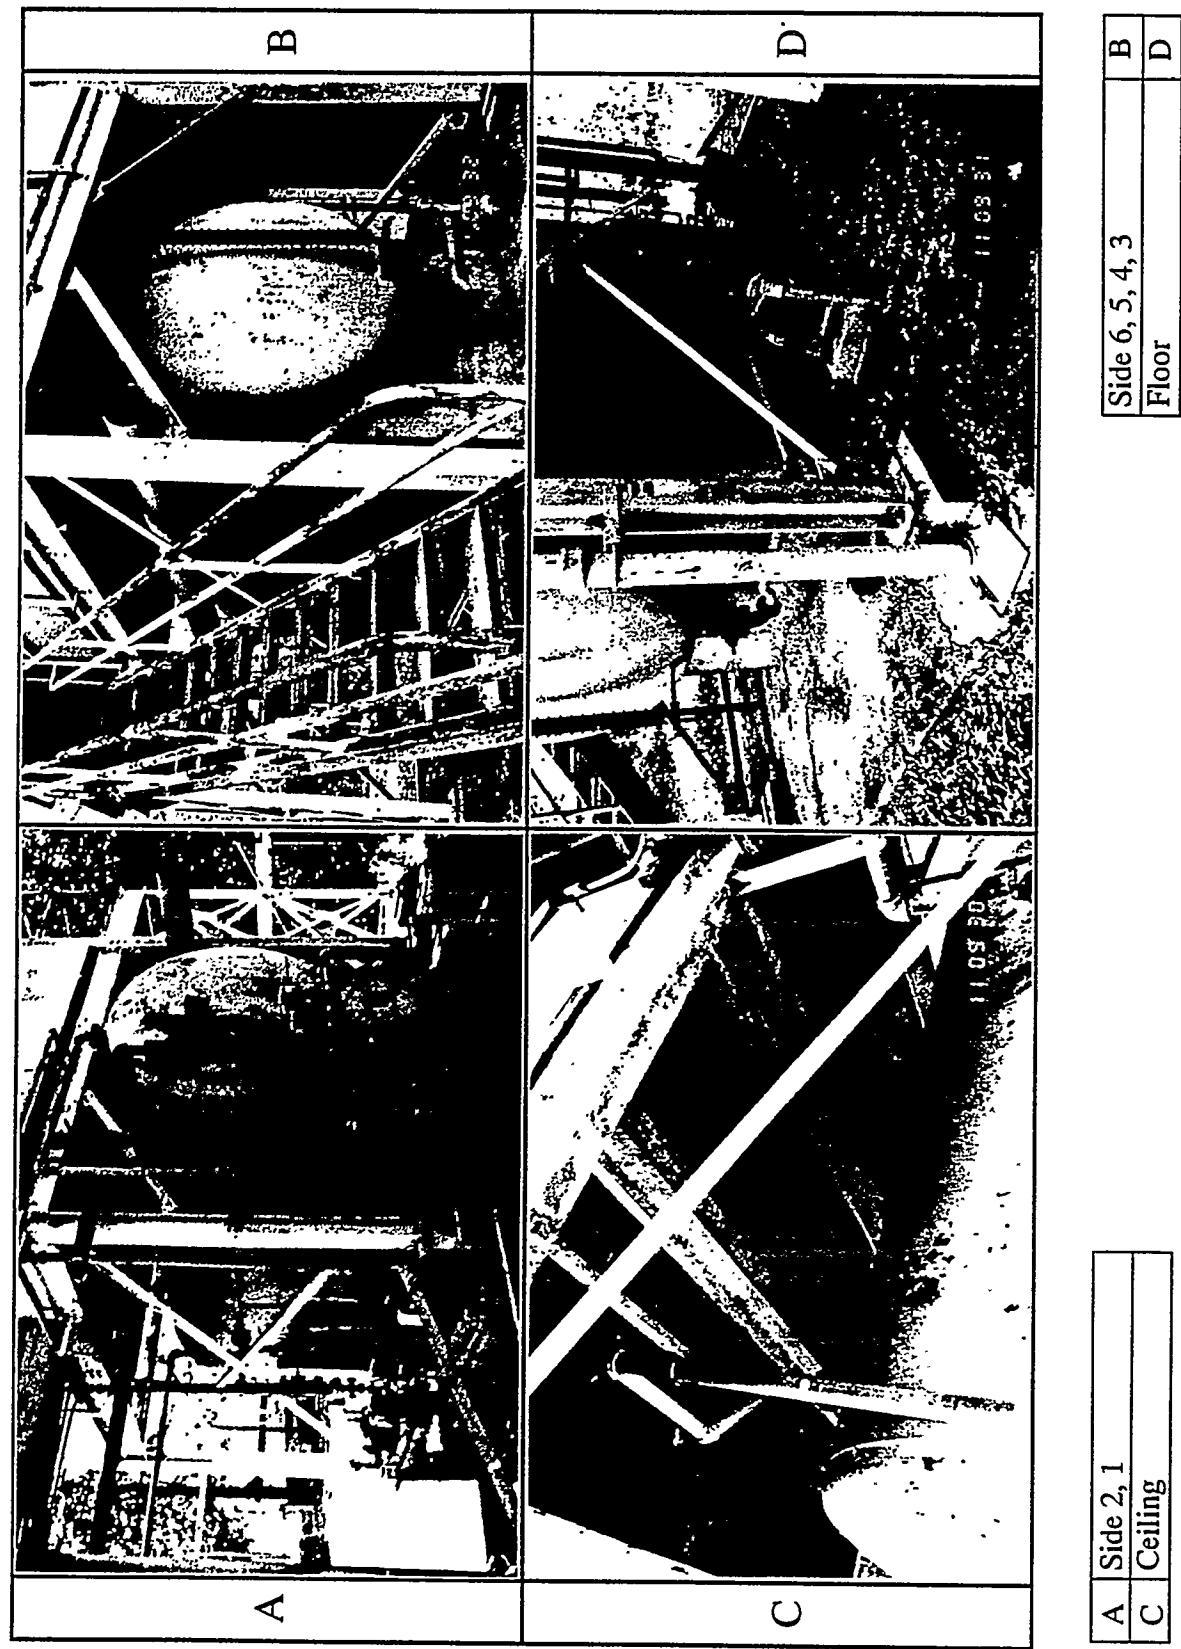
FIGURE 6 Photographs of First Floor, Room 1

The first floor of Building E3642 is concrete. The floor of the second story is wood. The floors are intact and in good condition.

Piping was observed east of the aboveground storage tank at the time of the ANL inspection.

One approximately 3,000-gal aboveground storage tank rests on concrete supports on the first floor of the building (Nemeth 1989). Piping associated with the tank is still attached. Two pumps are located on raised concrete pads along the south side of the tank. Along the west side of the room is a metal staircase with a handrail made of metal tubing and wooden steps.

No floor drains are located in room 1. A raised metal cylinder was observed on the floor near the west side of the room. The ceiling (the underside of the second floor room 1) consists of wooden planks supported by a structural steel frame.

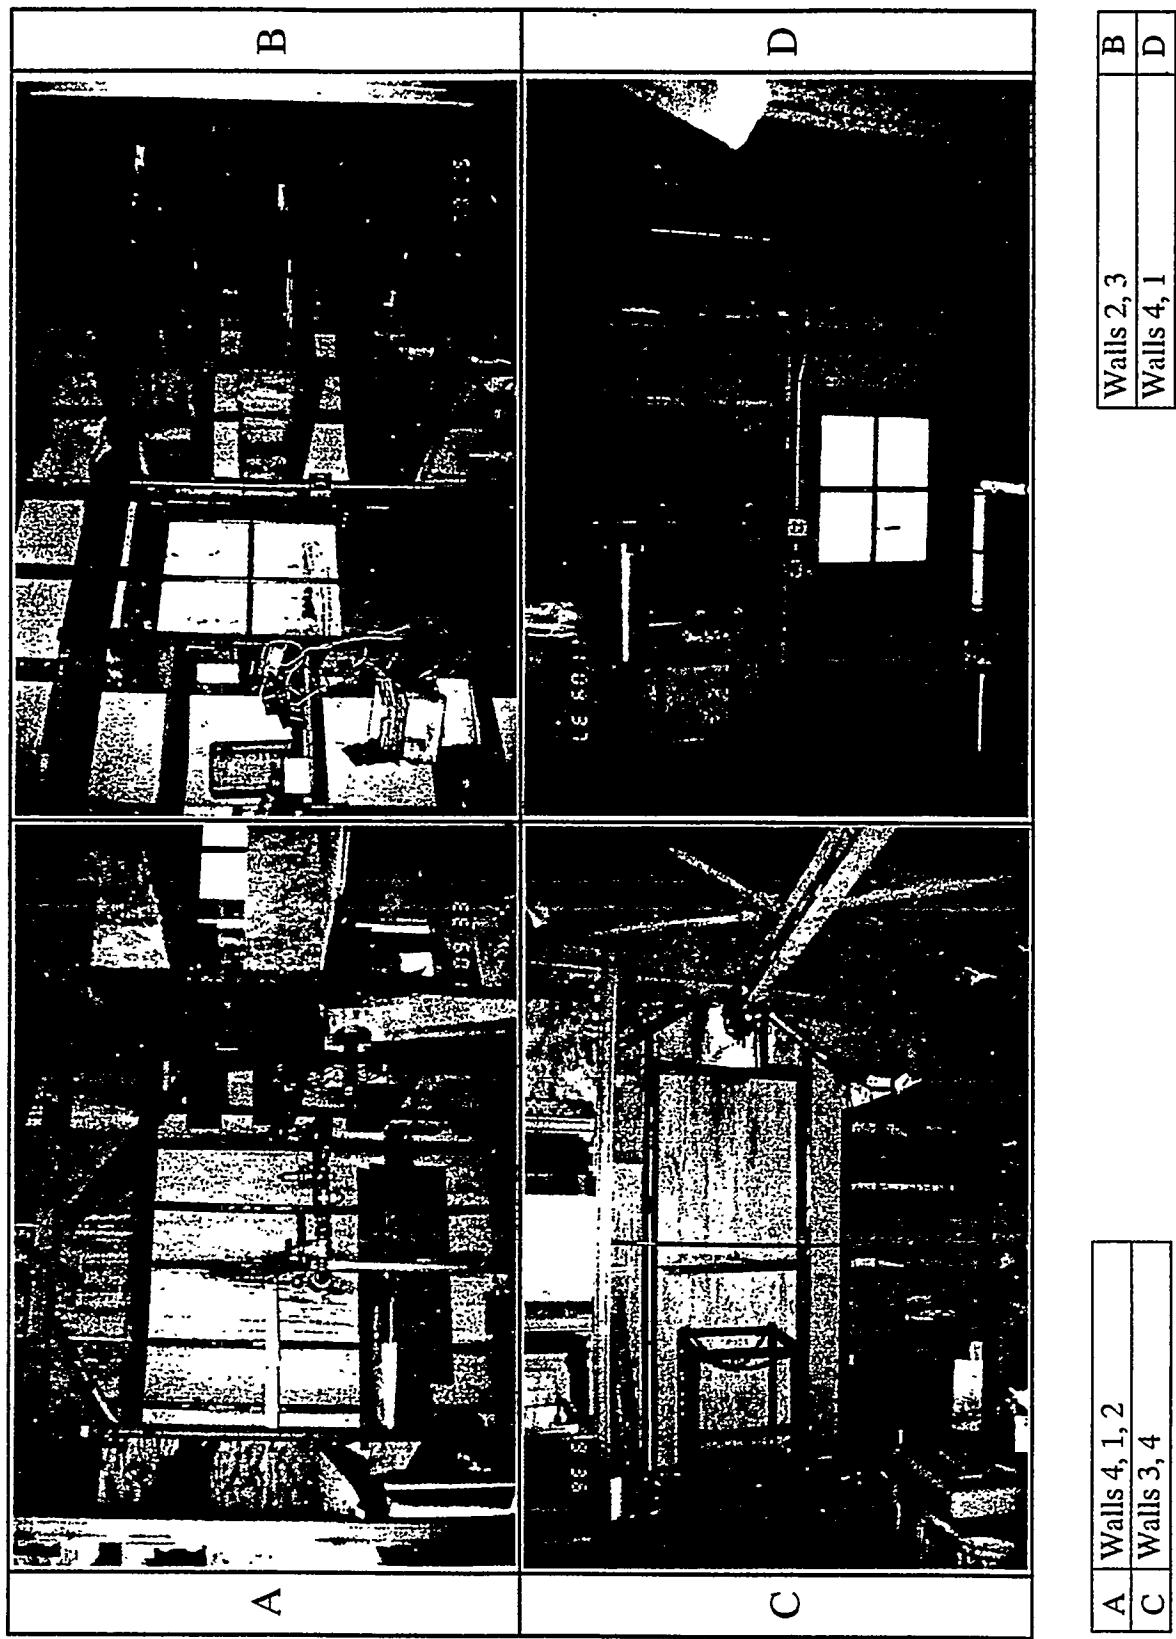
FIGURE 7 Photographs of Second Floor, Room 1—Walls

Walls are constructed of sheet metal attached to a wooden frame (Figure 6).

The interior walls are painted light blue.

The north wall contains piping, possibly for heating. Electrical conduit along the east and west walls leads to switch boxes and outlets.

Wooden shelves on a steel frame were observed along both the east and west walls. Miscellaneous equipment is located on the shelves and floor of the room. A steel I-beam that extends through the center of the room and exits the south wall is associated with a hoist device.

This room contains three doors: one on the east wall, one (hoist door) on the south wall, and one on the west wall. All three doors lead outside. There are no windows in this room.
