**Contamination Source Review for Building E2370,  
Edgewood Area, Aberdeen Proving Ground, Maryland**

## **Contamination Source Review for Building E2370, Edgewood Area, Aberdeen Proving Ground, Maryland**

D.P. O'Reilly, M.A. Glennon, A.K. Draugelis, J..Rueda, and R.E. Zimmerman

September 1995

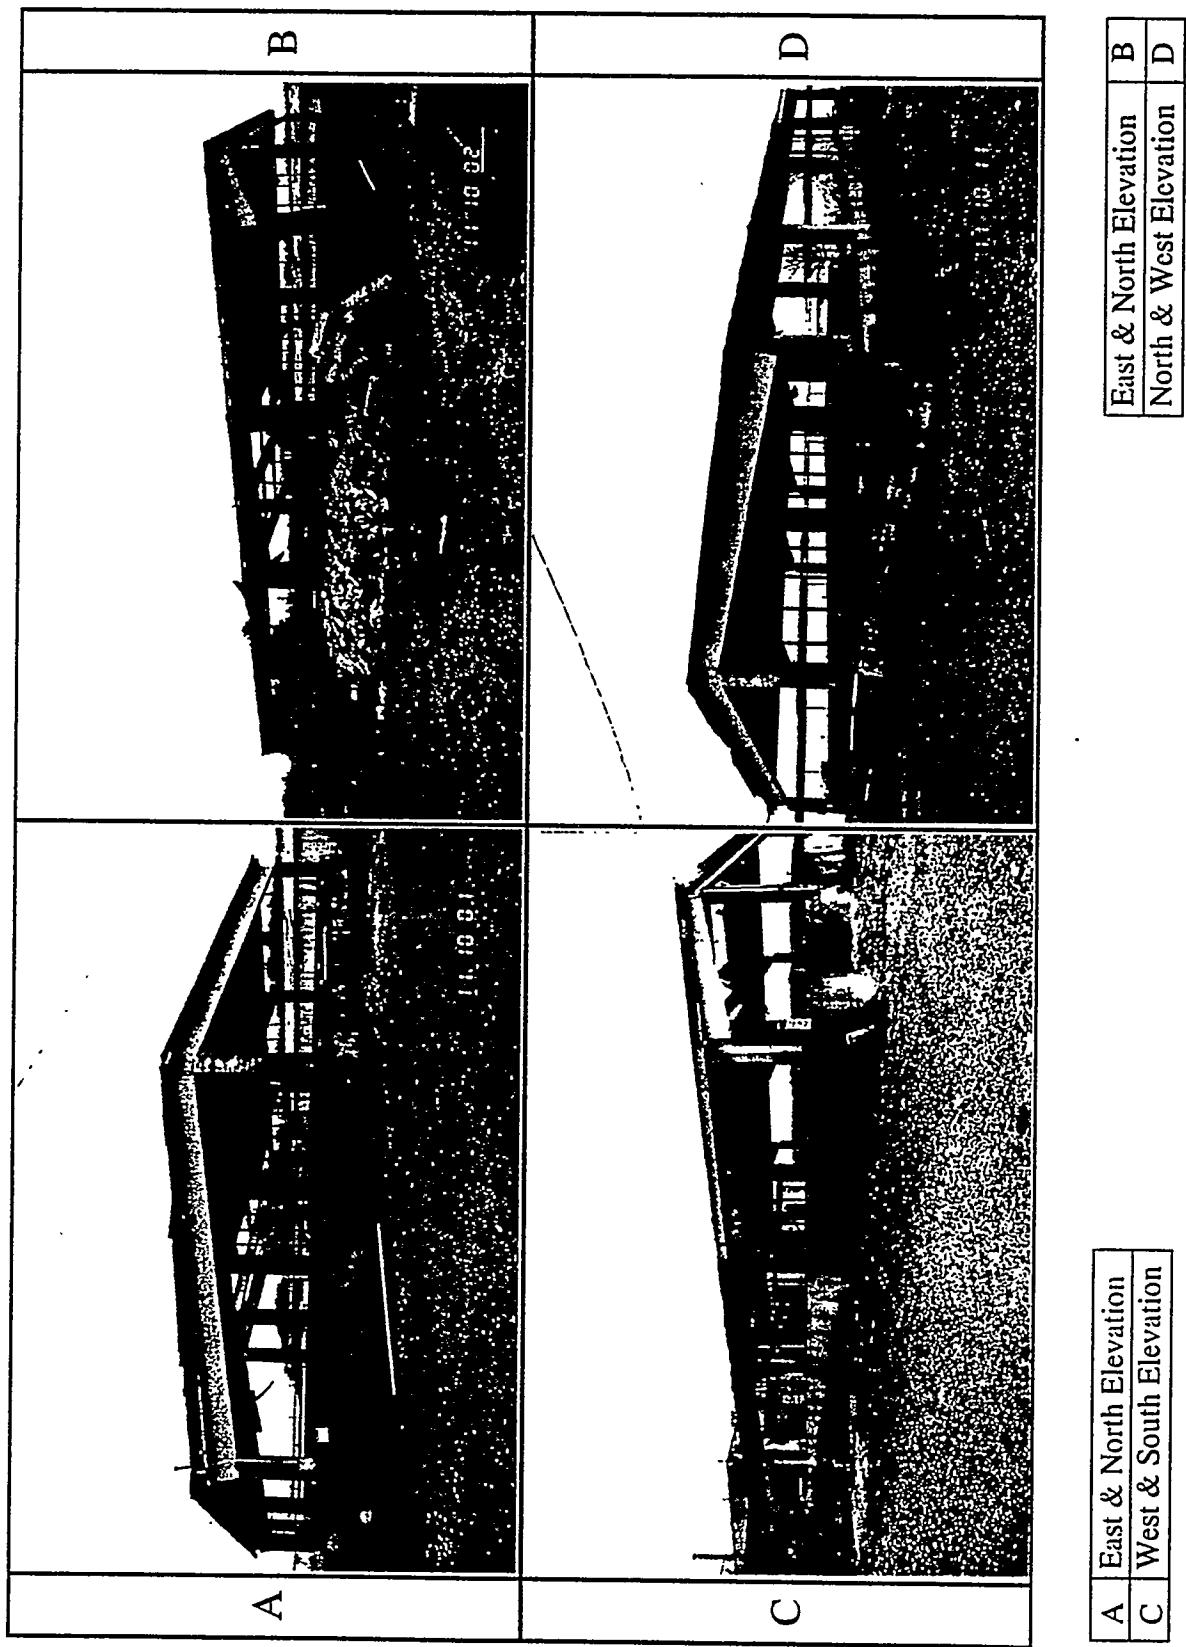
FIGURE 4 Photographs of Building E2370 Exterior

Because of a lack of maintenance, the north elevation shows signs of deterioration and weathering. Oxidized metals and cracks in the concrete were observed at the time of this investigation.

Because of a lack of maintenance, the east elevation shows signs of deterioration and weathering. Oxidized metals and cracks in the concrete were observed at the time of the investigation.

Because of a lack of maintenance, the south elevation shows signs of deterioration and weathering. Oxidized metals and pieces of the concrete wall that had been removed and fallen to the ground were observed at the time of this investigation.

Because of a lack of maintenance, the building shows signs of deterioration and weathering. Oxidized metals and cracks in the concrete wall were observed at the time of the investigation.

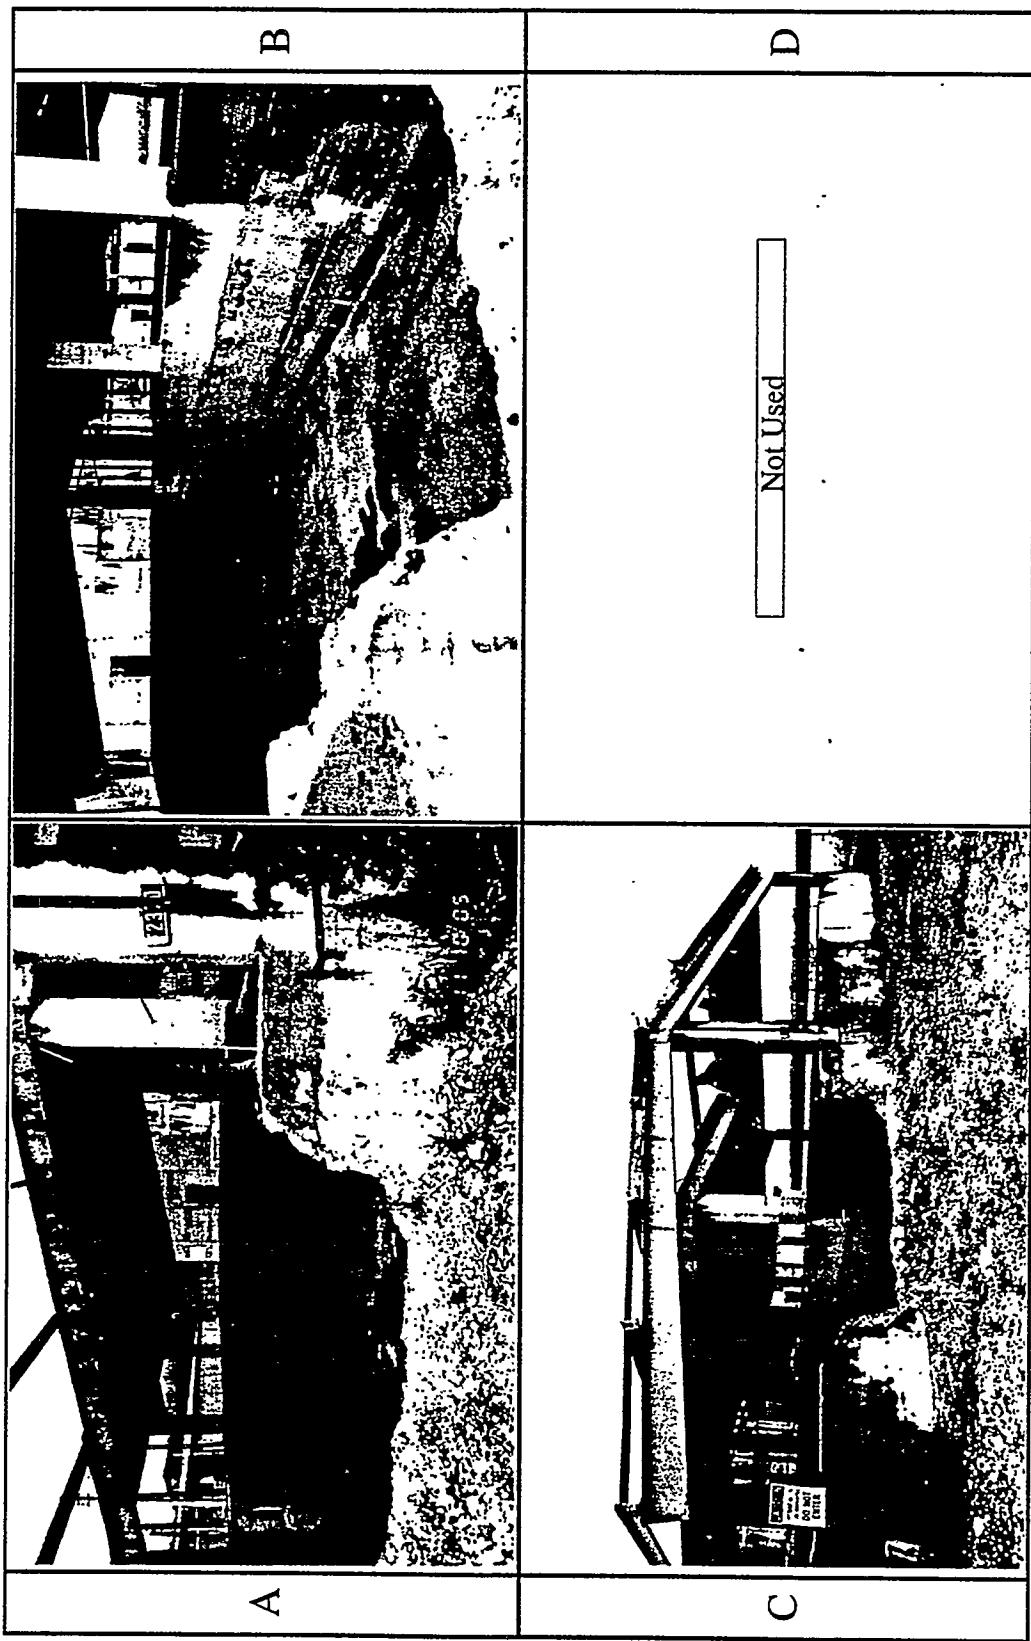
FIGURE 6 Photographs of Room 2

The building contains no floor drains, sumps, or sinks (EAI Corporation 1989). An 8-in.-diameter air vent pipe is located in room 2 along wall 3.

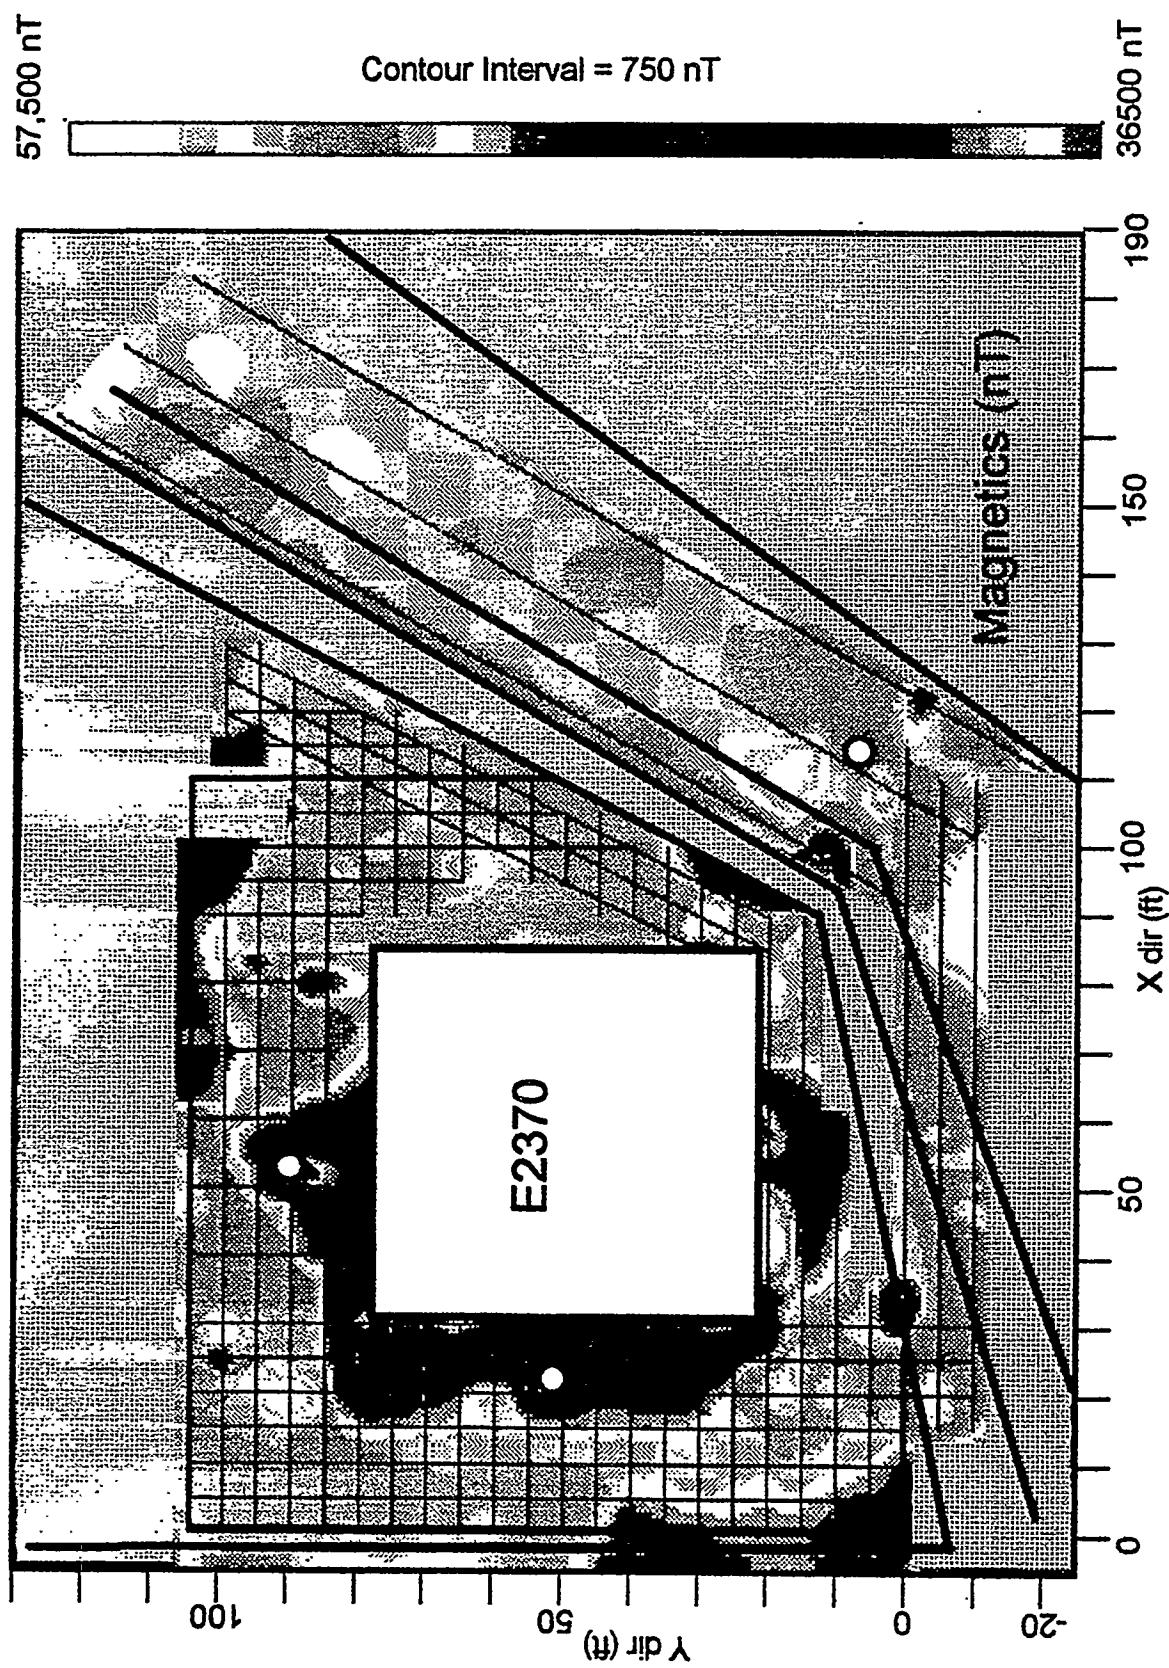
FIGURE 3 Map of the Total Magnetic Field Anomalies at Building E2370 (measured by using a Geometrics G-822L cesium-vapor magnetometer)

The isolated magnetic highs observed near the southern corner of the building at coordinates (20, 15) are unexplained. EM-61 anomalies and a small GPR hyperbola are also found in this area.

According to site maps, the observed magnetic high south of Building E2370, between  $X = 80$  and  $X = 100$ , is located near Building E2371, which was used as a tool shed. No remains of the building were observed by ANL personnel.

The diffuse magnetic high along the perimeter of the survey area may be caused by roadbed material. However, isolated magnetic anomalies probably have a different, and unknown, origins. Unexplained magnetic anomalies are observed at (20, 90); (30, 100); (90, 30); (97, 65), (80, 95), (108, 75), (95, 85), (3, 45) and (110, 83). An EMF anomaly is also observed near the magnetic anomaly at  $X = 30$ ,  $Y = 100$ .

Outside of the survey area, subtle point magnetic anomalies are observed near the southern end of each transect [at (90, 11), (115, 13), and (122, -3)]. The cause of these anomalies is unknown. A magnetic anomaly is also observed between (152, 109) and (163, 95).

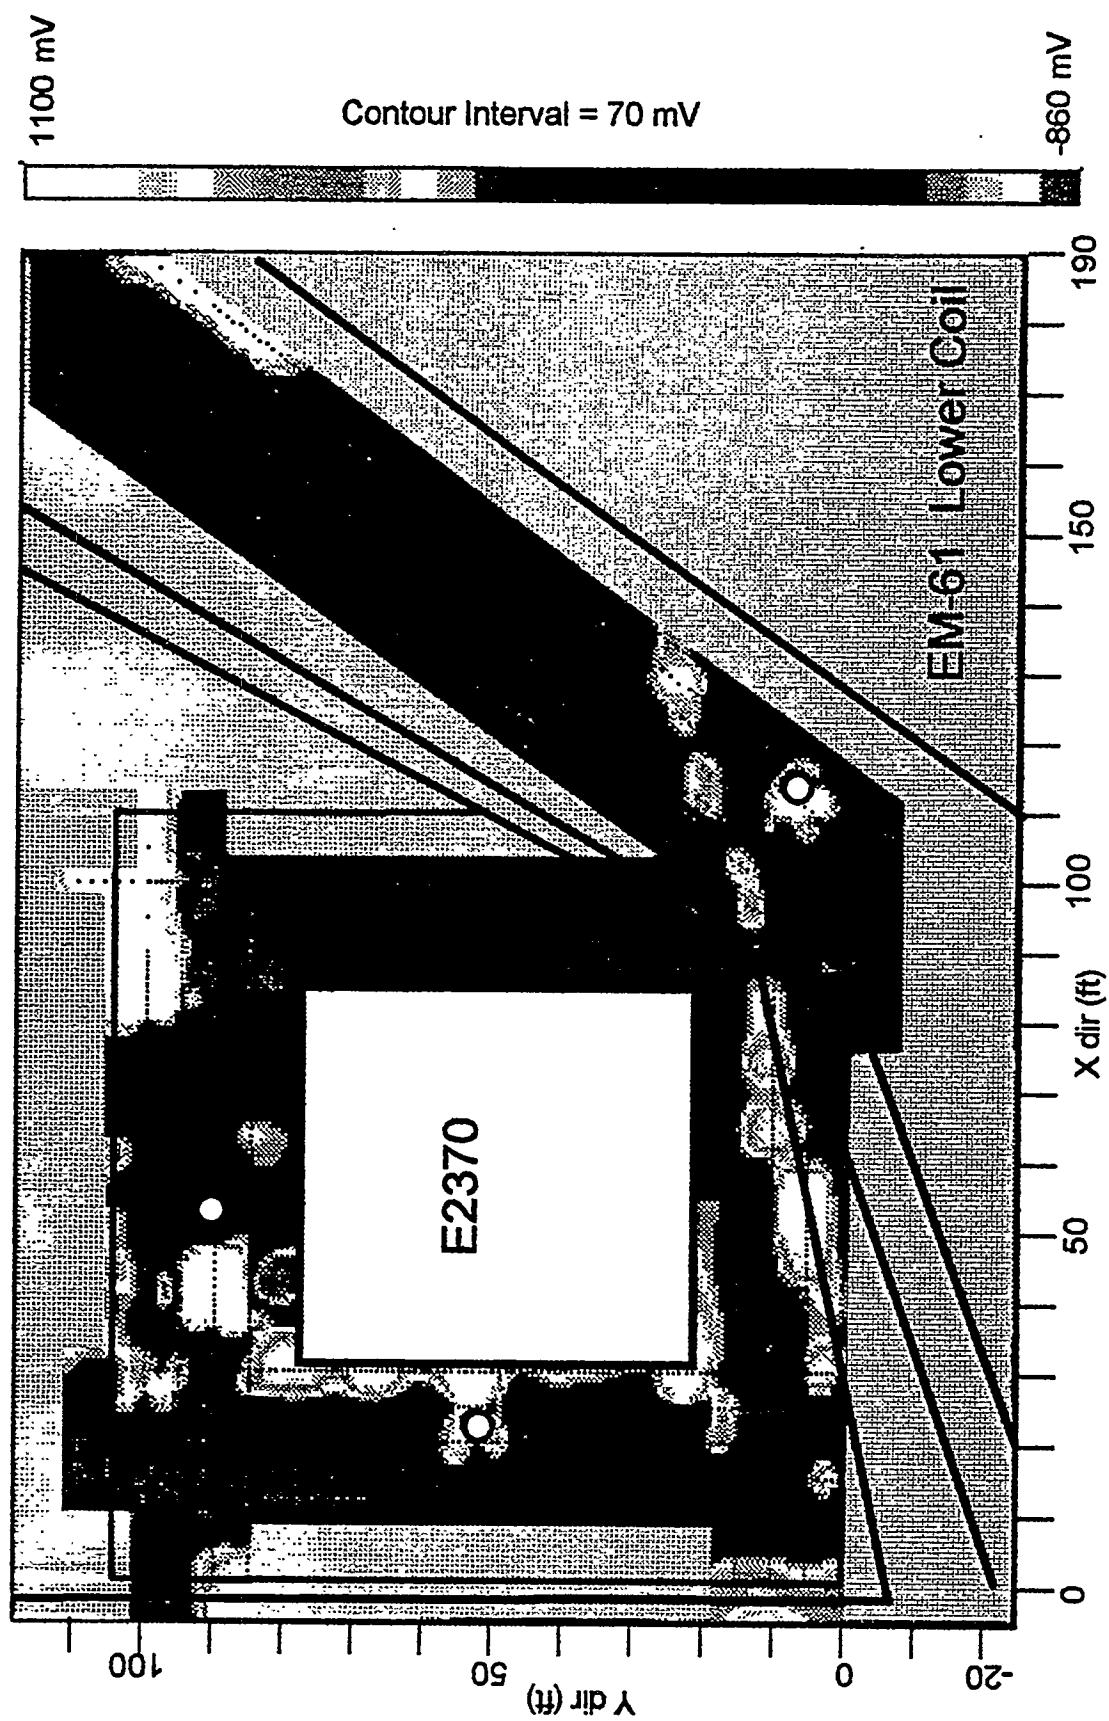
FIGURE 4 Map of the EMF Anomalies at Building E2370 (measured by using a Geonics EM-61 instrument)

A color-contour map constructed from EM-61 lower coil data is shown in Figure 4. The positive anomalies centered at (40, 90) and (113, 5) are probably caused by the nearby wells, WBR-90 and -92. Although the anomalies are not centered on the wells, some positioning error is expected because of surface obstructions at the site. An EMF anomaly is also centered on well WBR-91. The EMF positive in the northeast corner of the survey area is probably caused by metals associated with Building E2368, located north of the survey area. Metallic objects associated with Building E2364, located northwest of Building E2370 (Figure 1), could cause the EMF anomaly along Y = 105.

Within the geophysical survey area, an EMF positive trend extends diagonally from (15, 2) to about (101, 13). Most of the anomaly is produced by the fence; however, an extension of the EMF positive anomaly continues to the northeast, toward the Bush River. Scattered magnetic anomalies are observed in the same general area, but they do not seem to follow the same trend. A GPR anomaly is also located near the south end of one profile. We infer that a lineation, such as a buried metal pipe, lies beneath the area. Because of interference from the fence, it is not known with certainty if the lineation extends beneath the fence to the southwest.

Between the two fences, a low-amplitude EMF high, centered on (160, 100) correlates with magnetic observations. A strong EMF anomaly is observed between (172, 80) and (189, 99). The causes of these anomalies are unknown. A complete list of the significant EMF anomalies and their corresponding grid locations is given in Table 1.

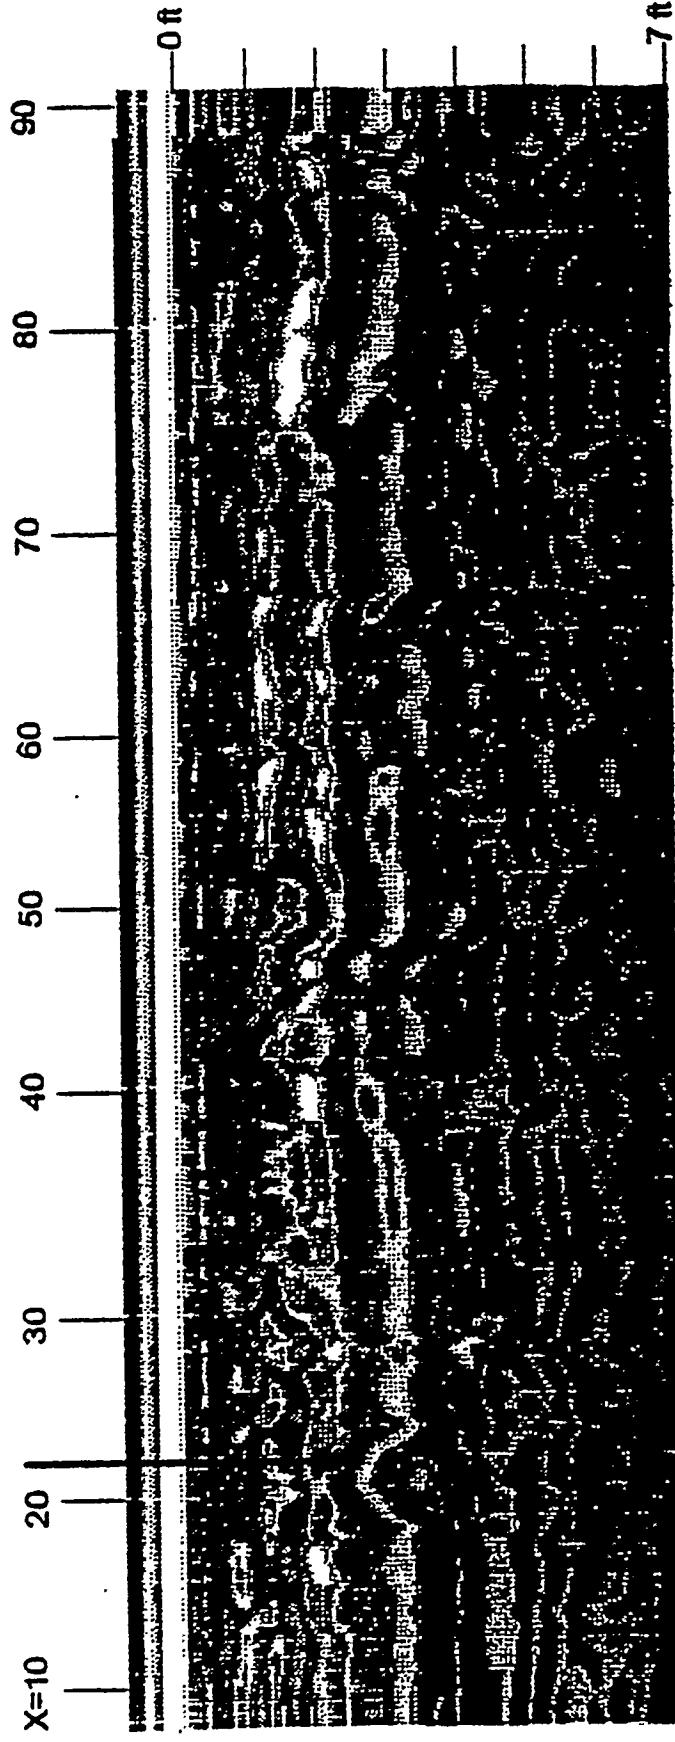
**FIGURE 6 GPR Profile along Line Y = 15**

Figure 6 shows an example of GPR observations along  $Y = 15$ . Although strong magnetic and EMF anomalies are observed at about (25, 15), a small hyperbola is observed  $X = 22$  at about a 2-ft depth. Another small hyperbola was detected at (42, 100); however, this anomaly has not been verified with other geophysical data.

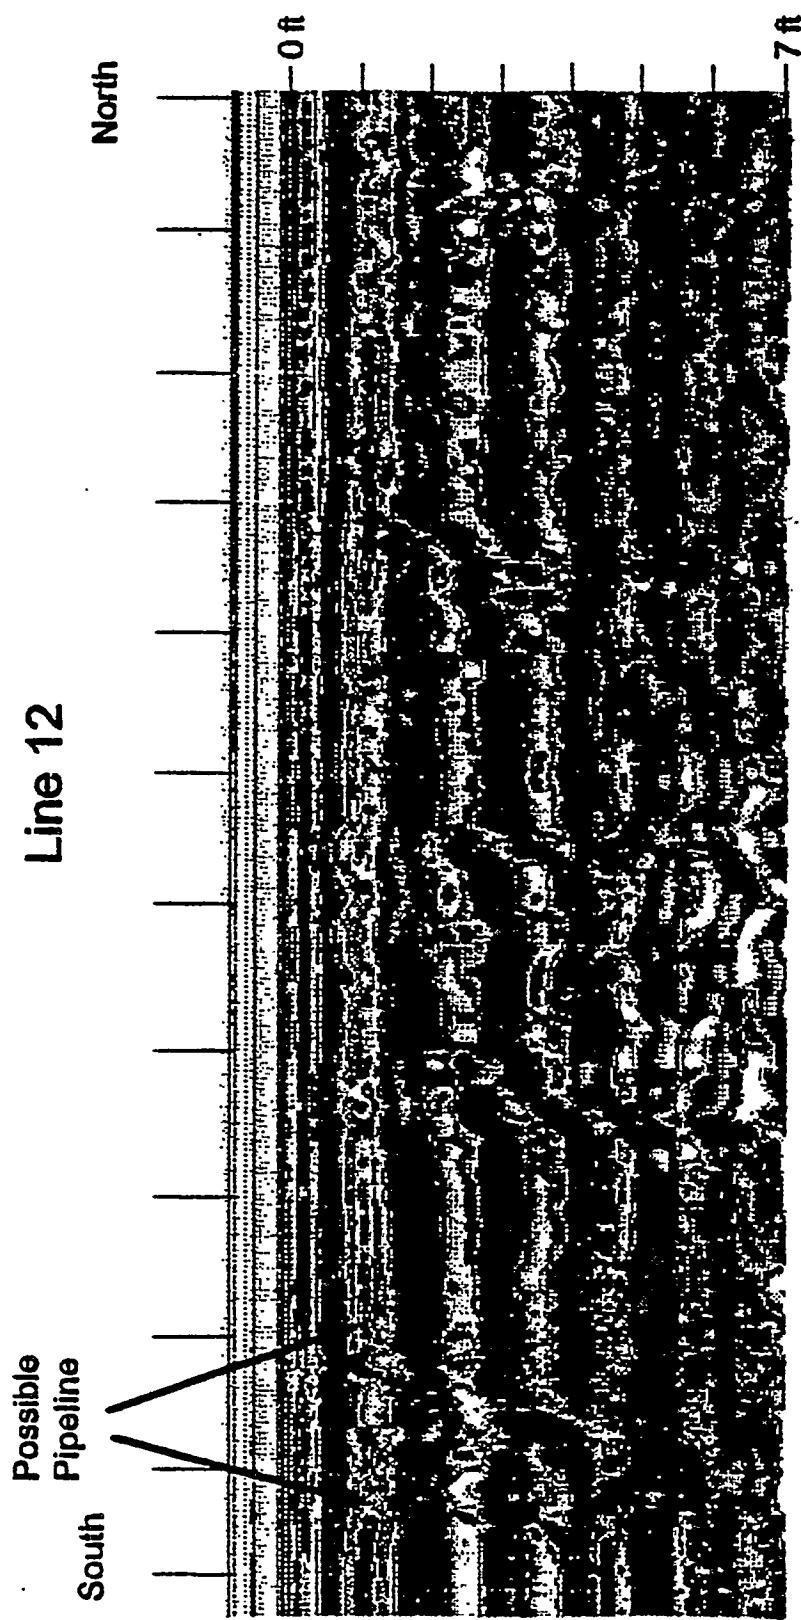
FIGURE 7 GPR Profile between the Two Fences

Between the two fences, three GPR profiles were conducted, and better resolution was generally achieved (Figure 7). On one profile, a GPR anomaly loosely correlates with the linear

EMF anomaly observed in the area. In addition, scattered point magnetic anomalies are also observed nearby. Although spatial control is limited, these observations suggest that a lineation, such as a buried pipe, may exist in this region.
