**Summary Environmental Site Assessment  
Report for the U.S. Department of Energy  
Oxnard Facility, Oxnard, California**

**February 1996**

Prepared by  
Rust Geotech  
Grand Junction, Colorado

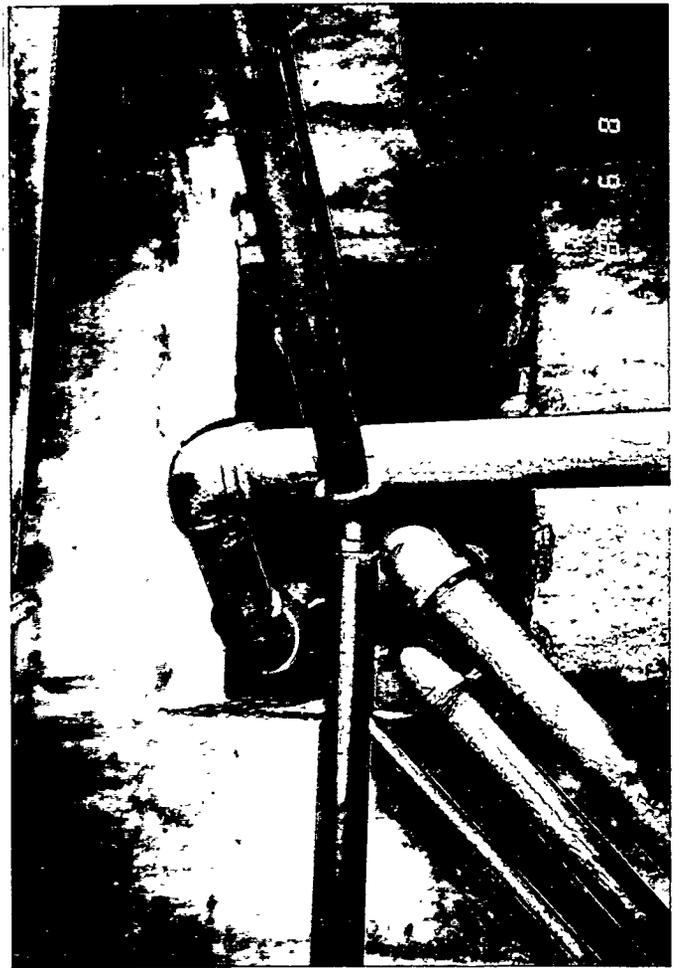
Building #6  
Forging Hammer Trench  
Metallic Oily Water Sludge  
Beneath Grating
