**Contamination Source Review for Building E3163,  
Edgewood Area, Aberdeen Proving Ground, Maryland**

## **Contamination Source Review for Building E3163, Edgewood Area, Aberdeen Proving Ground, Maryland**

A.K. Draugelis, K.L. Muir-Ploense, M.A. Glennon, J. Rueda, and R.E. Zimmerman

September 1995

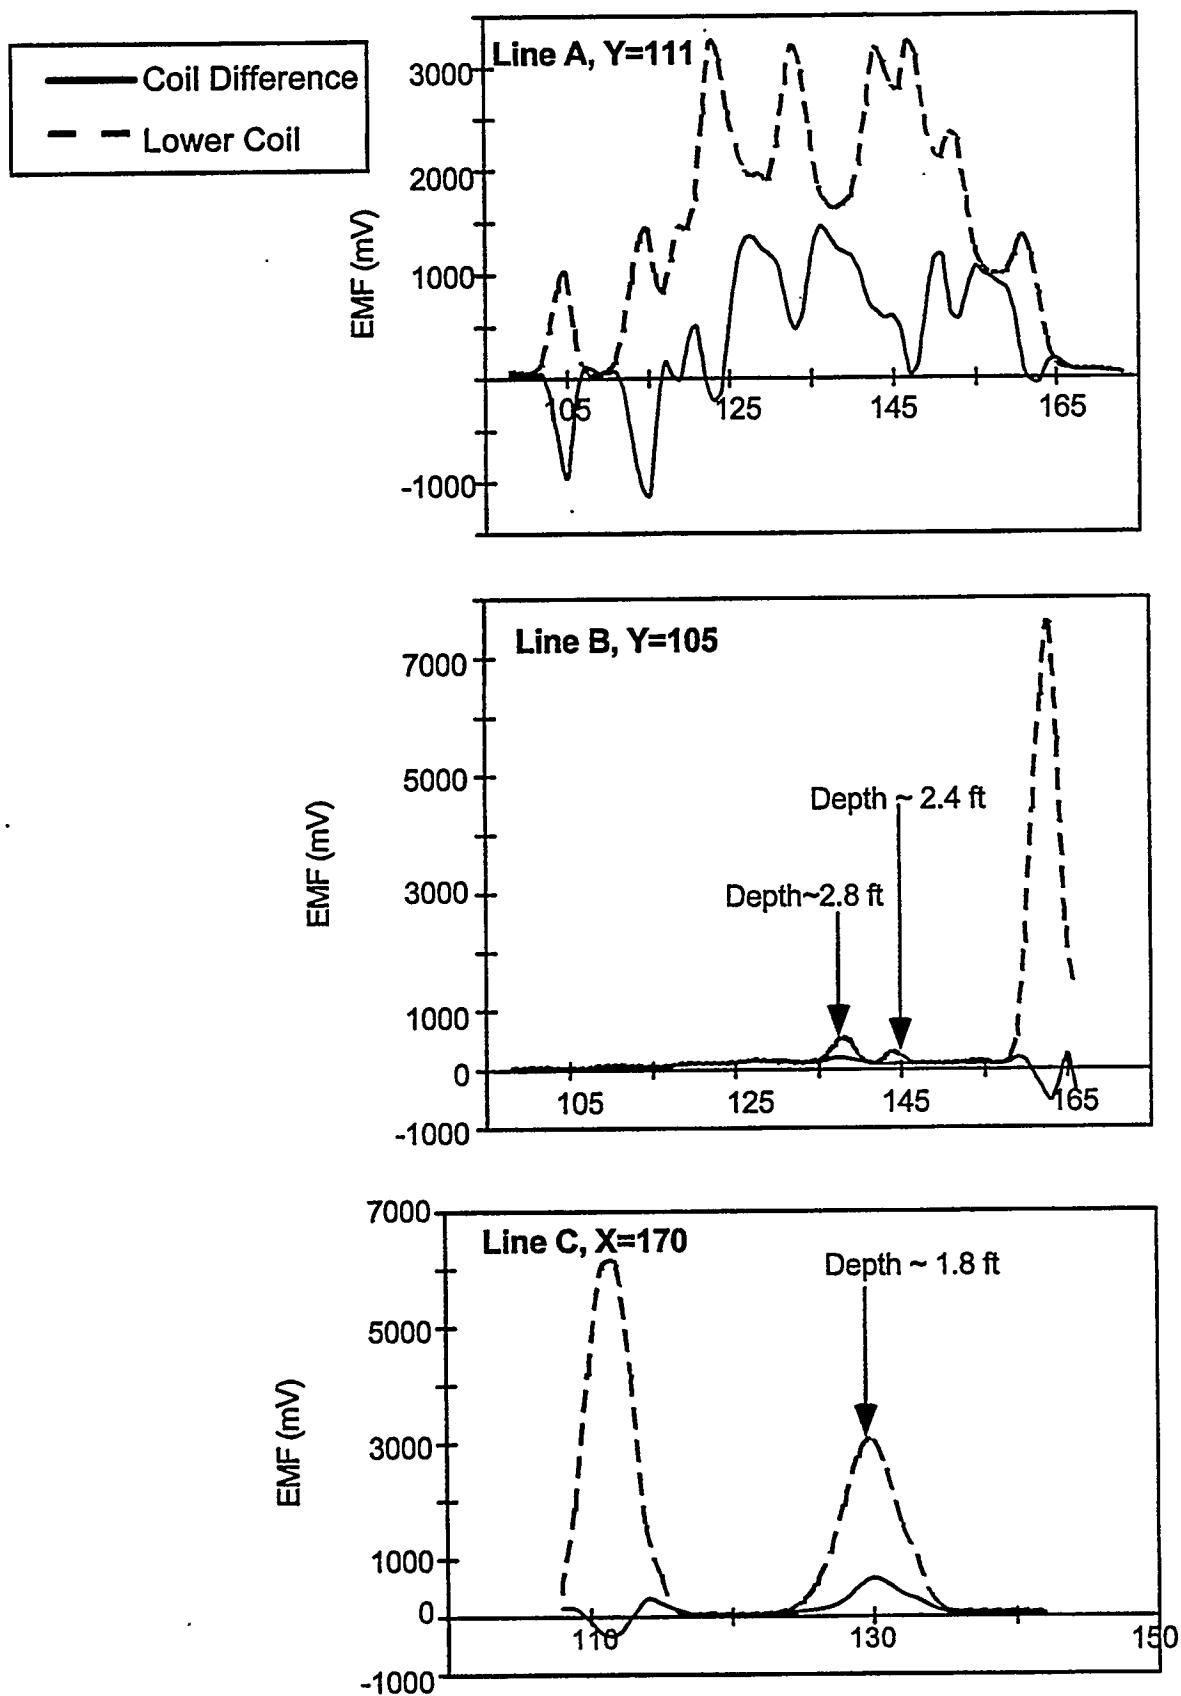
FIGURE 4 Three EMF profiles conducted near E3163

Lower coil and coil difference channels are plotted in Figure 4 for the three EM-61 profiles conducted near E3163. Profile A was conducted adjacent to the metal pipes and the complicated lower coil signals combined with the negative coil difference anomalies suggests interference from these structures. The highest amplitude lower coil anomalies on lines B and C have negative coil difference anomalies, suggesting an above ground target. On the other hand, positive lower coil and coil difference anomalies at (132, 105), (145, 105) and (170, 130) suggest subsurface sources. The apparent depth to each target, approximated with software supplied with the EM-61 instrument (Geonics Limited 1994), is greater than 1.8 ft (Figure 4). The sources of these anomalies are unknown.

Interference from metal poles located along Y=110 probably cause the EMF positive anomalies along profile A (Figures 3 and 4). Deep GPR reflections are detected at (103, 108) which could also be sourced by subsurface disturbances associated with a metal pole.

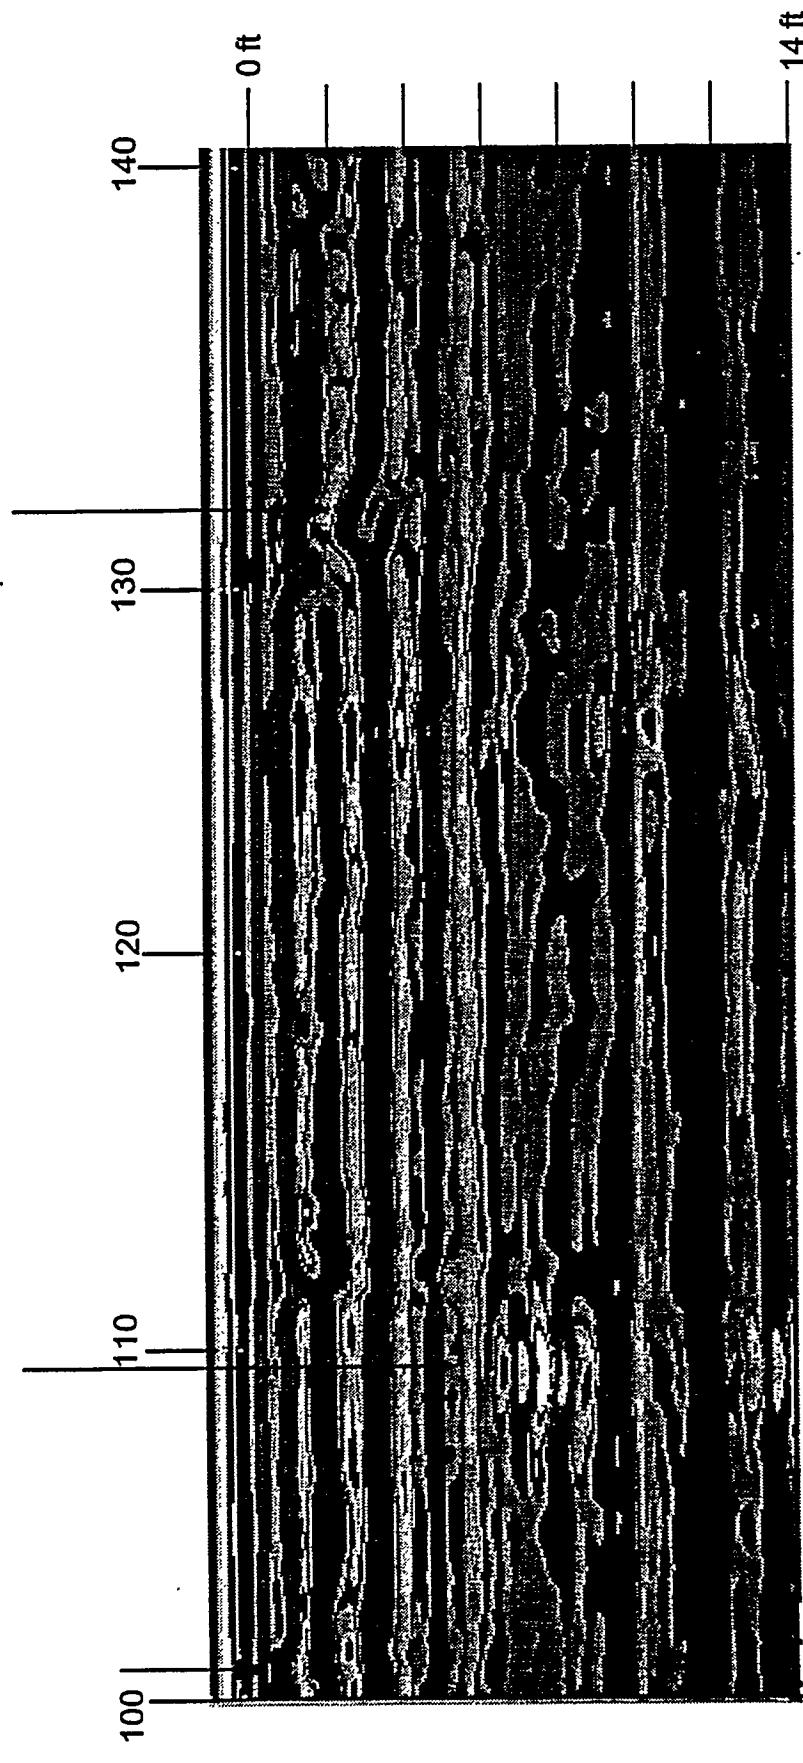
FIGURE 5 Ground-Penetrating Radar Profile along  $X=103$

Four GPR profiles were conducted in the vicinity of E3163 (Figure 3). Along X=103 (Figure 5), two shallow hyperbolas are detected at Y=103 and Y=133. The sources of these anomalies are unknown. Along the same profile, strong reflections are observed at depths greater than about 6 ft near Y=108, which may be sourced by subsurface disturbances associated with the nearby metal pole. The strong reflections along X=170 between Y=122 and 128 can be attributed to the concrete slab (Figure 6). However, along the same profile, similar reflections are also detected between Y=128 and Y=140 that can not be associated with that structure. Along Y=100 and Y=105, shallow hyperbolas are detected at X=150. The sources of these anomalies are unknown.

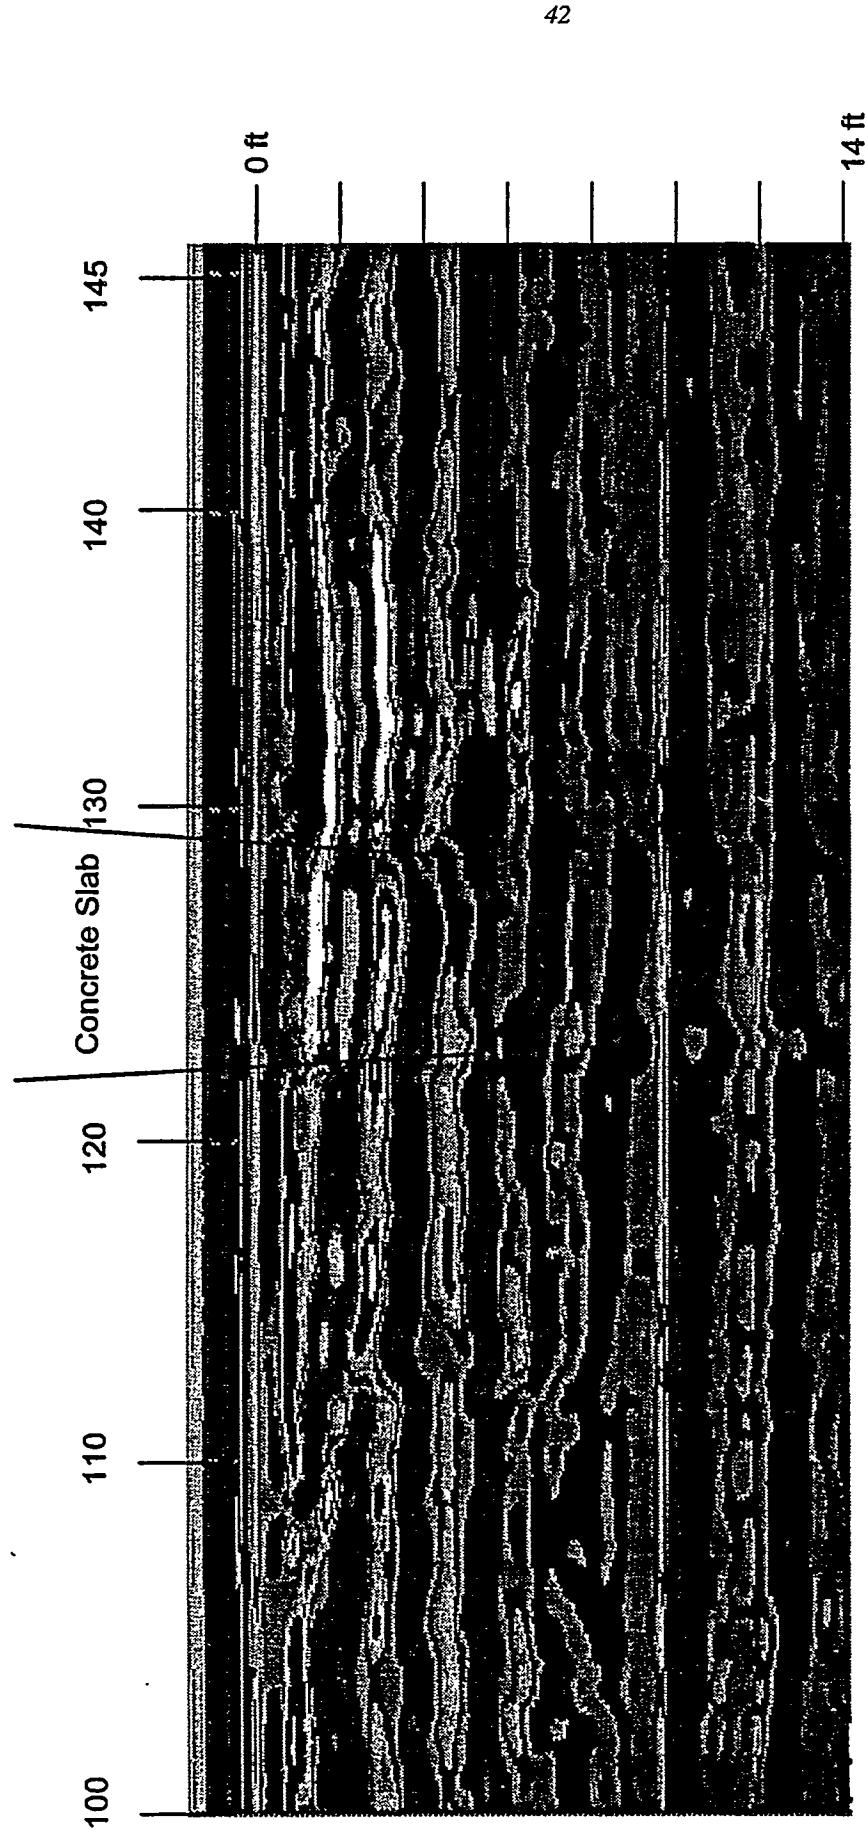
FIGURE 6 Ground-Penetrating Radar Profile along X=170

1. EMF and GPR anomalies are observed along  $X=145$  between  $Y=100-105$  at a depth of about 2.4 ft.
2. Strong GPR reflections are detected along  $X=170$  between  $Y=128-140$ . An EMF anomaly at 1.8 ft is centered on 170, 130. The source of this anomaly is unknown.
3. Isolated GPR and EMF anomalies are detected with unknown sources.
