**Post-Closure Inspection  
and Monitoring Report  
for Corrective Action Unit 417:  
Central Nevada Test Area Surface,  
Hot Creek Valley, Nevada**

**October 2010**

Legacy  
Management

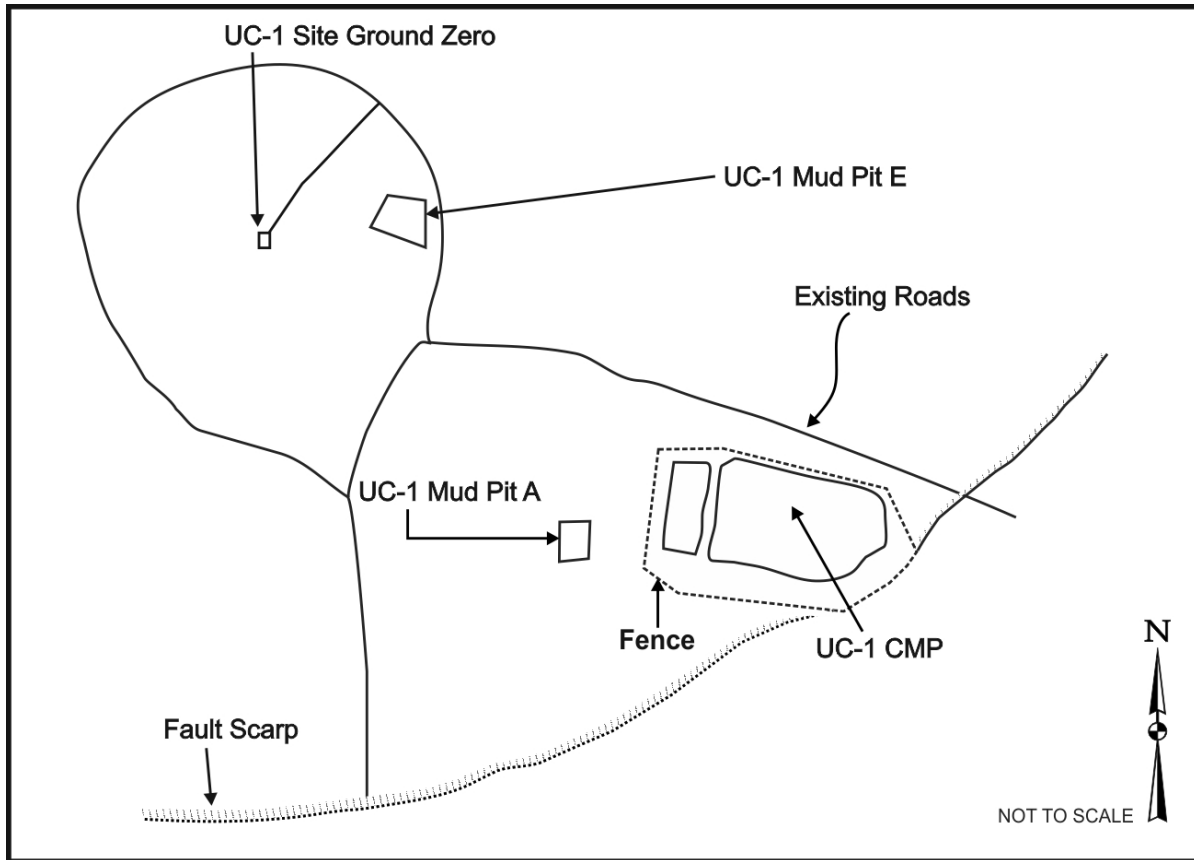
Figure 3-1. Location of UC-1 Significant Features

The locks, fencing, SMs, and signs associated with the CMP were in good order, with the exception of one sign that had fallen along the southeast side of the fence line and was reattached to the fence at the time of this inspection. One new and two existing cracks or fractures were identified in the soil cover, indicating that consolidation (settling) due to the weight of the cover on the CMP continues, and were repaired at the time of the inspection. The vegetation on the cover continues to look healthy. All other signs and monuments at Mud Pits A and E (Figure 3–1) were in excellent condition.

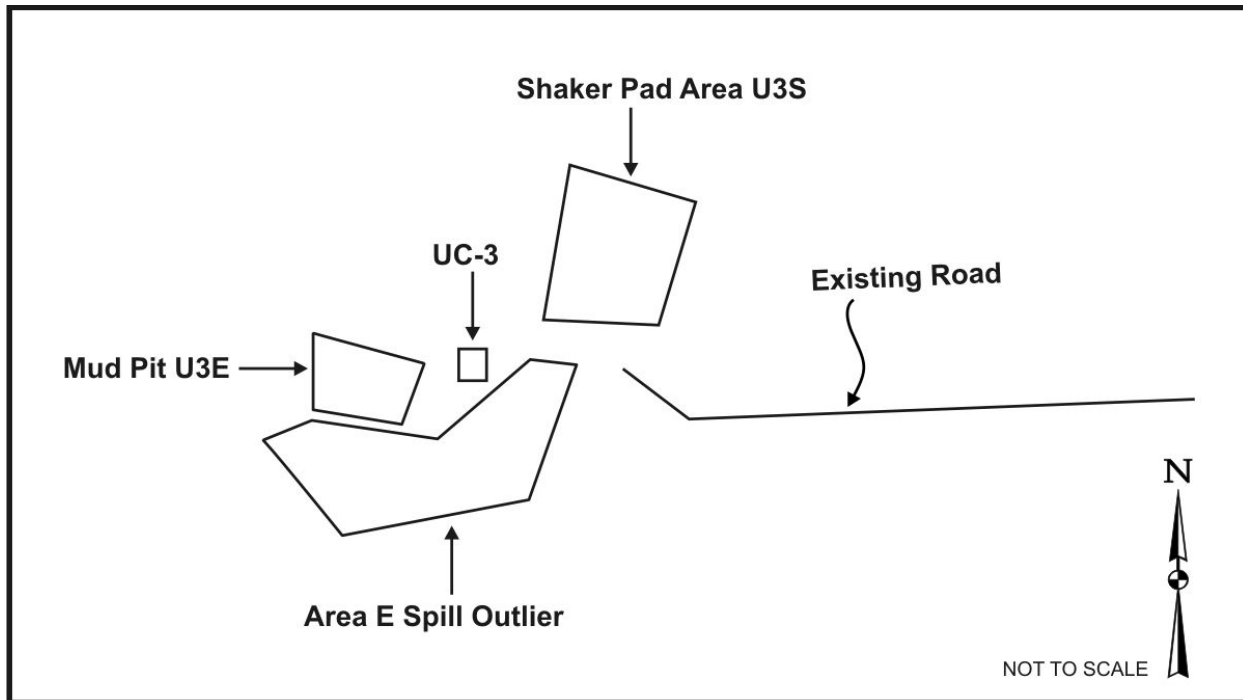
Figure 3-2. Location of UC-3 Significant Features

The site was in excellent condition (Figure 3–2). No issues with the monuments or signs were identified, and no maintenance or repairs were recommended.

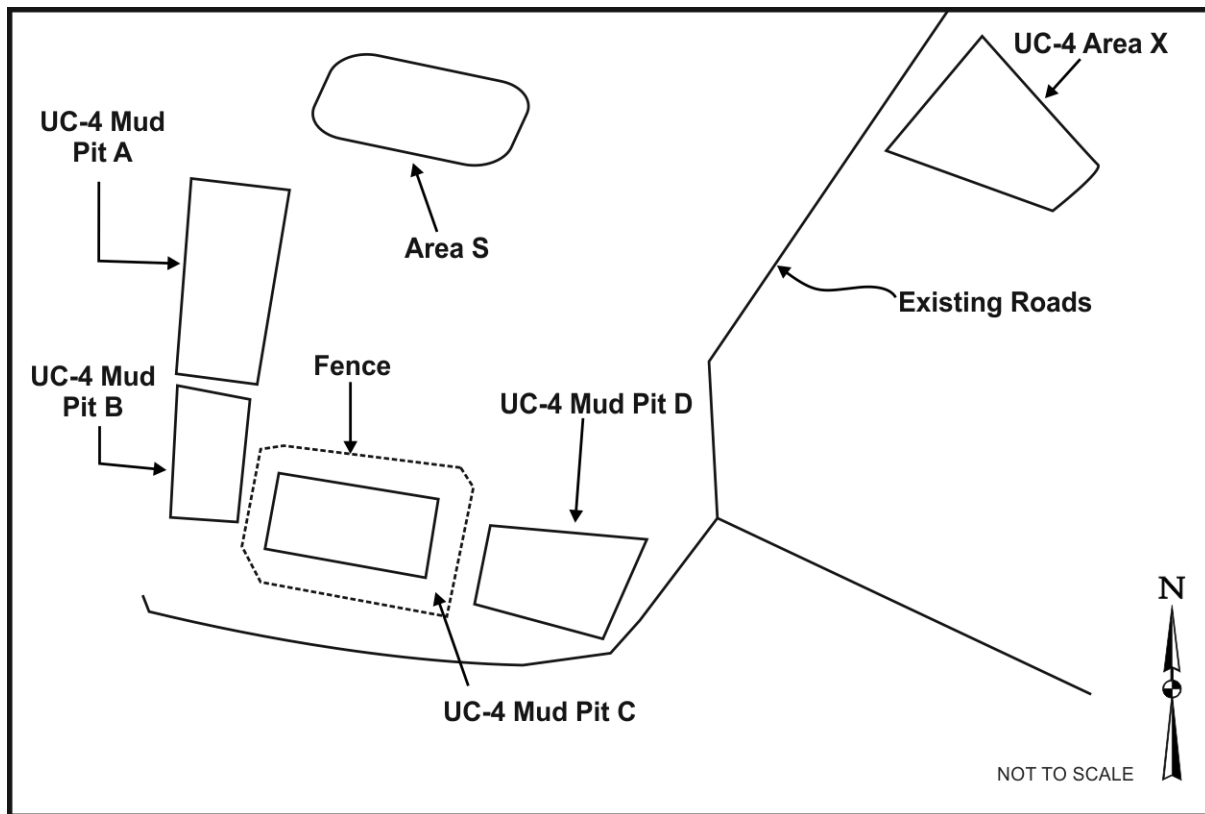
Figure 3–3. Location of UC-4 Significant Features

The Mud Pit C fence and SMs were in good condition. A pin on the gate lock hasp was missing, but it does not affect the integrity of the locking mechanism. The two small erosion rills that were identified and repaired at last year's inspection showed no further signs of activity. No new erosion concerns were apparent at this year's inspection. Some vegetation is growing on the cap, however, and the inspection team removed a large amount of the sagebrush that was growing on the west side of the cap. No issues that affected the integrity of the cover and appurtenances were noted. Mud Pits A, B, and D were in excellent condition, and no issues were identified with Area S or Area X (Figure 3–3).

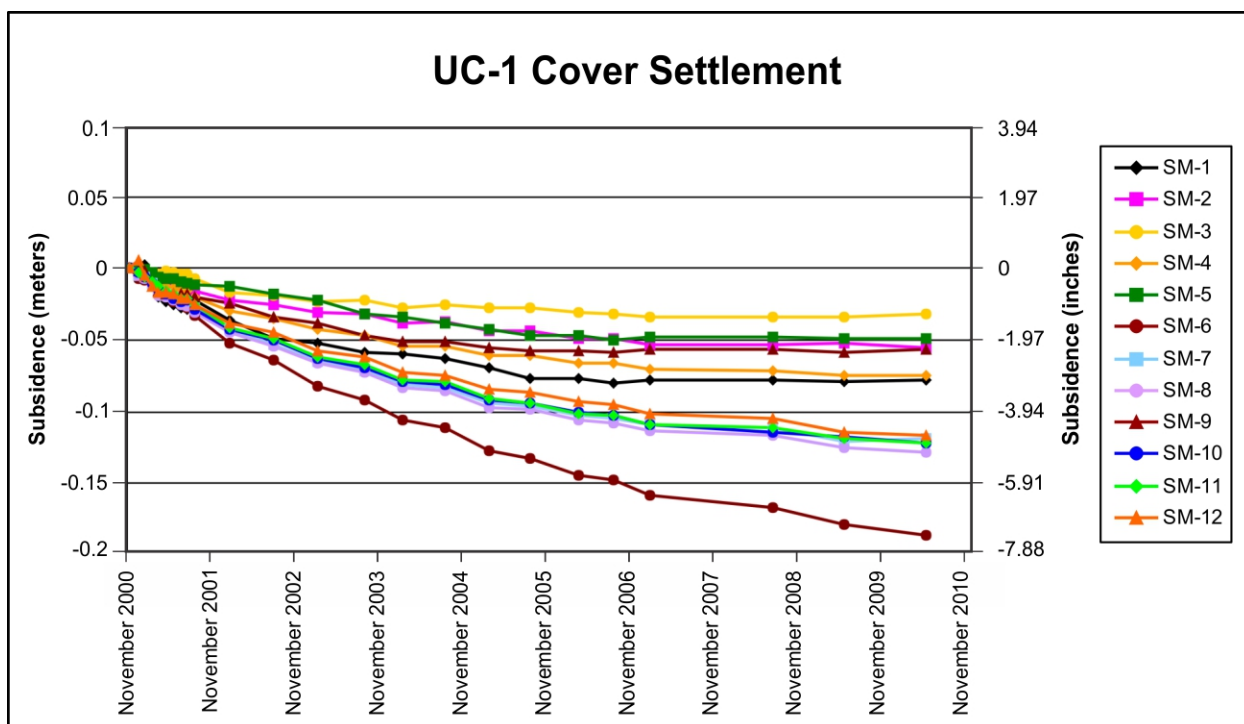
Figure 3–4. UC-1 Cover Settlement

Twelve SMs were installed on the UC-1 CMP cover to provide elevation control and measure subsidence of the cover and relocation trench (NNSA/NV 2001). Figure 2–1 shows these SMs. The baseline subsidence survey was completed on December 4, 2000, and is used as the reference to calculate subsidence for each subsequent survey. Beginning in 2007, annual subsidence monitoring replaced the biannual subsidence monitoring that had taken place since 2002. The UC-1 baseline survey locations and elevations are provided in Table B–1 in Appendix B, and are presented in graphical form in Figure 3–4.

The degree of settlement in the relocation trench and CMP is within the predicted range and shows no unusual subsidence. The data collected over the CMP section of the cover indicate that the largest subsidence is along the centerline of the CMP, including SM-6, SM-7, and SM-8, and along the southern portion of the cap at SM-10, SM-11, and SM-12. This was expected because of the thicker layer of underlying mud in these areas. The northern monuments (SM-2, SM-3, and SM-4) and the westernmost monuments (SM-1, SM-5, and SM-9) show the least subsidence because the layer of underlying mud along these margins of the cover is thinner. The greatest degree of settlement continues to be on SM-6, which has subsided a total of 0.186 m (7.32 in) since the baseline survey in December 2000.

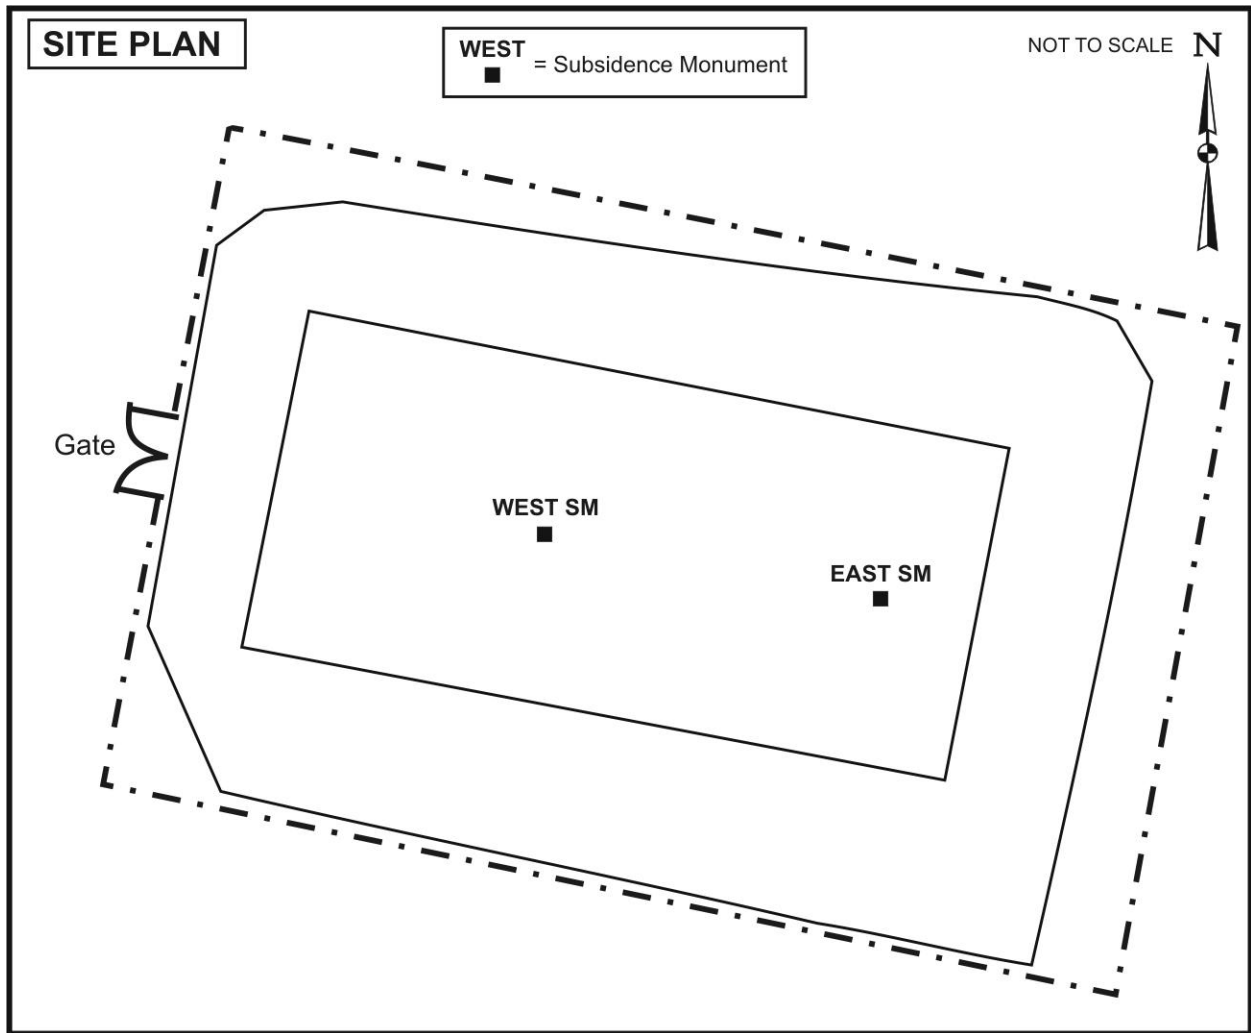
Figure 3-5. UC-4 West and East Monuments

Two SMs (west and east monuments) were installed in the UC-4 cover to provide elevation control for measuring the subsidence of the cover. Figure 3–5 shows these SMs. An initial subsidence survey was completed on October 12, 1999, and is used as a baseline to calculate subsidence. The UC-4 baseline survey locations and elevations are provided in Table B–2 in Appendix B, and are presented in graphical form in Figure 3–6. Since the last subsidence survey in 2009, both SMs continued to show increases in elevation. The elevation of the east SM increased 0.003 m (0.12 in), and the elevation of the west SM increased 0.007 m (0.28 in) since the last subsidence survey.

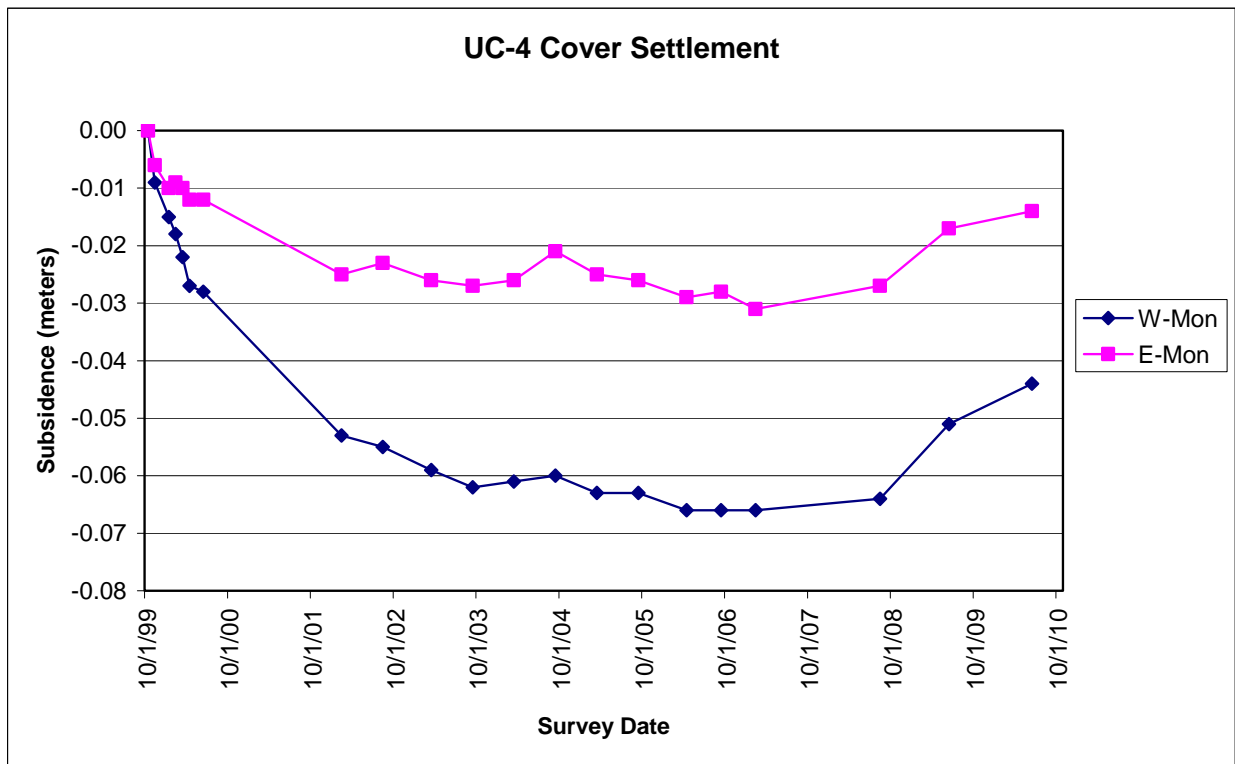
Figure 3–6. UC-4 Cover Settlement

Historically, settling of the west SM is still slightly greater than the predicted settling of 0.05 m (2 in); the total subsidence is 0.066 m (2.60 in) since the baseline survey in October 1999. The east SM has subsided a total of 0.031 m (1.22 in) since the baseline survey. The largest changes occurred during the first three years.

In the annual subsidence survey, measurements at the UC-4 east monument indicated a continued slight increase in elevation. Subsidence at the west monument is still slightly greater than the predicted settling; the total subsidence was 6.6 cm (2.6 in) since the baseline survey in October 1999. The cause of the continued increase in elevation of the two UC-4 monuments is unknown.

- No significant concerns were noted on the subsidence surveys for UC-1 and UC-4. The increases in elevation of the UC-4 monuments will be further evaluated during the 2011 annual inspection.

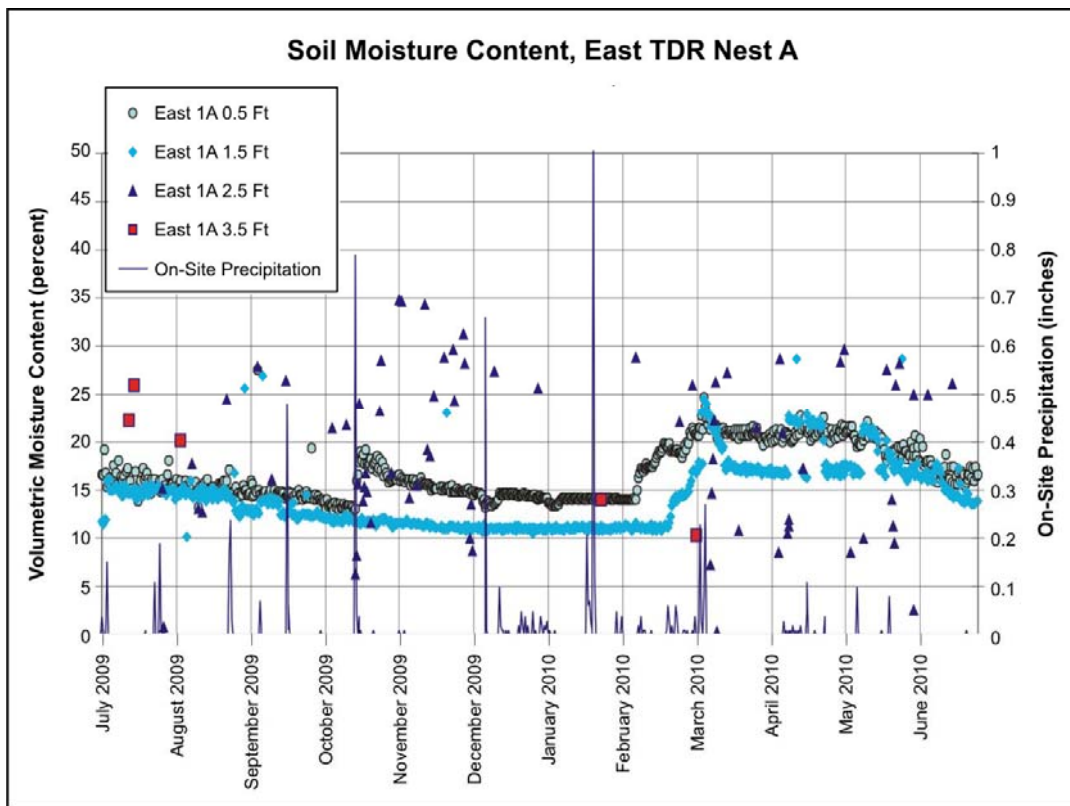
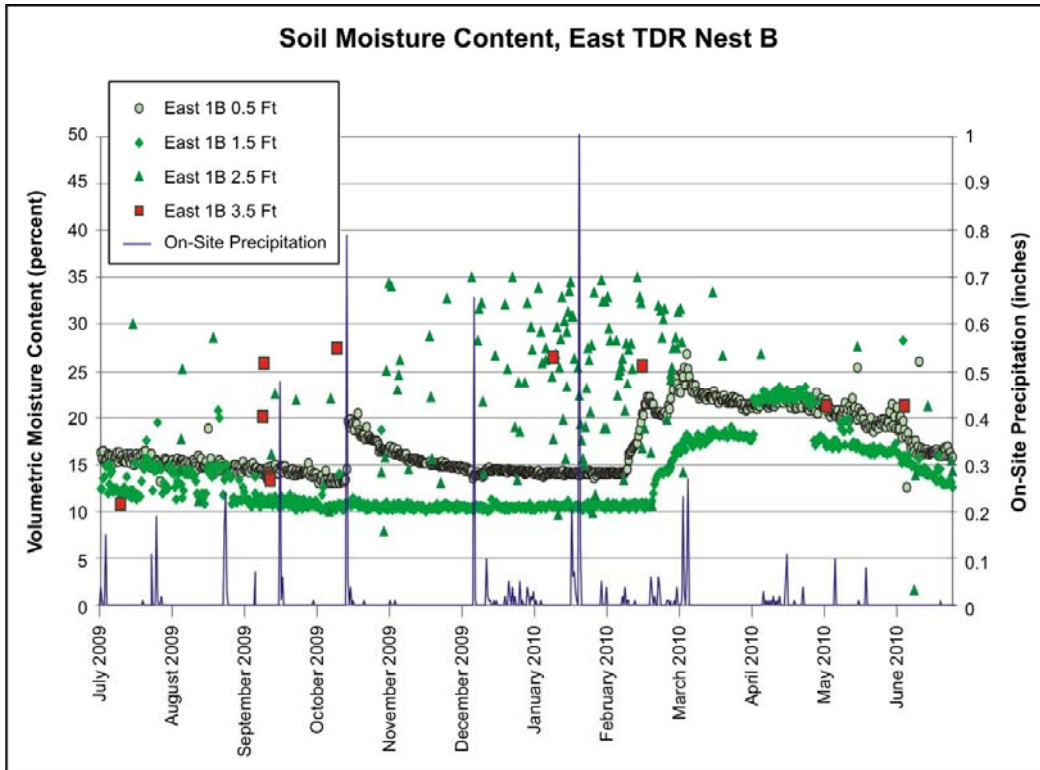
Soil moisture data obtained for the east TDR nests (Figure 3–8 and Figure 3–9), measured at depths of 0.76 m and 1.07 m (2.5 and 3.5 ft), and were corrupted by an unknown cause. Previously, the lengthy cable created a problem in measuring the reflected signal from the TDR probes (NNSA/NV 2007). Inappropriate signal responses from the two lower stations in the east TDR nest make interpreting the data difficult. The TDR data from all depths are presented in Figure 3–8 and Figure 3–9 but only the two TDR sensors at the shallower depths appear to be responding to the infiltrating moisture. The VMC data fluctuates seasonally in response to snow melt during spring thaw and precipitation events. Annually, the VMC data are highest during spring thaw and slowly decreases throughout the Spring and early Summer when VMC reaches steady state conditions ranging from 11 to 15 percent in the upper 1.5 ft of the cover.

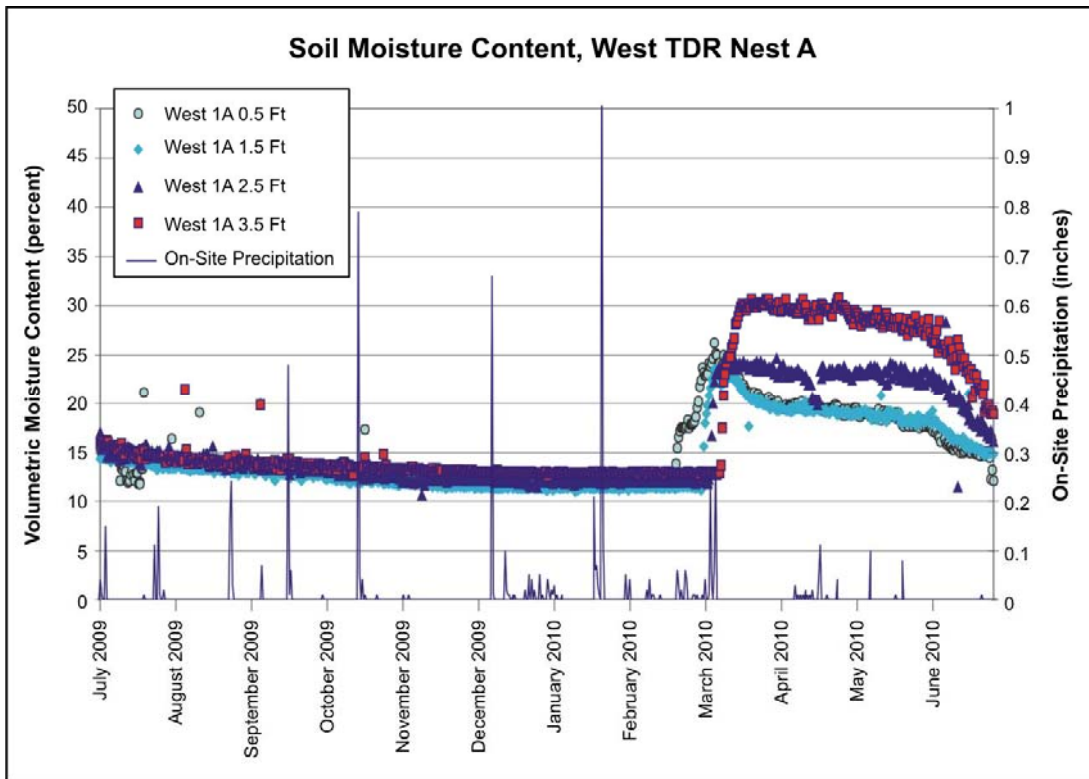
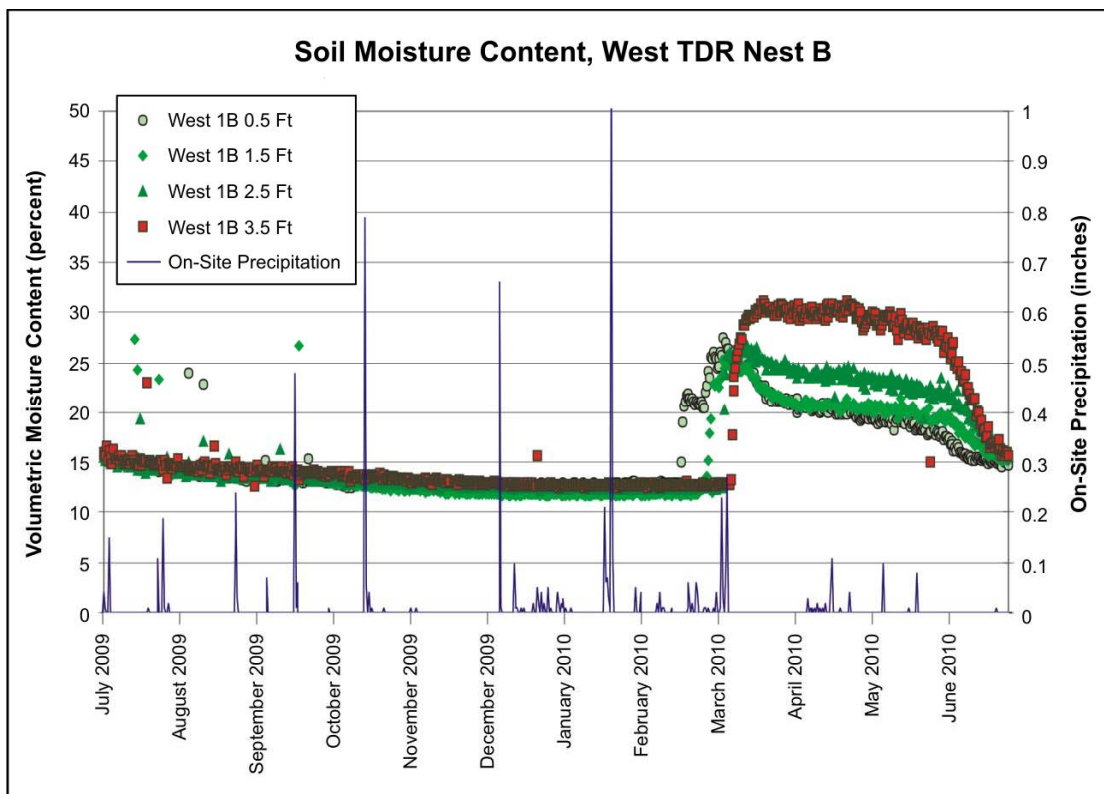
Soil moisture data obtained for the west TDR nest (Figure 3–10 and Figure 3–11) indicate that conditions have been steady throughout most of the year and that VMC has varied by less than 1 percent in the upper 2.5 ft of the cap. The VMC data fluctuates seasonally in response to snow melt during spring thaw. Annually, the VMC data are highest during spring thaw and slowly decreases throughout the Spring and early Summer when VMC reaches steady state conditions ranging from 11 to 15 percent in the upper 3.5 ft of the cover. These trends extended into mid-May, when surface temperatures increased and evapotranspiration again began removing moisture from the cover effectively.

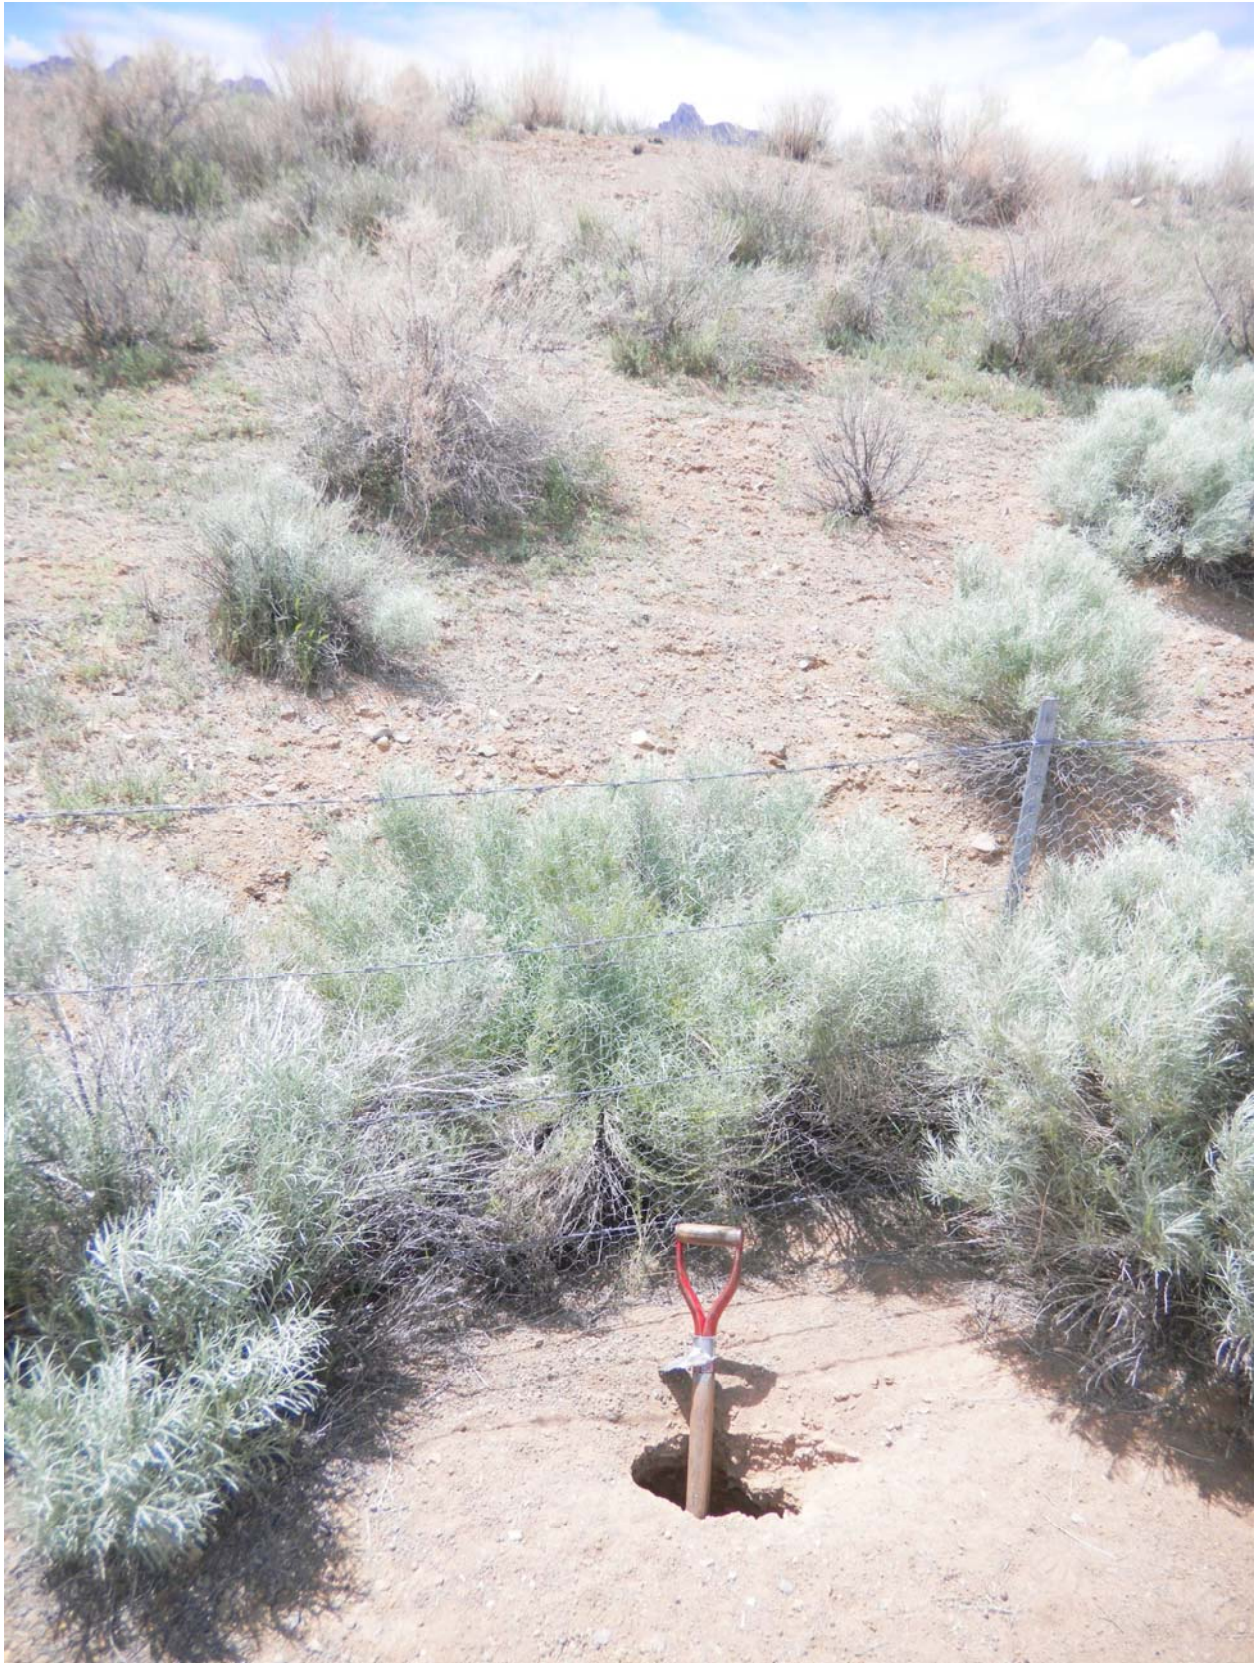
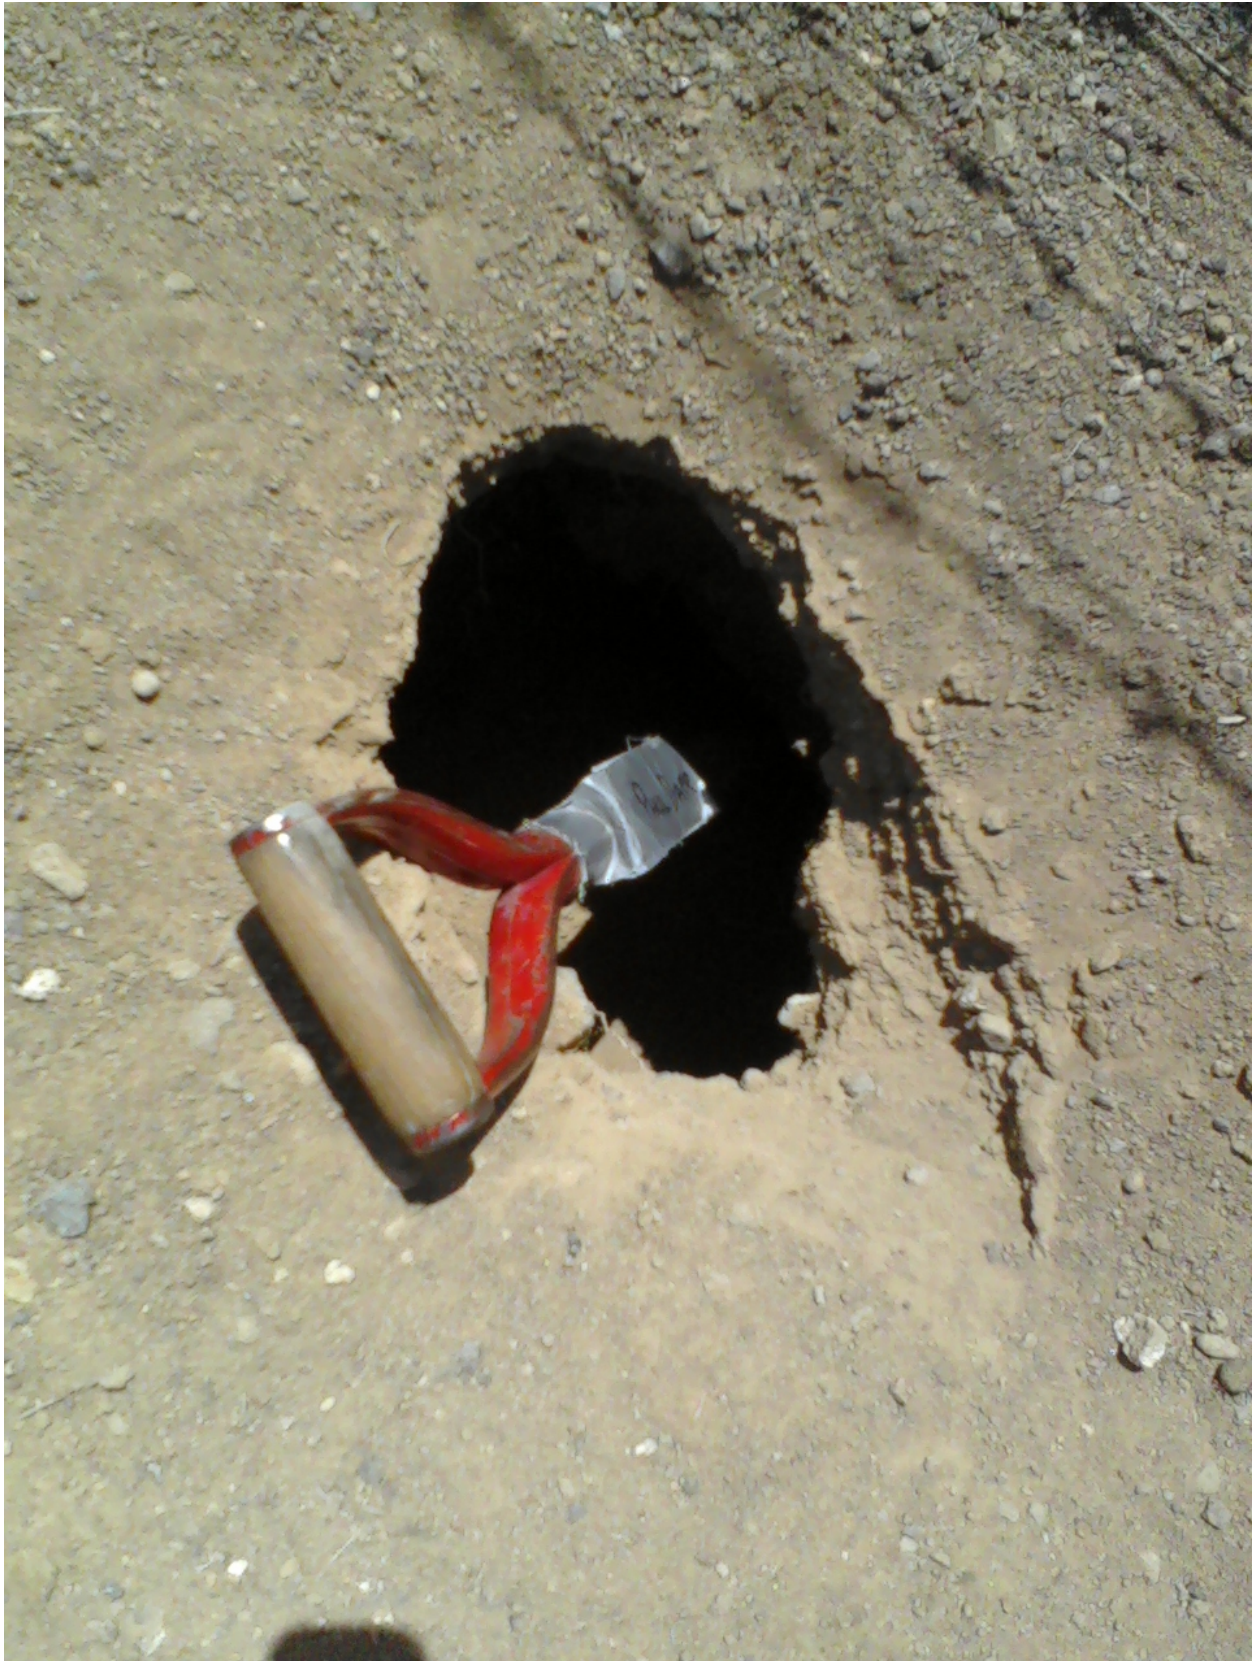
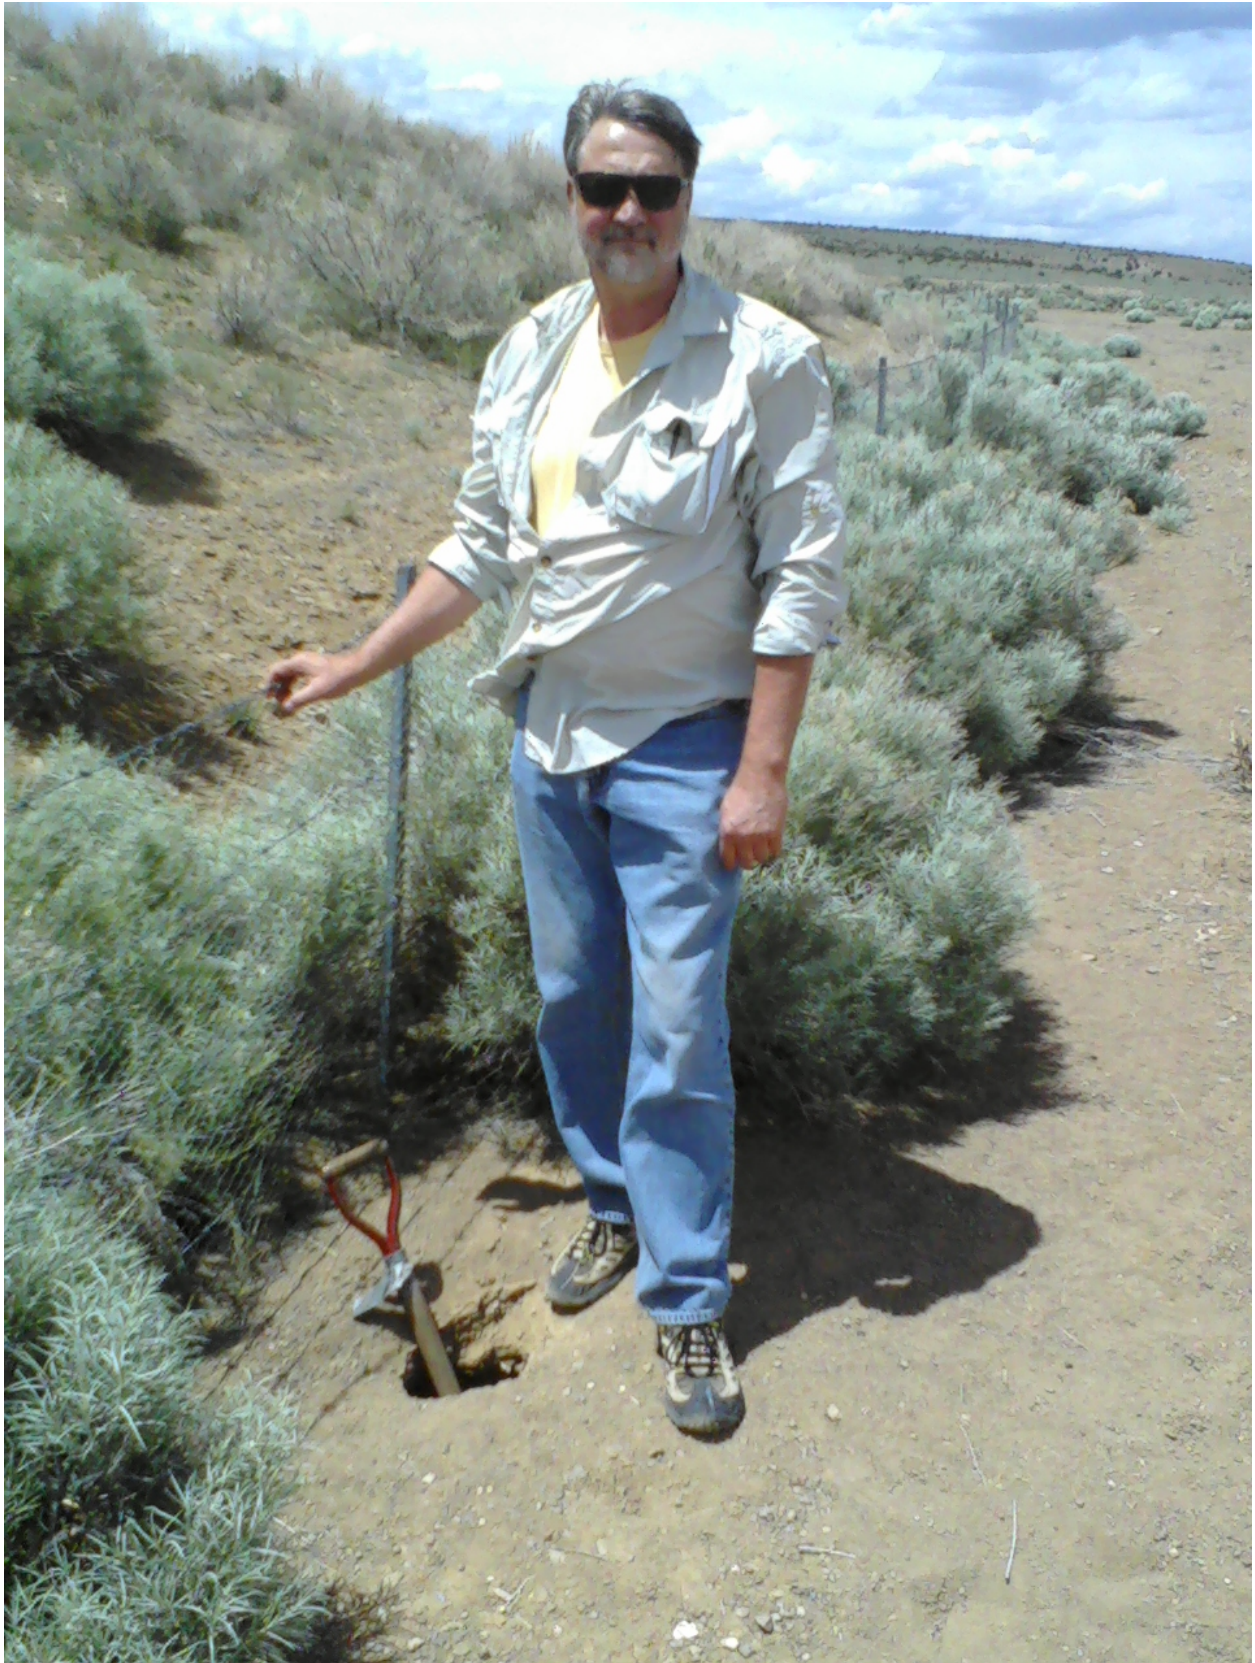
Near the downstream toe of the CMP, outside of the perimeter fence, a hole in the ground was observed in the drainage channel extending along the northeast side of the CMP. The hole was approximately 1.5 ft in diameter, and a shovel placed into the hole went in approximately 2 ft. There was no mounding of dirt around the hole, which indicates that the hole was not an animal borrow. The feature looks to be a result of piping erosion. Piping is a subsurface form of erosion that involves the removal of subsurface soils in pipe-like erosion channels to a free or escape exit. No exit area was observed. Photographs 13 through 15 in Appendix A show the erosion piping feature. At the time of the inspection, this erosion feature was backfilled up to surface grade with a mixture of soil and a 50-lb bag of bentonite.

6. Rationale for field conclusions: Overall integrity of the site is good. Only one small tensional crack filled this time. A small hole (1.5 ft in diameter) noted outside of fence east of the cap was observed. Appears to be piping erosion in the channel adjacent the cap. The hole was filled in with dirt and one bag of bentonite hole plug was mixed in with the backfill dirt.

*Photograph 13. UC-1, Possible piping structure near east toe of cap*

*Photograph 14. UC-1, Possible piping structure near east toe of cap*

*Photograph 15. UC-1, Possible piping structure near east toe of cap*

- No significant concerns were noted for the UC-1 CMP and UC-4 Mud Pit C covers during the annual inspection, and no further maintenance or repairs are recommended at this time. However, personnel traveling to CNTA for routine work will monitor the erosion piping feature on the northeast side of the downstream toe of the CMP throughout the coming year.
