# Postclosure Inspection and Monitoring Report for Surface Corrective Action Unit 417 at the Central Nevada Test Area, Nevada, Site

February 2021

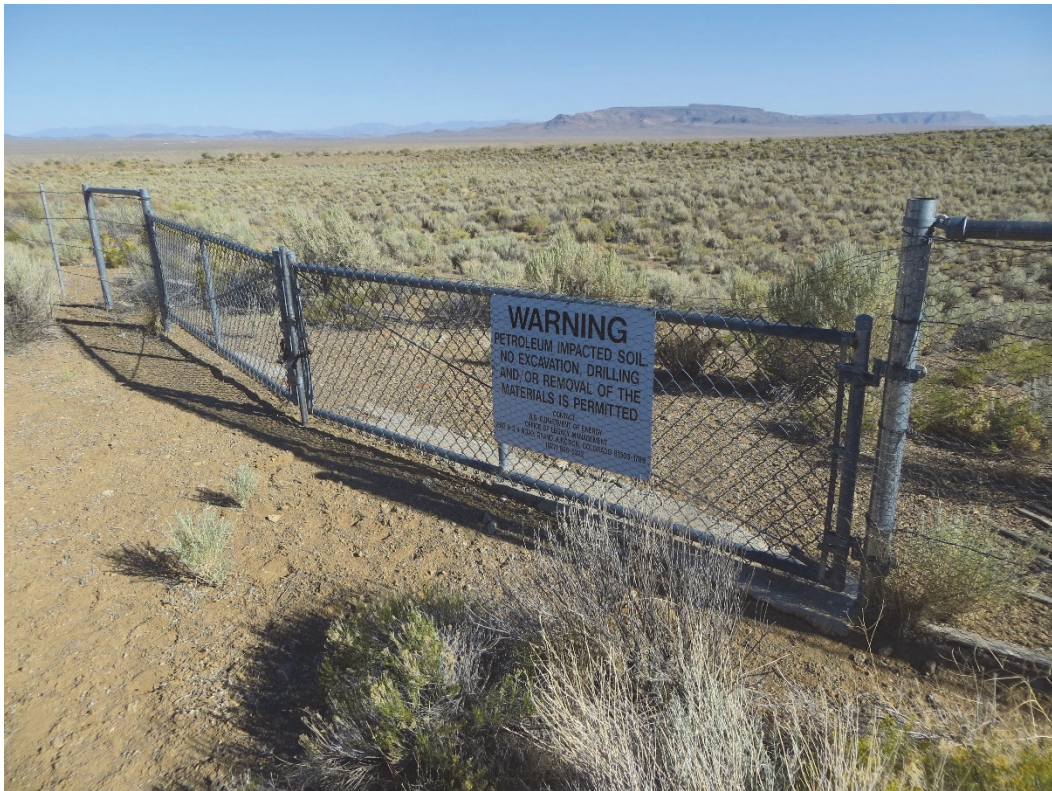
The UC-1 site (Figure 4) was in good condition at the time of the inspection. The locks, fencing, and signs associated with the CMP were in good condition. A sign was rehung on the southeast side of the CMP fenced area because the clasps that secured the sign to the fence had failed, and a few minor cracks on the CMP cover were repaired during the inspection. No issues that affected the integrity of the cover—including cracks, fractures, or extensions of existing cracks and fractures—were noted. The vegetation on the cover continued to look healthy and stable. The stormwater diversion channels designed to divert stormwater runoff around the CMP were observed as being in good condition with no unusual erosion features or breaches in the constructed channels. All signs and monuments at Mud Pits A and E (Figure 4) were in good condition. No additional maintenance or repairs are recommended at this time. Photographs 1 through 5 in Appendix B show the condition of the UC-1 site at the time of the inspection.

The inspection of UC-1 indicated that the site was in good condition. A sign was rehung on the southeast side of the CMP fenced area, and a few minor cracks on the CMP cover were repaired during the inspection. No other cracks, fractures, or extensions of existing cracks and fractures that would affect the integrity of the cover were observed, and no issues with the fence, gate, or monuments were identified. The vegetation on the CMP cover continued to look healthy. No issues were identified, and no additional maintenance or repair activities are recommended at this time.

*Photograph 1. UC-1 CMP (view from entrance gate on north fence line, looking southeast)*

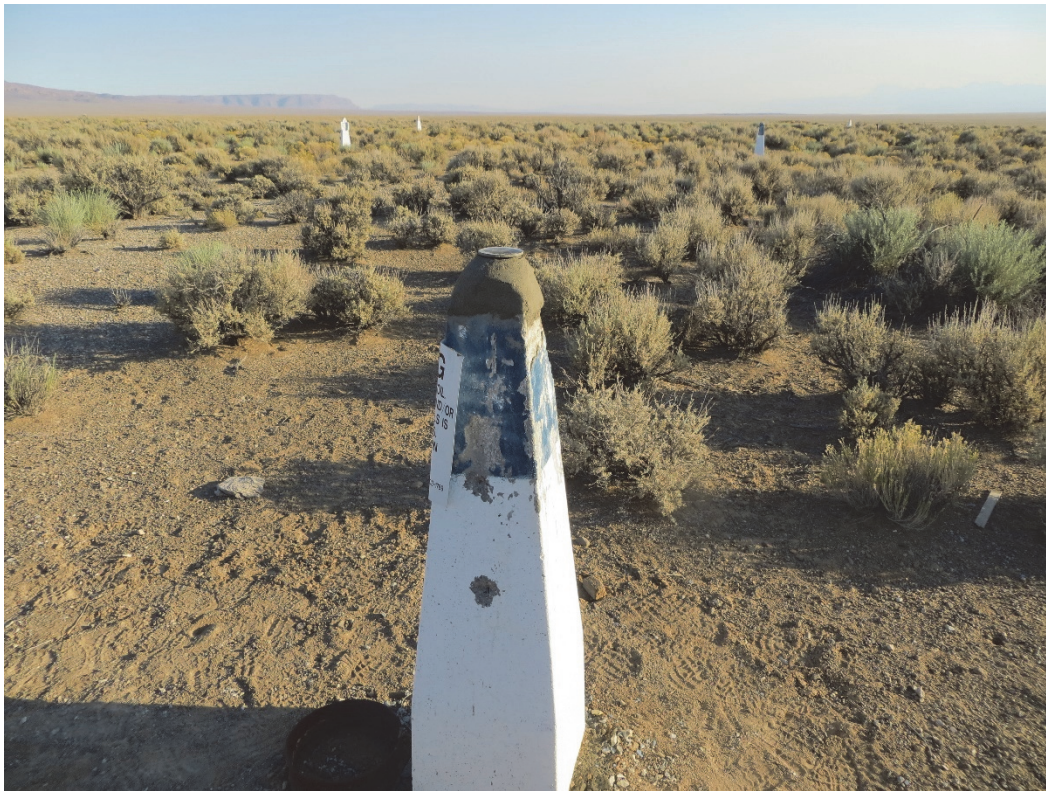
The UC-3 site (Figure 5) was in good condition at the time of the inspection. The 2018 inspection revealed damage to the concrete monument at the northeast corner of Mud Pit U3E (DOE 2020); that damage was repaired (Appendix B, photograph 7) during the 2020 inspection with a concrete patch material designed to reduce further deterioration and to protect the survey pin on top of the monument. The survey pin remains in good condition, and the repaired monument continues to function as designed. No other issues with the monuments or signs were identified during the inspection, and no additional maintenance actions or repairs are recommended at this time. Photographs 6 through 8 in Appendix B show the condition of the UC-3 site at the time of the inspection.

The inspection of UC-3 indicated that the site was in good condition. Damage to the concrete monument at the northeast corner of Mud Pit U3E (identified during the 2018 inspection) was repaired. The repaired monument continues to function as designed. All other monuments and signs were in good condition. No issues were identified, and no additional maintenance or repair activities are recommended at this time.

5. Is current status/condition of unit satisfactory?	X		
6. Rationale for field conclusions: The concrete monument at the northeast corner of Mud Pit U3E was identified as being damaged during the 2018 inspection. The damage was minor and the concrete monument and survey pin at the top of the monument still functioned as designed. This monument was repaired during the 2020 inspection to reduce any further deterioration. No other maintenance actions were identified during the inspection, and the site was in good condition at the time of the inspection.			
<b>E. CERTIFICATION</b>			
I have conducted an inspection of UC-3, CAU 417, at the Central Nevada Test Area in accordance with the Post-Closure Monitoring Plan (see Closure Report) as recorded on this checklist, attached sheets, field notes, photo logs, and photographs.			
Chief Inspector's Signature:

*Photograph 7. UC-3 Mud Pit U3E, Showing Repairs Made to the Top of the Monument (view from northeast monument, looking south)*

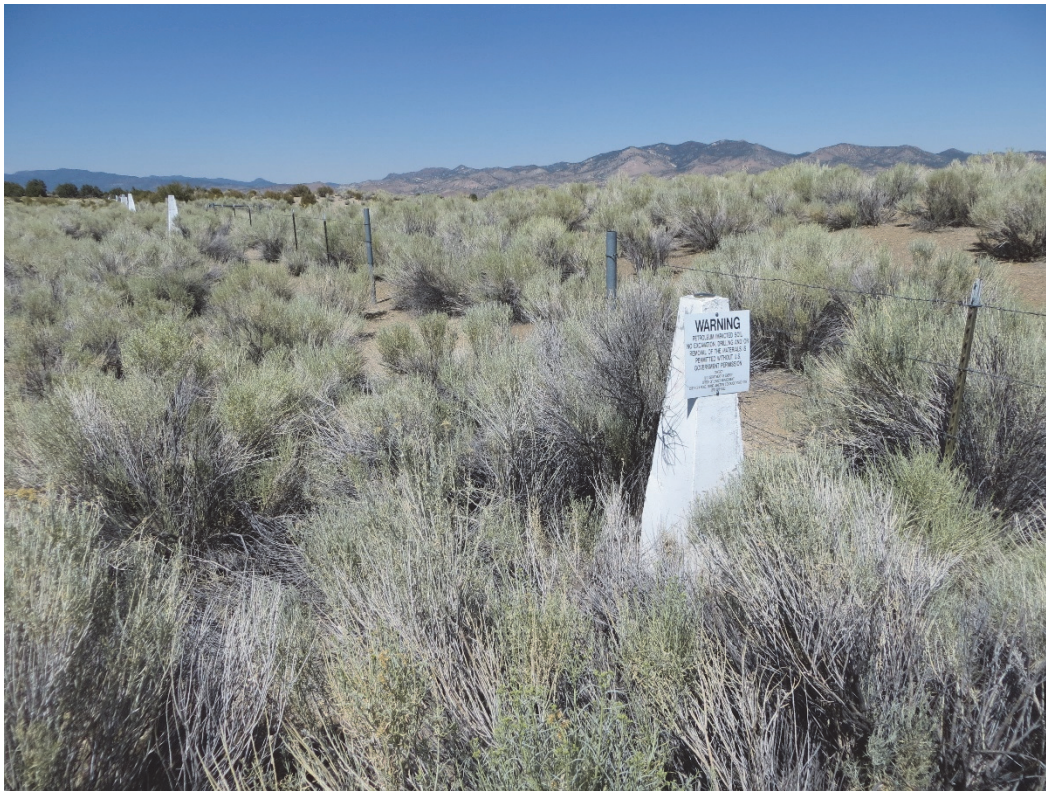
At the UC-4 site (Figure 6), a gate was missing from the Mud Pit C fenced area (Appendix B, photograph 11). A replacement gate was not available in Ely at the time of the inspection. The gate will be special ordered so it can be replaced during the next site visit planned for mid-2021. The remainder of the Mud Pit C fence, signs, and monuments were in good condition. No erosion rills were identified on Mud Pit C, and no issues that affected the integrity of the cover, including cracks or fractures, were observed. All signs and monuments at Mud Pits A, B, and D and Area X were in good condition (Figure 6). The gate to the Mud Pit C fenced area will be replaced during the next site visit, but no additional maintenance or repairs are recommended at this time. Photographs 9 through 14 in Appendix B show the condition of the UC-4 site at the time of the inspection.

The inspection of UC-4 revealed that the gate to the Mud Pit C fenced area was missing, though the remainder of the site was in good condition. No erosion rills, new fractures or extension of existing fractures were observed, and no issues with the fence, monuments, or signs were identified. Replacement of the gate to the Mud Pit C fenced area is planned for the next site visit in mid-2021. No other issues were identified, and no additional maintenance or repair activities are recommended at this time.

5. Is current status/condition of vegetative cover satisfactory?	X		
6. Rationale for field conclusions: The gate to the UC-4 Mud Pit C was missing at the time of the inspection, but the remainder of the site was in good condition – no erosion rills were observed, the fence is in good condition, and no signs were down.			
<b>E. CERTIFICATION</b>			
I have conducted an inspection of the UC-4 Mud Pit C Cover, CAU 417, at the Central Nevada Test Area in accordance with the Post-Closure Inspection Plan (see Closure Report) as recorded on this checklist, attached sheets, field notes, photo logs, and photographs.			
Chief Inspector's Signature:

*Photograph 11. UC-4 Mud Pit C (view of entrance to fenced area with missing gate, looking northeast)*

- Replace the gate to the Mud Pit C fenced area during the next site visit planned for mid-2021
- Implement an inspection and reporting frequency of every 6 years, with the next inspection report in 2026 with submittal to NDEP in 2027
- Continue to respond within 90 days to any reports from the public about detrimental conditions at the site
