Case Study: Metallurgical and Mechanical Analysis of *Castellated Via* Rigid-Flex Connection

Rebecca Wheeling, Ph.D.
Sandia National Laboratories
NM, USA
rwheeli@sandia.gov

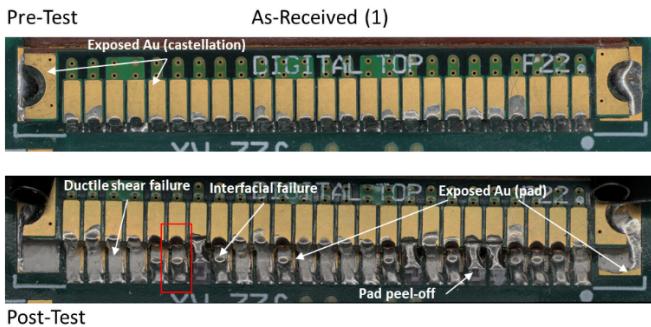
While the table above does identify common failure modes, note that these identifications have been made using only optical imaging. While the ductile and interfacial failure modes are likely to be correct, scanning electron microscopy (SEM) imaging is required to confirm.

Figure 1. Top views of a flex cable connected to the PCB with castellated via solder joints, before (top) and after (bottom) shear testing. The red box highlights the inset shown in Figure 2. This unit was tested in the as-received condition. Sample ID is shown in parenthesis.

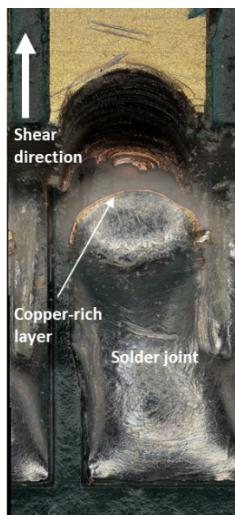
A higher magnification image of a potential interfacial failure highlighted in the red box above is shown in **Figure 2**. The failure occurs along the castellation-Cu interface. The two options for the exact interface are: 1) along a board-Cu

plating interface; or 2) along a Cu-Cu₆Sn₅ interface. SEM imaging is required for confirmation, however.

Figure 2. Higher magnification optical image of a potential interfacial failure at the castellation-Cu plating interface.

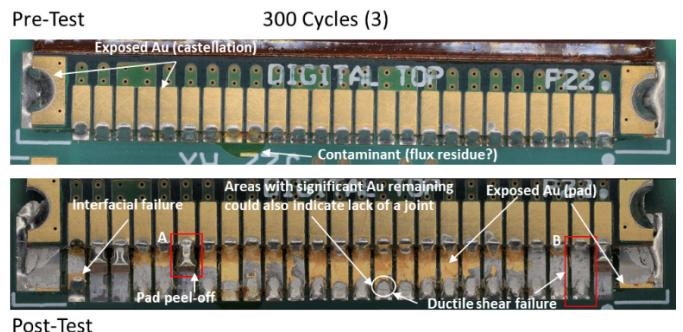
Figure 3. Top views of a flex cable connected to the PCB with castellated via solder joints, before (top) and after (bottom) shear testing. The red box highlights the insets shown in Figure 4. This unit was tested after 300 cycles. Sample ID is shown in parenthesis.

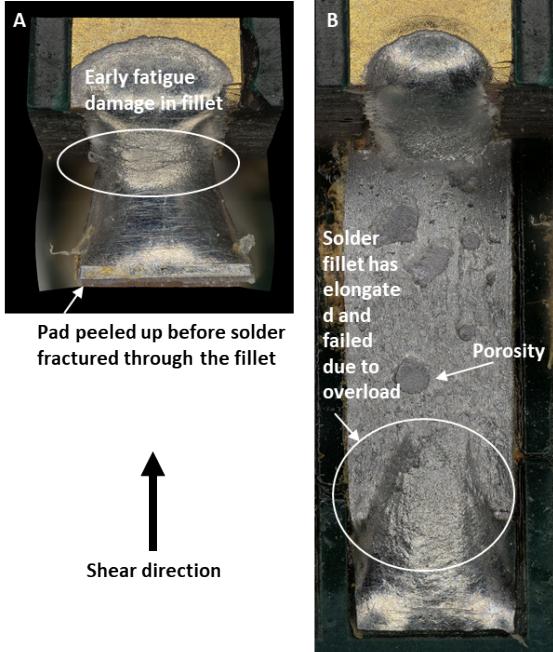
Figure 4. Higher magnification optical images highlighting pad peel-off (A) and ductile shear (B) failure modes.

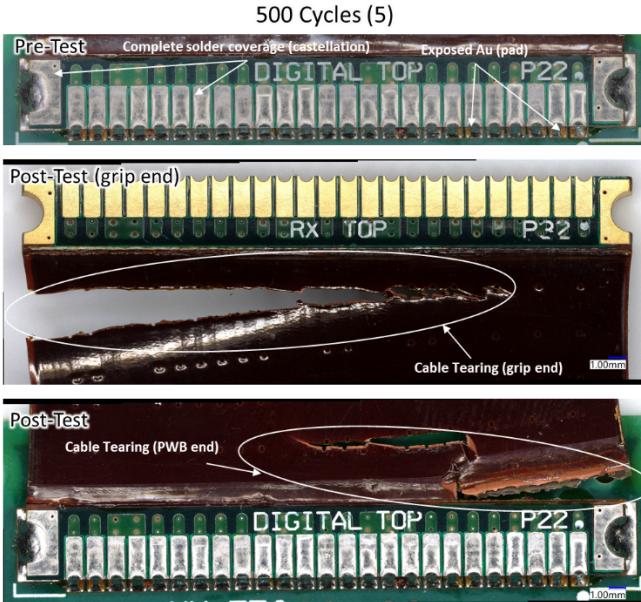
Figure 5. Top views of a flex cable connected to the PCB with castellated via solder joints, before (top) and after (middle, bottom) shear testing. This unit was tested after 500 cycles. Sample ID is shown in parenthesis.

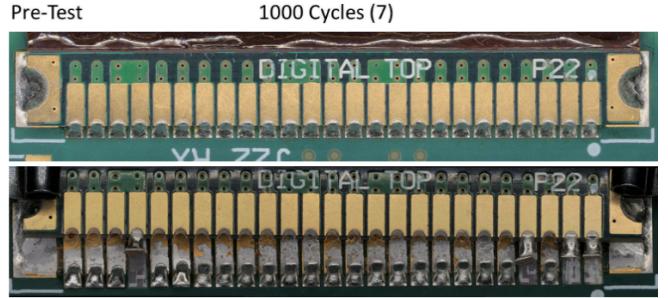
Figure 6. Top views of a flex cable connected to the PCB with castellated via solder joints, before (top) and after (bottom) shear testing. This unit was tested after 1000 cycles. Sample ID is shown in parenthesis.

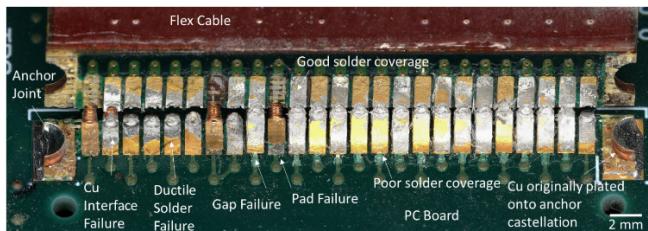
Figure 16 shows an optical image of a cable assembly post-peel test, with various failure modes identified.

Figure 8. Top view of a flex cable connected to the PCB with castellated via solder joints, after peel testing. This unit was tested in the as-received condition.

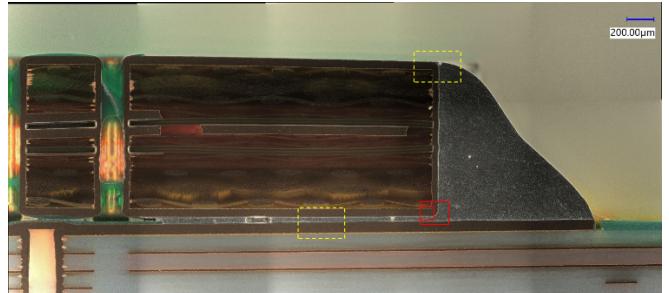
Figure 17 shows the general cross-sections that were cut through the castellation joints and highlights the key areas for potential Au embrittlement (yellow boxes). The red boxes indicate the higher magnification SEM inset images shown in Figure 18.

Figure 17. Optical image showing a low magnification cross-section through a castellated via solder joint. Yellow boxes highlight the high-risk locations for potential Au embrittlement. The red boxes highlight the locations where EDS maps were acquired, in Figure 19.

Au signals were absent within the bulk solder and along the interfaces where solder was present. No signs of Au intermetallic formation or Au embrittlement along the interfaces was observed, even at the high-risk areas where the solder does not fully wet the pads, leaving elemental Au adjacent to solder. The lack of Au embrittlement can be attributed to the small Au concentration and thickness of the ENEPIG finish. further investigation into microstructure continues but is unavailable at the time of publishing this report.

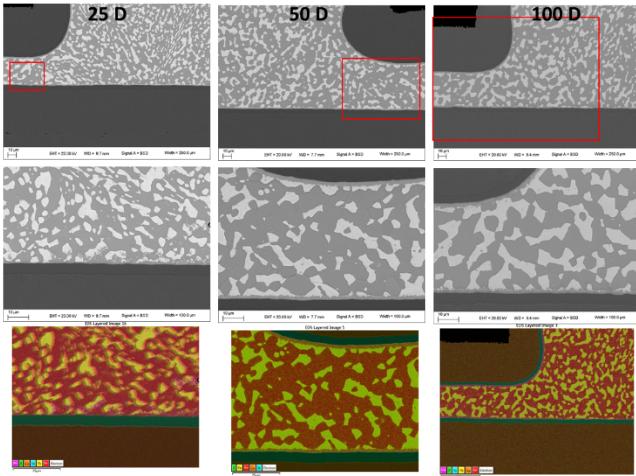
Figure 18. Higher magnification SEM images of the red insets from Figure 17. The columns represent a given aging condition: 25, 50, and 100 days (left, middle, and right, respectively). The middle row shows a higher magnification image highlighted by the red inset box. The bottom row shows corresponding EDS maps. All three samples were aged at the more extreme 100C.

The joint microstructure appears to be relatively stable with increasing time at 100C. The 70C results are not shown here because the 100C condition is expected induce more significant microstructural change, if any. While coarsening of the bulk solder microstructure (Fig. 18) is evident, the interfaces appear to remain stable over time, both the Cu-SnPd intermetallic and the SnPd intermetallic-solder. No voiding is observed, so the concern for microstructural instability over time is relatively low.
