Case Study: Metallurgical and Mechanical Analysis of Castellated Via Rigid-Flex

Connection

Rebecca Wheeling, John Laing, Shelley Williams

Sandia National Laboratories

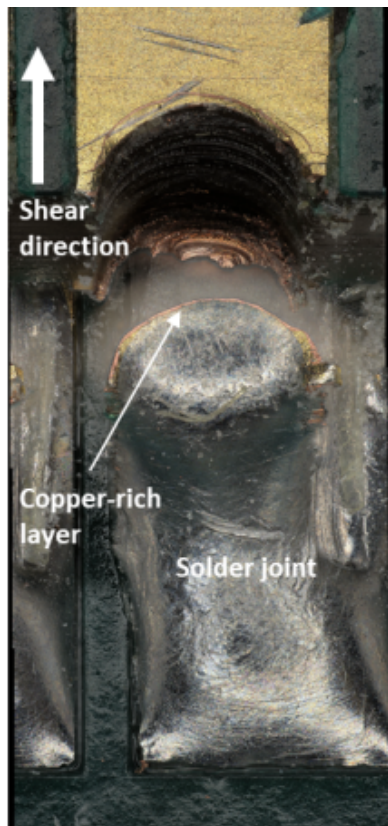
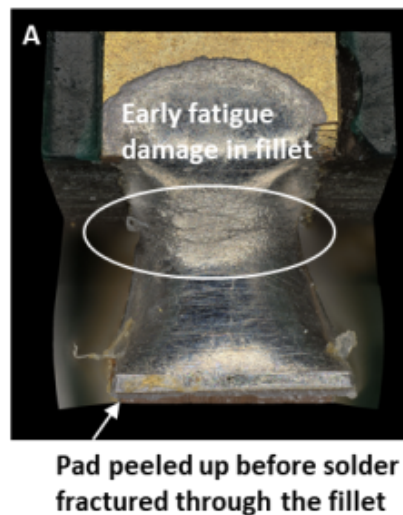
Higher magnification optical images highlighting pad peel-off (A) and ductile shear (B) failure modes.

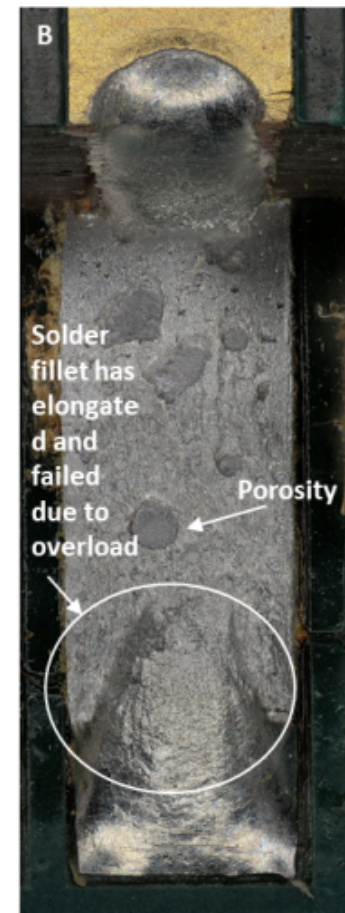
Higher magnification optical image of a potential interfacial failure at the castellation-solder interface.

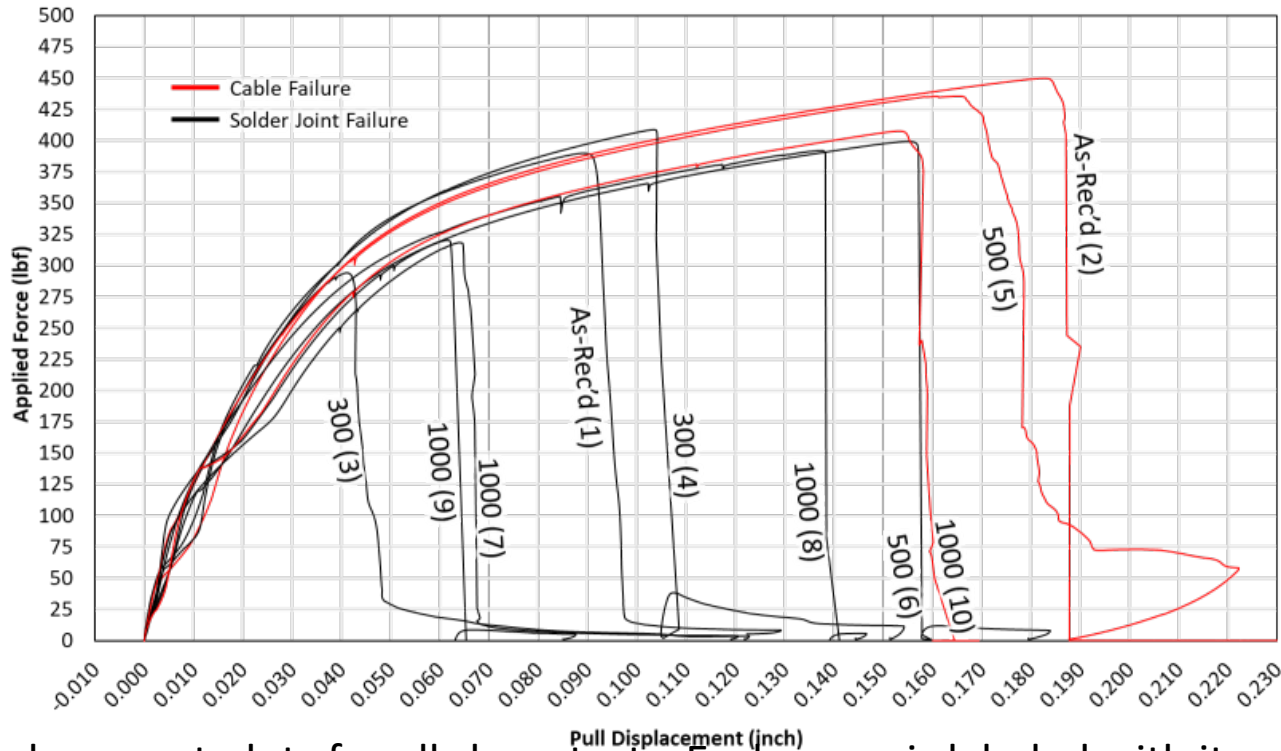
Force vs. displacement plots for all shear tests. Each curve is labeled with its aging condition in number of cycles and its sample ID in parenthesis. Black curves indicate solder joint failures and red curves indicate flex cable failures.

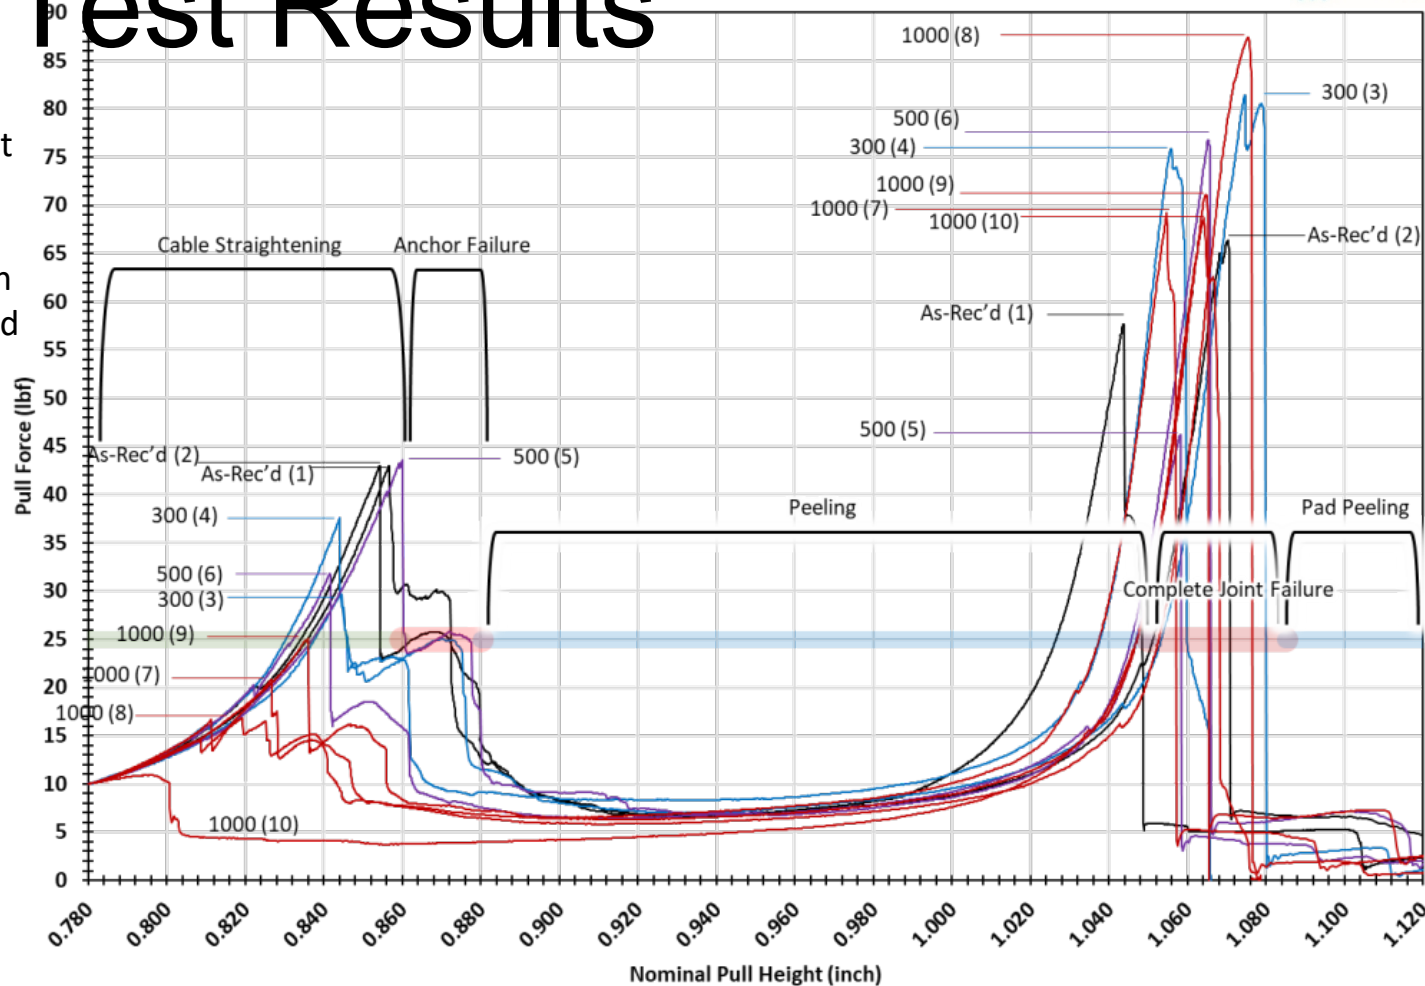
Force vs. displacement plots for all peel tests. Each curve is labeled with its aging condition in number of cycles and its sample ID in parenthesis. Black, blue, purple, and red curves denote as-received, 300 cycle, 500 cycle, and 1000 cycle conditions, respectively. The curves are broken into 5 regions, denoting observed behavior during testing.

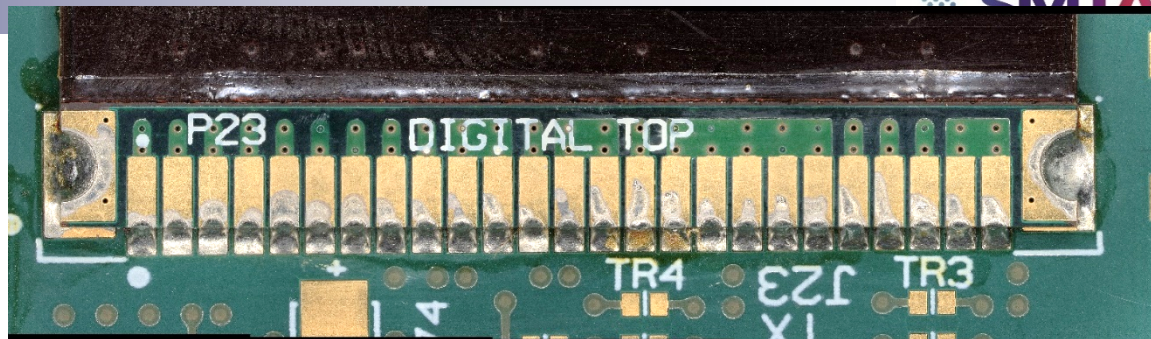
Slight Misalignment in Anchor to PWB Pads

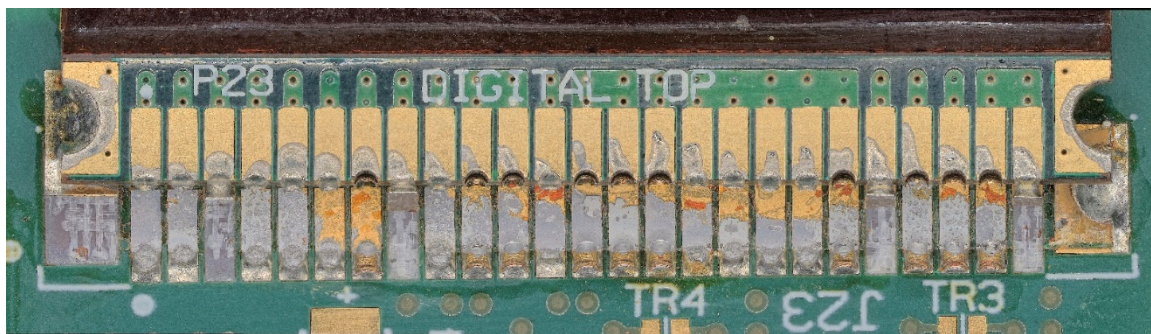
POST TEST – TOP

Left Anchor Pad Pull-Off PWB;
Right Anchor Pad Pull-Off Cable Board;
Interfacial Castellated Failures
