**Contamination Source Review for Building E6891,
Edgewood Area, Aberdeen Proving Ground, Maryland**

S.D. Zellmer, A.K. Draugelis, J. Rueda, and R.E. Zimmerman

September 1995

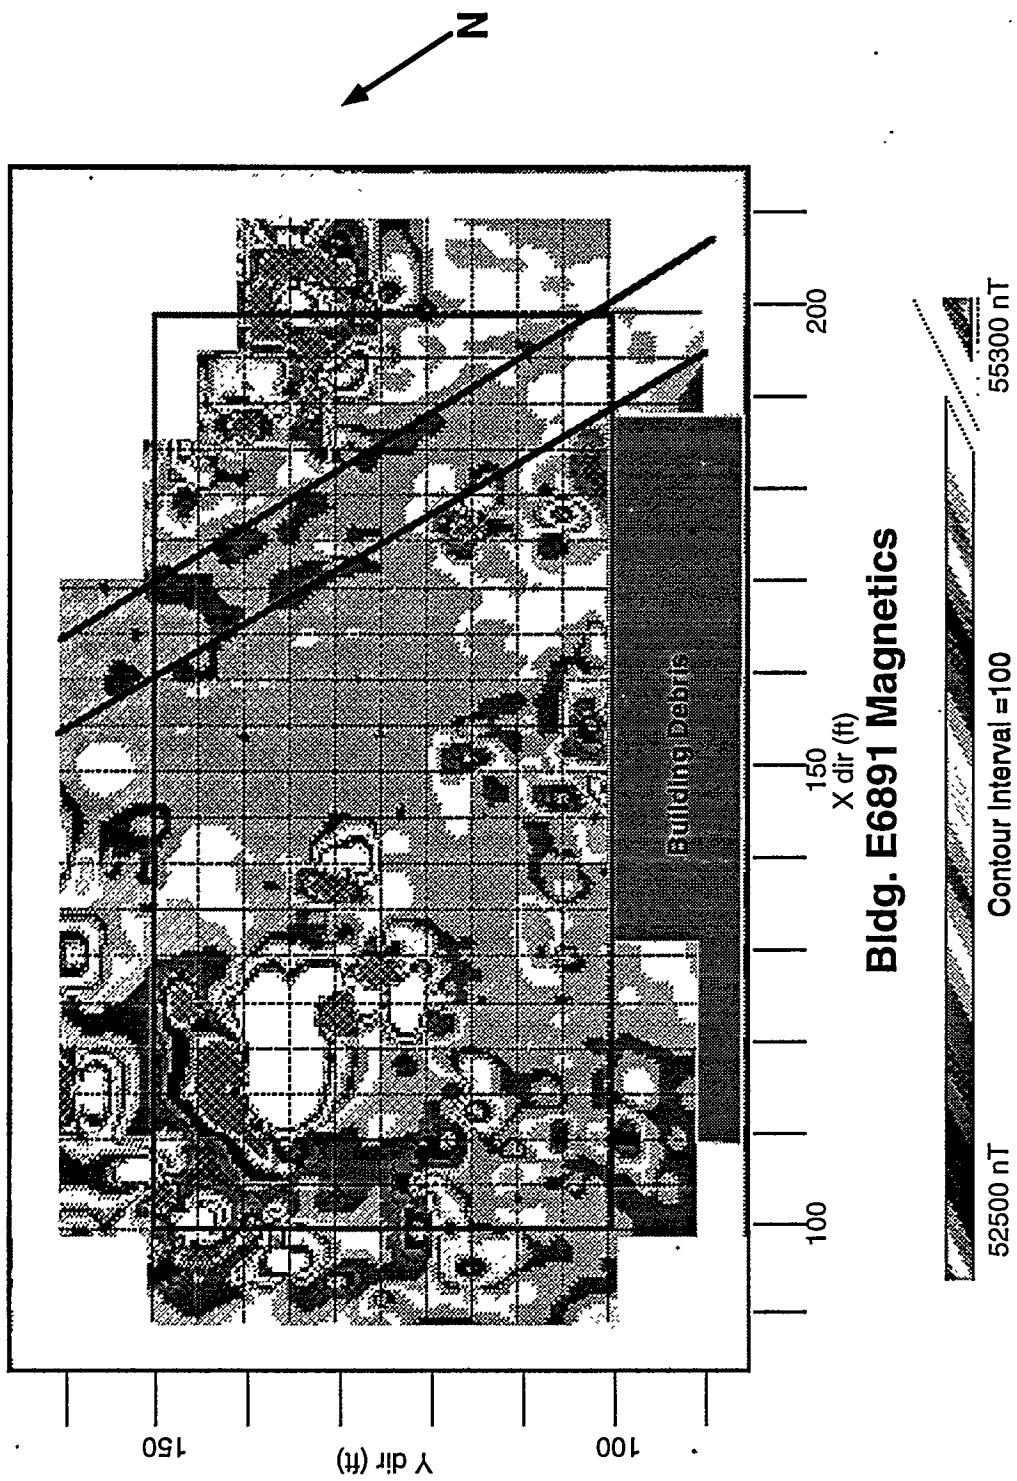
FIGURE 4 Map of Total Magnetic Field Anomalies at Building E6891 Site (measured by using a Geometrics G-822L cesium vapor magnetometer)

The magnetic field measured around Building E6891 is shown in Figure 4 using a 100 nT contour interval. Also shown are the location of sample points, which, due to the density of data collection, appear as solid black lines in the figure. A prominent magnetic high, centered on (120, 135), dominates the observed magnetic field. This anomaly measures about 16' along profile Y=135 and just less than 10' along profiles parallel to the Y axis. However, along profile X=125, the magnetic positive continues as a series of high/low magnetic pairs to about Y=120. This anomaly is sourced by buried metal of significant size. Scattered small diameter high/low magnetic pairs surround the large anomaly on all sides. Small diameter iron-rich debris is probably buried in these areas.

A complex distribution of high and low magnetic anomalies is observed over a large region, northeast of the gravel road. At this location, the ground surface is uneven relative to the southwest side of the gravel road. Iron-rich debris may be buried beneath the area.

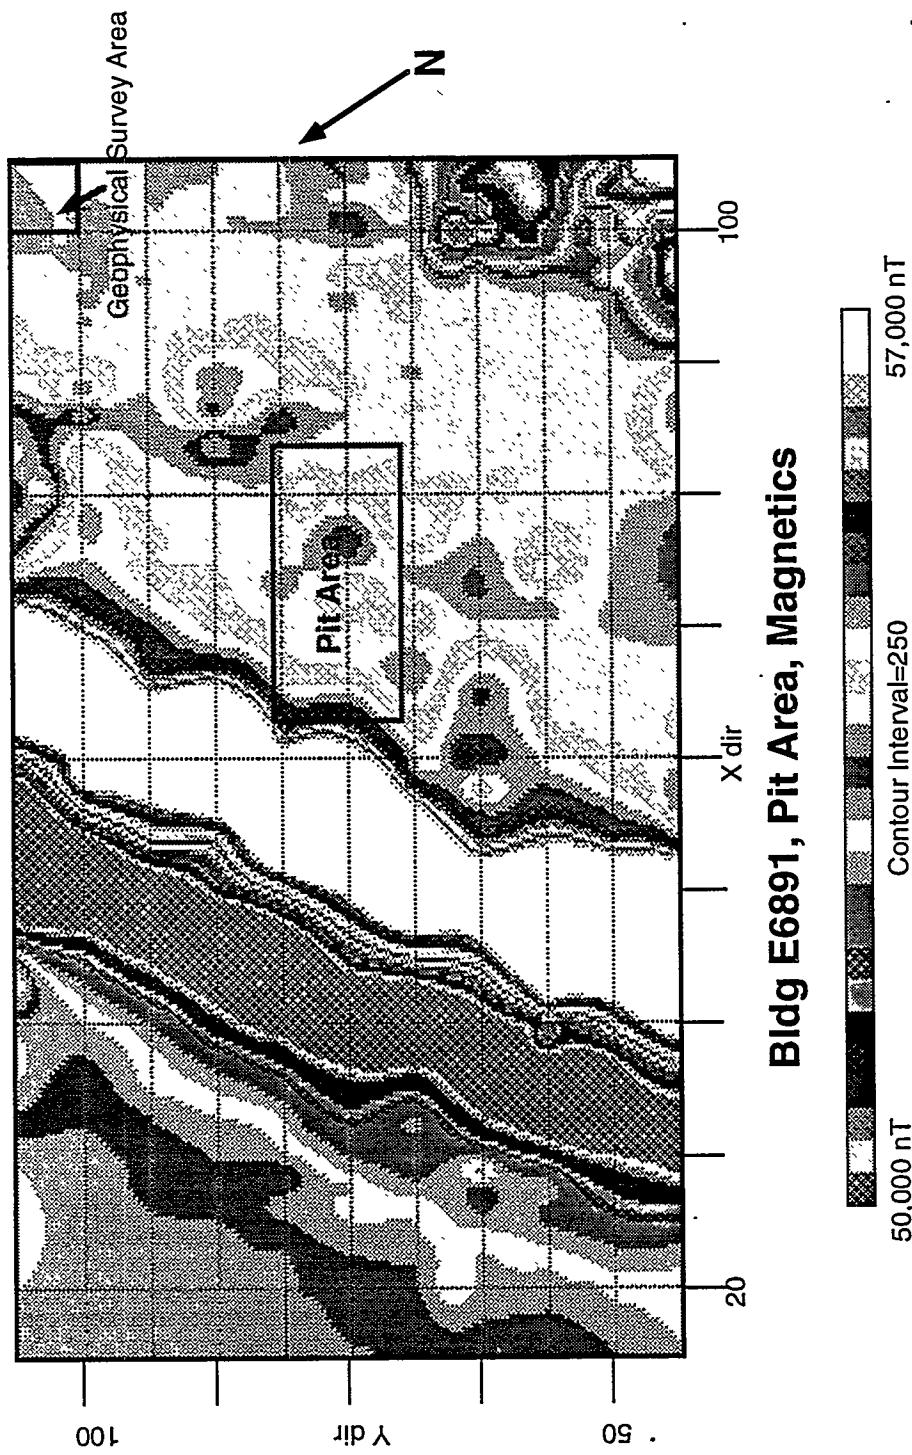
FIGURE 5 Map of Total Magnetic Field Anomalies of the Area Surrounding the "Pits" (measured by using a Geometrics G-822L cesium vapor magnetometer)

The magnetic field map over the surface depressions ("pits") utilizes a 250 nT contour interval (Figure 5). No significant magnetic anomalies are observed over the surface depressions (pit area). However, a major northeasterly trending linear magnetic positive anomaly measuring 10 ft wide and 55 ft long is located west and north of the pit area. The northeastern or

southwestern limits of this feature are unknown. To the northwest, a magnetic low parallels this anomaly. This signature is typical of buried iron-rich material in the northern hemisphere that becomes magnetized in the earth's field. Because of the dipolar nature of the magnetic field, a positive anomaly is produced over the source with a negative companion anomaly offset to the north.

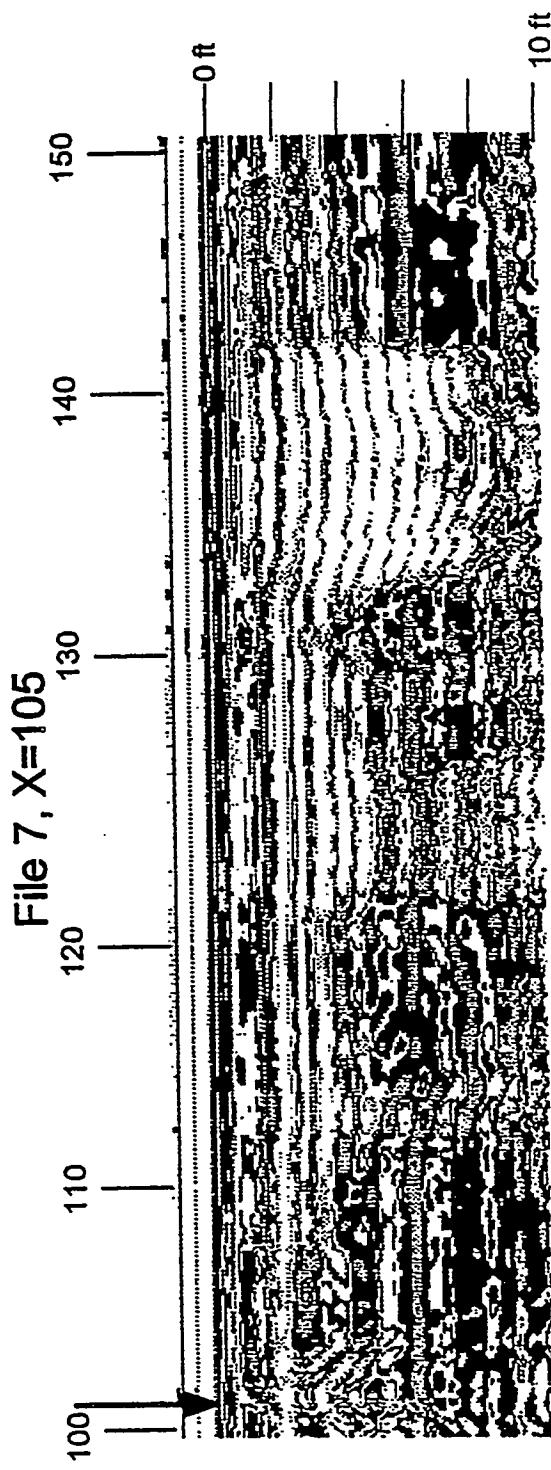
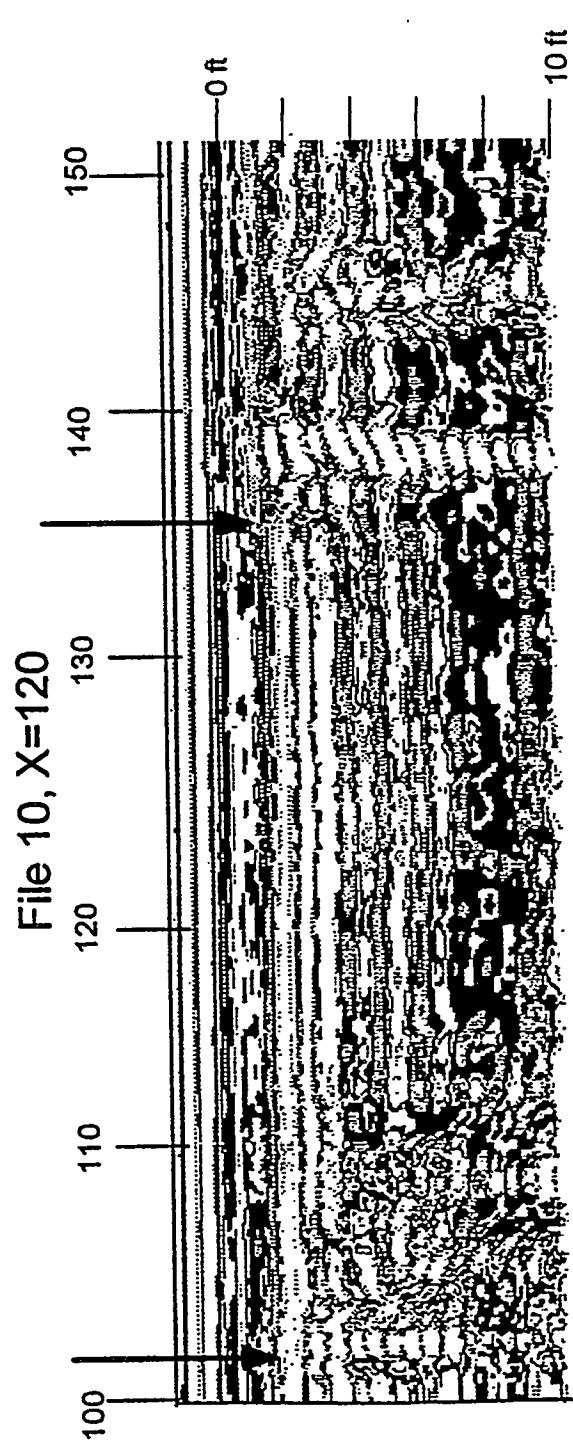
FIGURE 11 Ground Radar Images along Transects Parallel to the Y-Axis near Building E6891 (The maximum penetration depth is estimated at 10 feet.)

Hyperbolic GPR anomalies along profiles between X=105 and X=130 at about Y=103 (Figure 11) are not detected by magnetic or electromagnetic surveys, indicating a non-metallic source. Therefore, this apparent lineation could be caused by a thin buried plastic or clay pipe.

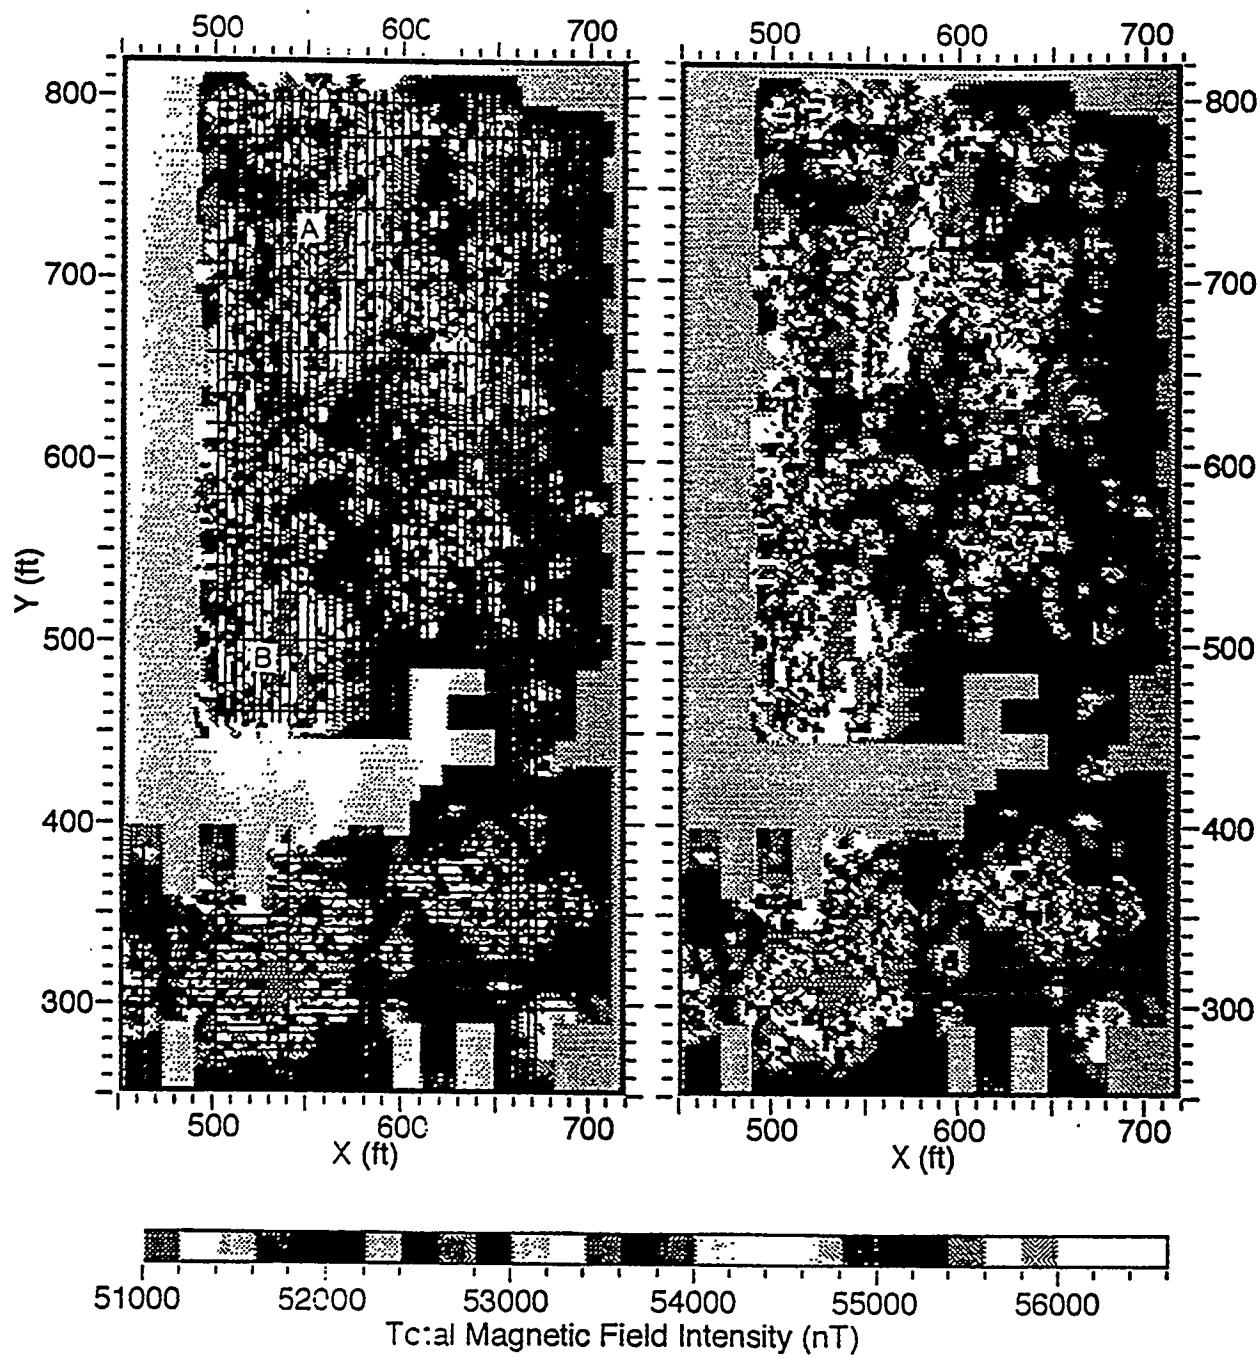
FIGURE 12 Total Magnetic Field Anomaly Map inside the Southeast Dump Site Survey Boundary

The total-intensity magnetic field measured over the survey area is shown in Figure 12. The coarse contour interval between color values (200 nanoteslas) is indicative of the large amount of scattered metallic debris. Many magnetic anomalies are observed throughout the site, some quite strong, that can be directly correlated with observed debris at the surface. Notice the common occurrence of small magnetic anomalies in Figure 12 at locations where surface debris are indicated in Figure 3. A few relatively large anomalies are discussed below. Of these, at least two prominent linear trends are not associated with any surface debris, and are attributed to buried metallic objects.

A strong magnetic anomaly is observed in the southwest corner of the study area centered at grid coordinates (535, 310). The anomaly coincides with a mound of debris with metallic objects scattered throughout the mound. A large cluster of magnetic anomalies is observed centered at grid coordinates (650, 360), and somewhat smaller clusters are observed centered at grid coordinates (630, 660), (620, 560), and in the southwest corner of the study area both west and north of the mound of debris described above. At each location stated above, a relatively large amount of surface metallic debris, including corroded remnants of steel drums and other large items, were observed in the field. The north-to-south trend of small anomalies along $X=670$ are caused by fence posts.

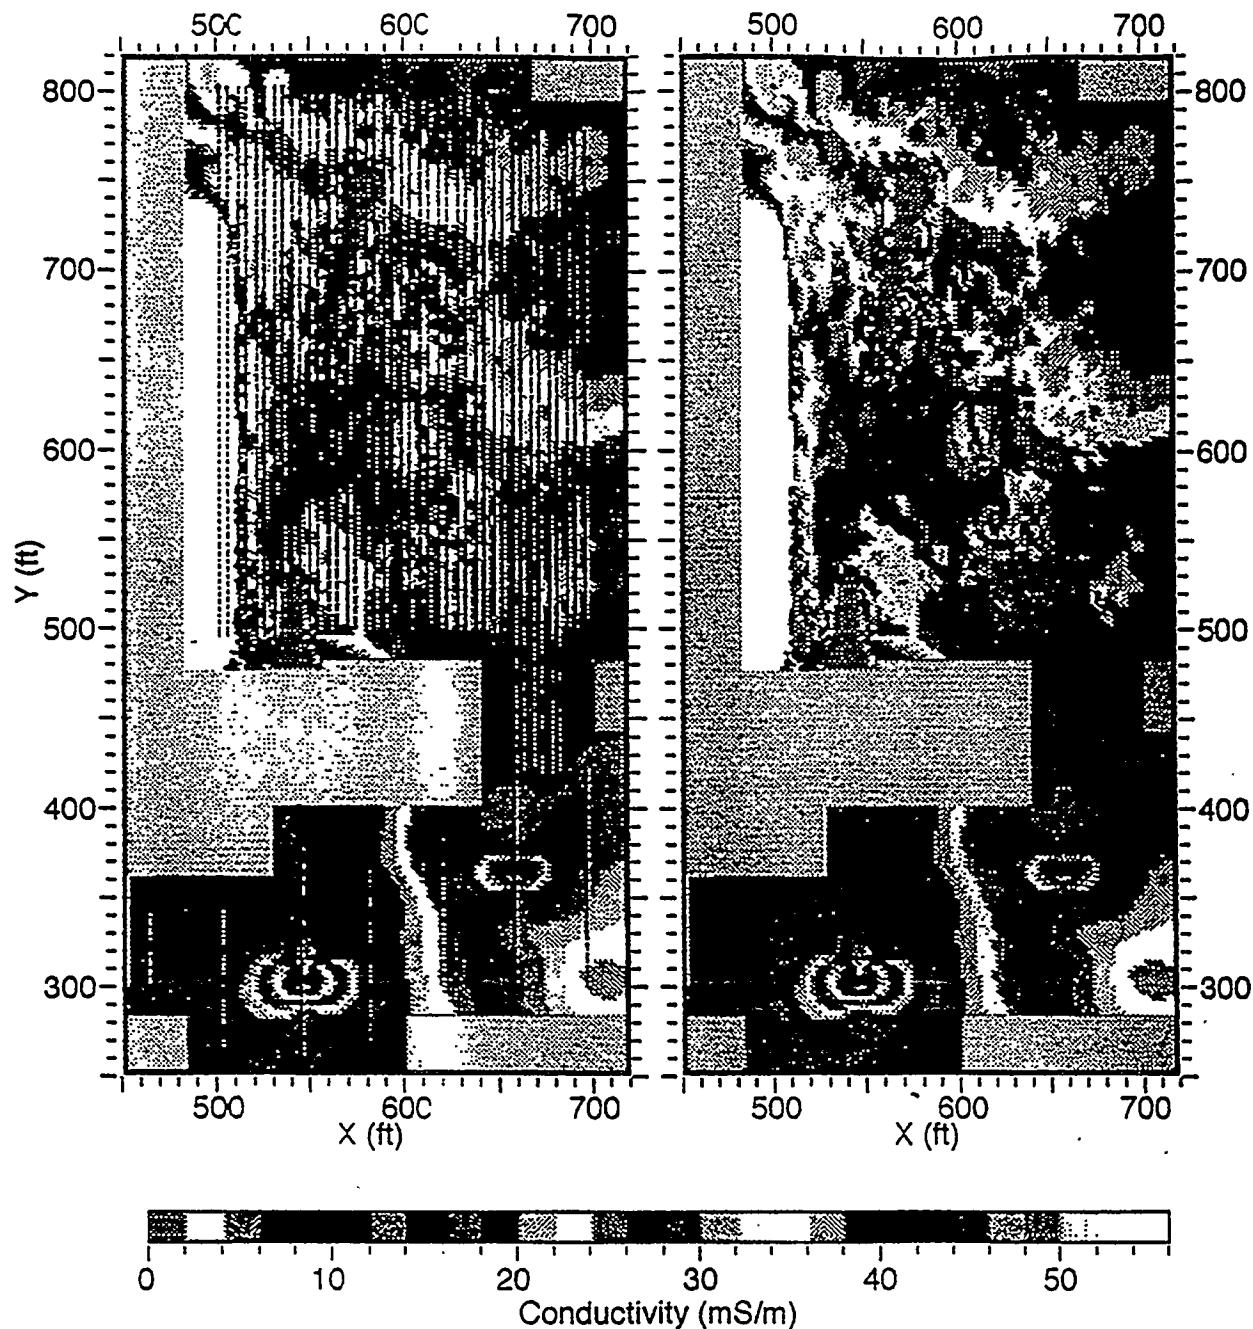
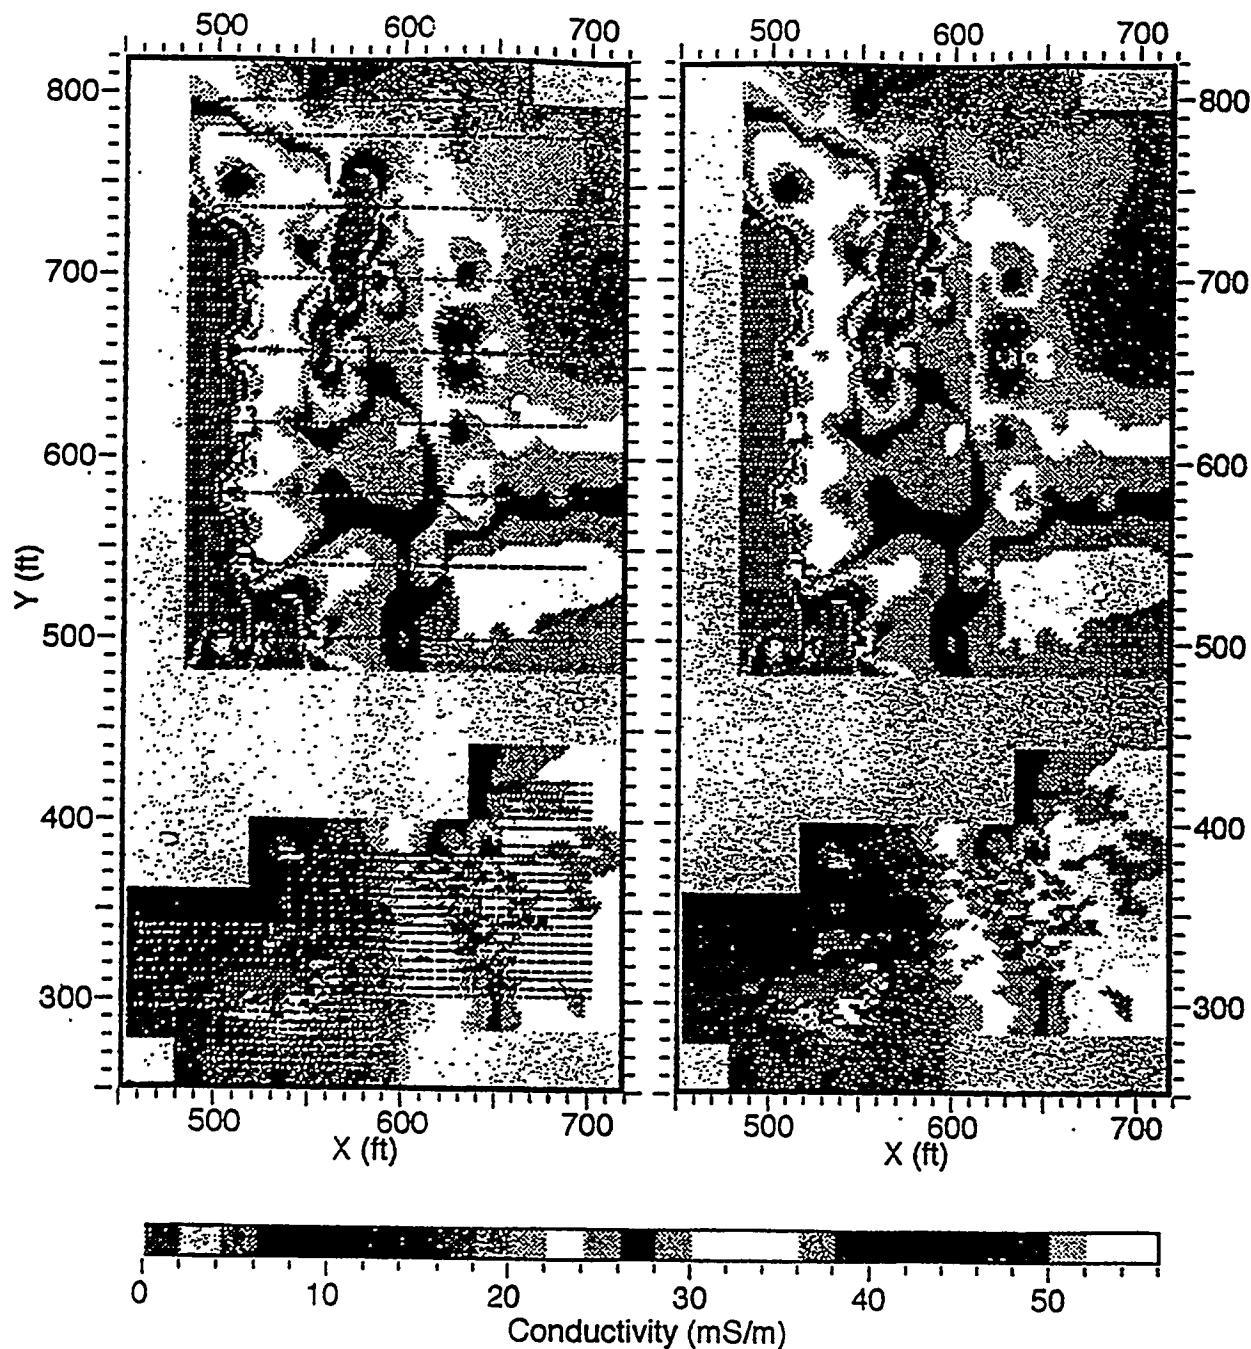
Strong conductivity anomalies observed in both Figures 13 and 14 correlate with prominent magnetic anomalies discussed in the previous section and shown in Figure 12. The strong linear trend along $Y=500$ is caused by steel within the cement slab. The anomaly centered at (530, 310) coincides with the mound of metallic debris described earlier. Likewise, smaller

The two well-defined, linear conductivity anomalies labeled A and B on both Figures 13 and 14 are coincident to the magnetic anomalies with the same labels in Figure 12. As noted in the previous section for the magnetic anomalies, the conductivity anomalies are not associated with any significant accumulations of surface debris, but are attributed to buried metallic objects.

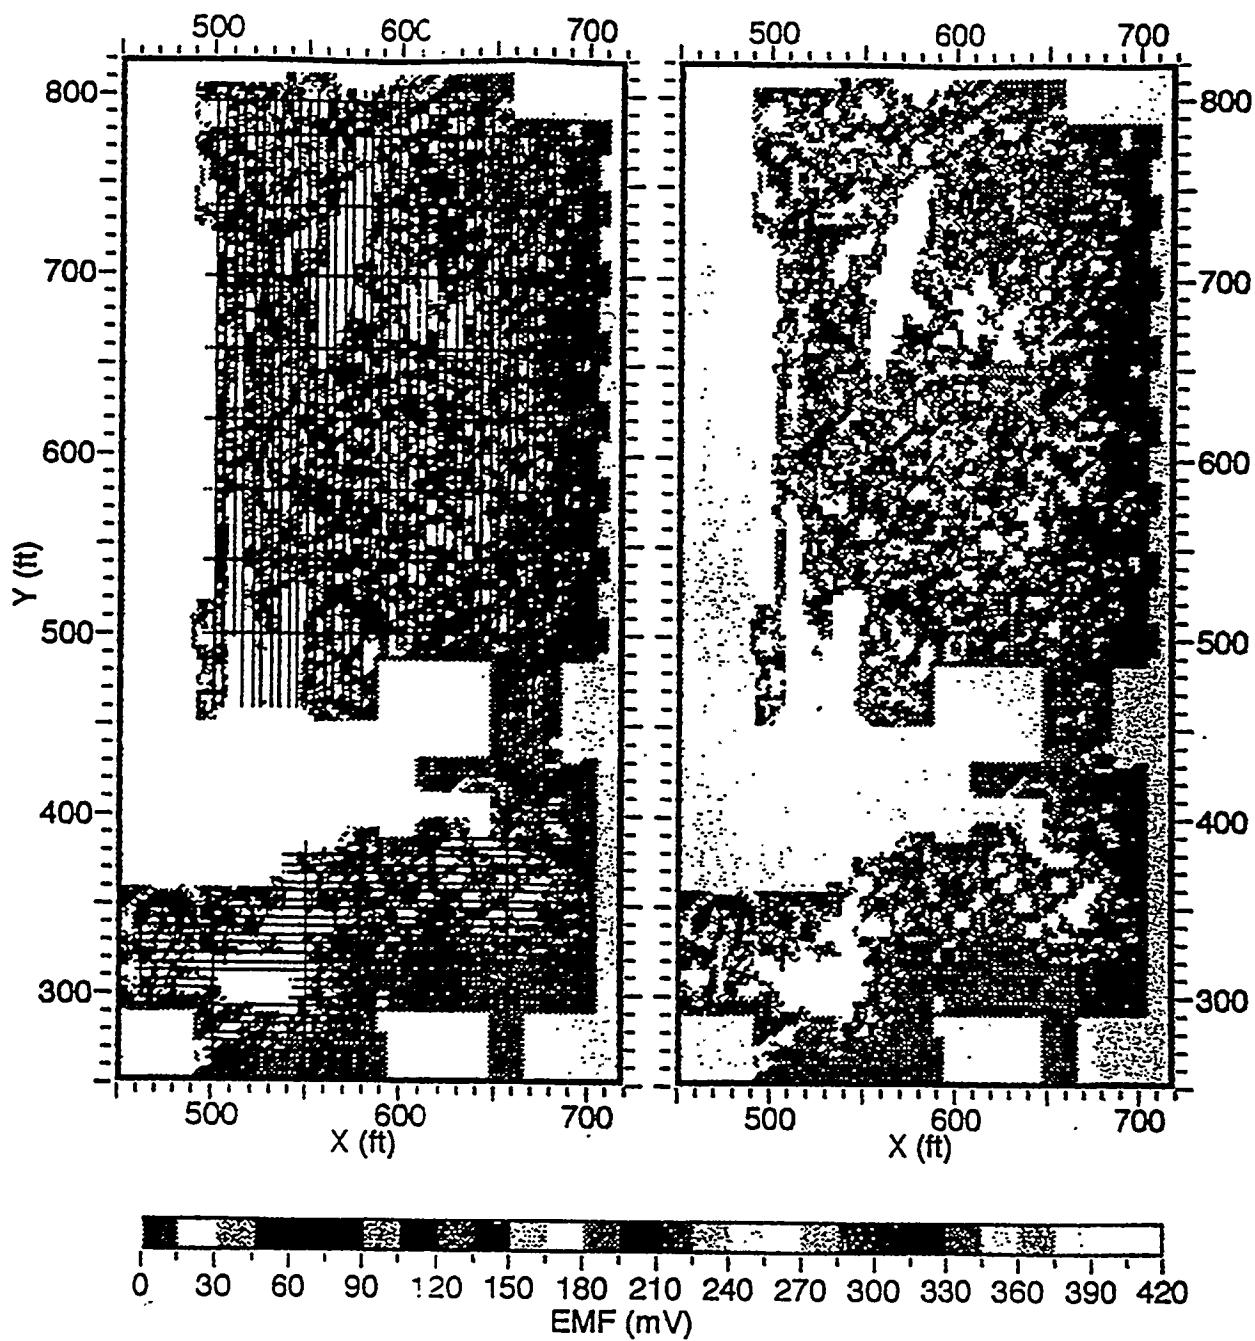
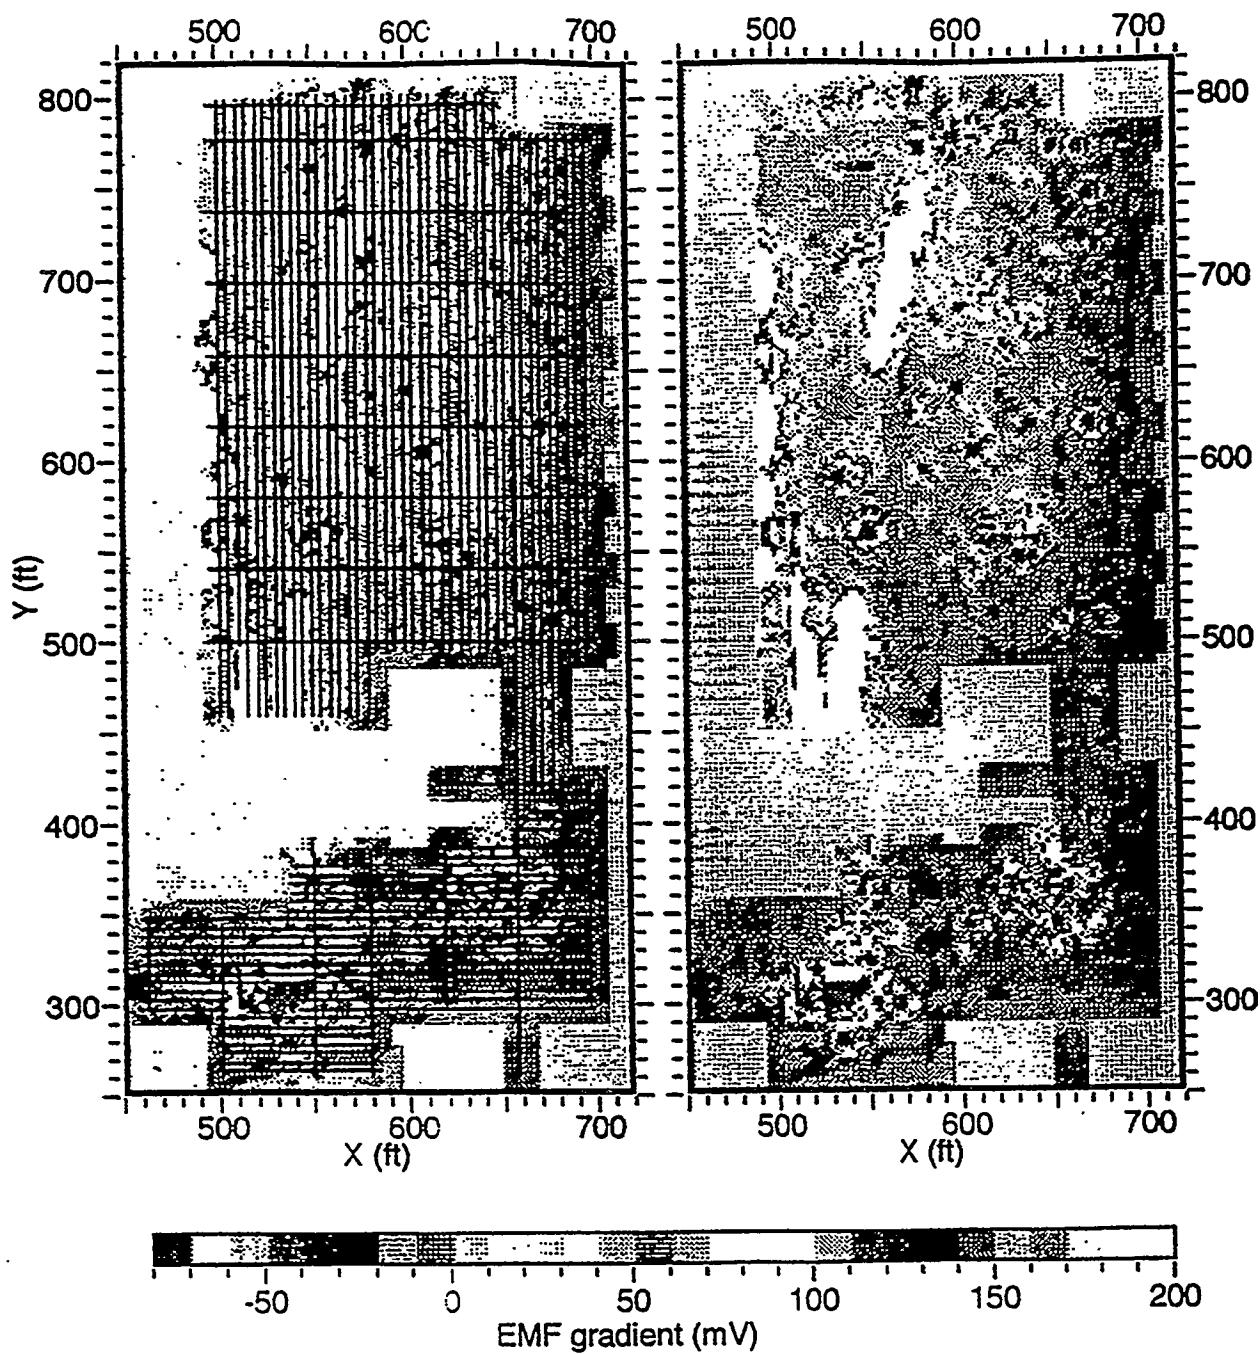
The time-domain electrical-induction measurements using the lower-coil data from the EM-61 conductivity meter are shown in Figure 15. Difference measurements between lower and upper coils are shown in Figure 16. Strong EMF anomalies in Figure 15 and EMF difference anomalies in Figure 16 correlate both with prominent magnetic and conductivity anomalies discussed in the previous two sections (Figures 12-15). The background data in Figure 16 are relatively less sensitive to scattered surface debris, thereby allowing the relatively large anomalies to be observed more readily. Otherwise, the anomalies observed in both figures are similar and in the same locations. Once again, the strong linear trend along $Y=500$ (in both Figures 15 and 16) is caused by steel within the cement slab. The EMF anomaly centered at (530, 310) coincides with the previously described mound of metallic debris. The anomaly centered at (650, 365) coincides with observed surface metallic debris and with both magnetic and conductivity anomalies. The north-to-south trend of small anomalies along $X=670$ are caused by fence posts.

The two well-defined, linear EMF anomalies labeled A and B on both Figures 15 and 16 are coincident to the magnetic and conductivity anomalies with the same labels in Figure 12-15. As noted in the sections for magnetic and conductivity anomalies, the EMF anomalies are not associated with any significant accumulations of surface debris, but are attributed to buried metallic objects.

A color-contour map constructed from EM-61 lower coil data, which responds to all signal from the surface to approximately nine feet, is shown in Figure 15. EM-61 highs correspond with EM-31 and magnetic highs described previously. Figure 16 shows the EM-61 vertical gradient (which essentially filters out the response from surface debris). Again, the EM-61 vertical gradient map corresponds very closely with the EM-31 and magnetic maps with respect to the suspected trenches.
