**Contamination Source Review for Building E3236,
Edgewood Area, Aberdeen Proving Ground, Maryland**

ANL/ESD/TM-104

S.D. Zellmer, M.P. Smits, A.K. Draugelis, M.A. Glennon, J. Rueda, and R.E. Zimmerman

September 1995

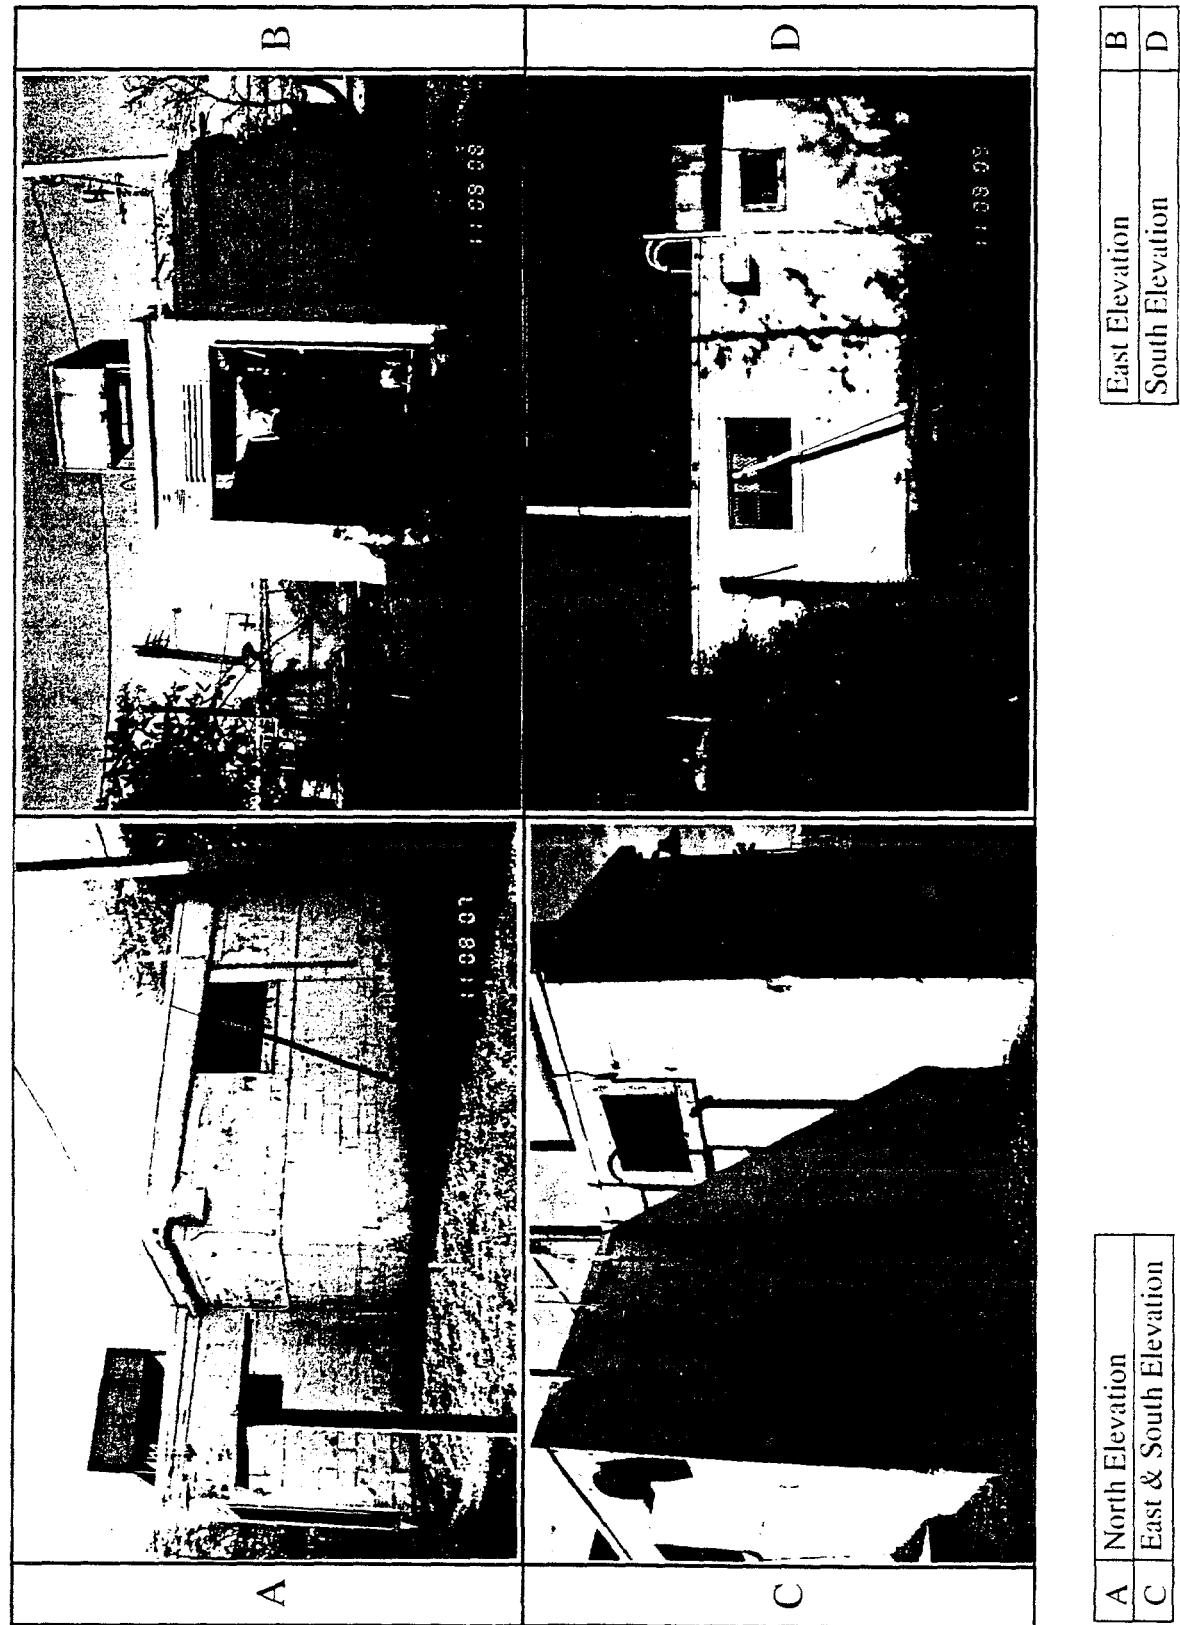
FIGURE 4 Photographs of Building E3236 Exterior — North, East, and South Elevations

An air conditioning condenser is mounted near the north end of the roof (room 1). A metal access ladder is attached to the east exterior wall of room 2 (Figure 4B). Ventilation duct work was observed on the roof of the wooden addition (room 3), at the west end of the building (Figure 5C). A metal vent is located near the south end of the roof of the semi-trailer truck addition (room 4) (Figure 5A), and metal ventilation ducts are located in the upper northeast and upper southeast corners of the original building (room 2).

A small-diameter pipe enters the north wall from the ground about 8 ft from the northeast corner of the building (Figure 4A). A pipe covered with suspected asbestos-containing insulation extends just below the roof line along the north and east exterior walls of the building (Figure 4A). Vent pipes exit the north and east walls and extend above the roof (Figures 4A and 4B). Electrical conduit is also attached to the north and east exterior walls. A pipe exits through the window in the south wall and extends to a concrete platform adjacent to the south wall of the building; a second pipe on the south wall extends downward (Figure 4D). Another pipe covered with suspected asbestos-containing insulation extends down the west wall of the building (Figure 5A).

The north side of the building is in good condition but shows signs of weathering.

The east elevation of the building is in good condition but shows signs of weathering. The semi-trailer truck addition is rusted.

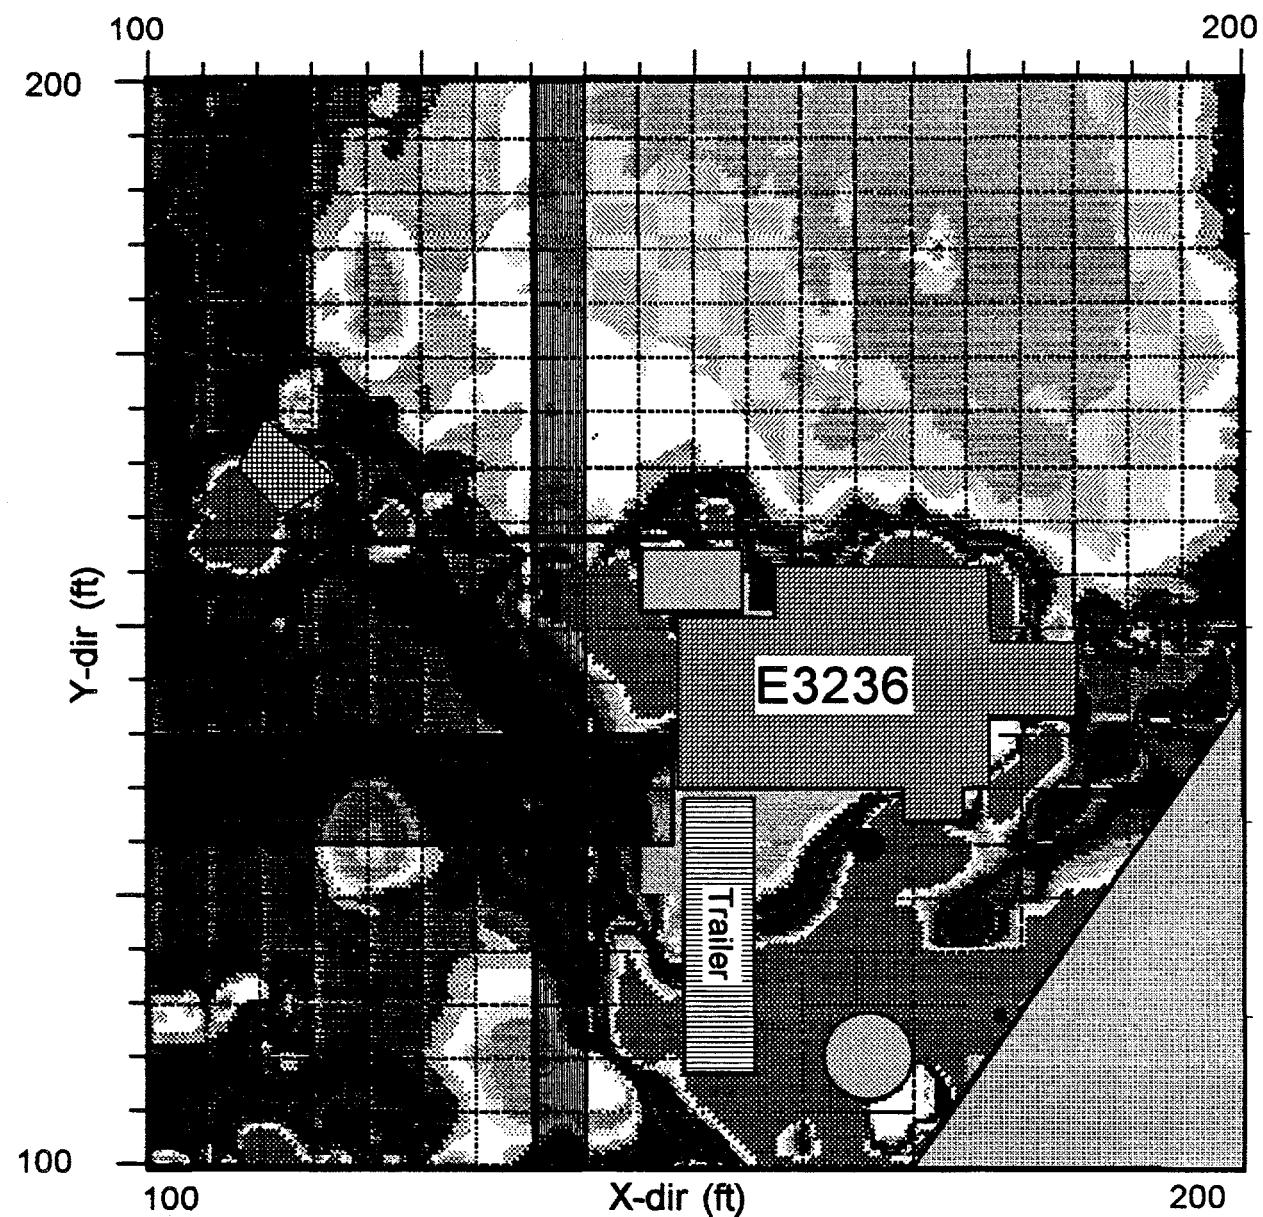
Building E3236: Magnetics (nT)

A color-contour representation of the total magnetic field measured around Building E3236 is shown in Figure 4. Also shown are appurtenances associated with activity around the building and the location of the magnetometer profiles, which were run in both X and Y directions. Dominating the figure are magnetic lows associated with interference effects from the metal fence, the building, footings for the overhead pipe works, and a small fenced area (Figure 2). Combined, these anomalies form a NW-SE trending low that exits the survey area south of the NW corner.

The low magnetic anomalies located along the southern boundary may also be due to interference effects of a metal fence (Figure 2). On the other hand, isolated magnetic highs with centers at (120, 200) and (120, 130), and a more complex magnetic anomaly centered at (107, 115) have EM-61 counterparts and are probably sourced by a buried utility line. The source of the small-diameter magnetic anomaly centered on (114, 170) is unknown.

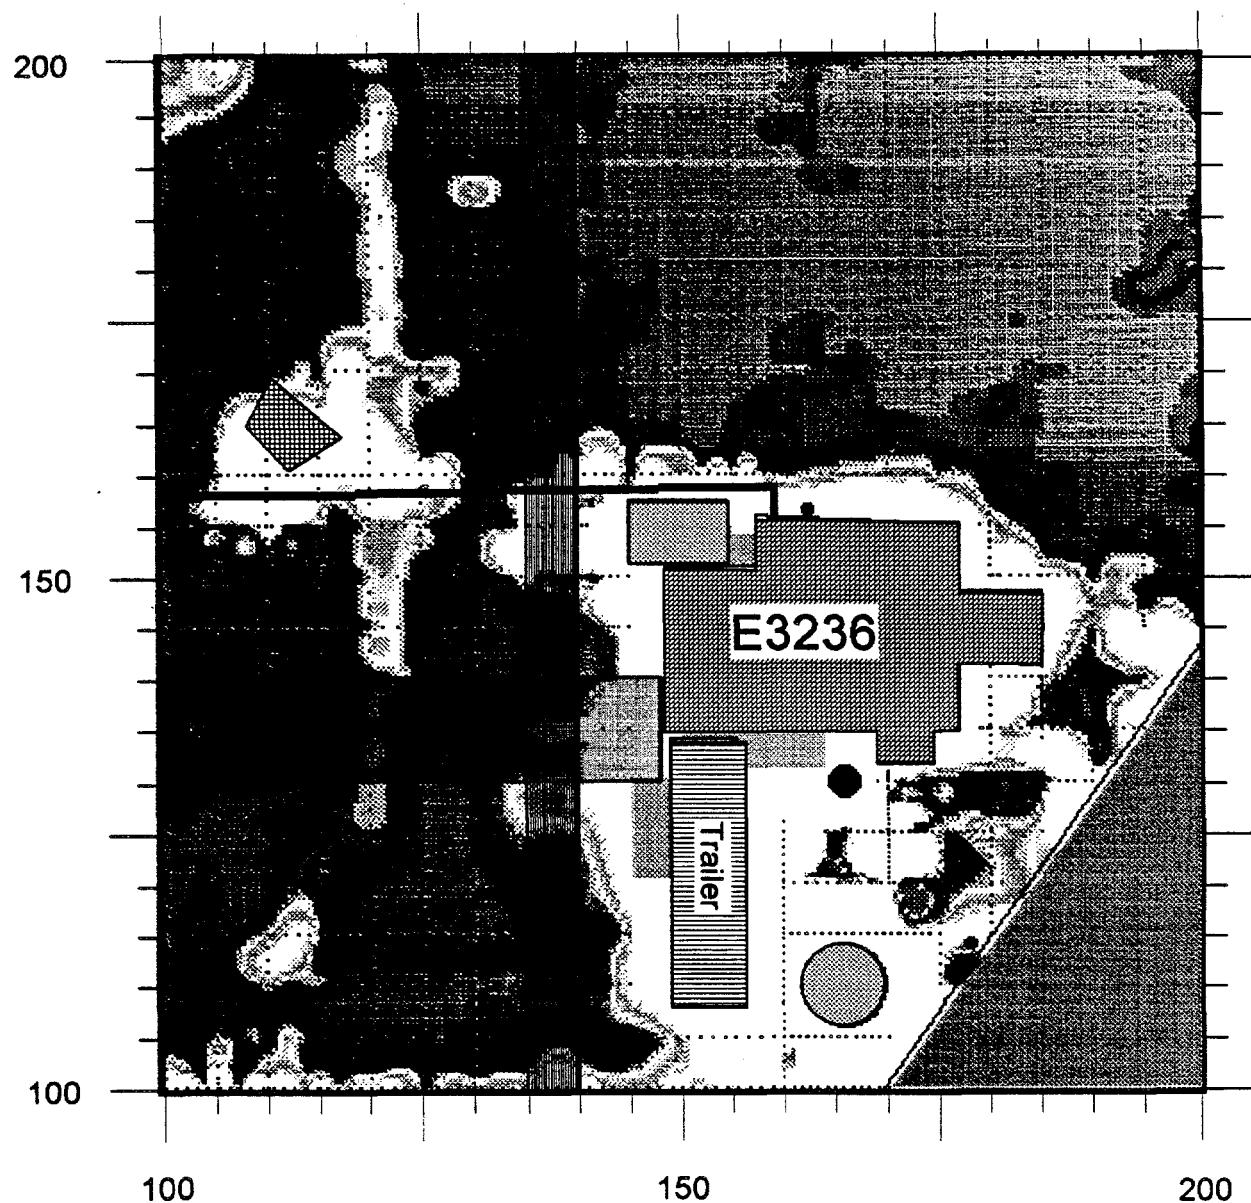
Building E3236: EM-61 Lower Coil

A prominent north-south trending EMF positive anomaly is observed along $X=120$. At about $Y=125$, this anomaly trends more westerly and appears to exit the survey area near the southwest corner. Isolated magnetic and GPR anomalies are also detected within this lineation, which may be sourced by a buried utility or water main.

Small diameter EMF positive anomalies are centered at (100, 200), (130, 187) and (100, 135). The sources of these anomalies are unknown.

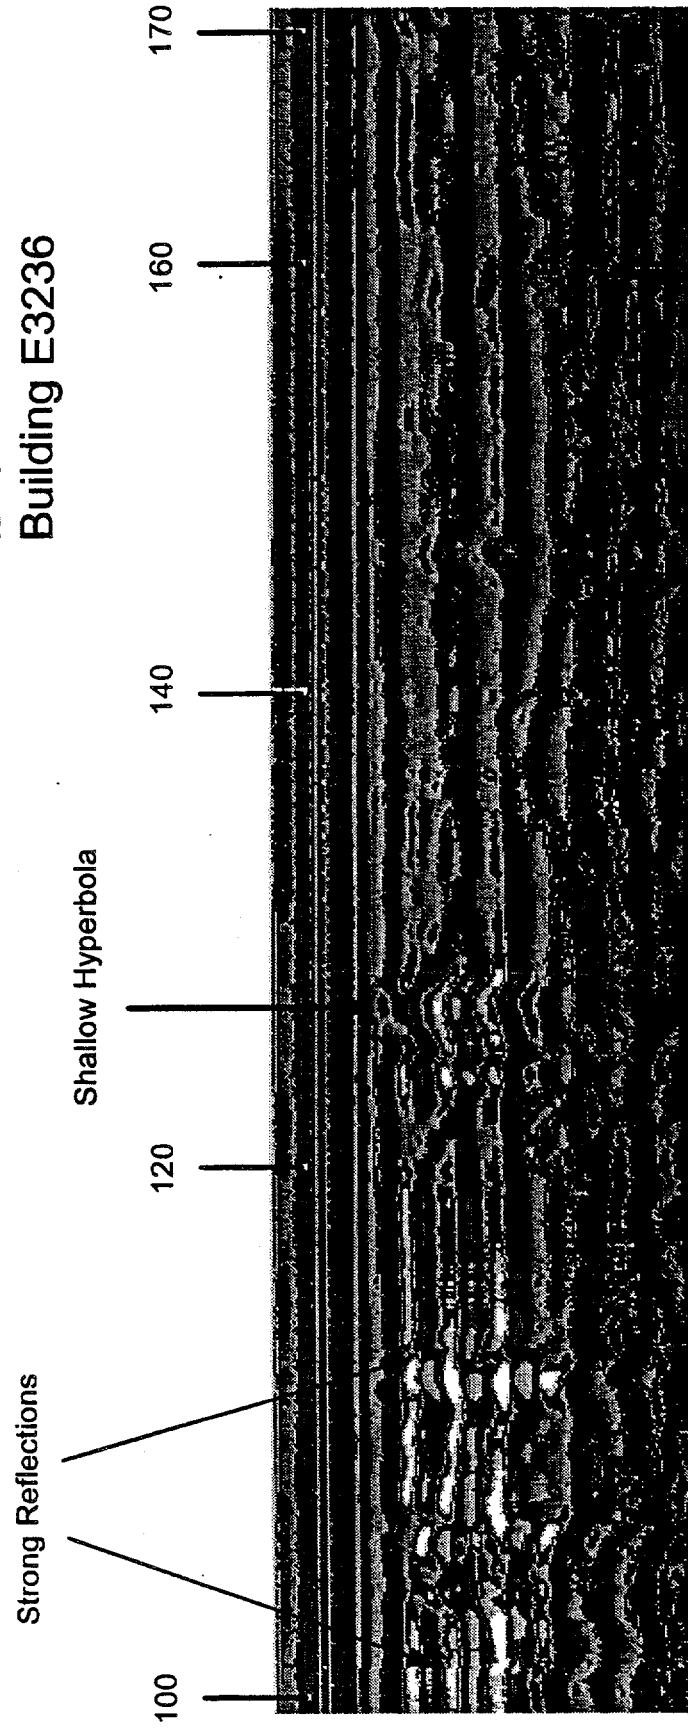
FIGURE 6 Ground Penetrating Radar Profile along Y=100

Good penetration was observed over most of the site. Isolated hyperbolas are detected along transects parallel to the Y axis at X=120-125, near the observed linear EMF positive anomaly (Figure 6). In addition, strong reflections and shallow hyperbolas are observed along profiles Y=100 and Y=105 between X=100 and 120. Subsurface disturbances caused by the nearby fence may explain these anomalies. However, the shallow hyperbola located at about X=127 has a different and unknown source.

Isolated GPR anomalies are detected at (160, 105) and (170, 105) but do not correlate with anomalies detected by other geophysical techniques. The sources of these anomalies are unknown.

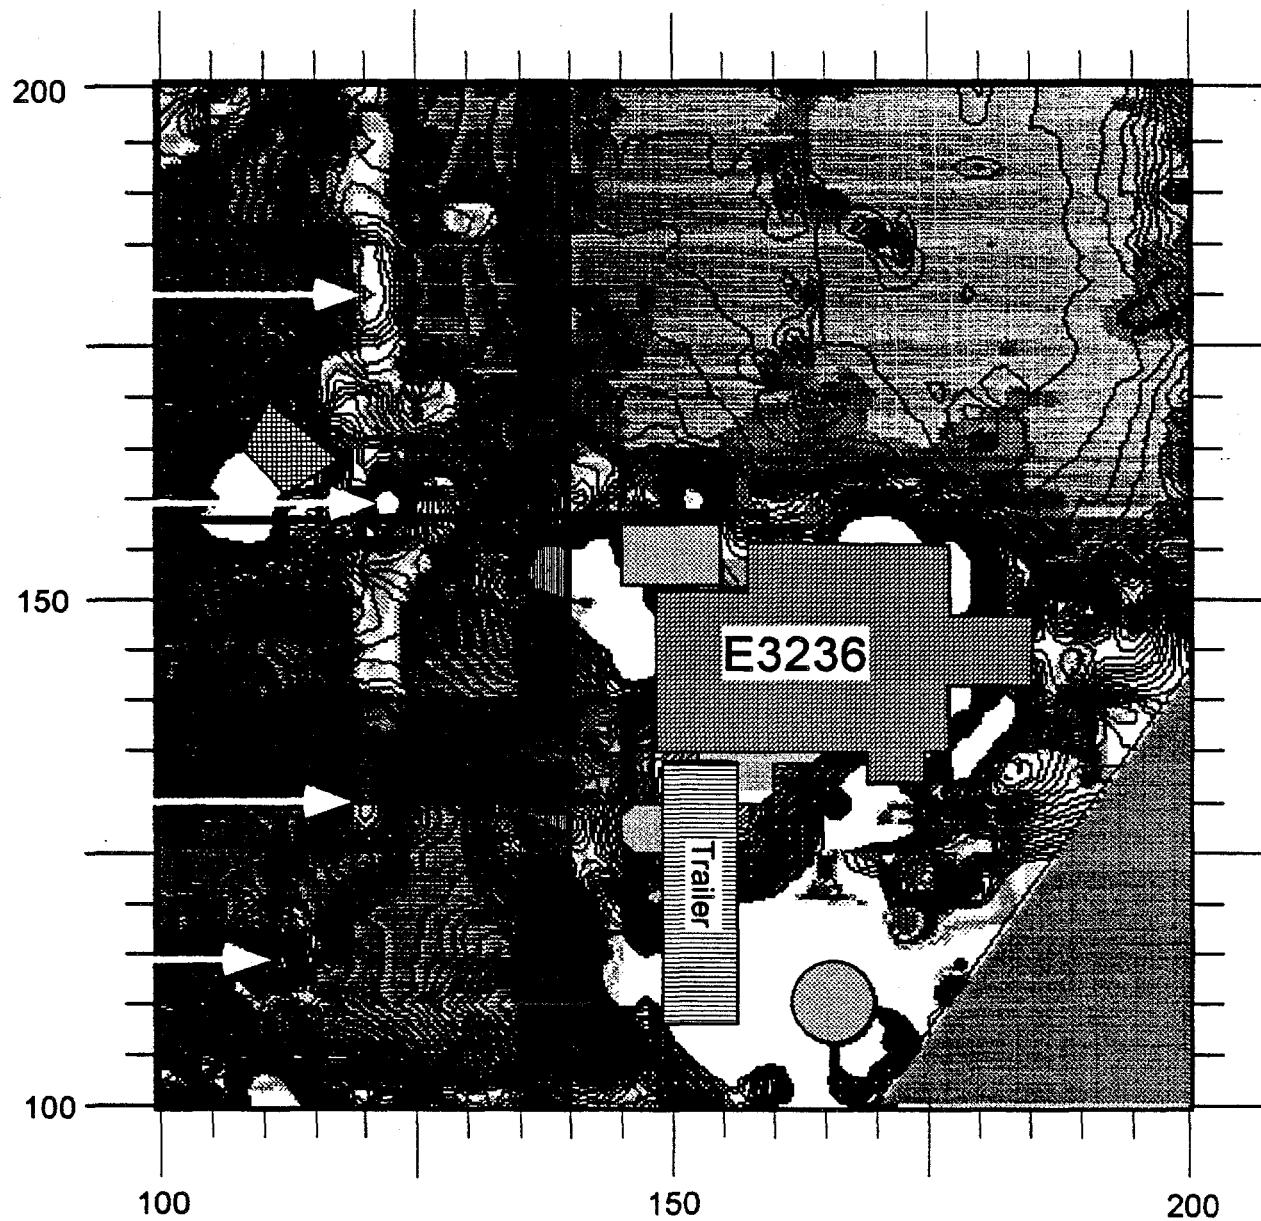
Building E3236: EM-61 Lower Coil w/Magnetics Overlay

Table 1 summarizes the locations of the observed geophysical anomalies around Building E3236, as well as their probable cause. Isolated magnetic anomalies are observed along the narrow north-south EMF positive anomaly (Figure 7) which are probably caused by joints/connections in an underlying utility line. Hyperbolic GPR anomalies are detected at shallow depths on at least seven EW transects near X=120.

- A linear EMF anomaly is observed between (120, 115) and (120, 200), which is probably sourced by a buried metal pipe or utility. Magnetic anomalies are observed along this linear feature. In addition, isolated GPR hyperbolas detected along this lineation suggest that this feature is shallowly buried.
- GPR anomalies are detected along two transects near the southern-most metal fence which suggest an anthropogenic source. Magnetic and EMF anomalies are also detected in this area, however, interference from the fence prevents interpretation with certainty.
- Magnetic and EMF anomalies are observed near the building, the overhead pipes and metal fences.
- Isolated magnetic, EMF and GPR anomalies are detected in the area; however, they are not spatially associated. The sources of these anomalies are unknown.
