# **Landslide Remediation on Ohio State Route 83 Using Clean Coal Combustion By-Products**

University of Kentucky Ash Utilization Conference

Renee Payette, *District 5, Ohio Department of Transportation, Jacksontown, Ohio*; Xi You Chen, William Wolfe, *The Ohio State University, OH*; Joel Beeghly, *Dravo Lime Co., PA*

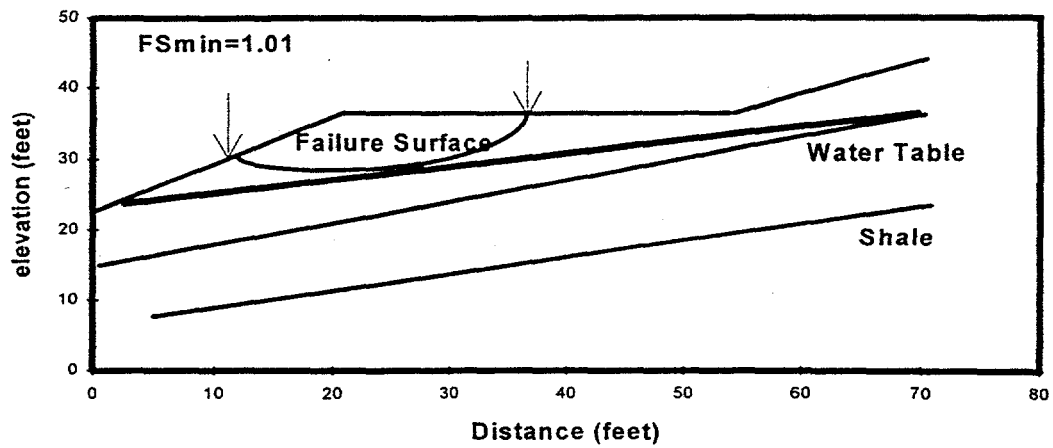
Figure 2 Failure surface in soil only

Stability analyses of the three different reconstruction configurations were performed using the slope stability program PCSTABL (Lovell, 1988). The locations of structural features as determined in the borings and verified during the construction were included in the computer models of the three sections. Figure 2 shows the critical surface and calculated factor of safety for the soil only sections. The presence of the FGD key has forced the potential failure surface away from the hillside with the result that the most likely failure is fairly shallow but still is one with a low safety factor that may involve the highway. Figure 3 shows the analysis conducted on the FGD-soil repair. The strength properties used were measured on laboratory prepared FGD-soil samples. Note that for this case the critical failure surface would pass through the FGD-soil mix but the lowest factor of safety is 1.9 indicating a very low probability of failure. Figure 4 presents the

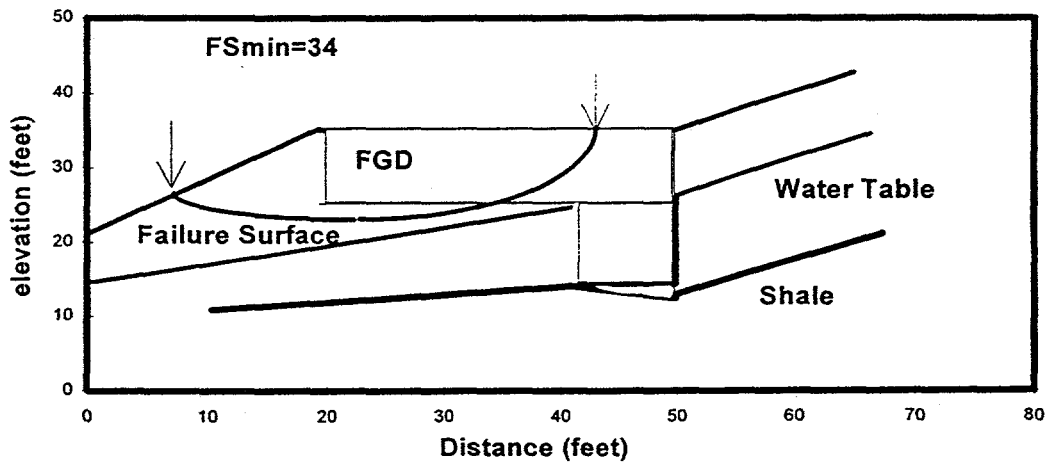
Figure 4 Failure surface in FGD

results of the stability computations for the FGD only section. As in the case of the FGD-soil mixture, the critical failure surface passes through the FGD. Also, as was found with the mixture, the minimum Factor of Safety is very high, in this case in excess of 33. It is clear that the use of FGD or FGD modified soil can significantly improve the safety and stability of hillside construction of the type found on Ohio SR 83.
