**Contamination Source Review for Building E5485,
Edgewood Area, Aberdeen Proving Ground, Maryland**

Energy Systems Division
Argonne National Laboratory

September 1995

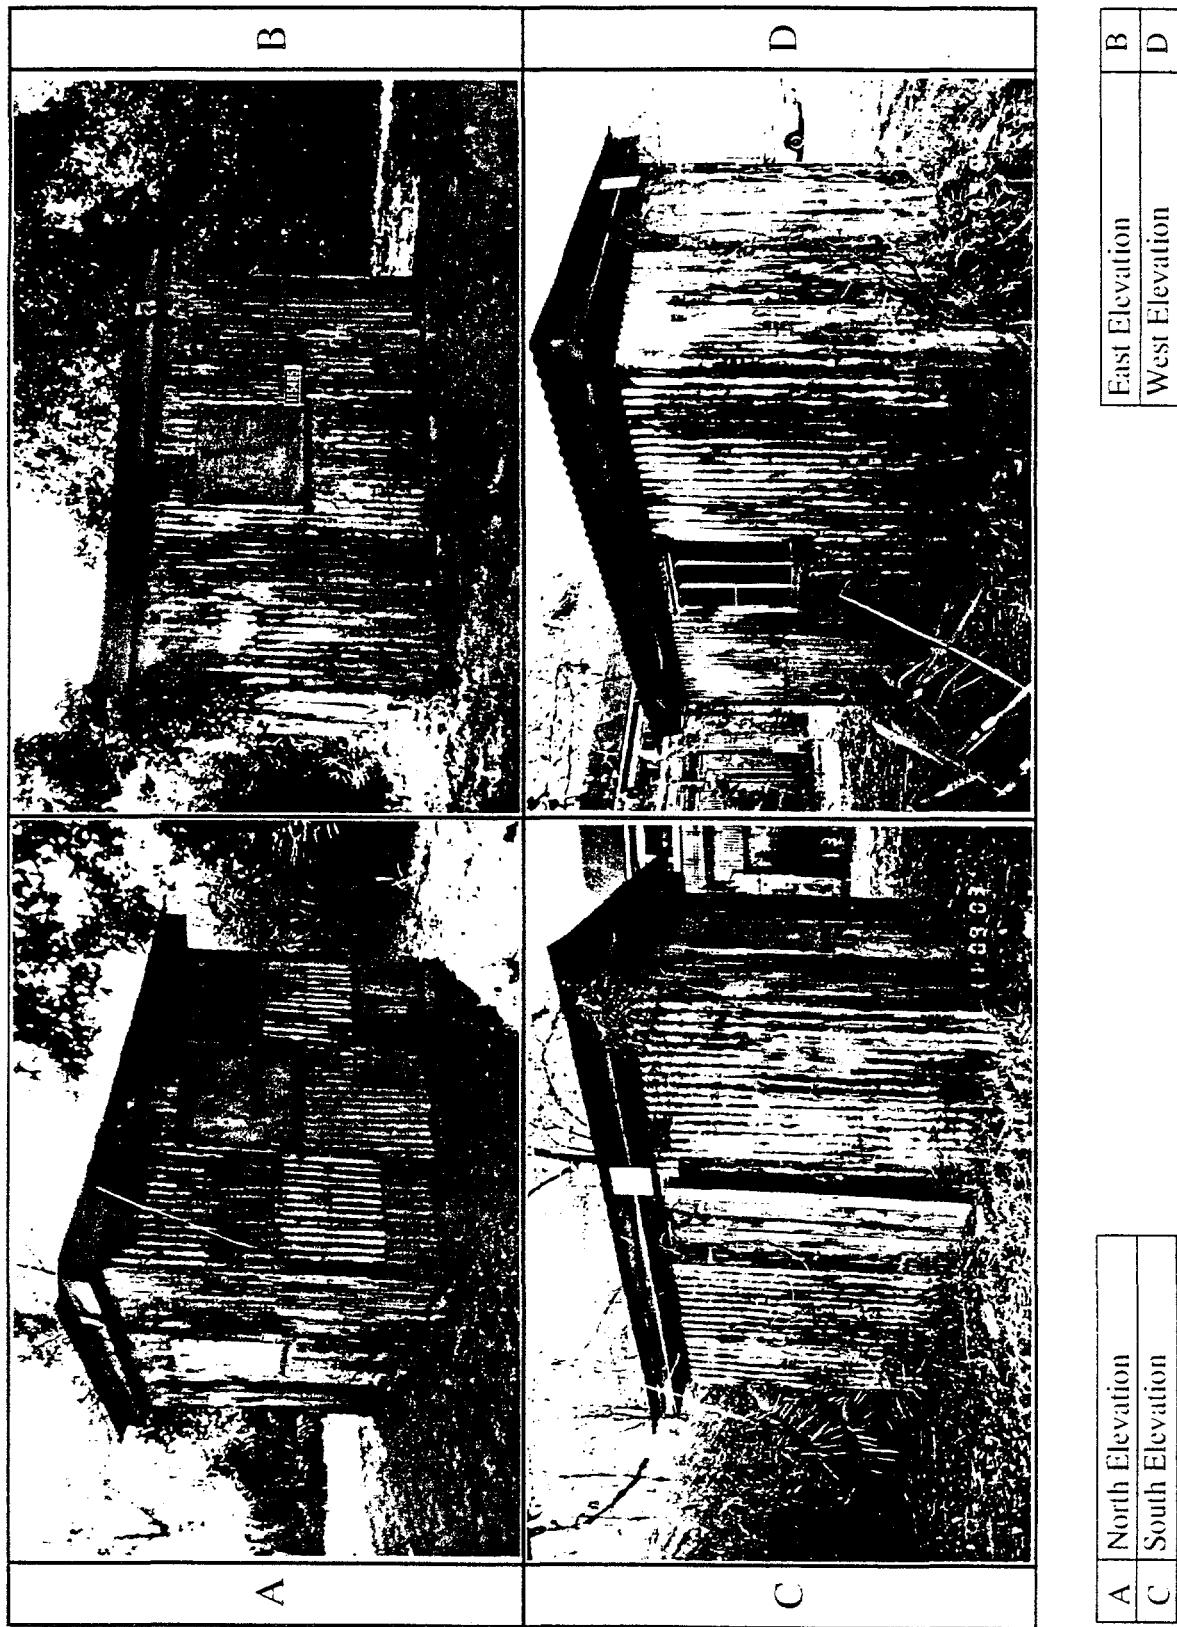
The vegetation surrounding Building E5485 consists of cut grass and an uncut mixture of forbs, vines, and grasses. There are several trees growing along the south and west sides of the building (Figure 4).

Because of a lack of building maintenance, the corrugated sheet metal walls are rusting; areas have been patched with corrugated sheet metal (Figure 4).

Because of a lack of building maintenance, the east exterior wall is rusting.

The vegetation surrounding Building E5485 consists of cut grass and an uncut mixture of forbs, vines, and grasses. There are several trees growing along the south side of the building (Figure 4).

Because of a lack of building maintenance, the corrugated sheet metal walls are rusting.

The vegetation surrounding Building E5485 consists of cut grass and an uncut mixture of forbs, vines, and grasses. There are several trees growing along the west side of the building (Figure 4).

Because of a lack of building maintenance, the corrugated metal walls are rusting; some areas have been patched with corrugated sheet metal (Figure 4).

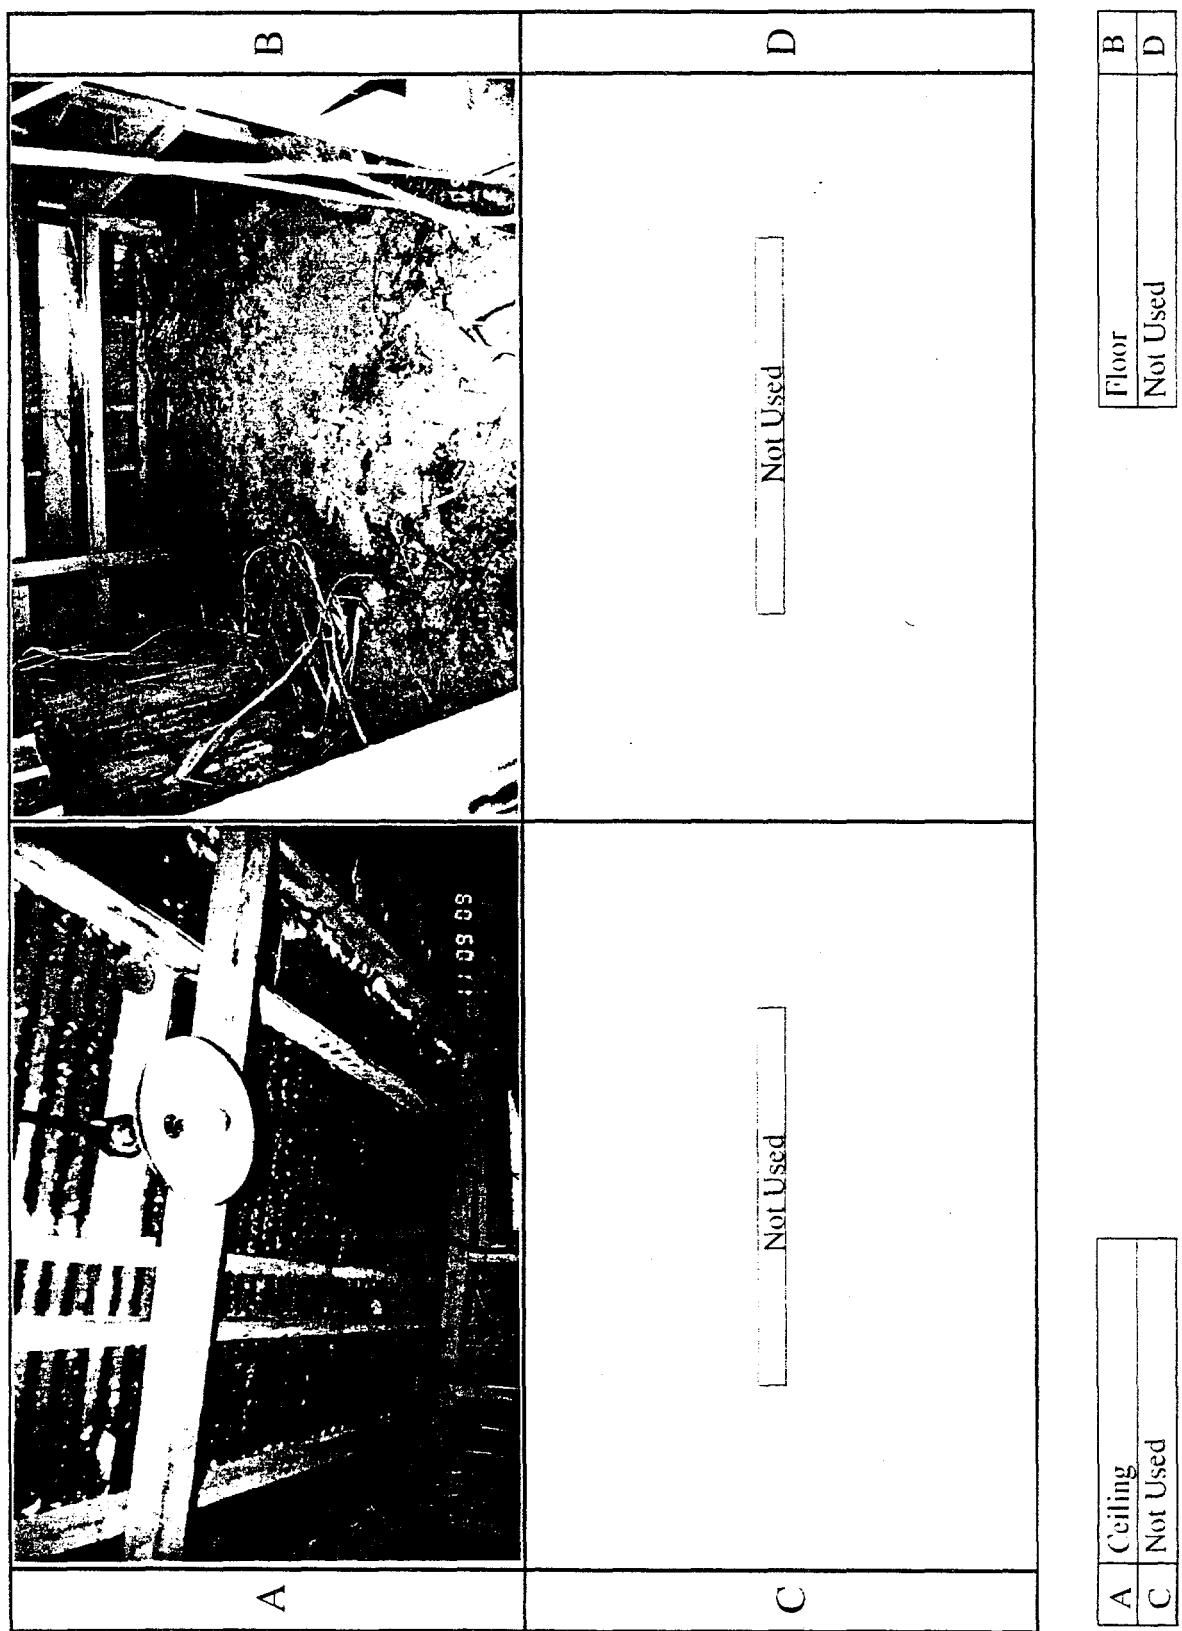
FIGURE 6 Photographs of Building E5485 Interior — Ceiling and Floor

The floor consists of a concrete slab (Figure 6).

The concrete slab is in good condition, with no noticeable cracks.

The ceiling is corrugated sheet metal on a wooden frame. A single light bulb fixture hangs from the center of the ceiling; electrical wire extends the length of the room.

The floor is a concrete slab that is in good condition, with no noticeable cracks.

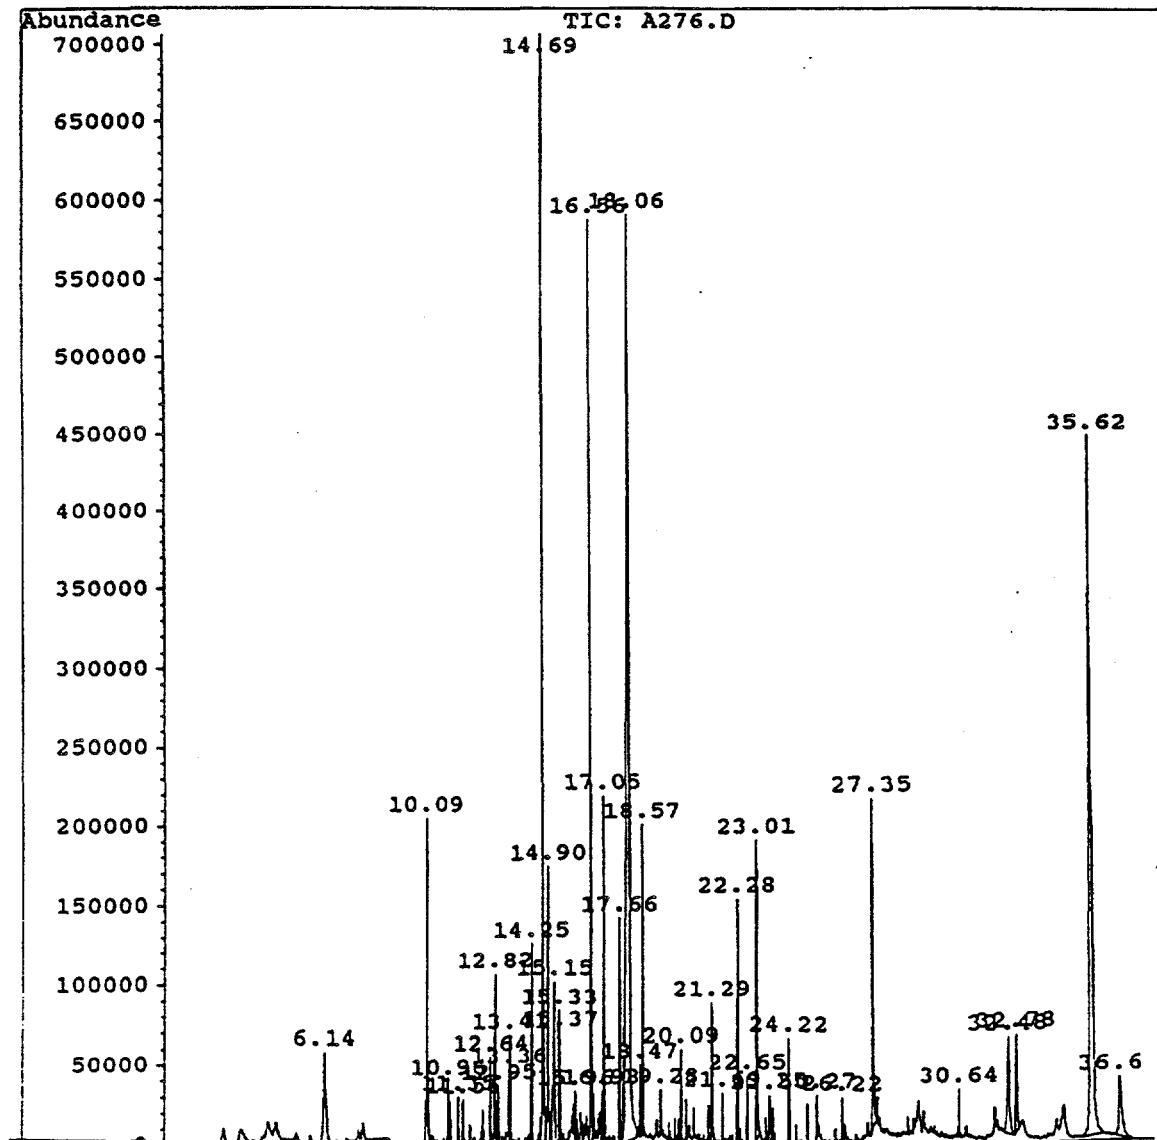
File : A:\A276.D
Operator : lar
Acquired : 19 Nov 94 10:28 pm using AcqMethod PILOT
Instrument : 5972 - In
Sample Name: 276(61) TE5485 main rm, 12:53-2:53 200mL/min
Misc Info : start, 200mL/min end, facing ceiling
Vial Number: 1

Figure 1 is a total ion chromatogram (TIC) of the air sample taken in E5485. Figures 2 and 3 are TICs of the outside air samples. Table 1 is the air sampling data sheet.
