**Contamination Source Review for Building E3162,  
Edgewood Area, Aberdeen Proving Ground, Maryland**

G.A. Miller, A.K. Draugelis, J. Rueda, and R.E. Zimmerman

September 1995

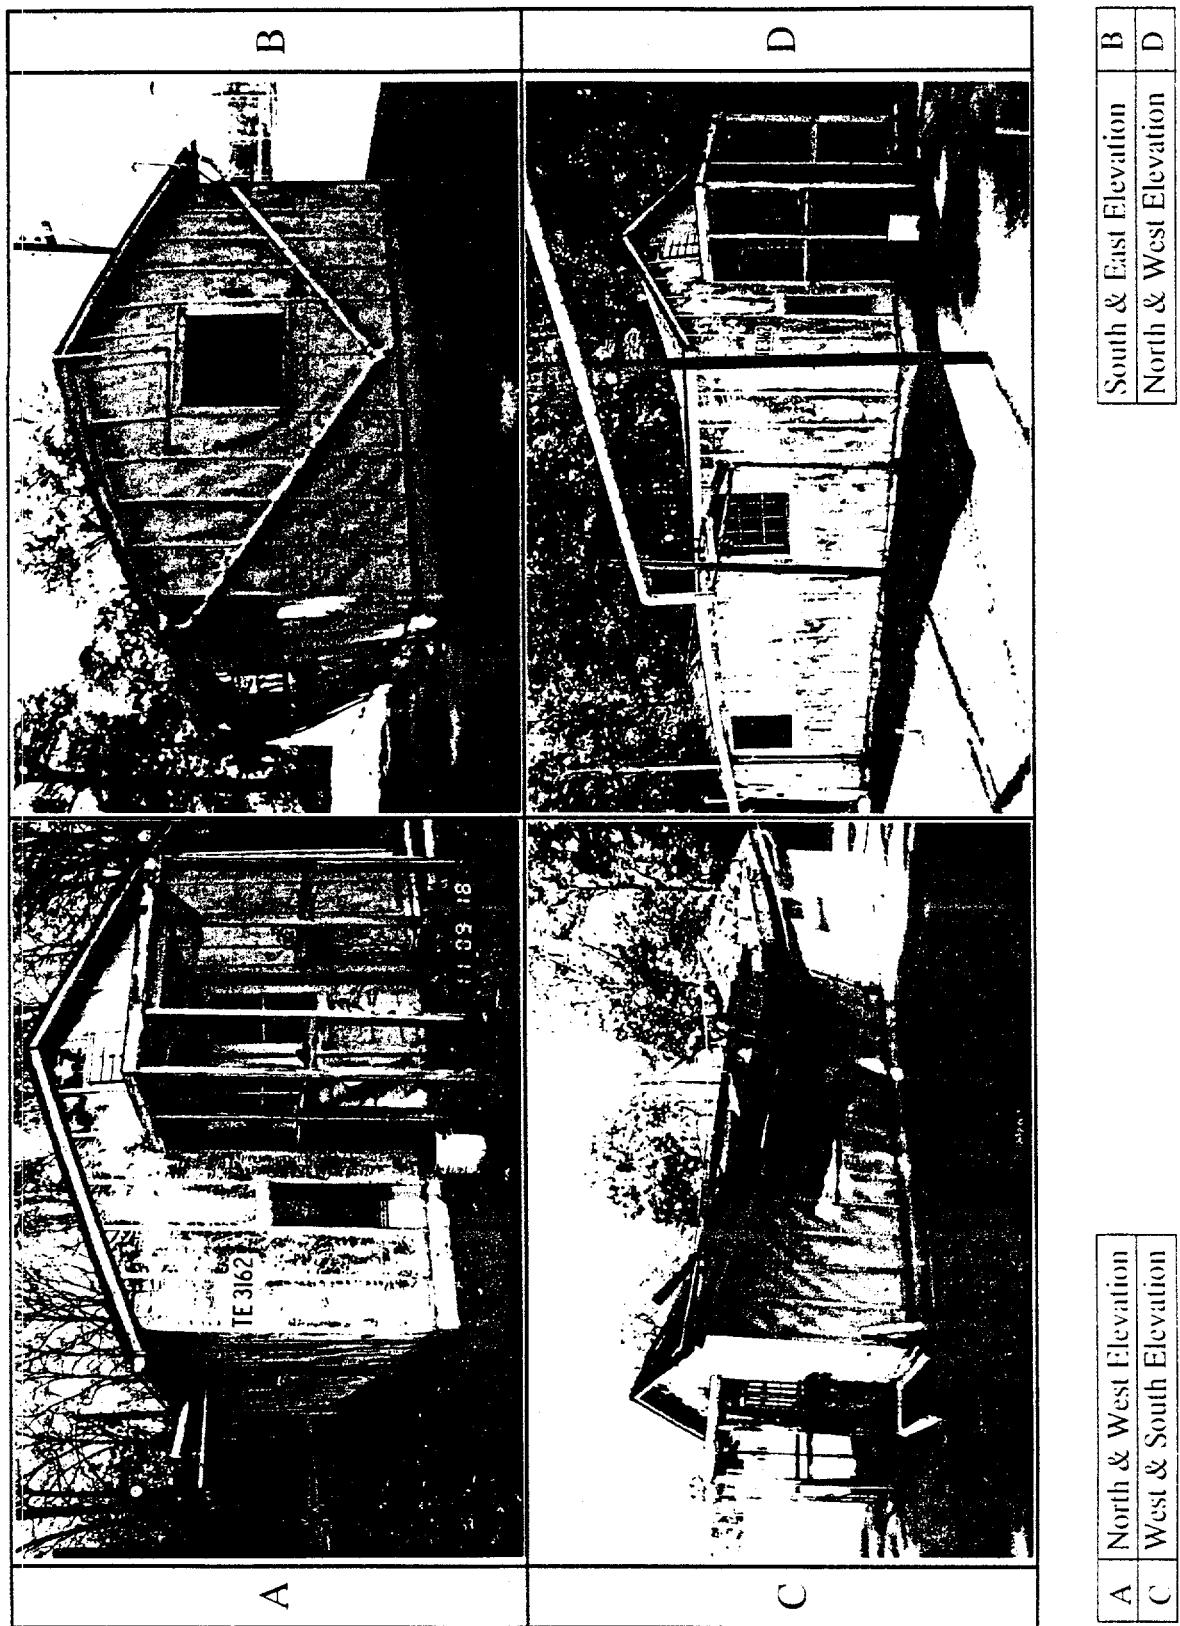
Disconnected electrical lines from a wooden pole and steam pipes were observed on the north side of the building.

Because of a lack of building maintenance, the north elevation shows signs of deterioration and weathering.

Because of a lack of building maintenance, the east elevation shows signs of deterioration and weathering.

Because of a lack of building maintenance, the west elevation shows signs of deterioration and weathering.

The roof was collapsing and leaking at the time of the investigation.

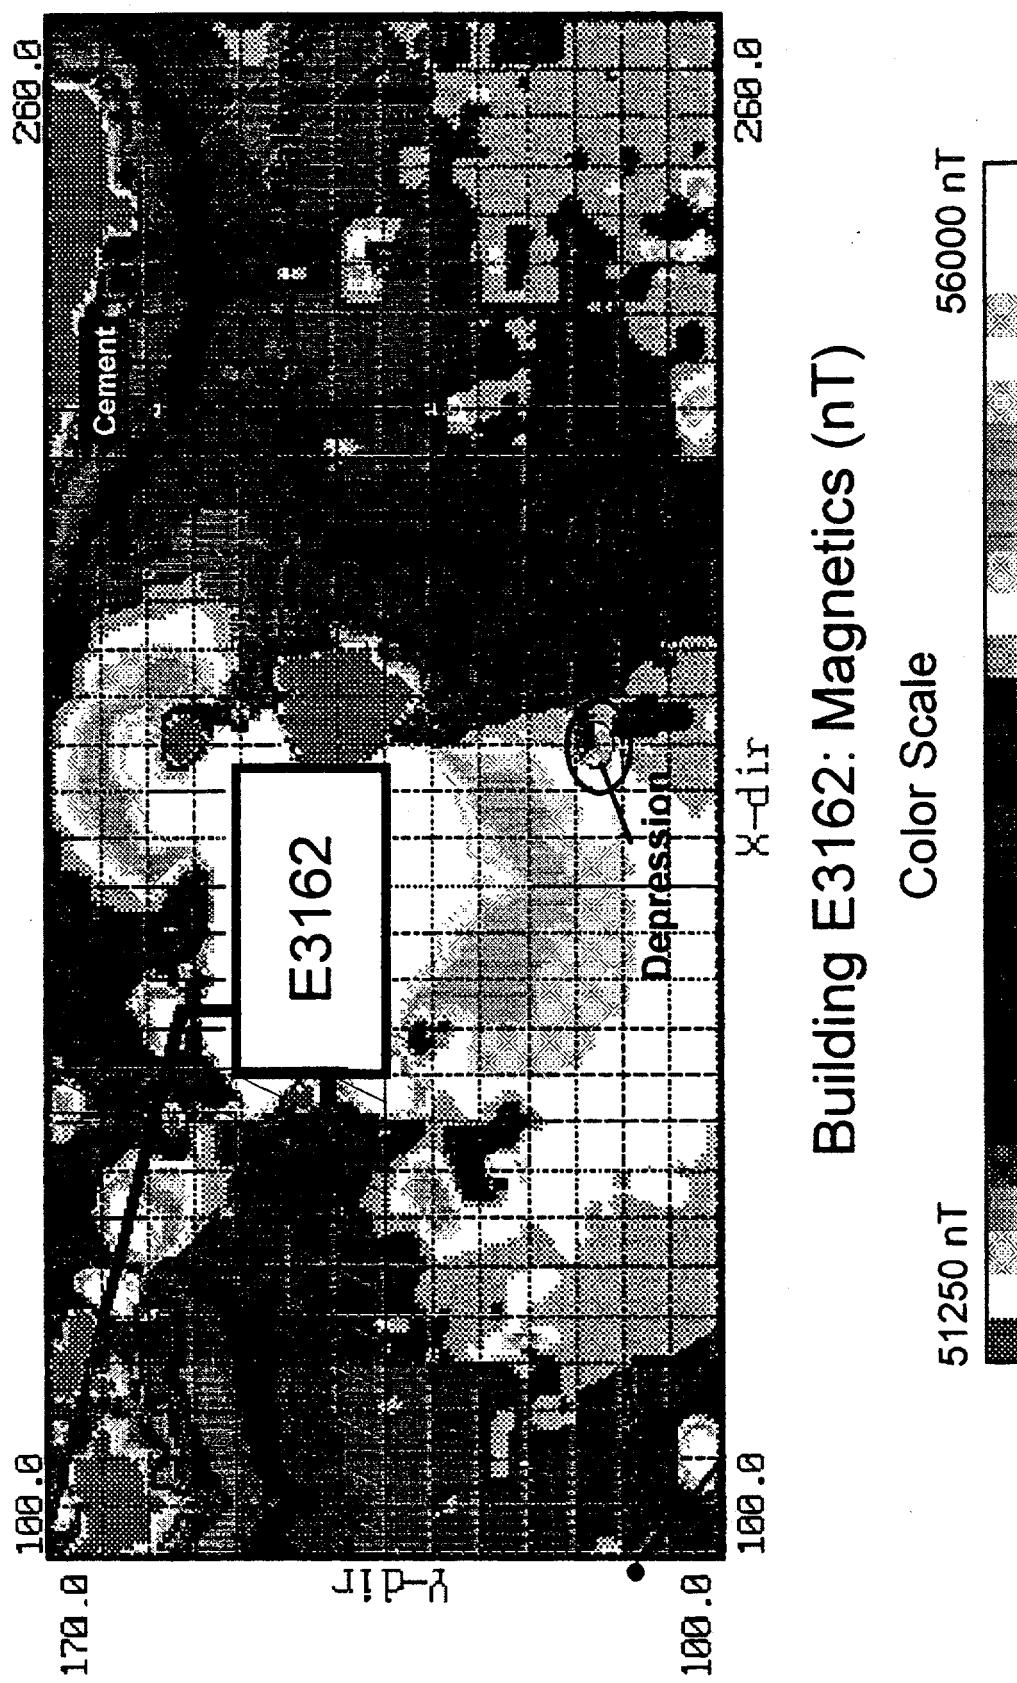
FIGURE 3 Total Magnetic Field Anomaly Map

The central part of the figure is dominated by magnetic anomalies associated with Building E3162. A circular magnetic high in the southwest corner of the survey area is probably caused by a metallic anchor stake for the utility pole's support wire. Magnetic anomalies between the northwest corner of the building and the northwest corner of the survey area are caused by metal poles supporting the overhead steam line.

The 10-ft wide magnetic low located immediately east of the building may be caused in part by a pair of rain gutters on the east-facing wall of the structure. However, another magnetic low anomaly is centered at grid coordinates (208, 110), and the two low anomalies are connected by a northwest-southeast magnetic trend. A buried metallic linear feature (e.g., a metal pipe) is a possible cause for the trend, which runs from the east side of Building E3162 in a southeast direction and continues south of the geophysical survey area. A high/low magnetic anomaly pair is located at the northeast corner of Building E3162, centered at grid coordinates (185, 157). The anomaly might be a continuation of the linear trend described above, or it might be caused by another, unrelated, buried metal-bearing object.

The northeastern edge of the survey area contains a broad magnetic low that is immediately adjacent to a 12 ft  $\times$  4 ft concrete pad and north of an asphalt walkway. The anomaly is probably caused by interference from Building E3165, which is located immediately to the north.

Scattered isolated magnetic anomalies are observed to the southwest and to the southeast of Building E3162. The anomalies to the southwest, in the vicinity of a vertical PVC pipe, approximately outline the relic foundation for Building E3164, which was torn down after the 1991 site reconnaissance. The anomalies southeast of Building E3162 do not have associated surface features and are interpreted to represent buried metallic debris.

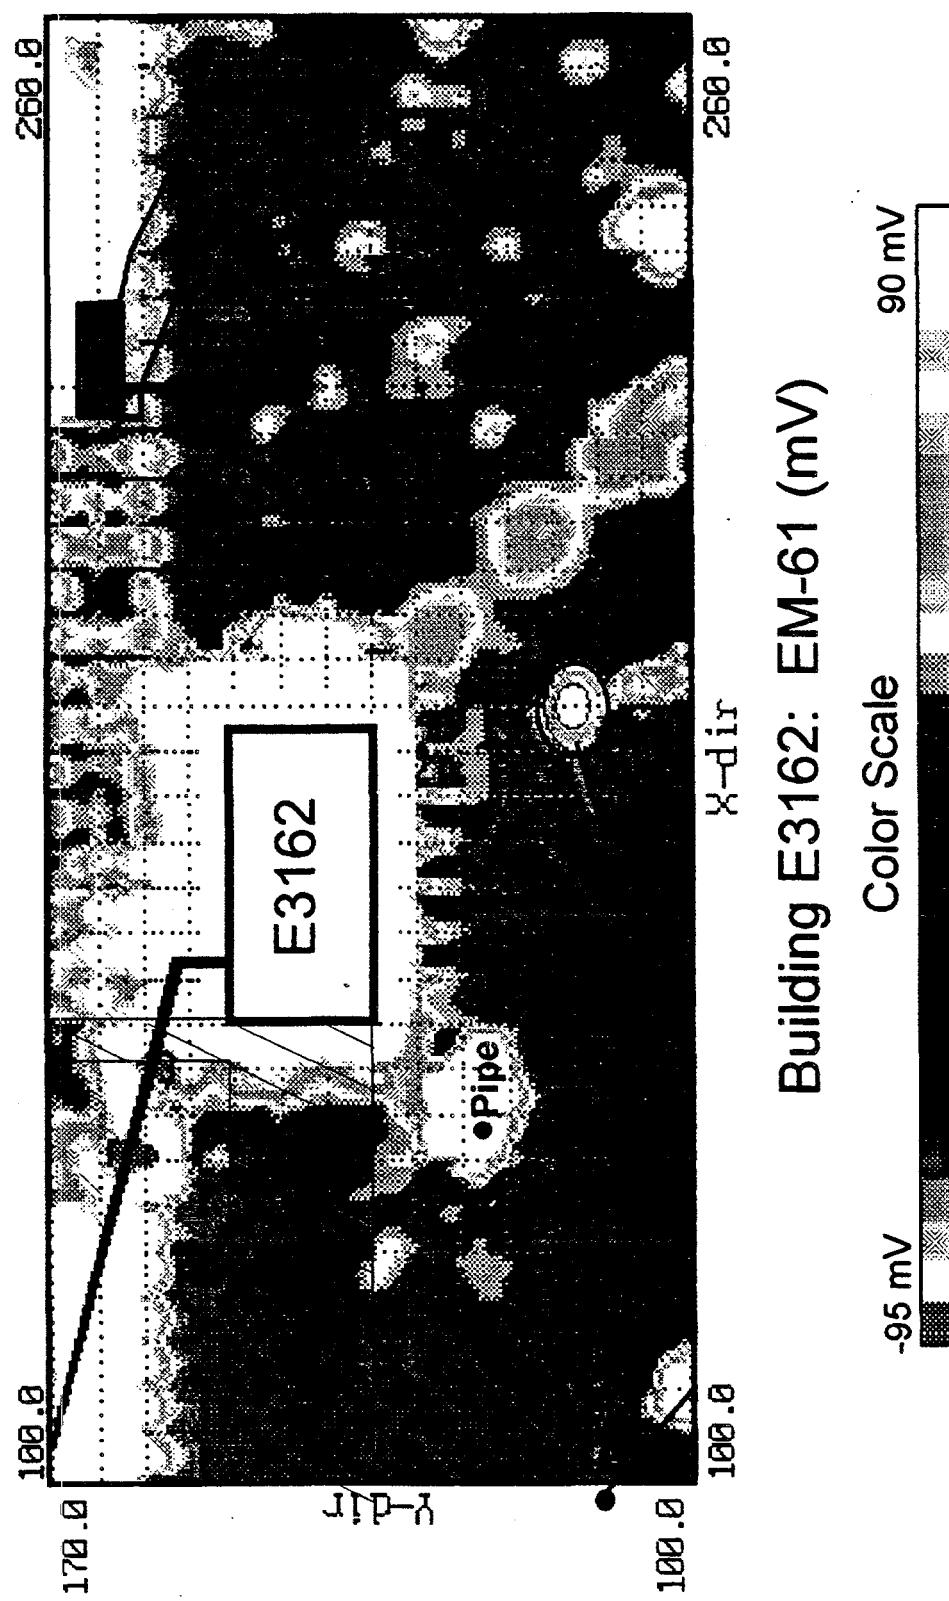
FIGURE 5 EMF Anomaly Map

A northwest-southwest trend is indicated southwest of Building E3162 by EMF anomalies located at (220, 100); (215, 105); (204, 116); and (193, 127). The linear trend may also continue north of the building. The anomaly, which has no surface expression, coincides with magnetic and conductivity anomalies at the same locations.

A 10-ft wide east-west-trending zone of scattered EMF positive anomalies is located along the northern edge of the survey area. The source of the anomalies is apparently buried, since no surface features or structures are present in the area. However, the anomalies appear to be a collinear extension of the anomalies caused by a series of vertical steel poles that support the steam pipe in the northwest portion of the survey area. While the suspended steam pipe angles into the building from the northwest corner of the survey area, the vertical steel support poles are parallel to the east-west grid lines. The vertical poles are located on both north and south sides of the steam pipe, approximately along  $y = 170$  ft and  $y = 150$  ft, respectively. The anomalies west of the place where the steam pipe enters Building E3162 may be caused by buried remnants of a former continuation of the steam line. Whatever the cause of the anomaly, the source is probably relatively shallow, because neither magnetic nor conductivity data show a similar anomaly across the length of the survey area.

Three isolated EMF positive anomalies can be associated with observed features. The first anomaly, at grid coordinates (110, 100), is probably caused by a metal anchor for the guy-wire supporting the utility pole. The second anomaly, 10 ft  $\times$  15 ft wide, centered at grid coordinates (140, 125), is next to a vertical pipe constructed of PVC, and it is coincident with the former site of Building E3164.

The third EMF anomaly, with center at grid coordinates (185, 114), has an associated surface depression that is roughly the same dimensions as the anomaly. A weak magnetic anomaly is also observed at this location. A related EMF anomaly continues south beyond the boundary of the survey area. The metallic source of the anomalies is not visible at the surface. The anomalies suggest the presence of a south-southeast trending metal object below the surface.

A 5-ft diameter EMF anomaly, located at grid coordinates (237, 103), does not coincide with any observed structure or feature on the surface. This anomaly has a magnetic equivalent, and it is spatially located on the eastern flank of a 40-ft wide electrical conductivity anomaly. Another EMF anomaly of similar size and shape is located at grid coordinates (260, 127). The latter anomaly has both a small magnetic anomaly and a conductivity anomaly associated with it. The character of the anomalies at these two locations suggests the presence of buried metal objects.

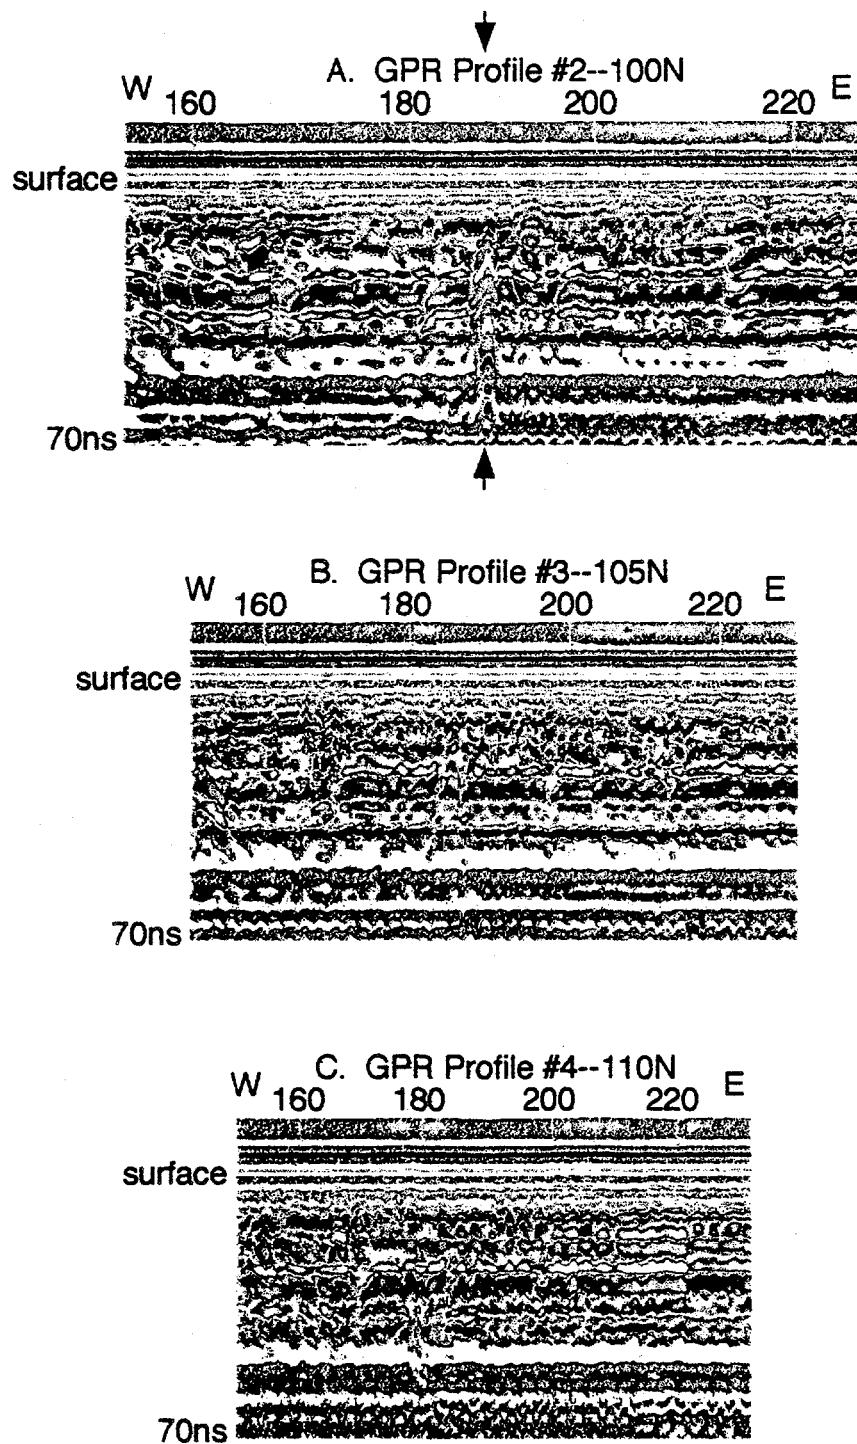
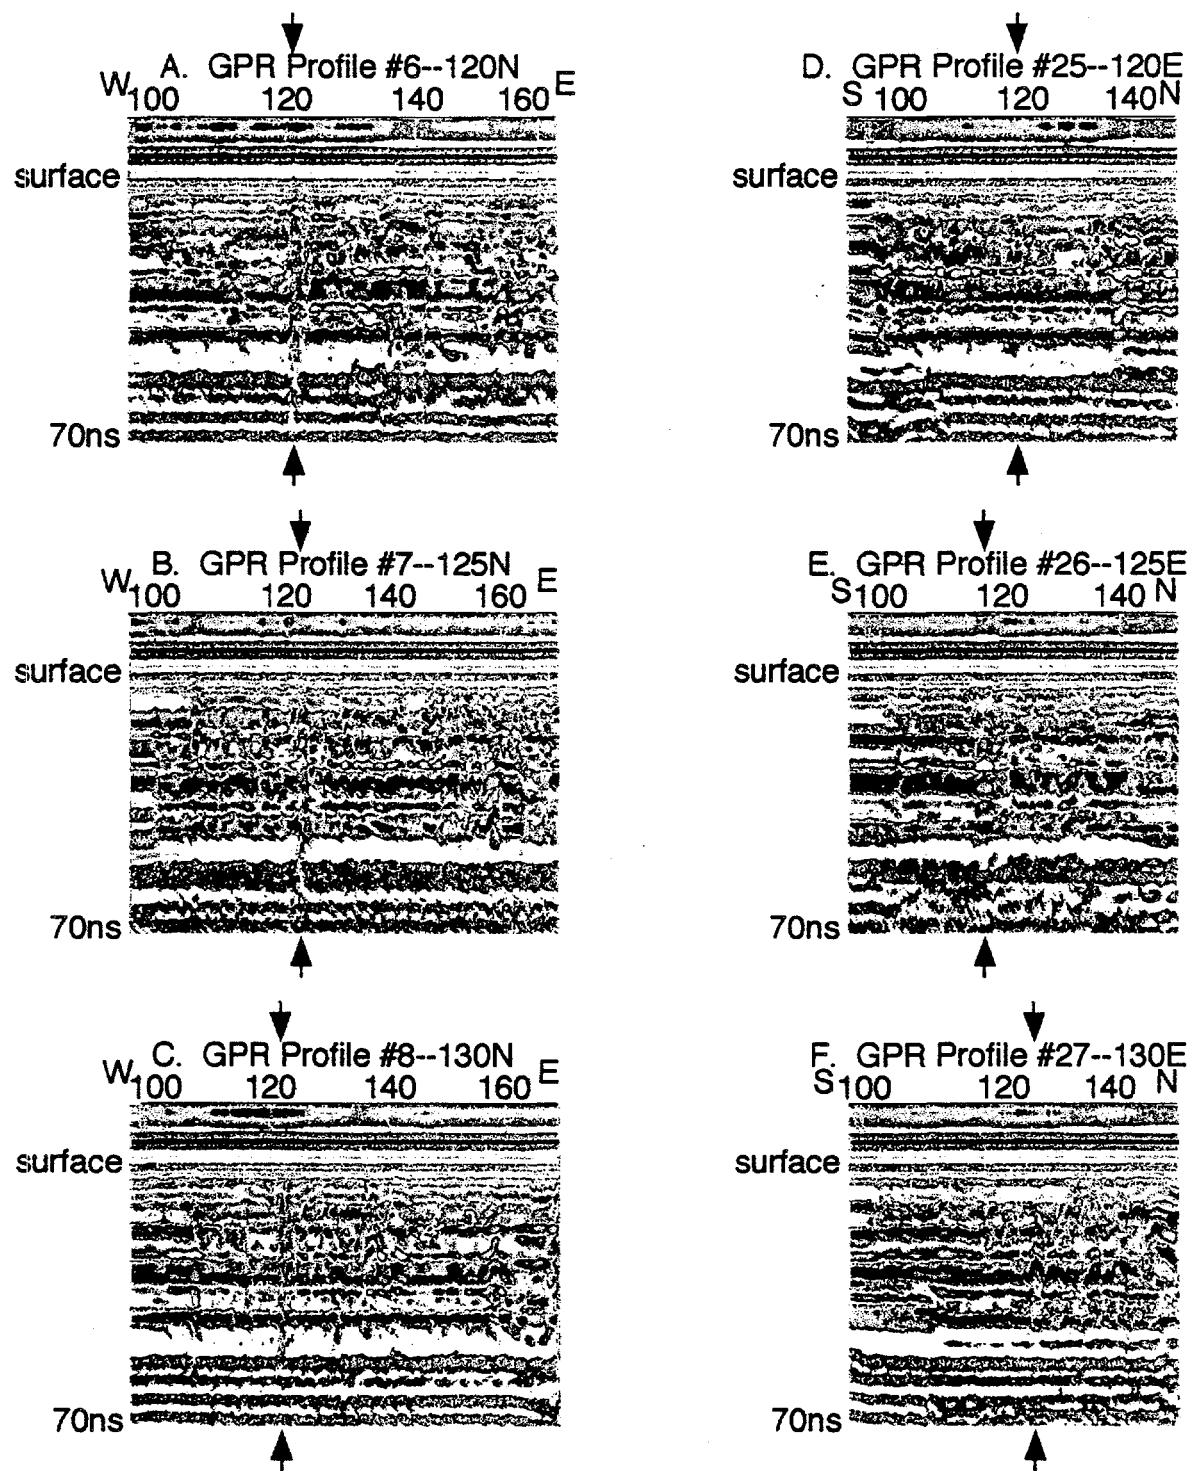
For the most part, GPR anomalies at Building E3162 were surprisingly subtle and inconclusive, considering the presence of several striking potential-field anomalies as described in the preceding sections. A few strong GPR anomalies were observed at single-point locations; for example, an anomaly was observed at grid coordinates (188, 100) in GPR profile #2 (Figure 6A), which coincides with the southeast-trending magnetic and conductivity anomalies near the surface depression and also at the south edge of the survey area. No similar anomalies were observed along the adjacent parallel GPR profiles #3 and #4 (Figures 6B and 6C, respectively), nor are they observed along perpendicular profiles (not shown). The absence of GPR anomalies for most profiles near the surface depression at grid coordinates (185, 114) suggests that the metallic object causing southeast-trending anomalies in magnetic and EMF data is too small in diameter (for example, a small diameter pipe) to cause observable GPR reflections.

Another set of strong GPR reflections was observed at grid coordinates (187, 155) along profile 13 (not shown). Other strong reflections were observed in proximity to buildings or other surface features. Most GPR reflections, however, were subtle, such as is shown in Figure 7 for profiles in close to grid coordinates (120, 120). Individually, the anomalies are not strong enough to conclude any information about the subsurface. Either the Building E3162 site lacks buried debris of substantial size that would result in GPR reflections or the soil conditions at the site are not conducive to penetrating radar signals. The anomalies described by the potential-field data discussed in previous sections may be caused by pipes and other small-diameter objects that are too narrow to produce GPR reflections.
