## **Tidd Hot Gas Clean Up Program**

### **Final Report**

October 1995

The Tidd Hot Gas Clean Up (HGPU) system was installed in the Tidd Pressurized Fluidized Bed Combustion (PFBC) Demonstration Plant, which is the first utility-scale PFBC plant in the United States. The plant is owned and operated by Ohio Power Company and is located on the banks of the Ohio River, approximately 75 miles downstream of Pittsburgh, Pennsylvania.

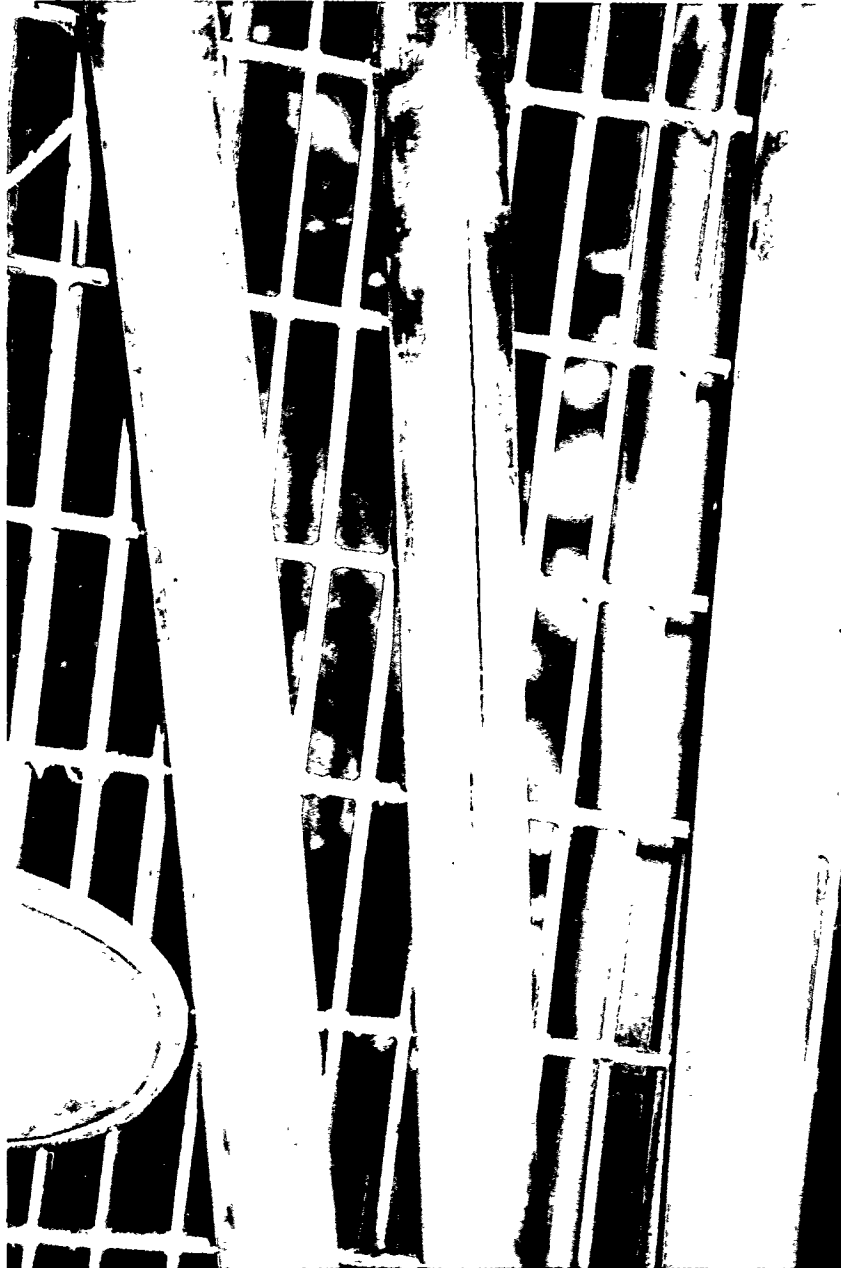
Two of the nine backpulse tubes were found to have longitudinal cracks, believed to be due to thermal fatigue. All nine tubes were replaced in kind following this test series.

**Figure 4.6.17 - Photograph of Crack in Back Pulse Tube**

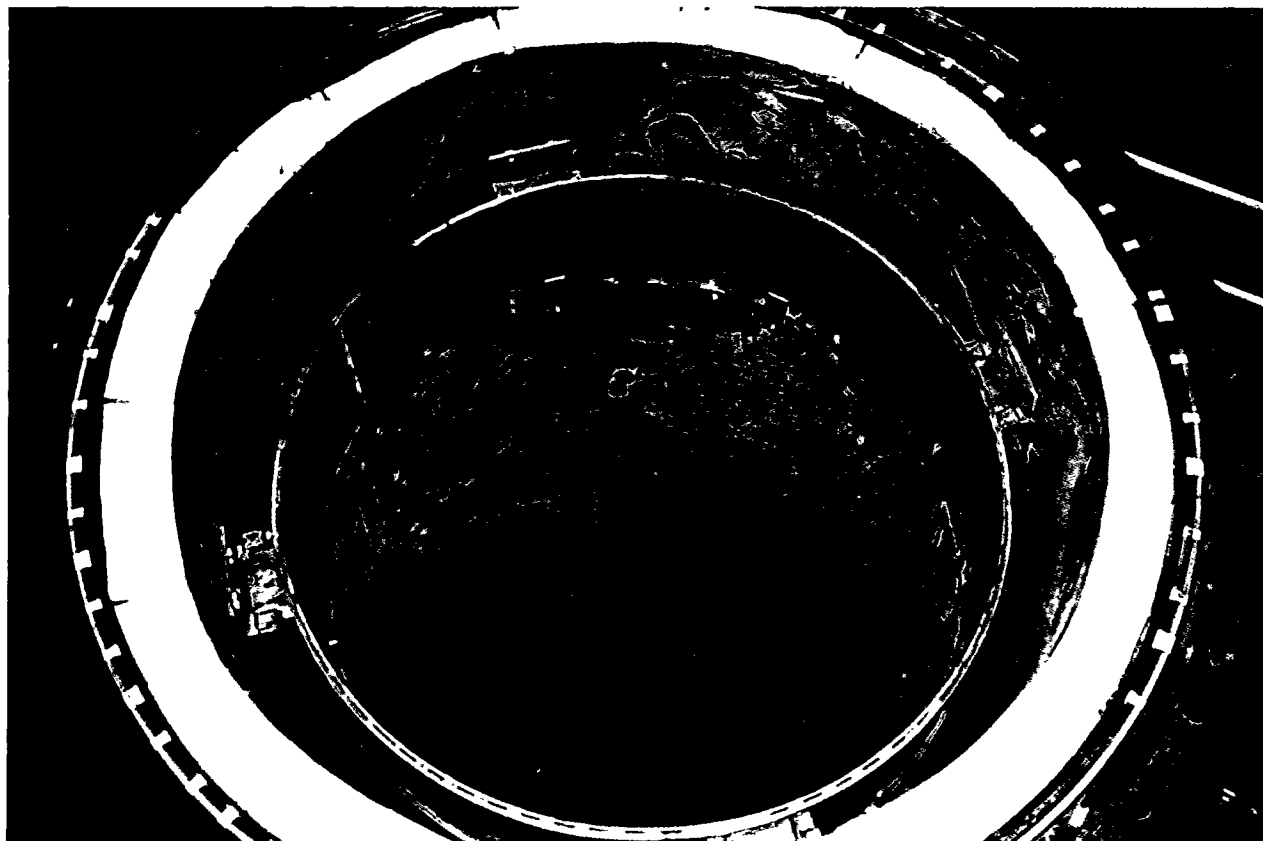
**Figure 4.6.22 - Photograph of APF Shroud After Replacement of Upper Portion**

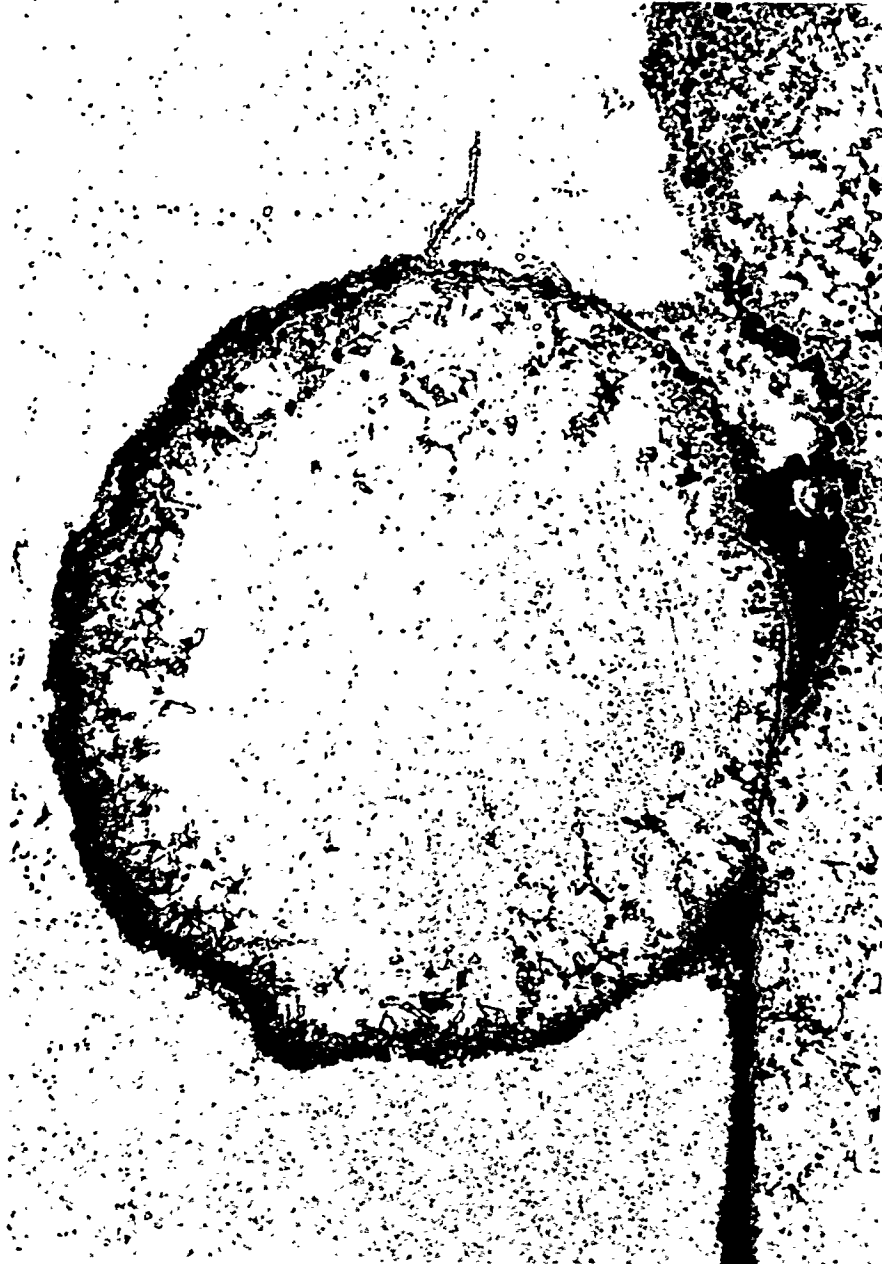
**Figure 4.9.3 - Cross Section of 0.005-inch Wire from Fine Fail-safe Mesh After 1110 hours at Tidd-700X**

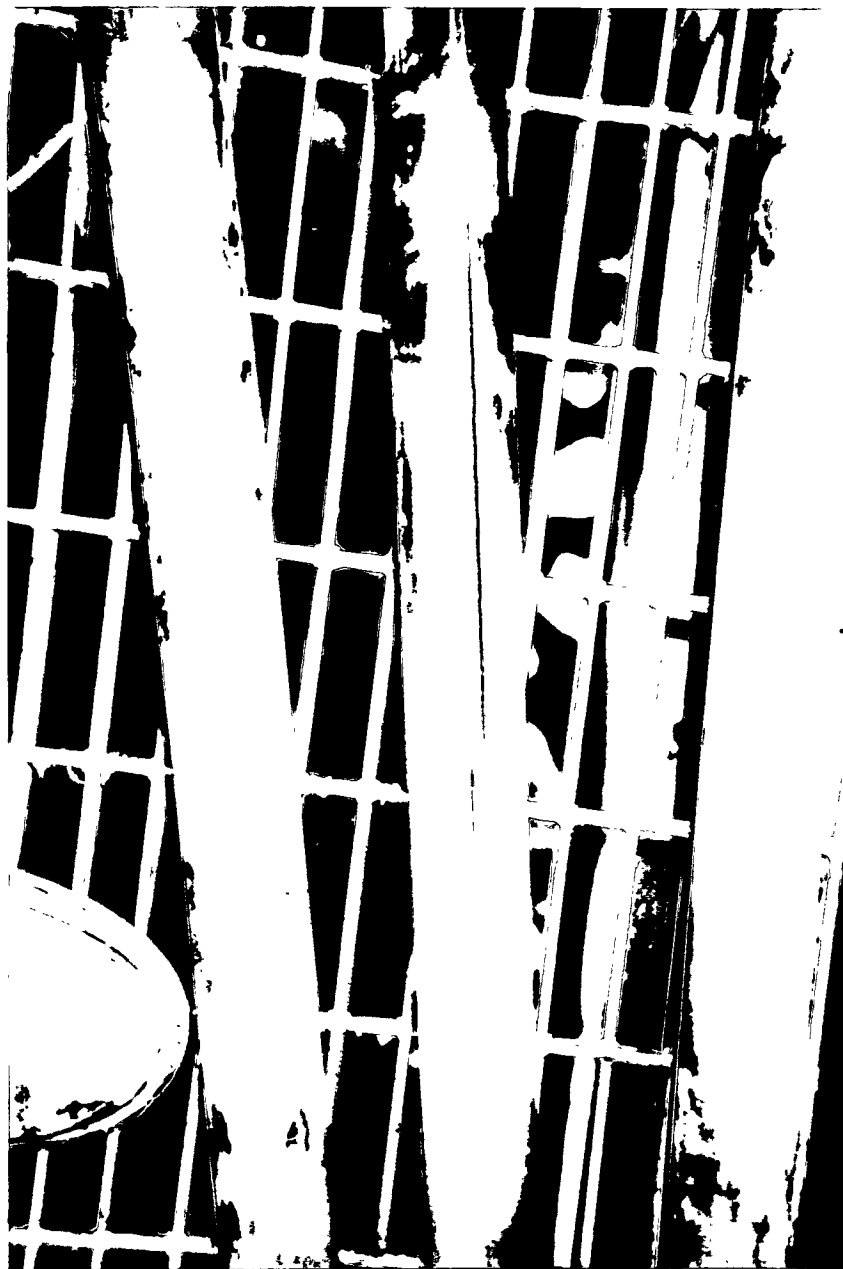
**Figure 4.6.17 - Photograph of Crack in Back Pulse Tube**

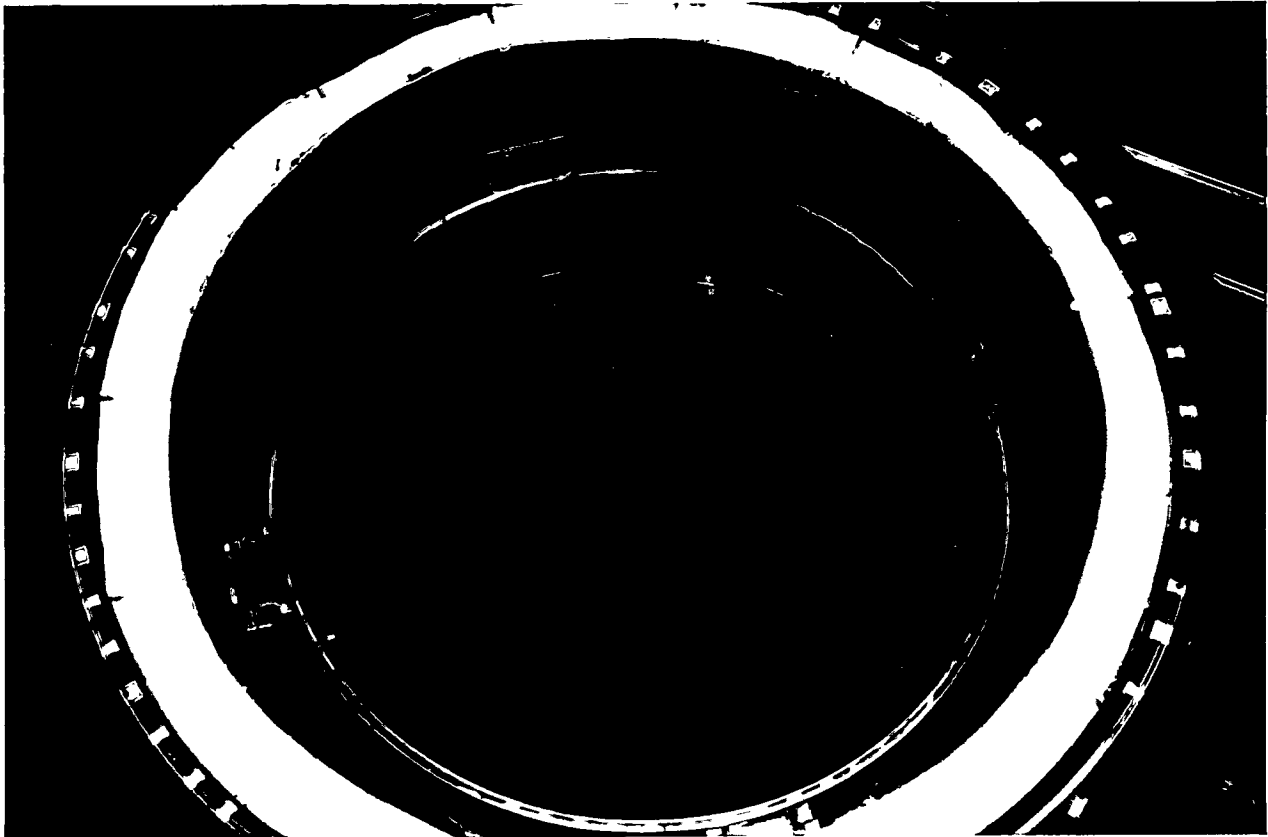
**Figure 4.6.22 - Photograph of APF Shroud After Replacement of Upper Portion**

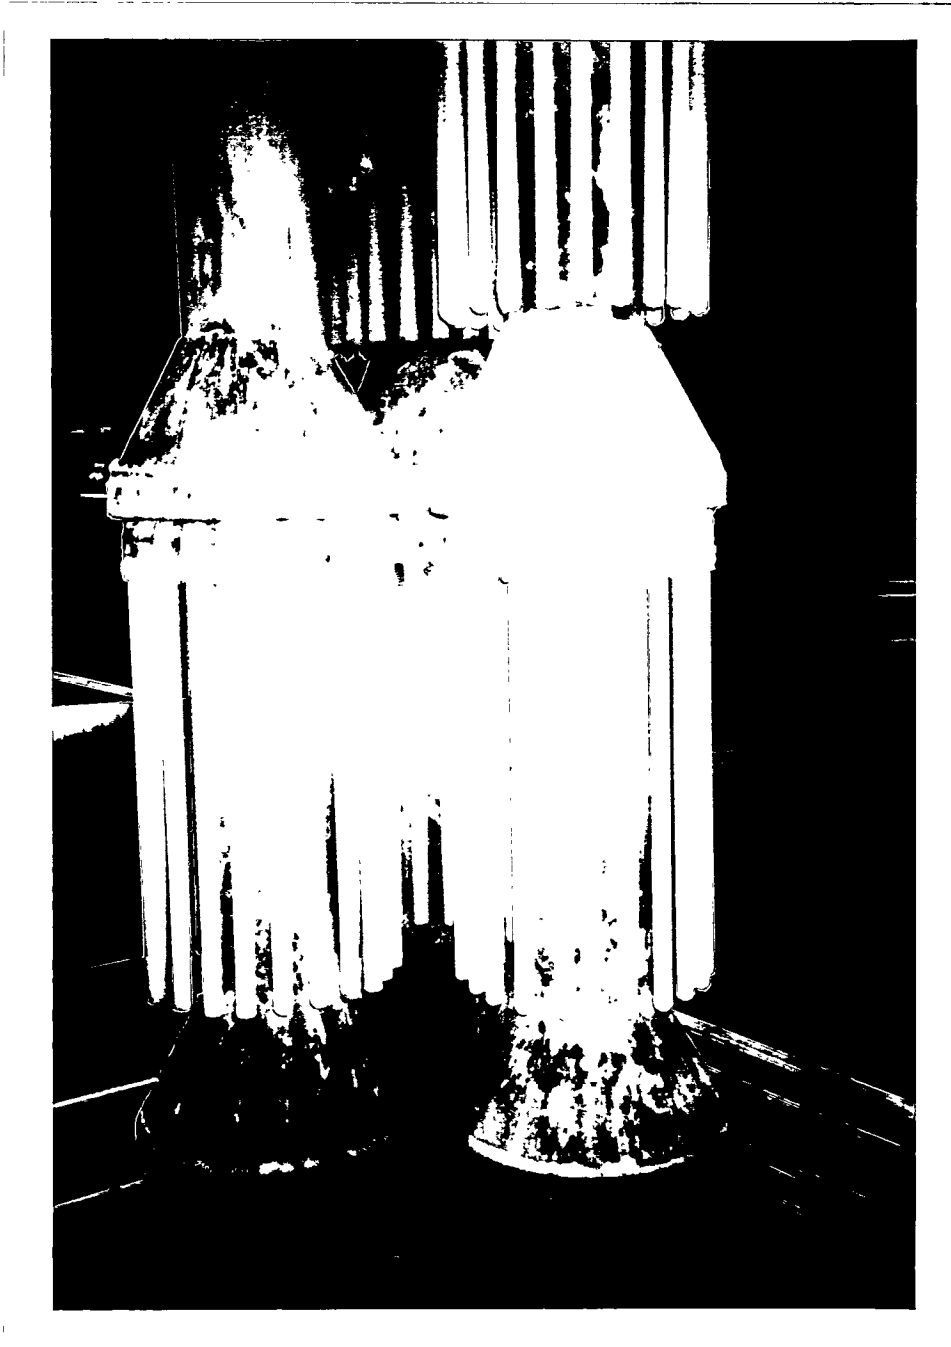
**Figure 4.7.12 - Photograph of Filter Internals Following Test Run 34**

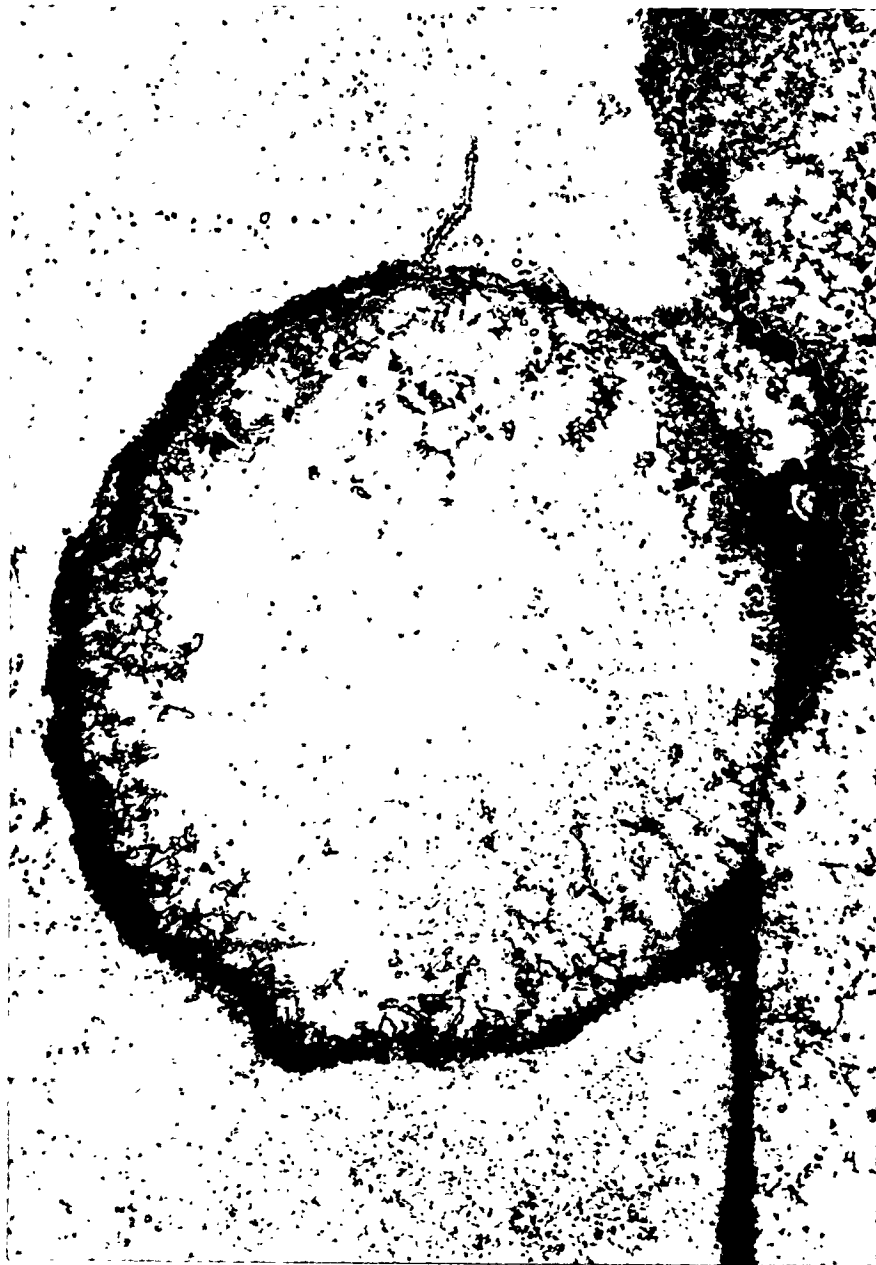
**Figure 4.9.3 - Cross Section of 0.005-inch Wire from Fine Fail-safe Mesh After 1110 hours at Tidd-700X**
