# Post-Closure Inspection and Monitoring Report for Corrective Action Unit 417: Central Nevada Test Area Surface, Hot Creek Valley, Nevada

March 2013

LMS/CNT/S09307

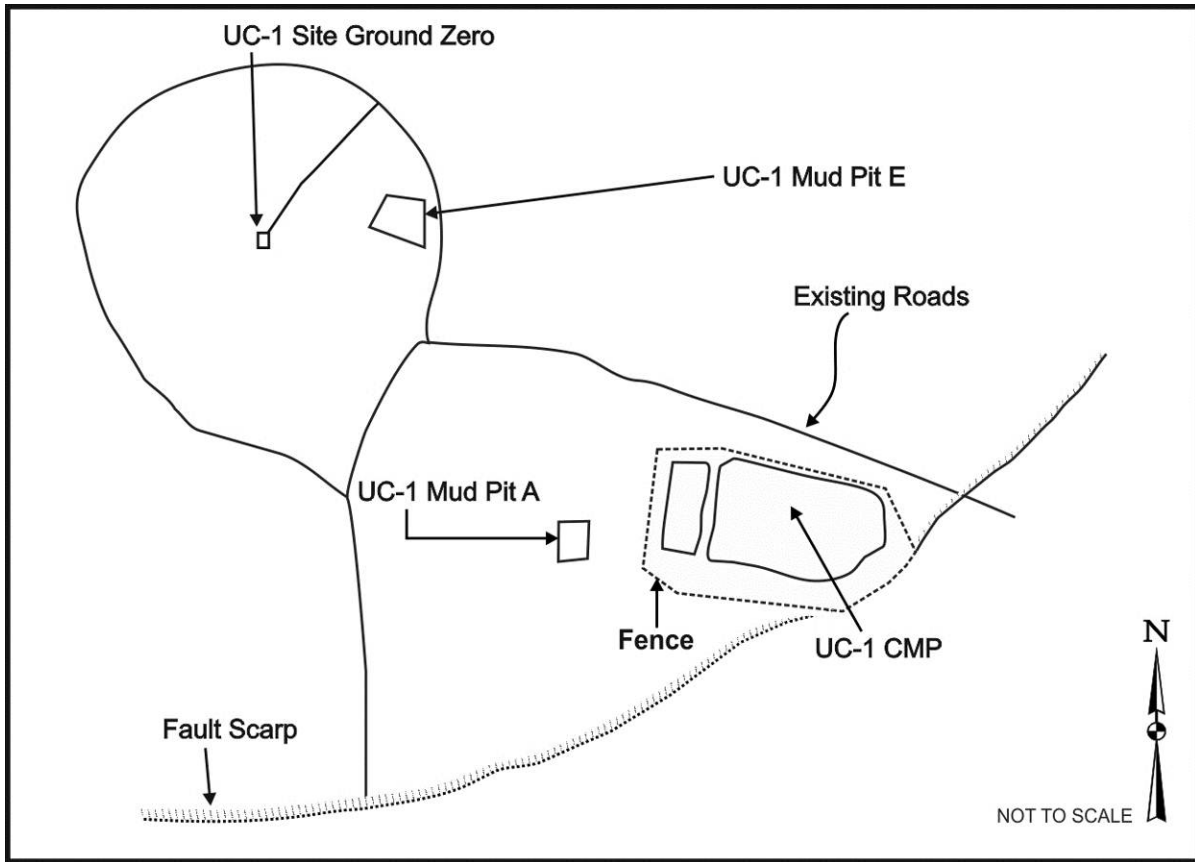
Figure 4. Location of UC-1 Significant Features

The locks, fencing, SMS, and signs associated with the CMP were in good condition, with the exception of one sign that had fallen along the southern side of the fence line. The sign was reattached to the fence at the time of the 2012 inspection. No new cracks or fractures, and no extension of existing cracks or fractures, were identified in the soil cover at the time of the inspections. The vegetation on the cover continues to look healthy. All other signs and monuments at Mud Pits A and E (Figure 4) were in excellent condition.

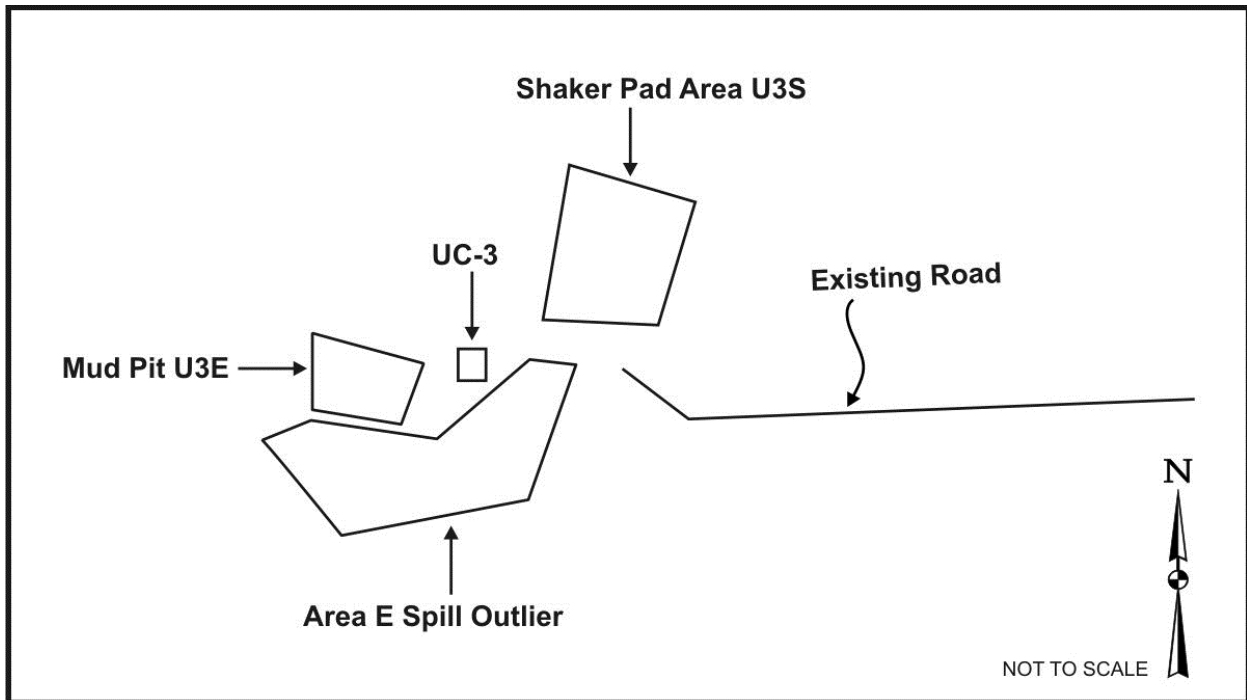
Figure 5. Location of UC-3 Significant Features

The site was in excellent condition (Figure 5). No issues with the monuments or signs were identified at the time of the inspections, and no maintenance or repairs were recommended.

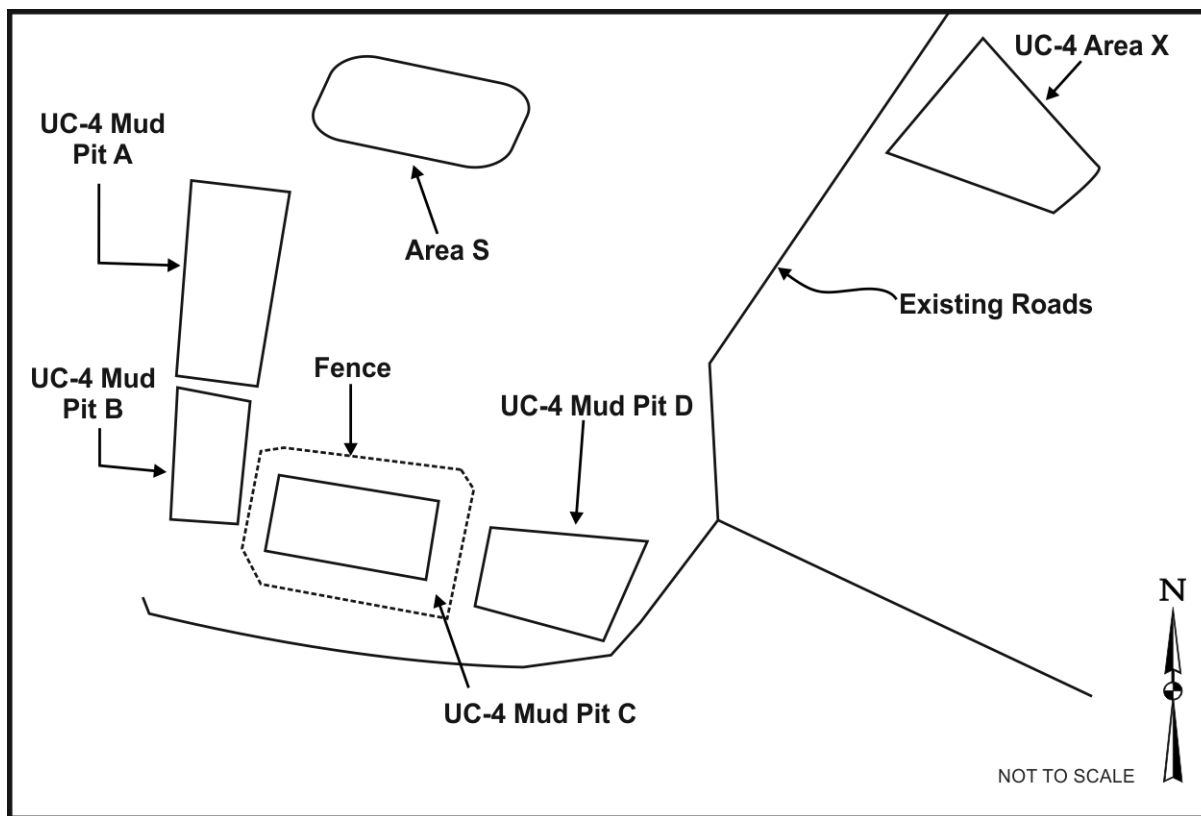
Figure 6. Location of UC-4 Significant Features

The Mud Pit C fence and SMS were in good condition at the time of the inspections. No erosion rills were identified, and previously identified rills showed no further signs of activity. No new erosion concerns were apparent at the time of the inspections. Some sagebrush was growing on the surface of the cap, but the inspection team used mechanical methods to remove a large amount of the vegetation during the 2012 inspection. No issues that affected the integrity of the cover and appurtenances were noted. Mud Pits A, B, and D were in excellent condition, and no issues were identified with Area S or Area X (Figure 6).

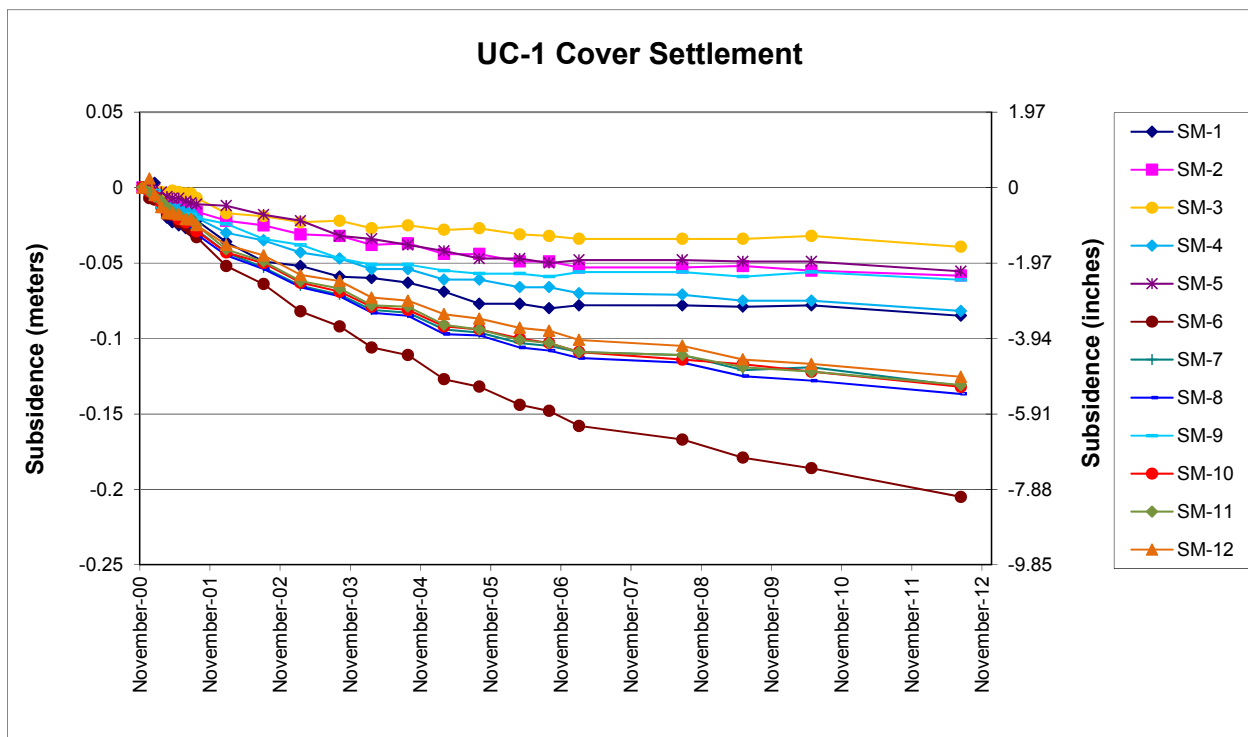
Figure 7. UC-1 Cover Settlement

The degree of settlement in the relocation trench and CMP is within the predicted range and shows no unusual subsidence. The data collected over the CMP section of the cover indicate that the largest subsidence is along the centerline of the CMP, including SM-6, SM-7, and SM-8, and along the southern portion of the cap at SM-10, SM-11, and SM-12. This was expected because of the thicker layer of underlying mud in these areas. The northern monuments (SM-2, SM-3, and SM-4) and the westernmost monuments (SM-1, SM-5, and SM-9) show the least subsidence because the layer of underlying mud along these margins of the cover is thinner. The greatest degree of settlement continues to be on SM-6, which has subsided a total of 0.205 m (8.07 in) since the baseline survey in December 2000.

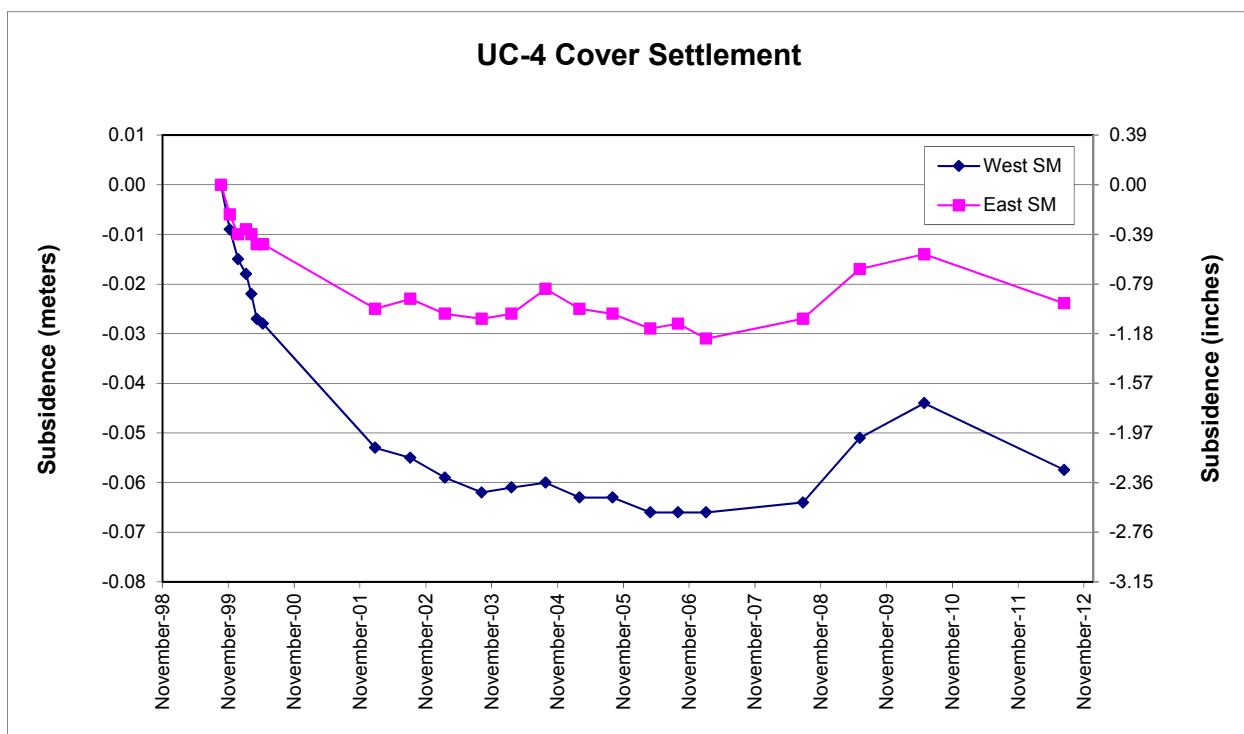
Figure 9. UC-4 Cover Settlement

Historically, settling of the west SM is still slightly greater than the predicted settling of 0.05 m (2 in); the total subsidence is 0.057 m (2.24 in) since the baseline survey in October 1999. The east SM has subsided a total of 0.024 m (0.94 in) since the baseline survey. The largest changes occurred during the first 3 years.

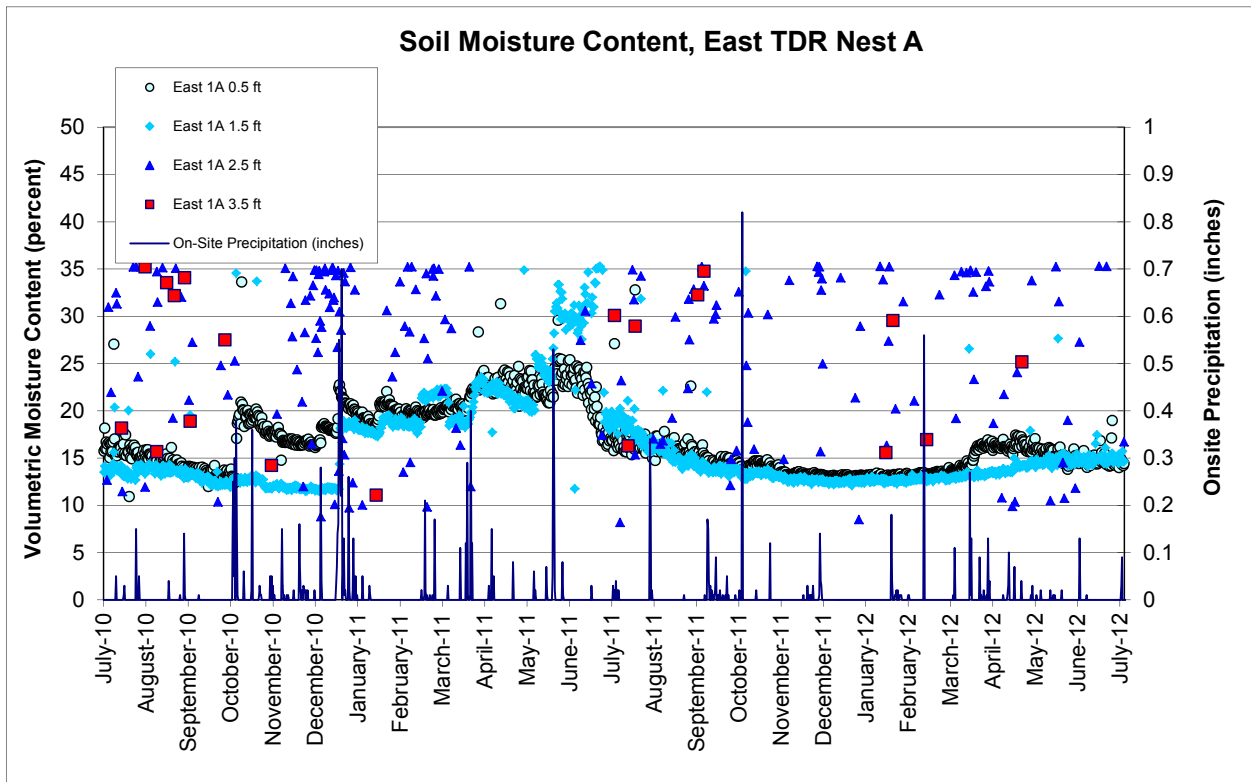
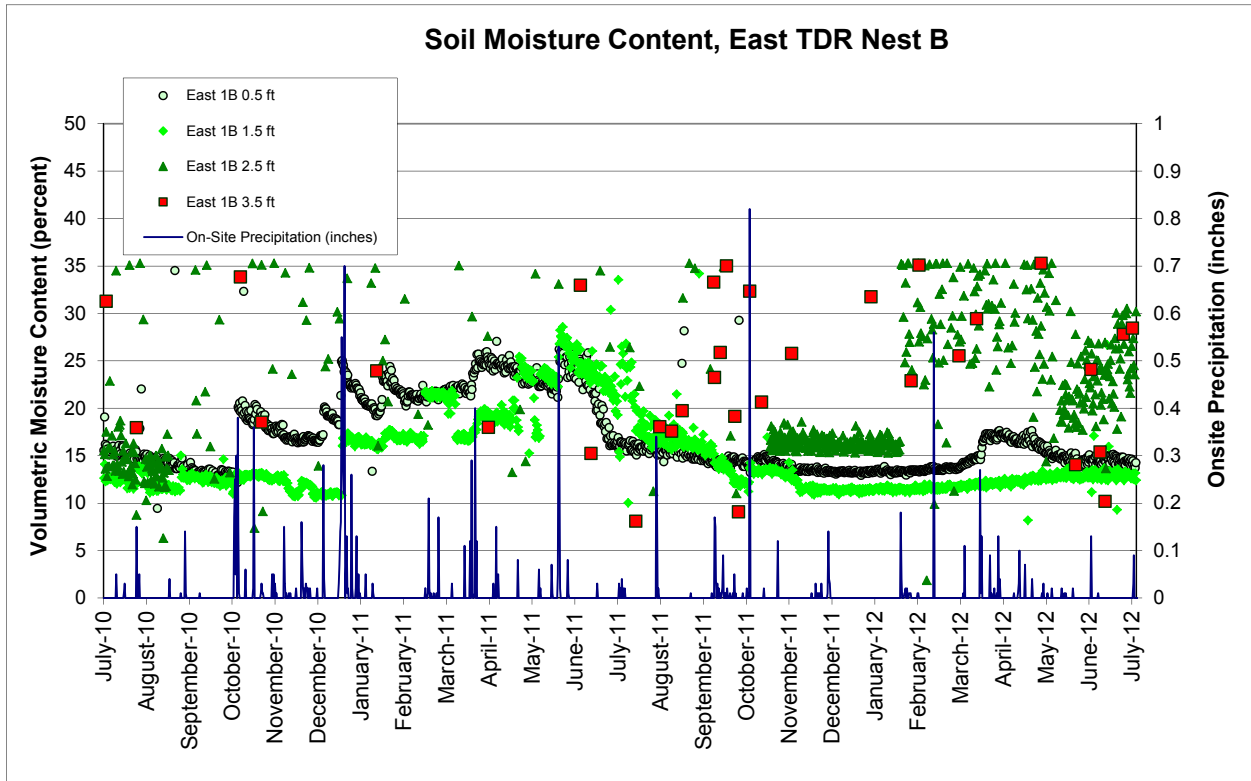
Soil moisture data obtained for the 2.5 and 3.5 ft depths of the east TDR nests (Figure 11 and Figure 12) are discontinuous and may be corrupted or an indication of saturated conditions at these depths. Previously, the lengthy cable created a problem in measuring the reflected signal from the TDR probes (NNSA/NV 2007). The TDR data from the shallower depths appear to be responding to the infiltrating moisture that corresponds to a decrease in precipitation during the 2-year monitoring period. The VMC data fluctuate seasonally in response to snowmelt during spring thaw and precipitation events. Annually, the VMC data are highest during spring thaw, and they slowly decrease throughout the spring and early summer when the VMC reaches steady-state conditions, ranging from 11 to 15 percent in the upper 1.5 ft of the cover. Refer to Appendix B (Figures B-2 and B-3) for historical moisture data obtained from the 0.5, 1.5, and 3.5 ft depths from 2007 through 2012.

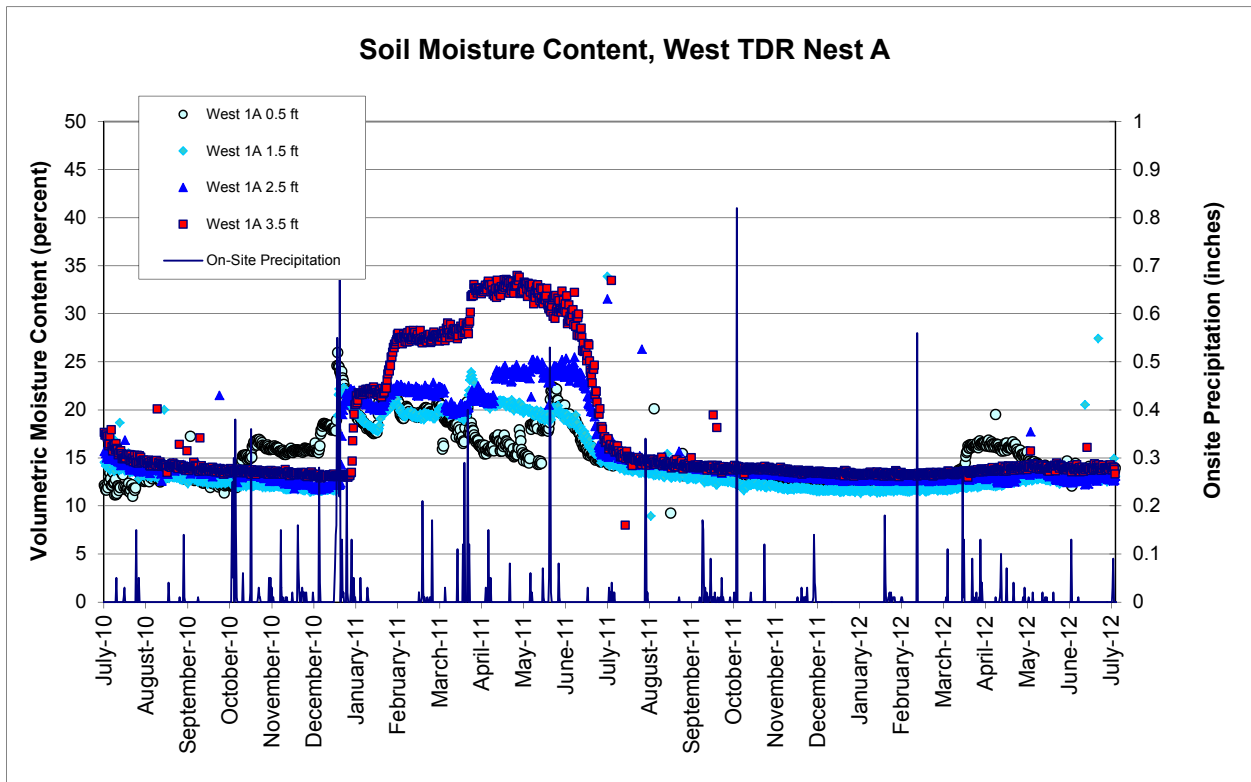
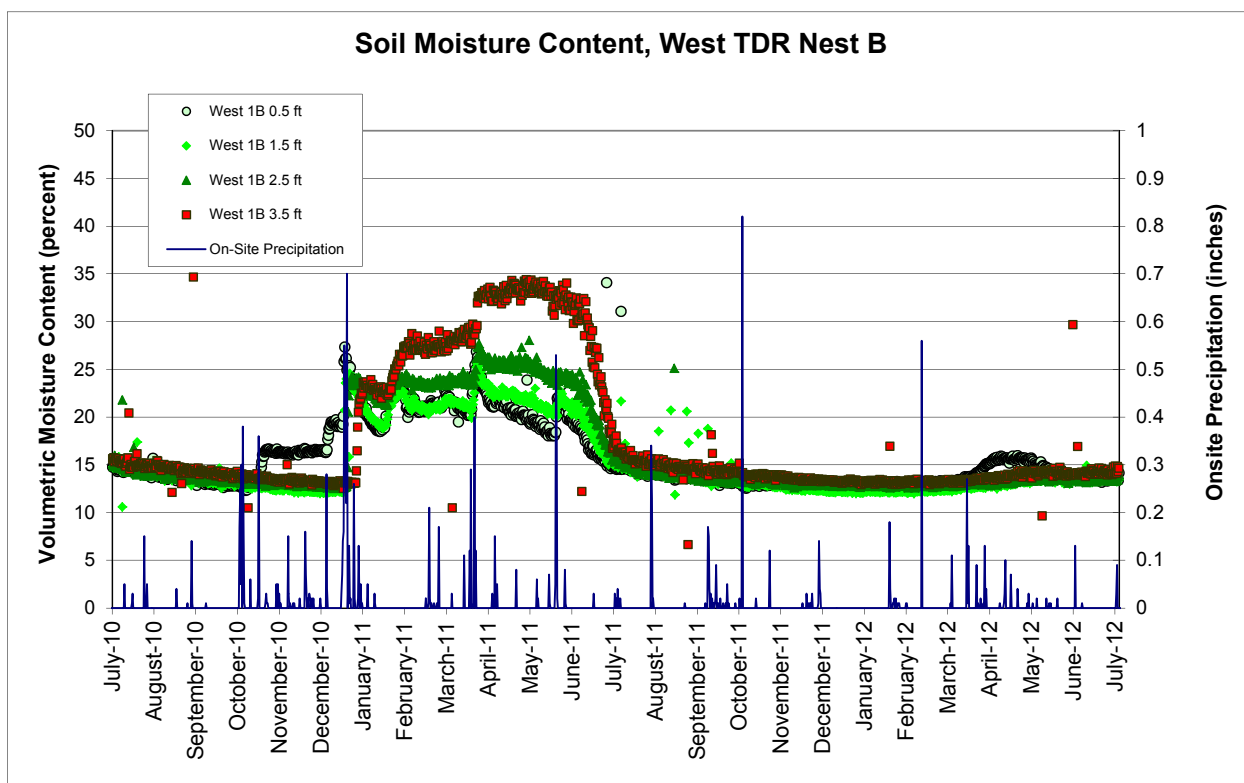
Soil moisture data obtained for the west TDR nests (Figure 13 and Figure 14) corresponds to a decrease in precipitation during the 2-year monitoring period. The VMC data fluctuate seasonally in response to snowmelt during spring thaw. Annually, the VMC data are highest during spring thaw, and they slowly decrease throughout the spring and early summer when the VMC reaches steady-state conditions, ranging from 11 to 15 percent in the upper 3.5 ft of the cover. These trends extended into May and June, when surface temperatures increased and evapotranspiration again began removing moisture from the cover. Refer to Appendix B (Figures B-4 and B-5) for historical moisture data obtained from the 0.5, 1.5, 2.5, and 3.5 ft depths from 2007 through 2012.

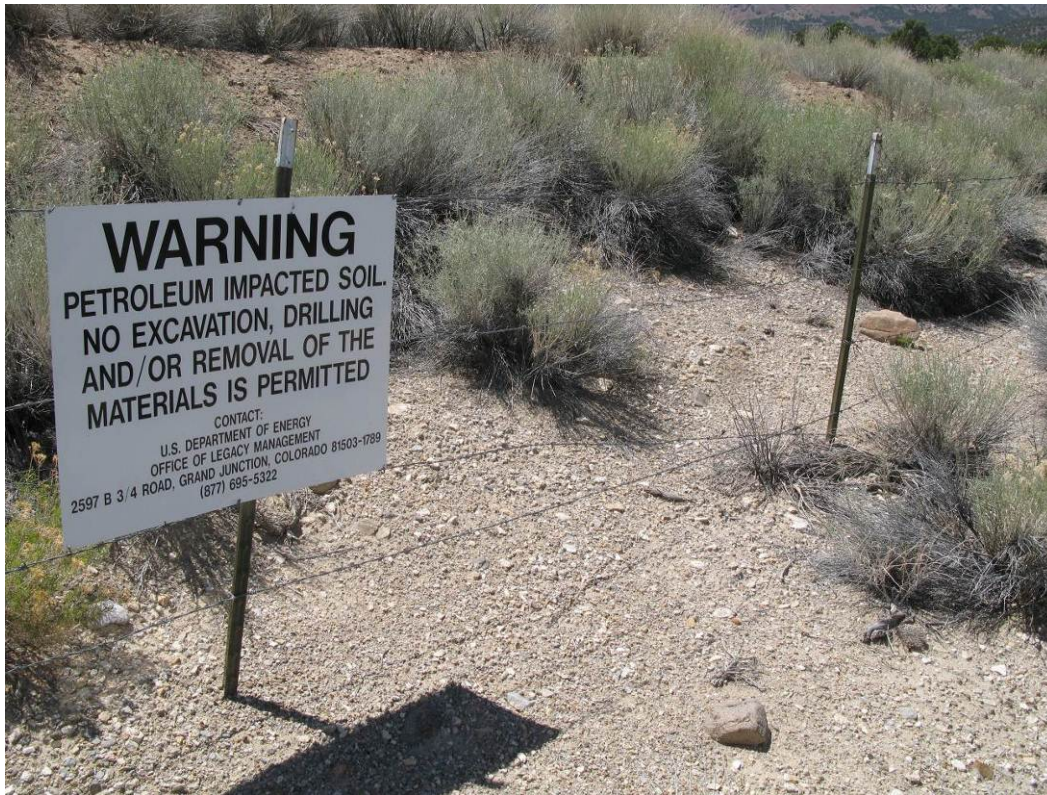
*Photograph 19. UC-4, view of broken barbed-wire strand along north side of cap*
