Title: 43-0434 Bridge Inspection Report 2019

Report Date: 15 August, 2019

- Cover Letter Jauregui to Mondragon, 4 Pages
- Los Alamos Canyon Bridge Inspection and Rating Report Narrative, 94 Pages

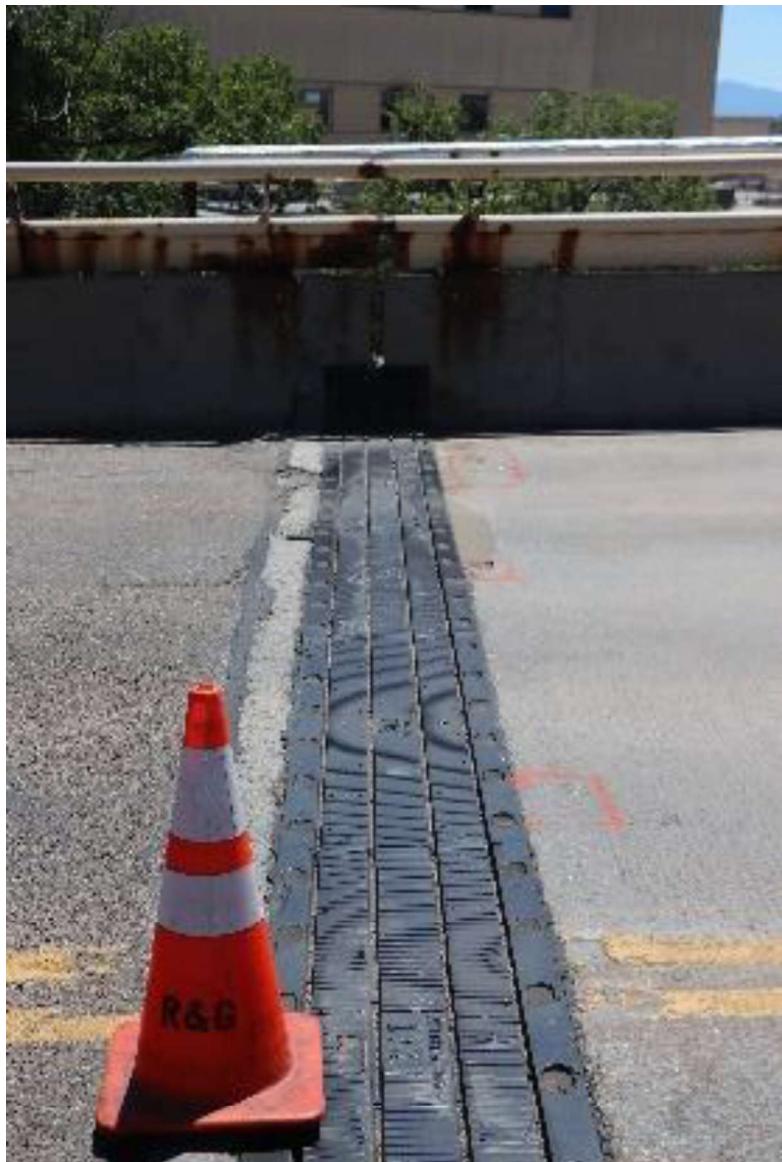
LANL 4 (Picture IMG_1395.jpg)

The **deck edges** adjacent to the east and west bridge barriers have map cracking, leaching, and several spalls. This condition is likely caused by the accumulation of water which drains transversely in the east and west directions and then from the south to north end of the bridge. Alignment issues were observed between the bridge and the south approach roadway and there is new joint damage possibly caused by roadway equipment and the overall bridge movement. See pictures LANL 1, LANL 2, and LANL 3. The **north expansion joint** has significant damage and replacement of this joint is recommended. See pictures LANL 4, and LANL 5.

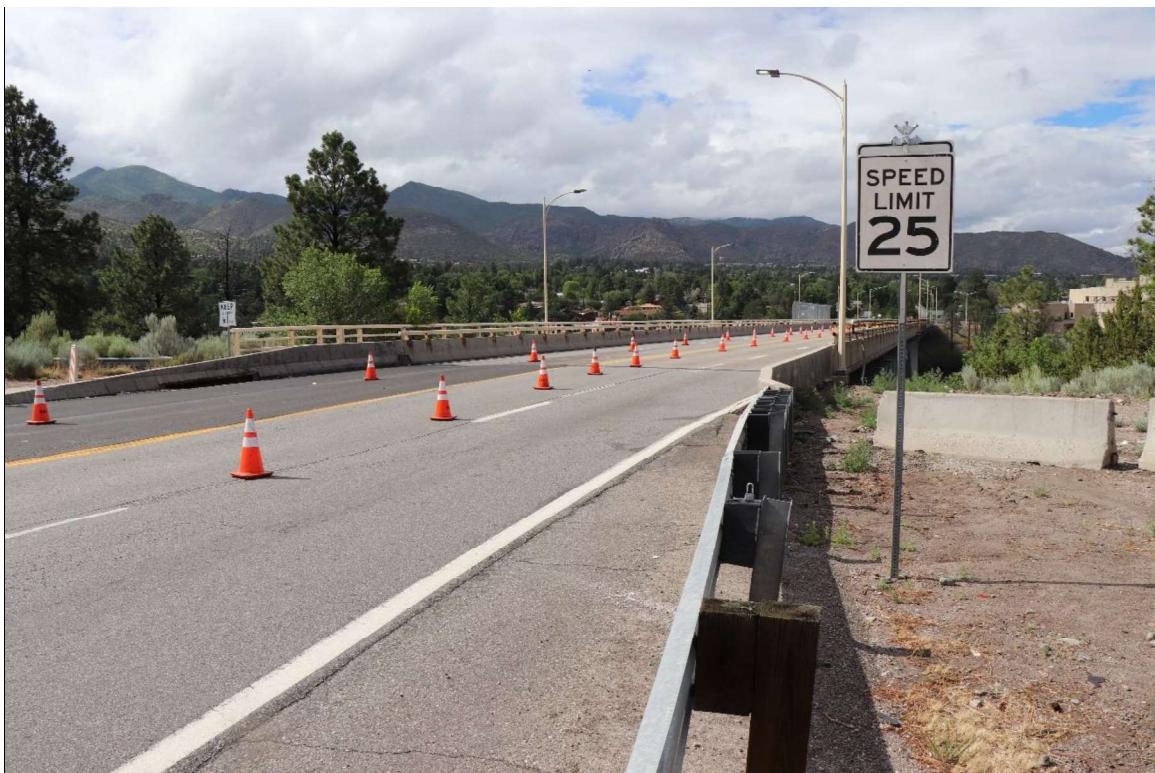
LANL 38 (Picture IMG_6767.jpg)

At the south approach guardrail, collision damage was observed; the steel guardrail was deformed and some of the timber posts were split along their height and/or deformed at the base See pictures LANL 38, LANL 39, and LANL 40.

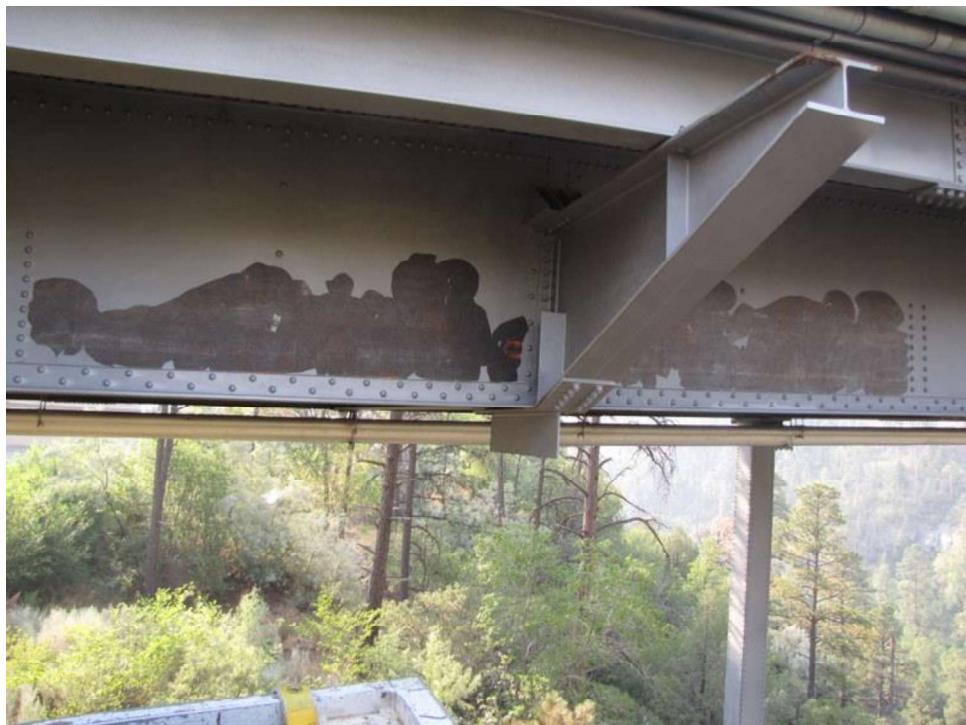
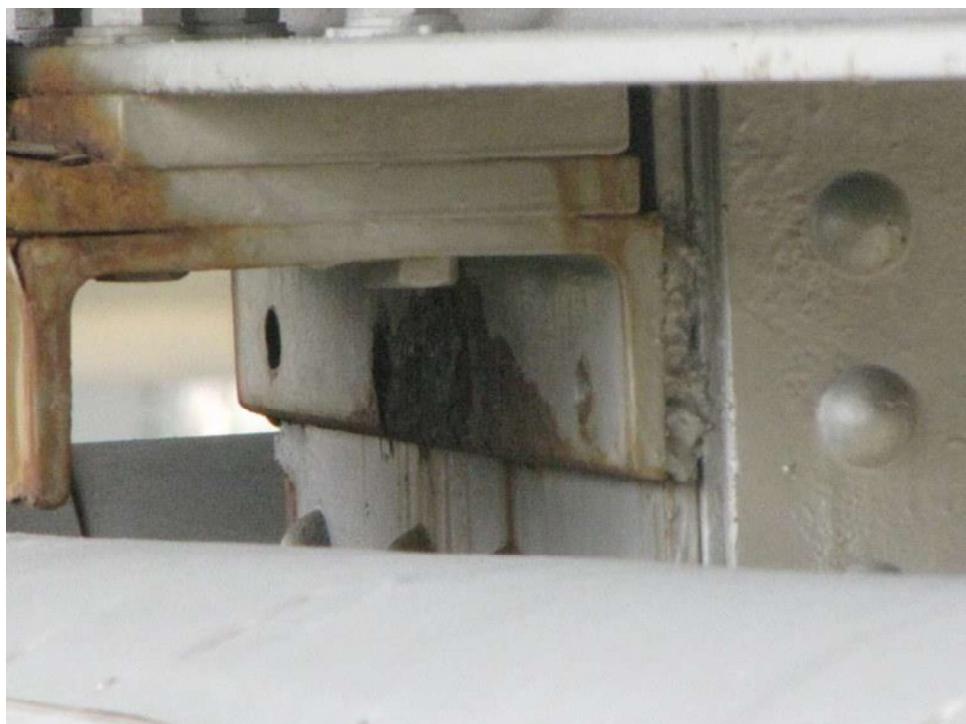
Paint failure on spandrel girder and missing bolts / poor welds at channel connection to spandrel column (2011).

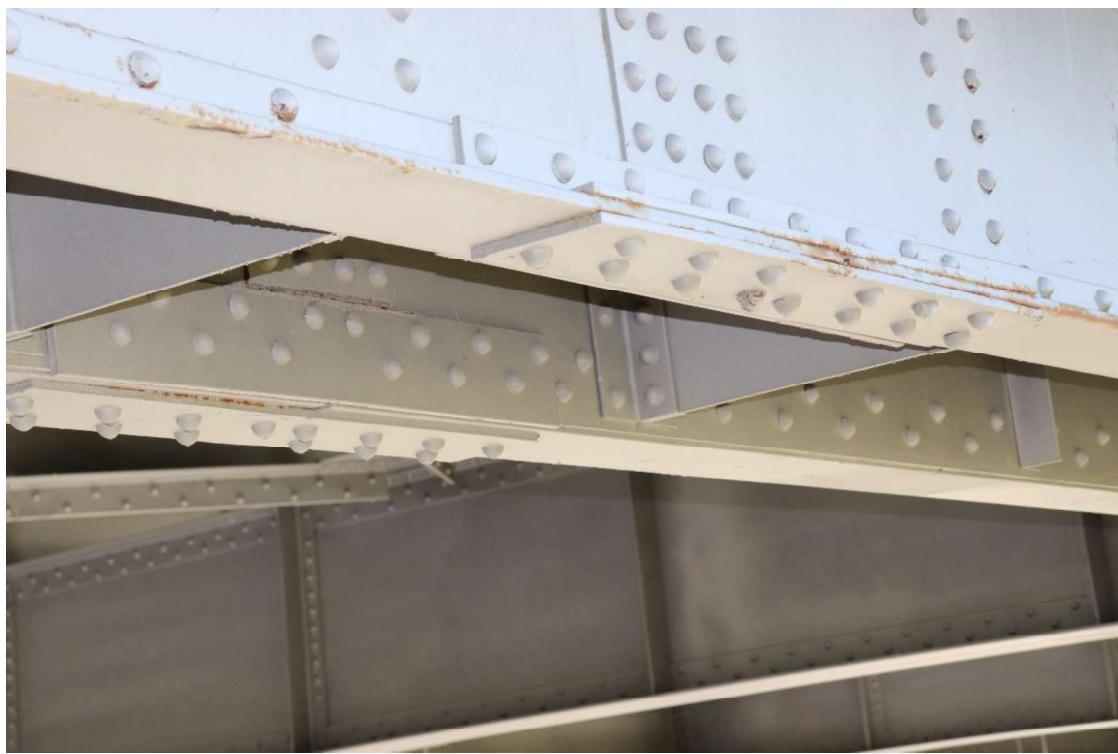
Corrosion and pack rust on bottom flange splice connection at west spandrel girder (IMG_0249).

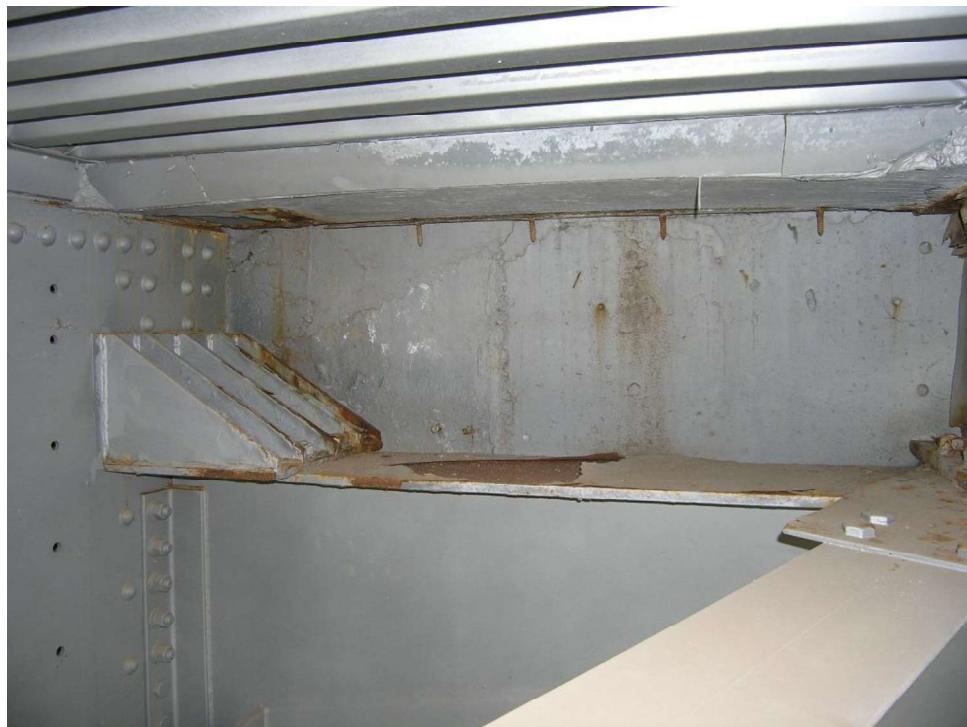
Paint failure and corrosion on west outrigger top flange at south abutment (2014).

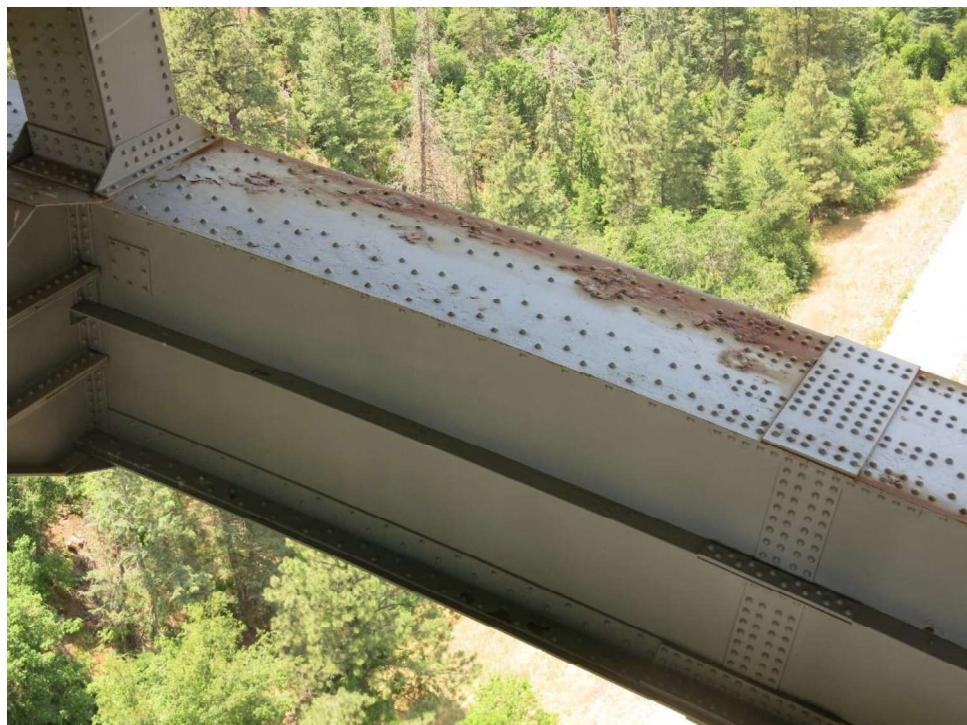
Pack rust at spandrel column to arch rib connections (IMG_8757.jpg [2018]) and corrosion on top flange of arch rib (2017).

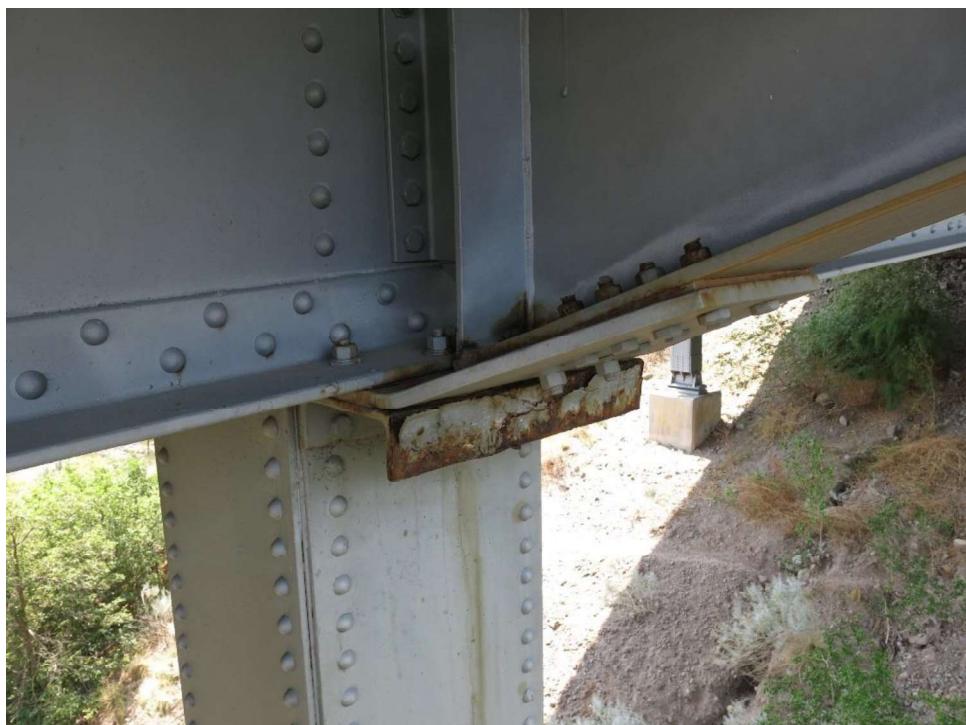
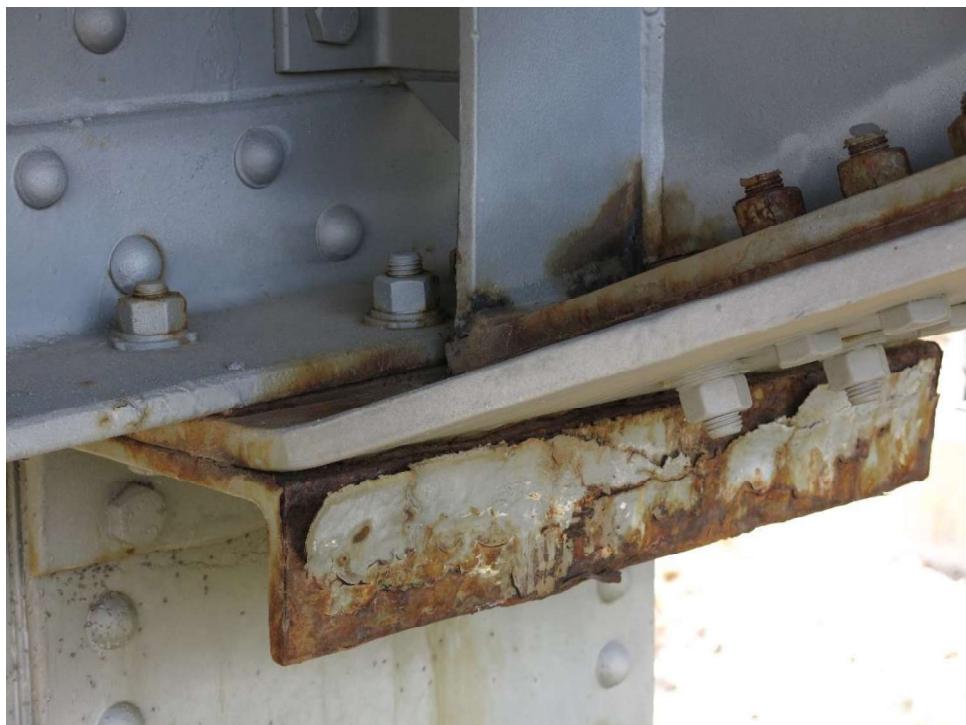
Heavy corrosion at top of spandrel columns (2017).

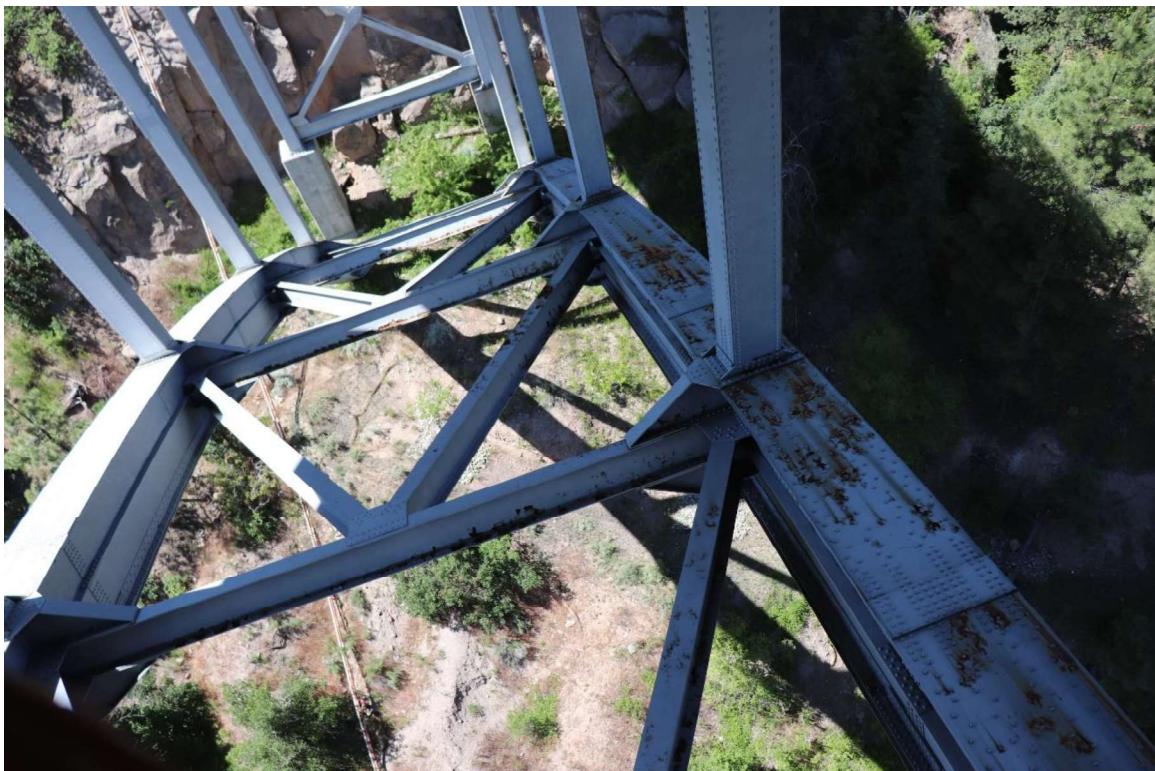
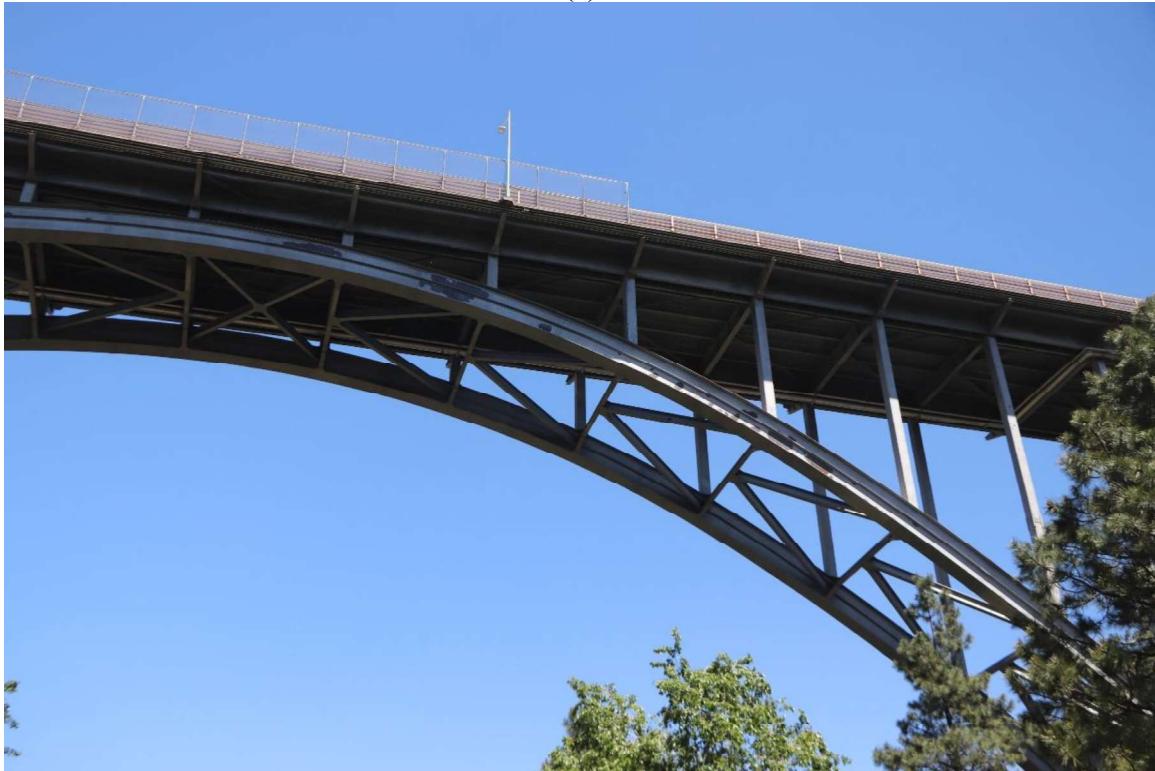
West arch rib (typical): paint failure / corrosion of top plate (IMG_0310) and
paint peeling on web (IMG_0828)

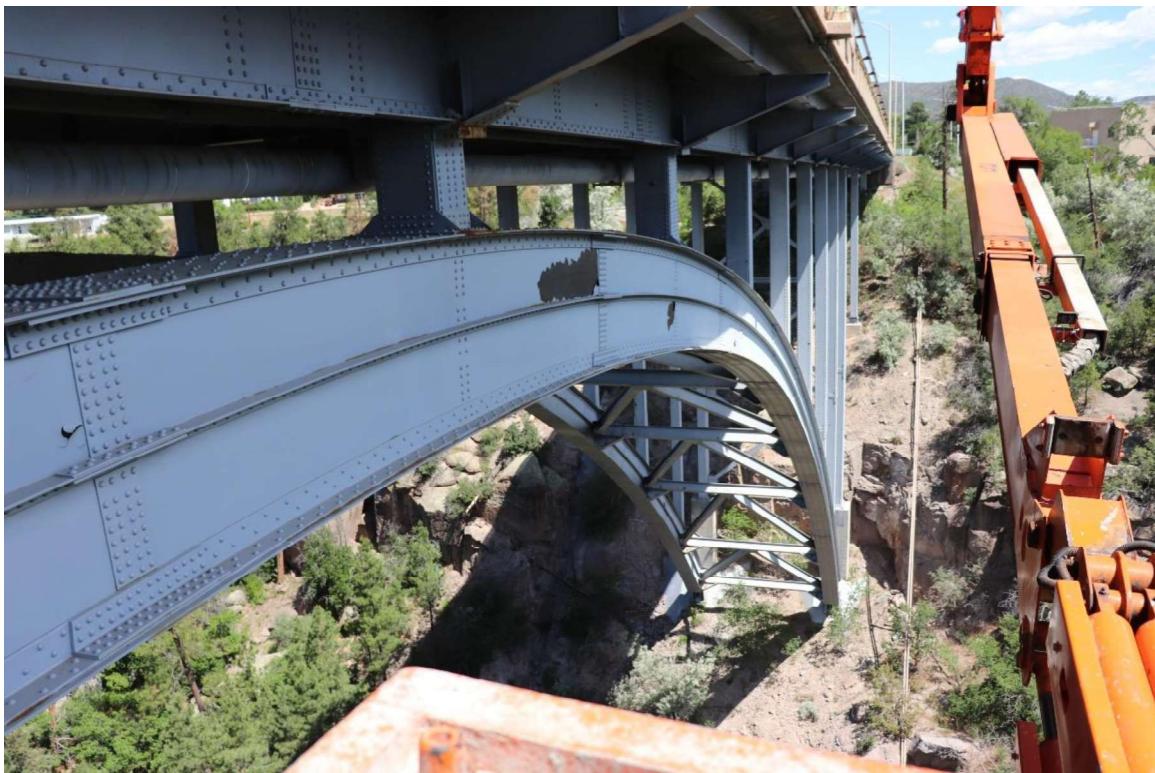
East arch rib (typical): minor paint peeling on web (IMG_0180)

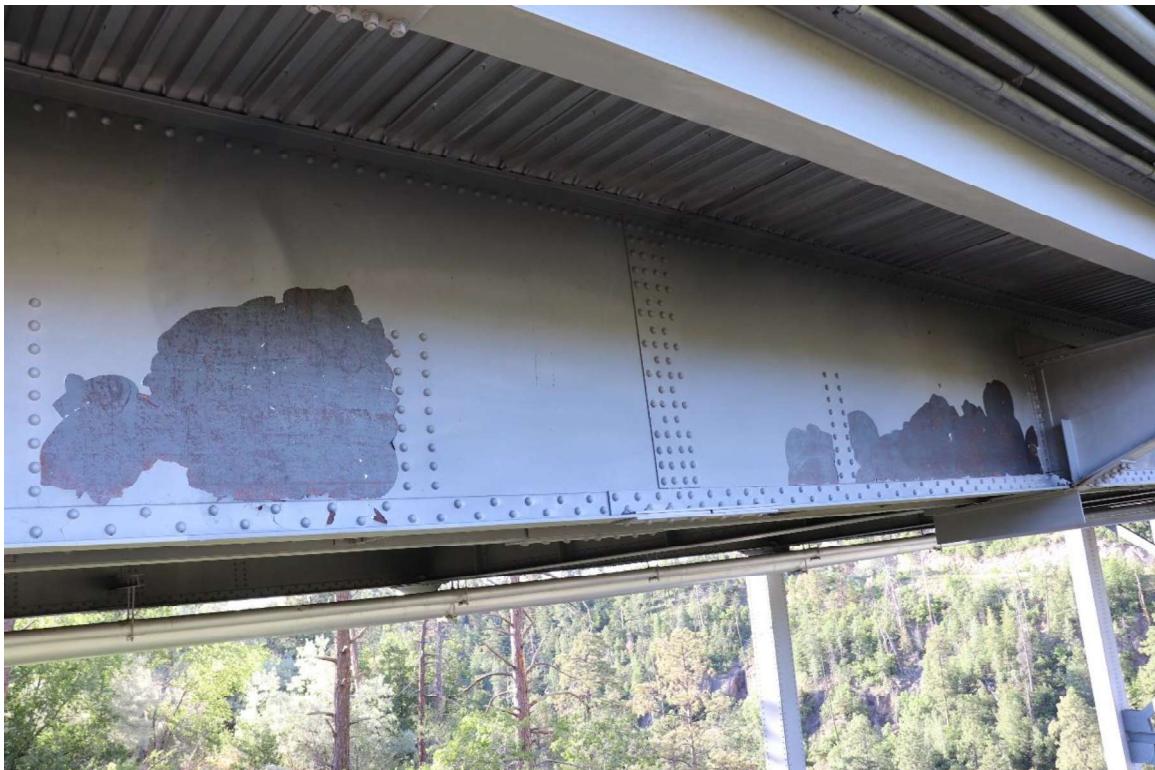
West spandrel girder (typical): paint peeling on web and minor corrosion (IMG_0215)

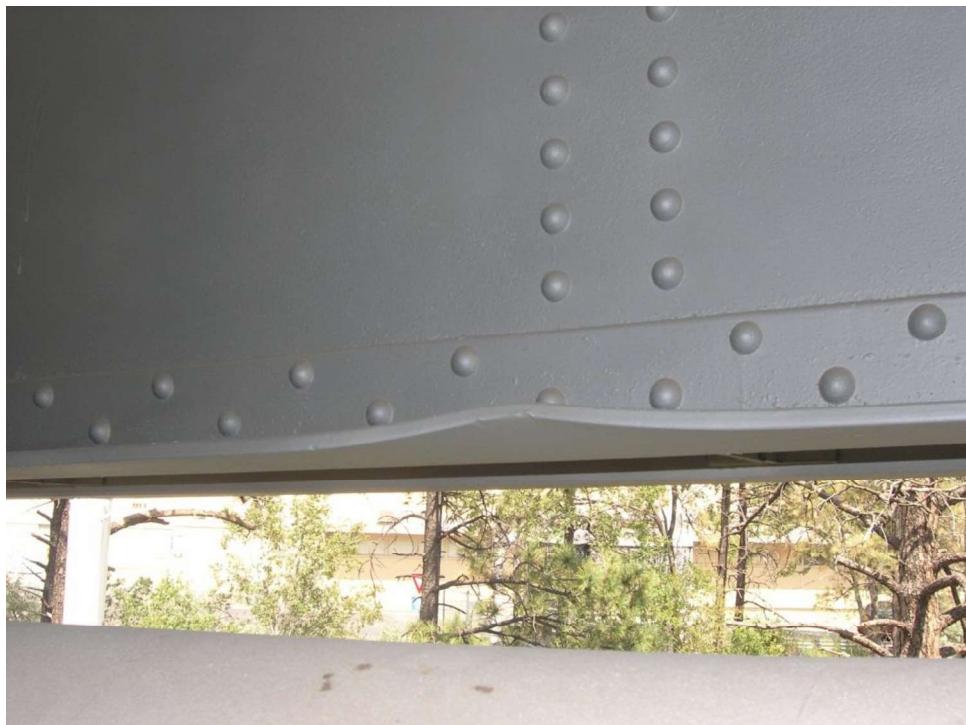
East spandrel girder: impact damage to bottom flange angle (2012)

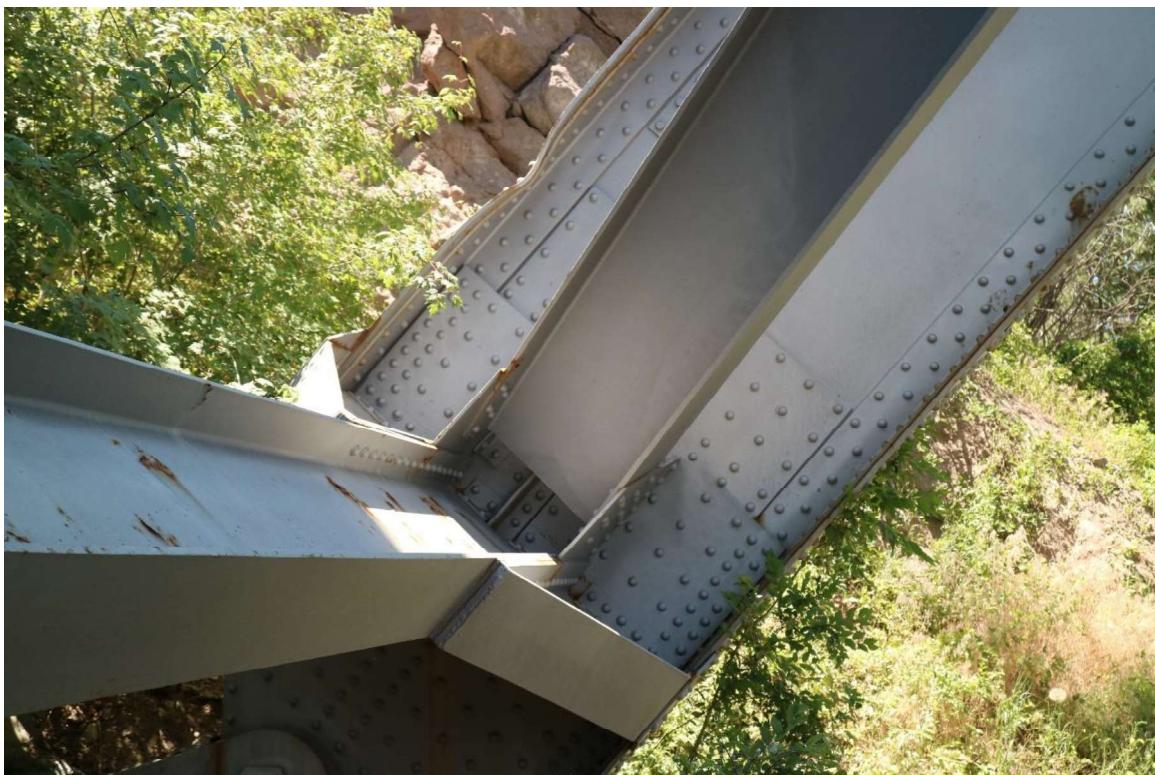
Arch rib: impact damage to top plate (IMG_3771 [2018])

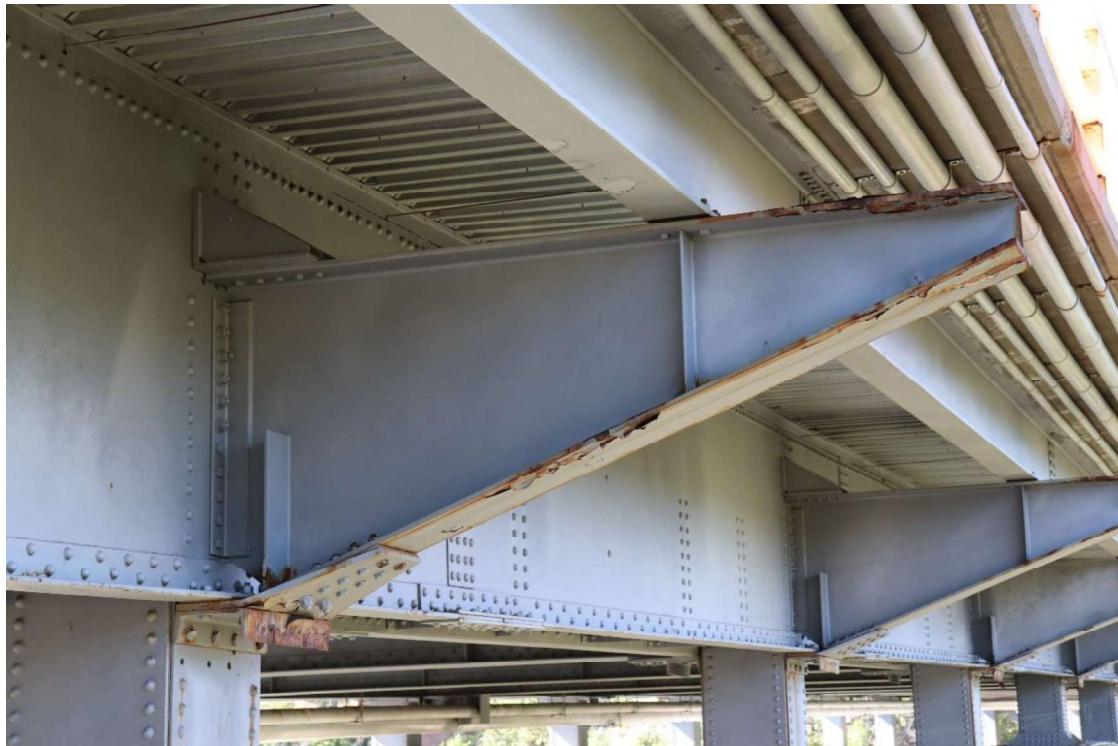
West outrigger beam (typical): paint failure / moderate corrosion of beam and corrosion / pack rust / distortion at bottom channel connection to column (IMG_0262)

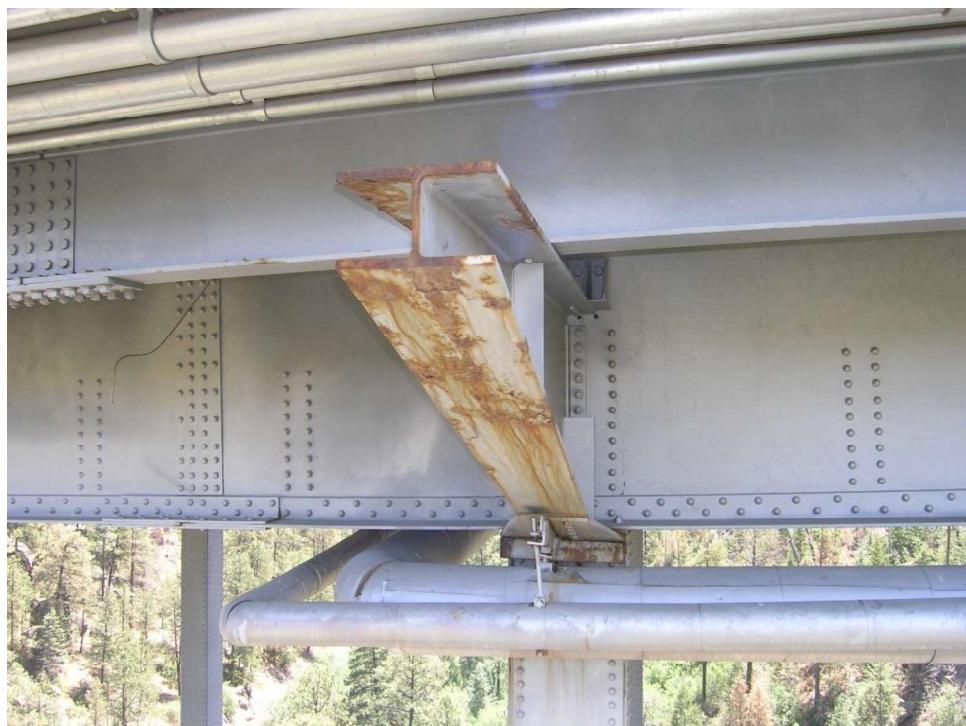
West outrigger beam (typical): paint failure / heavy corrosion of beam and corrosion / pack rust / distortion at bottom channel connection to column (2013)

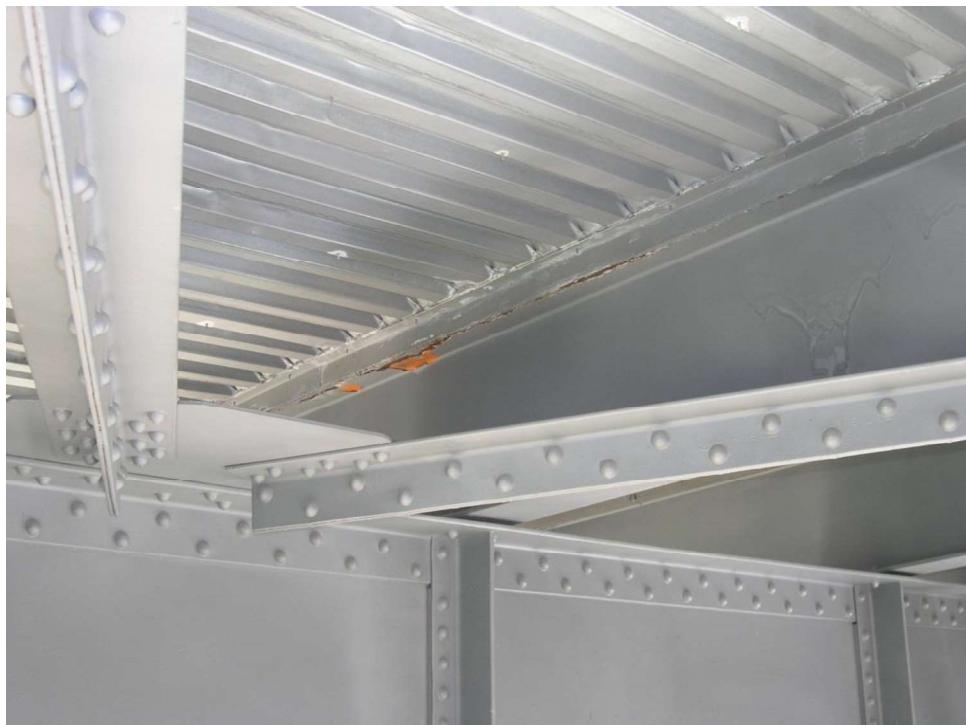
Stringer: note leaching, paint failure, and corrosion at top flange (2012)

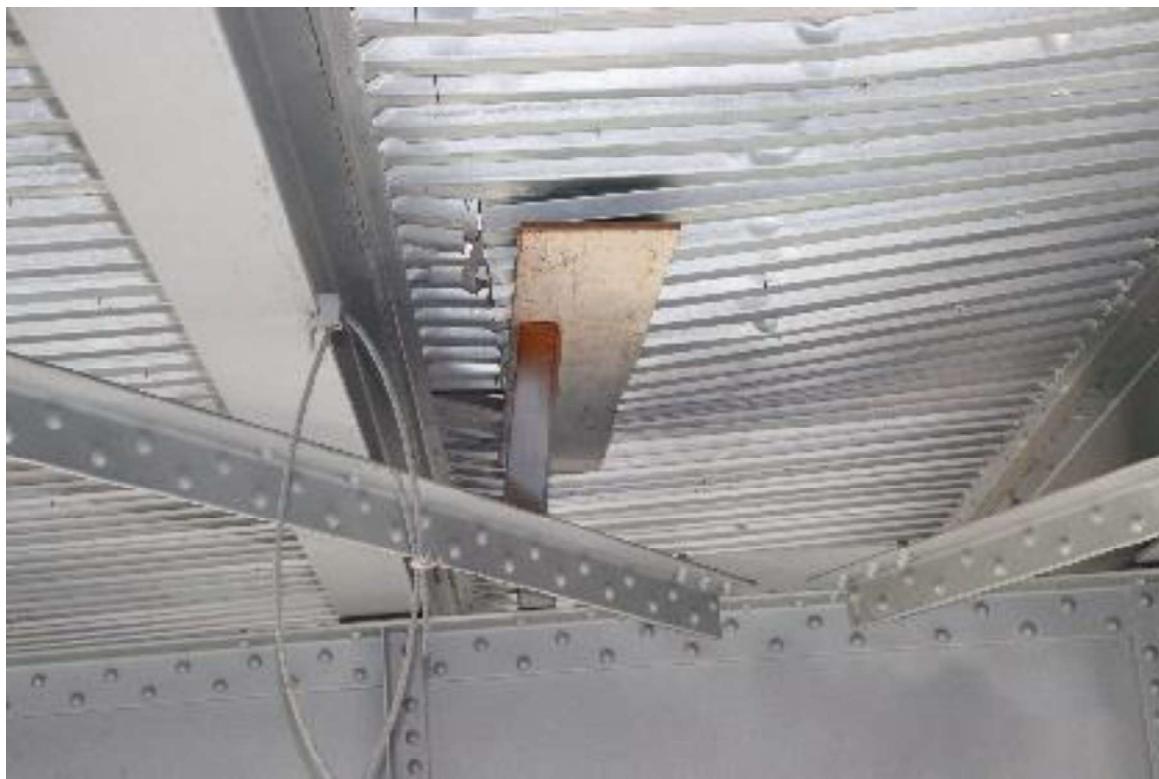
Stay-in-place forms: note haphazard support by timber shoring (IMG_0173)

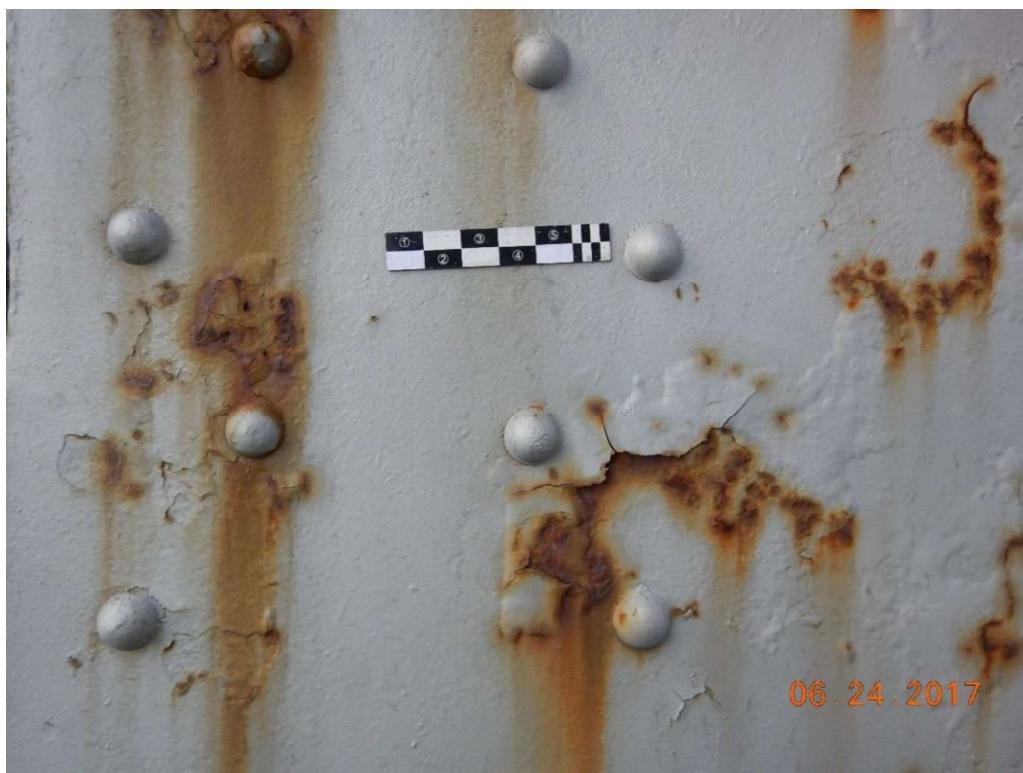
East Arch, typical paint peeling/cracking and surface corrosion on top flange

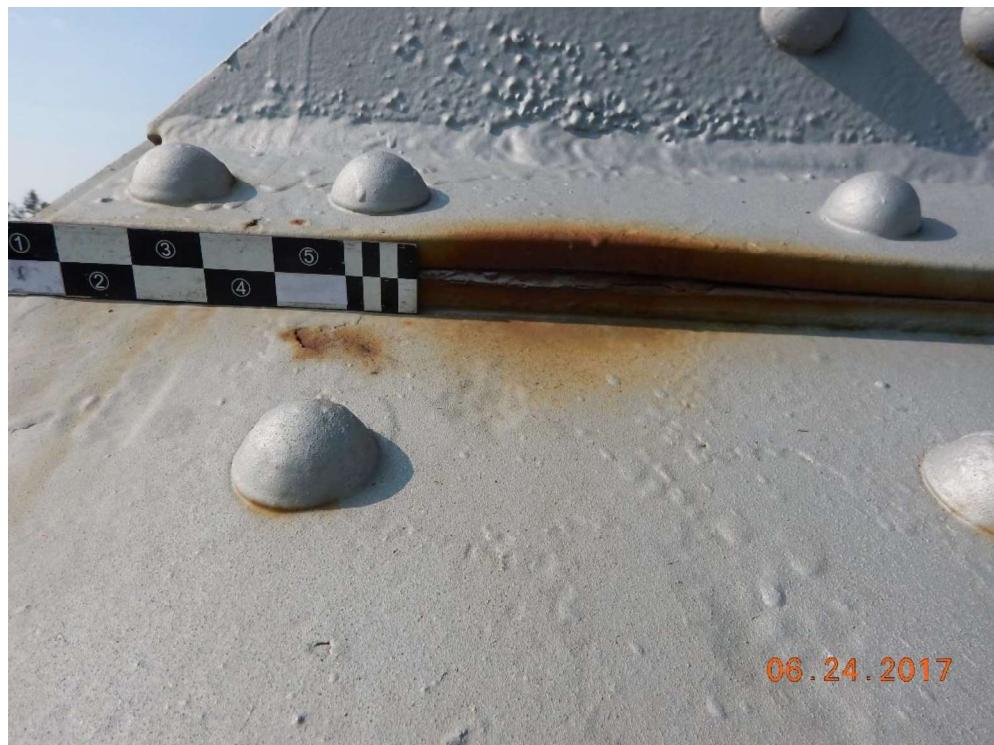
East arch, column 14, 1/16" pack rust at base

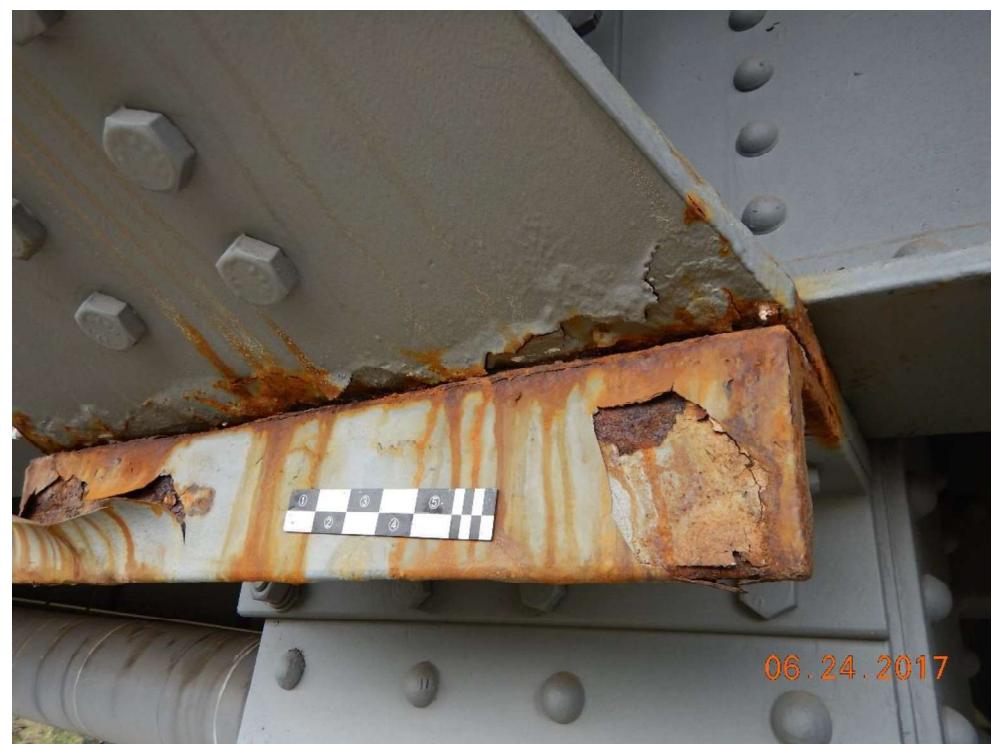
East arch, column 8, knee brace at floorbeam 15, outside face, typical corrosion

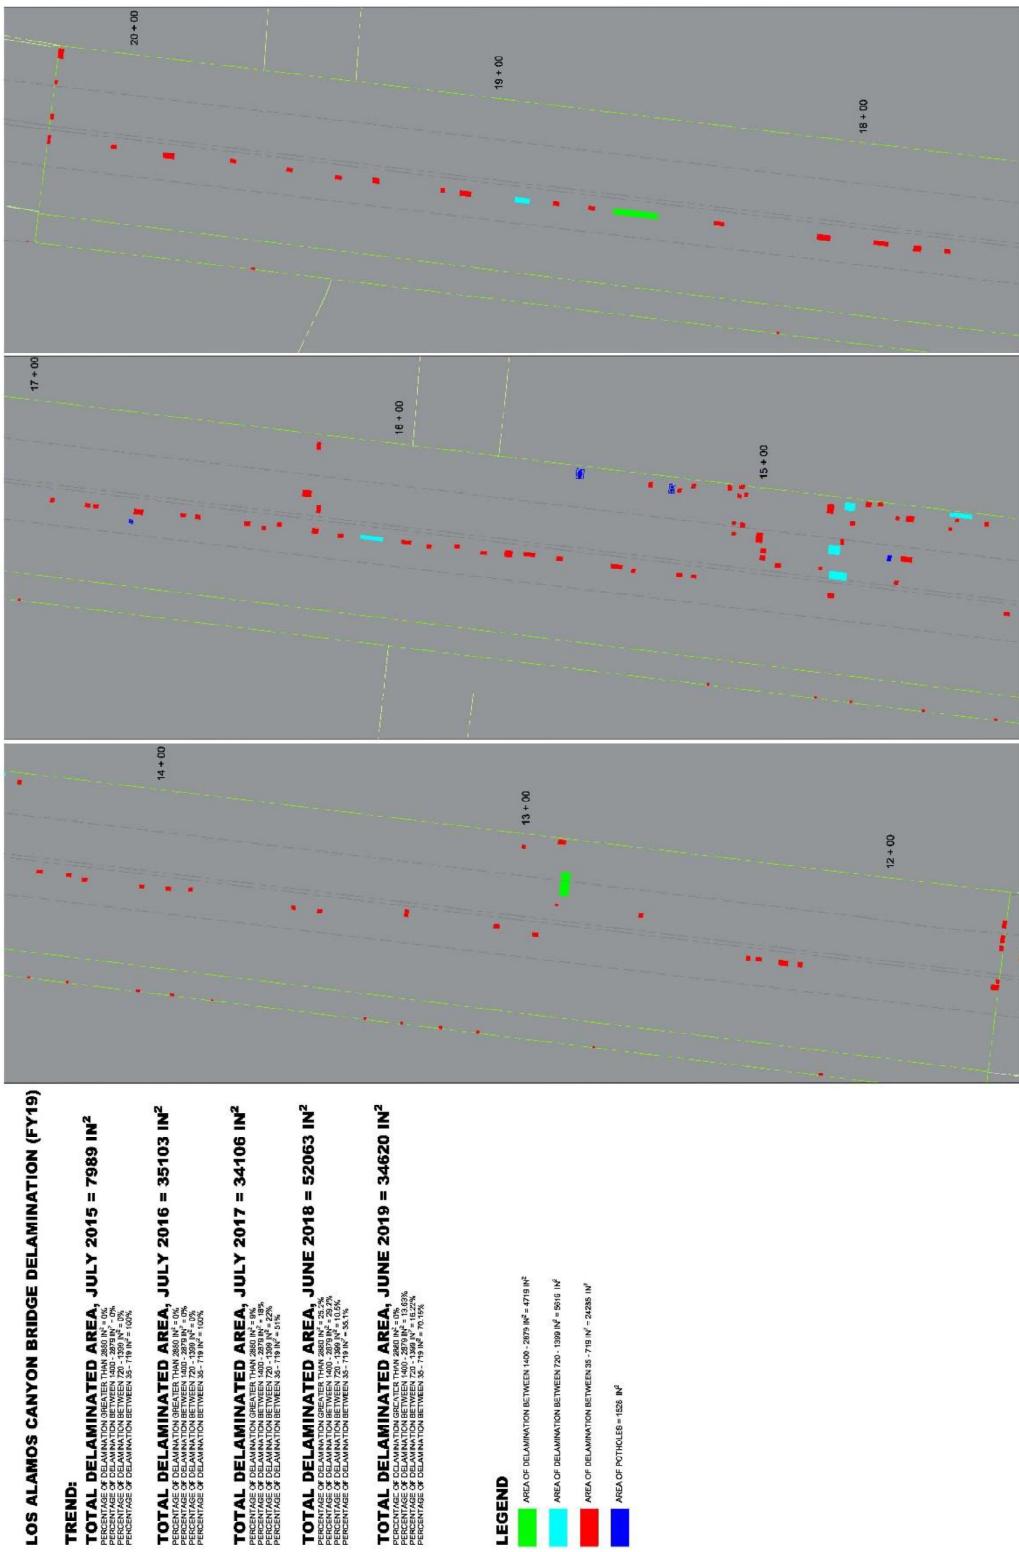
2019 Delamination map

Based on the 2019 inspection, the bridge deck is rated in “fair” condition. Chain dragging the deck identified several areas with delamination. The delaminations are concentrated near the expansion joints, in the closure joint of the deck near the bridge centerline, and at the south end northbound lanes. The chain drag performed during the 2019 inspection revealed 34,620 sq. in. (240 sq. ft.) of delaminations (not including the sidewalk). It is recommended that the delaminations and spalls with exposed rebar be repaired. The “delaminated area” map for the 2019 inspection is provided in the supplemental report.
