Title: 43-0434 Bridge Inspection Report 2022

Routine & Fracture Critical Member (FCM) Inspection Report (Interim)

Property ID No. 43-0434 – Los Alamos Canyon Bridge

Inspection Date: September 23 - 25, 2022

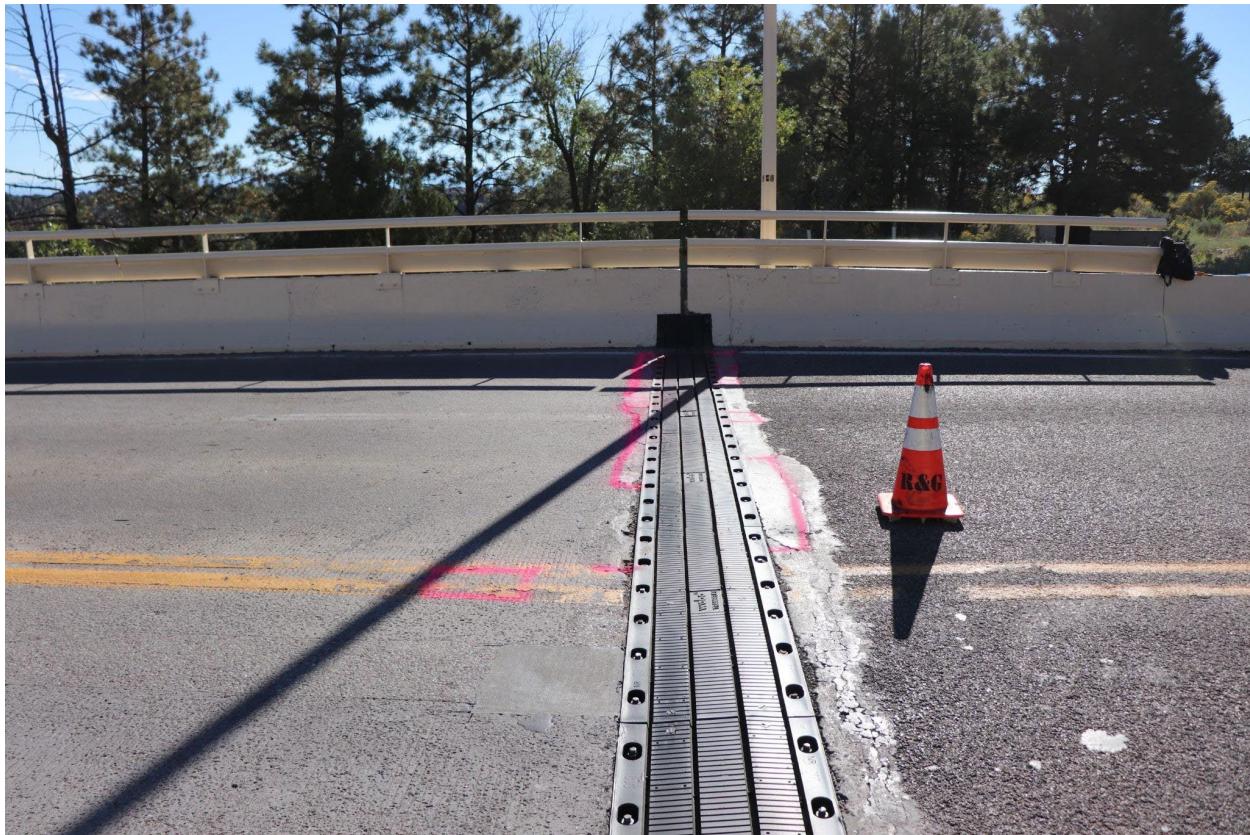
LANL 2 (IMG_7112.jpg)

The **deck edges** adjacent to the east and west bridge barriers have light map cracking, light leaching, and several small spalls. This condition is likely caused by water runoff which drains transversely in the east and west directions and then from the south to north end of the bridge. Installation of new north and south joints was being completed during the time of the 2022 inspection. See pictures LANL 1, LANL 2, and LANL 3 (south joint), and LANL 4 (north joint).

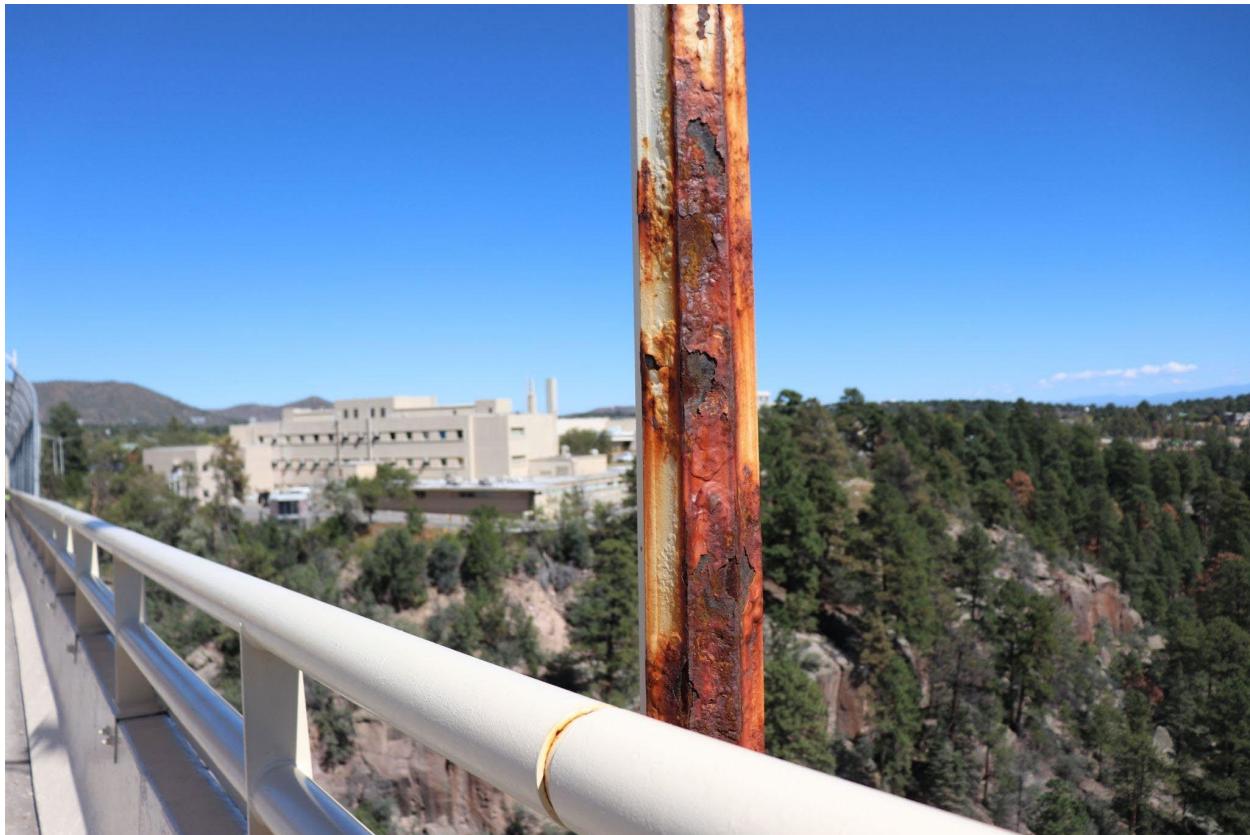
LANL 7 (IMG_7214.jpg)

The light poles and supports also have corrosion. See pictures LANL 7 and LANL 8.

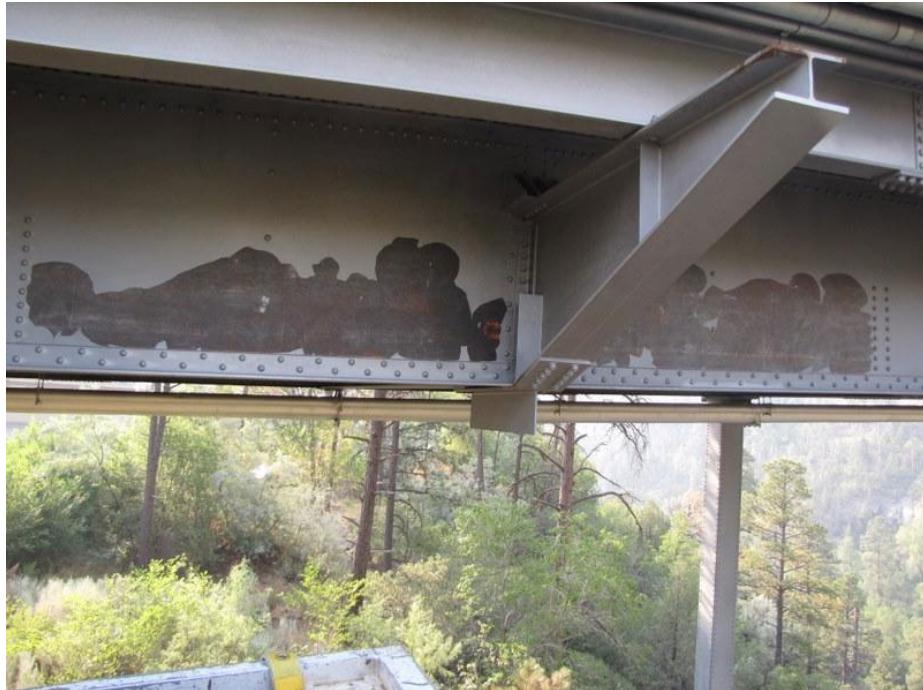
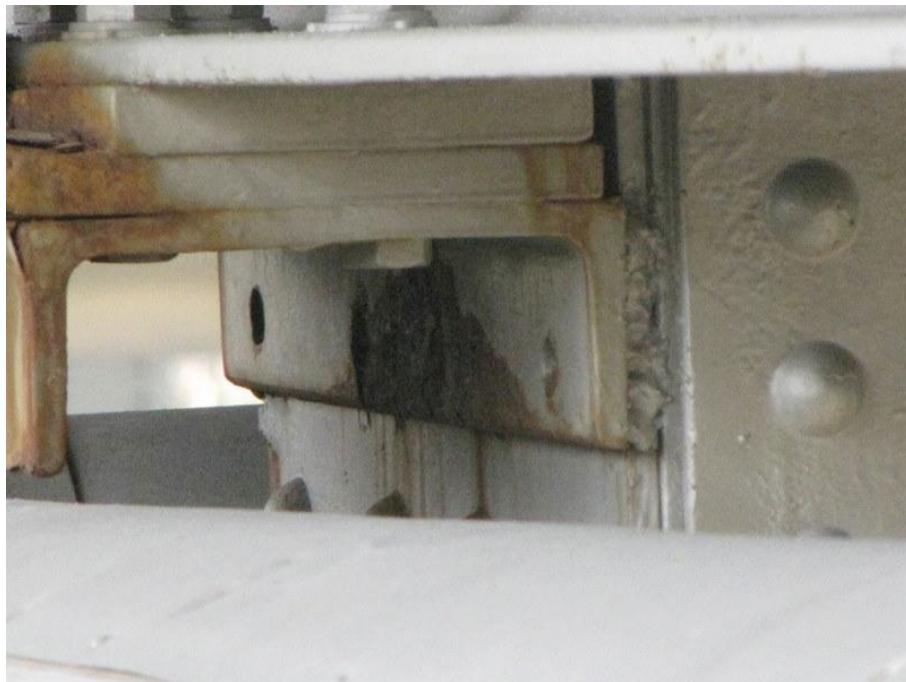
LANL 17: Paint failure on spandrel girder and missing bolts / poor welds at channel connection to spandrel column (2011).

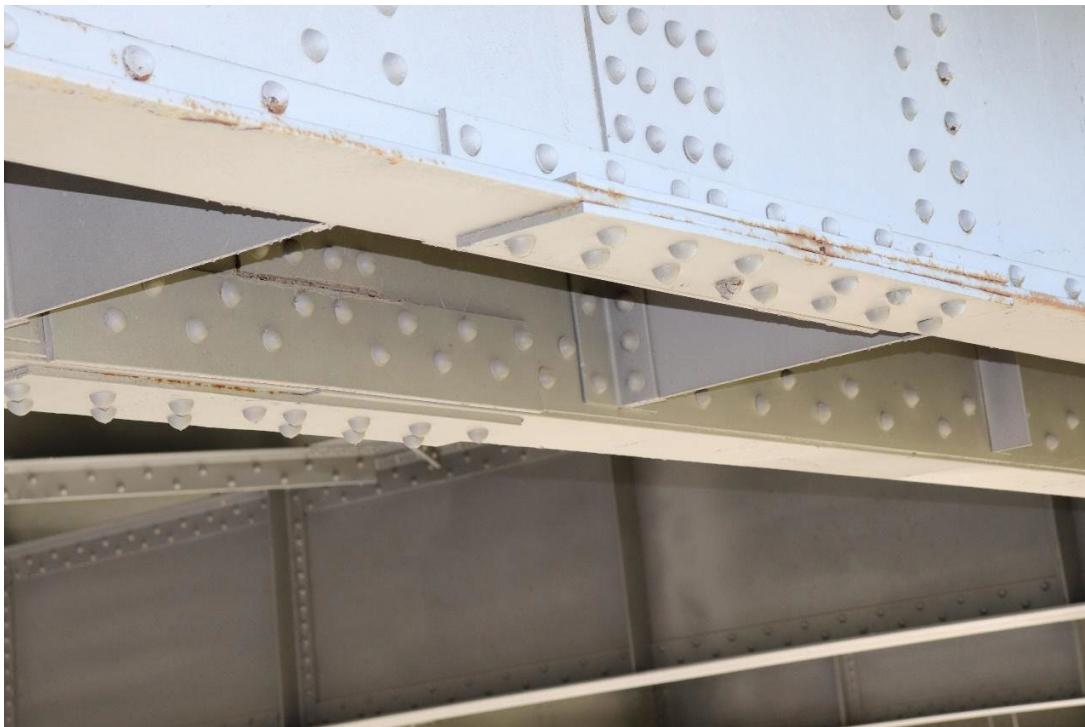
LANL 18A: Corrosion / pack rust on BF splice connection at west spandrel girder (2014).

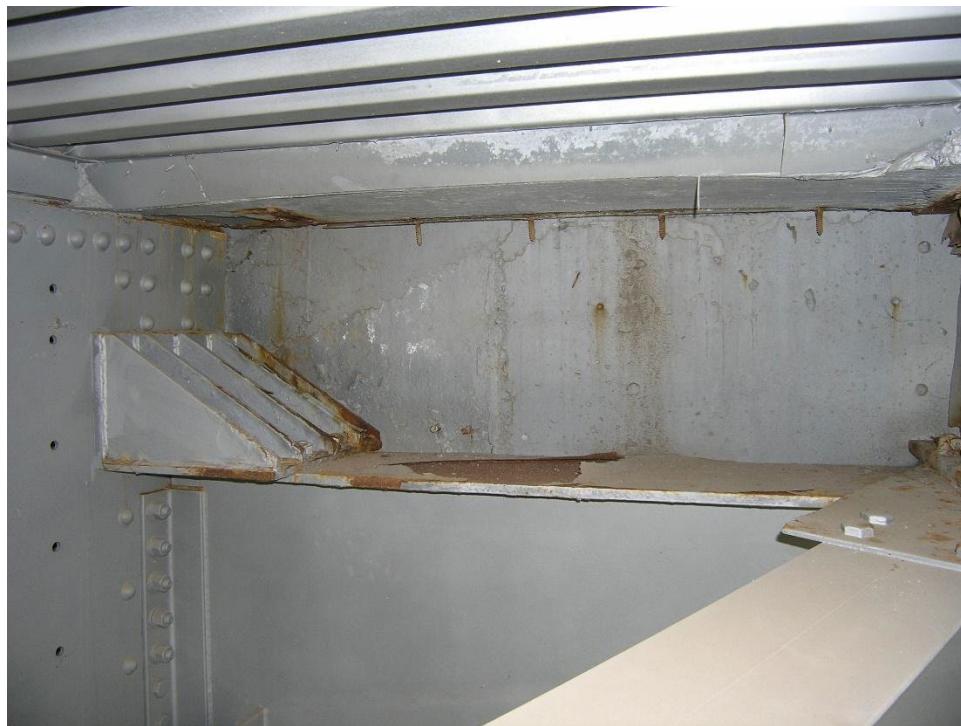
LANL 18B: Paint failure / corrosion on west outrigger TF at south abutment (2014).

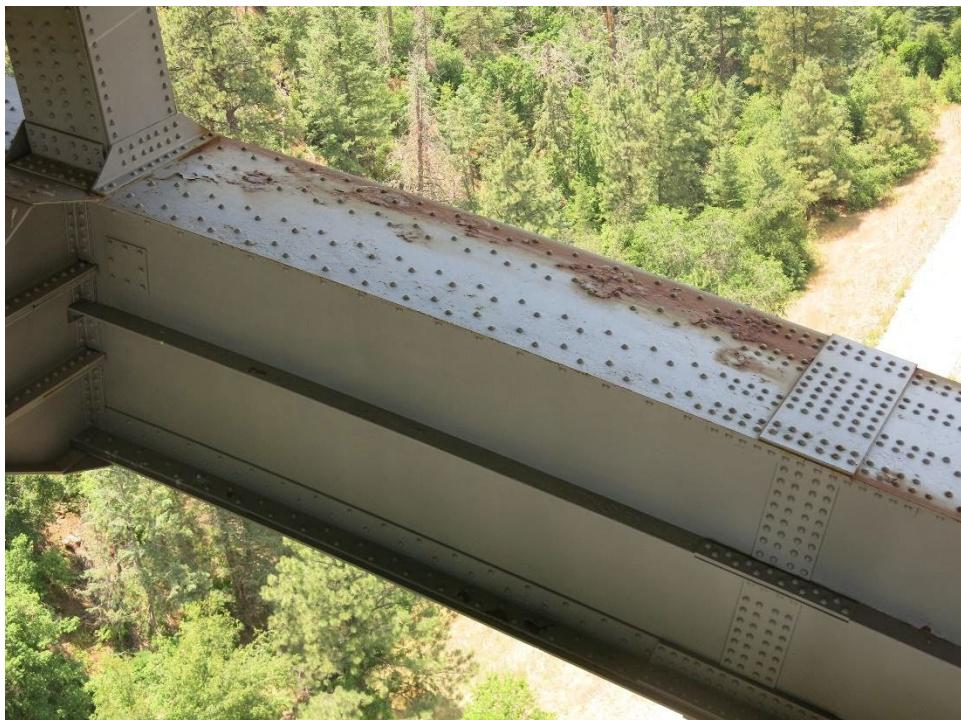
LANL 21: Pack rust at spandrel column to arch rib connections (2018) and corrosion on top flange of arch rib (2017).

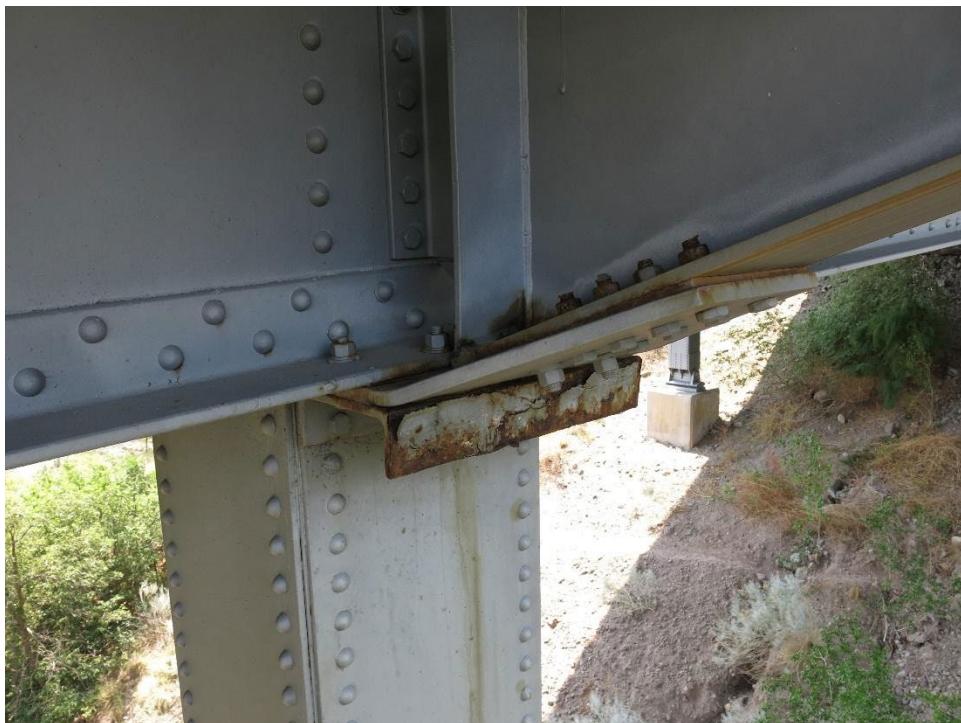
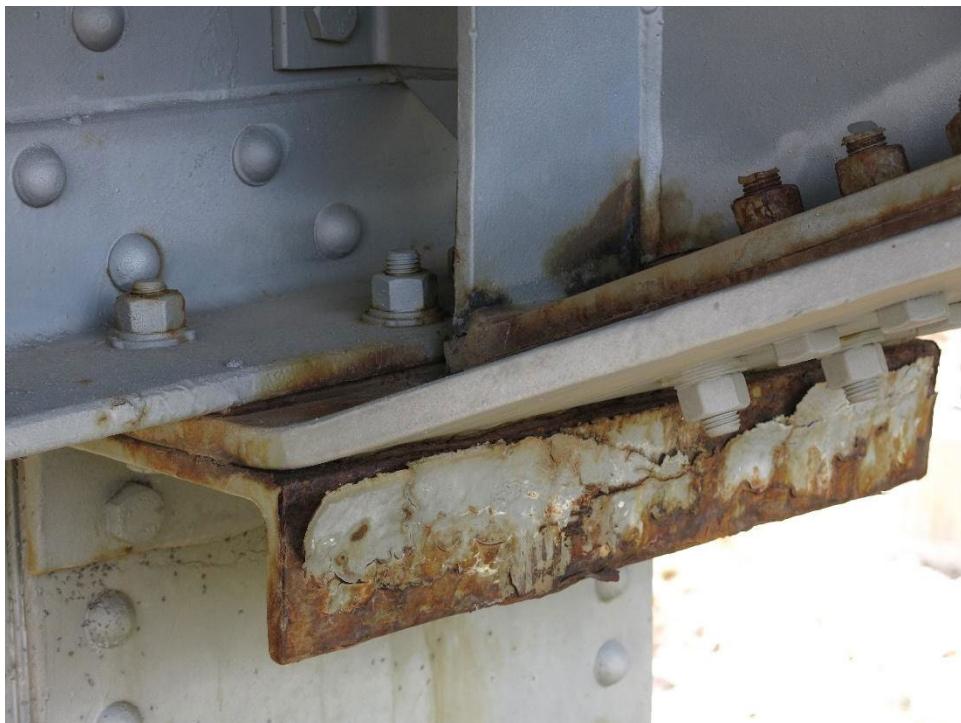
LANL 22: Heavy corrosion at top of spandrel columns (2017).

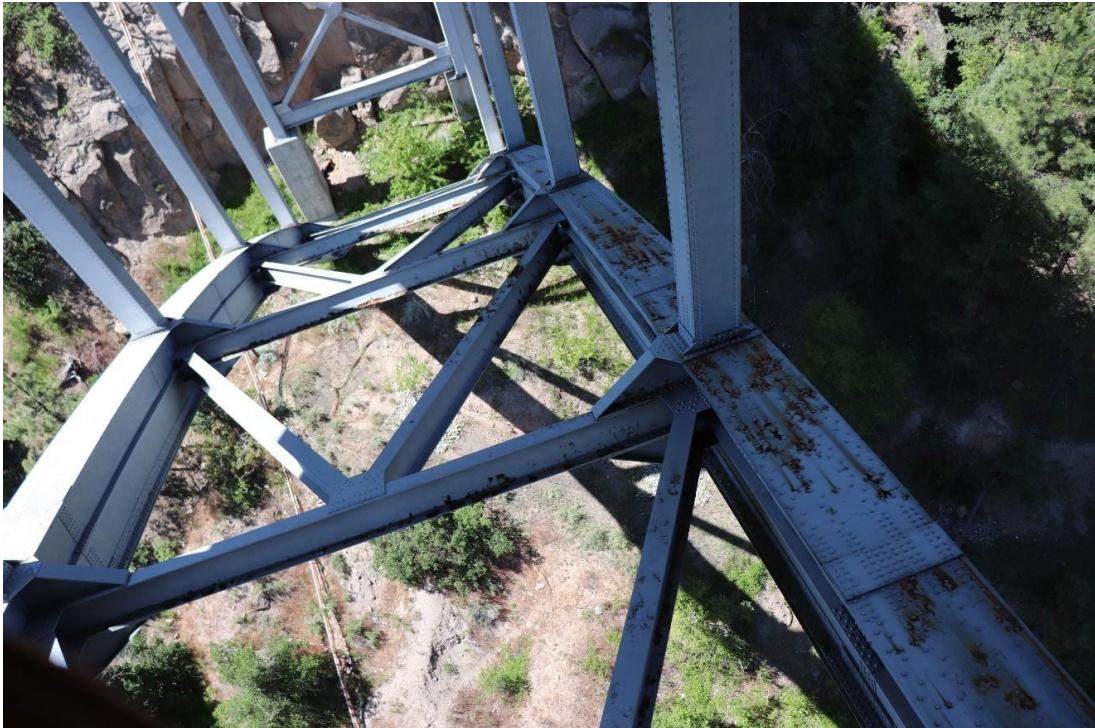
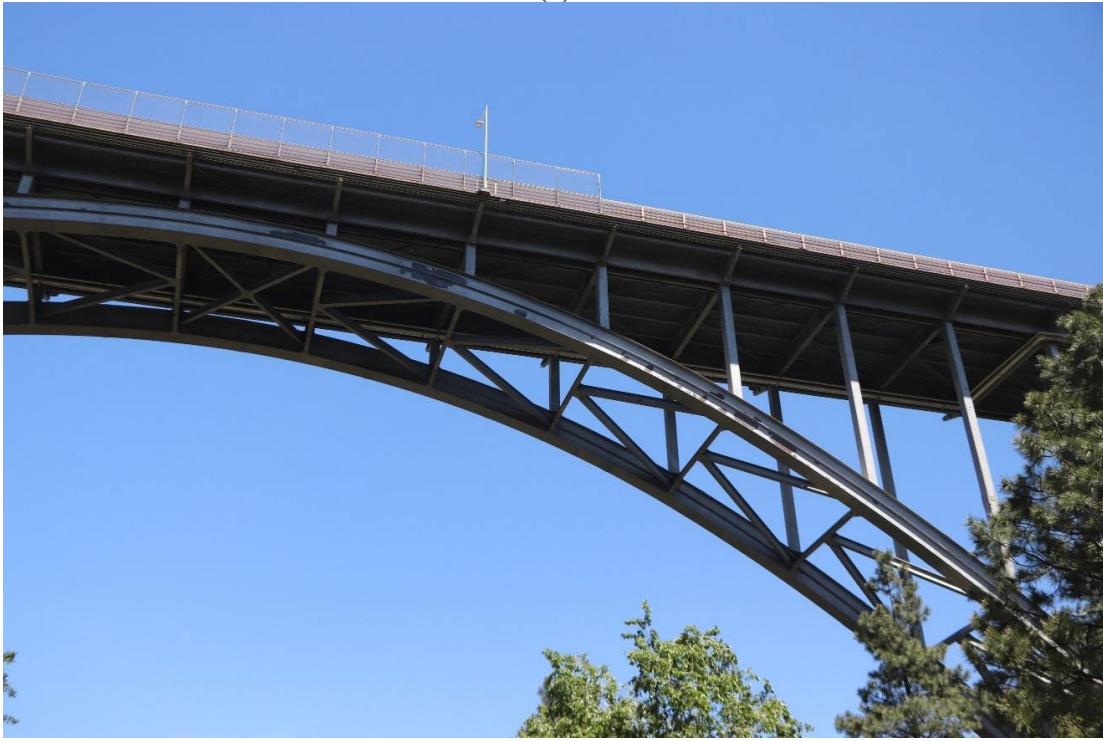
LANL 23: West arch rib (typical): paint failure / corrosion of top plate and paint peeling on web.

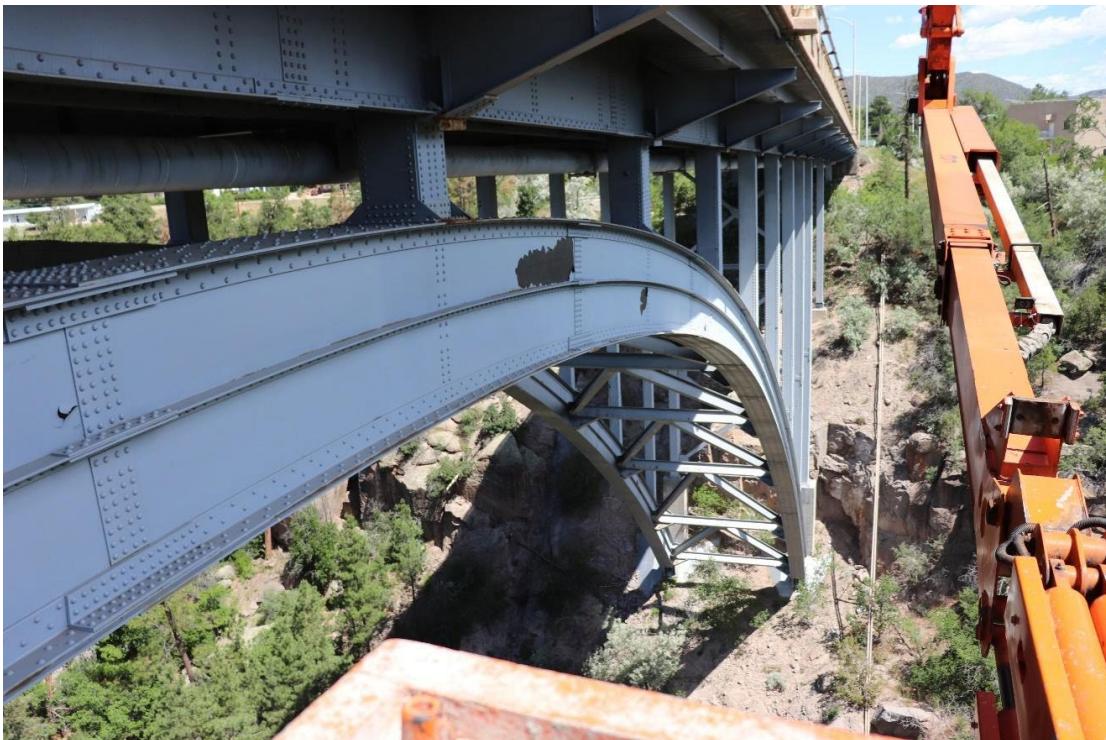
(a) East arch rib (typical): minor paint peeling on web

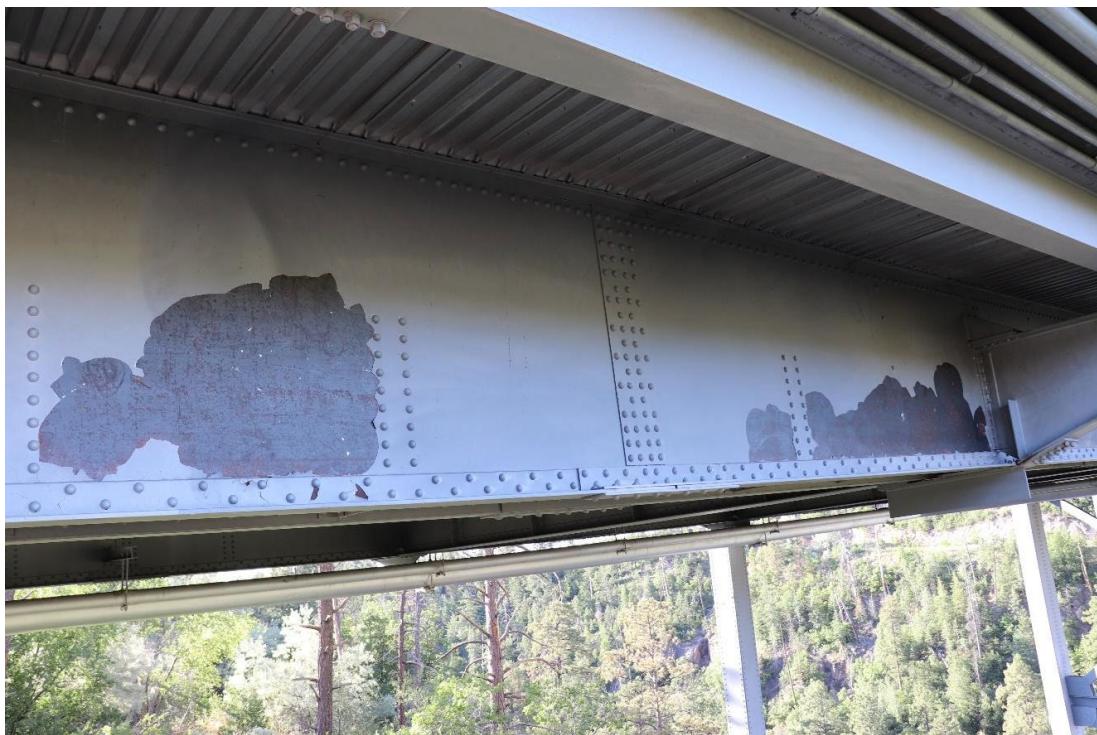
LANL 24: (b) West spandrel girder (typical): paint peeling on web and minor corrosion

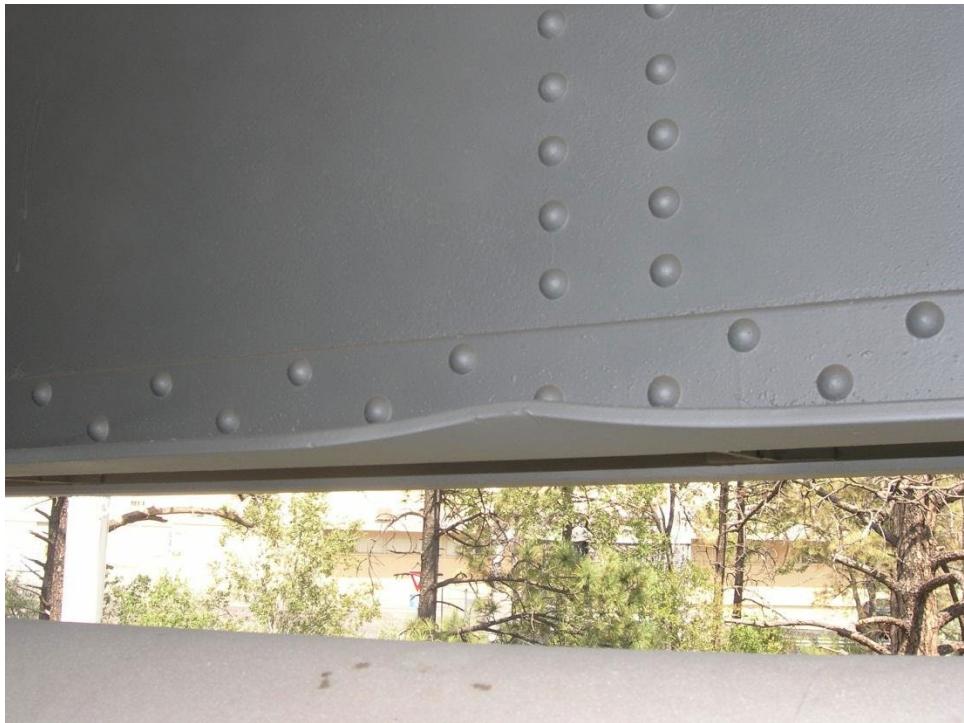
(a) East spandrel girder: impact damage to bottom flange angle (2012)

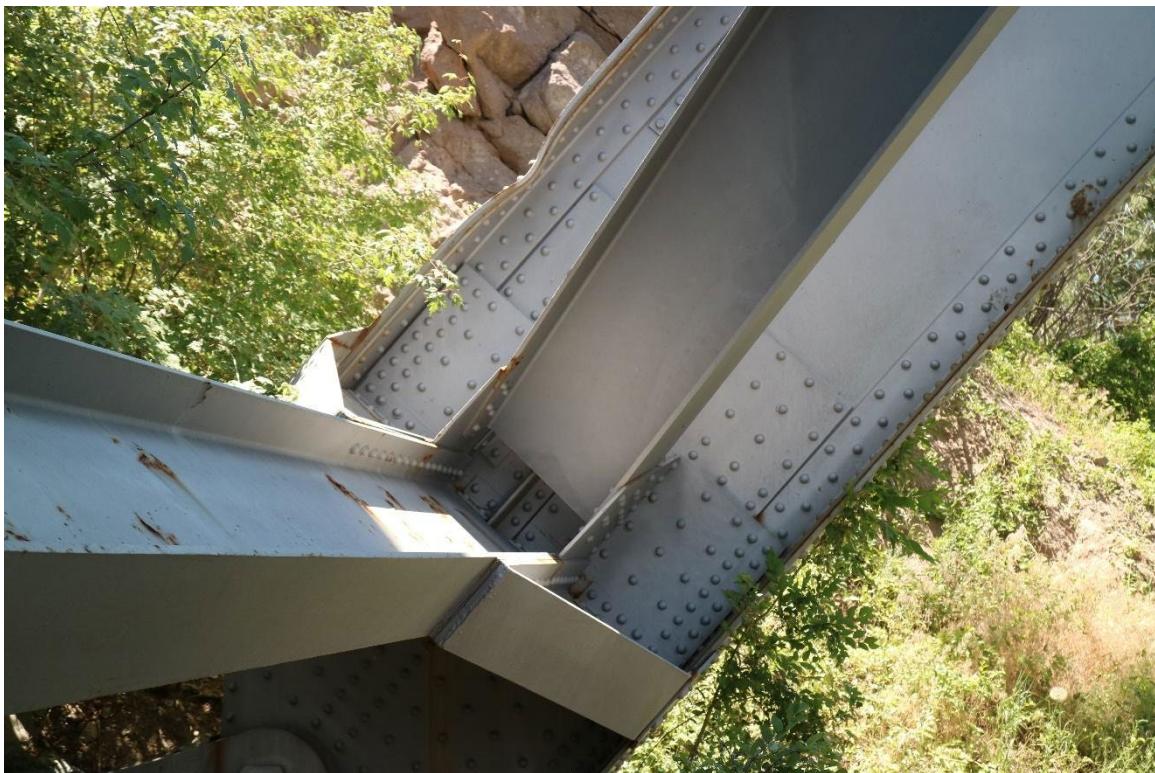
LANL 25: (b) Arch rib: impact damage to top plate (2018)

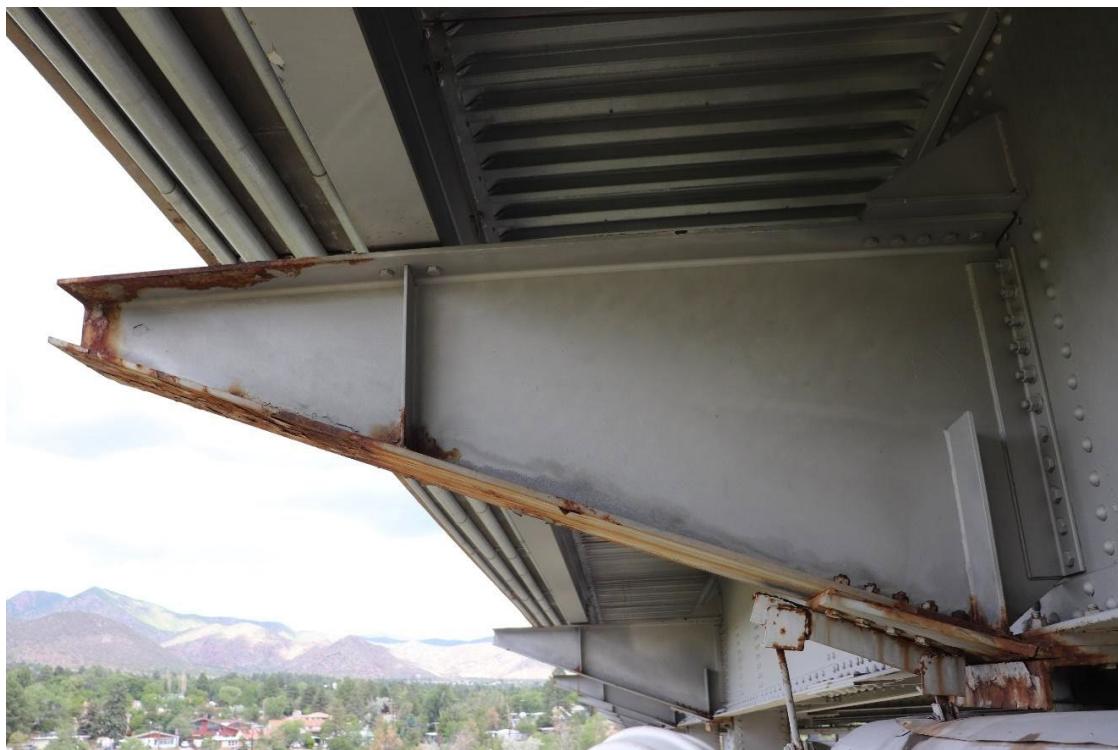
(a) West outrigger beam (typical): paint failure / moderate corrosion of beam and corrosion / pack rust / distortion at bottom channel connection to column

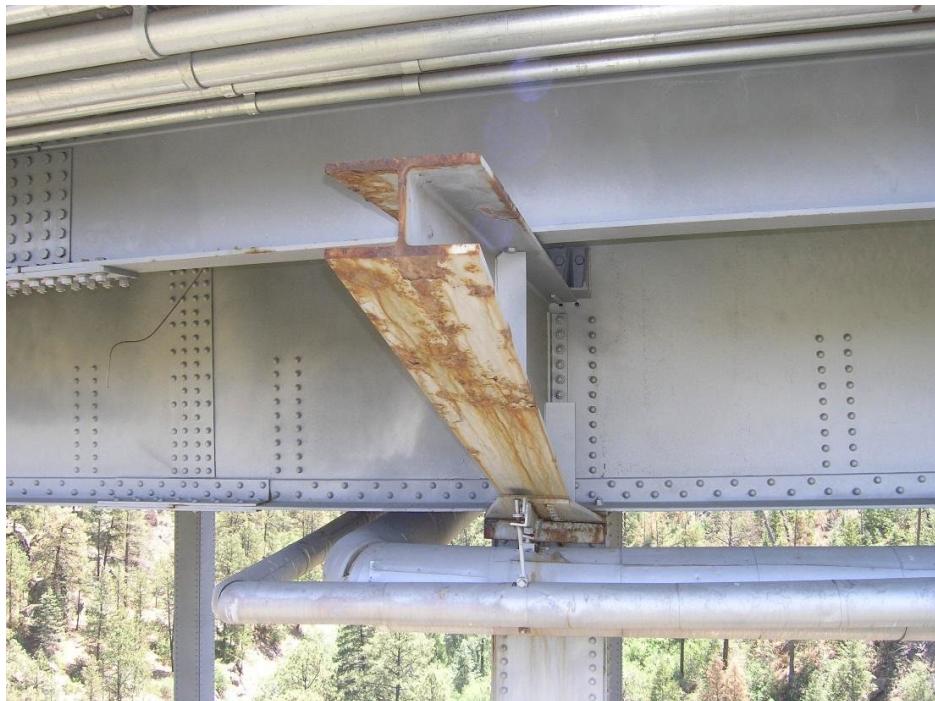
LANL 26: (b) West outrigger beam (typical): paint failure / heavy corrosion of beam and corrosion / pack rust / distortion at bottom channel connection to column (2013)

- Repair the outriggers with special attention to those with significant section loss.
- Repair the deck locations with delaminations and spalls.
- Repaint and continue to clean movable bearings at abutments.
- Repair corroded light poles.
- Perform ultrasonic testing of pins at abutment, pier, and arch bearings.
- Repaint arch ribs and outriggers (including connections).
- Measure section loss on members with moderate to heavy corrosion.

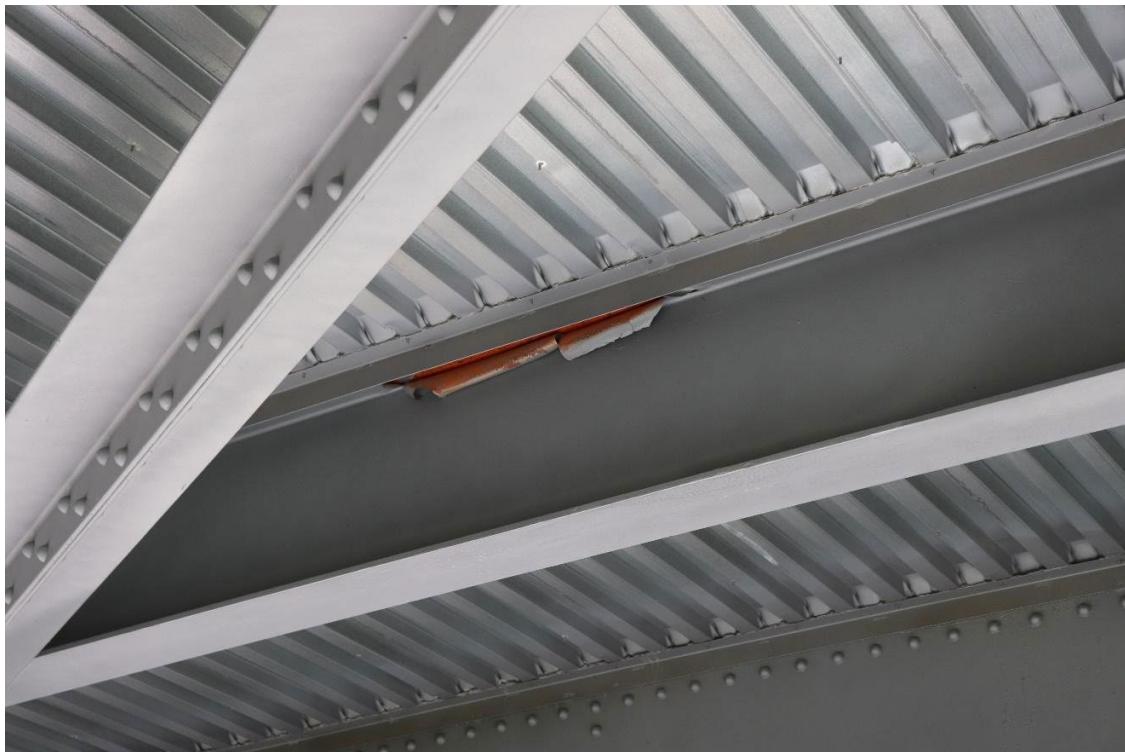
(a) Stringer: note leaching, paint failure, and corrosion at top flange

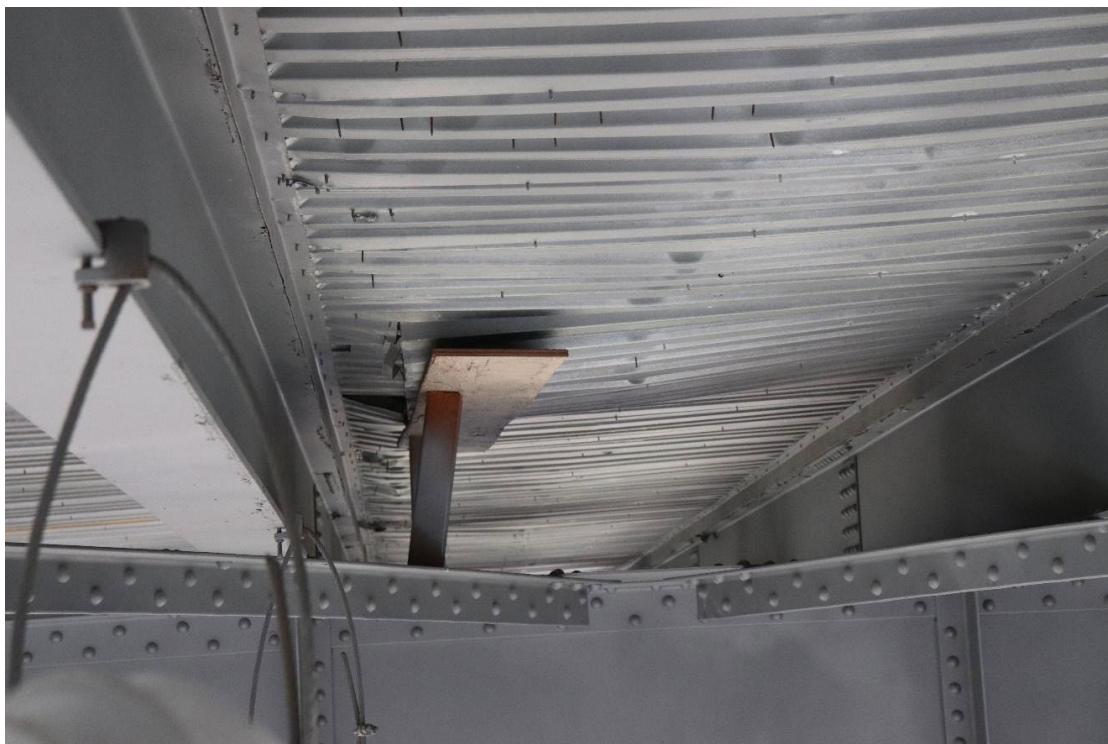
LANL 27: (b) Stay-in-place forms: note haphazard support by timber shoring

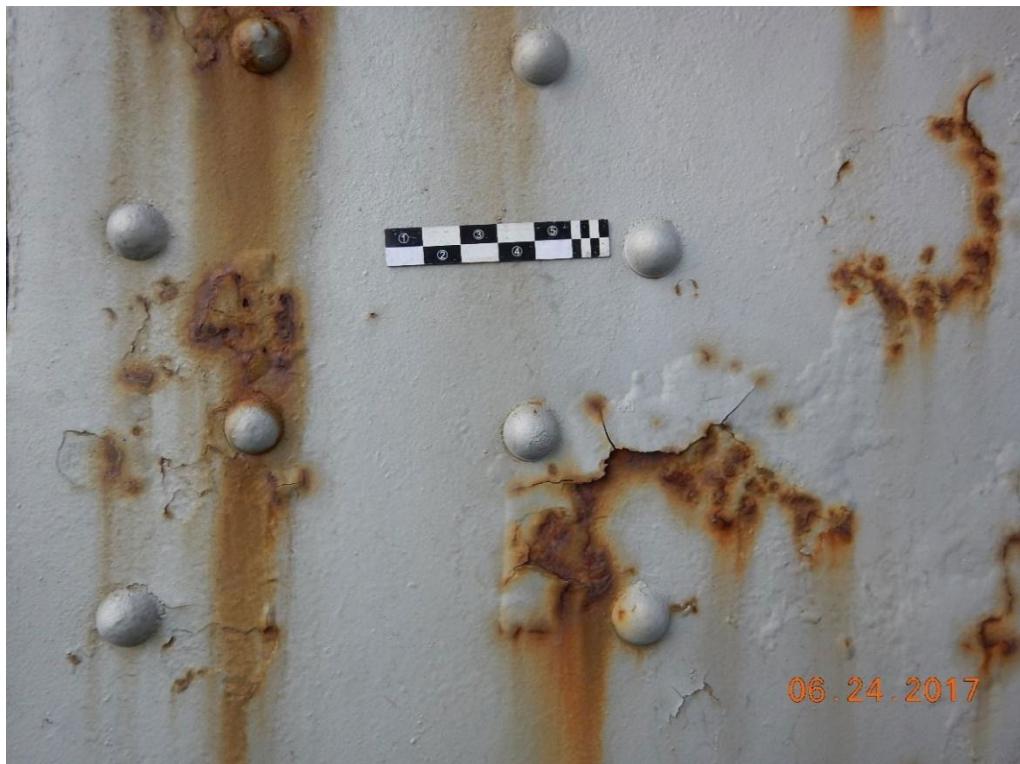
LANL 28: (b) East Arch, typical paint peeling/cracking and surface corrosion on top flange

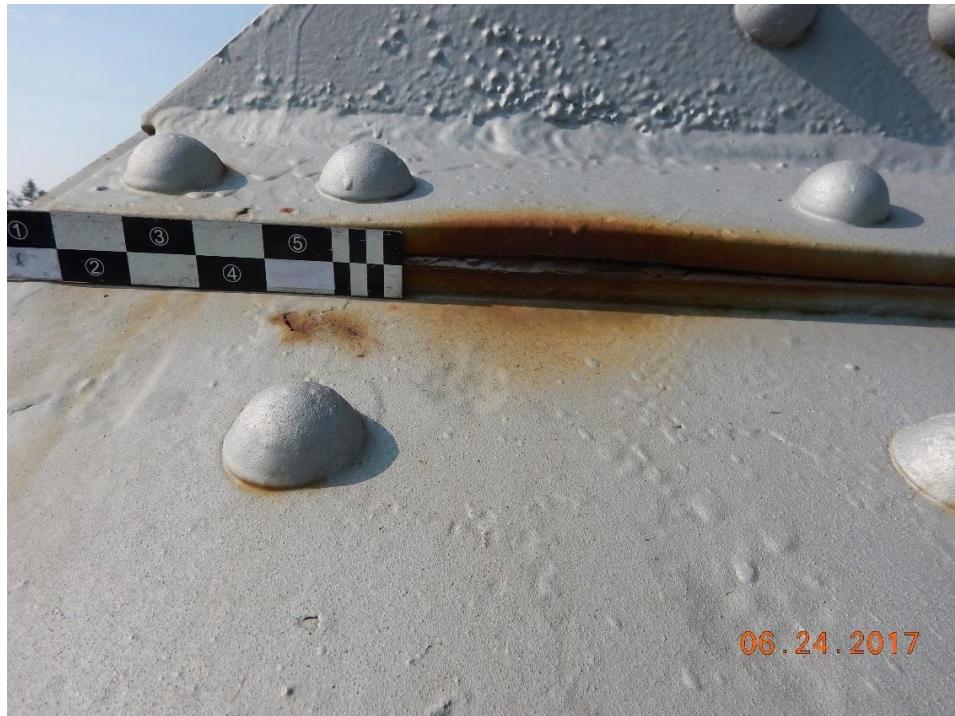
(a) East arch, column 14, 1/16" pack rust at base

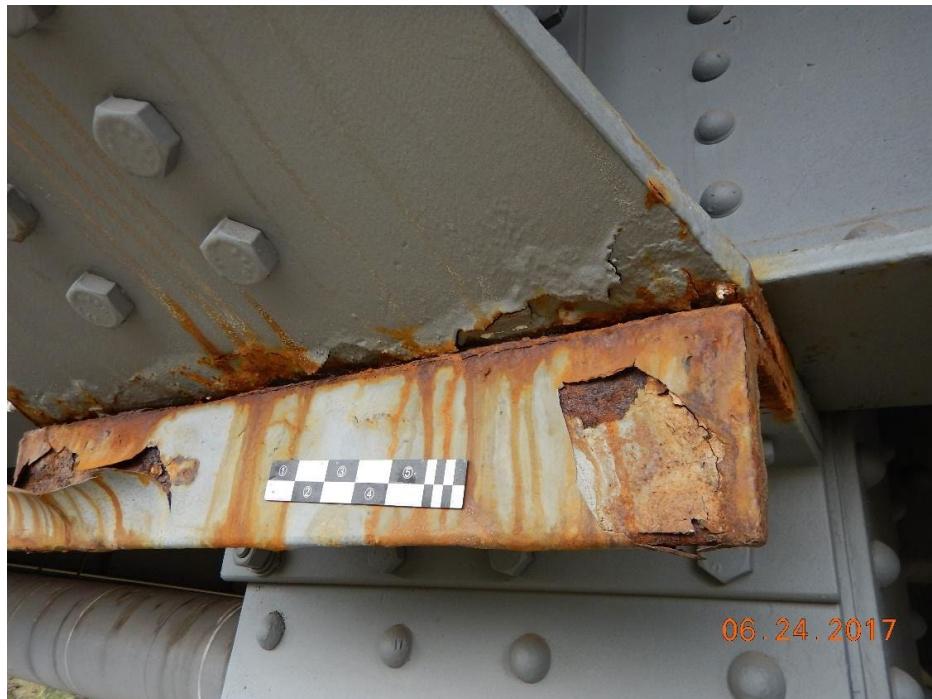
LANL 29: (b) East arch, column 8, knee brace at floor beam 15, outside face, typical corrosion

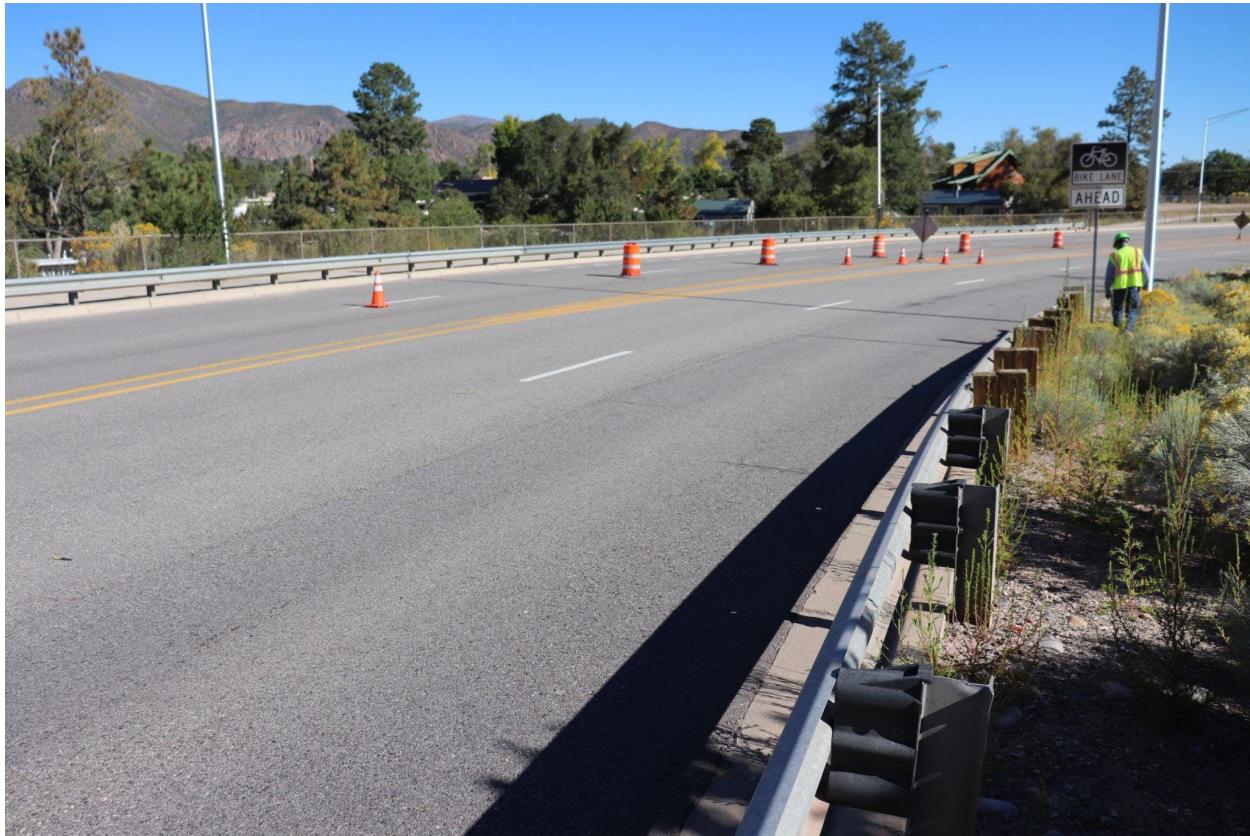
LANL 66 (IMG_7143.jpg)

At the south approach guardrail, there is collision damage. The steel guardrail is distorted and some timber posts are split along their height and/or deformed at the base. Spalling and damage is present near the joint on the east CBR. Significant corrosion with large cracks was noted near the joint on the steel rail on top of the CBR. [See pictures LANL 66 through LANL 69](#).
