DEVELOPMENT OF A SYNTHETIC FUEL
RECIPROCATING CHARGE PUMP

Quarterly Technical Progress Report

1 January 1987 - 31 March 1987

Ingersoll-Rand Company
942 Memorial Parkway
Phillipsburg, NJ 08865

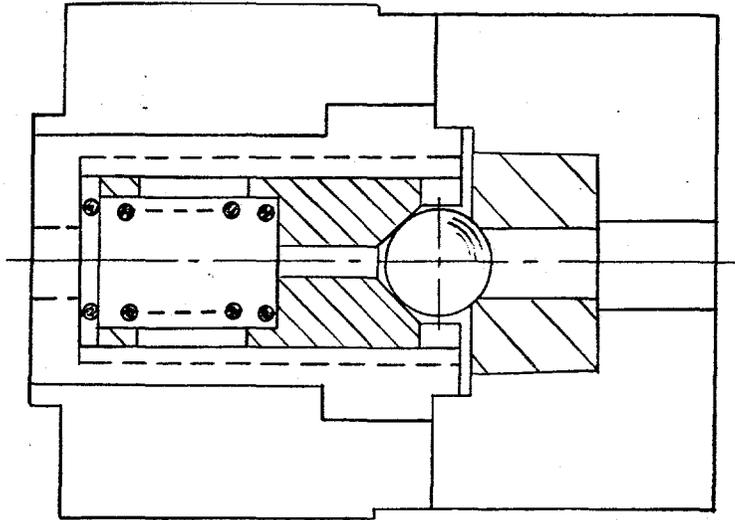
FIGURE 1

The major problem with the valves has been their inability to seal shut when pumping slurry. The average flow velocity per plunger is lower than the calculated critical velocity to maintain sand in solution (1.7 fps @ 105 rpm, and 2.4 fps @ 150 rpm per plunger, versus 2.3 fps to keep sand in solution per the Durand equation). This effect, plus the valve ball and seat wear, plus the changing flow directions combines to have sand settling in the working volume between the valves. The valves then jam up, the effect compounds, the volumetric efficiency declines, the FPS piston can also jam up, and the discharge pressure decays (the discharge pressure has been seen to decay at 20 to 130 psig/hr). The valve balls have been measured to wear 0.001 - 0.004" diametral/10 hrs. The valve seats have been measured to wear 0.003 - 0.005" depth/10 hrs. Ovality and egg-shaped wear also occurs to increase the loss of sealing.

GUIDED VALVE BALL

The effects of increasing the valve spring rate, and of changing to an unguided valve configuration were tested. The increased spring rate with the guided configuration required excess NPSH which was not available from the slurry test loop. The original spring rate was reinstalled. The unguided configuration caused the valve ball wear to increase because the ball would not rotate. The ball is always in contact with the valve spring and cannot float as in the guided configuration (see Figure 1). The rotation evens the ball wear. Also, the timing was not precise using the larger diameter balls with the existing springs. This caused a severe loss of volumetric efficiency and discharge pressure. The original guided valve will be reinstalled.

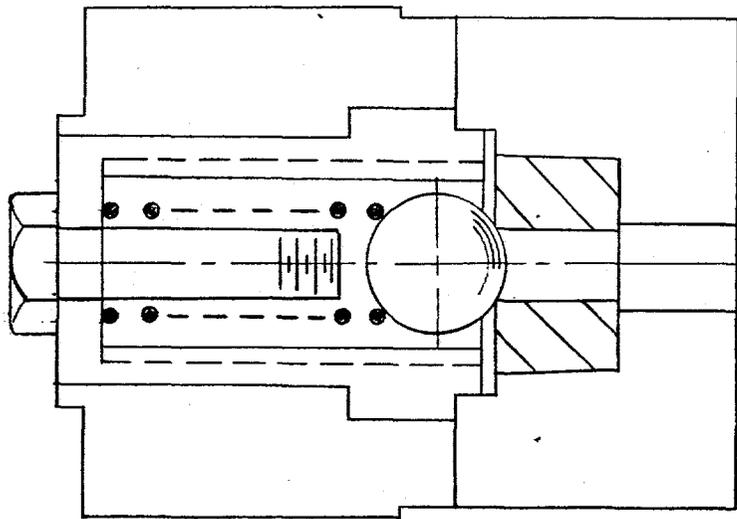
UNGUIDED VALVE BALL
