LA-UR-24-21637

Approved for public release; distribution is unlimited.

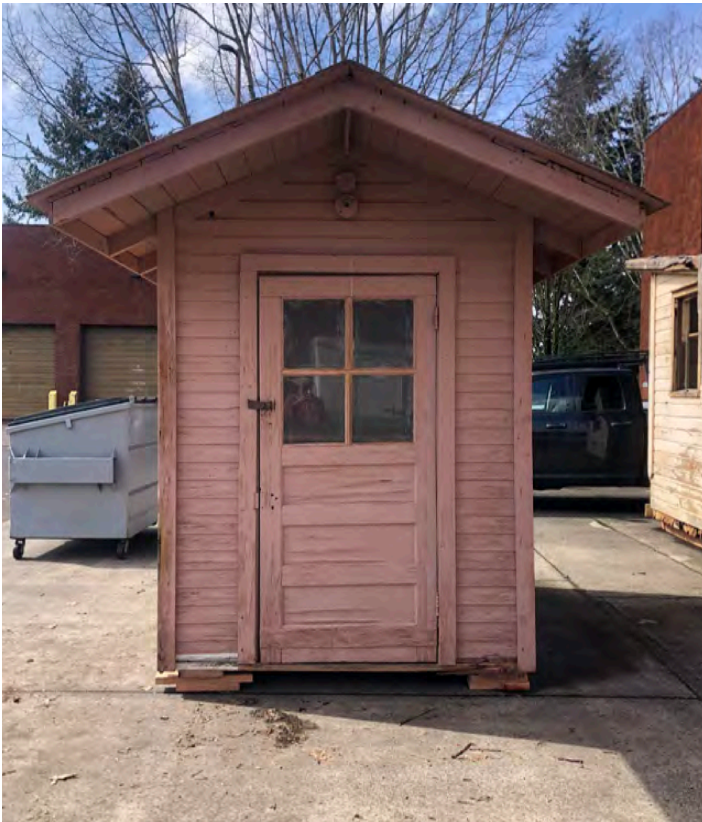
TA-18-111 in March 2023.

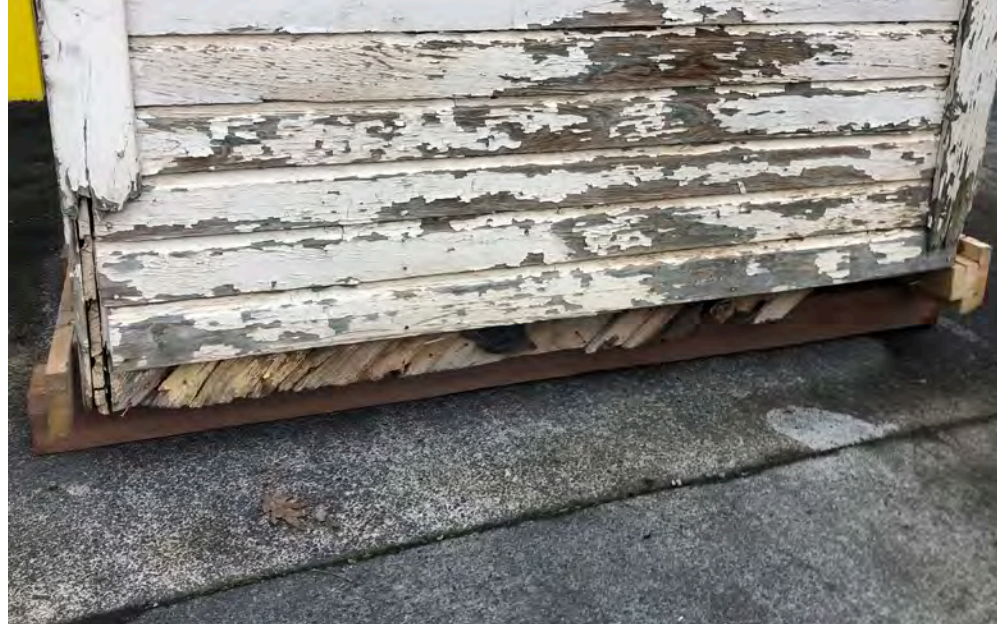
Base of the left elevation, where floor framing damage is damaged and missing toward the back (left) side of the elevation.

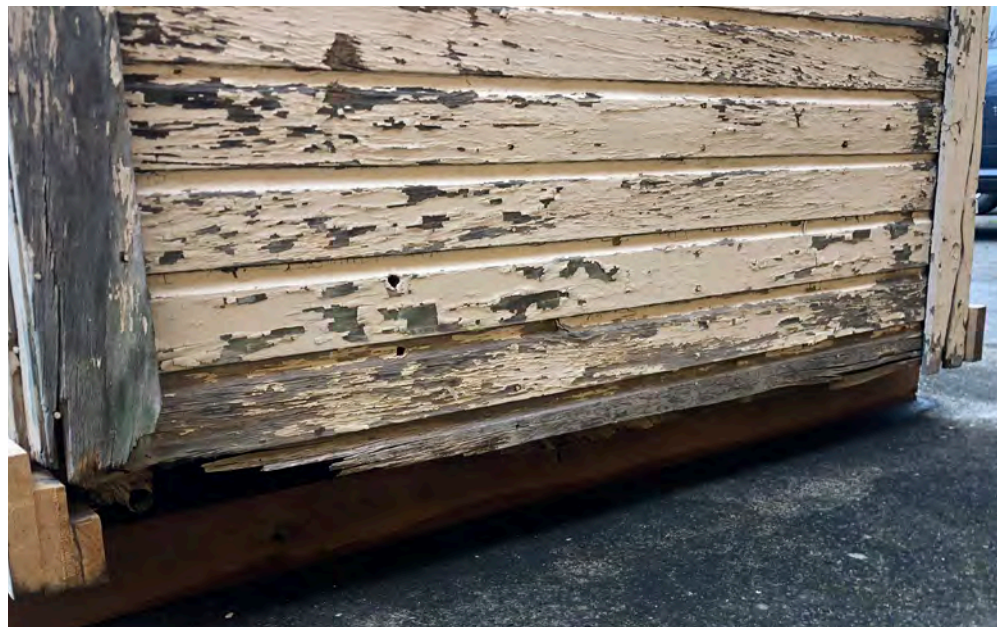
Floor joists along the back of the structure have lost significant section, up to 4"; the connection between a diagonal cripple (at right of photo) and the joist is gone.

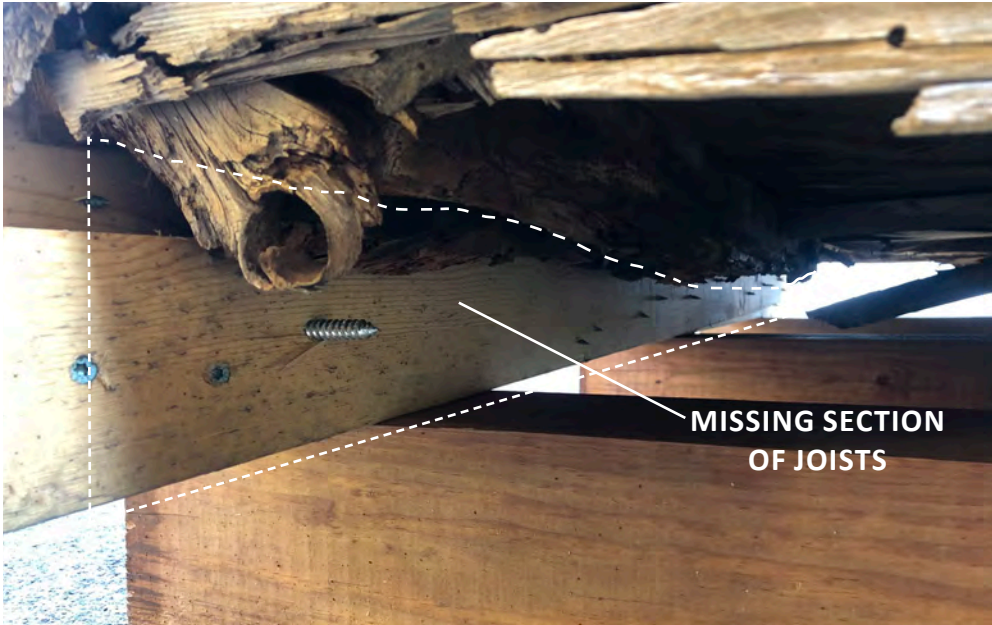
Missing blocking between floor joists on the right elevation, towards to the back of the structure. Missing wall siding and diagonal sheathing have also left the end grain of the joists exposed to moisture and generalized weathering.

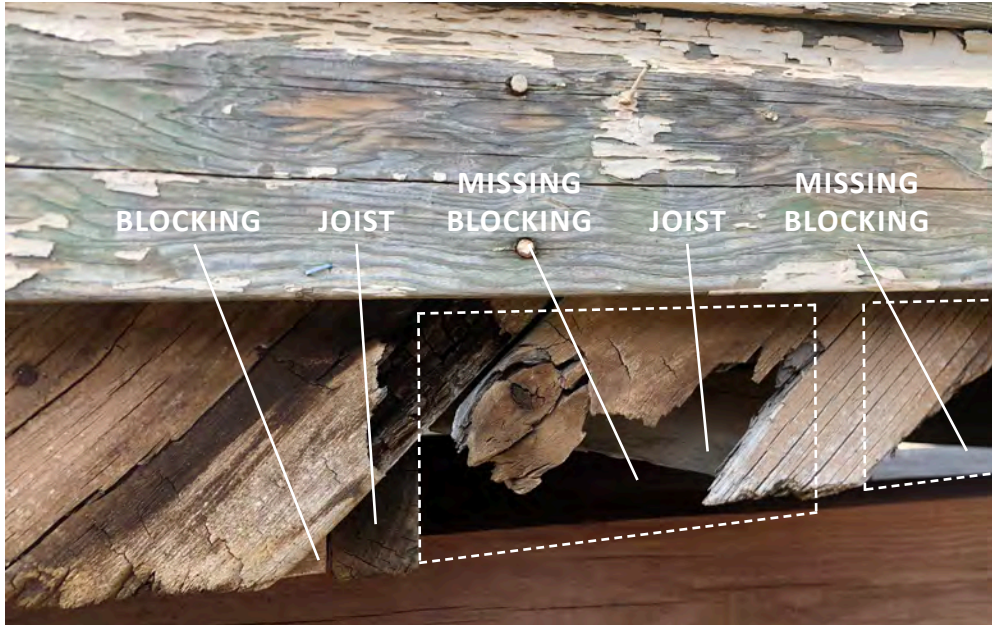
The T&G flooring materials in TA-8-172 demonstrate moisture damage, staining, and mechanical damage.

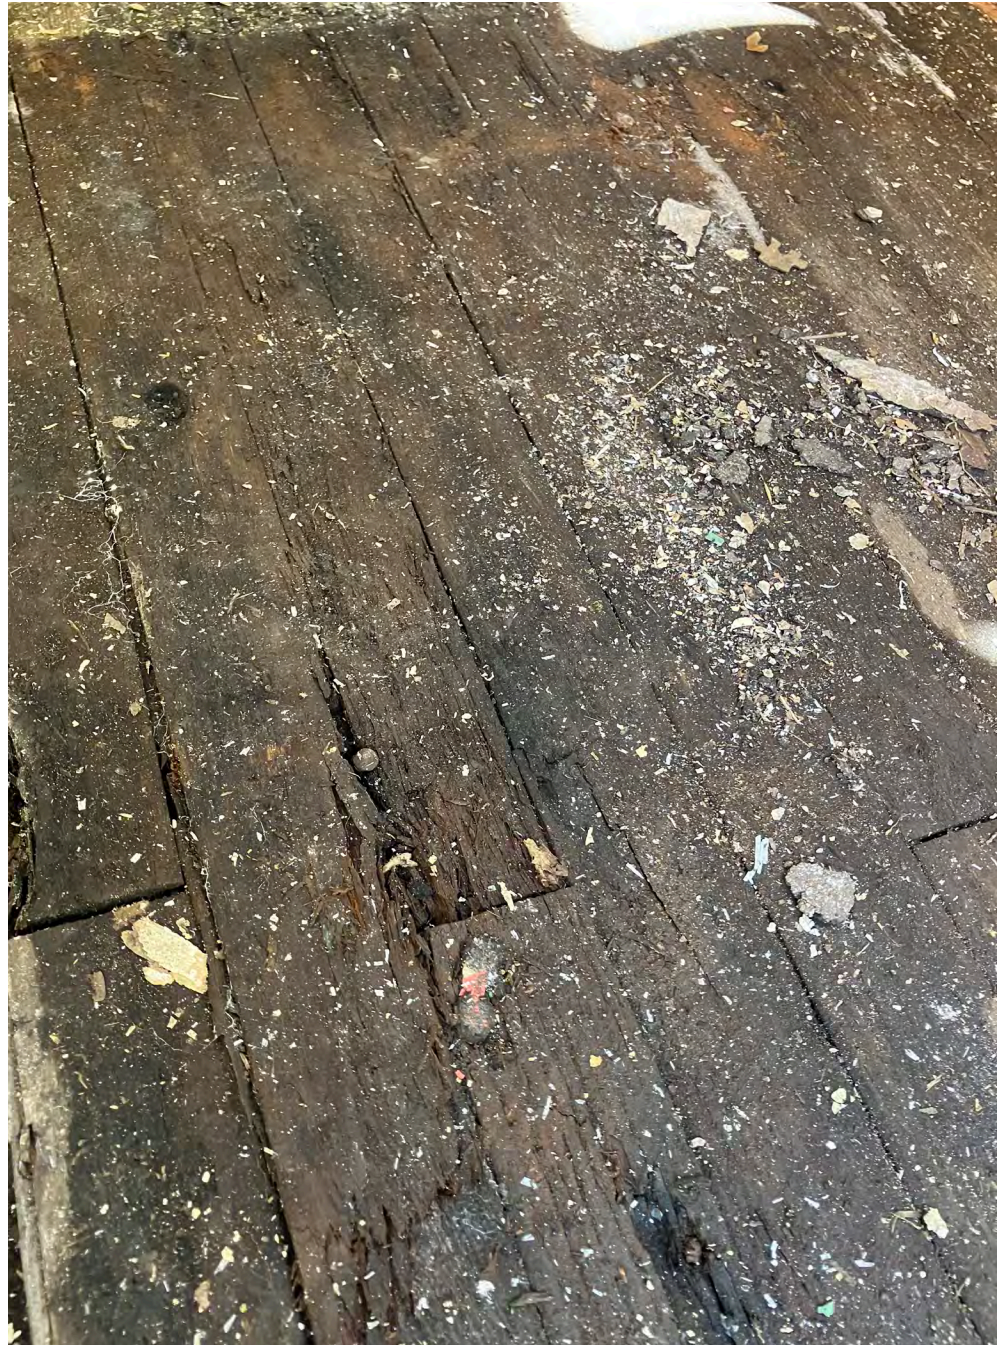
Daylight coming through a hole in the T&G flooring at back right corner of TA-8-172. Moisture damage on the T&G flooring was also encouraged by non-historic felt flooring.

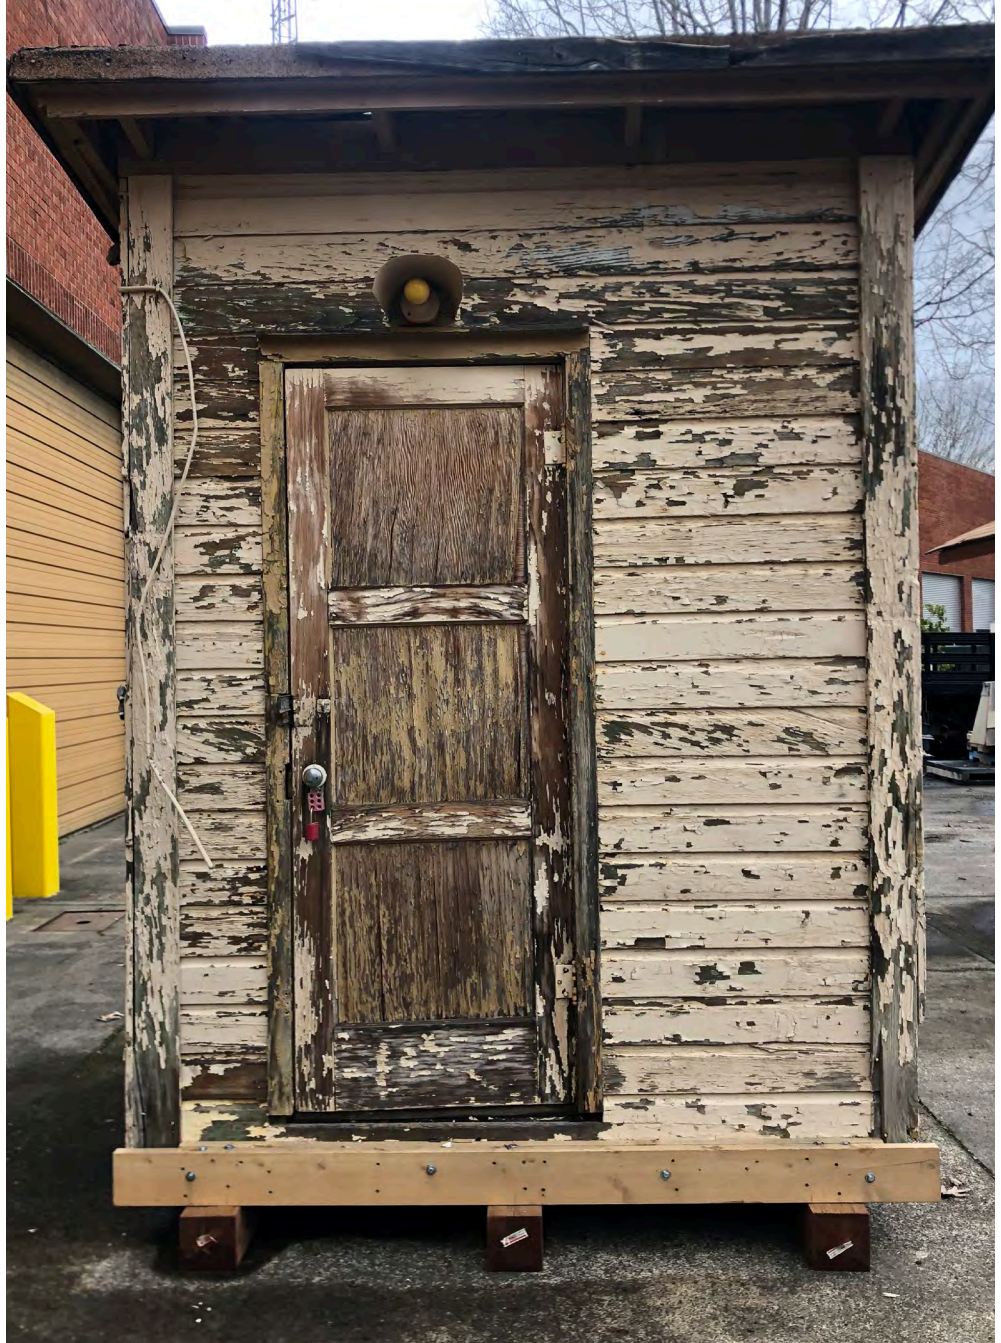
Condition of exterior wall siding and corner trim on the left elevation.

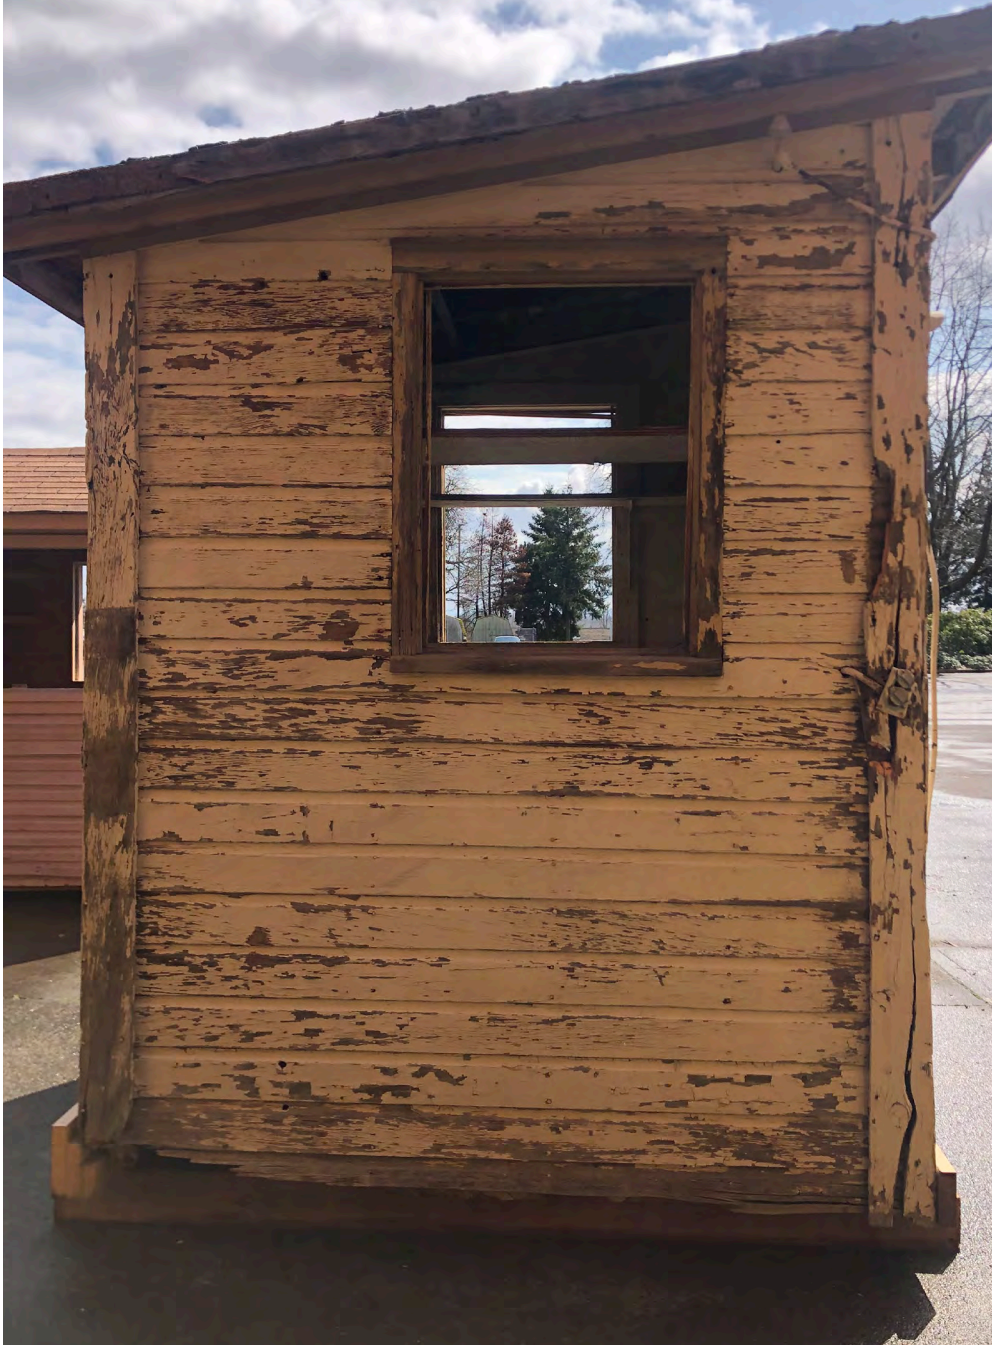
Condition of exterior wall siding and corner trim on the back elevation.

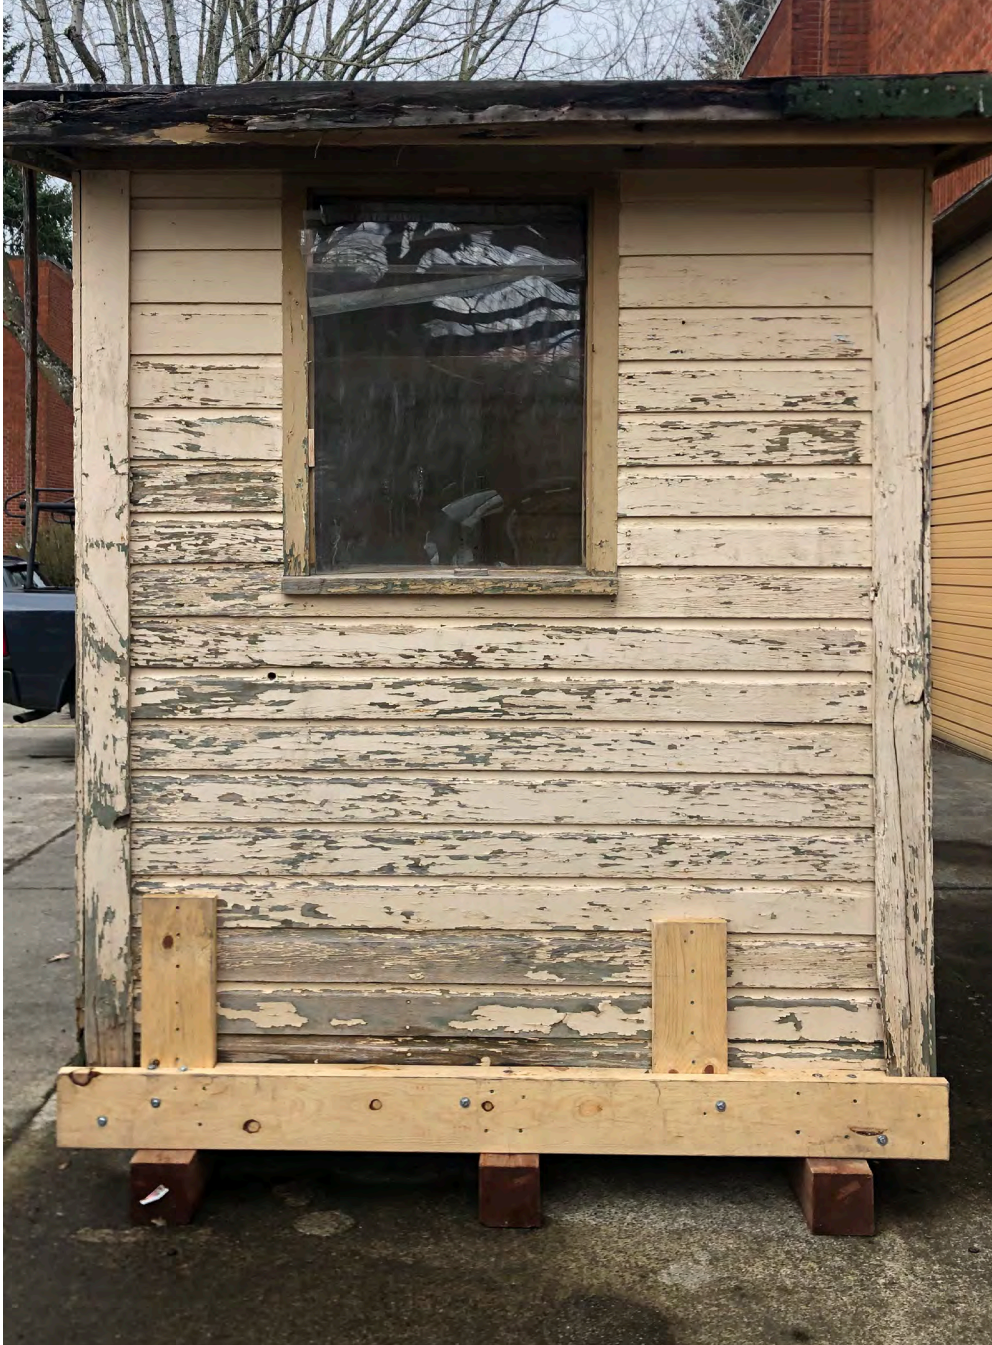
Condition of exterior wall siding and corner trim on the right elevation.

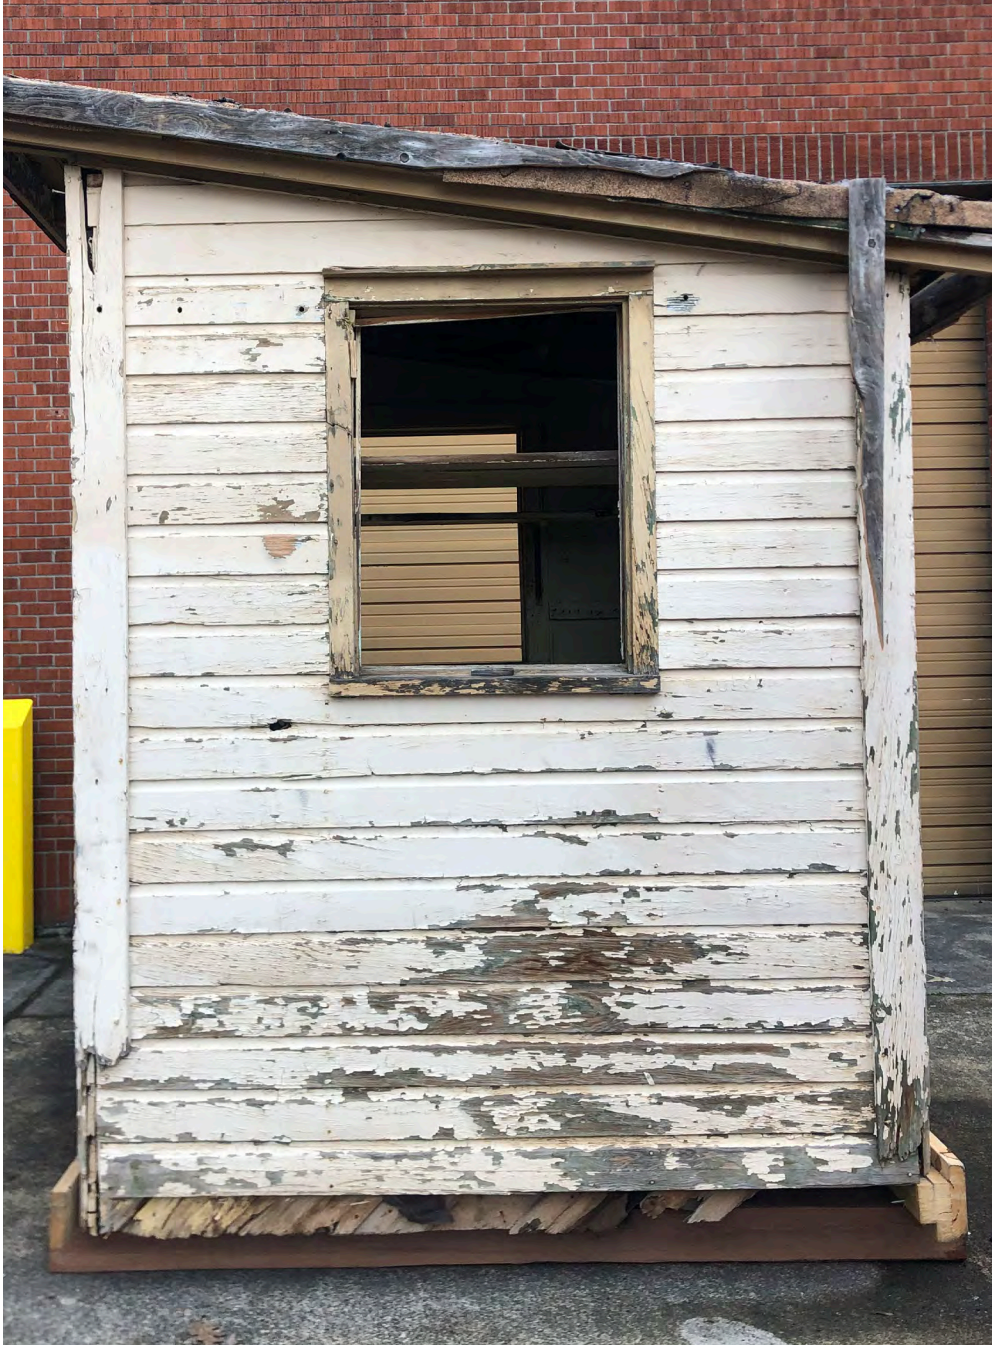
End grain of trim at the right back corner exhibit checking and loss. These trim pieces are candidates for dutchman repairs and consolidation with epoxy.

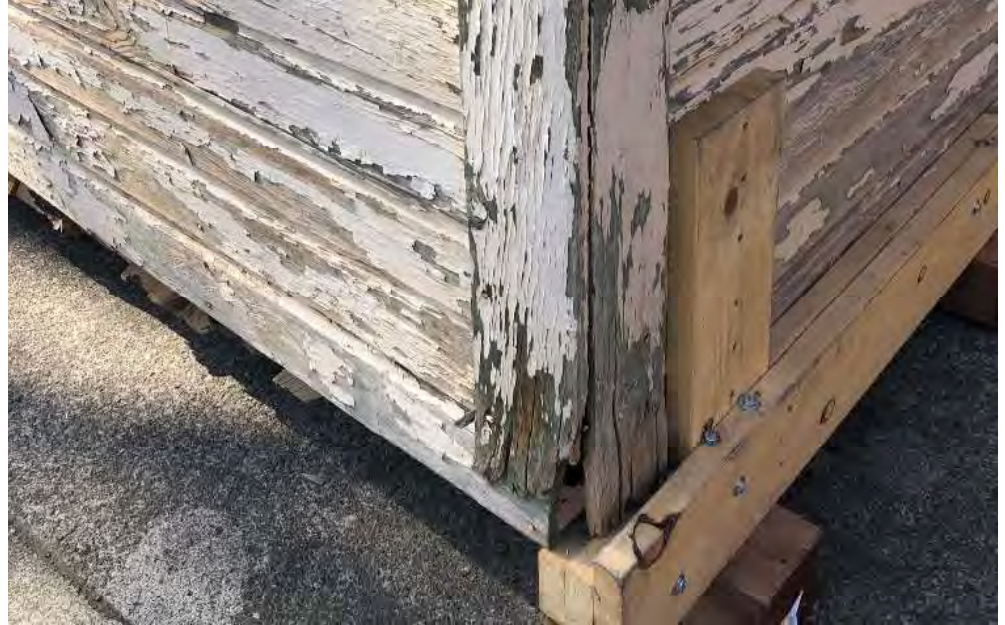
The diagonal wall sheathing at the back end of the right elevation are lost, in proximity to interior moisture damage and loss of flooring.

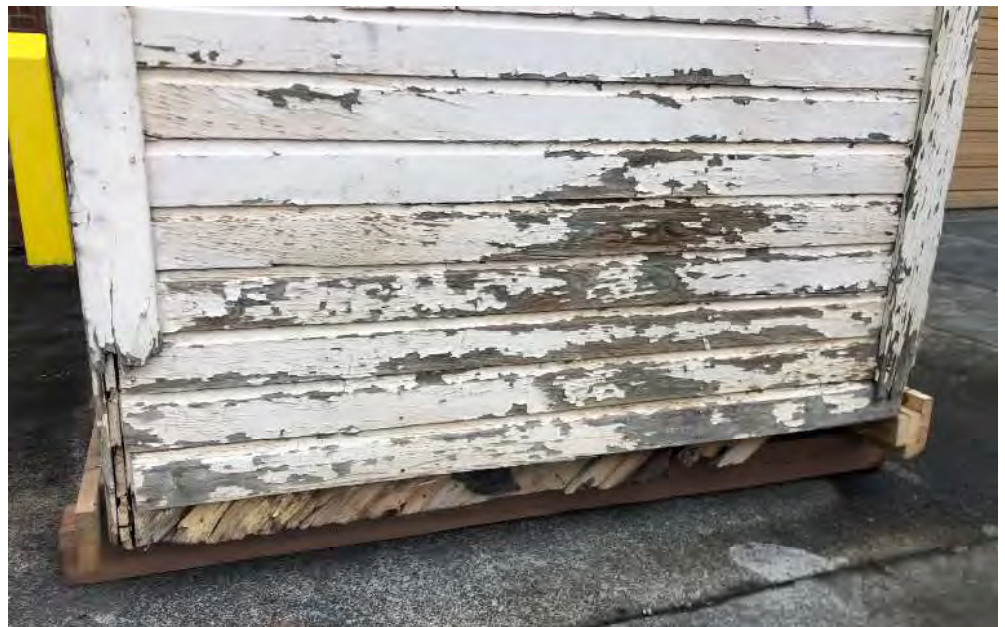
Photo of TA-08-172 prior to acquisition by LANL. The in situ photo shows soil accumulation at the back of the structure; water retained in the soil is the cause for concentrated evidences of moisture damage in this area.

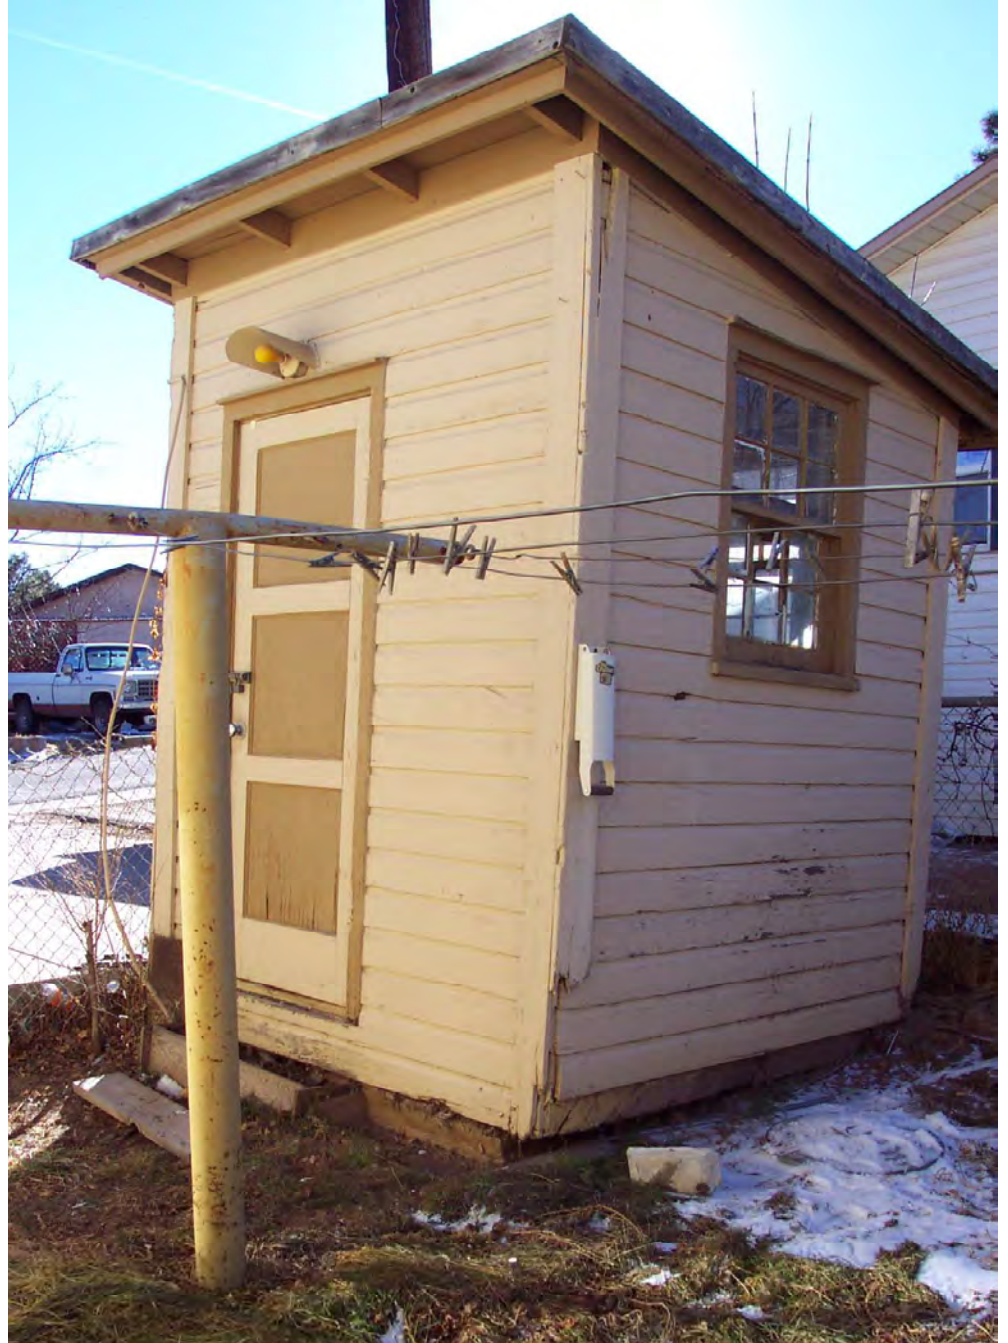
Siding near grade is highly deteriorated, demonstrating significant areas of loss. These are prime candidates for replacement with in-kind materials.

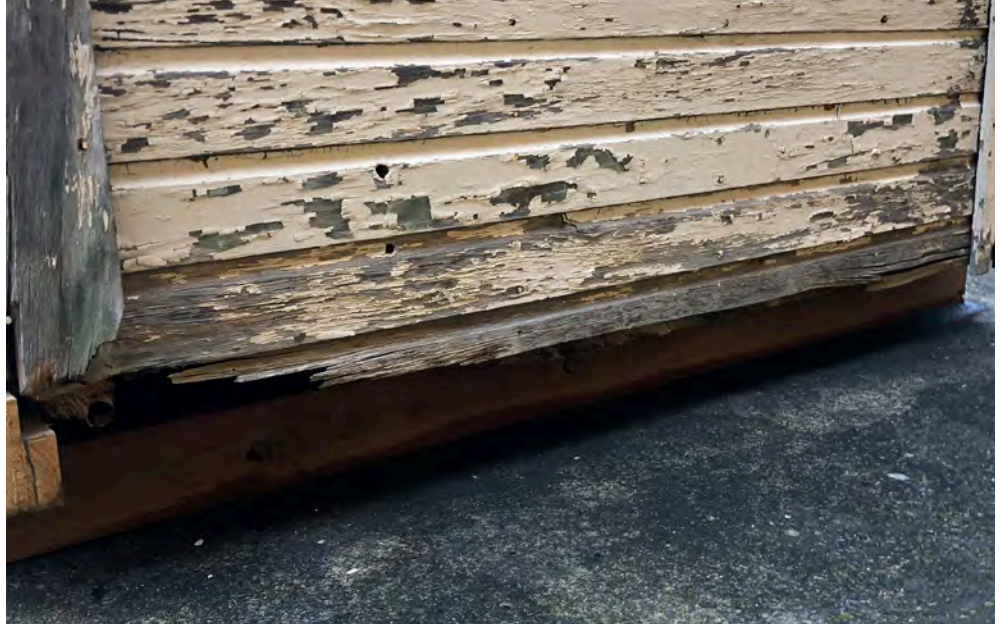
Evidences of an oil-based olive drab (OD) green paint are visible beneath failing paint coatings.

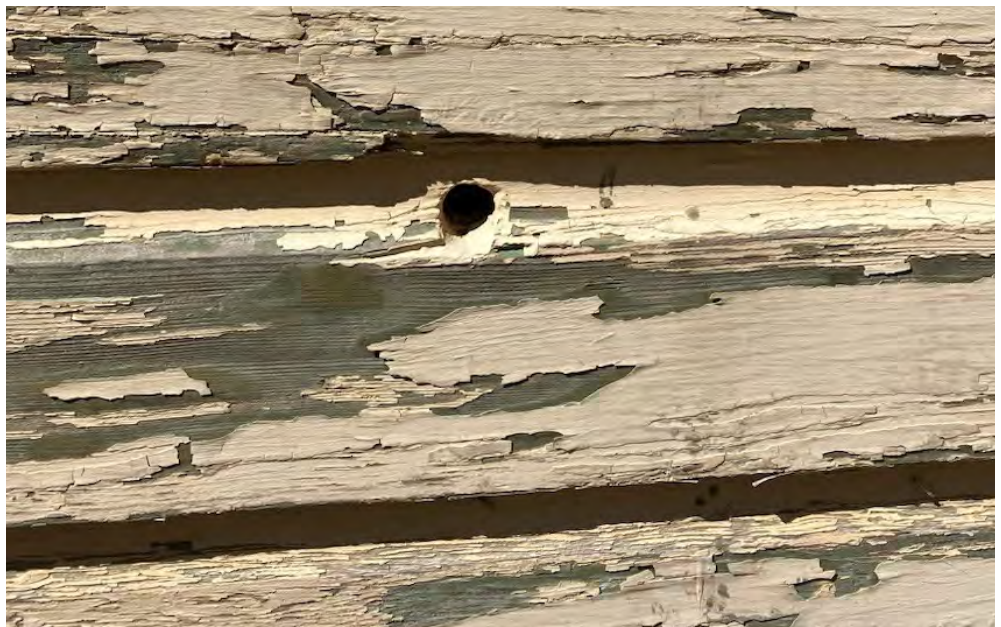
Bracing installed prior to relocating TA-8-172 to LANL. Bolt holes will be documented and filled during siding repairs.

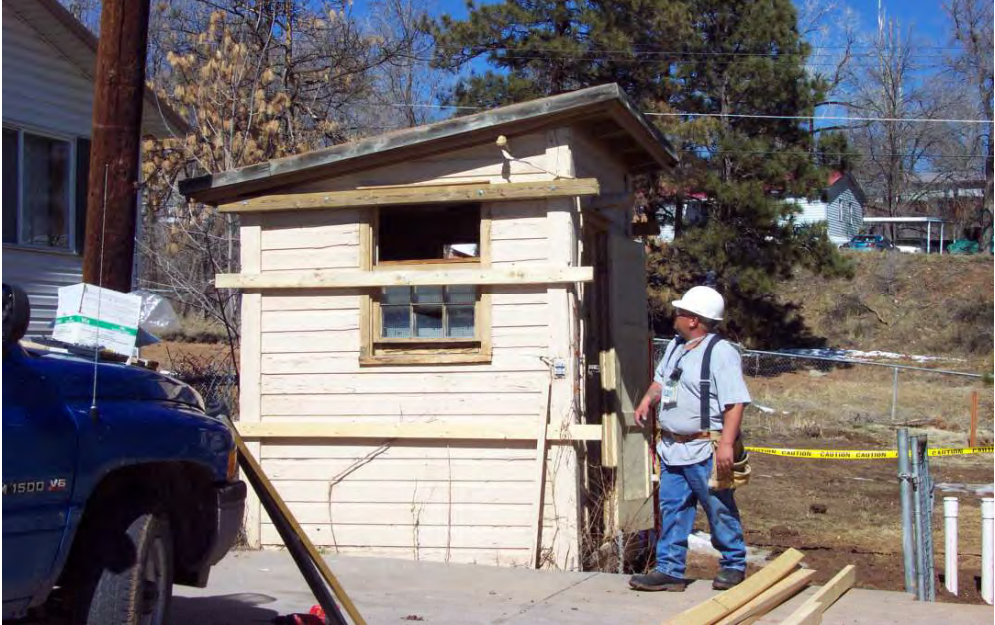
Wooden siding with extensive checking, such as sections on the front elevation, may be candidates for epoxy repairs.

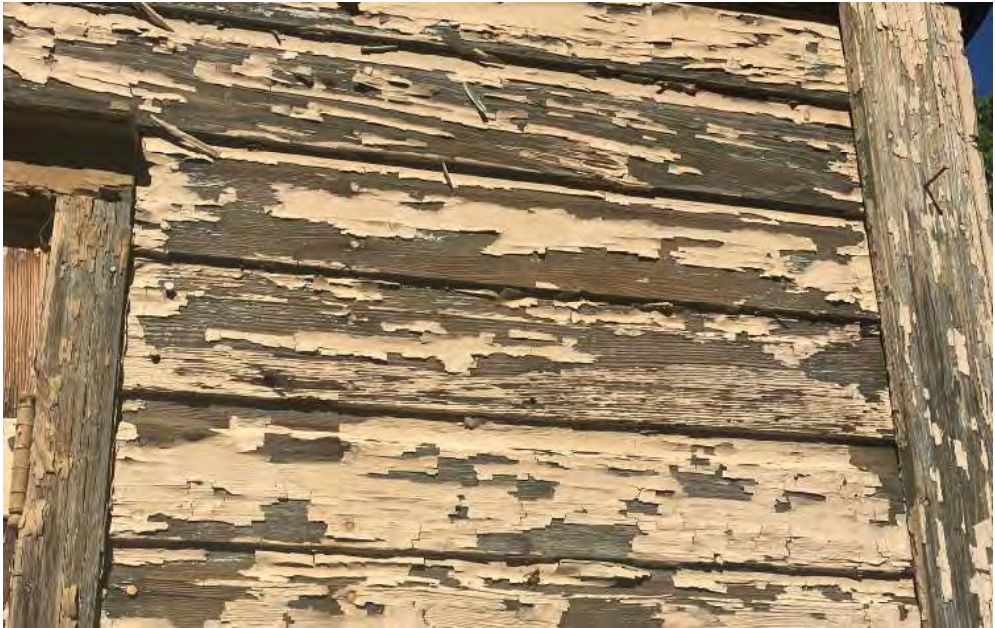
Historic weatherhead, electrical line, and metal staple on the front left corner will be preserved.

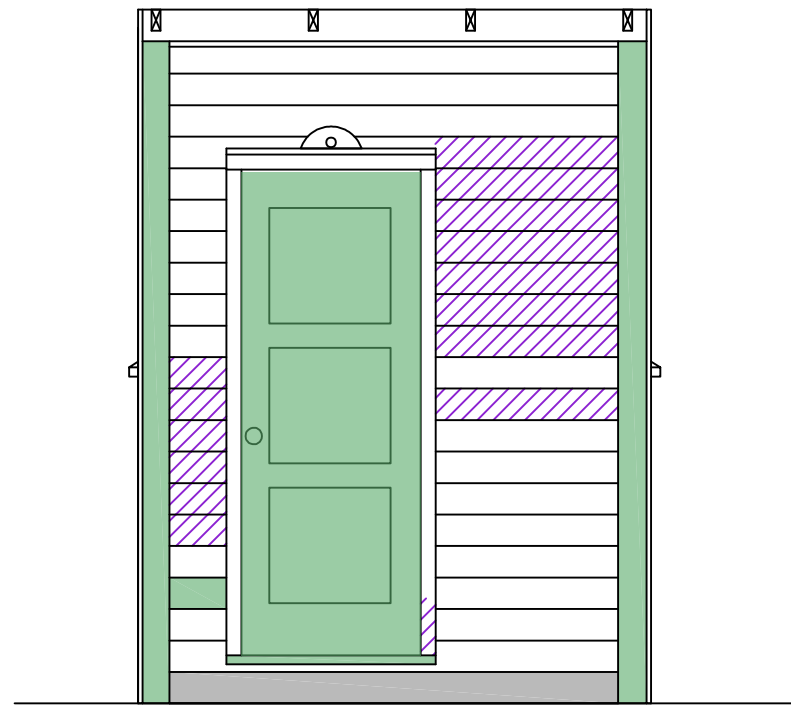
ACTUAL EXTENTS OF EPOXY REPAIRS MAY VARY FROM WHAT IS INDICATED; REPAIRS WILL DEPEND ON THE CONDITION OF THE BOARDS AFTER REMOVING PAINT AND PRELIMINARY SANDING.

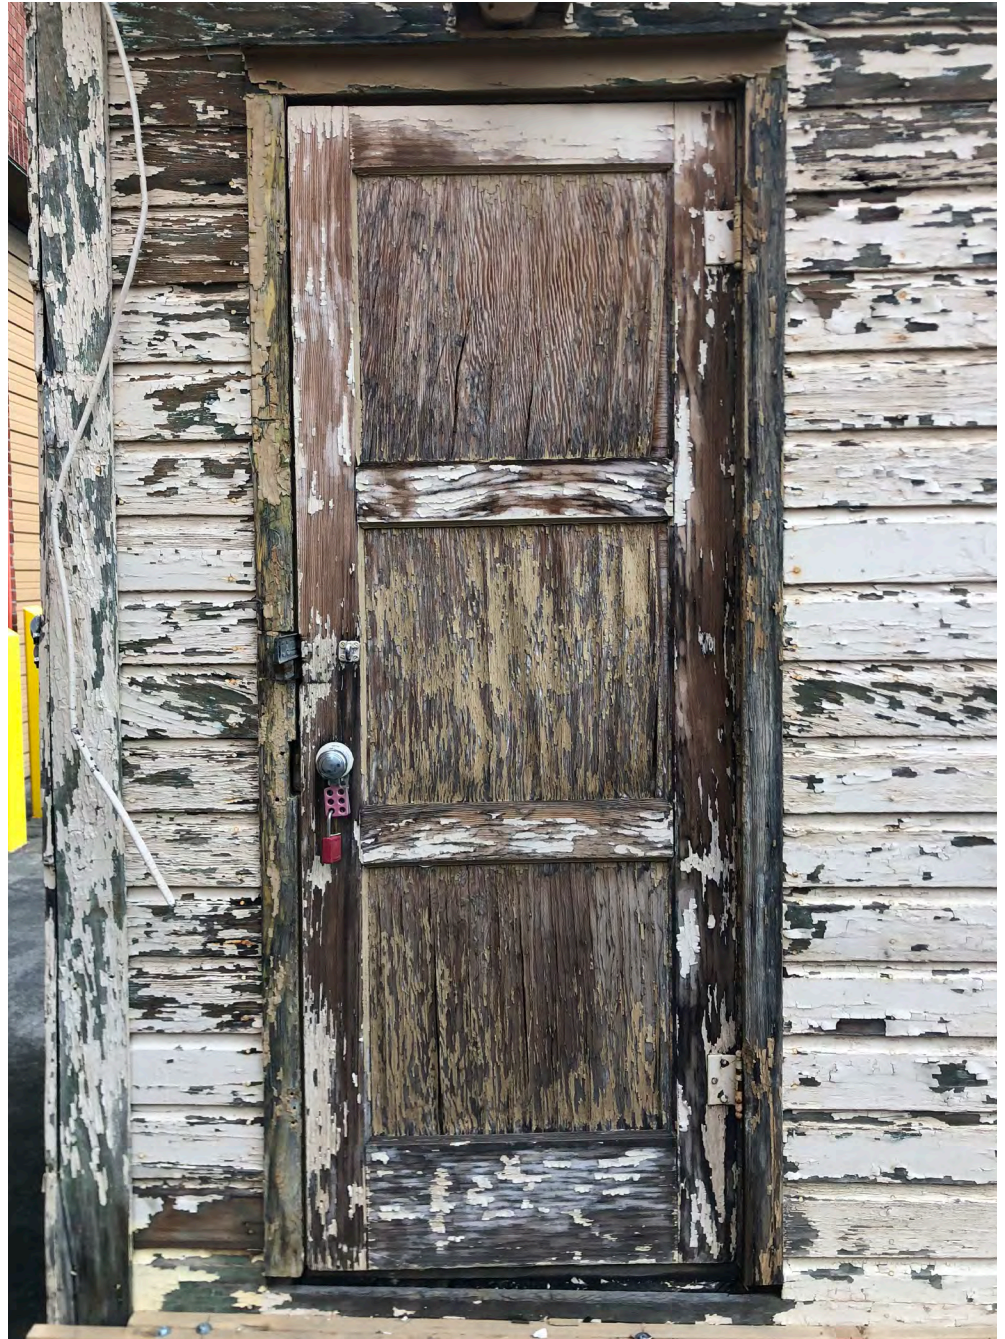
The window opening on the right elevation is representative of typical damage to openings on TA-8-172. Deteriorated wooden surfaces will be stabilized with epoxy, sanded, and then repainted.

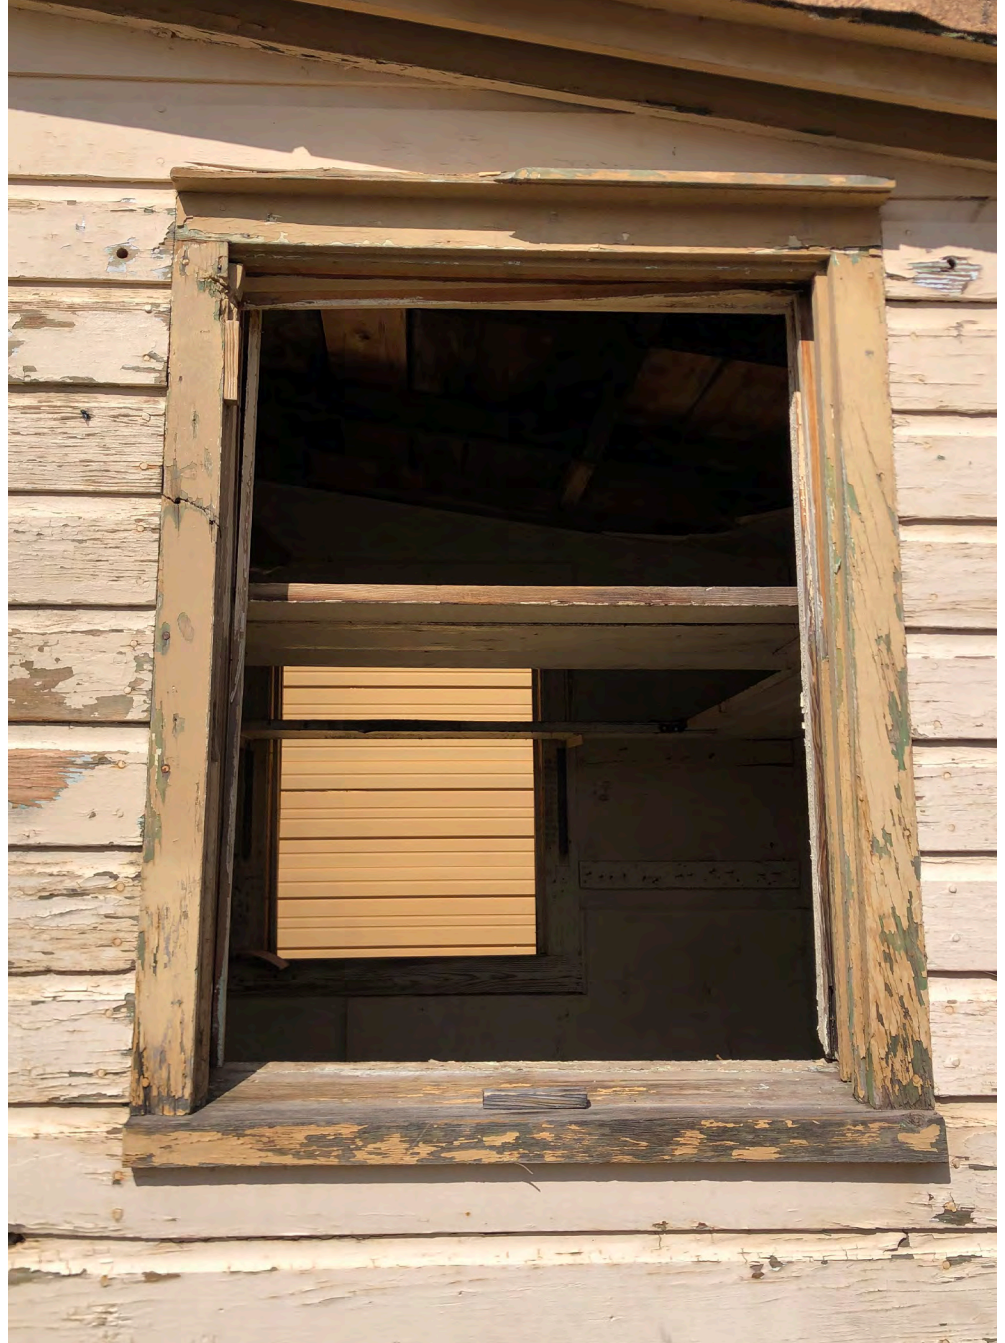
Paint stratigraphy on window sash from TA-8-172 indicate that the exterior surfaces were first painted olive green (left) and interiors were sea foam green (right). Paint samples will be analyzed to confirm colors before re-painting sash and door.

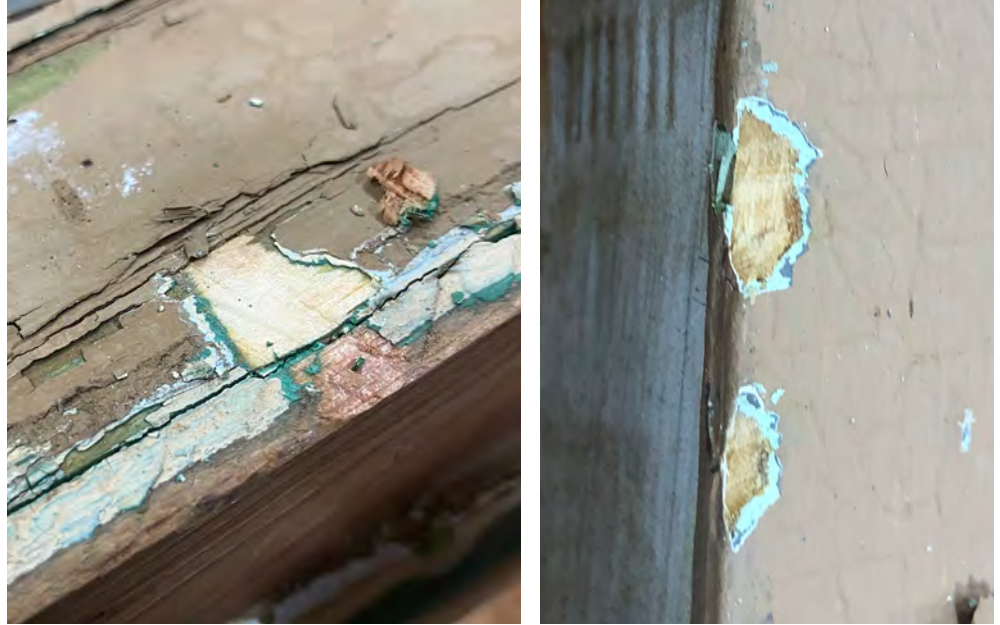
The window opening interior on the back elevation is representative of typical damage to interior casings and openings on TA-8-172. The right blind stop is missing and the paint is deteriorated. The stool is cracked and will be glued.

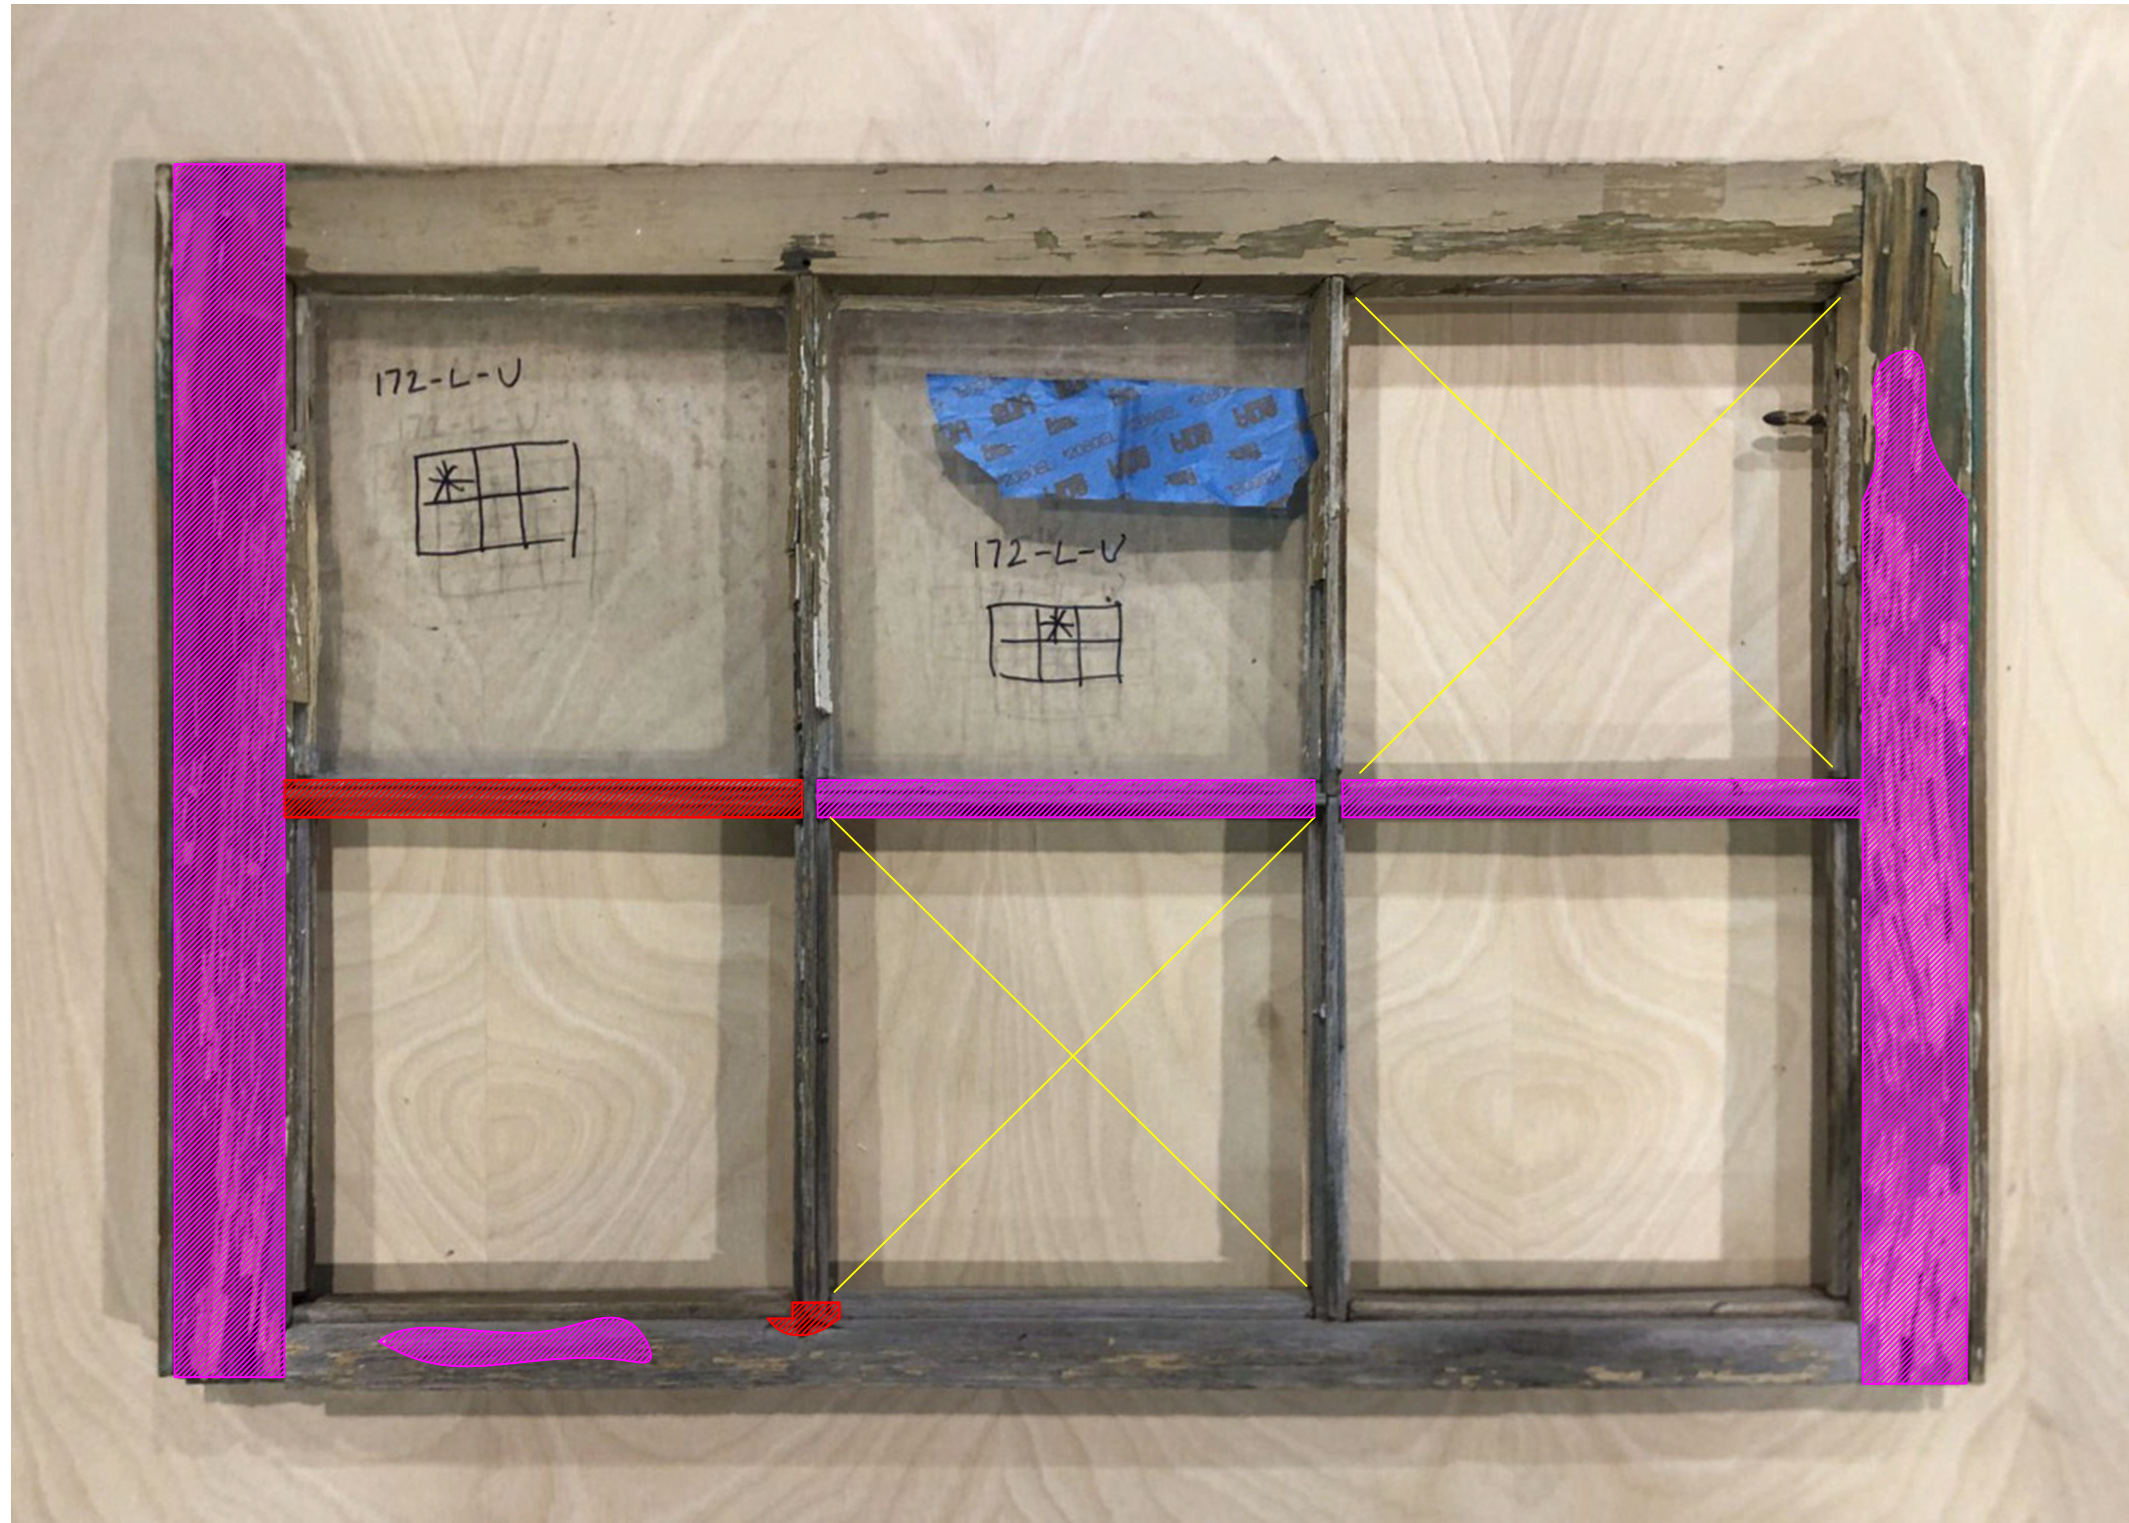
TITLE OF SHEET:
SASH DETERIORATION
CONDITIONS
