LA-UR-24-21637

Approved for public release; distribution is unlimited.

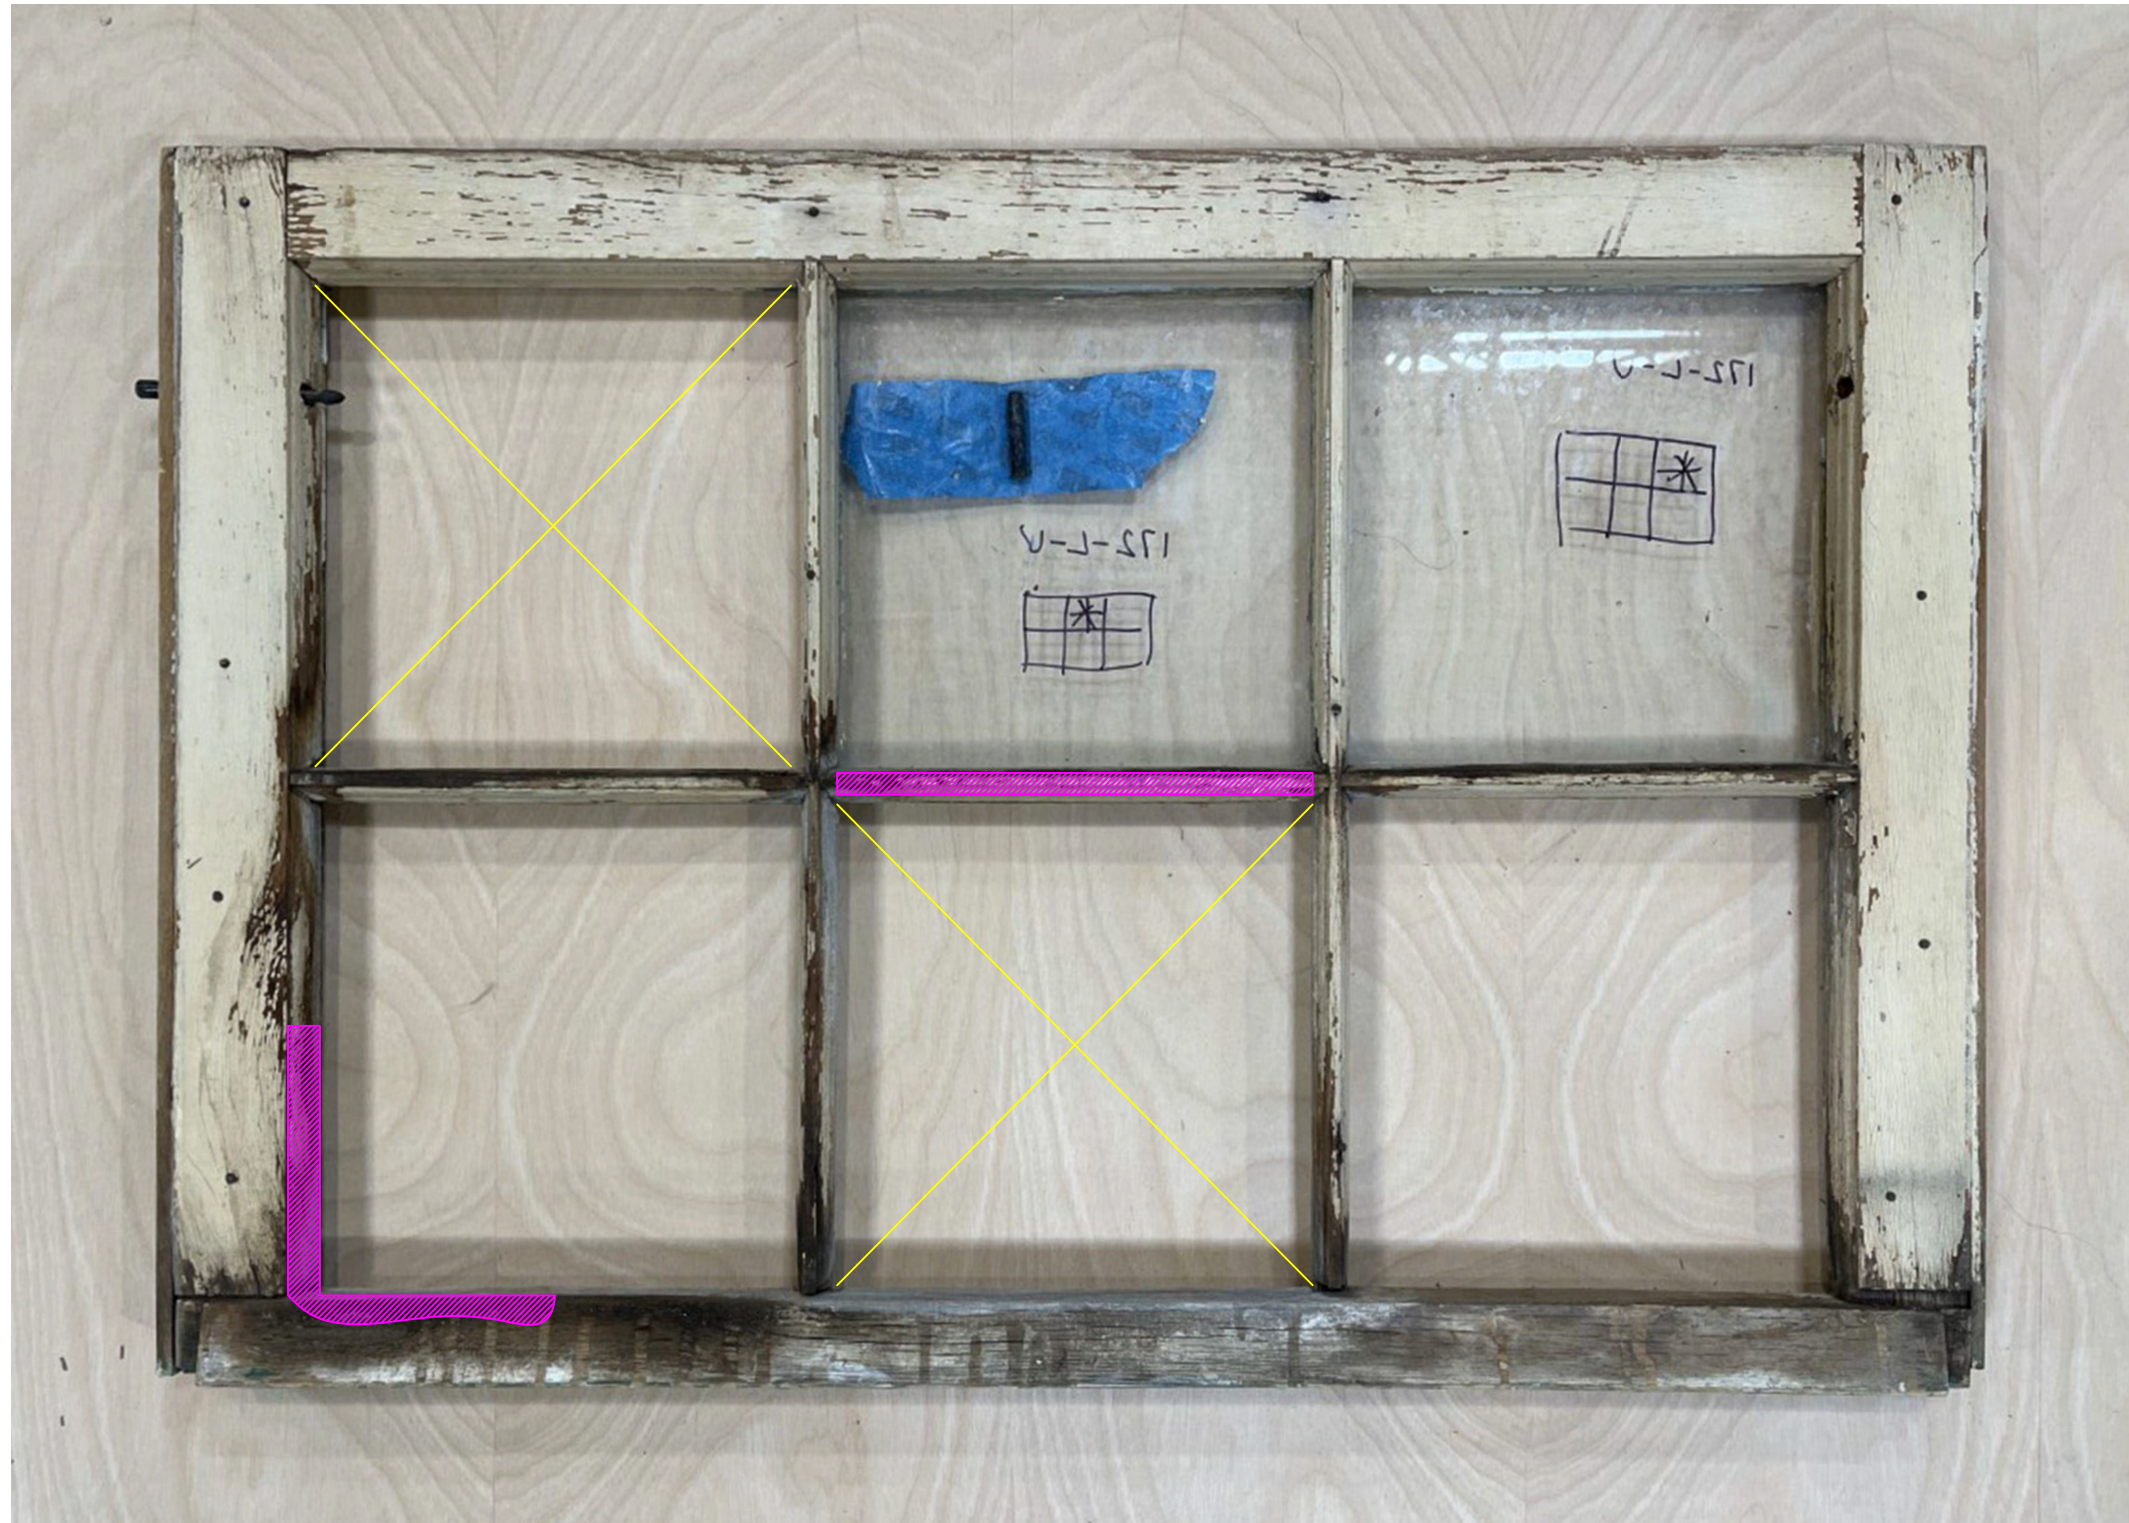
TITLE OF SHEET:
SASH DETERIORATION
CONDITIONS

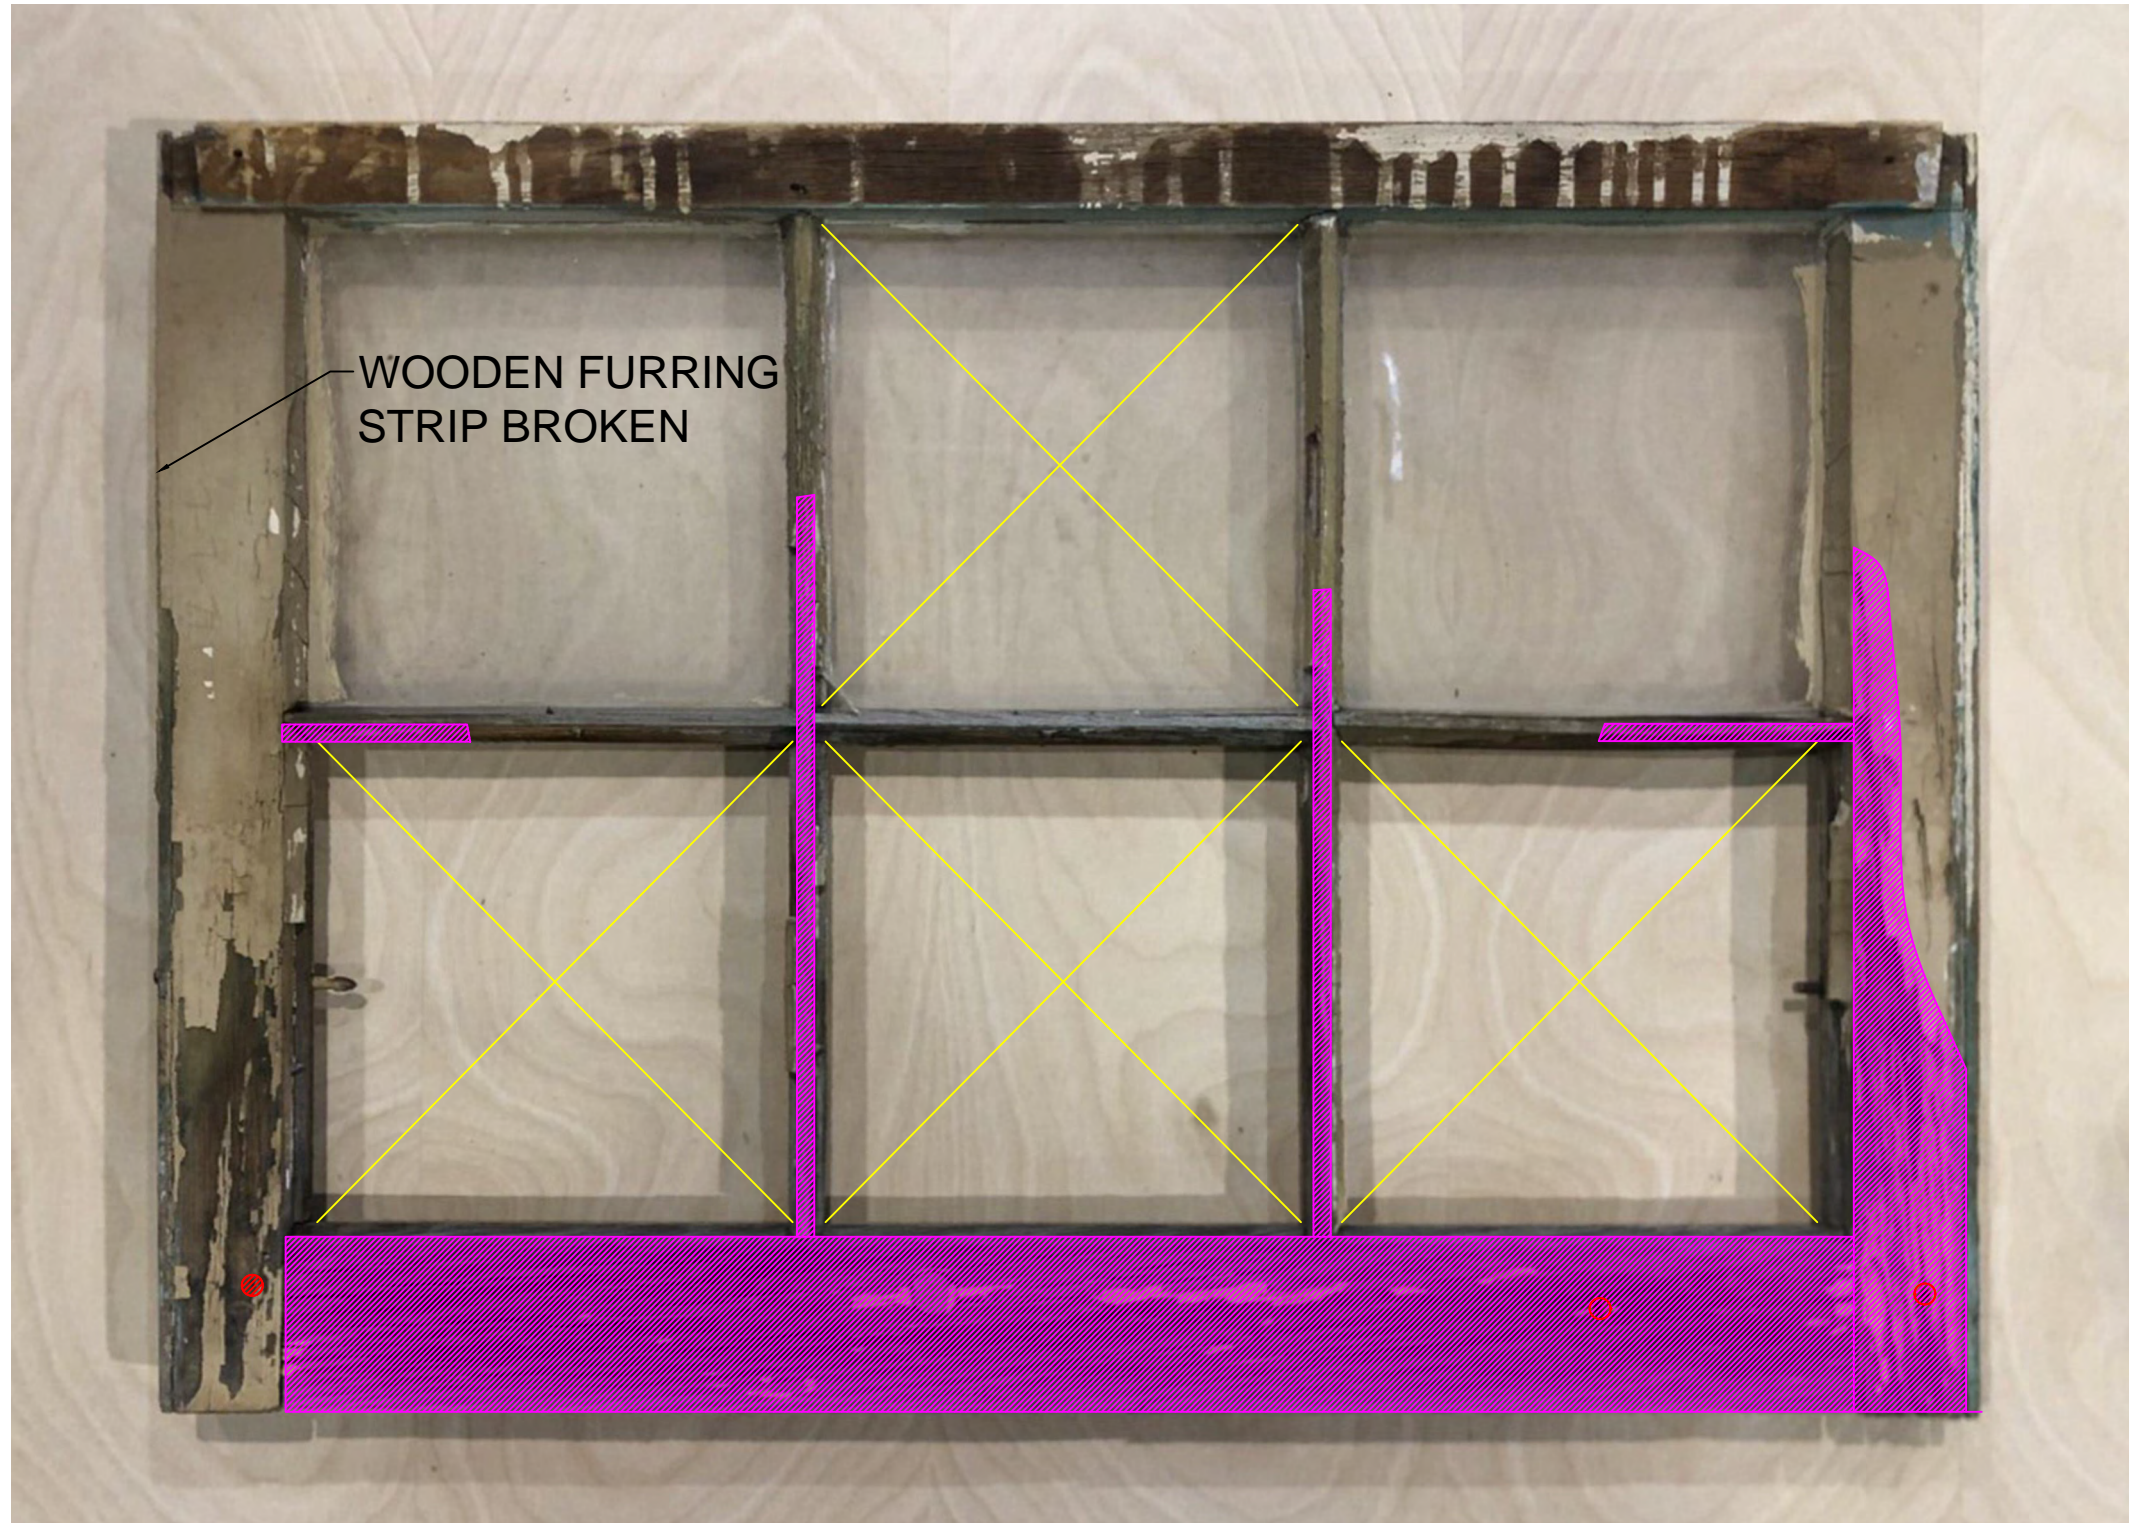
WOODEN FURRING STRIP BROKEN

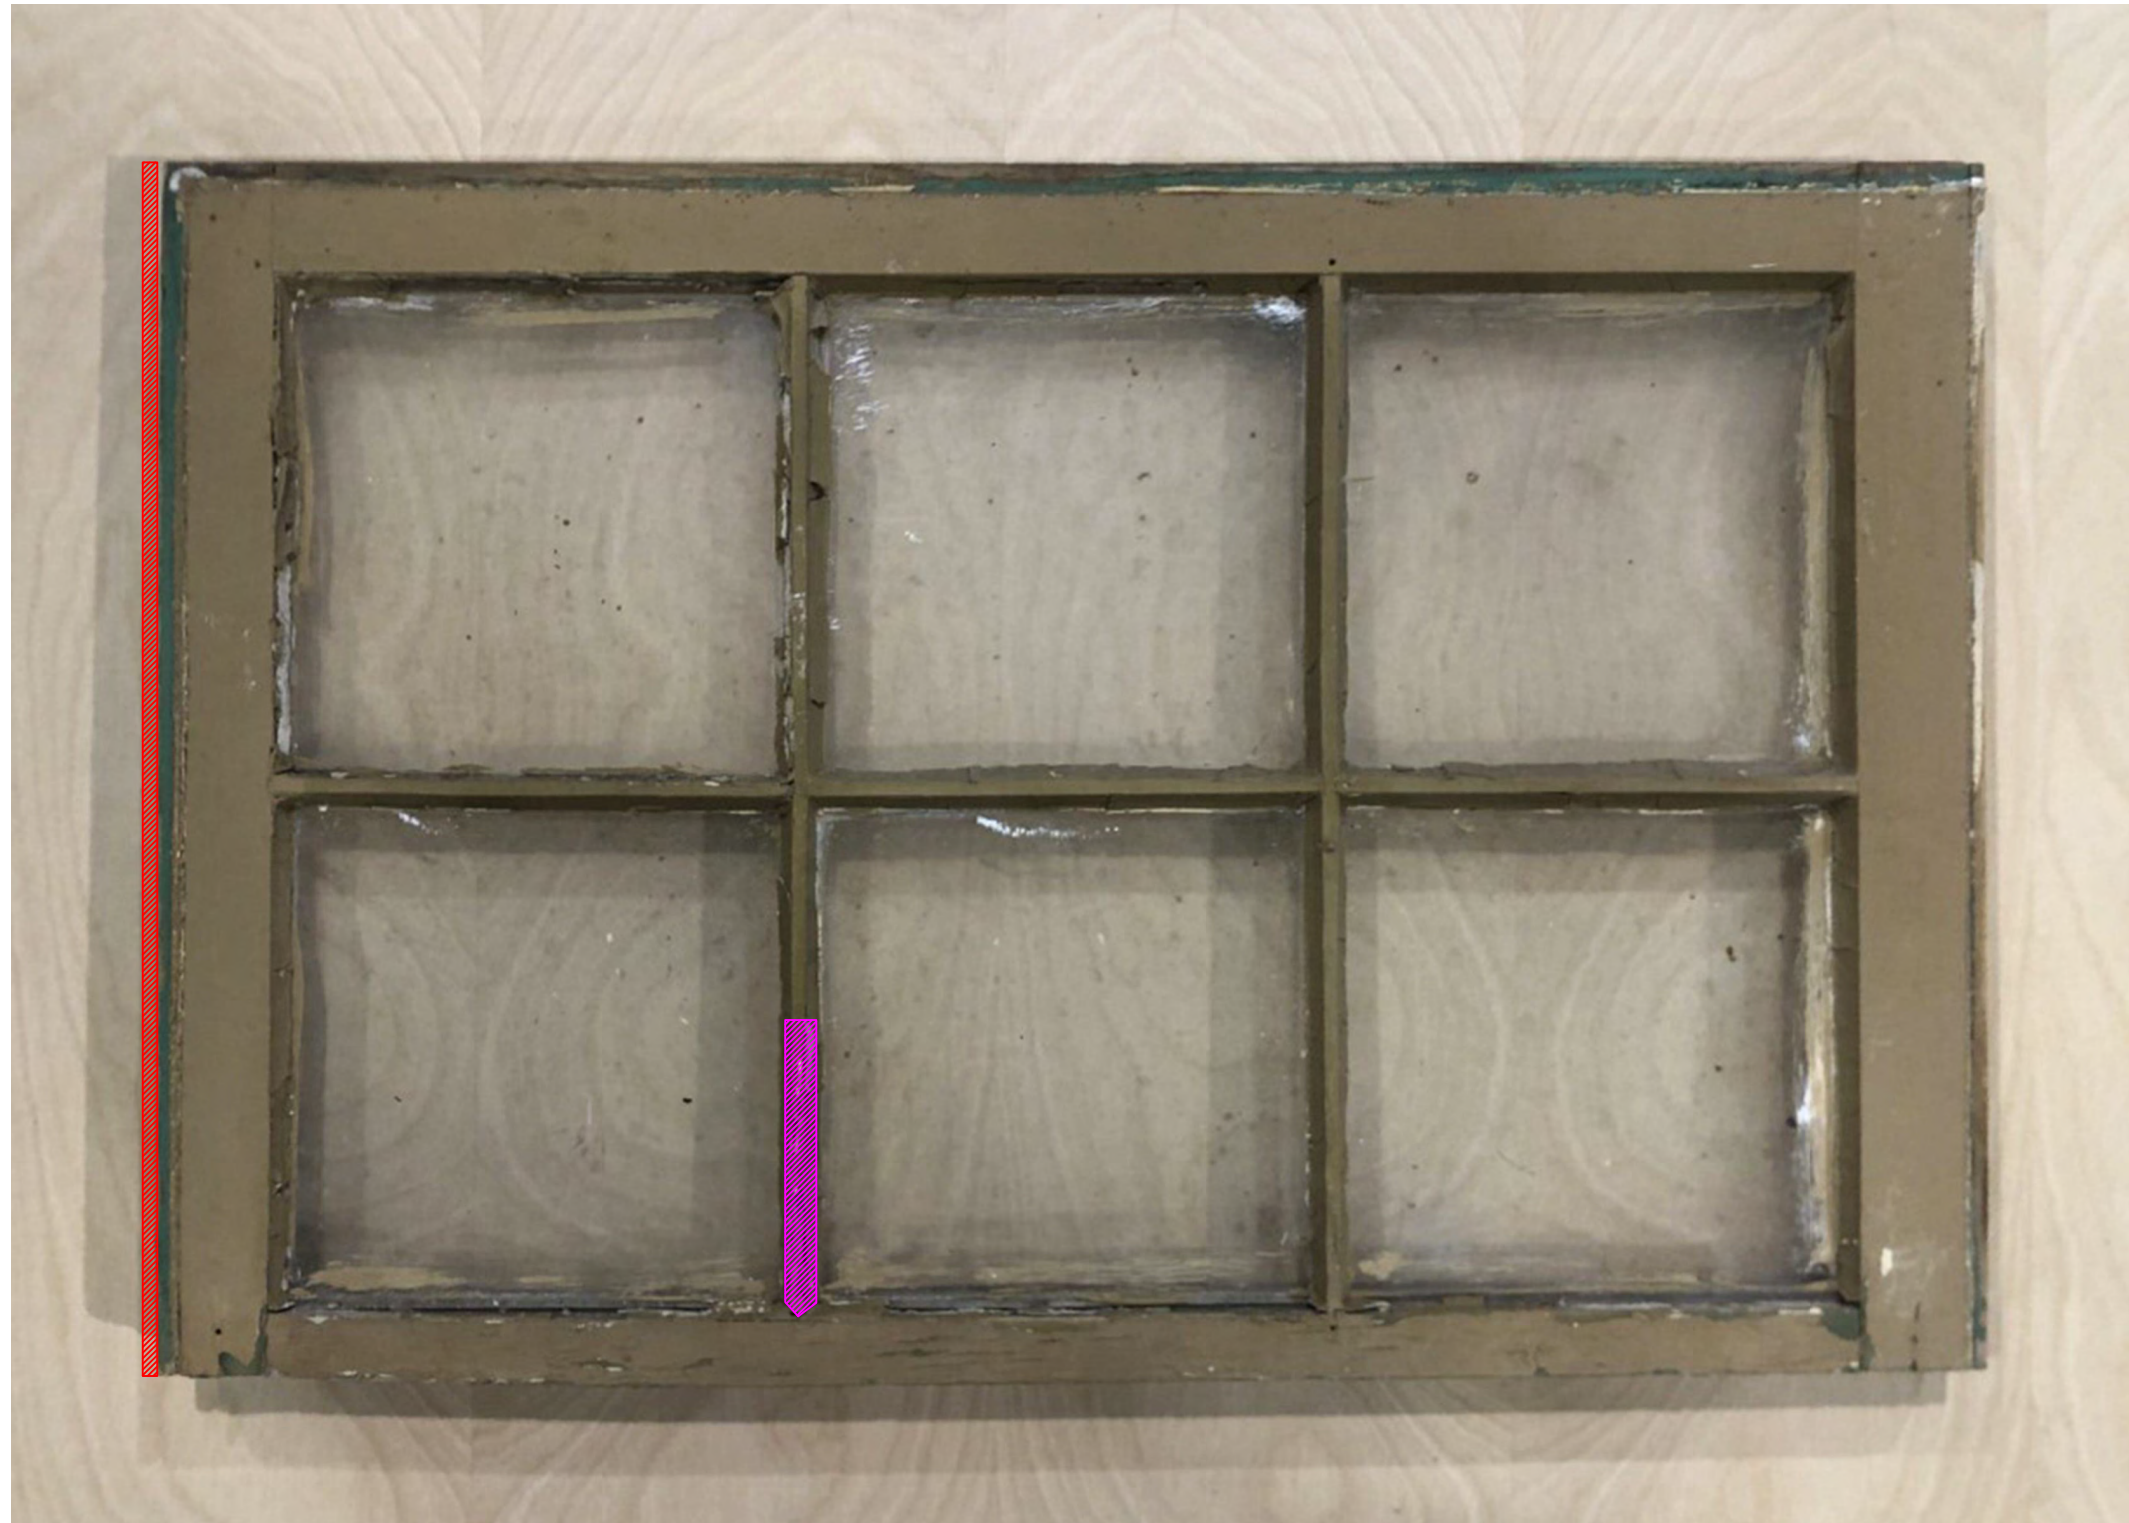
TITLE OF SHEET:
SASH DETERIORATION
CONDITIONS

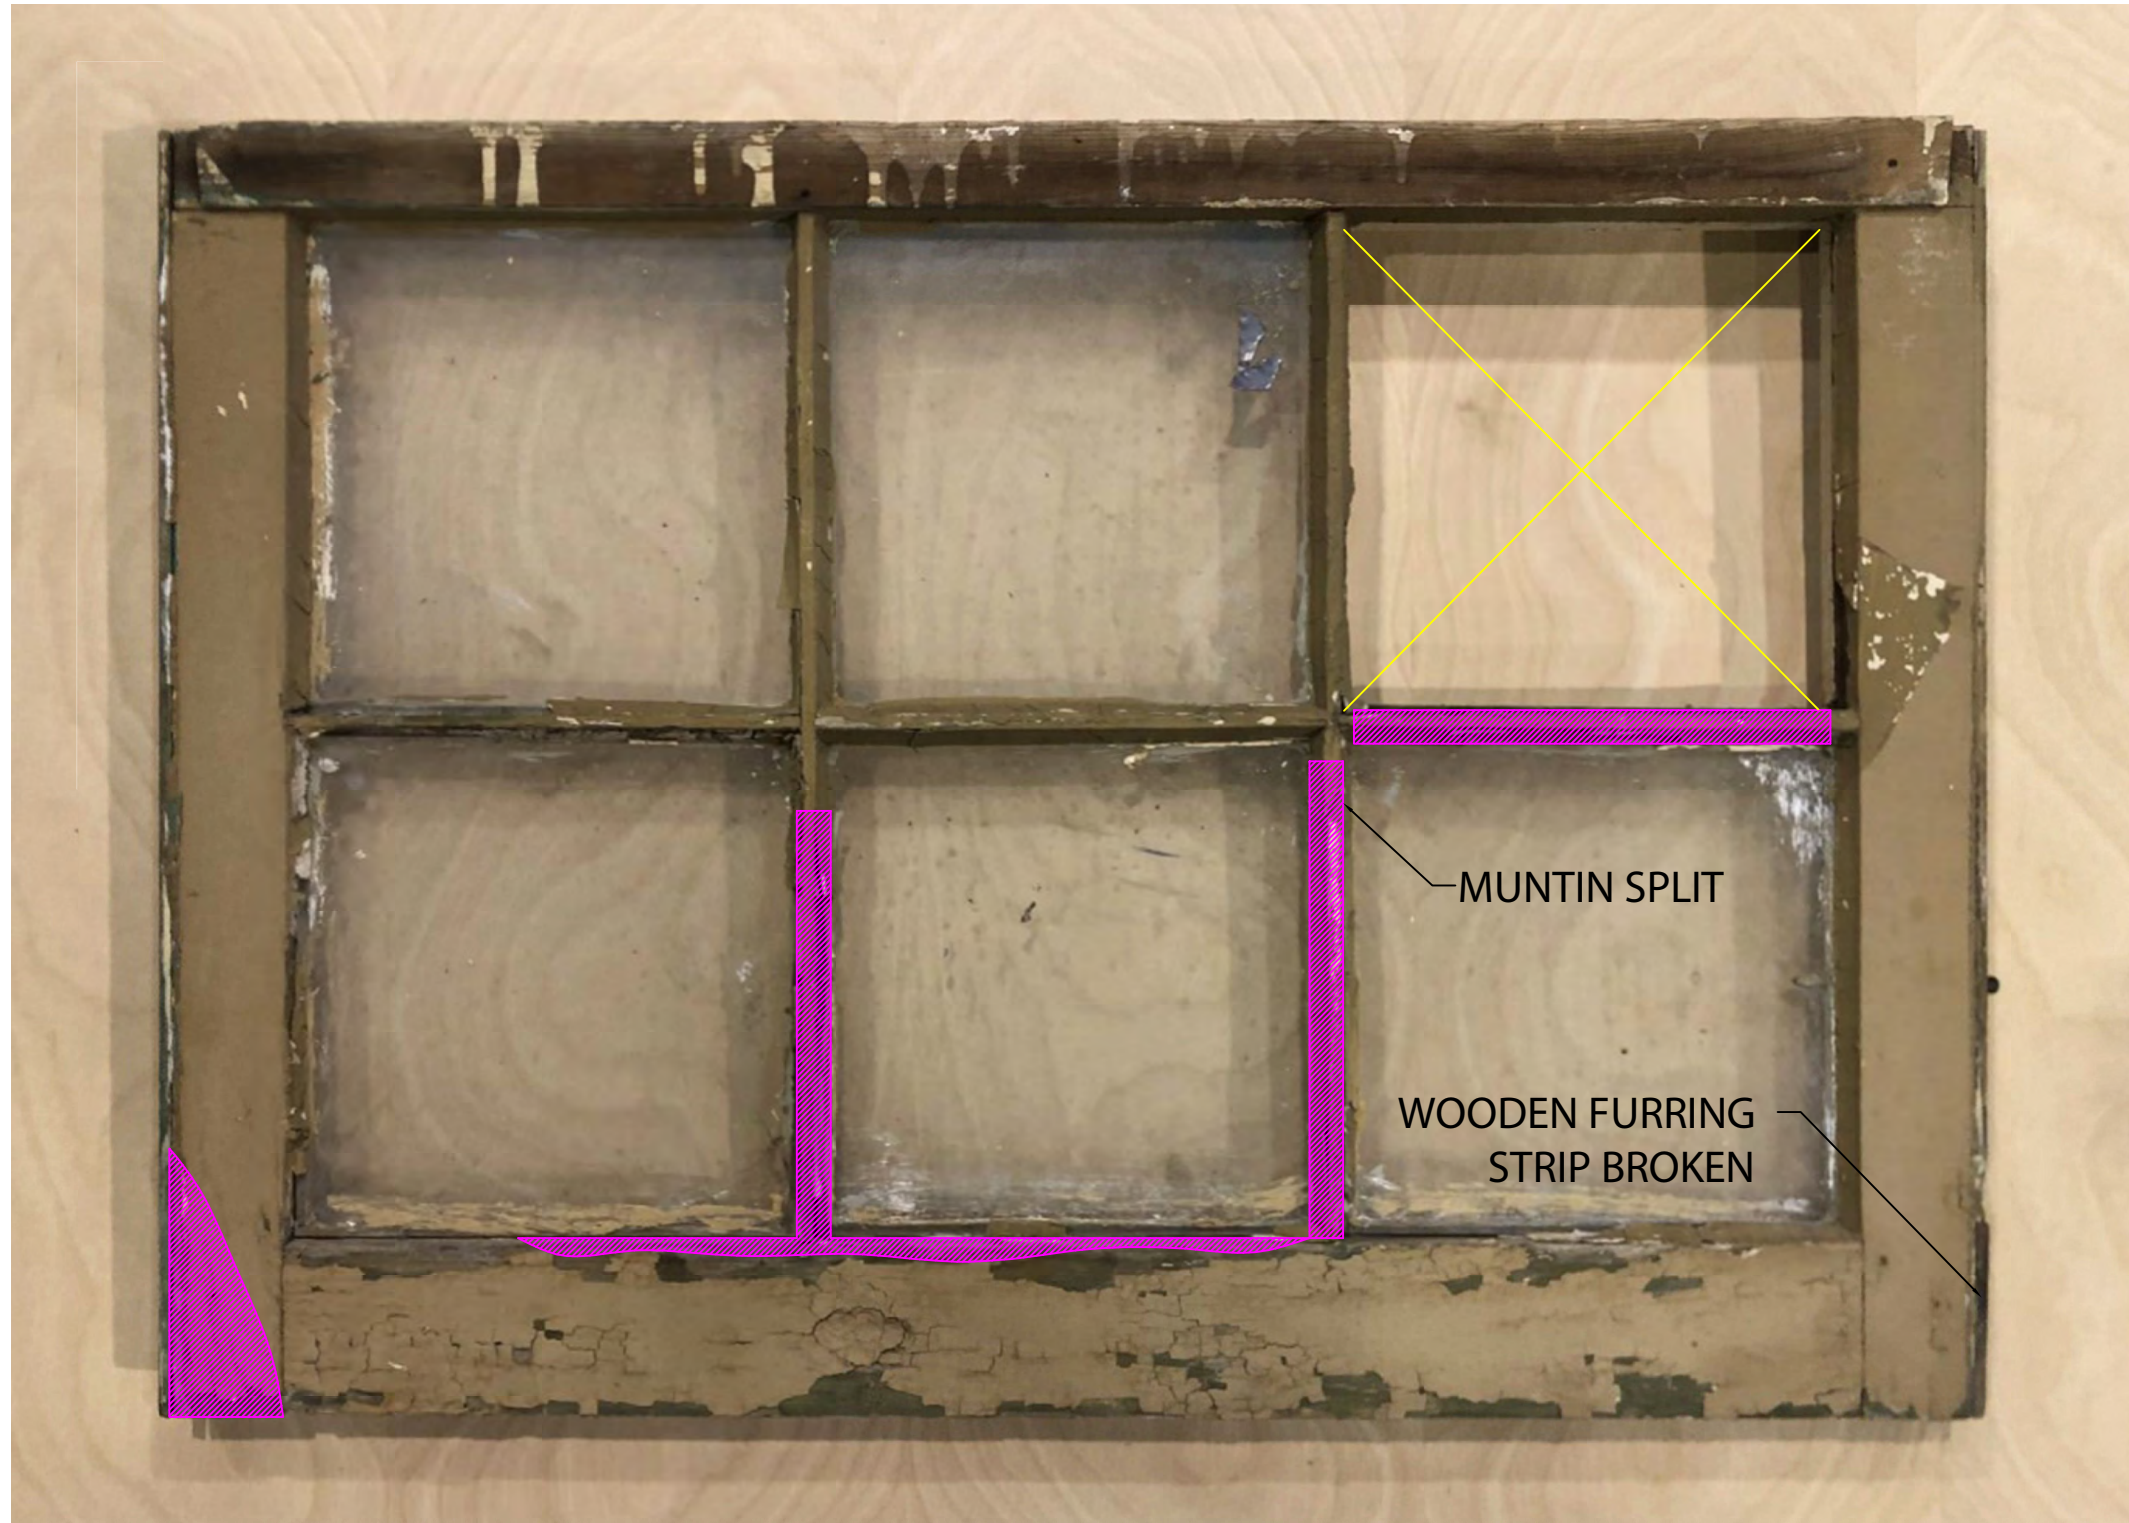
TITLE OF SHEET:
SASH DETERIORATION
CONDITIONS

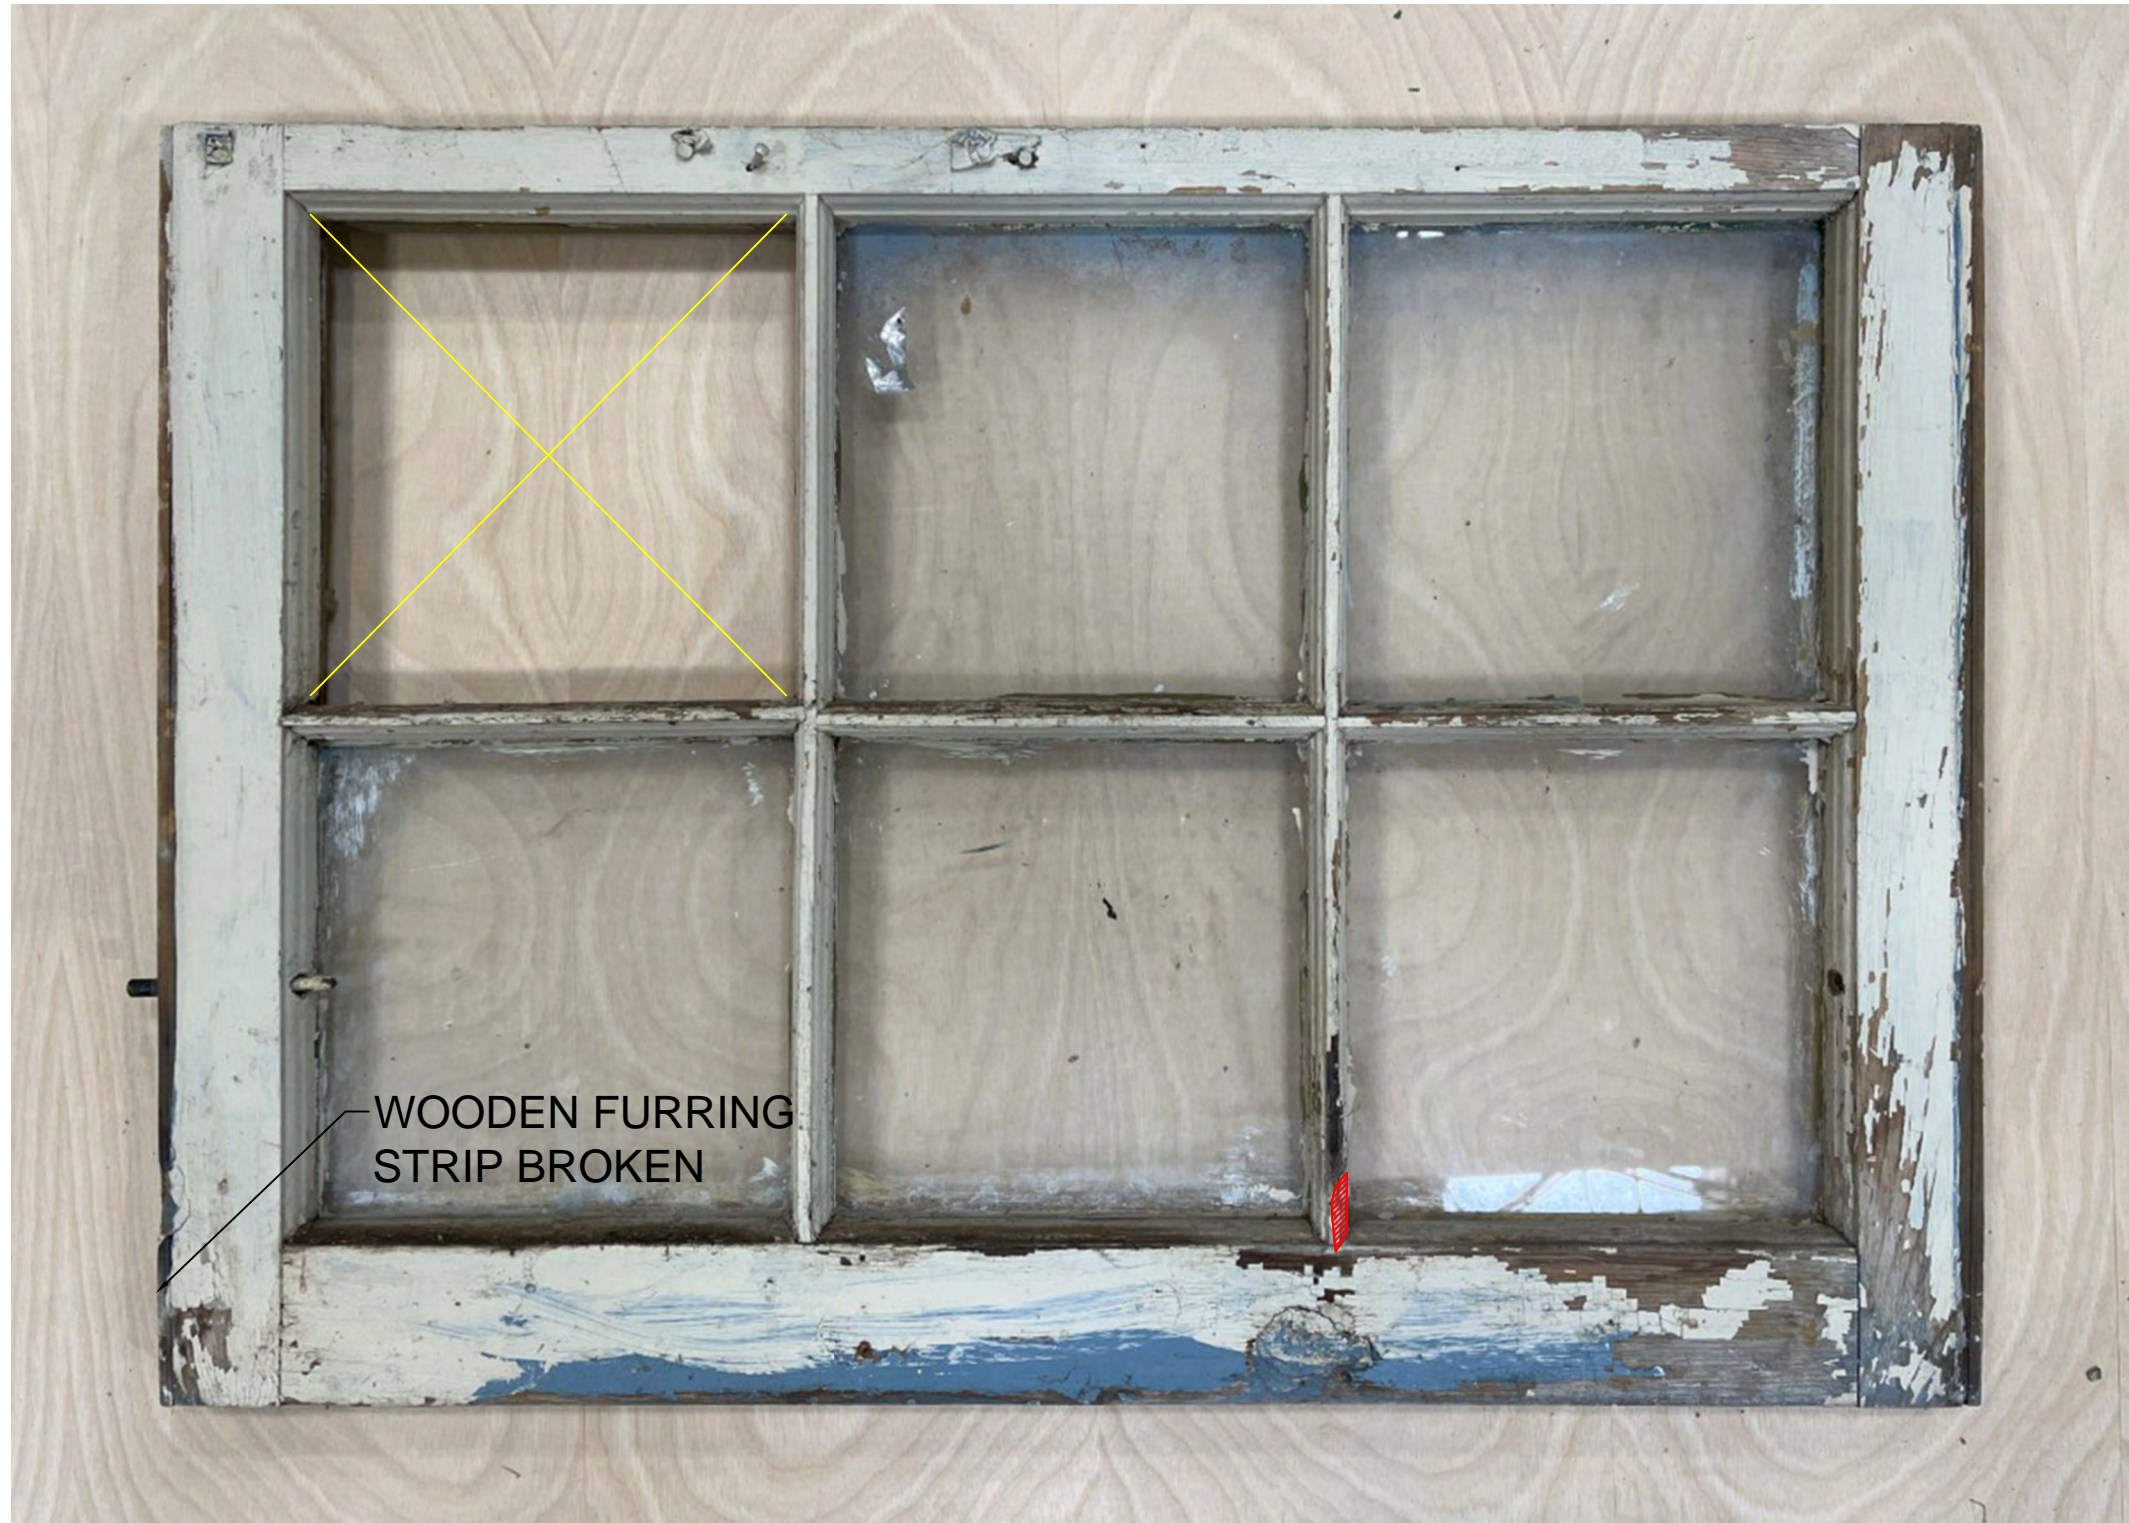
WOODEN FURRING STRIP BROKEN

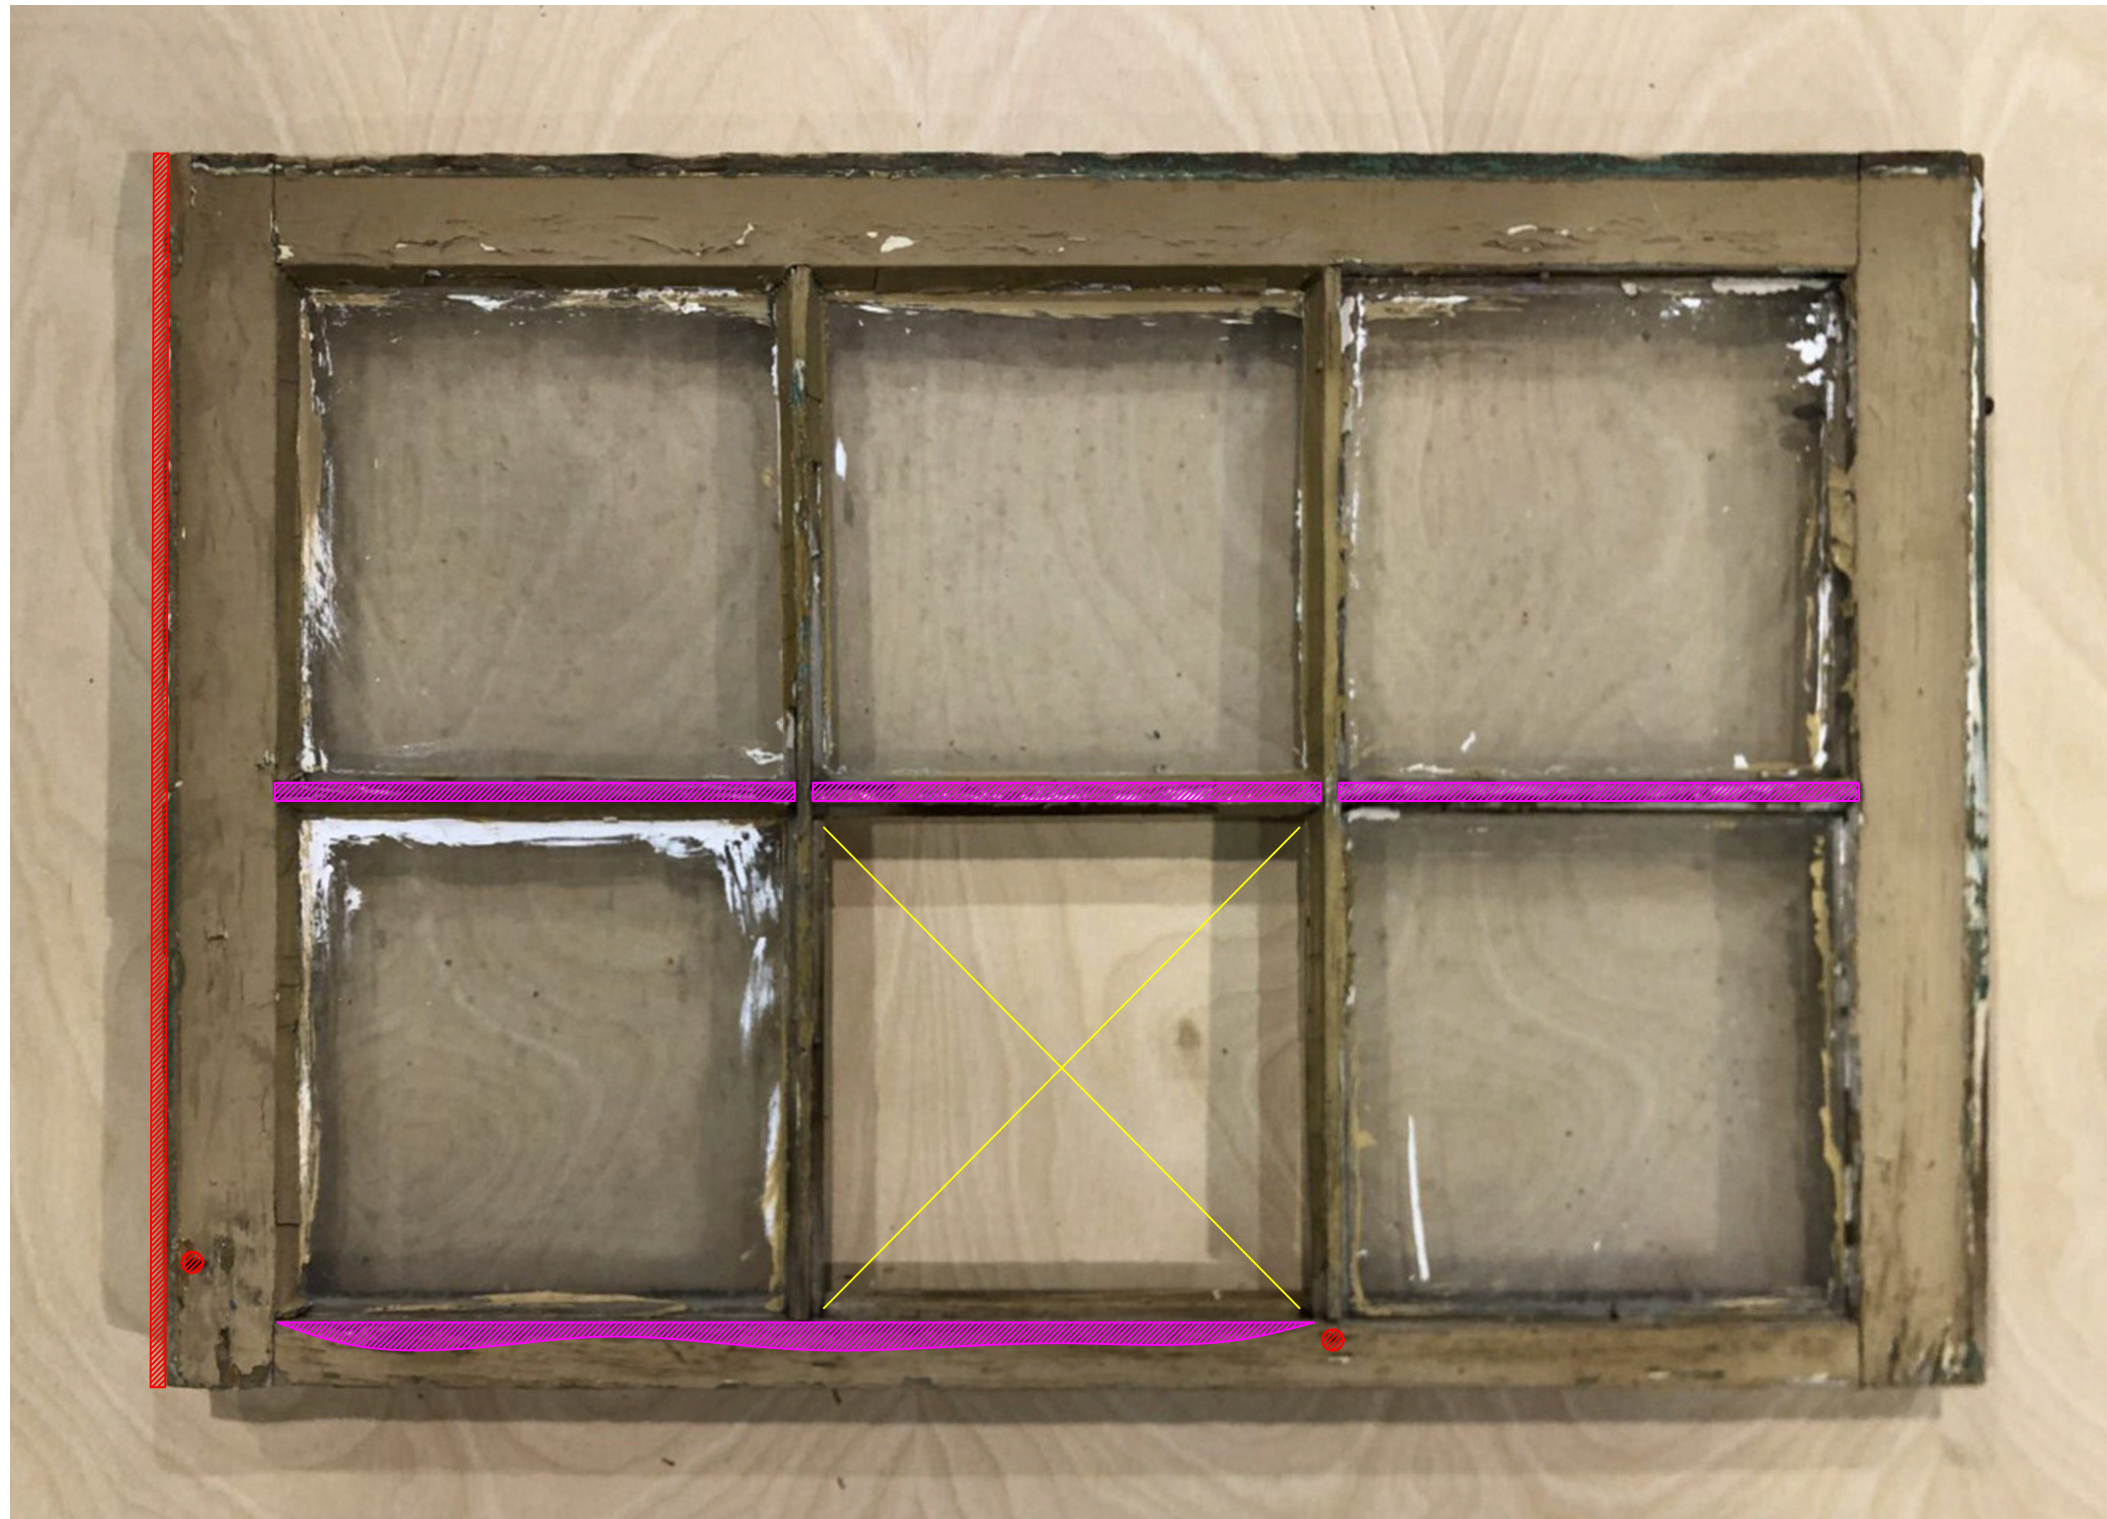
TITLE OF SHEET:
SASH DETERIORATION
CONDITIONS

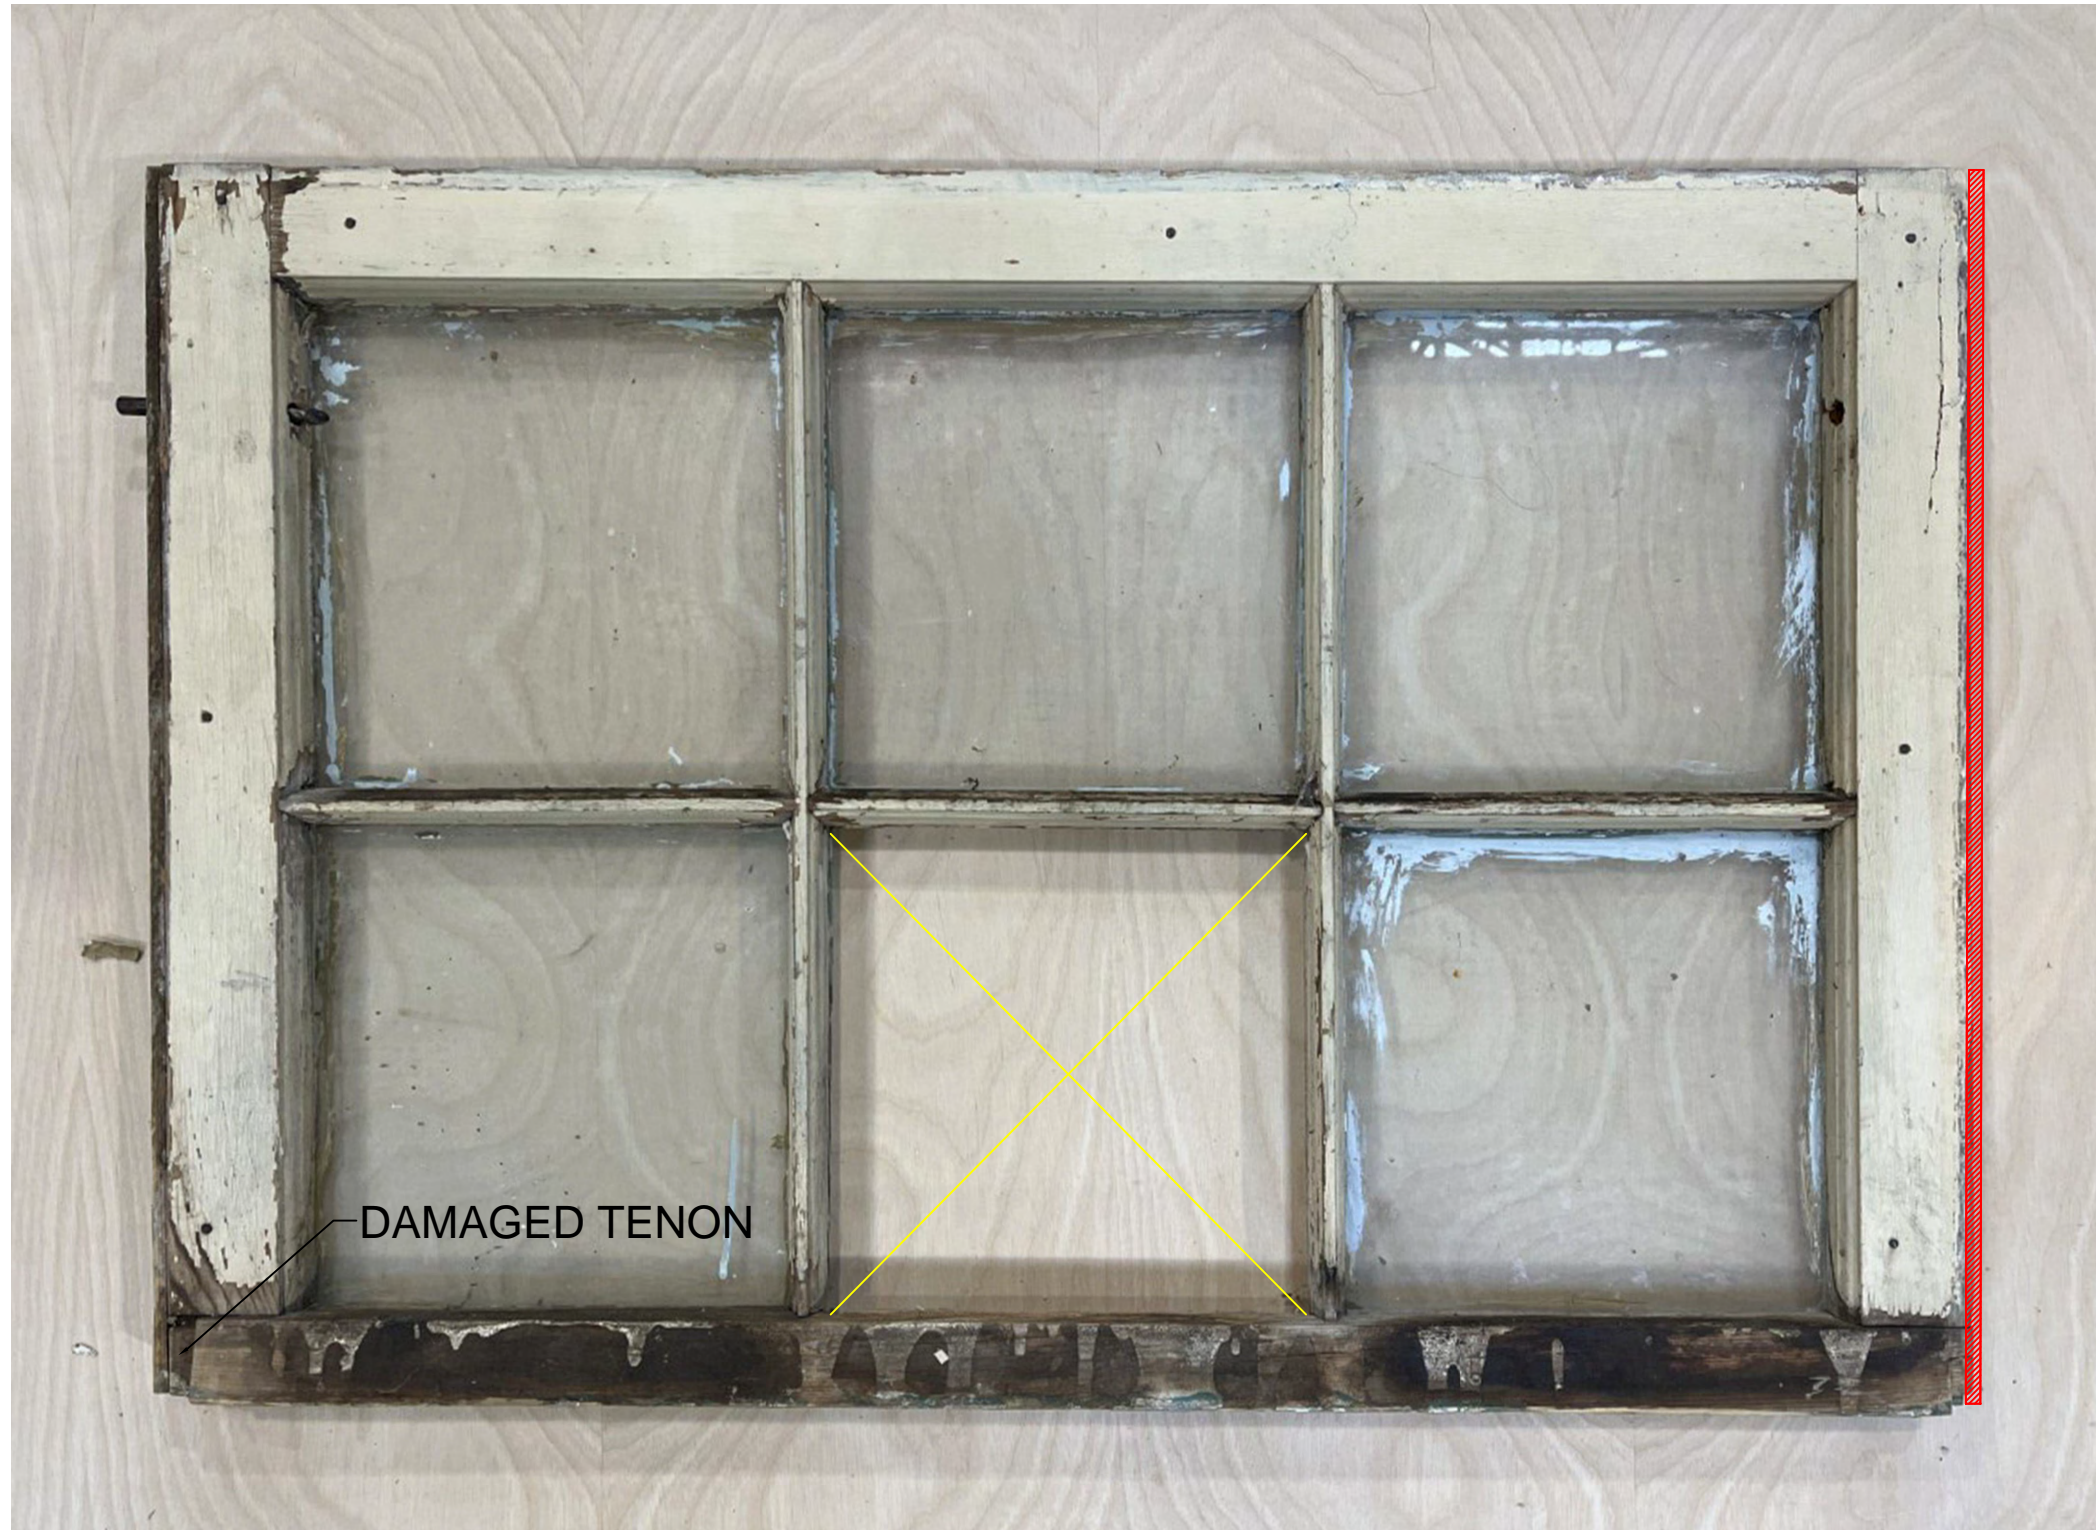
TITLE OF SHEET:
SASH DETERIORATION
CONDITIONS
