LA-UR-24-21637

Approved for public release; distribution is unlimited.

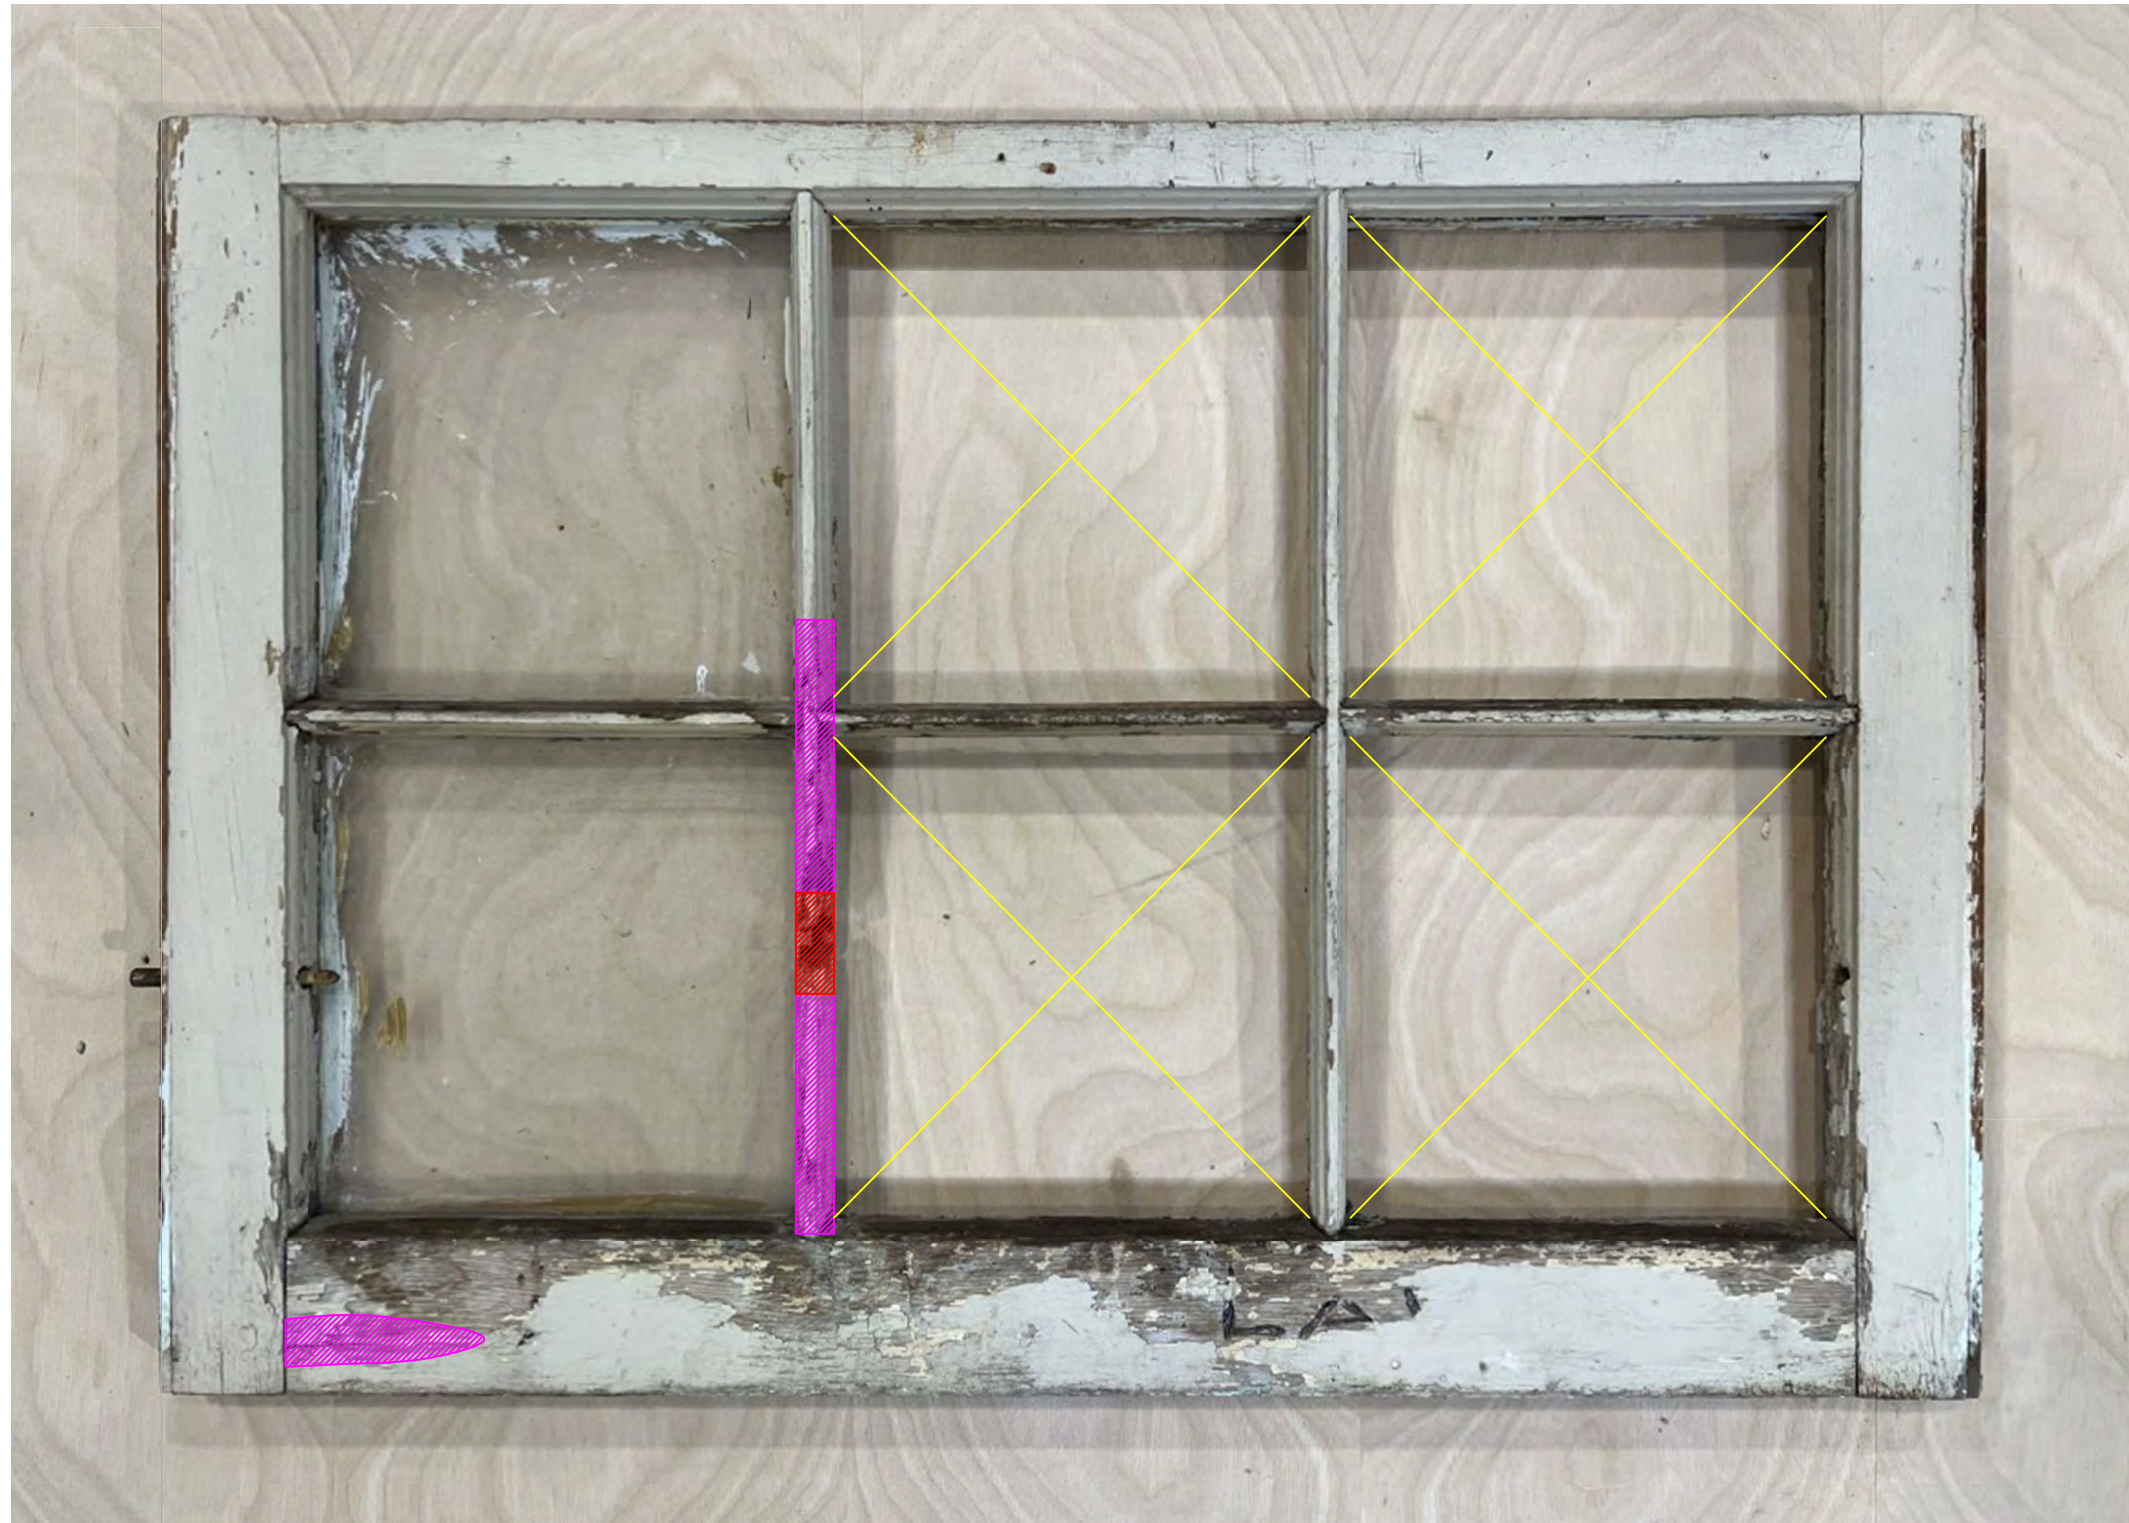
TITLE OF SHEET:
SASH DETERIORATION
CONDITIONS

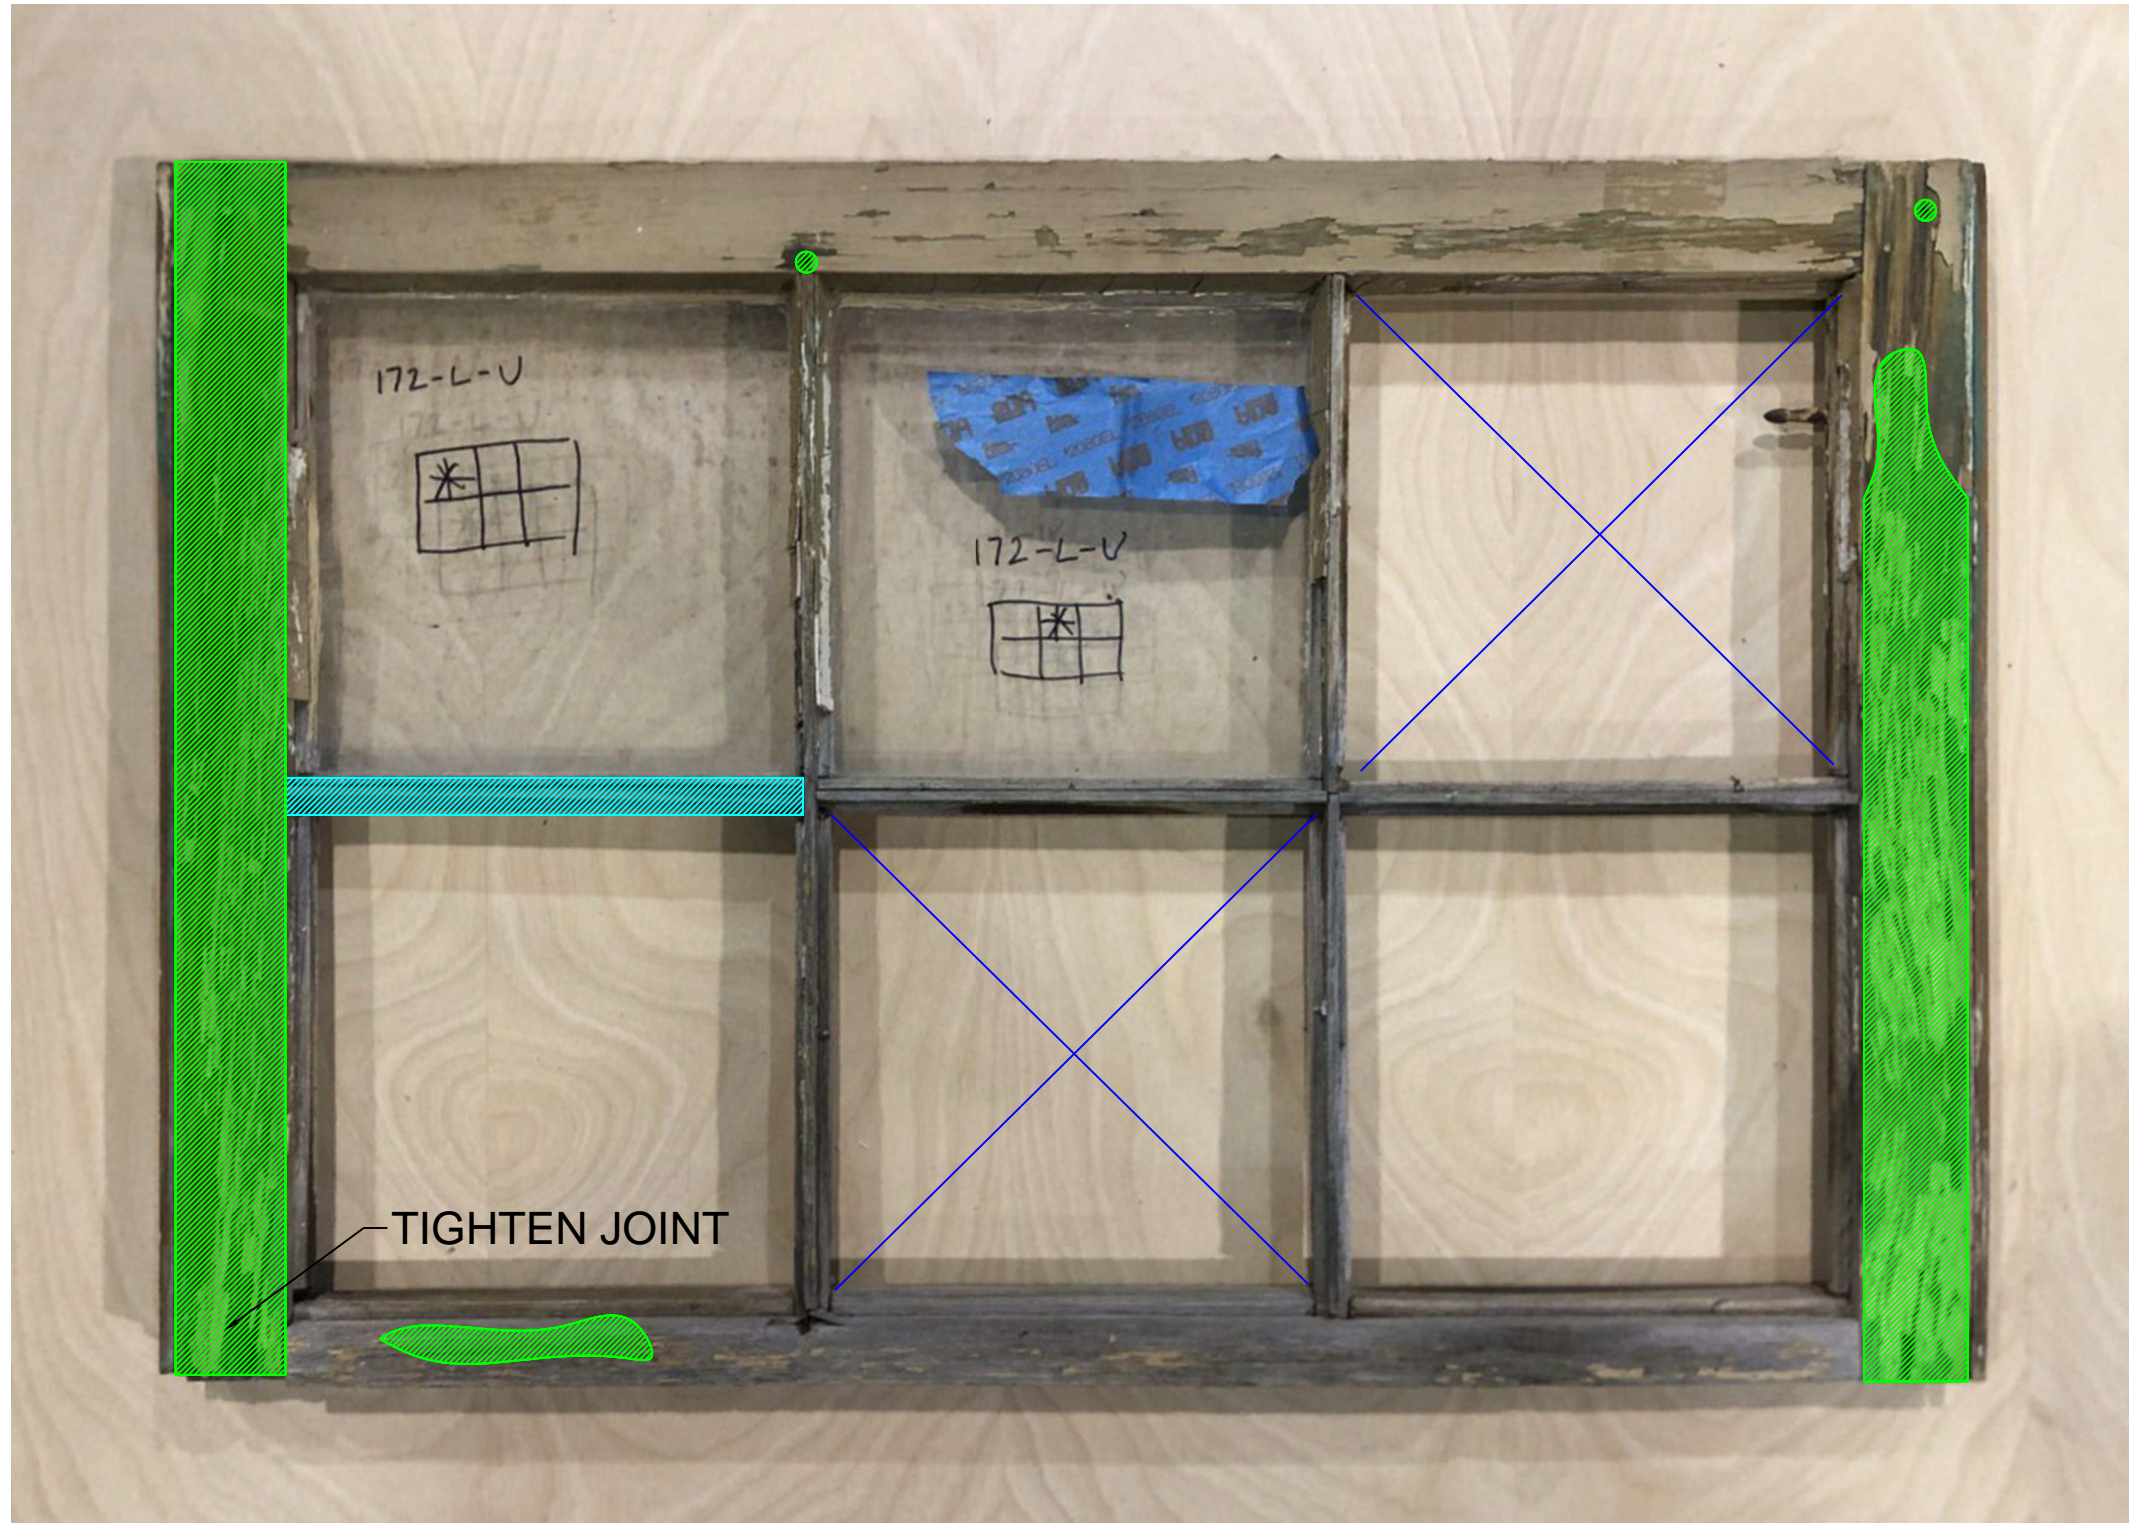
TITLE OF SHEET:
PROPOSED REPAIRS FOR
WINDOW SASH

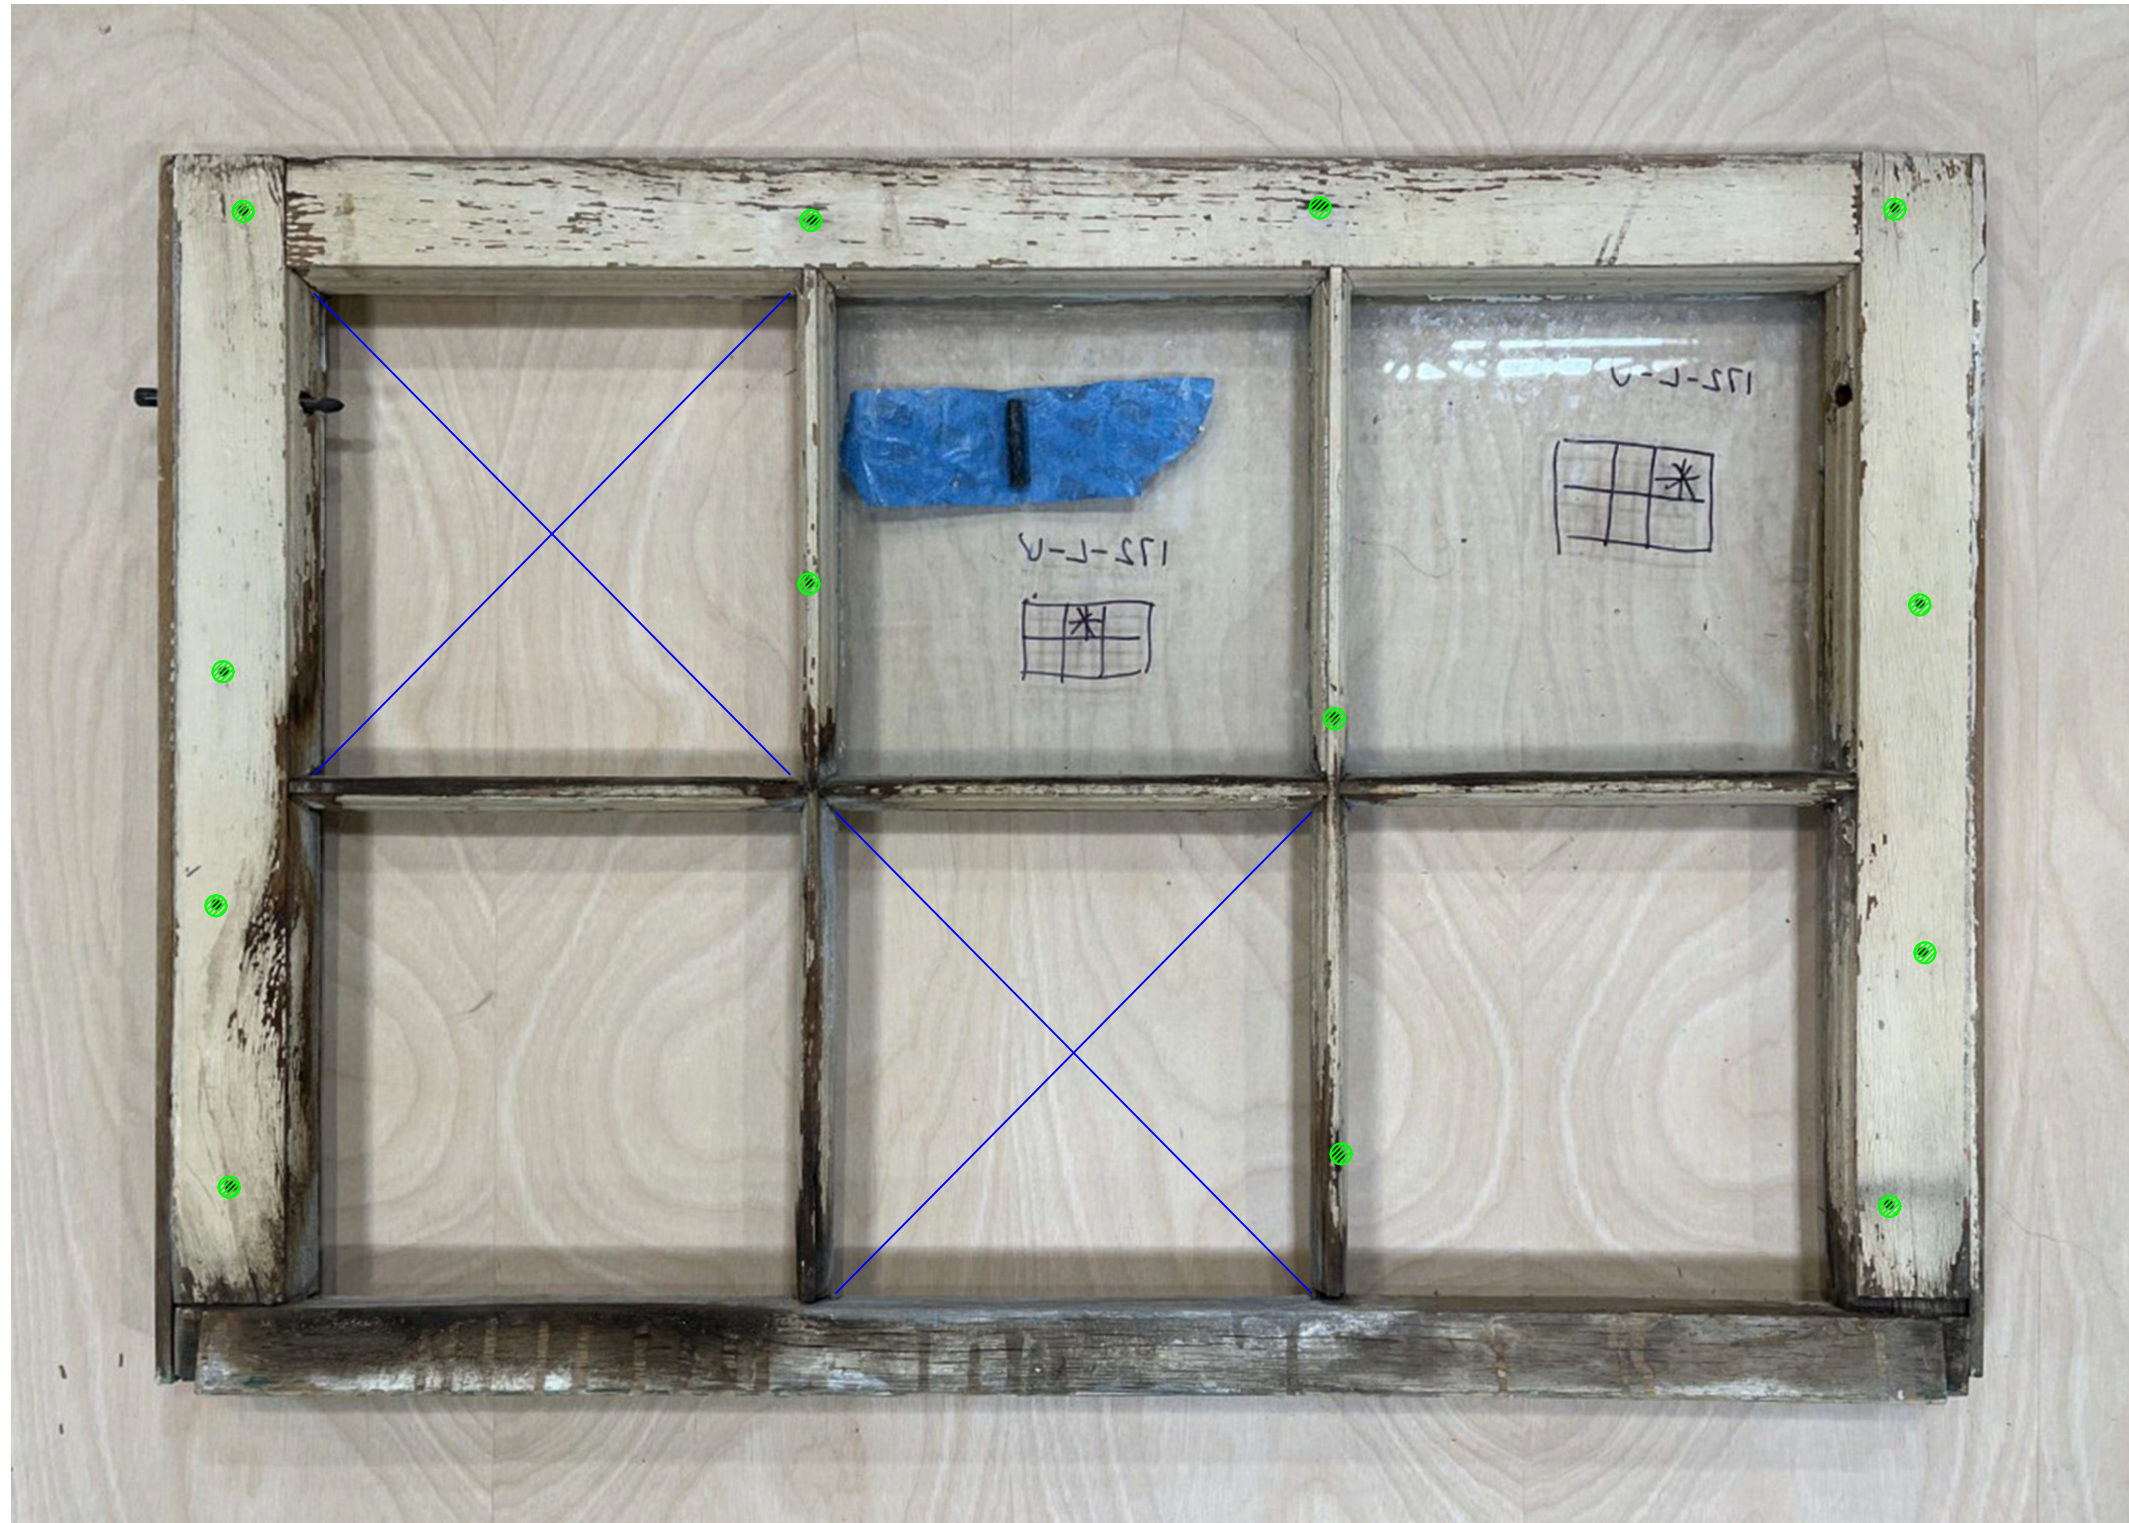
TITLE OF SHEET:
PROPOSED REPAIRS FOR
WINDOW SASH

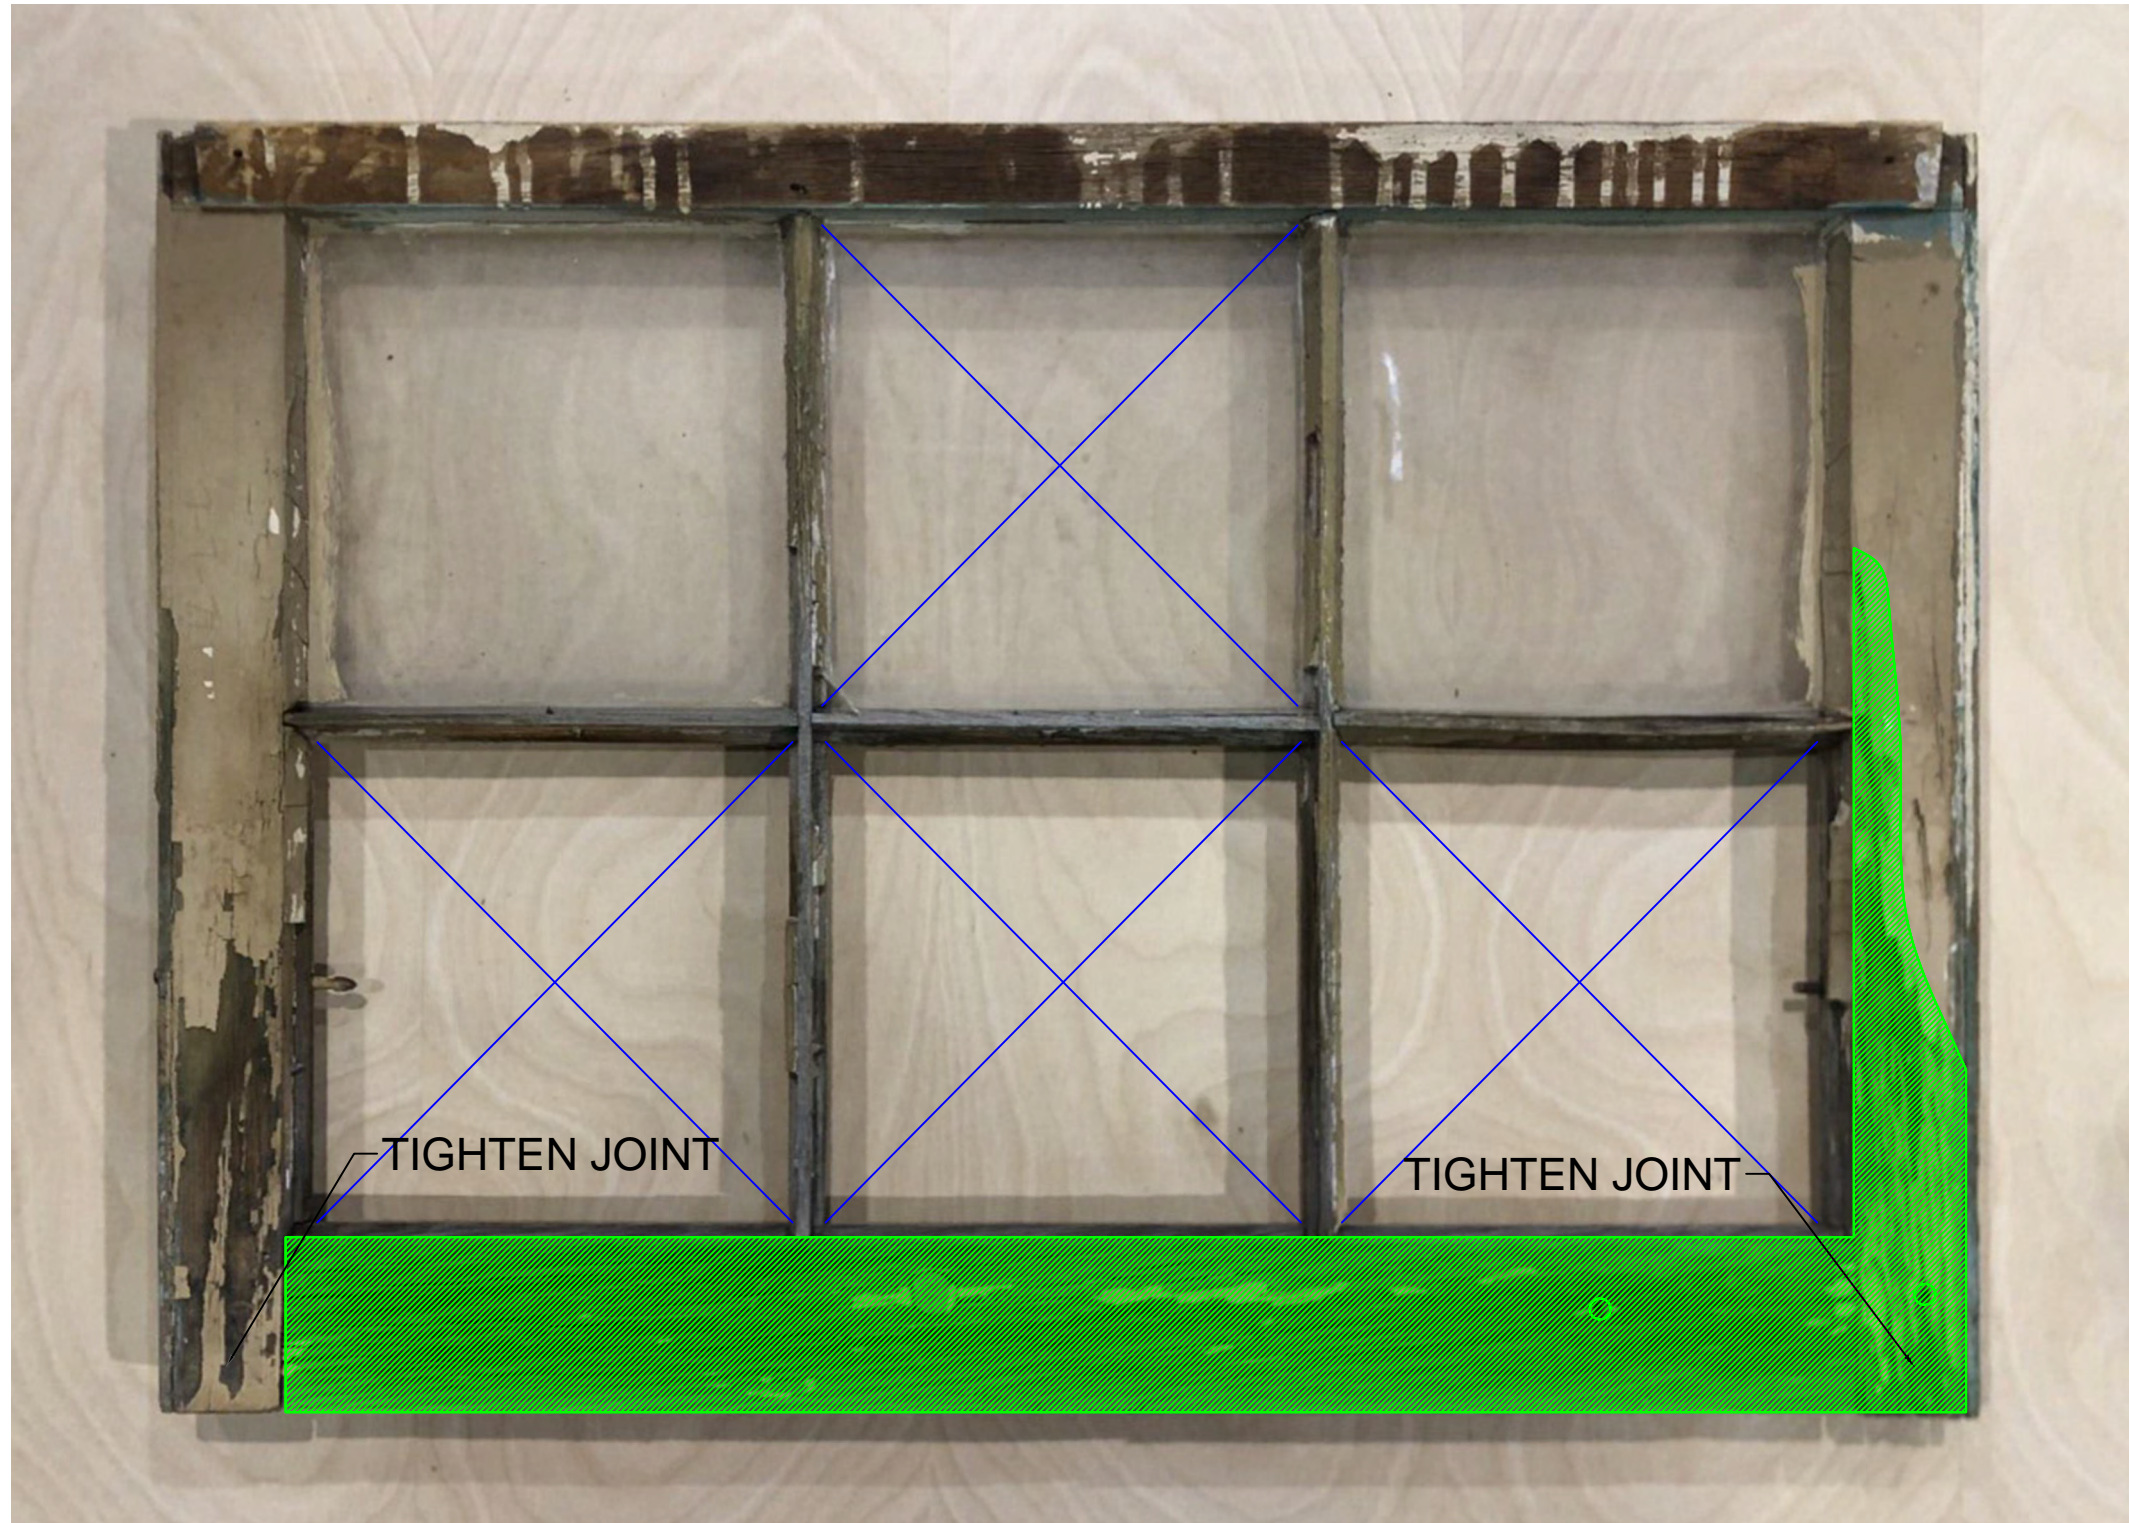
TITLE OF SHEET:
PROPOSED REPAIRS FOR
WINDOW SASH

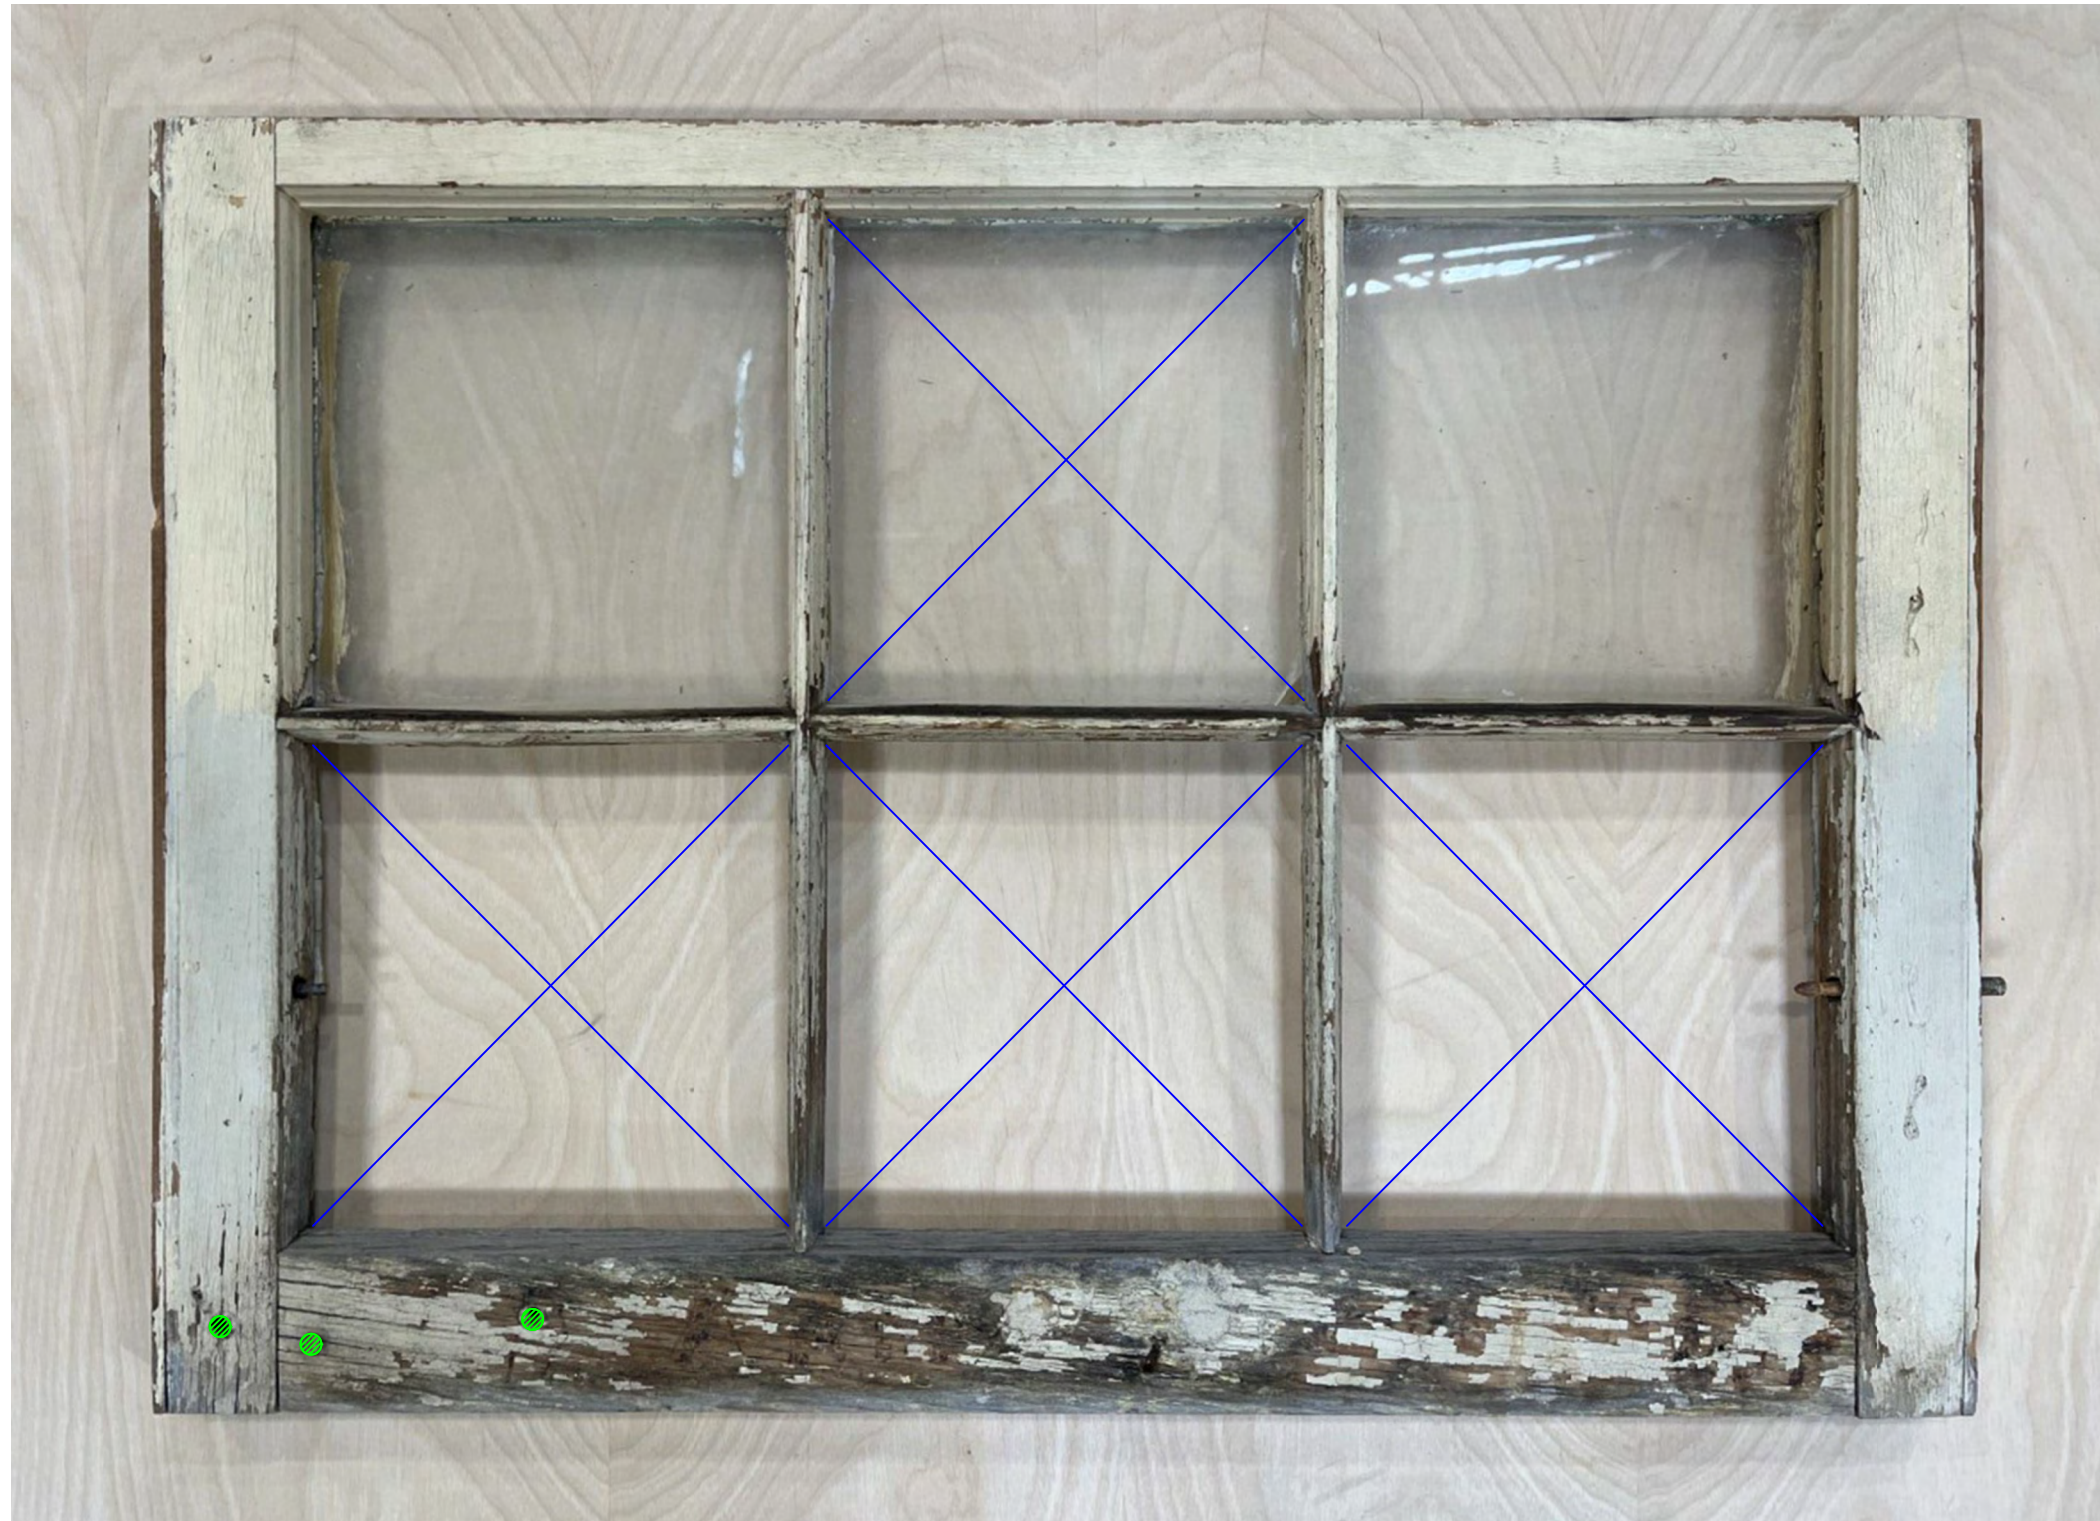
TITLE OF SHEET:
PROPOSED REPAIRS FOR
WINDOW SASH

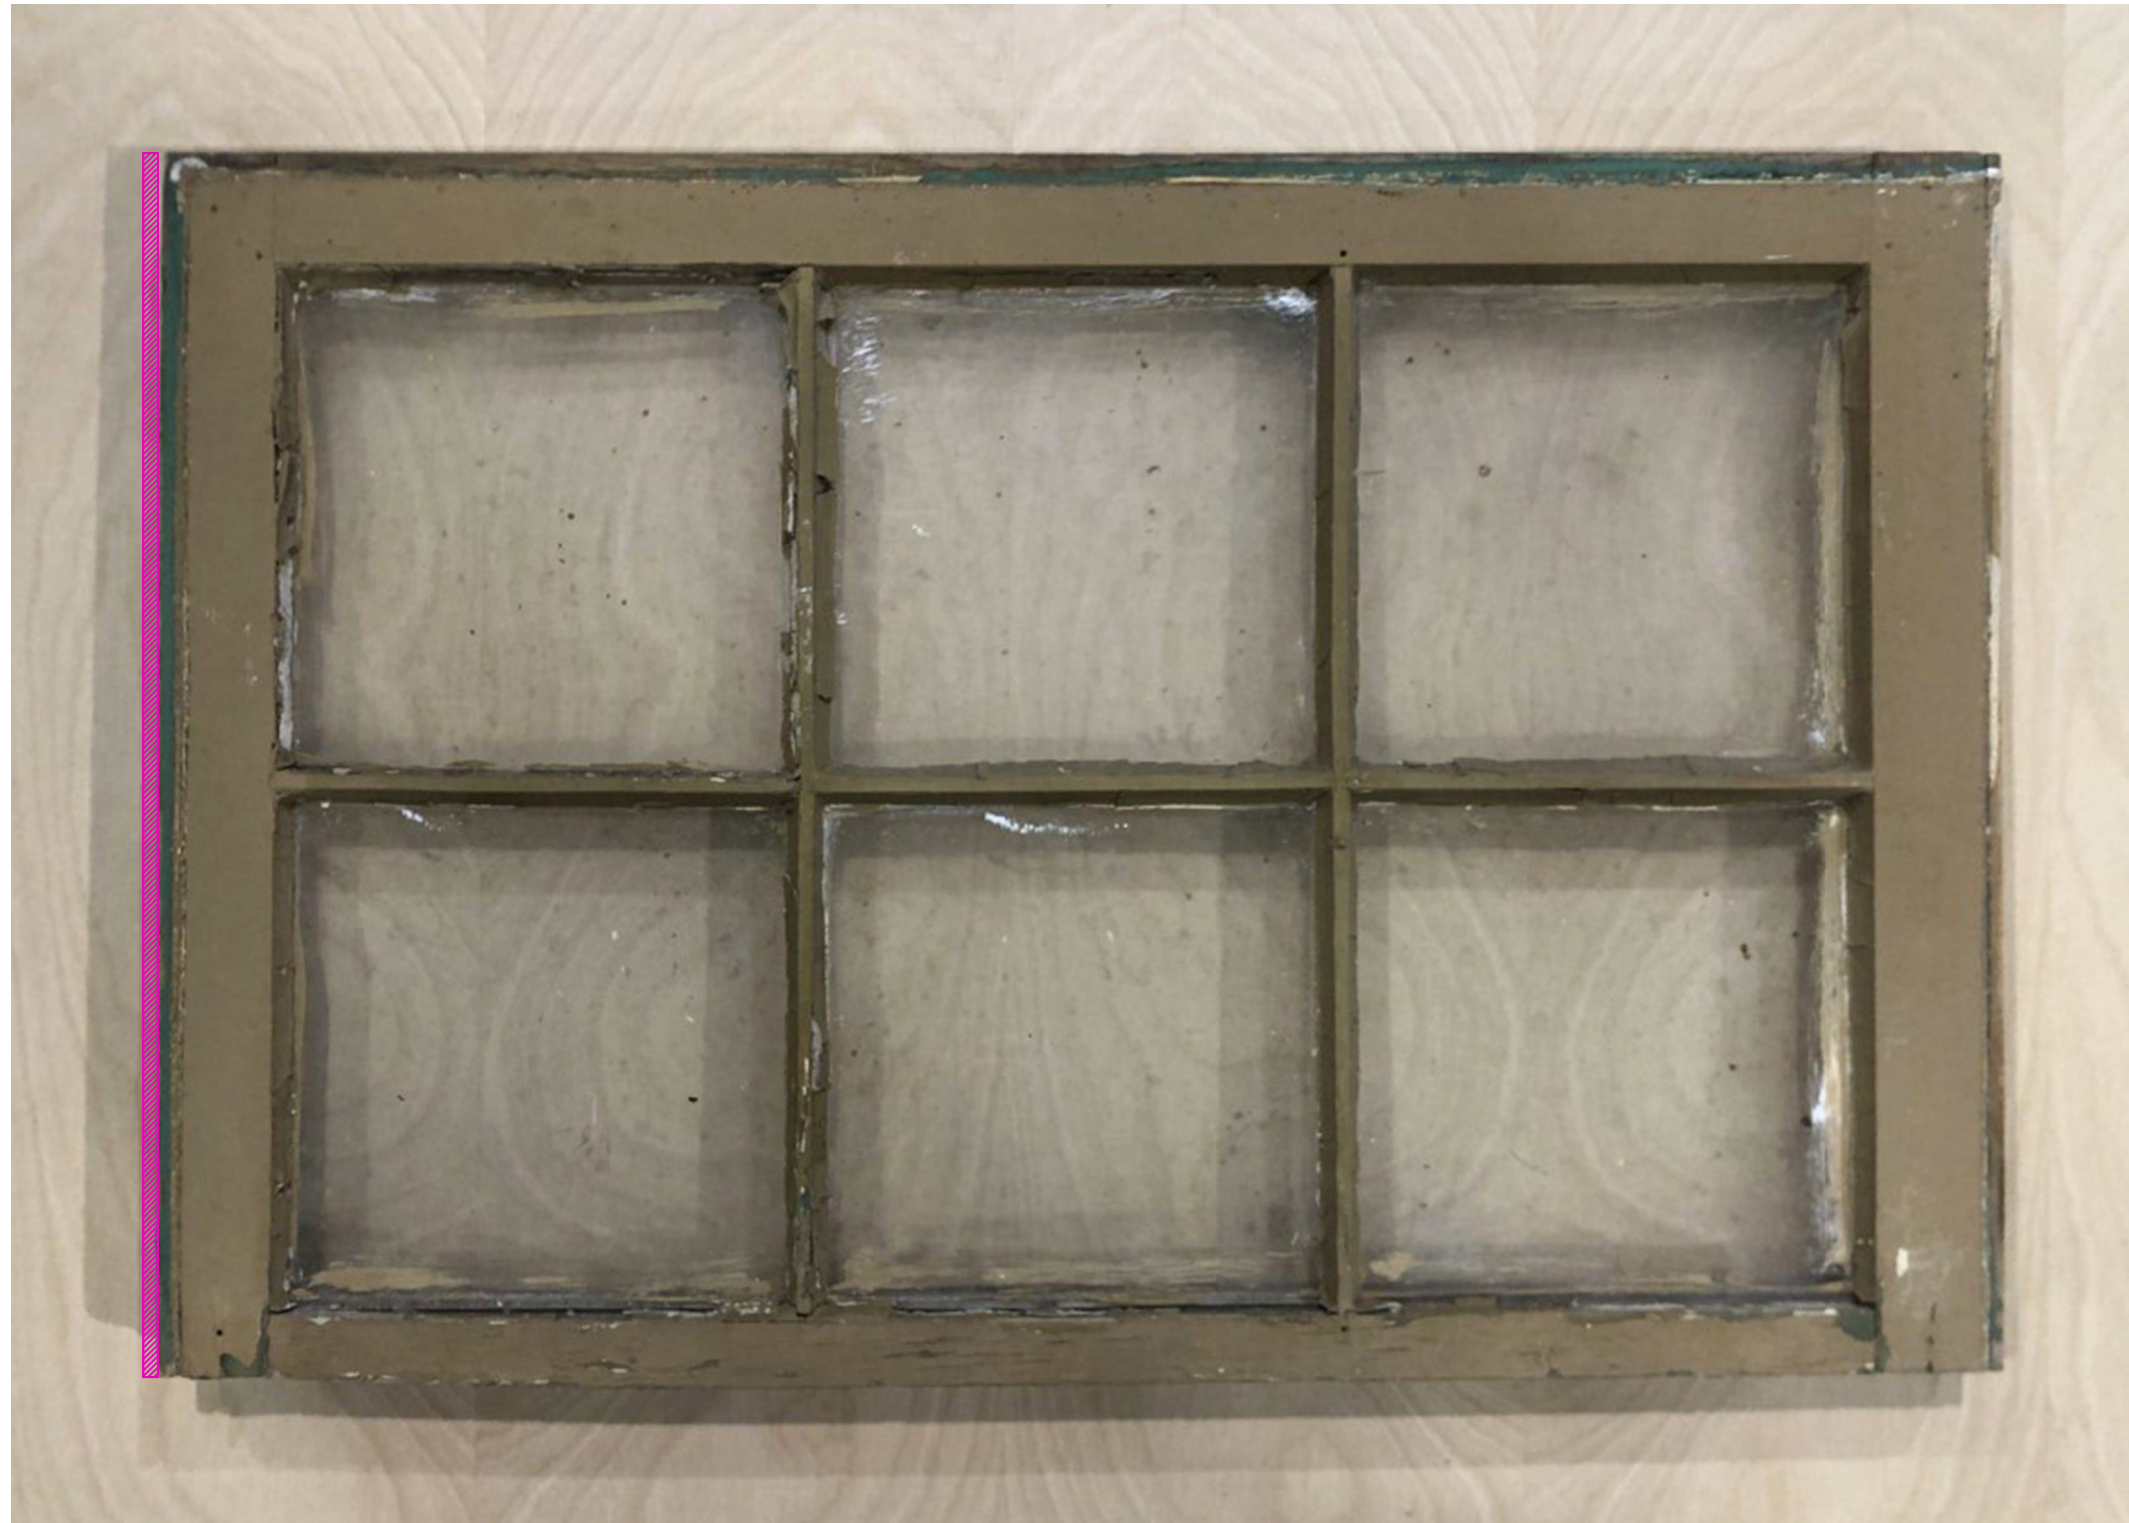
TITLE OF SHEET:
PROPOSED REPAIRS FOR
WINDOW SASH

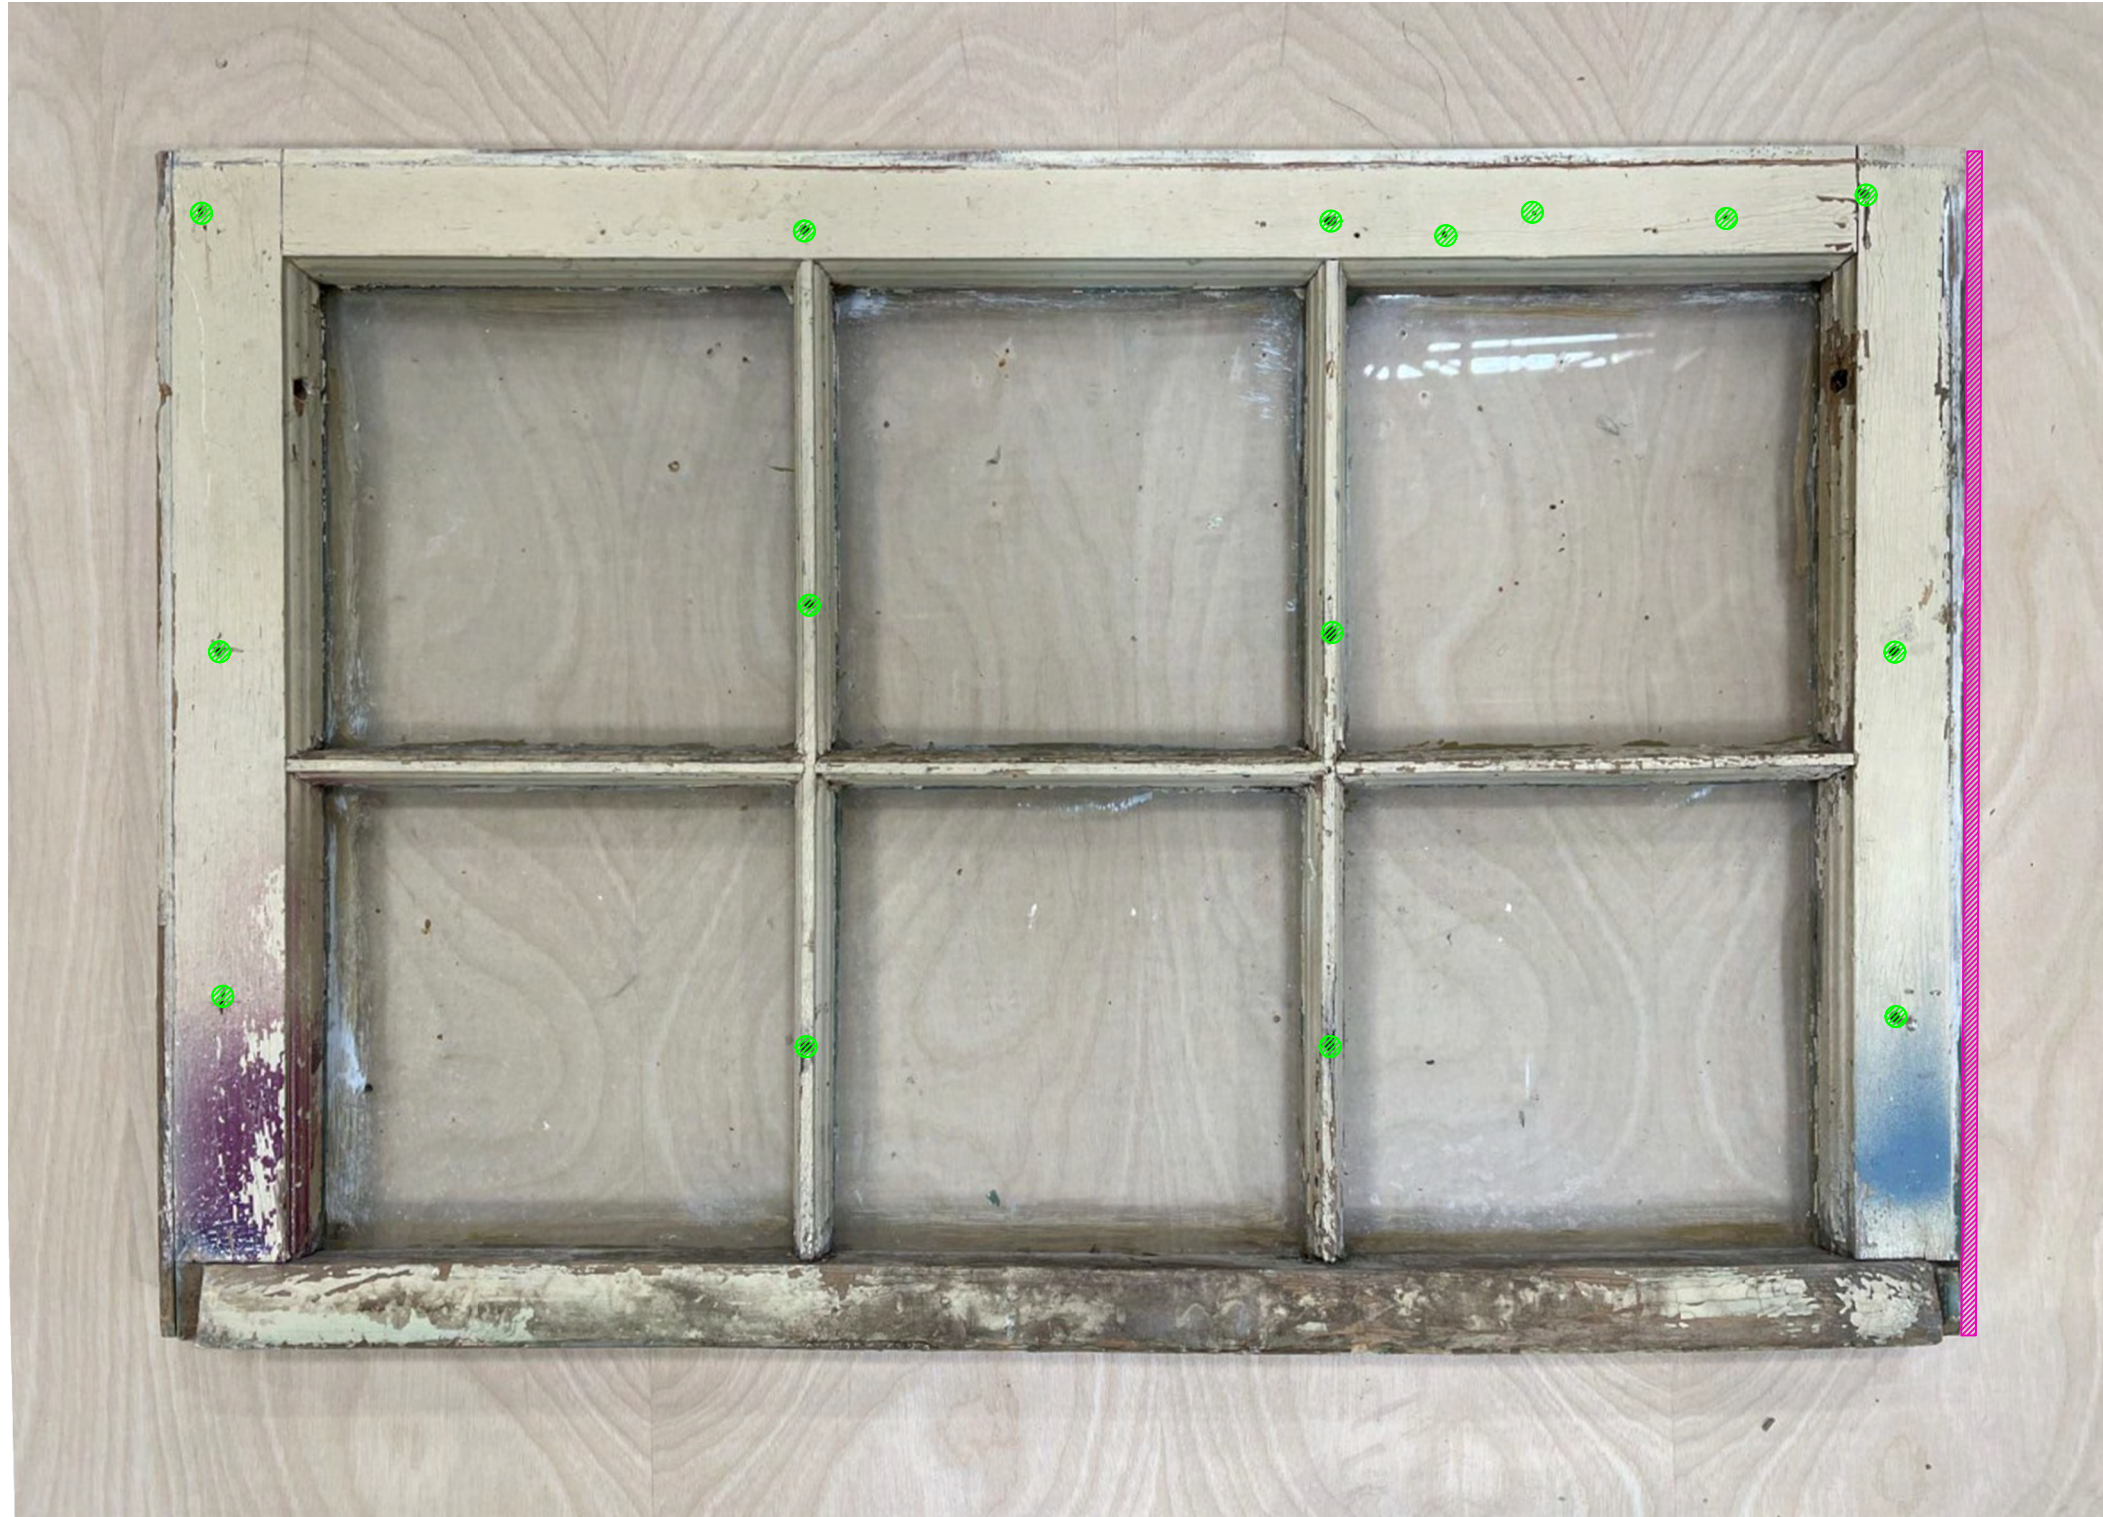
TITLE OF SHEET:
PROPOSED REPAIRS FOR
WINDOW SASH
