LA-UR-24-21637

Approved for public release; distribution is unlimited.

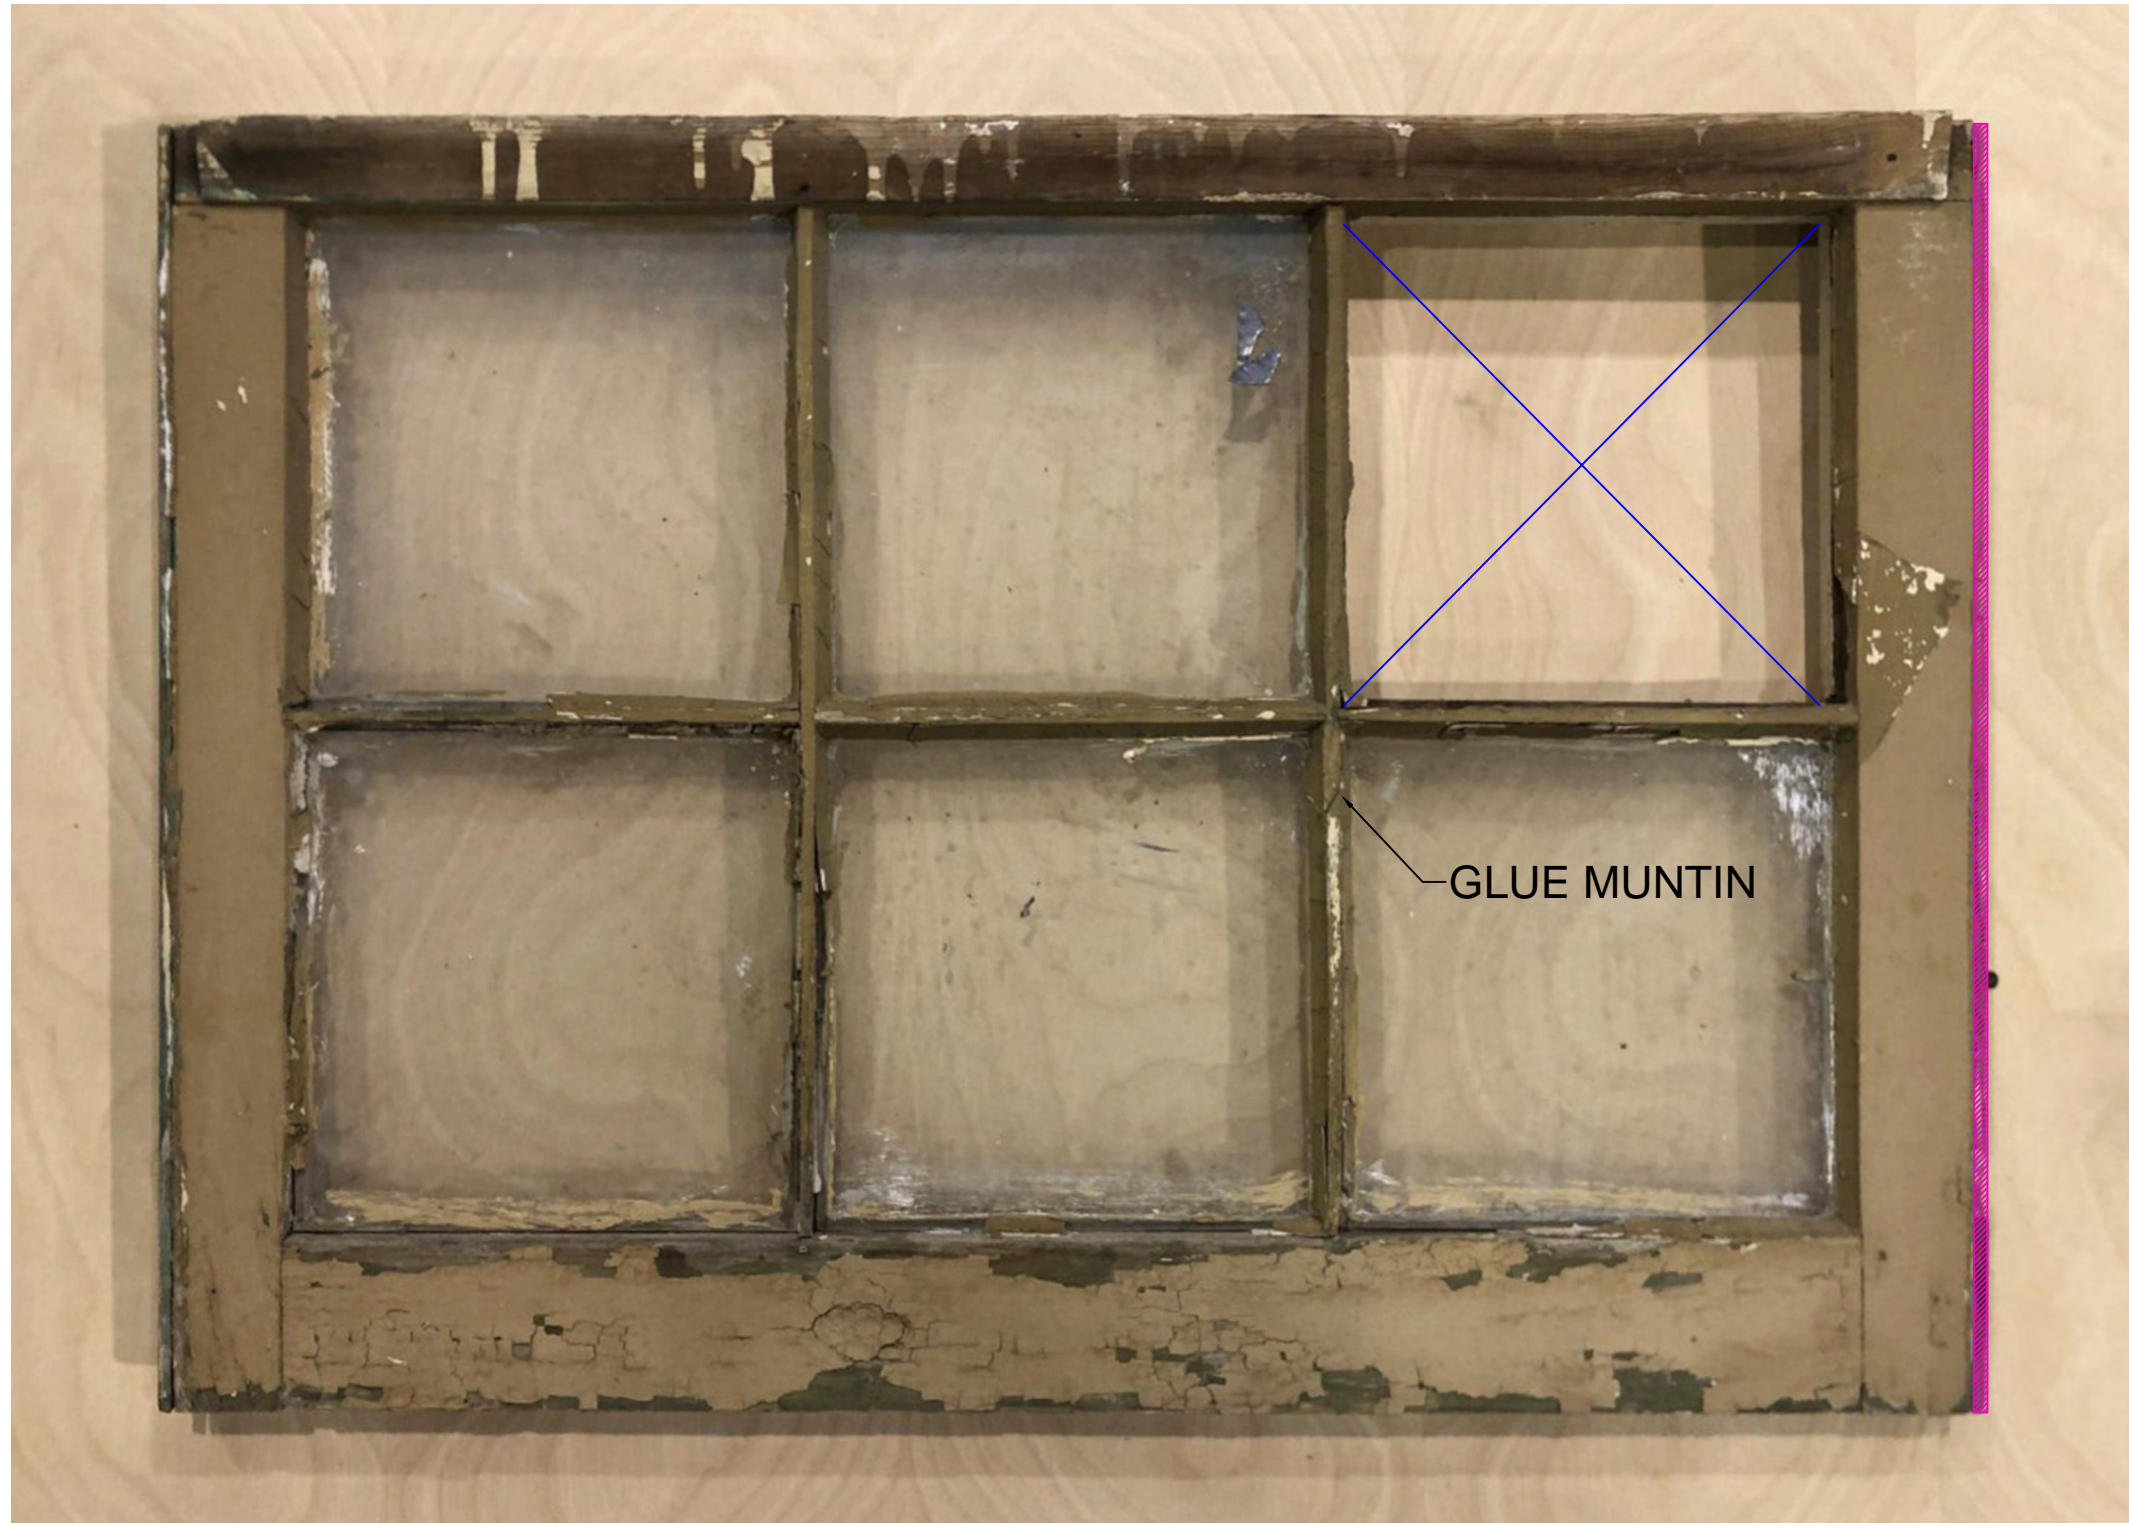
TITLE OF SHEET:
PROPOSED REPAIRS FOR
WINDOW SASH

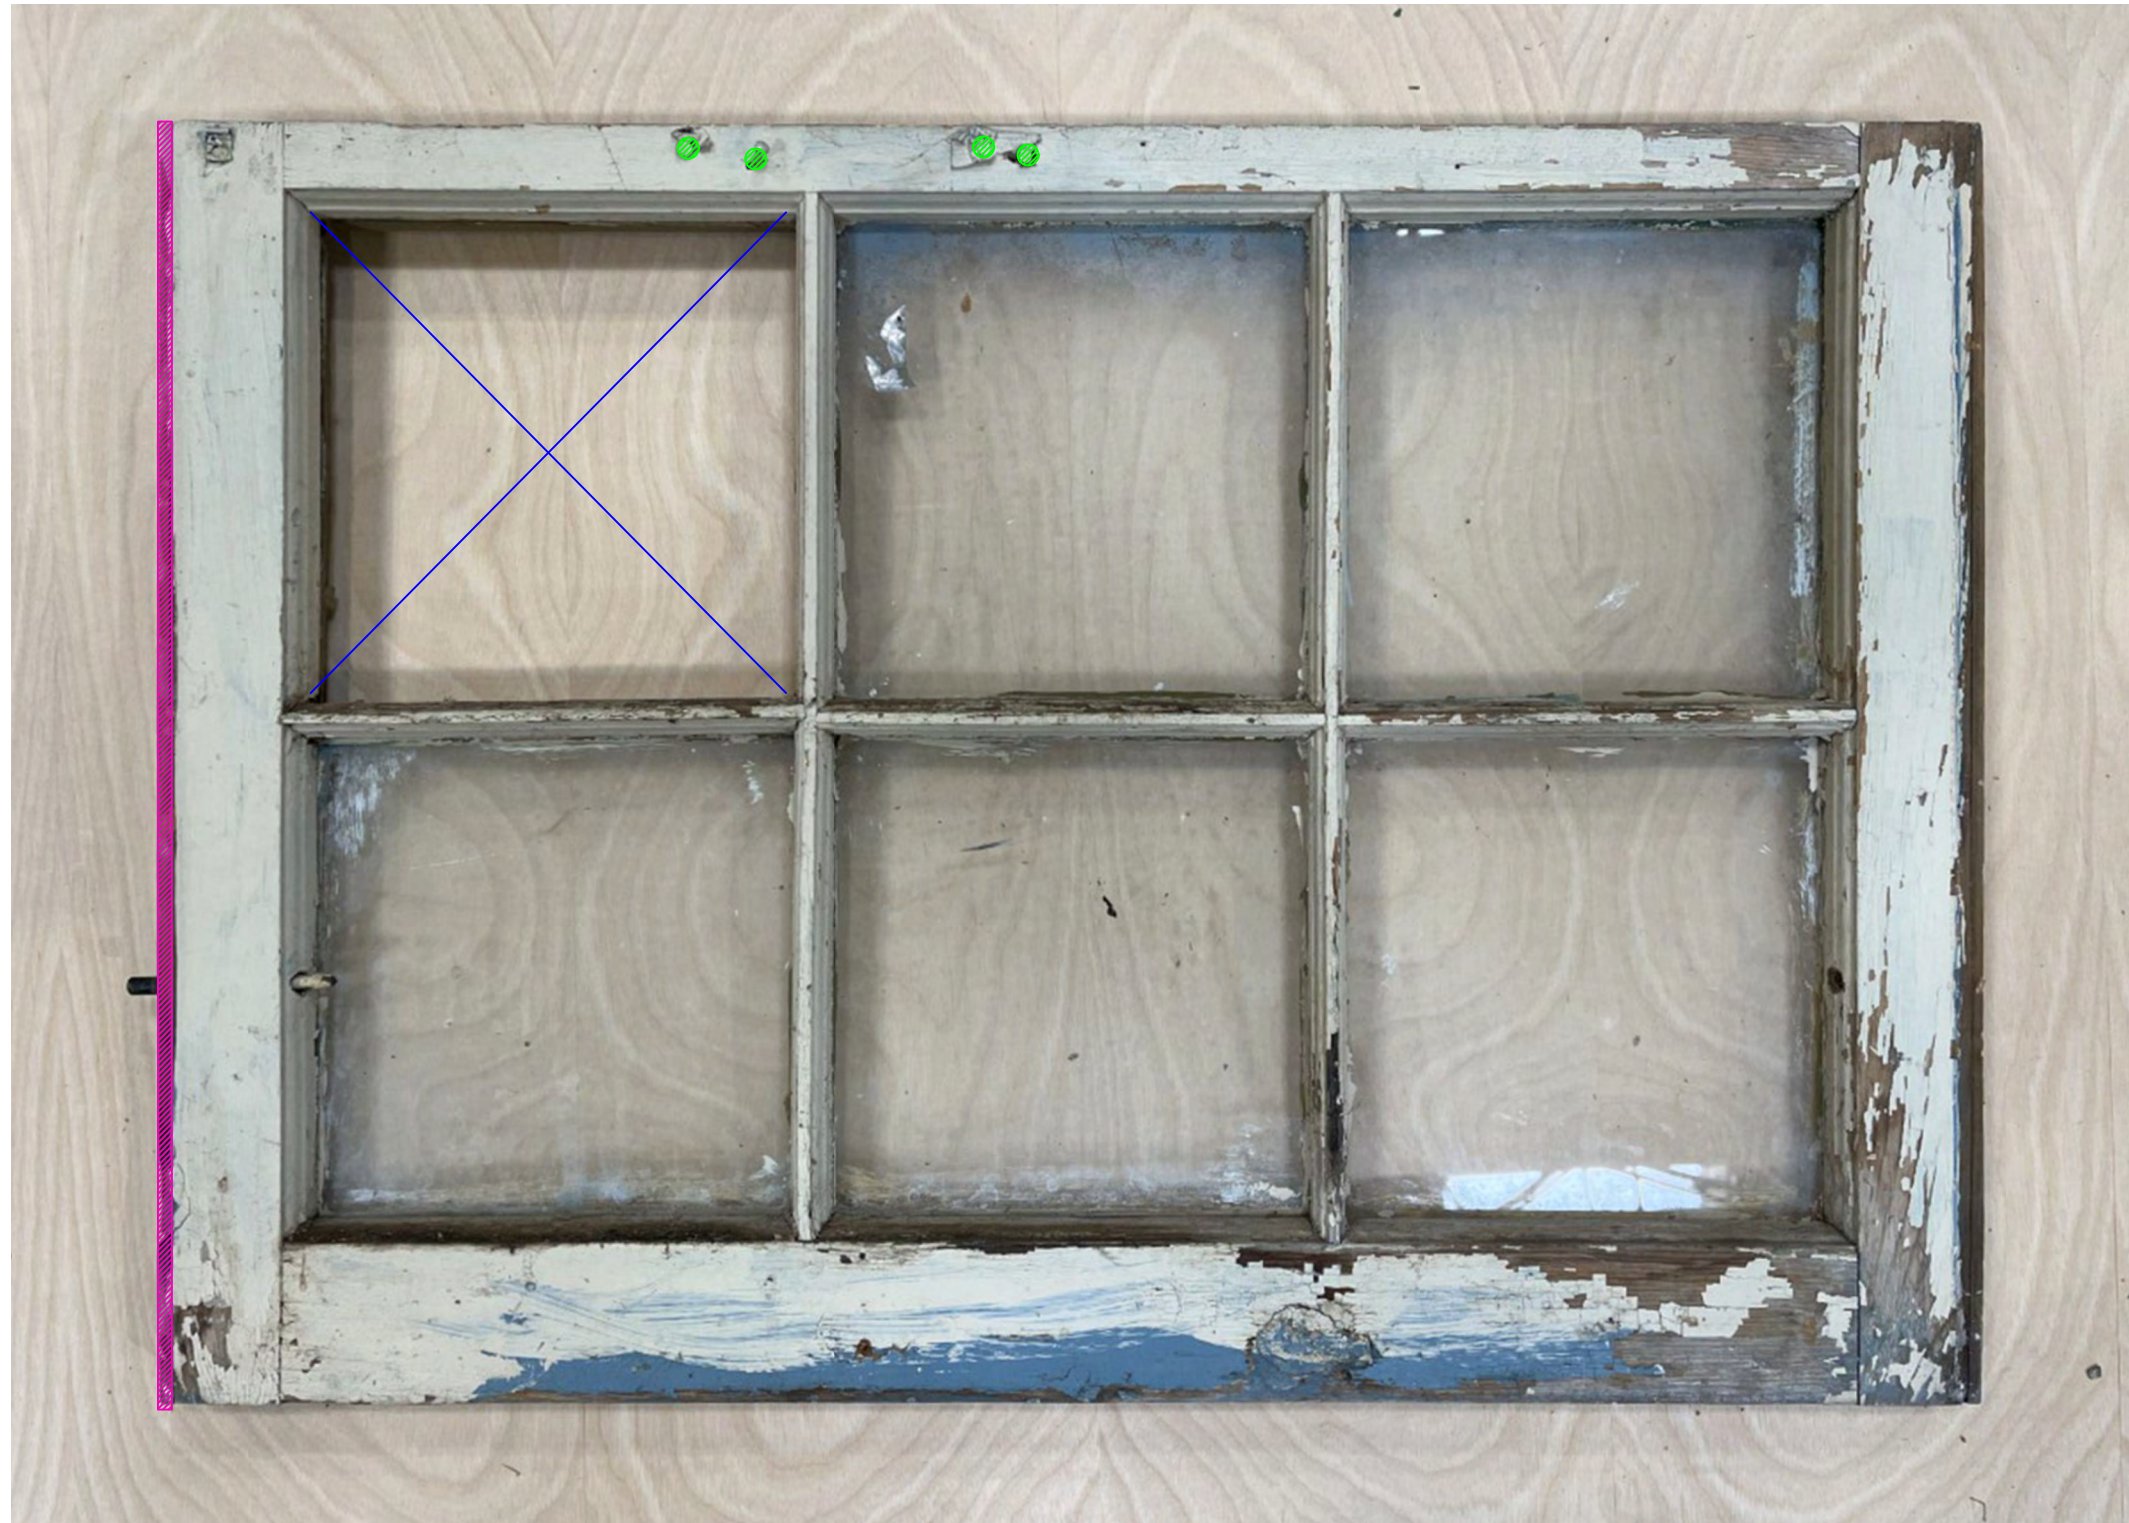
TITLE OF SHEET:
PROPOSED REPAIRS FOR
WINDOW SASH

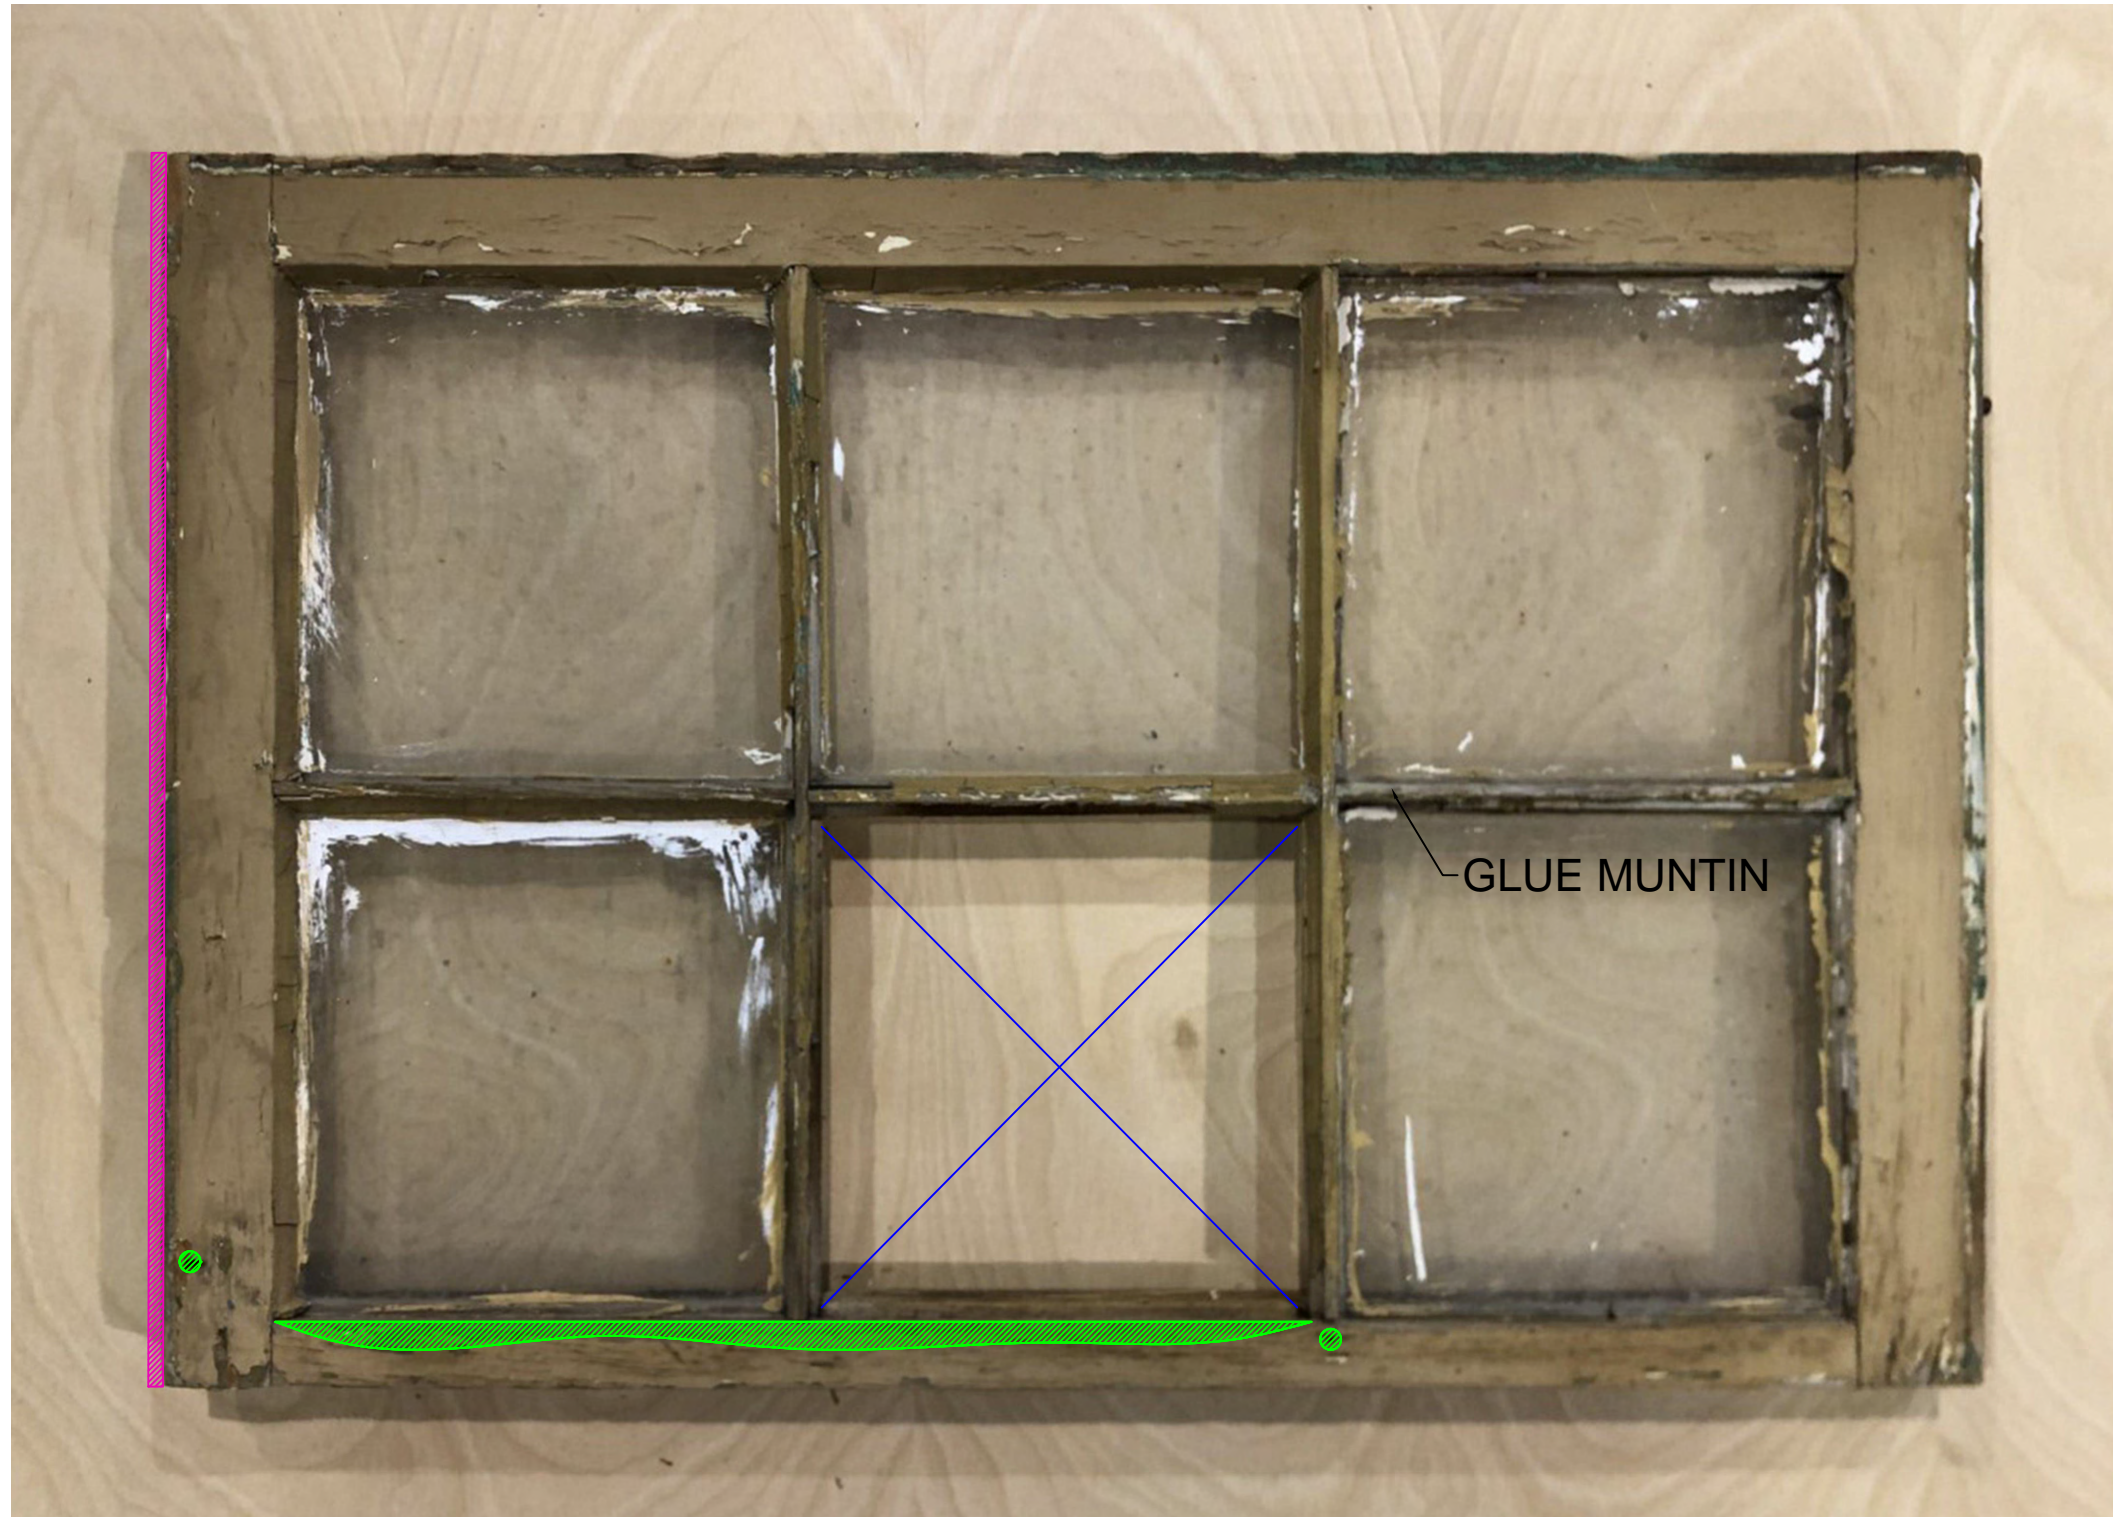
TITLE OF SHEET:
PROPOSED REPAIRS FOR
WINDOW SASH

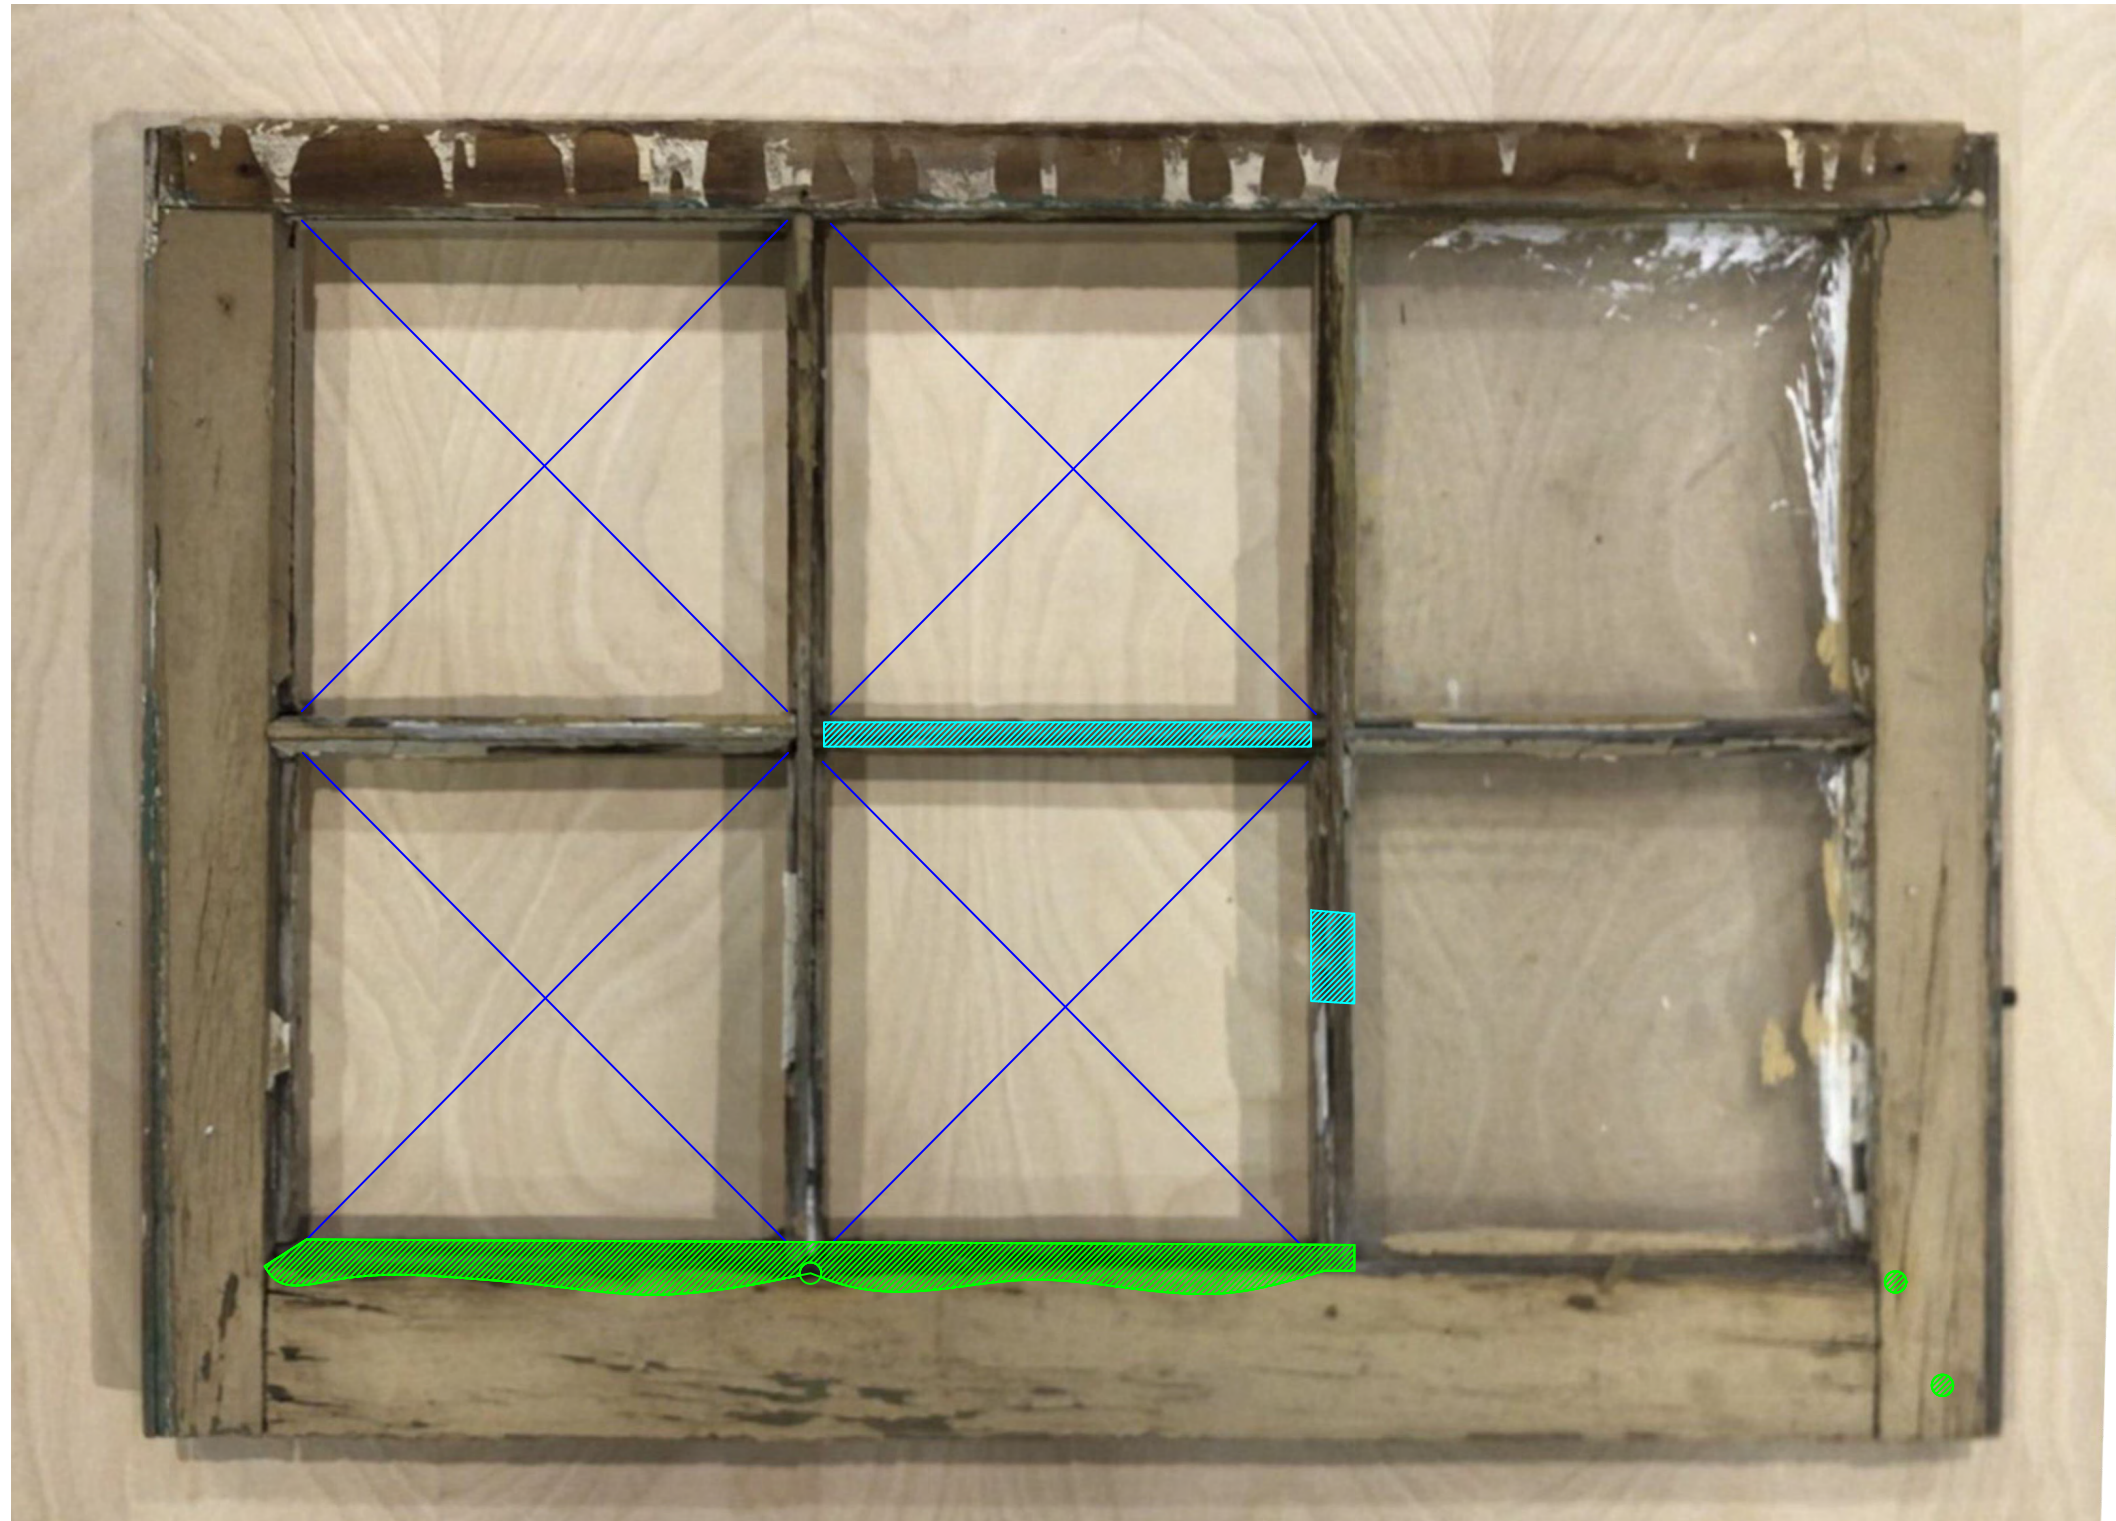
TITLE OF SHEET:
PROPOSED REPAIRS FOR
WINDOW SASH

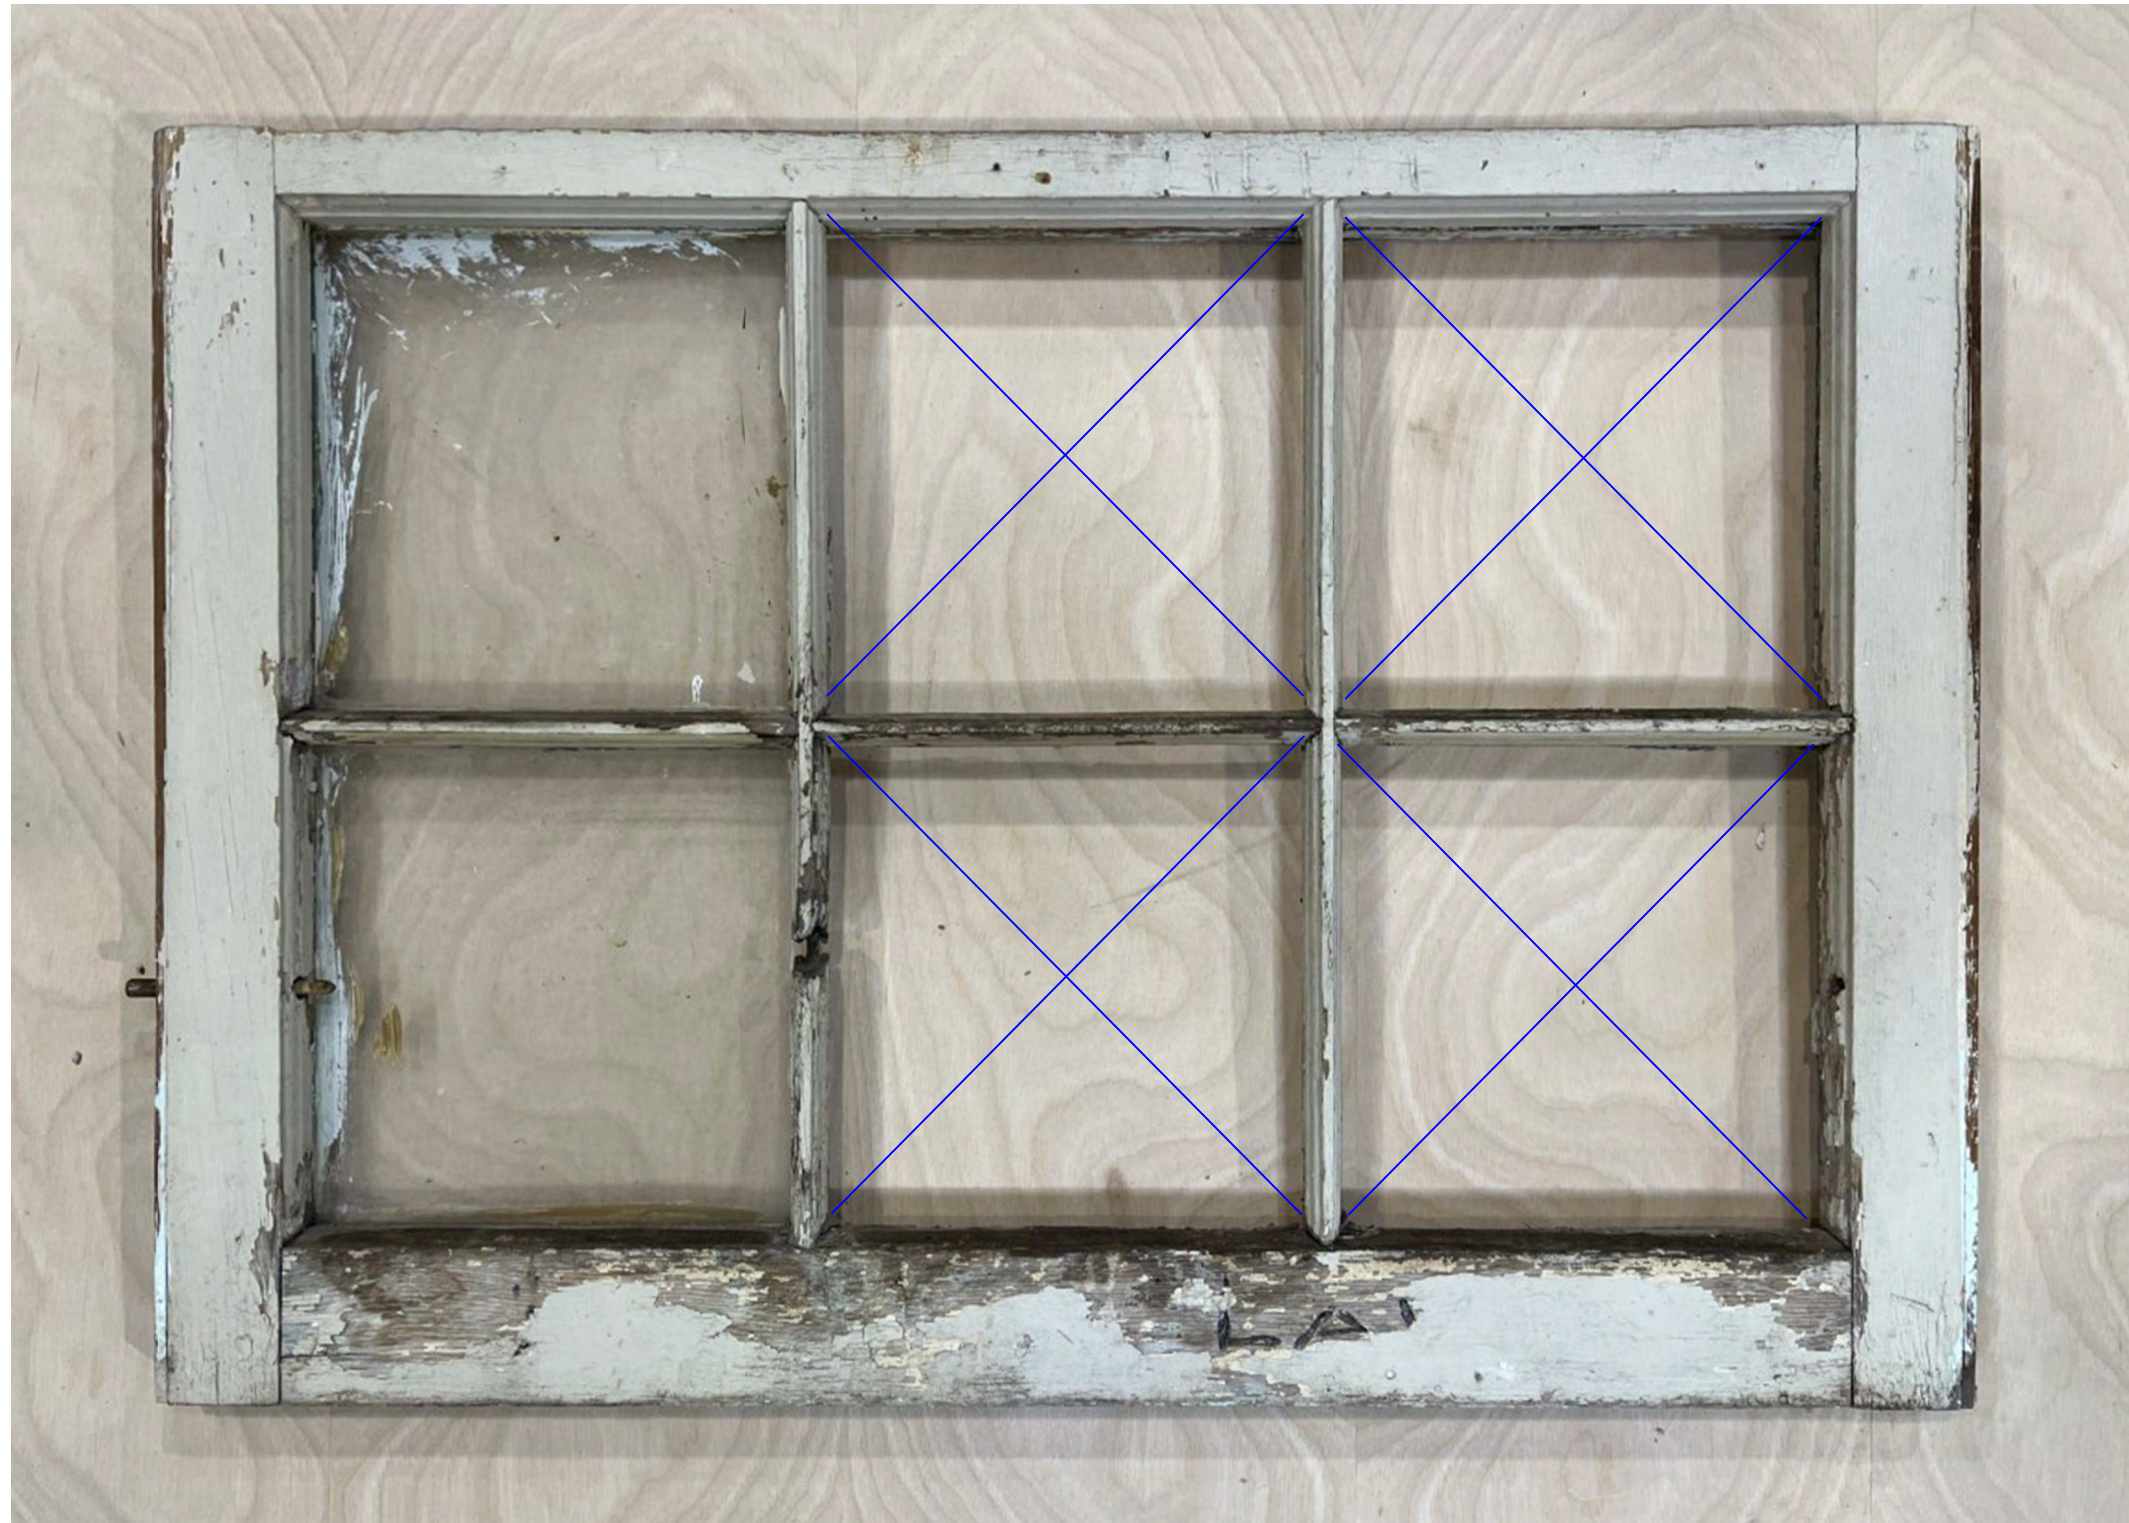
TITLE OF SHEET:
PROPOSED REPAIRS FOR
WINDOW SASH

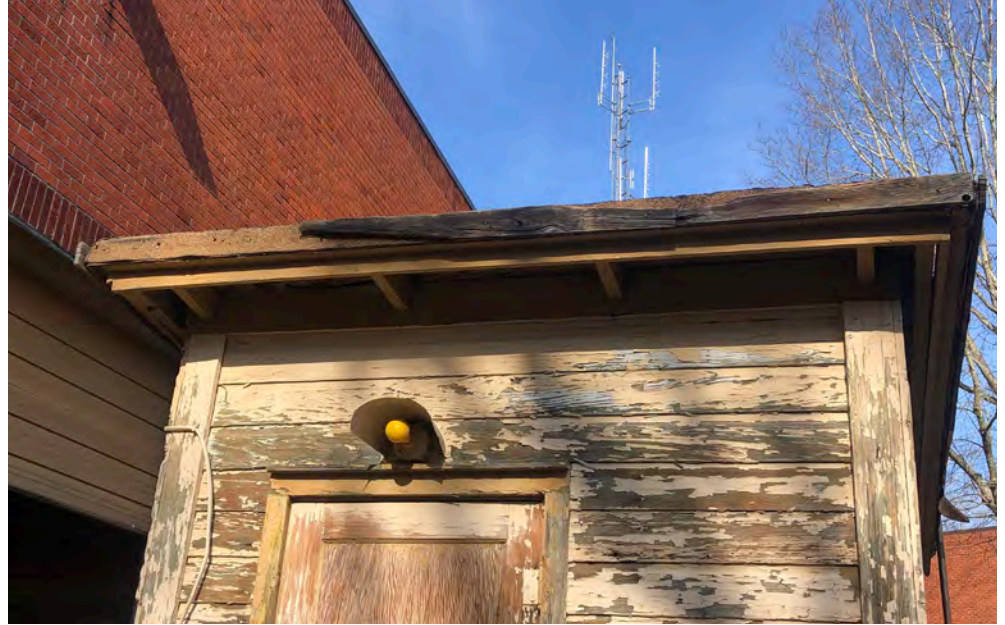
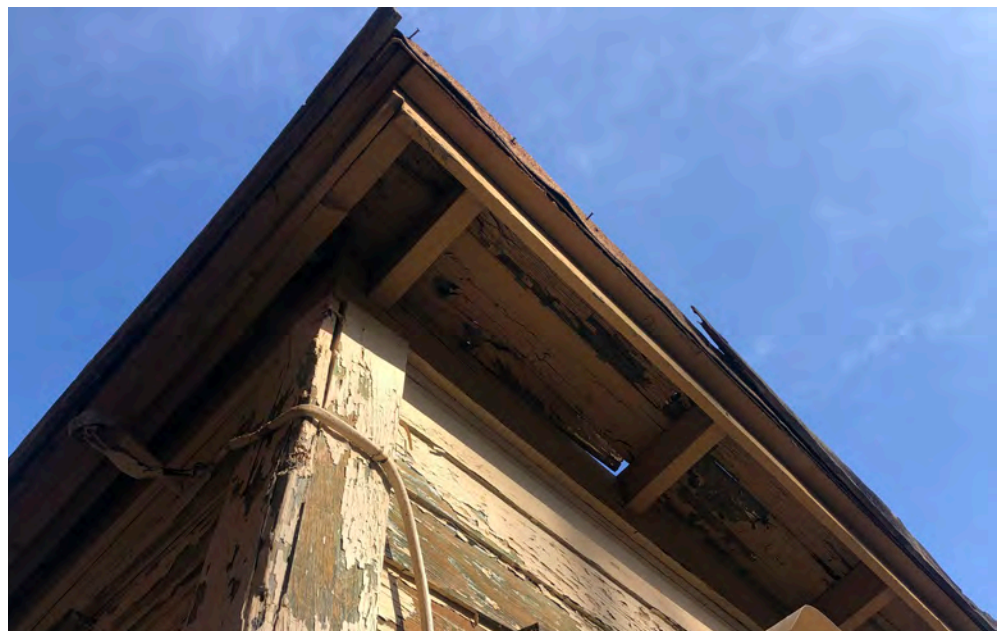
At the back of the structure, the roof is more deteriorated. The fascia at the back right corner is heavily weathered and will need to be replaced. The adjacent roof decking is missing and will need to be replaced with new in-kind materials. The rafter tails have some evidence of moisture damage as well in this area; whether this damage should be fixed with epoxy repairs or partial dutchmen will be determined after deteriorated roofing elements are removed.

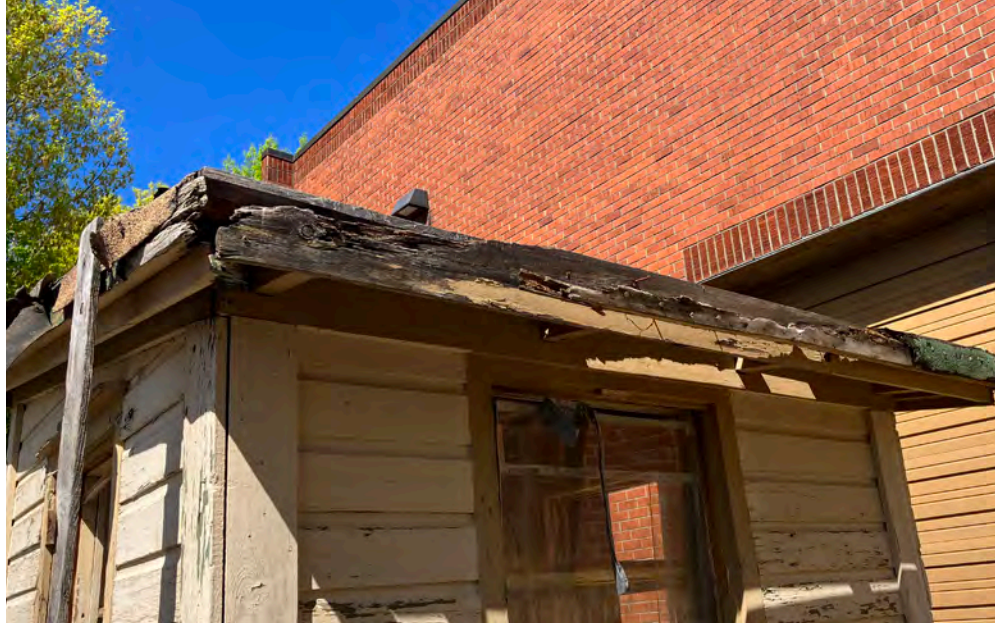
Several layers of mineral rolled roofing are present on TA-8-172, however they are deteriorated and have left the roof decking exposed to weathering and moisture.

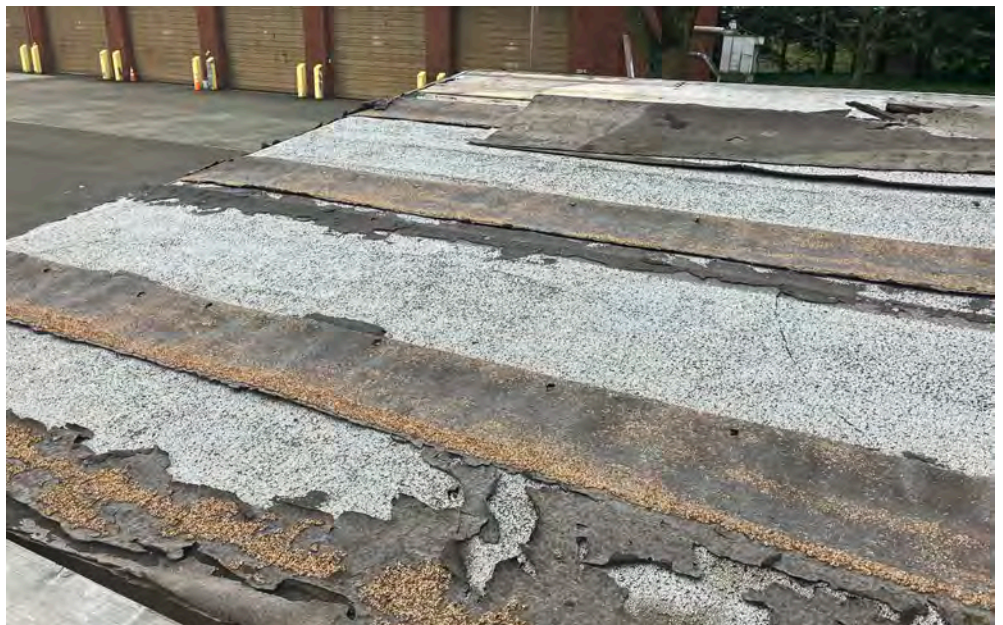
The present drip edge detail consists of a fascia (1" x 5"), 2" x 4", and batten (1" x 4"). Repairs will consist of repairing the fascia and removing the 2 x 4's and battens.

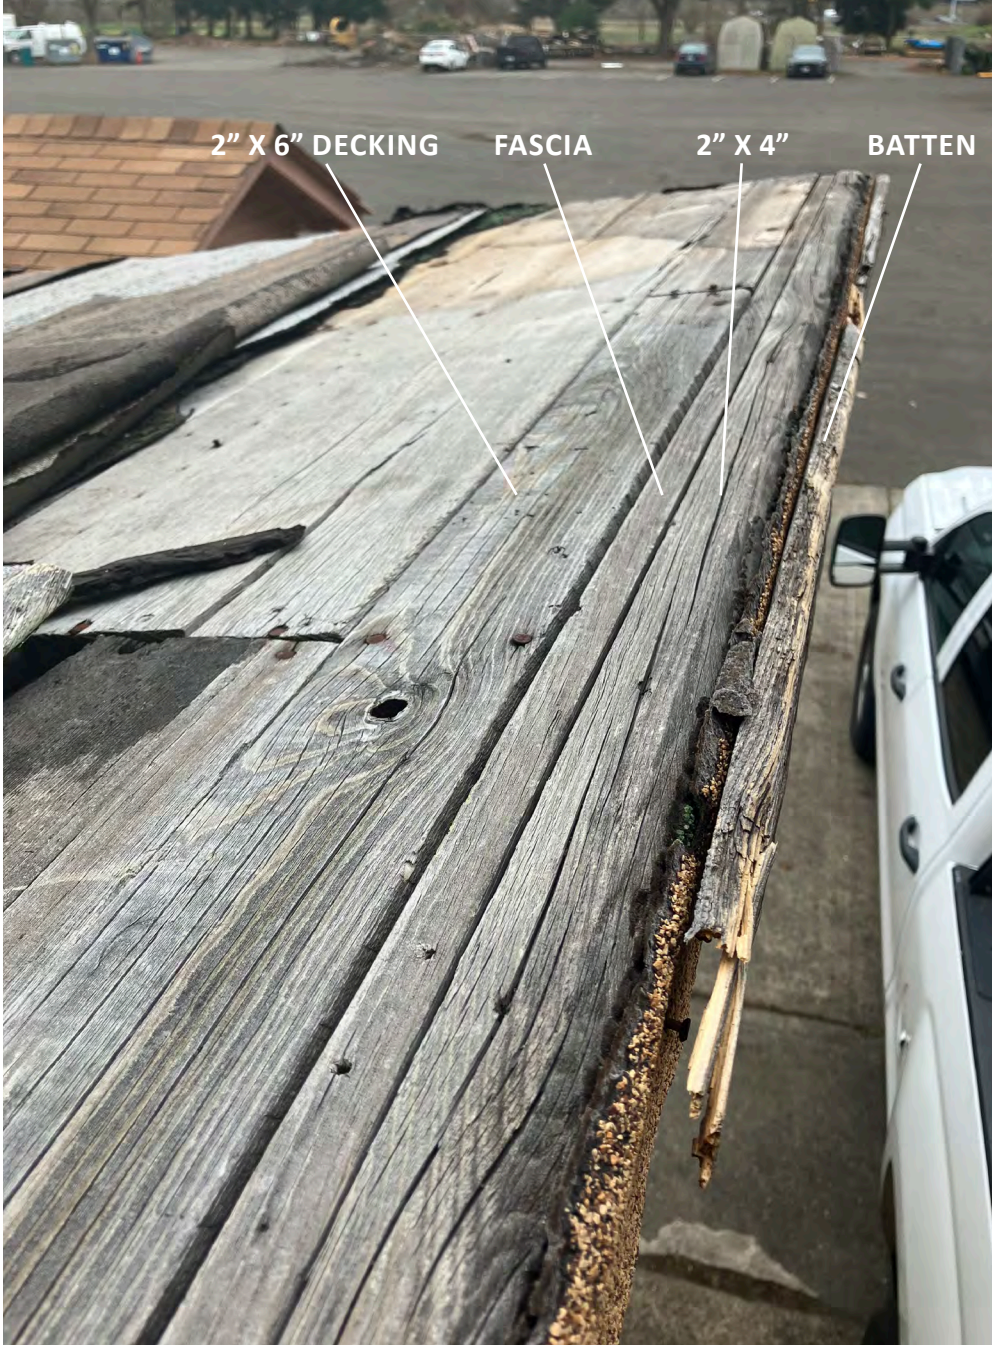
Roof decking on TA-8-172 has extensive evidence of moisture staining, both on older and newer boards, likely the result of deteriorated rolled roofing. Boards which are deteriorated will be replaced in-kind with new materials stamped "NPS2023."

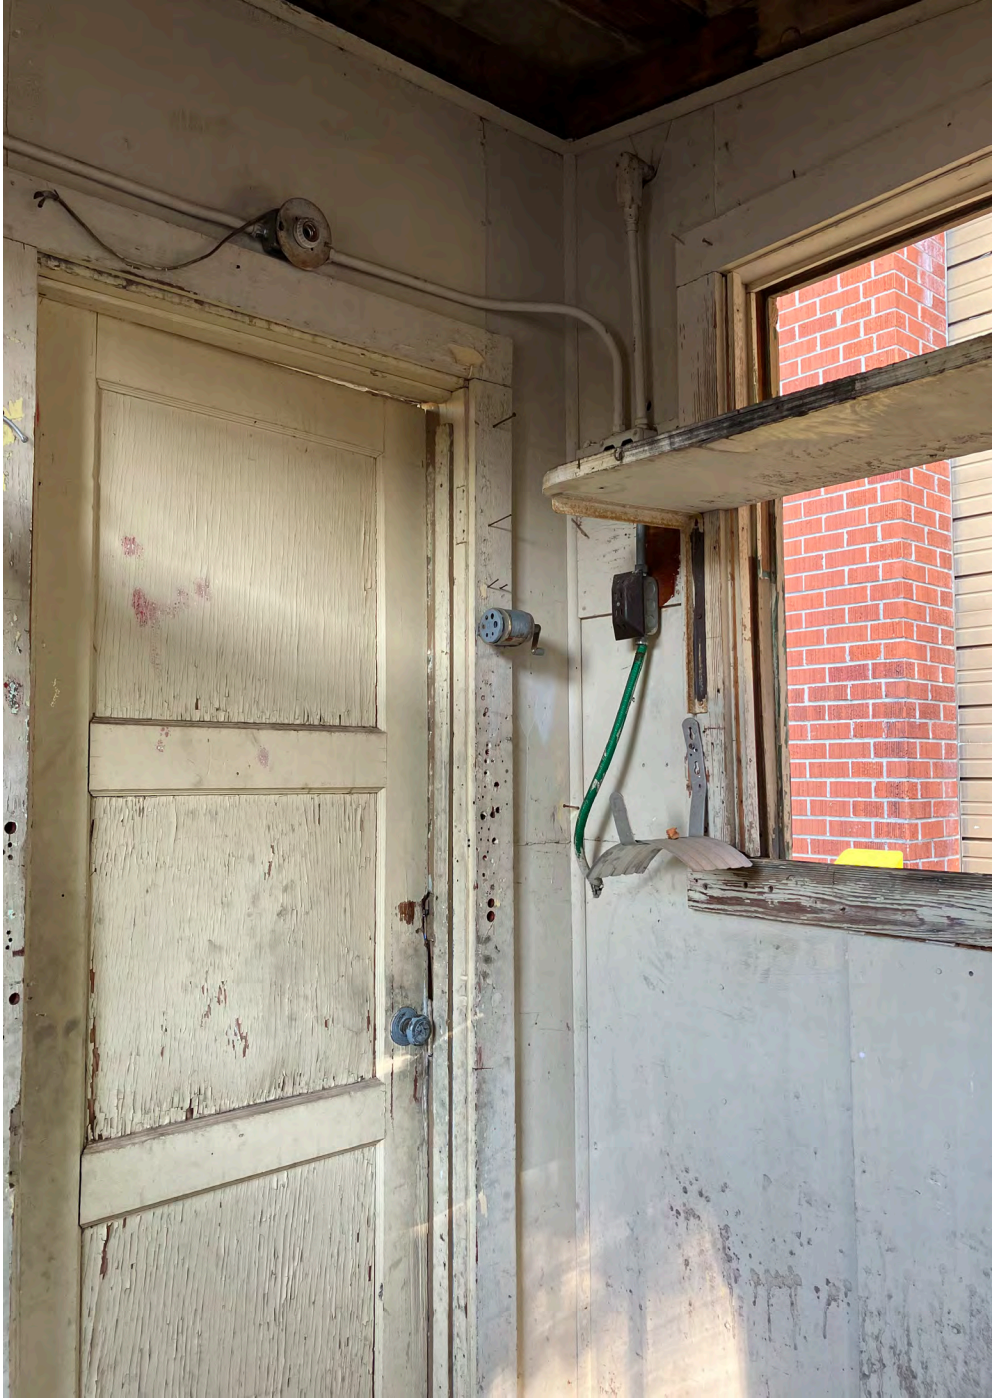
The interior of the back left corner.

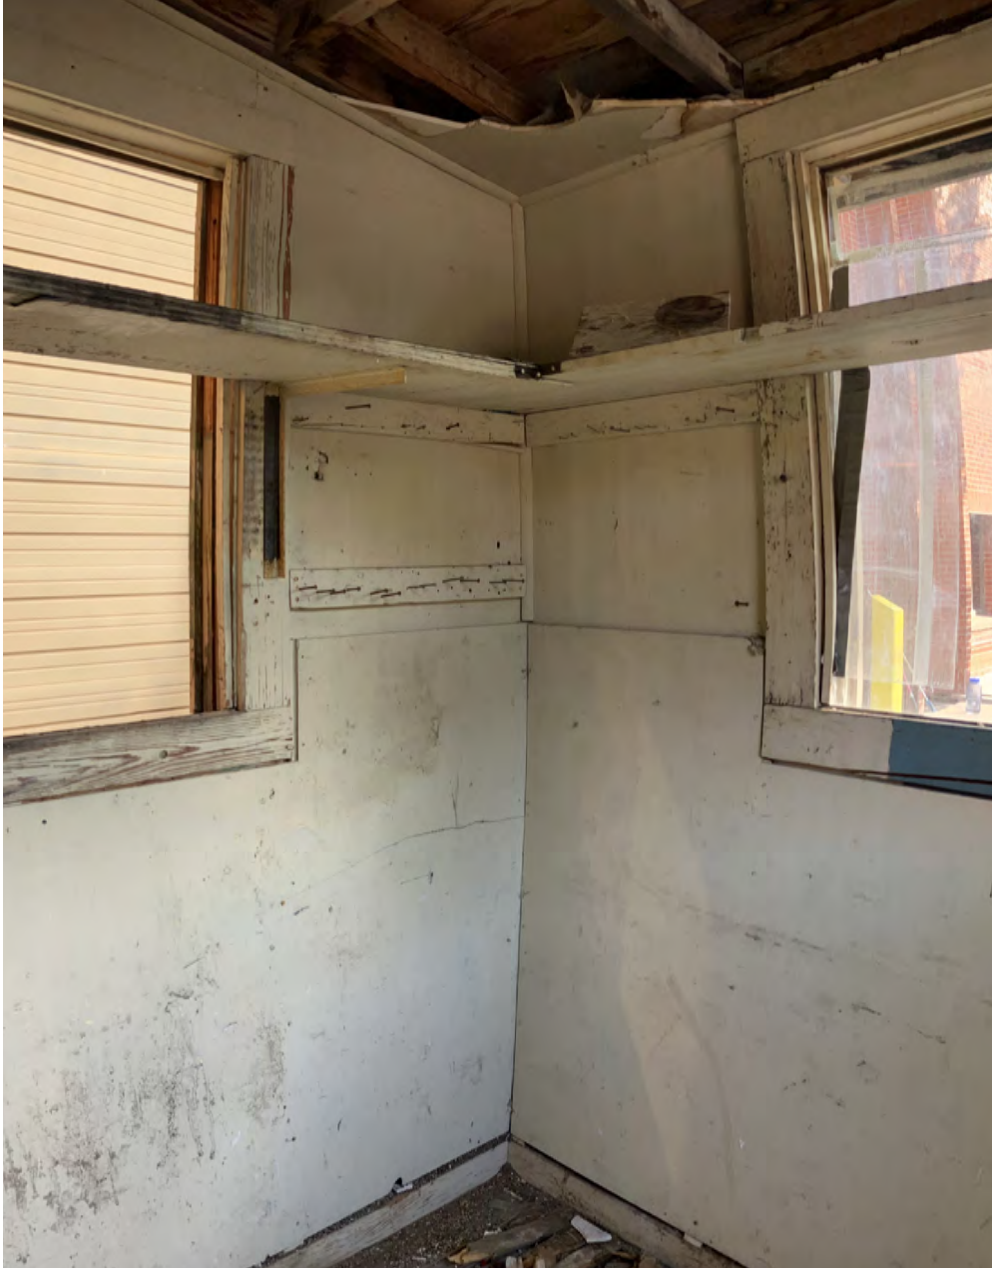
The interior of the back elevation. Note the bare seams between the gypsum board, which is typical throughout the interior of the structure. The gypsum board has moisture-related deterioration in the back right corner and extensive loss of the ceiling boards.
