LA-UR-24-21637

Approved for public release; distribution is unlimited.

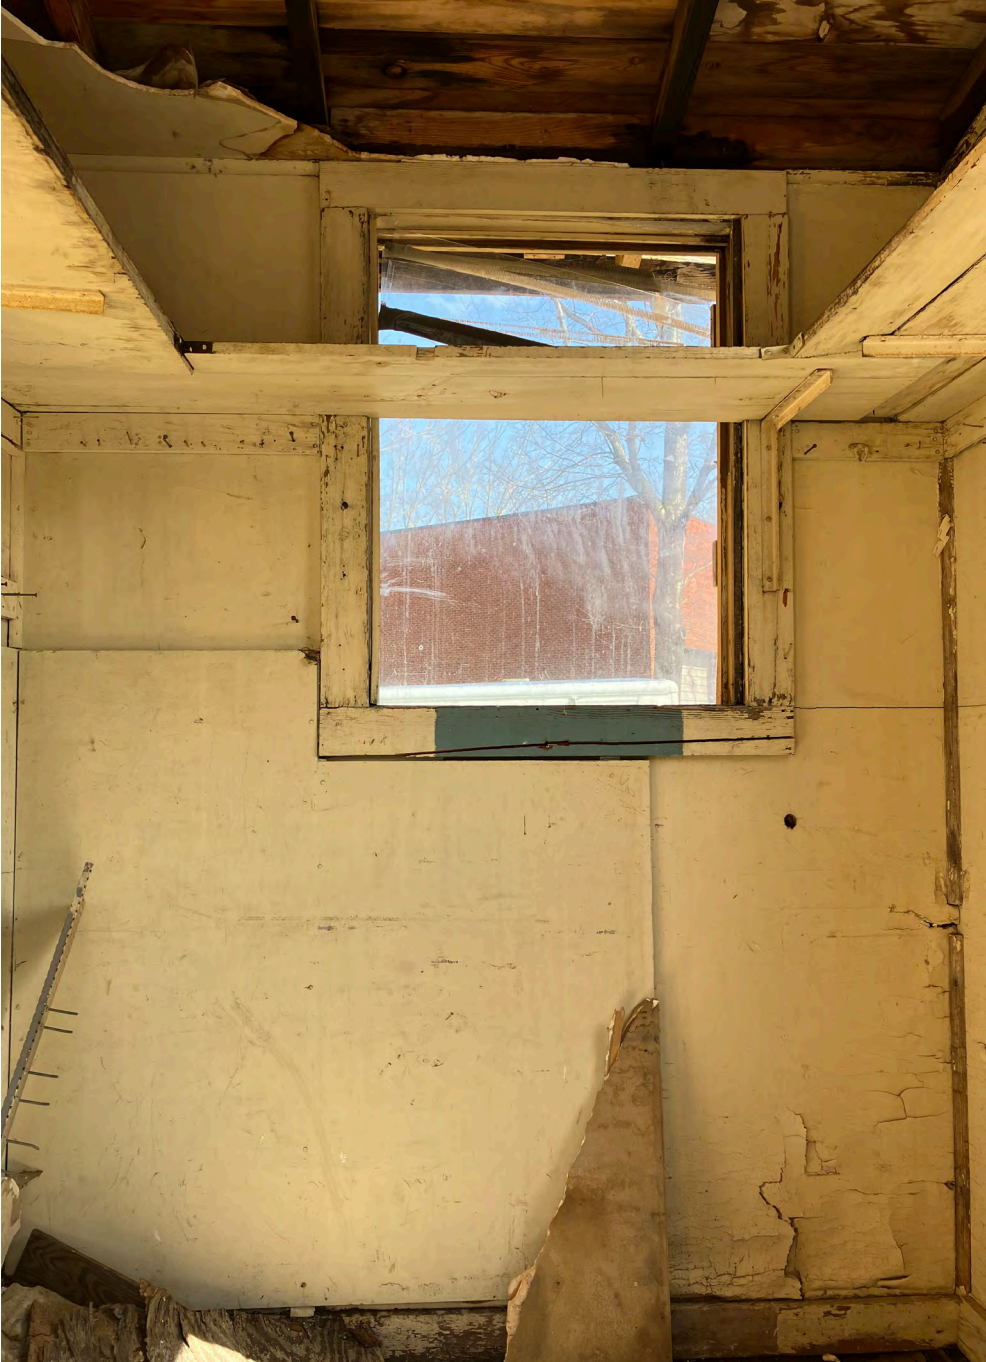
The interior of the back left corner.

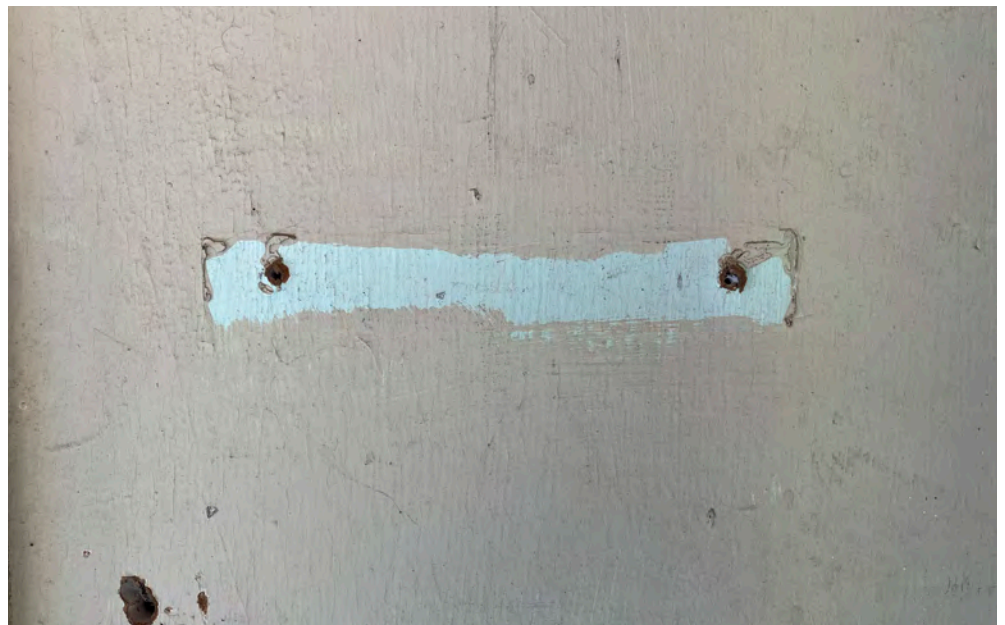
Floor Framing and Flooring

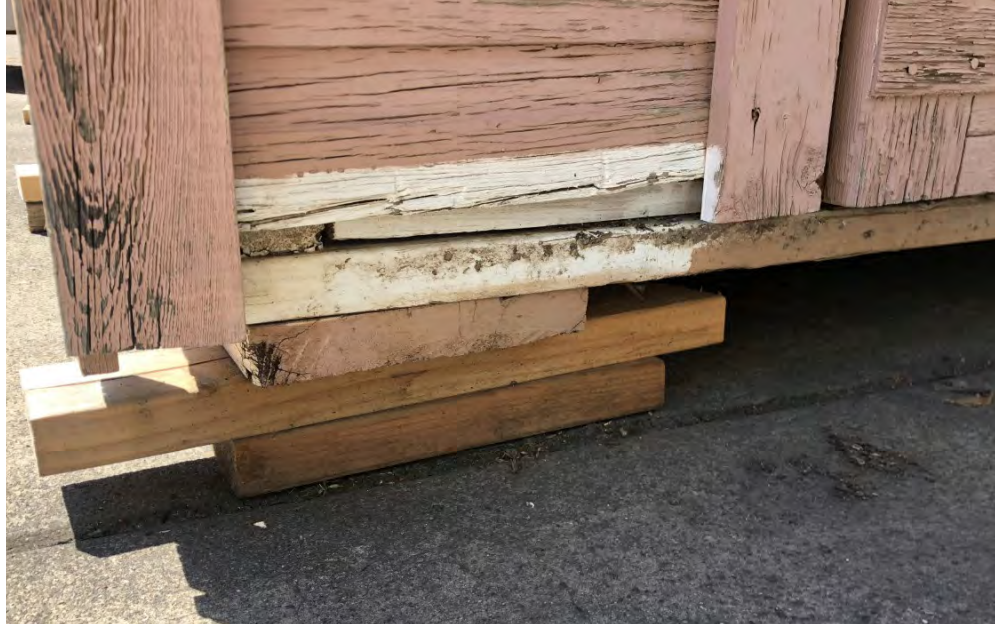
While the flooring and floor structure was removed from TA-18-111, the historic base molding was left in place as evidenced by traces of sea foam green paint.

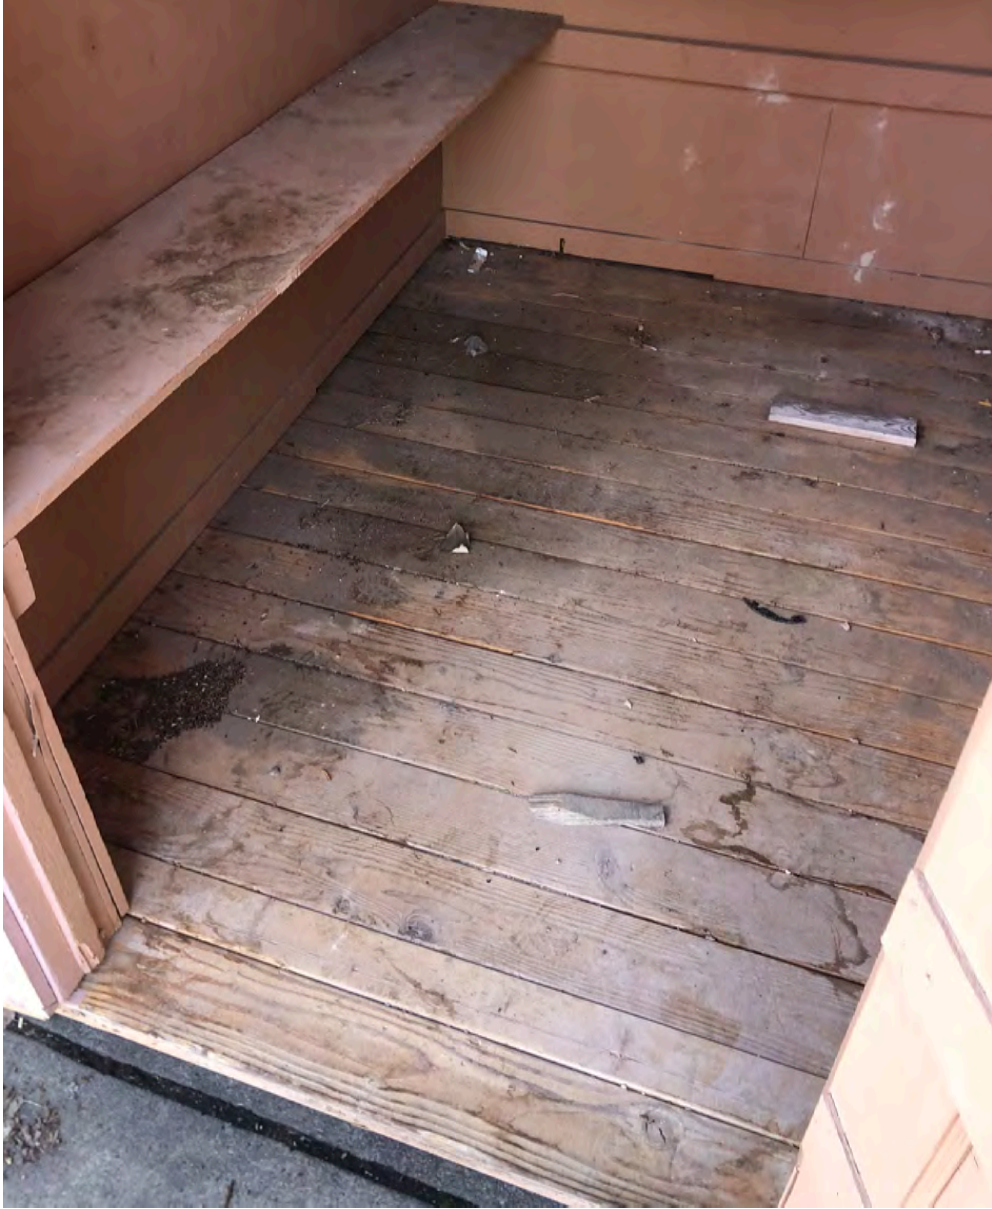
The wall system on TA-18-111 consists of stud wall frames sitting directly on top of the current floor decking. Drop channel lapped siding (3/8" x 3 3/4 ") directly attached to the stud wall frame. The trim along the corners of the structure all appear to be later replacements, as evidenced by a difference in species (Doug Fir rather than pine), surface treatment (smooth, without evidence of more extensive weathering), and lack of green paint evidence. Based on visual observations, the exterior siding of TA-18-111 has evidence of three paint campaigns: olive drab green on the surface of the wood, a white/off white primer, gray, and the present pink color. Paint samples will be taken prior to the initiation of work and embedded in resin for later paint analysis.

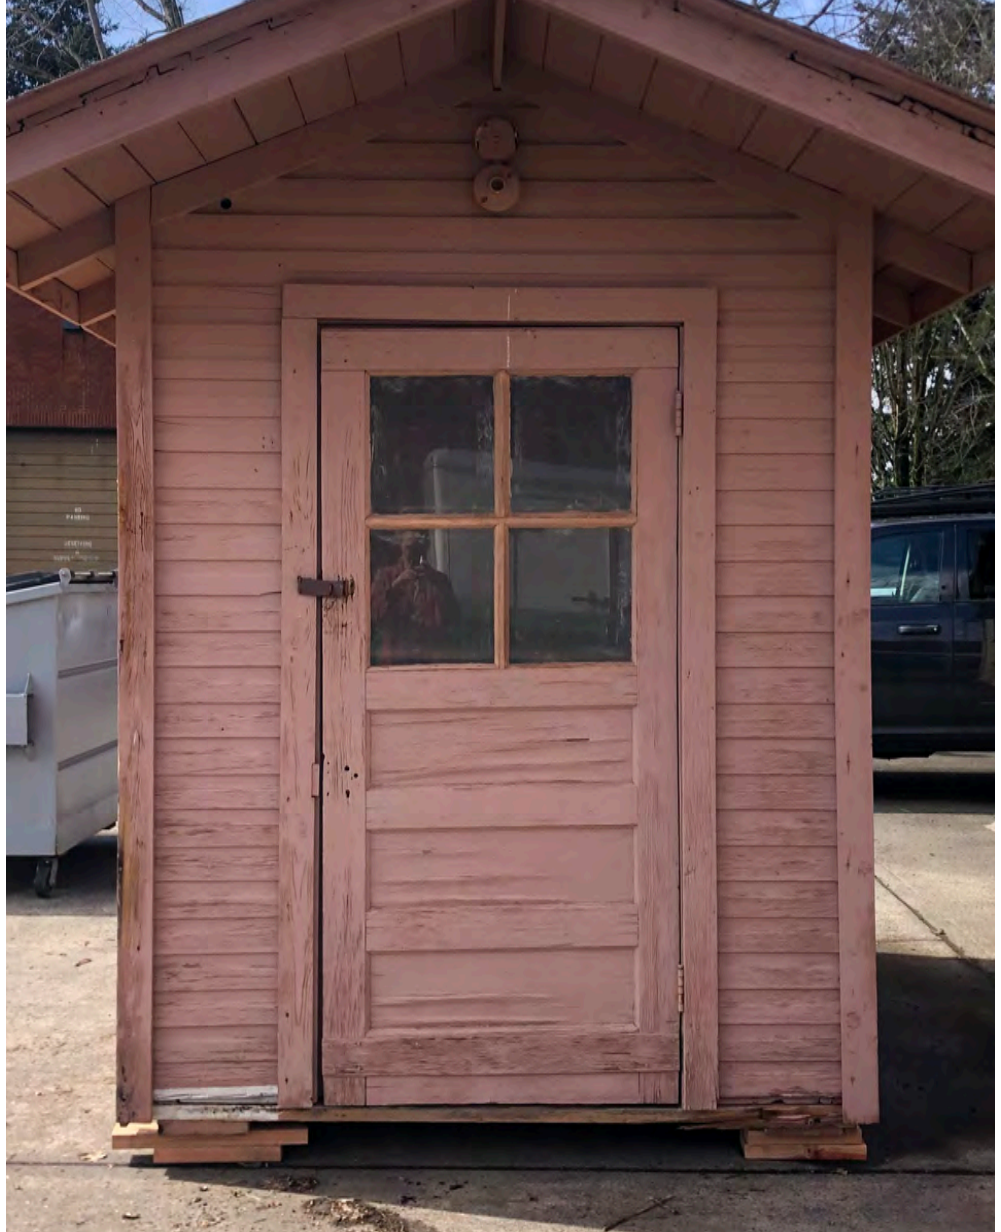
Condition of exterior wall siding and corner trim on the left elevation.

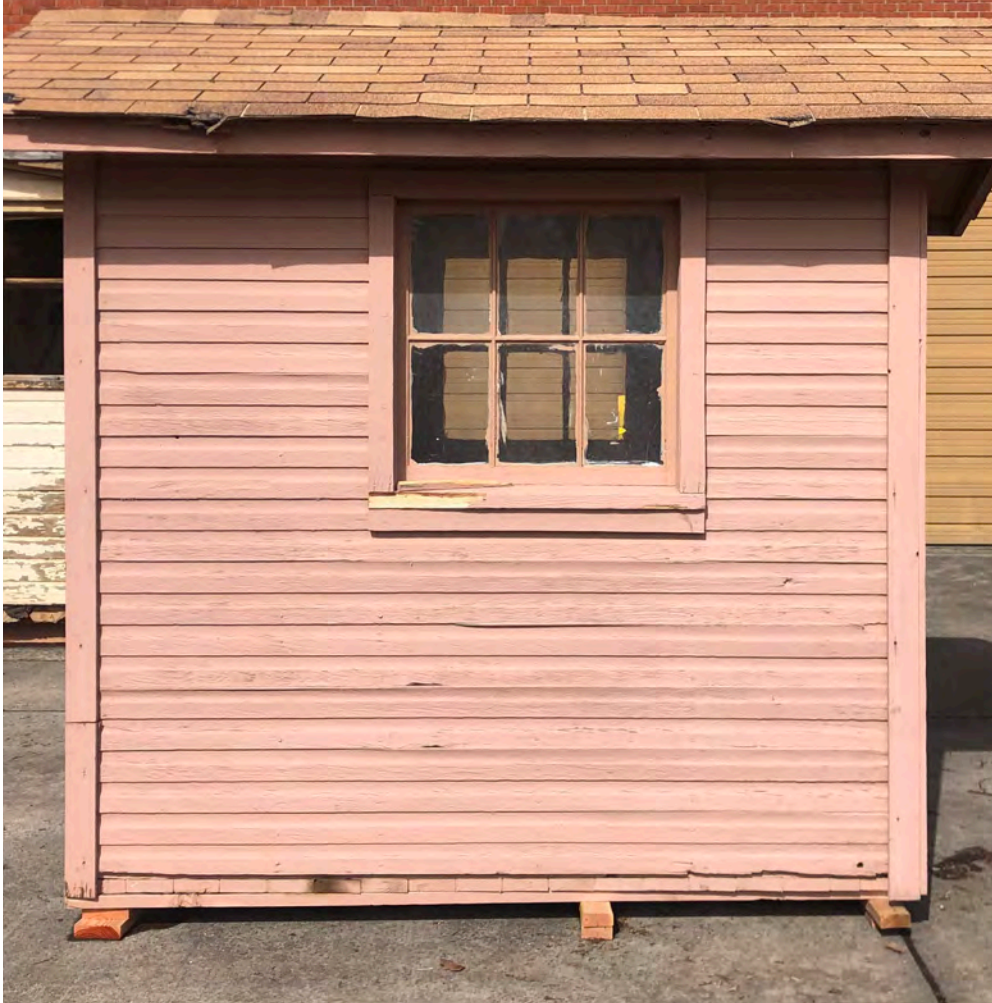
Condition of exterior wall siding and corner trim on the back elevation.

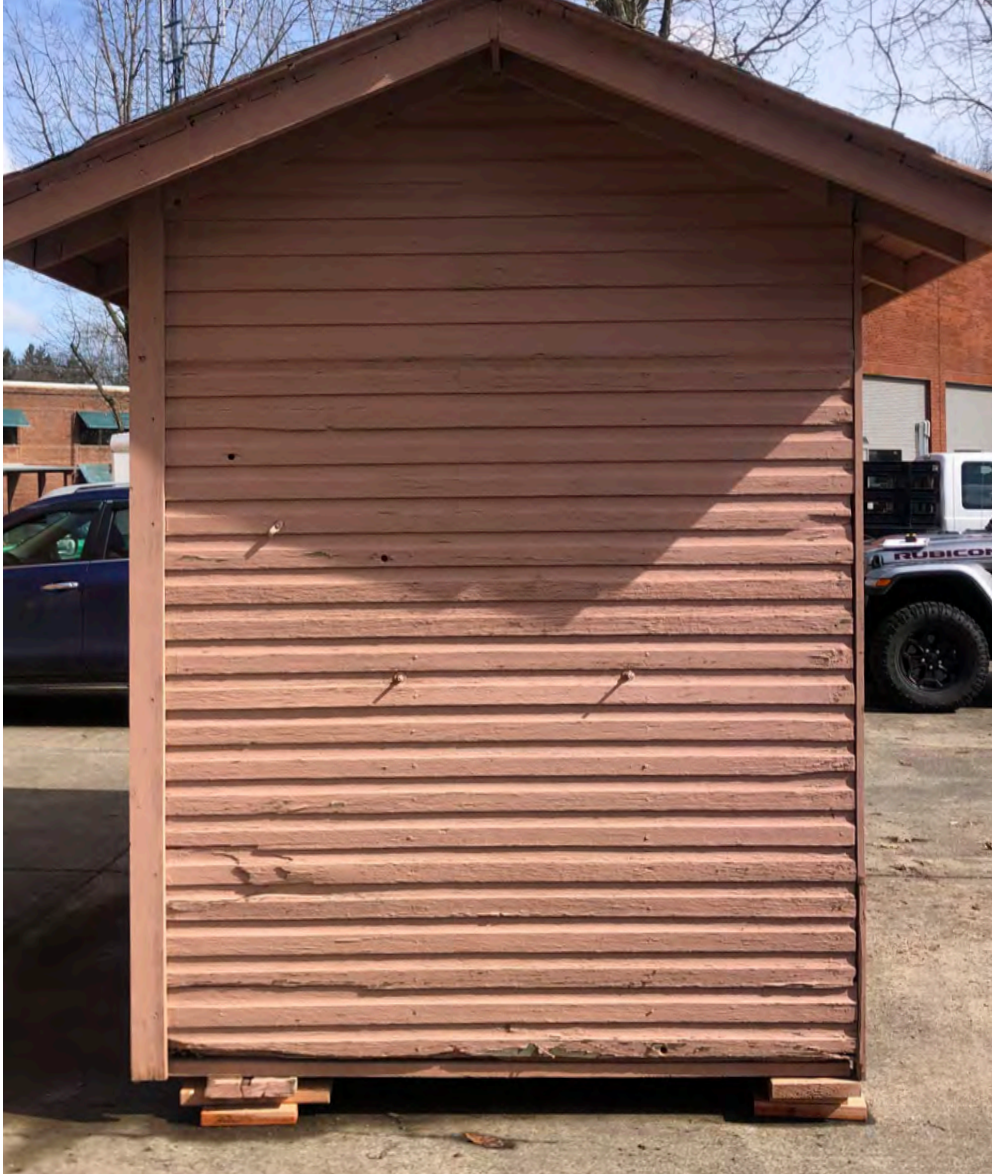
Condition of exterior wall siding and corner trim on the right elevation.

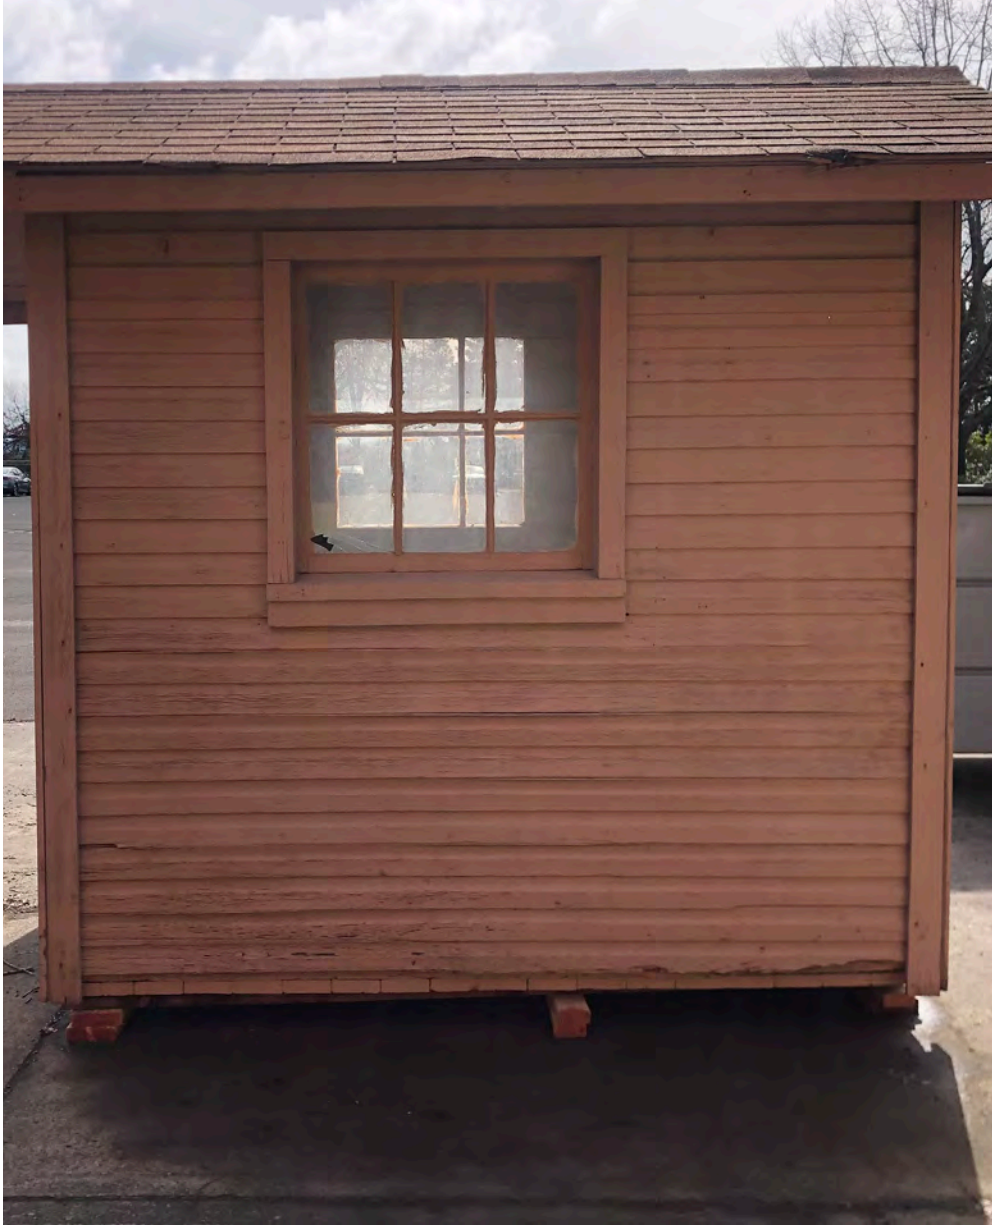
Section of damaged siding on the back of the structure; anecdotal evidence attributes the damage to a boulder rolling down the canyon at Bandelier.

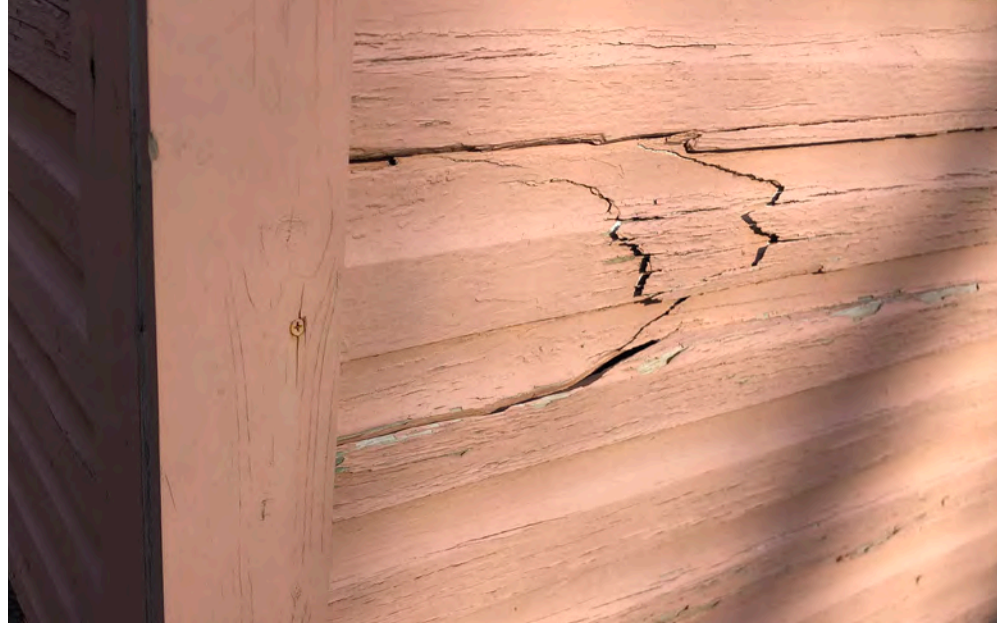
Evidence of green paint beneath the pink on the exterior siding.

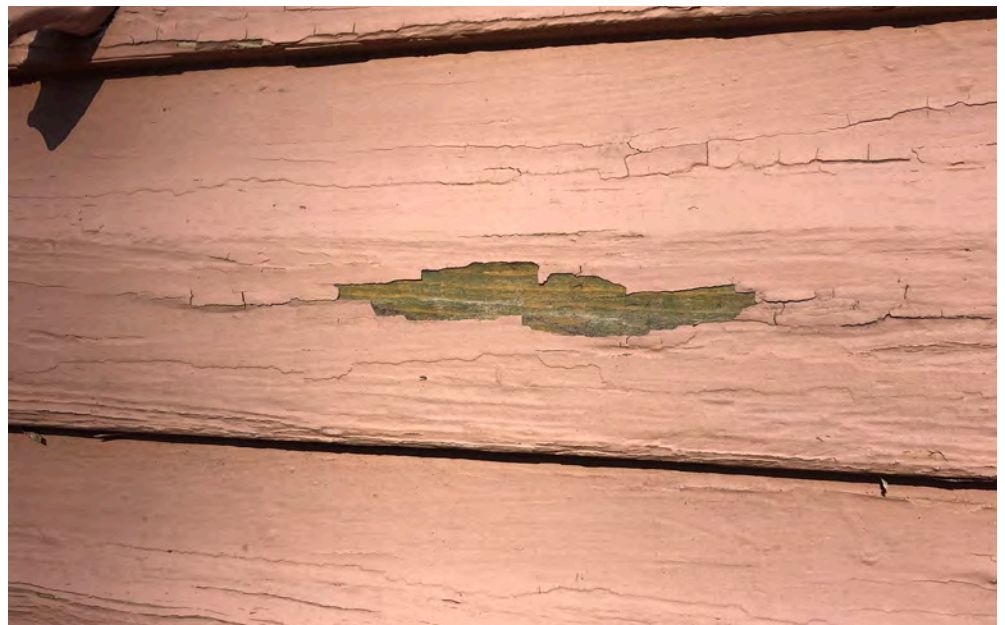
Corner trim on the front elevation does not appear to be original to the structure, based on paint evidence and finish of the boards.

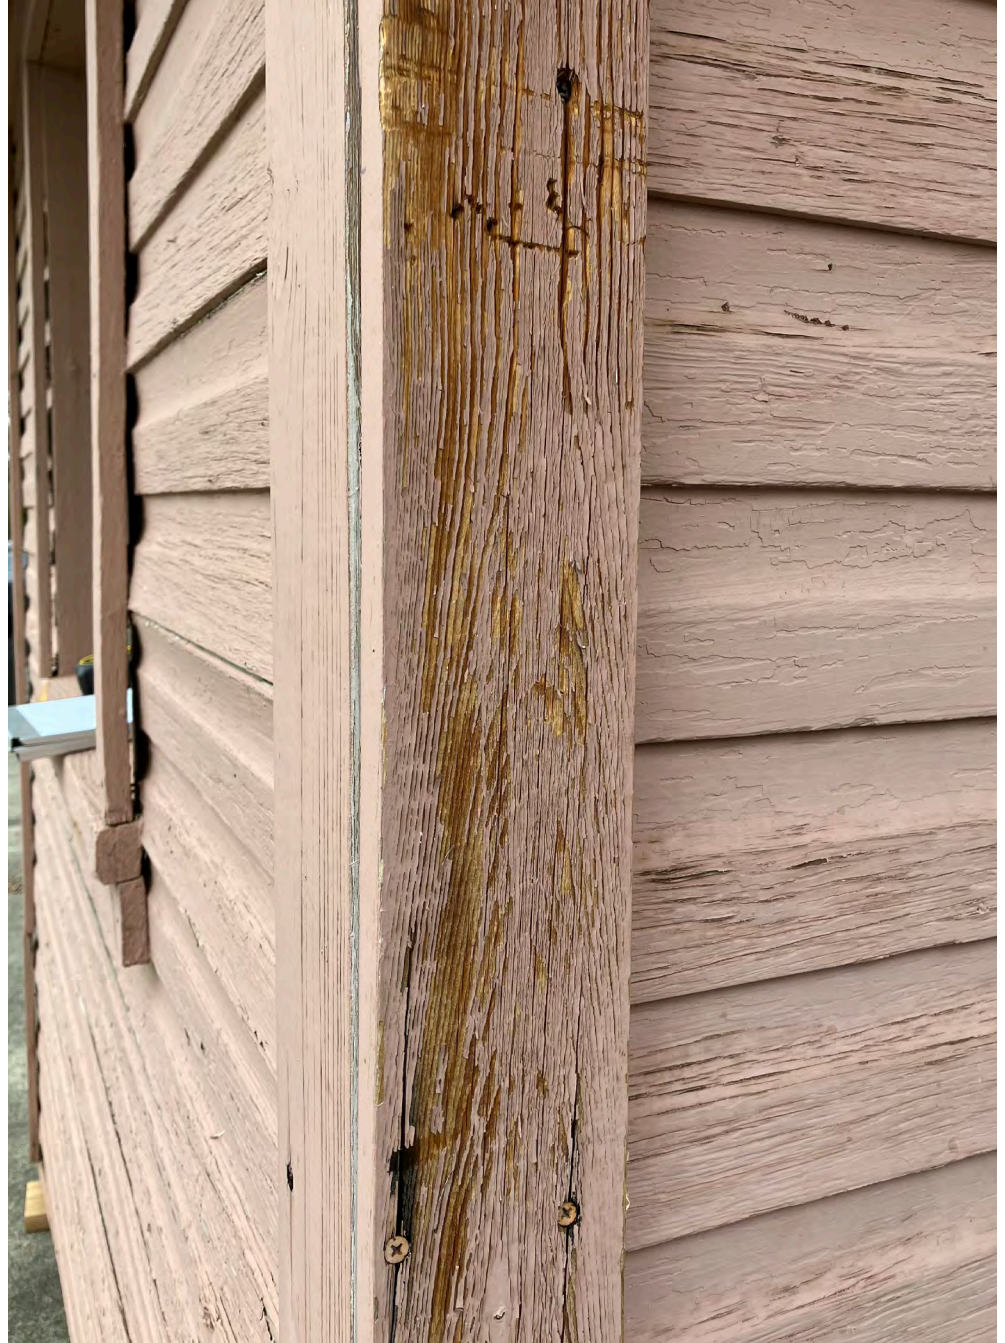
On the back elevation, non-historic bolts will be removed and the holes filled. One insulated clamp, which may have held electrical conduit, will be preserved in place.

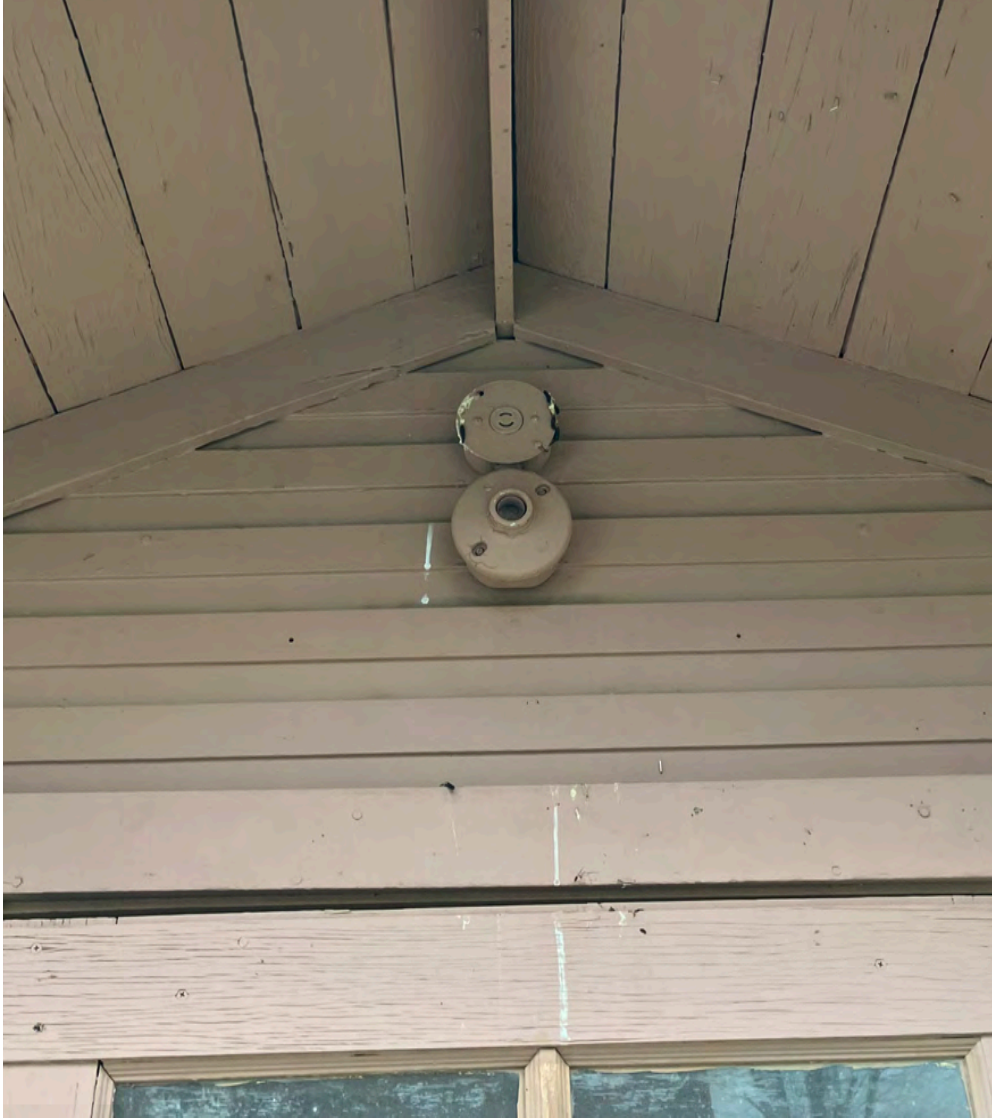
TITLE OF SHEET:
SIDING AND TRIM
DETERIORATION
CONDITIONS

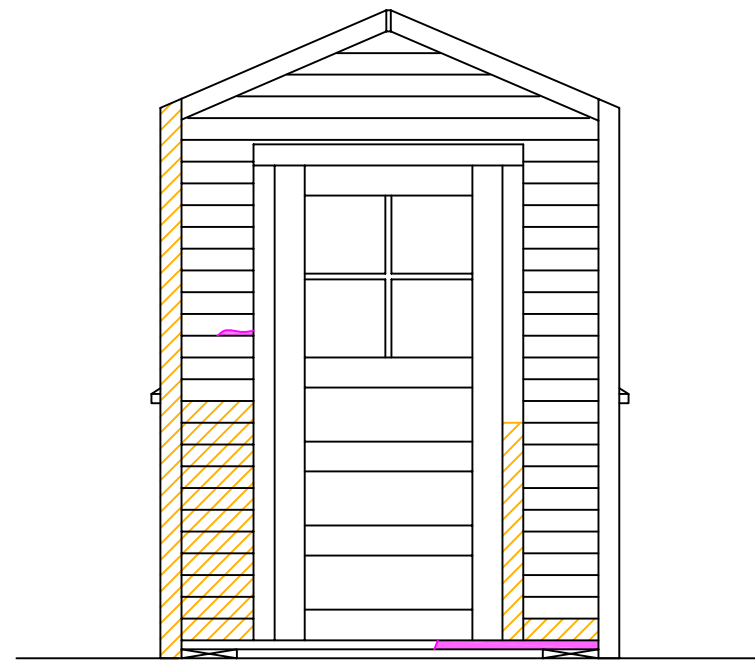
-   WEATHERING
-   WARPING
-   LOSS
-   IMPACT DAMAGE
-   GRAFITTI

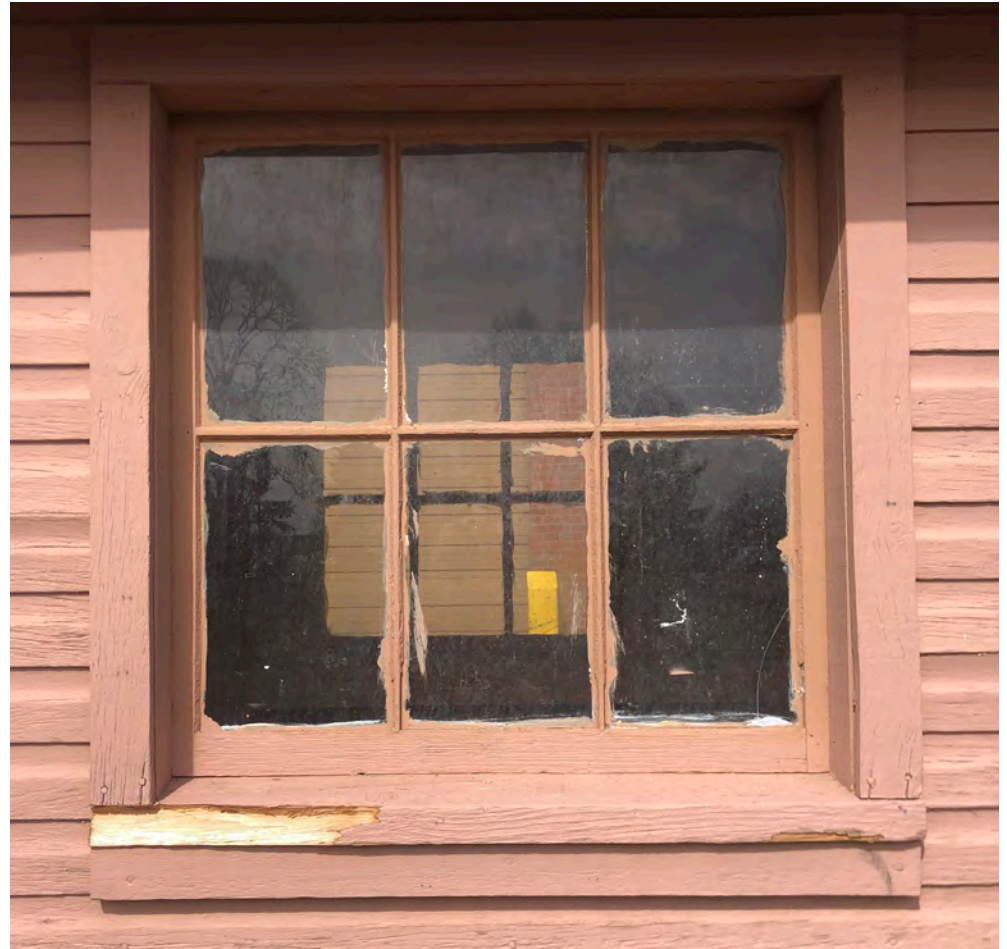
The original casing elements on the door opening have some paint loss and minor surface weathering.

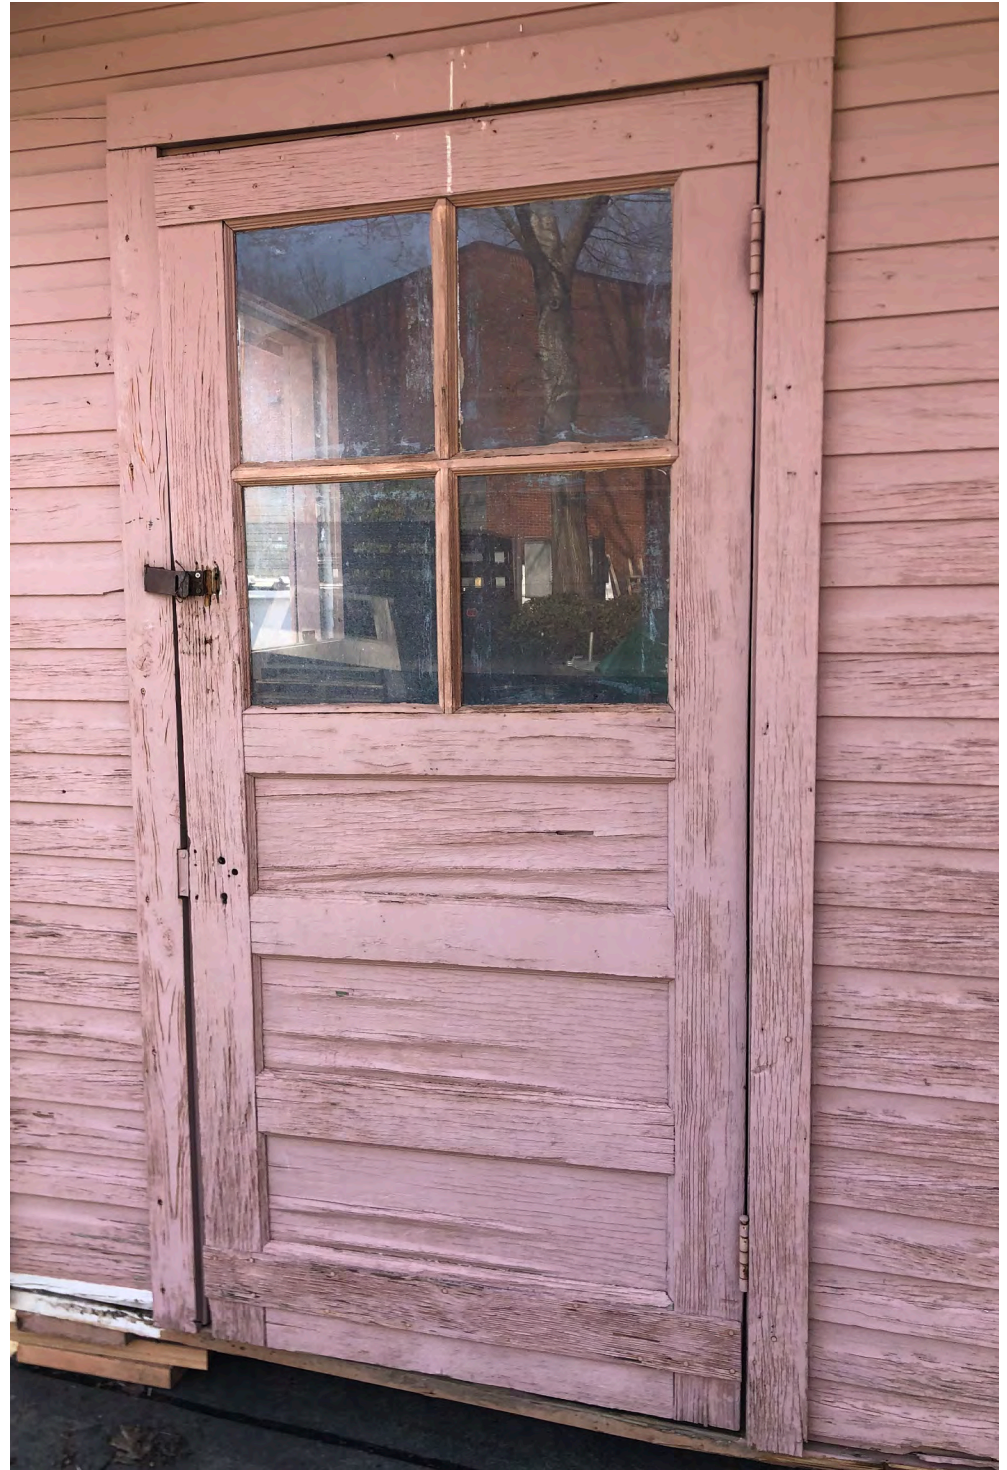
Deterioration on the door includes weathering of the wooden surfaces, checking, and deterioration of the plywood panels.

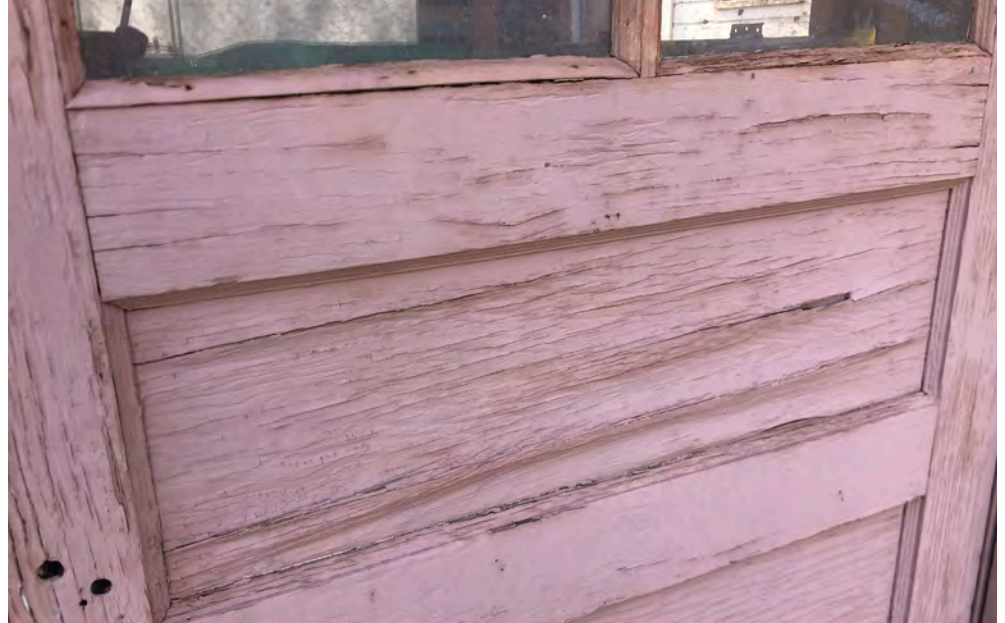
The rail and stile connections at the top and bottom of the door have been reinforced with wooden straps. These elements will be removed and the joints will be repaired.

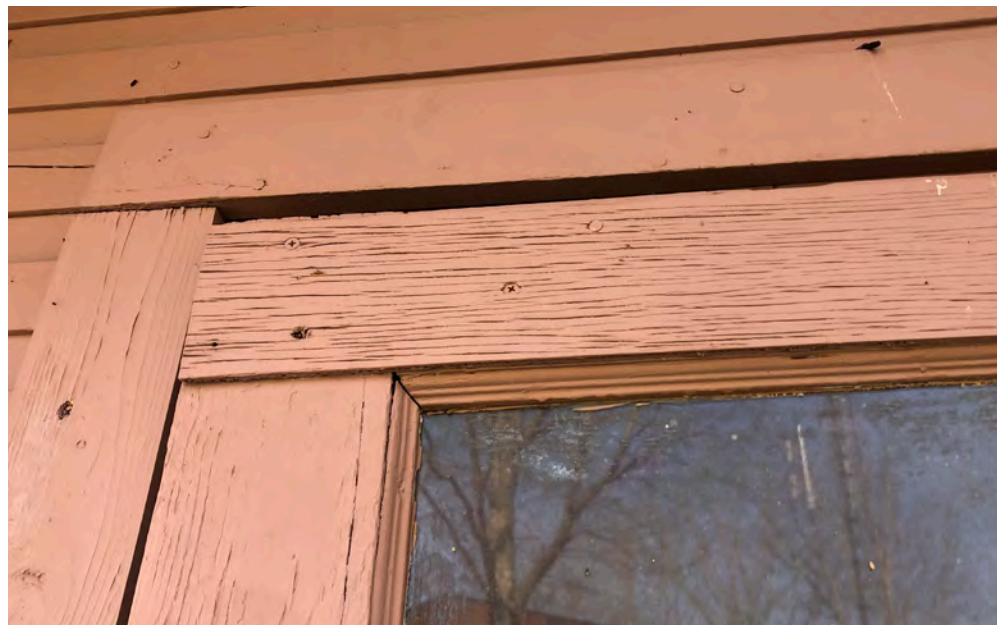
Graffiti incised onto the exterior surface of glass in the sash on the left elevation. Inscriptions are found on each of the three bottom lights; "BA" on the left pane (left), "HO[?]" on the middle pane (right), and "Los Alamos" on the right pane (bottom).

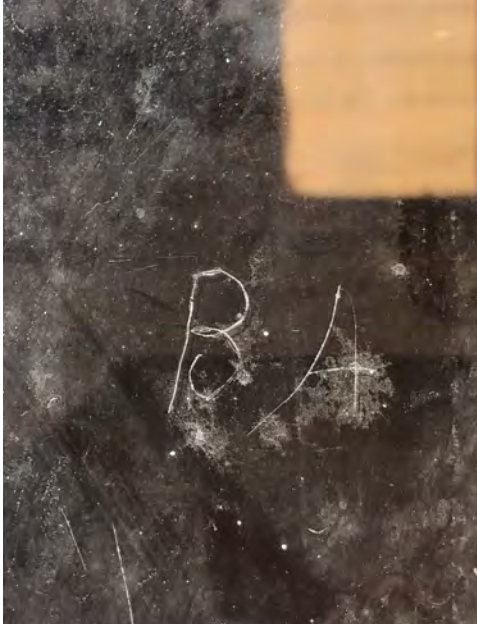
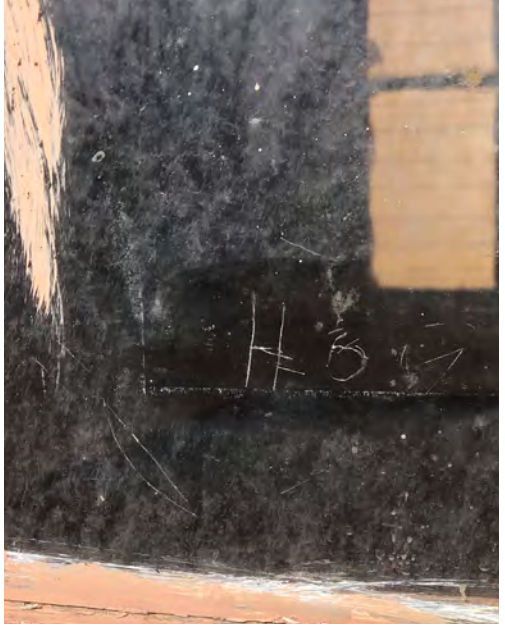
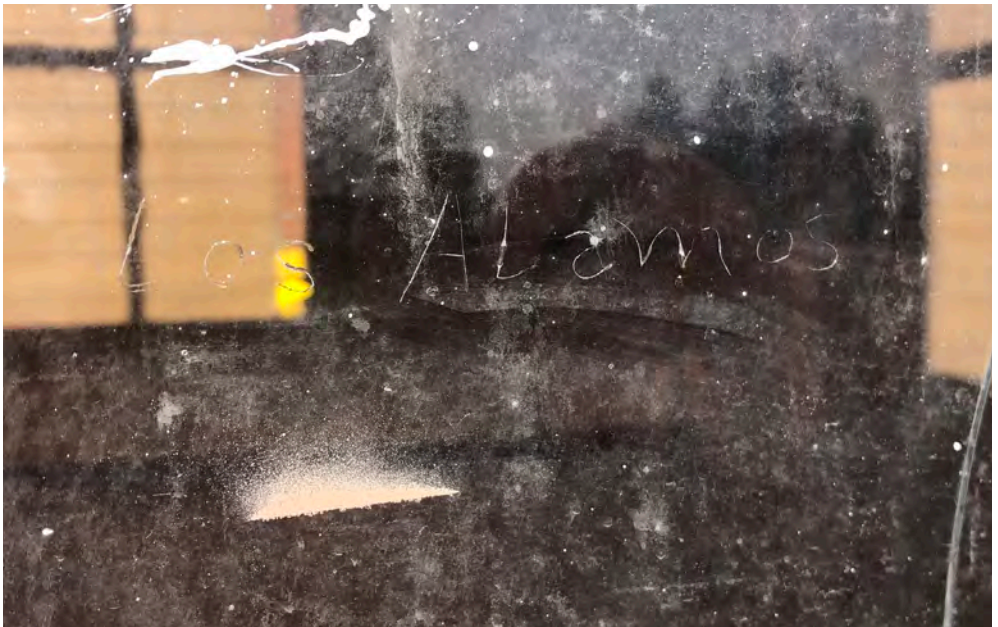
Paint evidence on the door casing shows that the exterior of the openings were painted olive drab green (left) and the interiors were sea foam green (right).

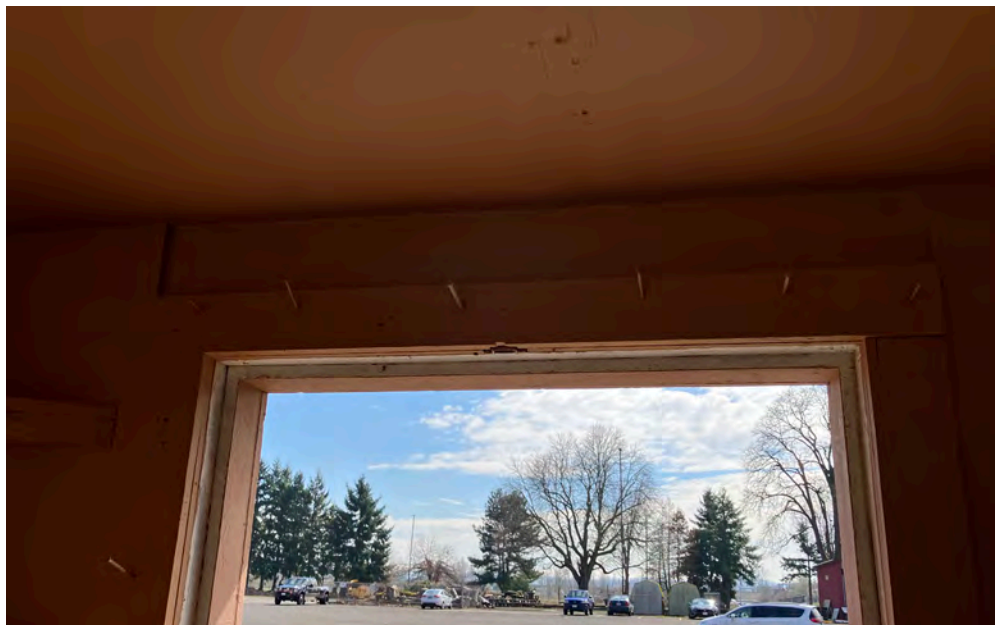
The interior left casing is missing; the other casing boards appear to be historic. New elements will match the existing in kind.

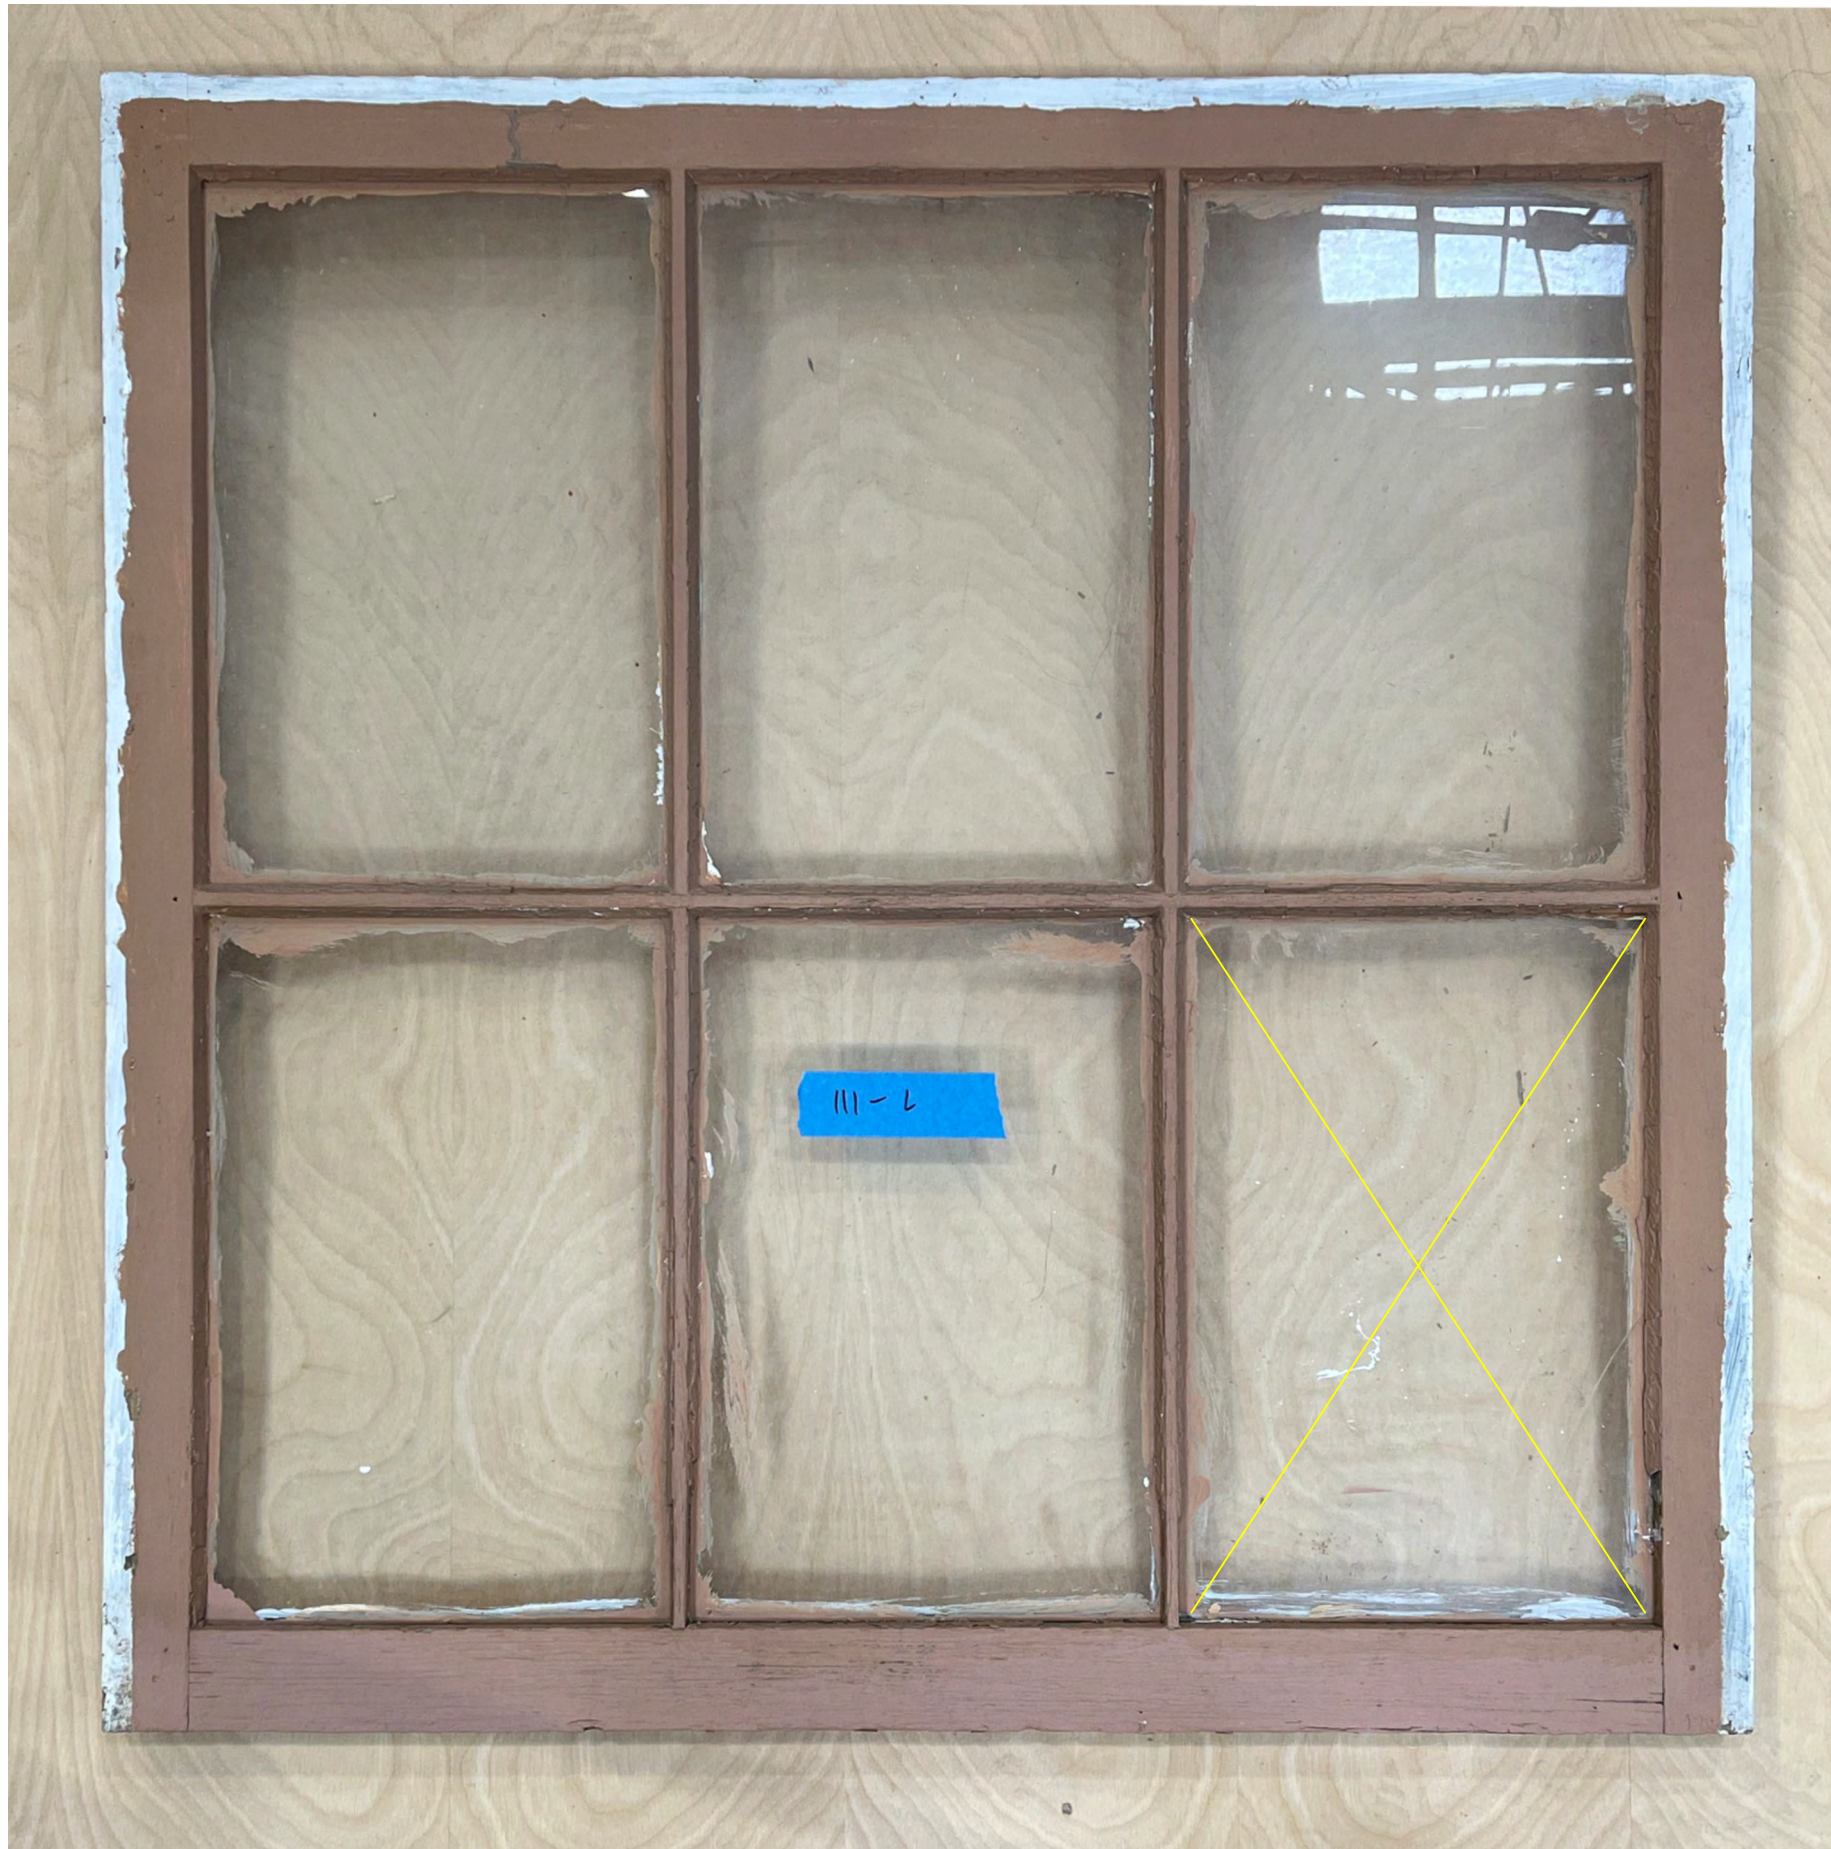
TITLE OF SHEET:
SASH DETERIORATION
CONDITIONS
