LA-UR-24-21637

Approved for public release; distribution is unlimited.

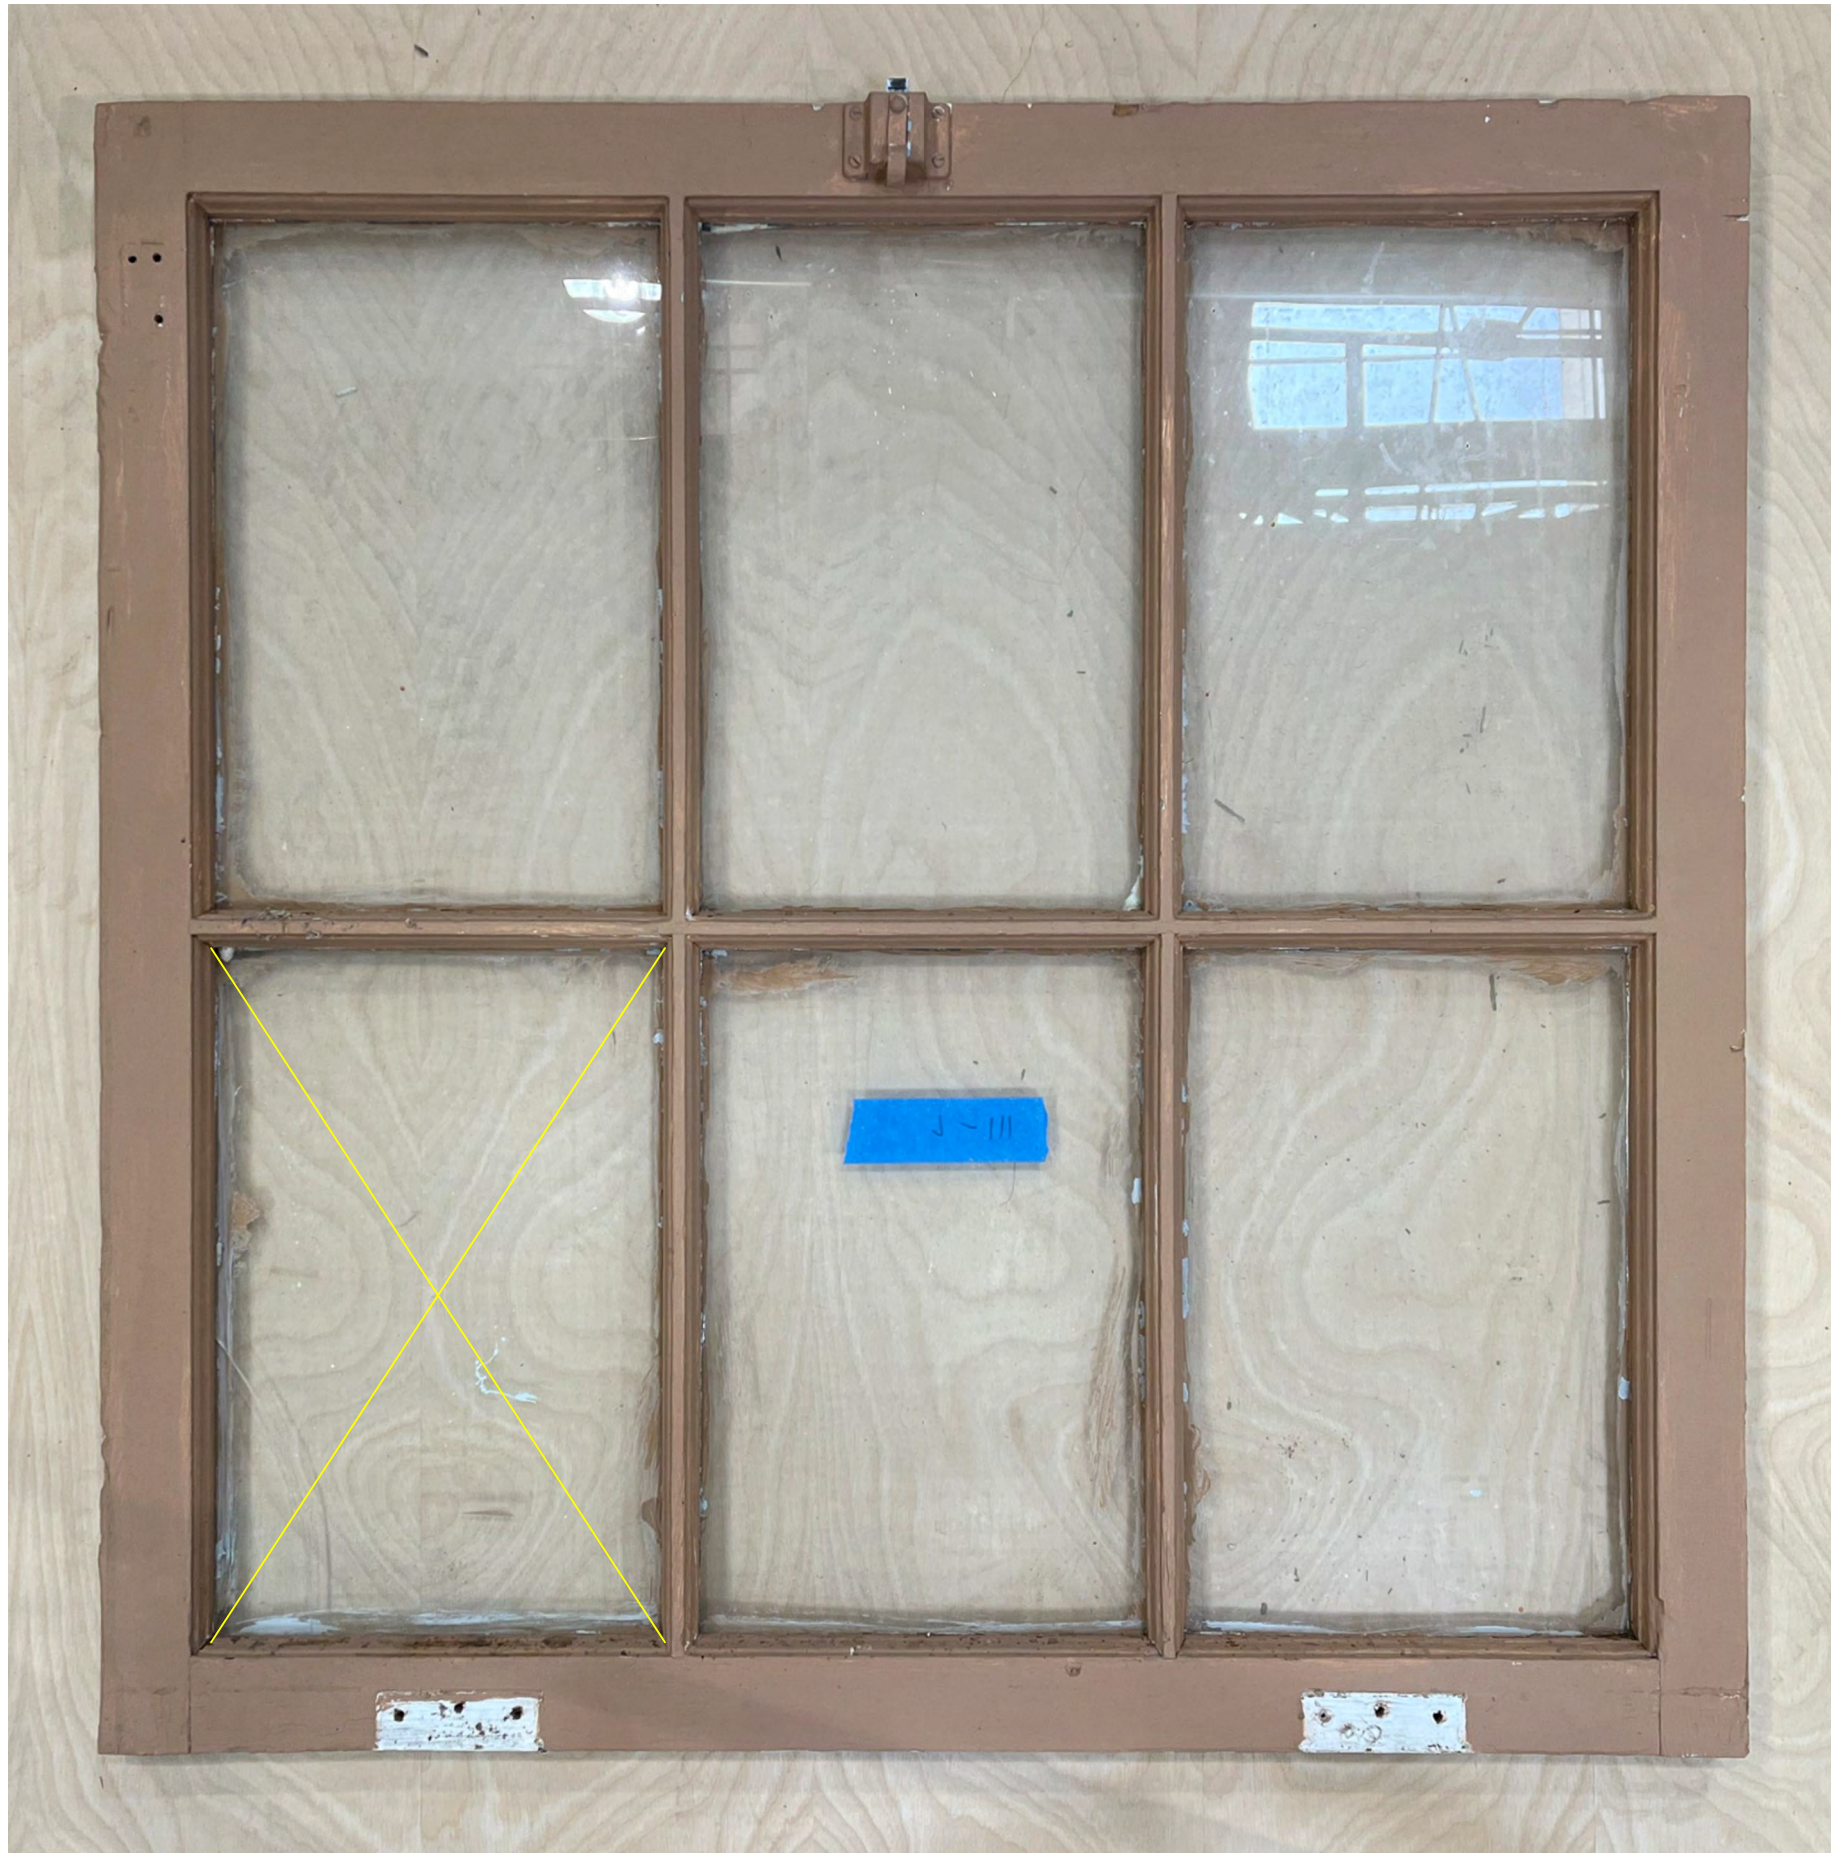
TITLE OF SHEET:
SASH DETERIORATION
CONDITIONS

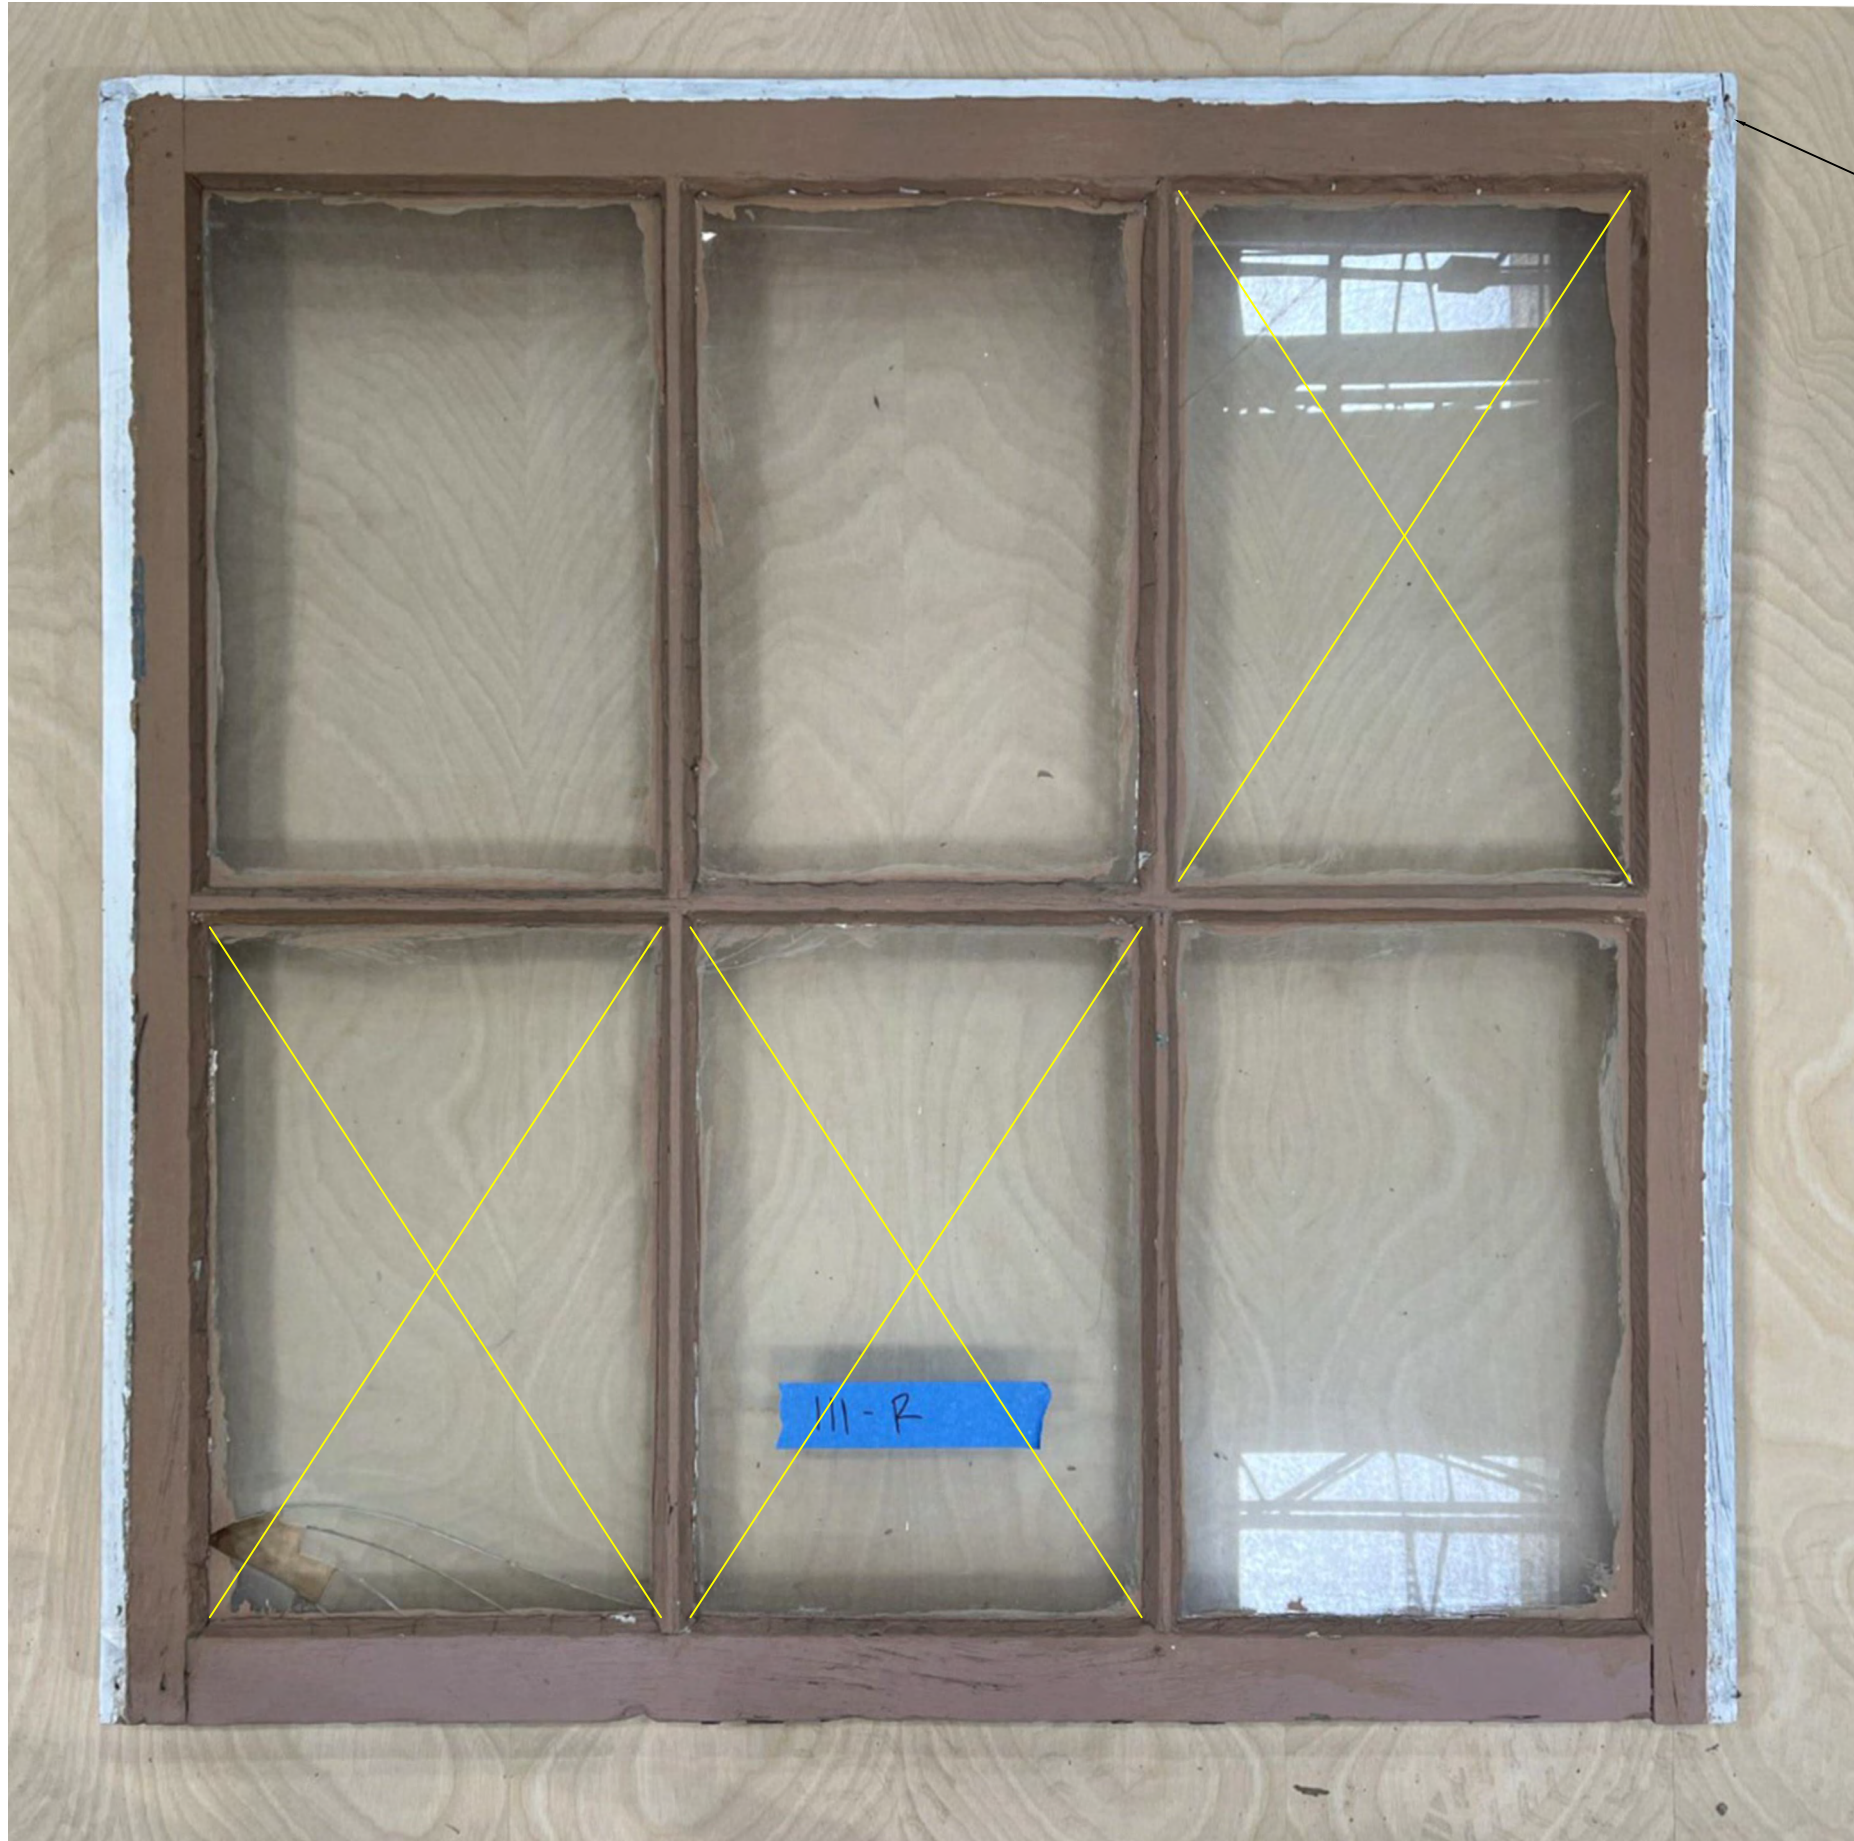
TOP OF STILE
IS SPLIT

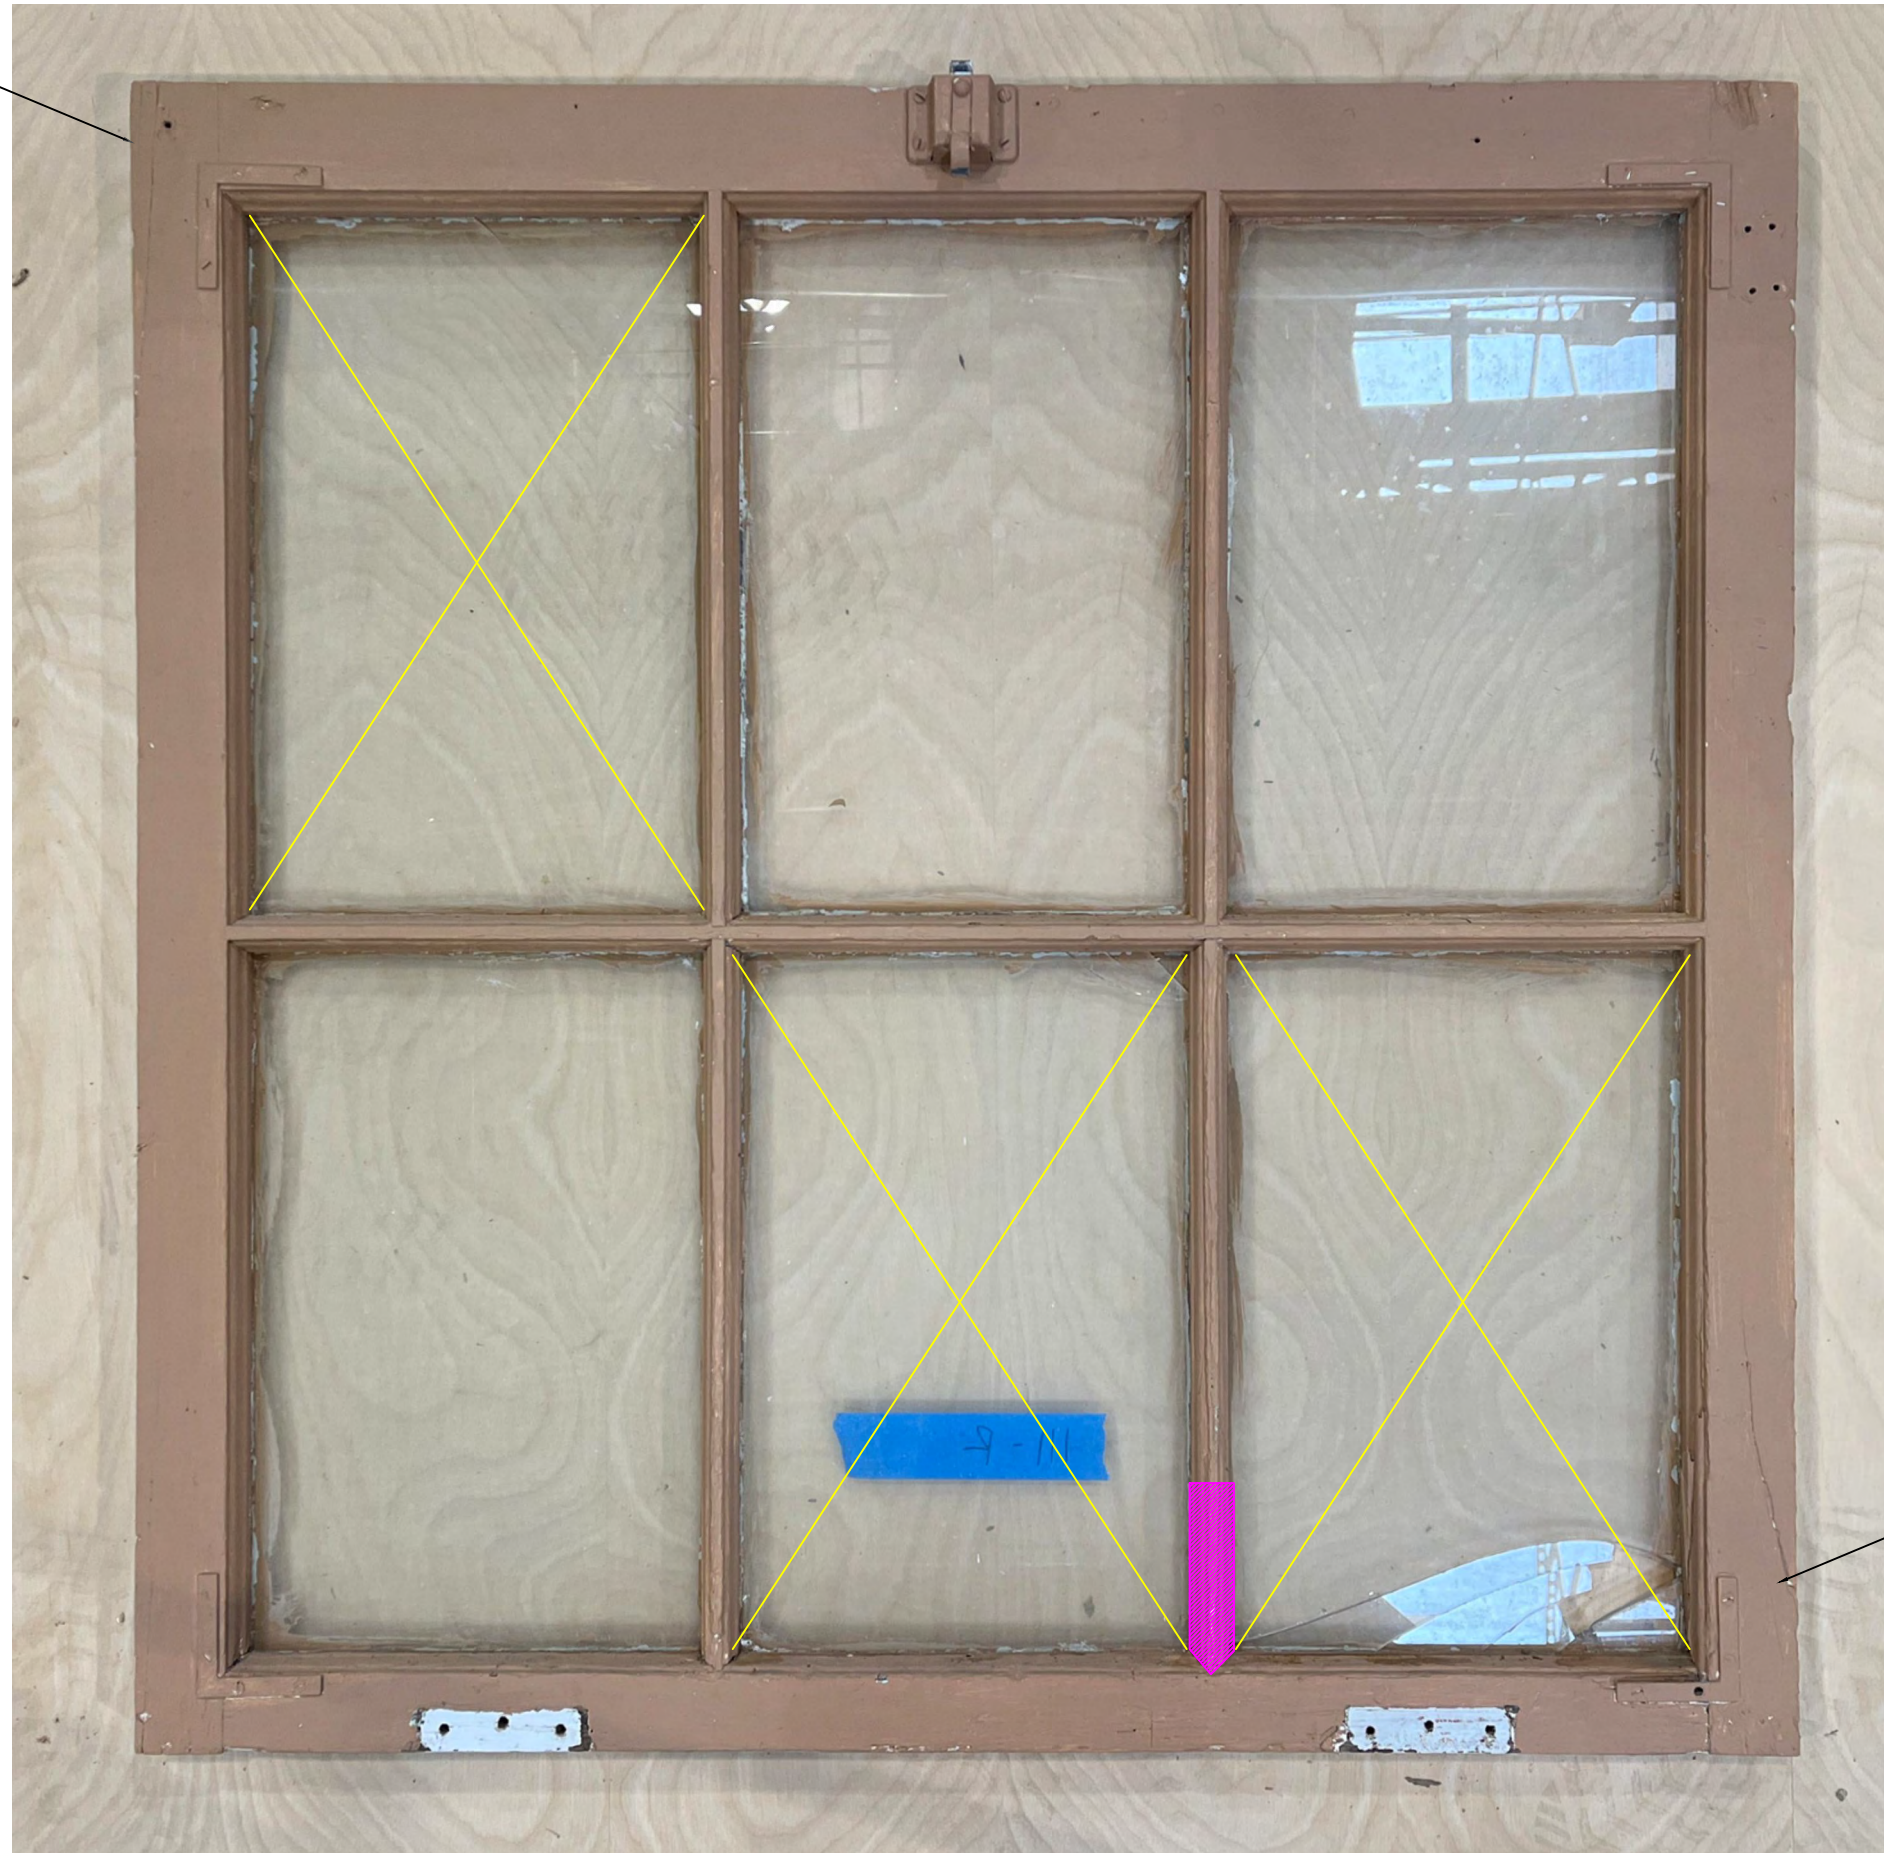
TOP OF STILE
IS SPLIT

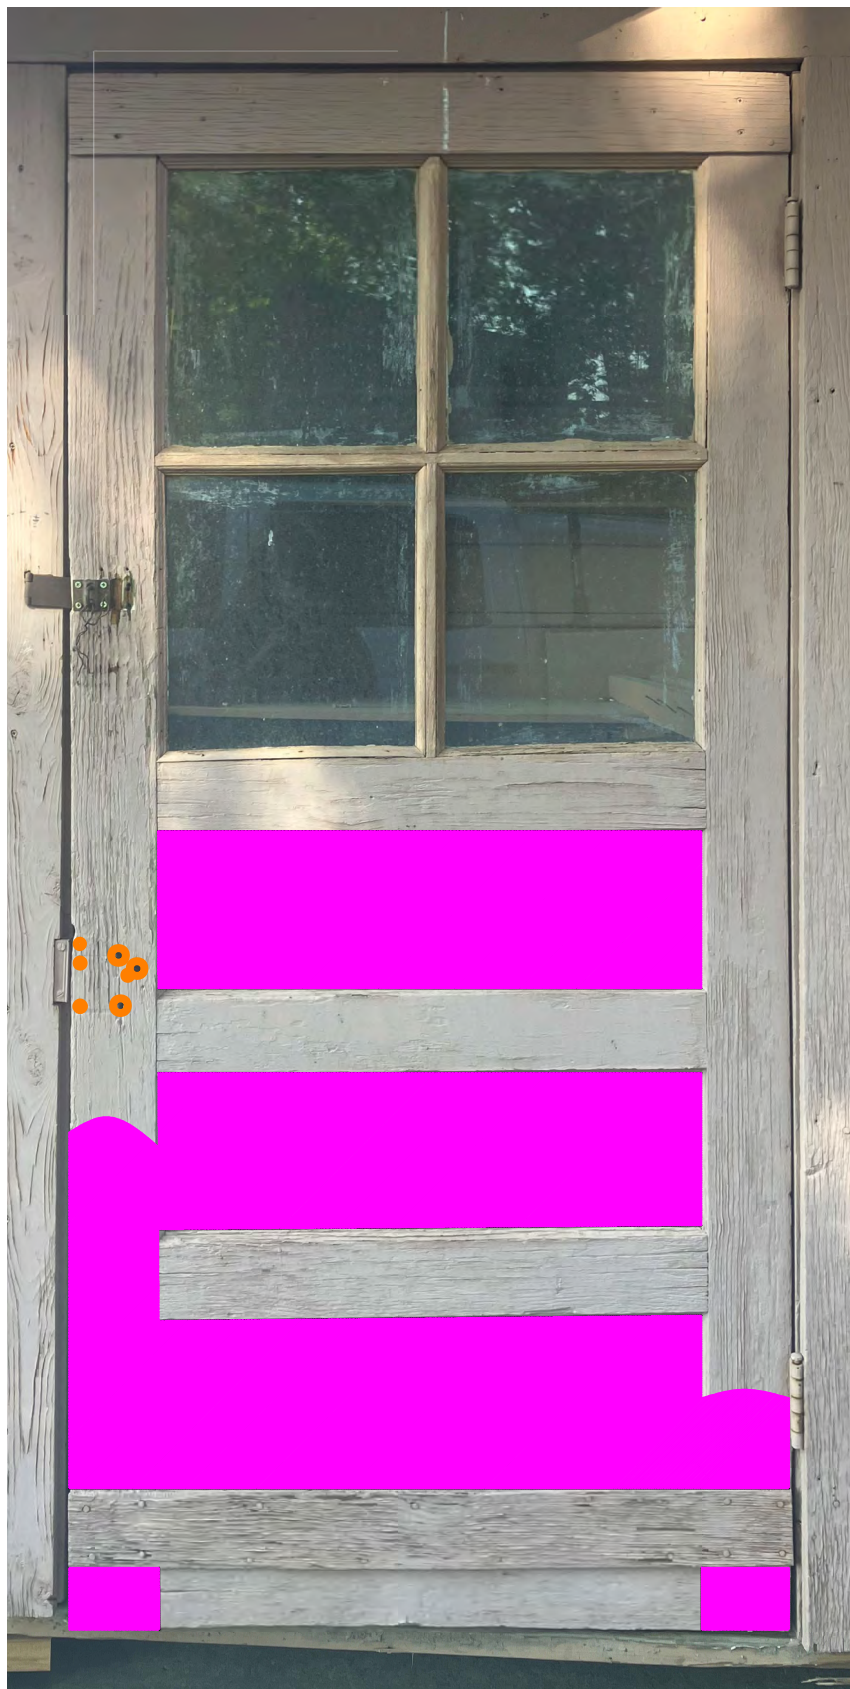
-   Broken light
-   Weathering
-   Loss

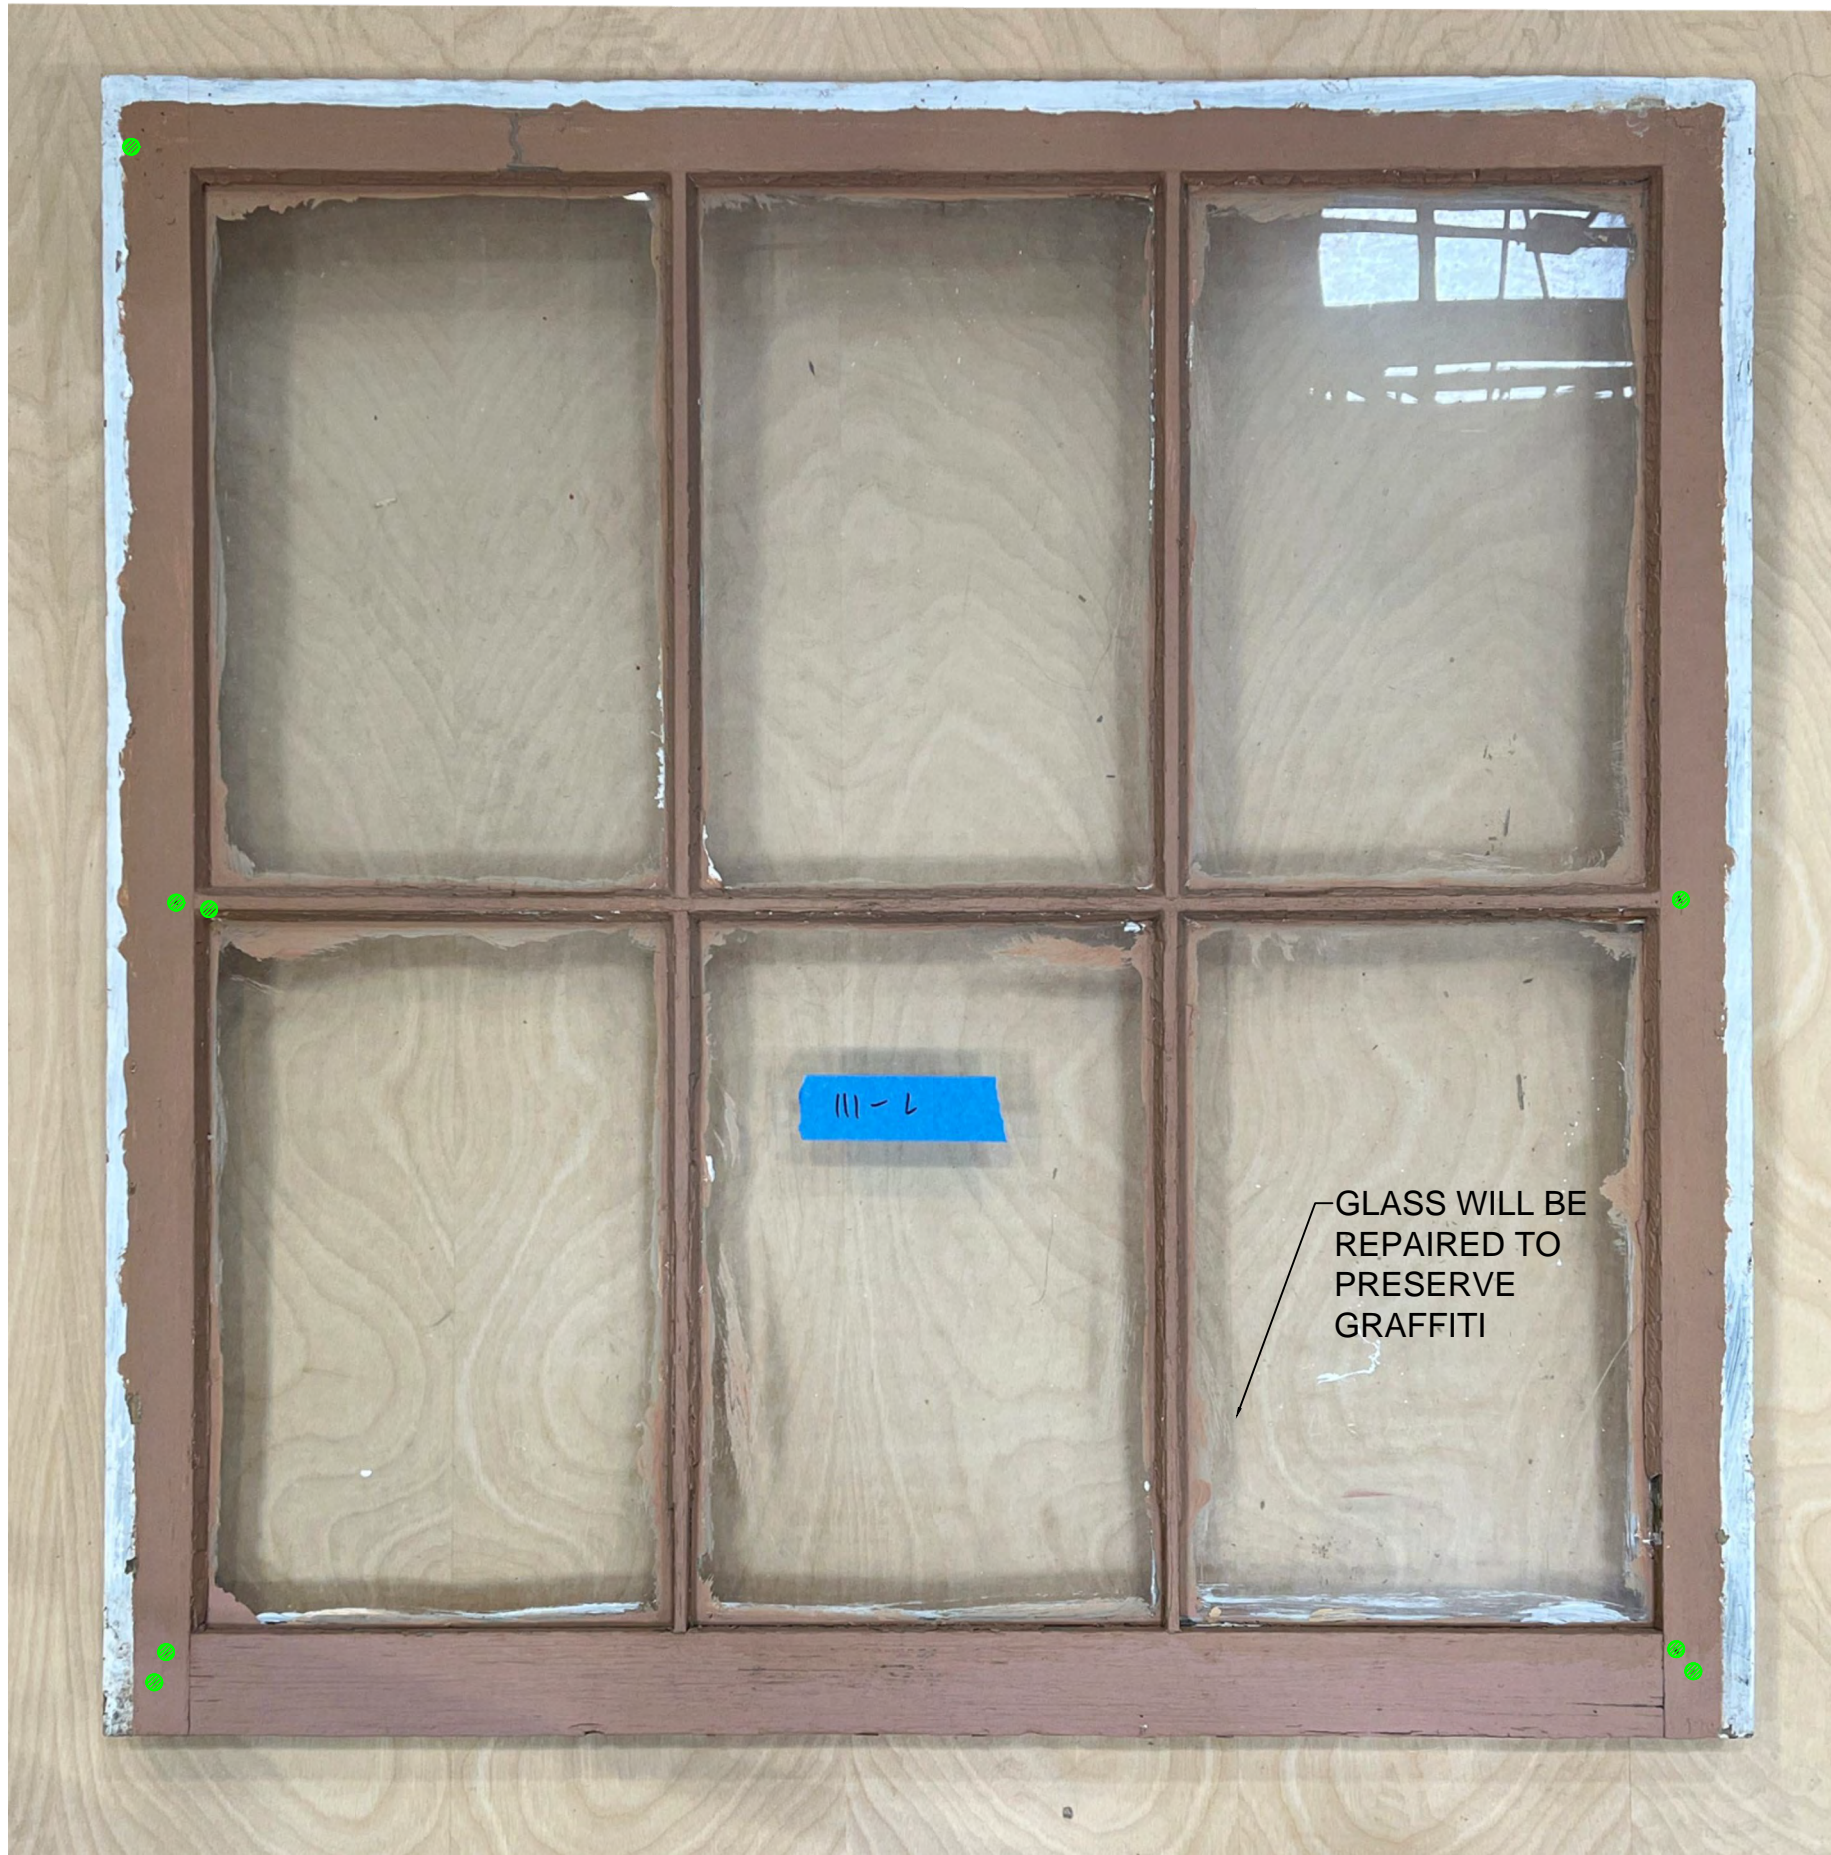
TITLE OF SHEET:
PROPOSED REPAIRS FOR
WINDOW SASH

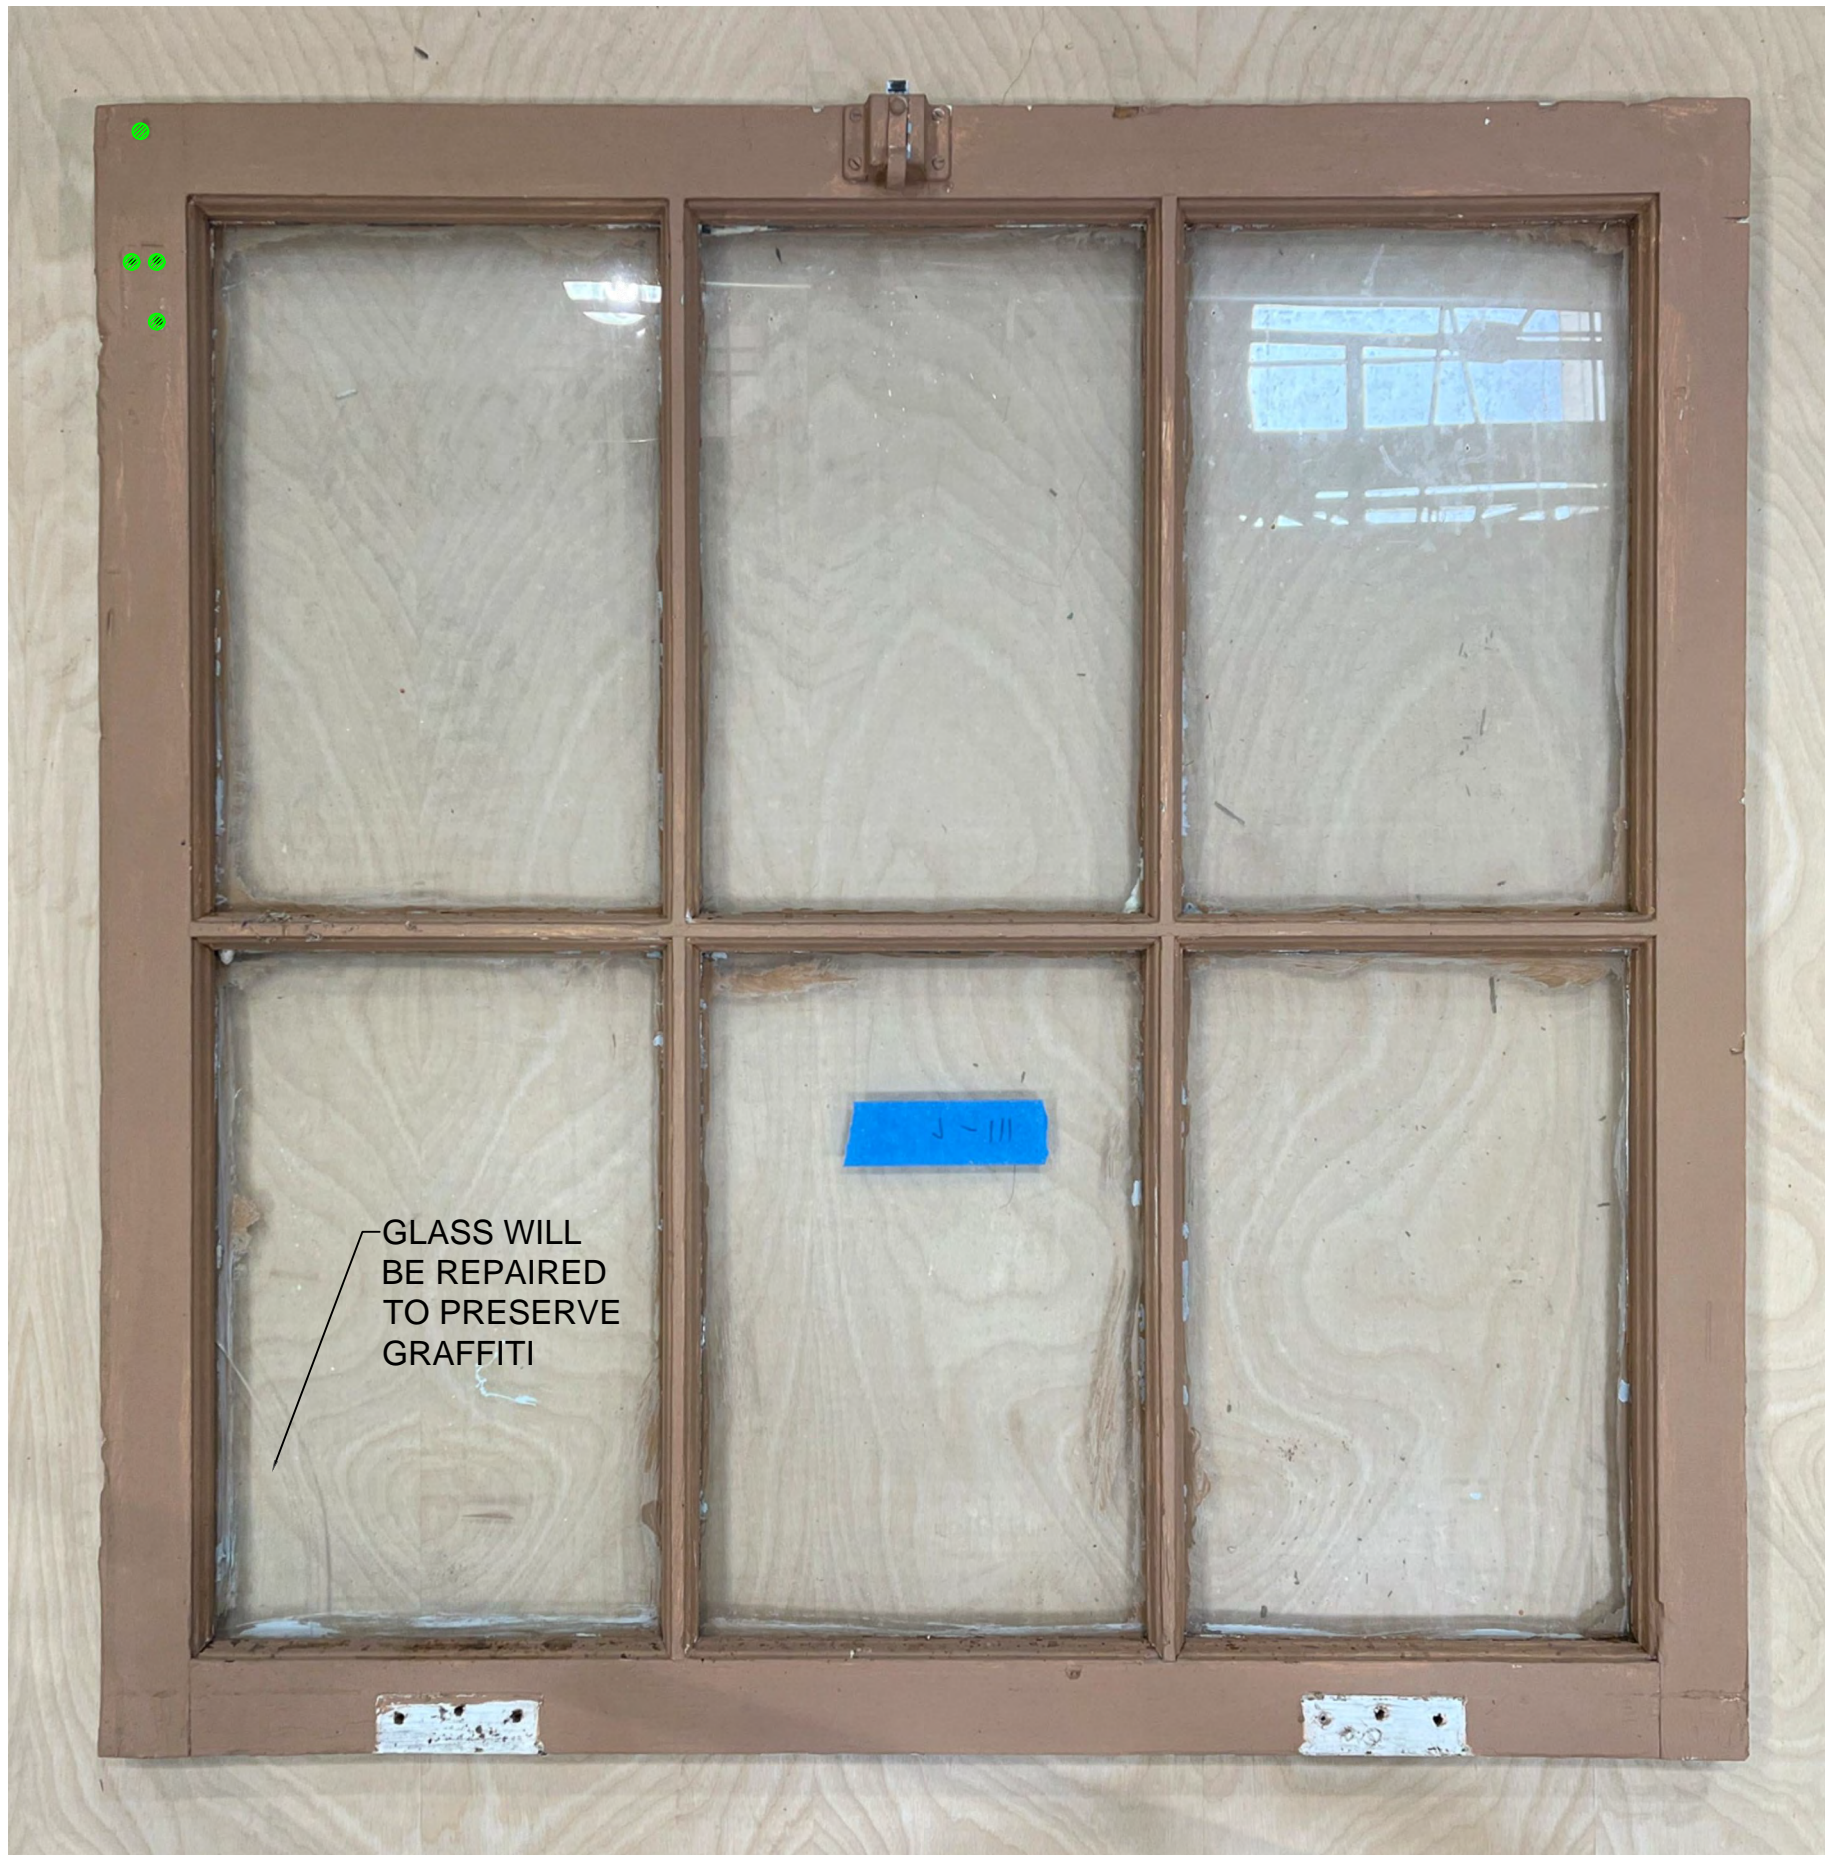
GLASS WILL
BE REPAIRED
TO PRESERVE
GRAFFITI

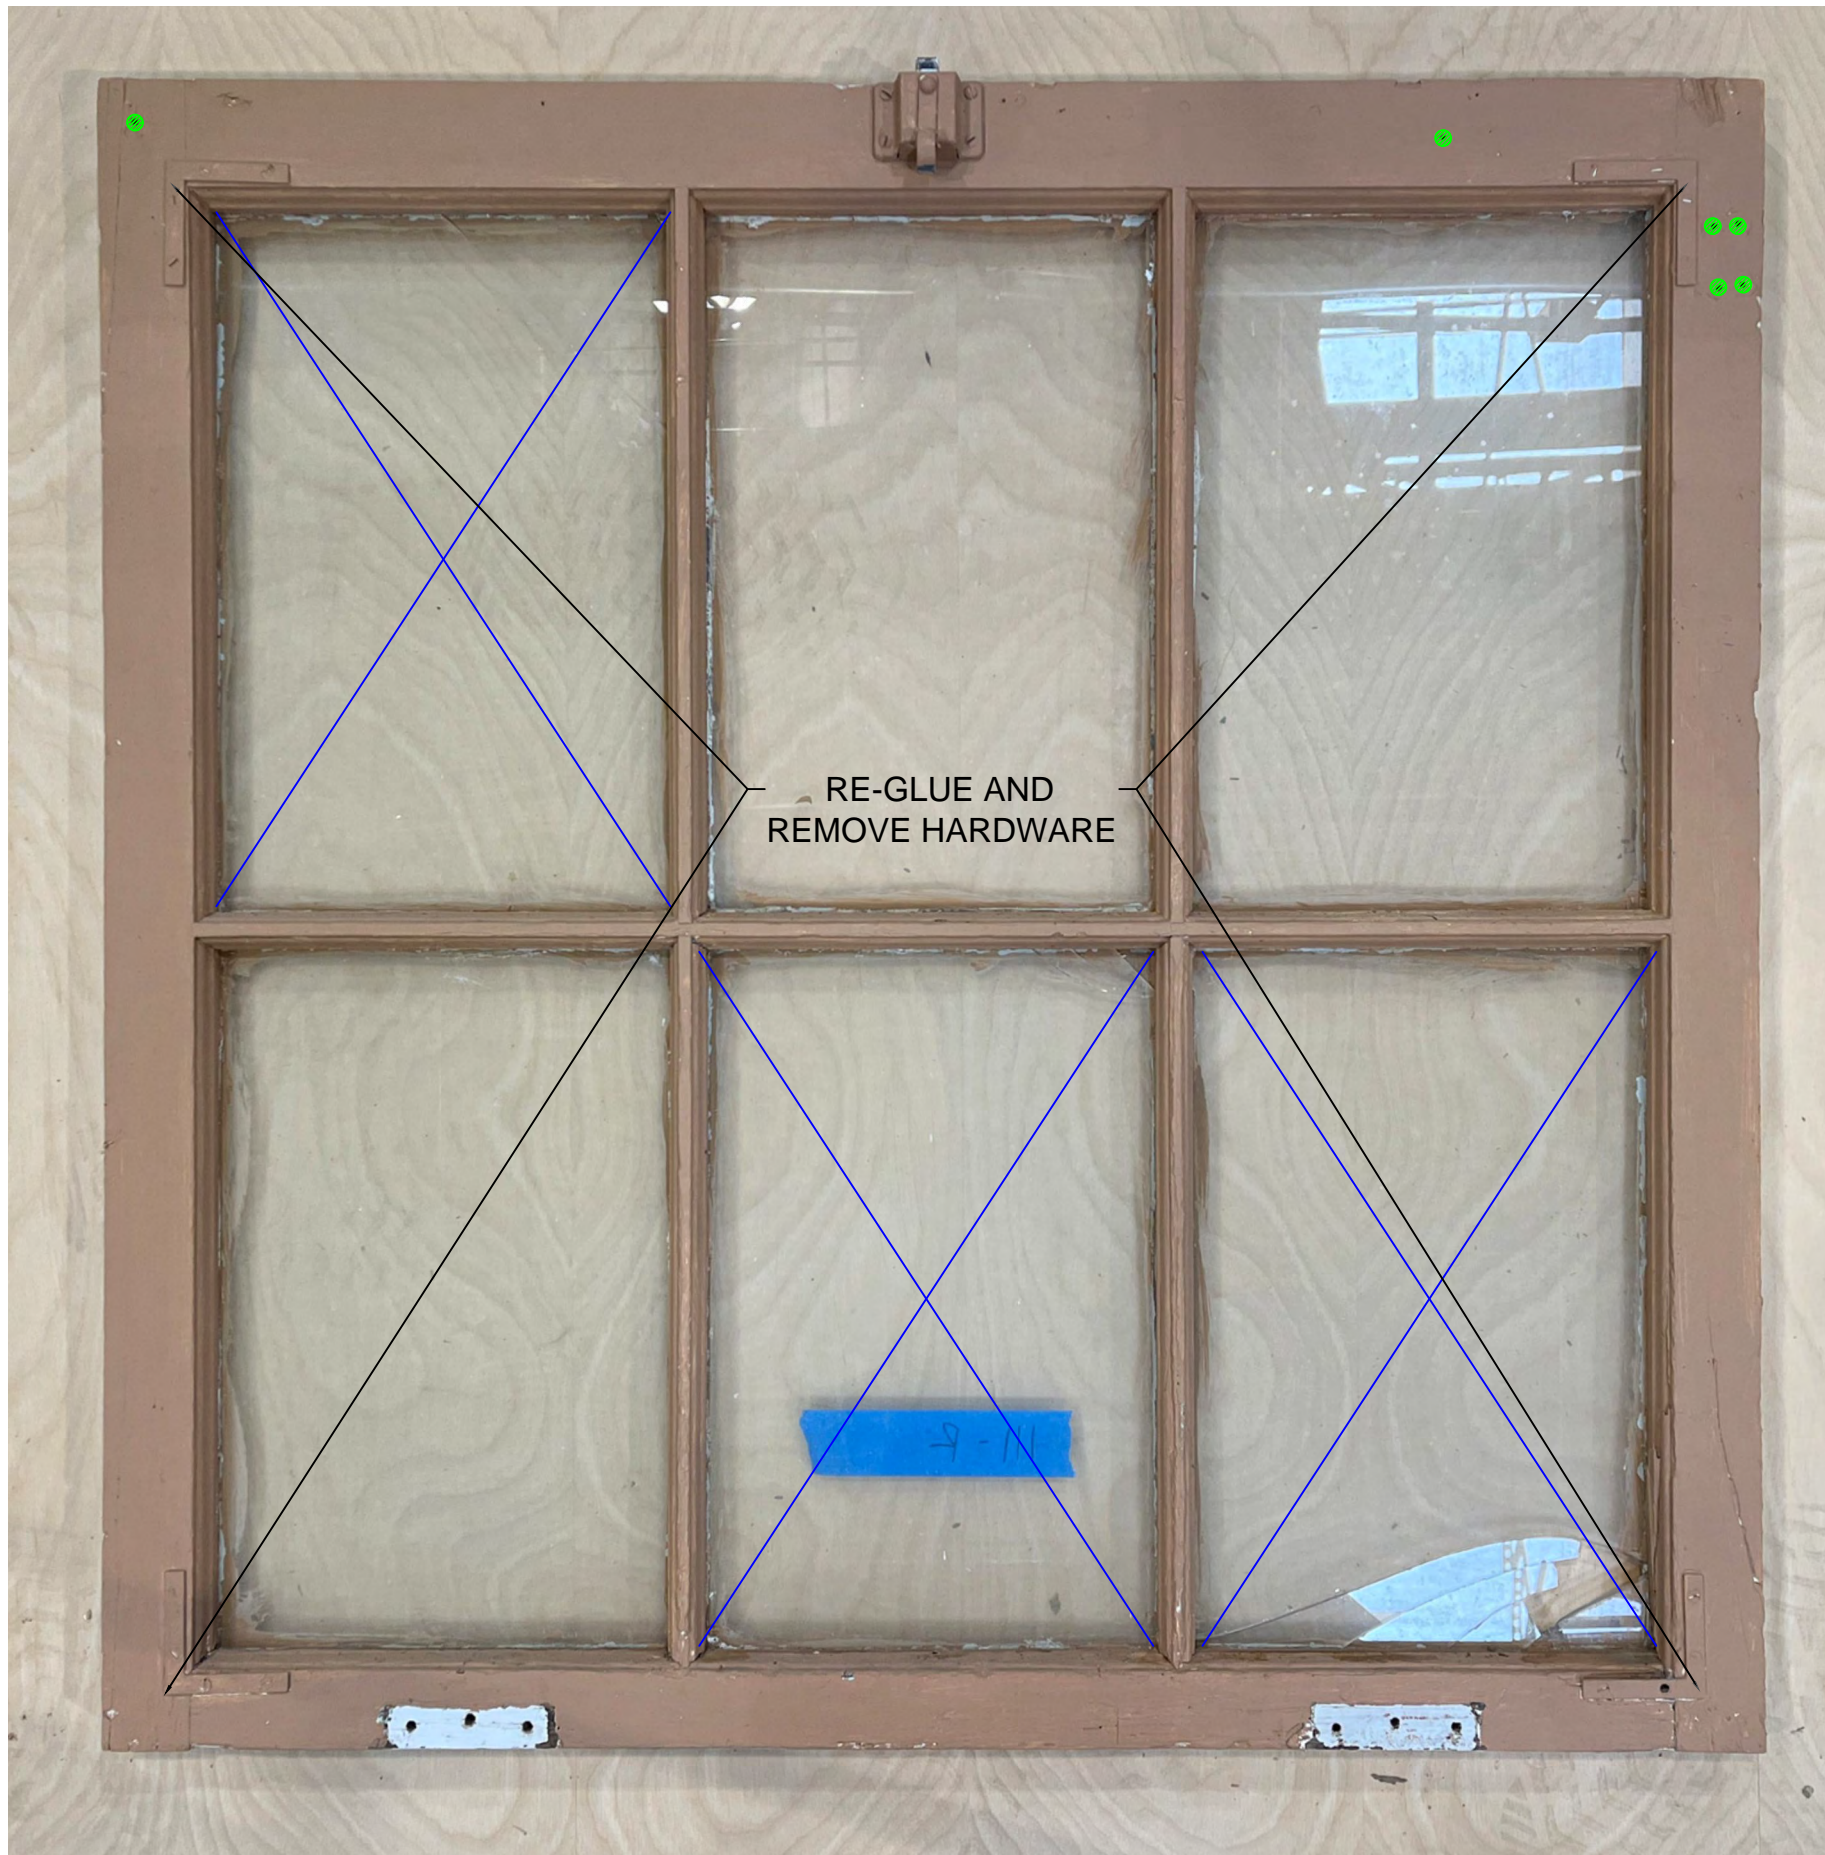
TITLE OF SHEET:
PROPOSED REPAIRS FOR
WINDOW SASH

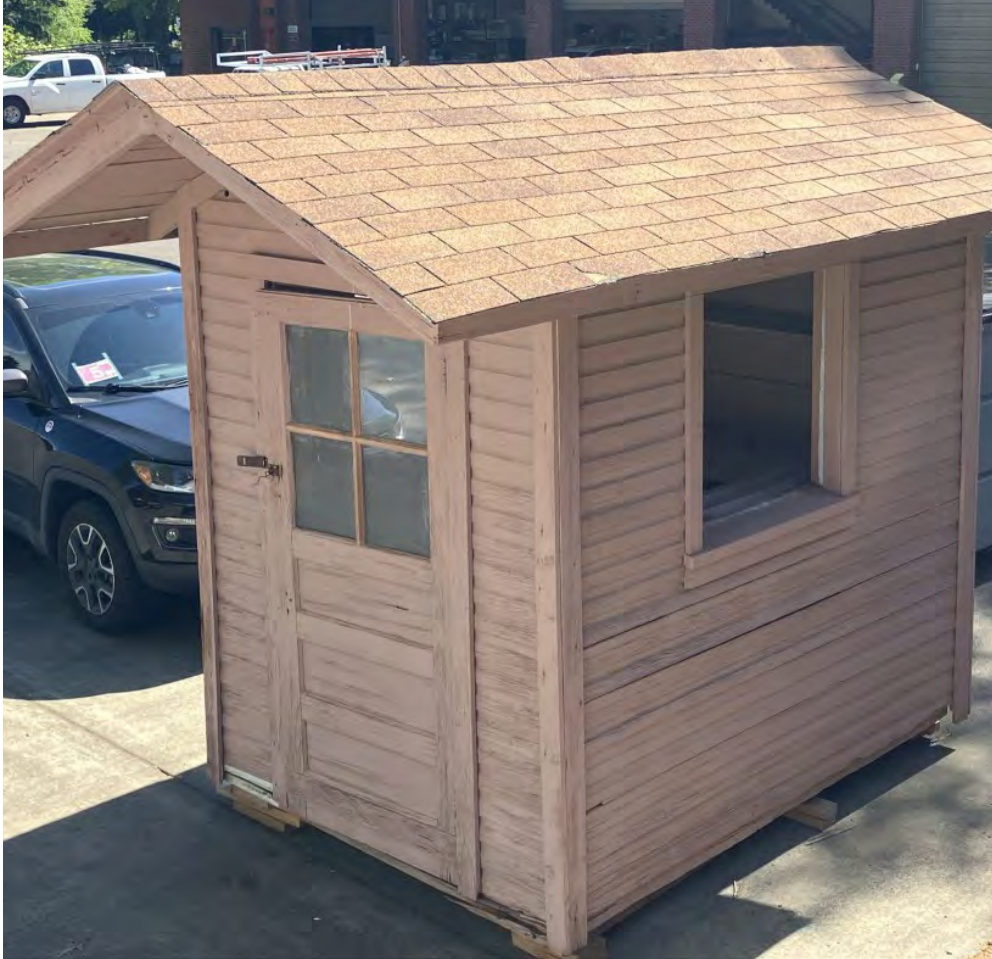
The rafters and fascia on TA-18-111 all appear to be in good condition.
