LA-UR-24-21637

Approved for public release; distribution is unlimited.

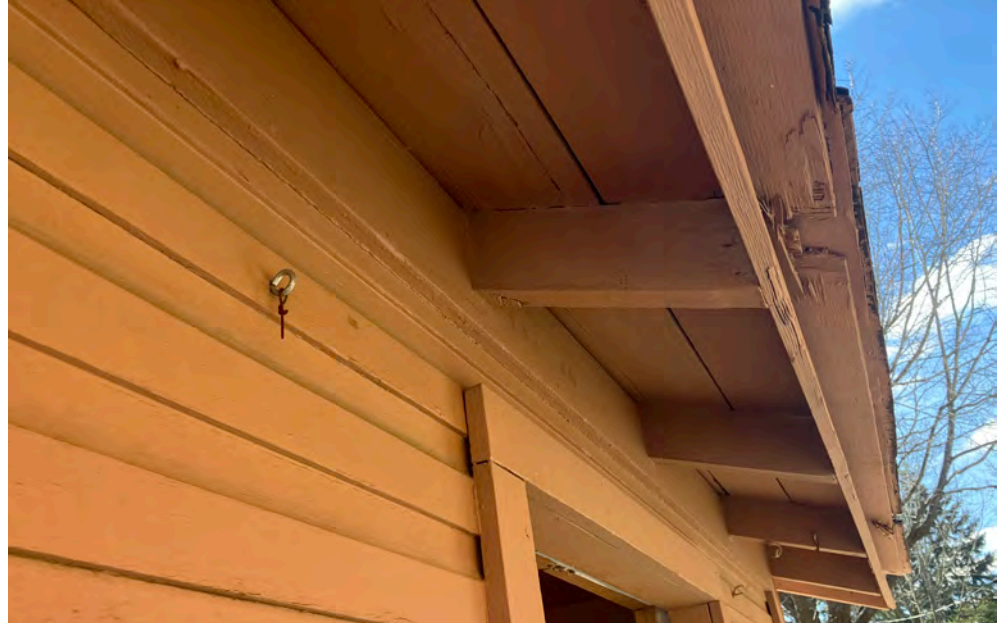
The original T&G roof decking may be seen beneath non-historic plywood materials.

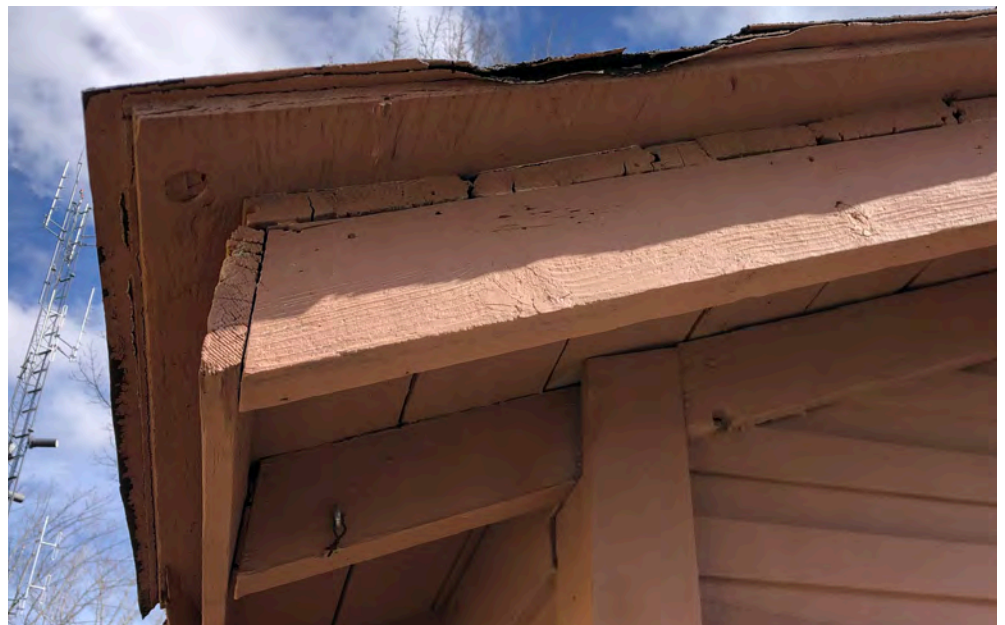
Non-historic plywood and 3-tab asphalt shingle roofing will be removed. Damaged elements will be repaired or replaced in-kind.

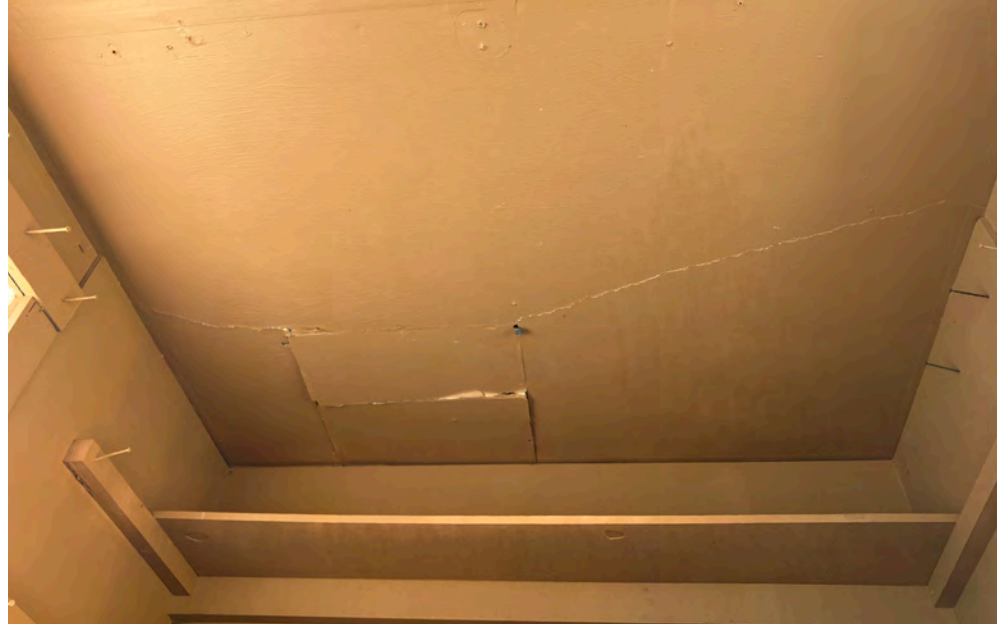
Evidence of a fixture on the gypsum board at the center of the ceiling.

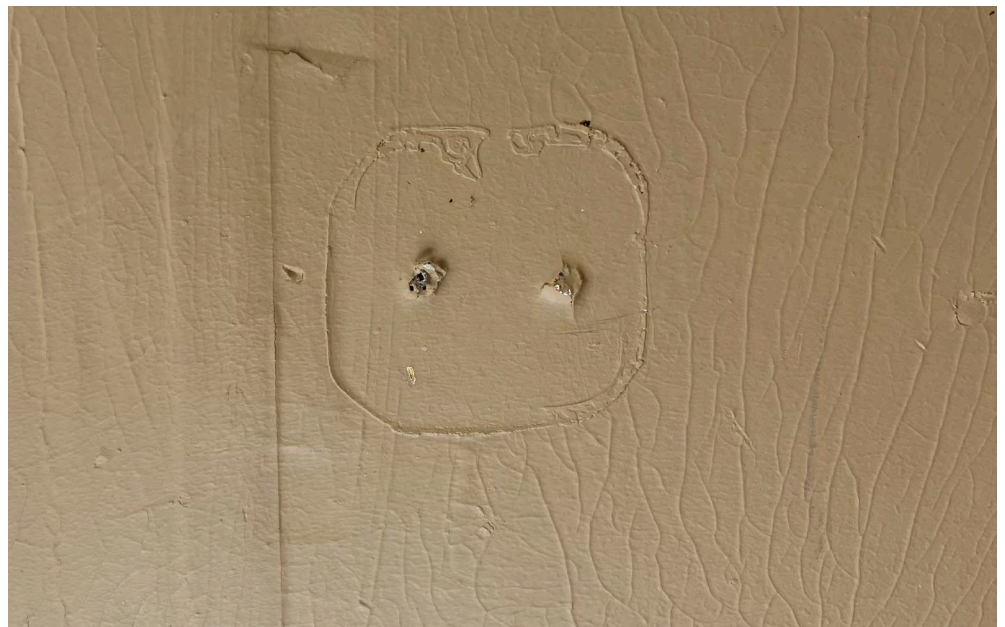
The interior front and left corner. The bottom half of the wall appears to be original fire-backer. Above the fire backer, non-historic plywood sheeting and wooden shelves were installed.

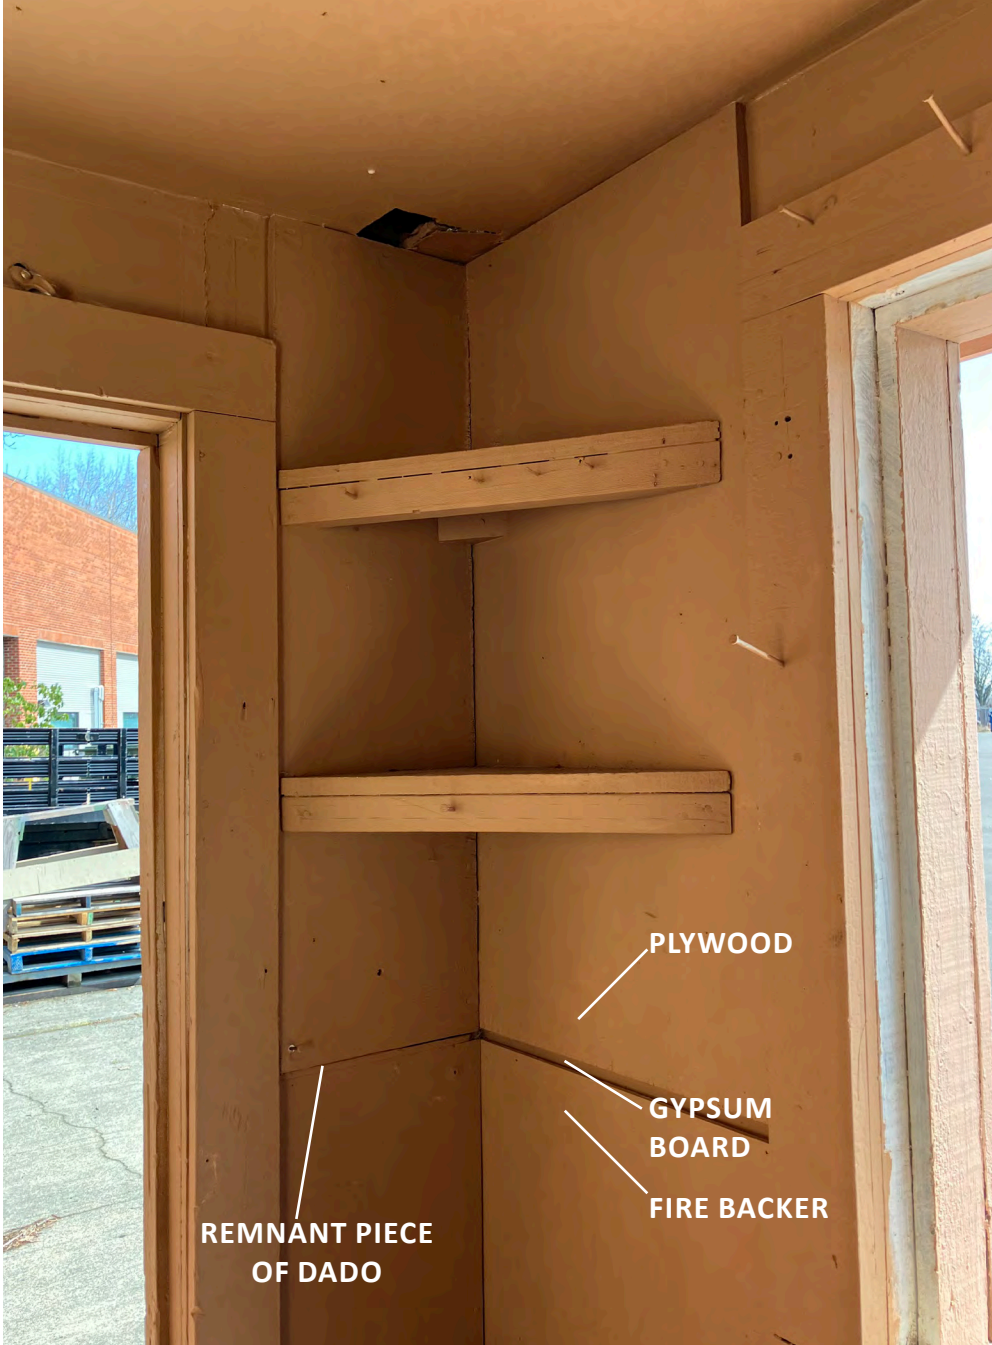
The interior back of the structure. The presumed original fire-backer continues around the interior on bottom half. Above the fire backer, non-historic plywood sheeting and wooden shelves were installed. Intact chair rail molding rests on top of the fire-backer.

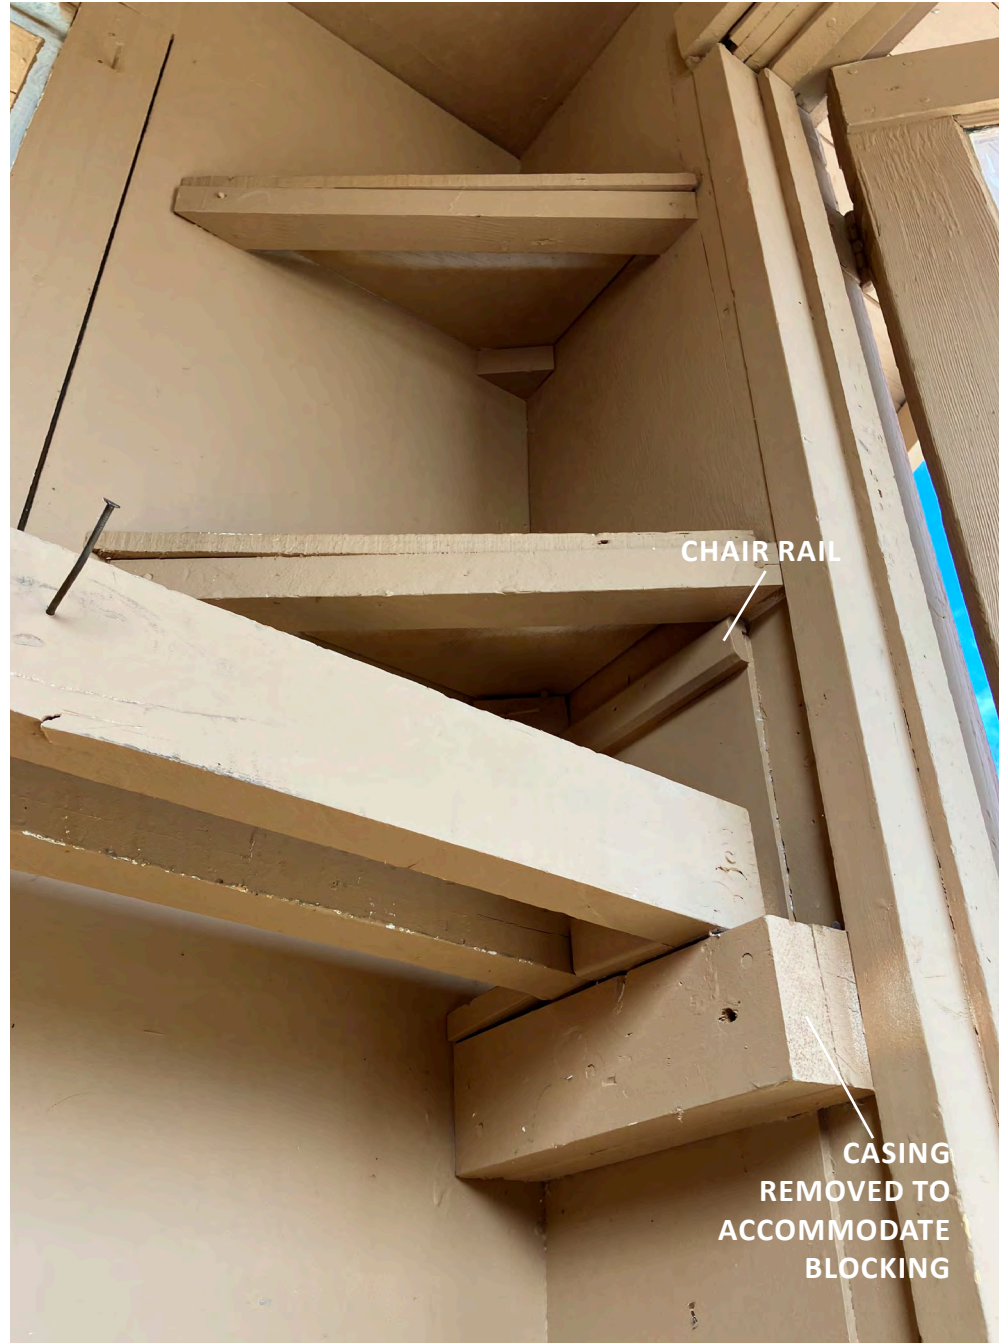
The chair rail molding has evidence of sea foam green paint. Enough of the material remains intact from which to fabricate new molding to replace missing sections.

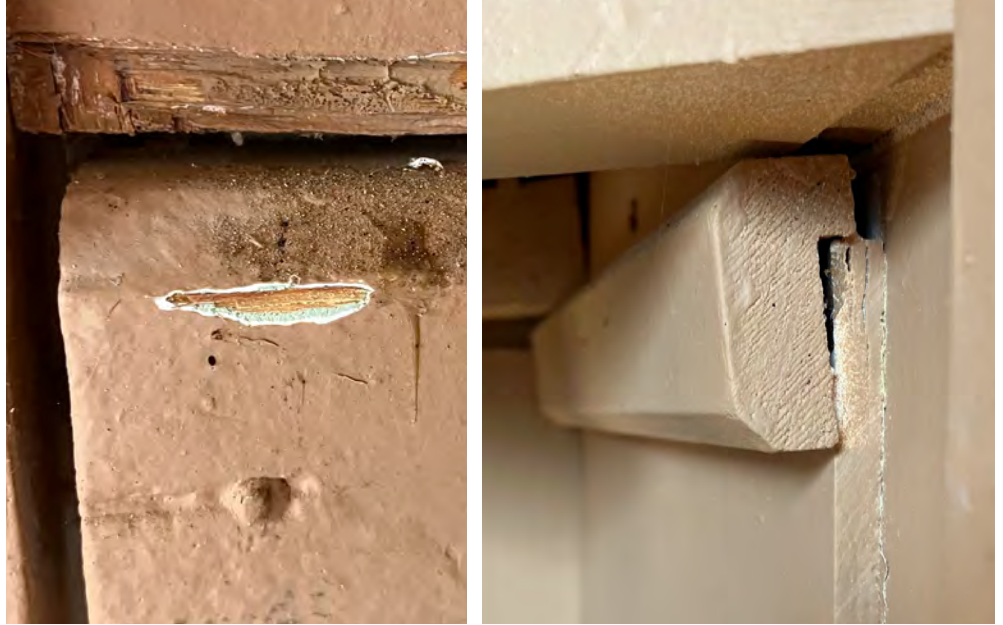
While the historic flooring and floor framing was removed, the base molding appears to be the original due to paint evidences.

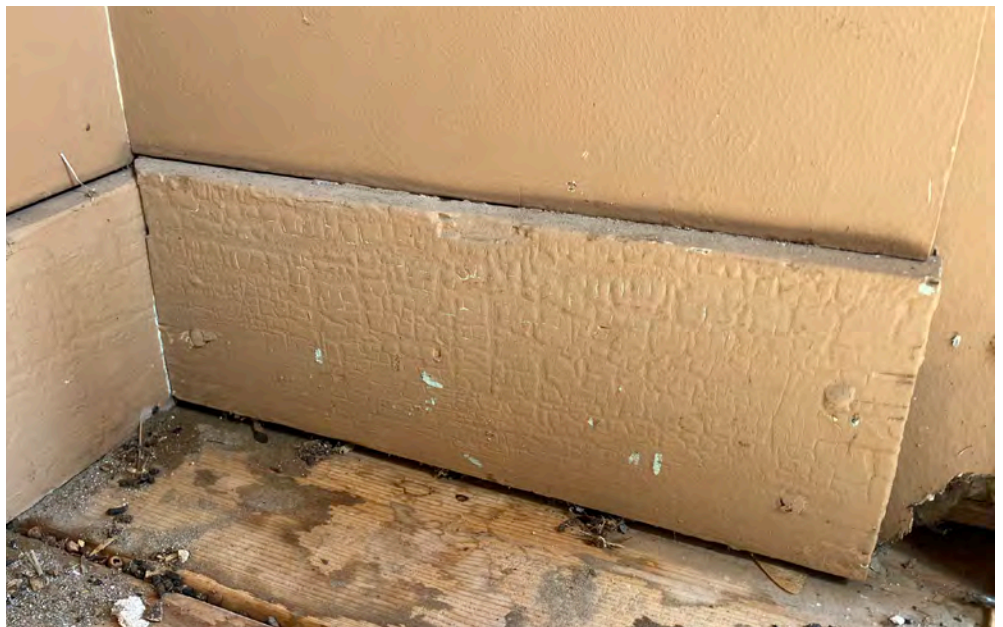
A detail from above the window casing on the interior left elevation shows the plywood installed over gypsum board. Drywall tape is evident on the majority of visible seams. Any repairs will maintain or replicate this detail, where necessary.

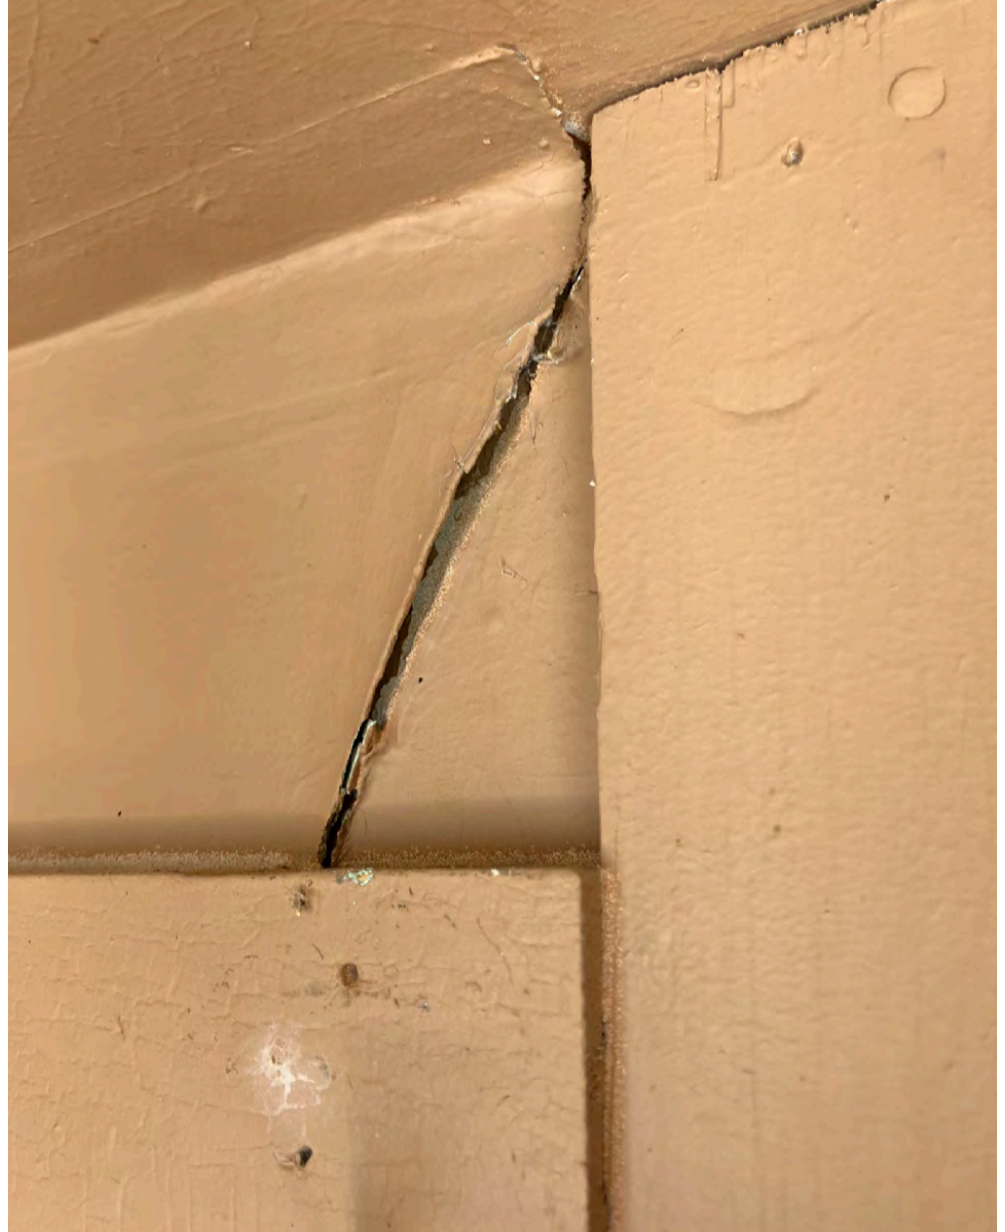
Remaining evidence of utilities on the interior of TA-18-111: a junction box, electrical conduit clamp, and hole in the ceiling gypsum board through which the conduit may have passed through a hole in the exterior siding.
