Microstructure and In-Service Degradation of Baffle-Former Bolts – In-Core Components of Light-Water Reactors

ORNL/TM-2023/3118
M4LW-23OR0402027

**MICROSTRUCTURE AND IN-SERVICE DEGRADATION OF BAFFLE-FORMER
BOLTS – IN-CORE COMPONENTS OF LIGHT-WATER REACTORS**

Prepared under the direction of the
U.S. Department of Energy
Office of Nuclear Energy
Light Water Reactor Sustainability Program
Materials Research Pathway

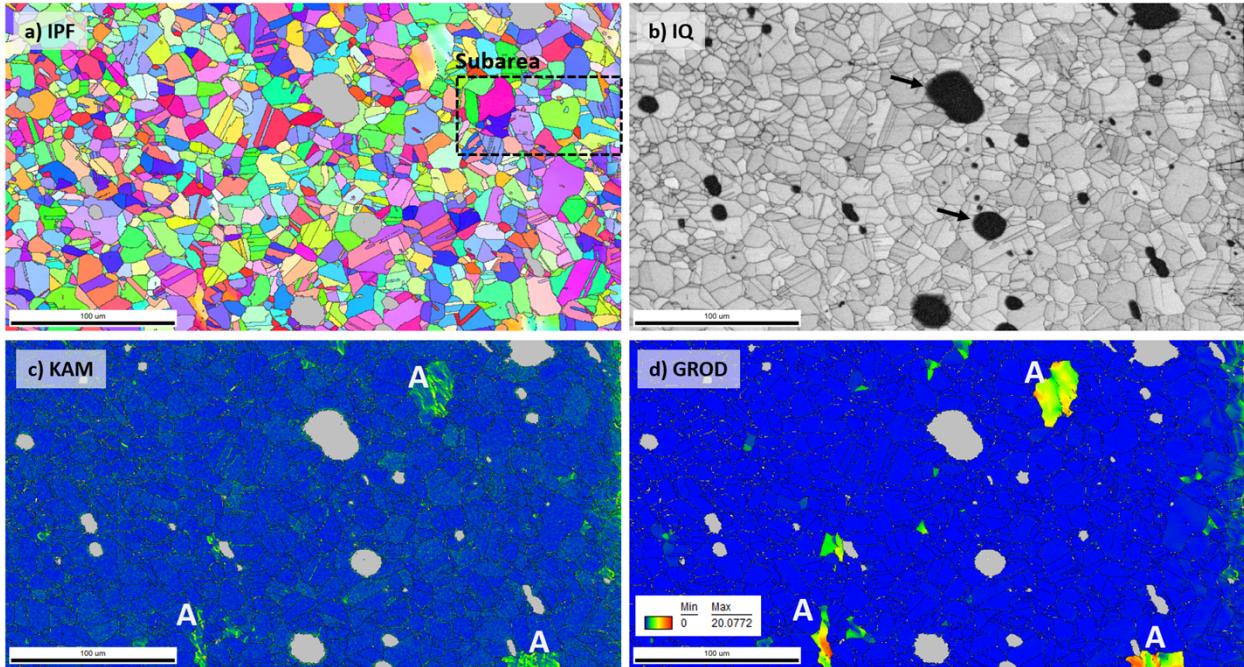
Figure 7. Microstructure of the BFB head (edge area; see Figure 3 for specimen location and orientation). A dominating recrystallized microstructure with a few abnormal grains (marked as *A*) can be seen. Carbon contamination spots are indicated with arrows in the IQ map. The subarea was rescanned using a smaller EBSD step, as seen in Figure 8.

Figure 7 shows the microstructure of the BFB edge area; this location is close to the edge. Analysis of the EBSD maps (especially KAM and GROD) shows mostly annealed austenite with a few abnormal grains. The general appearance of the edge area microstructure is very close to the bulk area (Figure 6). The only significant difference is the appearance of the area on the right, which contains obvious signs of plastic deformation. The layer with increased KAM and GROD values has a \sim 15–20 μm thickness. This may suggest that the thin near-surface layer was subjected to local loading and deformation.

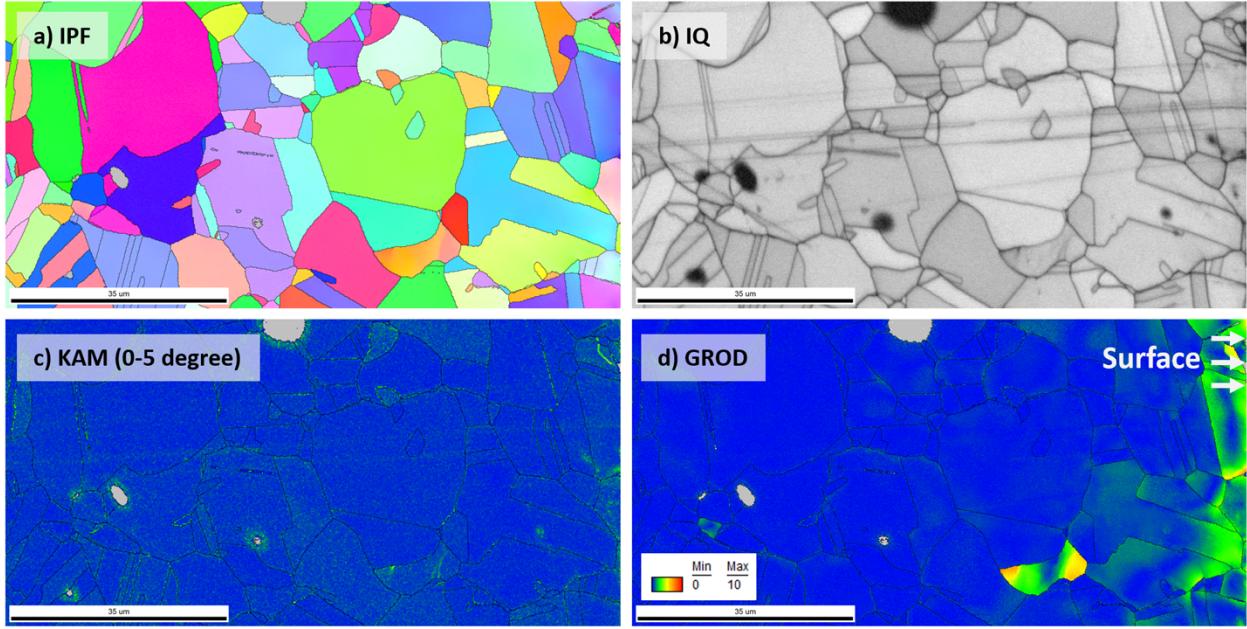
A small subarea was rescanned with a reduced EBSD step size of 125 nm, as shown in Figure 8. The presence of a thin \sim 15 μm deformed layer is obvious. The misorientation pattern (smooth changes in GROD, absence of hot spots typical for irradiated austenitic steel [8]) indicates that this near-surface deformation occurred before irradiation. Additionally, the deformation could occur at small damage doses of less than \sim 1 dpa, which are insufficient to stimulate defect-free channel formation.

Of special interest is the IQ map shown in Figure 8b, which illustrates the quality of the EBSD patterns. Although IQ (Kikuchi pattern image quality) is a qualitative parameter (better/worse), it decreases as defect density increases (e.g., dislocation density increase near the dislocation pile-up) and near grain boundaries, inclusions, phase boundaries, and so on. The map in Figure 8 clearly shows preparation-induced scratches intersecting the whole view field. The scratches are formed by hard particles rolling along the specimen's surface. Commercial alloys often have metallurgical or second-phase inclusions that fall off during specimen preparation. Hard inclusions easily generate scratches, and because inclusions are supplied by material volume, scratching may be difficult to avoid entirely. Because a scratch is a subsurface plastic strain, it will overlap with strain from other sources. As a rule, scratches form straight lines that intersect grain boundaries without changing direction. Except in coincidental cases, scratches do not follow slip plane traces (e.g., (111)-planes in face-centered cubic (fcc) materials).

Figure 8. A magnified view of the subarea shown in Figure 7. The BFB edge (surface) is shown on the right in each image.

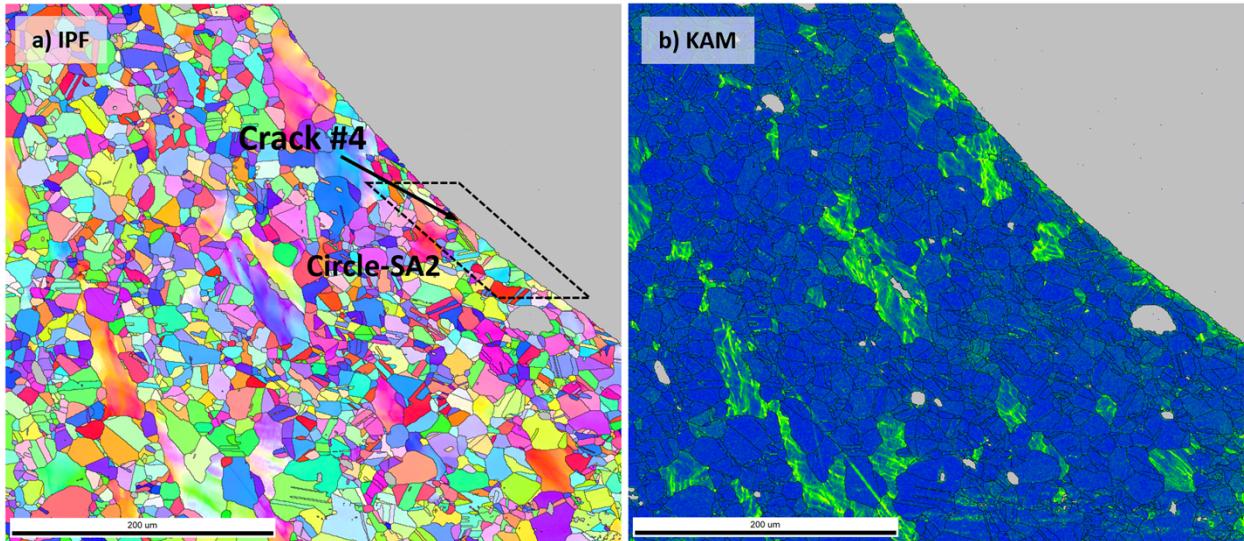
Figure 9 shows the microstructure of the *circle area* shown in Figure 3; the same pattern of dominating annealed grains mixed with abnormal grains can be seen. The abnormal grains are more abundant here, forming specific groups or lines. Such groups are elongated in the direction parallel to the edge, likely reflecting some preexisting texture or deformation structures related to BFB manufacturing. Also, there is a thin, slightly deformed layer along the edge with a thickness estimated at 10–15 μm .

Figure 9. The microstructure of the *circle area* shown in Figure 3.

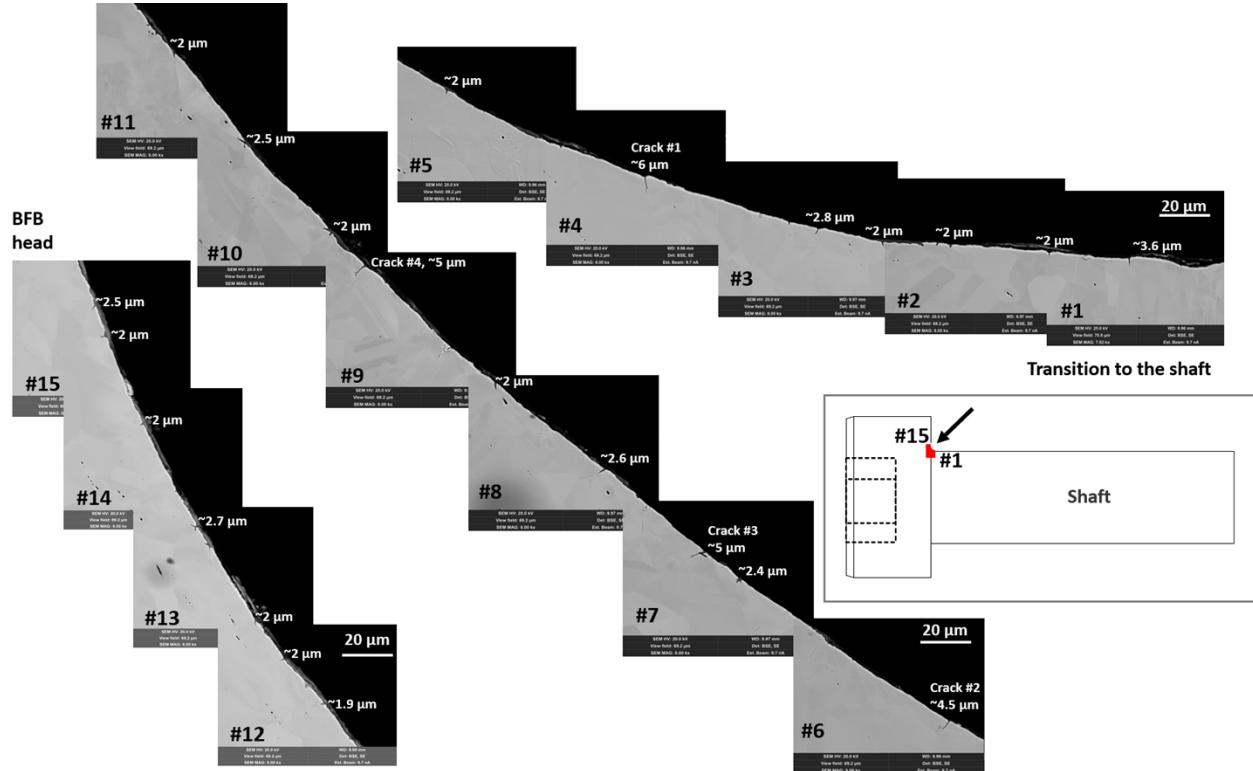
The detailed survey of the 4412-CS-1-1 specimen brought up the unexpected result depicted in Figure 10. The SEM images along the edge showed features resembling short corrosion cracks. Based on the grain contrast shown in the SEM / backscatter electron (BSE)-images, all features were related to grain boundaries. Evidence of mechanical damage was minimal, thus ruling out indents or mechanical contact with a sharp object as a cause for damage. The features are believed to be caused by corrosion and were most likely formed in-service during irradiation.

Figure 10. SEM-image collage (BSE-detector, zero-degree SEM stage tilt) showing corrosion damage distribution and depth. Image #1 (right) was taken close to the BFB shaft, and image #15 was recorded close to the BFB head.

The depths of most features from the surface varied between 2 and 3 μm , but a few exceeded $\sim 4 \mu\text{m}$. Morphology variations between these features and the histogram plot in Figure 11 suggest two types of damage: shallow pit-like objects or degraded grain boundaries 2–3 μm in depth, as well as deeper 4 μm + features appearing as short cracks. These deep crack-like formations were in the middle of a curved area, whereas the circled area's beginning and end had only shallow degraded grain boundaries.

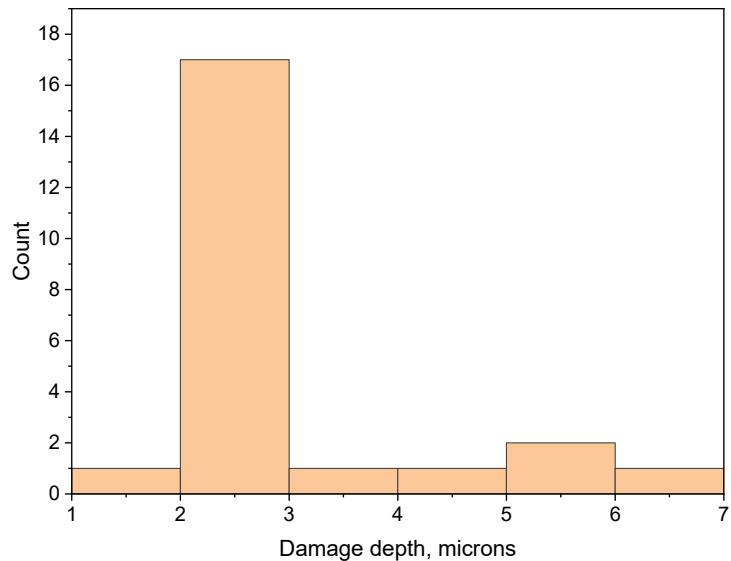
Figure 11. Number and depth of corrosion-related pits and cracks observed on the 4412-CS-1-1 specimen.

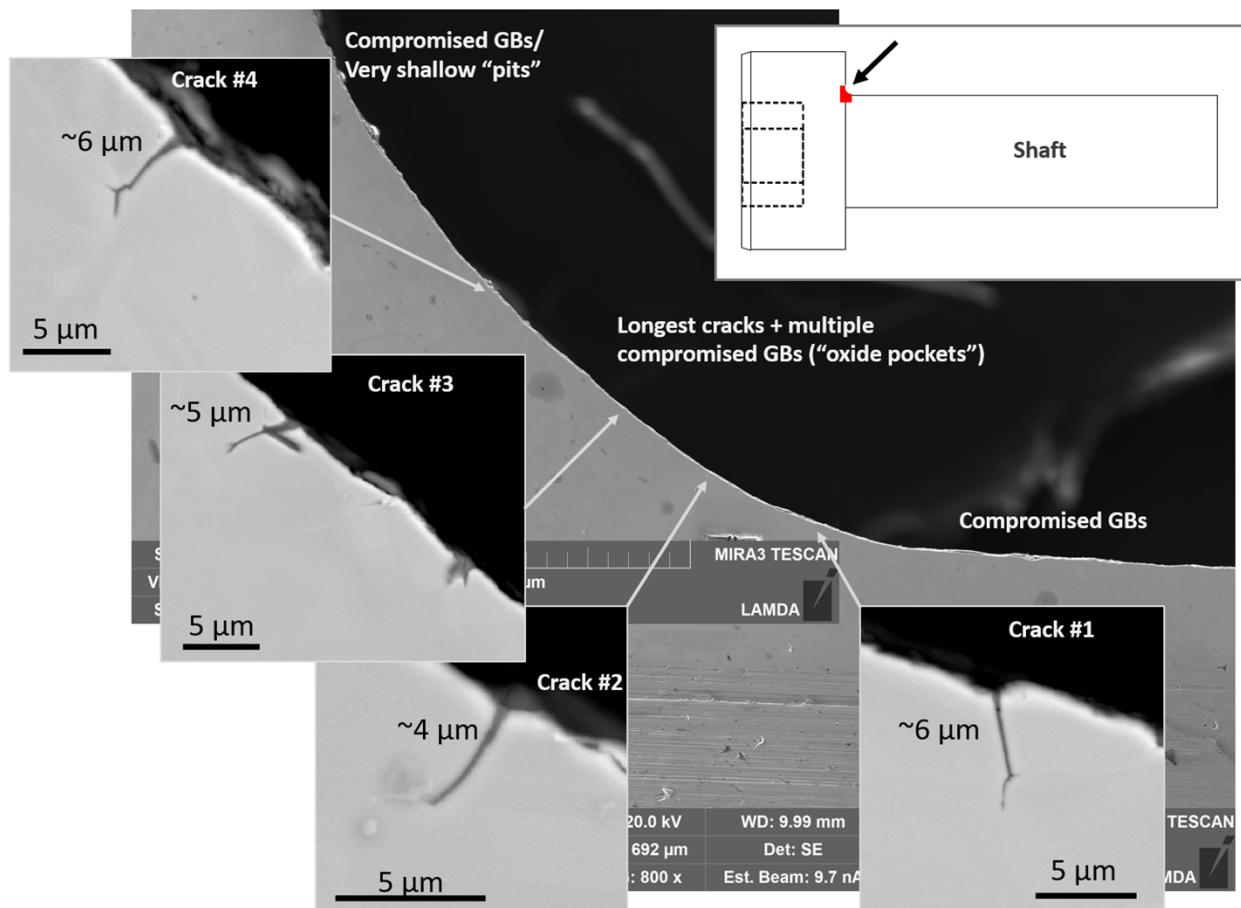
Figure 12. Identified cracks #1-#4 (objects with depths 4 μm +) located along the curved (circular) area of the BFB. Branching can be seen in cracks #1, #3, and #4. The collage combines low-magnification general view SE/SEM images with high-magnification BSE/SEM images taken for individual cracks. The inset at the top right shows the location and orientation of the area.

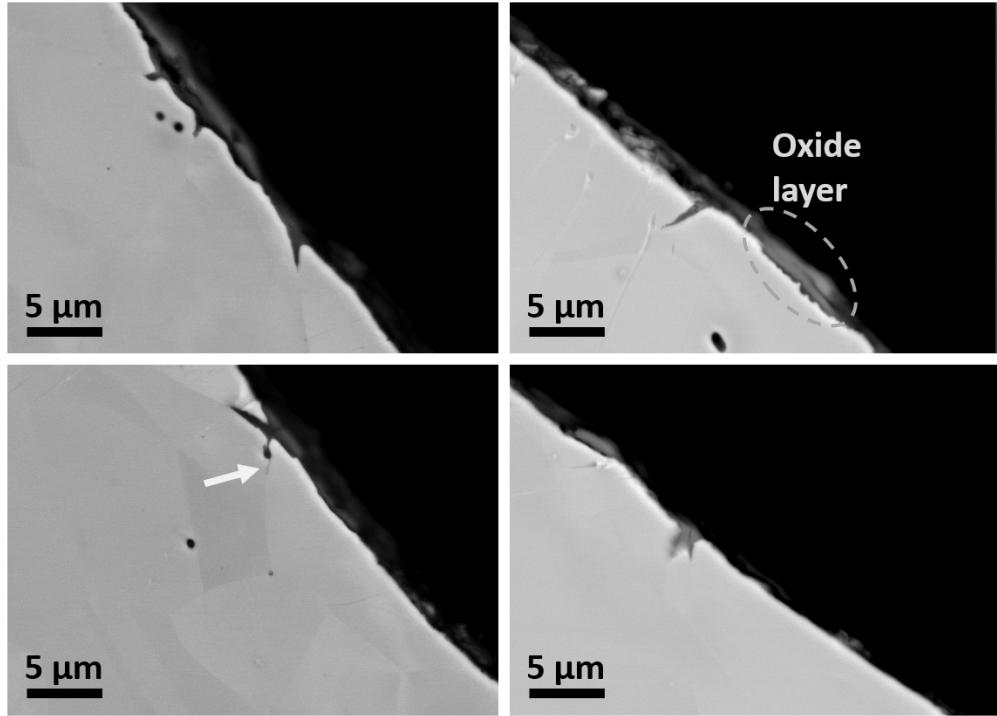
Figure 13. Enlarged view of degraded grain boundaries (SEM/BSE images). The damage penetrates at $\sim 2\text{--}3\ \mu\text{m}$ from the surface; features have triangle- or wedge-like shapes. Note the fine hair-like crack (indicated by black arrow) starting from the degraded boundary in the bottom left image.

A dashed oval shows a remnant of the oxide layer.

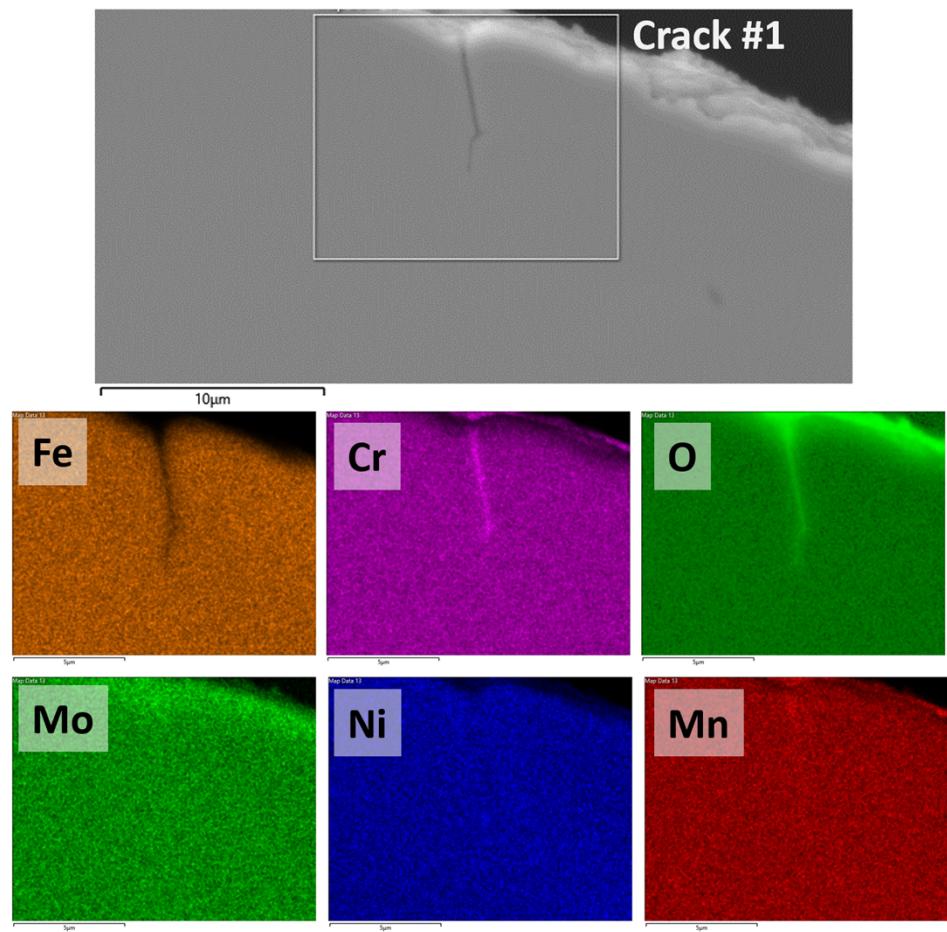
Figure 14 and Figure 15 show the results of SEM/EDS scans performed for the identified cracks. The figures show that the cracks are filled with Cr- and O-rich substances, most likely Cr-rich oxide. Mo enrichment exists in the near-surface layer and near the crack “mouth.” There is also some depletion in Ni and minor enrichment in Mn inside the cracks. Mn enrichment should be confirmed because EDS tends to overestimate Mn in austenitic steel irradiated in power reactors with thermal spectra.

Figure 14. SEM/EDS maps for Crack #1 shown in Figure 12. The crack is likely filled with Cr-rich oxide. Oxygen enrichment along the surface suggests the presence of an oxide layer.

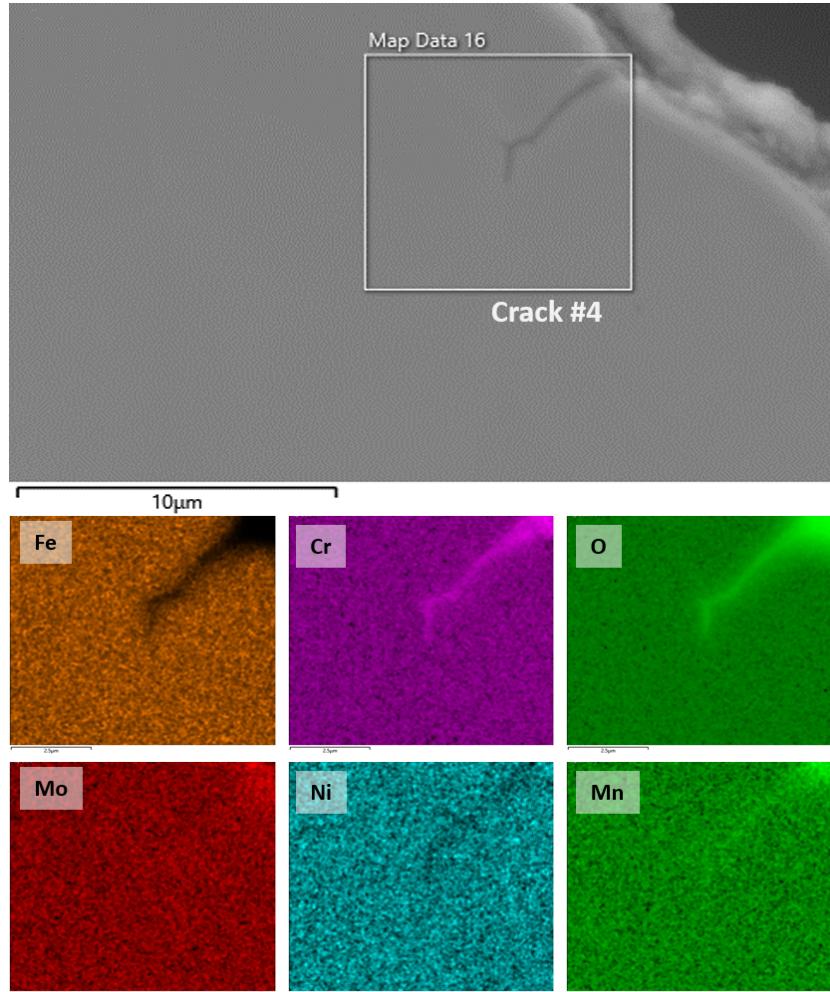
Figure 15. SEM/EDS maps for Crack #4 shown in Figure 12.
The SEM image suggests the presence of a surface oxide layer.

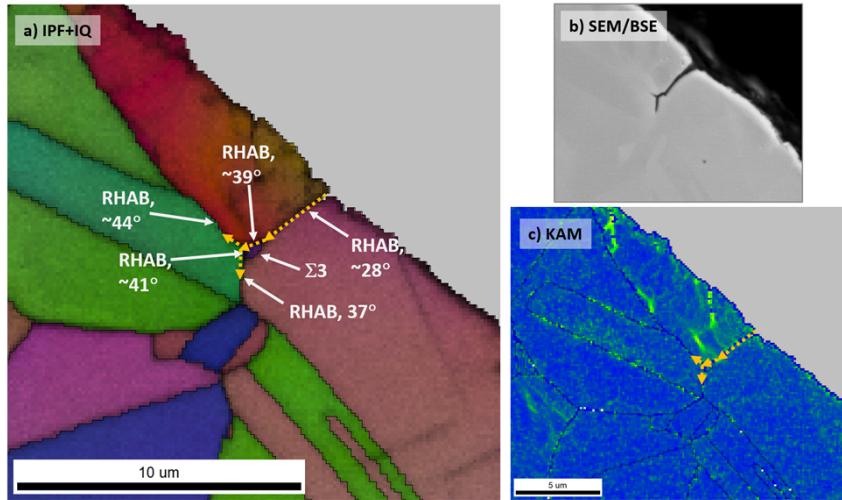
Figure 16 shows the grain's microstructure and the character of grain boundaries (misorientation in degrees and type random high-angle boundary [RHAB] or $\Sigma 3$) in the vicinity of Crack #4. The crack propagated in an intergranular fashion can be seen along grain boundaries. At triple junction points, the crack tended to branch, and new branches also formed along the GBs. Only RHABs were involved in cracking. Although there was a short $\Sigma 3$ -boundary, the crack moved along the RHAB after reaching the triple junction point, and $\Sigma 3$ was immune.

Figure 16. Grain microstructure in the vicinity of Crack #4 (Figure 12): (a) IPF+IQ, (b) SEM/BSE image, and (c) KAM map for the same location. The crack propagated in an intergranular fashion and along RHABs.

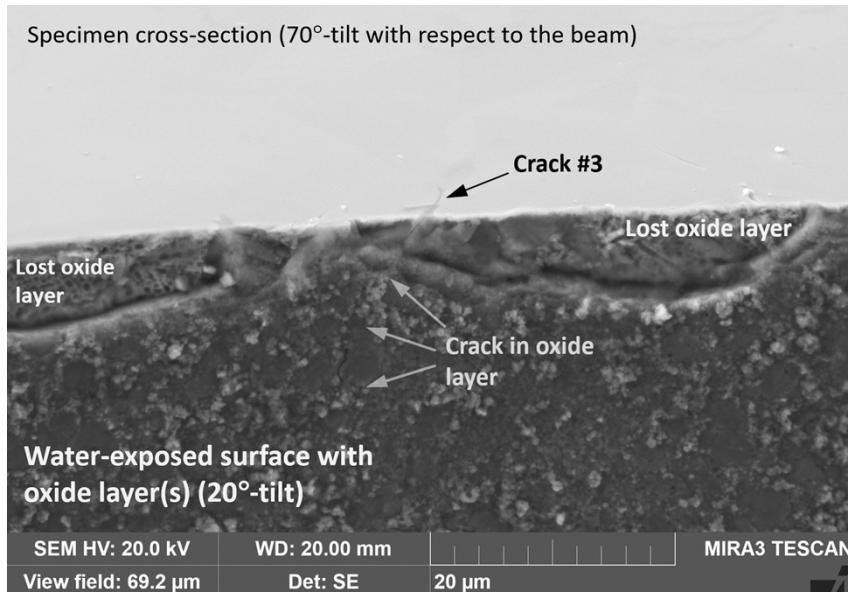
A survey of the BFB surface exposed to high-temperature high-pressure water (Figure 17) revealed a thin crack in the oxide layer. The crack in the oxide layer appears to be connected with Crack #4, as observed at the BFB cross-section.

Figure 17. Crack in the oxide layer in the vicinity of Crack #3. Note that the oxide layer was lost directly near the specimen edge (likely during specimen preparation). The water-exposed surface shows partially preserved oxide particles, (some of which were likely removed during component handling).

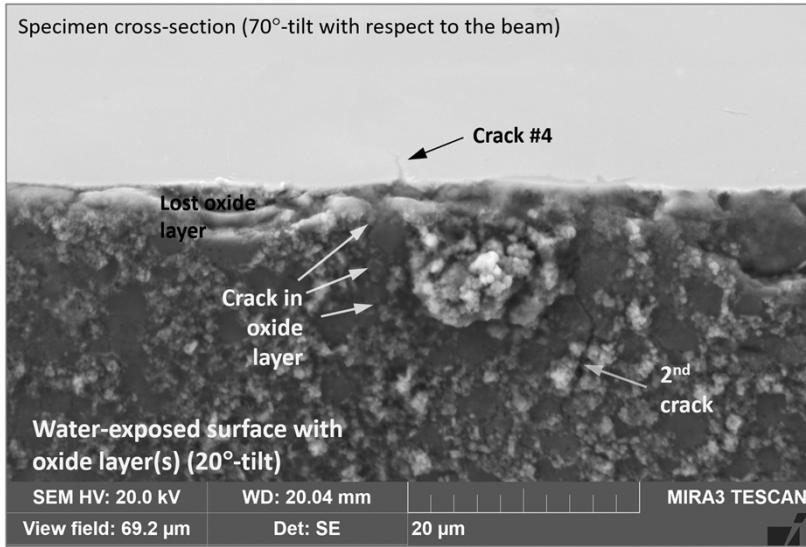
Figure 18 provides additional evidence regarding spatial correlation of corrosion cracking in the BFB, as well as cracking (likely of mechanical origin) in the oxide layer.

Figure 18. Oxide layer cracking in the vicinity of Crack #4. A second crack can also be observed, likely correlating with the degraded grain boundary.

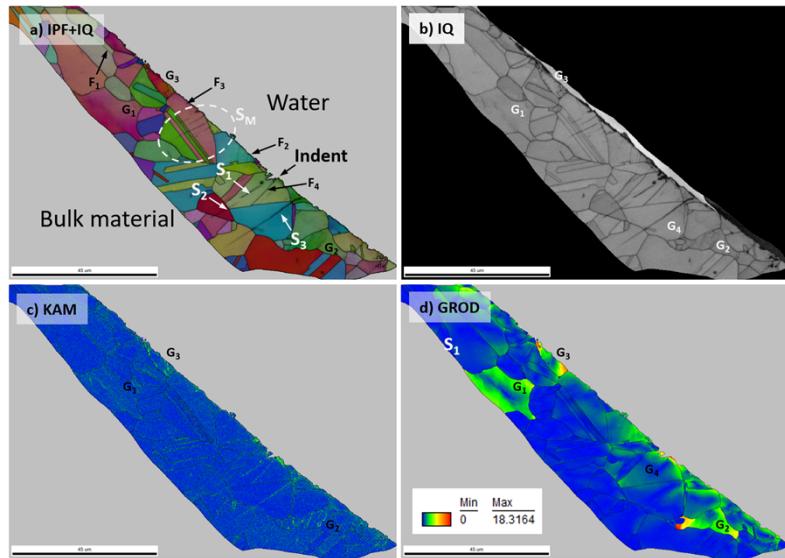
To assess this concept, a larger region around Crack #4 was scanned using EBSD, as shown in Figure 19. Based on an analysis of the EBSD maps, multiple signs of plastic deformation can be recognized, some relating to specimen preparation (i.e., scratches formed during preparation). The scratches may start and end inside the grain (see a group of scratches in area S_m and individual examples S_1 through S_3). Scratches intersect grain boundaries without changing directions. Also, the scratches do not follow (111)-plane traces (usual slip traces for fcc-materials) except in rare coincidental cases. Scratches often form in groups and appear as parallel lines.

If the scratches are excluded, then the remaining plastic deformation signs will be pre-service (pre-irradiation, including manufacturing) strain-induced, and in-service or post-irradiation features. Pre-service damage may be seen in grains G_1 , G_2 , and G_3 , which are likely the result of AGG, as described in Section 3.1. Furthermore, minor in-grain misorientation exists in the near-surface layer. The AGG-related features and plastic strains in the near-surface layer are of limited interest here and should be excluded.

Figure 19. EBSD dataset for the area surrounding Crack #4. Multiple signs of plastic deformation can be seen in many grains. S_M indicates the area with multiple short scratches; S_1 , S_2 , and S_3 indicate believed-to-be scratches; and F_1 through F_4 show strain-induced features.

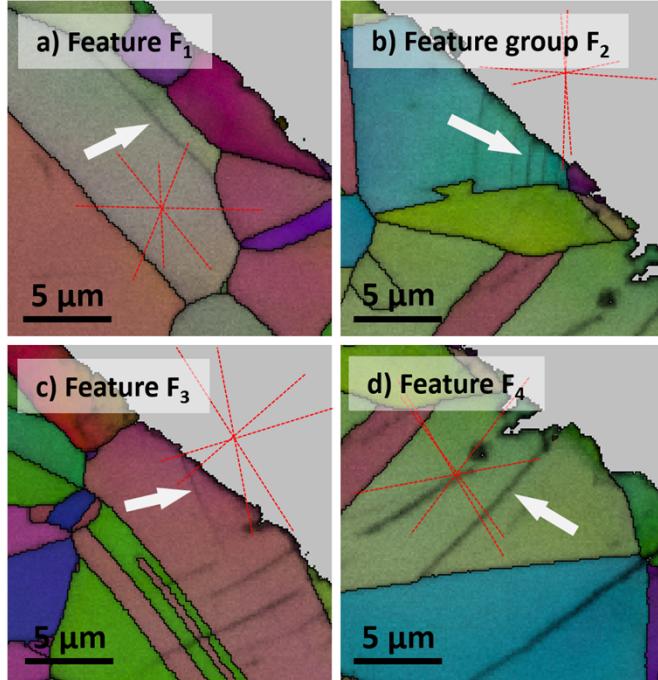
Because the remaining features are of very high importance in this effort, F_1 —a dark line starting and ending at grain boundaries—exists within one grain and follows the (111)-plane trace (see Figure 20) with reasonable accuracy. Following the (111)-plane trace is a very strong sign of a strain-induced feature, a slip line or a defect-free channel; however, the accuracy (angular difference between predicted and projected plane traces) of this sign is limited by the EBSD system absolute error, which is usually less

It is possible to conclude that objects F_1 through F_4 are defect-free channels formed at some point after the material reached $\sim 2\text{--}5$ dpa. The appearance of defect-free channels strongly suggests that the material reached levels of stress that were close to yield stress (YS). The exact stress level and loading conditions are unknown; channels may form at stress levels as low as ~ 0.8 YS in a routine tensile test and at ~ 0.5 YS during slow strain rate testing. Because channels exist only in some grains and the majority of grain population is channel free (i.e., no bulk deformation is observed, by analogy with [10]), slow loading may be expected at stresses comparable but still below the bulk YS.

Figure 20. Detailed view of the features F₁ through F₄ from Figure 19. Red dashed lines show projections of (111)-slip planes (possible slip traces). Good agreement in orientation can be observed between a slip plane projection and features F₁ and F₂, reasonable agreement for F₃, and a deviation of about 5° for F₄.
