*General-Purpose Heat Source:  
Research and Development Program*

*High-Silicon Fuel Characterization Study;  
Half Module Impact Tests 1 and 2*

*M. A. H. Reimus  
T. G. George*

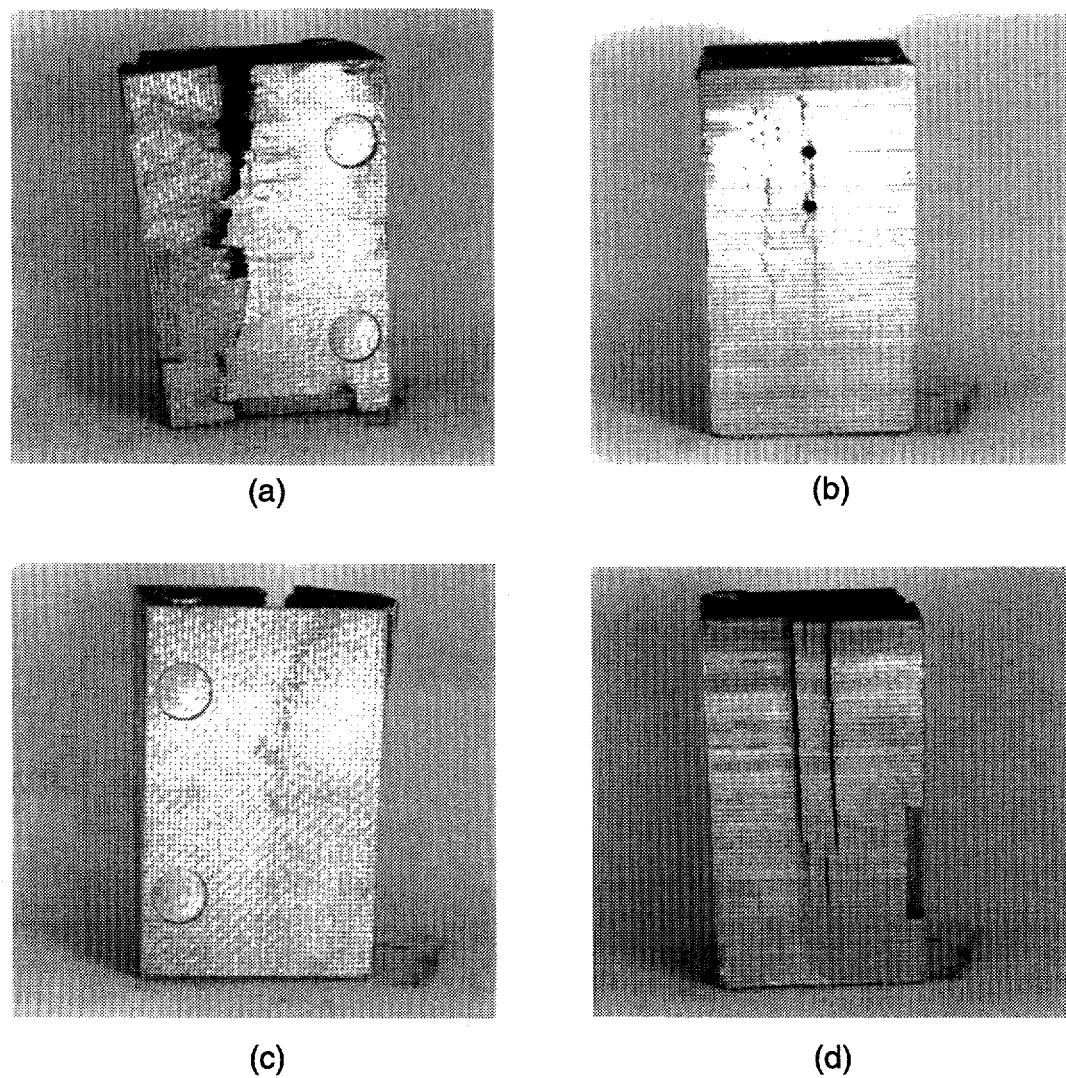
The half module was impacted on a steel target at 54.8 m/s and 970°C. The impact orientation was side on, with the edge having the flight bevels leading. Upon opening the inner catch tube (ICT), no detectable amounts of contamination were found on the ICT lid, ICT interior, or outer surface of the module. There was no detectable deformation of the steel target. The module was relatively intact (Fig. 2), with a large crack on the impact face. The opposite face of the module was not cracked, but the cover for the GIS cavity had been dislodged.

Fig. 2. HSC-1 Half module; (a) impact face, (b) 90 deg face, (c) 180 deg face, and (d) 270 deg face.  
(NMT-9 Negs. 955-75, 955-78, 955-76, 955-77)

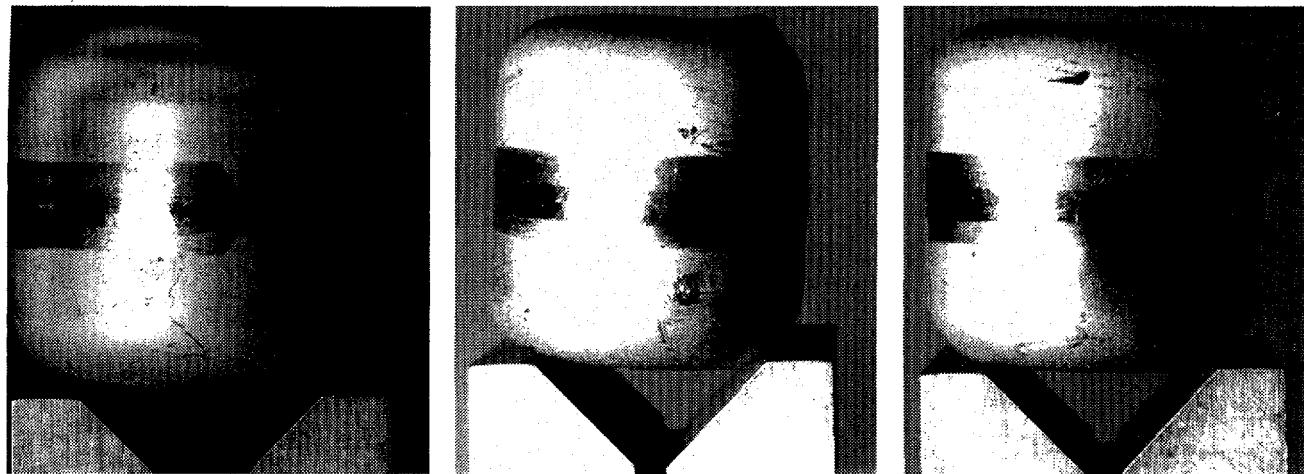
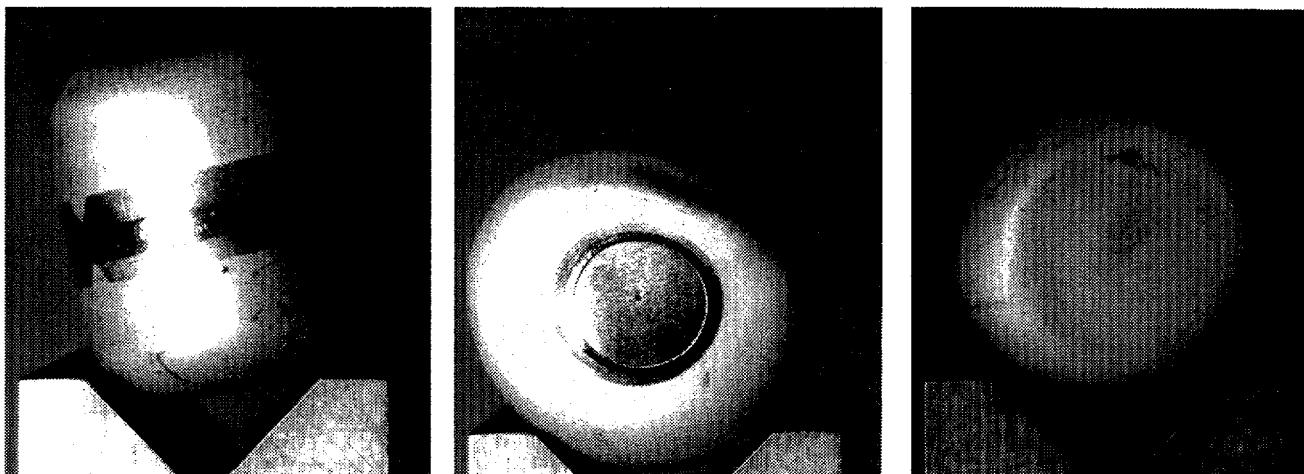
Fig. 3. Capsule FC0007 was moderately deformed by the impact; (a) 0 deg weld location, (b) 90 deg weld location, (c) 180 deg weld location, (d) 270 deg weld location, (e) vent end, and (f) blind end. (NMT-9 Negs. 955-36, 955-37, 955-38, 955-39, 955-34, 955-35)

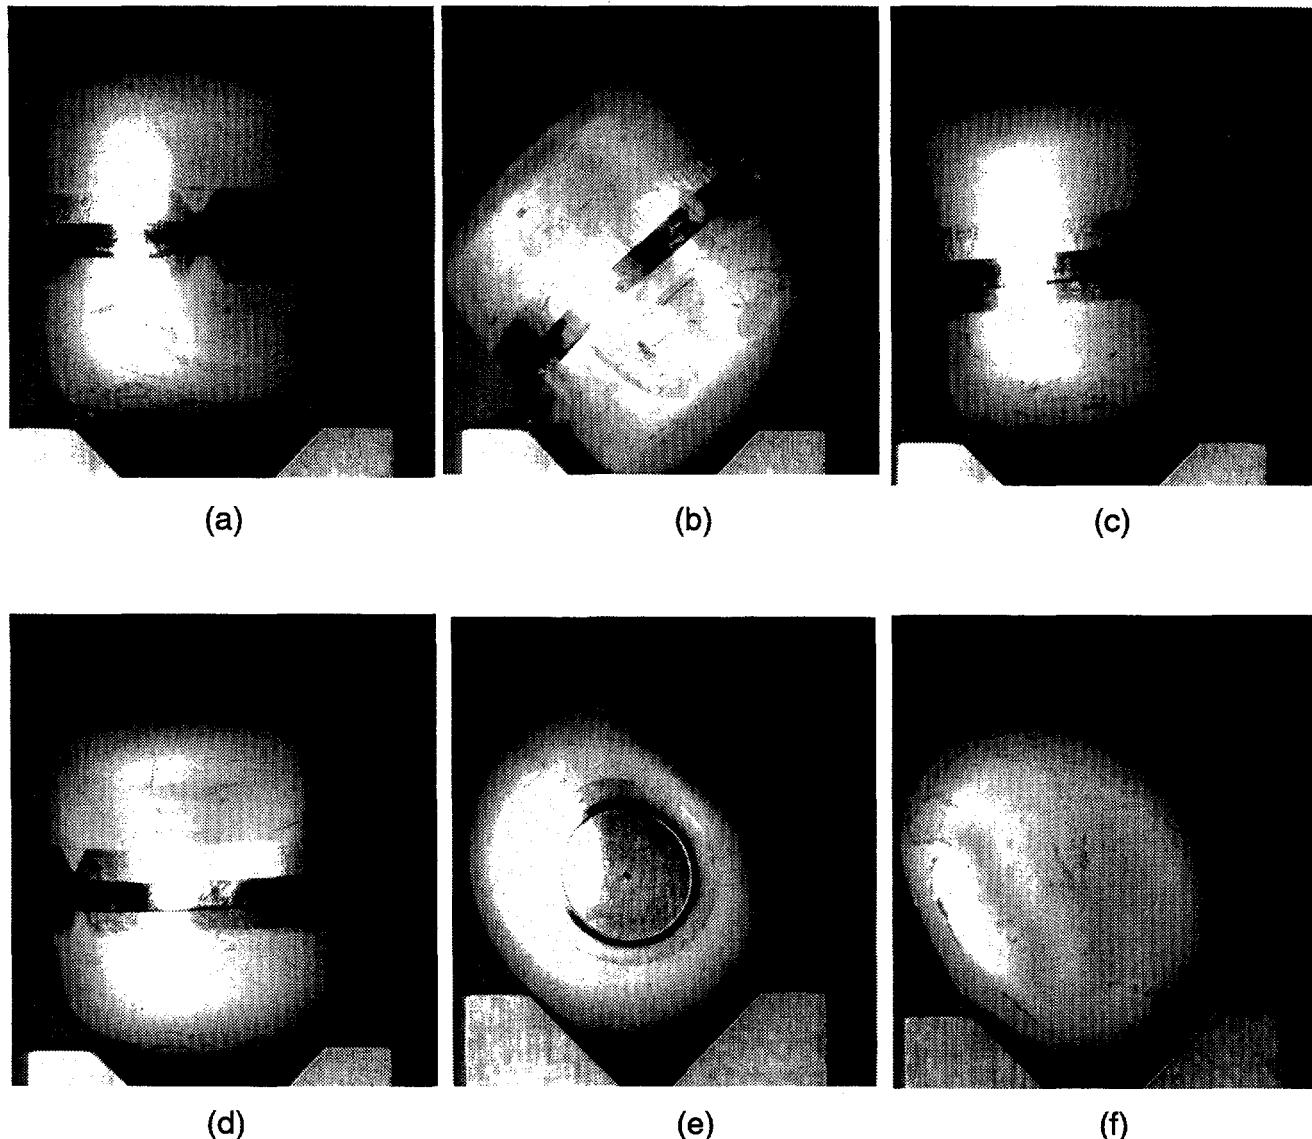
Fig. 4. Capsule FC0010 also experienced significant deformation; (a) 0 deg weld location, (b) 90 deg weld location, (c) 180 deg weld location, (d) 270 deg weld location, (e) vent end, and (f) blind end. (NMT-9 Negs. 955-42, 955-43, 955-44, 955-45, 955-40, 955-41 )

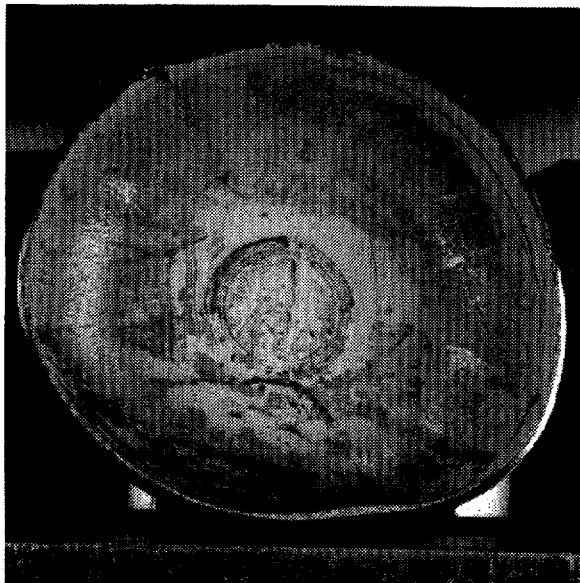
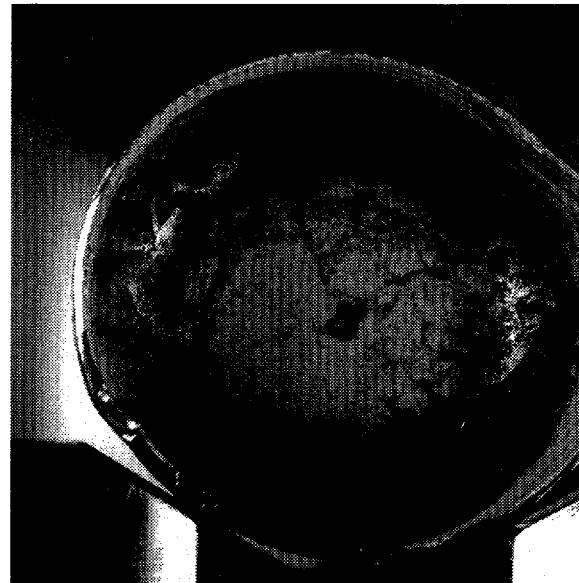
When the fueled clads were opened, a thin coating of white powder was observed on both capsule interiors (Figs. 5 and 6). The deposits tended to be most pronounced at the vent ends of the capsules but were observed to a lesser degree on all interior surfaces. A white deposit, identical in appearance to the deposit on the capsule interiors, was also observed on the exterior of the fuel pellet recovered from FC0007 (Fig. 7). The deposits on the capsule interiors did not tightly adhere and were easily scraped from the surface. Samples of the deposits were taken and submitted for chemical analysis by electron microprobe analysis.

Because the fuel had a high silicon impurity level relative to the silicon specification of 200 ppm, the deposits on the capsule interiors were suspected being  $\text{SiO}_2$ . This premise was based on the volatility of  $\text{SiO}_2$  at the temperatures experienced by these fueled clads and on the appearance of the deposits. The results of the electron microprobe analyses indicated that the deposits were in fact  $\text{SiO}_2$  with small amounts of Ti, Fe, and Pu.

Fig. 5. A thin coating of white powder was observed on the interior of capsule FC0007; (a) vent cup, and (b) shield cup. (NMT-9 Negs. 955-46, 955-47)

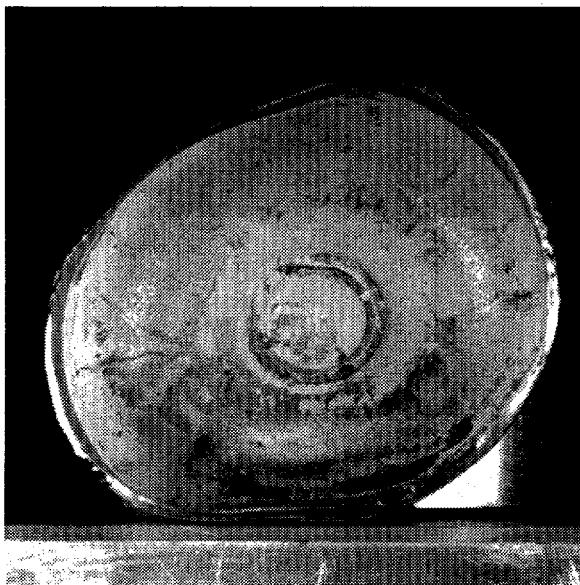
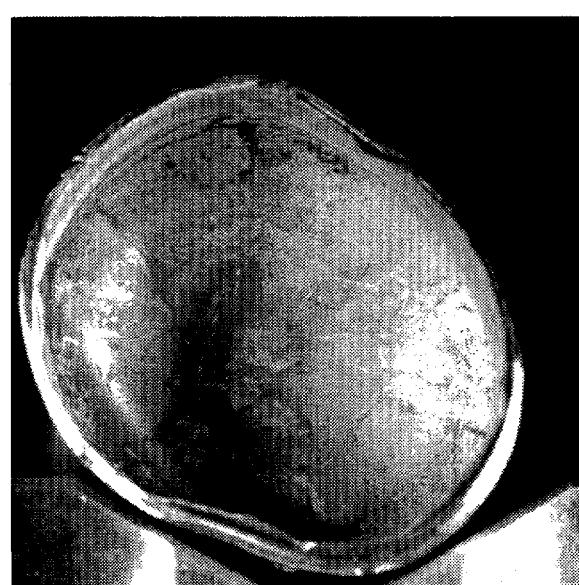
Fig. 6. The interior of capsule FC0010 also had a white coating on the interior of both cups; (a) vent cup, and (b) shield cup. (NMT-9 Negs. 955-68, 955-67)

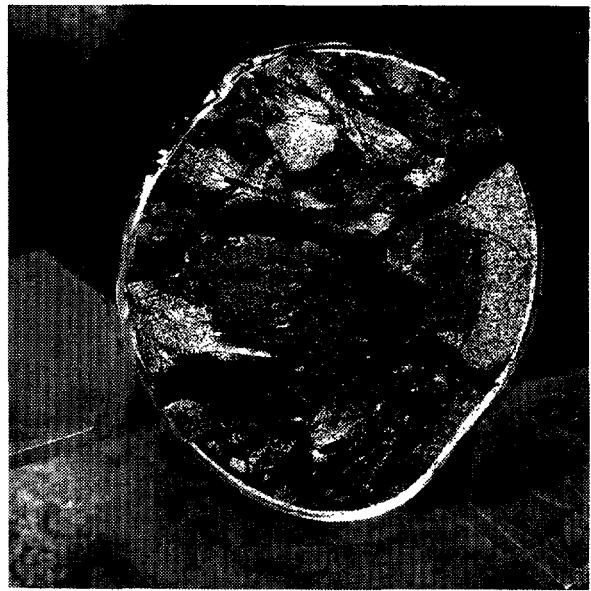
Examination of the as-opened FC0007 fuel capsule revealed the pattern of fuel breakup (Fig. 8). The fuel tended to fragment outward in a radial pattern from the point of initial impact.

Fig. 8. Breakup of the GQ-02 fuel pellet was typical of previous GPHS impacts.  
(NMT-9 Neg. 955-48)

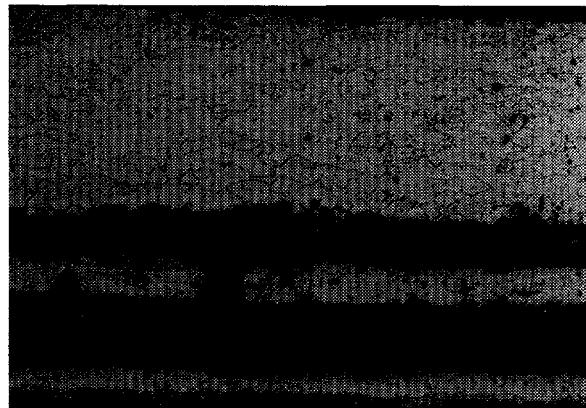
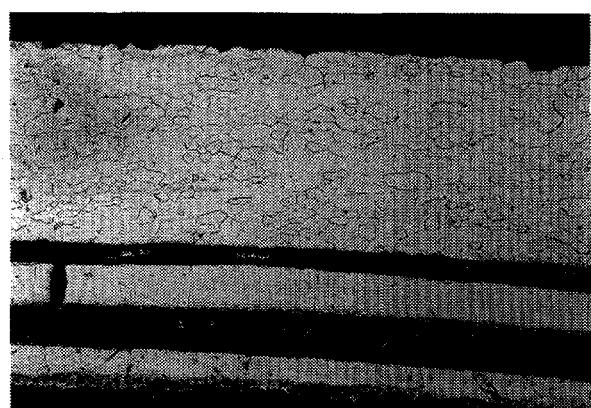
Five sections were cut from the iridium shell of capsule FC0007 and four sections were cut from FC0010. All nine sections were mounted in epoxy and prepared for metallography. Examination of cross sections from both capsule vents did not reveal any deposits or anomalous microstructures in the vent frits or orifices (Fig. 9). However, there was a thin layer of discoloration on the interior surface (fuel side) of the vent assemblies. The discolored layers on the interior of the FC0007 and FC0010 vents were approximately 30 and 20  $\mu\text{m}$  thick, respectively.

Fig. 9. The HSC-1 capsule vents were free of deposits or anomalous microstructures; (a) capsule FC0007 vent, (b) FC0010 vent, both as-etched and at 50X magnification.  
(NMT-9 Negs. 959-16, 957-94)

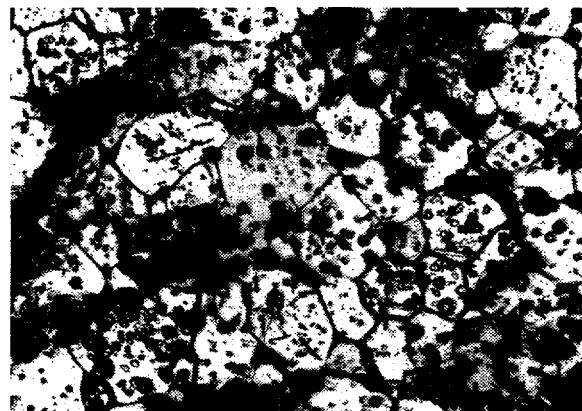
Microscopic examination of a sample removed from fuel pellet GQ-02 (originally loaded in capsule FC0007) revealed a typical plutonia microstructure (Fig. 10) with no obvious evidence of additional phases, intergranular deposits, or other anomalies. A fuel sample removed from pellet GQ-04 (originally loaded in capsule FC0010) was also submitted for examination. However, this fuel sample was unaffected by the standard etchant (93% HBr, 5% HCl, 2% HF) during the normal 8 h etch cycle, and in fact, remained unetched even after a 24 h treatment. The as-polished appearance of the sample was normal (Fig. 11).

Fig. 10. The GQ-02 pellet microstructure appeared normal. (a) As-polished, 100X magnification; (b) etched, 100X magnification; and (c) etched, 250X magnification. (NMT-9 Negs. 959-42, 9513-90, 9513-88)

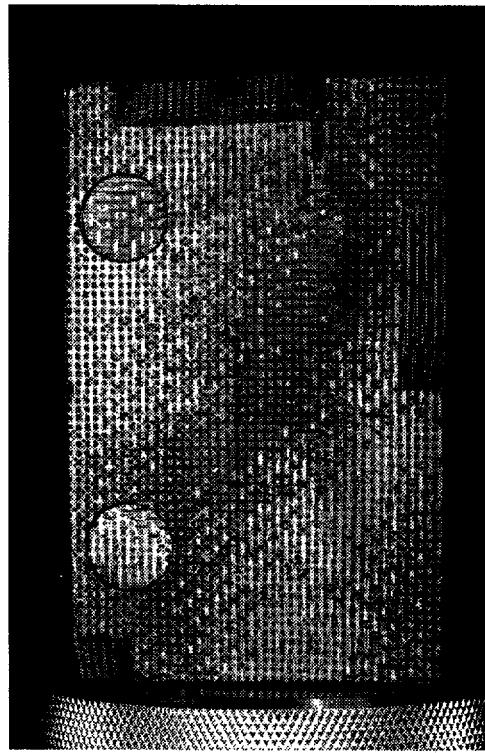
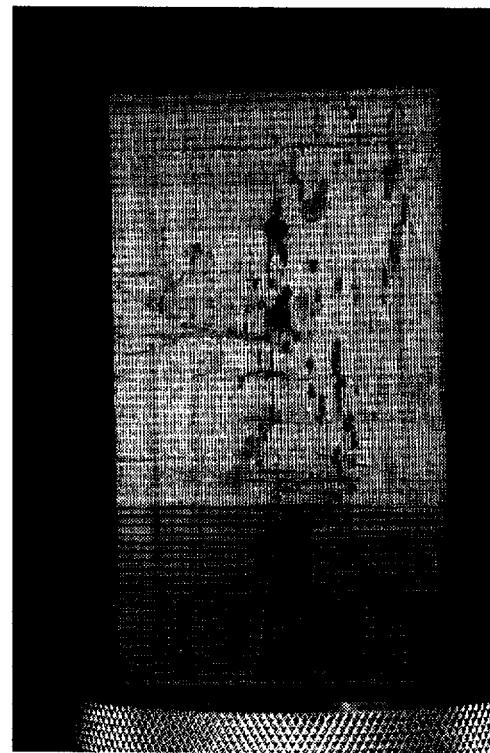
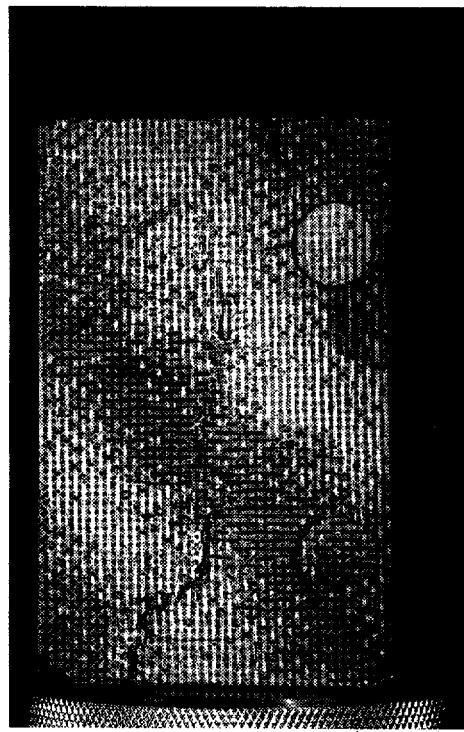
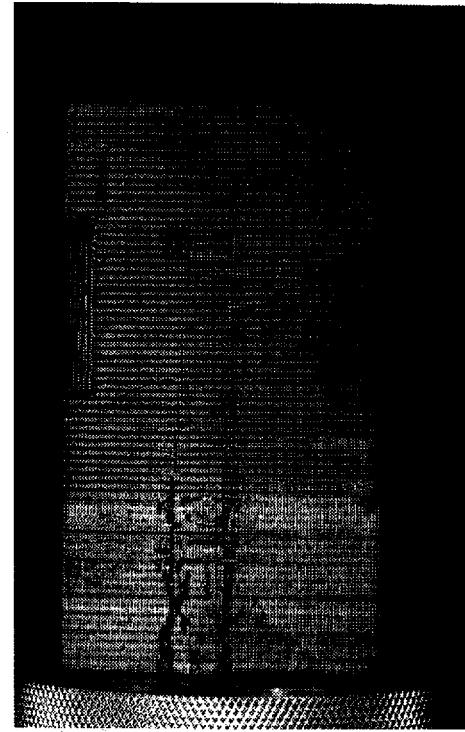
Macroscopic examination revealed that the module was relatively intact (Fig. 12), with longitudinal cracks on the impact and opposite faces. The cap of the GIS cavity was dislodged during impact, but the GIS remained inside the module. The GIS was intact (Fig. 13), with several longitudinal cracks on the impact face.

Fig. 12. HSC-2 half module; (a) impact face, (b) 90 deg face, (c) 180 deg face, and (d) 270 deg face. (NMT-9 Negs. 955-51, 955-52, 955-53, 955-54).

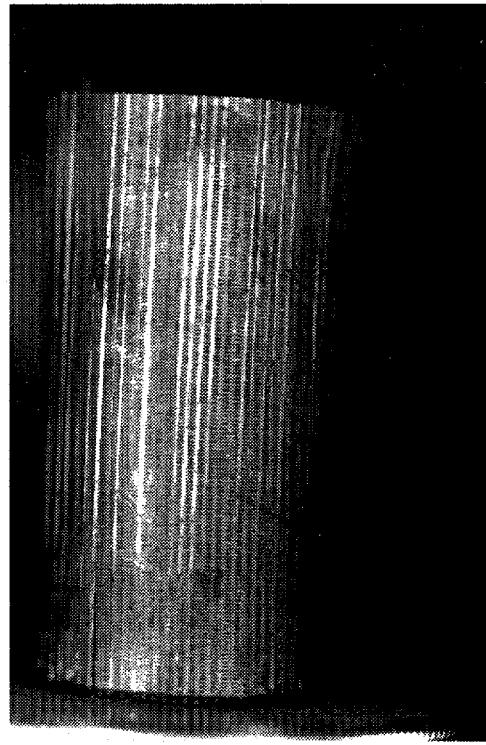
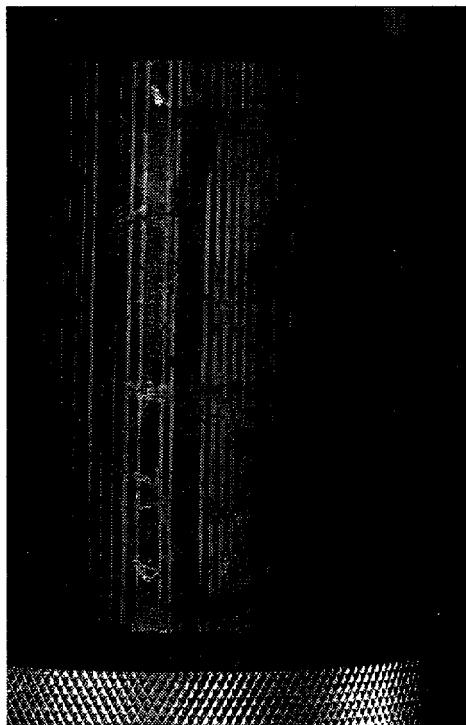
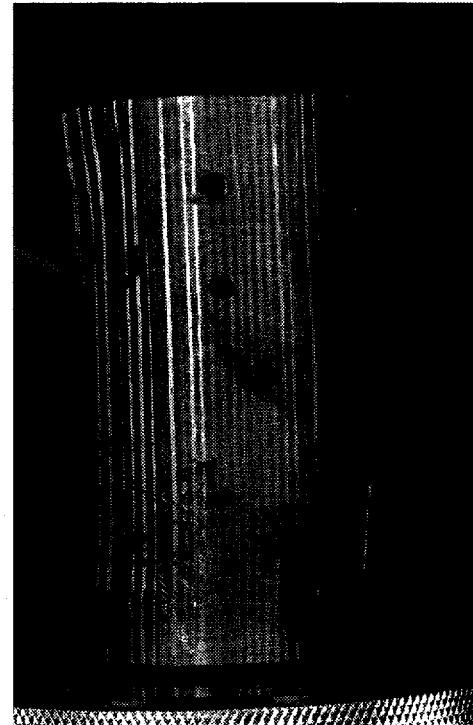
Fig. 13. The HSC-2 GIS was relatively intact; (a) impact face, (b) 90 deg face, (c) 180 deg face, and (d) 270 deg face. (NMT-9 Negs. 955-57, 955-61, 955-59, 955-58)

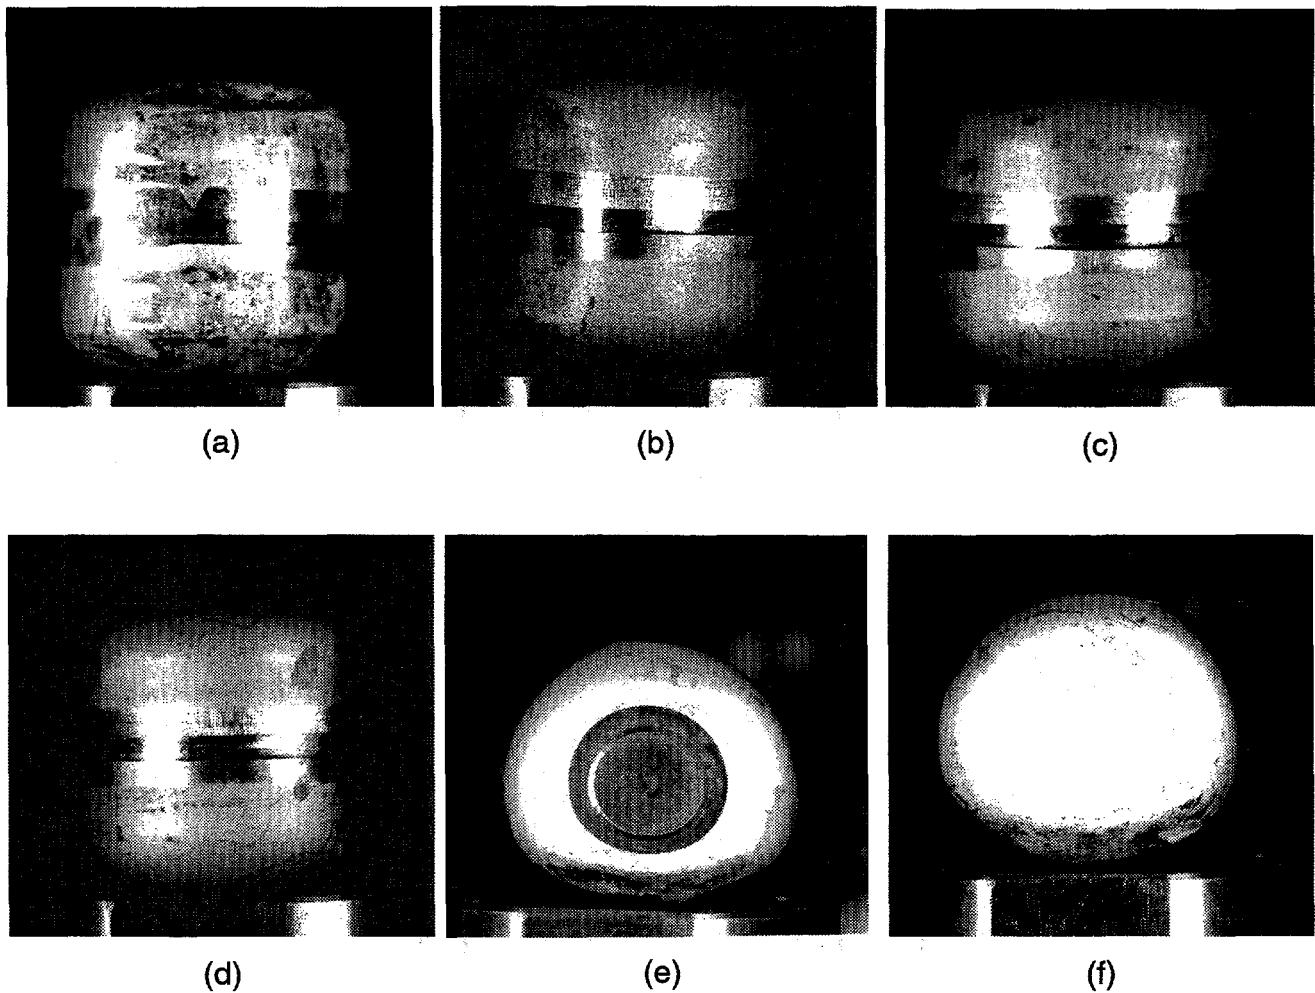
**1. FC0033.** GPHS capsule FC0033, which was loaded in the open end of the GIS was moderately deformed. Its impact face was centered at approximately 0 deg. No cracks or clad breaches were observed (Fig. 14). The vent area of the clad was clean, with no evidence of deposits or other foreign material. There was slight discoloration centered around the vent hole on the exterior of the capsule.

Fig. 14. Capsule FC0033 was unbreached; (a) 0 deg weld location, (b) 90 deg weld location, (c) 180 deg weld location, (d) 270 deg weld location, (e) vent end, and (f) blind end. (NMT-9 Negs. 955-74, 955-72, 955-73, 955-74, 955-69, 955-70)

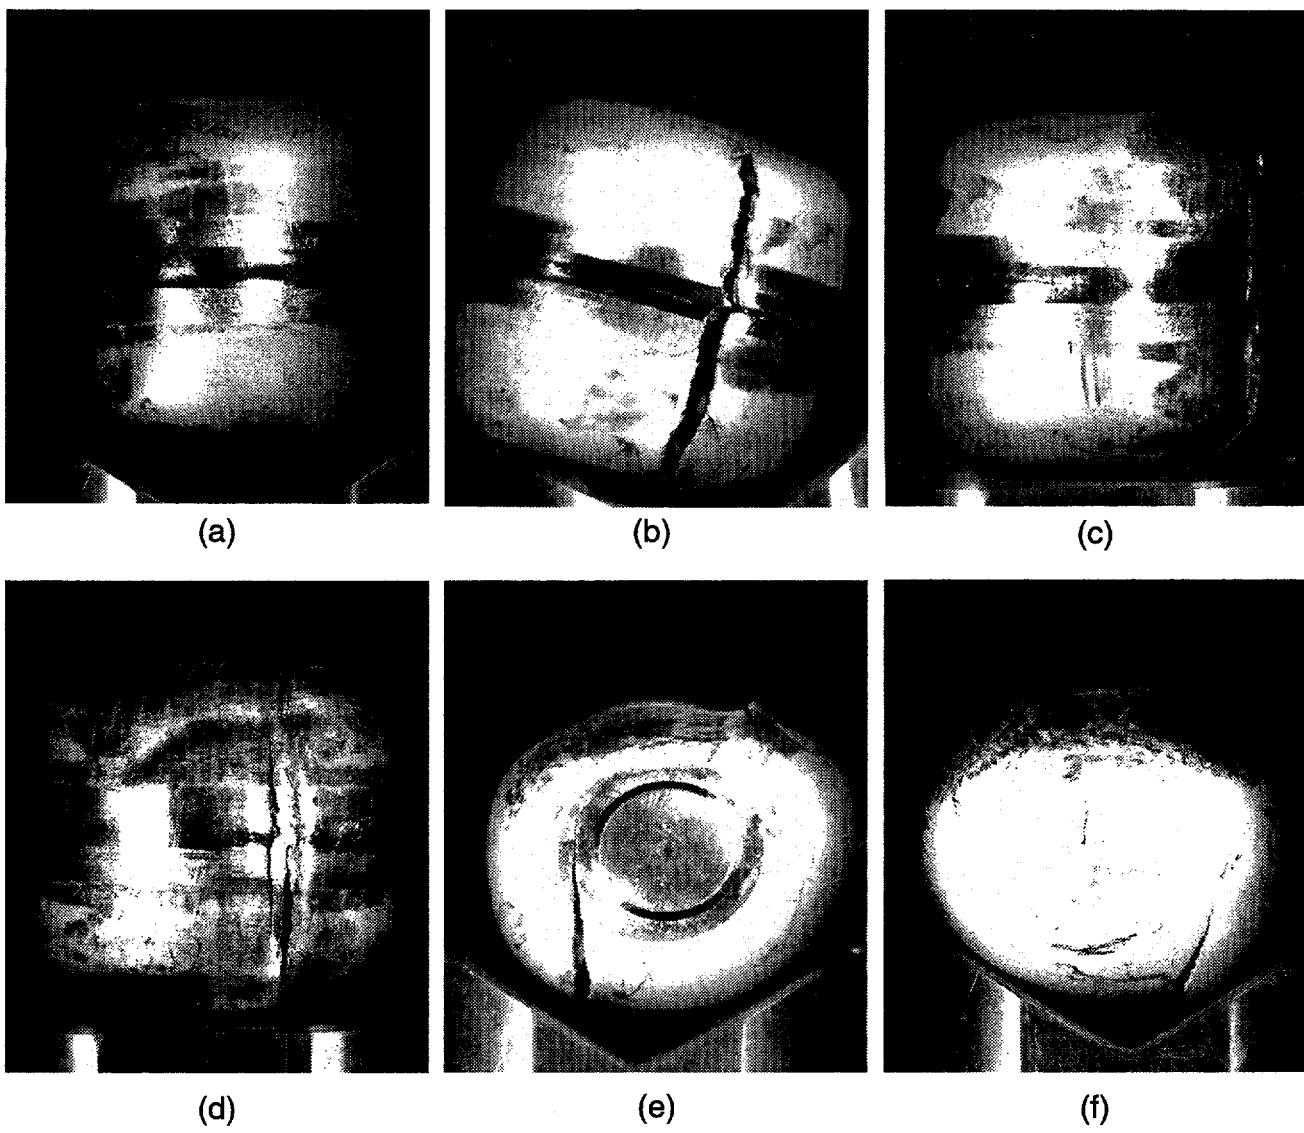
The impact face of capsule FC0035 was centered at approximately 90 deg from the weld start (Fig. 16). Three axial breaching cracks were observed on the impact face. One crack transected the weld but appeared to have been initiated outside the weld in the shield cup. This crack had an approximate length of 15.1 mm and a maximum width of 0.56 mm. Another crack was located on the vent cup; this crack had a length of 12.6 mm and a maximum width of 1.37 mm. A hairline crack that was located on the shield cup had a length of 39.1 mm. All of these cracks on the impact face were on, or in close proximity to, a ridge that had apparently been caused by the differential displacement of fuel pellet fragments. Examination of the GIS impact face at a location corresponding to the position of FC0035 revealed an indentation on the interior of the GIS. This indentation suggested that the damage to the clad in the ridge area was not caused externally.

Examination of the trailing face of capsule FC0035 also revealed a large breaching crack that extended from the top of the vent cup to the shield cup radius (approx. 30 mm) and had a maximum width of 1.88 mm. The crack was located directly opposite the axial ridge noted on the impact face of the capsule. A weld centerline crack intersected and was apparently initiated by the displacement associated with the large axial crack. The weld centerline crack had an approximate length of 18.8 mm, and a maximum width of 0.7 mm.

Extension of this hypothesis to the behavior of capsules tested in the HSC tests would provide an explanation for the apparent anomalies in capsule deformation and failure. FC0035 breached as a result of massive fuel fragment displacement and was the sole capsule tested in these two impacts that had been loaded with a nonintegral fuel pellet (pellet GF-22 was in four pieces at the time of capsule loading). In addition, as opposed to the capsules and fuel pellets evaluated in the DIT and SVT test series, none of the HSC capsules were subjected to additional stresses such as flight-acceptance vibration, cross-country shipment, and long-term storage that would be expected to accelerate fuel pellet degradation. Further, the capsules used in HSC-2 were aged at temperature for nearly thirteen times as long as were the capsules tested in HSC-1; both capsules used in the second test had deformations similar to those observed in the SVT and DIT test series.

Fig. 16. Capsule FC0035 was breached by the massive differential displacement of large fuel fragments; (a) 0 deg weld location, (b) 90 deg weld location, (c) 180 deg weld location, (d) 270 deg weld location, (e) vent end, and (f) blind end. (NMT-9 Negs. 955-63, -64, -65, -66, -61, -62)

If the extent of pretest pellet breakup is indeed an indicator of impact response, it would seem prudent to radiograph each GPHS capsule selected for evaluation immediately before testing. This was the standard practice for capsules tested in the DIT and SVT series.

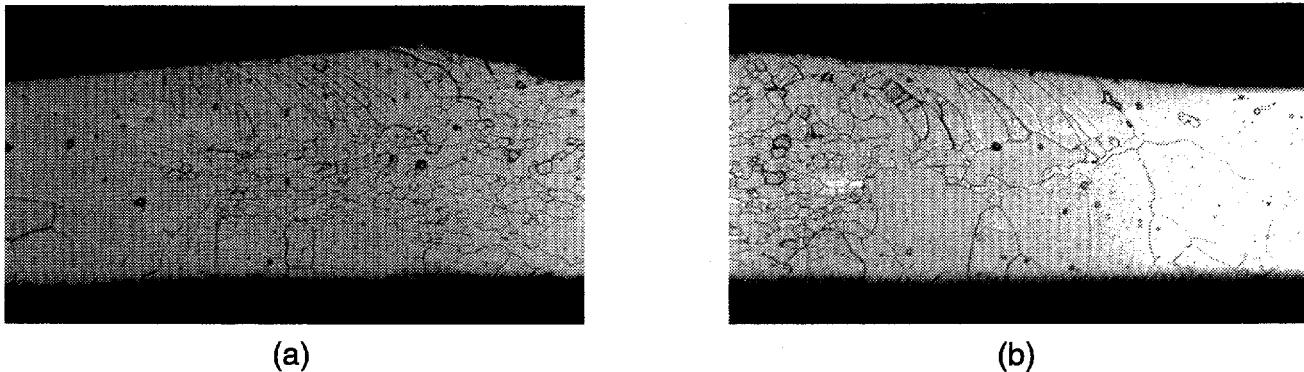
Numerous sections for metallographic examination were removed from capsule FC0035. Pronounced grain coarsening was observed in a vent cup section, below and adjacent to the vent cover welds (Fig. 17). Although the wall adjacent to one of the welds contained only two grains/thickness, the coarsening effect was localized and did not appear to have affected other regions of the iridium clad. The remainder of the vent cup, as well as the shield cup, had typical microstructures. Unfortunately, during metallographic preparation of the cross section that contained the FC0035 vent, the central vent structures were destroyed and it was not possible to microscopically examine the vent frit or orifices.

Fig. 17. Pronounced grain coarsening was observed in an FC0035 vent cup section, below and adjacent to the vent cover welds; (a) and (b), both etched and at 50X magnification. (NMT-9 Negs. 959-49, 959-50)
