HW - 29132

SEVERE PITTING ATTACK OF PILE PROCESS TUBES AND SLUGS

M. LEWIS AND R. A. ROHRBACHER

JUNE 30, 1953

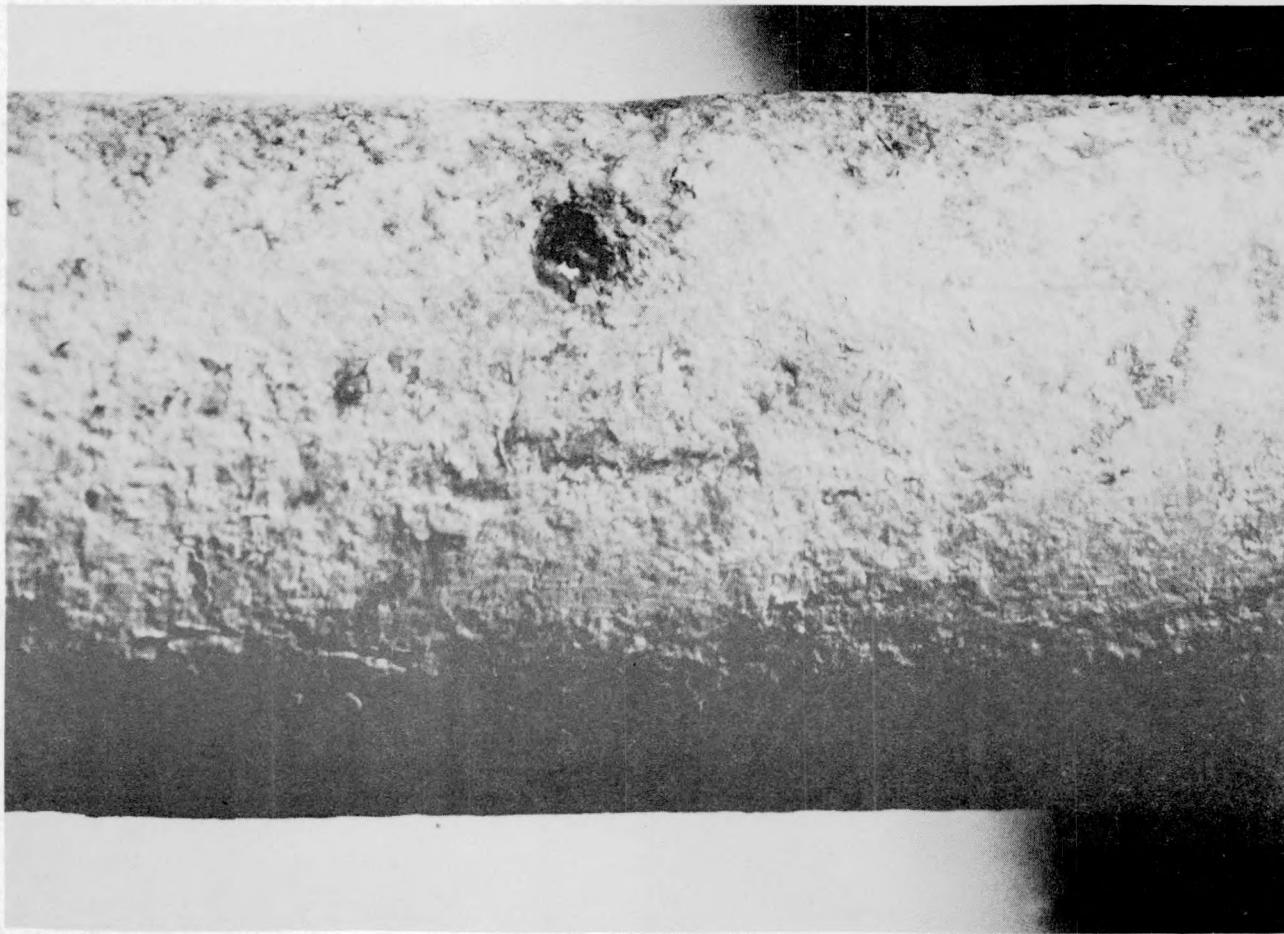
FIGURE 1

Figure 1. Since this tube suffered an entirely different type of attack, it is included here only for comparison purposes. This tube, 0486-F, was found to be a leaker on February 11, 1952, and was made an air tube until its removal from the pile on July 9, 1952.

OUTSIDE VIEW OF TUBE 0486-F, REMOVED FROM THE PILE ABOUT JULY 9, 1952

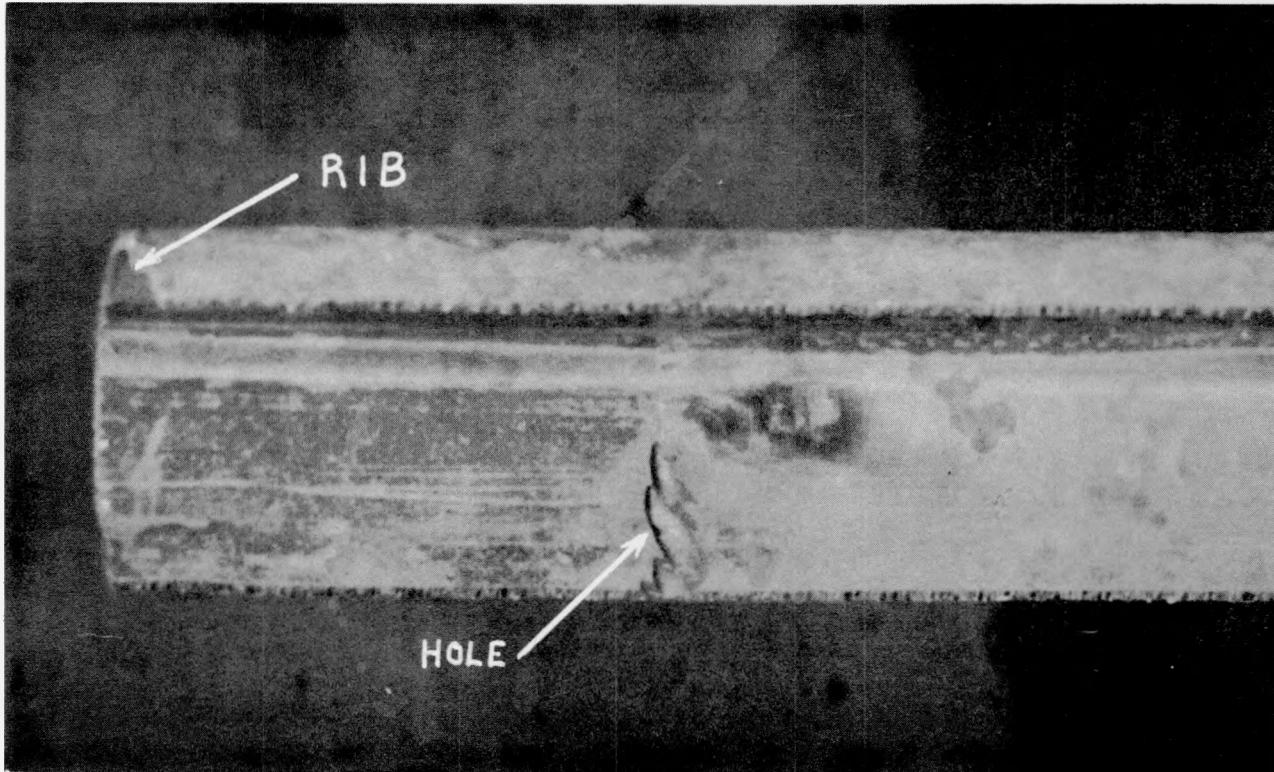
FIGURE 2

INSIDE VIEW OF TUBE 3883-F, REMOVED FROM THE PILE ABOUT JULY 21, 1952

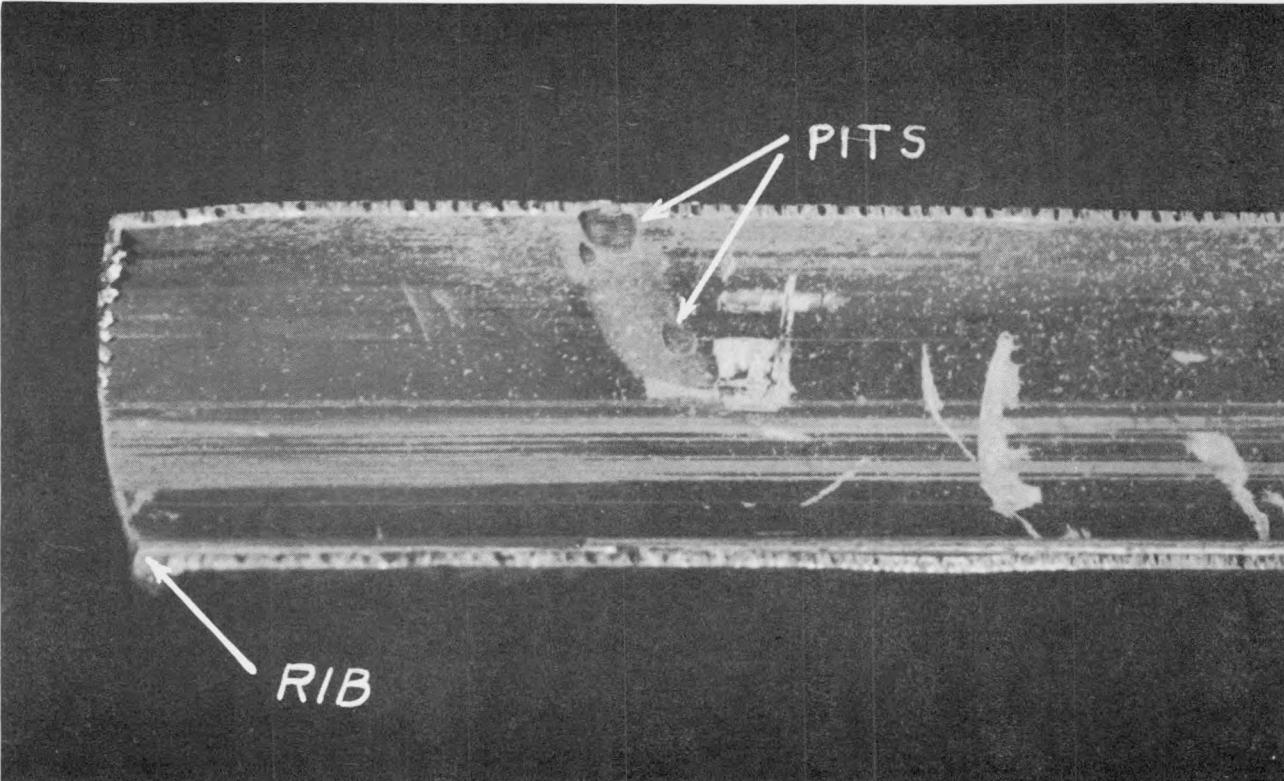
FIGURE 3
INSIDE VIEW OF TUBE 3883-F, REMOVED FROM THE PILE ABOUT JULY 21, 1952

Pitting attack shown here is opposite the hole shown in Figure 2.
The light colored areas are scratches made during or after tube removal.

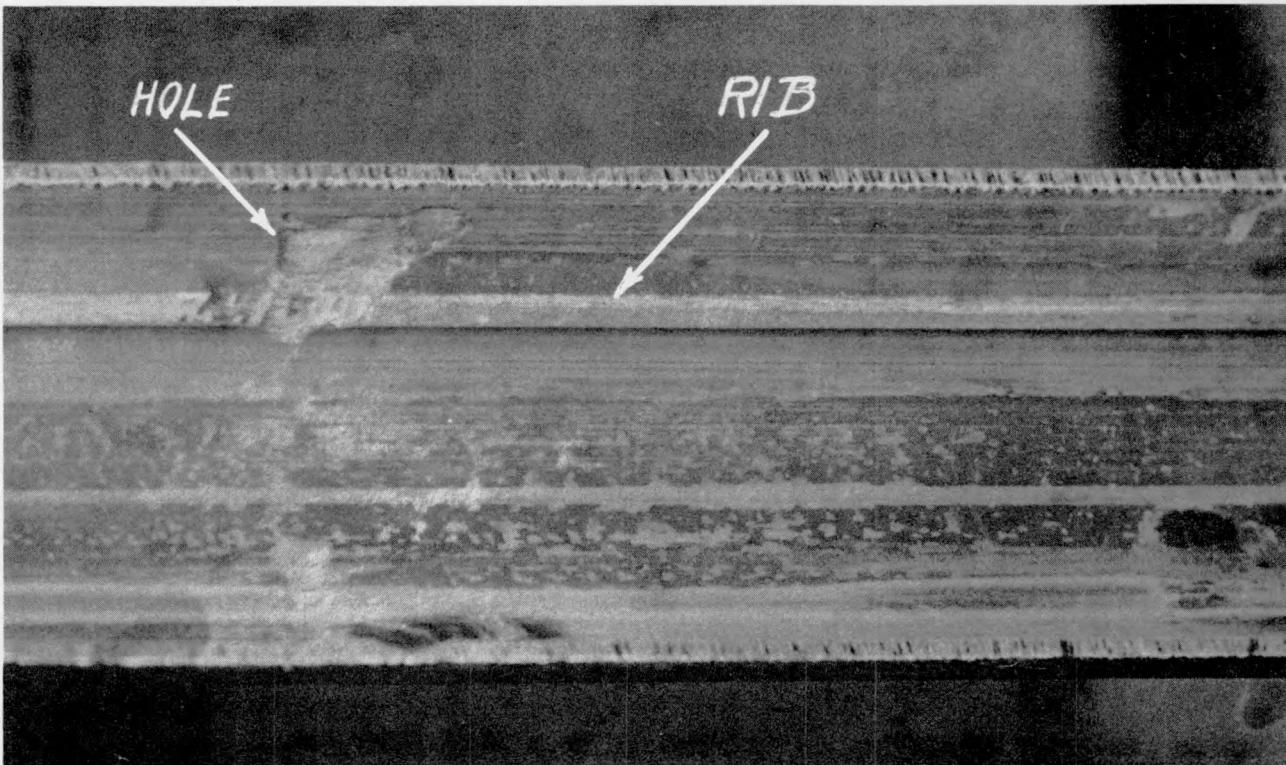
FIGURE 4

INSIDE VIEW OF TUBE 3883-F, REMOVED FROM THE PILE ABOUT JULY 21, 1952

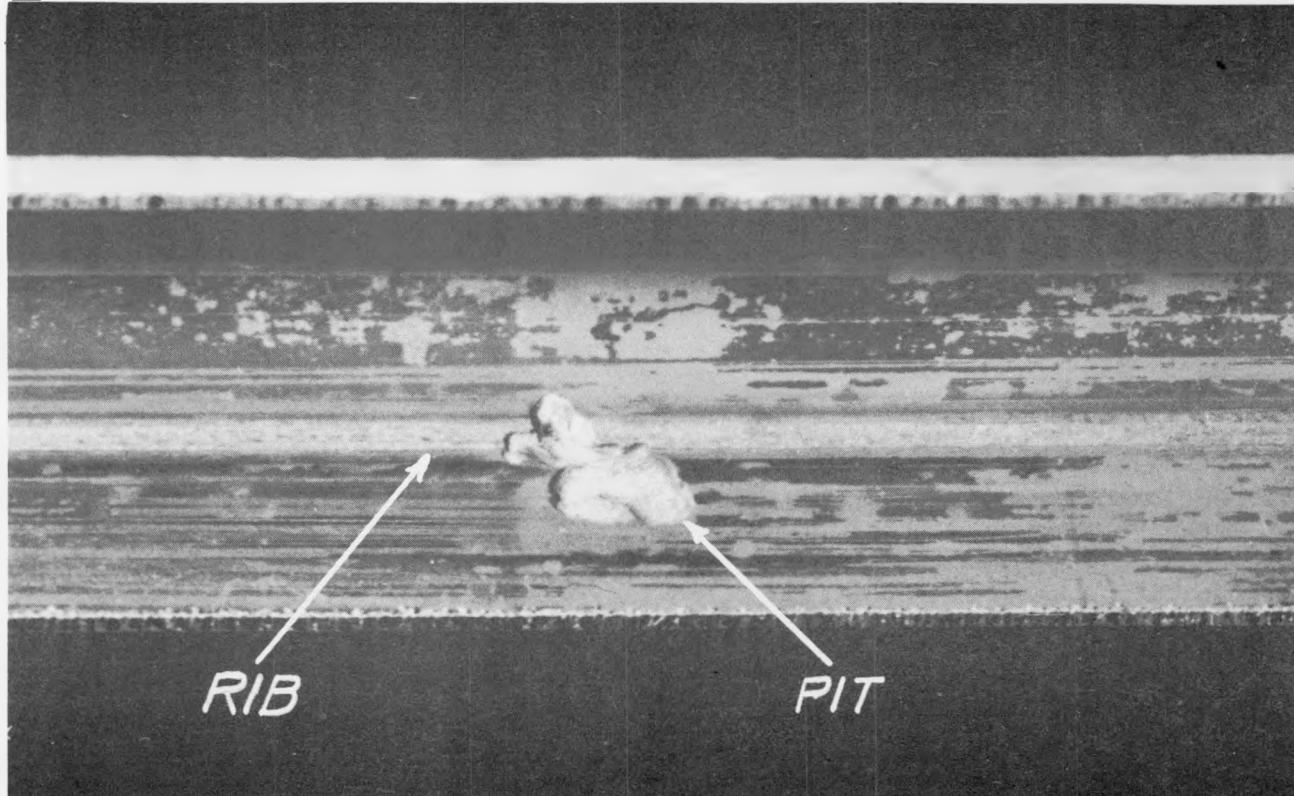
FIGURE 5

INSIDE VIEW OF TUBE 3883-F, REMOVED FROM THE PILE ABOUT JULY 21, 1952

The area in the vicinity of the pit is essentially void of film.

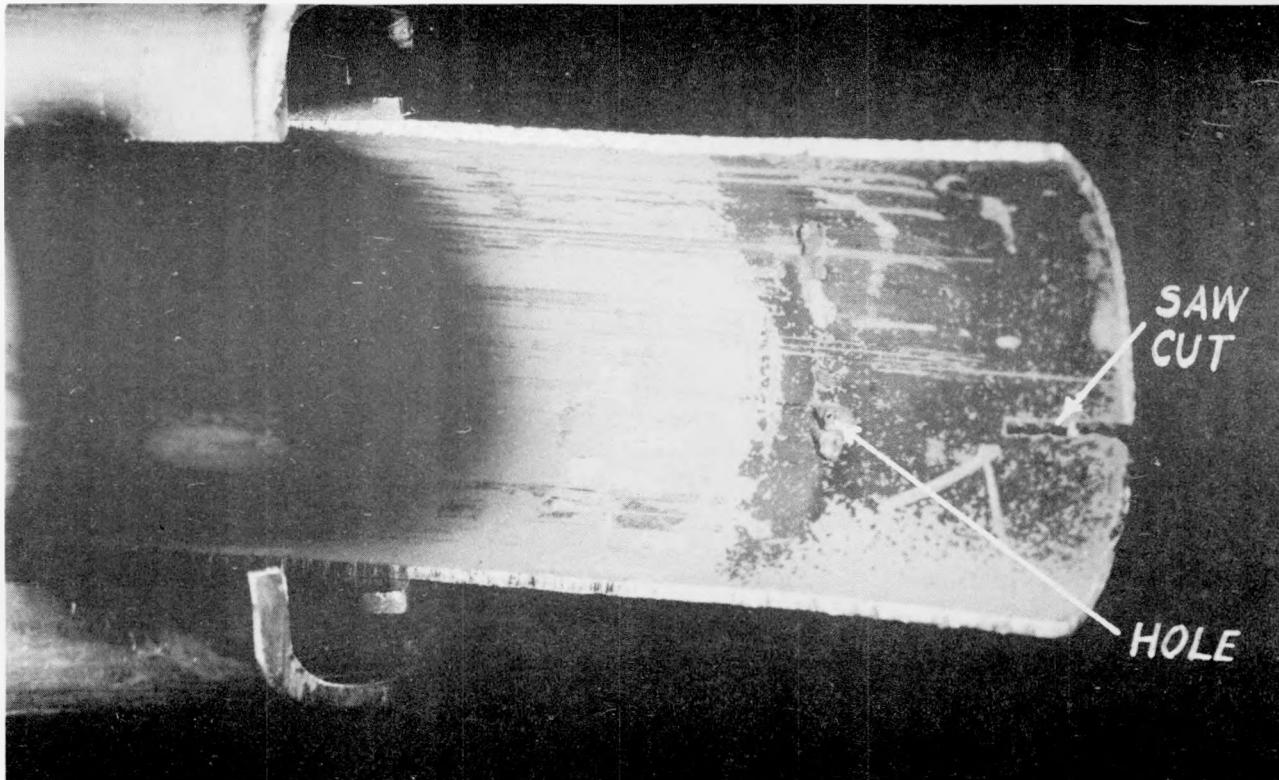
FIGURE 6

INSIDE VIEW OF TUBE 1475-F, REMOVED FROM THE PILE ABOUT JULY 21, 1952

The light colored area to the left of the pitting attack is essentially devoid of film.

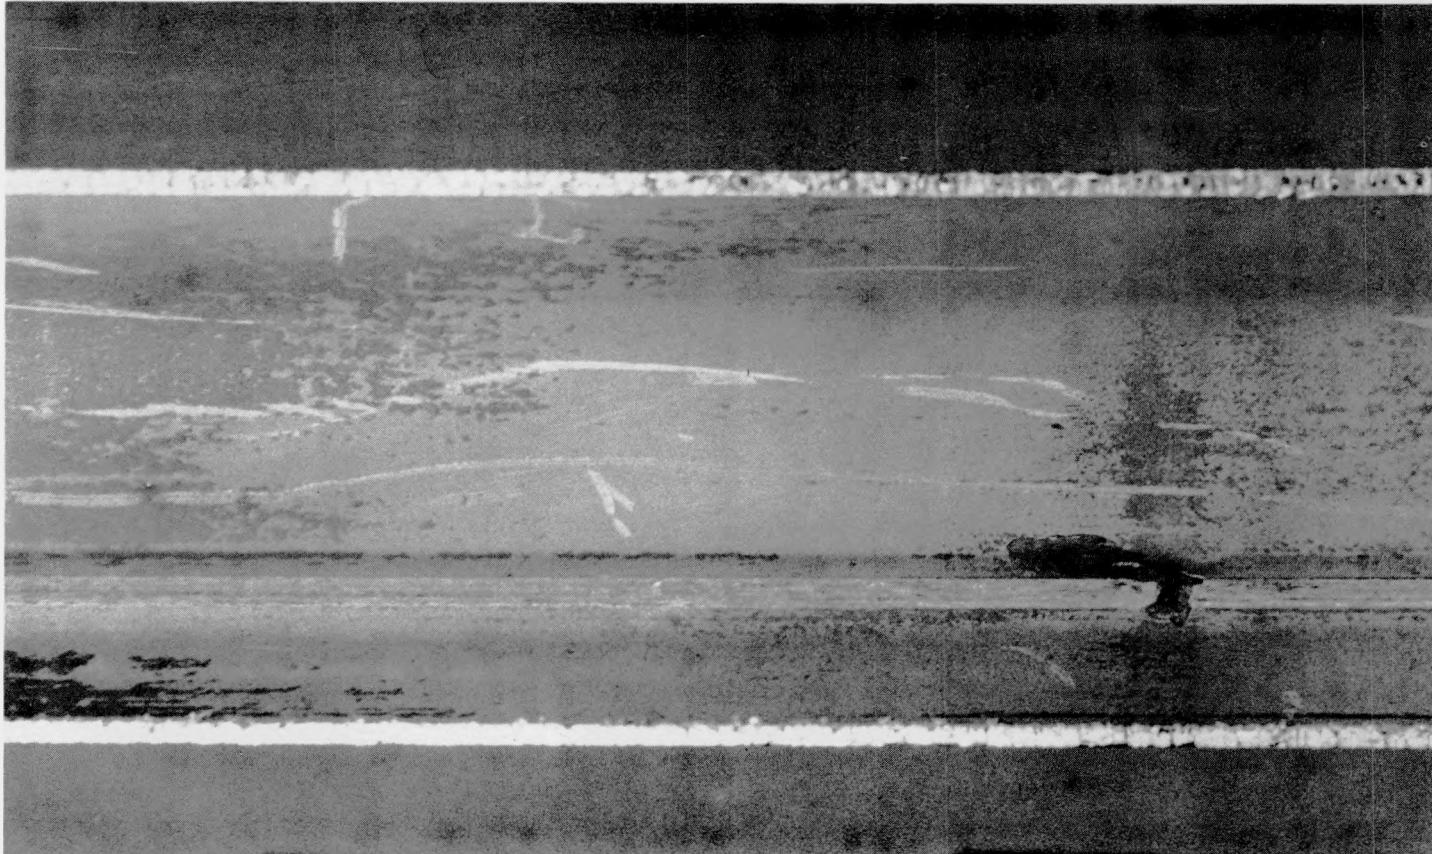
INSIDE VIEW OF TUBE 3684-F, REMOVED FROM THE PILE ABOUT AUGUST 8, 1952

The area where this pit occurred is about nine or ten feet from the rear Van Stone flange. Note that the pit occurred at a "slug junction". Downstream is to the left.

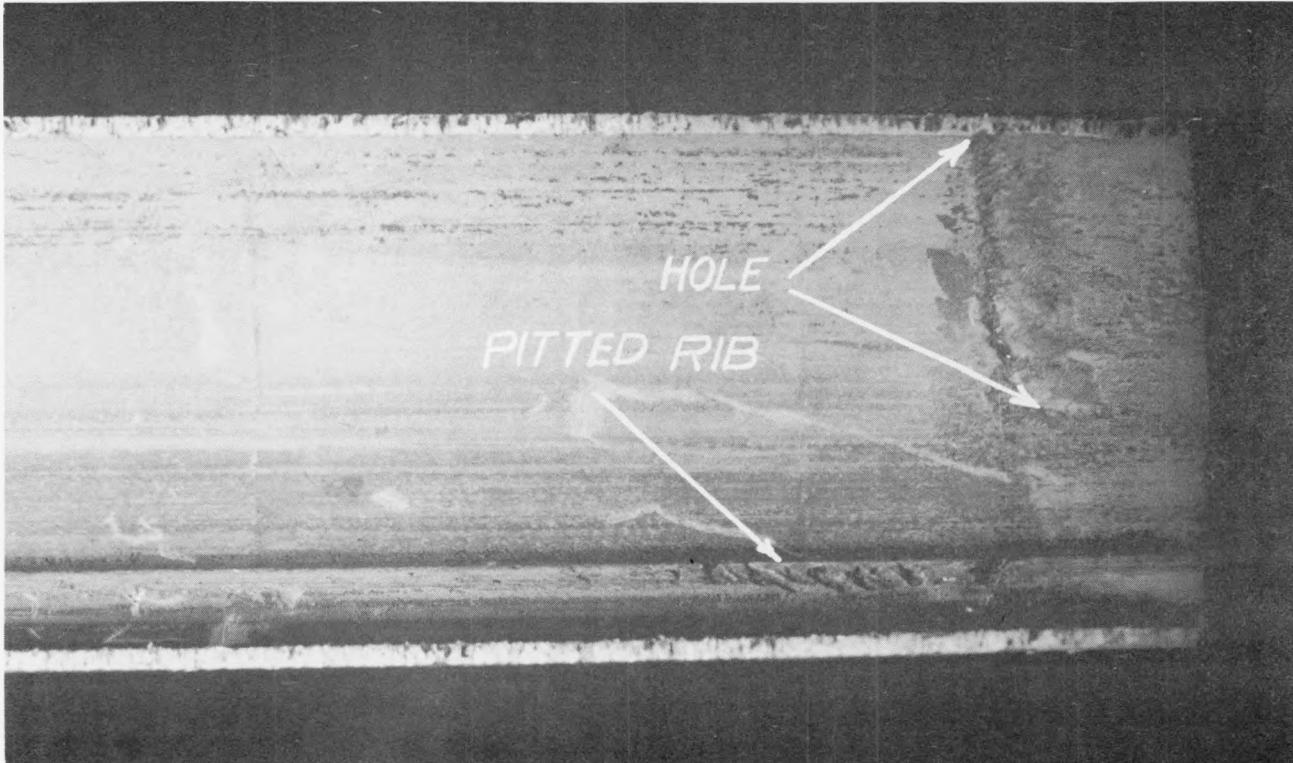
FIGURE 9

INSIDE VIEW OF TUBE 3668-F, REMOVED FROM THE PILE ABOUT JULY 21, 1952

The pitting attack at this "slug junction" extends beyond the top of the tube. Three holes were found at this "slug junction". Two are indicated here, the third was located on the other side of the tube.

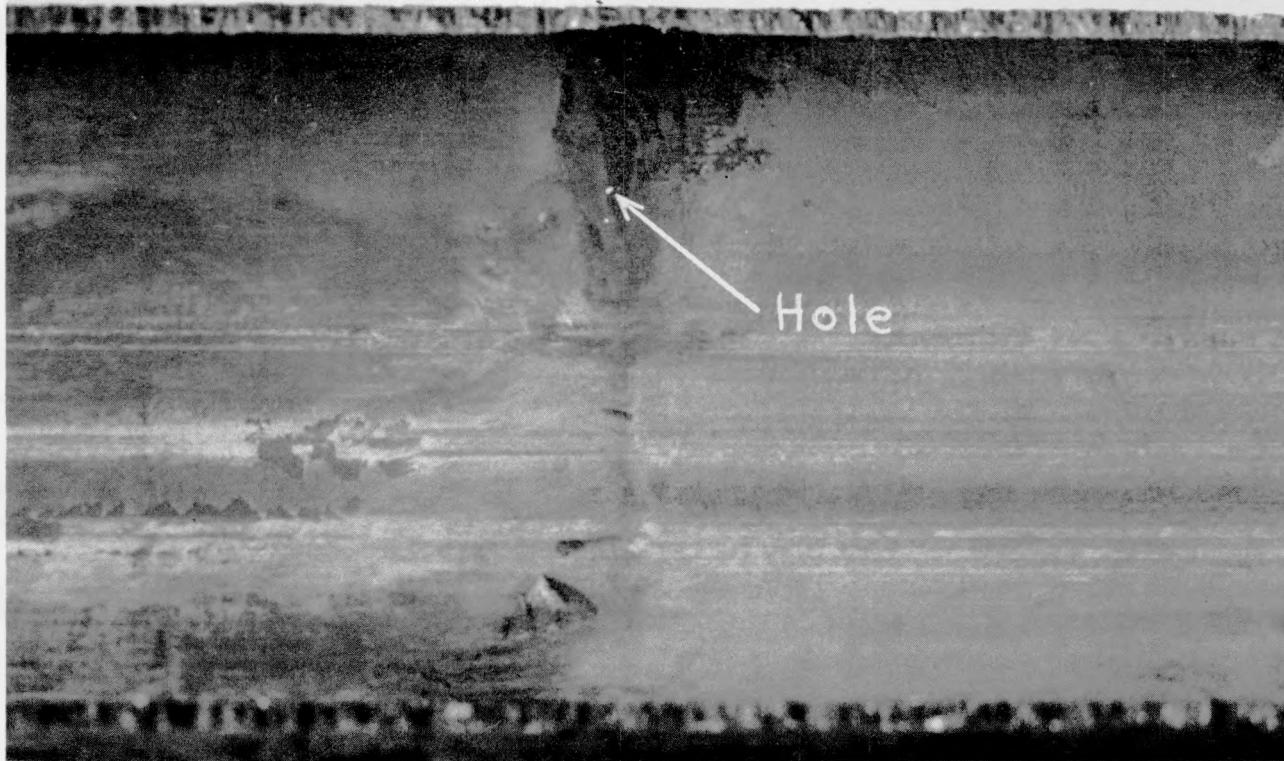
FIGURE 10

INSIDE VIEW OF TUBE 0867-F, REMOVED FROM THE PILE ABOUT JULY 9, 1952

The hole in this tube is at the bottom of the pit. This area is about twelve feet from the rear Van Stone flange.

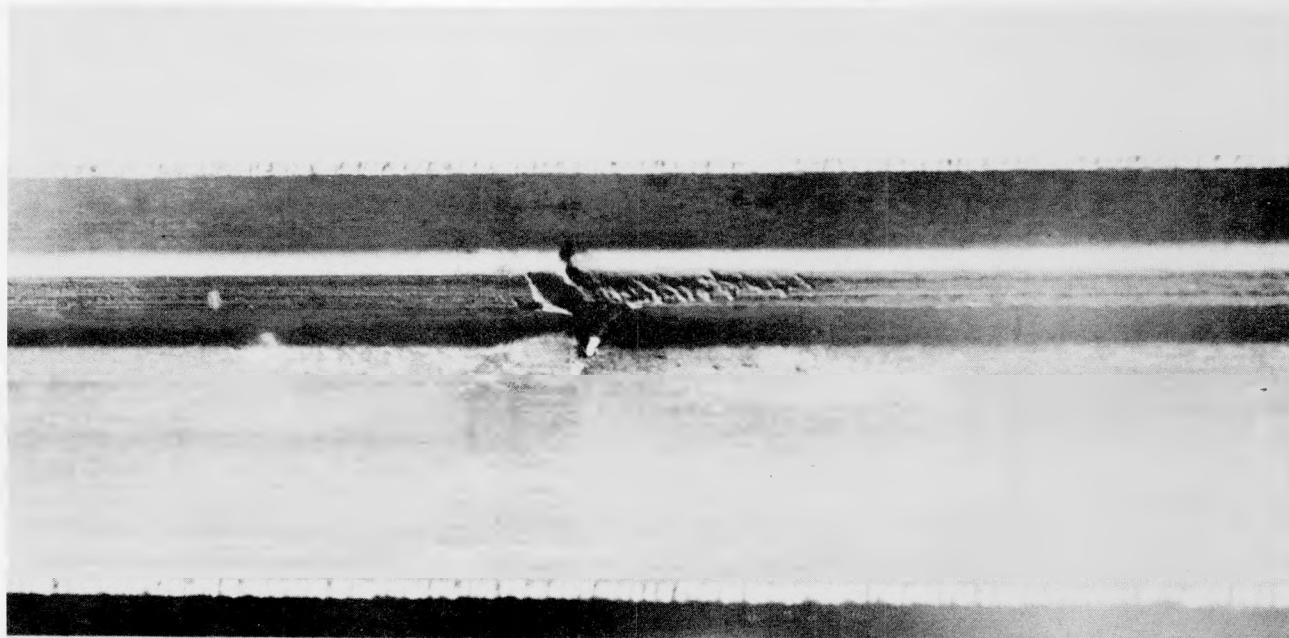
FIGURE 11

INSIDE VIEW OF TUBE 3175-D, REMOVED FROM THE PILE ON AUGUST 8, 1952

The pit, which penetrated the tube about eight feet from the rear Van Stone flange, is just below the badly pitted rib. Downstream is to the left.

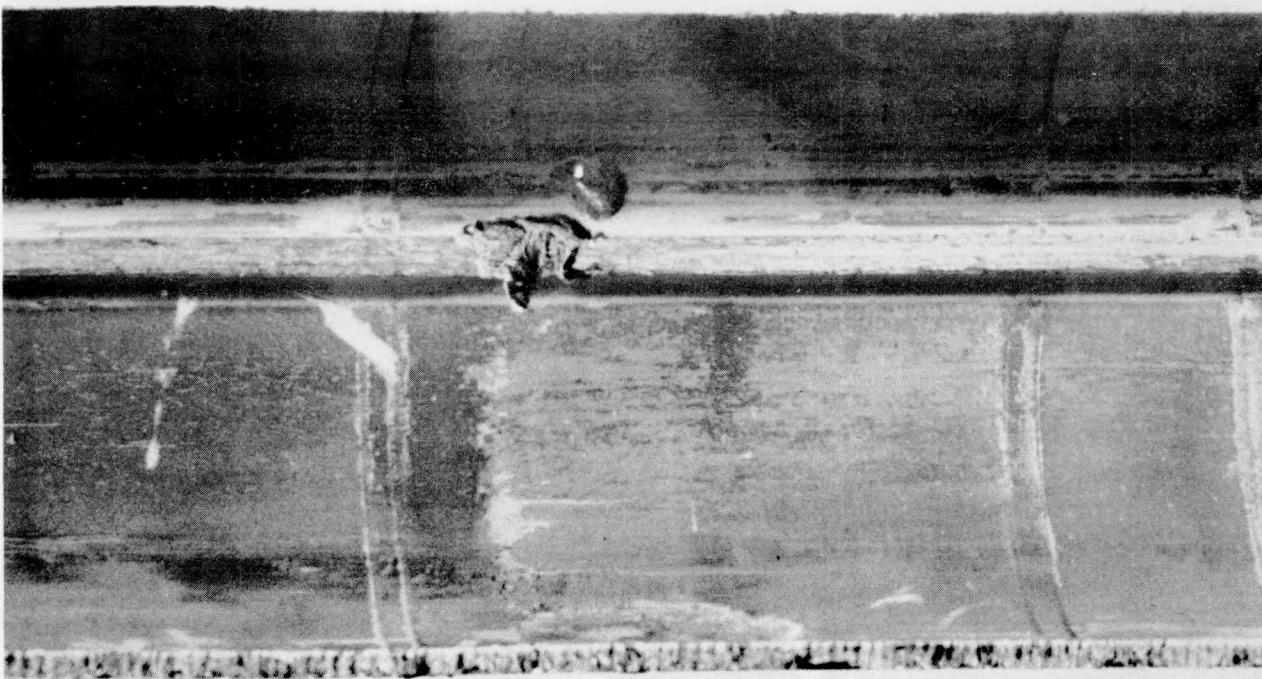
FIGURE 12

INSIDE VIEW OF TUBE 1692-D, REMOVED FROM THE PILE ON AUGUST 26, 1952

This pit penetrated the tube wall between the ribs about eight and one half feet from the rear Van Stone flange. Downstream is to the right.

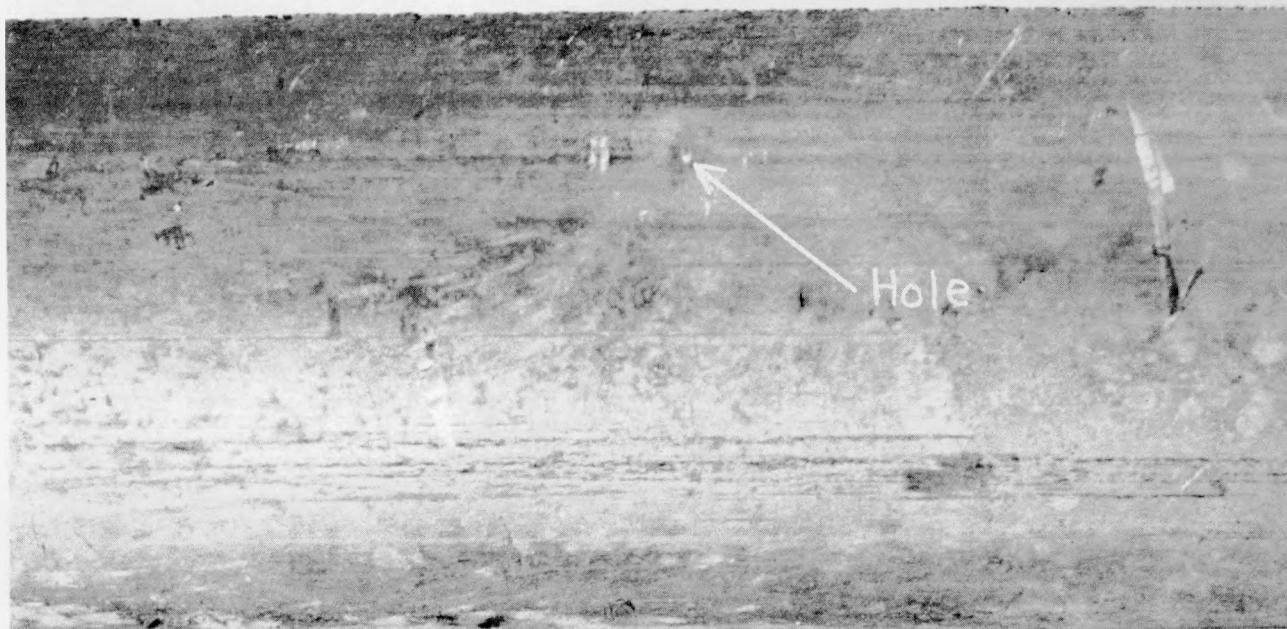
OUTSIDE VIEW OF TUBE 0867-F, REMOVED FROM THE PILE ABOUT JULY 9, 1952

The galvanic attack which is usually visible on leakers of this type was not apparent on this tube.

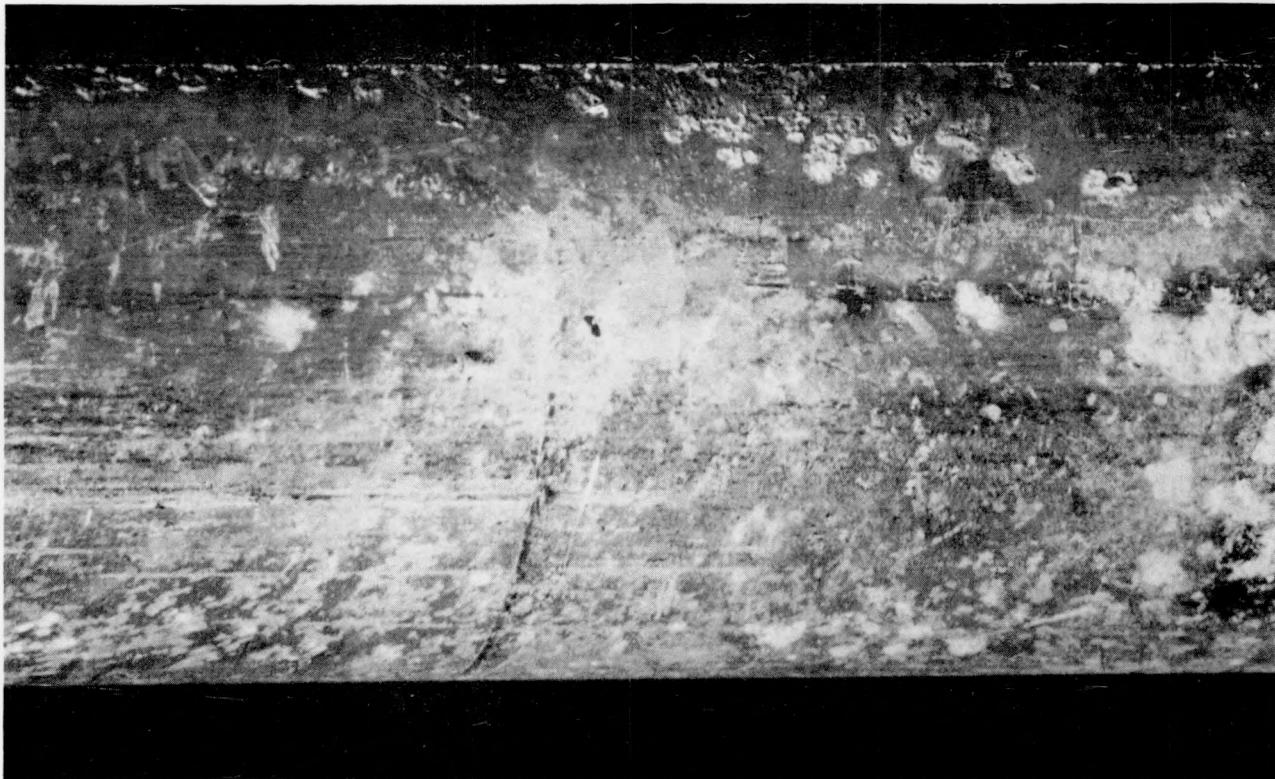
FIGURE 14

OUTSIDE VIEW OF TUBE 3175-D, REMOVED FROM THE PILE ON AUGUST 8, 1952

This figure shows the condition of the outside tube surface around the hole shown in Figure 11. The white spots are mounds of corrosion product. Downstream is to the right.

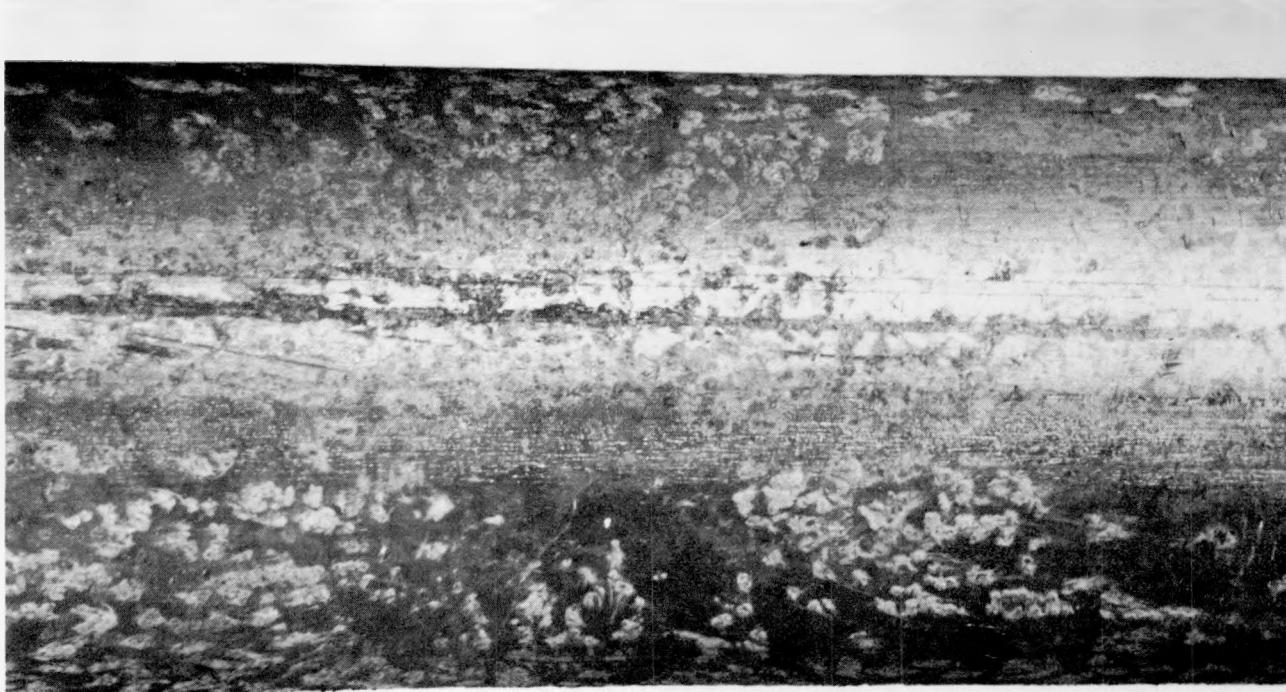
FIGURE 15

OUTSIDE VIEW OF TUBE 1692-D, REMOVED FROM THE PILE ON AUGUST 26, 1952.

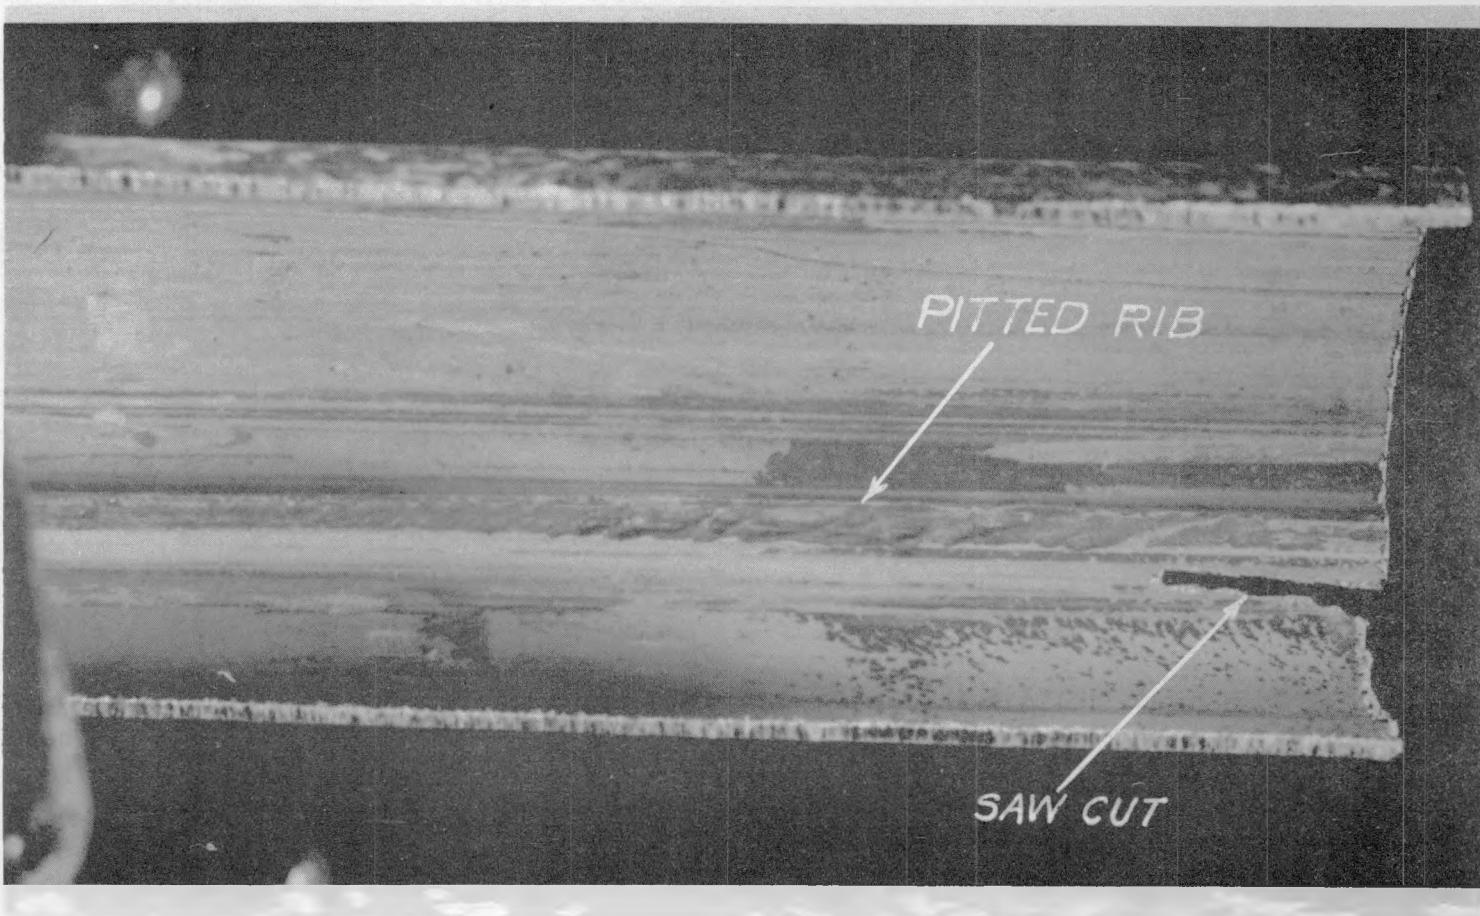
FIGURE 16

INSIDE VIEW OF TUBE 1475-F, REMOVED FROM THE PILE ABOUT JULY 21, 1952

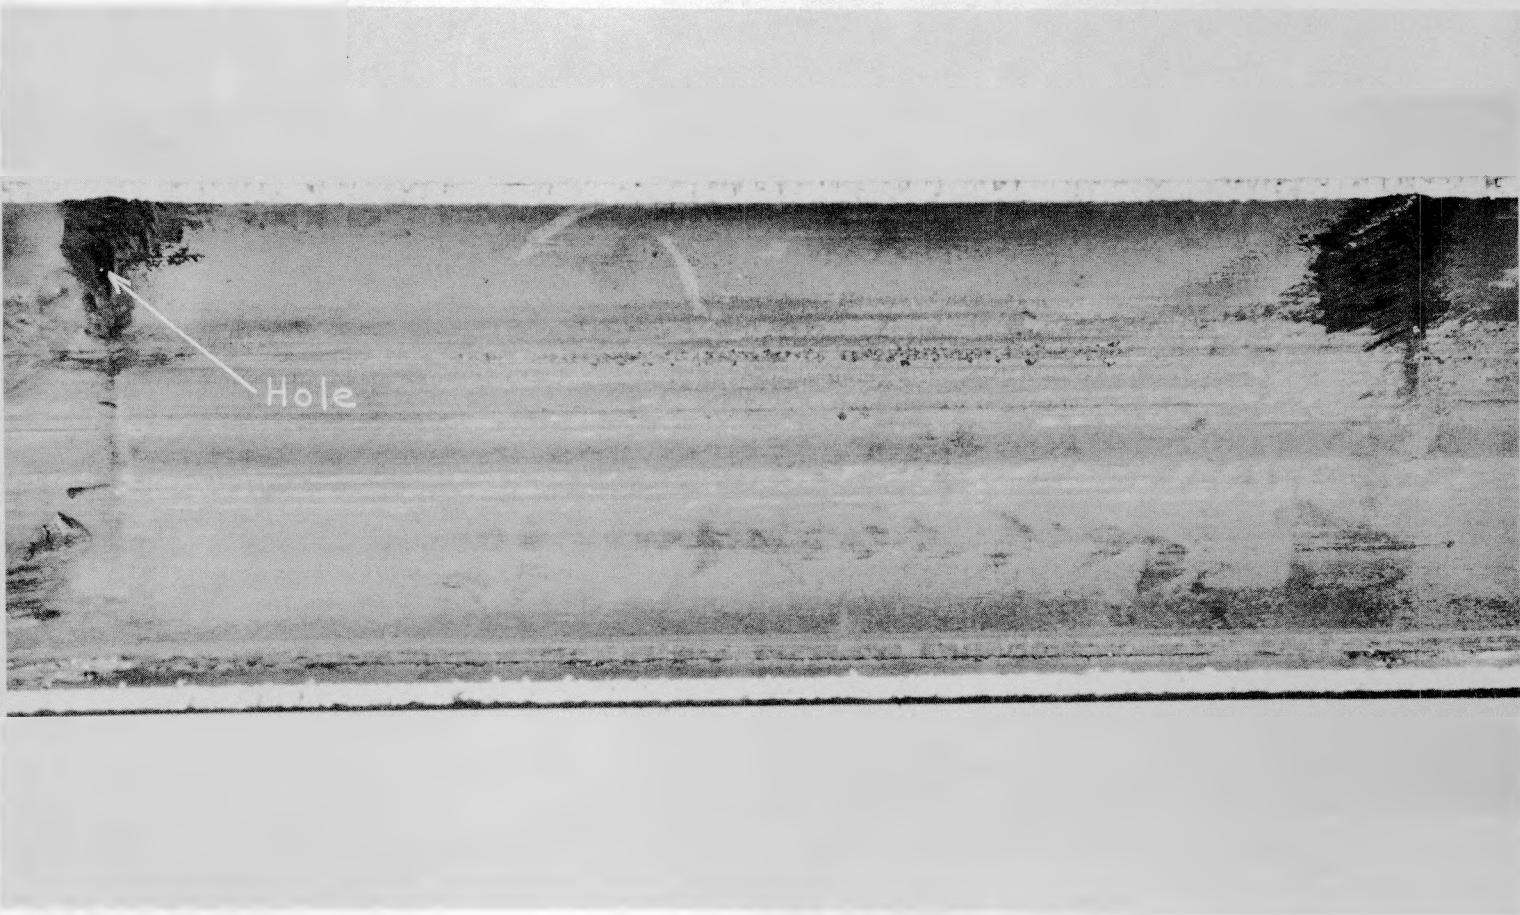
INSIDE VIEW OF TUBE 0867-F, REMOVED FROM THE PILE ABOUT JULY 9, 1952

The pit which penetrated the tube can be seen at the left side of the figure.
The pitting attack at the right is about four to five inches from the hole area.
The dark areas are the surfaces of the pit which are covered with film.

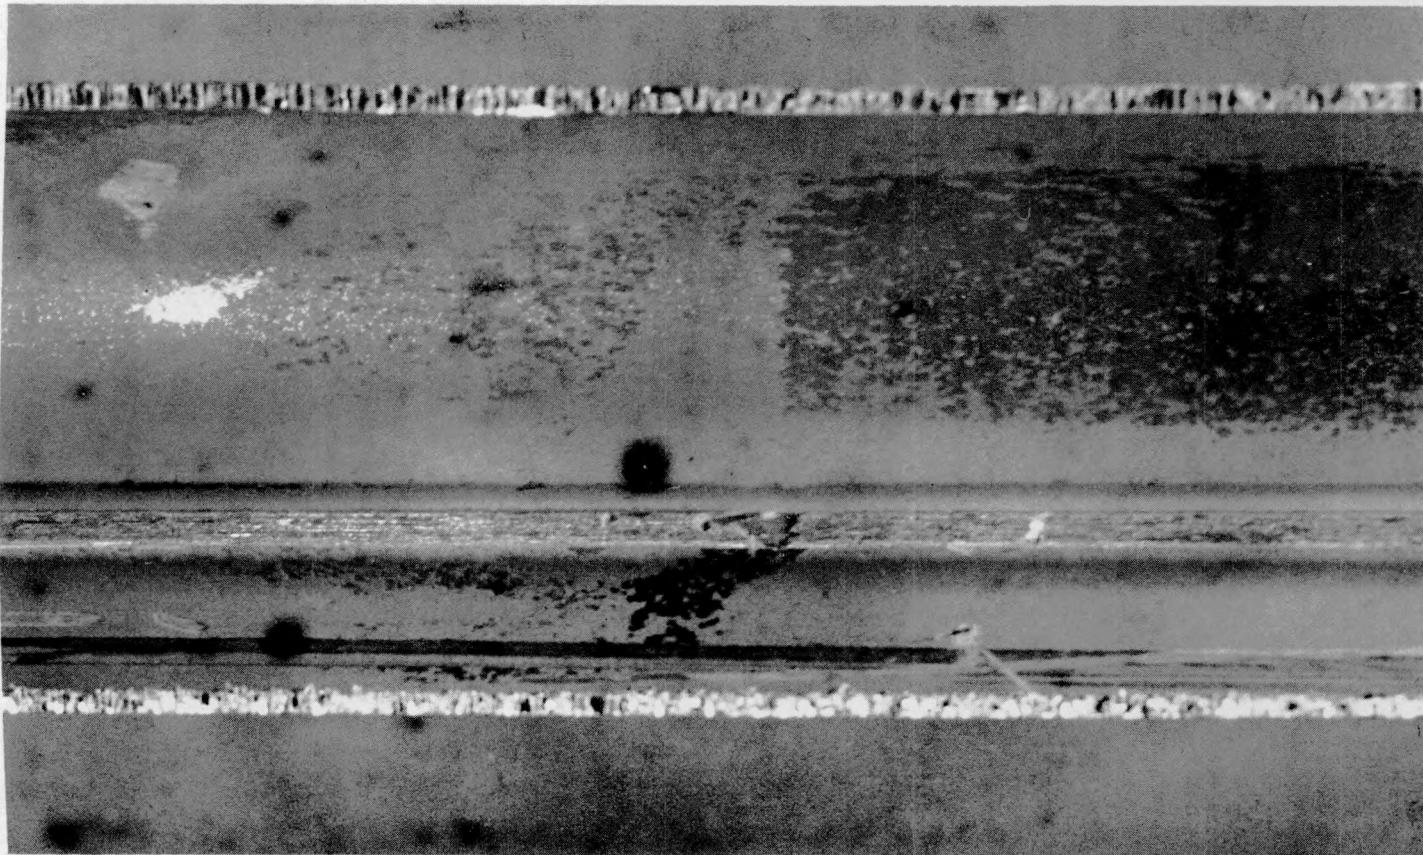
FIGURE 18

INSIDE VIEW OF TUBE 3684-F, REMOVED FROM THE PILE ABOUT AUGUST 8, 1952

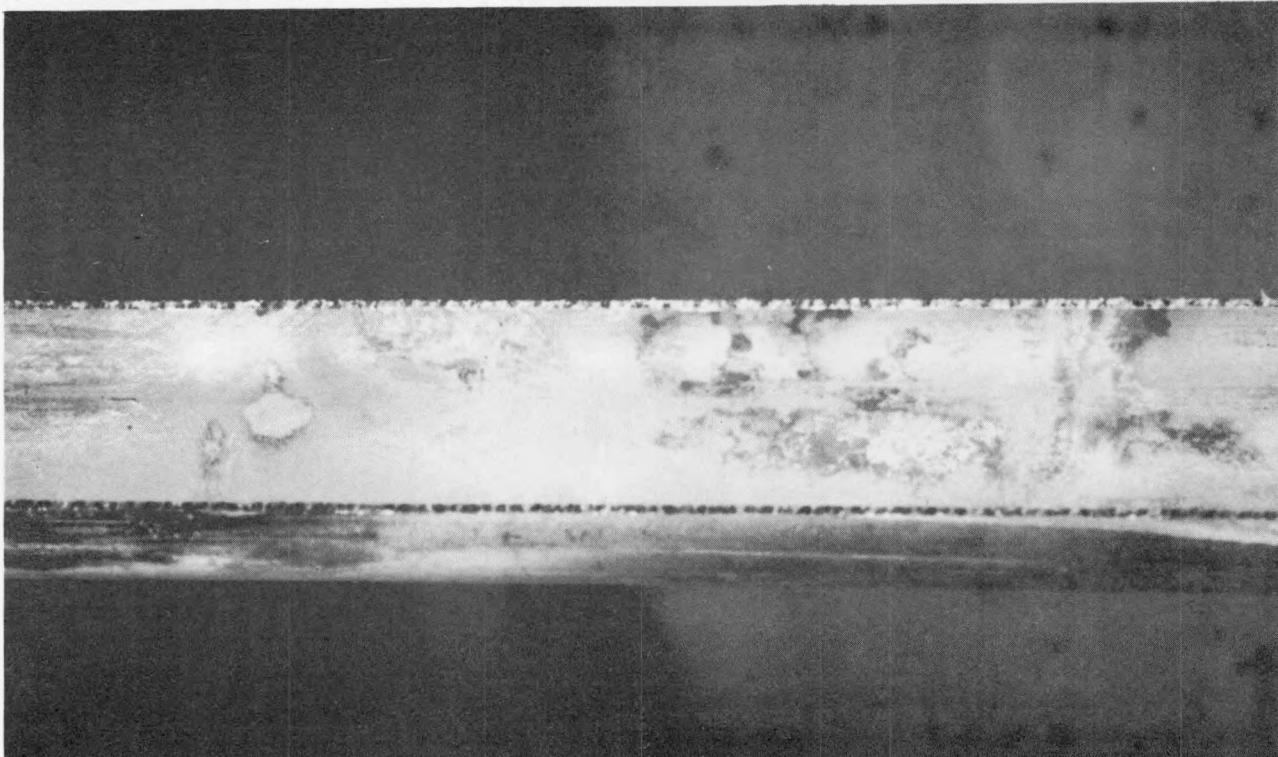
FIGURE 19

INSIDE VIEW OF TUBE 3773-F, REMOVED FROM THE PILE ABOUT AUGUST 8, 1952

This section is about 21 feet from the rear Van Stone flange. The patch of film near the center of this figure may indicate that a slug was close to or in contact with the tube at this point.

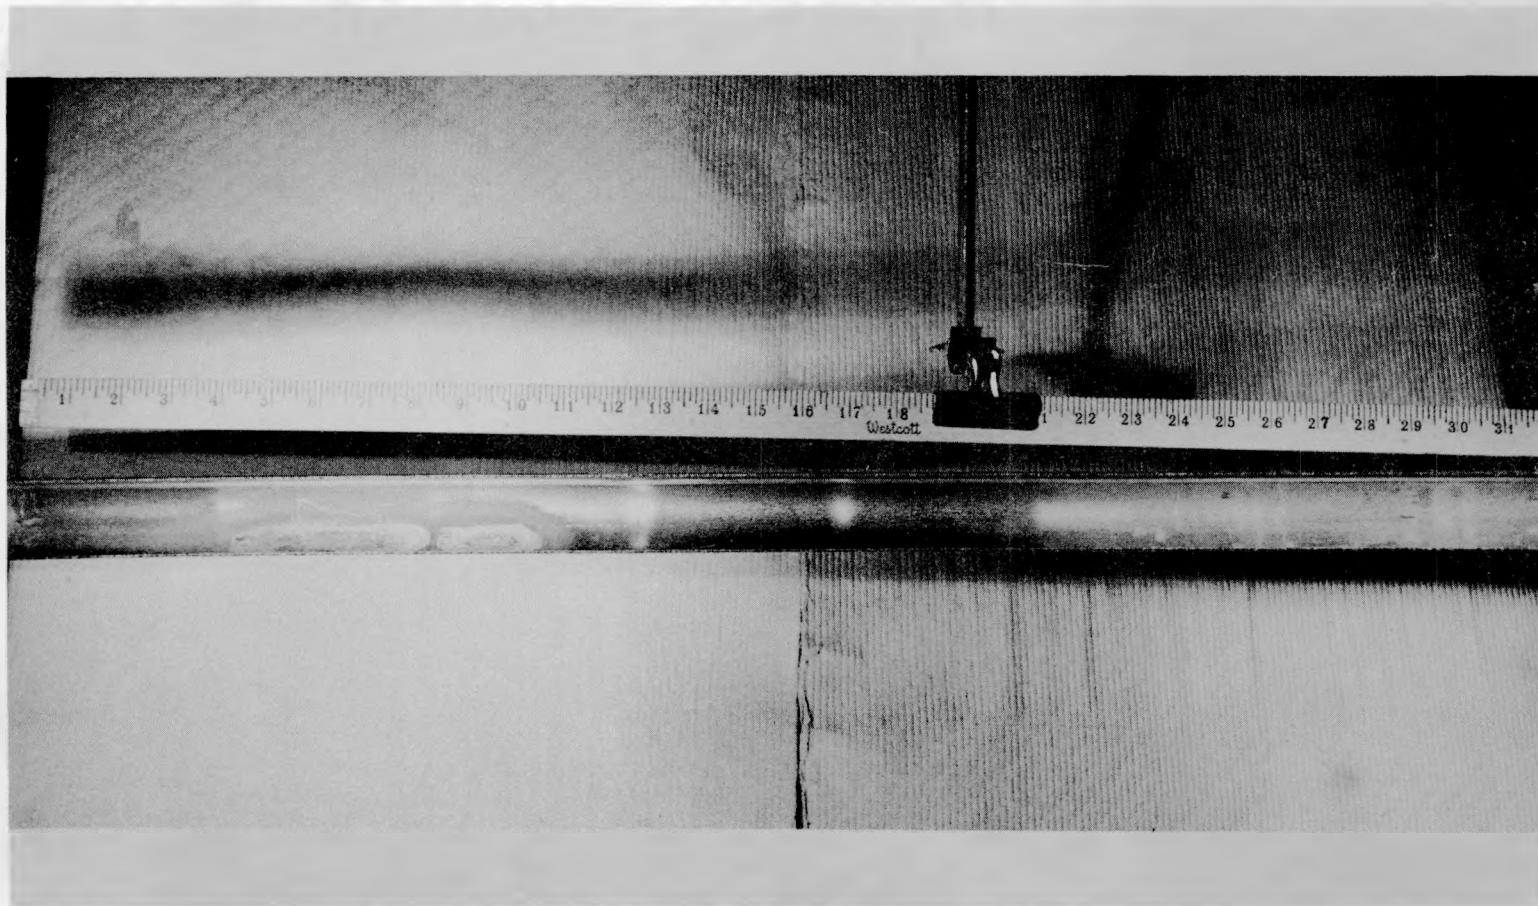
FIGURE 20

INSIDE VIEW OF TUBE 3175-D, REMOVED FROM THE PILE ON AUGUST 8, 1952

The two film patches at the left are "burned" areas where slugs may have been close to or made contact with the tube wall. Downstream is to the left.

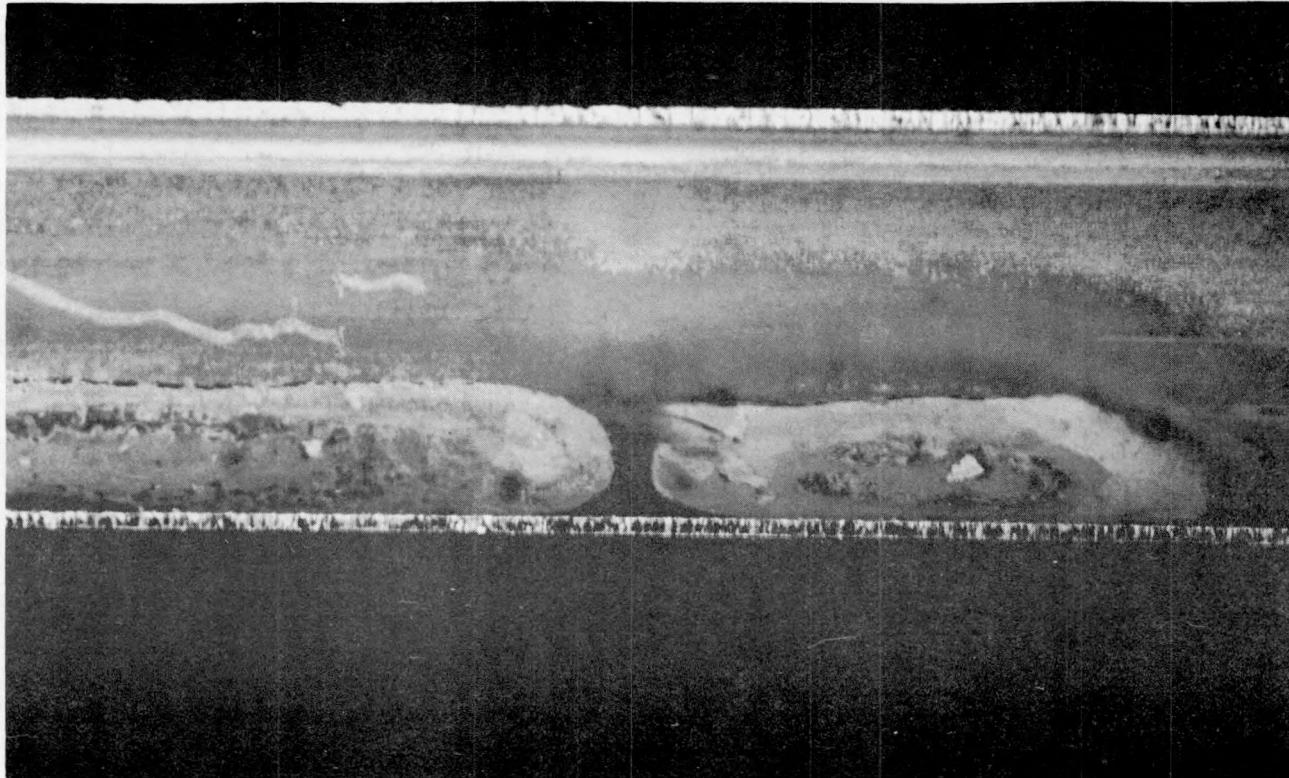
FIGURE 21

INSIDE VIEW OF TUBE 3175-D, REMOVED FROM THE PILE ABOUT AUGUST 8, 1952

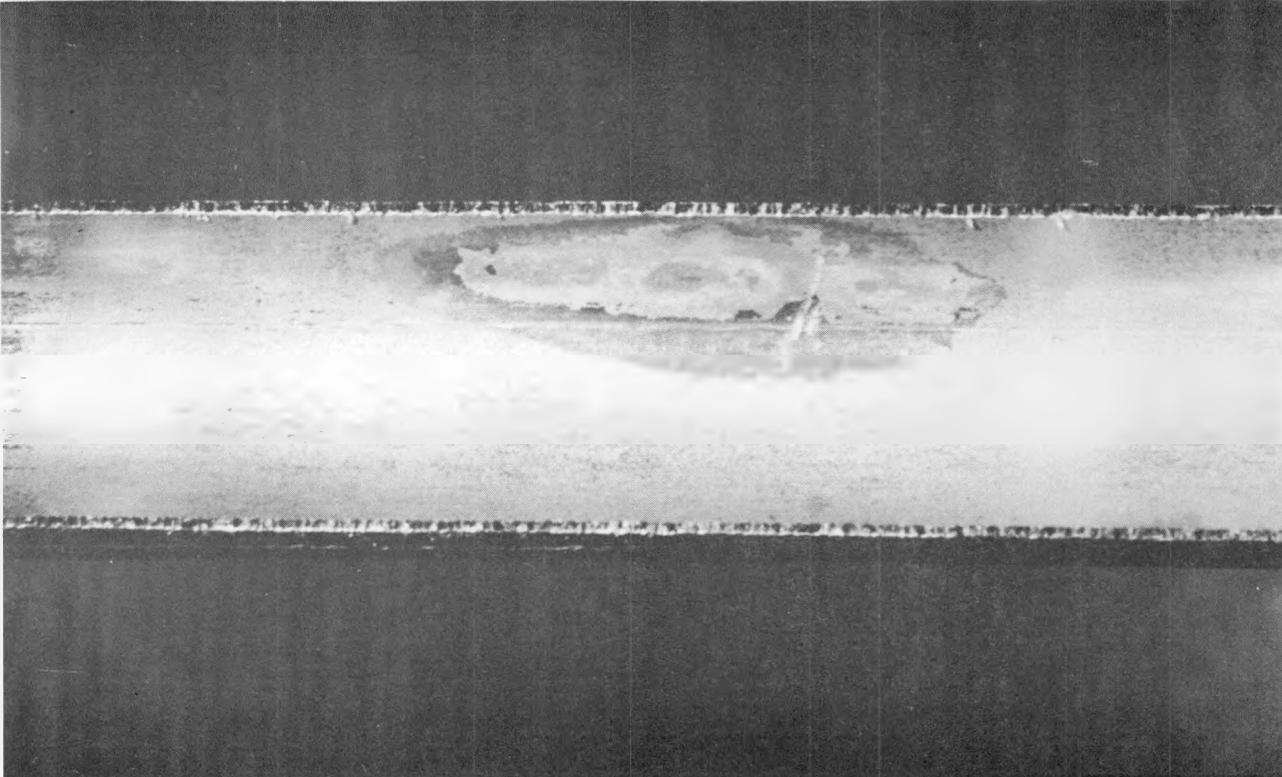
FIGURE 22

INSIDE VIEW OF TUBE 3175-D, REMOVED FROM THE PILE ON AUGUST 8, 1952
