HW - 29132

SEVERE PITTING ATTACK OF PILE PROCESS TUBES AND SLUGS

M. LEWIS AND R. A. ROHRBACHER

JUNE 30, 1953

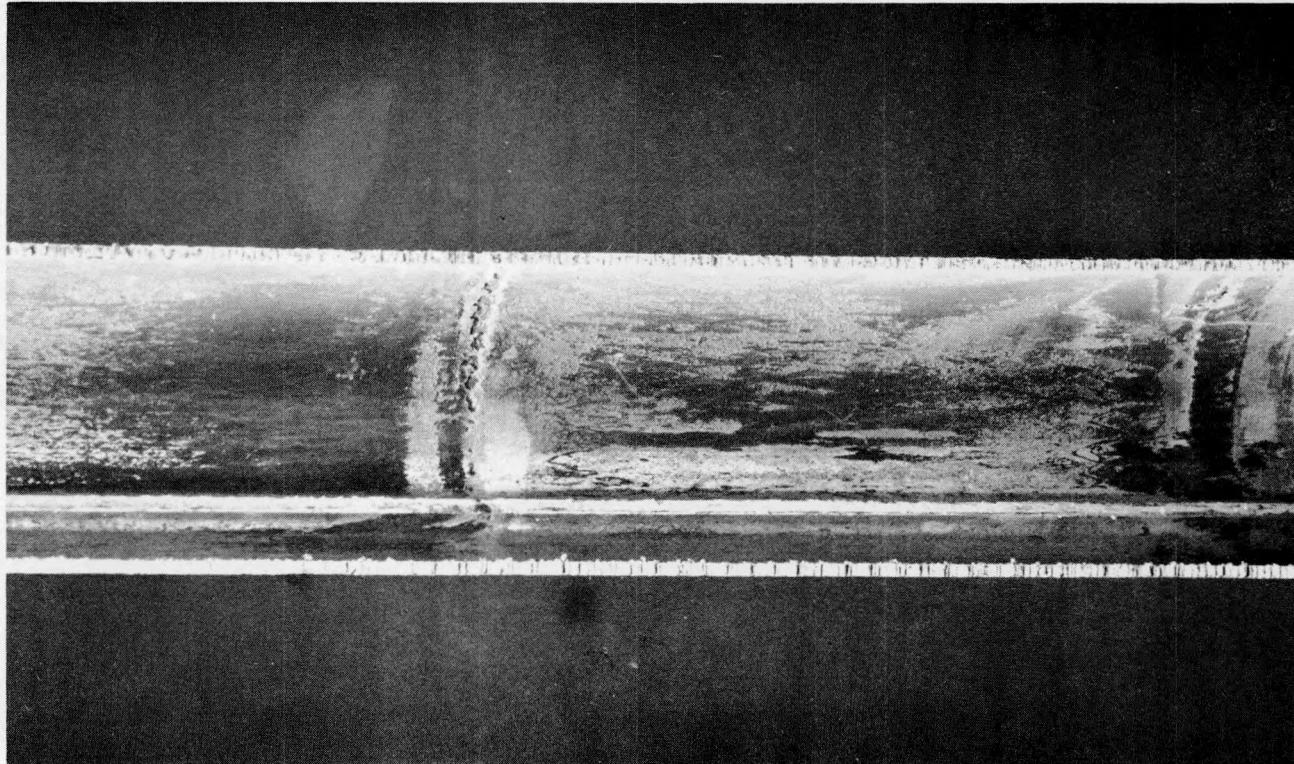
FIGURE 23

INSIDE VIEW OF TUBE 3178-DR, REMOVED FROM THE PILE ABOUT SEPTEMBER 6, 1952

The exact location in the pile of this pitting at a "slug junction" is not known.

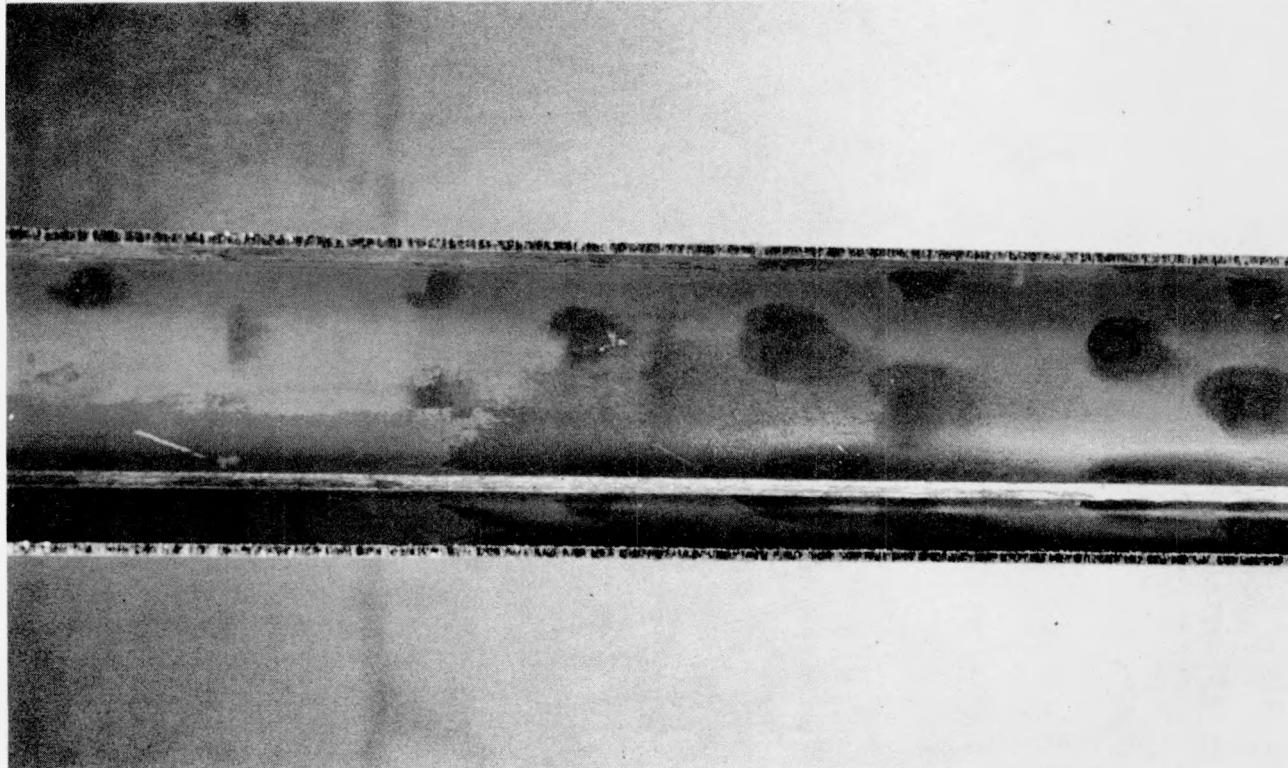
FIGURE 24

INSIDE VIEW OF TUBE 3773-F, REMOVED FROM THE PILE ABOUT AUGUST 8, 1952

This section is about three feet from the rear Van Stone flange. The black spots on the tube conform to holes in the perforated dummy slugs which were located in this section of the tube. Downstream is to the right.

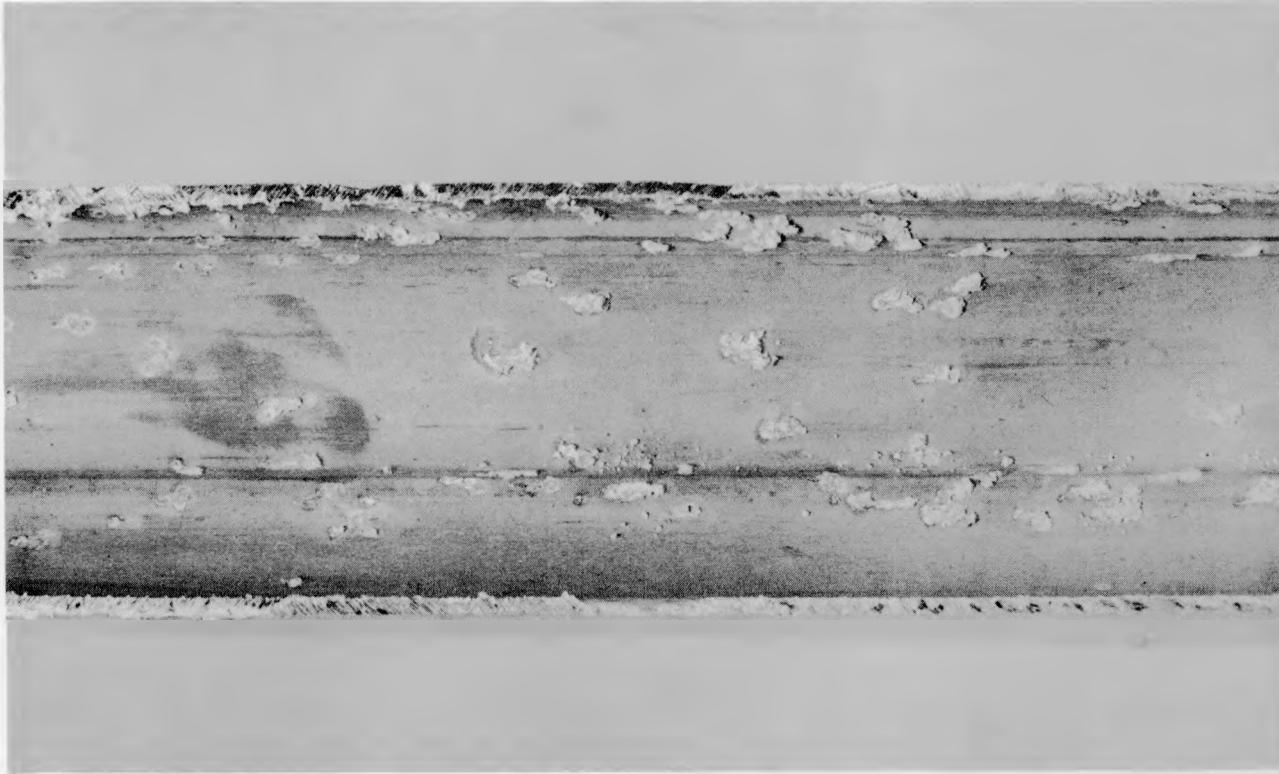
9. Some tubes containing areas of this pitting attack had spots of white corrosion product, or barnacles, on the sides and tops of the ribs in the front section of the tube upstream from the charge, as shown in Figure 25.

FIGURE 25
SECTION OF PROCESS TUBING CONTAINING CORROSION PRODUCT
"BARNACLES" ON INSIDE OF TUBE

Eighteen gallons per minute of cold ferric sulfate treated, dichromate-free water flowed through this empty tube section for two and one-half months.

It is recommended that action be taken to eliminate the causes of misaligned slugs, and to remove the barnacle-like corrosion products that have been found in the front portions of the pile tubes. Because contamination by mercury is a possible cause of the observed attack, all possible sources of mercury contamination of slugs, tubes, and cooling water should be evaluated as to the potential hazard. Experimental evidence indicates that the observed attack is inhibited by the presence of dichromate ions in the cooling water.

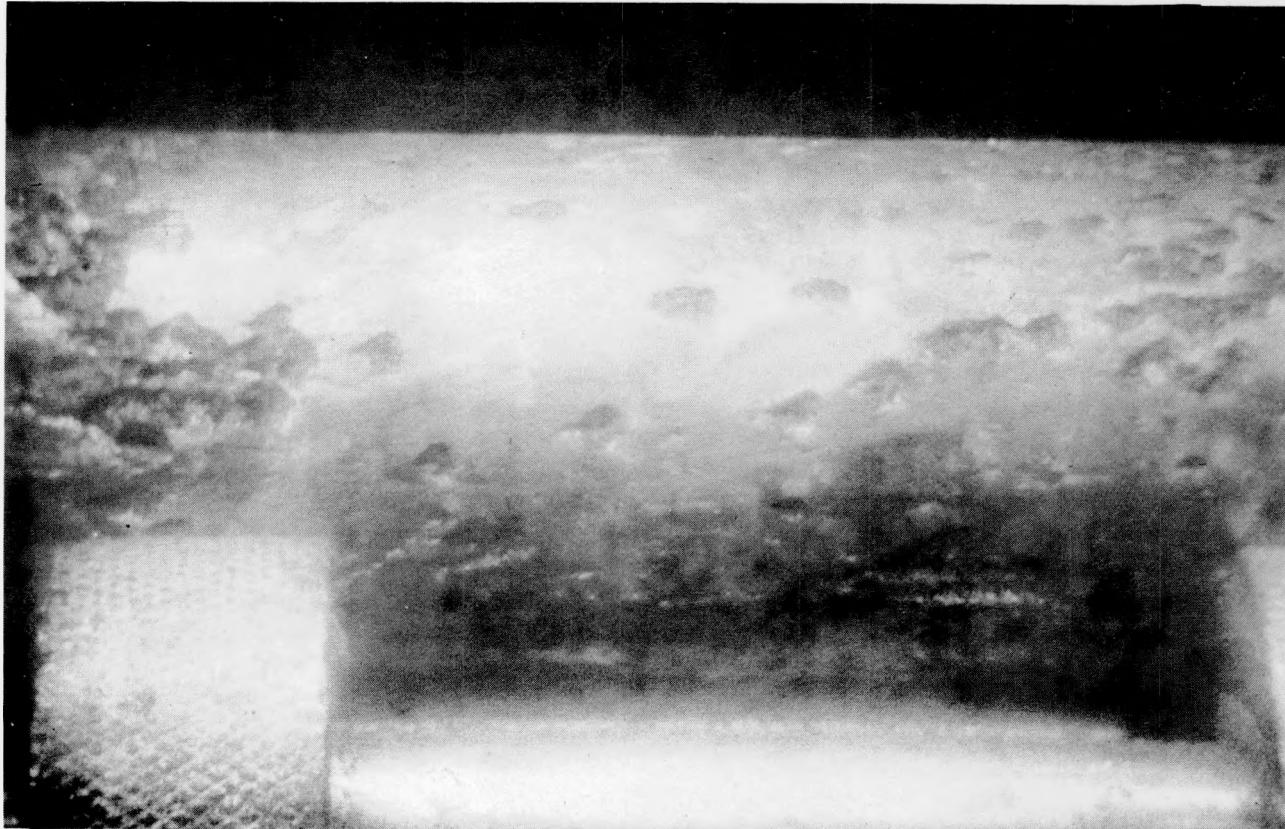
FIGURE 26

SLUG DISCHARGED AUGUST 30, 1952, FROM TUBE 3879-F

Note discrete pits.

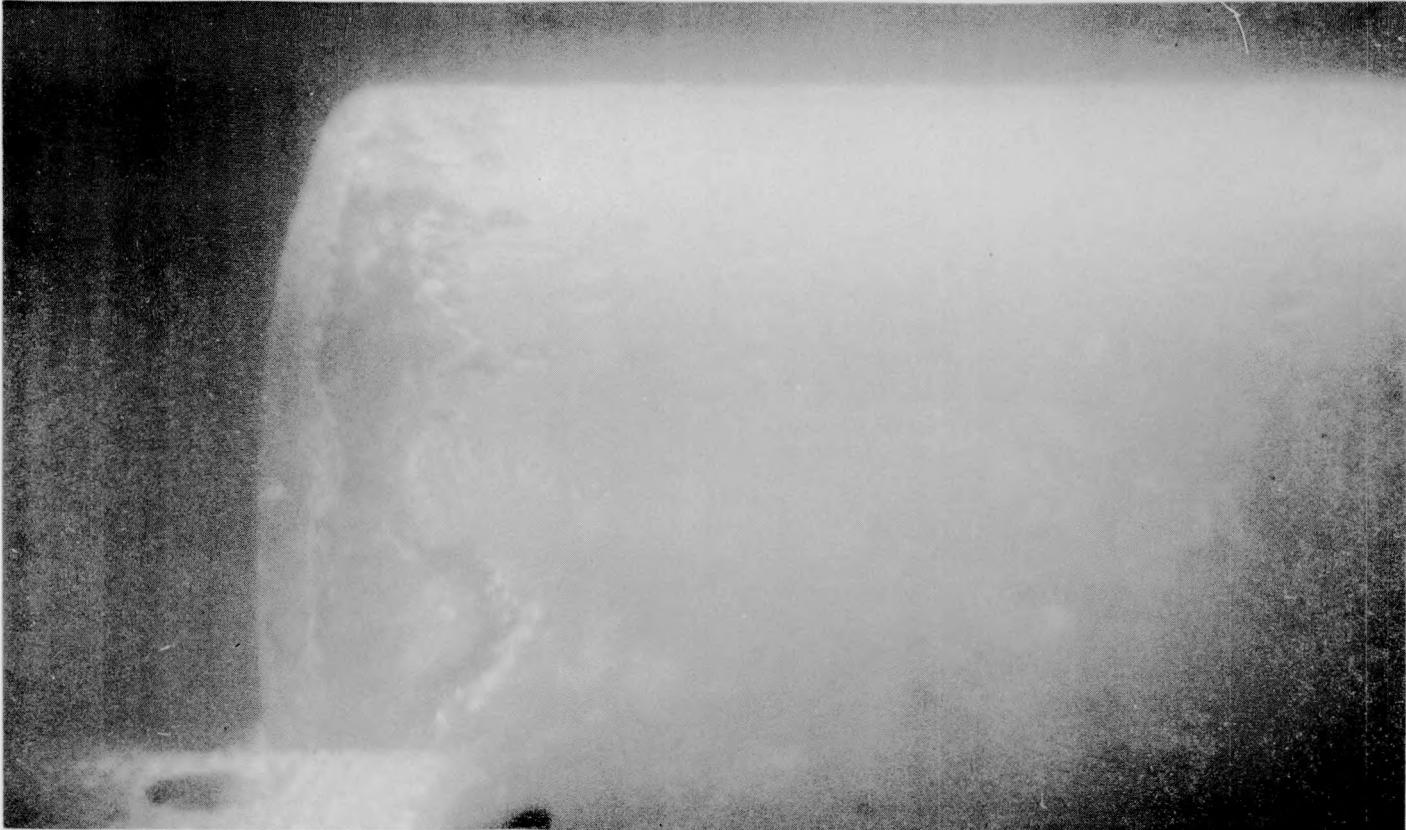
FIGURE 27

SLUG DISCHARGED JULY 29, 1952, FROM TUBE 3773-F

Pitting attack is concentrated near both ends. Can end is shown here.

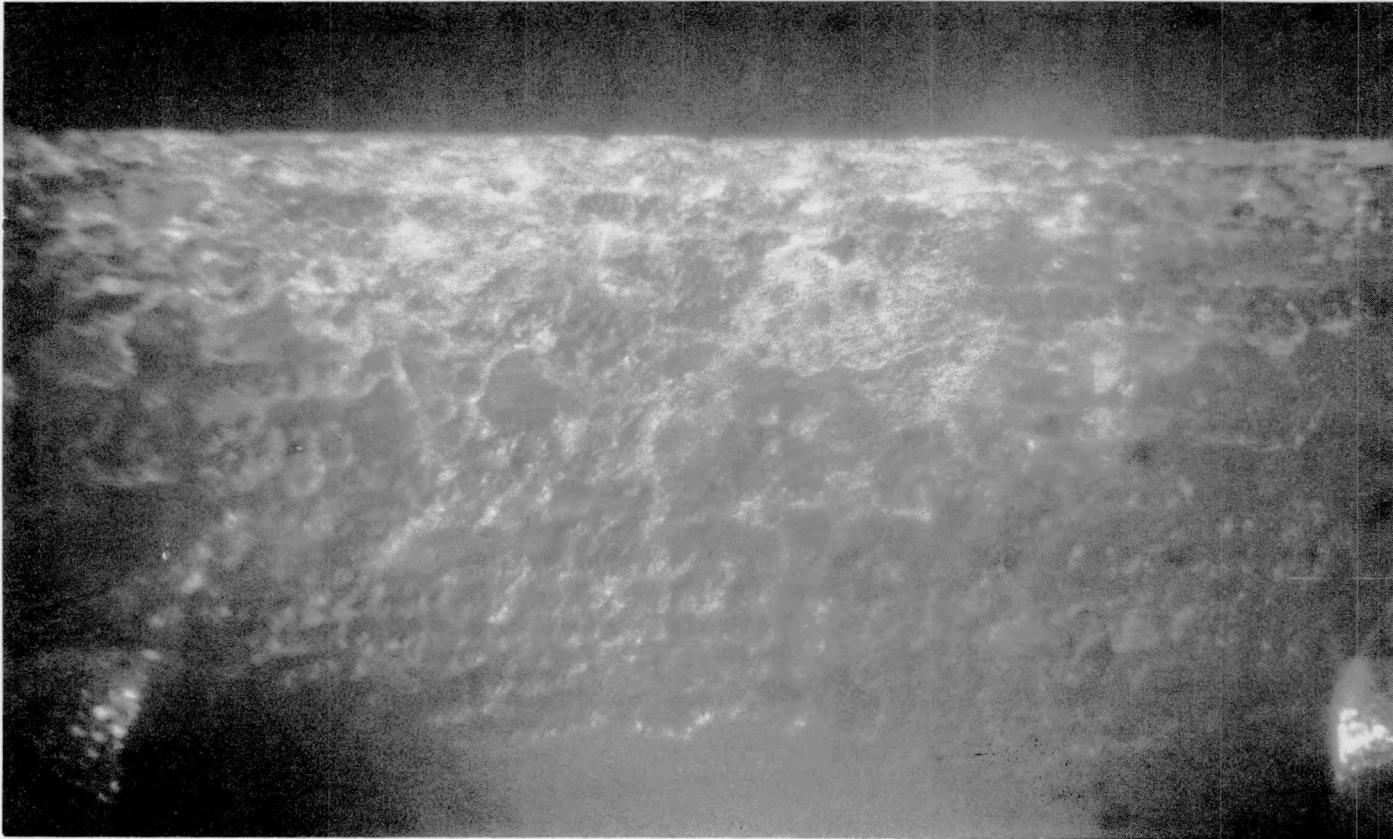
About 85 per cent of the jacket surface was attacked.

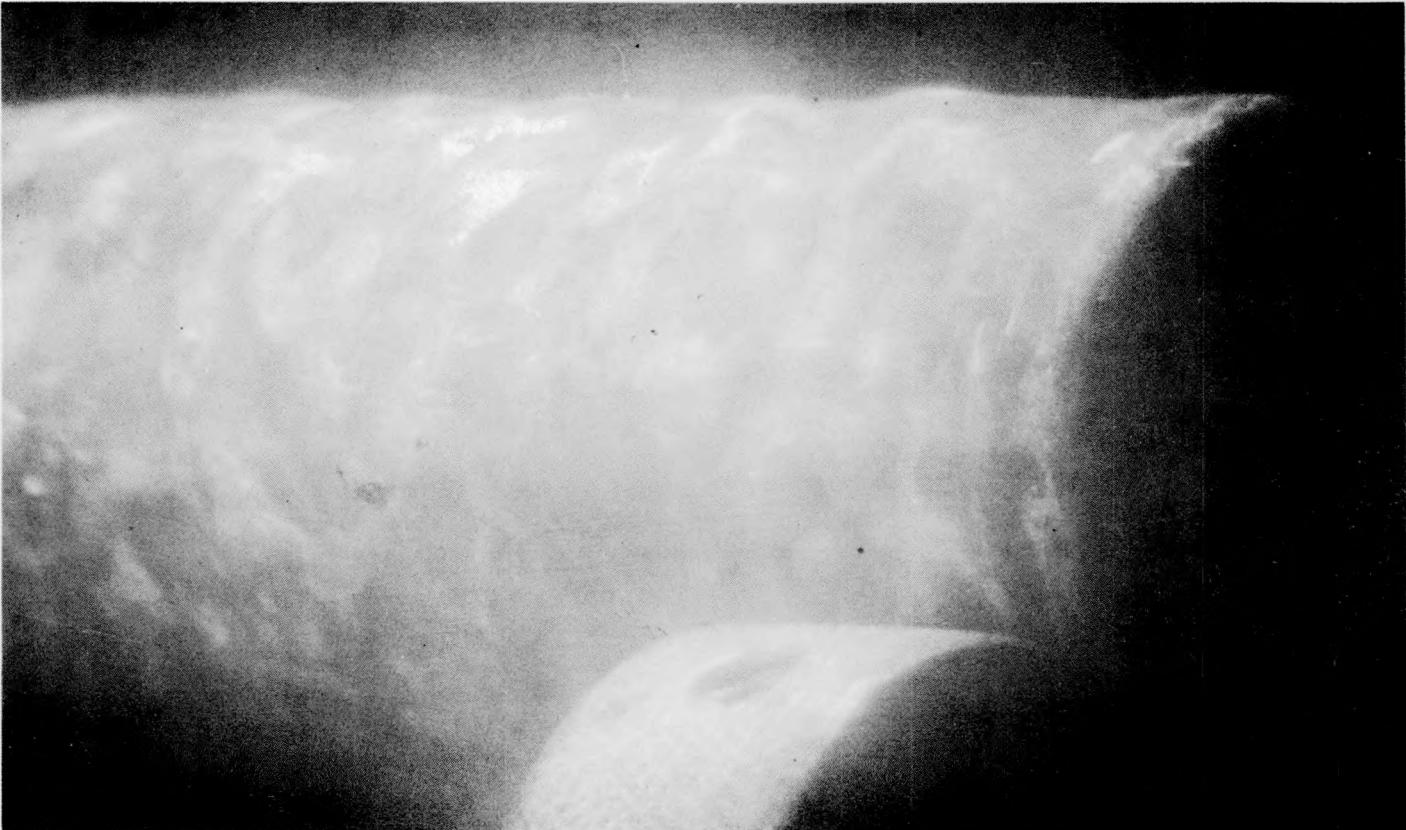
FIGURE 29

of an inch wide and parallel to the long axis of the slug was practically unattacked. About ten slugs from this tube showed signs of blistering or rippling on the surface of the slug jackets. Figure 29 shows the most severe attack of this type found in the tube.

SLUG DISCHARGED JULY 29, 1952, FROM TUBE 3773-F

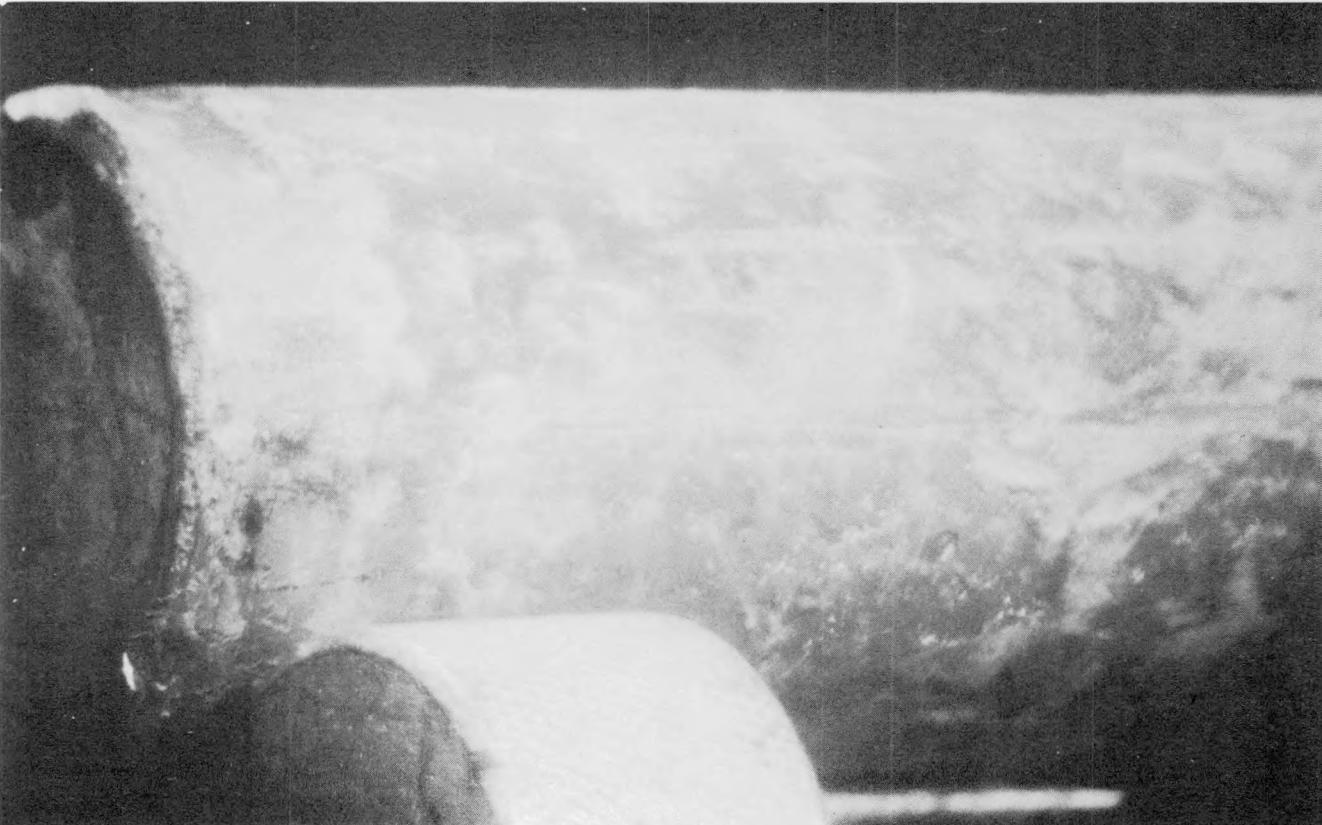
FIGURE 30

SLUG DISCHARGED JULY 31, 1952, FROM TUBE 3684-F

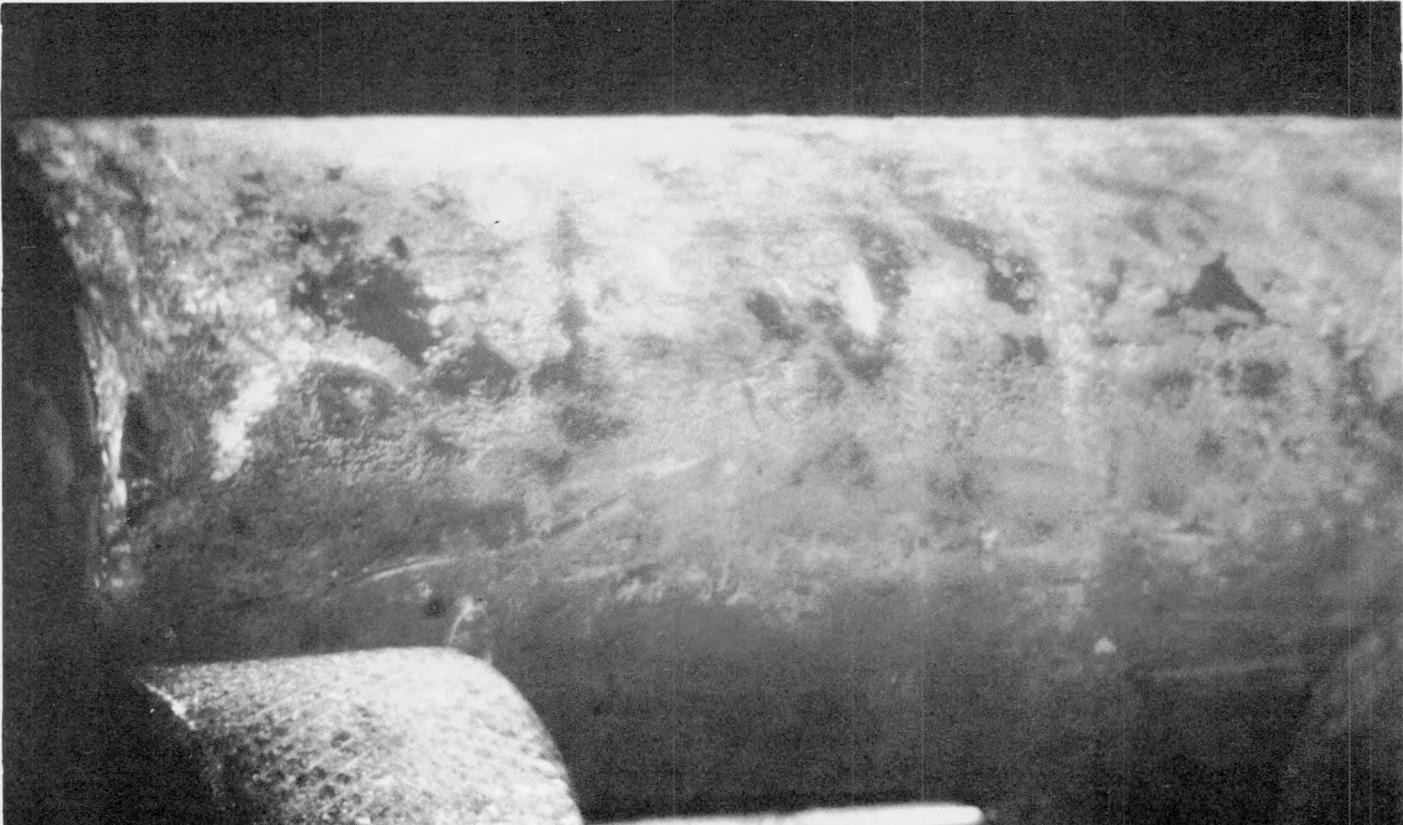
FIGURE 31

SLUG DISCHARGED JULY 31, 1952, FROM TUBE 3684-F

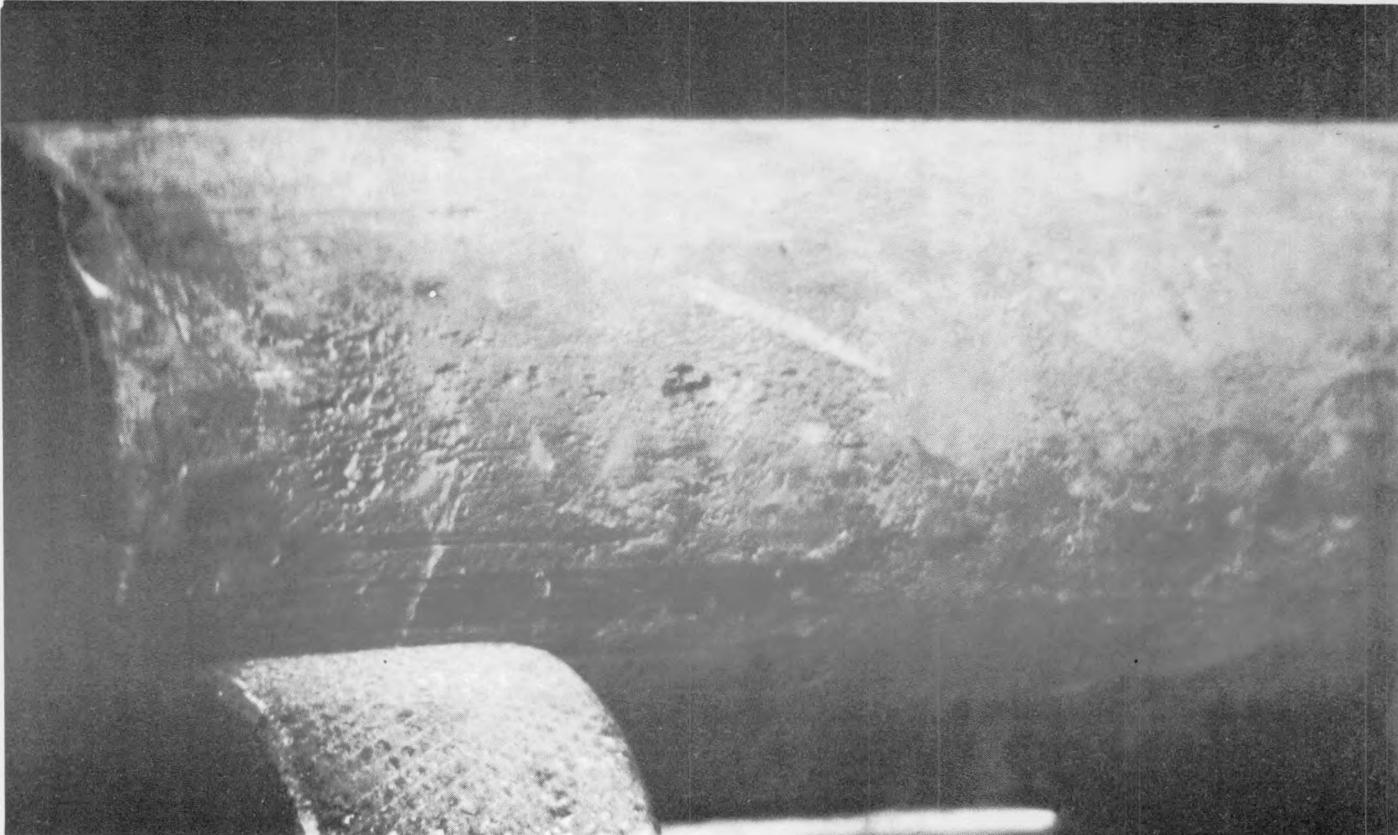
FIGURE 32

SLUG DISCHARGED JULY 31, 1952, FROM TUBE 3684-F

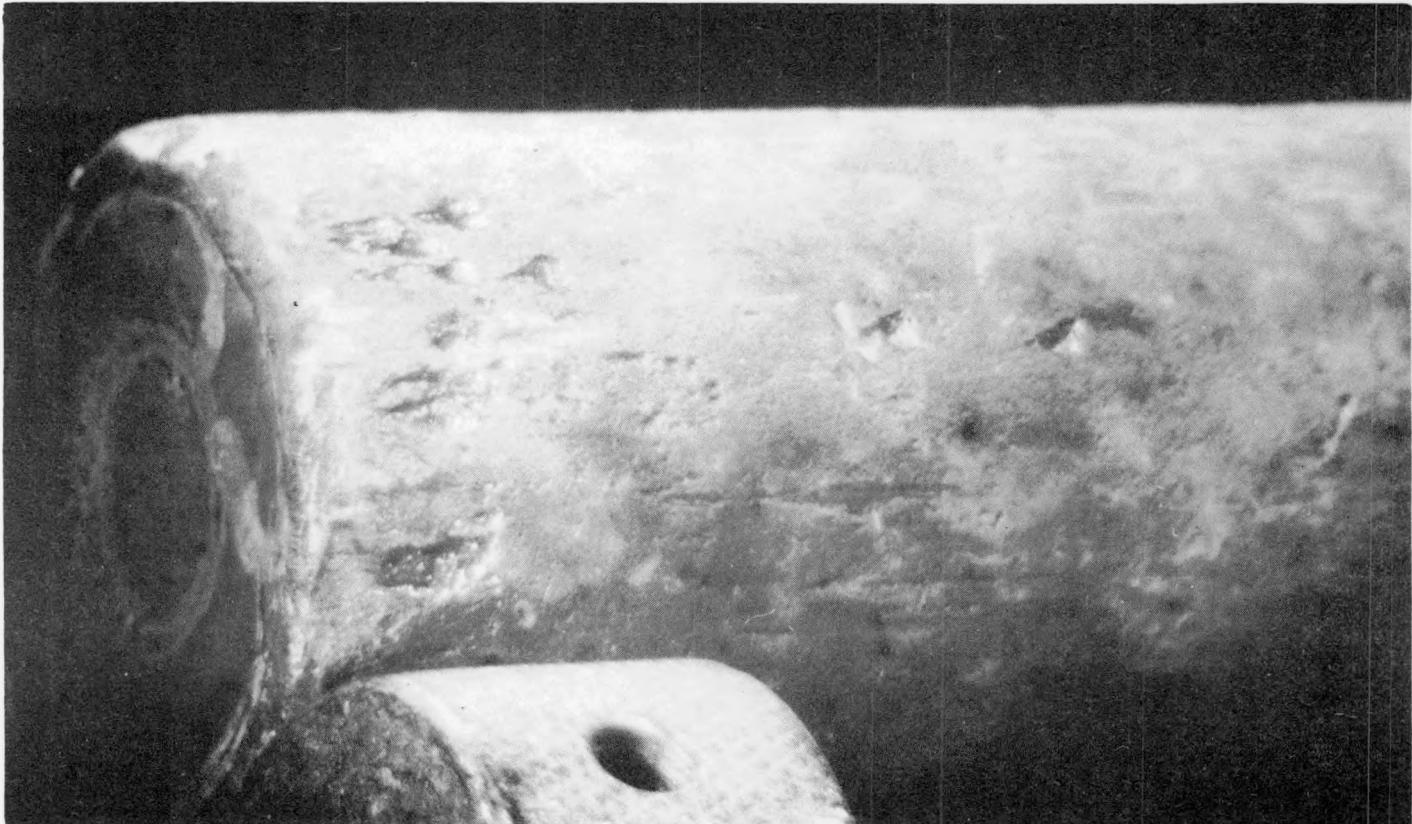
FIGURE 33

SLUG DISCHARGED JULY 31, 1952, FROM TUBE 3684-F

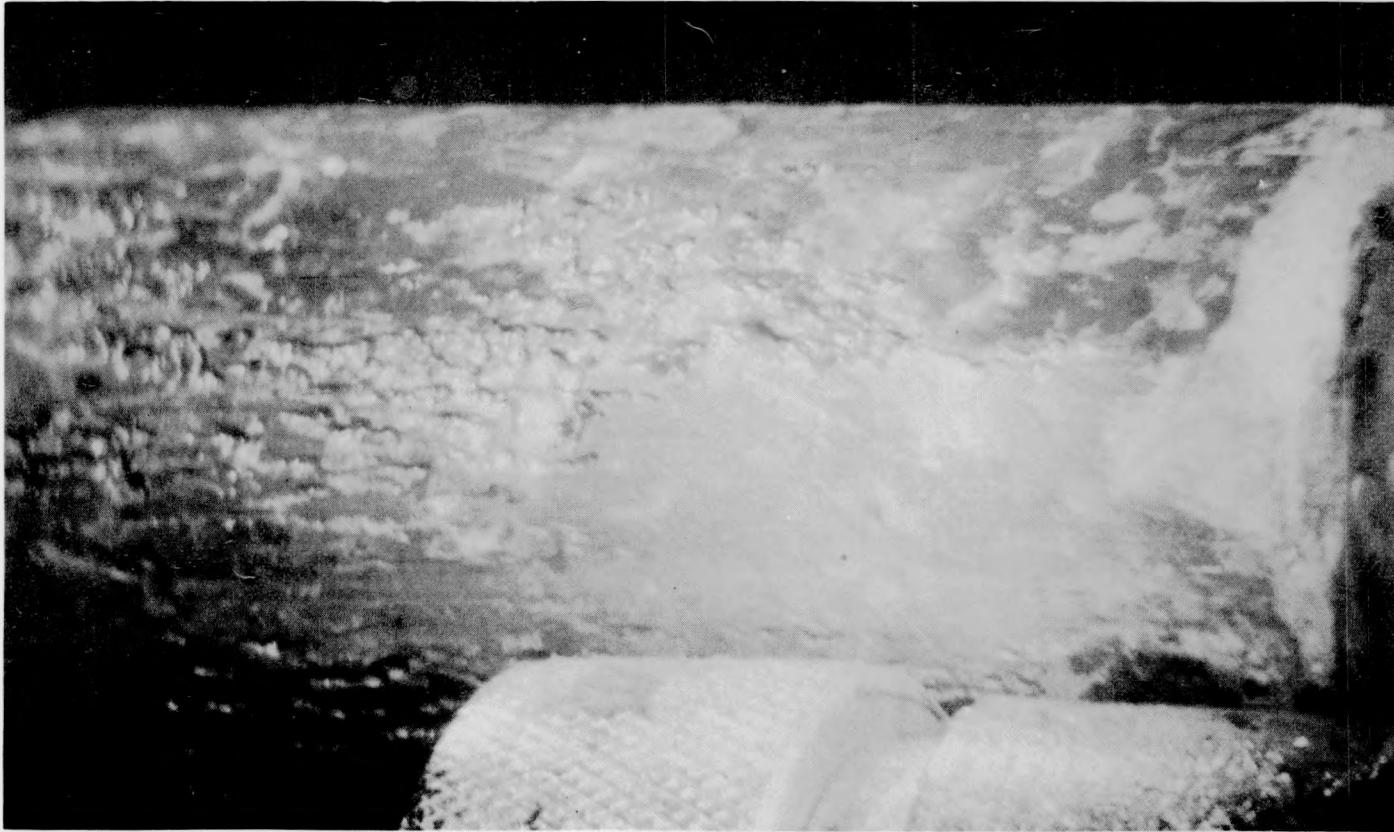
FIGURE 34

SLUG DISCHARGED JULY 31, 1952, FROM TUBE 3684-F

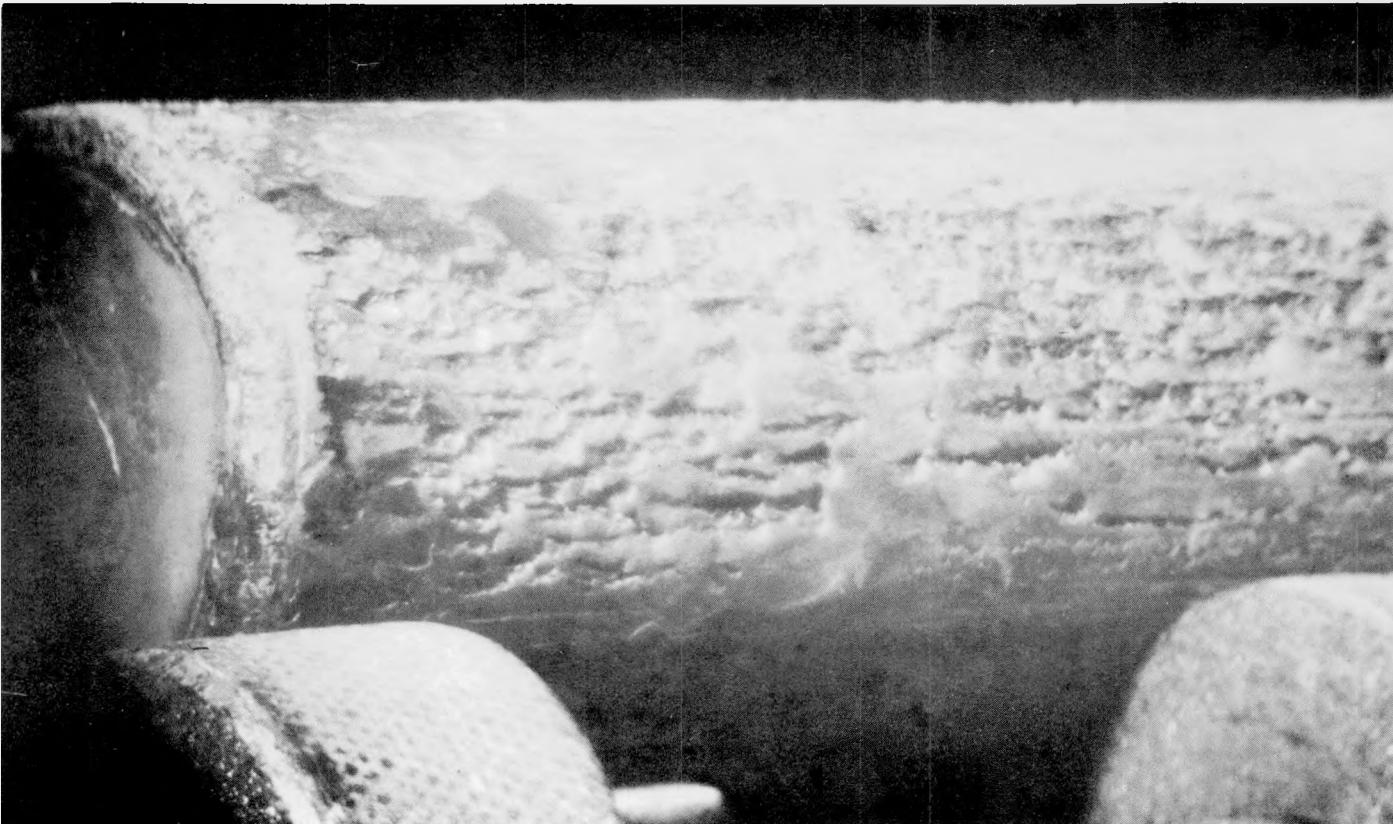
FIGURE 35

SLUG DISCHARGED JULY 31, 1952, FROM TUBE 3684-F

Another view of the slug shown in Figure 34.

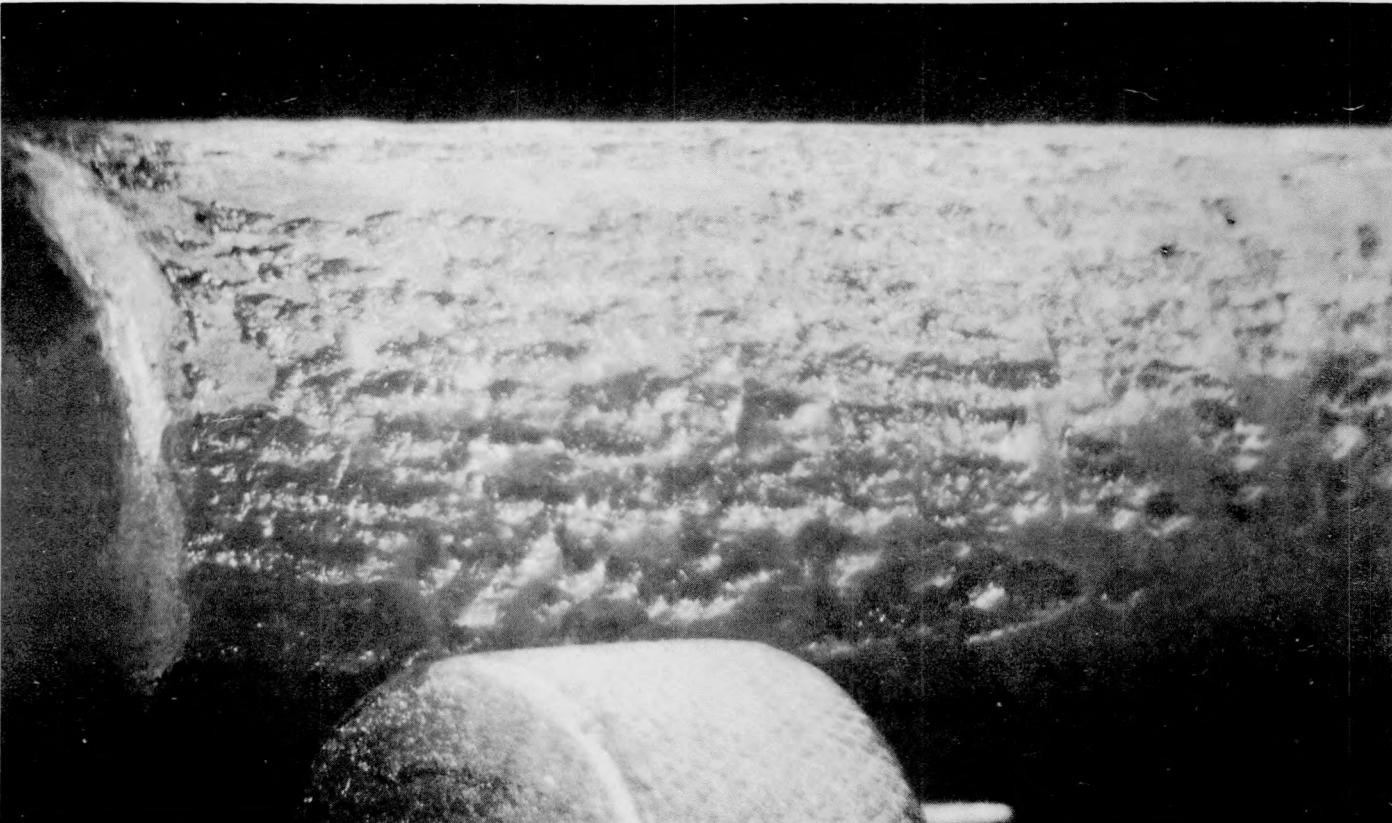
FIGURE 36

SLUG DISCHARGED JULY 31, 1952, FROM TUBE 3684-F

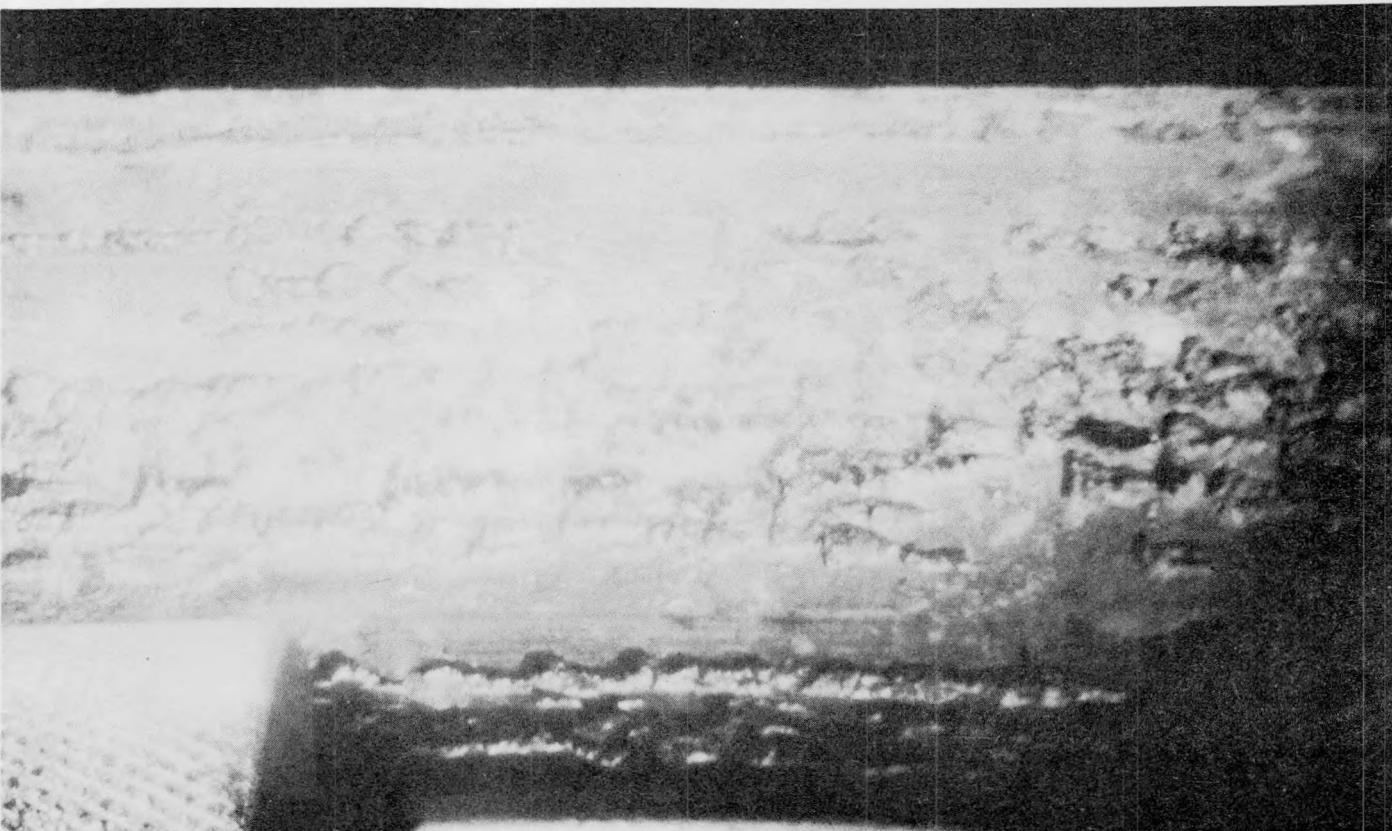
FIGURE 37

SLUG DISCHARGED JULY 31, 1952, FROM TUBE 3684-F

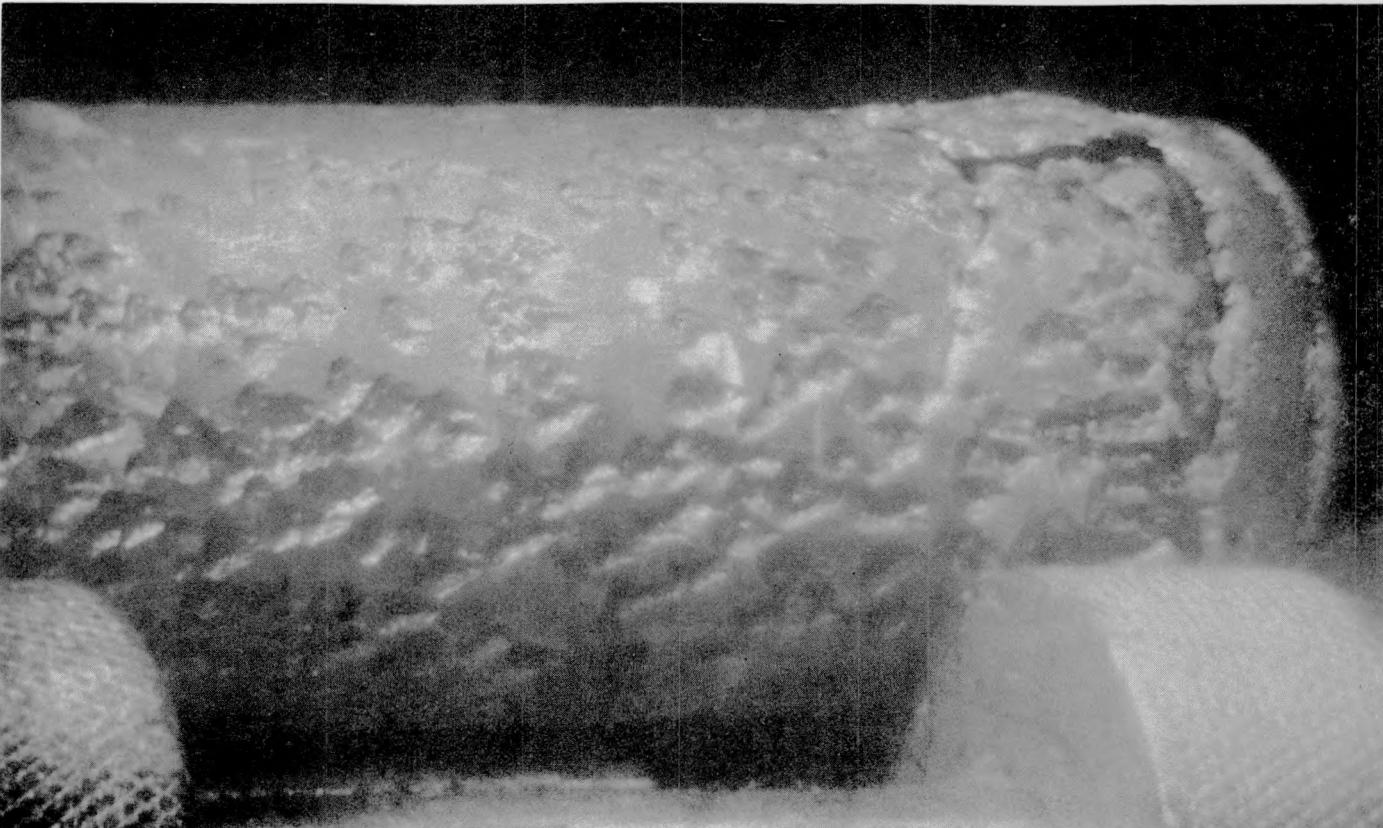
FIGURE 38

SLUG DISCHARGED AUGUST 24, 1952, FROM TUBE 3781-F

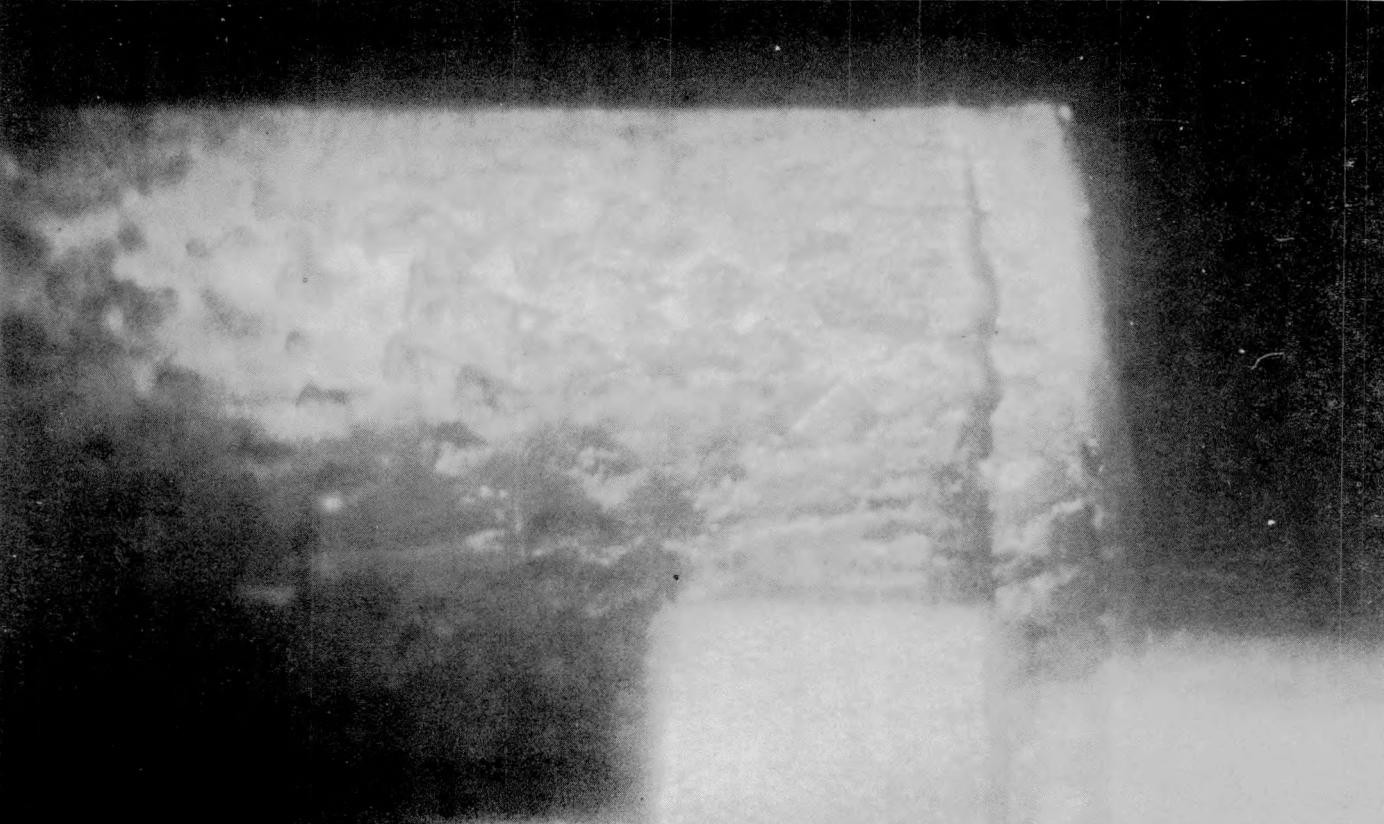
FIGURE 39

SLUG DISCHARGED AUGUST 24, 1952, FROM TUBE 3781-F

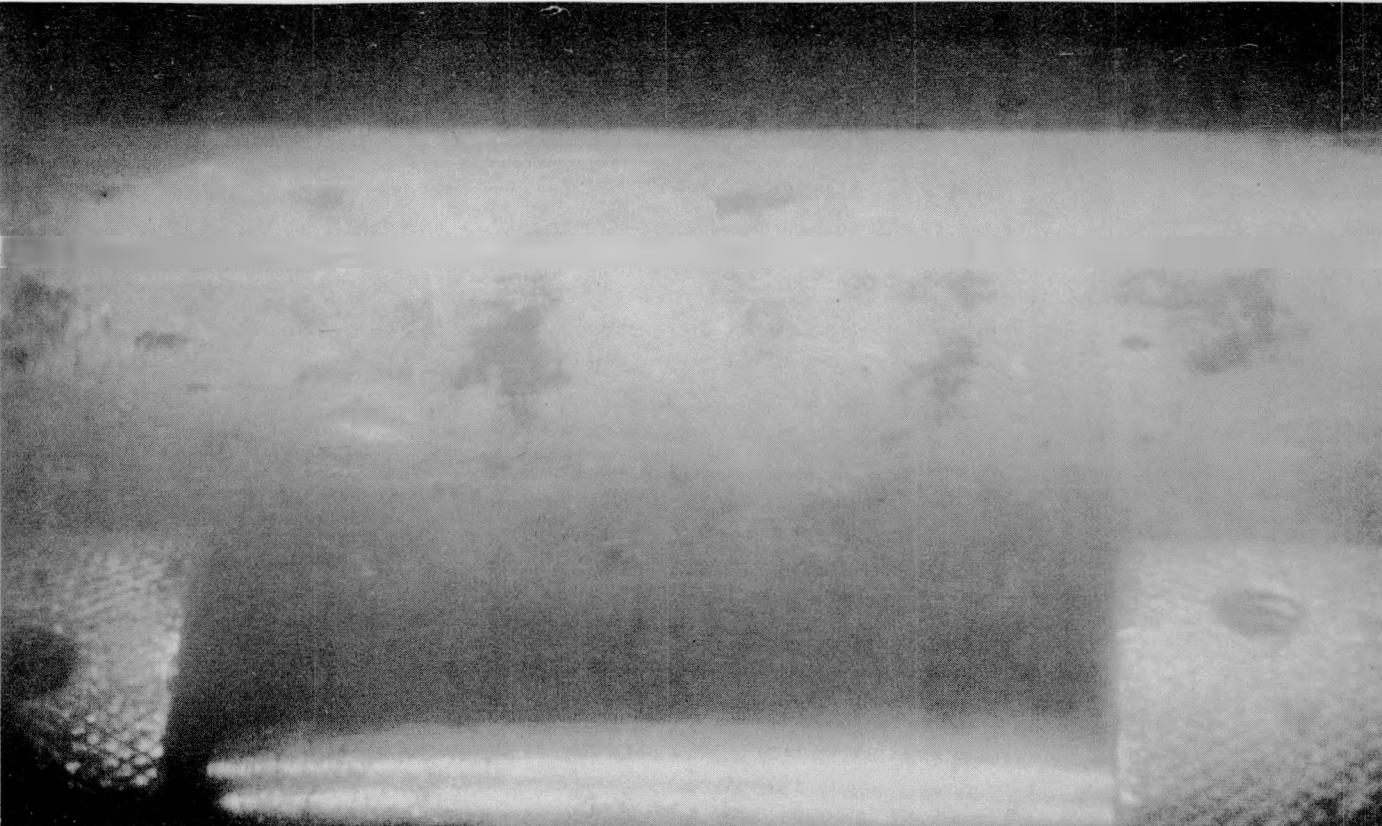
FIGURE 40

SLUG DISCHARGED AUGUST 31, 1952, FROM TUBE 3582-F

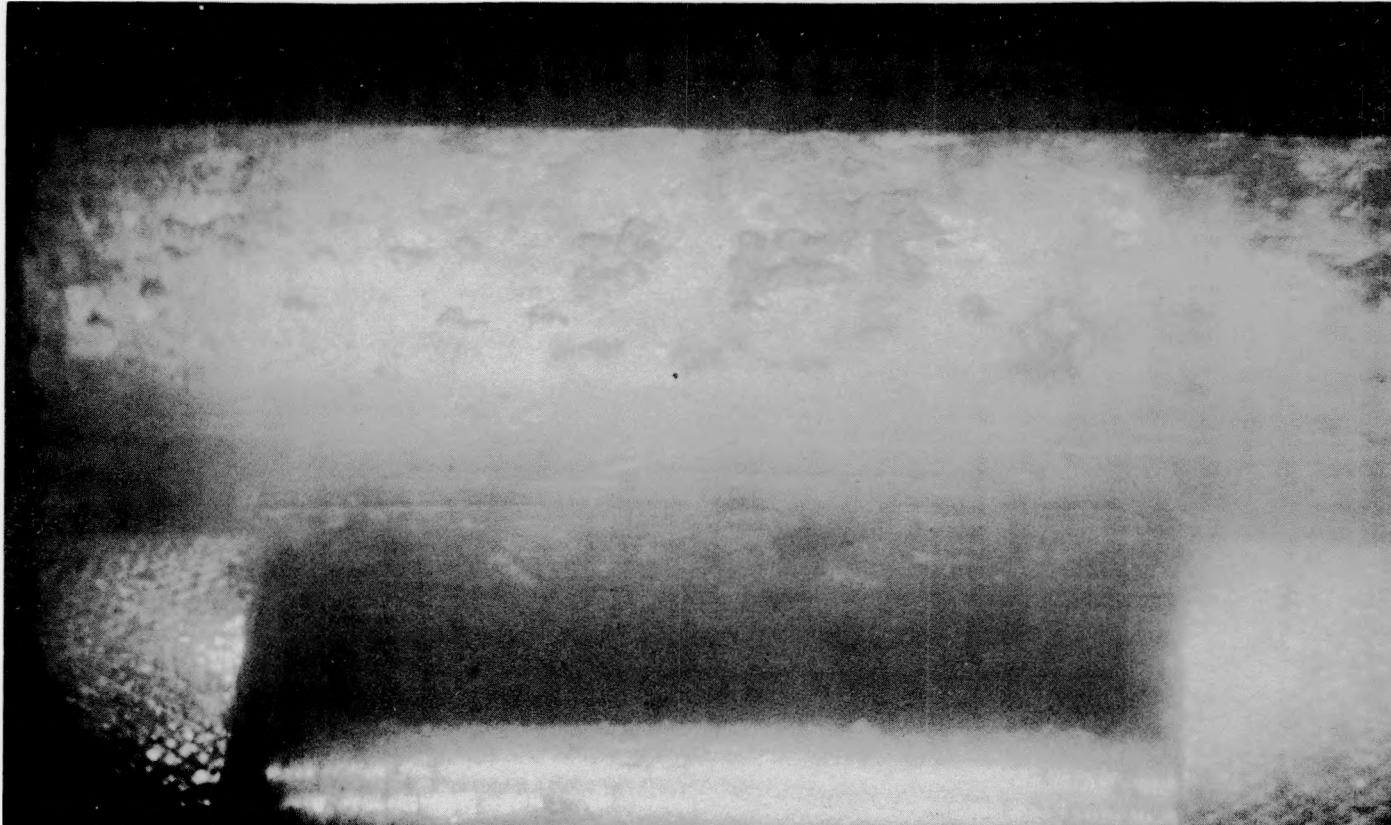
FIGURE 41

SLUG DISCHARGED AUGUST 31, 1952, FROM TUBE 3582-F

Another view of the slug shown in Figure 40.

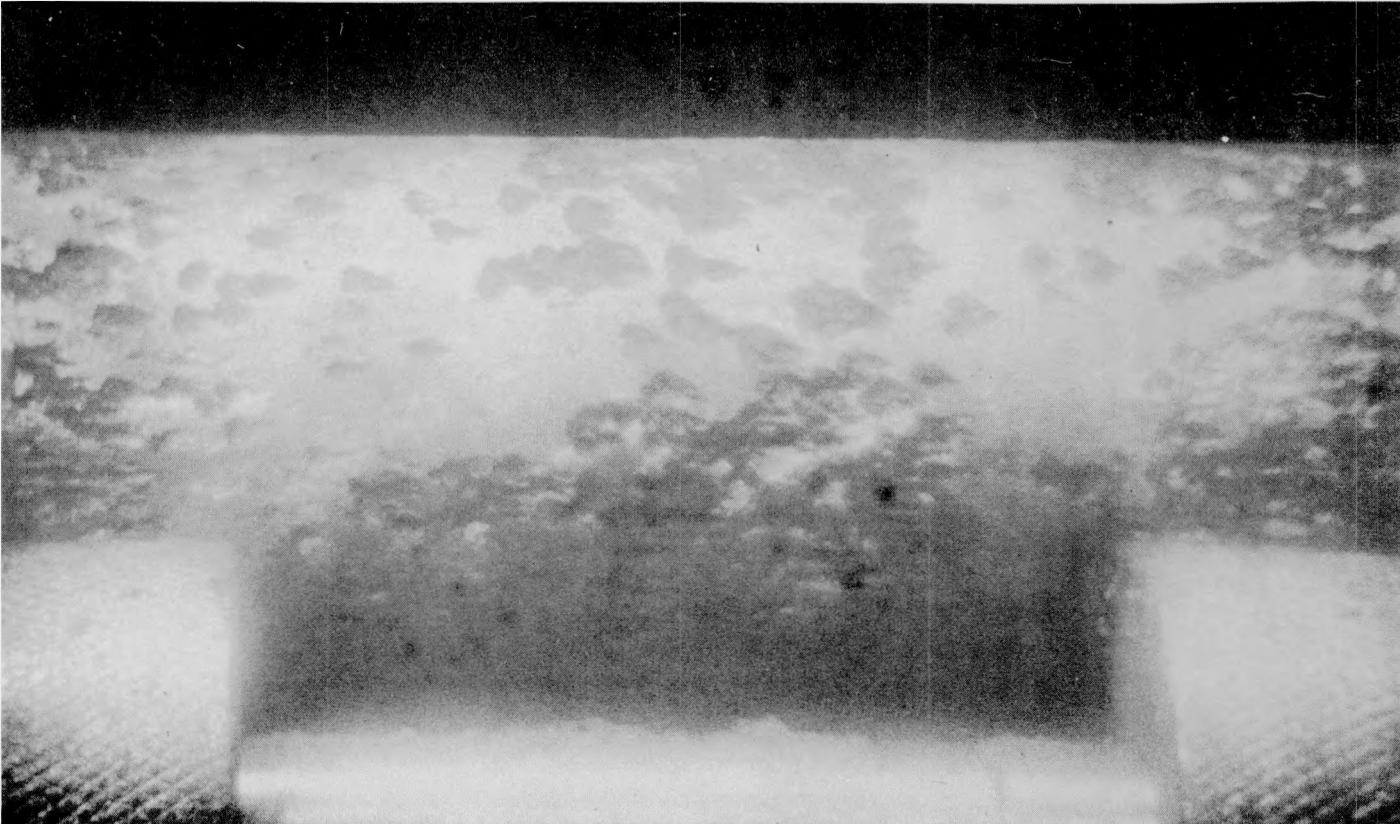
FIGURE 42

SLUG DISCHARGED AUGUST 31, 1952, FROM TUBE 3582-F
