HW - 29132

SEVERE PITTING ATTACK OF PILE PROCESS TUBES AND SLUGS

M. LEWIS AND R. A. ROHRBACHER

JUNE 30, 1953

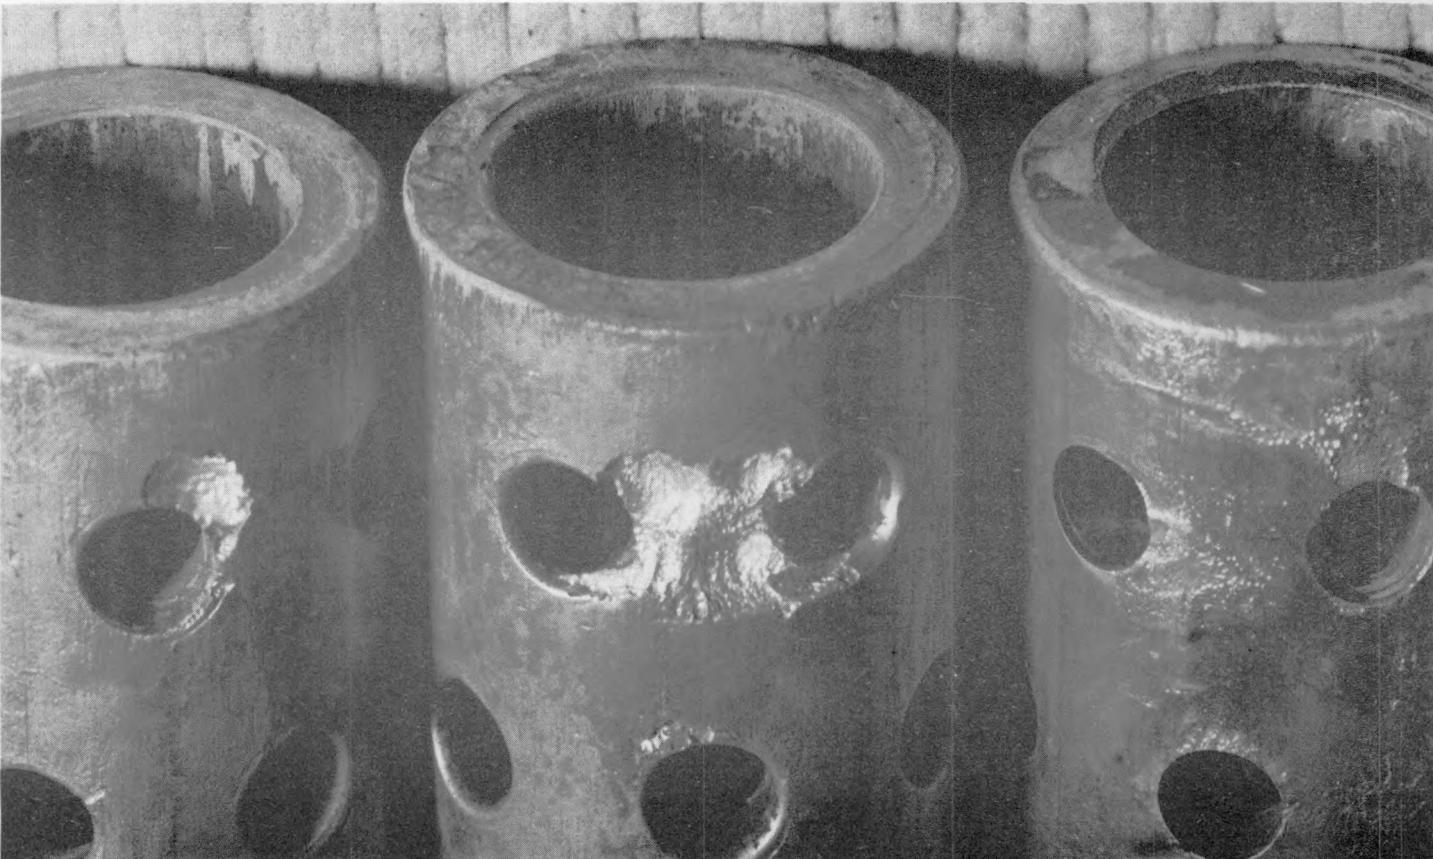
FIGURE 43

PERFORATED DUMMY SLUGS DISCHARGED FROM TUBE 3178-DR ON AUGUST 6, 1952

Note that the pitting attack on these dummy slugs is very similar to that shown in earlier figures which resulted in holes in process tube walls. The attack occurred only adjacent to the edge of the holes.

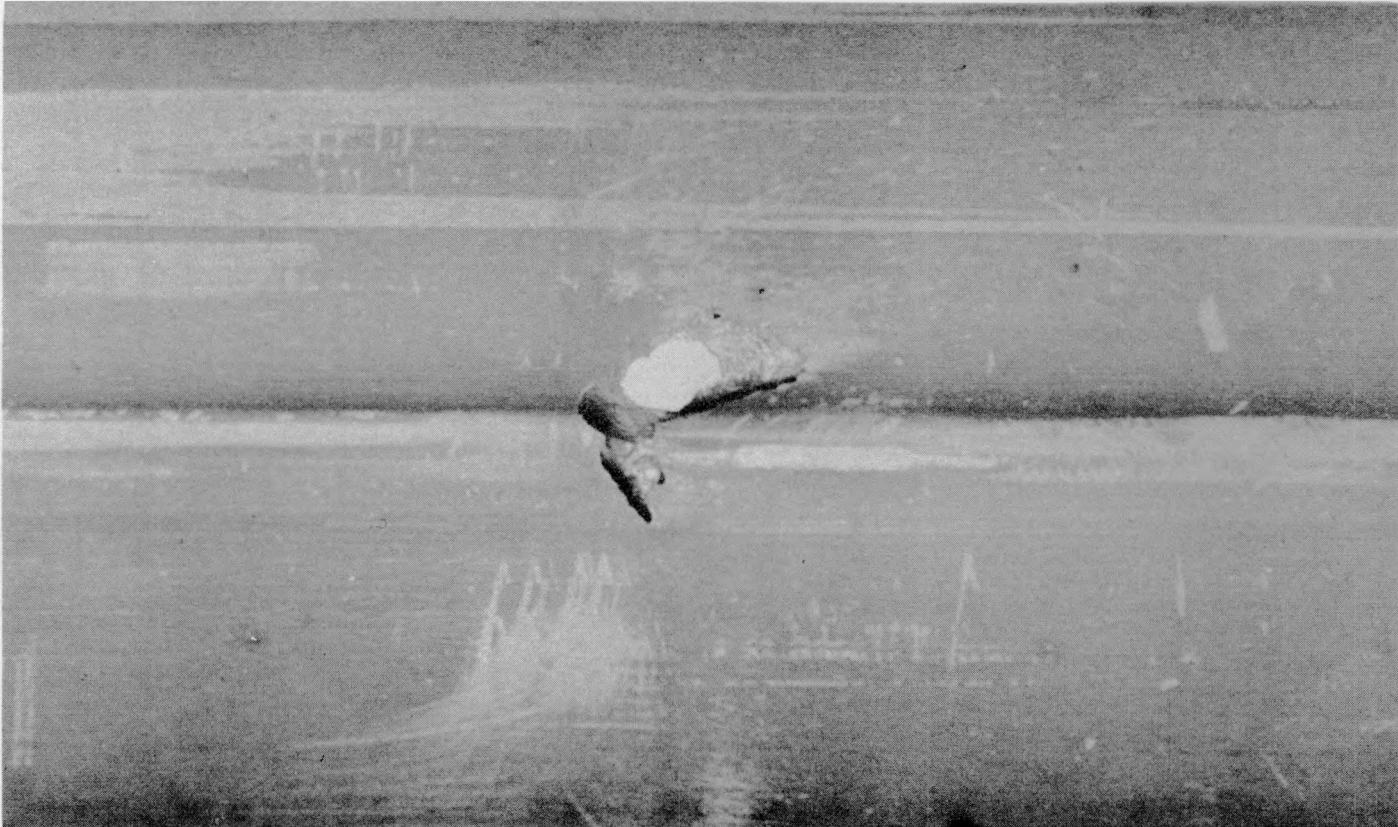
FIGURE 44

HOLE ADJACENT TO RIB INSIDE FLOW LABORATORY TUBE

Raw Columbia River water flowed from left to right in this tube at 20 gallons per minute and 95 C. Note the straddling of the rib by the pits. Compare with Figure 11.

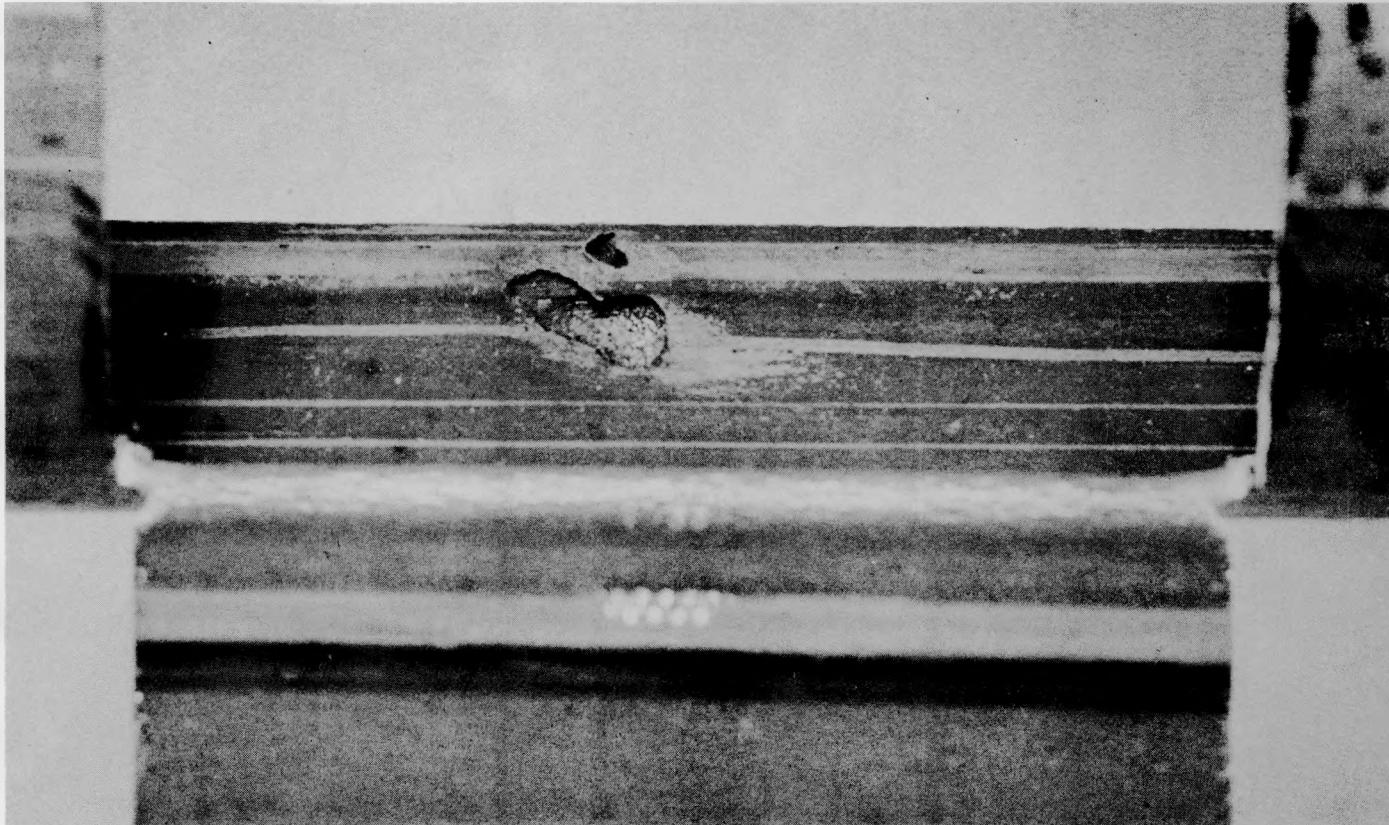
FIGURE 45

PITS ADJACENT TO RIB INSIDE FLOW LABORATORY TUBE

Same tube as Figure 44. These pits are located on opposite rib and one slug length upstream from the hole in Figure 44. Downstream is to the right.

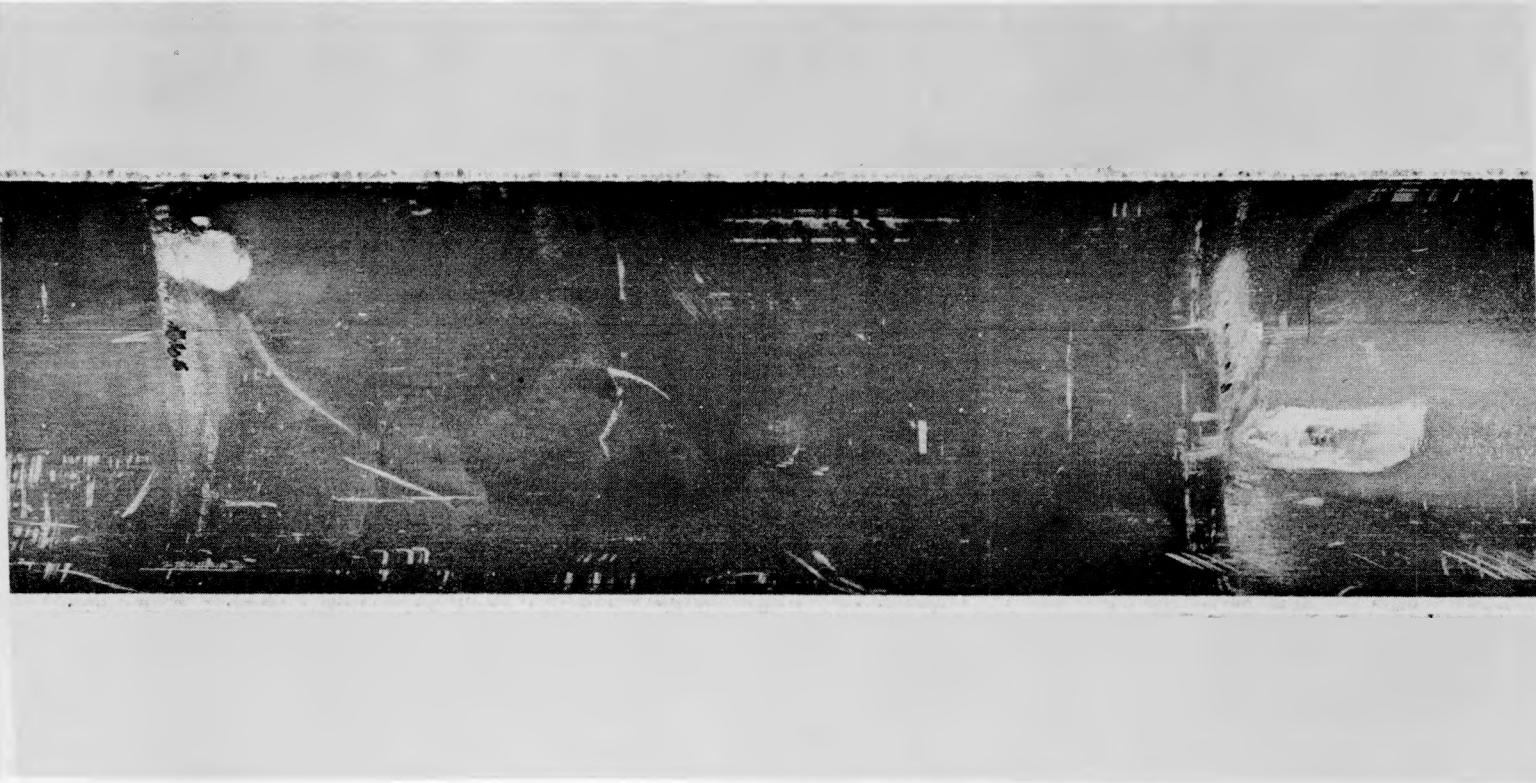
FIGURE 47

CLOSE-UP OF PITS INSIDE TOP OF FLOW LABORATORY TUBE

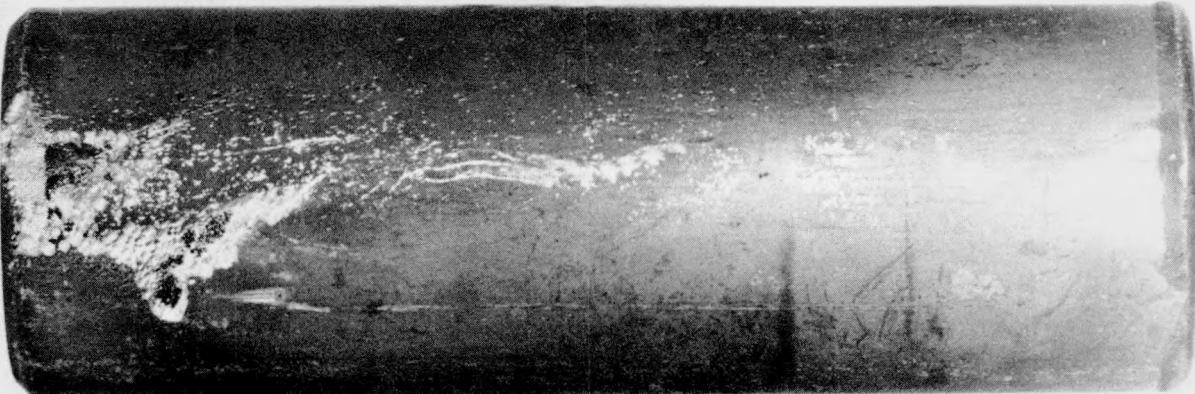
FIGURE 48
PITTED SLUG FROM FLOW LABORATORY TUBE

This slug was the first upstream slug in a tube through which ferric sulfate treated, dichromate-free water flowed at 20 gallons per minute and 95 C. The pitted end was upstream.

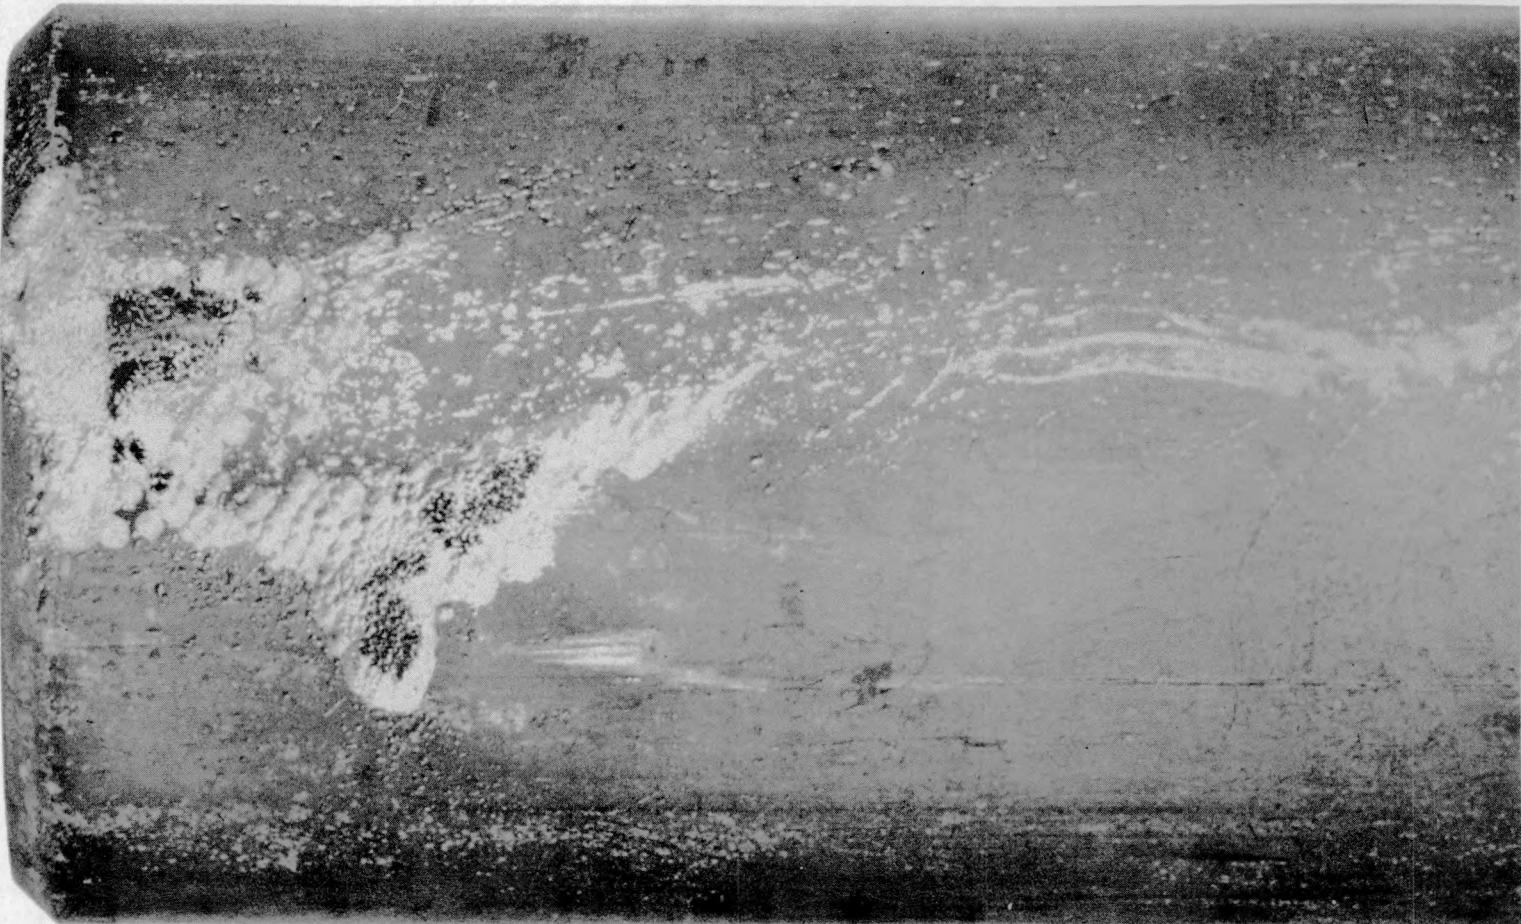
FIGURE 49
ENLARGEMENT OF PITTED SLUG IN FIGURE 48

This enlargement of the upstream end of the slug shows the discrete nature of the pits. The black areas are AlSi.

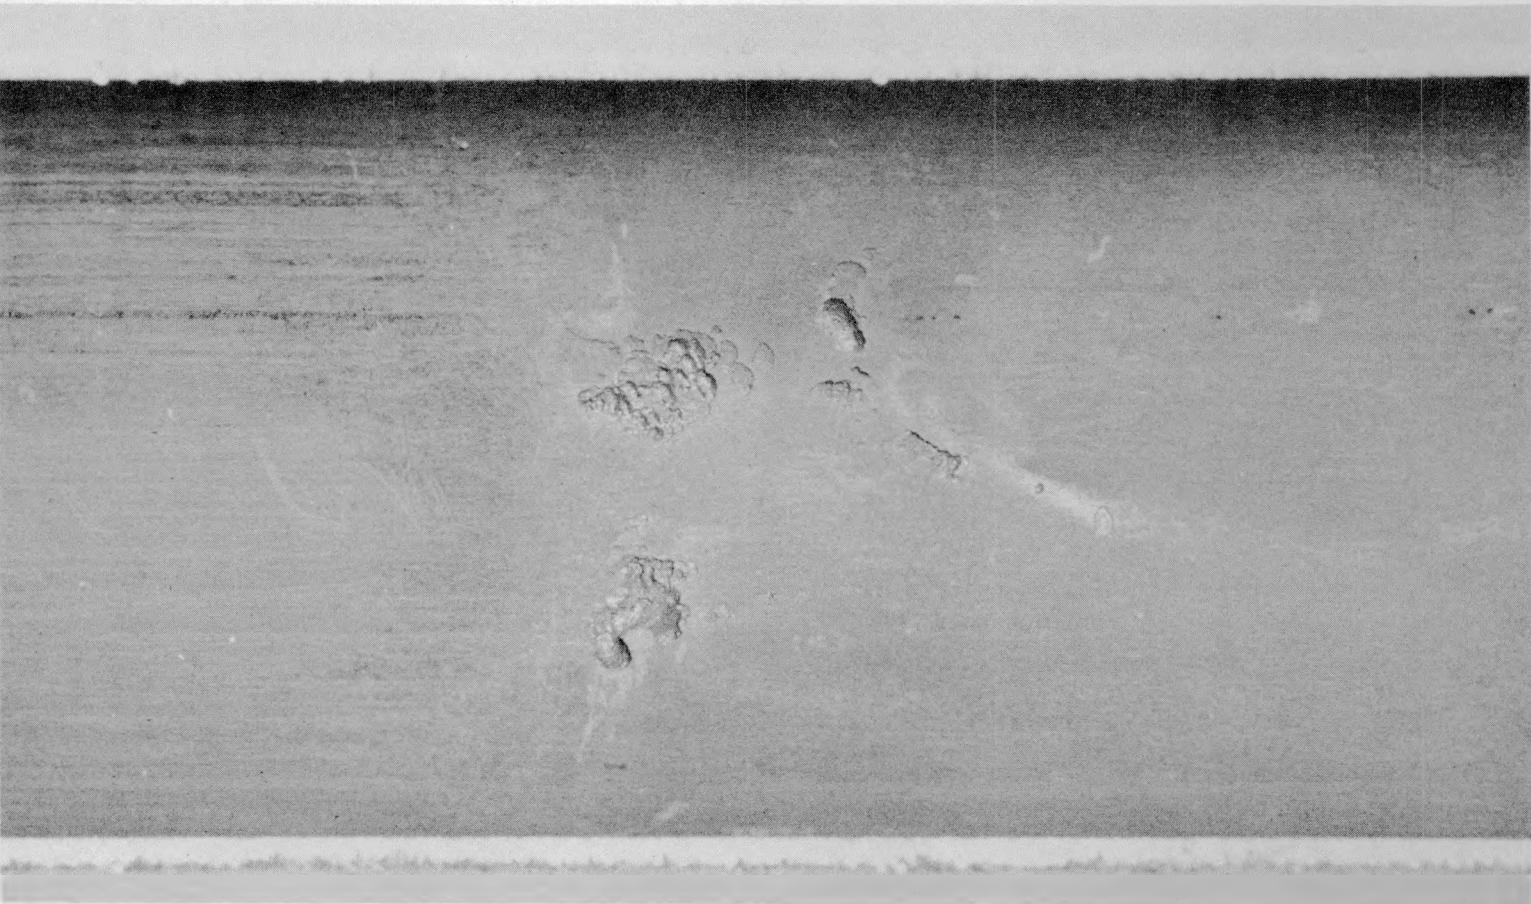
FIGURE 50

PITS INSIDE TOP OF FLOW LABORATORY TUBE

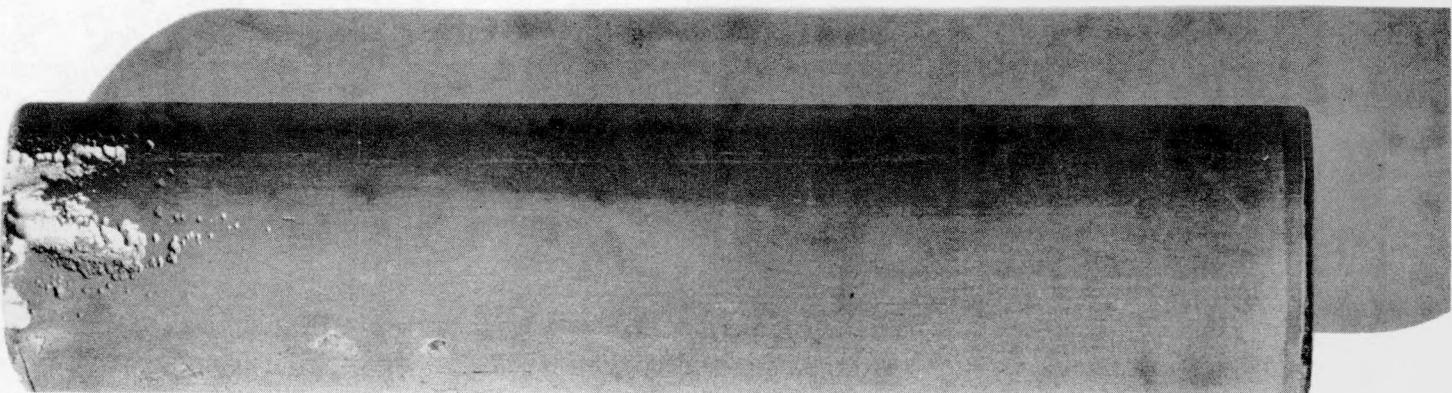
FIGURE 51

PITTED LEAD DUMMY SLUG FROM FLOW LABORATORY TUBE

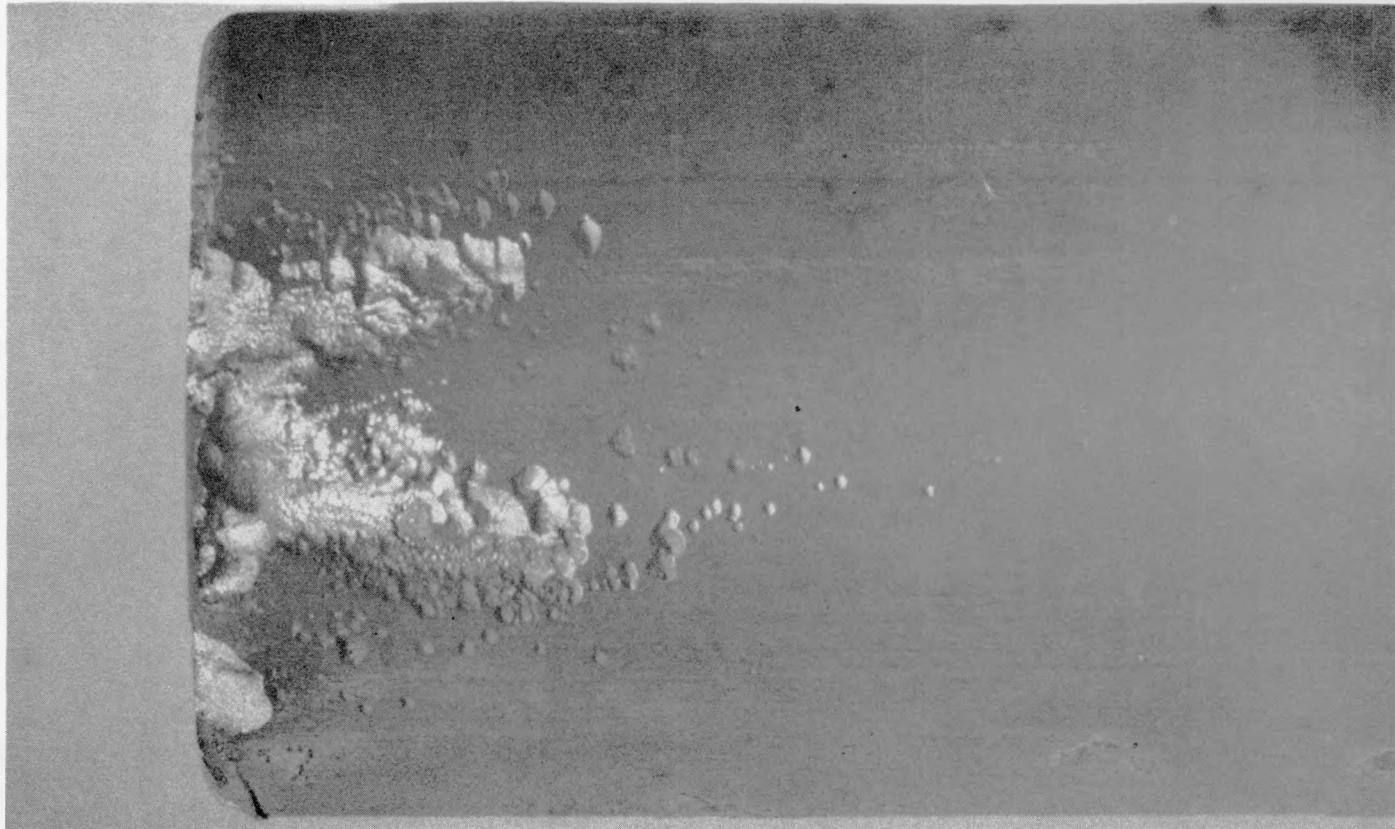
FIGURE 52

ENLARGEMENT OF PITTED SLUG IN FIGURE 51

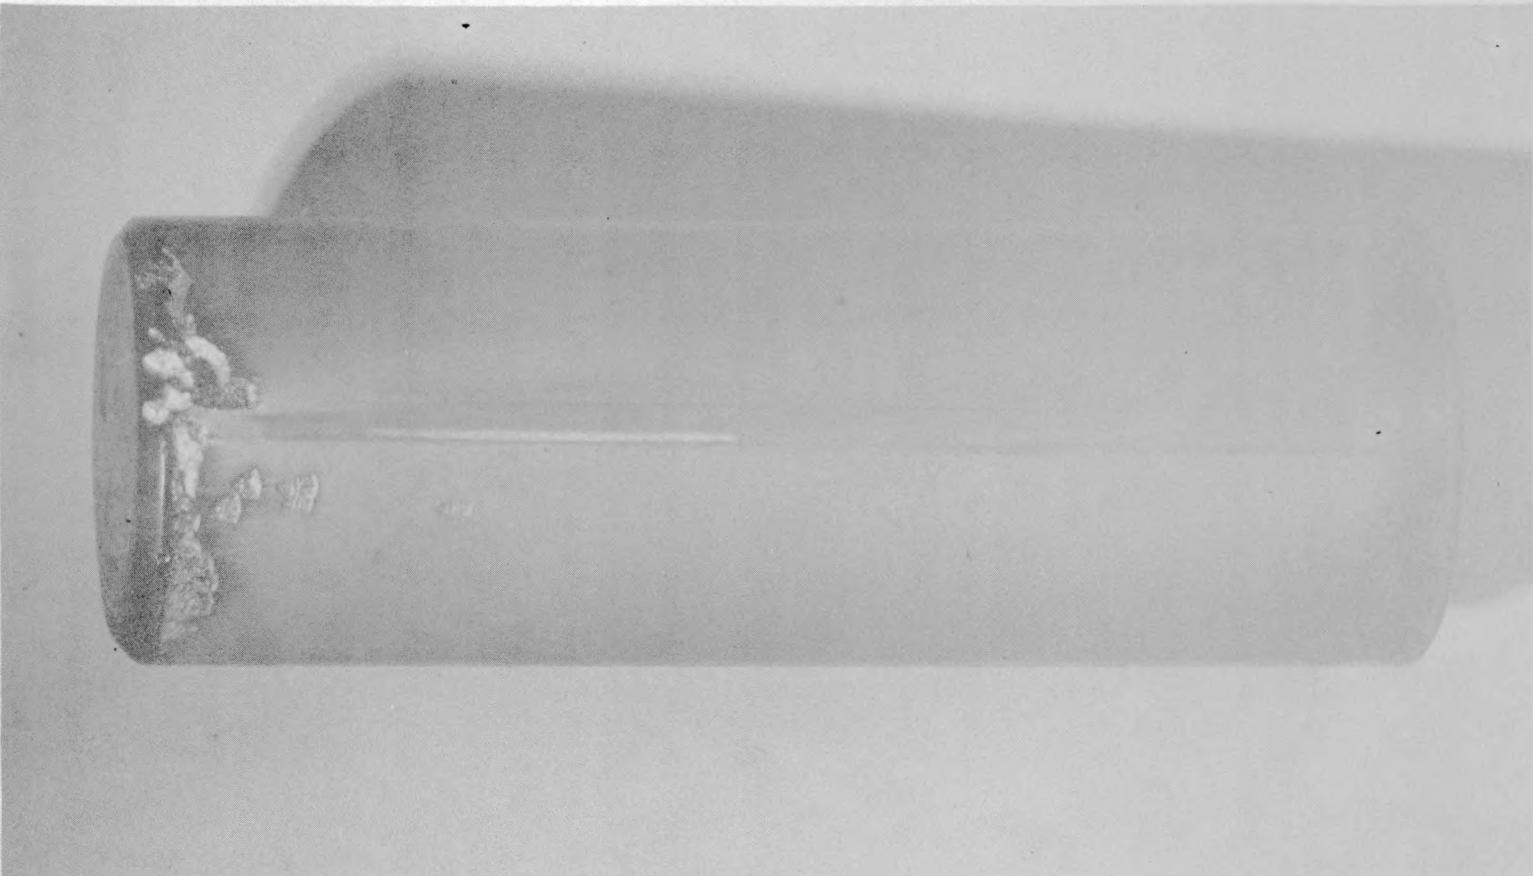
FIGURE 53

PITTED SLUG FROM FLOW LABORATORY TUBE

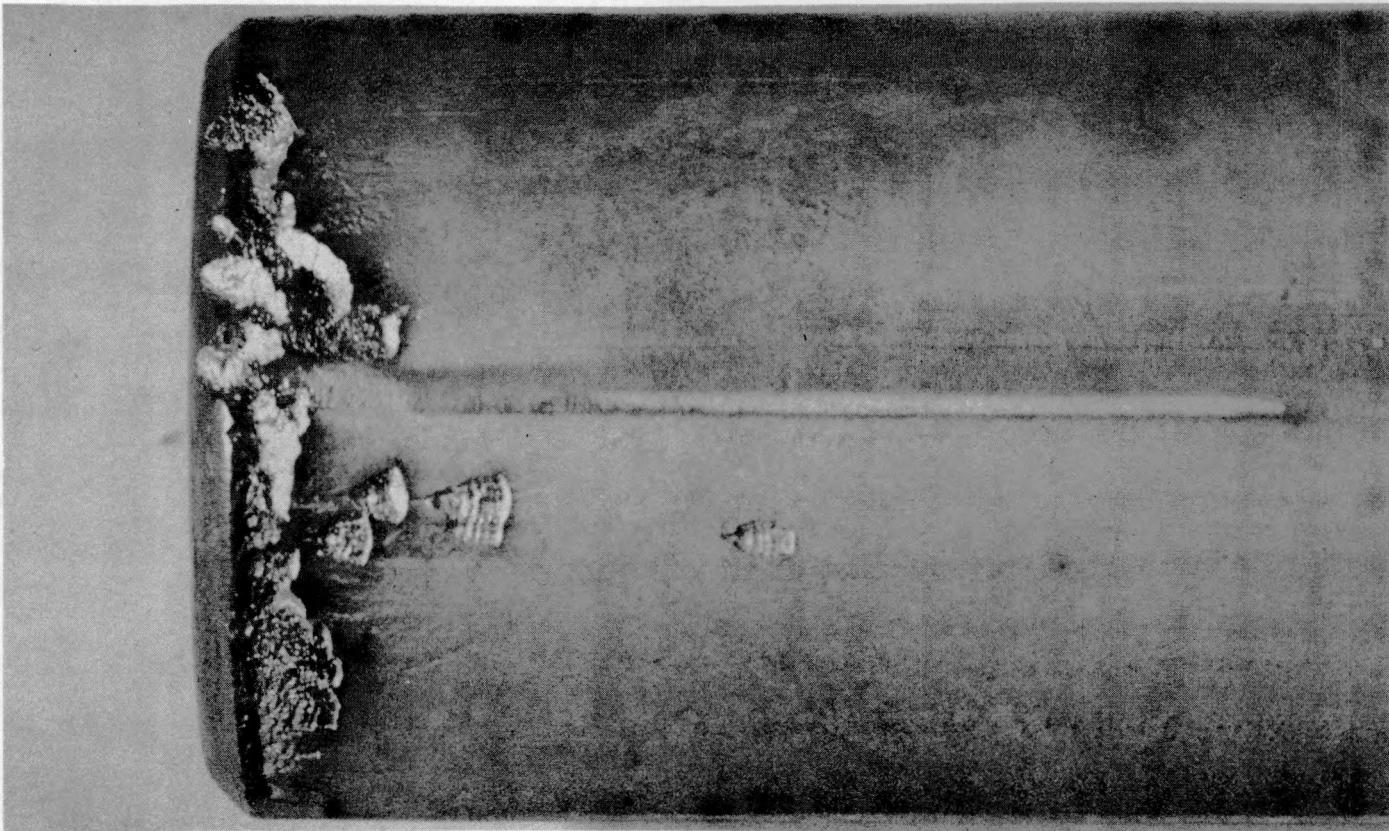
FIGURE 54
ENLARGEMENT OF PITTED SLUG IN FIGURE 53

Note the sharply defined, triangular pits with apexes pointing upstream. Note the sharp line of demarcation where the pitted area starts at the downstream edge of the bevel.

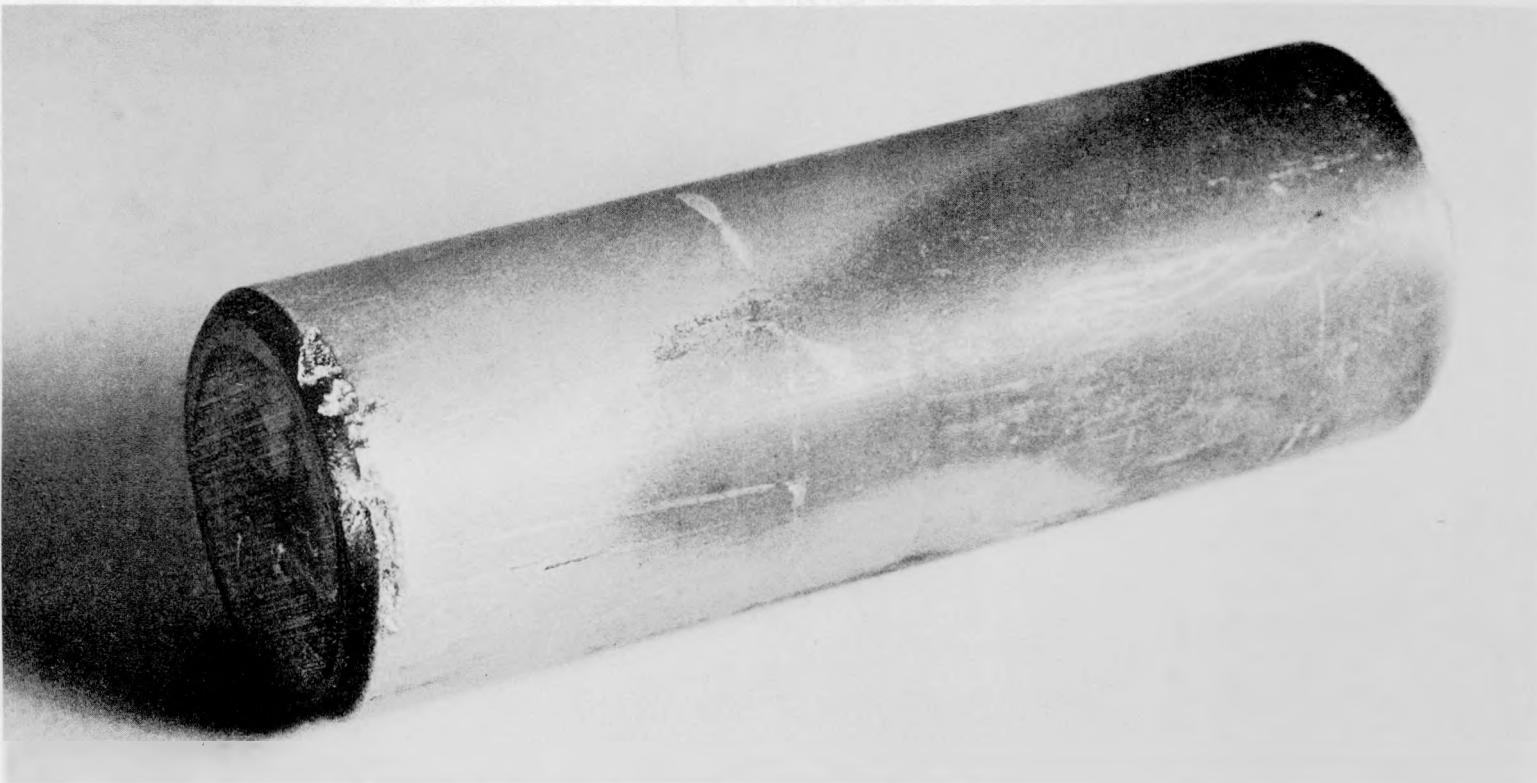
FIGURE 55

PITTED SLUG FROM SAME TUBE AS SLUG IN FIGURE 53

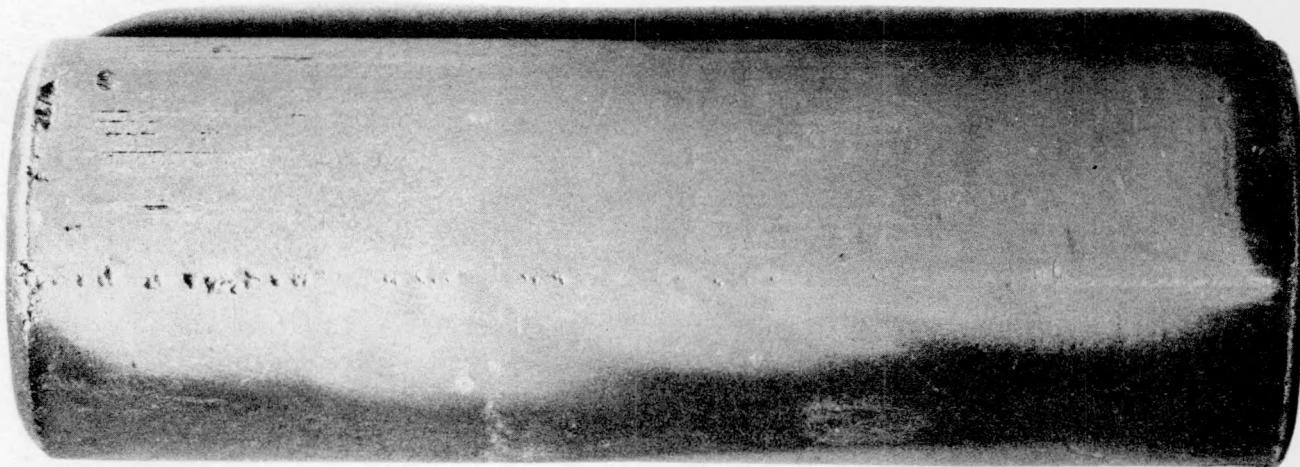
FIGURE 56
OPPOSITE SIDE OF SLUG IN FIGURE 55

Note additional pits immediately downstream from bevel, and pits along line opposite tube rib.
Particles that may have lodged between slug and rib may have caused pits.
Rib and slug were in direct contact at downstream end.

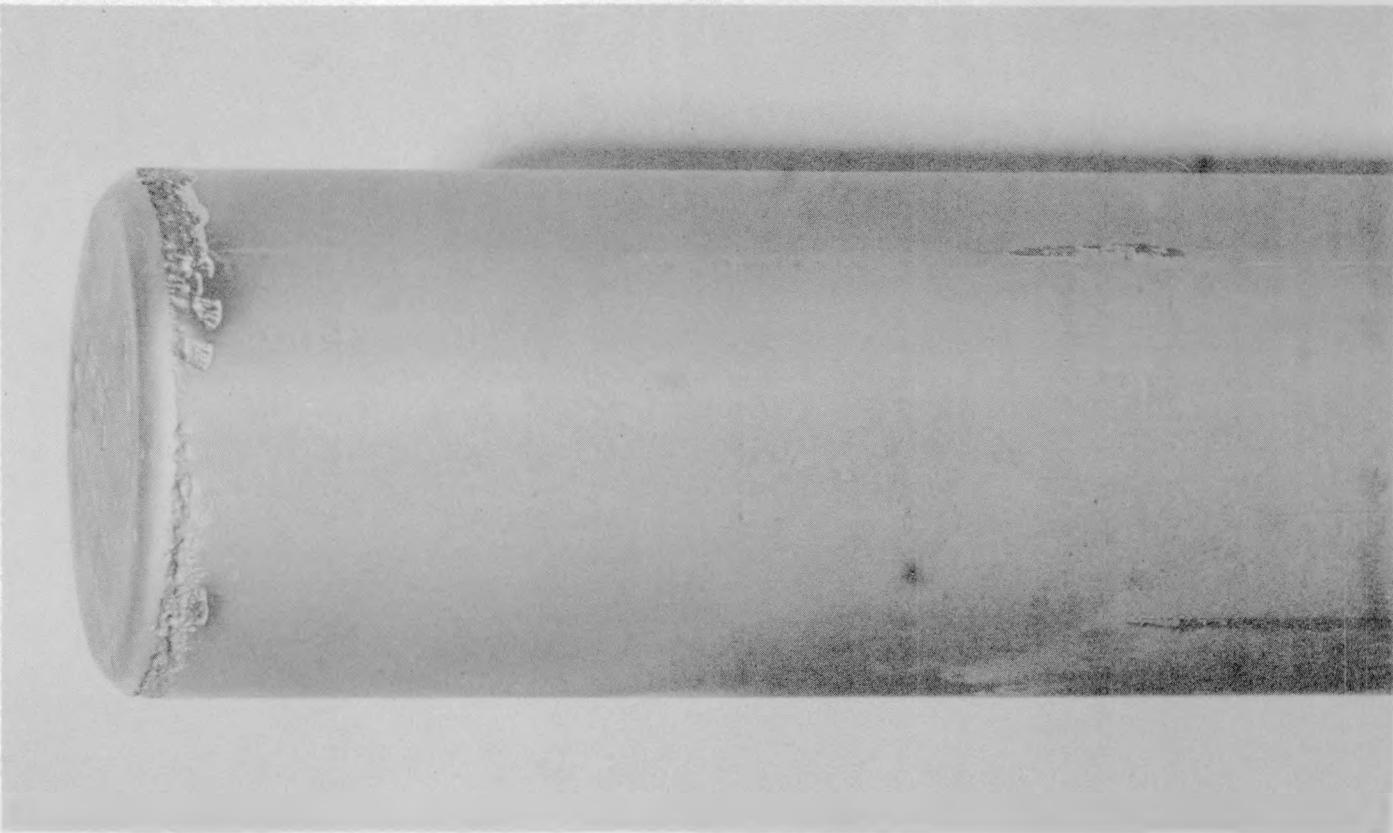
FIGURE 57
PITTED SLUG FROM TUBE SHOWN IN FIGURE 58

This slug was not intentionally cocked and may not have been cocked at all. A cocked slug located two slug lengths upstream of this one was not pitted nor was the slug between them. Note sharp demarcation of pitted areas immediately downstream of the bevel.

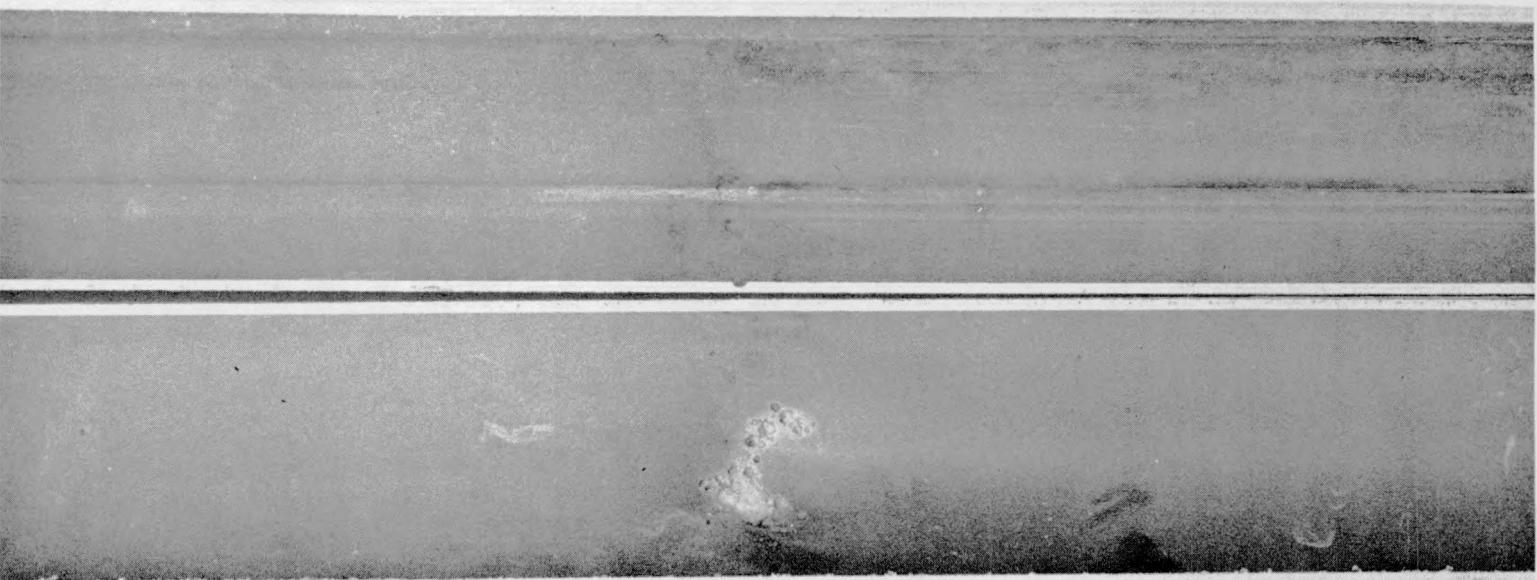
FIGURE 58

PITTED AREA INSIDE TOP OF TUBE
