Corrosion of SA1388-1 Diodes

Carol Krska and Chuck Stimetz
Allied Signal - FM&T

Jeff Braithwaite, Rob Sorensen, and Paul Hlava
Sandia National Laboratories - NM

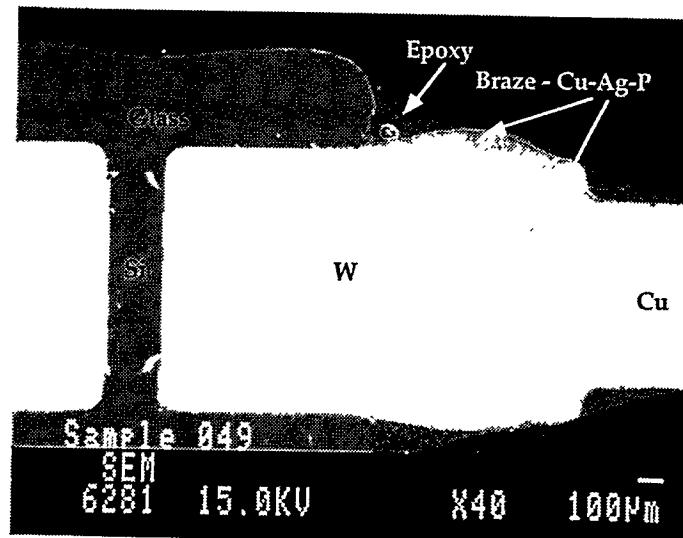
The physical configuration of the SA1388-1 diode is shown in Figure 1. The primary function of this device is performed by a silicon-based semiconductor that is bonded to two cylinders of tungsten. Copper headpins (Cu wire with a flat "nailhead" formed on one end) are brazed to the exposed tungsten cylinders. A toroidal ring of glass protects the Si chip. An immersion plating of Ag covers all exposed metal parts. The entire assembly is coated with black epoxy ink, and a band of green ink is applied to the cathode end. During storage, each diode was placed in a cardboard holder and secured in packages of about ten with rubber bands. In some cases, these packages were then placed in plastic bags.

Figure 1. SEM image of the diode at 40x showing the basic construction
