PHOTOVOLTAIC LIGHTING SYSTEM PERFORMANCE

Steve R. Harrington
 Formerly of Ktech Corporation at
 Sandia National Laboratories, Dept. 6218
 Photovoltaic Systems Applications.
 Albuquerque, New Mexico USA

Thomas D. Hund
 Sandia National Laboratories, Dept. 6218
 Photovoltaic Systems Applications
 Albuquerque, New Mexico USA

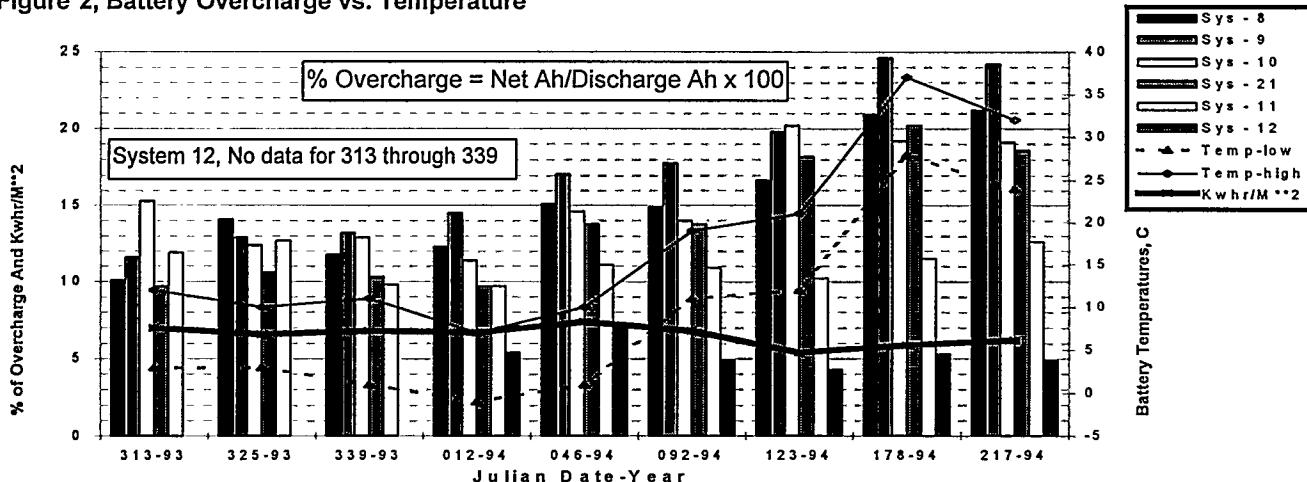
Figure 2, Battery Overcharge vs. Temperature

Figure 2 shows the percentage of overcharge and the effect temperature has on it from Nov. 9, 1993 (313) through Aug. 5, 1994 (217). The PV array is tilted at 45° to optimize for winter operation which results in a fairly even distribution of solar energy on the array throughout the year. The days picked are clear days of full sun. The batteries are still affected by temperature changes from the seasons even though the charge controllers have temperature compensation. All of the systems use a Zomeworks Coolcell_{tm} which reduces the battery temperature swings. Outside ambient temperatures are not available. As seen in Figure 2, the batteries in systems 8, 9, 10, and 21 are all flooded deep-cycle lead-antimony batteries and received 10 to 25% overcharge; they require about 15-25% overcharge. The constant voltage systems 8 and 9 appear to deliver slightly more overcharge than the on/off controllers in system 10 and 21. The batteries with more overcharge should have a higher specific gravity, higher water consumption, and higher available capacity.

Systems 11 & 12 use VRLA batteries and require less overcharge (~ 5-10%). Overcharge for the VRLA batteries appears to be less affected by the increase in temperature when compared to flooded batteries and more affected by

the type of charge control. The two charging strategies show significant differences (50%) in the overcharge delivered to the VRLA batteries. These systems will be monitored until end of life to determine the effect of the variations in measured overcharge.
