ORNL/RASA-95/2

**Results of the Independent
Radiological Verification Survey
of the Remedial Action
Performed at 525 S. Main Street
Oxford, Ohio
(OXO002)**

HEALTH SCIENCES RESEARCH DIVISION
Environmental Restoration and Waste Management Non-Defense Programs
(Activity No. EX 20 20 010)

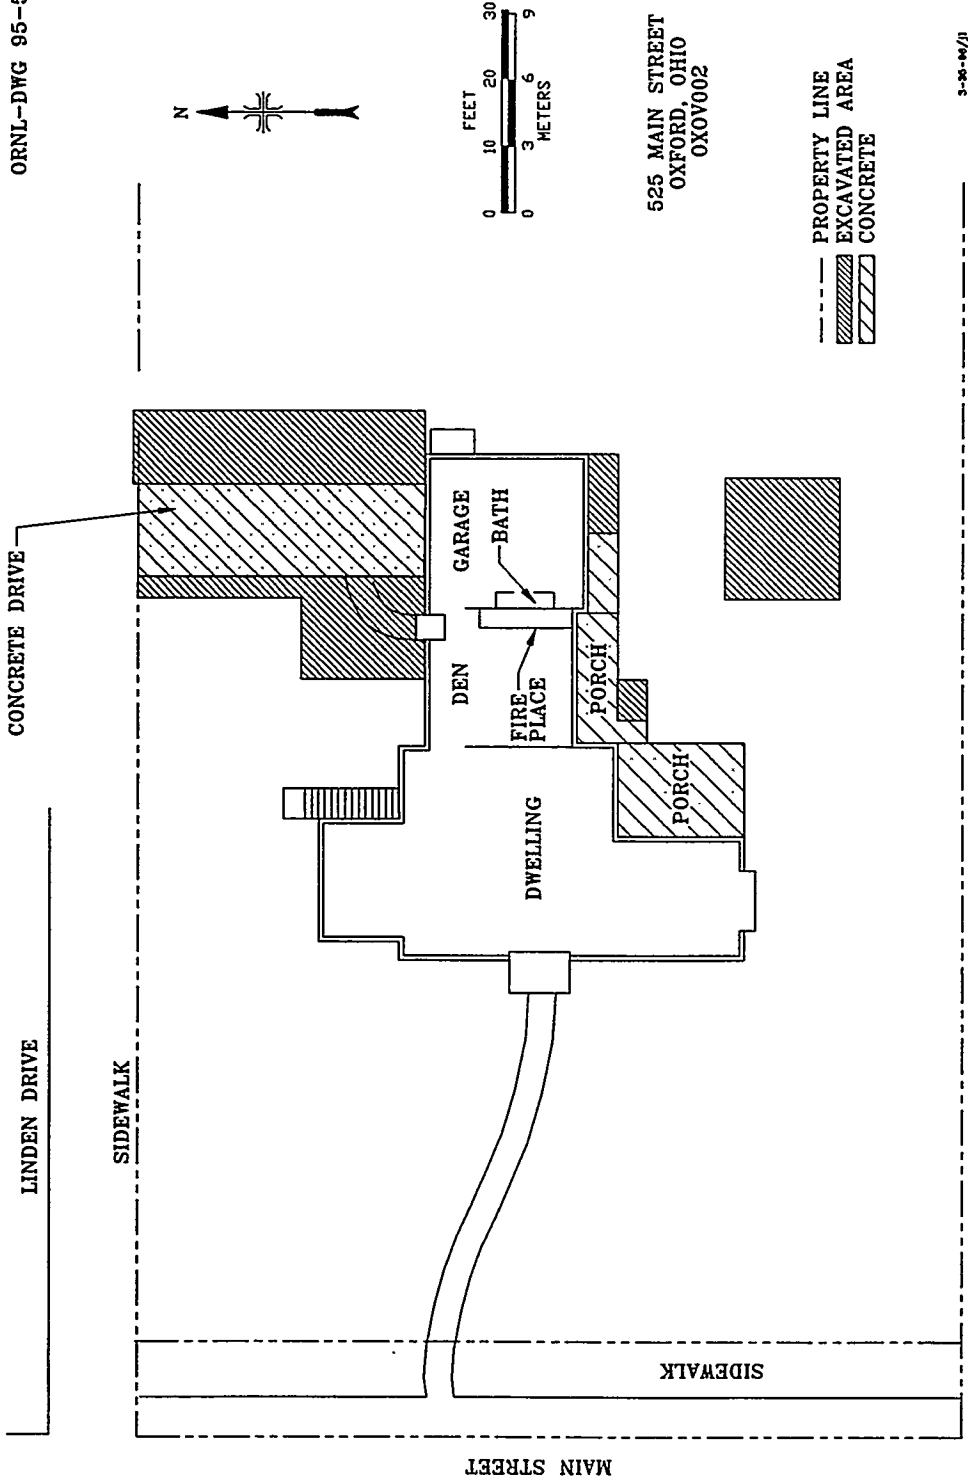
ORNL-DWG 95-5605

Fig. 3. Diagram showing the layout of the residential property at 525 S. Main Street and the excavated areas.

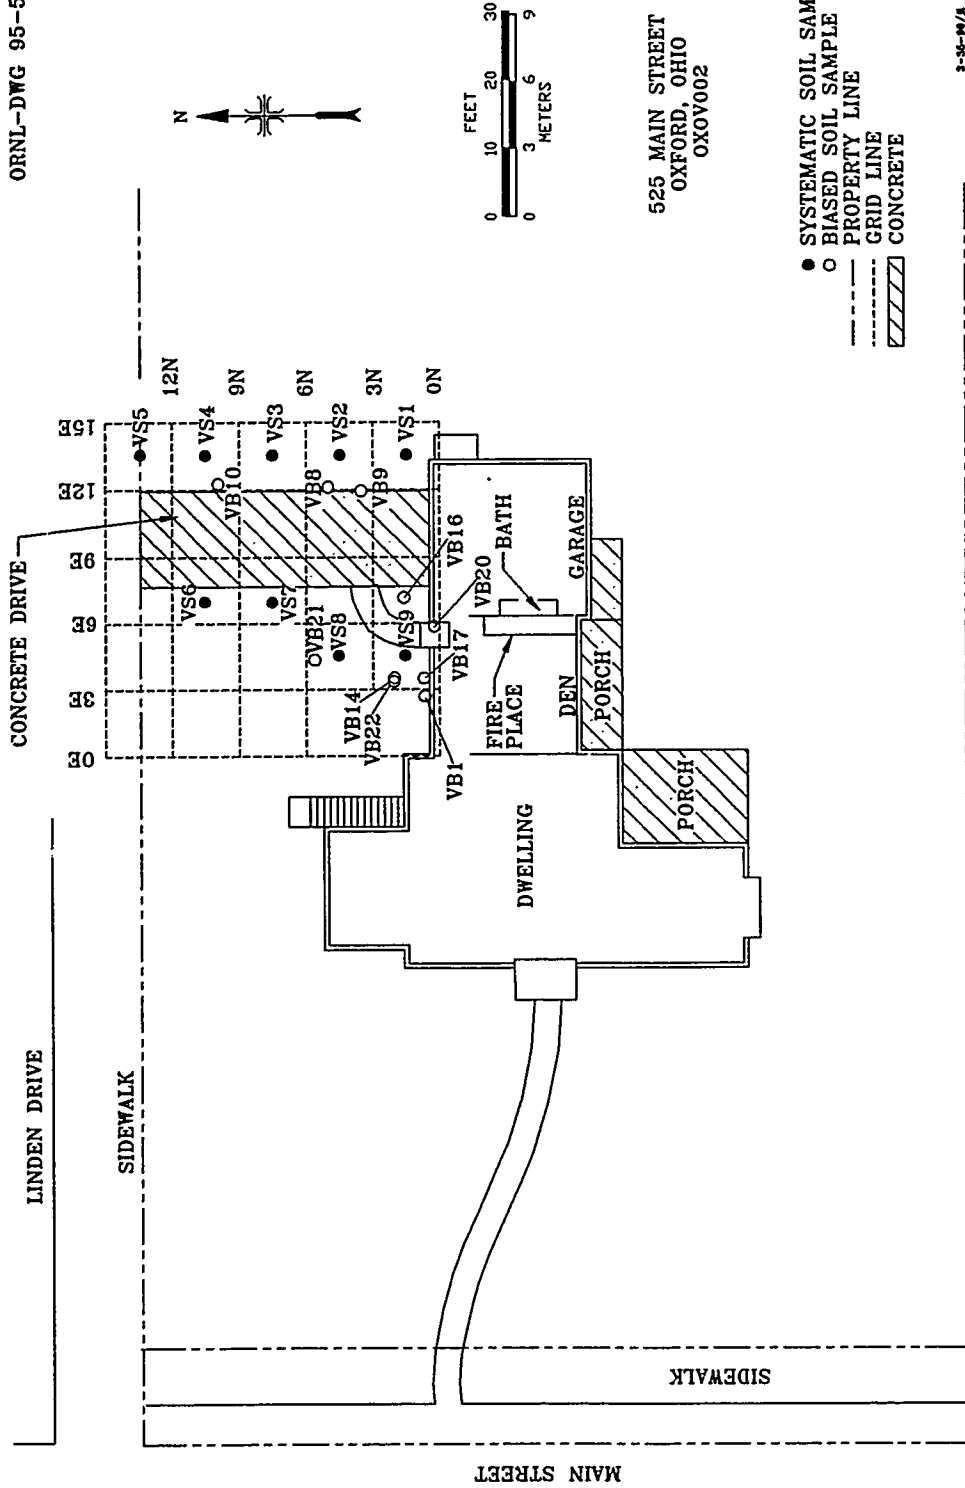
Beta-gamma scanning over the two excavated areas in the north yard (Fig. 4) revealed several anomalies (i.e., beta activity at $>3,000$ dpm/cm²) on both sides of the driveway although gamma exposure rates were no more than $8 \mu\text{R}/\text{h}$. The areas were re-sampled at nine systematic locations (VS1 to VS9) and seven biased locations. Field screening of the systematic samples showed ^{238}U concentrations ranging from less than background to 12 pCi/g (Table 3). Field screening for five of the biased samples showed values exceeding the ^{238}U soil contamination guidelines for Oxford with a maximum concentration of 79 pCi/g. ORNL requested that BNI conduct further remediation in these areas. Photographs showing views of the excavated areas in progress are shown on Figs. 6 and 7.

ORNL repeated the beta-gamma scanning on December 8 following re-excavation of those areas of the north yard. Several anomalies were again found on both sides of the driveway. Field screening of samples VB1 through VB10 taken from the east side of the driveway showed concentrations of ^{238}U ranging from 2 to 17 pCi/g (Table 3), values less than the guideline (Table 1). That area was released to BNI for final restoration. Field screening indicated concentrations of ^{238}U ranging from 31 to 140 pCi/g in three samples from the area on the west side of the driveway. Additional cleanup of that area was requested and performed.

Fig. 4. Diagram showing grid and locations of soil samples collected from the North Yard at 525 S. Main Street.

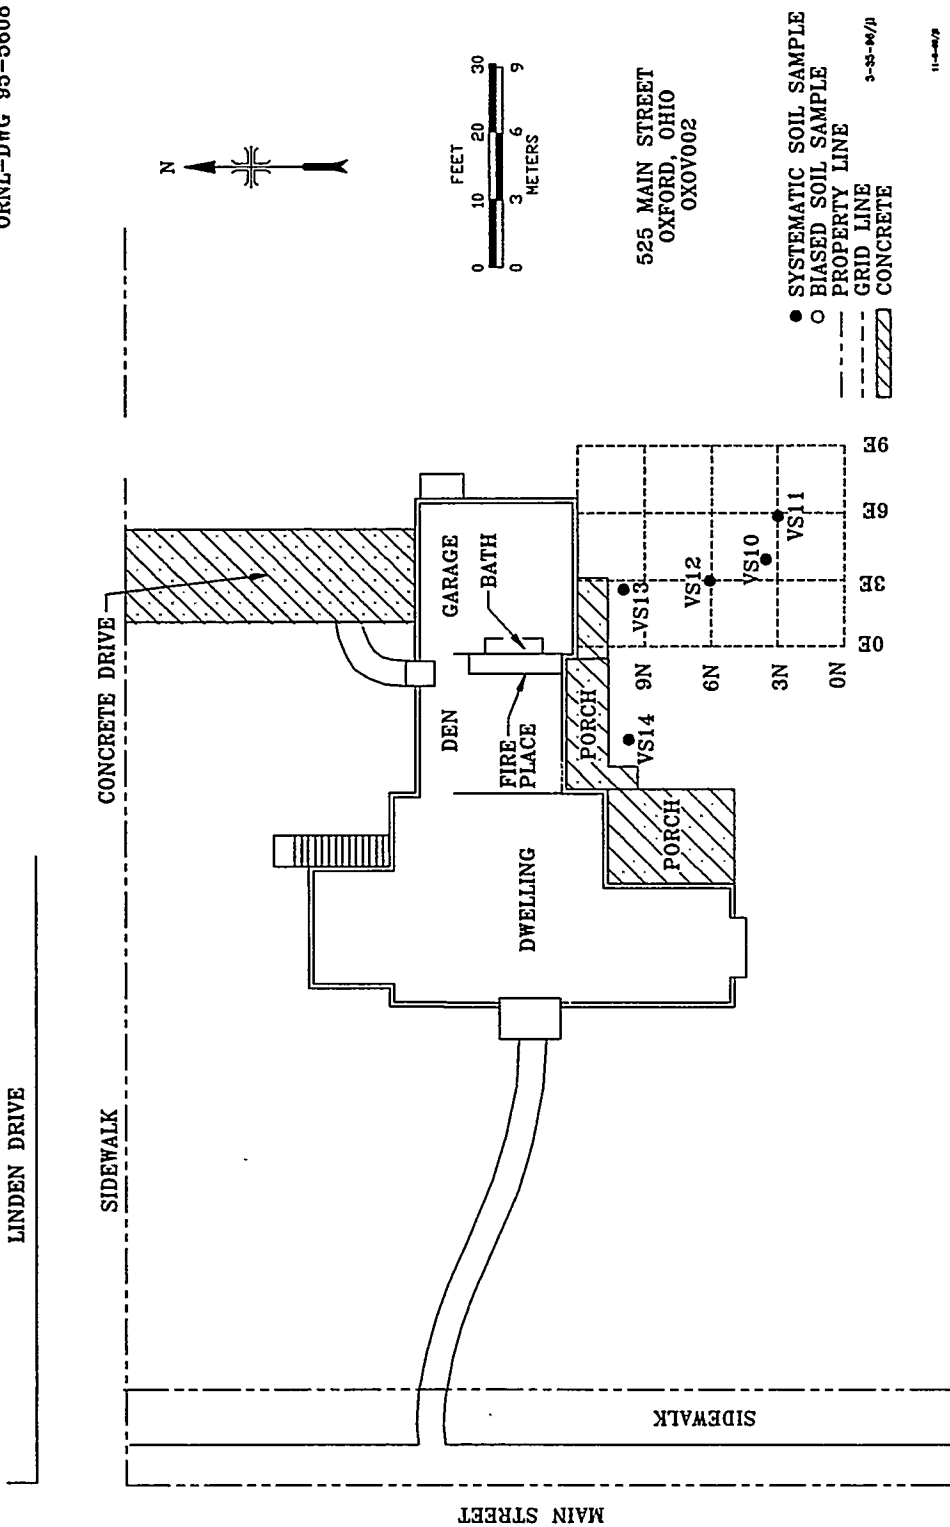
The three excavated areas in the yard south of the house showed no anomalies during the scans. Gamma exposure rates ranged from 3 to 8 $\mu\text{R}/\text{h}$ and beta-gamma measurements were $<3,000$ dpm/100 cm^2 . Because the results were comparable to typical background and less than DOE guidelines, no biased samples were collected. Systematic samples (VS10 through VS14) were collected at five locations from the three excavated areas in the south yard (Fig. 8). Field screening of these samples showed ^{238}U concentrations ranging from less than background to 4.9 pCi/g, well below the site-specific soil contamination guideline of 17.5 pCi/g derived for the Oxford, Ohio sites (Table 1). ORNL then released the remediated south yard areas to BNI for restoration. Final analytical results in soil samples from those areas are shown in Table 3.

Fig. 5. Diagram showing grid and locations of soil samples collected from the South Yard at 525 S. Main Street.

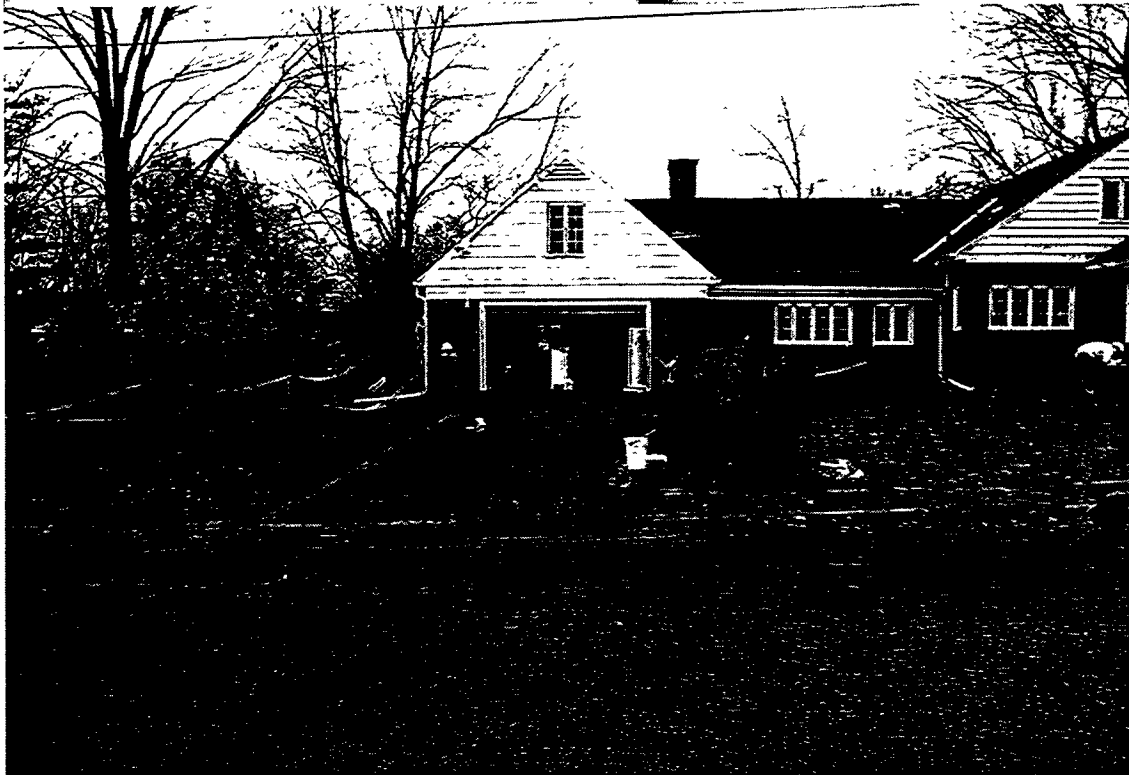
Fig. 6. Photograph showing excavated areas in the north yard on each side of the driveway at 525 S. Main Street.

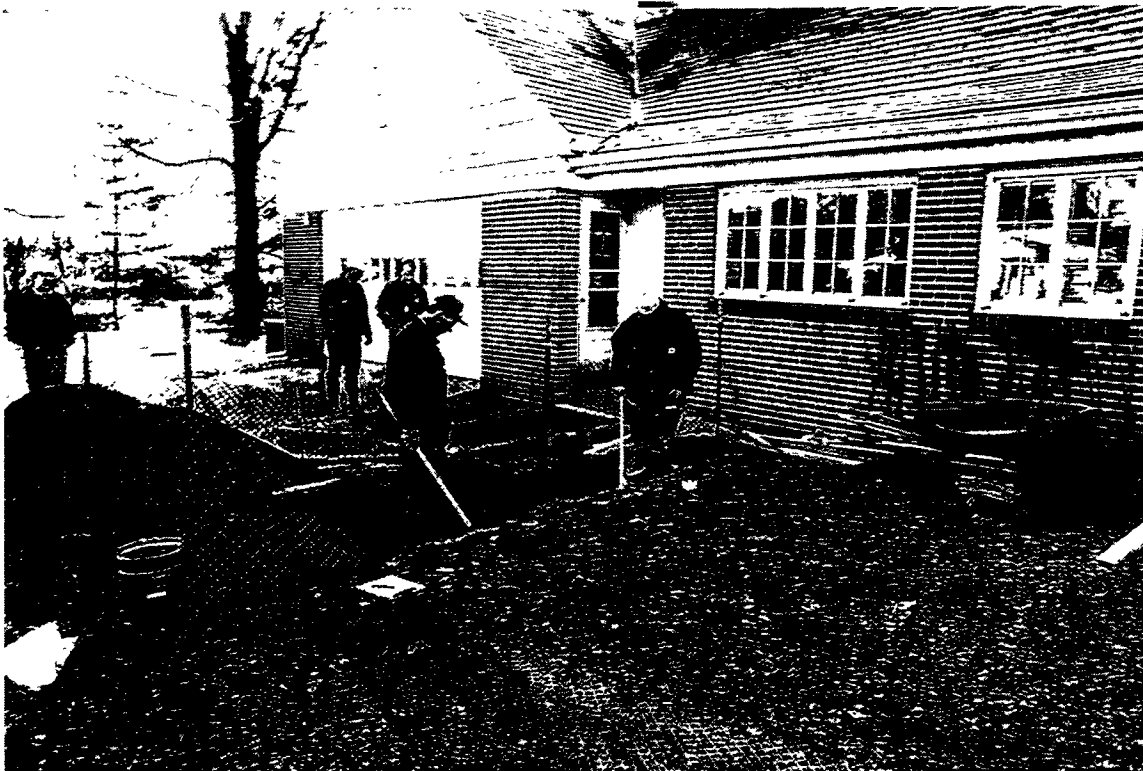
ORNL-PHOTO 9881-95

Fig. 7. Photograph showing excavated area in the north yard on the west side of the driveway at 525 S. Main Street.

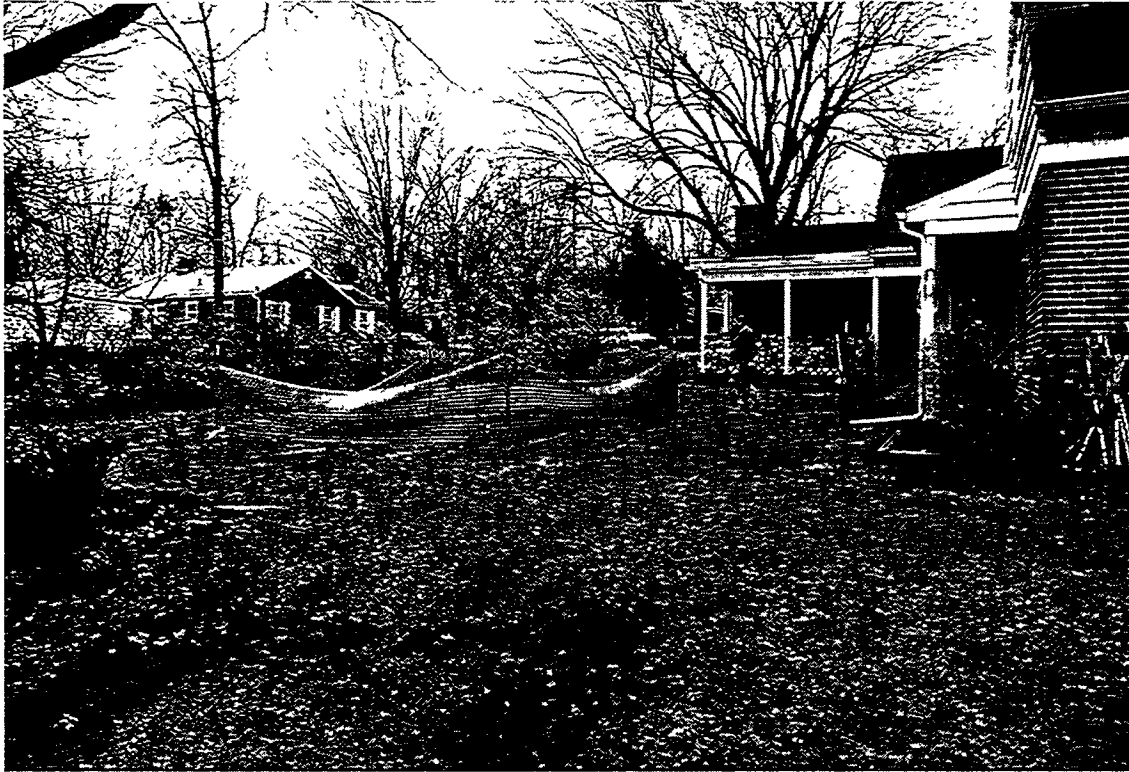
Fig. 8. Photograph showing excavated areas in the south yard at 525 S. Main Street.

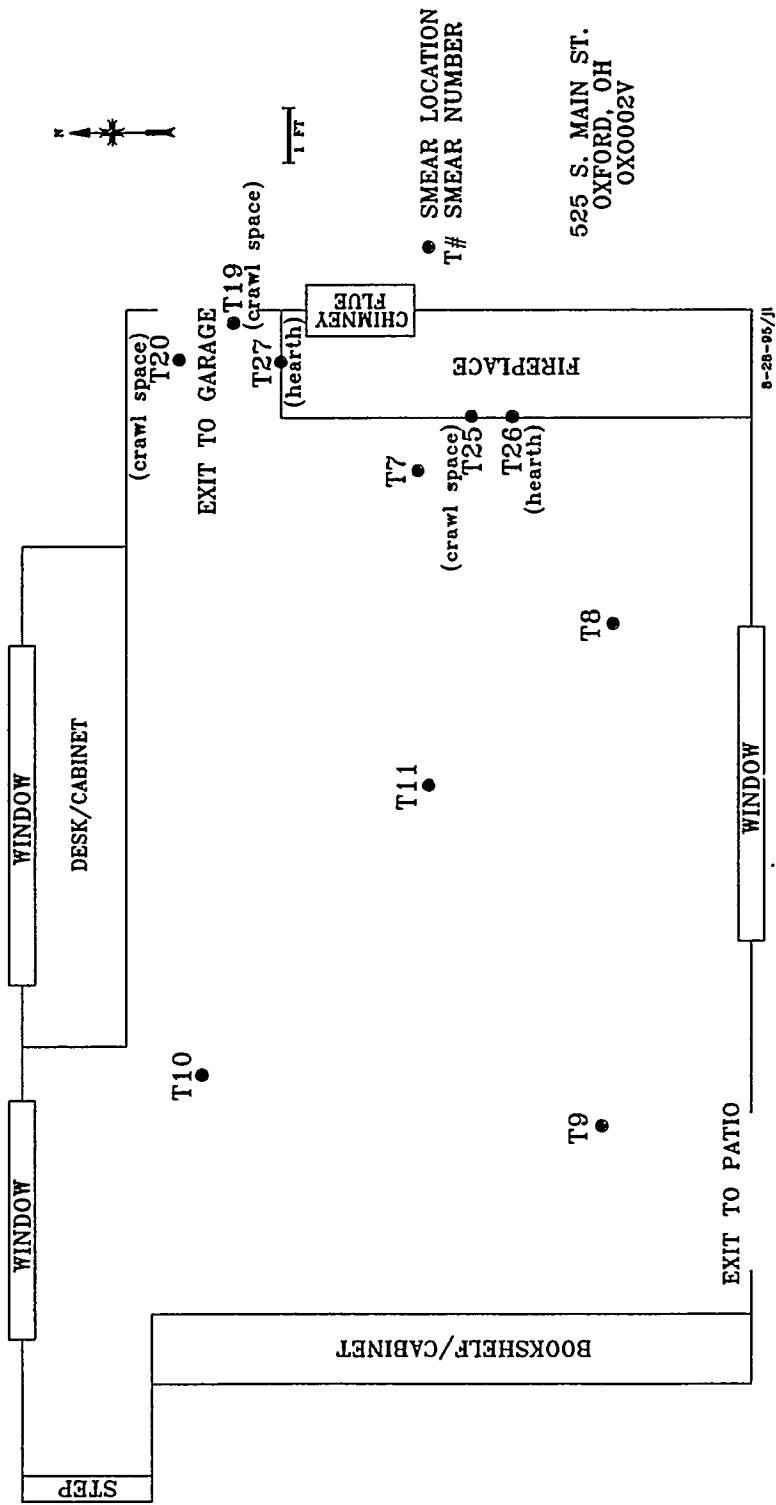
October 25, 1993, the ORNL team found elevated beta-gamma activity levels in the den following removal of the tarpaper that had underlain the hardwood flooring. Anomalous areas ranged from 3,000 to 12,000 dpm/100 cm^2 (0.05 to 0.2 mrad/h). Two spots were remediated with tape. Additional BNI remediation lowered all previously ORNL-identified anomalies in this area of the den to acceptable levels (Table 1). A 100% walkover scan with gamma scintillators

On January 6, 1994, ORNL conducted verification activities as BNI remediated the crawl space beneath the den. After BNI removed a section of the sub-floor and a few floor joists, TMA/Eberline** and ORNL surveyed the joists and the fireplace hearth facing. In general, the fireplace hearth facing had beta-gamma activity levels ranging from 1,100 to 3,000 dpm/100 cm^2 (0.02 to 0.05 mrad/h). A particle or shaving (apparently uranium) had beta-gamma activity levels of 60,000 dpm/100 cm^2 (1 mrad/h). Anomalous beta-gamma activity levels in other locations in the crawl space ranged from 5,400 to 60,000 dpm/100 cm^2 (0.09 to 1 mrad/h). The elevated spots were remediated by BNI and ORNL. ORNL re-surveyed the area and collected additional smears showing analytical results of all to be less than MDA.

Fig. 9. Diagram showing layout and locations of smears taken in the den and the areas beneath the floor.

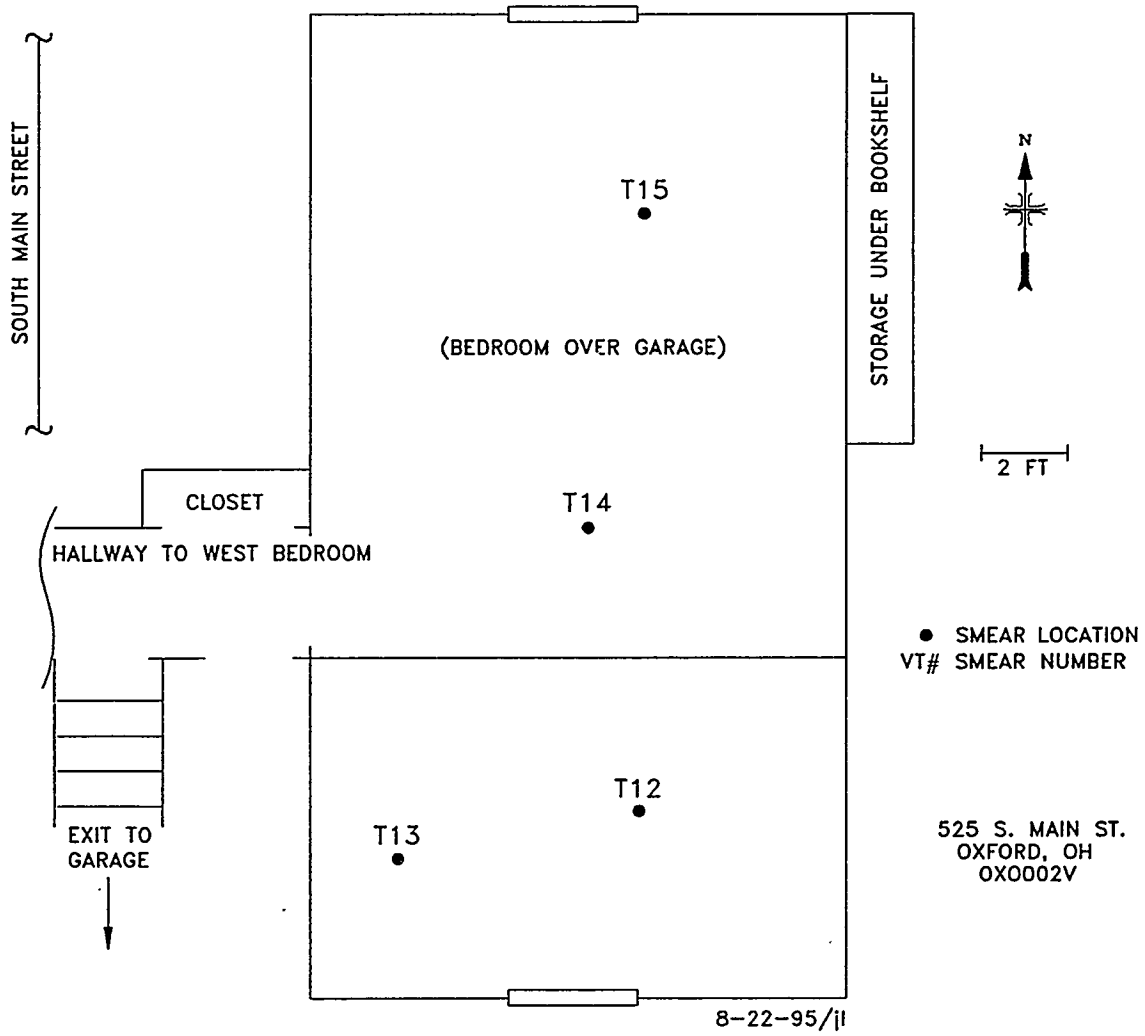
Elevated areas found on the east bedroom floor above the garage ranged from 4,500 to 37,000 dpm/100 cm² (0.08 to 0.61 mrad/h) beta-gamma. Some removal of the sub-floor was required to remediate all areas to $<3,000$ dpm/100 cm² beta-gamma. A 100% scan with gamma scintillators disclosed exposure rates of 6 to 8 μ R/h, values well below the guideline of 20 μ R/h above background (Table 1). Spot-checking showed alpha activity levels of less than MDA to 22 dpm/100 cm². Four smear samples (VT12 - VT15) were taken from the locations as shown on Fig. 10. The values were less than MDA.

Fig. 10. Diagram showing layout and locations of smears taken in the east bedroom area.

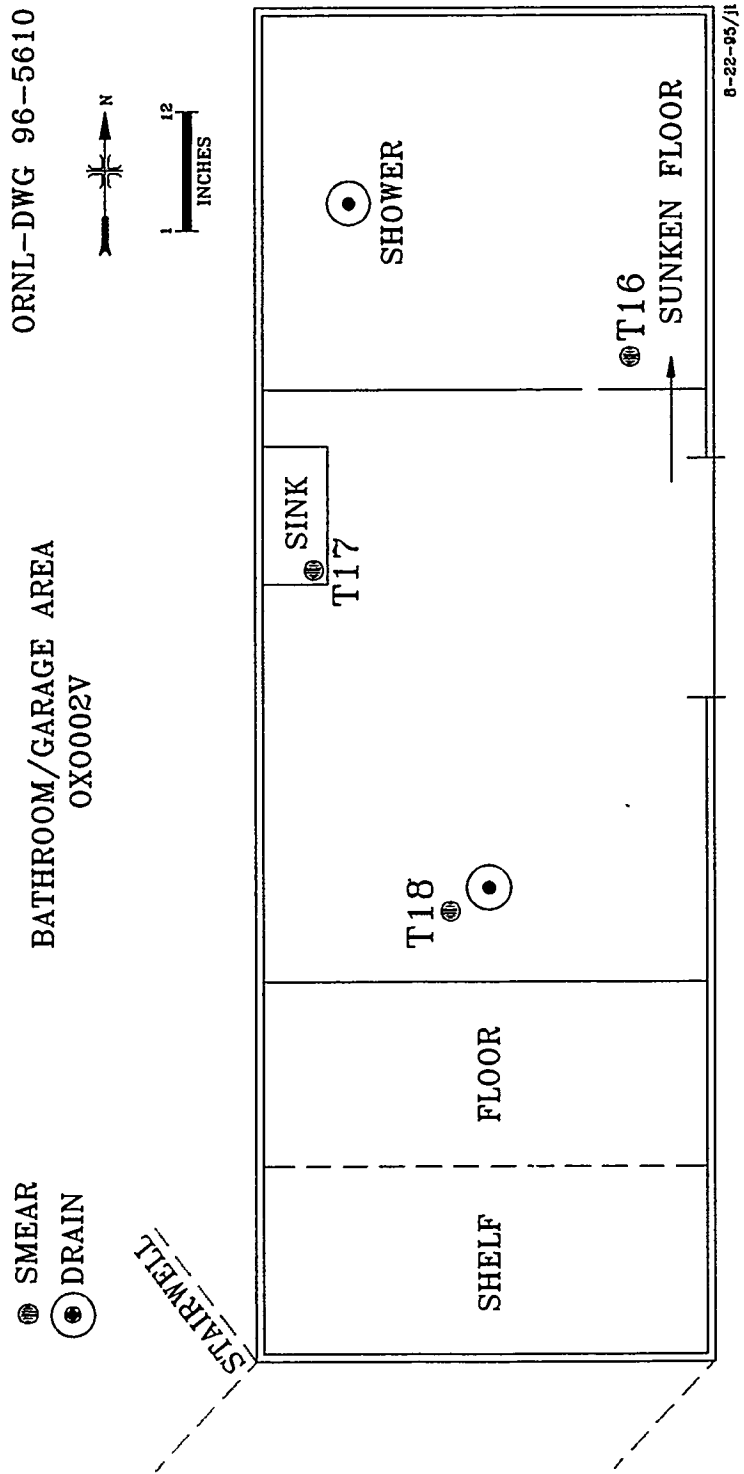
On October 27, 1993, IVC surveying of the bathroom in the garage disclosed areas of elevated beta-gamma activity ranging from 6,000 to 225,000 dpm/100 cm² (0.1 to 3.4 mrad/h) in eleven unremediated locations. Approximately 50% of the hidden wooden shelf behind the commode ranged from 3,000 to 30,000 dpm/100 cm² (0.05 to 0.65 mrad/h) requiring supplementary BNI remediation. Measurements on the floor areas underneath the shelf and the stairs revealed no anomalies.

Later that afternoon, ORNL repeated the verification survey of the garage bathroom after supplemental BNI remediation. Seven new beta-gamma anomalies were identified, ranging from 4,500 to 15,000 dpm/100 cm² (0.08–0.25 mrad/h). A debris sample was collected from the shower drain (Fig. 11). Laboratory analysis later showed that the sample contained 280 pCi/g ²³⁸U. ORNL notified BNI that additional remediation of the bathroom floor was required. Remedial action was followed by a 100% scan showing gamma exposure rates ranging from 9 to 12 μ R/h, and total (fixed and removable) alpha measurements ranging from 29 to 94 dpm/100 cm². Three smear samples were taken from the floor in the locations shown on Fig. 11 (T16, T17, T18). Results showed values of less than MDA for both alpha and beta-gamma measurements. All results are below DOE guidelines (Table 1).

Fig. 11. Diagram showing layout and locations of smears taken in the garage bathroom.
