In-service Oxidation and IASCC in High Fluence Baffle-Former Bolts Retrieved from a Westinghouse PWR

**ORNL/SPR-2024-3523
M3LW-24OR0402053**

Light Water Reactor Sustainability (LWRS) Program
Materials Research Pathway

**IN-SERVICE OXIDATION AND IASCC IN HIGH FLUENCE BAFFLE-FORMER
BOLTS RETRIEVED FROM A WESTINGHOUSE PWR**

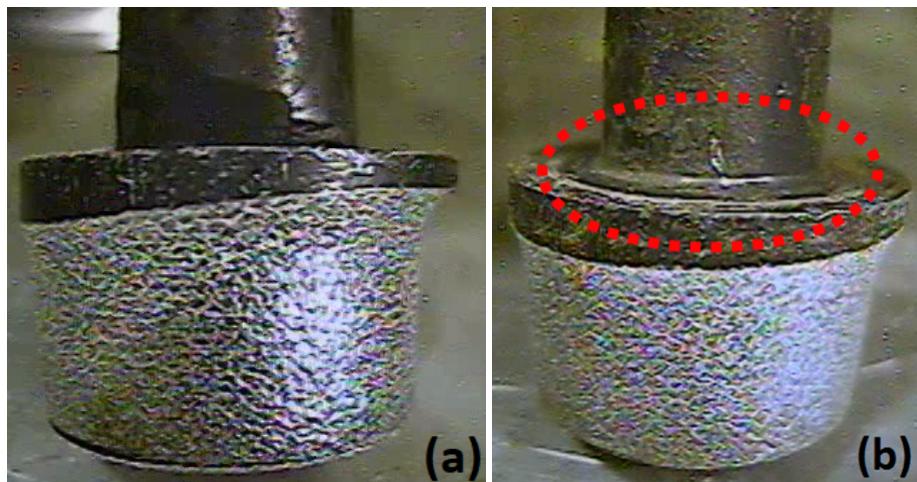
Figure 1: Images of bolt heads for bolt #4412 in (a) and bolt #4416 in (b). Surface of bolt at bolt head/shank intersection (circled) was exposed to primary water and is still intact [7]

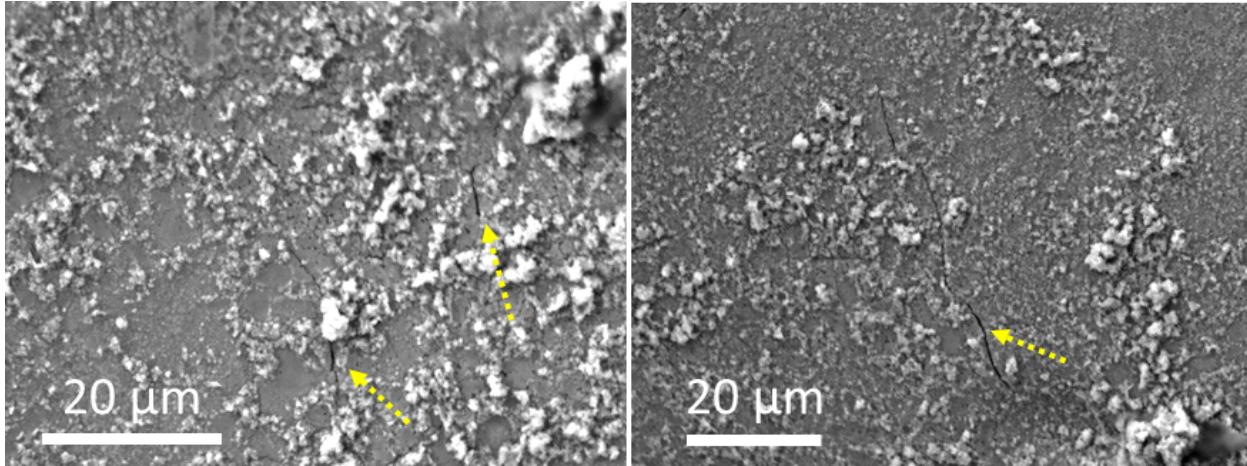
Part of the collar slice or bolt head/shank intersection region was exposed to the primary water coolant in the two-loop downflow Westinghouse PWR [13]. The CS slice in these bolts still had the exposed surface retained without excessive handling or processing damage, as shown by the SEM image of the BFB #4412 surface in Figure 3. The SEM analysis of the surface showed the oxide layer with multiple fine cracks and rough particles which are Fe-rich oxide.

Figure 3: Secondary electron SEM images of the surface of the head/shank transition area of BFB #4412. There are multiple small crack visible (yellow arrows) and rough Fe-rich oxide particles across surface.

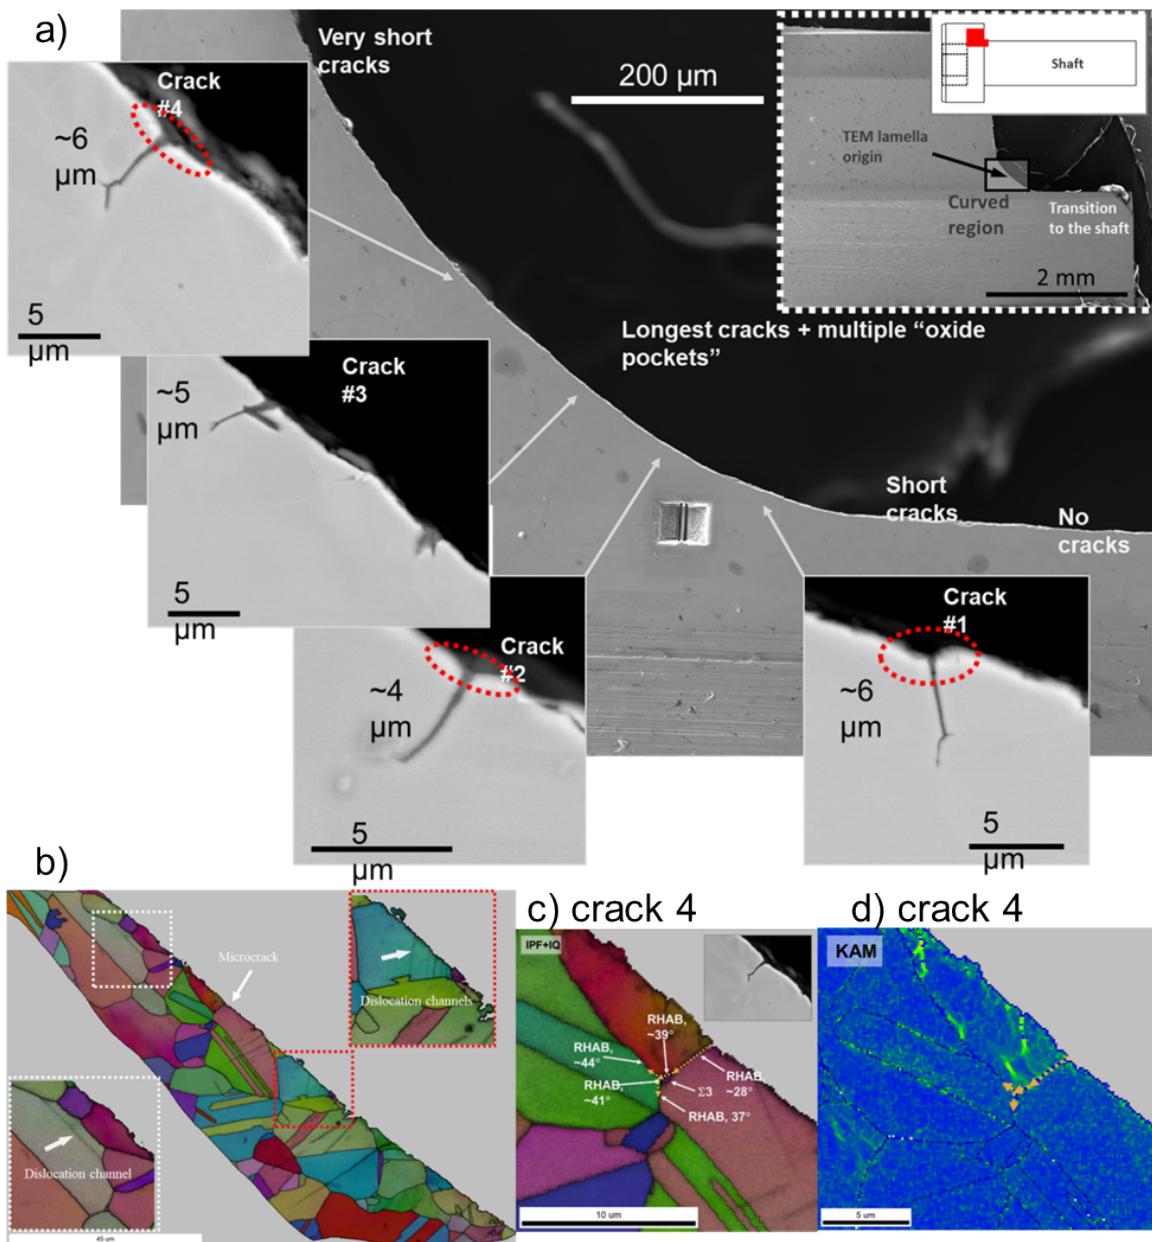
SEM analysis of the cross-section, as shown in BFB #4412 in Figure 4, demonstrated multiple small cracks along the specimen edge; all observed cracks were located inside the curved area, where stress would be highest. The longest crack reached $\sim 6 \mu\text{m}$. Based on the EBSD data, the corrosion crack readily propagated along random high-angle grain boundaries (RHAB) and actually splits into two different directions at a triple junction of RHABs. Special boundaries such as low-angle grain boundaries (LAGB) or twin boundaries ($\text{sigma-3 } [\Sigma 3]$) appear to be immune from cracking as seen in Figure 4c, where the crack deflects and only travels along the RHAB despite hitting a triple junction of RHAB hitting a RHAB and a $\Sigma 3$ boundary. Cracks propagated in the direction, normal to the surface suggesting the stress corrosion nature of this particular crack. In the near surface region, there is also evidence for localized deformation in the form of dislocation channels as highlighted in the EBSD maps. An oxidation environment, localized mechanical stress, and irradiation are present and make the material susceptible to IASCC. To investigate further the oxidation behavior and grain boundary attack at the cracks, targeted FIB liftouts were taken from the oxidized surface at cracks. One such liftout is shown in Figure 5 for BFB #4412. The STEM-ADF image and tKD maps in Figure 5 highlight the features that will be discussed further in full through this document: complex surface oxidation, grain boundary oxidative attack and cracking, and localized deformation in the form of dislocation channels.

Figure 4: SEM images from the curved section of BFB #4412 where the bolt head meets the bolt shank. Microscale cracks indicative of IASCC are found in the curved region and not in the straight regions.

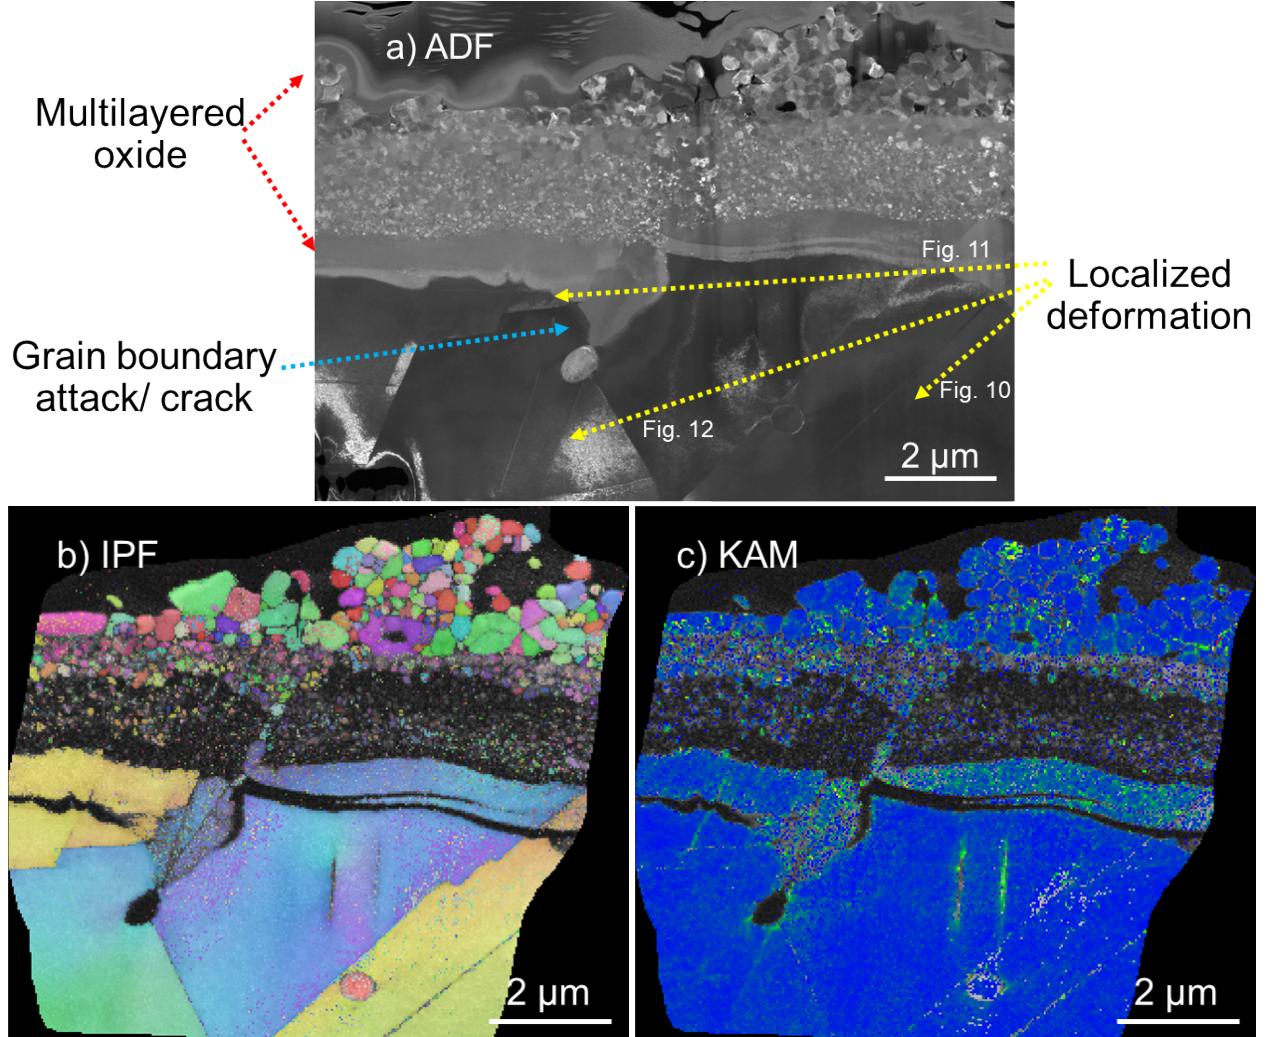
Figure 5: a) STEM-ADF image of liftout from BFB #4412 taken from oxidized surface near “crack #4” in Figure 4. b) tKD IPF and c) KAM maps of the same liftout. Multiple features are apparent including a multilayered oxide (red arrows), grain boundary attack (blue arrow), and localized deformation features inside the bolt (yellow arrows). These localized deformation features will be discussed in Figures 10-12.

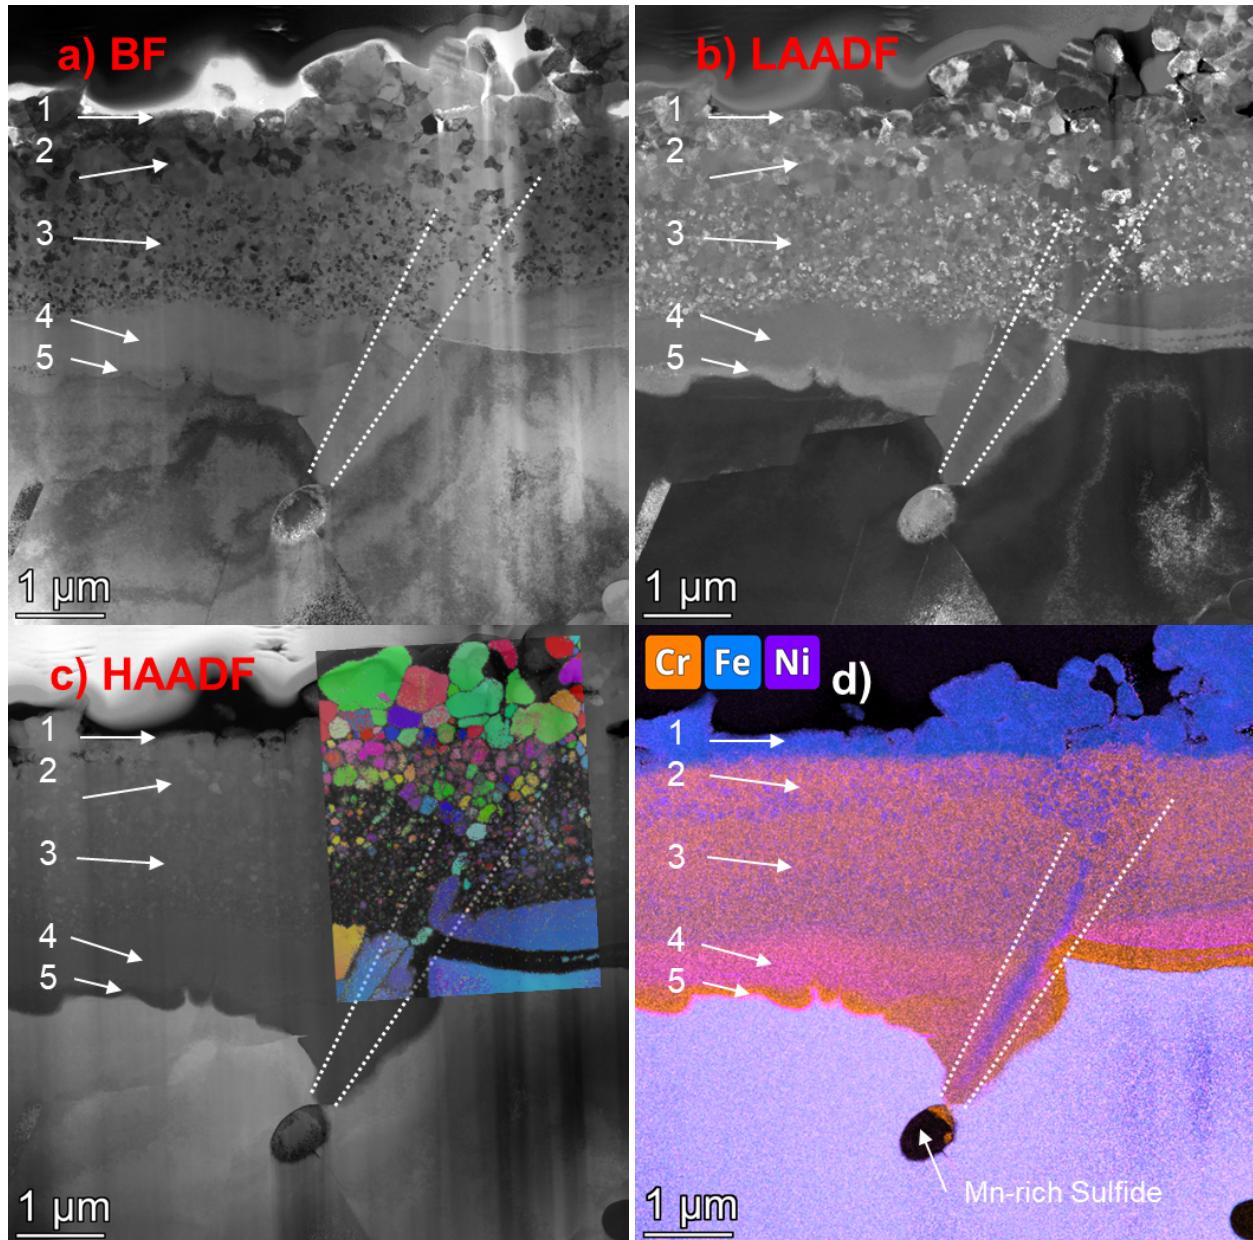
The surface oxide on the curved section of the BFBs is complex. The STEM images, tKD IPF map, and EDS map for BFB #4412 in Figure 6 highlight the five distinct layers of the surface oxide that separate themselves by composition and by grain size. Interestingly, instead of five layers, only three layers are commonly identified for corrosion and radiation-enhanced corrosion [14,15]. This finding alone signals the need for extended radiation and corrosion studies, including studying the effect of dose rate. The total oxide thickness for this BFB is ~3 μm near its thinnest point and up to ~5 μm near grain boundaries. The outer most oxide layer, denoted as layer 1, is an Fe-rich oxide with large grains ~250-500 nm in size. The thickness of this layer varies from one grain thick (~250 nm) to multiple grains but seems to be largest around grain boundaries. The second layer is an intermixed Fe/Ni-rich and Cr-rich oxide with grain sizes of ~100-200 nm and a thickness of about 600-700 nm. The grains appear to be Fe/Ni-rich while the oxide boundaries are Cr-rich. The third layer is similar in composition to layer 2 but is marked by a much finer grain size of well under 100 nm. For this BFB #4412, this layer is ~1.3 μm thick. As is shown in Figure 8, this oxide layer thickness can vary substantially from bolt to bolt (only ~150-400 nm for the sample taken from BFB #4416). The fourth and fifth oxide layers appear monolithic in nature but are segregated by

composition with the fourth layer being Cr/Fe/Ni-rich while the fifth layer closest to the alloy surface is depleted in Fe and Ni. Layer 5 may also be amorphous as the tKD mapping was unable to index any Cr-rich crystalline oxide. The composition gradient of each layer, 1 through 5, are shown in 1-D composition profiles in Figure 7c/d. Each of layers 4 and 5 are ~ 300 nm, which is about the same thickness as in BFB #4416 in Figure 8. The total thickness of the surface oxide in BFB #4416 in Figure 8 and Figure 9 is ~ 1.7 – 2 μm , or about two-thirds the thickness of the oxide in BFB #4412. This could be due to multiple reasons, such as the following: (1) the thickness of the oxide likely can vary locally within the same bolt; (2) the radiation dose is different and could affect oxide formation; and (3) the PWR water conditions and flow could be slightly different.

Figure 6: a) STEM-BF, b) STEM-LAADF, c) STEM-HAADF with tKD-IPF map overlayed, and d) STEM-EDS Cr/Fe/Ni map of BFB #4412 highlighting the multilayered oxide and grain boundary attack. Numbers correspond with each oxide layer based on grain size and composition. The two near-parallel dotted lines highlight pathway along the grain boundary for Fe/Ni to out layers.

Figure 6 and Figure 7 also highlight the interesting oxidative grain boundary attack. The near-parallel dotted lines in Figure 6 highlight two features: the grain boundary oxide is enriched in Fe or conversely depleted in Cr and the grain size is much larger than the oxides in layers 3, 4, and 5 away from the grain boundary. The grain boundary acts a diffusional pathway or pipeline for Fe and Ni to move to the outer oxides, especially layer 1 which is thickest around the grain boundary. The larger grains in layer 1 and 2 along the ‘pipeline’ are all enriched in Fe and Ni as highlighted in the concentration profiles in Figure 7e/f. This is likely exacerbated by radiation-induced segregation of Ni and Si to the grain boundary and depletion of Cr at the grain boundary. This same behavior observed in BFB #4412 can also be seen in BFB #4416 as layer 3 is clearly interrupted by larger grains near the grain boundary in Figure 8 and the original grain boundary location within the oxide is enriched in Fe and Ni and depleted in Cr as shown in Figure 9. Radiation-induced segregation not only enhances grain boundary attack, but it also enhances external oxide growth.

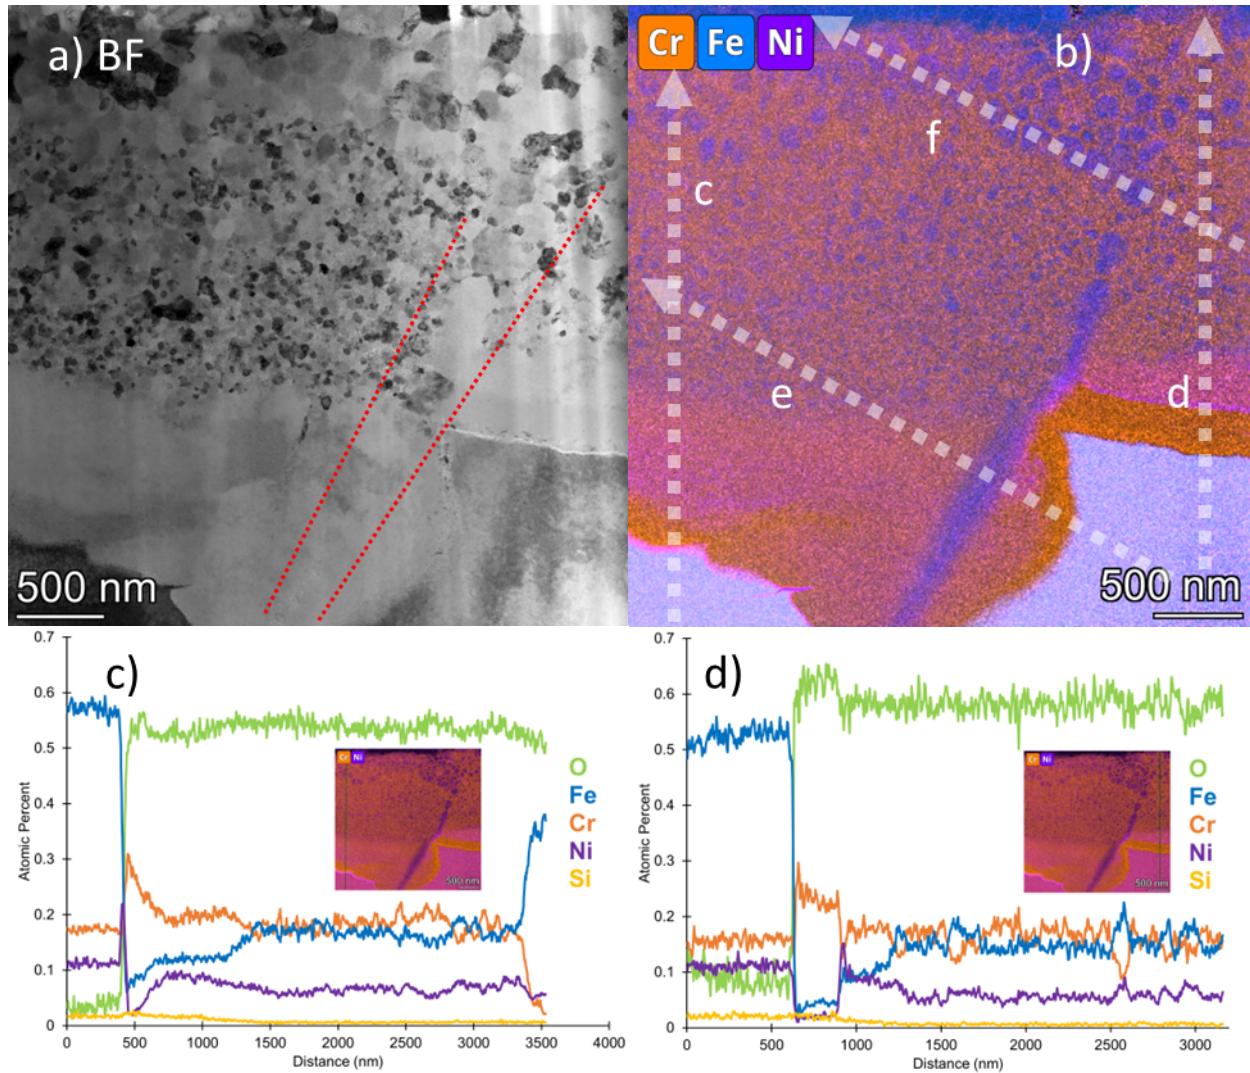
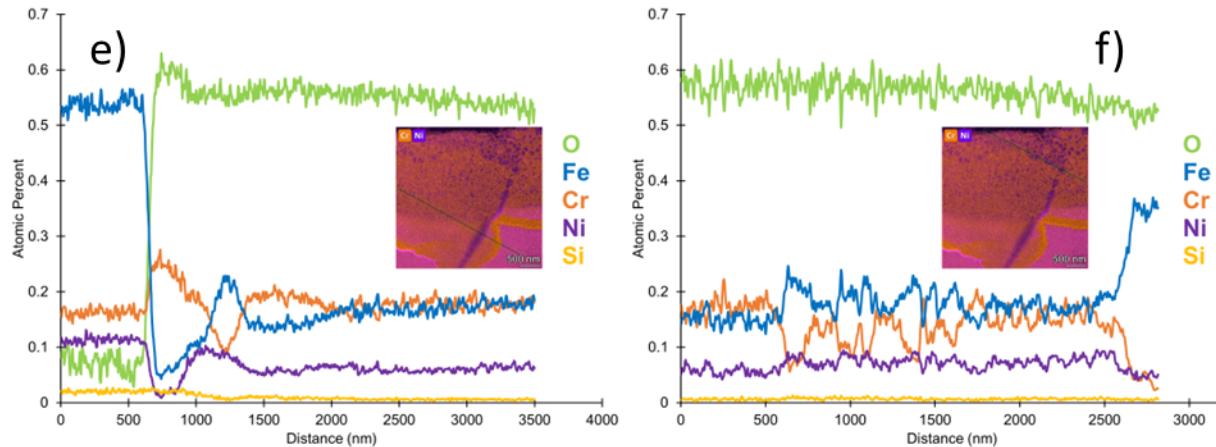
Figure 7: Liftout from oxide of curved region in BFB #4412. a) STEM-BF image and STEM-EDS map of Cr/Fe/Ni overlayed showing oxide and grain boundary attack. (c-f) Concentration profiles corresponding to arrows in (b).

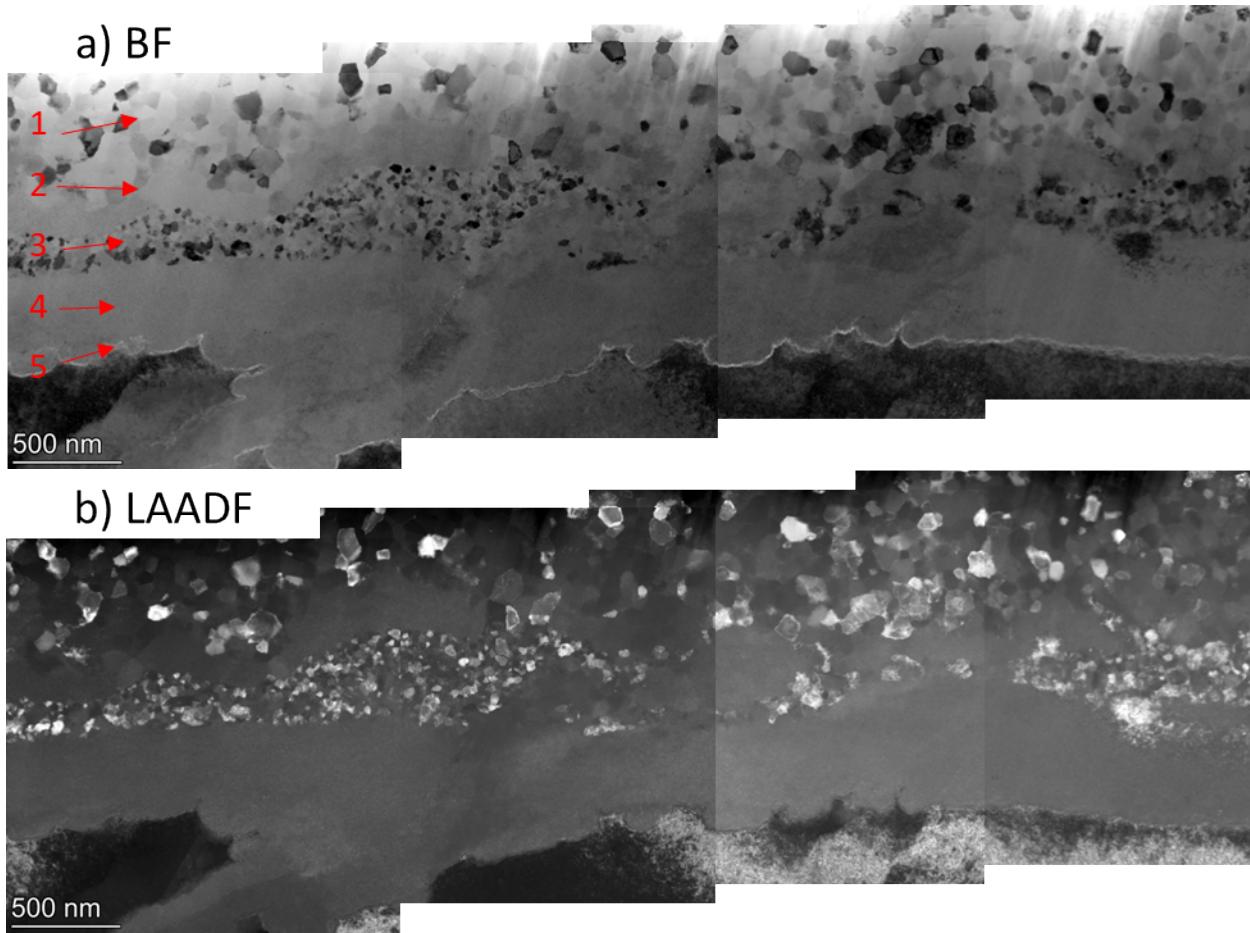
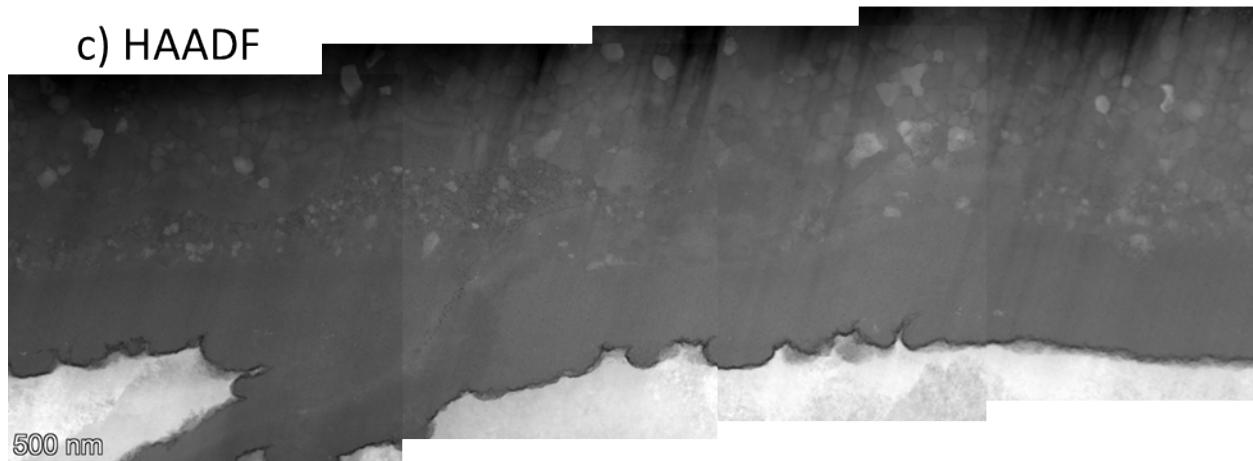
Figure 8: a) STEM-BF, b) STEM-LAADF, c) STEM-HAADF images stitched together of surface oxide near an oxidized grain boundary in BFB #4416 highlighting the multilayered oxide and grain boundary attack. Numbers correspond with each oxide layer based on grain size and composition.

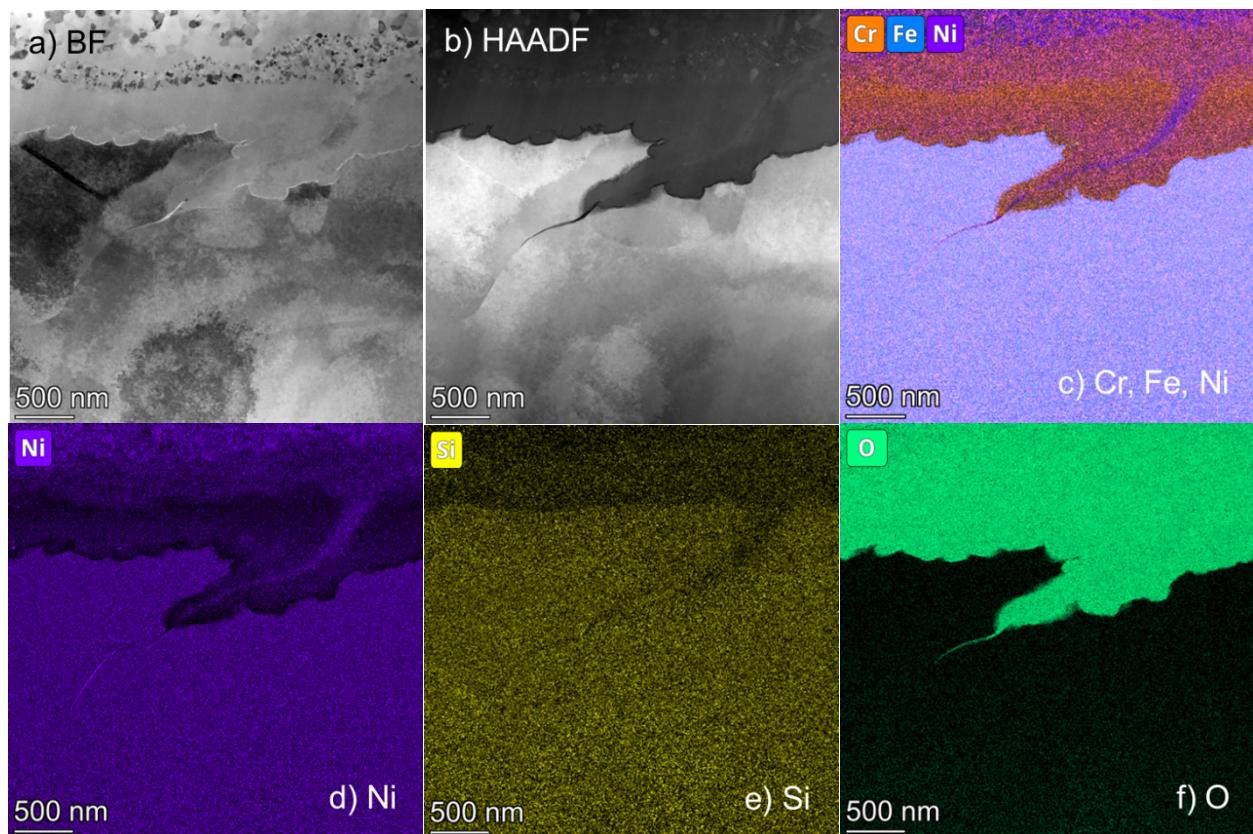
Figure 9: Liftout from oxide of curved region in BFB #4416. a) STEM-BF and b) STEM-HAADF images showing oxide and grain boundary attack. STEM-EDS maps of c) Cr, Fe, Ni overlapped, d) Ni, e) Si, and f) O showing segregation of Ni at grain boundary but a depletion of Si near the oxidized grain boundary.

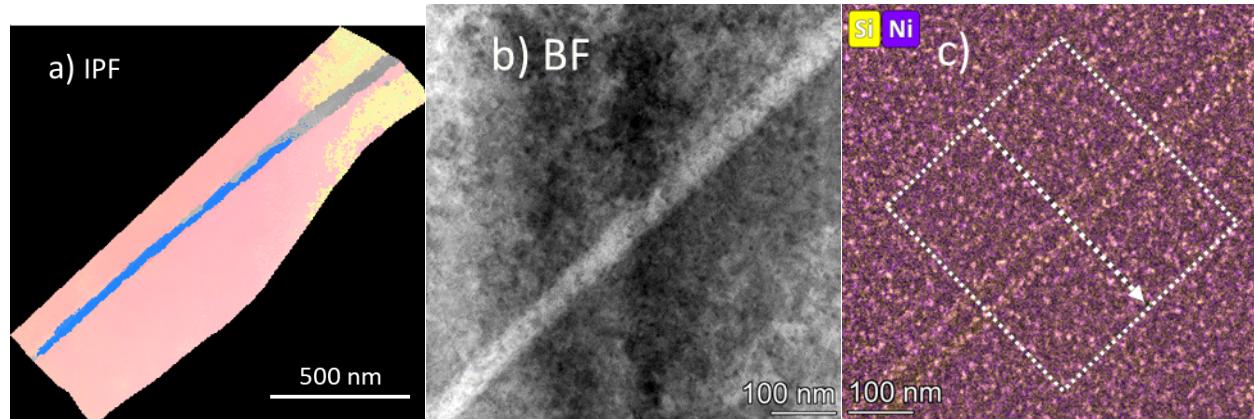
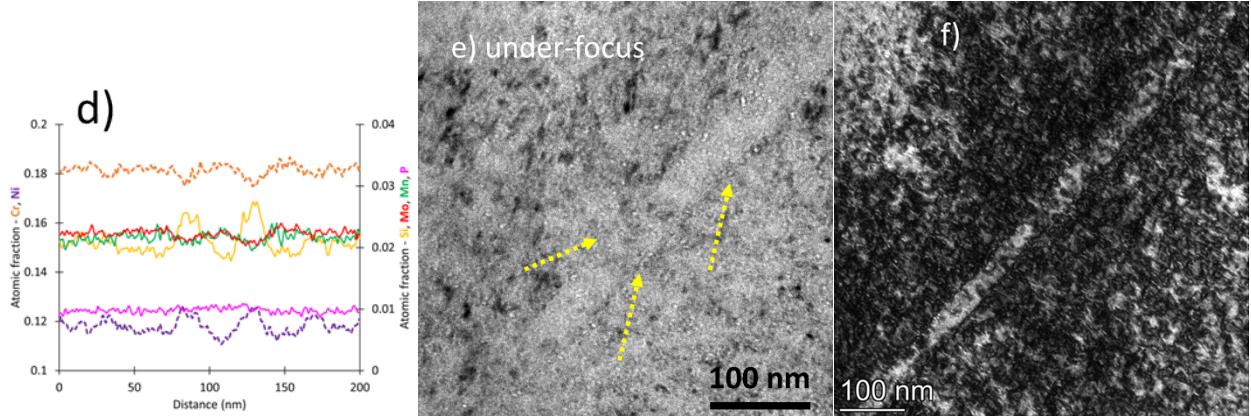
The IPF map in Figure 10a shows the channel has a twin across its length based on the misorientation being about 60° , indicative of a strain-induced twin with two $\Sigma 3$ boundaries. STEM-bright field (BF), STEM-EDS analysis, and TEM-BF imaging, as shown in Figure 10b-f, were conducted at the same ~ 50 nm wide feature. The most notable aspect is in the EDS map in Figure 10c showing clear segregation along channel boundaries. The surrounding matrix has a high density of Ni/Si-rich clusters, but there is an excess of clusters along the boundaries. The EDS concentration profile in Figure 10d shows the Ni/Si enrichment corresponds with a depletion of Cr, Mo, and Mn; there may be a slight enrichment of P within the channel though it is minimal. Additionally, the Ni and Si concentration between the boundaries is below that of the matrix outside the channel. The lack of precipitates between the boundaries suggests this is a defect-free dislocation channel, the result of localized deformation. There may also be a denuded zone where there is a slight reduction of Ni/Si relative to the matrix just outside the channel. Qualitatively, these results agree with previous studies on radiation-induced segregation (RIS) to $\Sigma 3$ grain boundaries. [16–18].

The lack of precipitates inside the channel does not mean that no defects are observed within the channel. Nanoscale cavities and dislocation loops are observed within the channel in the under-focus TEM-BF images in Figure 10e and the TEM-BF image in Figure 10f, respectively. The nanocavities are in high density throughout the matrix just as reported elsewhere [8]. There appear to be fewer cavities within the channel, though it is difficult to quantify if there is a significant difference between the matrix and within the channel boundaries. However, there do appear to be cavities that build up on the channel boundaries as denoted by the dotted arrows. Similarly, the dislocation loop density appears to be much lower within the channel than in the matrix. Taken together, the total density of defects including precipitates, nanocavities, and dislocation loops are lower within the channel.

Although segregation at $\Sigma 3$ boundaries, particularly coherent $\Sigma 3$ boundaries, is weaker compared to random high-angle grain boundaries (RHAGBs) [17], this process cannot be dismissed. While there is evidence of twinning in the channel in Figure 10, destruction of Ni/Si-rich precipitates suggests the passage of multiple dislocations along the channel, since a single twinning event would likely be insufficient to destroy precipitates [19]. The motion of dislocations, especially through heavy or severe deformation, has been shown to dissolve precipitates [20,21] and is likely what happens here at the local scale.

Figure 10: a) tKD IPF map with 5 nm step size showing strain induced channel with deformation twin occupying most of the channel; b) STEM-BF and c) STEM-EDS Ni and Si map of same channel; d) concentration profile based on box in c) across the channel; e) under-focus TEM-BF images highlighting nanocavities including those along channel boundaries (arrows); and f) TEM two-beam BF image showing dislocation loops in matrix and channel.

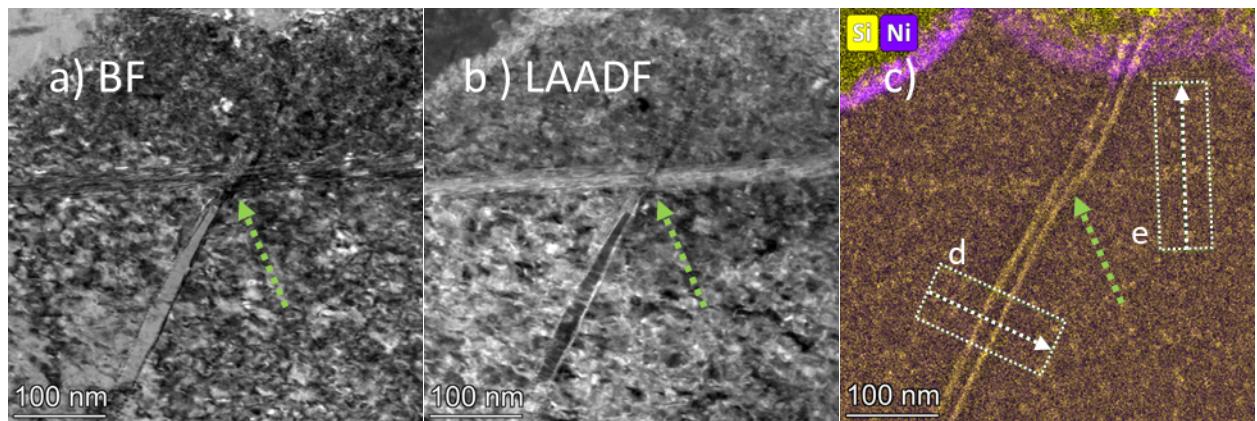
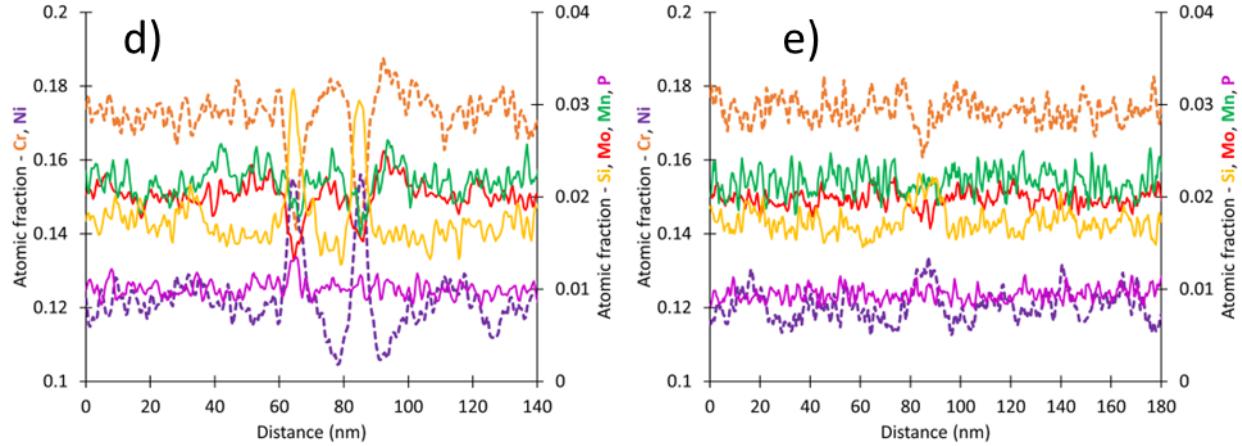
Similar STEM-EDS analyses were completed on other channel and localized defect features as well, as shown in Figure 11 and Figure 12, which are from the same liftout from BFB #4412. The region in Figure 11 shows two localized dislocation channels – the near vertical one (marked as d) and the horizontal one (marked as e). The near-vertical channel has extensive Ni/Si segregation and Cr/Mo/Mn depletion at the channel boundaries, more so than the channel boundaries in Figure 10. Two maximums in Si and Ni curves in the near-vertical channel in Figure 11d suggest strain-induced twins occupying a portion of the channel. However, instead of discrete precipitates, the segregation to the channel boundaries appears to be smooth here and reaches a much higher level than the channel in Figure 10. The BF and LAADF images show there is some but relatively low dislocation content within the channel. The horizontal channel on the other hand has elongated diffraction features as dislocations passed along it. This channel intersects with the other channel and looks like it causes channel ‘d’ to bend or be compressed slightly (the bending is pointed by dashed arrow in Figure 11). This horizontal channel does have some slight Ni/Si segregation to it as shown in the concentration profile in Figure 11 but no evidence of a strain-induced twin. The higher degree of segregation at the near-vertical channel ‘d’ boundaries also means these boundaries may likely be incoherent $\Sigma 3$ boundaries due to being a good sink for defects and solute and comparable to RHAGBs [17]. The segregation to the non-twinned channel suggests that localized strain-induced features can serve as sinks for defects and solutes just as a dislocations and dislocation cells can [22].

Figure 11: a) STEM-BF, b) STEM-LAADF, and c) STEM-EDS Ni and Si map showing dislocation channel (d) with likely internal twin intersecting with another dislocation channel (e); d) concentration profile based on box in c) across the channel with twin; e) concentration profile based on box in c) across the untwinned channel

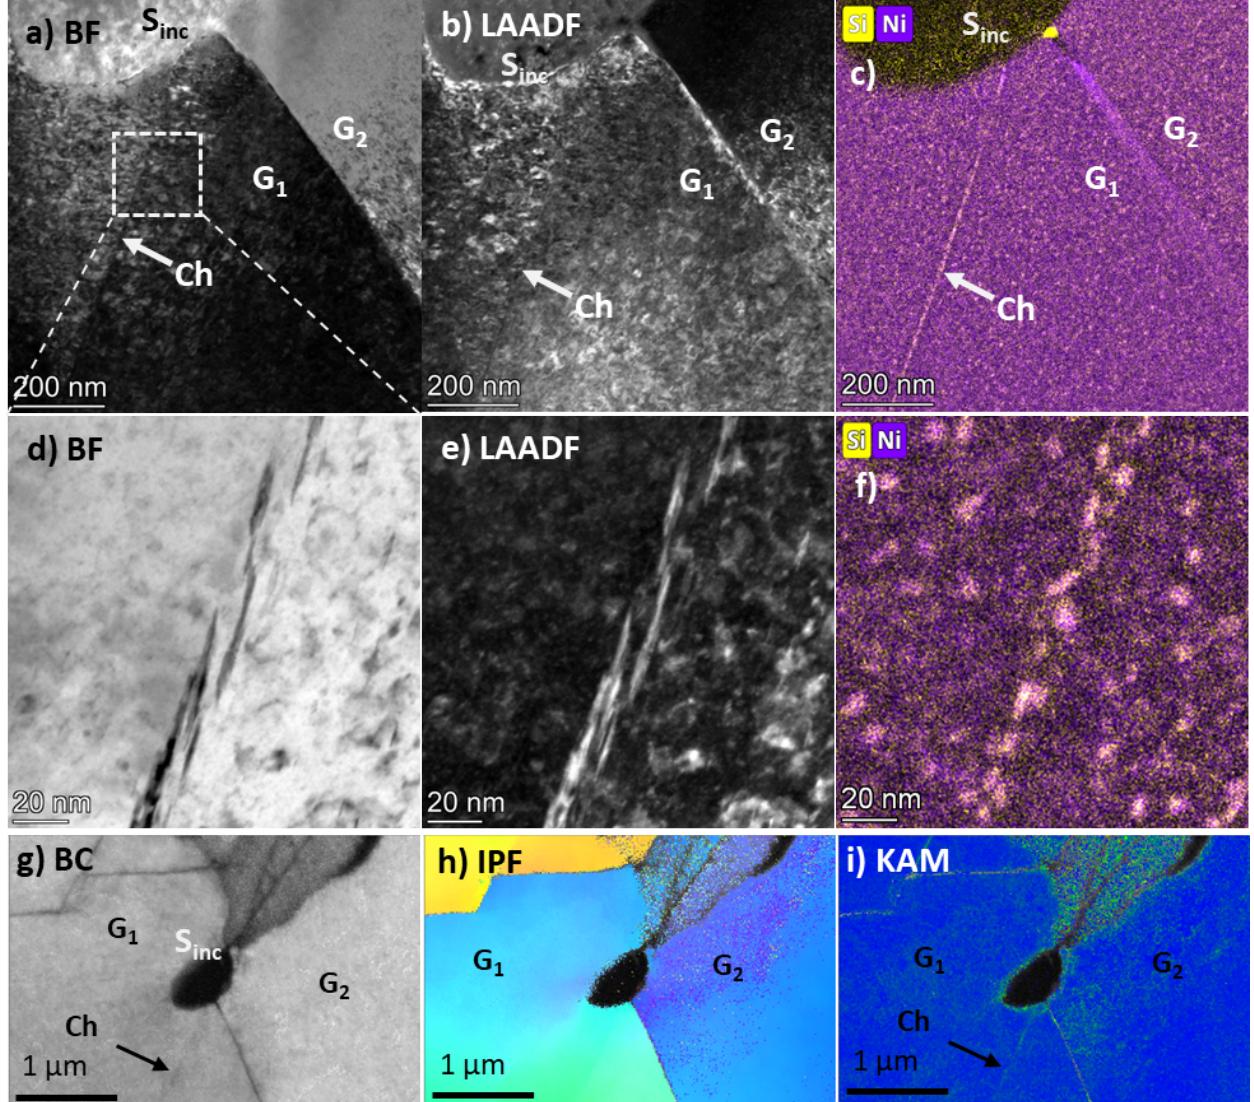
The third localized deformation feature near the sulfide inclusion from Figure 5 is characterized with tKD, STEM imaging, and STEM-EDS mapping in Figure 12. In the STEM in Figure 12a/b, one may see two grains, G_1 and G_2 , as well as a dislocation channel (Ch) that nearly intersects with a grain boundary at a sulfide inclusion (S_{inc}). The grain boundary between G_1 and G_2 is a RHAGB. The EDS map, Figure 12c, show obvious segregation inside the channel. STEM-EDS performed at elevated magnification, Figure 12d/e, does not show evidence of twinnig. One may see also much larger Ni/Si-rich precipitates but no general segregation, Figure 12f. The band contrast and IPF maps, Figure 12g/h, show minimal change across the channel, but the KAM map, Figure 12i, highlights there is increased KAM values at the channel that is similar to the grain boundary between G_1 and G_2 . The STEM imaging and EDS analysis in Figure 12e-f, shows the channel is similar to the horizontal channel in Figure 11 with elongated features, but it does not have any twin character. In this sense, there are not clear channel boundary walls like the twinned-channels in Figure 10 and Figure 11. This suggests that localized strain-induced features can serve as sinks for defects and solutes just as a dislocations and dislocation cells can [22].

Figure 12: a) STEM-BF, b) STEM-LAADF image, and c) STEM-EDS Ni and Si map of channel and grain boundary showing channel nearly intersecting with a random high angle grain boundary at a sulfide inclusion; d) STEM-BF, e) STEM-LAADF image, and f) STEM-EDS Ni and Si map zoomed in on the zoomed in on the channel, but tilted to a kinematical condition. g, h, i) tKD band contrast, IPF, and KAM maps, respectively.
