# Complexity of segregation behavior at localized deformation sites formed while in service in a 316 stainless steel baffle-former bolt

Post-irradiation evaluation was performed on a 316 stainless steel baffle former bolt harvested after 40 years of service in a pressurized water reactor. Microstructure analysis revealed the presence of defect-free dislocation channels and strain-induced twins, indicative of loading at a stress level close to yield stress at least once while in service. Primary radiation-induced Ni/Si precipitates were likely destroyed during channel and twin formation, and secondary, significantly coarser Ni/Si precipitates formed inside the newly formed dislocation channels and along  $\Sigma 3$  boundaries during the continued irradiation. Complex chemistry inside the strain-induced features may overlap with dislocation pileups and impact localized corrosion and material long-term performance.

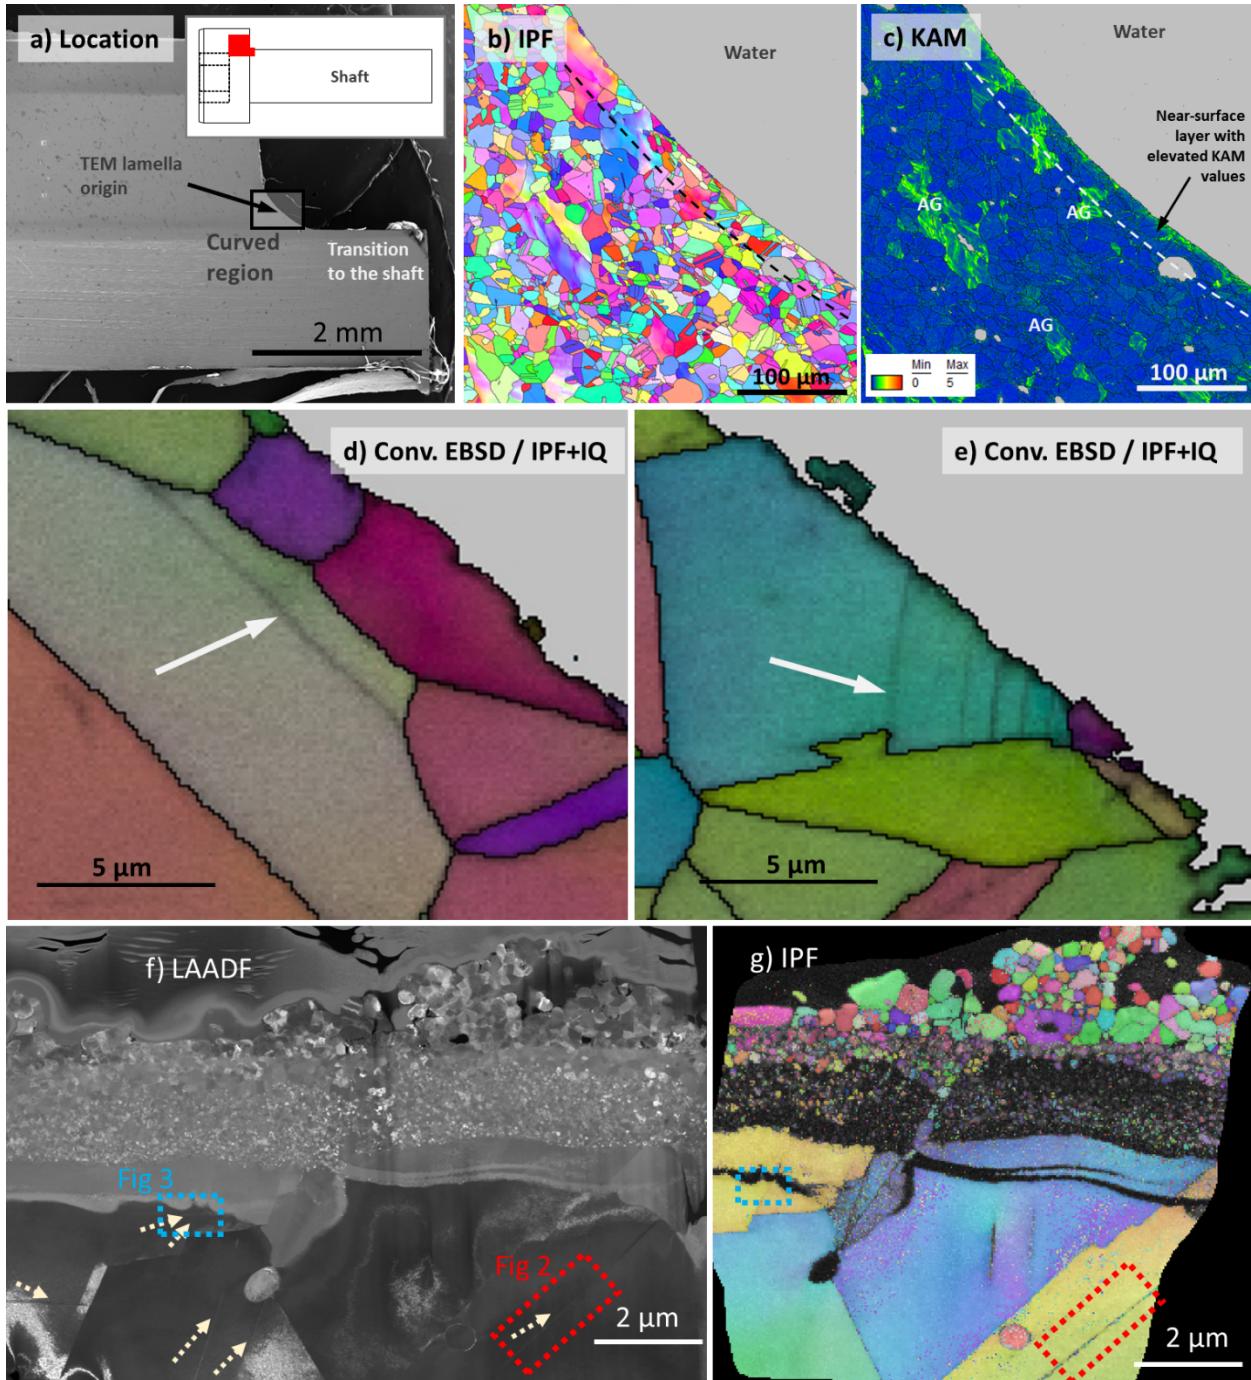
Figure 1b shows the grain structure of the BFB “circle area.” It has a dominating annealed austenite structure with equi-axial grains and the presence of abnormal grains (AGs), a result of accelerated growth of some grains, a process often called “abnormal grain growth” [20]. The EBSD kernel average misorientation (KAM) map, Figure 1c, shows low dislocation density in the equi-axial grains. The AG population shows multiple in-grain low-angle boundaries and overall elevated dislocation density, visible as color variations in the inverse pole figure (IPF) map and green region in the KAM map. The AGs have elongated shapes parallel to the BFB surface and often form specific chains, likely reflecting deformation processes during BFB manufacturing.

A thin near-surface layer along the BFB surface is of special interest for the present work. This layer, having a thickness of ~20-25  $\mu\text{m}$  and elevated KAM values, Figure 1c, reflects accumulated plastic deformation due to the BFB processing, handling, installation, and in-service loading events. Analysis of this layer, as believed, may allow for revealing the component history. Thus, scratches may appear in the EBSD maps as artefacts related to specimen preparation. Usually, scratches intersect GBs without changing directions. Scratches do not follow (111) plane slip traces except as a coincidence and are easy to exclude. If artefacts are excluded, the remaining plastic deformation is a combined result of pre-service and in-service deformation processes. Pre-service plastic deformation is also easy to exclude: deformation in non-irradiated austenitic steel occurs along multiple fine slip lines in contrast to coarse dislocation channels in irradiated steel [21,22]. This mechanism generates smooth in-grain lattice orientation gradients, in contrast to sharp, localized “hot spots” in irradiated steel [23].

Figure 1. a) Analyzed location of the investigated baffle former bolt (BFB); b,c) EBSD maps representing grain structure at the head-to-shaft transition area. The dashed line in IPF and KAM maps limits the near-surface layer with elevated KAM values. “AG”: abnormal grains. Overlapped EBSD IPF and IQ maps showing in-service formed dislocation channels (white arrows). d) Conventional EBSD map showing channel formed in a sub-surface grain; e) EBSD map, demonstrating a series of channels formed in the near-surface grain; f) STEM-LAADF image and g) tKD IPF map of a FIB-liftout taken from the oxidized surface of the curved region. Dotted boxed regions in (f, g) highlight regions analyzed in Figures 2/3. Dotted arrows in (f) point to localized deformation features. The surface and grain boundary oxidation will be the subject of future work.

If pre-irradiation plastic deformation is excluded, some remaining features appear as dark lines starting and ending at GBs, Figure 1d. The typical feature exists within one grain, and its appearance closely resembles

the defect-free channel typically observed in irradiated and deformed austenitic stainless steels [24]. Figure 1e demonstrates a group of similar features that belong to one grain; spacing between these features is  $\sim 1\text{--}2\ \mu\text{m}$ , a typical distance for dislocation channel spacing [21]. The liftout shown in Figure 1f/g has several strain-induced channel features, as noted by the dotted arrows. Two of these areas are discussed in Figures 2/3. The channels each have different and complex structural features, such as twins and variation in segregation/ precipitation behavior.

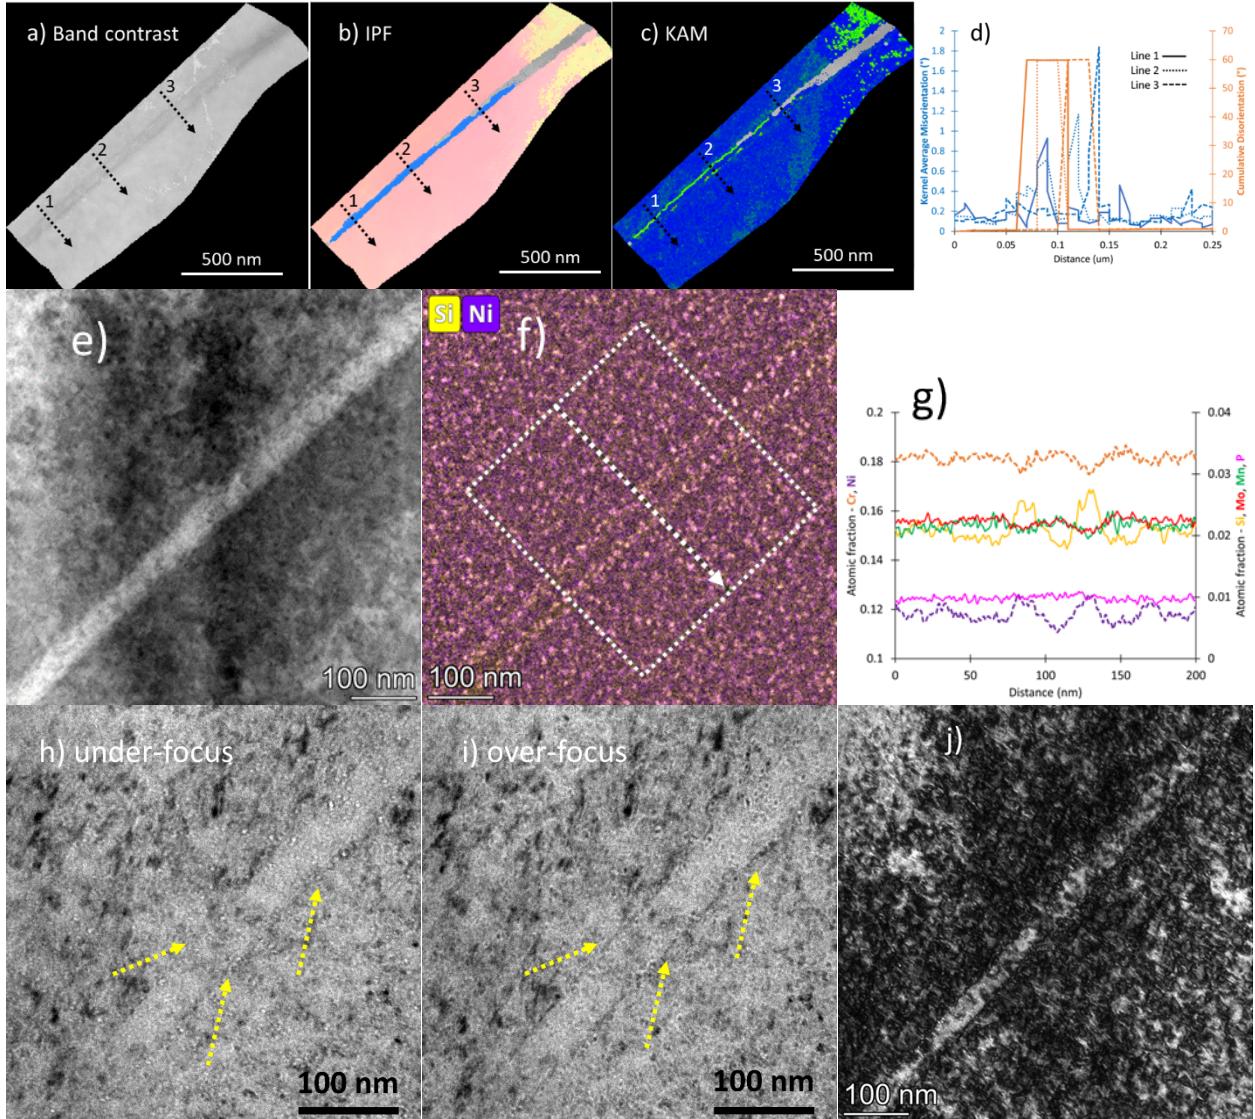
Figure 2 shows tKD analysis for the red boxed regions from the liftout in Figure 1f/g with strain-induced features: dislocation channels intersecting the field of view. The channel in the band contrast, IPF, and KAM maps in Figure 2a-c has twin across its length. The KAM values reach up to  $2^\circ$  at the channel boundary, and the cumulative disorientation across the channel is near  $60^\circ$ , which is indicative of a strain-induced twin with two  $\Sigma 3$  boundaries.

STEM-bright field (BF), low angle annular dark field (LAADF), STEM-EDS analysis, and TEM-BF imaging, as shown in Figure 2e-j, were conducted at the same  $\sim 50\ \text{nm}$  wide feature. The most notable aspect is in the EDS map in Figure 2f showing clear segregation along channel boundaries. The surrounding matrix has a high density of Ni/Si-rich clusters, but there is an excess of clusters along the boundaries. The EDS concentration profile in Figure 2g based on the boxed region in Figure 2f shows the Ni/Si enrichment corresponds with a depletion of Cr, Mo, and Mn; there may be a slight enrichment of P within the channel though it is minimal. Additionally, the Ni and Si concentration between the boundaries is below that of the matrix outside the channel. The lack of precipitates between the boundaries suggests this is a defect-free dislocation channel, the result of localized deformation. There may also be a denuded zone where there is a slight reduction of Ni/Si relative to the matrix just outside the channel. Qualitatively, these results agree with previous studies on radiation-induced segregation (RIS) to GBs, in particular to  $\Sigma 3$  boundaries. [25–27].

The lack of precipitates inside the channel does not mean that no defects are observed within the channel. Nanoscale cavities and dislocation loops are observed within the channel in the under and over-focus TEM-BF images in Figure 2h/i and the TEM-BF image in Figure 2j, respectively. The nanocavities are in high density throughout the matrix just as reported elsewhere [18]. There appear to be fewer cavities within the channel, though it is difficult to quantify if there is a significant difference between the matrix and within the channel boundaries. However, there do appear to be cavities that build up on the channel boundaries as denoted by the dotted arrows. Similarly, the dislocation loop density appears to be much lower within the channel than in the matrix, as noted in Figure 2j. Taken together, the total density of defects including precipitates, nanocavities, and dislocation loops are lower within the channel.

Although segregation at  $\Sigma 3$  boundaries, particularly coherent  $\Sigma 3$  boundaries, is weaker compared to random high-angle grain boundaries (RHAGBs) [26], this process cannot be dismissed. While there is evidence of twinning in the channel in Figure 2, destruction of Ni/Si-rich precipitates suggests the passage of multiple dislocations along the channel, since a single twinning event would likely be insufficient to destroy precipitates [28]. The motion of dislocations, especially through heavy or severe deformation, has been shown to dissolve precipitates [29,30] and is likely what happens here at the local scale.

Figure 2. tKD a) band contrast, b) IPF, and c) KAM maps with 5 nm step size of red dotted box in Figure 1 showing strain induced channel with deformation twin occupying most of the channel; d) KAM and cumulative disorientation point-to-point profiles #1–#3 shown in a-c); e) STEM-BF and f) STEM-EDS Ni and Si map of same channel; g) concentration profile based on box in f) across the channel; h) under-focus and i) over-focus TEM-BF images highlighting nanocavities including those along channel boundaries (arrows); and j) TEM two-beam BF image showing dislocation loops in matrix and channel.

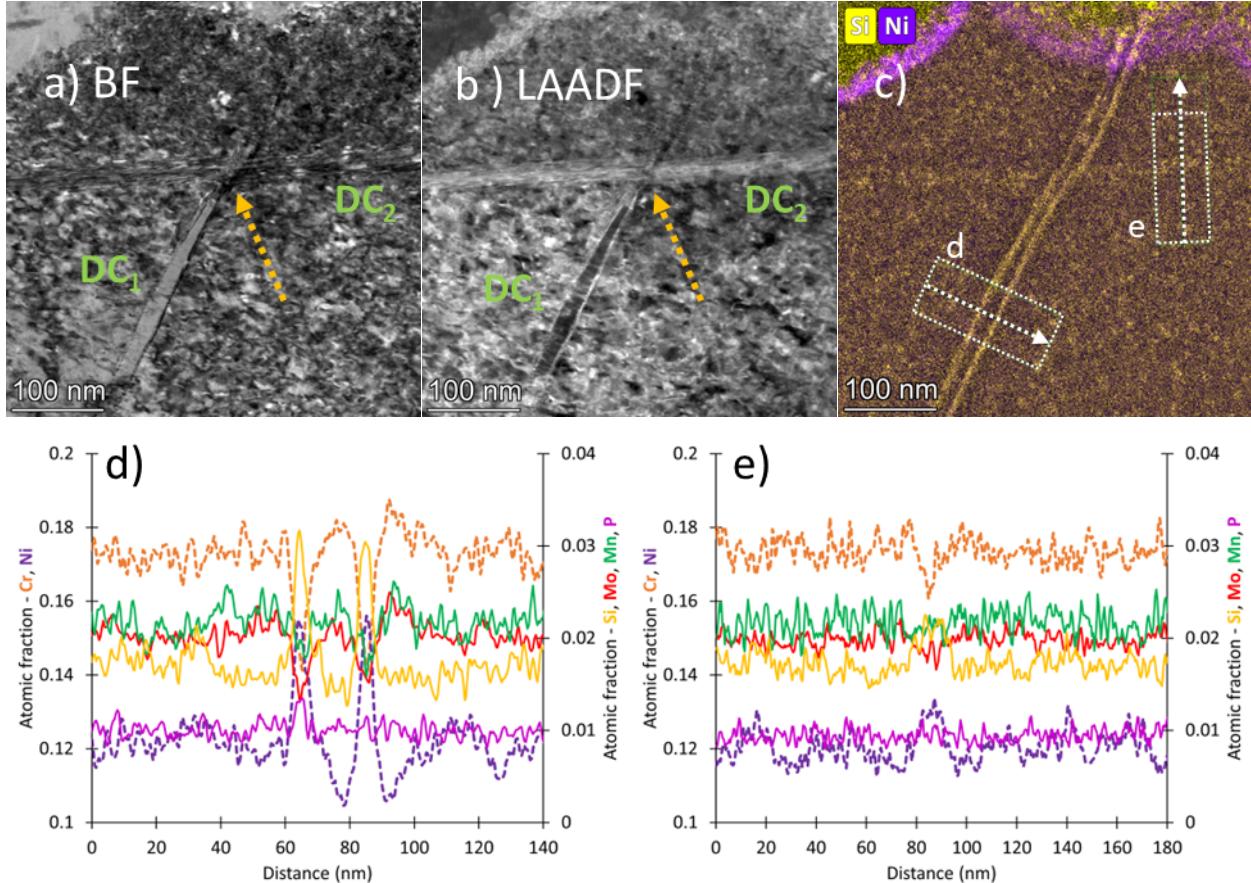
Similar STEM-EDS analyses were completed on other channel and localized defect features as well. The blue-boxed region in Figure 1f/g is characterized with STEM imaging and STEM-EDS analysis in Figure 3. This region shows two localized dislocation channels, DC<sub>1</sub> and DC<sub>2</sub>, Figure 3a – the near vertical one (DC<sub>1</sub>) and the horizontal one (DC<sub>2</sub>). The DC<sub>1</sub> channel has extensive Ni/Si segregation and Cr/Mo/Mn depletion at the channel boundaries, Figure 3d, more so than the channel boundaries in Figure 2. Two maximums in Si and Ni curves suggest strain-induced twins occupying a portion of the DC<sub>1</sub> channel. However, instead of discrete precipitates, the segregation to the channel boundaries appears to be smooth here and reaches a much higher level than the channel in Figure 2. The BF and LAADF images show there is some but relatively low dislocation content within the channel. The DC<sub>2</sub> channel on the other hand has elongated diffraction features as dislocations passed along it. This channel intersects with the other channel and looks like it causes DC<sub>1</sub> channel to bend or be compressed slightly (the bending is pointed by dashed arrow in Figure 3a,b). This horizontal channel does have some slight Ni/Si segregation to it, Figure 3c but

no evidence of a strain-induced twin. The higher degree of segregation at the  $DC_1$  channel boundaries in Figure 3 also means these boundaries may likely be incoherent  $\Sigma 3$  boundaries due to being a good sink for defects and solute and comparable to RHAGBs [26]. The segregation to the non-twinned channel suggests that localized strain-induced features can serve as sinks for defects and solutes just as a dislocations and dislocation cells can [32].

Figure 3. a) STEM-BF, b) STEM-LAADF, and c) STEM-EDS Ni and Si map of blue dotted box in Figure 1 showing dislocation channel ( $DC_1$ ) with likely internal twin intersecting with another dislocation channel ( $DC_2$ ); d) concentration profile based on box in c) across the channel  $DC_1$ ; e) concentration profile based on box in c) across the channel  $DC_2$ .
