**Type A Accident
Investigation Board Report
on the January 17, 1996,
Electrical Accident with Injury in
Building 209, Technical Area 21
Los Alamos National Laboratory**

**Type A Accident
Investigation Board Report
on the January 17, 1996,
Electrical Accident with Injury in
Technical Area 21
Tritium Science and Fabrication Facility
Los Alamos National Laboratory**

April 1996

**Office of Oversight
Environment, Safety and Health
U.S. Department of Energy**

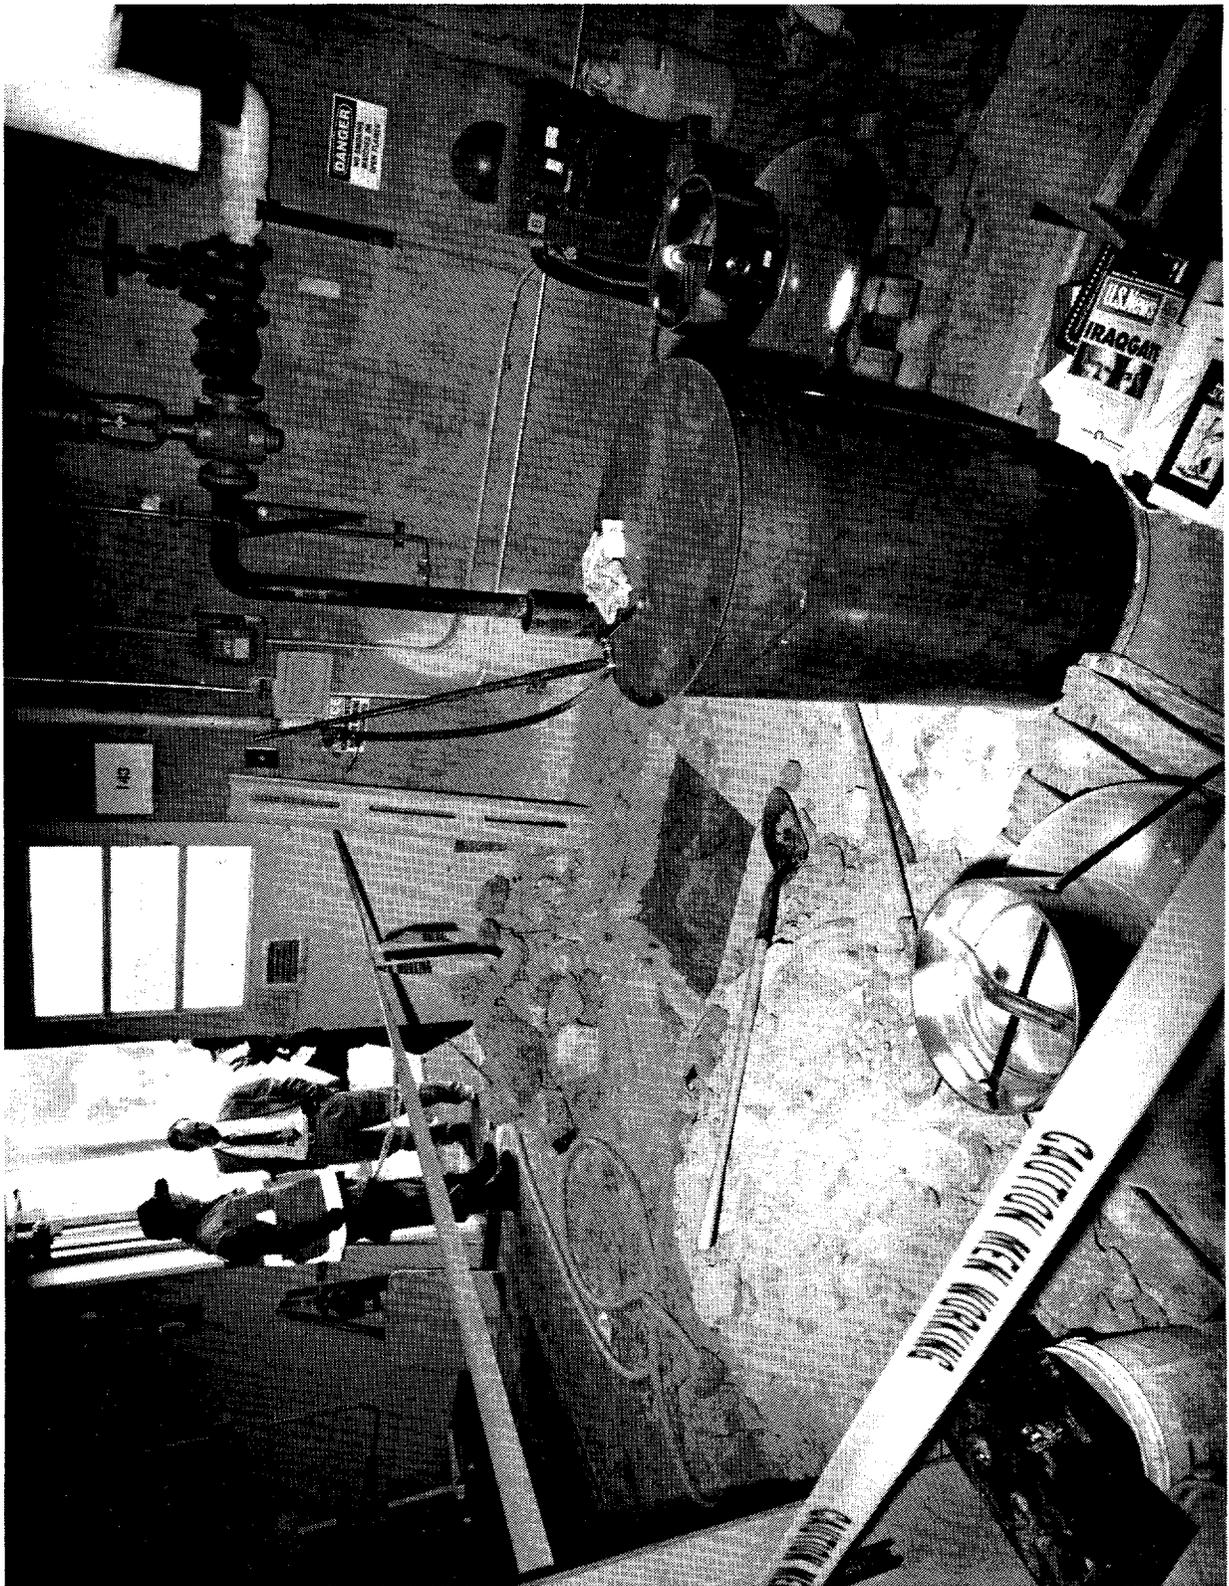
Figure 2-2. General View of the Accident Work Site

By 9:30 a.m. the masons at Building TA-21-209 had excavated to a depth of 39 inches (Figure 2-3) by using an air-powered jackhammer, a pry bar, and a shovel to loosen and remove the rubble from the sump pit. At 9:34 a.m., the jackhammer being used by the mason tender broke through a concrete-encased conduit containing a 13.2 kV electrical cable. The jackhammer bit penetrated the conduit several times before coming into contact with the cable, as illustrated in Figure 2-4. The accident victim was observed by the other mason tender to "shake" from the electrical contact, a buzzing sound like that of "an electric welder" was heard, and a bright flash of light was emitted, followed by an apparent explosion from within the sump pit. Power was apparently lost to Building TA-21-209 at approximately 9:34 a.m., as shown in Figure 2-5. Figure 2-6 shows the conduit that was struck by the jackhammer.

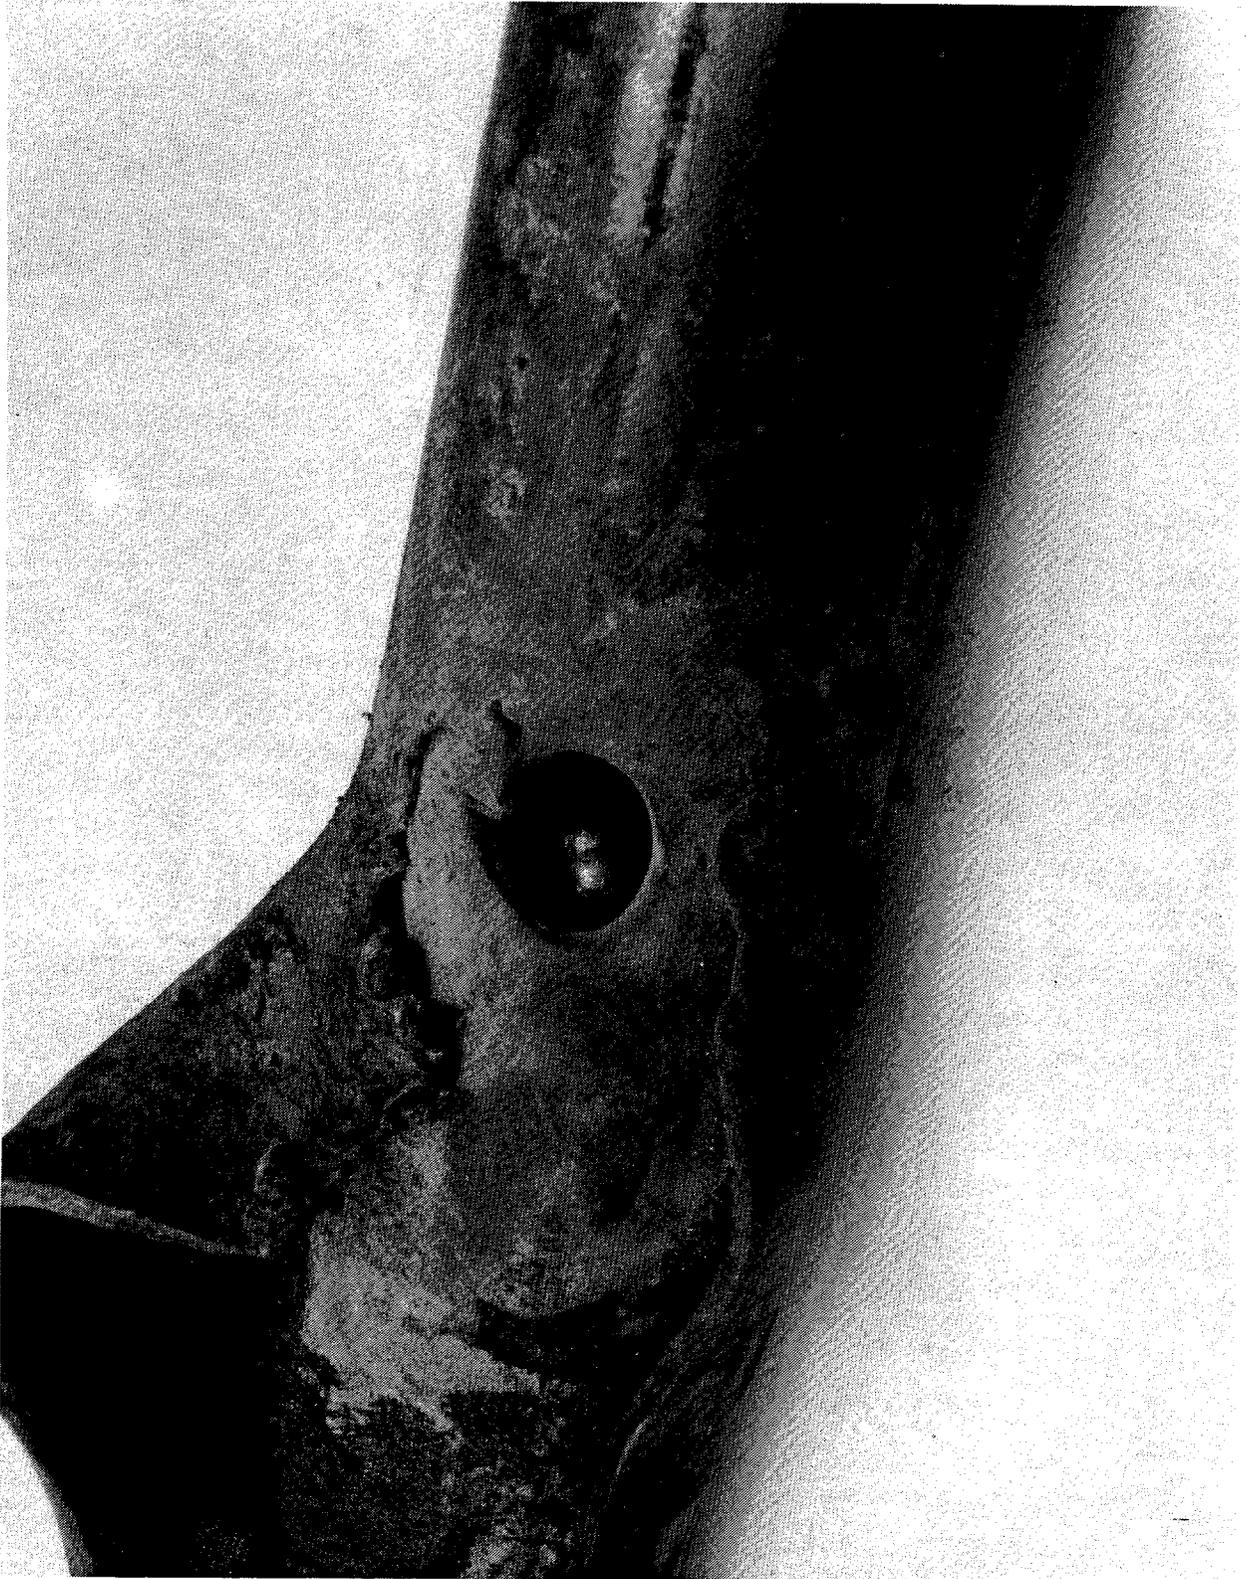
Figure 2-4. Conduit Penetrated by Jackhammer Bit

The direct cause of the electrical accident with injury was the chisel bit of the air-powered jackhammer coming into contact with the 13.2 kV energized electrical cable in the sump pit being excavated in the basement of Building TA-21-209.

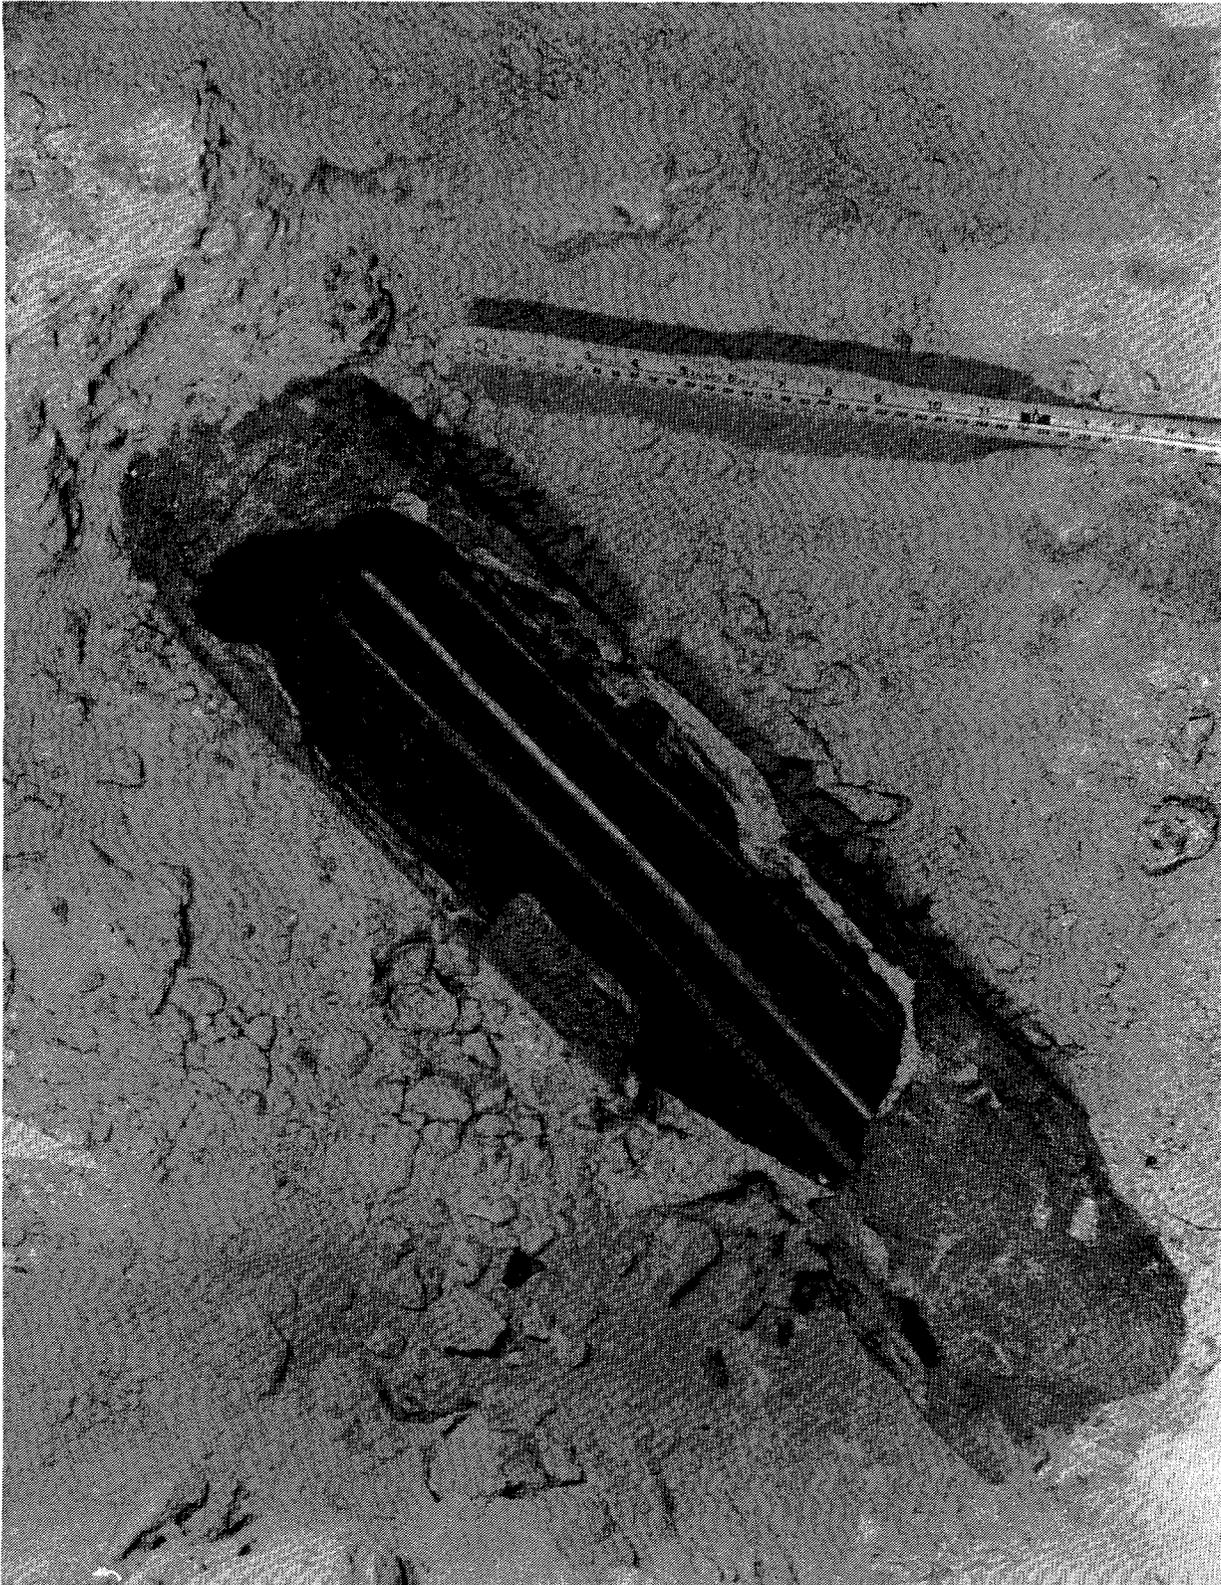
Figure 2-6. Cutaway View of Conduit Cable Penetrated by Jackhammer

The accident victim's jackhammer penetrated a 13.2 kV electrical cable, severely injuring him and cutting power to the building.

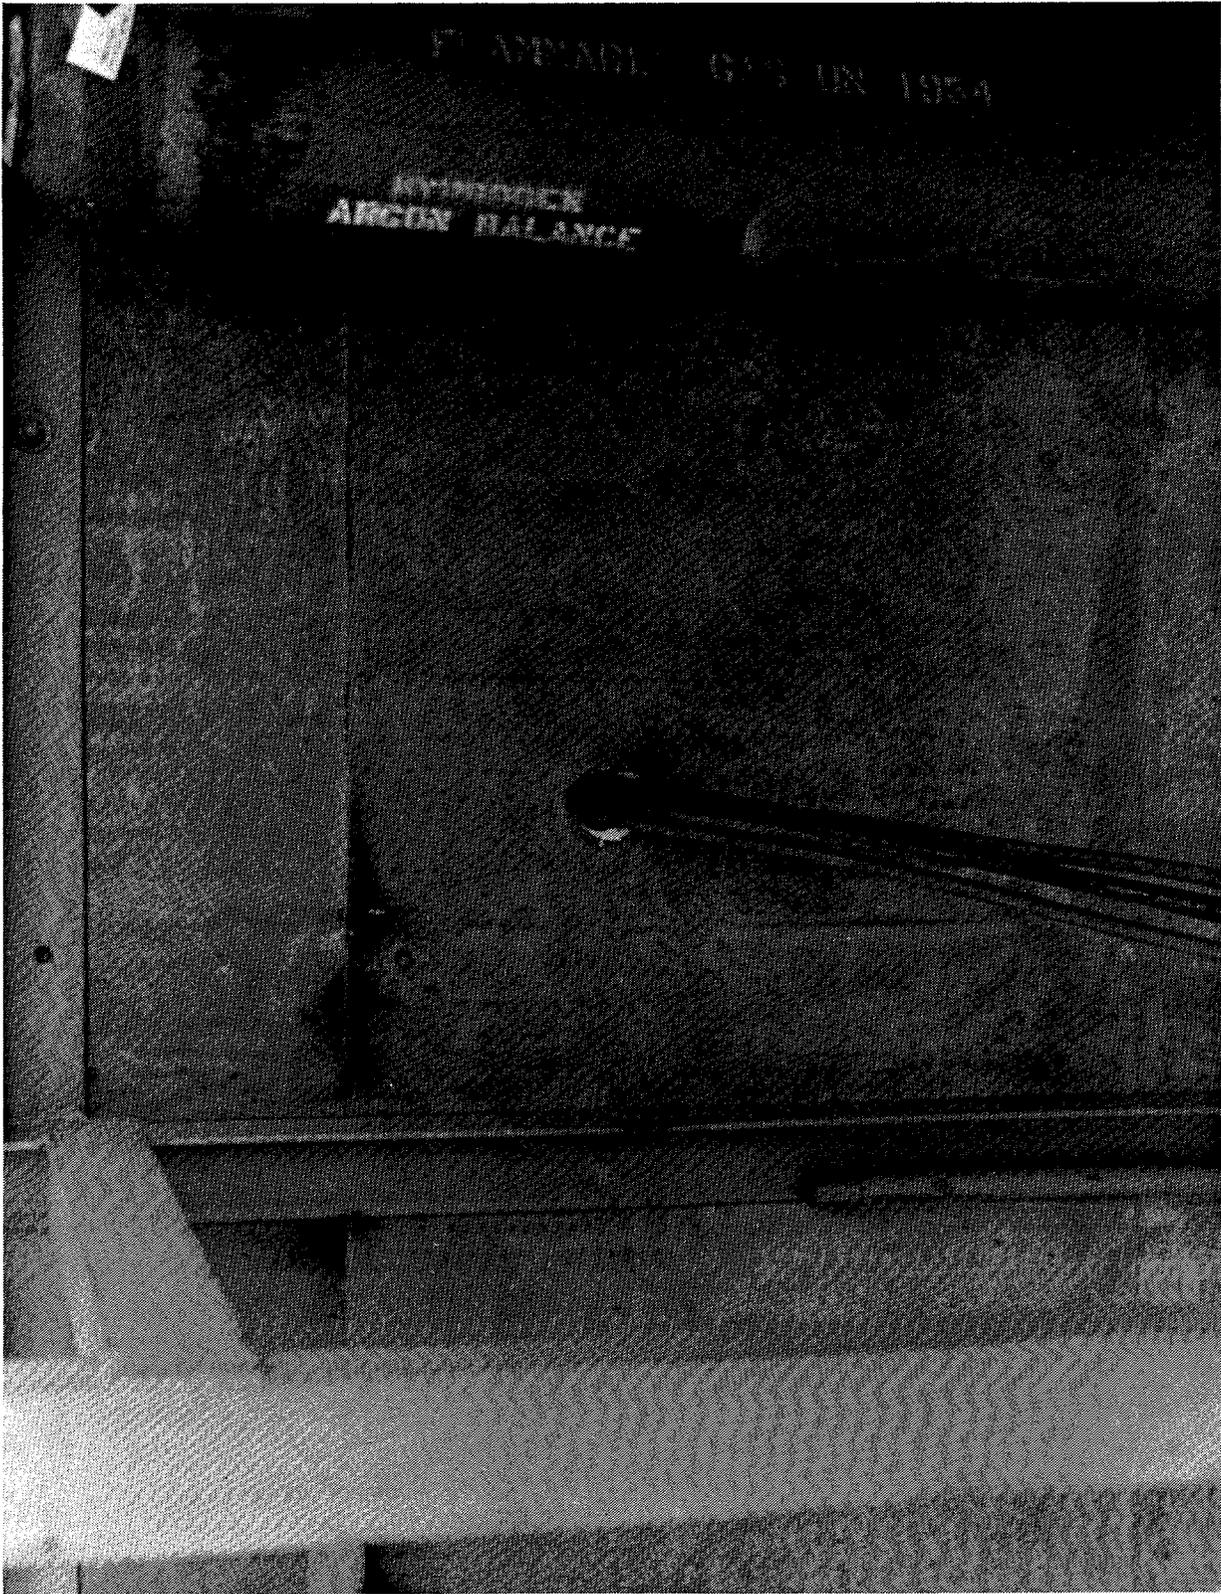
Some safety concerns were noted in how the generator was connected and grounded.

Figure 3-5. Electrical Cables Extending From the Mobile Generator Through the Wall to Temporarily Restore Power

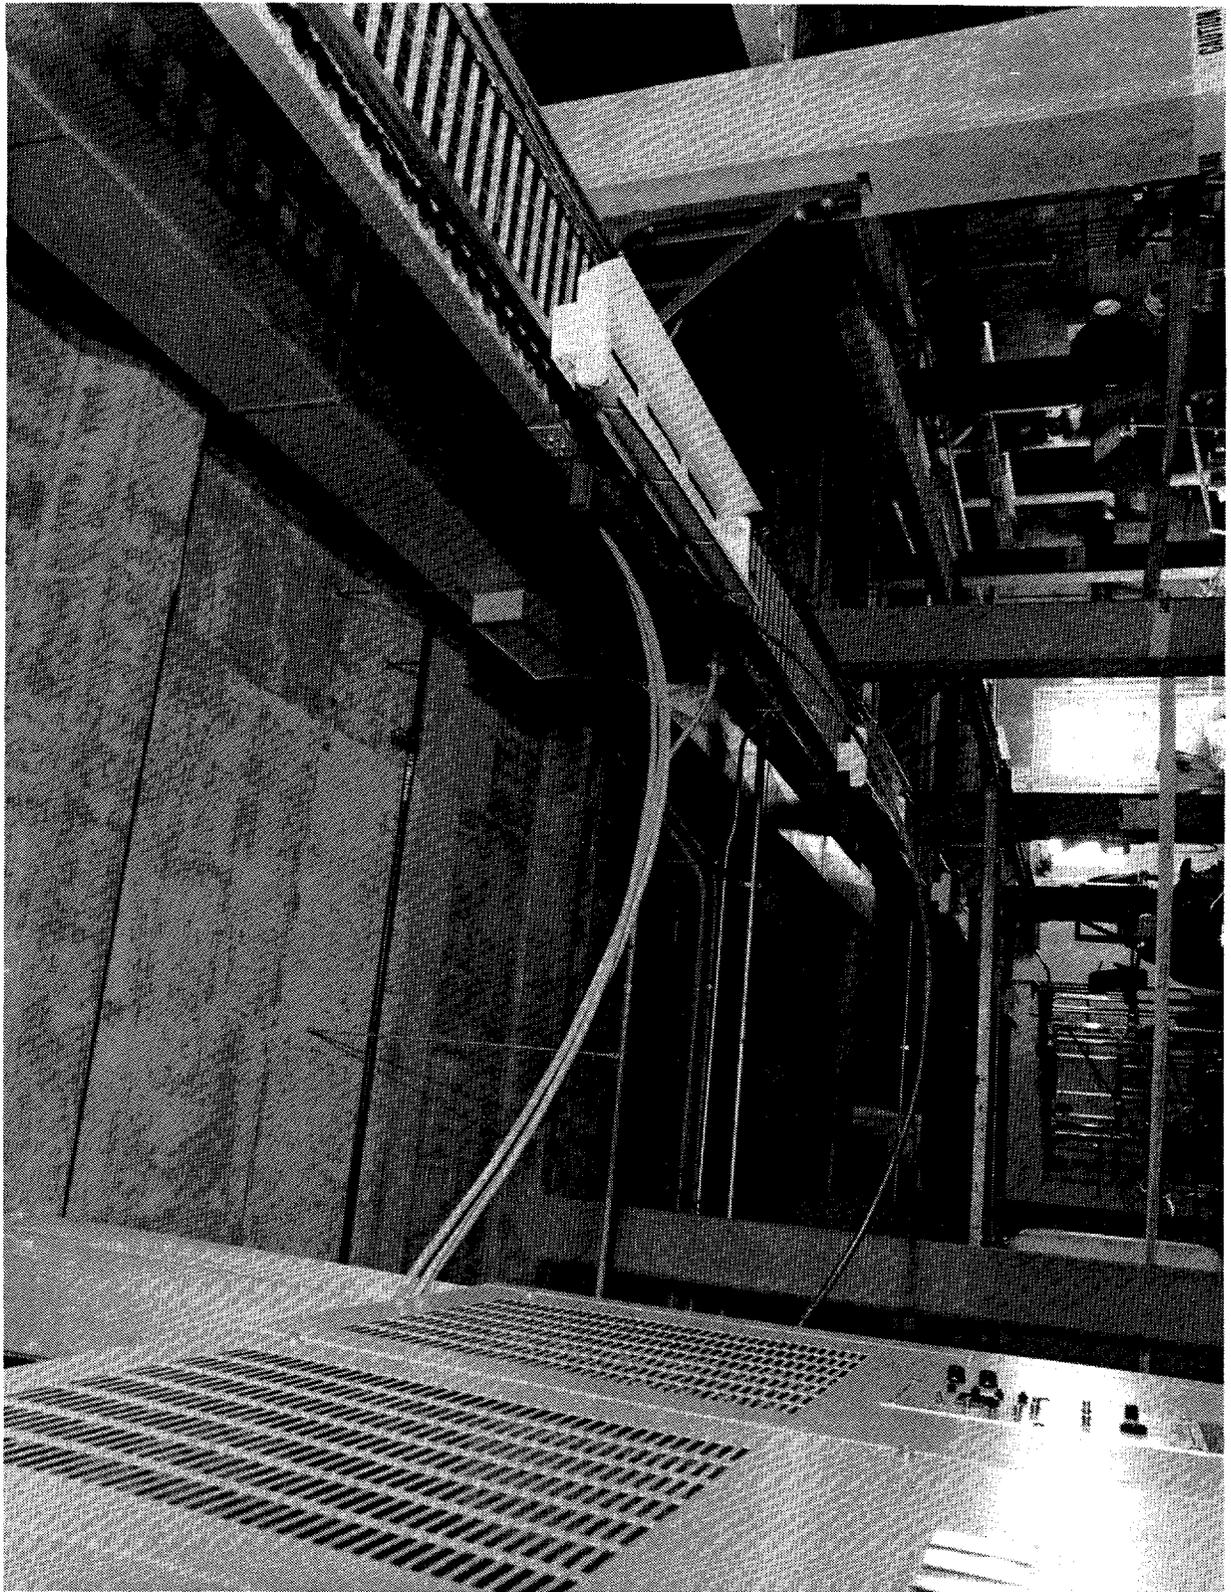
Figure 3-6. Electrical Cables Draped Over Electrical Utility Trays

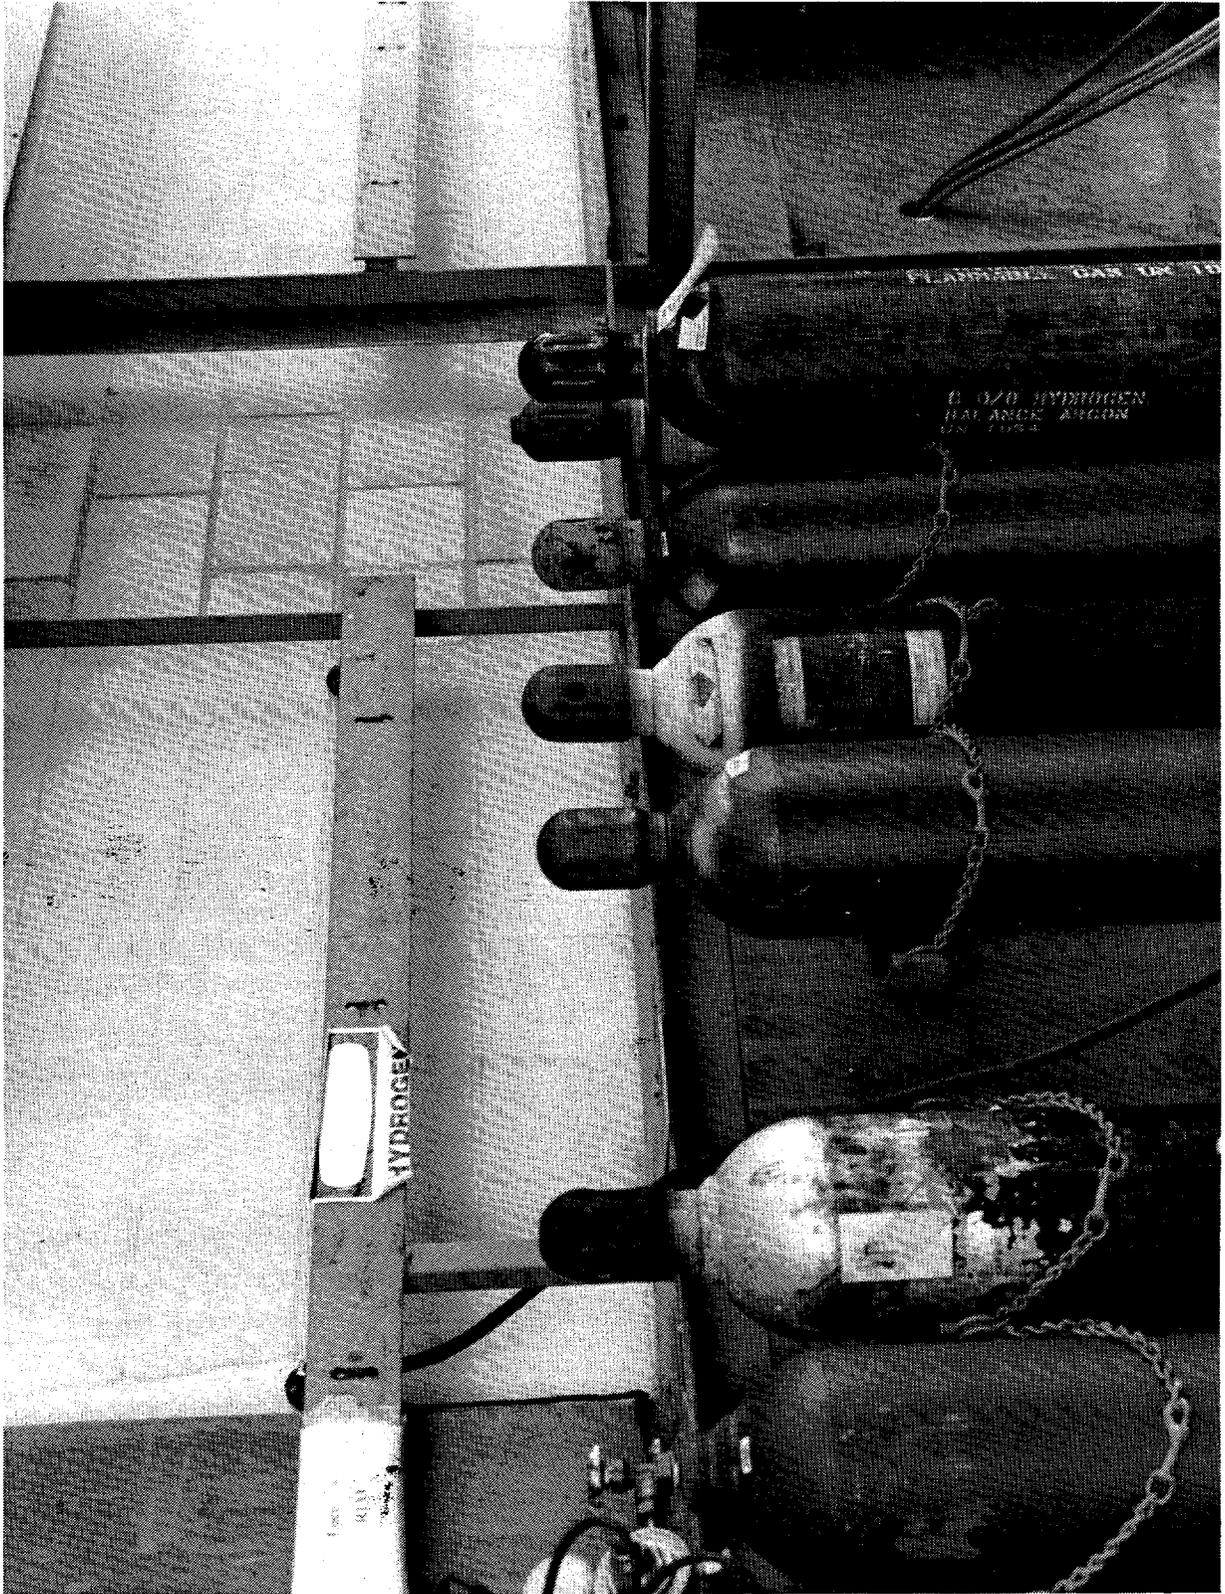
Figure 3-7. Electrical Cables Grounded Near Hydrogen Bottles and Warning Sign

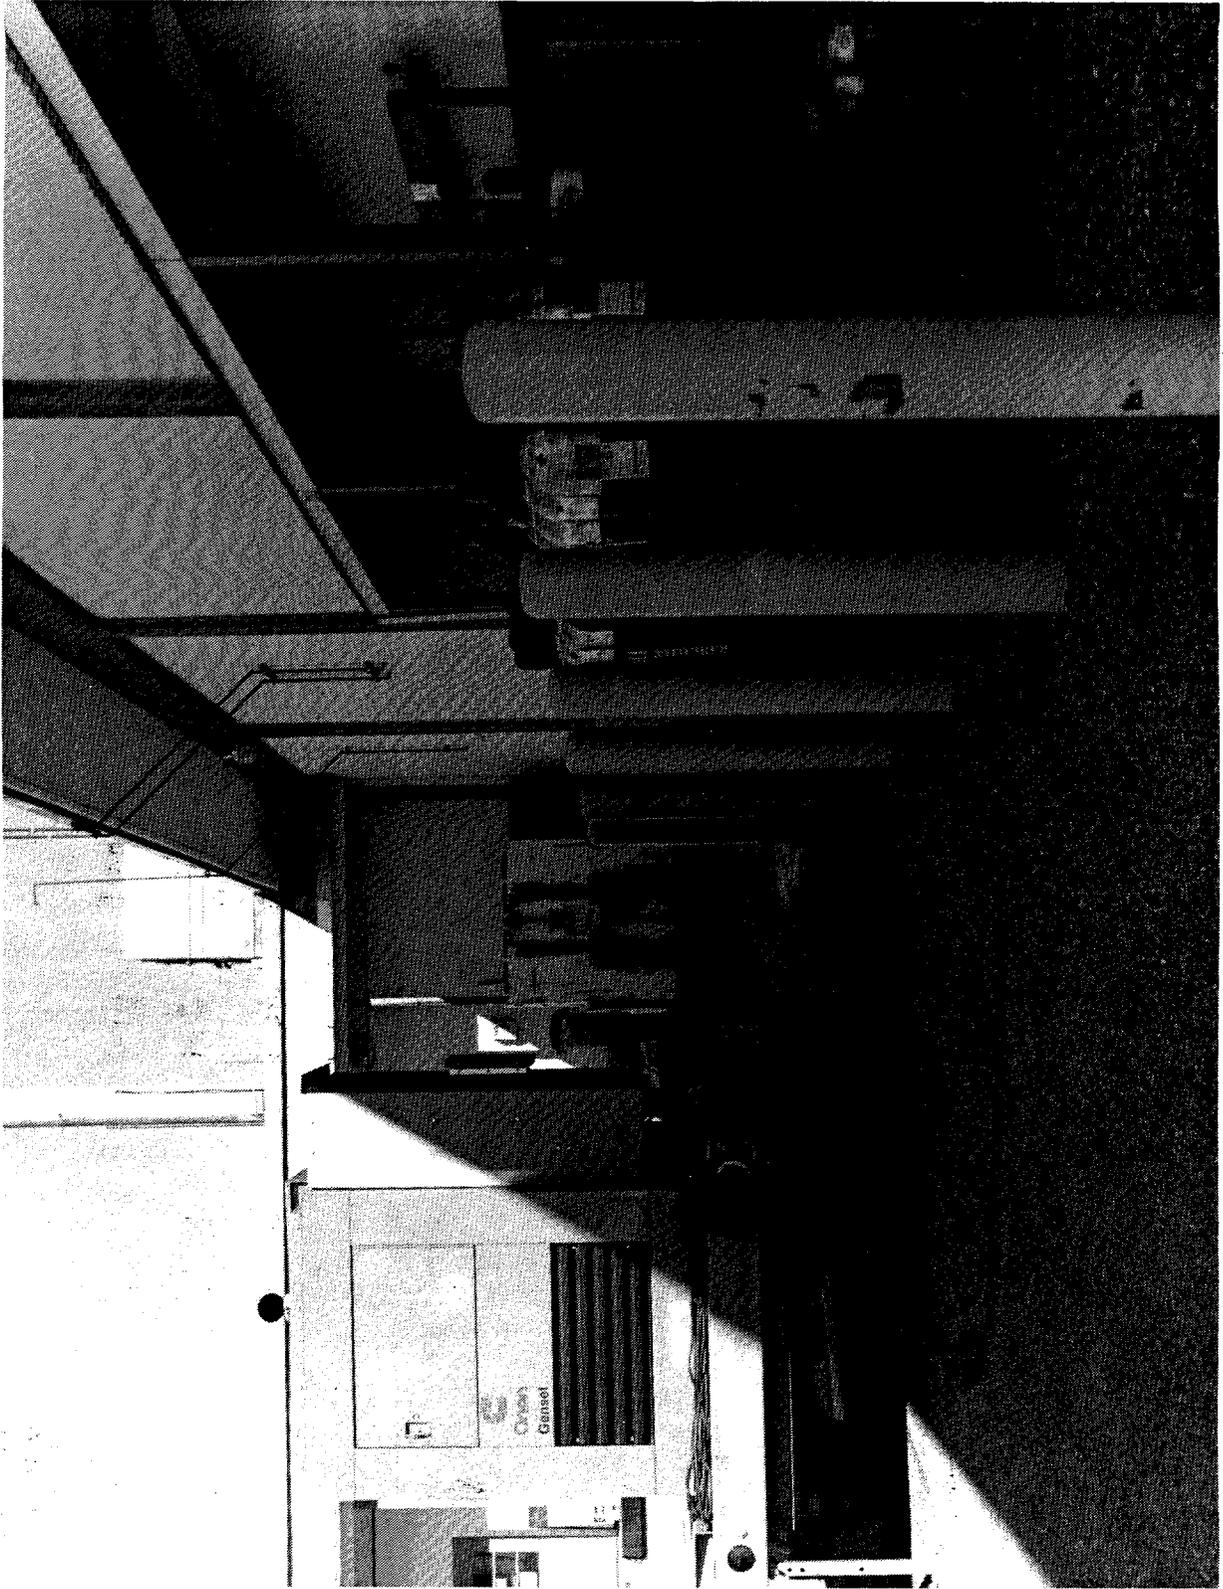
Figure 3-8. Electrical Generator, Cables, and Adjacent Hydrogen Bottles
