UNITED NUCLEAR, INC.  
RICHLAND, WASHINGTON

INVESTIGATION OF N REACTOR SCRAM  
OF  
SEPTEMBER 30, 1970

G. C. Coleman

DUN-7342

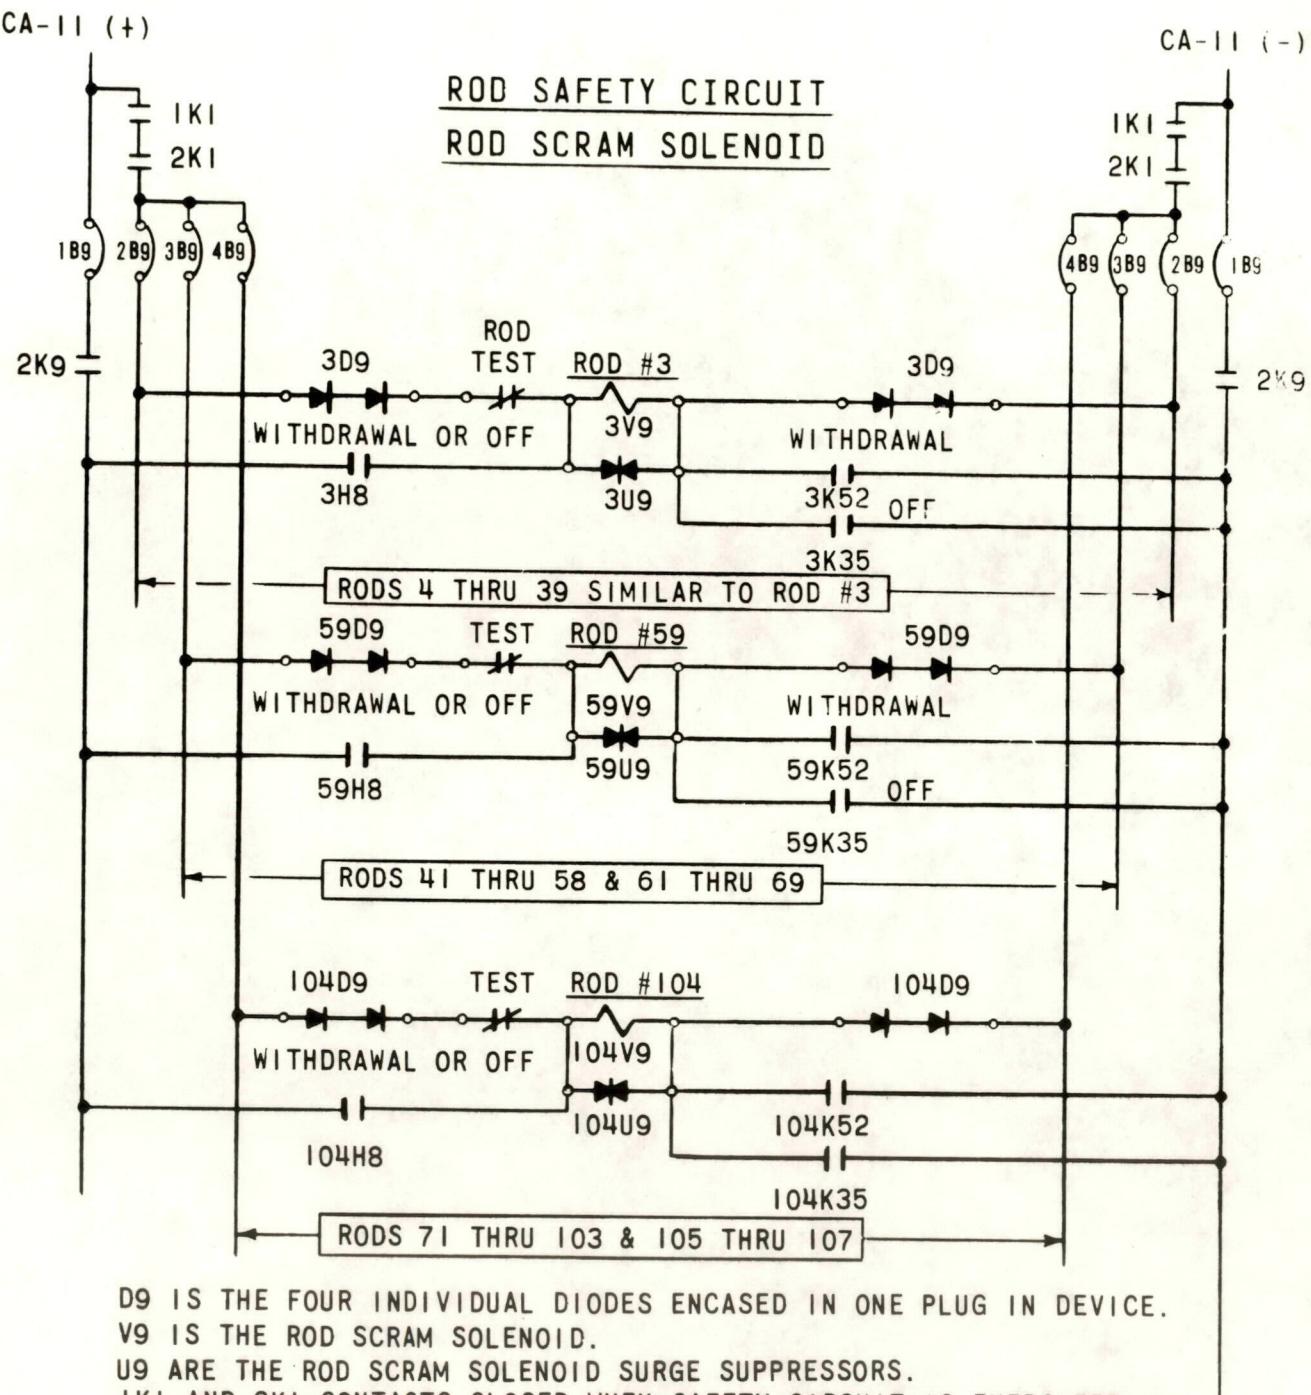
Review of the circuitry design indicated that the most probable cause of the rod scram failure was the continuing energization of the rod scram solenoids by the auxiliary circuit which was used to electrically put control rod 59 in the "off" condition prior to the scram. For this to occur, however, shorting failures would be required of four diodes in series (DUN P/N 59D9, GE P/N AJA420BX8) which are specifically included in the control rod circuits to prevent power from the rod "off" or "withdrawal" circuits from inadvertently energizing the rod scram solenoids. (Reference: Figure 3 and Drawing H-1-32025).

D9 IS THE FOUR INDIVIDUAL DIODES ENCASED IN ONE PLUG IN DEVICE.  
V9 IS THE ROD SCRAM SOLENOID.

119 ARE THE BOD SCRAM SOLENOID SURGE SUPPRESSORS

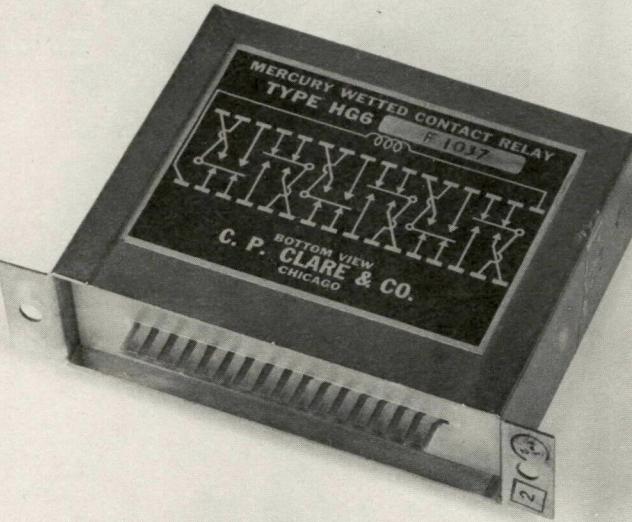
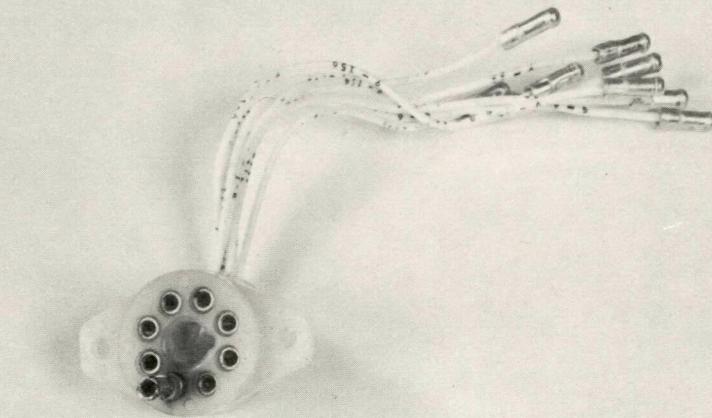
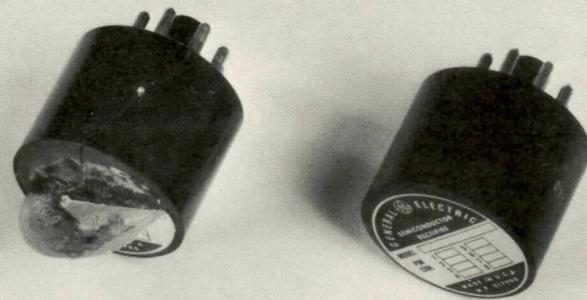
Figure 4. Rod Control Components

MERCURY WETTED RELAY (59K35)

FAILED DIODE SOCKET

FAILED DIODE

Following the completion of the previously described rod control tests, the rod 59 diode package (59D9) was manually pulled from the circuit, as a positive demonstration of the fact that the power holding the scram solenoids was coming through the diode package. All six remaining control rods immediately scrammed into the reactor. Circuit measurements also confirmed that all extraneous voltage had been removed from the scram solenoid circuits. Diode 59D9 was found to be very hot to handle and was very difficult to pull. In fact, one of the socket contacts was pulled out during removal. This socket contact contained solder from the diode on its inner surface.

The diode resistance was measured and the reading on each diode was essentially zero in both directions. It was also verified that there was no continuity or short between the four diodes. (They were all electrically separate.) The surge suppressor 59U9 was checked for resistance and found normal.

3. Critical jumper No. 194 was removed so that annunciation could again be restored to the rod 59 scram accumulator.
4. Rod 59 "off" relay (59K35) and "withdrawal" relay (59K52) were removed. A new relay was installed in 59K35 because the current rating of the contacts had been exceeded. 59K52 was inspected and showed no signs of damage. It was then re-installed.

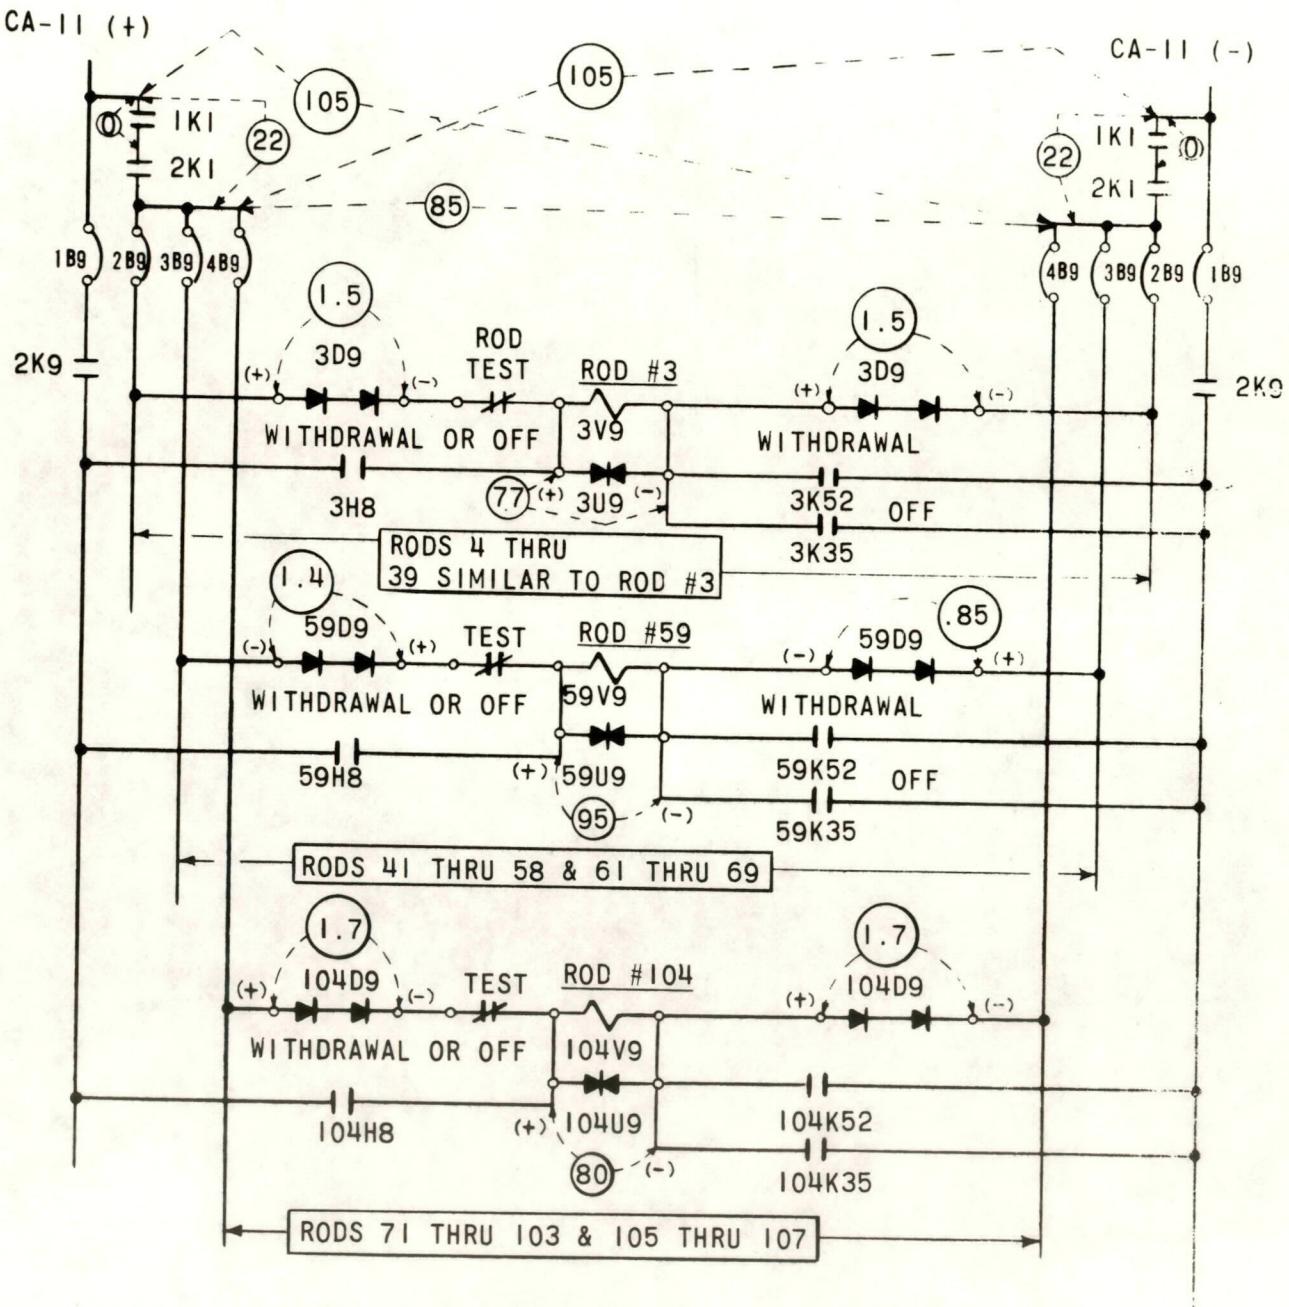
Figure 5. Rod Scram Circuitry  
(Showing Voltage Measurements)

The current being drawn through the 1B9 circuit breaker feeding the rod "off" and "withdrawal" circuit was measured with a clamp-on ammeter at 10 amperes (breaker trip setting 12.5 amps), again indicating that multiple coils were being energized through this circuit.

VOLTAGE MEASUREMENTS MADE ON SEPT. 30, 1970  
READINGS IN VOLTS

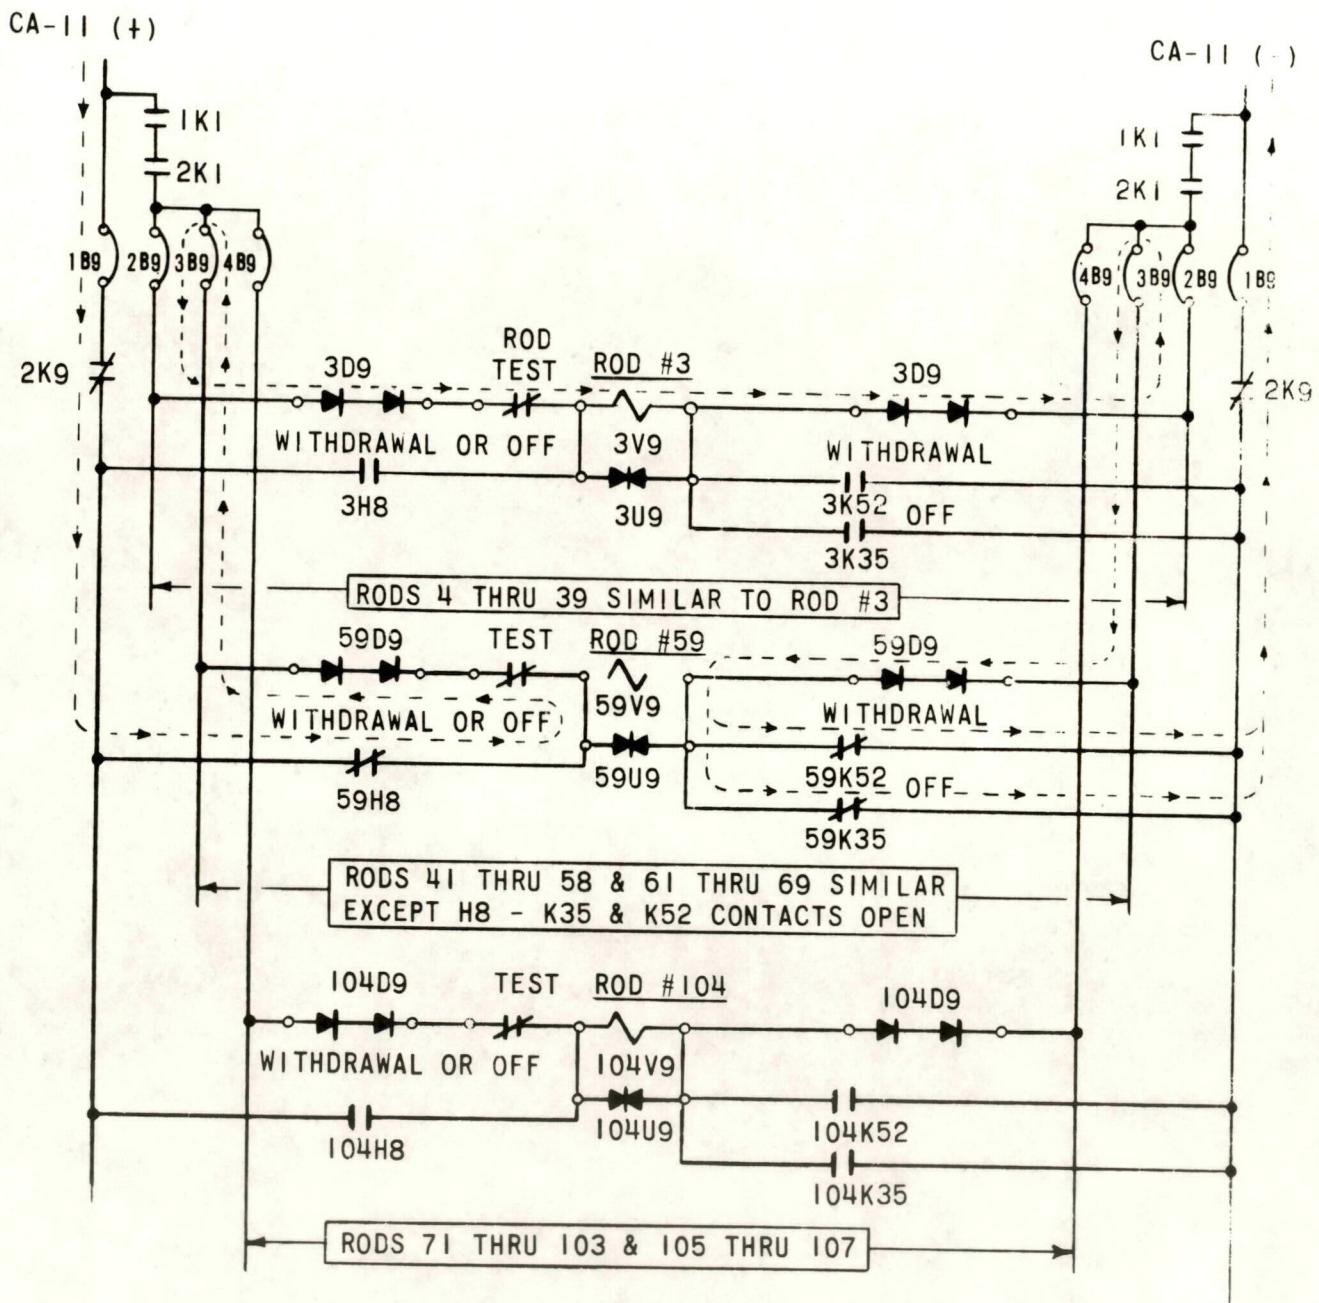
Additional voltage and amperage measurements were made by the investigating team and further verified that the all-rod scram solenoids were being held energized by the rod "off" or "withdrawal" circuit being fed through the four shorted AJA420BX8 diodes, the 59K35 relay "off" contacts, and the 59H8 selector switch contacts of rod 59. (Reference: Figure 6.)

CIRCUIT SHOWN AS FOUND SEPT. 30, 1970  
 CURRENT PATH SHOWN FOR ROD 3 & ROD 59  
 ALL OTHER RODS CURRENT PATHS SIMILAR TO ROD #3

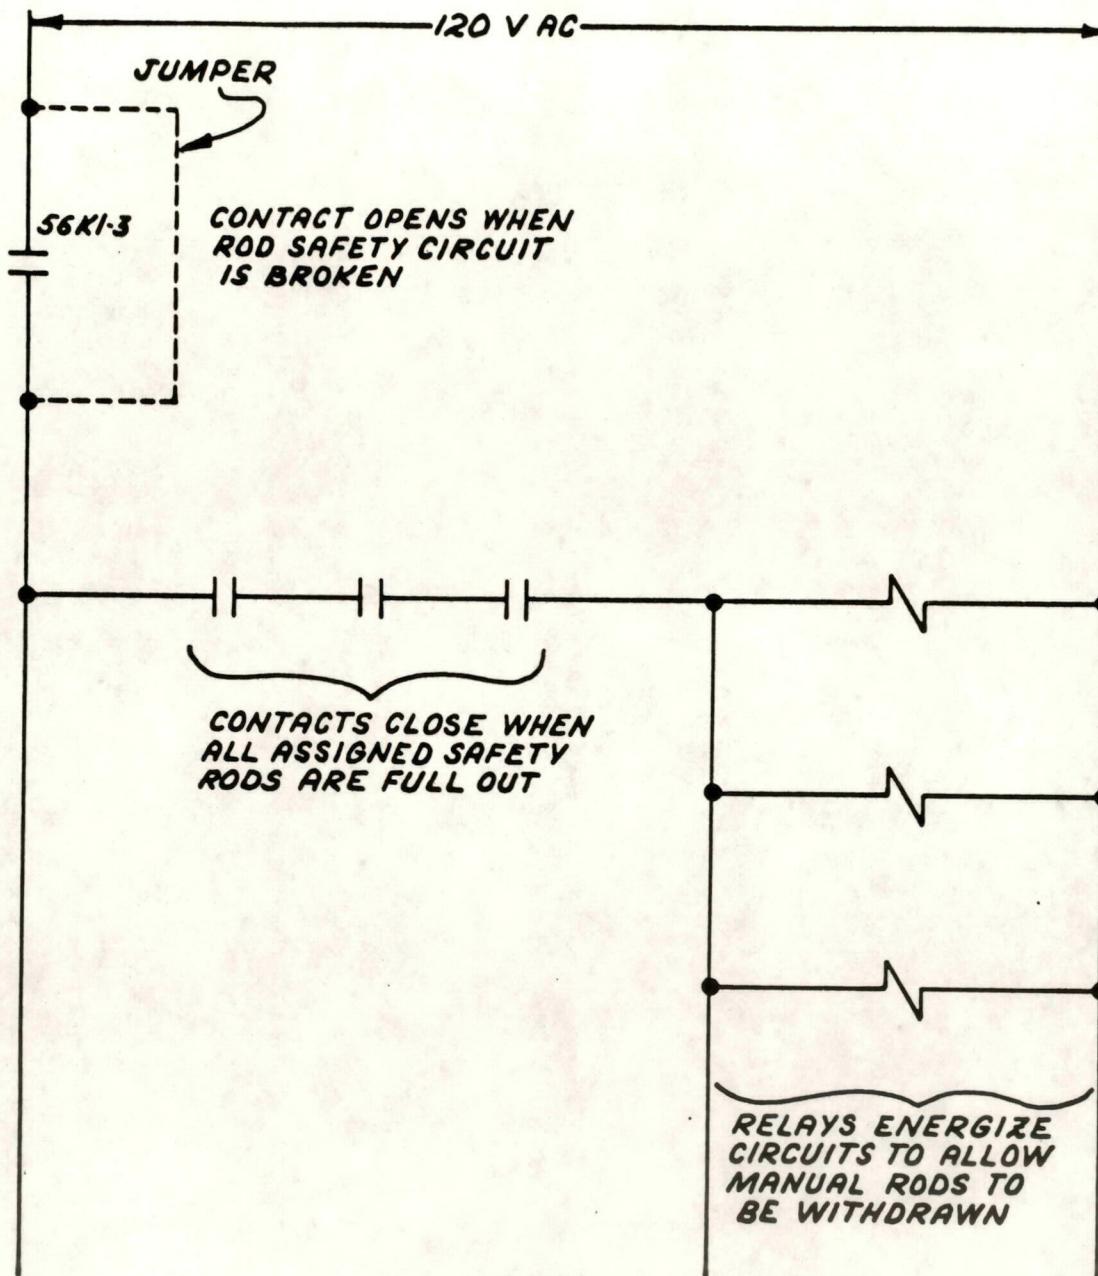
Figure 7.

During the testing, it was determined that rods could be withdrawn as well as inserted by using the gang switches. Withdrawal capability should not have been electrically possible with the reactor in a scrammed condition and, therefore, the cause of this discrepancy was traced down to determine its connection, if any, to the rod scram problem. An unauthorized jumper was found across the contacts of relay 56K1 which was the interlock which should have disabled the normal rod withdrawal AC circuits at the receipt of a scram signal. (See Figure 7.) It should be noted that, under normal scram conditions, the scram vent valve opens and bypasses any hydraulic fluid coming from the "out" control solenoid and makes it hydraulically impossible to withdraw a rod during a normal scram. (See Figure 2 or Attachment A.) This fact would also prevent the jumper from being noticed during normal testing.

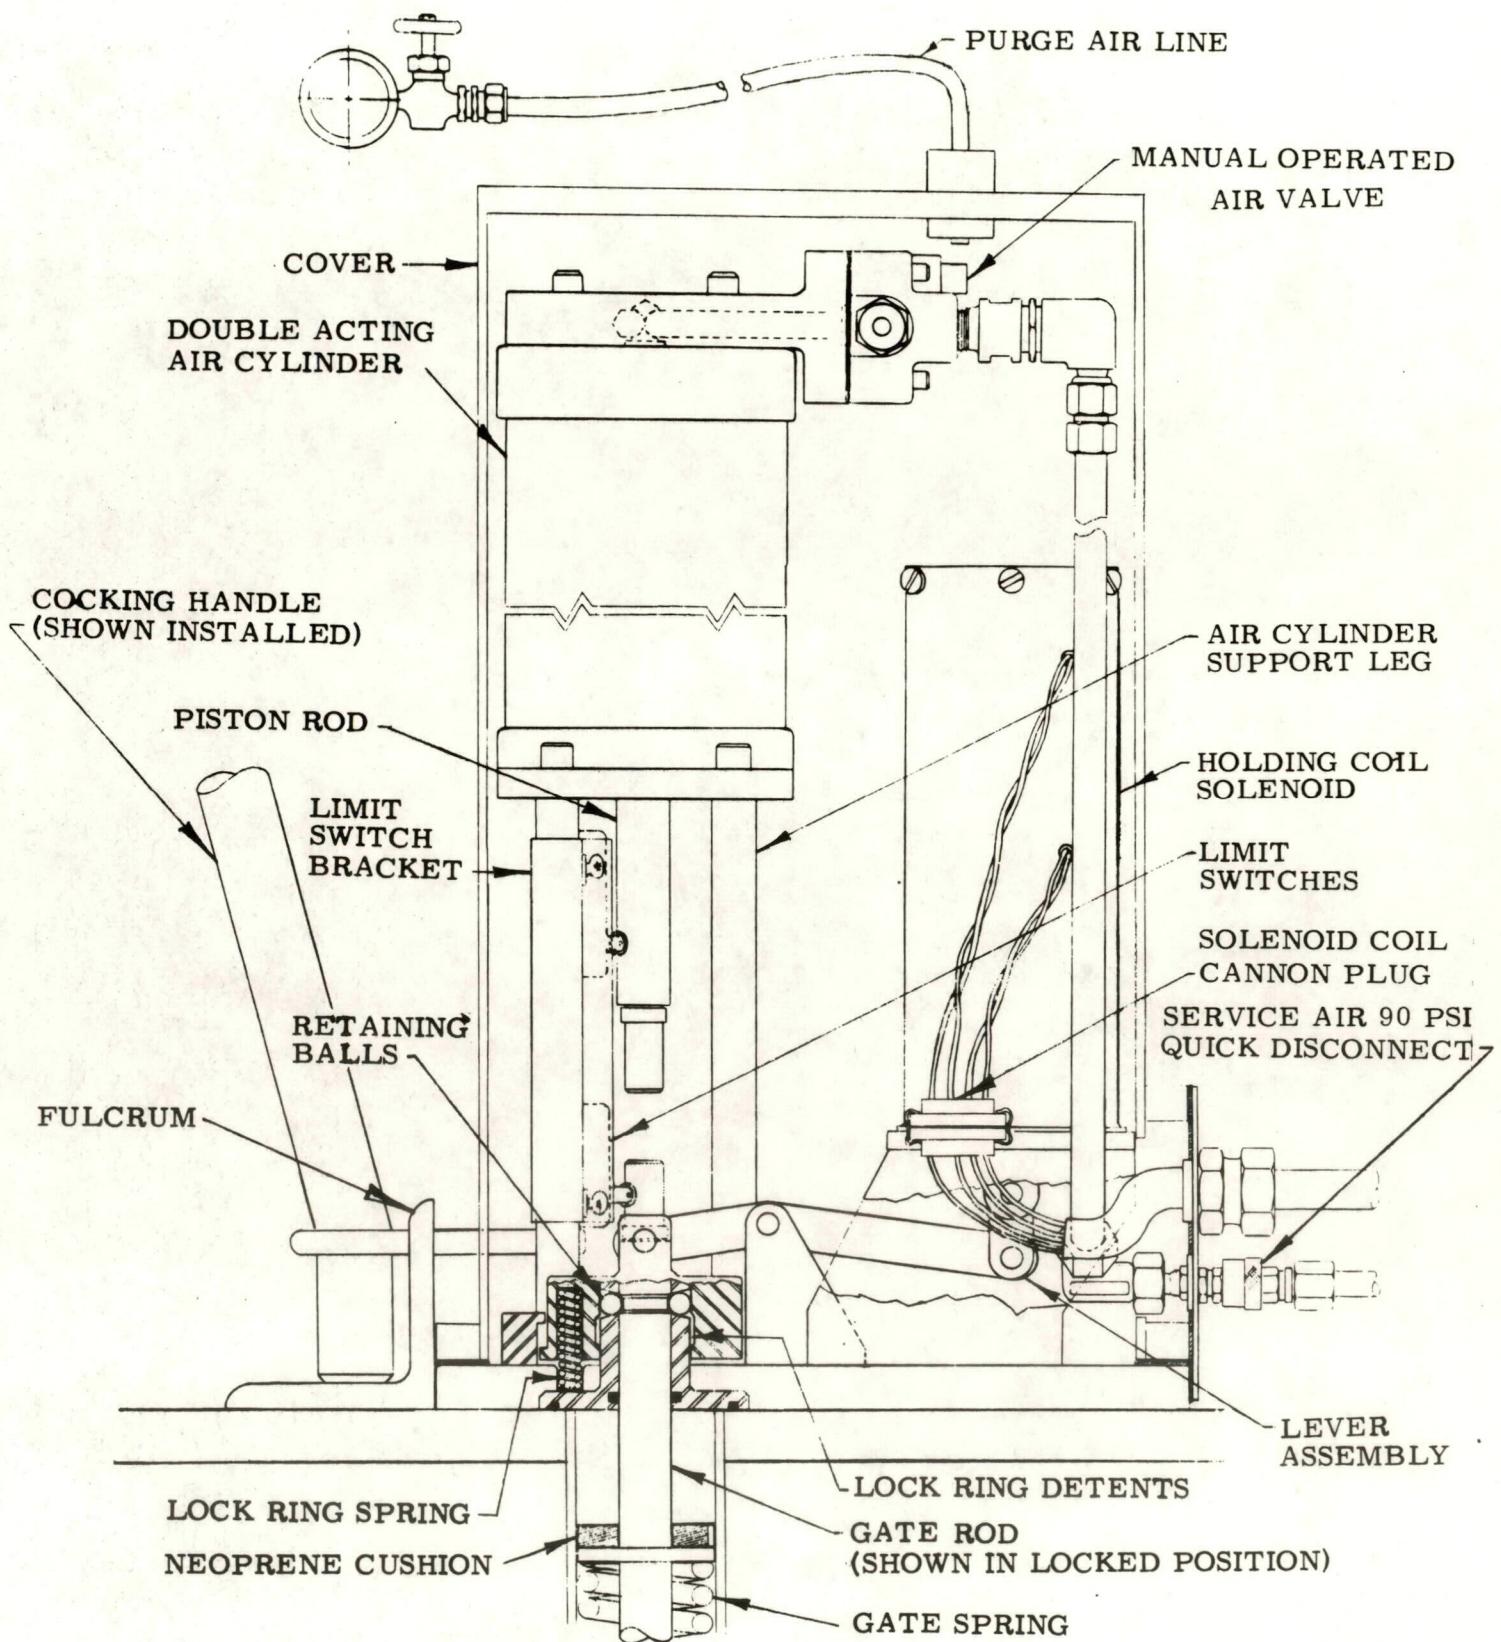
Figure 12. Ball Trip Mechanism

An examination of hopper No. 3 revealed that the hopper gate did not open because the trip mechanism locking collar failed to release. Only

one probable cause as to why the collar failed to release could be found when carefully disassembling all of the hopper components; for example, one of the four steel retaining balls in the latching mechanism was missing. (See Figure 12.) The missing retaining ball allowed the hopper gate locking collar to misalign sufficiently to prevent opening of the hopper gate. The missing ball was found near the No. 3 hopper and had apparently dropped out of place during assembly.

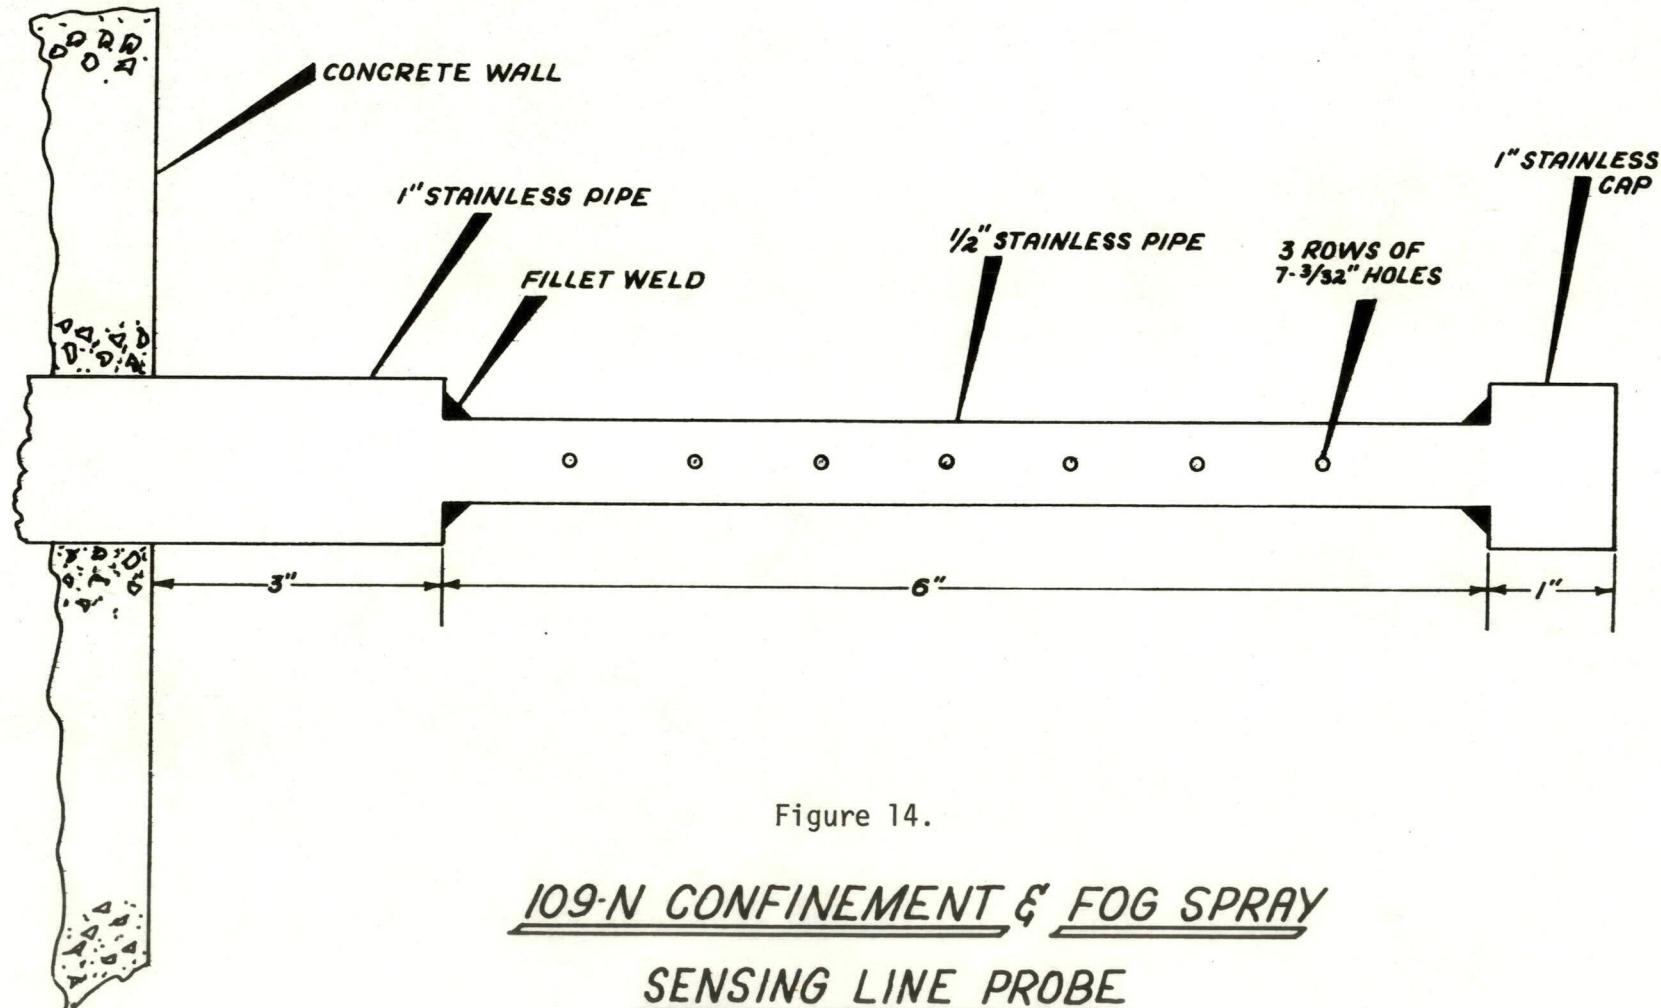
Figure 14.

As a result of the special test, all eight sensing lines for the fog spray and confinement pressure switches in cells 1, 2, 4, and 5 were inspected and found sealed off. (Reference: DUN-7395, dated October, 1970.) One line in cell 1 was sealed off with self-tapping screws and rubber gaskets in each of the 21 holes in the specially made probe of the sensing line. (See Figure 14.) The other seven lines were sealed by wrapping the sensor heads with black plastic electrical tape. The sensing lines in cells 3 and 6 and the pipe gallery were unobstructed. However, tape marks were visible on the cell 3 sensing lines.

The evidence of cell wall elastomer coating on the outside of the tape indicates that the taping was done prior to the coating of the cell walls prior to initial reactor startup in 1964. Initial cell leak-tightness tests or pressure or vacuum tests during initial startup may have been the type of activity for which sealing of the pressure sensing lines was necessary.

1. Testing of these pressure switches should be covered in the future by proposed EMS-603, which in its present form should detect any capped sensing lines. It is recommended that EMS-603 be modified to also detect closed isolation valves.
2. Signs should be placed at all the sensing lines and isolation valves to warn against inadvertent closing or plugging.
3. Isolation valves for pressure switches which provide control inputs to safety systems should be included in the "N Plant Operations Subsection Equipment Status Control System," DUN-7201, DL Howard, dated August 31, 1970.
4. Confinement Backup Devices
