Title: Routine & Nonredundant Steel Tension Member (NSTM) Inspection Report (Final) Property ID No. 43-0434 - Los Alamos Canyon Bridge

Inspection Dates: June 7-9, 2024

Property ID No. 43-0434 - Los Alamos Canyon Bridge

Los Alamos Canyon Bridge on NM-501 (Diamond Drive) over Omega and Dulce Roads

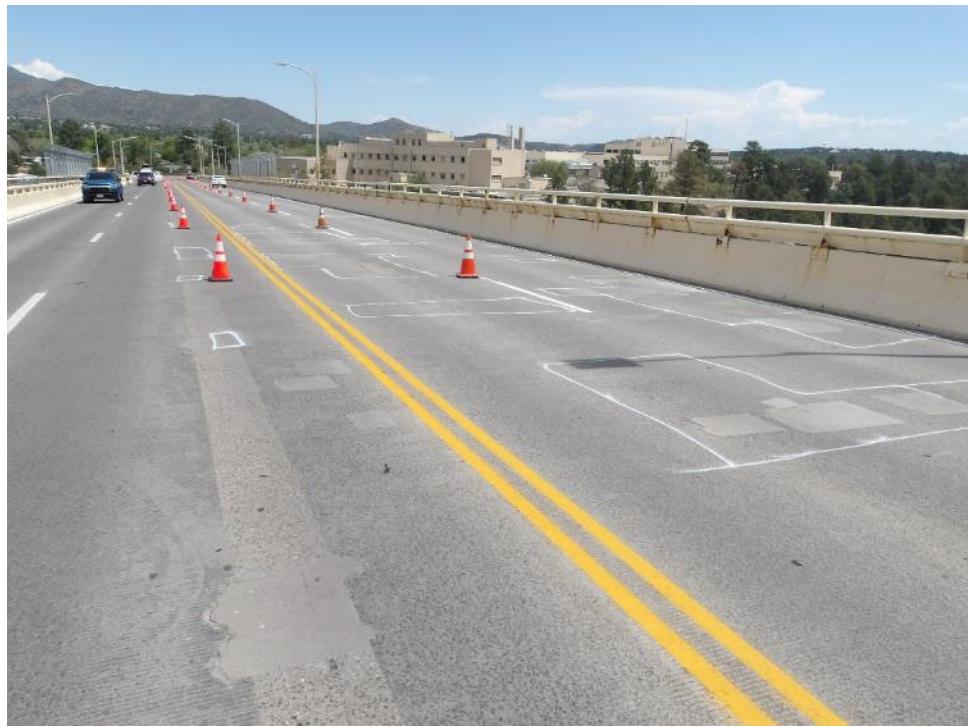
In the deck closure joint near the bridge centerline, there were several delaminated areas found over the total bridge length; the delaminations usually extend the full width (1-ft., 4- in.) of the closure joint (**Photo 1**).

Photo 1- Elevation view of deck, looking north. White outlines indicate locations of deck delaminations.

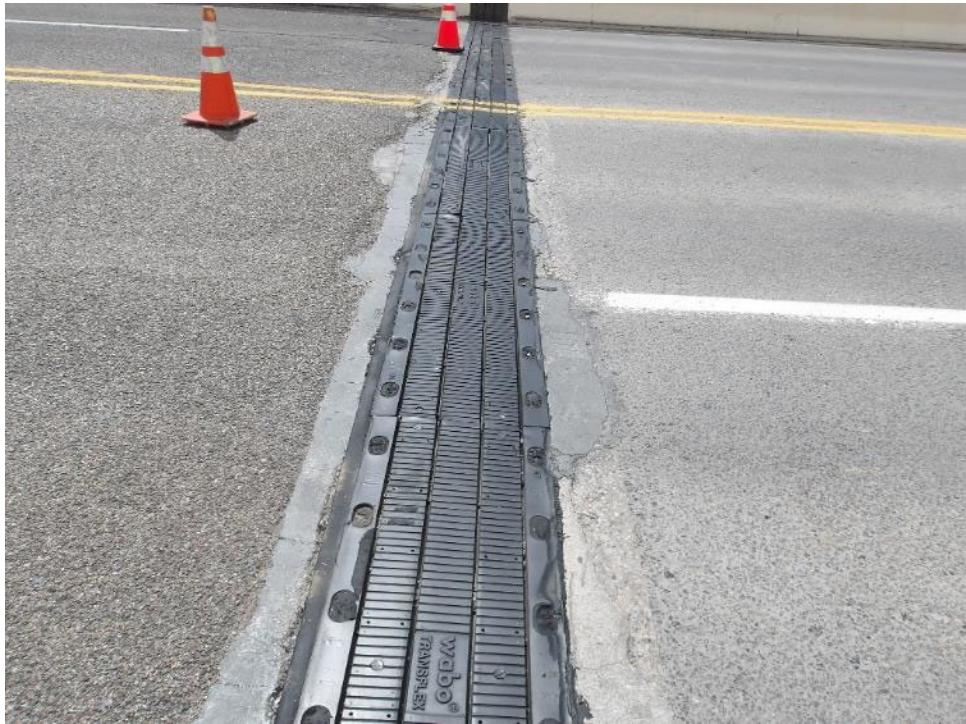
At the south joint, delaminated areas were found on the adjacent header areas of the bridge deck and approach roadway. Patch repairs at both the north and south expansion joints are adhering but there are cracks and delaminations at both joints (**Photos 2 & 3**). Additionally, cracking and spalling continues outside of the patches immediately north of the north expansion joint. There is a $\frac{3}{4}$ " vertical displacement in the southern expansion joint at the pedestrian walkway (**Photo 4**). Installation of new north and south joints was completed in September 2022 (**Photos 3 & 5**).

Photo 3- South expansion joint looking west. Note small spalls and delaminations (up to 1') at both edges of the deck joint.

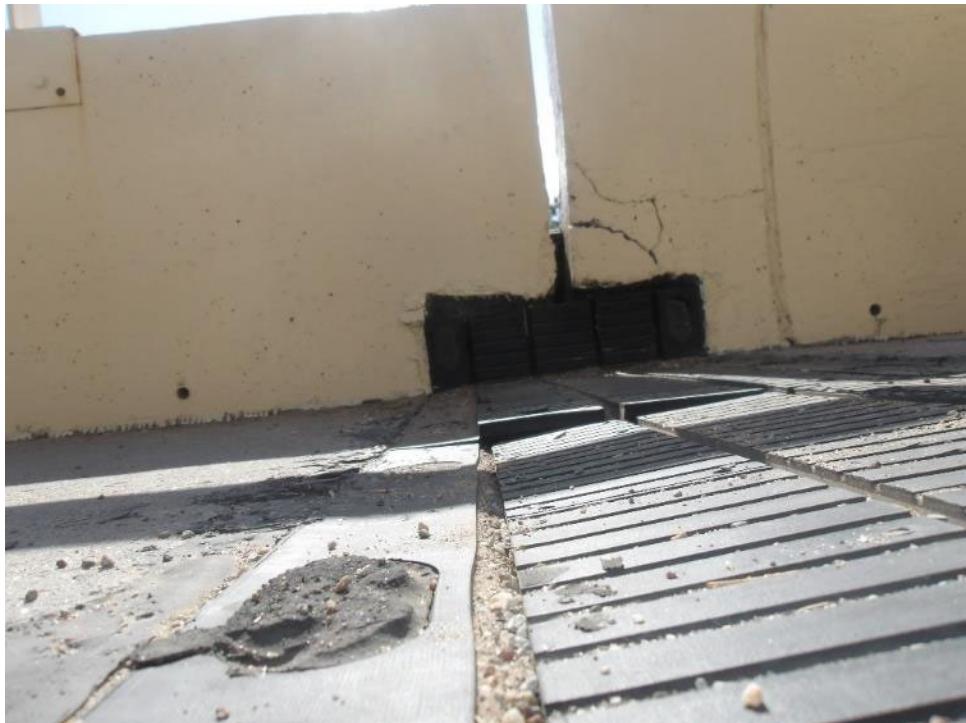
Photo 4— $\frac{3}{4}$ " vertical displacement in south expansion joint at pedestrian walkway.

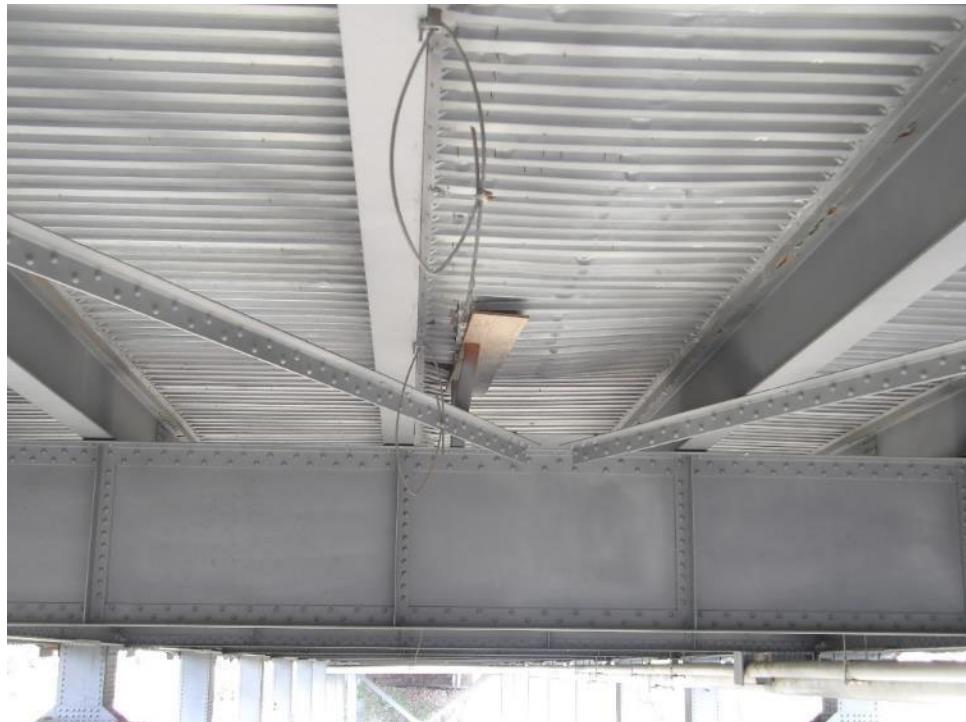
The stay-in-place forms do not show any signs of corrosion, indicating no water leakage is occurring through the deck (**Photo 7**). An area of formwork has a temporary support at FB14 (**Photo 6**). This was used during construction and is no issue for the deck.

Photo 6– Temporary support at failed stay in place forms at Floorbeam S14.

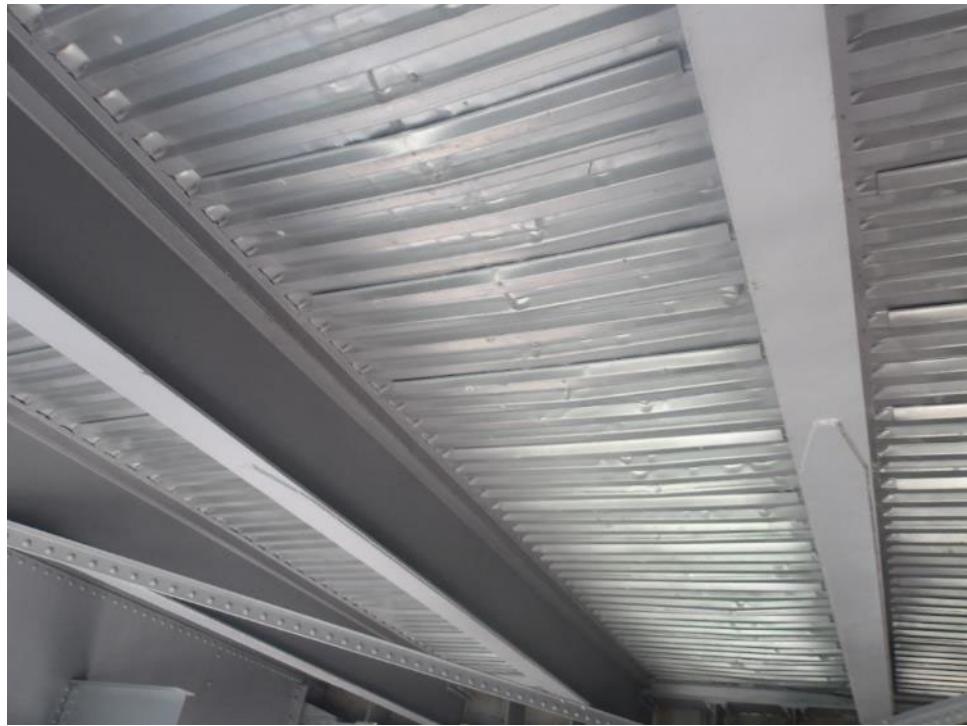
Photo 7- Minor damage throughout the stay-in-place forms at span 1.
Typical up to bay 4.

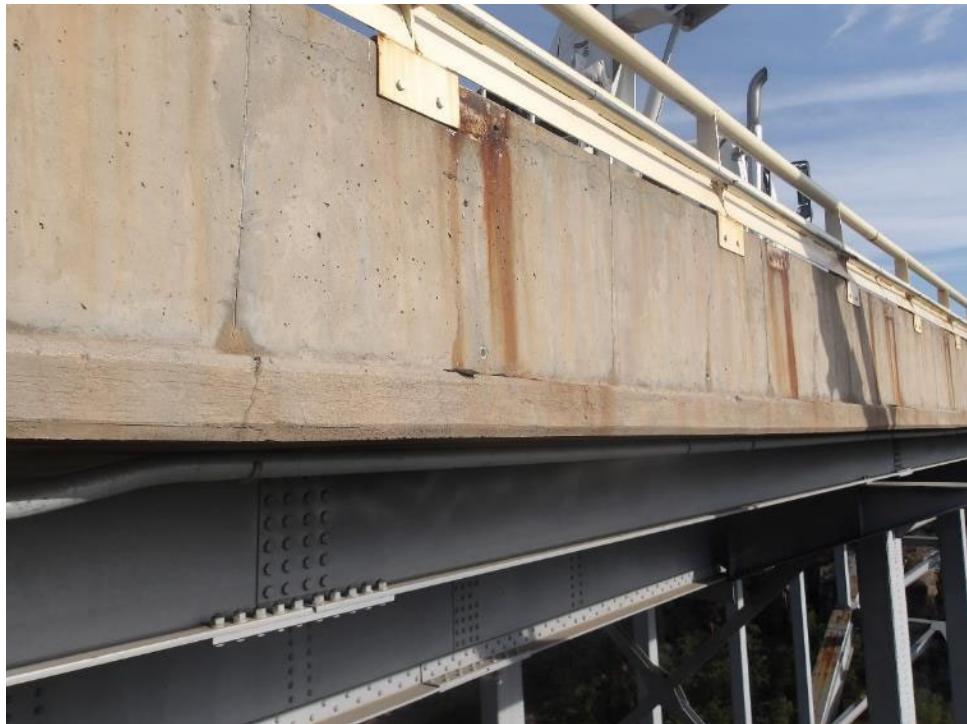
leaching, and several small spalls (**Photo 8**).

Photo 8– General photo of east facia. Note rust staining and cracking.

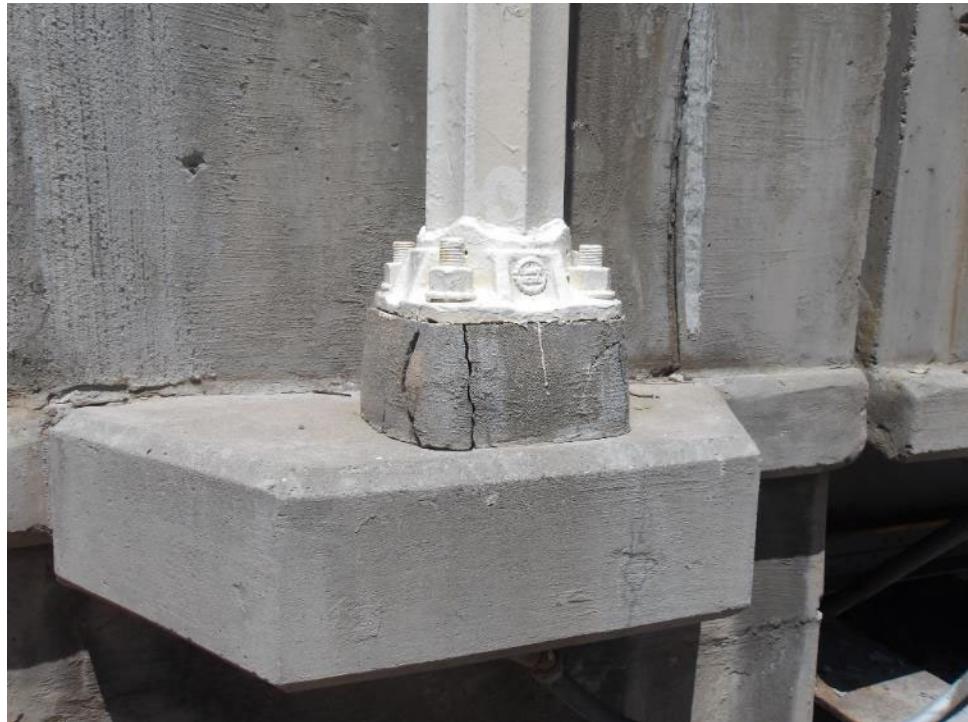
The light poles and supports previously had corrosion but were repainted in 2022 (**Photo 9**). The utility conduit clips under the western deck are heavily corroded due to the drainage at the west side of the bridge (**Photo 10**).

Photo 9- Repainted light pole and support with cracking at light pole foundation.

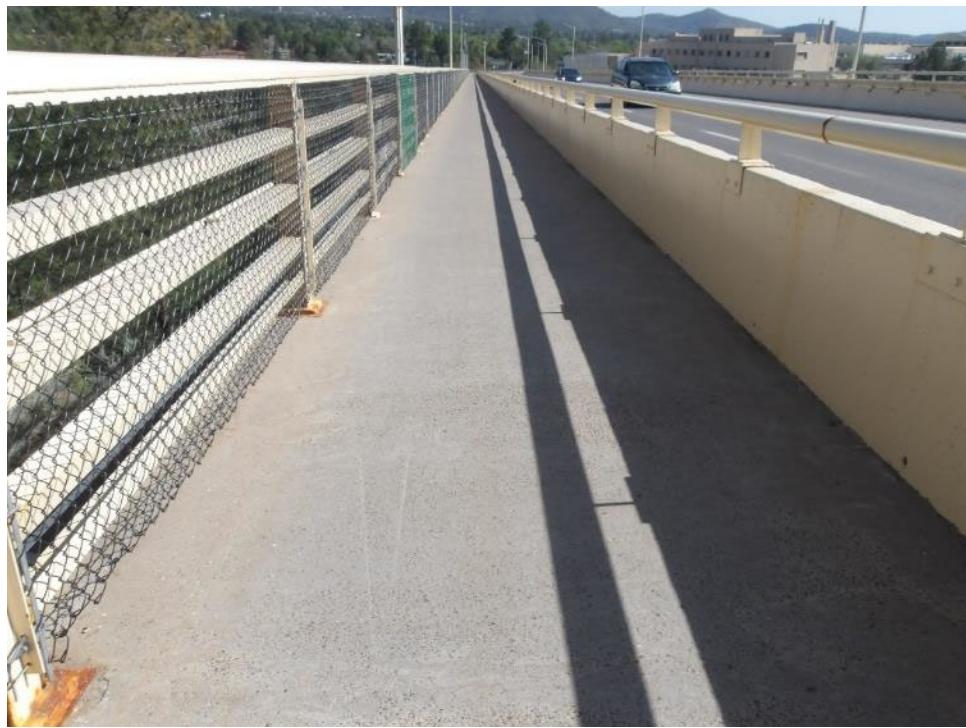
Photo 11 – General view of pedestrian walkway and guardrail, looking north.

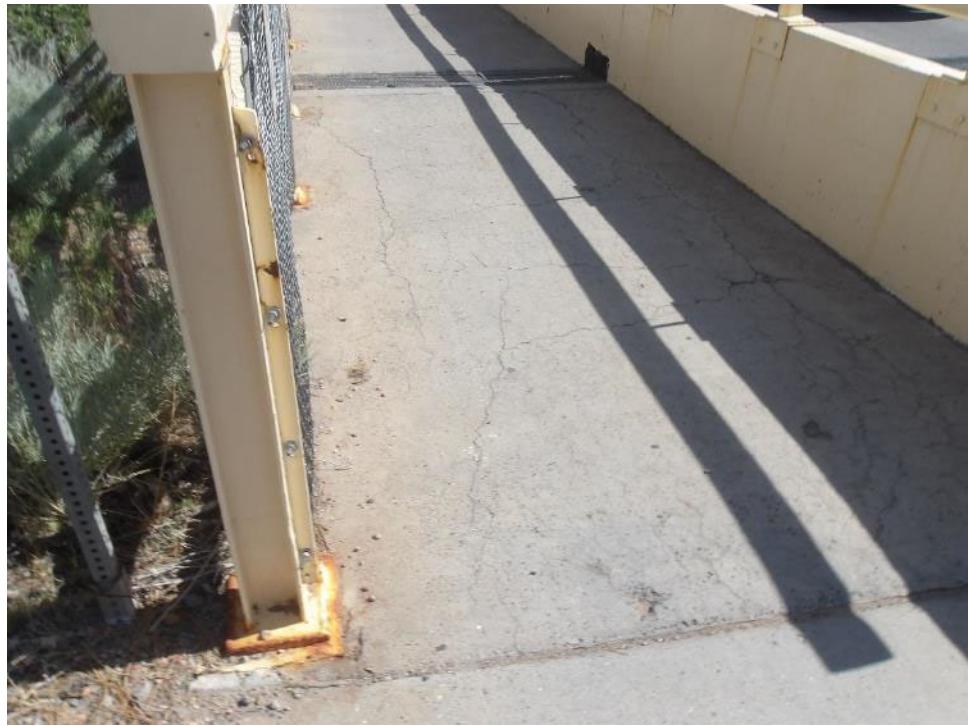
Photo 13- Map cracking at the north end of the pedestrian walkway (TYP).

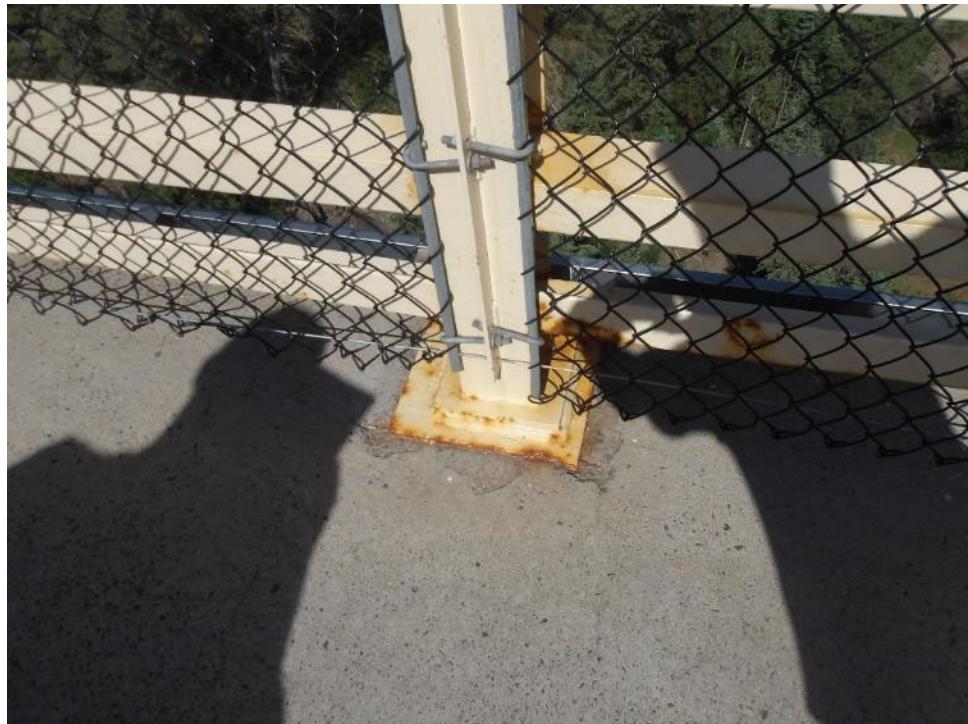
Photo 14- Corroded base plate with small spalls on surrounding walkway.

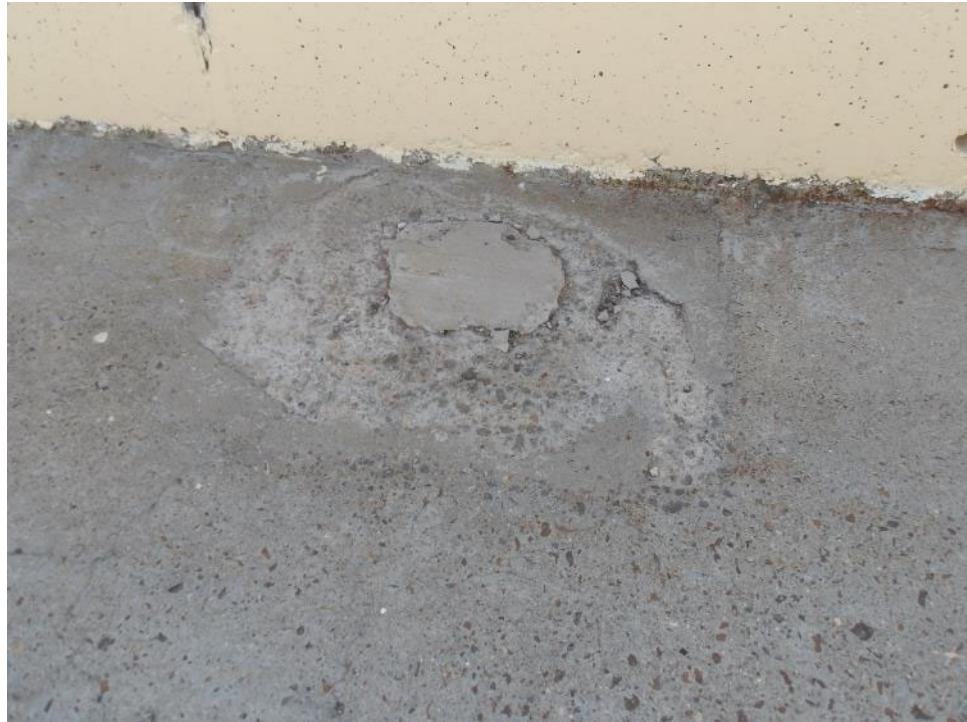
Photo 16- (14"x10"x1/2") spall at failed concrete repair towards north end of the pedestrian walkway.

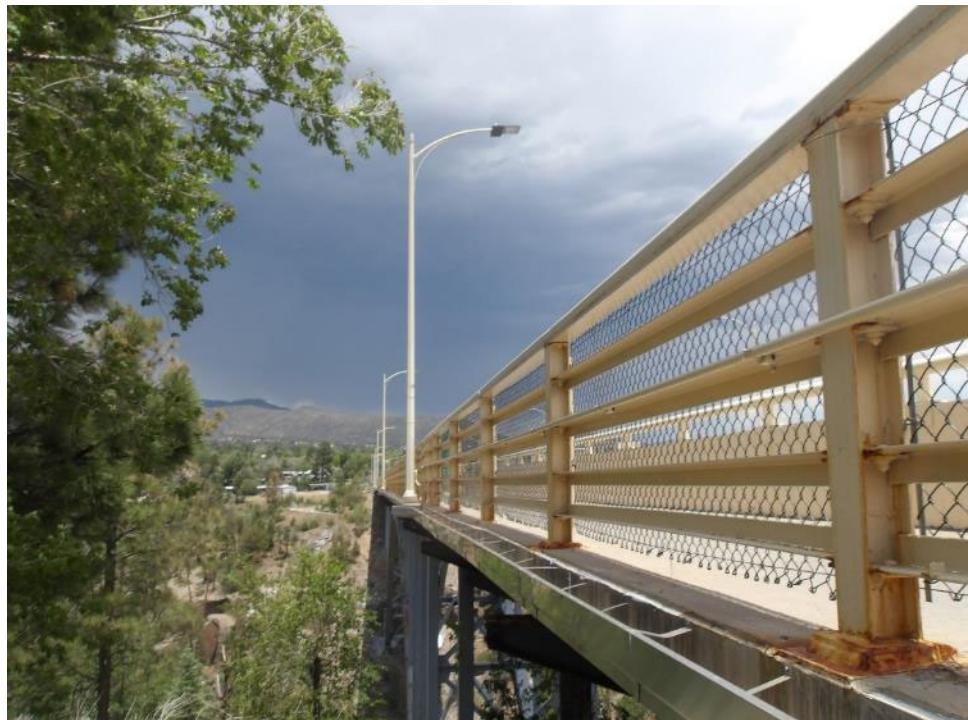
Photo 18- Drainage system (gutter) on west side of deck.

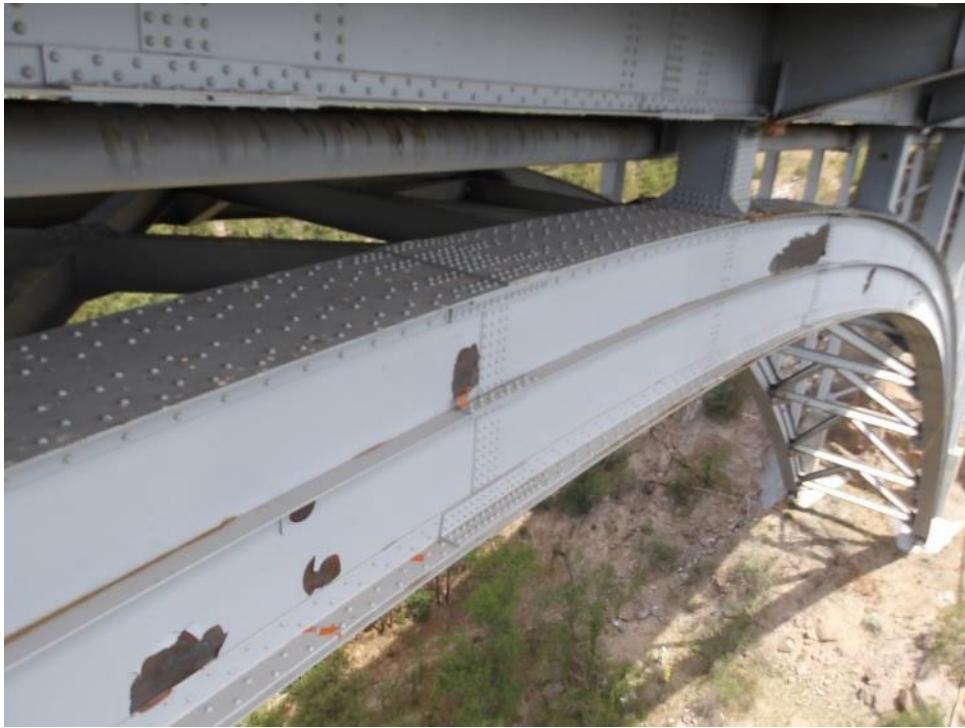
Photo 19- East arch rib at column 7, peeling paint and minor surface corrosion with no measurable section loss.

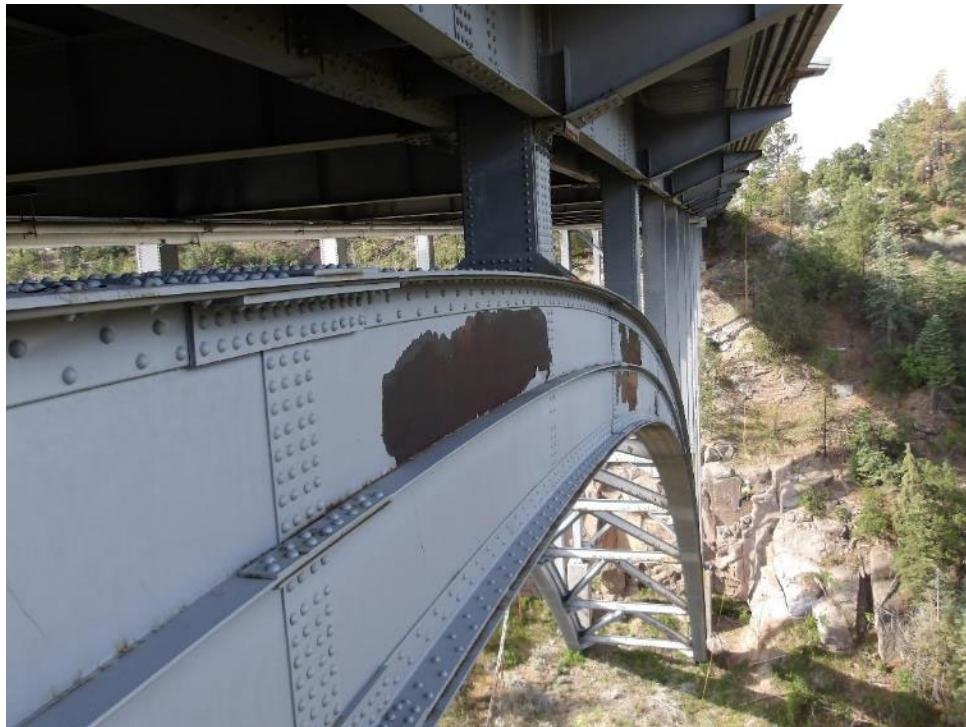
Photo 20- West arch rib at column 7, peeling paint and minor surface corrosion with no measurable section loss.

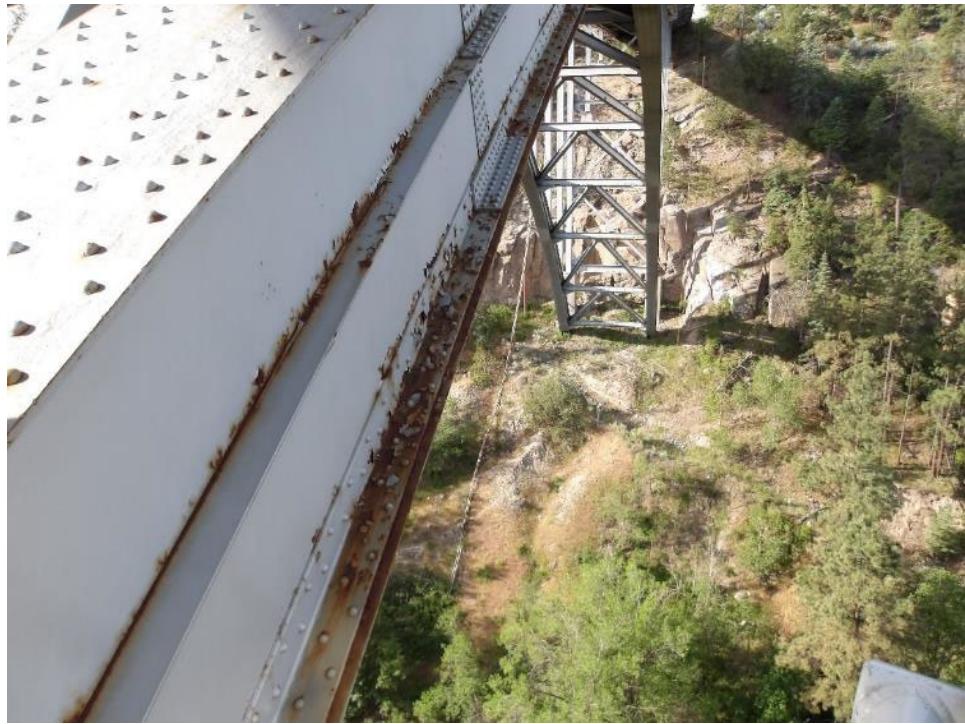
Photo 23- Minor corrosion on top of bottom flange of west arch rib at column 11.

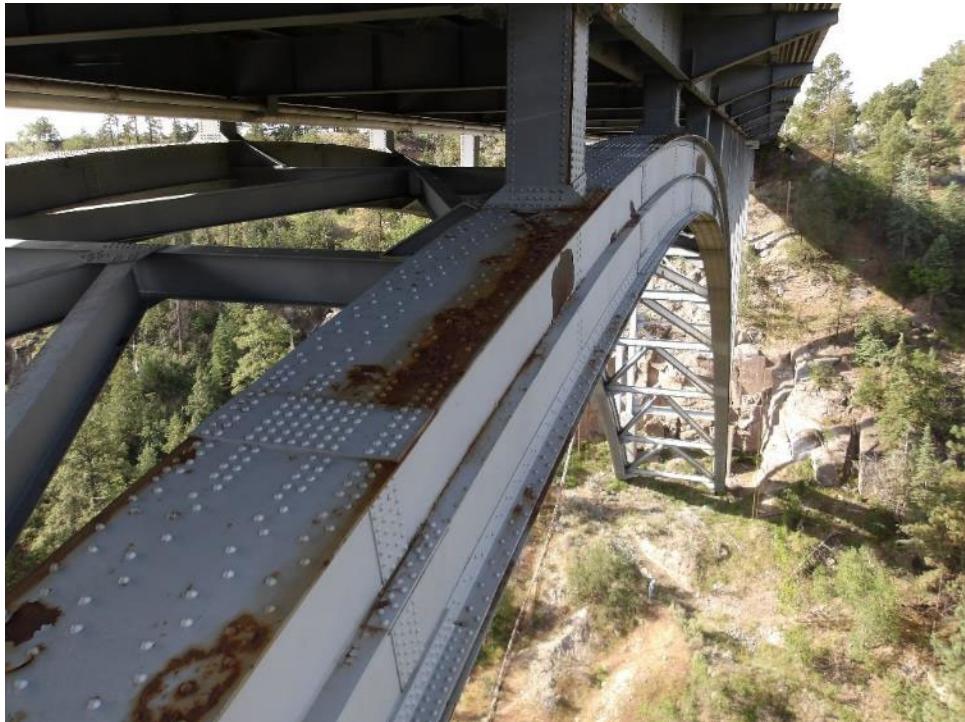
Photo 24- Minor corrosion on top plate of west arch between columns 10 and 9.

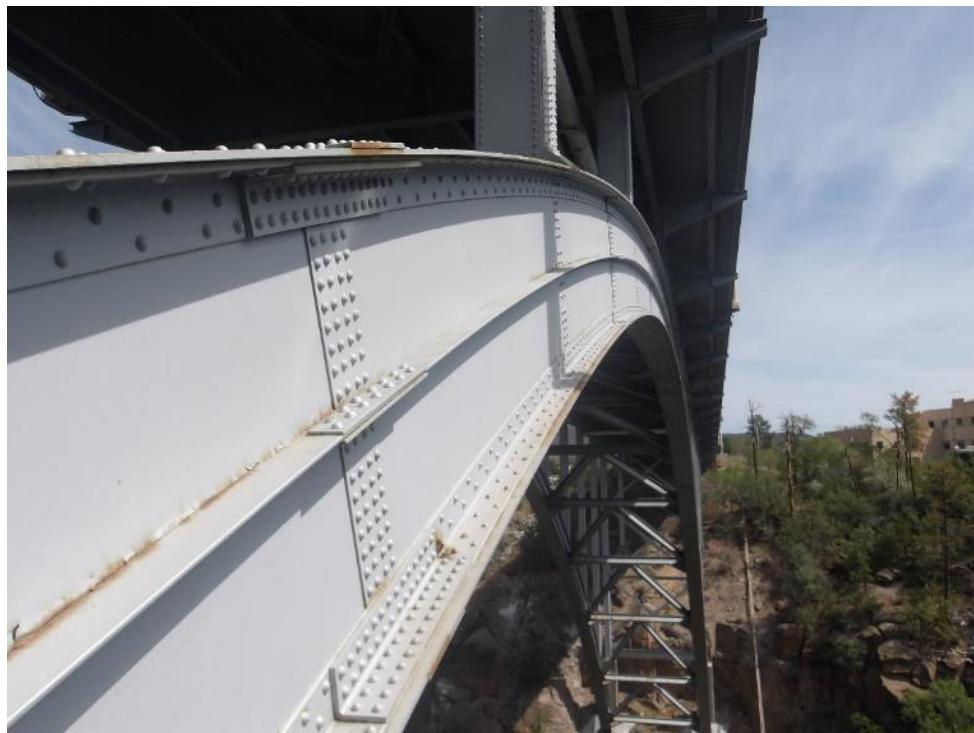
Photo 25- Minor corrosion on east arch at column 5.

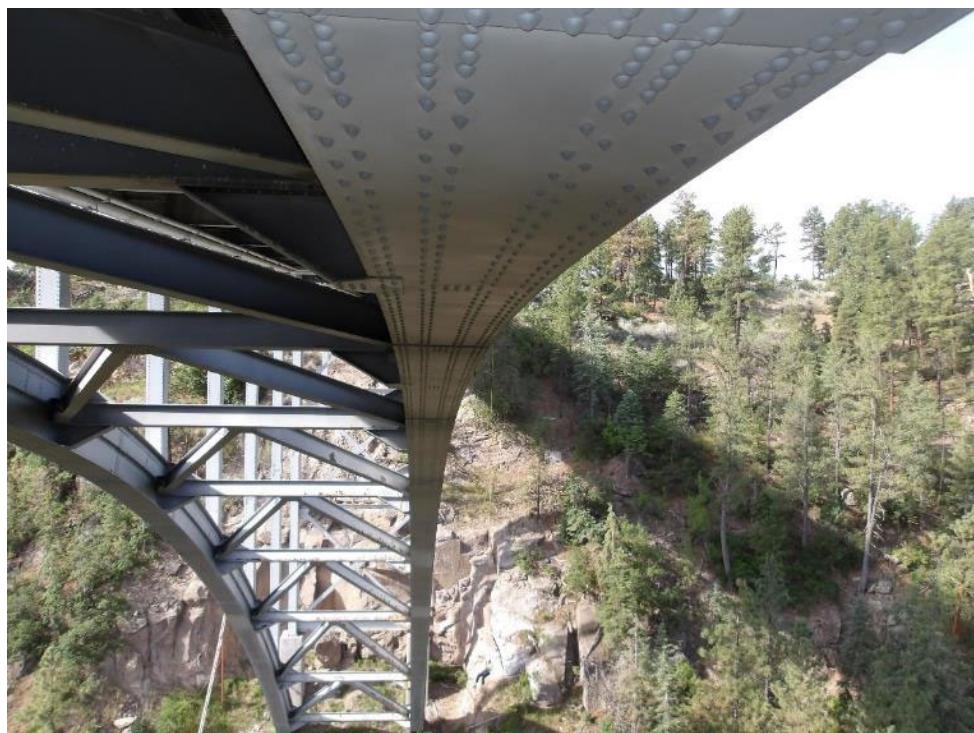
Photo 26- Bottom of steel arch in good condition, at west arch center span looking south.

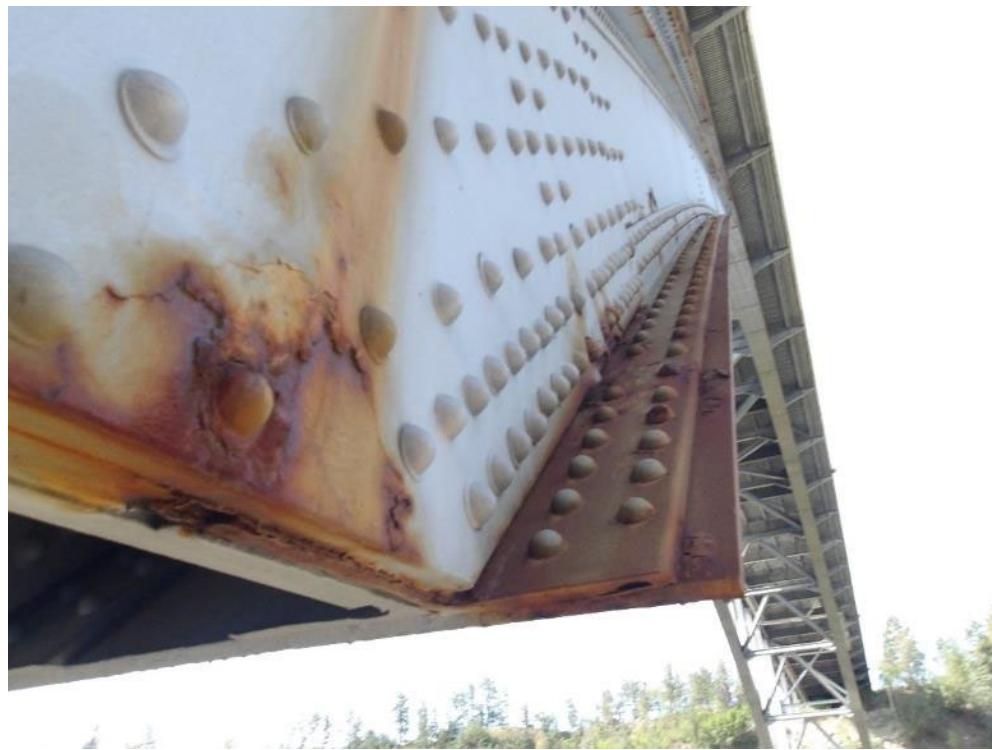
Photo 27- Minor corrosion at north end of west arch at the bearing.

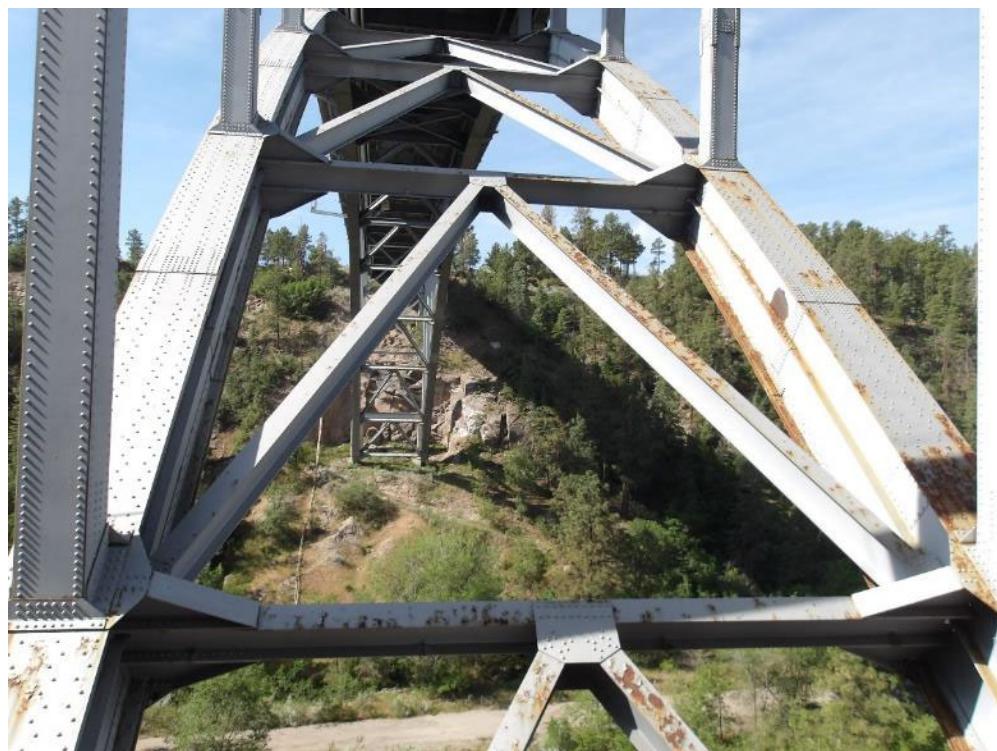
Photo 28- General condition of bracing with minor corrosion and paint peeling at north end, looking south from skewback column.

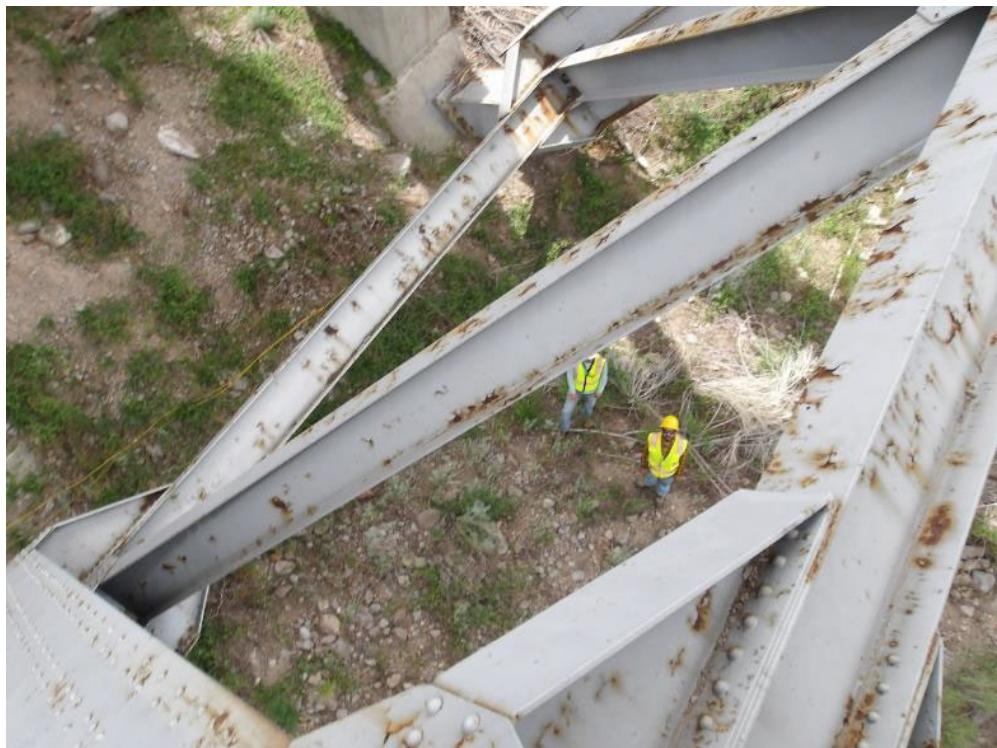
Photo 29- General condition of bracing with minor corrosion and paint peeling at south end, looking west from arch column 1.

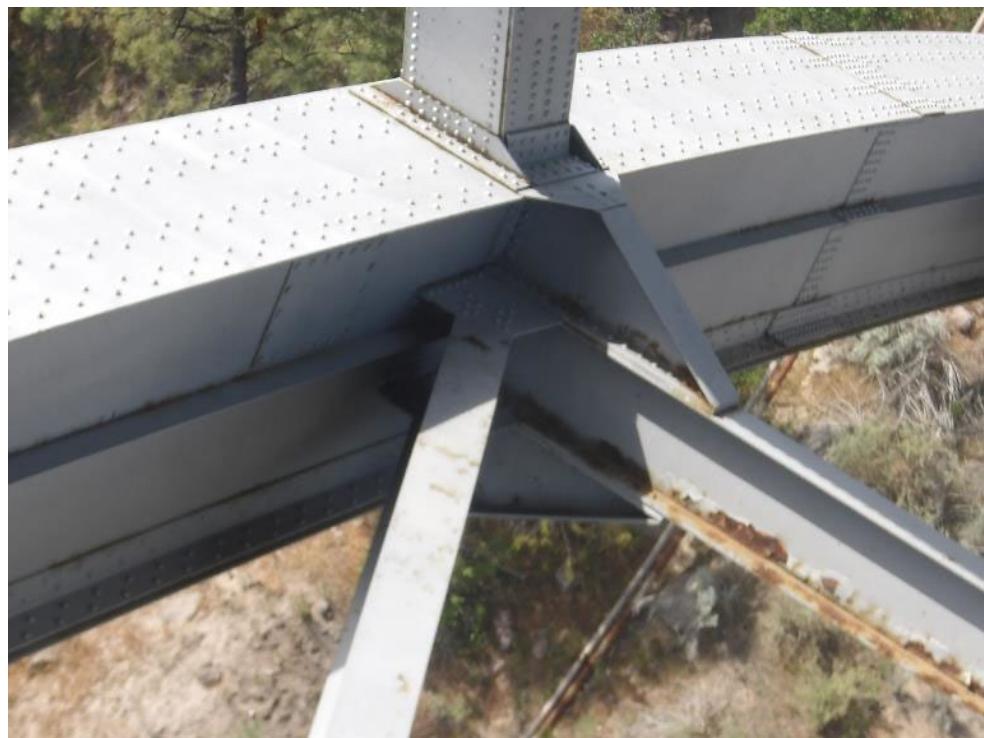
Photo 30- Bracing connection at arch column 4 on E arch, paint failure and minor corrosion, typical.

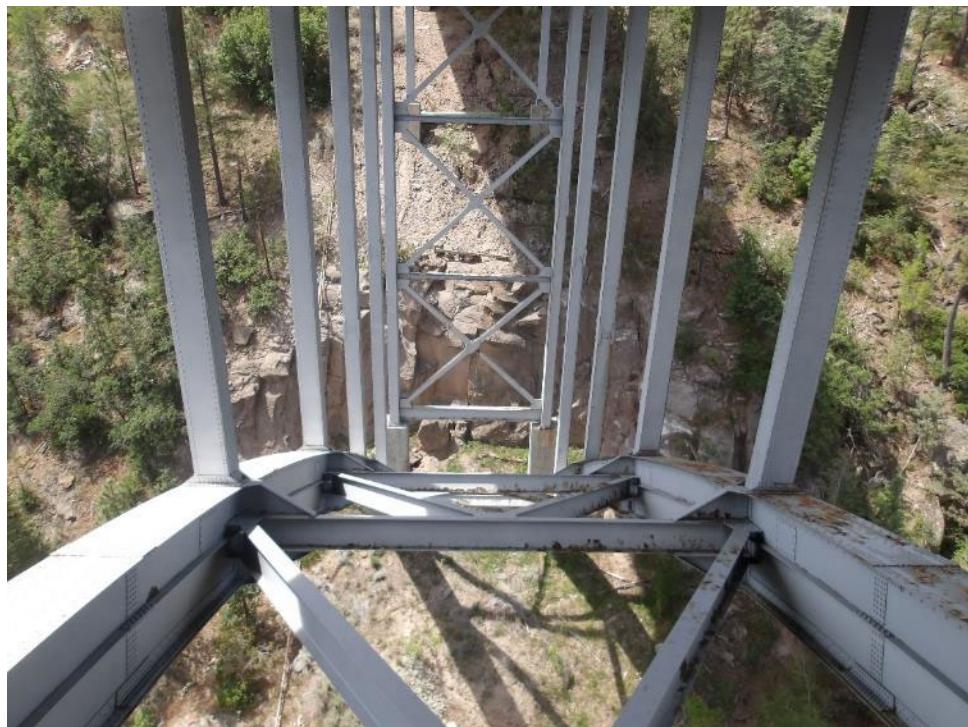
Photo 31- General view of bracing looking south from arch column 5.

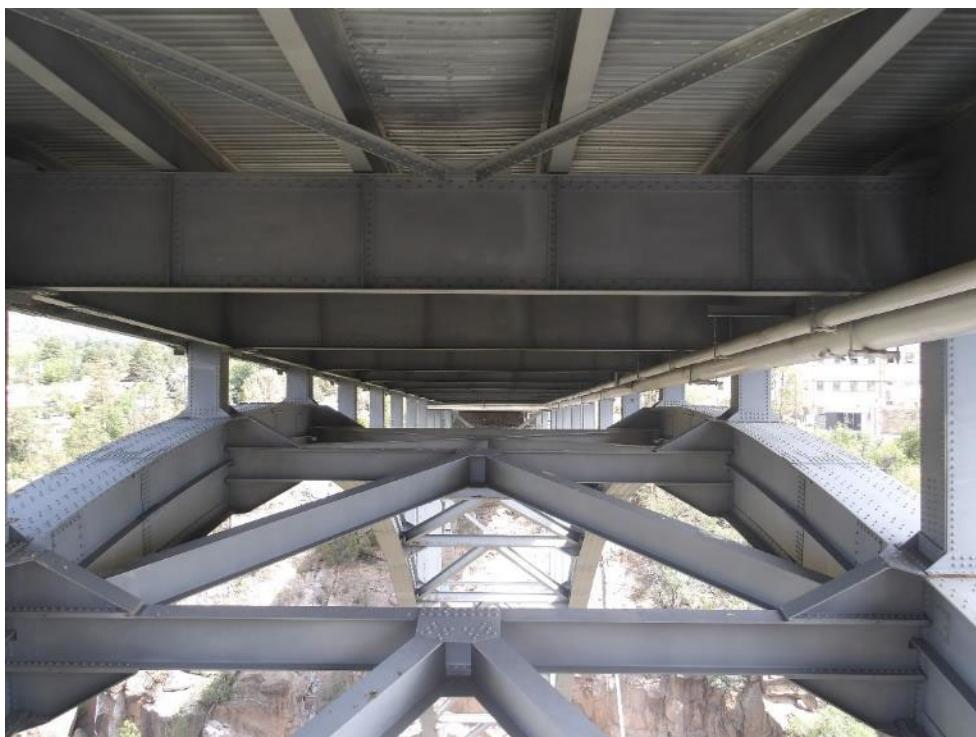
Photo 32- General view of bracing at center of arch in good condition.

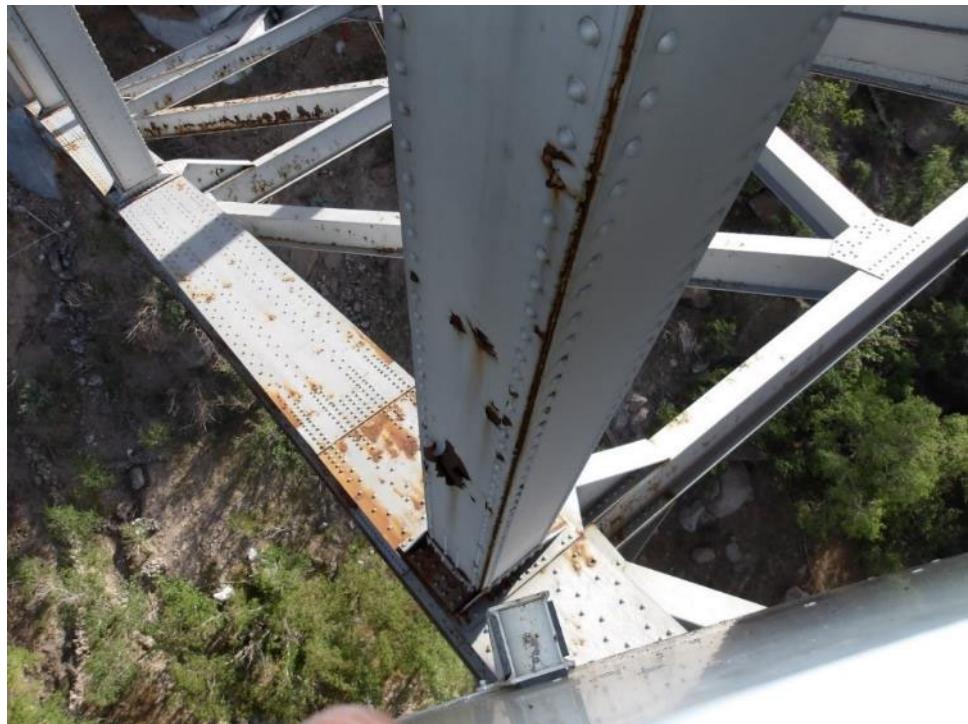
Photo 33- Surface corrosion and paint failure at arch column 11, west.

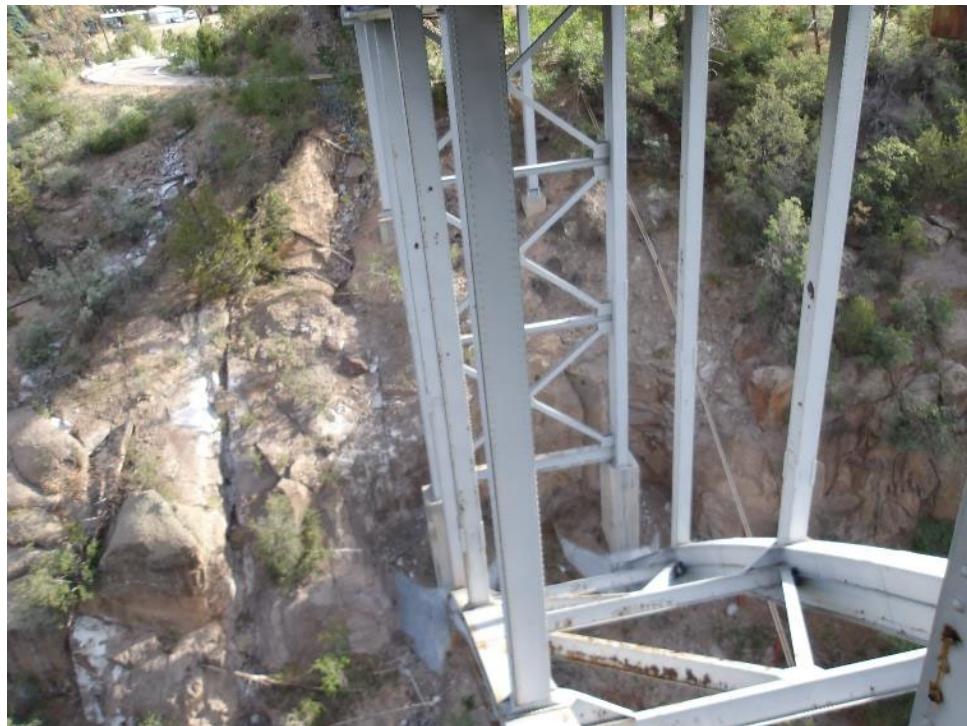
Photo 34- General view of arch columns, looking north from arch column 11W.

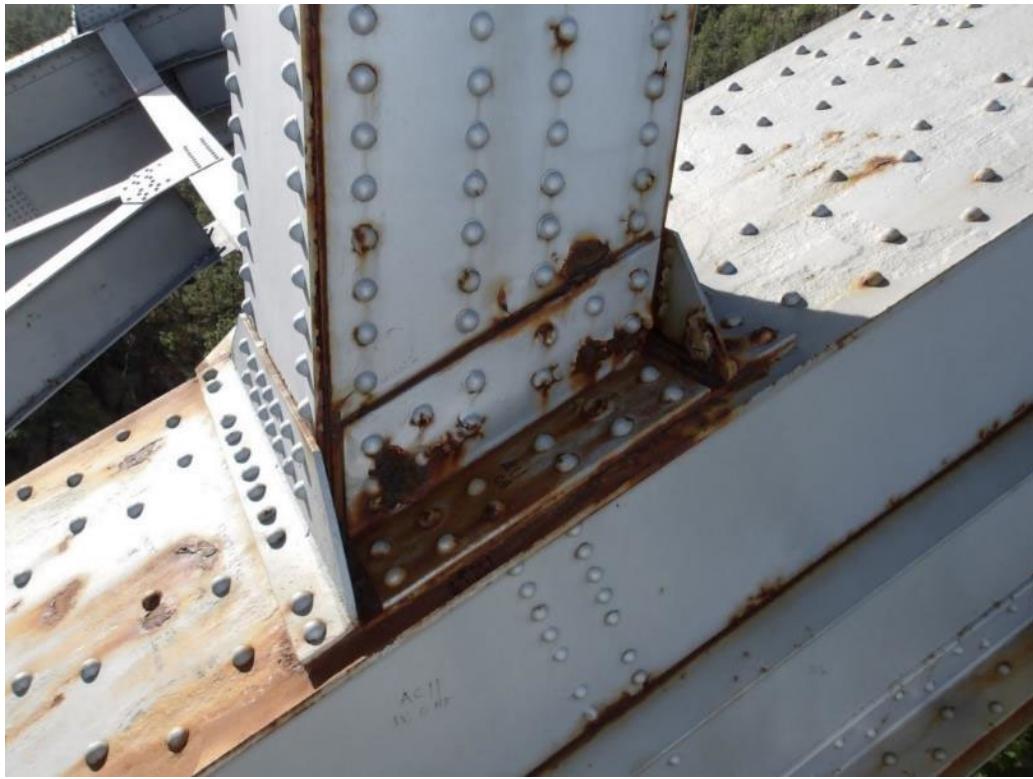
Photo 37- Heavy corrosion and minor thickness loss (1/32") at the steel angle connection of arch column 11W.

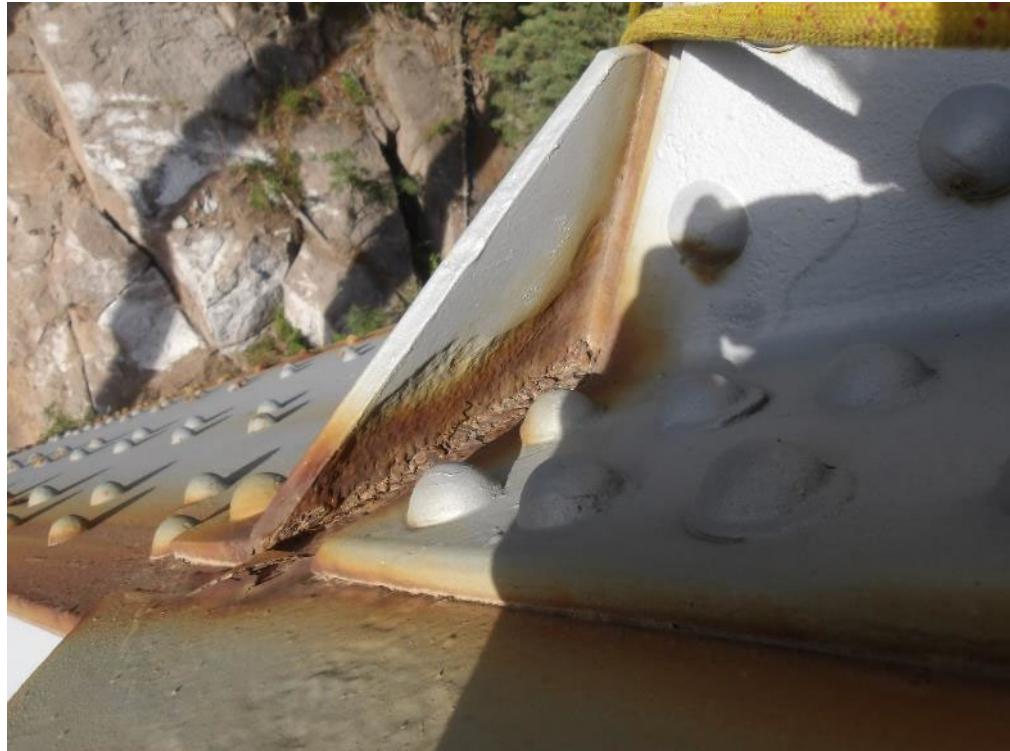
Photo 38- 1/16" thickness loss to vertical gusset plate at arch column 2W.

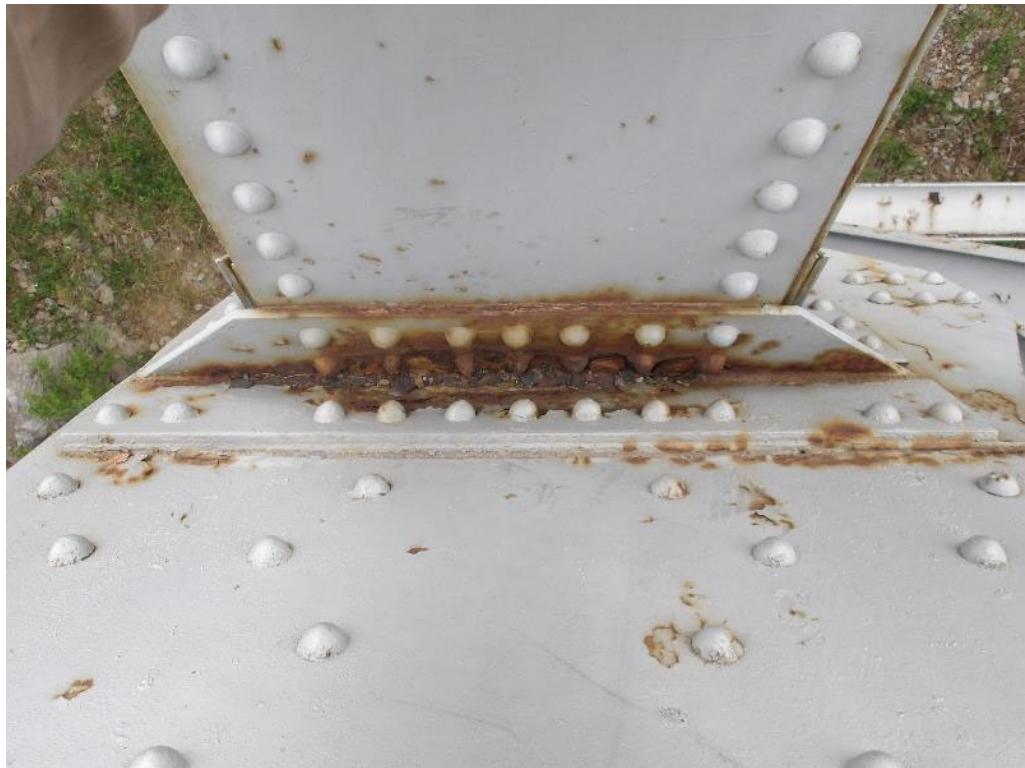
Photo 39- Moderate corrosion and section loss to rivet heads on N side of arch column 1E.

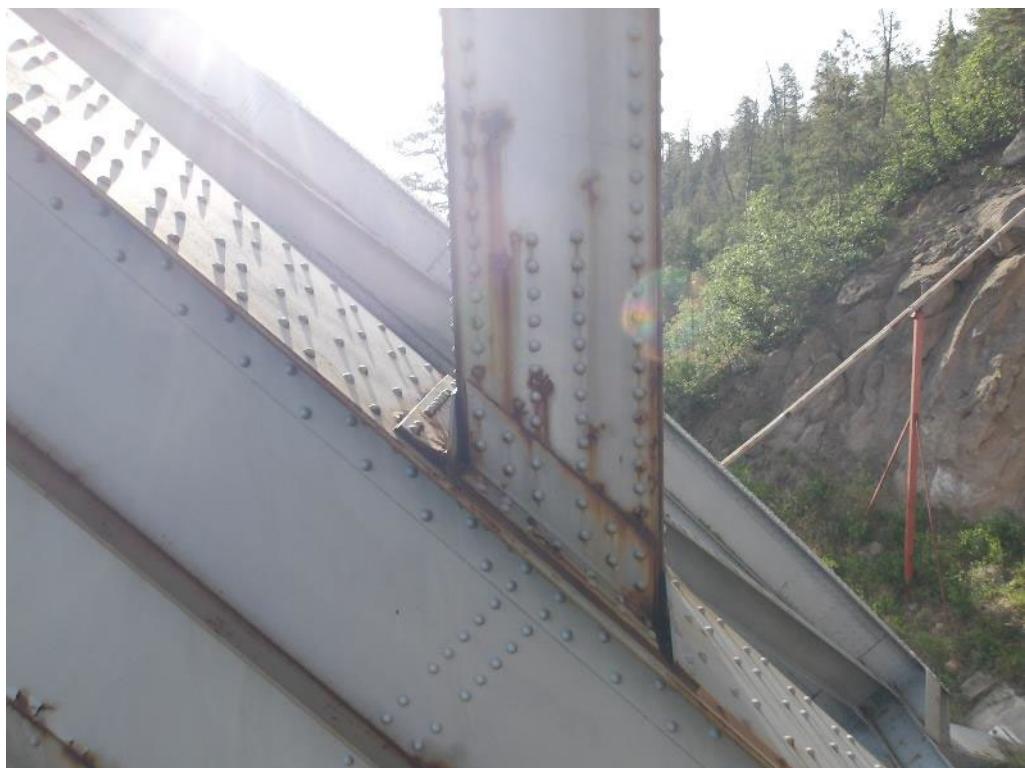
Photo 40- Moderate corrosion on W side of arch column 1W.
